Harper Hills Landslides, Canterbury

Following the Mw=7.1 Darfield earthquake on 4th September 2010, a local farmer (Mrs Christine Denisse of Steeles Road) identified several cracks on the hillside above her property.

On 17th September 2010 David Petley, Nick Rosser (both of Durham University, UK) and Chris Massey (GNS Science) carried out a walkover of the Harper Hills area to make a preliminary assessment of the likely origin of the cracks.

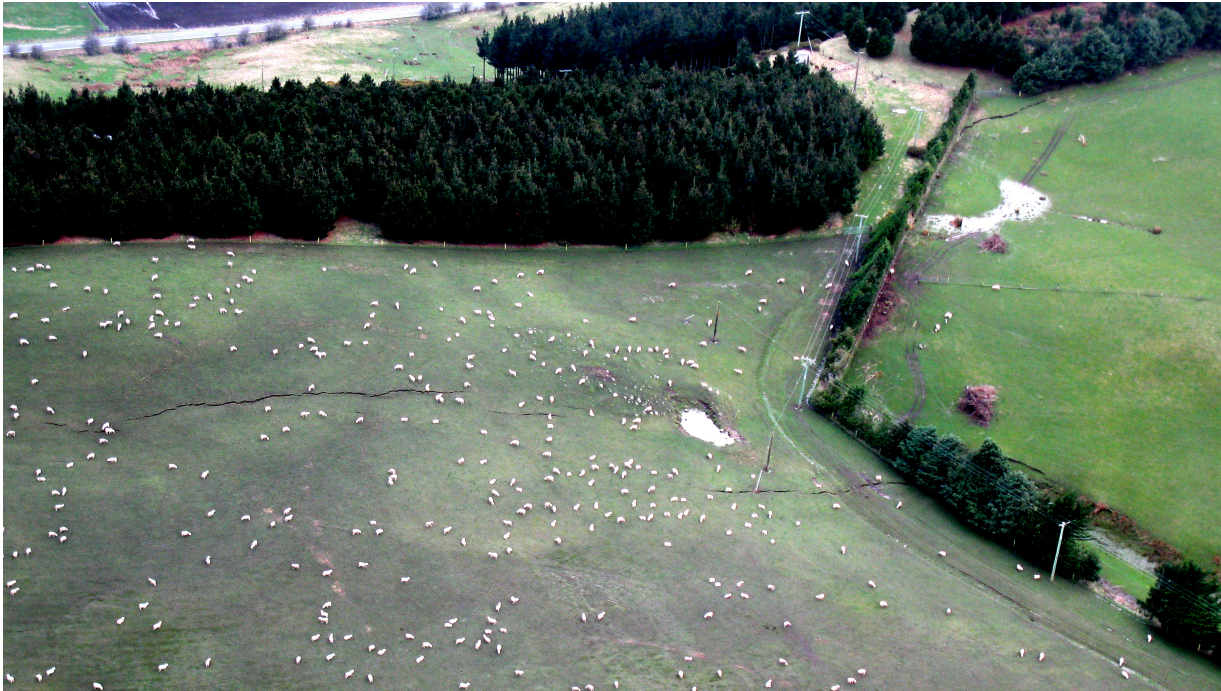
Figure 3. Aerial oblique view of cracks (taken by Mark Quigley, Canterbury University)

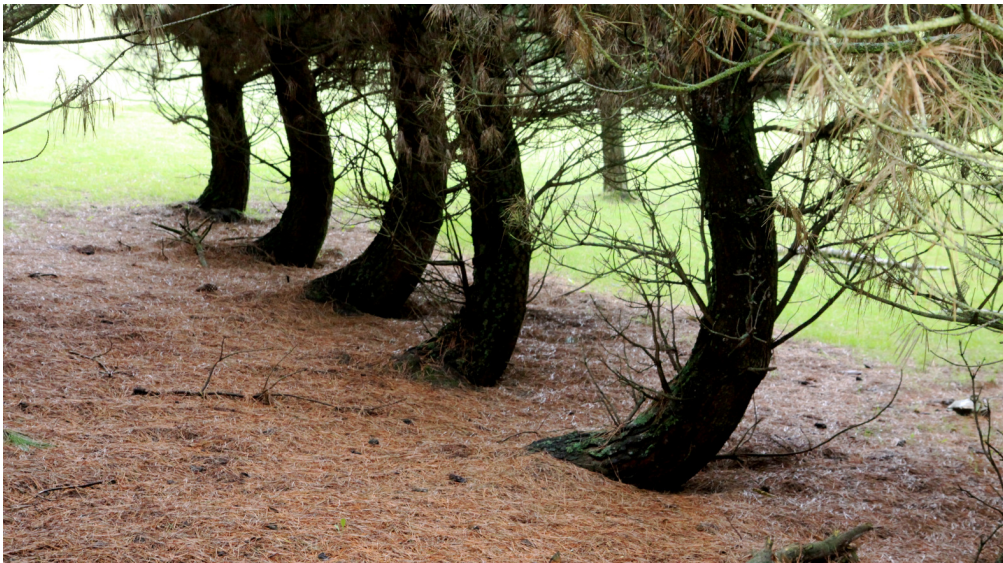
Figure 4. Consistently deformed trees on the dip slope.

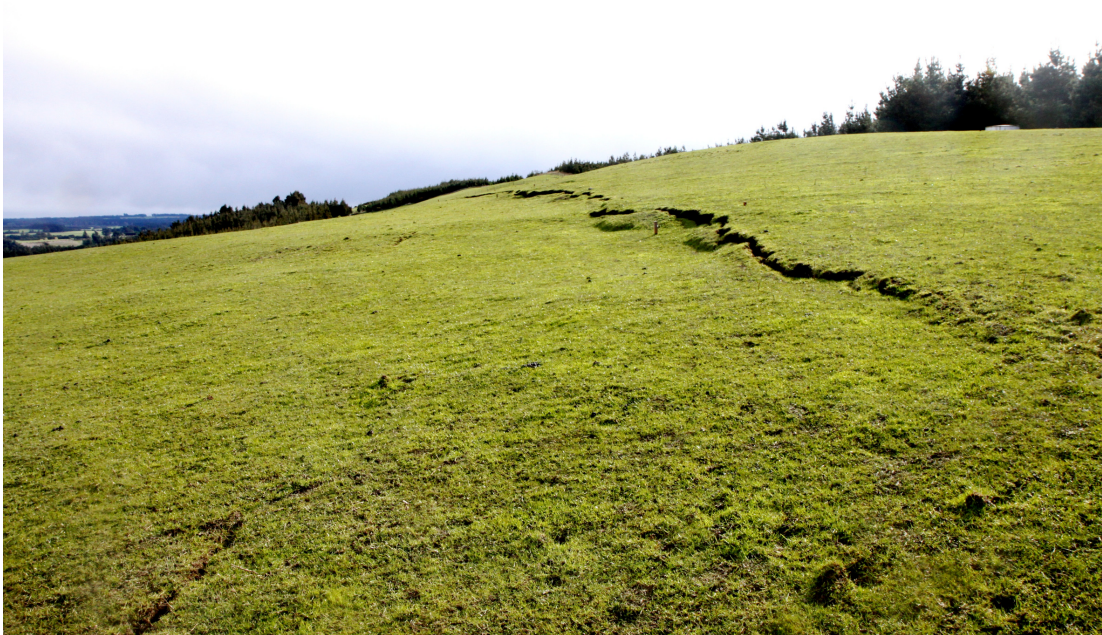
- A prominent linear concave break-in-slope appears to mark the toe of the dip slope about 1 km southeast from the ridge crest.
- Several new prominent and persistent (several hundreds of meters in length) cracks were apparent in the pastureland at the top of Steeles Road, above and to the western side of the road. These cracks, which were noticed after the earthquake, are reasonably linear and stepped (Figures 3 and 5), and were located about 100 m below the ridge top on the southeast facing dip-slope. The cracks through the pastureland extended for about 100 metres. The cracks appeared not to be affected by minor changes in the topography, for example cutting across a pond.

- The cracks showed varying magnitudes of offset, but typically comprised about 0.2 m of each of vertical and horizontal displacement (opening). There was no indication of lateral horizontal displacement. Vertical displacement was consistent with a lowering of the ground surface down slope towards the southeast, indicating down-dip extensional gravitational movement.

Figure 5. Photograph showing the tension cracks towards the west of Steeles Road

1. Ongoing monitoring of the tension cracks following periods of heavy rain (typically >50 mm of rain over consecutively wet days), and after large aftershocks.
2. Monitoring should comprise the already installed “knock-out” pegs located either side of the tensions cracks west of Steeles Road, plus additional pegs located either side of the tension cracks towards the east of Steeles Road. However, these pegs should have nails installed on them to improve measurement quality. Ideally the local landowner should be responsible for monitoring the pegs
3. More detailed mapping should be undertaken of all of the slope cracks in this area, including those identified during previous helicopter flights
4. Attention should be made to the area east of Steeles Road as the cracks are upslope of a residential property.

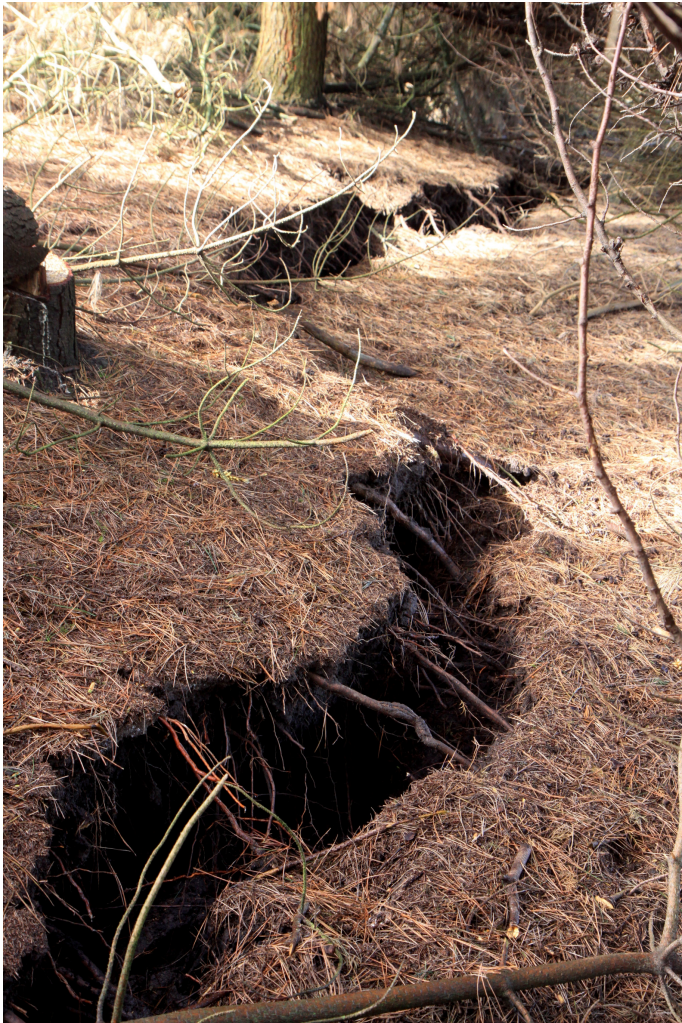
- A second set of cracks extended from above the top of Steeles road towards the east traversing the edge of a pine plantation.
- These cracks were below the ridge top on the southeast facing slopes and were located upslope of a subtle concave depression.

- Although these cracks were linear in parts they appeared to be more arcuate in form than those towards the west of Steeles Road. These cracks also displayed larger vertical and horizontal displacements, typically 0.5 m vertical and about 0.5 to 1 m horizontal. In some locations these cracks were up to 4 m deep.

- Vertical displacements across these cracks were consistent with a lowering of the ground surface towards southeast, indicating down-dip extension.
- Additional cracks had also been identified part way up Steeles Road by University of Canterbury scientists. However, at the time of this walkover, surface evidence of these cracks had been removed by the farmer. At the time of this walkover a team of Scientists from Canterbury University were carrying out geophysical measurements at this location.

Figure 6. Photograph showing the tension cracks towards the east of Steeles Road
