# Rockfalls and landslides triggered by the February 2011 Christchurch (NZ) earthquake: the GeoNet response

The magnitude 6.3 Christchurch earthquake on 22 February 2011 triggered land movement, the collapse of cliffs, and many rockfalls in the Port Hills area beside Christchurch. The Port Hills are the flanks of an eroded extinct basalt volcano. Coastal erosion and the quarrying of rock have produced steep cliffs at the base of the hills. At least five people were killed by falling rocks—three in the Sumner-Redcliffs area and two walking on Port Hills foot tracks. Several hundred homes were evacuated because they were close to the foot or top of dangerous cliffs or on cracked and unstable steep slopes.

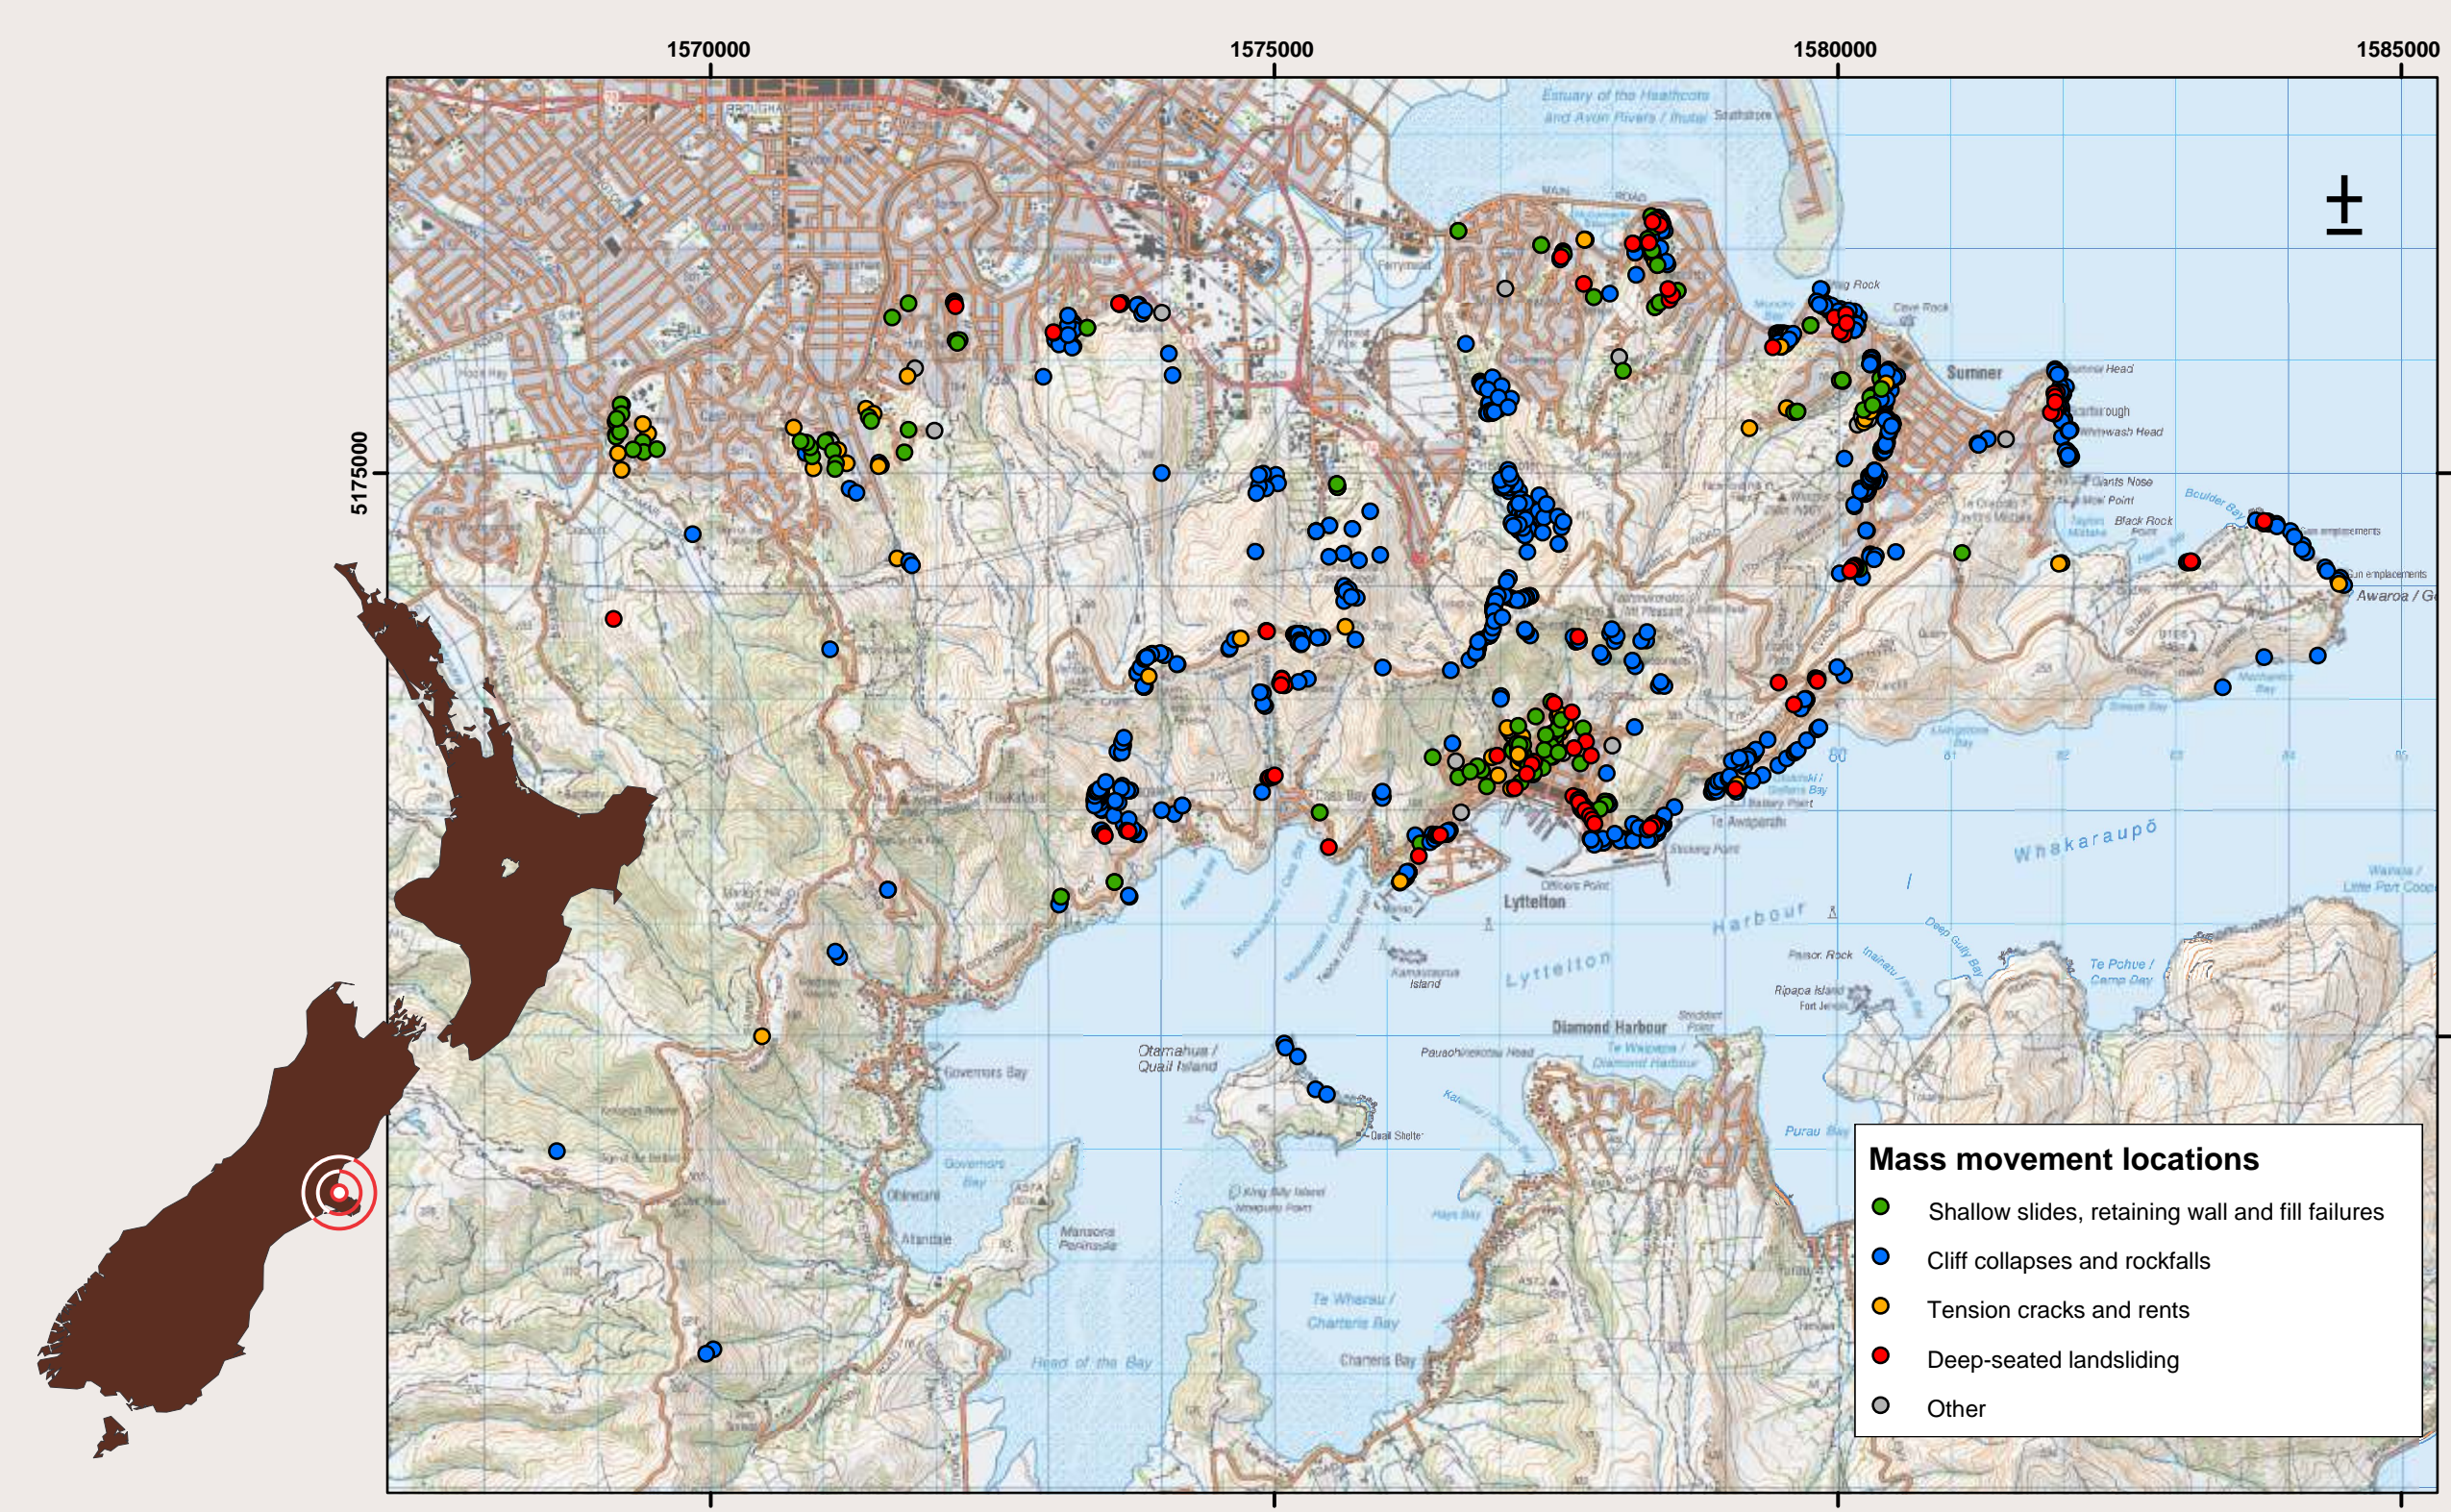
Map showing the distribution of the different types of mass movements (data from field information from the inspection teams and aerial photographs taken after the earthquake by New Zealand Aerial Mapping).

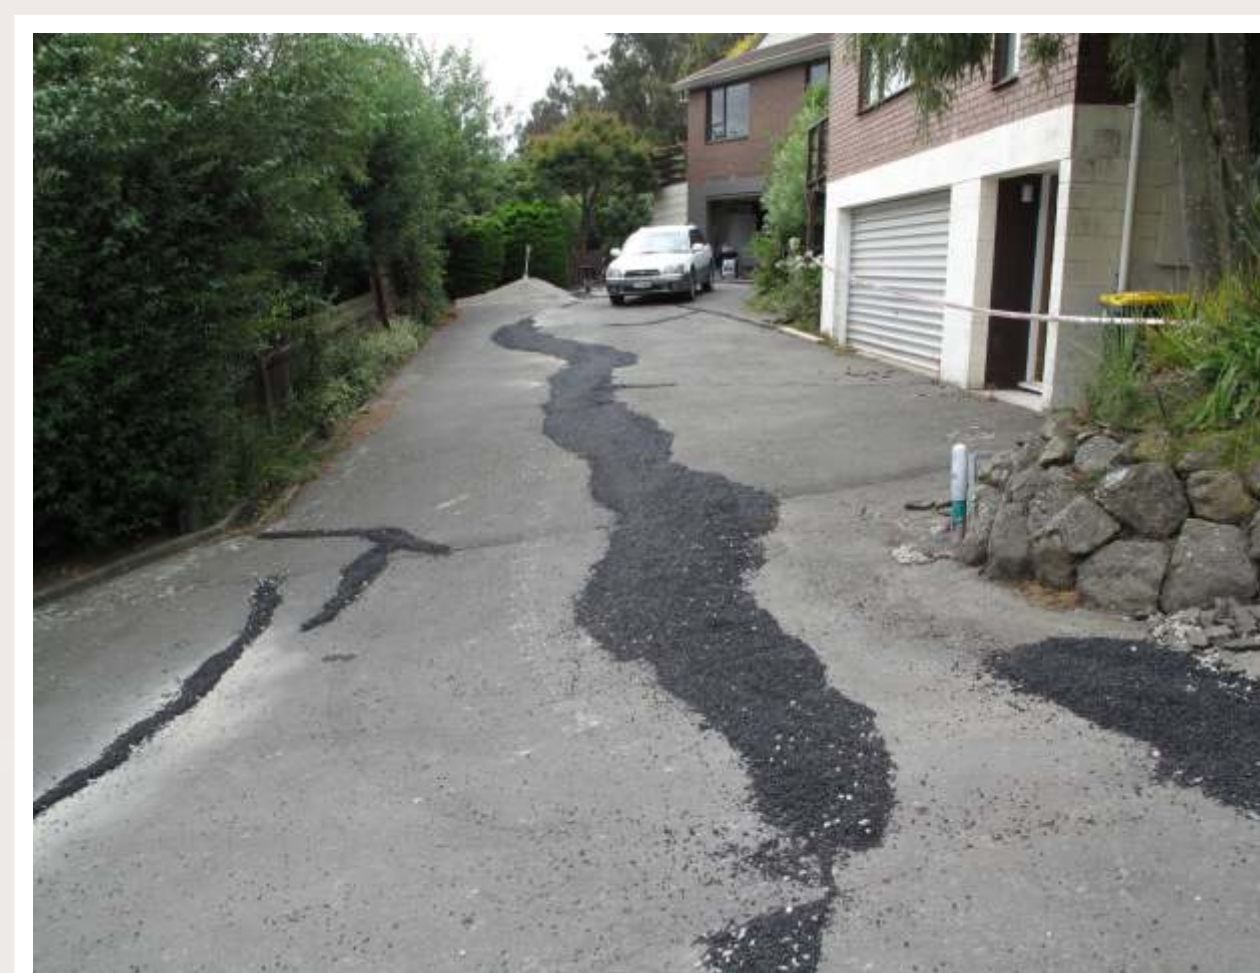
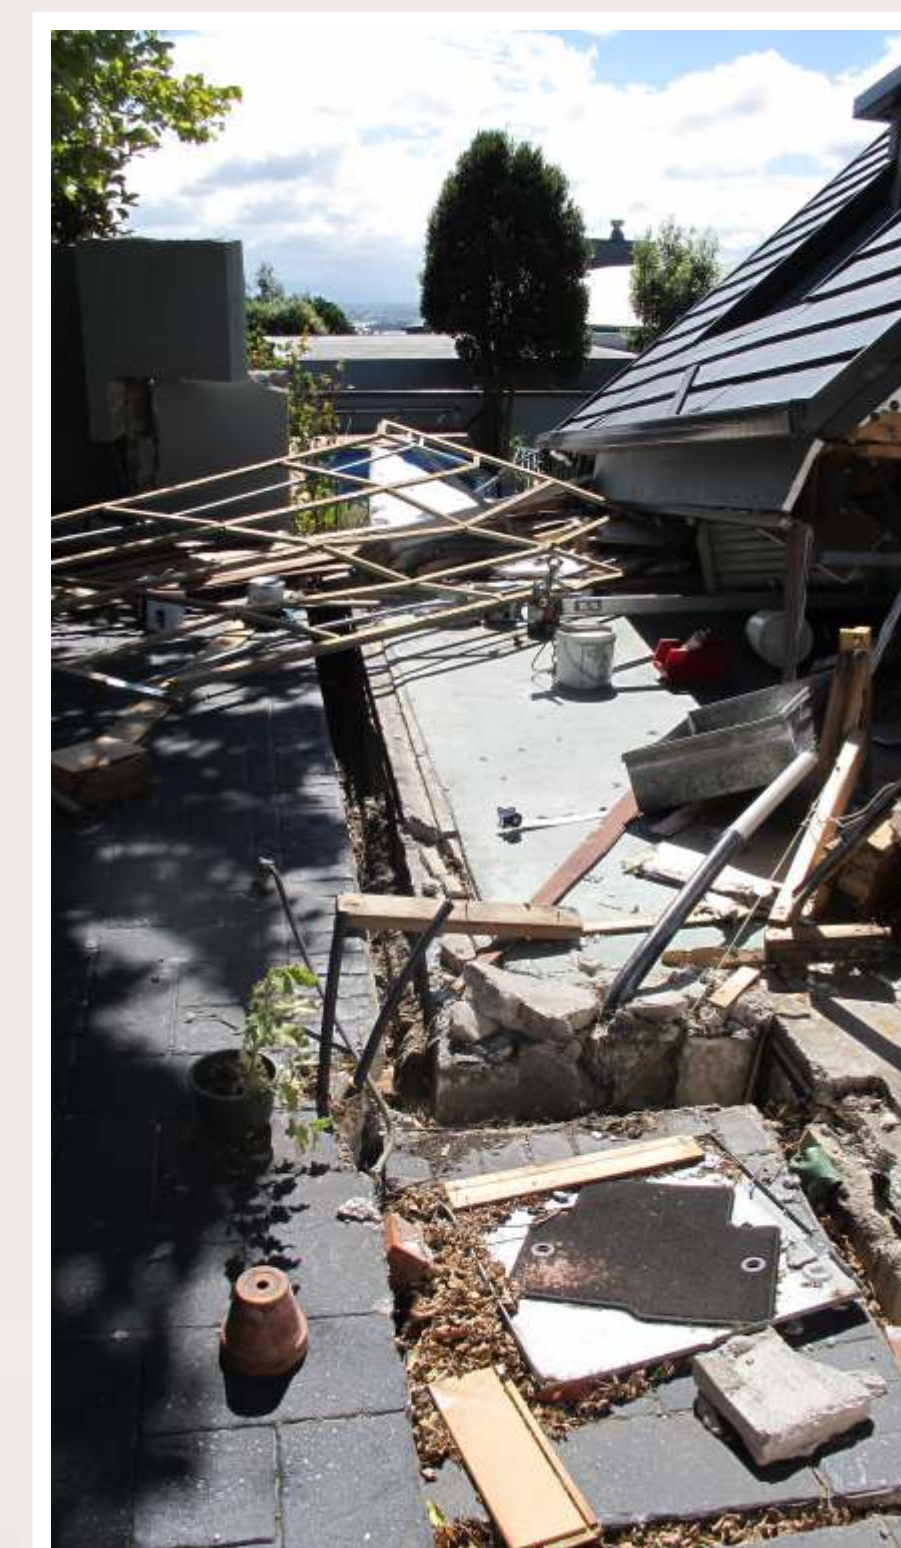
## Cracks and rents

Many slopes show deep tension cracks and rents that may indicate sections of slope with potential for further collapse. Most cracks are along the top edges of cliffs and along sharp breaks in slope.

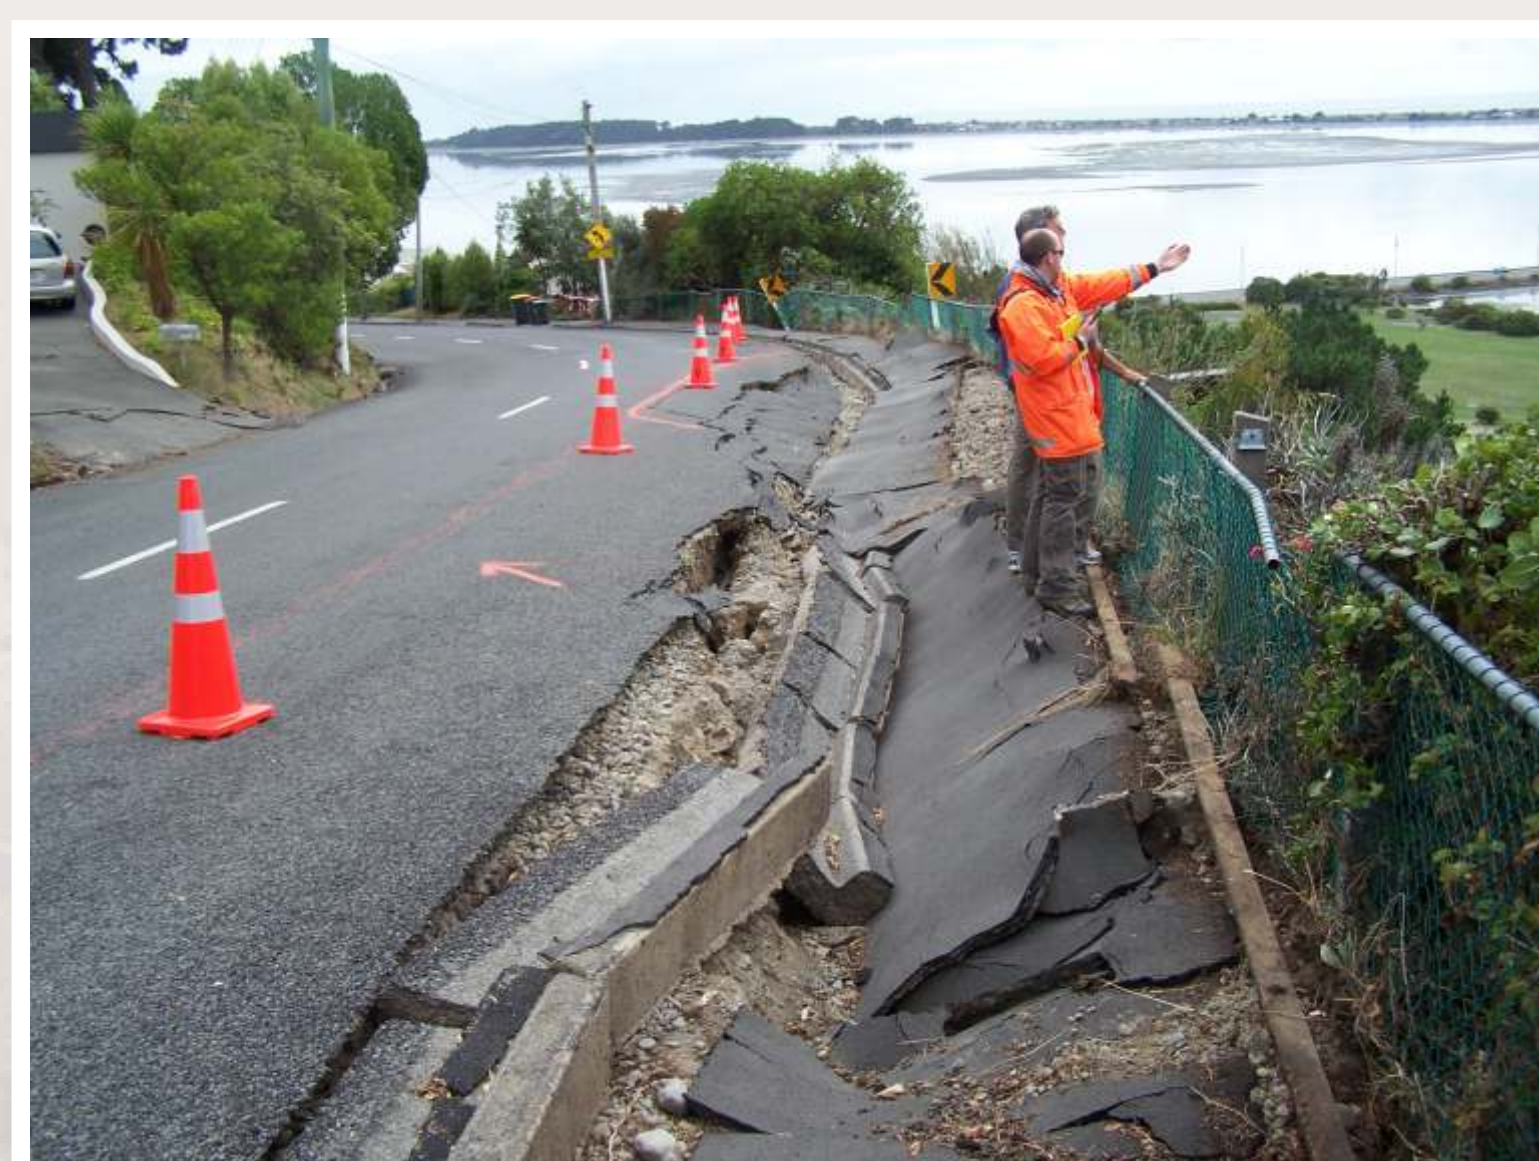
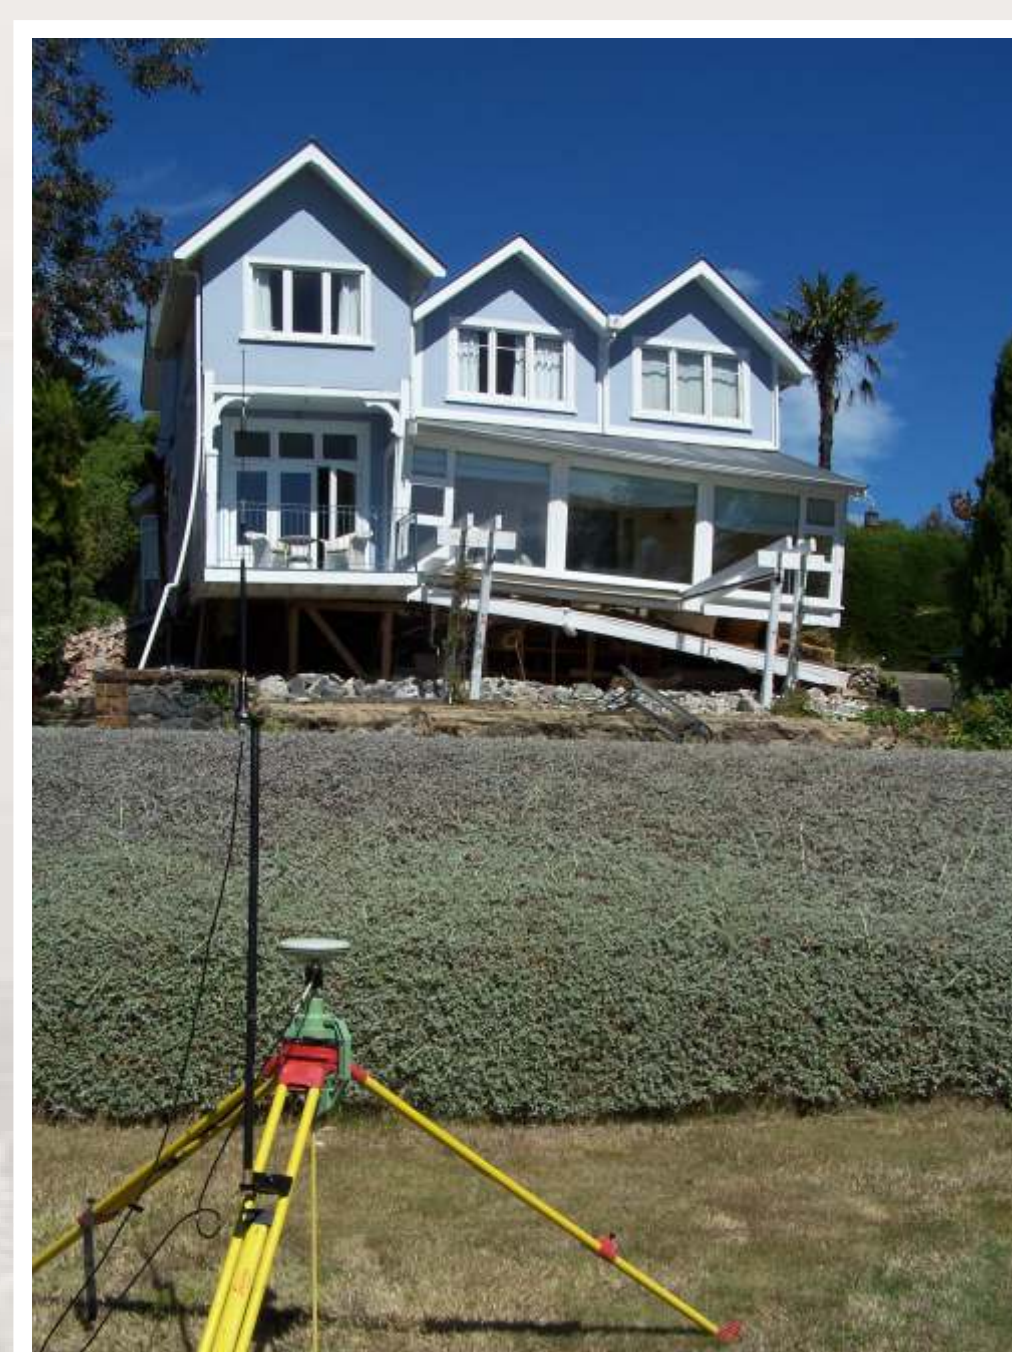
## Localised shallow landslides and failure of retaining walls, fill slopes and homes

This type of damage was found over a large area, and was caused by the strong earthquake ground shaking. However, these failures are not necessarily evidence that the land has become unstable, i.e., they did not indicate slopes that retained potential to fail further.

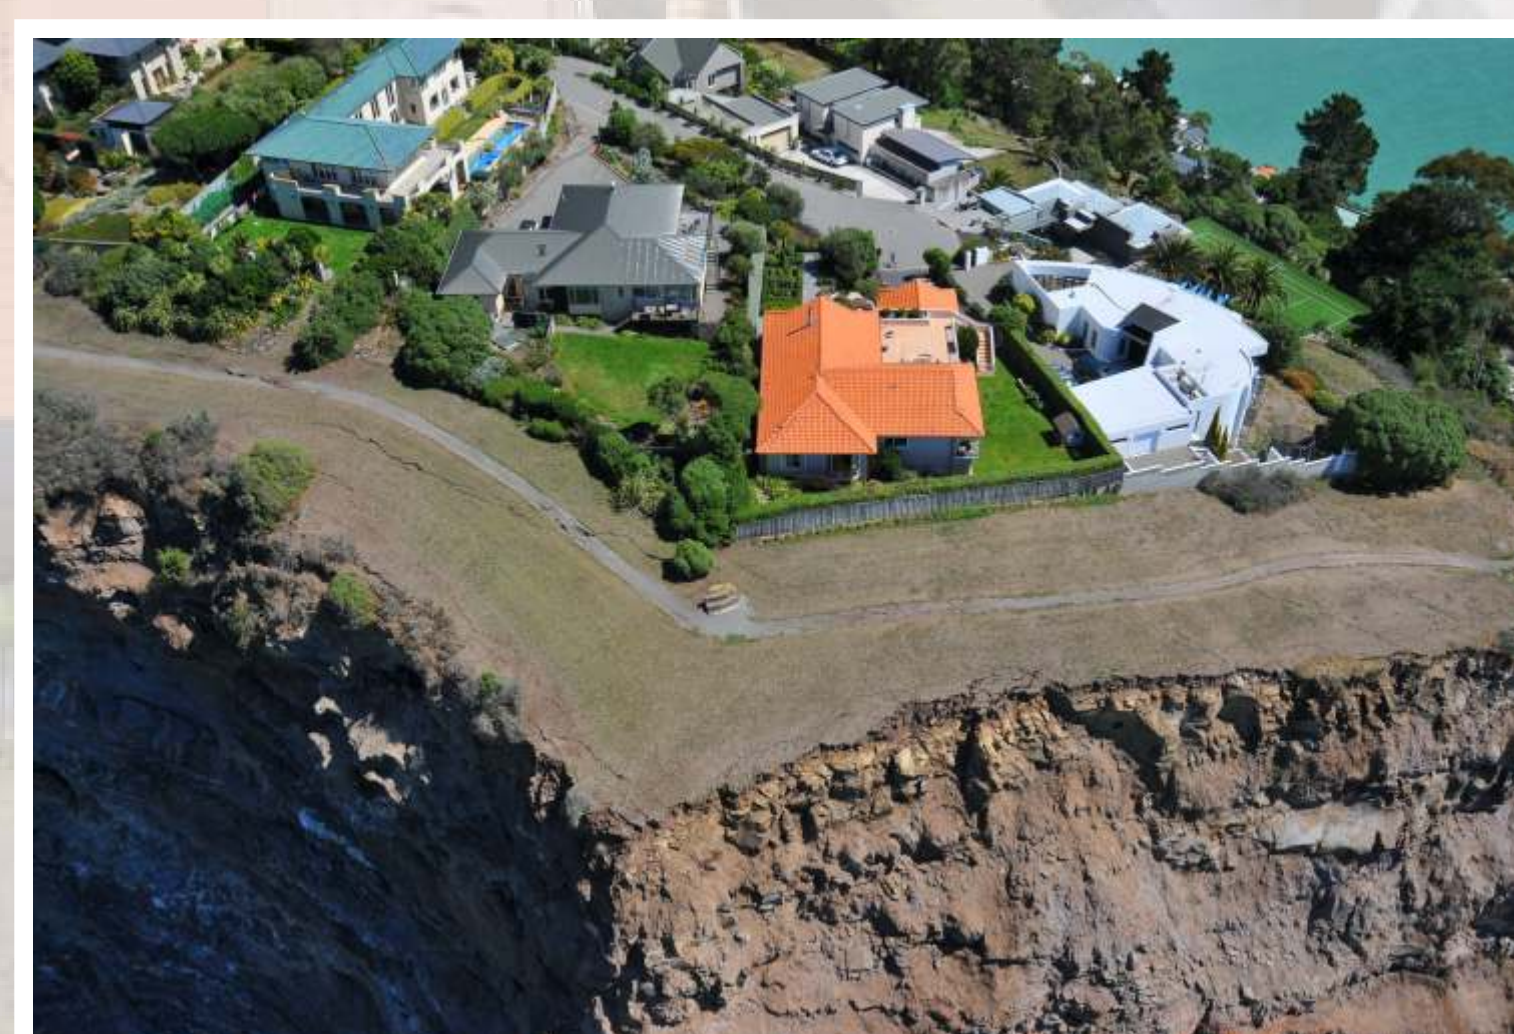
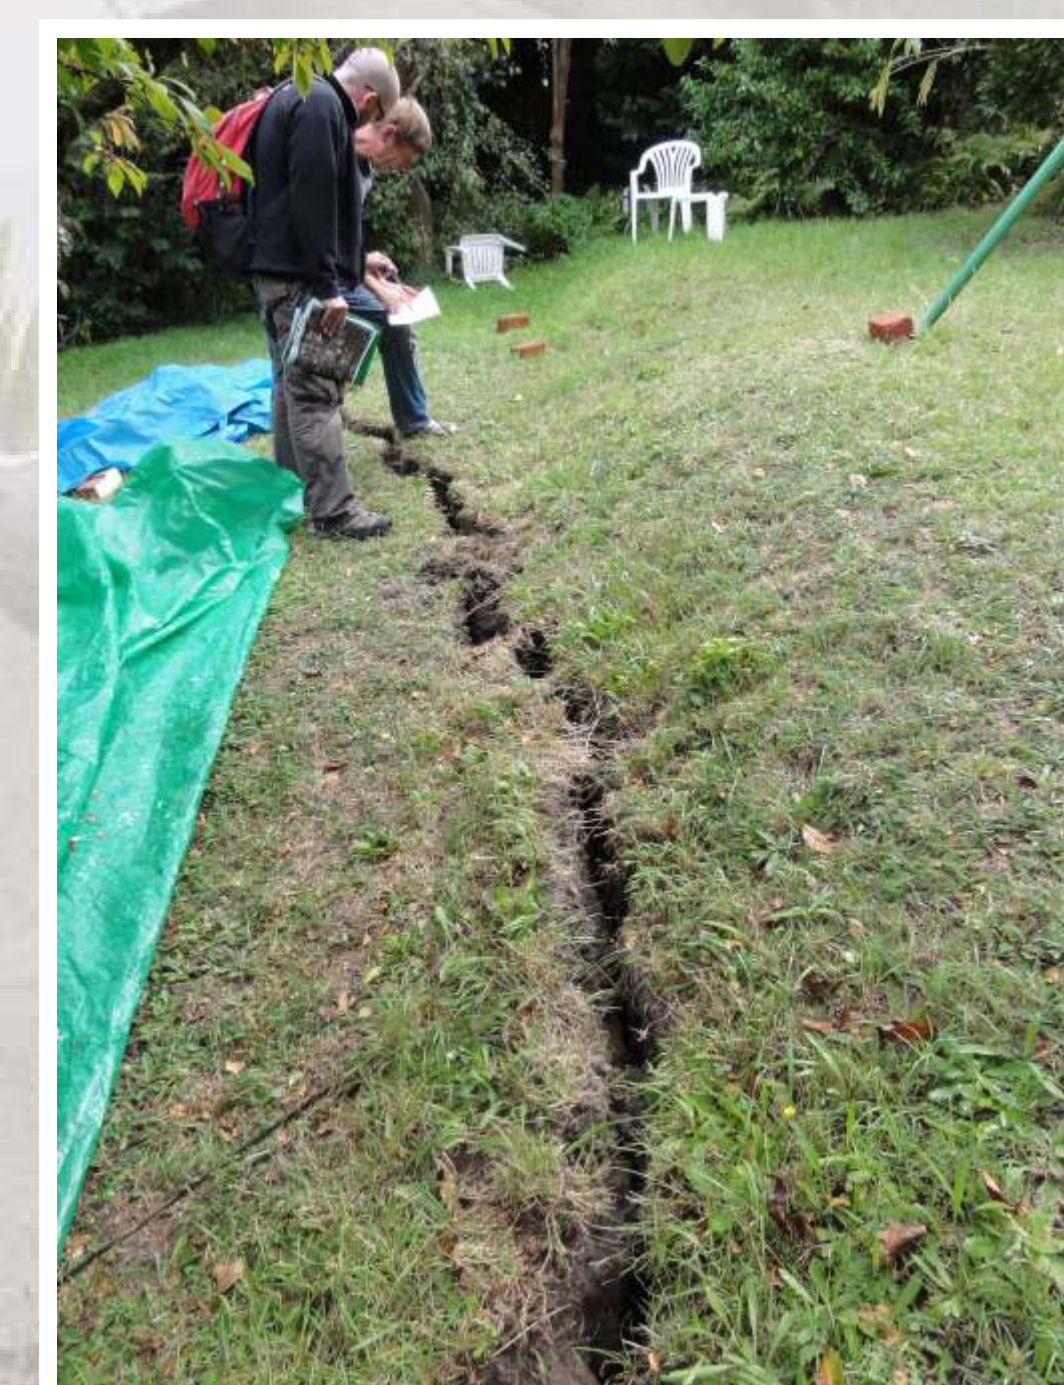
## Deep-seated landsliding

Deep-seated ground movement of large areas was indicated by clusters of large deformation features including cracks and bulges. Deep-seated landslides, together with tension cracks, caused the most damage to the ground and therefore to houses, roads etc on the hills. These features tended to be on or very close to cliff tops and convex breaks in slope. During the earthquake, the topographic position, and the morphology and geology of the slopes appear to have amplified the ground shaking, causing local areas of very heavy damage. Ground damage decreased rapidly away from these breaks in slope.

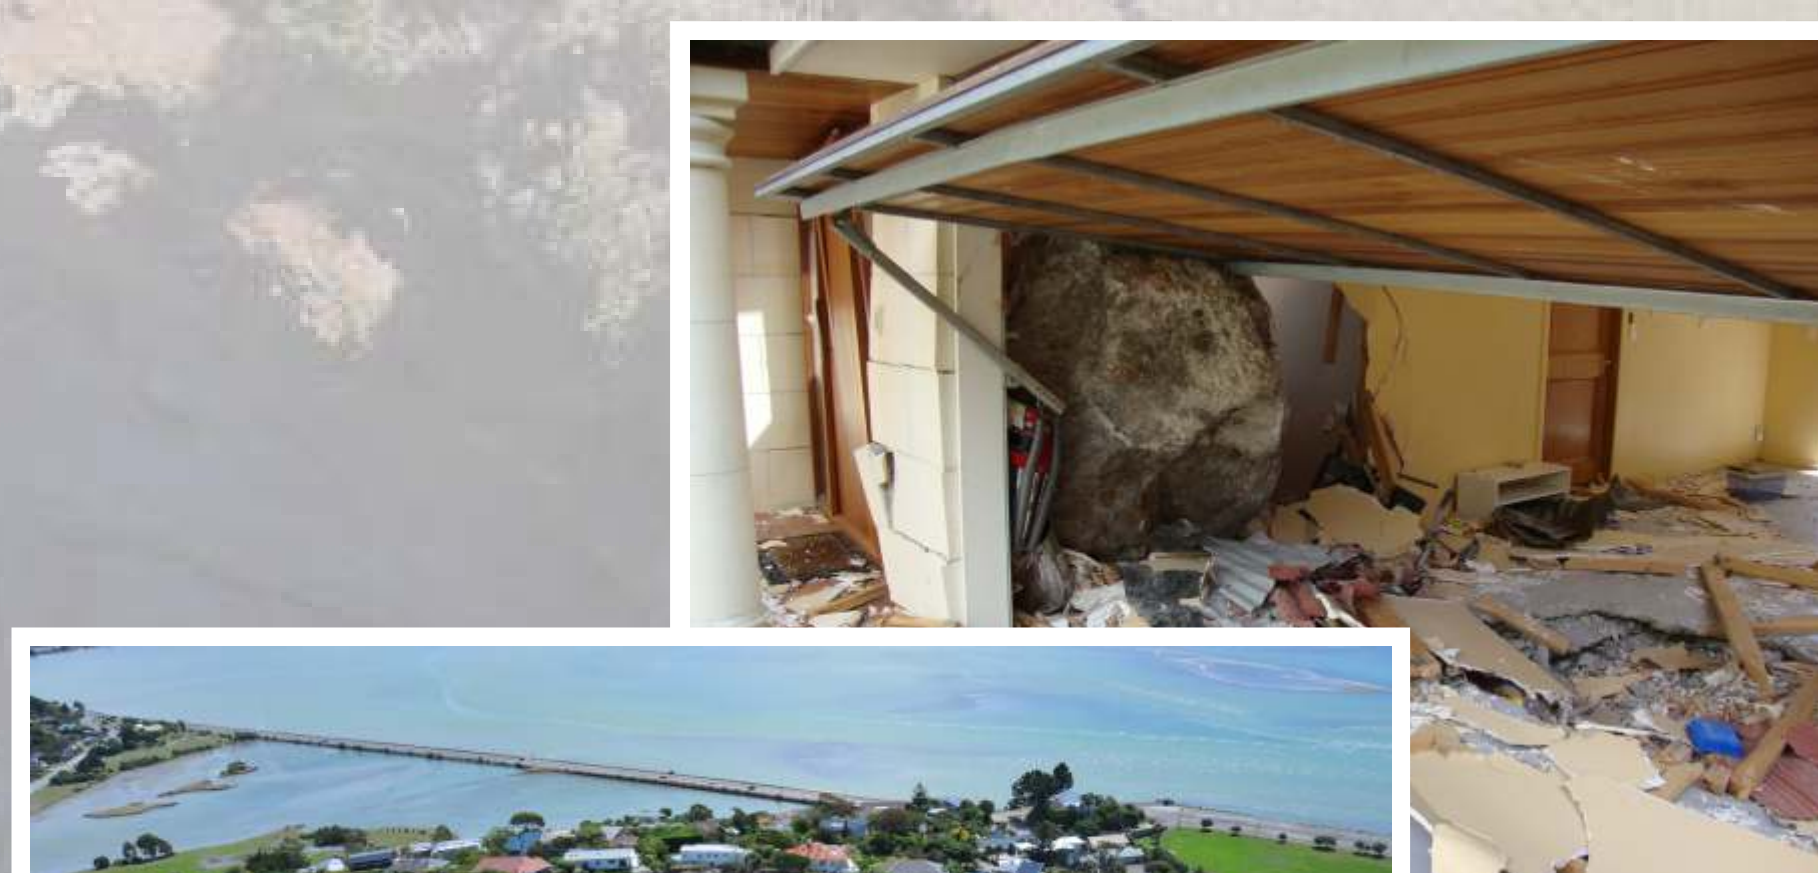
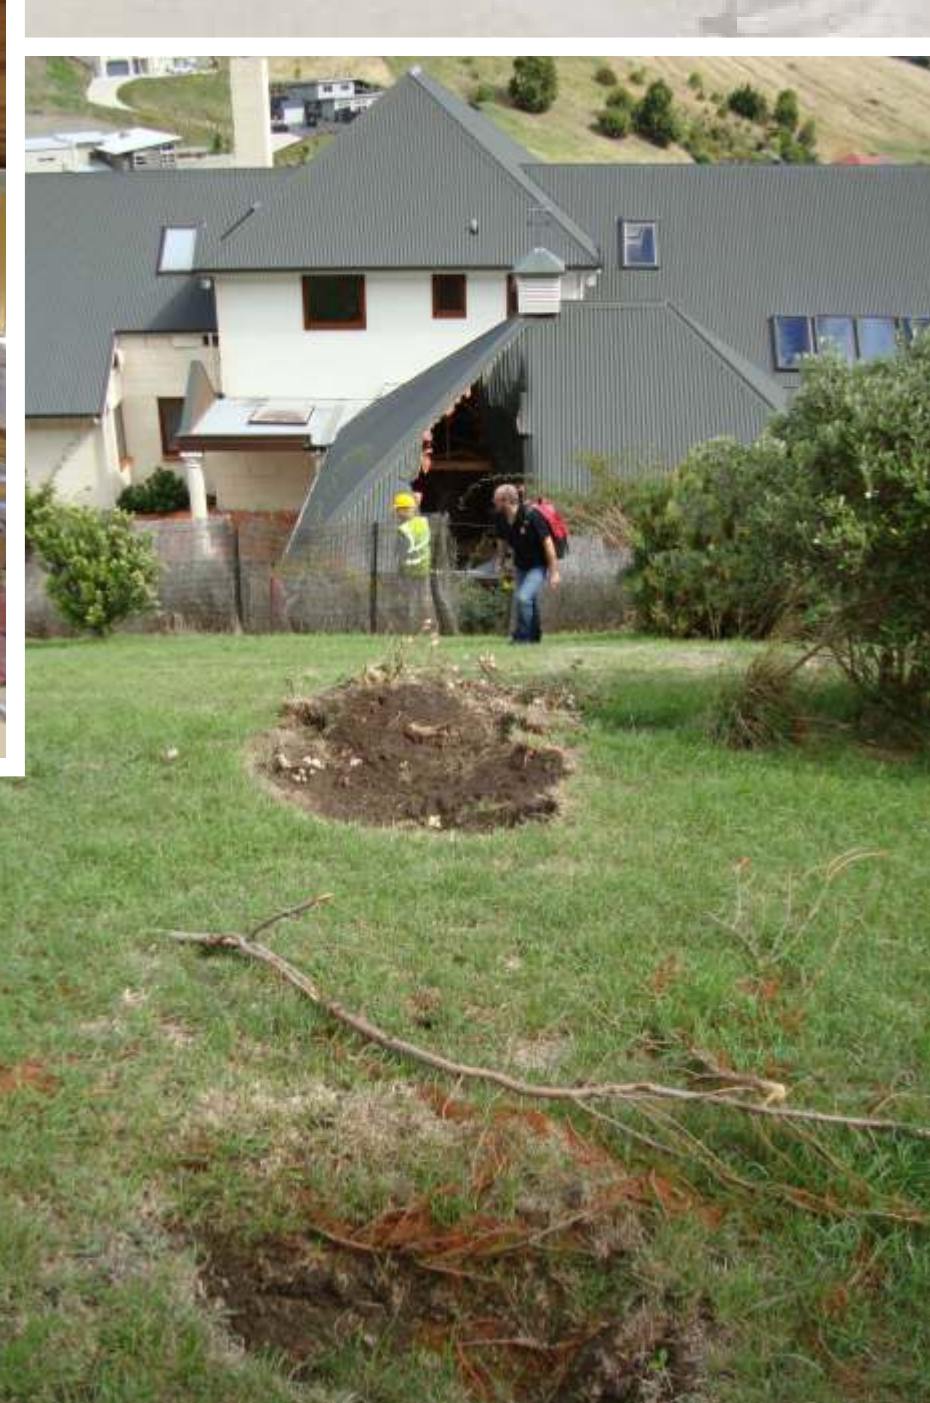
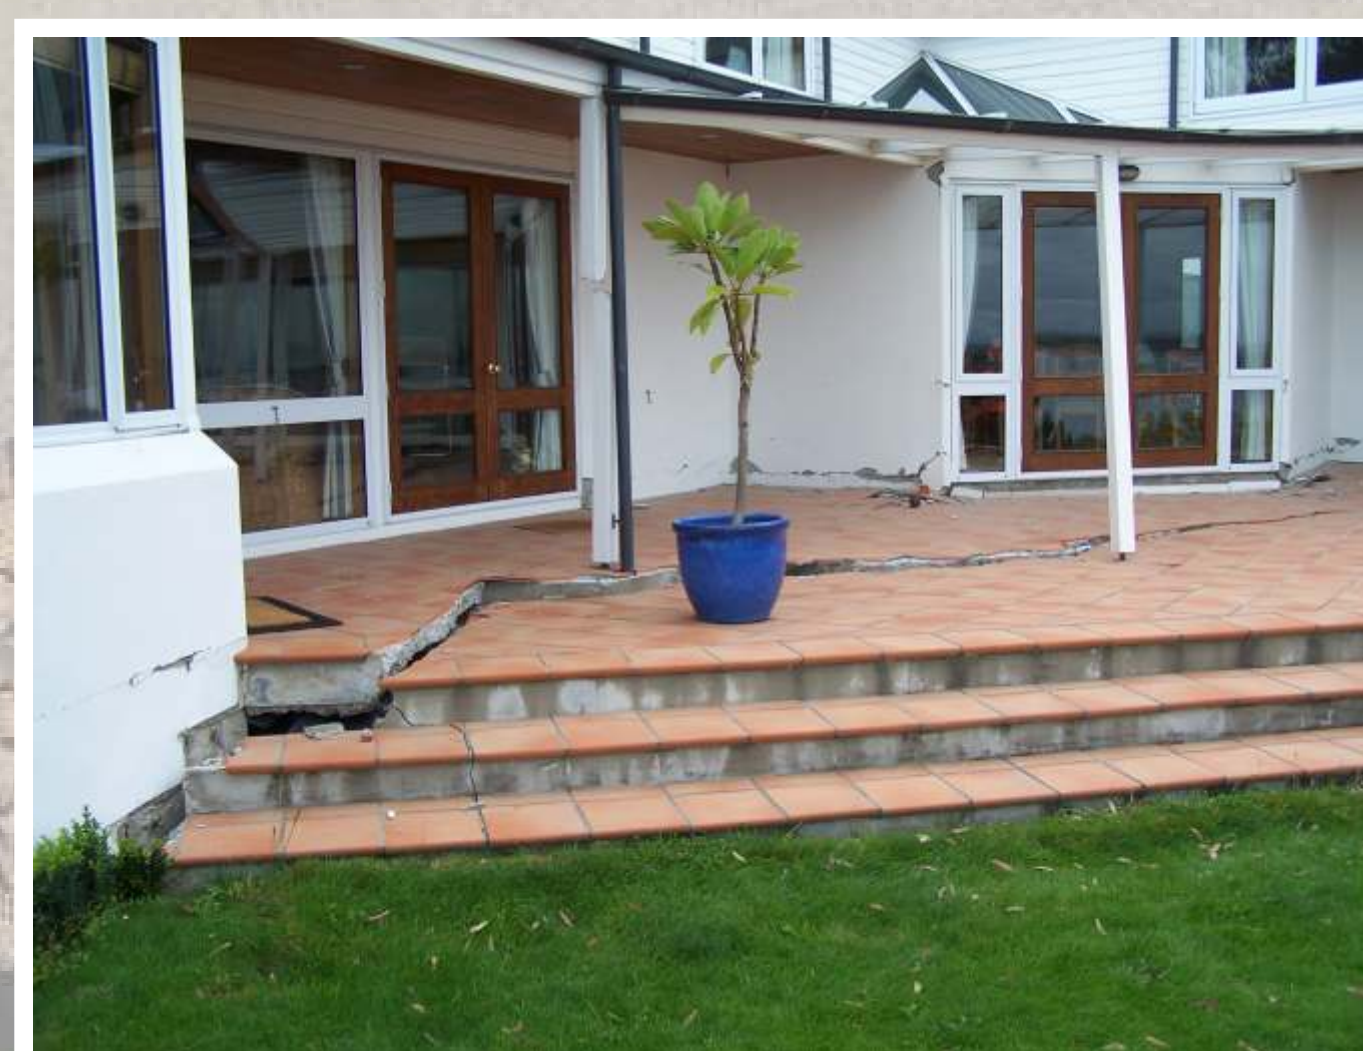
## Rockfalls and collapse of rock slopes and cliffs

The largest number of mass movements were rockfalls. They were responsible for the five fatalities, as well as substantial damage to properties, roads and other infrastructure. During the earthquake, sections of cliffs, rocky outcrops and slopes shed much rock debris. The rockfalls, some of which bounced and rolled long distances to smash through houses, ranged from single boulders to large masses of rocks.
