Report on the fatal rock fall on the coastal cliff south of Rothesay Bay, Auckland, on 2 July 2011

by Graham Hancox,
GNS Science, Lower Hutt,
5 August 2011

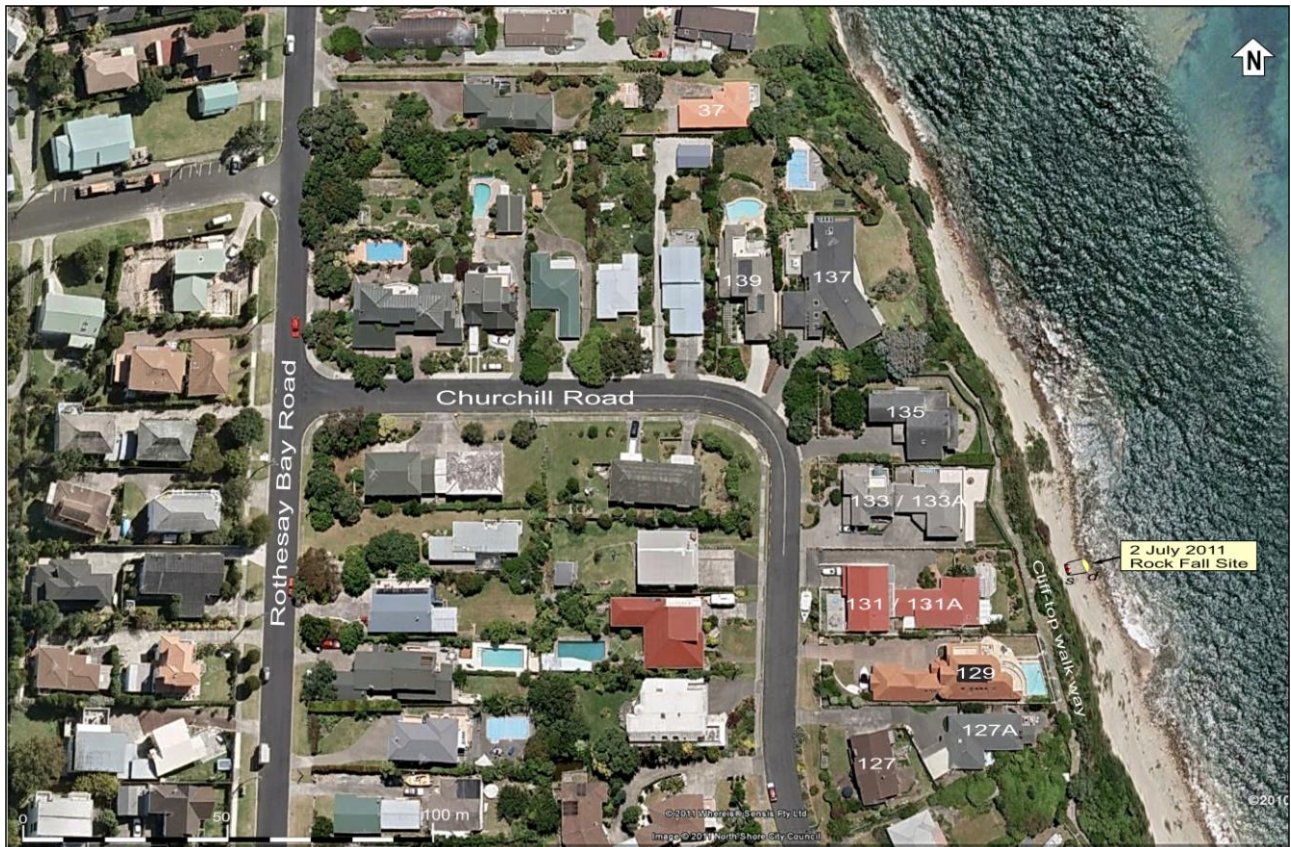
Figure 2. Annotated Google Earth Image (January 2008) showing the site of the 2 July 2011 rock fall on the coastal cliff below the cliff-top walkway at 131A Churchill Road.

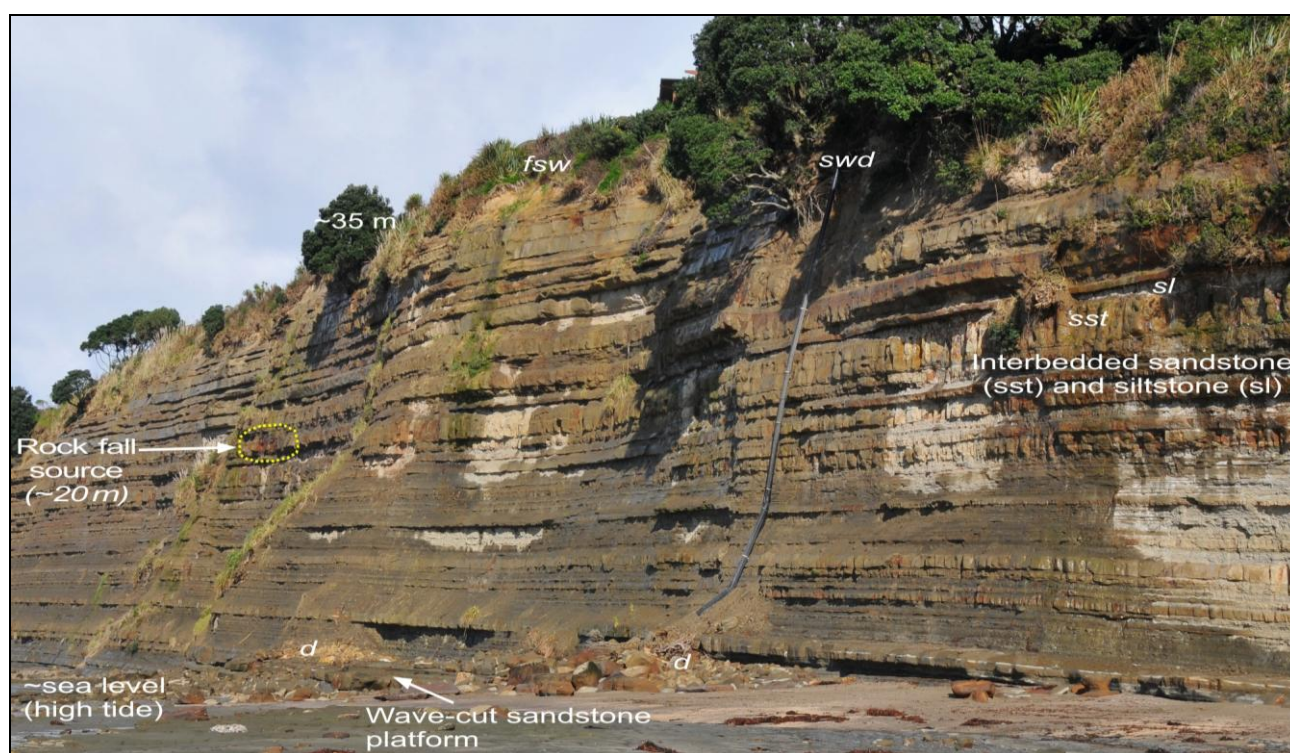
Figure 3. Area of the 2 July 2011 rock fall site on the near vertical ~35 m high coastal cliff at Rothesay Bay. This view, from the north at low tide, shows interbedded sub-horizontal sandstone (sst) and siltstone (sl) beds forming the cliff, with a thin (1–2 m) layer of soil and weathered rock at the top of the cliff face. Other features shown are a prominent sandstone wave-cut platform, an existing storm water drain (swd) and the site of former drain (fsw) ~50–100 m north of the rock fall site, and old rock and soil debris (d) at the base of the cliff below the storm water drain outlets.

As shown in Figure 3, the rock fall source area is located about 20 m above the base of the cliff. There are no storm water outlets in the immediate vicinity of the rock fall site. However, ~100 m north of the rock fall site a polythene storm water drain discharges water at the base of the cliff onto old rock and soil debris. Another drain outlet was previously located at the top of the cliff above an area of grass and algae growth, suggesting a greater water flow on that part of the cliff. The drain is visible in an aerial photo taken by the author in September 2008 (Figure 4). There is no evidence that these drains affected the 2 July rock fall site or contributed to the recent slope failure. However, they do appear to have caused or at least contributed to earlier small rock and debris falls in the immediate vicinity of the drain outlets (Figure 3).

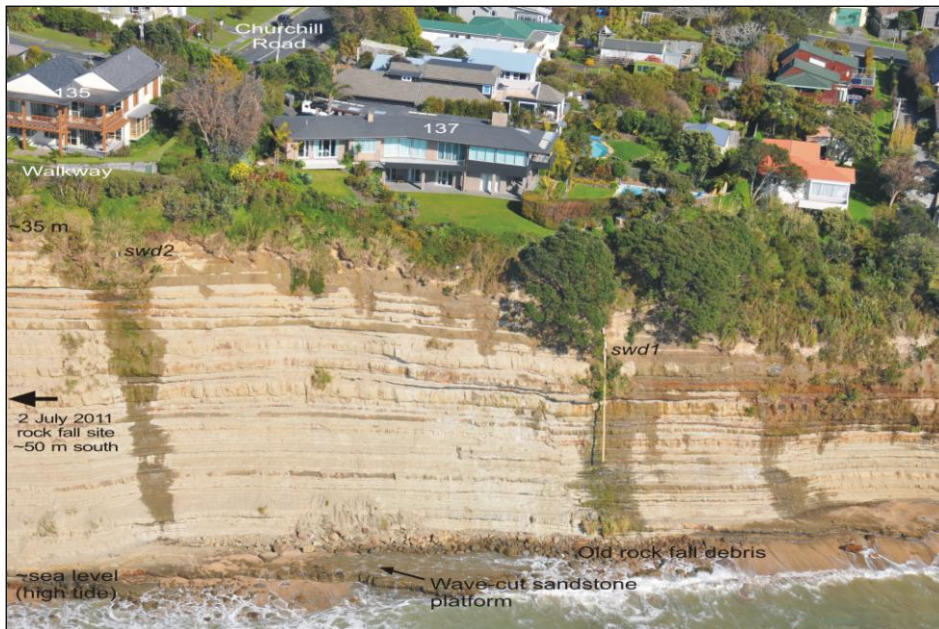
Figure 4. Aerial view of the area about 50 m north of the 2 July 2011 rock fall site (out of view to the left), showing two storm water drains (*swd1*, *swd2*) which discharged water down the cliff face south of Rothesay Bay in September 2008. The northern drain (*swd1*) now extends to the bottom of the cliff. Small rock falls ($\sim 0.5\text{--}1\text{ m}^3$) have since occurred at the site of the southern (*swd2*) drain (see Figure 3).

- (6) Better control of drainage on the cliff face, for example by ensuring that storm water drains discharge at the bottom of the cliff, rather than at the top or halfway down, may improve its stability and reduce the incidence of rock and soil falls.

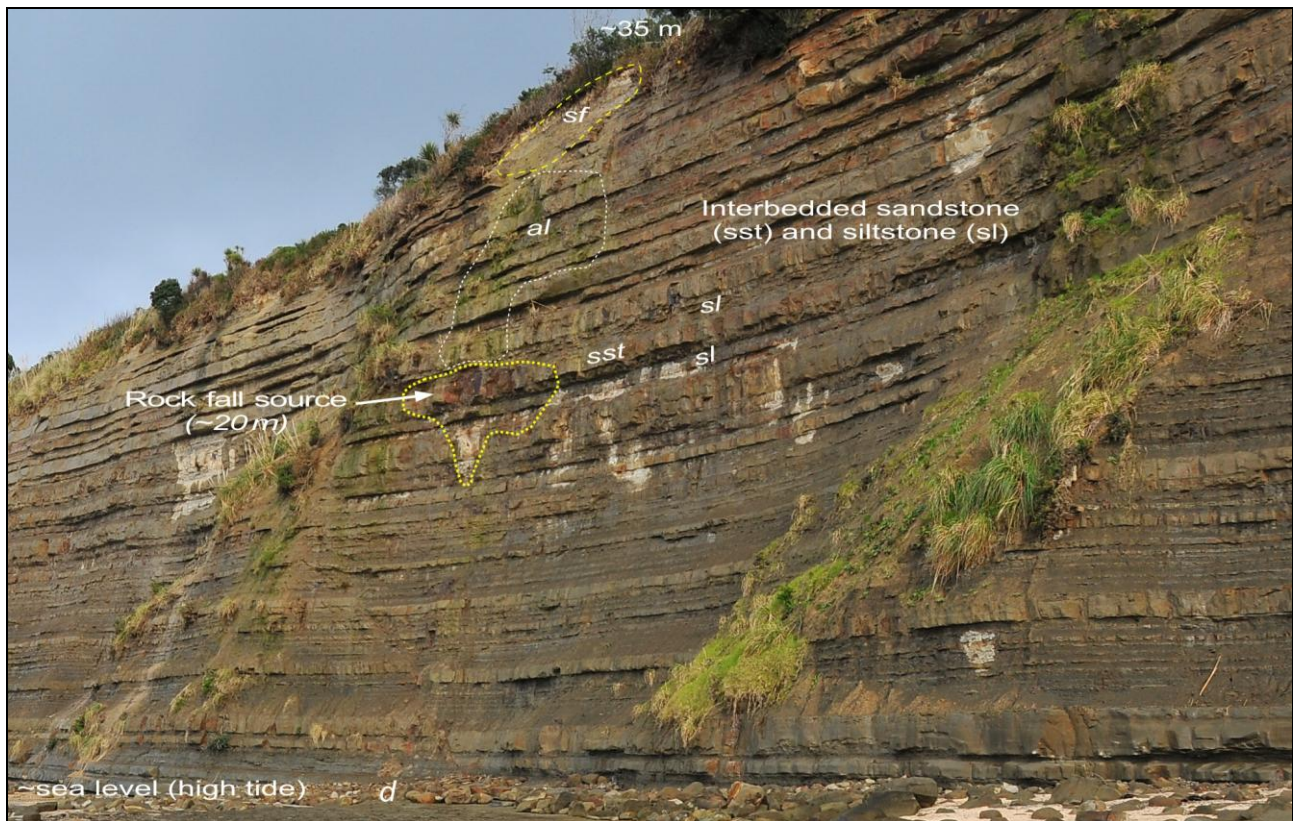
The rock fall occurred at around the middle of the near-vertical coastal cliff within a $\sim 800\text{ mm}$ thick sandstone bed. The $\sim 3\text{ m}$ long source area is clearly recognisable on the cliff face by the fresh iron-stained, joint-controlled scar (Figure 5). Details of the rock fall source are more clearly shown in a close up view of the scar (Figure 6).

Figure 5. Closer view of the source of the 2 July 2011 rock fall in a $\sim 800\text{ mm}$ thick sandstone bed (*sst*) about 20 m above the base of the 35 m high cliff. Grass and algal growth (*al*) above the rock fall scar, and the recent shallow soil failure (*sf*) at the top of the cliff suggests there has probably been more concentrated flow of natural run-off water down the cliff face at this location. Most of the debris (*d*) from the 2 July rock fall had been washed away or redistributed by wave action when this photo was taken on 15 July.

Although the source area of the rock fall was still clearly visible during the 15 July site visit, most of the rock fall debris had been washed away or redistributed by wave action (Figure 5). However, from inspections carried on the day of the failure the total volume of fresh angular rock fall debris (~200-300 mm boulders) at the site is estimated to have been less than ~¼ m³, which extended up to ~7 m out from the cliff face (Tonkin & Taylor 2011). The woman killed by the rock fall was found within the area of new debris at about 1 pm on 2 July 2011 (low tide was at 1:49 pm), approximately 7 m from the base of the cliff (pers. comm. Ian McCormick, AC).

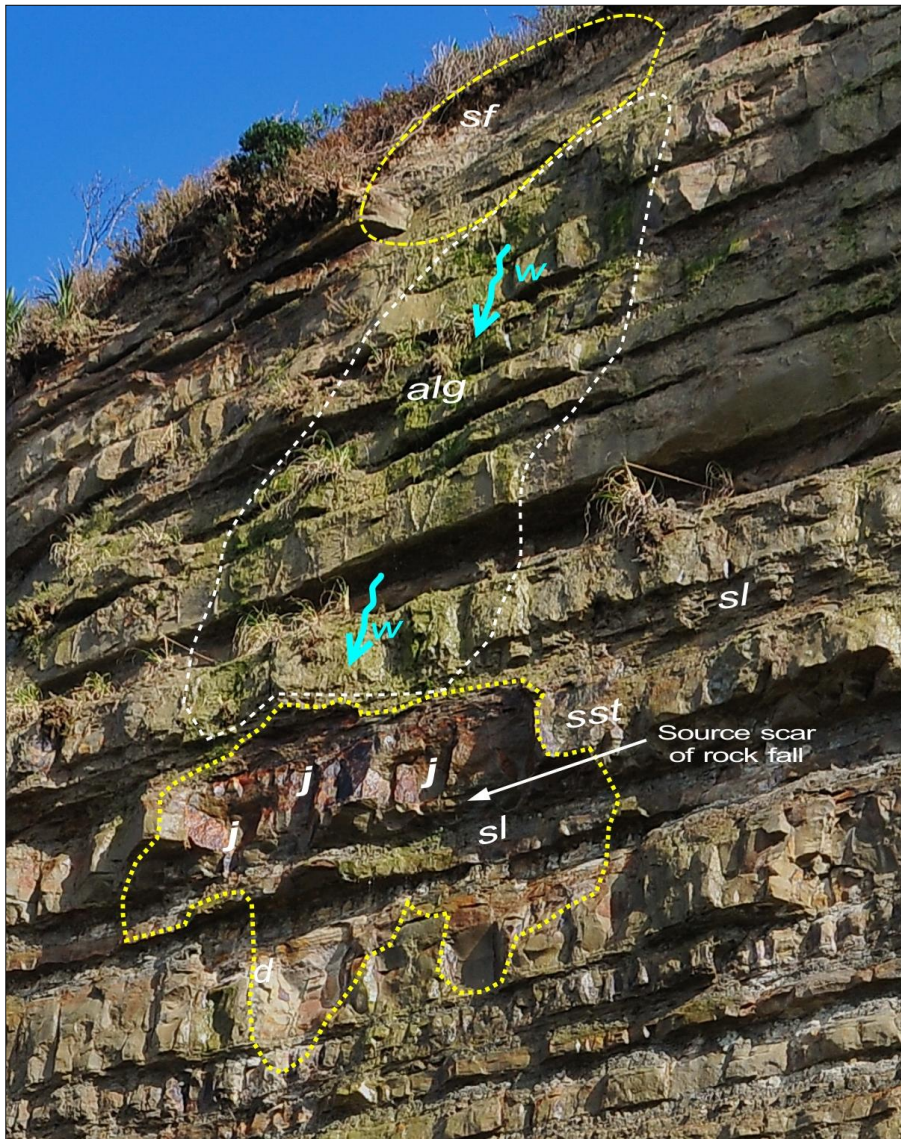
Figure 6. Closer view of the 2 July rock fall scar in the thick sandstone bed showing the iron stained joints (*j*) on which the break-out occurred, and obvious undercutting of the sandstone bed caused by erosion of the underlying siltstone (*sl*) layer. The strong algae and grass (*alg*) growth above the scar, and the shallow soil failure (*sf*) at the top of the cliff face, are both indicative of greater water flow (*w*) down the cliff at this location, as is the heavy iron staining of joints exposed in the rock fall scar.

Most of the material in the 2 July rock fall was clearly derived from a ~800 mm thick sandstone bed, with a minor amount from the underlying siltstone and sandstone beds. The rock fall source scar shows that it was a typical block failure, with break-out controlled by prominent, near vertical iron stained joints (Figure 6). Locally greater water flow down the cliff face at the rock fall site, as shown by algae and grass on the cliff above the source scar, is thought to have been responsible for iron staining of the joint surfaces, and hence reduced joint strength and increased likelihood of slope failure at this particular location. The source of the water is more likely to be from natural run-off. Construction of houses and the walkway along the cliff edge may have affected natural drainage paths on the cliff face, but there is no direct evidence of this. There are no storm water drains in the immediate vicinity of the site, and I therefore agree with Tonkin & Taylors (2011) conclusion that there is no evidence that stormwater discharge was a factor in the failure.

- (1) The rock fall was a relatively small ($\sim\frac{1}{4}$ m³ or less) joint-controlled, sandstone block failure, which is the most common form of slope instability on Auckland's east coast cliffs. The failure is attributed to erosional undercutting of a sandstone bed, water flow on the cliff face, and joint opening, leading to the sudden collapse of loosened blocks of sandstone.
