**Institute of Geological
& Nuclear Sciences
Science Report**

2002/03

**The fatal Cleft Peak
debris flow
of
3 January 2002,
Upper Rees Valley,
West Otago**

**M. J. McSaveney
P. J. Glassey**

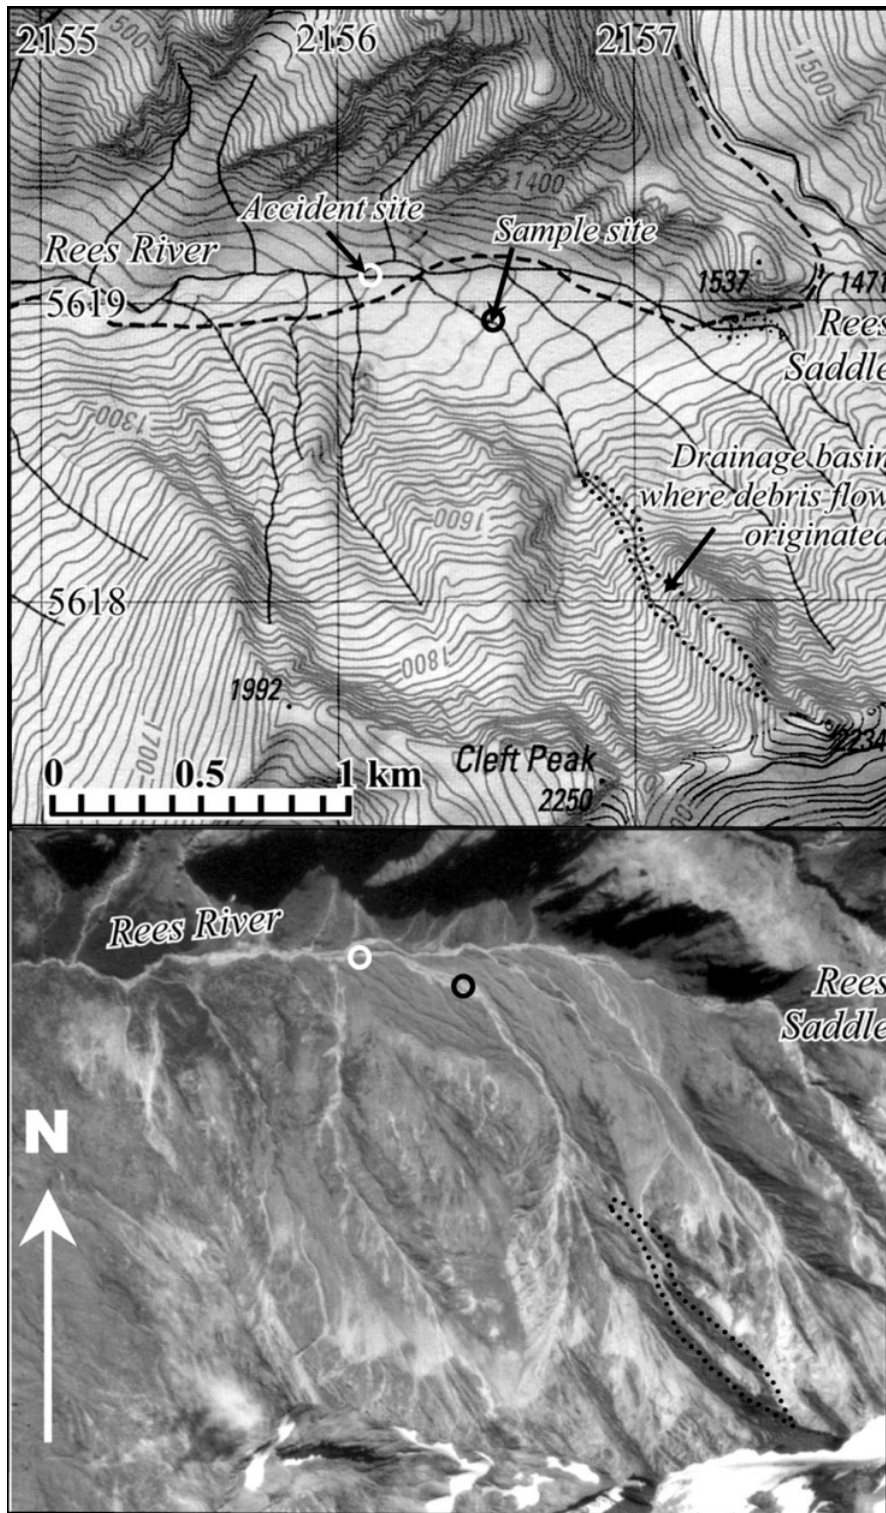
Upslope from the site of the accident, the slopes of the northern end of the Richardson Mountains are deeply dissected by a series of narrow gullies leading from minor drainage basins that head at Cleft Peak (2250 m) and several unnamed peaks along the ridge to the north (Figure 2). This is the largest such set of minor drainage basins in the upper Rees valley in the vicinity of Rees Saddle. The presence of fine gravel thinly deposited over live alpine tussock beside the stream channel (Figure 4), identified the active debris-flow source for the 3-January event in this set of basins as being the true rightmost (most easterly) of the minor

drainage basins (Figure 2). This basin is a peculiarly elongate basin about 800 metres long and <80 metres wide, perched on the side of the main basin contributing to this tributary of the Rees. Although the shape of the basin contributed some of the character of the debris flow (the precise timing in particular), there was nothing inherently “special” about the basin that led to anything special about the fatal debris flow. On the morning of 3 January 2002, debris flows were the norm, and not the exception, occurring in more than half of the tributaries in the upper Rees valley.

Figure 2 Detailed topographic map and vertical aerial photograph of the site of the fatal Cleft Peak debris flow of 3 January 2002. Note that the walking track location shown on the map is inaccurate: on the ground, the track passes through the marked accident site. Neither the inaccuracy, nor the true location of the stream crossing contributed to the fatality. Grid on map is New Zealand map grid. North is uppermost. Aerial photograph (part of SN3982/18 of 12 March 1966) is only partly rectified for distortion and topography.

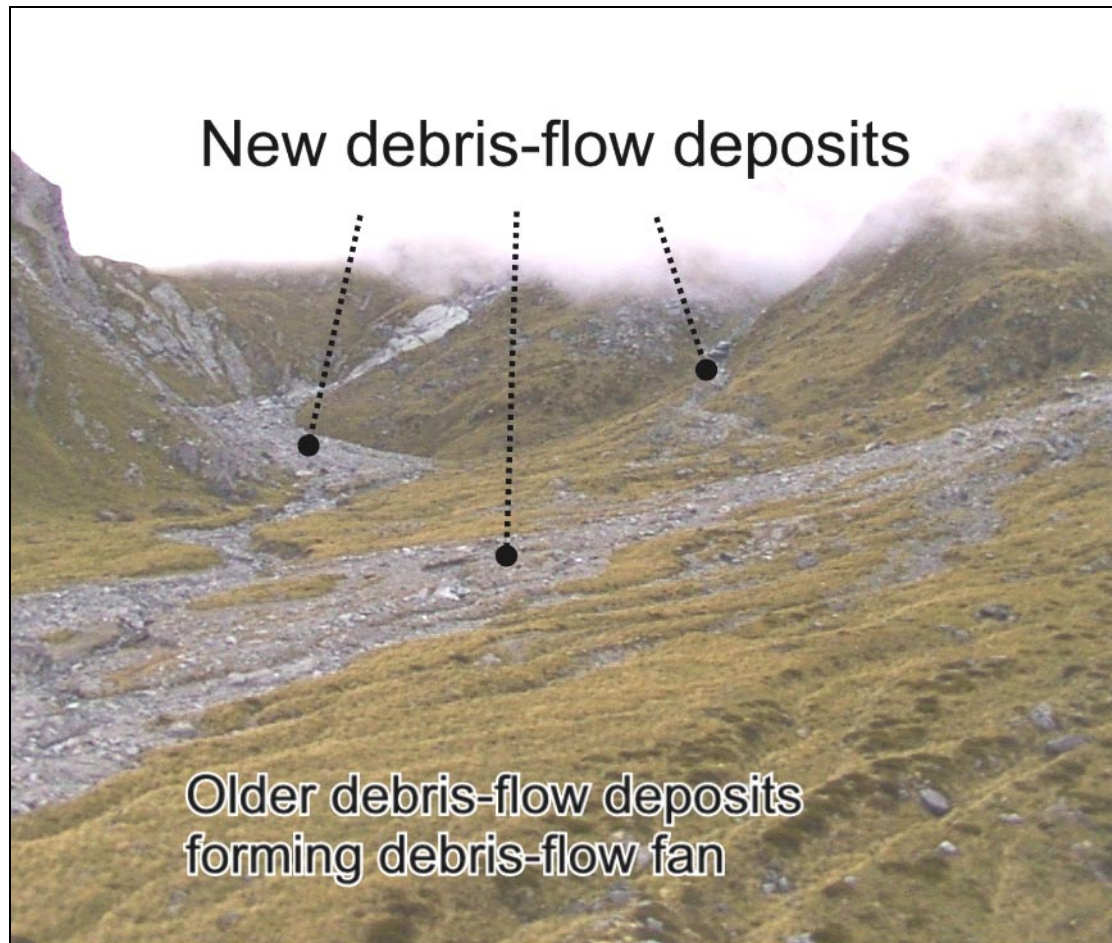
Figure 3 Oblique aerial view of some of the upper Rees valley debris-flow deposits upvalley from the accident site, towards Rees Saddle (background). The tussock-covered, bouldery surface forming the foreground is northeast margin of the debris-flow fan where the accident occurred. The mid-ground debris flow has spilled debris widely down many channels in the storm of 3 January 2002. Note how the fresh deposit from the debris flow below Rees Saddle fills the entire width of the upper valley. Had people been in these parts of the valley during the height of the storm, the debris flows would have been harder to escape from.

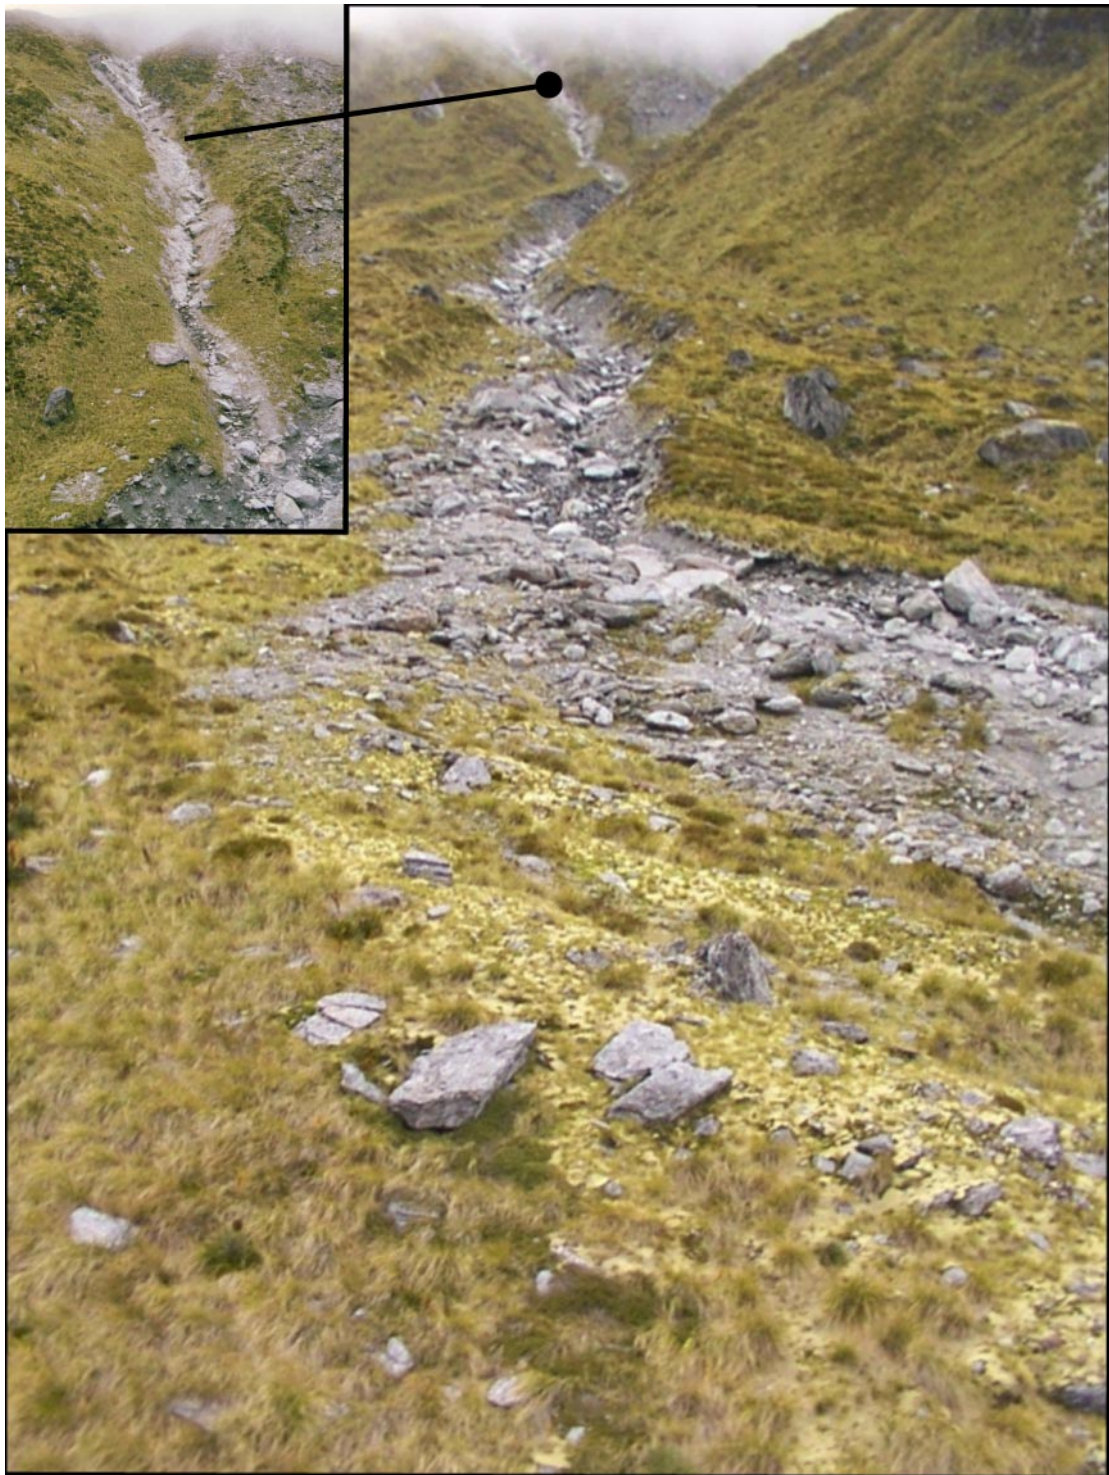
Figure 4 The path of the Cleft Peak debris flow of 3 January 2002 down the upper portion of the debris-flow fan. The debris flow appears to have originated from the true right (left in photo) tributary at the head of the fan. The debris flow remained confined to the stream channel in the upper portion of the fan, but spilled out of the channel on the lower fan where the channel was less confined. Inset is close view of the tributary that shows clear evidence (debris over live plants) of the passage of a large debris flow.

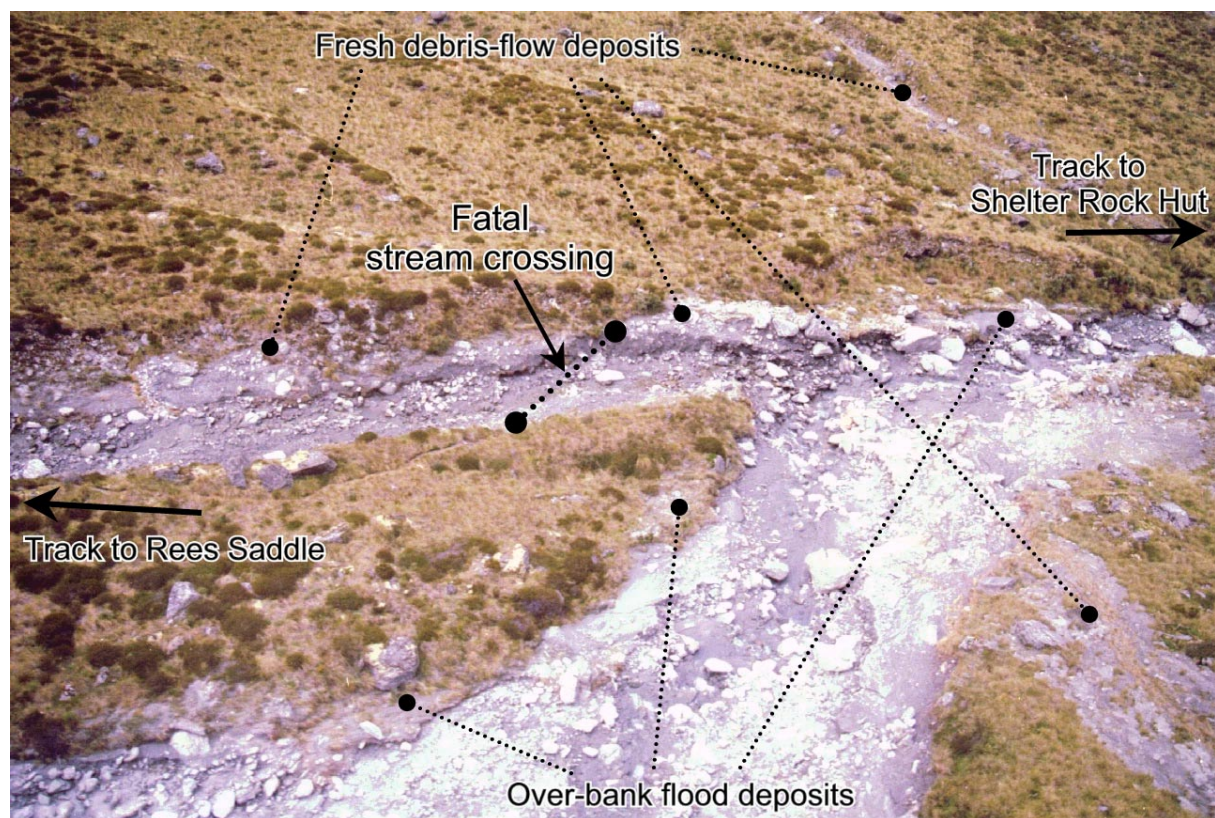
The accident site (Figure 6) was a logical and normally safe location to cross the stream. Had the crossing been located higher on the fan, in the position where it is marked on the topographic map for example (Figures 1 and 2), this particular accident might not have happened, because Mr Buxton would have taken longer to reach the crossing, and hence would not have been in the stream channel at the time the debris flow passed through it. However, the debris flow spread more widely in this area, and had the two been crossing there at the time the flow passed through, it is less likely that anyone would have been able to escape. Equally, if Mr Buxton had left Shelter Rock Hut some minutes earlier or later, or if he had walked faster or more slowly, the accident might not have happened.

Figure 6 Site of the fatal stream crossing on the track between Shelter Rock hut and Rees Saddle. Rees River flows from centre foreground to right centre of photograph. The tributary stream where the accident occurred enters from the left centre. This photograph was taken on 25 January and does not represent the state of the crossing on or before 3 January 2002.

DoC staff mentioned that some realignment of the track route would be undertaken to lessen the exposure of people to flooding on the valley bottom. This exposure results from bank erosion by the Rees River, and is not a result of the debris flow. It will not change the exposure to the risk of injury from debris flows, because this risk occurs at every tributary stream crossing regardless of the track alignment.

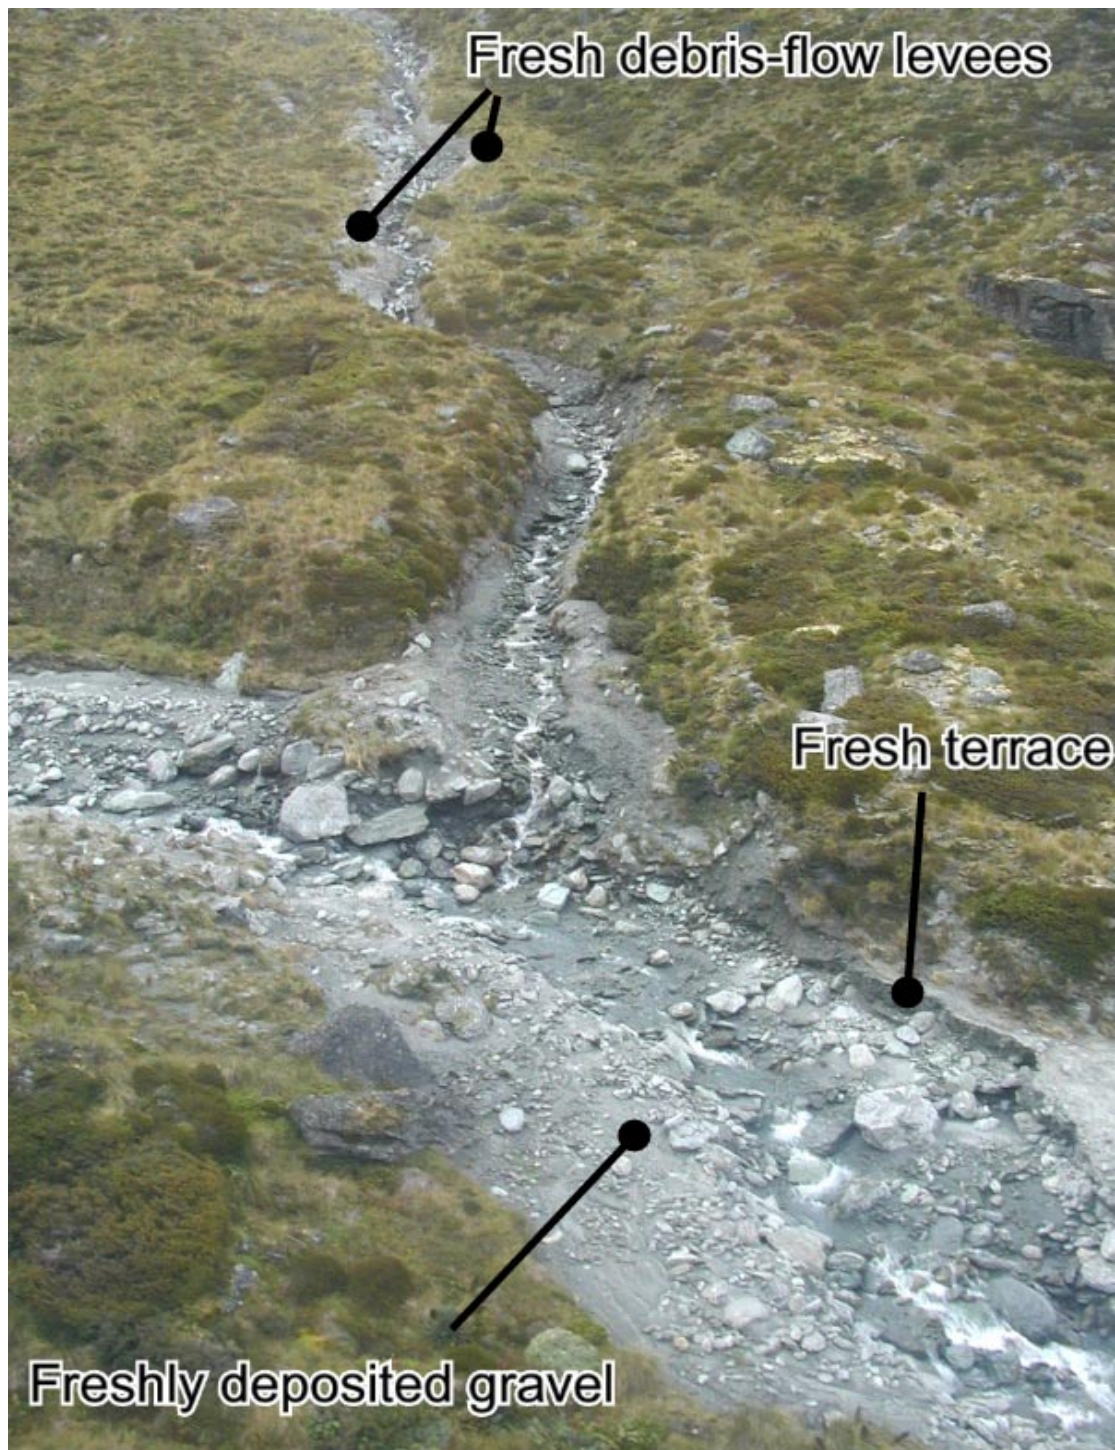
Trying to spot further sign of Mr Buxton, Mr Thrower ran along the river bank, but found that a creek they had crossed safely earlier in the morning, some 200 metres downstream, was now washed out and impassable (Figure 8). He had to ascend some 300 metres up its fan before finding a place to cross it. He then returned to Shelter Rock Hut along the walking track to notify others of the loss.

Figure 8 Tributary stream between Shelter Rock hut and the fatal crossing, that Bevan Thrower found to be washed out and impassable within minutes of the fatality. It too shows clear evidence of the passage of a debris flow, one of many triggered during a brief episode of very heavy rainfall about 10:00 am on 3 January 2002. Track between Shelter Rock hut and Rees Saddle crosses the tributary about 20 metres above the junction with the Rees River. Note the freshly deposited gravel and cut terrace in the Rees River channel from deposition during the storm of 3 January. Such deposition of sediment in the streambed contributed significantly to the high water surface level during the flood.

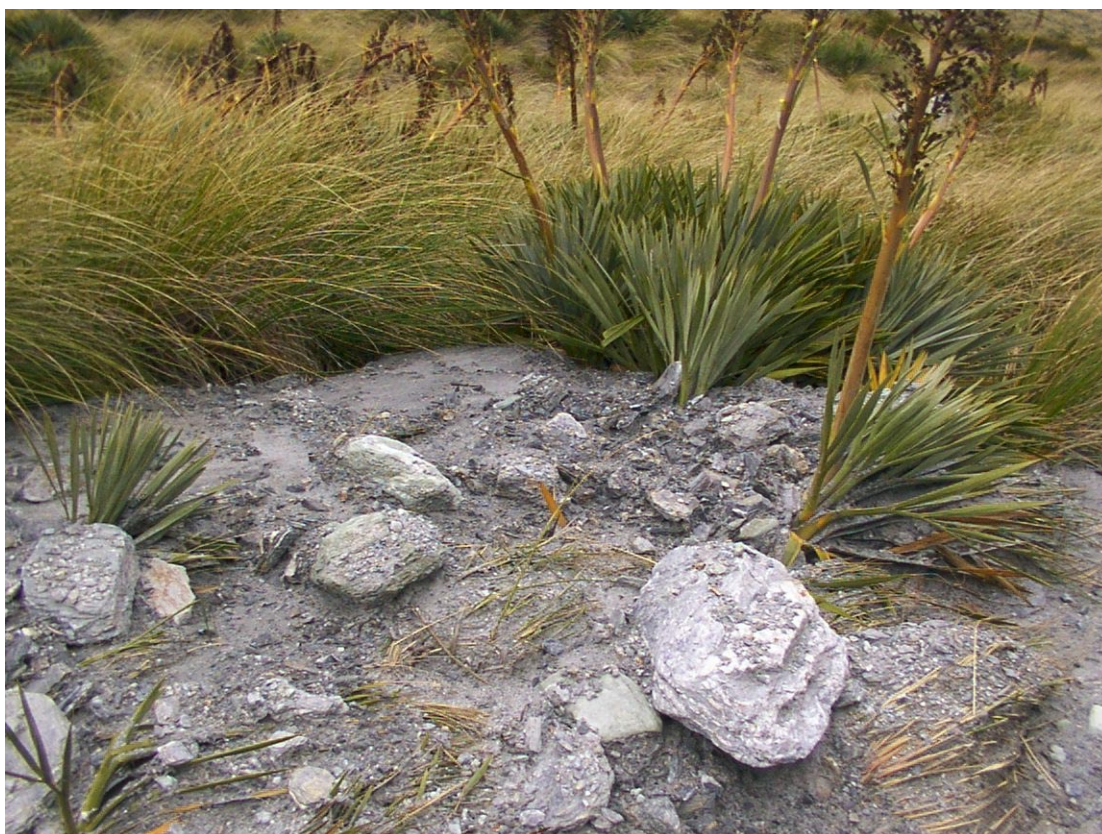
Figure 10 Close-up photograph of the debris-flow material where it spilled out of its channel onto surrounding plants here, largely *Aciphilla* (Speargrass, Spaniard).

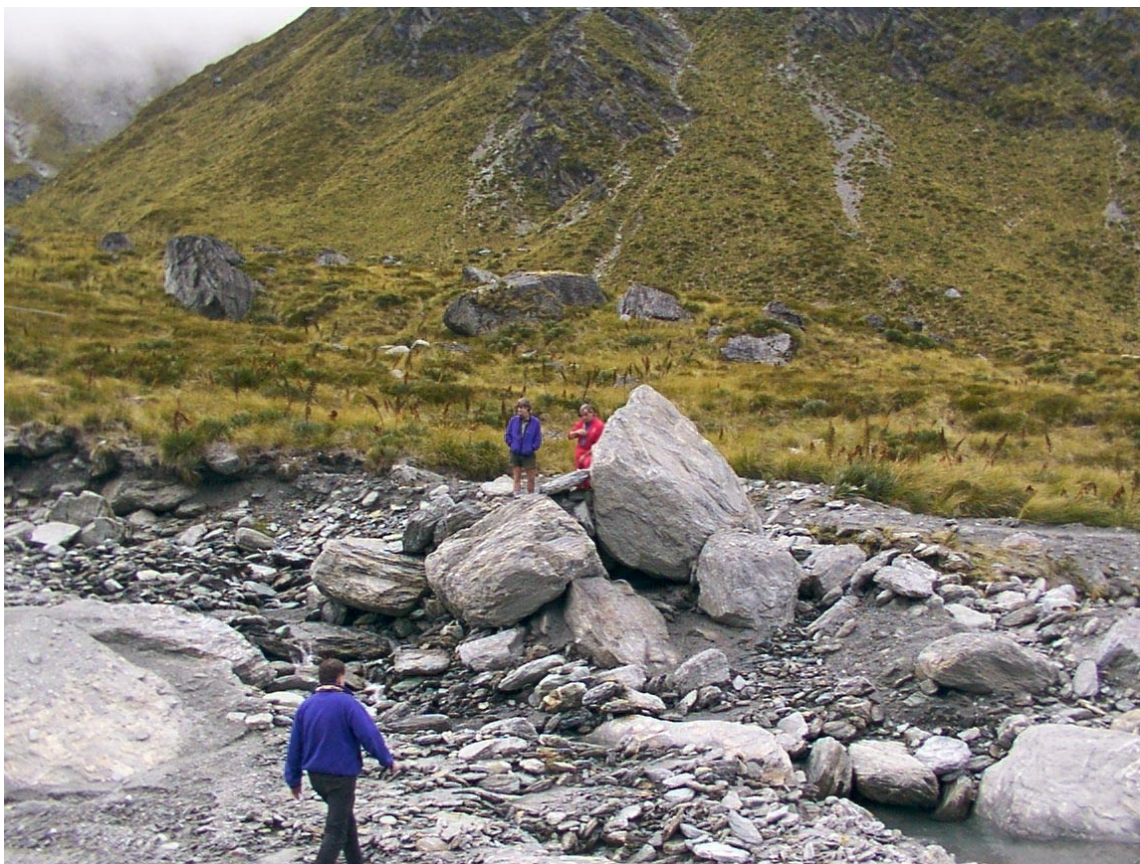
Figure 11 Example of the extremely large boulders moved hundreds of metres by the debris flow on the upper fan. Here a group of boulders have accumulated as a stable cluster when each became buttressed against the powerful debris-flow current by its surrounding boulders. In the background are other large boulders from a past debris flow, now overgrown by dense subalpine plant cover. The sample of the debris-flow matrix (Figure 9) came from this site.

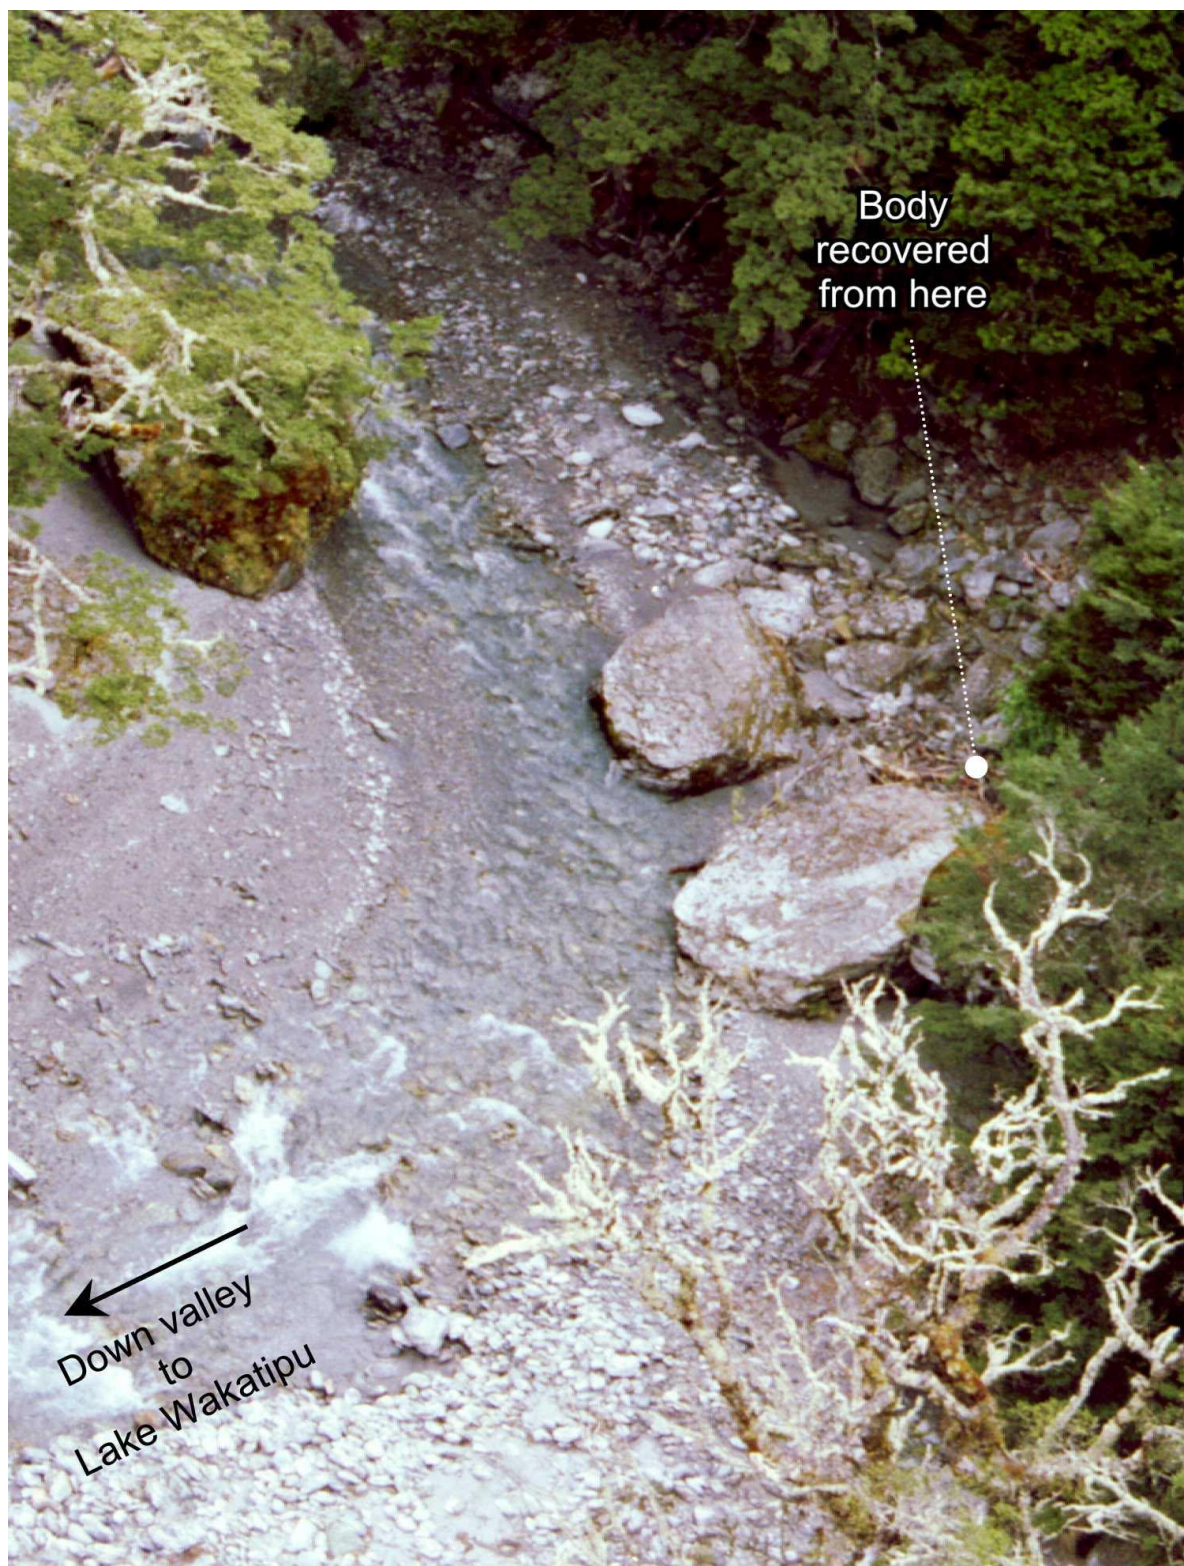
Figure 12 Site where body was recovered after the debris-flow fatality. Note that live trees were trimmed from here during the recovery. It appears that along with much other floating debris, Mr Buxton's body and pack were filtered out of the flood flow on the outside of this bend when the floodwater passed through a shrubby tree while flowing around several boulders.
