The fatal Ramsay Glacier rockfall of 9 November 2002

Institute of Geological & Nuclear Sciences science report 2003/2

November 2002

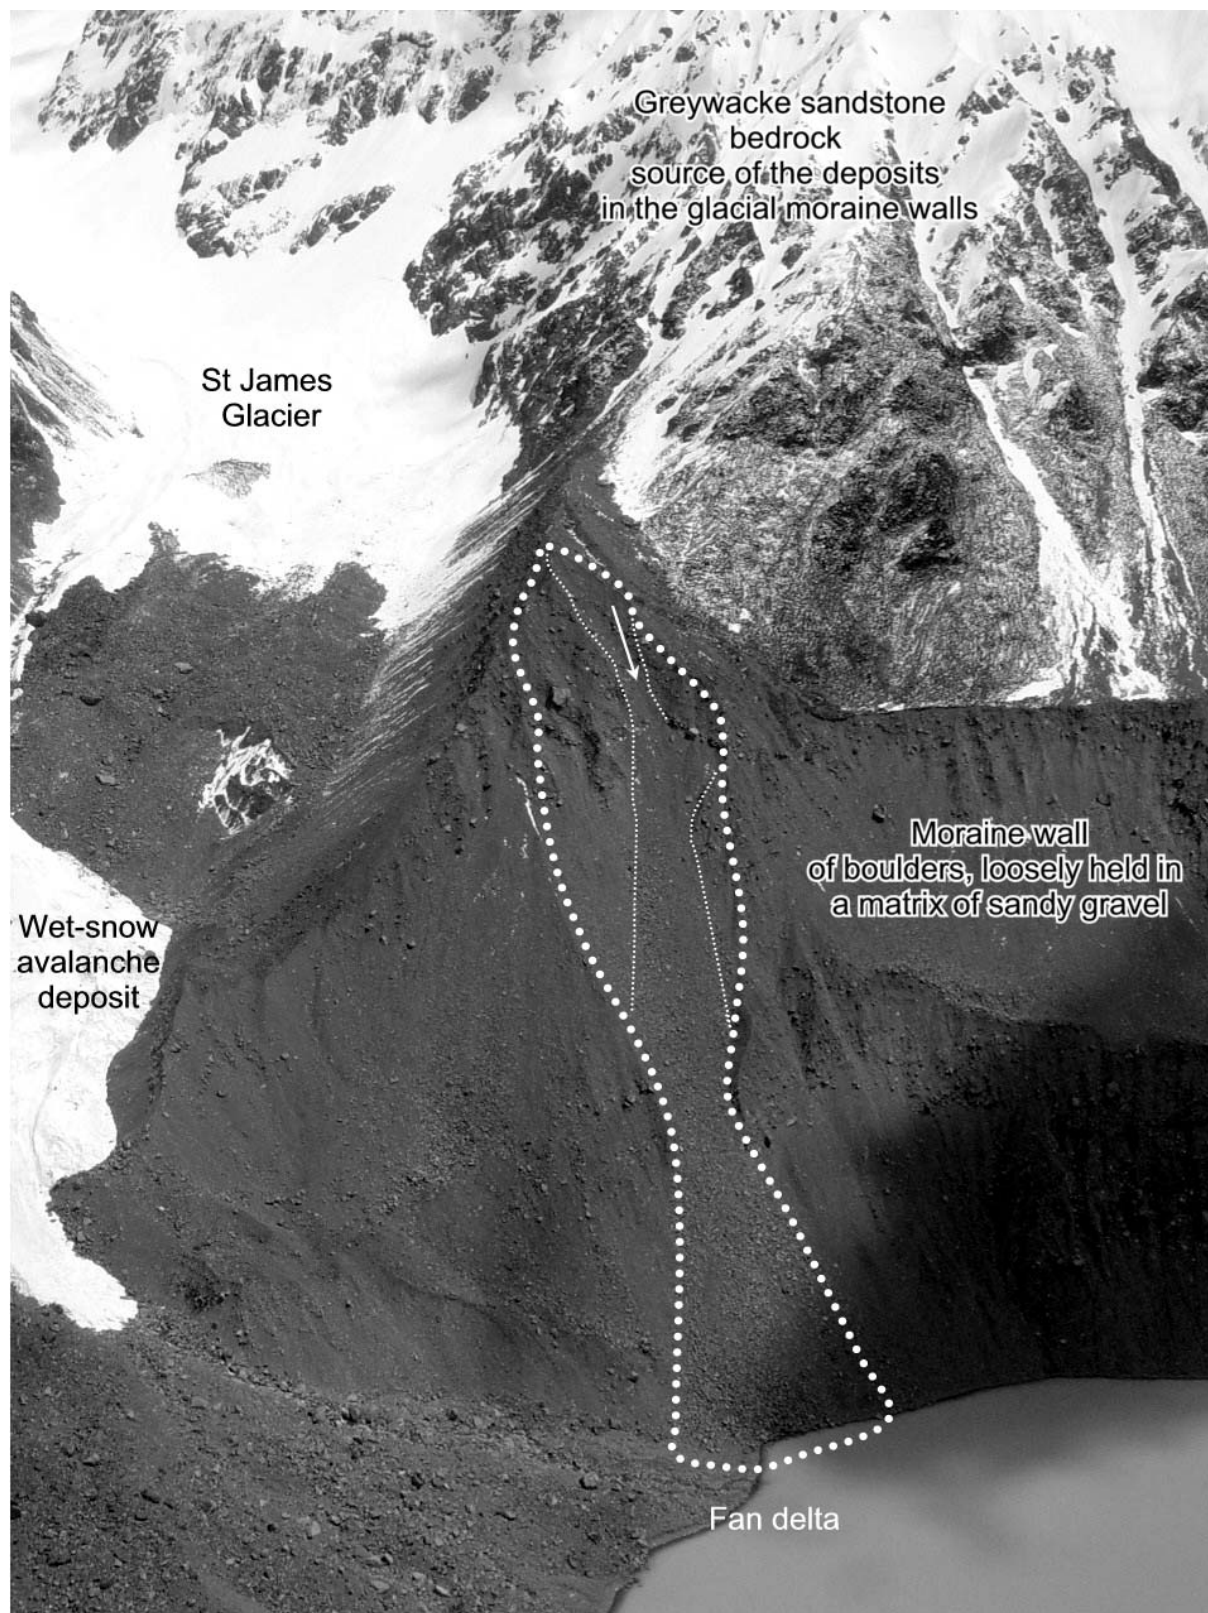
Frontispiece Hourglass shaped site of the fatal rapid debris fall (rockfall) that killed Simon Hassall on 9 November 2002. Some 5–10 thousand cubic metres of sand, gravel and boulders probably fell from the top right of the scar. Mr Hassall was traversing the lake edge from right to left and was within a few seconds of reaching the safe fan-delta in the centre foreground when one of many large boulders, travelling at 150 km/hr or more, knocked him into the lake. St James Glacier is at the upper left. Ramsay Glacier is to right of photograph.

The general bouldery gravel source of the rockfall was easily identifiable to within several hundred metres or so (Frontispiece, Fig. 6) during our visit, but the specific source scar could not be positively identified. A possible source suggested by the apparently very sharp edge to the local headscarp is indicated by the arrows on Figure 6. We could clearly recognise that the lower slope was a rockfall scree that had very recently experienced repeated rockfalls of a range of sizes. There was insufficient information to give us an accurate impression of the volume of the deposit of the fatal rockfall of 9 November 2002, but based on our estimate of the size of apparent scar at the crest (50m x 20 m and some 5 to 10 metres thick, Fig. 6), the collapse was likely to have been 5,000–10,000 cubic metres in volume. Within this debris, were many hundreds of very large boulders, greater than a metre in diameter, which were able to reach the lower slopes of the scree. We do not know how much debris went into the lake, and out of sight.

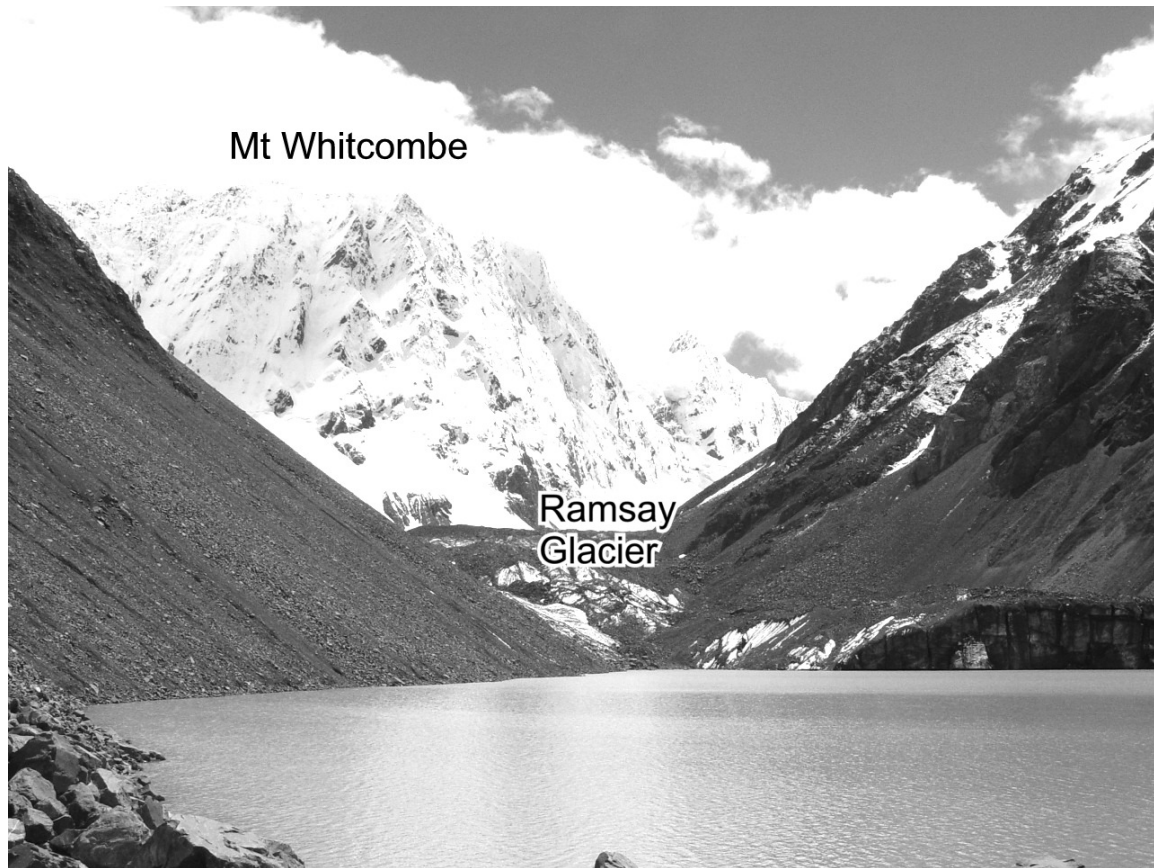
Figure 2a The access route to Ramsay Glacier, at the head of the lake, traverses the screes on the western, left, side of the lake. For the entire length of route over the screes, people are exposed to a risk of being hit by large boulders falling from the abandoned lateral moraine wall, deposited by Ramsay Glacier prior to 150 years ago. Debris from fatal rockfall forms the left foreground.

The route to Ramsay Glacier traverses amongst the boulders at the foot of the slope (Figs 2, 5). It is not a marked track or a discernible path - the screes are too active to retain evidence of human passage – but it is a logical route.

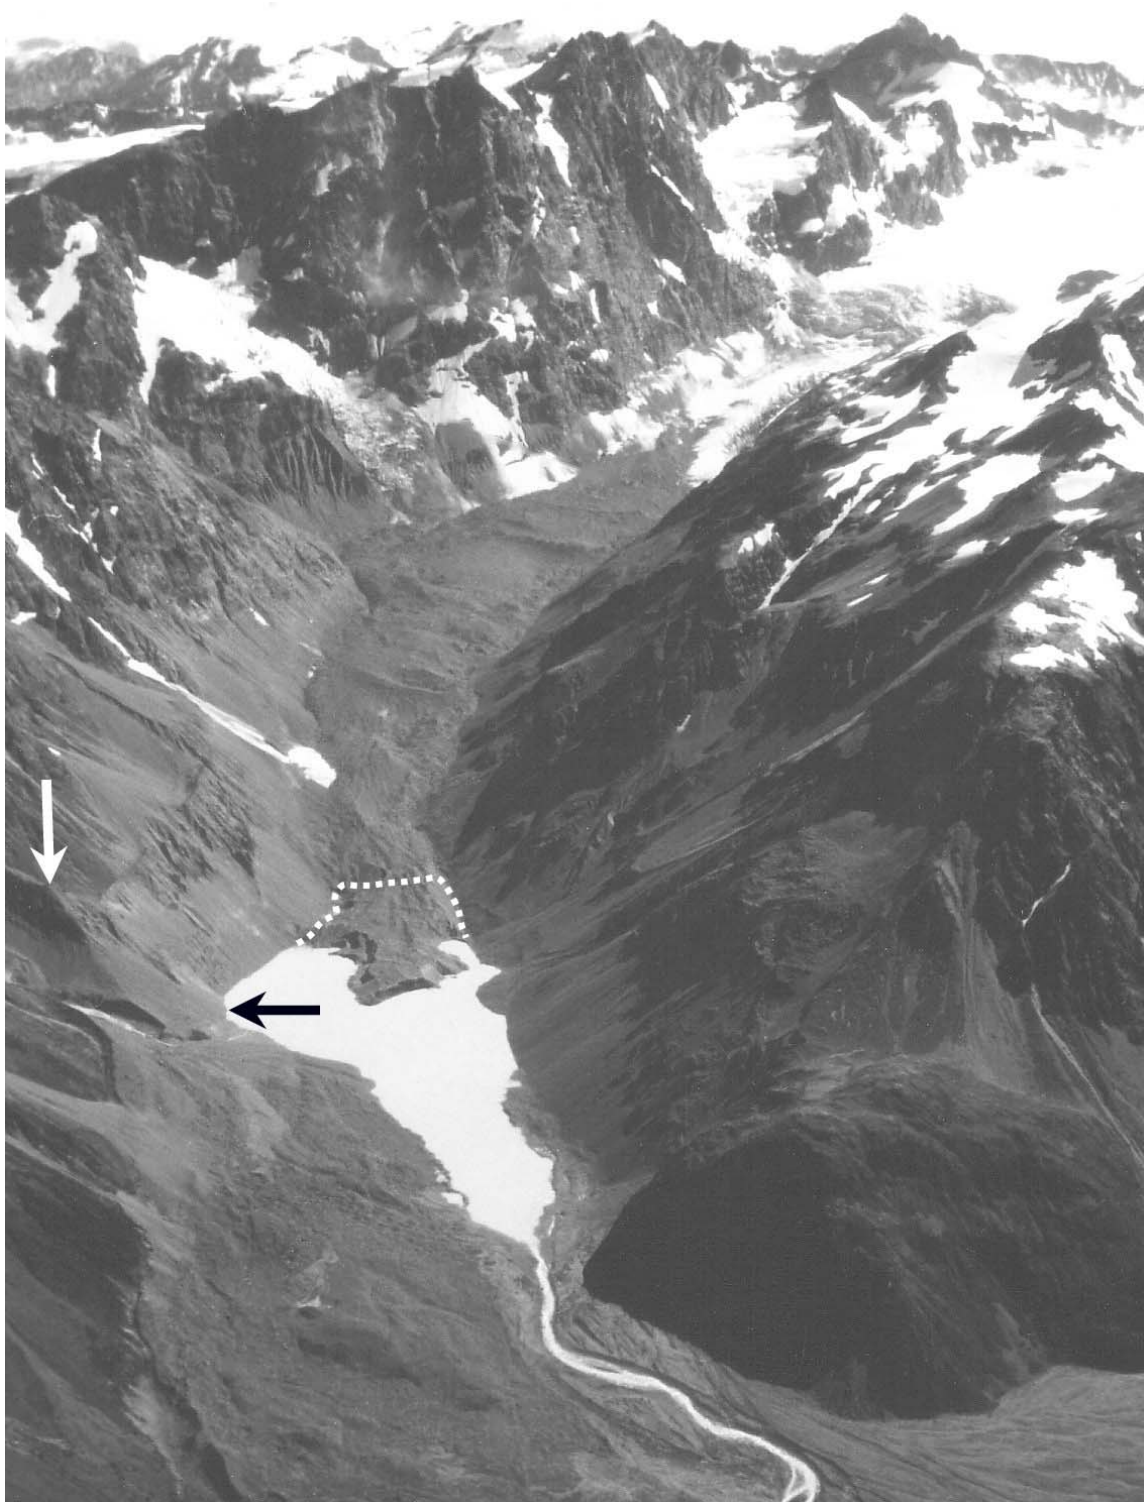
Figure 2b Aerial view to north of Ramsay Glacier. Approximate extent of lake in November 2002 is shown by the dotted line. Arrows mark the location of the fatal debris fall. The access route to the glacier traverses the western (left) side of the lake. For the entire length of route over the screes between the black arrow and the glacier, people are exposed to a risk of being hit by large boulders falling from above. The valley wall on the eastern (right) side of the lake lacks deposits of bouldery glacial moraine, but the highly fractured bedrock there is a source of rockfalls that were heard many times during our one-hour site inspection. There is no access route to the lower glacier not exposed to a rockfall hazard. Frequent rockfalls have created these screes that make the lakeshore route passable. Photograph taken in 1995 by Trevor Chinn.

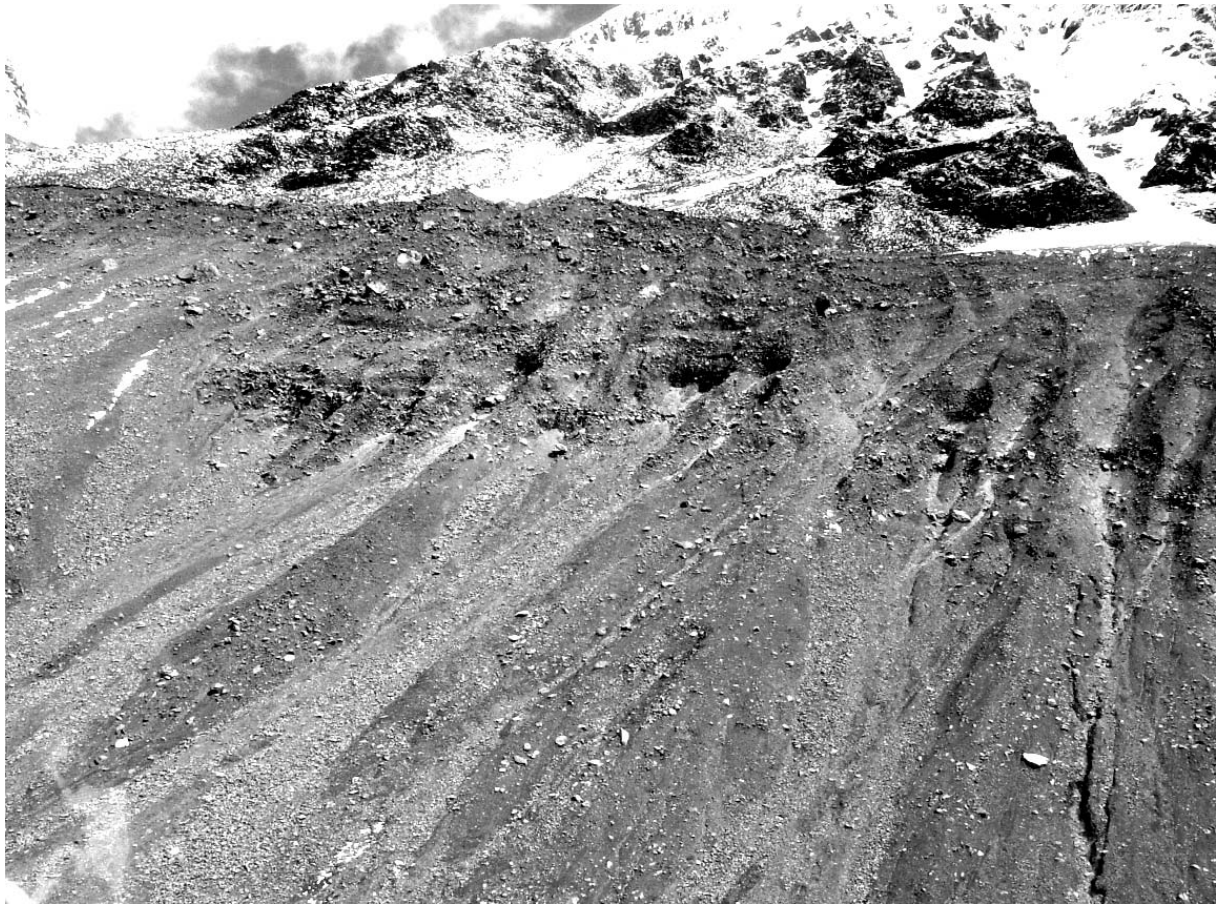
The moraine wall (Fig. 3) is made of weakly consolidated bouldery, sandy gravel, very weakly held together by coatings of silt. Many of the boulders exceed one metre across and some exceed 10 metres. The upper and middle slopes of the wall stand at slope angles of 50 to 60° (Fig. 4). The moraine was deposited by the Ramsay Glacier during the 18th and 19th centuries. The lower part of the wall is mantled by a series of coalescing screes along the lake shore (Figs 2, 5). These screes were formed by dry raveling of the loose moraine debris, after glacier recession removed the ice that previously supported the moraine. The screes stand at slope angles of 25 to 35° and are at the margin of stability (angle of repose) for their loose materials.

Figure 3 View of the upper moraine wall north of the site of the fatal debris fall (out of view to left). The moraine material consists of large boulders loosely held in a sandy gravel matrix. It loses much of its low strength when wet. Loosened debris cascades from the upper wall to form the bouldery scree slopes at the lake shore. The larger boulders in this view are around 10 metres across. The east face of Mt Ramsay forms the background.

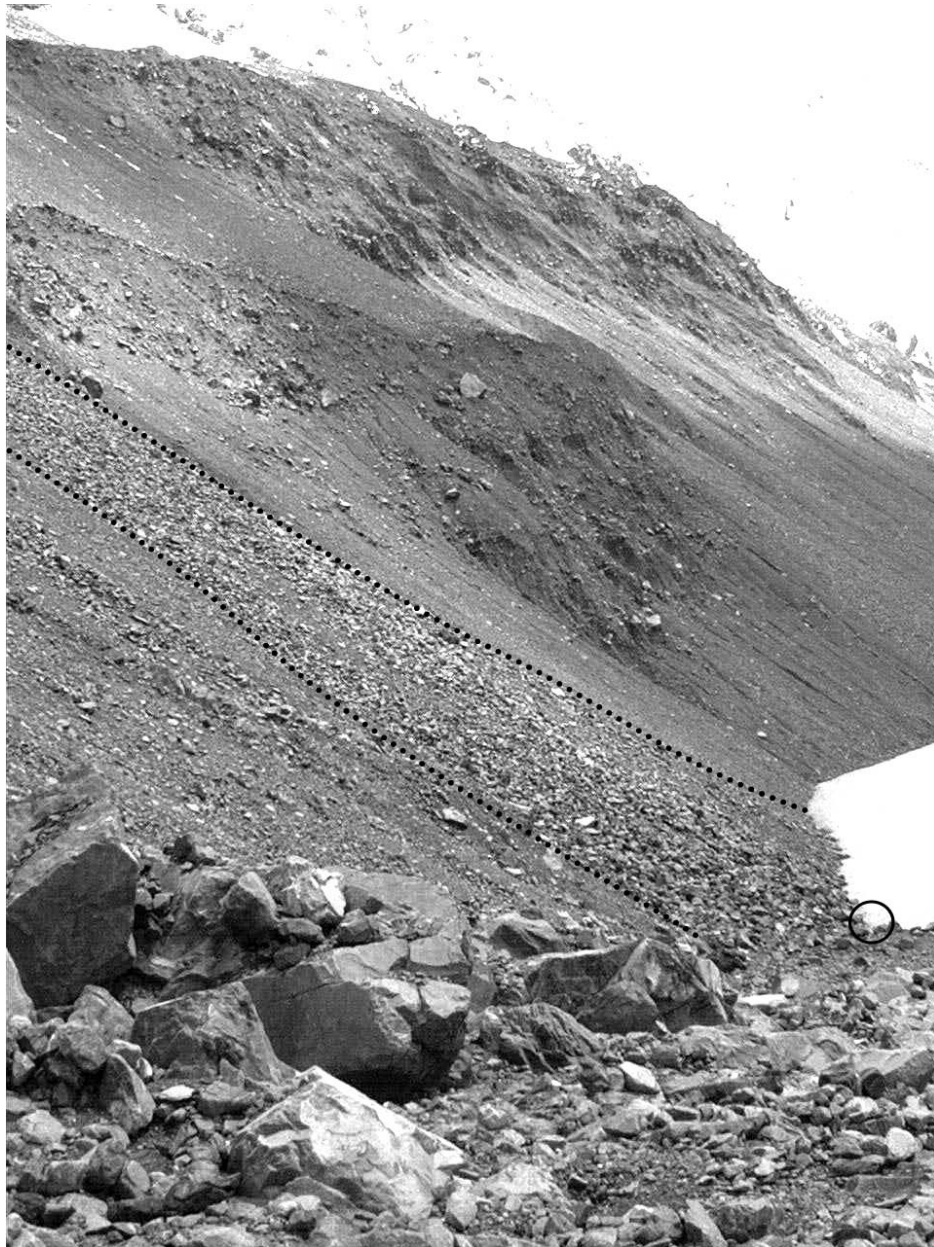
Figure 4 View to north along the abandoned lateral moraine wall of the Ramsay Glacier. The scree where the fatal rockfall (debris fall) occurred is outlined. Circle indicates approximately where Mr Hassall was hit by a boulder and knocked into the lake.

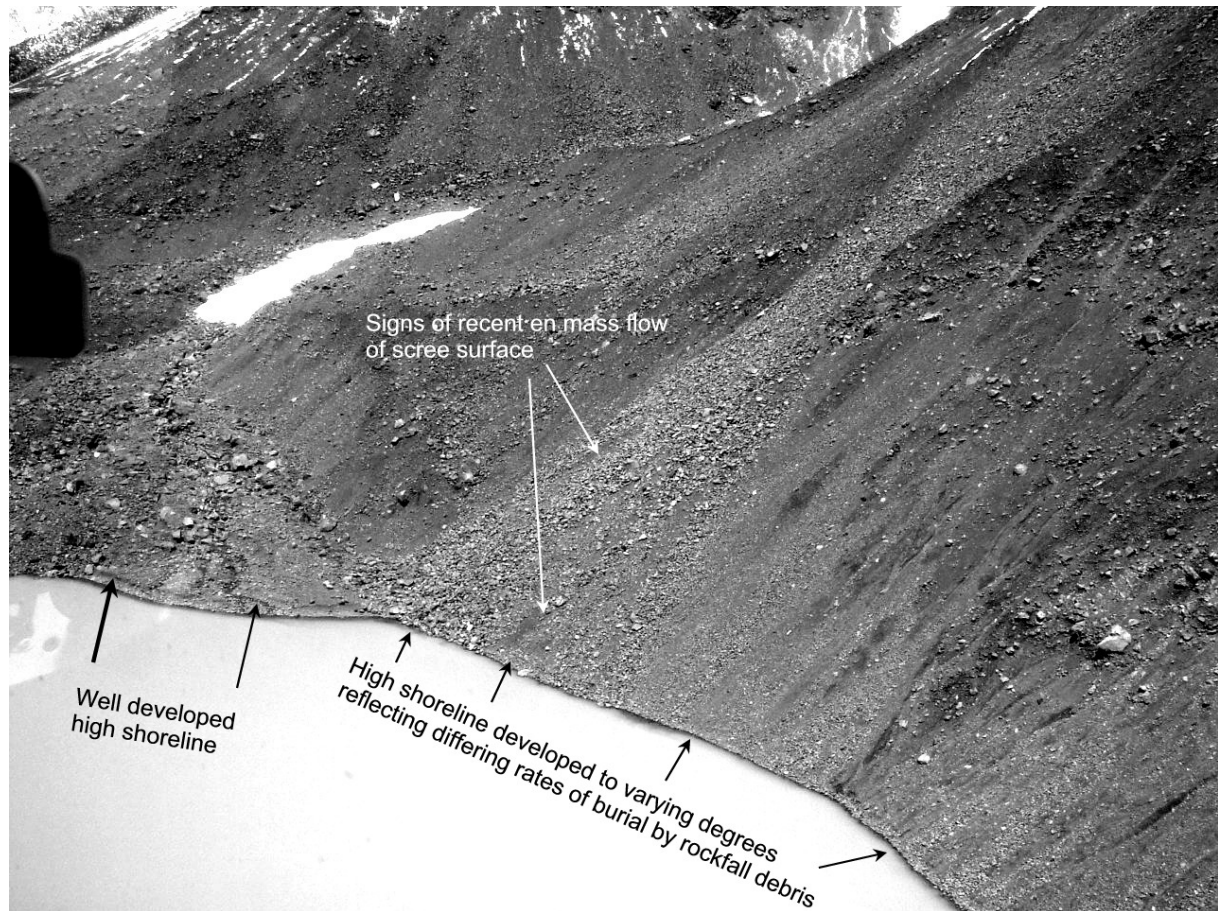
Figure 5 The edge of the lake showing accident site (circled) at the junction of the rockfall scree with the fan-delta. The faint line parallel to the lake shore is a shoreline formed when the lake level is higher during heavy rain. The route to Ramsay Glacier (out of view some 500 metres to right foreground) traverses at about this level. White arrows point to areas of recent *en masse* flow of the scree surface.

The material that collapsed was coarse gravel with boulders in it, but most of the stones that reached the accident site were very large boulders (up to several metres across) (Fig. 7), or fragments flying from them during very high velocity collisions with other boulders. All of the finer material from the source was trapped between boulders on the upper slopes of the scree, and only the coarsest boulders reached the bottom of the slope (Fig. 8). Most of the initial collapsing debris mass consisted of much finer material, and so, this process is steepening the upper scree slopes. Collapses have been occurring for decades. Episodically, the steepening surface layers of the scree are sufficiently disturbed that they begin to flow *en masse* to lower on the slope. Evidence of recent *en masse* flows of portions of the scree surface can be seen in Figs 5 and 7.

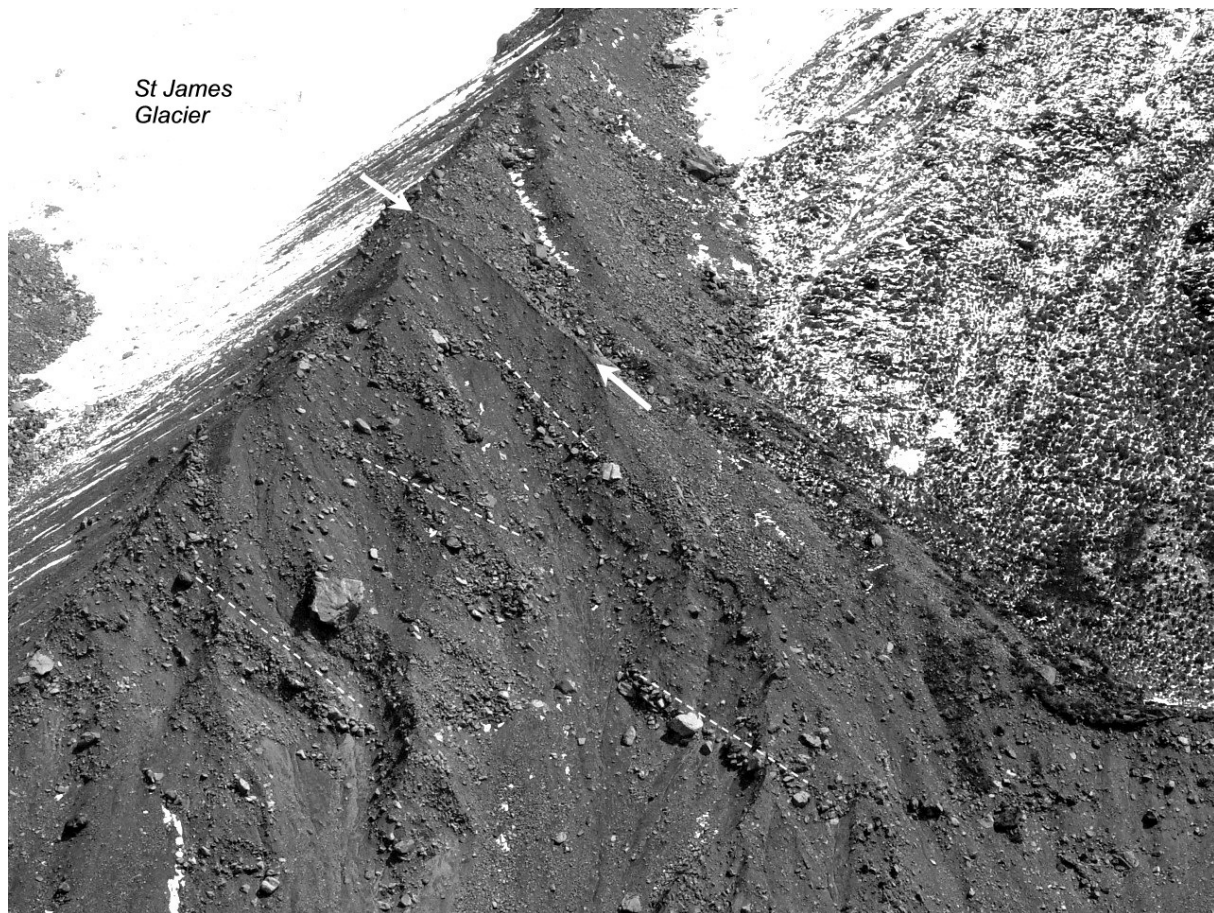
Figure 6 Closer view of the source area of the fatal rockfall (debris fall). Here dry ravelling of the loose material is sapping at the former left lateral moraine of St James Glacier. As sapping progresses, the height of the slope is increasing. The larger boulder here is about ten metres across. Note crude stratification in the deposits with bedding sub parallel to the upper surface of the glacier moraine (indicated by dotted lines). Boulders lie with their longer axes sub parallel to this bedding. The fatal rockfall came from within this view. Arrows indicate a section with apparently very sharp edges that may represent the fresh headscarp of the debris-fall zone of depletion. The “fresh” area is some 50 metres by 20 metres, representing a loss of some 5,000–10,000 cubic metres of debris. St James Glacier last stood at the crest of this moraine about the middle of the 19th century.

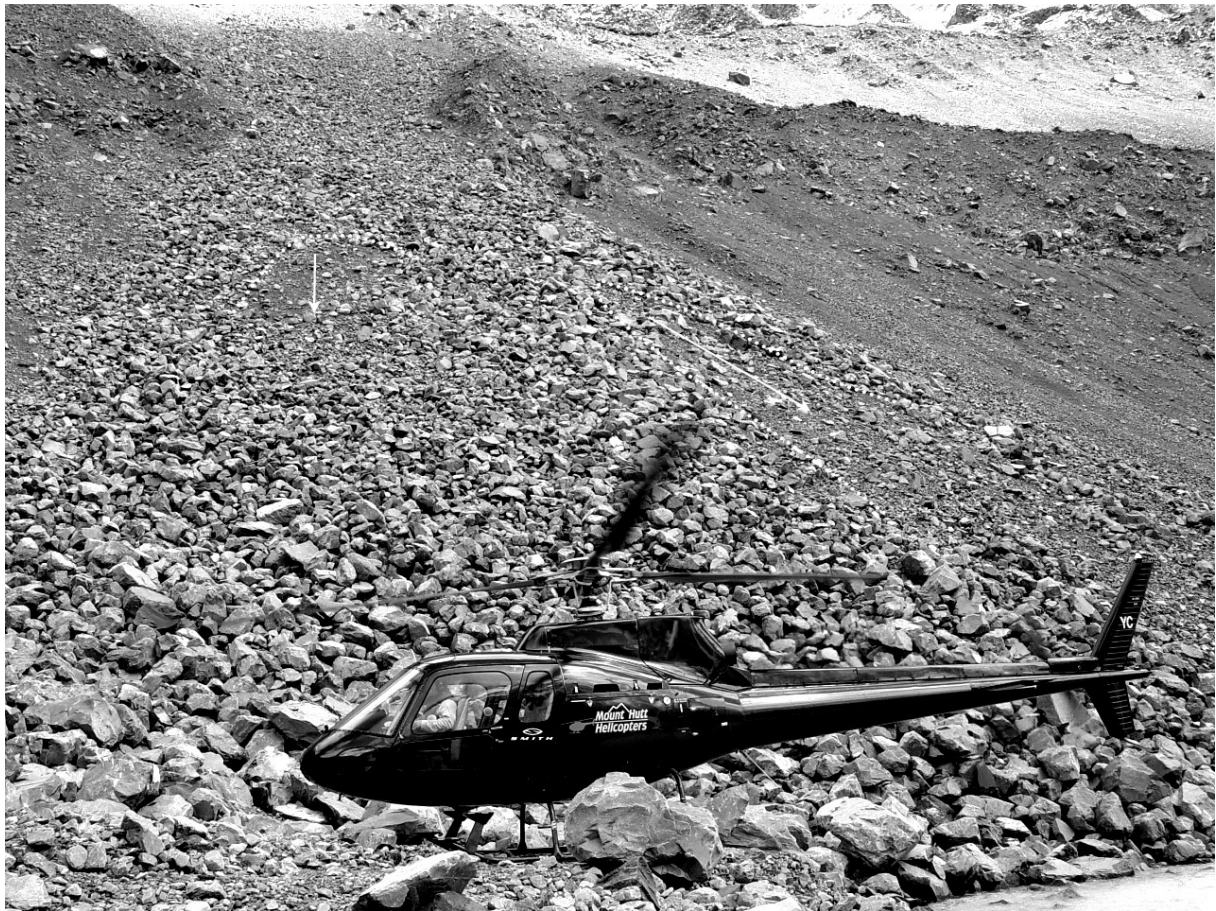
mostly by huge to enormous boulders (Fig. 7), representing the coarser debris transported downslope from the source area. The larger boulders falling from the upper slope reach to the base of the rockfall scree (Fig. 8) and out into the lake. The accident occurred at the southern foot of the scree below the scar (Fig. 1b).

Figure 7 The scree of large boulders where the accident occurred. The neck of the hourglass is in the upper left, and the lake edge in the lower right. Not all of these boulders fell in the debris fall (rockfall) of 9 November 2002. Note large boulders that have rolled or skipped beyond the foot of the scree. Boulders were found to 40 metres beyond the lower scree, indicating a minimum speed of 150 km/hr. Dotted lines indicate the headscarp of very recent *en masse* flows in the surface layers of the scree slope.

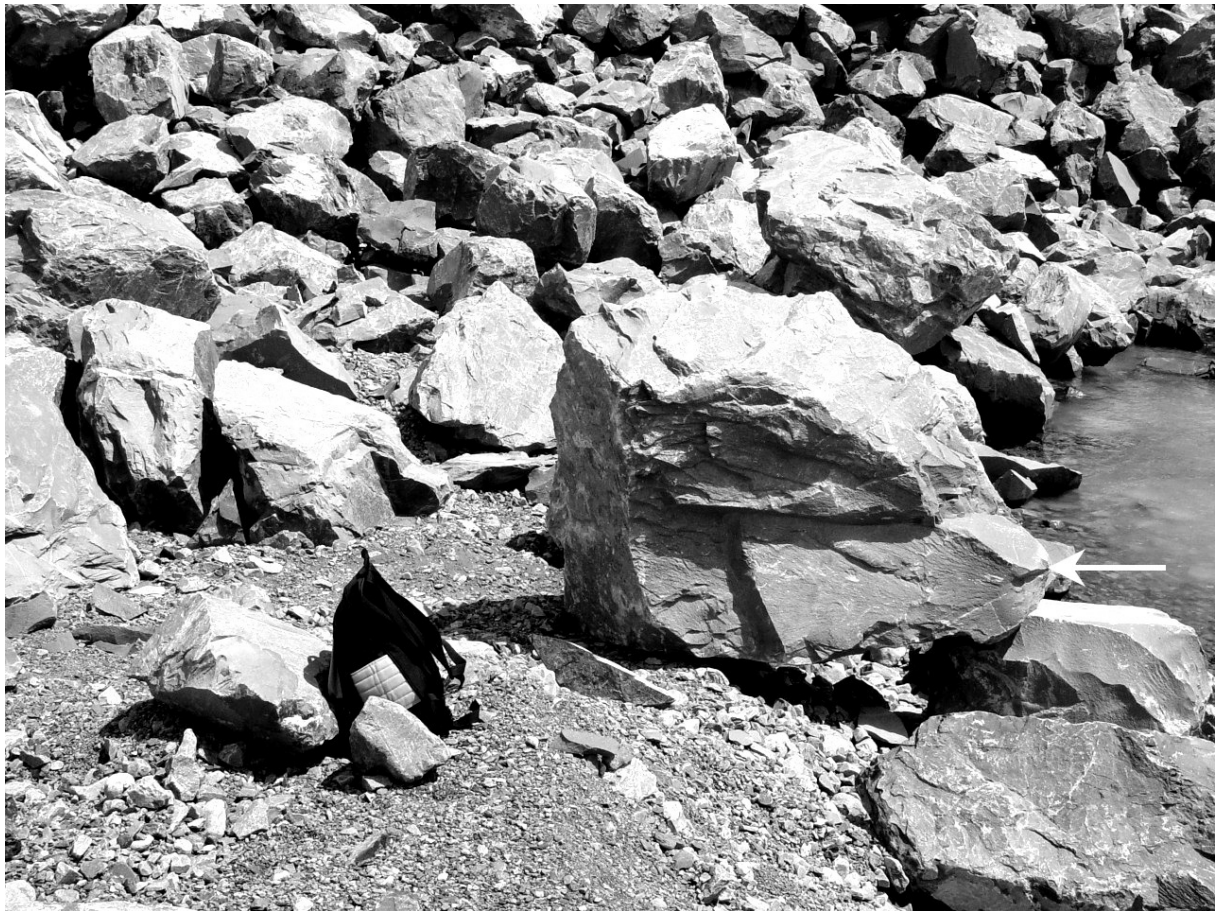
Figure 8 Close view of some of the freshly fallen boulders at the lake edge. Pack is 450 mm high for scale. Note the enormous fresh impact scar on the boulder to the right of the pack, marked by a fan-shaped array of lines on a rock face, radiating away from the point of impact. (marked by arrow). See Figure 9 for close view of this fresh impact scar.

The boulders that fell from the moraine were of high strength, grey to dark grey, fresh greywacke sandstone. There was abundant evidence for very-high-energy impacts between boulders (Figs 8, 9). Most boulders were sharply angular and had scratches, gouges and obvious fresh fracture surfaces due to impact with other particles. Fracturing of this very hard material (Figs 9, 10) required considerable energy, indicating that individual boulders were travelling at many metres per second during the event. Many of the boulders skipped and jumped along their fall path, and the slope would have been sprayed with “shrapnel” during the 9 November rockfall. Sharply angular, freshly fractured rock fragments (Fig. 11) were found up to 40 metres beyond the foot of the slope, attesting to the high velocity of the flying rock fragments (simple calculation of their ballistic trajectories indicates a minimum speed of 42m/s [150 km/hr]). There also were several impact craters about 150 mm deep and 200-300 mm across on the alluvial fan beyond the foot of the scree, marking where large boulders had hit the fan as they bounced beyond the foot of the scree.

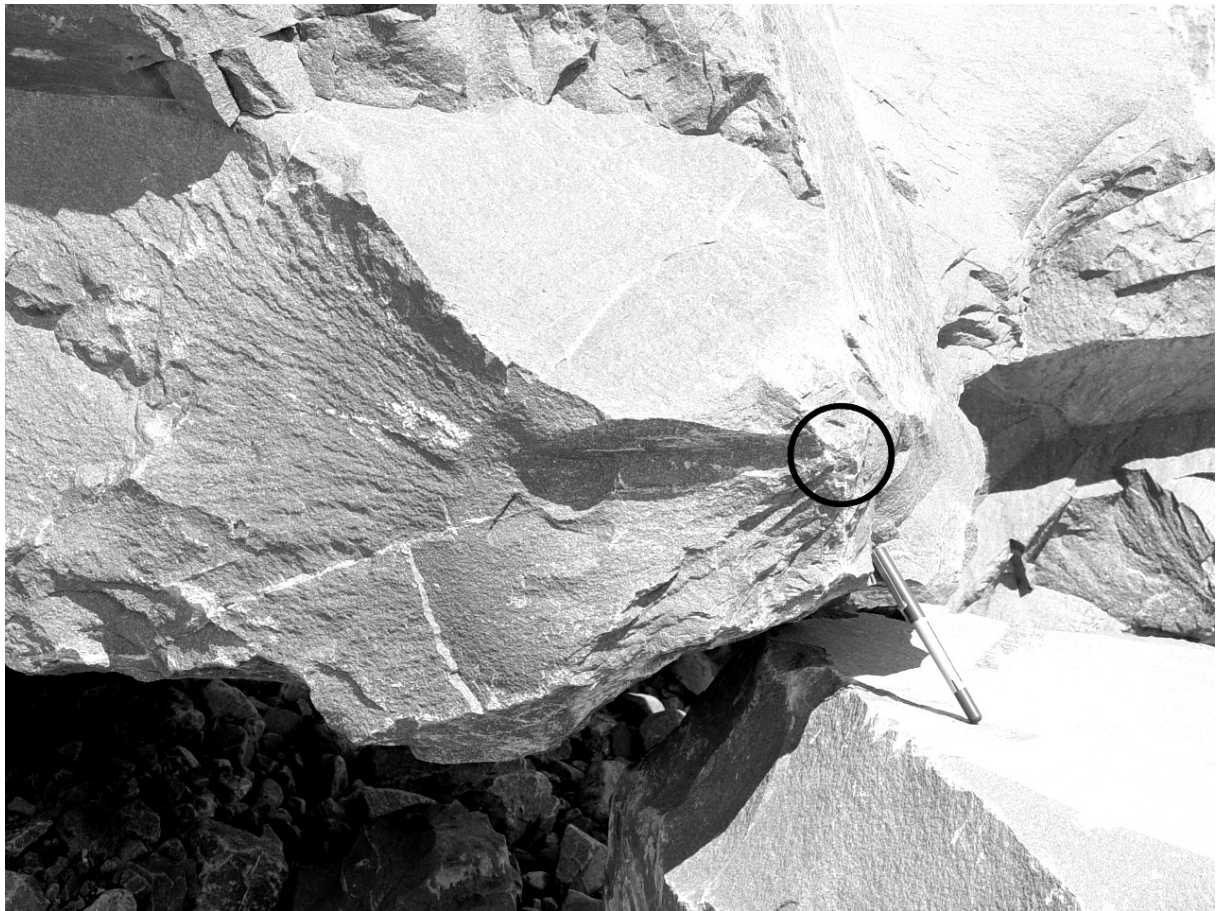
Figure 9 Close view of a typical scar on the fresh greywacke sandstone from the high-speed impacts of boulders during the debris fall. Some of these boulders were rolling and skipping down the scree and flew beyond the scree margins with minimum speeds of 150 km/hr. Pen is 140 mm for scale. Circle marks point of impact.

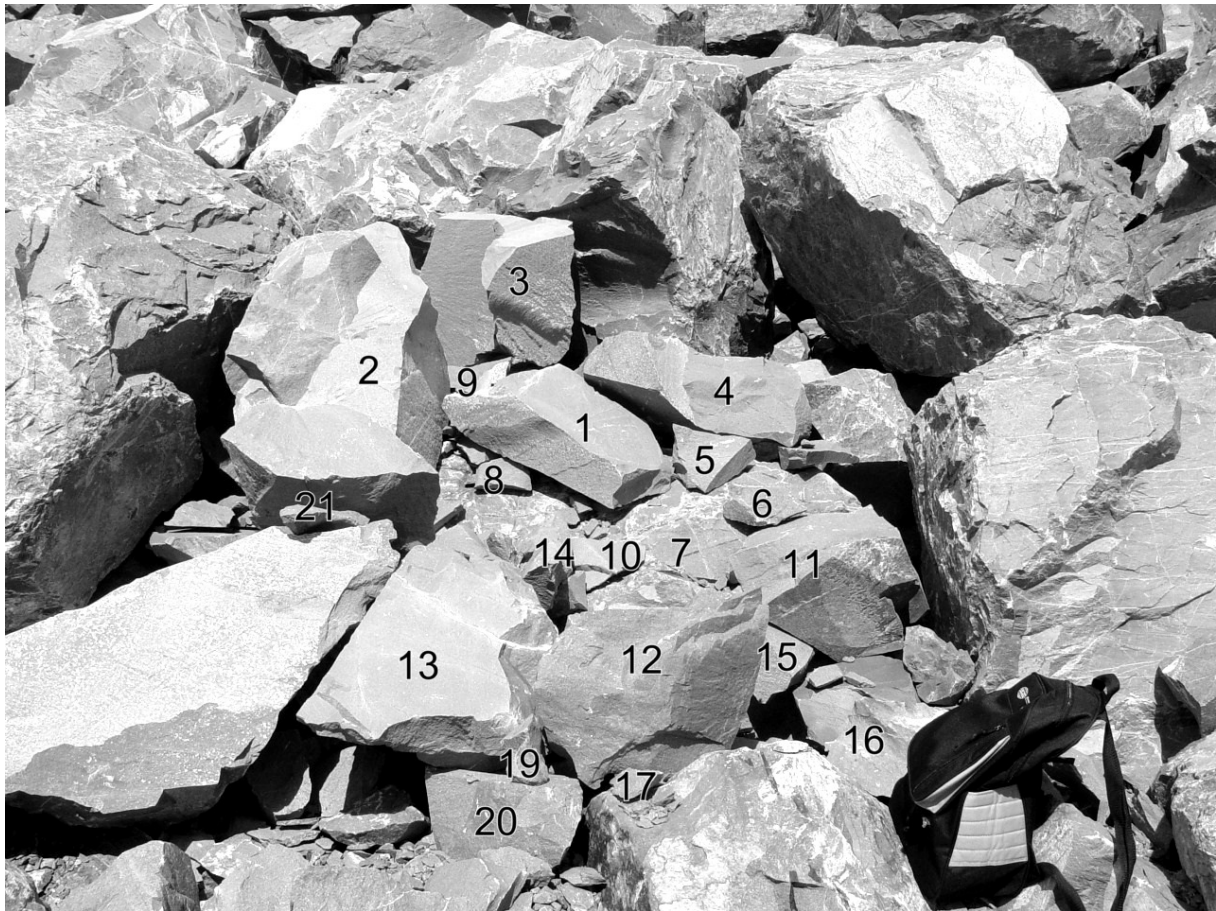
Figure 10 A cluster of fragments of a freshly fractured boulder at the foot of the rockfall scree. Pack is 450 mm high. All of these boulders are lying on alluvial gravel deposited by the stream draining from St James Glacier. Thus these boulders have travelled beyond the foot of the rockfall scree, either by rolling or leaping. To break a large fresh greywacke sandstone boulder into the myriad of fragments seen here requires an enormous amount of energy from a collision between two boulders. To reach this site requires one of them to have been travelling on a ballistic trajectory at a minimum speed of 150 km/hr. It is not known if these fragments are from the flying boulder, or from another hit by it.

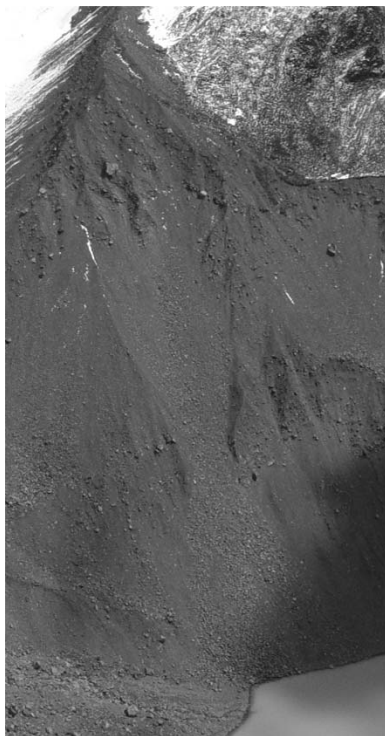
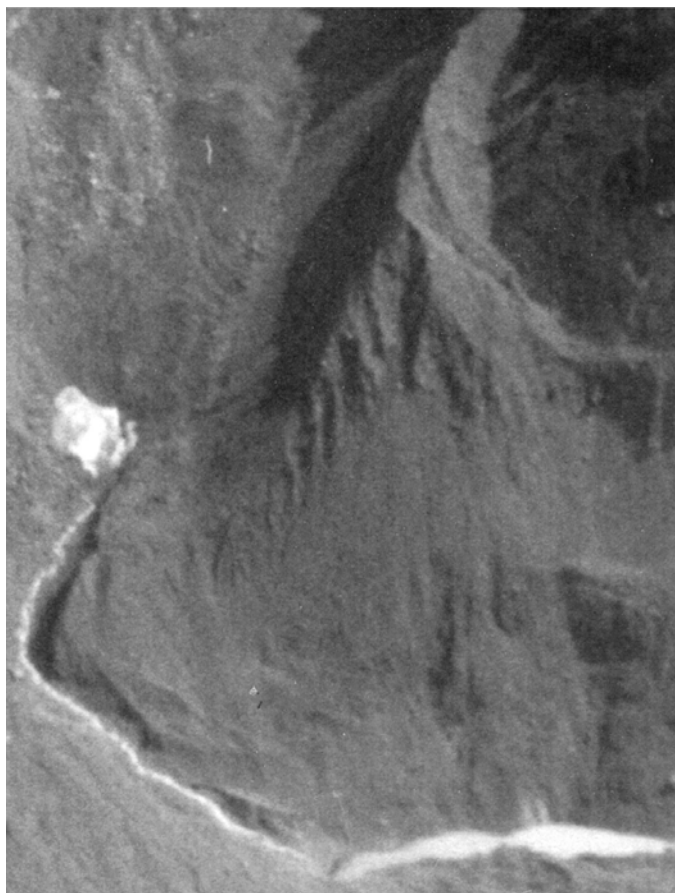
Endpiece Aerial views of the site of the fatal debris fall in November 2002 (left) and March 1985 (right). Earlier view is an extreme enlargement of a photograph by Trevor Chinn.
