**Reconnaissance studies
of landslides and other
ground damage caused
by the Mw 7.2 Fiordland
earthquake of 22 August
2003**

**G.T. Hancox, S. Cox,
I.M. Turnbull and
M.J. Crozier**

November 2003

Institute of Geological & Nuclear Sciences science report 2003/30

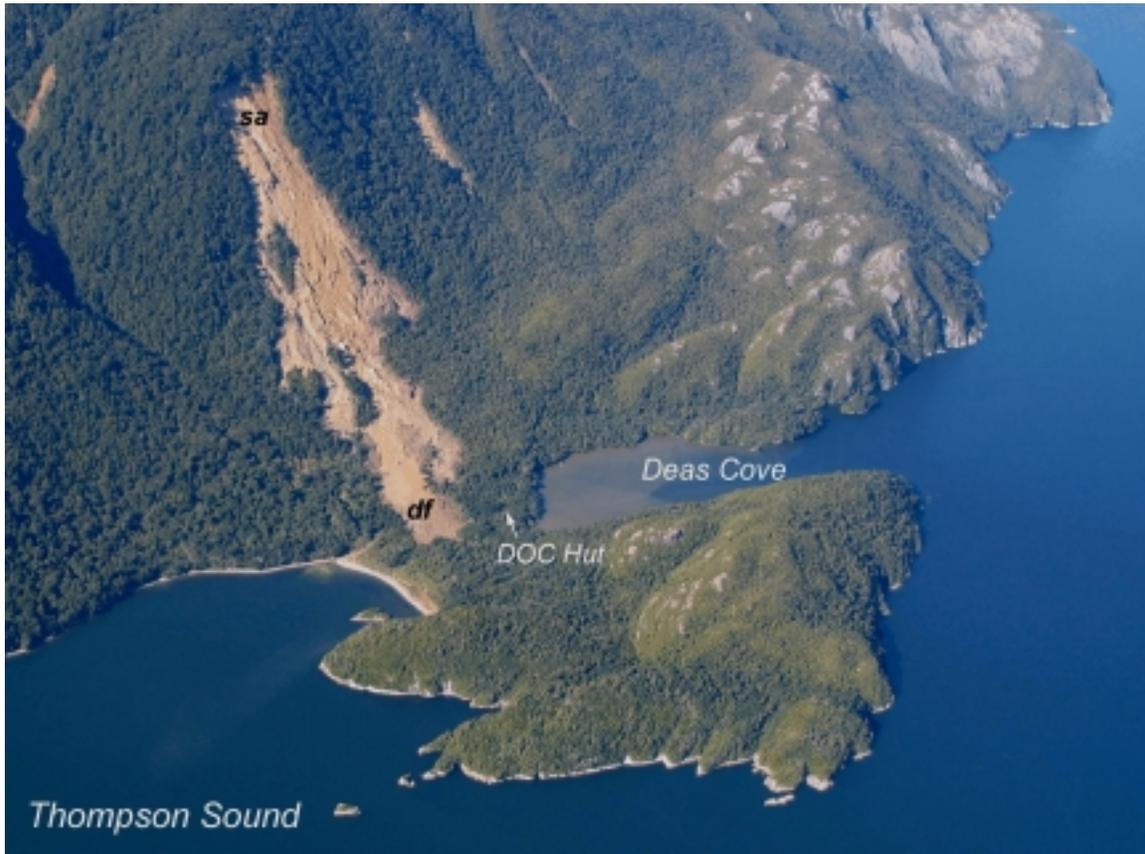
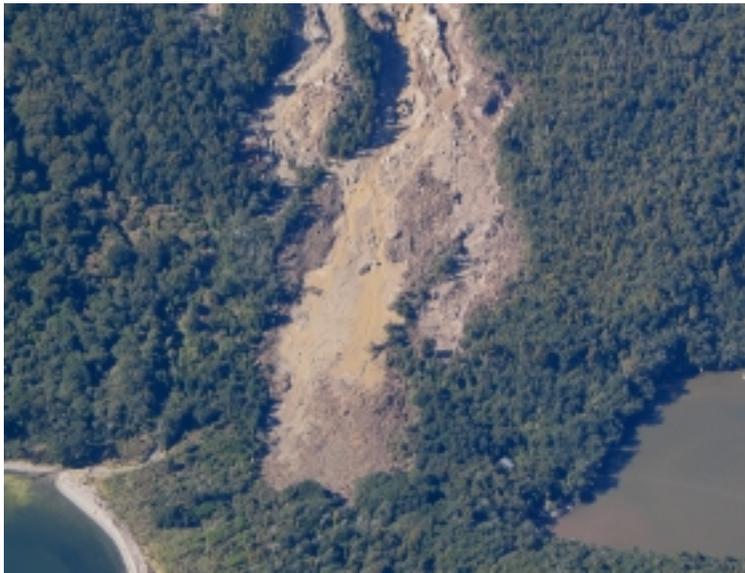
Figure 4. Aerial photos of the large ($\sim 625,000 \text{ m}^3$) debris slide at Deas Cove in Thompson Sound (Slide 1, Table 3). The upper photo shows the location and overall extent of the slide. The vertical fall is about 500 m from the source area (*sa*) to the debris flow (*df*) at the slide toe, which extends to about 50 m from the DOC hut. The lower photo shows more clearly the debris flow at the toe and its close proximity to the DOC hut (in small clearing to the right of the slide toe).

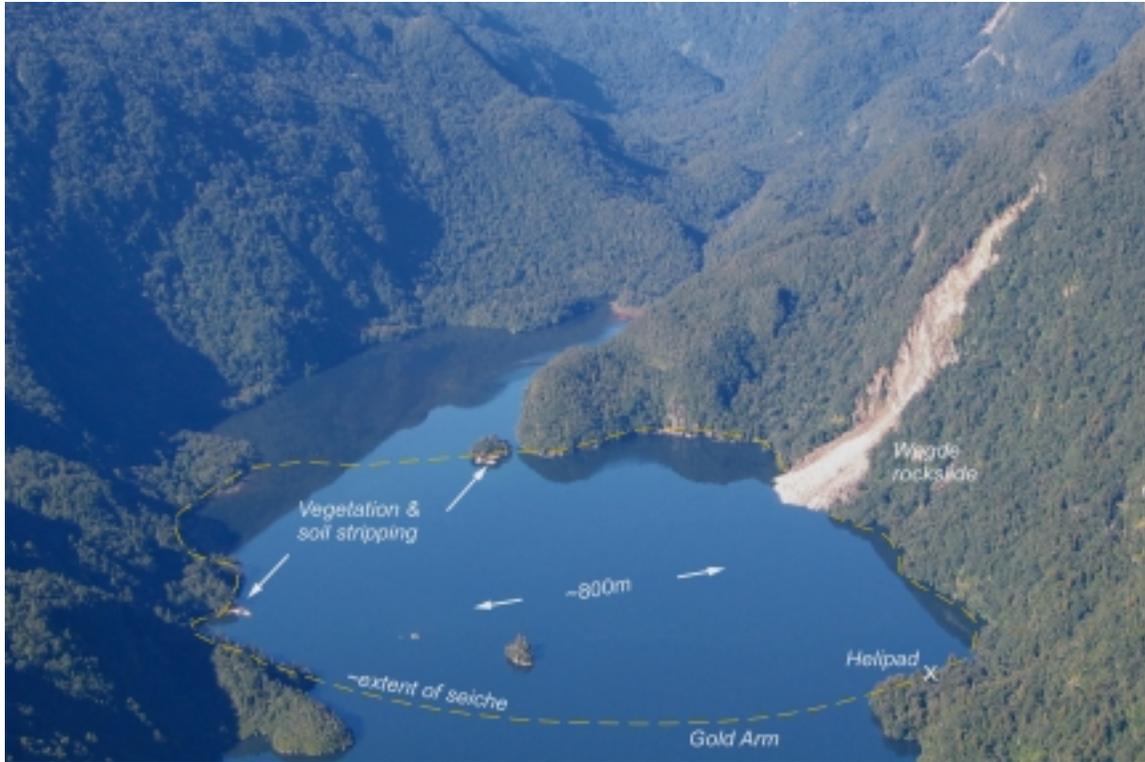
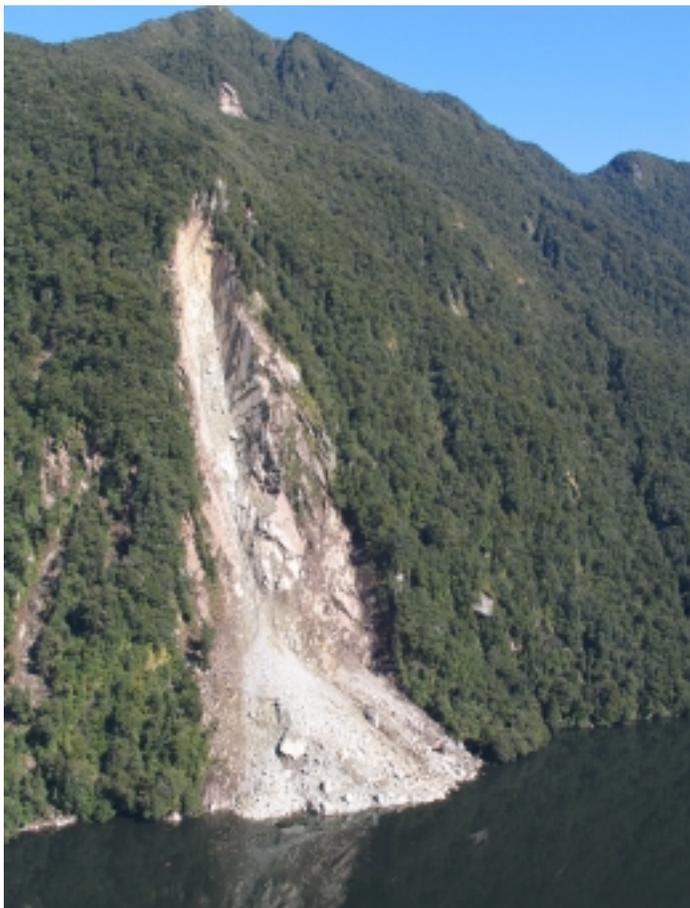
2. Gold Arm, Charles Sound	Rock slide (wedge failure)	0.05 (Depth ~3-4m)	150,000 - 200,000	40 (SA) 30 (DR)	N -350	Gneiss	Large rock wedge failure in gneiss bedrock. Map shows debris cone from previous failures at this location. Caused small tsunami (wave) in sound which affected an area of ~0.45 km ² .

Another spectacular slide occurred in Gold Arm of Charles Sound (Slide 2, Figure 3), where a large (150,000–200,000 m³) wedge failure in gneiss bedrock collapsed into the fiord from the steep (40°) southern slope (Figure 5). The rock fall created a wave which travelled ~800 m across the fiord and damaged vegetation up to 4-5 m above high tide on the northern side, where trees were debarked and soil and vegetation stripped from the rock. Similar damage also occurred across on the western half of a small island in the fiord, 500 m northeast of the rock slide. About 250 m to the west the wave displaced a helipad on piles and an adjacent wharf, moving them several metres up the beach – but without any other apparent damage. A pre-existing rock fall cone at the rock slide site shows that this too was a reactivated old landslide. Apart from this landslide-induced wave in Gold Arm, to the authors' knowledge no other earthquake-induced waves have been reported either on the sounds or in the lakes.

Figure 5. Aerial photos of the large (~200,000 m³) wedge rockfall slide in Gold Arm of Charles Sound (Slide 2, Table 3). The top photo shows the slide location and overall extent of the slide. The vertical fall is about 350 m, on a 40° slope. The rock fall caused a small tsunami (wave) which travelled ~800m across the sound, where it damaged vegetation and soil up to 4–5 m above high tide level on the northern side, and stripped vegetation off part of a small island. It also damaged a helipad ~250 m west of the slide (bottom right). The lower photo shows a closer view of the foliation and joint-controlled failure area and rock fall debris cone. Weathered rock adjacent to the slide and a pre-existing debris cone at the site show this to be an old slide area that was reactivated and enlarged by the earthquake.

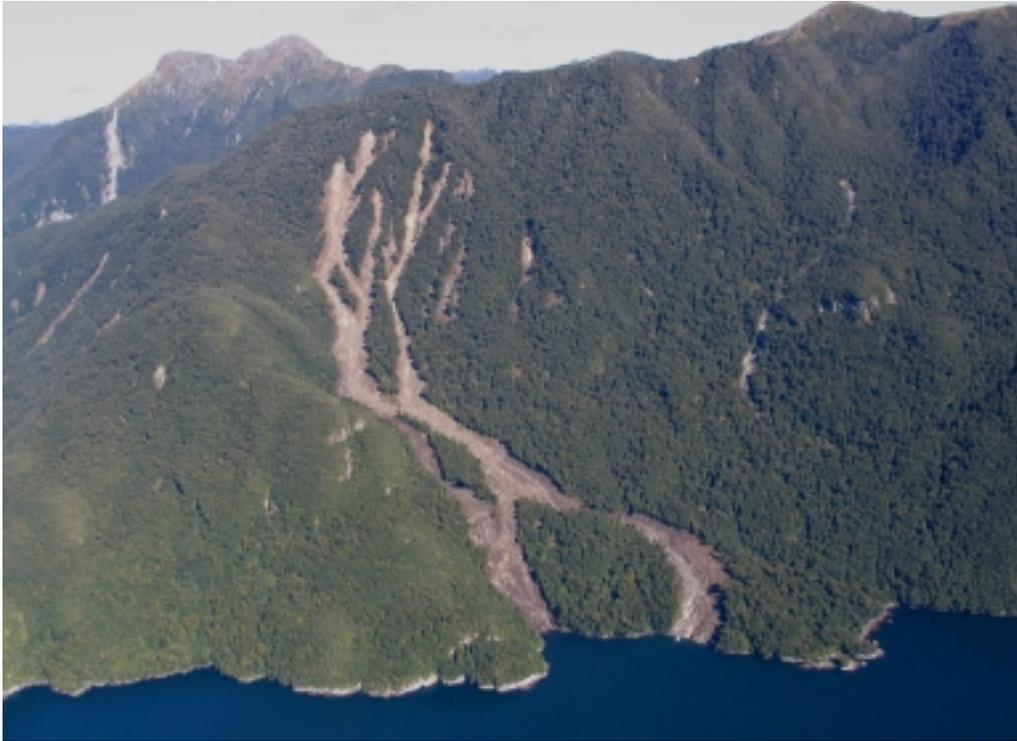
Figure 6. Large debris slide and flow on southern side of Charles Sound (Slide 3, Table 3), where multiple debris slides in steep gullies have merged forming a ~1600 m long debris flow runout zone which bifurcates and overtops the bounding ridge to the east (left). The vertical fall is ~800 m.

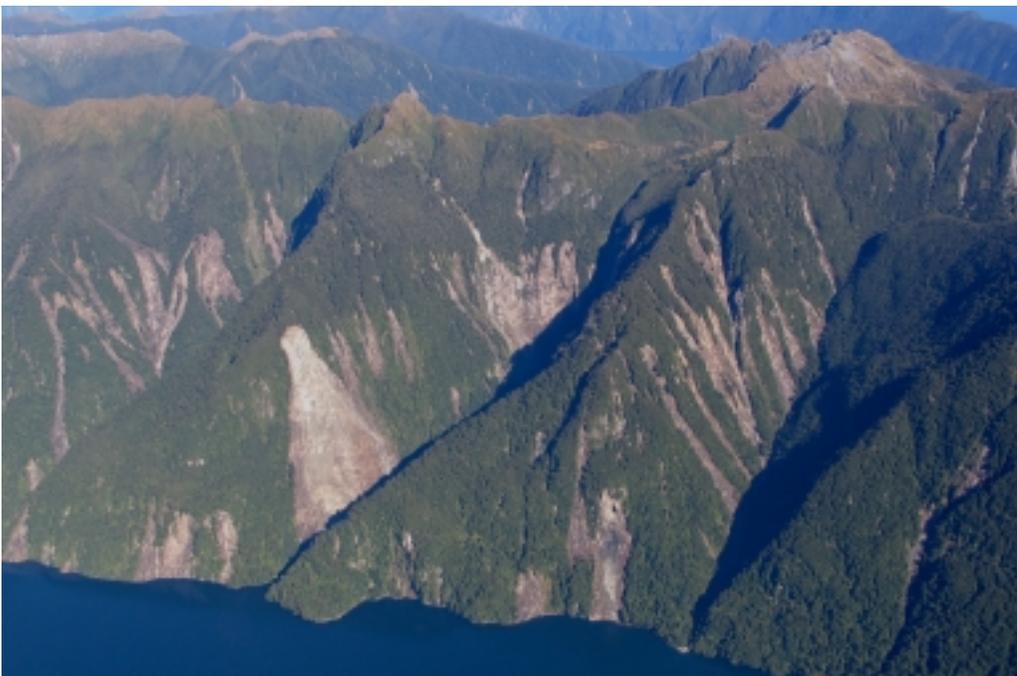
Figure 7. Large rock fall debris slide (centre left- slide 4, Table 3) and multiple shallow narrow debris slides on steep (45-50°) slopes of side streams on the south side of Nancy Sound. Note the preferential development of landsliding on north-facing slopes.

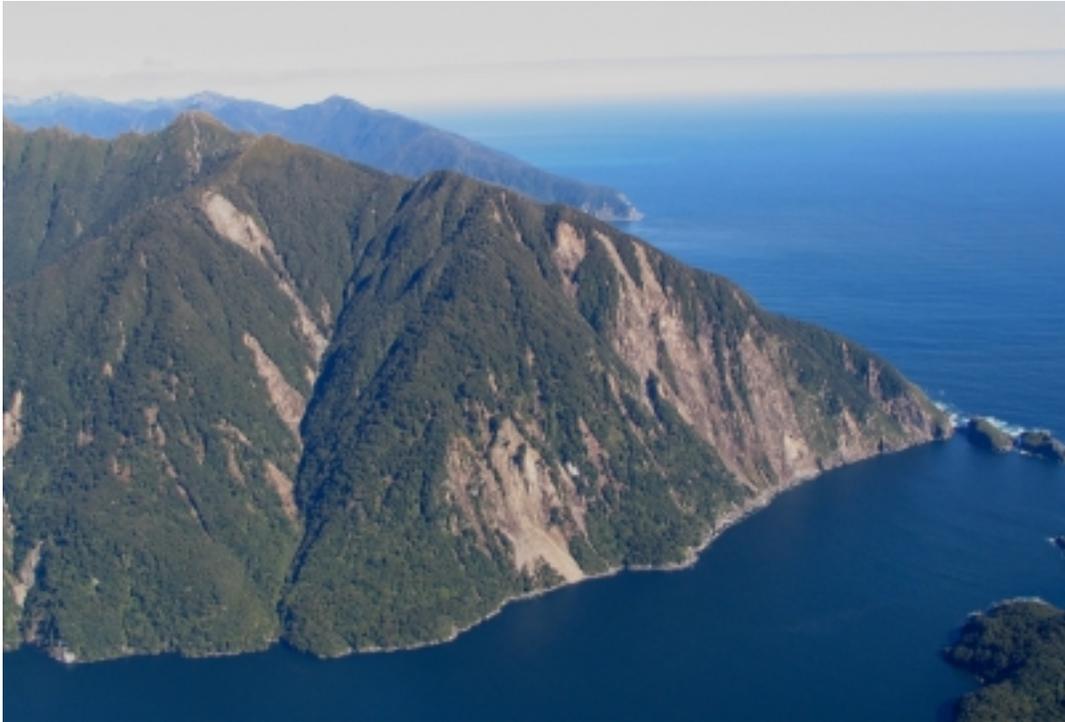
Figure 8. Multiple shallow debris slides on the steep ($45\text{-}55^\circ$) slopes of the headland on the south side of Nancy Sound (Slide 7, Table 3). Preferential landsliding on north-facing slopes is also evident here.

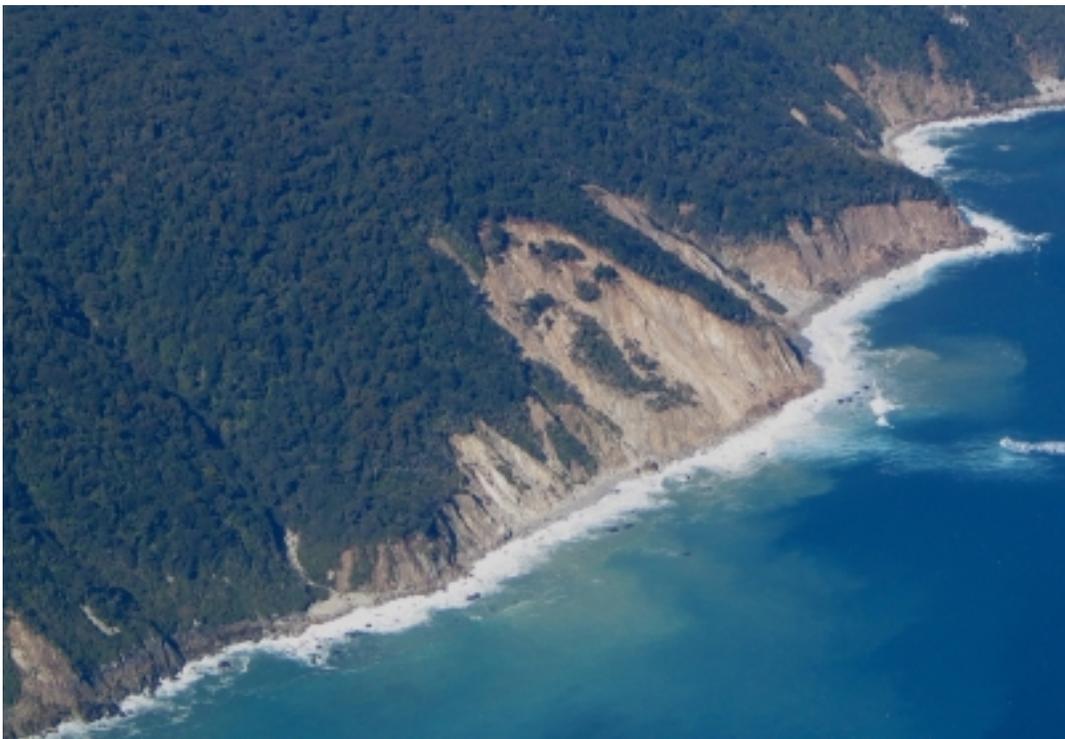
Figure 9. Debris slides and falls on the west coast of Secretary Island (Slide 5, Table 3).

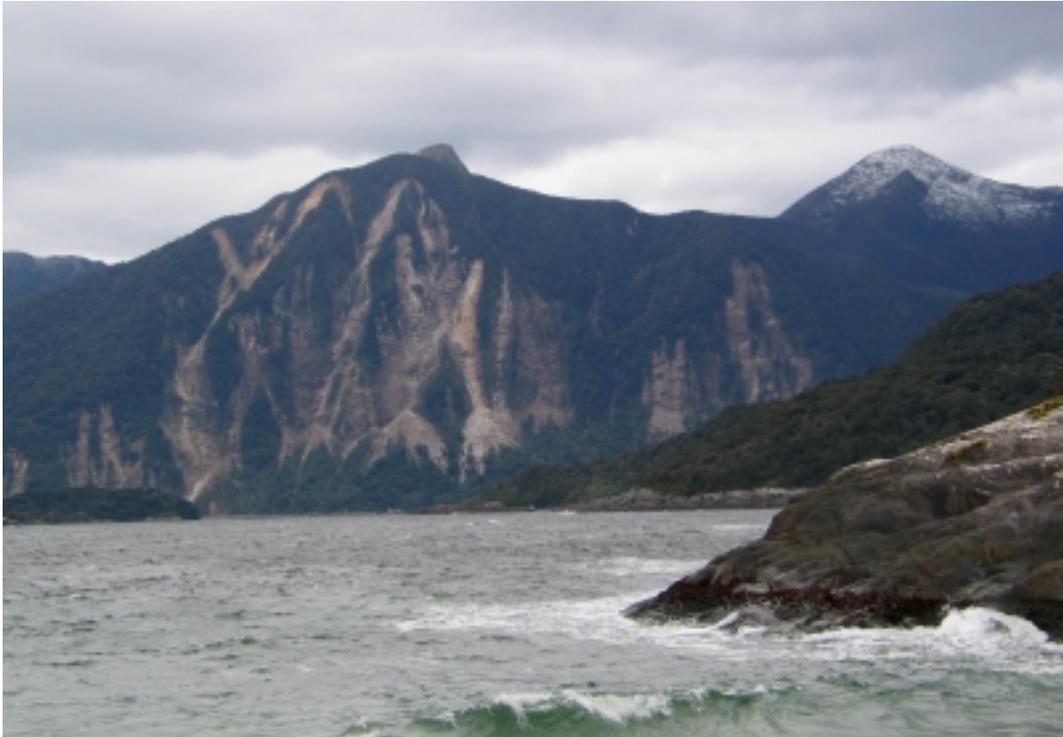
Figure 10. Multiple shallow debris slides on southwest coast of Secretary Island (Slide 14, Table 3).

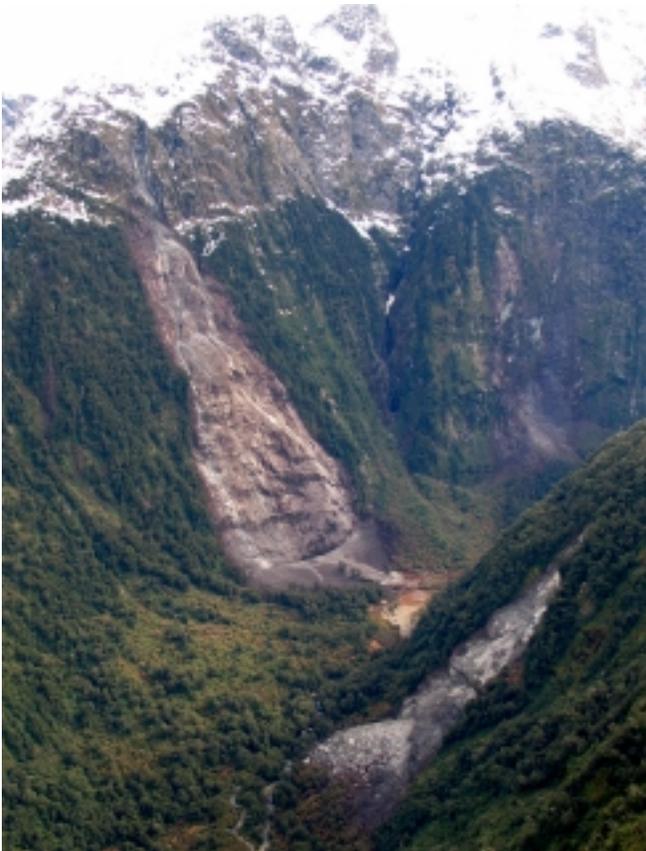
Figure 11. Large soil and debris slide above Stump Lake at the head of Hall Arm, Doubtful Sound. (Slide 12, Table 3).

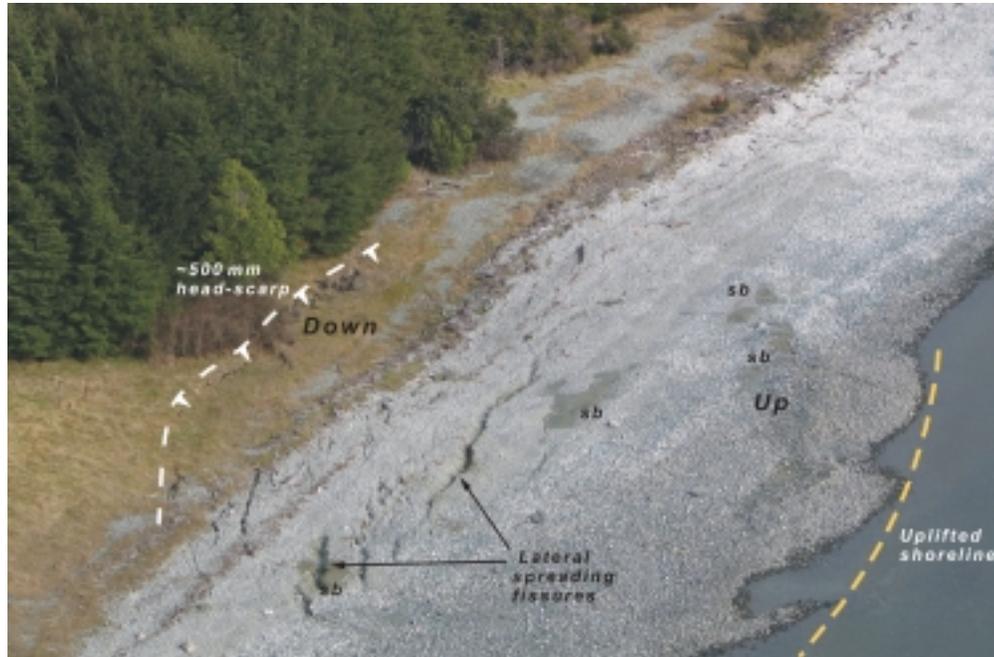
A spectacular liquefaction feature formed during the earthquake was observed on the southwest shore of Lake Te Anau, about 400 m west of the control structure. At this location a liquefaction-induced lateral spread and rotational failure uplifted an area of lake shore about 20 m long and 15 m wide (Figure 14). The area has a well defined ~400 mm wide head scarp, and there are several extensional fissures up to ~10 m long in beach gravels, from which fine sand was ejected. The back of the slumped area dropped 200–500 mm, while the slide toe at the lake edge was raised a similar amount, forming a low ridge on which sand boils formed. Although this failure did not cause any significant or long-lasting damage to the lake shore, it is interesting because of the combination of rotational and lateral spreading failure modes that are demonstrated, and the coarse alluvium in which failure occurred. This suggests that finer and more susceptible sandy materials underlie the beach gravel deposits in this area.

Figure 14. Aerial view of a shallow rotational slump and lateral spreading, with sand boils (*sb*) and fissuring on the shore of Lake Te Anau, approximately 400 m west of the lake Control Structure. The affected area is about 20 m long and 15 m wide, and has a 400 mm wide head scarp (in grassed area left) and several extensional fissures (300–400 mm wide and up to ~10 m long) in beach gravels, from which fine sand and water was ejected. The back of the slumped area dropped 200–500 mm, while the slide toe at the lake edge was raised a similar amount, forming a low ridge on which sand boils formed.

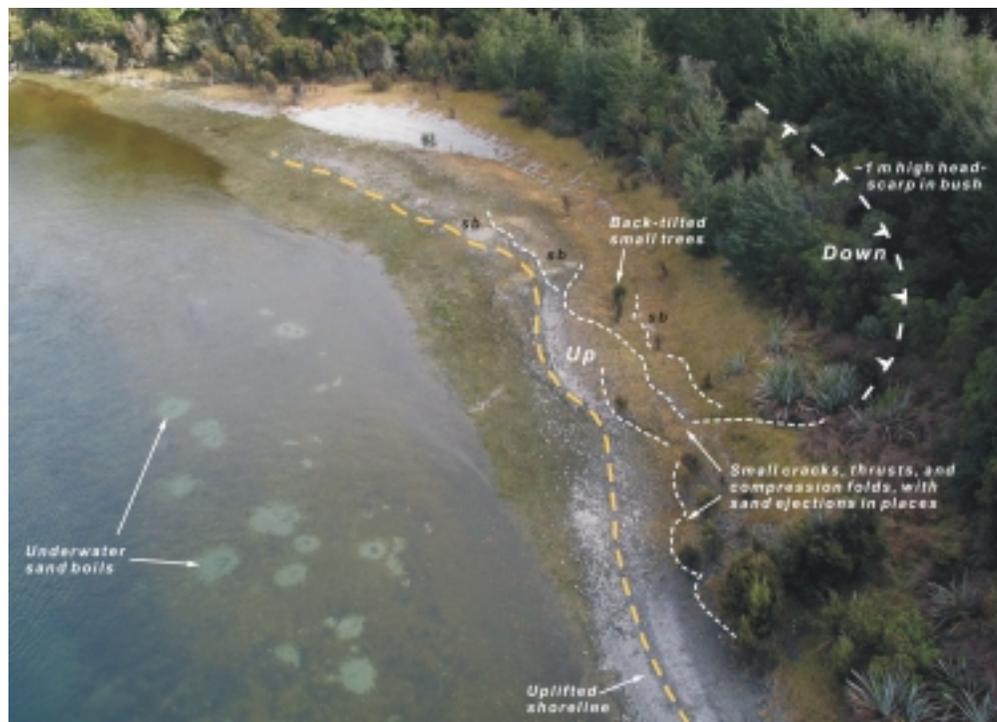
There was also an interesting area of sand boils, and lateral spreading cracks and shallow rotational deformation and uplift on the right abutment of the western (true right) bank of the Waiau River approximately 100 m downstream from the Lake Te Anau Control Structure, with a spectacular and unusual 'field' of underwater sand boils just off the beach (Figures 15–17).

Figure 15. Area of lateral spreading and shallow rotational failure, with cracks, thrusts and sand boils (*sb*) on the right bank of the Waiau River ~100 m downstream from the Lake Te Anau Control Structure (see Figure 17). An unusual field of underwater sand boils (*left*) was also formed at this site.

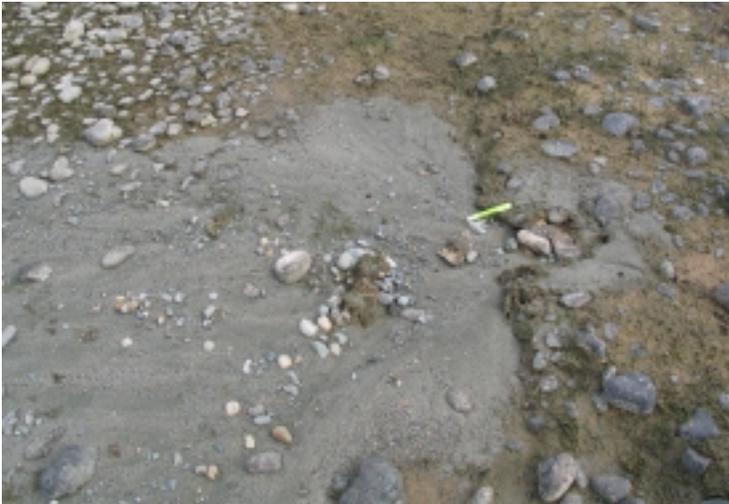
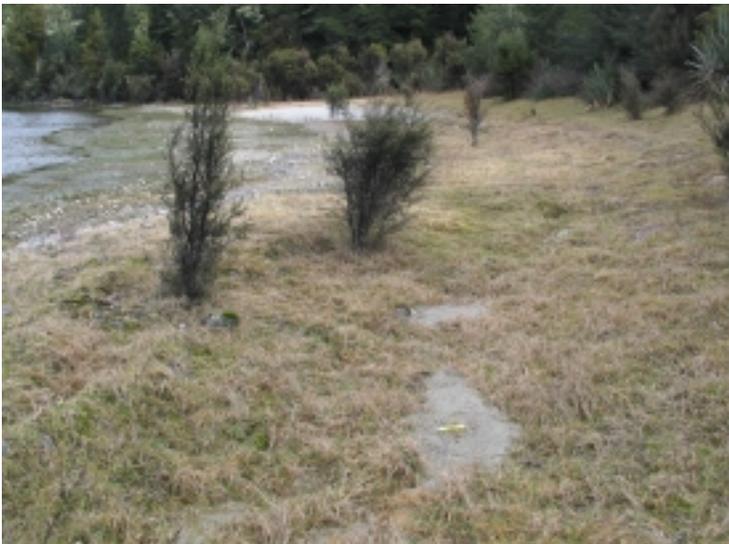
Figure 16. Closer views of a typical sand boil in stony gravels (top) with sand ejected from a small thrust crack (beside pen); and (bottom) sand ejected from a narrow lateral spreading crack in grassed area on the right bank of the Waiau River ~100 m downstream from the Te Anau Control Structure (see Figures 15 and 17) Note the small back-tilted trees on the toe of the shallow rotational slide area (left and centre).

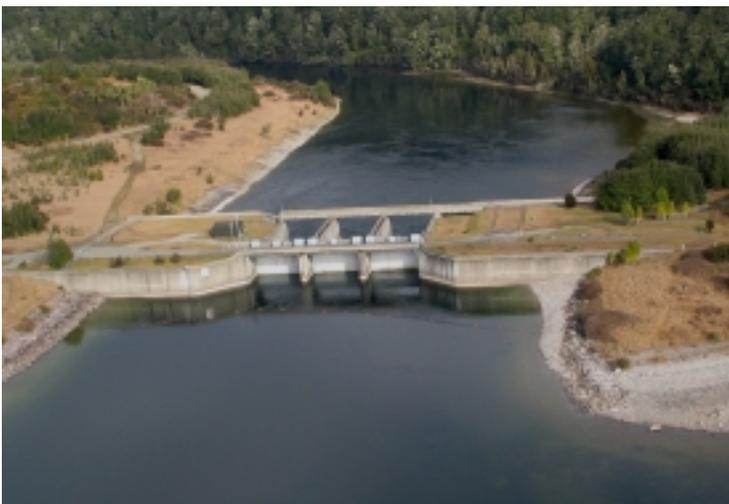
Figure 17. Aerial view of the Lake Te Anau Control Structure looking downstream. The area of lateral spreading and sand boils is on the right bank, ~100 m downstream from the structure (top right). Another area of spreading and slumping of gravels occurred on the west side of the intake channel next to the upstream concrete facing slabs (bottom right). This had no apparent effect on the structure.

The most spectacular, but relatively minor damage occurred at the Lake Te Anau Control Structure. The embankment fill is retained by a series of concrete slabs, which moved outward by up to 50 mm, and vertically relative to each other by up to 75 mm. Some inter-slab clashing has knocked concrete chips off in several areas (Figure 19). Liquefaction induced slumping of alluvium adjacent to the structure on the west side of the intake channel had no effect on the structure. Damage to buildings and other structures in the Te Anau–Manapouri area was also minor, and included cracking and breakage of chimneys and masonry in Te Anau, and cracking and breaks in concrete at the Te Anau Marina. Small (mm-wide) cracks were also observed in abutment earth fills at the Mararoa Dam ~10 km southeast of Manapouri, and at the Dawson City flood detention dam 15 km east of Te Anau (Figure 3).

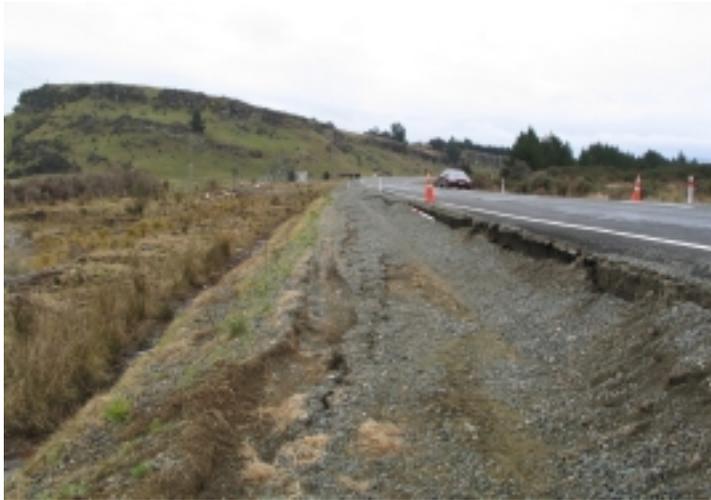
Figure 18. Lateral spreading and slumping of road edges along Hillside Road where it crosses a swampy area about 2.5 km east of Manapouri.

Other liquefaction and soft sediment deformation effects observed after the earthquake included lateral spreading and slumping of road edges along Hillside Road where the road crosses a swampy area (and is raised 1–2 m on fill) ~2.5 km east of Manapouri (Figure 18). Nearer the epicentre, only minor effects were noted, with sand boils observed in saturated alluvium in Campbell's Kingdom (valley on north side of Doubtful sound), and sand boils and small (mm wide) spreading failures in the bed of the lower Irene River (Figure 3). Further to the northeast, there were a few small cracks in snow-covered sand beside a deep pool in a creek at the mouth of Worsley River, but the gently sloping shoreline below the hut was unaffected. At Glade House wharf, near the southern end of the Milford Track (Figure 3), there was some subsidence of sandy gravel around piles, and pull-apart cracking (lateral spreading) 1–3 m back from the lake edge. The end of the delta at Sandfly Point also appeared to have collapsed, with a 500 mm high scarp beside the creek (this delta also collapsed during the 1988 earthquake; see Turnbull and Beanland, 1988). Several instances of cracking and slumping of beaches by ~250 mm were noted beside the Snag Burn in Middle Fiord (Figure 3). One bouldery delta was noted to have collapsed, with lateral spreading scarps up to 500 mm in the gravel and cracks 50–100 mm wide 5 m back from the lake shore among roots of mature trees.

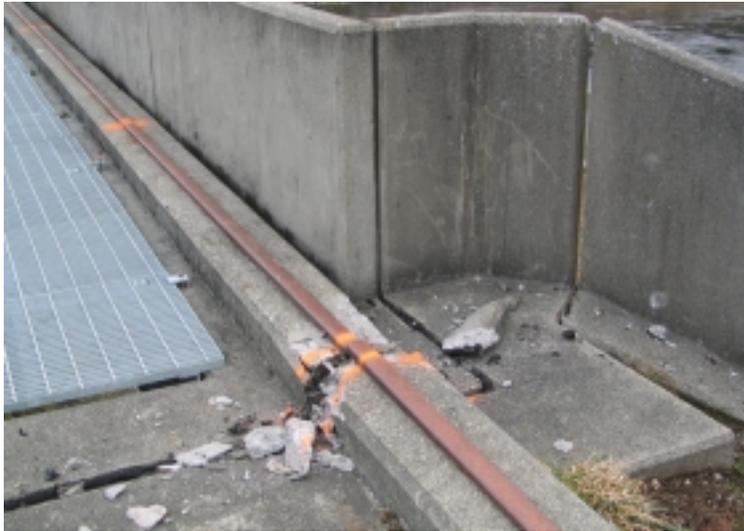
Figure 19. Minor cracking of concrete and small displacement (~30 mm) of a steel rail on the downstream side of the Control Structure. Such effects are typical of the minor damage sustained by the structure.

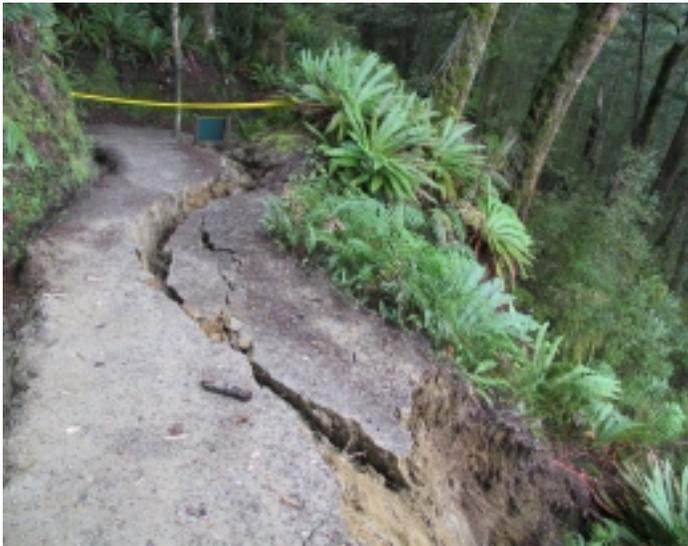
Figure 20. Slump in fill and soils caused closure of this section of the Kepler Track ~100 m south of the Rainbow Reach bridge. This failure was at the top of a reactivated larger failure area on the west bank of the Waiau River (see Figure 21).

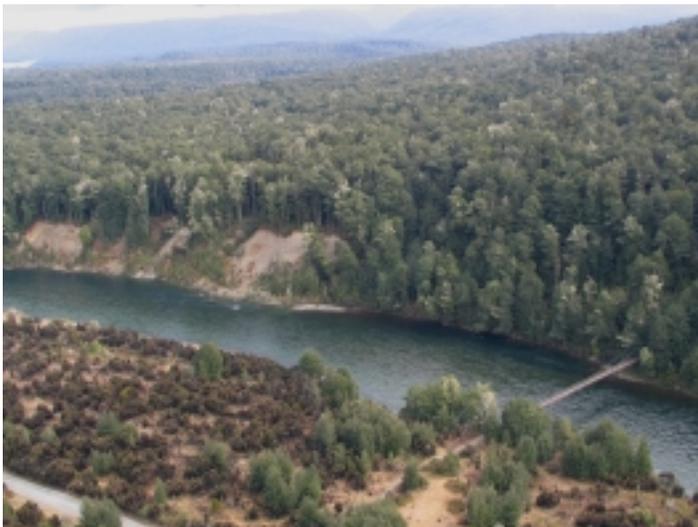
Figure 21. Aerial view of an older (but still active) area of river-bank erosion and collapse (middle left) on the west bank of the Waiau River ~100 m south of the Rainbow Reach Bridge (bottom right). This area was reactivated by the earthquake, with retrogressive slumping from the terrace edge undermining the Kepler Track causing its temporary closure at this point (see Figure 20 above).
