McSaveney, M. J.; Page, M. J. 2007. The Totara Reserve Regional Park cliff collapse of 15 December, 2006, *GNS Science Report* 2007/11 14 p.

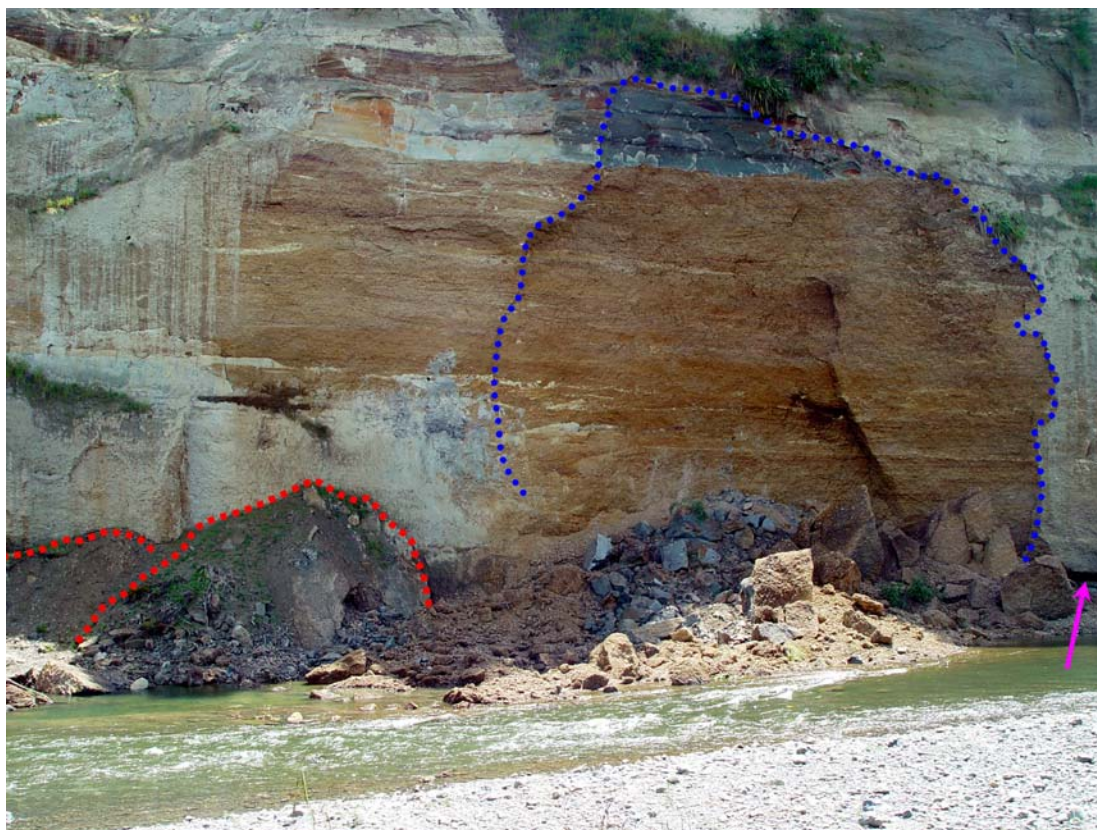
Figure 2 View of the swimming hole at the Totara Reserve Regional Park Camping ground showing the deposit in the Pohangina River from the fatal rockfall of 15 December 2006. The area of the rockfall scar is outlined in blue. The collapsing debris dropped vertically from the cliff, then sprayed outwards as it hit a narrow ledge beside the river. Photograph taken 19 December 2006. Note the piles of debris at left of photograph (outlined) from a past rockfall of several years ago (based on the sparse growth of weedy vegetation on it). Arrow points to eroded silt layer undercutting a small portion of the cliff.

The gravel at the collapse site is underlain by a thin, gently inclined silt layer, which locally has been selectively eroded by the river. The erosion has undercut the gravel by a small amount. The extent to which the undercut might have influenced the size of the collapse has not been evaluated. The collapse was not centred over the undercut, most of which still remains visible beside the rockfall deposit (Figure 2). The selective erosion will have contributed to the loss of stability, but it was not essential to it, and did not play an important role in determining where the failure occurred.

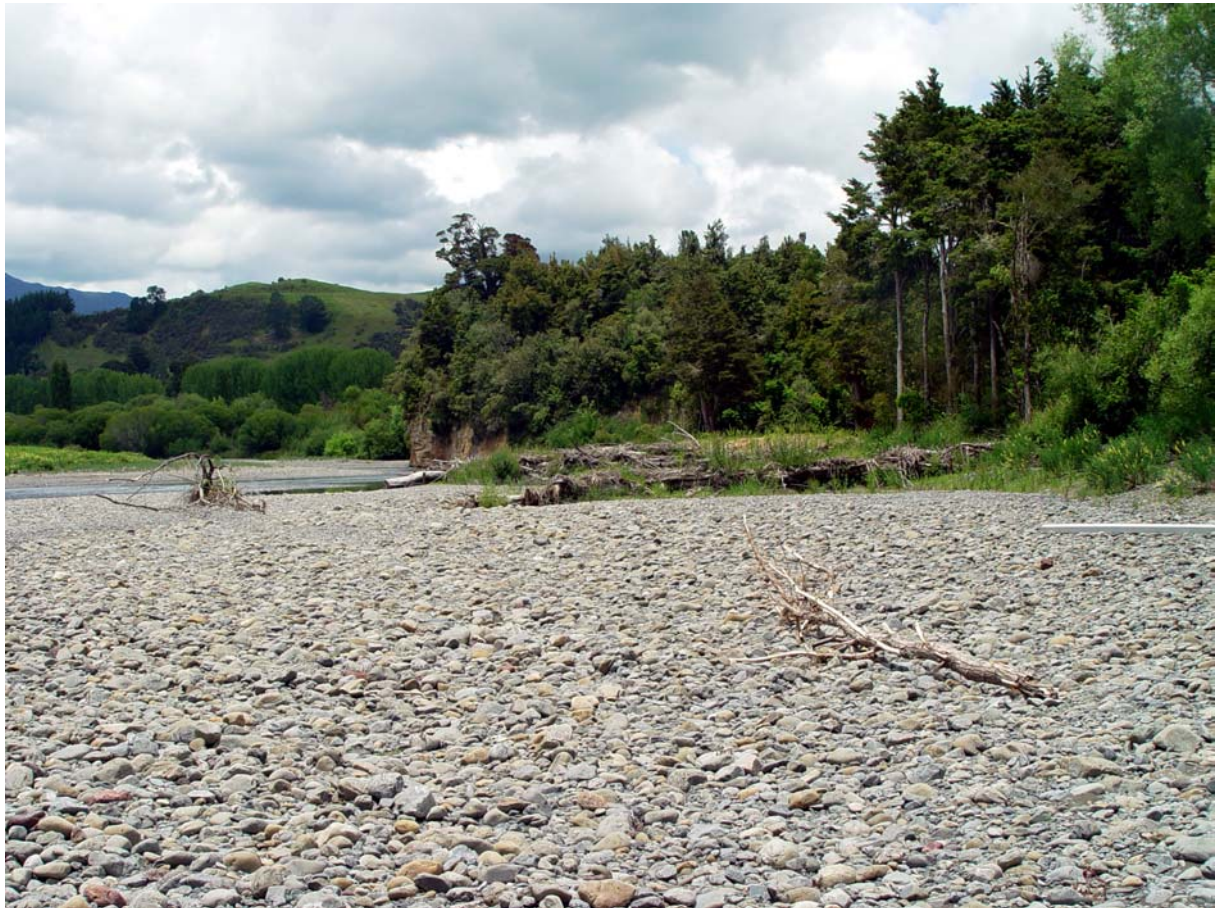
Figure 3 View of groynes constructed after the floods of 2004 to protect forest and the campground from further river erosion, immediately upstream of the swimming hole. Photograph taken 19 December 2006.

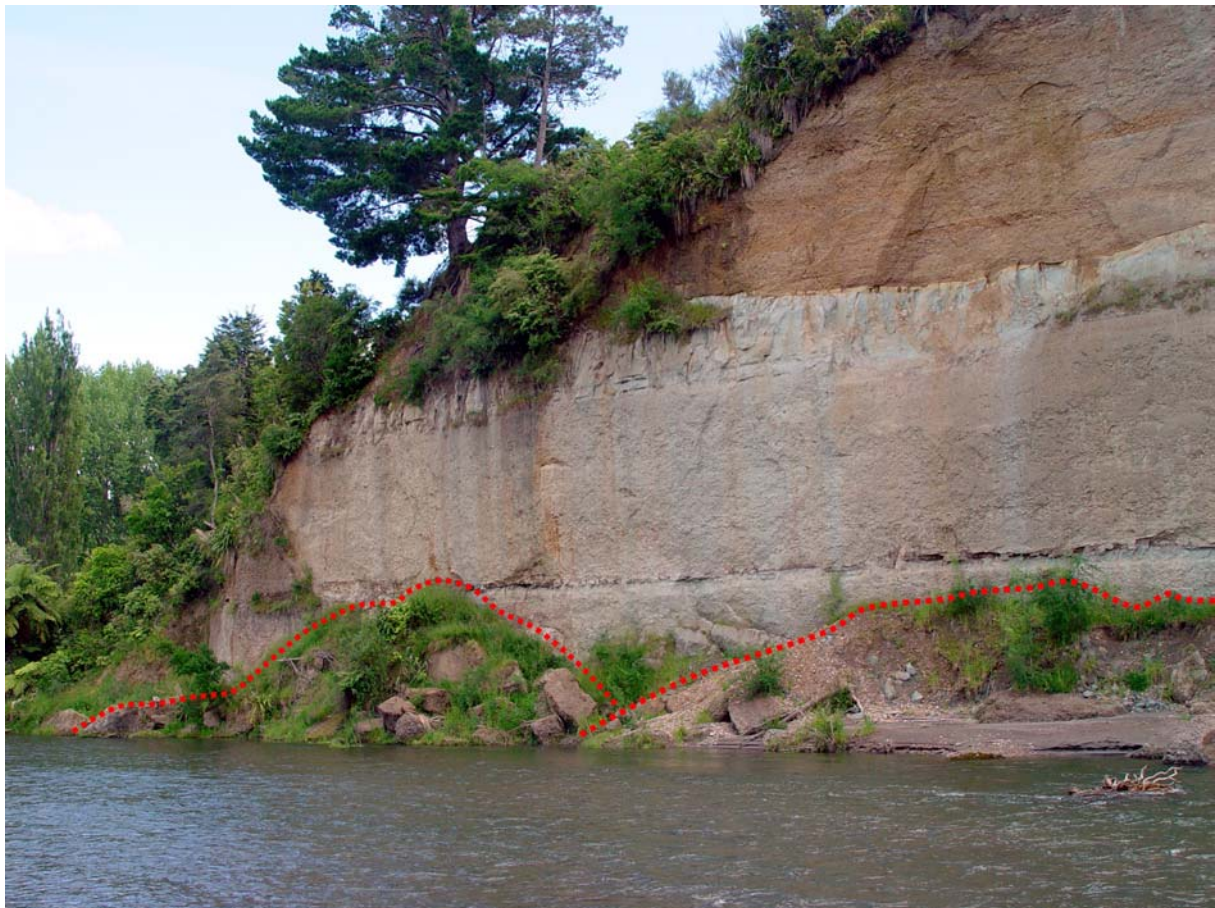
There is an unconfirmed report of a witnessed collapse at the site of some decades ago, but there have been no previously reported deaths or injuries. Witnessed collapses should not be a surprise, because there is clear evidence along the foot of the cliff for a number of previous rockfalls of a similar type to event of December 2006 (Figure 2, 4), although the latter is obviously the largest collapse that still leaves a deposit in the river. Although smaller, any of the previous rockfalls could have killed people had they been present near them at the time.

Figure 4 View of blocks of debris from past rockfalls (outlined) along the cliff immediately downstream of the Camping-ground swimming hole. The grey-brown cliff above them and the weedy plant growth among the blocks indicate that these fell some years ago. Compare with the fresh brown scar surface on Figure 2 from 15 December 2006.

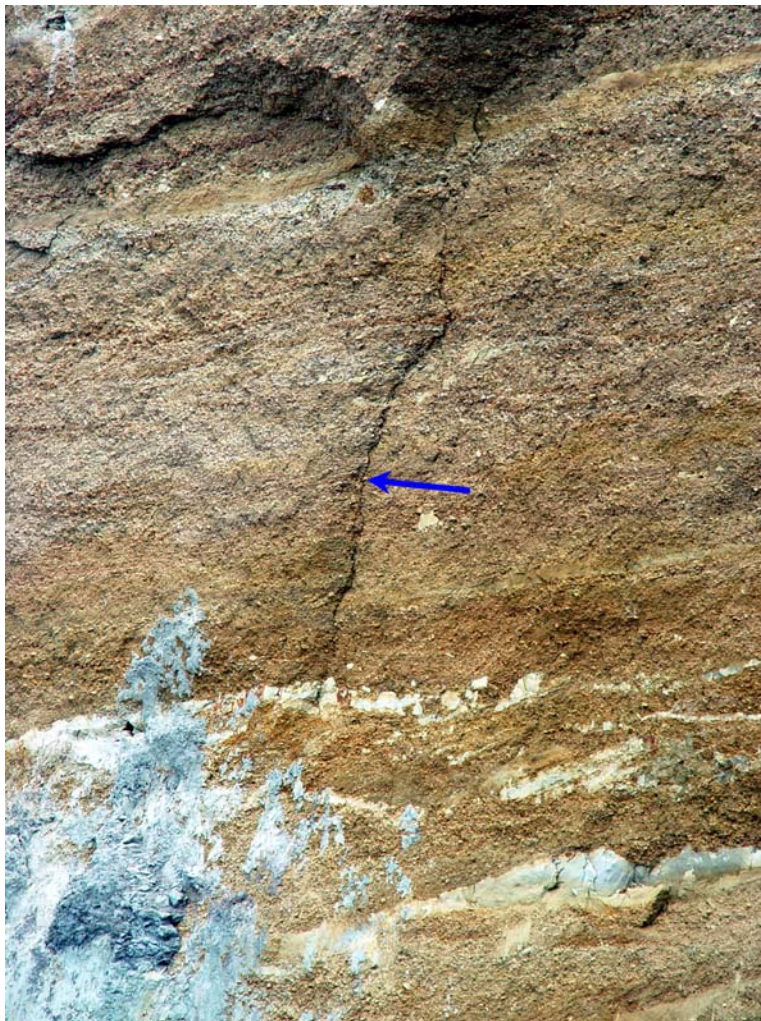
There is abundant evidence that a potential for future rockfalls remains at the site. This potential currently is heightened by the exposure of cracks in the cliff (Figure 5) and the significant reduction in support afforded to some remaining, smaller slabs on the face, by failure of the larger slabs on 15 December. There is little indication of when these might fall, but we expect them to fall sooner, in the next few years, rather than later.

Figure 5 An open crack in the cliff. A thin slab of rock on the left still clings to the cliff face after the collapse of 15 December 2006. Prior to 15 December, such cracks, little wider than a credit-card thickness, were hidden so that there were no external signs of the progressive weakening of the cliff face.
