Hancox, G.T., Nelis, S., 2009. Landslides caused by the June–August 2008 rainfall in Auckland and Wellington, New Zealand. *GNS Science Report 2009/04*. 30pp.

GeoNet Landslide Response Report (Project No. 430W6000)

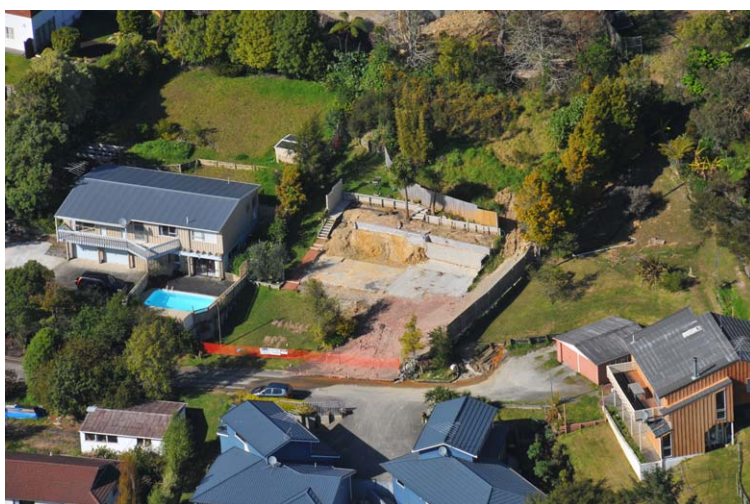
Figure 2. House site in Lingham Crescent, Torbay where a home damaged by slow movement (700 mm on 30 July 2008) of a creeping landslide was evacuated and later demolished. Site evidence suggests the landslide is an old feature that was active before the site was developed, and reactivated by the prolonged rainfall in July 2008.

The landslide that occurred in Lingham Crescent in Torbay was a deep-seated earth slide. Significant slide movements occurred on 30th July 2008 following a sustained period of heavy rainfall over two weeks. GNS Science staff (S Nelis and S McColl) inspected the site on 1st September 2008, after the most severely damaged house had been demolished and removed (Figure 2). The landslide is thought to be a reactivation of an older feature that was most likely active before the site was developed. Geomorphic evidence for this being a reactivated old landslide includes existing scarps 200-500 mm in height running through the back of the property (Figure 3).

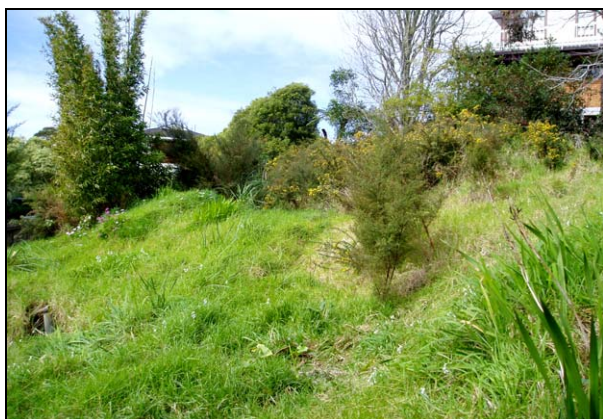
Figure 3. View of property, above the demolished house showing relict landslide scarps [Photo S Nelis].

The landslide scarps above the demolished house have clearly been modified during development of the site, but are continuous across property boundaries, suggesting that they are instability features that extend across part of the housing area, rather than being caused by landscaping of any one property. The scarps may be pre-existing natural failures, but they could have been initiated by earthworks during development of the subdivision.

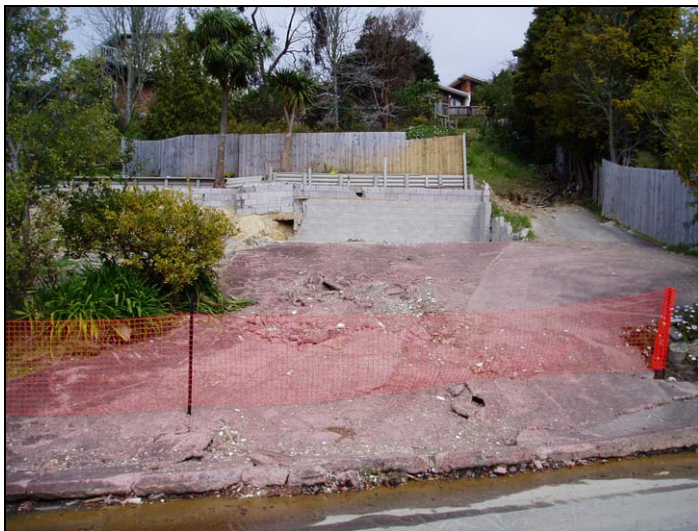
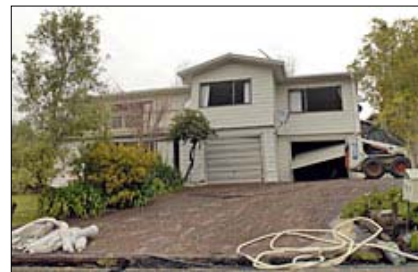
The main effect of the slide was to displace the building foundations downslope, resulting in structural damage to the property, which later had to be demolished (Figure 4). Monitoring data collected by North Shore City Council suggested that maximum vertical movements within the slide body were 700 mm over a 24 hour period. In an attempt to reduce the rates of movement in the landslide a number of sub-horizontal drainage holes were drilled into the slope, in addition to storm water drainage from adjacent properties being taken offsite. In addition, two piezometers were constructed to monitor water levels within the slope. The house eventually had to be demolished because engineers were unable to stop the landslide movement quickly enough to prevent significant damage to the house from occurring.

Figure 4. View of house foundations (left) after the most severely damaged house in Lingham Crescent (above) was demolished. The concrete driveway seen here has slid 100 mm towards the road as a result of the landslide movement.

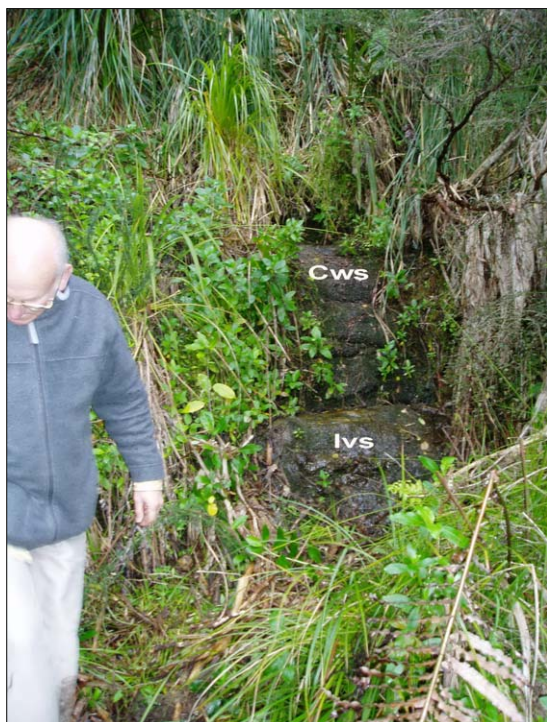
The landslide affected a subdivision at Huia. The slip plane has formed along the contact between intact, unweathered volcaniclastic sandstones and completely weathered overlying material. At the contact between the two materials, spring seepage was noted (Figure 5) indicating the permeability boundary created by the underlying volcaniclastic sandstone.

Figure 5. Completely weathered sandstone/residual soil (Cws) overlying intact, unweathered volcaniclastic sandstone (Ivs). The slip has formed at the boundary of the two material types with heavy seepage along the boundary. Damage includes structural damage to the house on the main slide, and damage to the vehicle access for the adjacent properties where the headscarp follows the driveway. [Photo S Nelis]

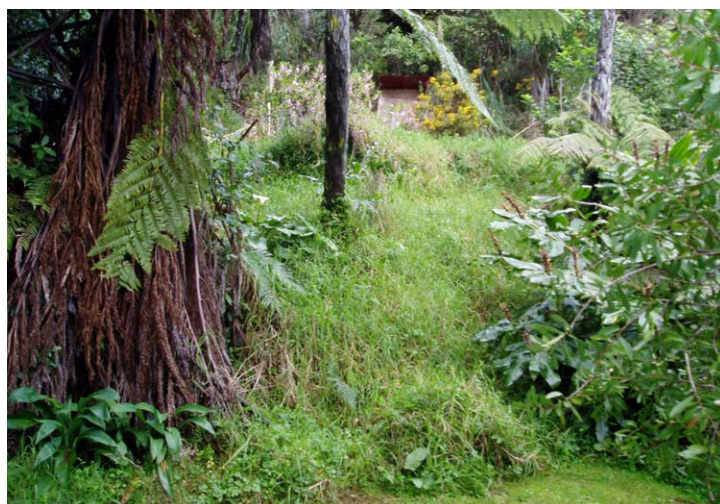
The Huia failure is an old reactivated landslide. This is indicated by numerous older scarps within the slide mass, including a 2-3 m headscarp about 10 m up slope of the main scarp of the present failure. Historical information suggests that there was a smaller failure within the landslide in 1968. The activity during August and September 2008 involved tension cracking and formation of other minor scarps up to 1 m high within the landslide body (Figures 6, 7, and 8).

Figure 6. Old scarp visible at the rear of the property indicating the landslide to be a reactivation of a much older feature. [Photo S Nelis]

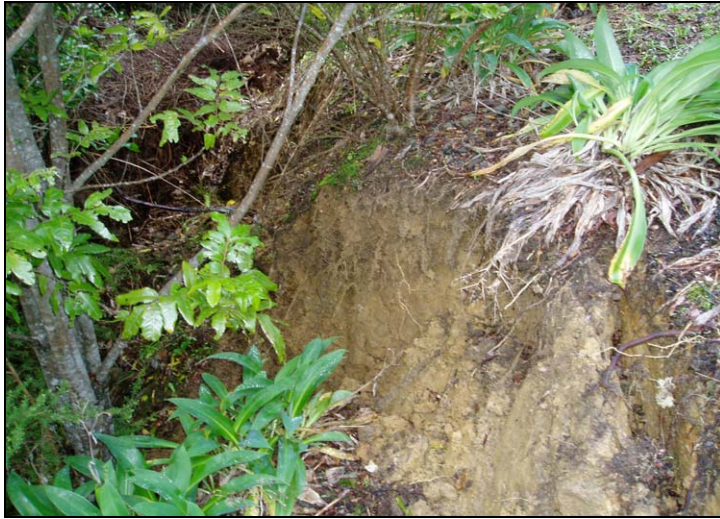
Figure 7. Fresh scarp showing recent landslide movement at Huia. *[Photo S Nelis]*

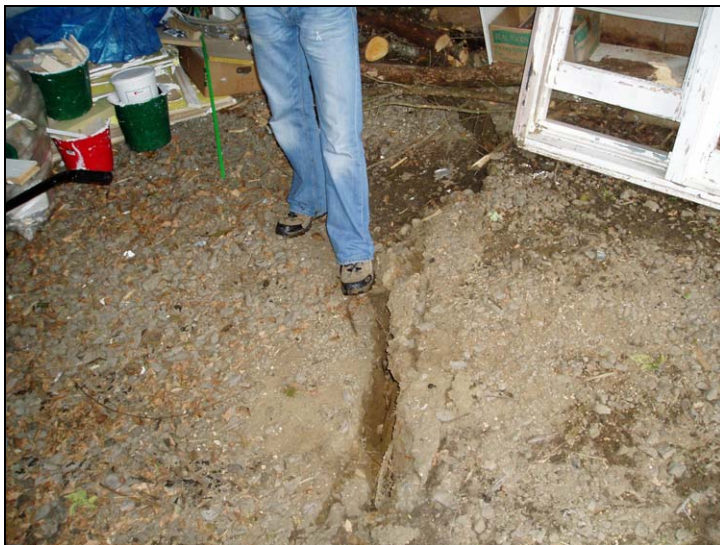
Figure 8. Tension cracking through the property garage, resulting in structural damage to the property. *[Photo S Nelis]*

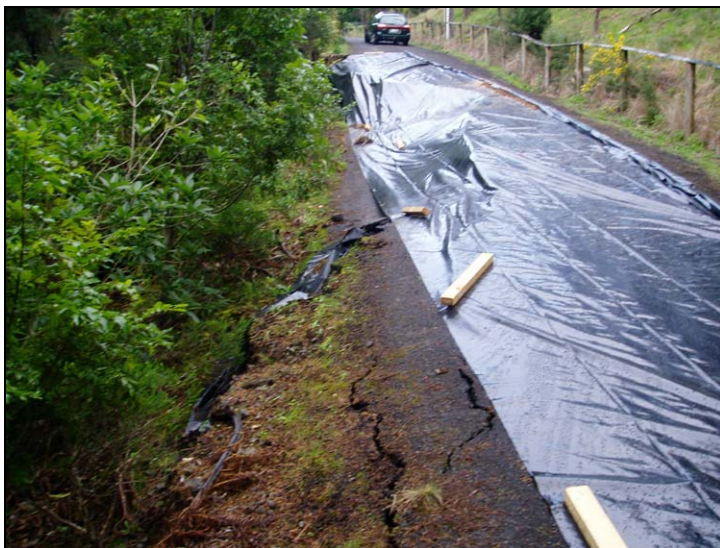
Figure 9. View of the main head ward scarp of the recent landslide movement showing the plastic sheeting used to reduce water entry to the slide plane. The bank on right of the photo is the main headscarp of the old landslide. *[Photo S Nelis]*

In an attempt to prevent further water from entering the slide, plastic sheeting had been placed at the head of the active area (Figure 9). At the time of the landslide site inspection by GNS Science there were plans to install sub-horizontal drains to help relieve pore water pressures at the slip plane. The Huia landslide did considerable damage to one property in August 2008, and also damaged a stormwater and sewer line in September.

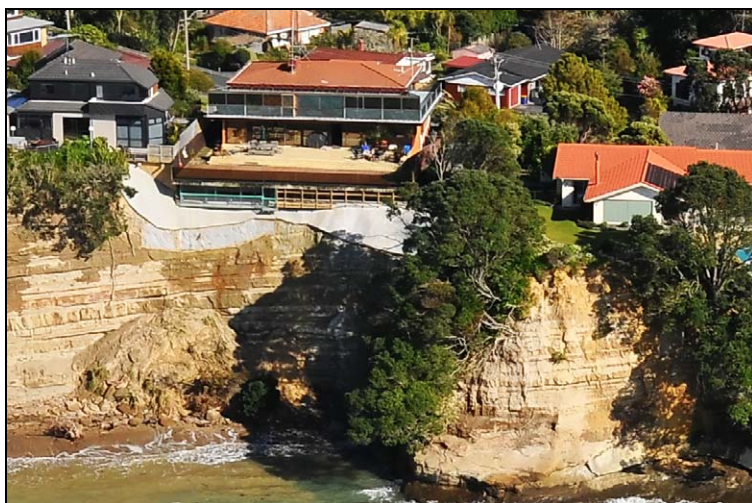
Figure 10. This landslide on the coastal cliff at Torbay was triggered by rainfall. However, building too close to the edge of the cliff will have contributed to the failure by locally overloading the slope. This landslide (soil and regolith debris fall) occurred despite ineffective shotcrete along the cliff edge aimed at keeping water out of the unstable slope.

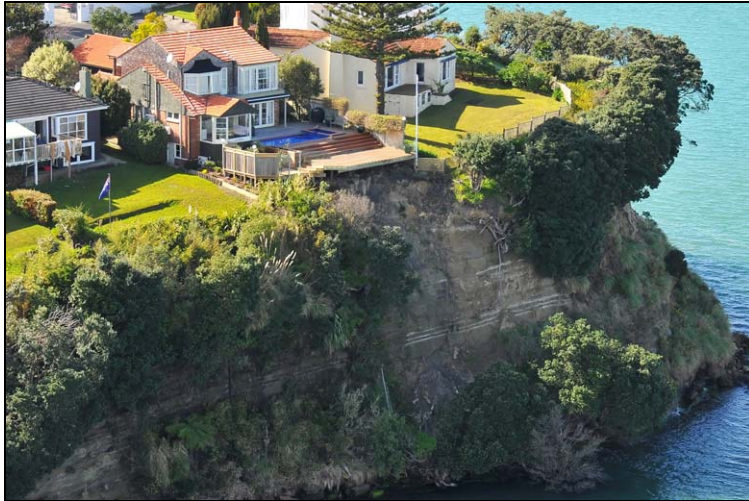
Figure 11 shows a landslide at Devonport where Pohutakawa trees planted along the cliff edge of have collapsed into the sea. This was one of several such failures that occurred. Figures 12 and 13 show other coastal cliff failures where trees appear to have decreased stability of the overlying soil and regolith layer. Trees make a good wind break in places, but on the edge of cliffs trees can reduce slope stability and cause failures by locally overloading the weak cliff edge, root wedging in joints, and tree movements due to wind. Although the landslide shown in Figure 11 was triggered by rainfall, all of these factors, as well the decks and swimming pool built very close to the edge of the cliff (in this case within the 9-30 m 'foreshore yard') seem to have contributed to the slope failure at this location.

Figure 11. Pohutakawa trees planted along the edge of this coastal cliff in Devonport make a good wind break. In this situation, however, trees can reduce slope stability by locally overloading the slope, root wedging in cracks, and tree movements due to the wind. Although the landslide seen here was triggered by rainfall, all of these factors, as well the decks and swimming pool built very close to the edge of the cliff seem to have contributed to the slope failure at this location. [GNS Photo: GTH-0551]

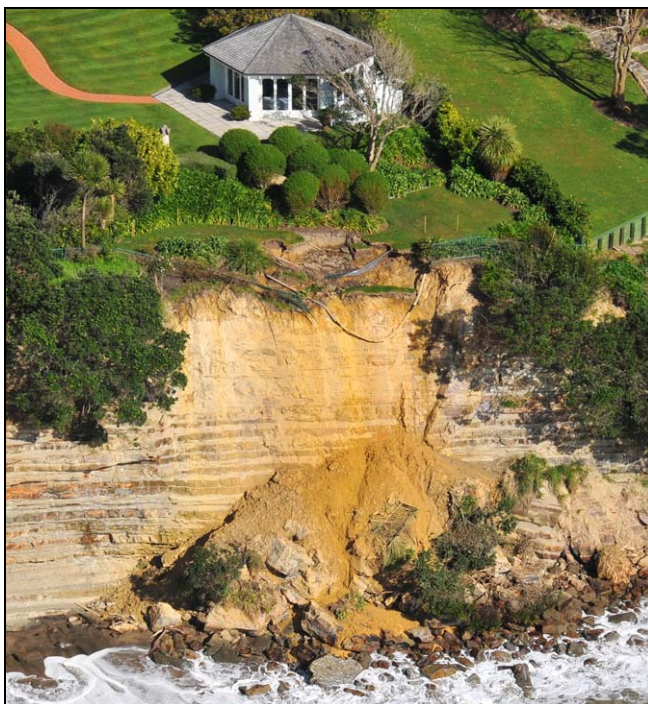
Figure 12. Small soil and regolith debris fall on the cliff face 1 km north of Castor Bay, where trees have contributed to the collapse instead of preventing it. [GNS Photo: GTH-0497]

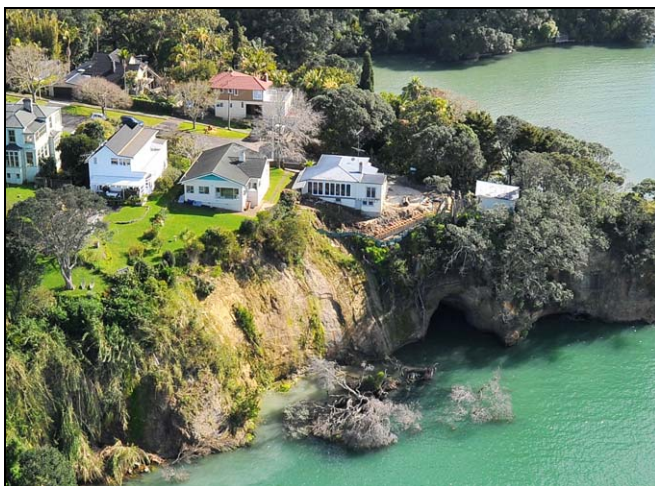
Figure 13. Cliff collapse at Birkenhead, showing trees that have fallen into the sea under their own weight overloading the cliff edge. The retaining wall being built along the cliff edge (right) must be founded on stable sandstone bedrock to be effective. [GNS Photo: GTH-0540]

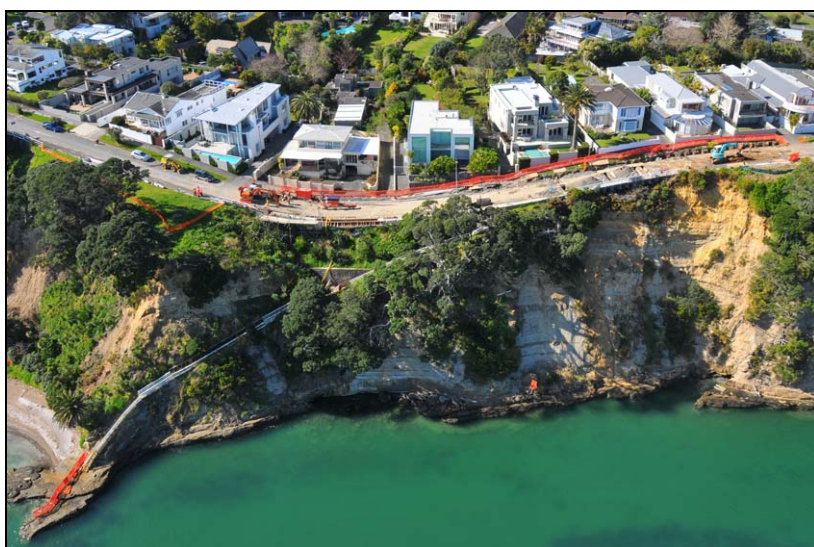
Figure 14. Aerial view showing engineering stabilisation works in progress at Cliff Road above Achilles Point (lower left) St Heliers, 4 September 2008. Rainfall during August caused small shallow slope failures (left) but did not adversely affect the area being stabilised.

In June 2008 emergency engineering works with an estimated cost of possibly \$4 million were initiated to stabilise part of Cliff Road at Achilles Point, St Heliers (Figure 1), which was in danger of subsiding during heavy rain, after movements and cracks were discovered in the ground in April and May. A geotechnical investigation confirmed that cracking and ground movements were occurring over a 200 m length of the footpath, possibly because of natural erosion of the adjacent sea cliff. The situation was potentially serious as the movements threatened 5 houses. Slumping of only 300 mm could have damaged underground services such as water supply, stormwater, power, telephone and gas, and affect property access. Heavy rainfall would increase the risk of slope failure. The proposed stabilisation works included extending a 100 m retaining wall to increase stability, and improve drainage. Figures 14 and 15 show the works in progress in early September 2008.

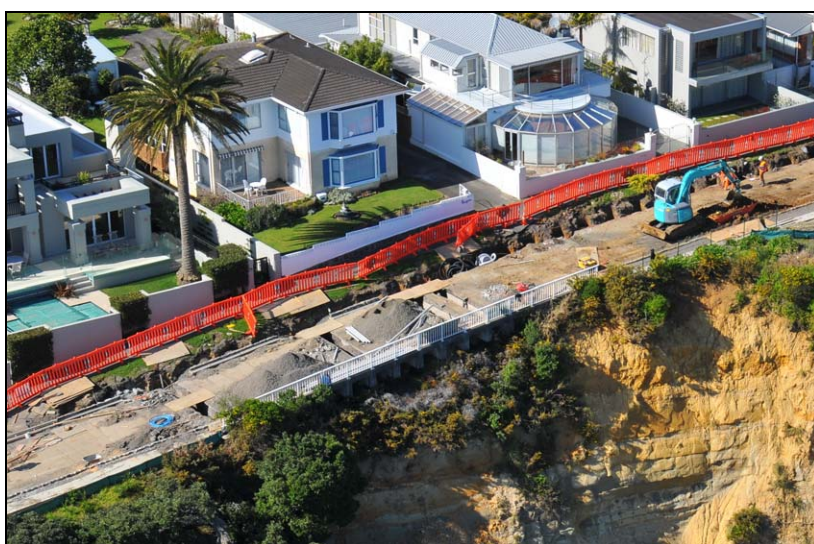
Figure 15. Closer view of the drainage system, tie-backs, and retaining wall, which was under construction in September 2008. The main failure here is deep-seated within the sandstone and siltstone bedrock, but there have also been small, shallow failures in the overlying soil and regolith (fresh scars lower right), which have typically resulted in the loss of cliff-edge vegetation.

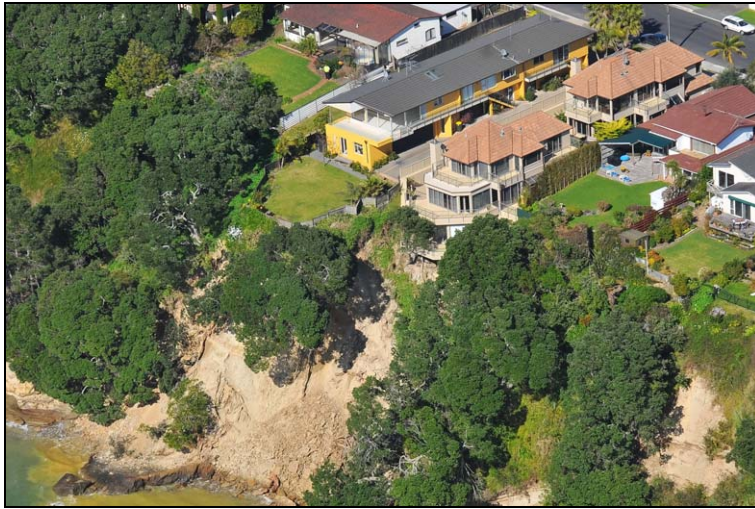
At Buckland's Beach in southeast Auckland, episodic movements of a slow-moving landslide on the coastal cliff adjacent to resulted in serious damage to one house causing that house and four other nearby houses in Covelly Road to be evacuated at the end of August 2008 (Figures 16 and 17). Slope movements continued after more rain fell in December 2008, and in February 2009 three houses were still unoccupied. The house at 116 Covelly Road (yellow house in Figure 16) has been most affected by the ground subsidence, with 100 mm wide cracks through the lower story, and up to 1 m subsidence of the lawn area (Figure 17).

Figure 16. This apparently innocuous landslide (lower left) severely damaged the yellow house (top centre) and the two houses on either side. These houses were still unoccupied in February 2009 as slope movements continued. Although rainfall seems to have triggered the landslide movements, excavation and building too close to the unstable cliff edge, especially the yellow house, and the large house to the north (right), were important underlying reasons for the failure.

The timing of the initial movements of the landslide can be linked to 116 mm rainfall over two weeks from mid-late August (Table 1). However, excavation and building too close to the unstable cliff edge most probably provided the basic preconditions for slope failure at this site, as it has at several other locations on Auckland's east coast cliffs (see Figures 10-13). Figure 16 clearly shows that the two houses that were most damaged by the ground movements have been built noticeably closer to the cliff edge. Siting the houses so close to the cliff is likely to have overloaded the top of the steep slope making it more susceptible to slope failure, especially during periods of intense or prolonged rainfall.

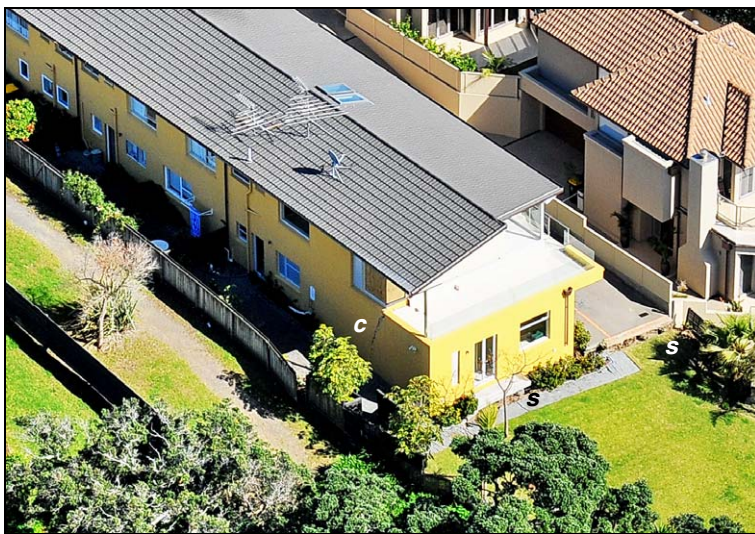
Figure 17. The yellow house at 116 Covelly Road was most damaged by the slow ground movements, which caused significant cracking (c) and structural damage to the front part of the house, and up to 1 m subsidence (s) of the lawn. [GNS Photo: GTH-0617]

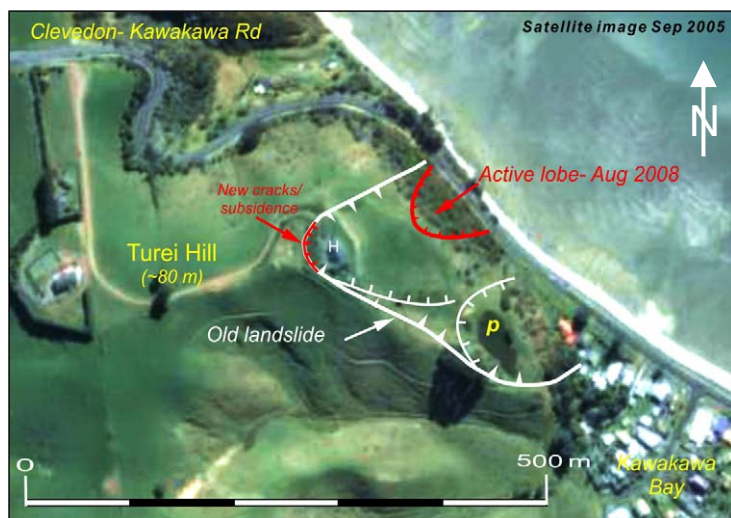
On Sunday 24 August, the prolonged rainfall over the preceding two weeks triggered a c. 500 m³ landslide at Turei Hill, closing the northern access road to the coastal settlement of Kawakawa Bay, 40 km southeast of Auckland (Figure 1). Three properties were found to be at risk because of a developing, slow moving large landslide mass above the road near the coast. This landslide, located only 200 m from Kawakawa Bay settlement, was found to be a newly-active lobe of a much larger old landslide which extended about 65 m above the coast road, almost to the top of Turei Hill (Figures 18 to 22).

Figure 18. Satellite image (Sep 2005) showing the newly-activated lobe (red) of a much larger old landslide at Kawakawa Bay (white). New cracking and subsidence extended to the head of the old slide, behind a recently-built house (*H*). The old landslide comprises two main lobes: a main (northern) lobe which was reactivated by rainfall; and a smaller southern lobe (lower right), which has a large landslide pond (*p*) at the back of the slumped block.

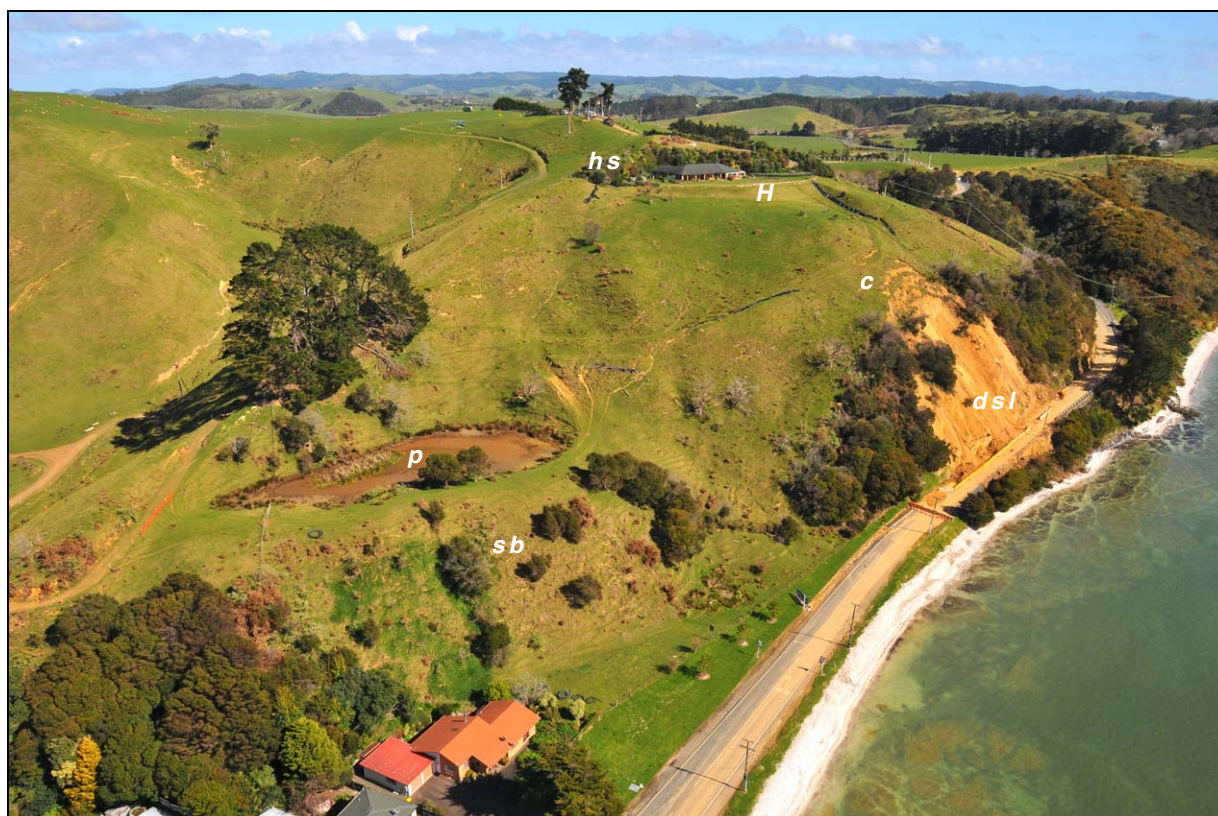
Figure 19. Oblique aerial photo of the Kawakawa Bay landslide showing the debris slide (*dsl*) reactivation at the slide toe, which recently closed the coast road. Cracks (*c*) and incipient slumping are clearly evident at the top of the new failure area. Tension cracks and subsidence of up to 1 m also occurred behind the house (*H*) on the head scarp (*hs*) of the old landslide, but the smaller slumped block (*sb*) and landslide pond (*p*) to southeast were not affected. [GNS Photo: GTH-0667]

The road to Kawakawa Bay was closed for a month while drainage and ineffective sluicing was carried out to dislodge partly failed material poised above the road (Figures 19 and 20). Slope movements slowed and stopped once the rain ceased, allowing the road to be reopened on 25 September, and easing the burden on Kawakawa Bay residents of having to make a 100 km detour, or a long walk over Turei Hill, just to go to work.

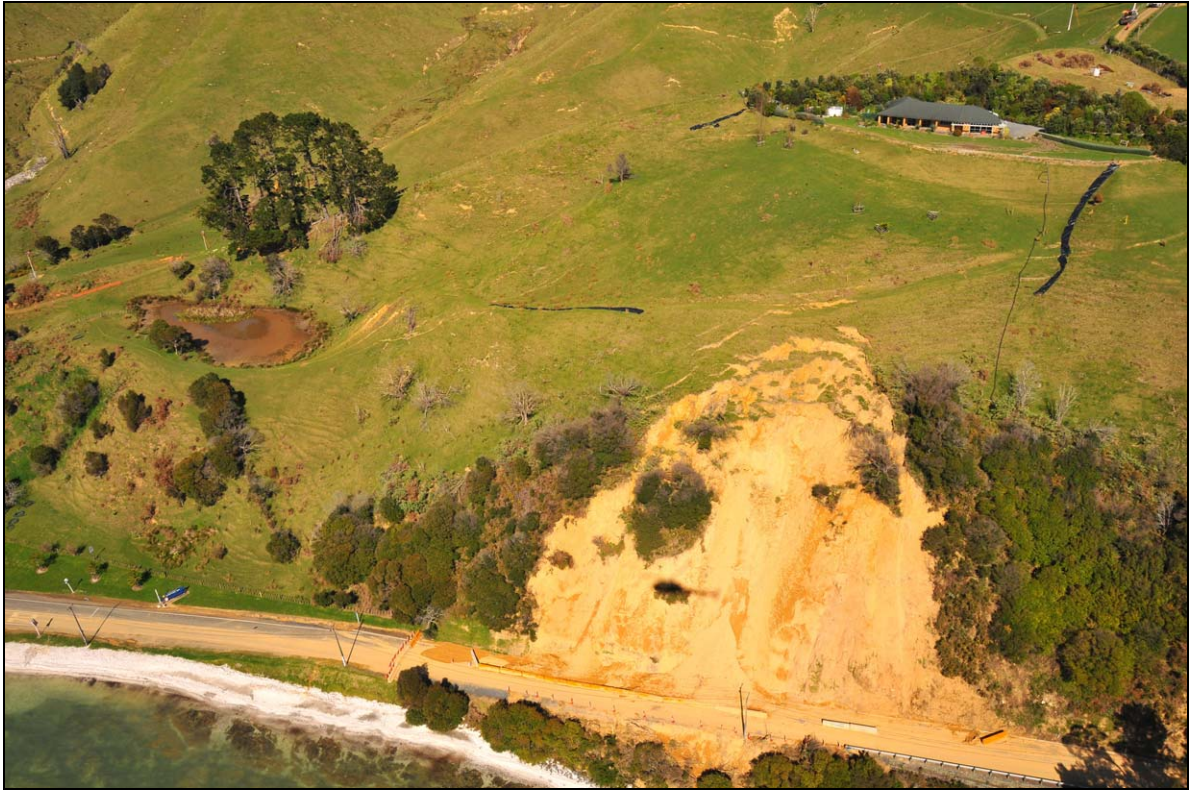
Figure 20. Closer aerial view of the large debris slide which blocked the road at Kawakawa Bay. Cracking and incipient slumping are obvious at the top of the new failure, but the reactivated area extends to the headscarp of the old landslide behind the house at the top of the slope (top right). The black polythene strips seen here were used to keep water out of cracks. [GNS Photo: GTH-0661]

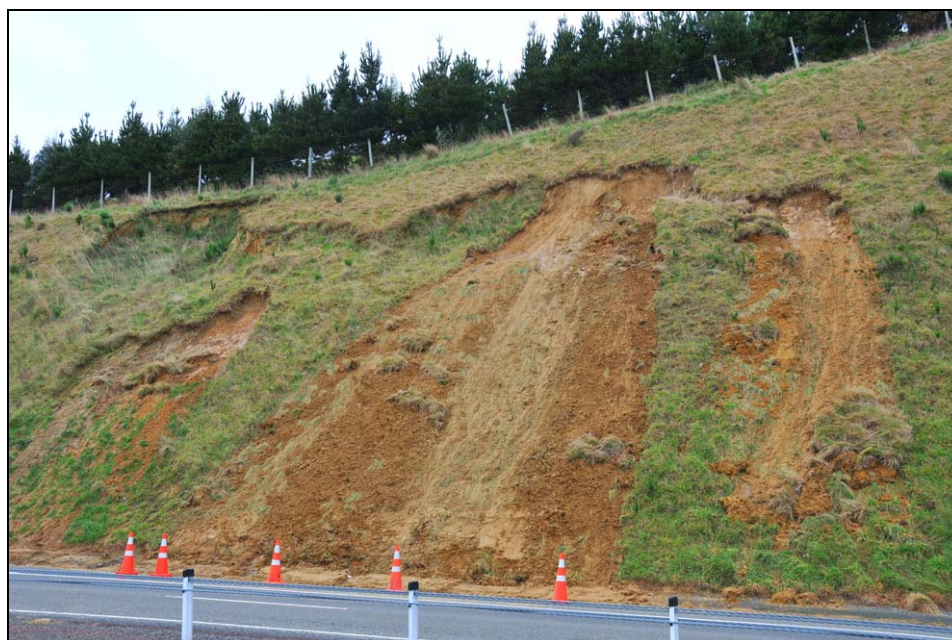
The same storm caused slips on SH 1 at Paekakariki and (as usual) between Pukerua Bay and Whenua Tapu Cemetery, blocking the south-bound lane for several hours (Figure 24). The vulnerable Rimutaka Hill and Manawatu Gorge roads were also reduced to one lane by slips brought down by the torrential rain.

Figure 24. Shallow earth slide on a relatively new road cut (constructed on the last 5 years), which blocked the south-bound lane of SH 1 between Pukerua Bay and Whenua Tapu Cemetery on 23 July 2008. Smaller similar failures occurred in several other locations. This landslide is formed in weak, sandy loess and weathered greywacke, and is typical of batter failures that occur frequently on this section of SH 1 during heavy rainfall.

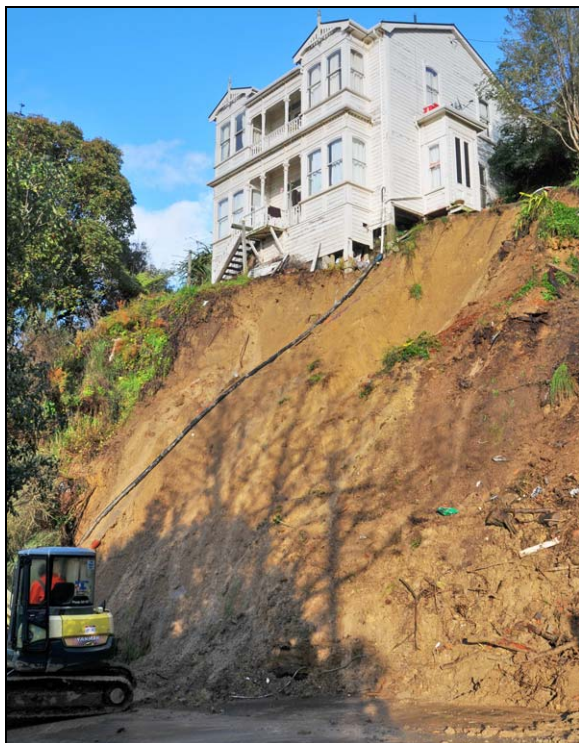
Figure 25. This house in Devon Street in the Aro Valley, Wellington, was undermined by collapse of a steep, unsupported road cut in weathered greywacke. This slope failure on 3 August during heavy rainfall caused the house to be evacuated.
Photo 5 August 2008: GTH-0178]

This type of cut slope failure is typical of those that frequently occur in Wellington during prolonged periods of wet weather, particularly in the older hill suburbs, where many high road cuts are unsupported. Not only was the batter unsupported, but the Devon Street house was built too close to the top of the road cut, as is the case in most failures of this type. Other failures of this type that occurred in August 2008 are discussed below.

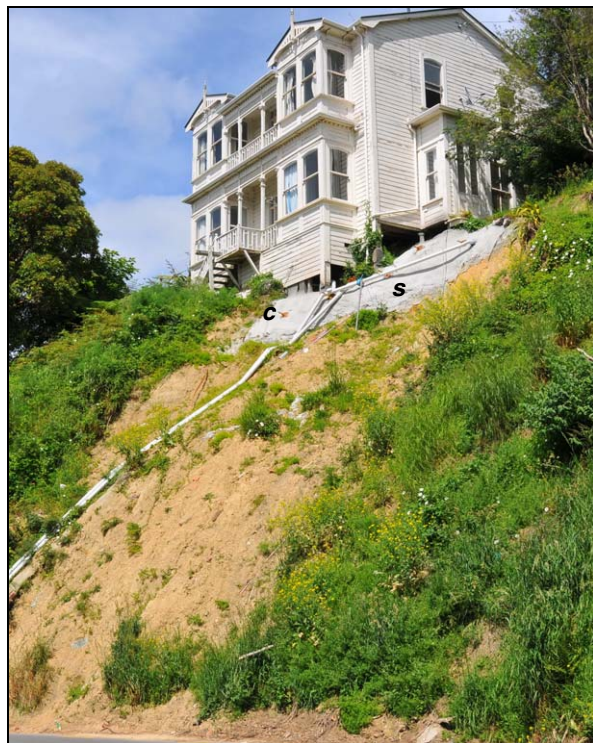
The landslide in Devon Street closed the road for several days while debris and unstable slope debris was cleared away. The failure partly undermined the house foundations, and destroyed a foot access path to dwelling. The slope below the house was eventually stabilised using grouted rock cables, shotcrete, and drainage works (Figure 26), allowing the house to be reoccupied.

Figure 26. Photo of the batter failure below the house in Devon Street taken in December 2008. It shows that the slope was eventually stabilised using long grouted cables (c), shotcrete (s), and drainage, allowing the house to be reoccupied.
[Photo 12 December 2008: GTH-1369]

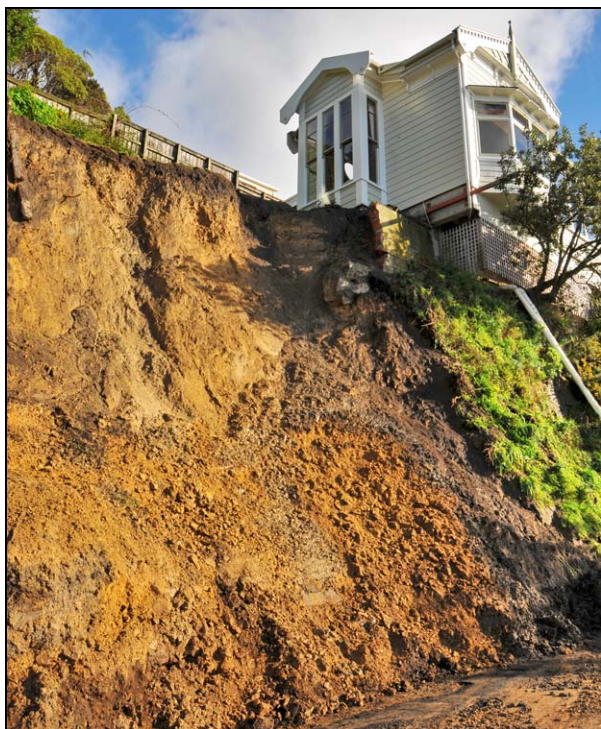
A similar landslide occurred in Palliser Road on 4 August, when a road cut failure endangered a house which was temporarily evacuated, and closing the road for two days while debris was removed (Figure 27). This earth and debris fall in soil and weathered greywacke (regolith) undermined part of the house foundations above the landslide scar, leaving it poised precariously above the road.

Figure 27. House in Palliser Road undermined by road cut failure in weathered greywacke on 4 August, after 26 mm rain the previous day. The house was evacuated and the road closed while the debris was cleared away. [Photo 5 August 2008: GTH-0196]

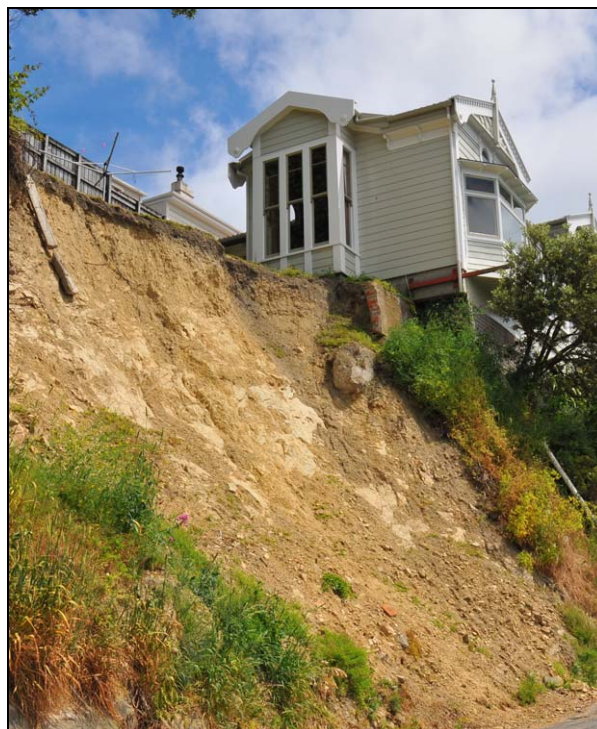
Figure 28. Photo of the batter failure in Palliser Road, December 2008, by which time no further failures had occurred, and the house had been reoccupied. Stabilisation measures here are still to be decided. [Photo 12 December 2008: GTH-1373]

Figure 28 shows this landslide in December 2008. After four months no further failures had occurred, and the house had apparently been reoccupied. Permanent stabilisation works still need to be carried out at this site, as the house is still highly vulnerable to foundation collapse, especially if a strong earthquake occurs.

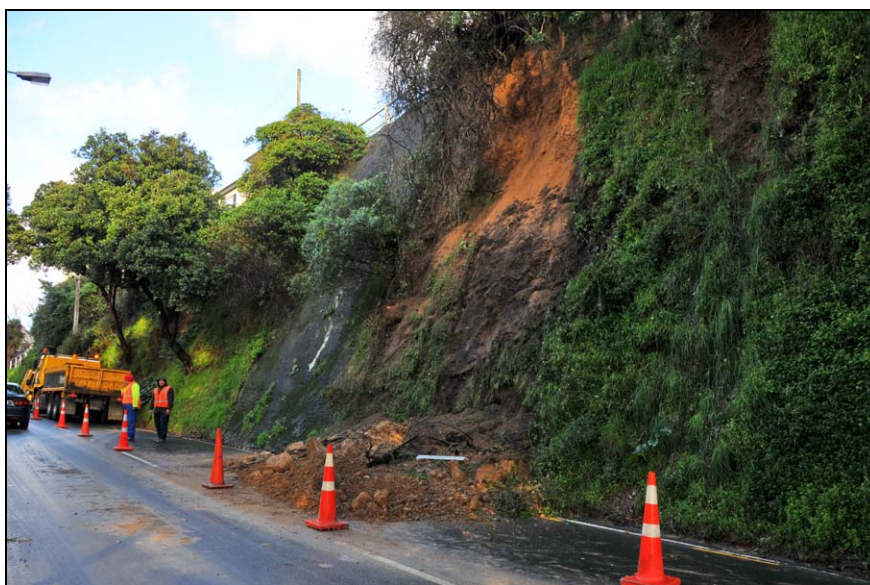
After more rain two similar landslides occurred in Tinakori Road on the morning of 5 August, closing one lane of the road near the Thorndon Quay intersection (Figures 29 and 30). The failure at the northern site undermined a house at the top of the batter, leaving it vulnerable to collapse (Figure 30). Permanent stabilisation measures have yet to be implemented at that site. Failure of this unsupported road cut is typical of those that occur in Wellington during prolonged rainfall. Where houses have been built too close to the tops or bottoms of steep, unsupported cut slopes that are susceptible to such failures, there is substantial risk to property and life during heavy rain, and also strong earthquake shaking (Figure 31).

Figure 29. This small ($\sim 20 \text{ m}^3$) debris fall from an unsupported road cut blocked one lane of Tinakori Road near the Thorndon Quay intersection on 5 August. To the left an older failure area (where the Wellington Fault was formerly exposed) has been treated with shotcrete. [Photo 5 August 2008: GTH-0163]

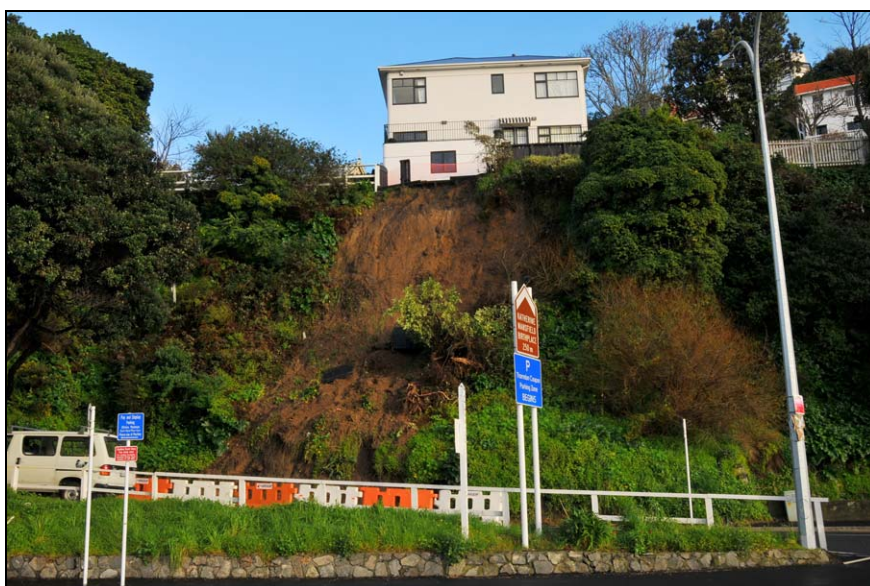
Figure 30. Another debris fall on 5 August from the same road cut (but 20 m north of Figure 29) also partially blocked Tinakori Road, and significantly undermined the house at the top of the batter. Permanent stabilisations measures at this site are still to be implemented. In the meantime the house remains vulnerable to collapse, especially during a strong earthquake. [Photo 12 December 2008: GTH-0158]
