**Field investigations at Waihi
Landslide, Taupo 30 June & 1 July
2009**

**GNS Science Report 2009/34
July 2009 FINAL**

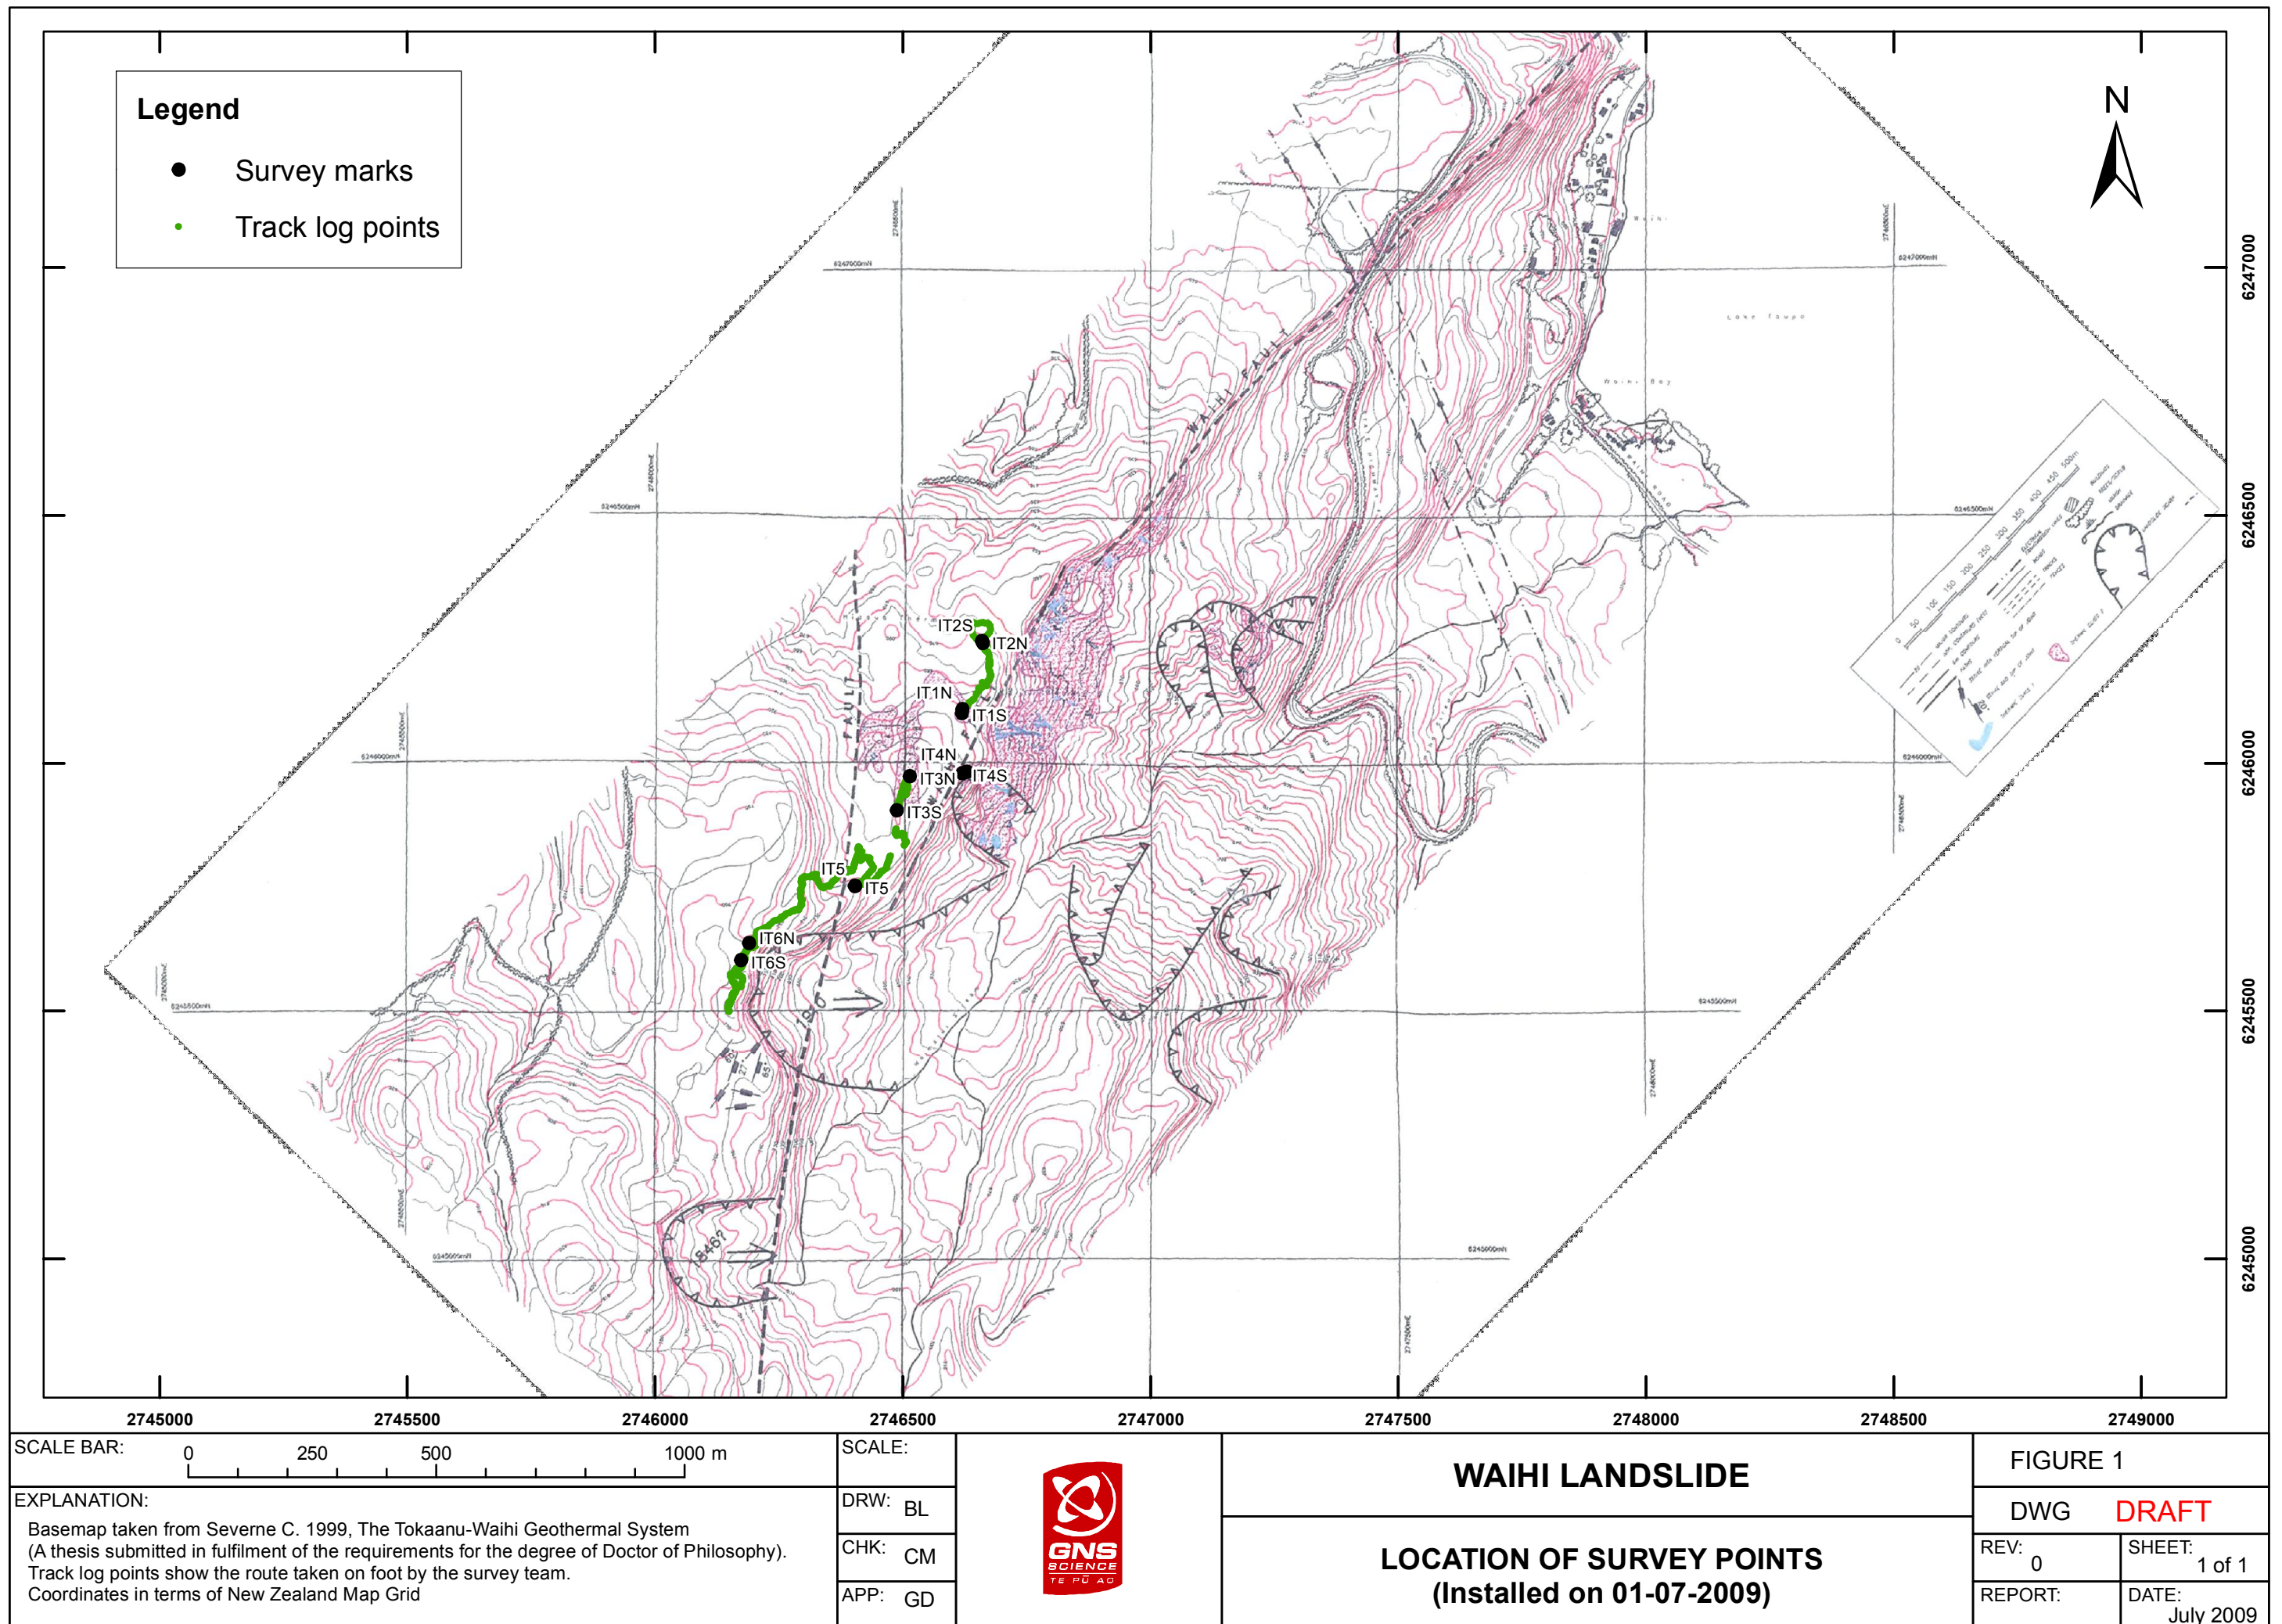
Figure 1	Waihi Landslide, location of survey points
----------	--

- On the 1 July 2009 the GeoNet landslide response team along with a local surveyor Russell Dick (Central Surveys, Taupo) installed 11 survey marks along the ridgeline (Figure 1). The marks comprised iron tubes 600 mm in length hammered into the ground surface. The marks were located in and around potential future landslide source areas (Severne, 1989; Hegan et al., 2001; Hancox, 2002, 2006), which if failure were to occur would have potential to impact parts of the village. The source area is defined as the location from where a landslide could initiate. Leica RTK GPS equipment was used to survey the marks. Access was via helicopter drop-off, with walking through the dense bush.

In the short term it is recommended that the survey marks installed are surveyed daily for three days to establish a baseline (using the local surveyors), including the OPUS marks.

It is recommended that additional survey marks be installed in other critical areas, which could not be accessed on 1/7/09. Localised vegetation clearance should be carried out to allow these additional marks to be properly located, and access routes should be cut between them. This work would best be carried out by the local surveyors, with guidance from GNS Science.

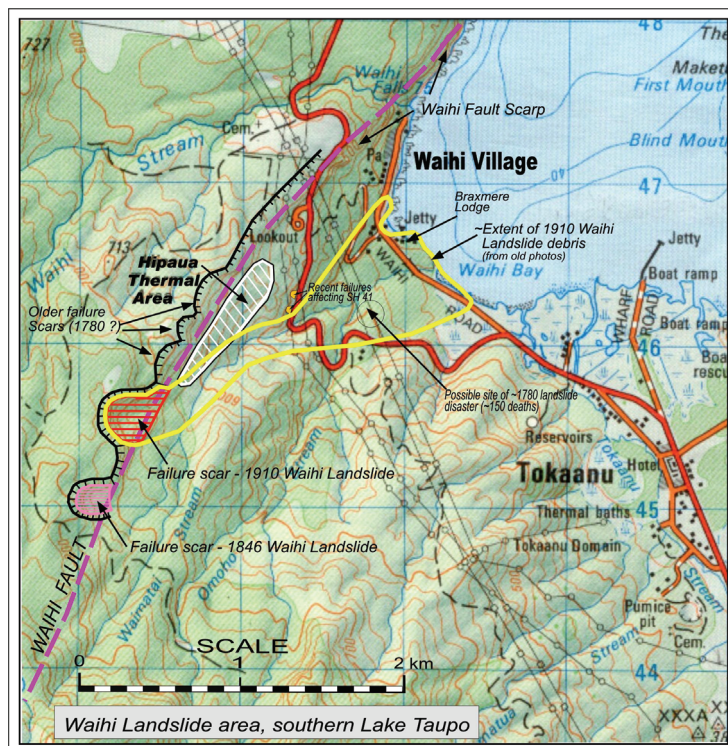
Figure 1 Map of Waihi Village area, southern Lake Taupo showing Waihi Landslide features.

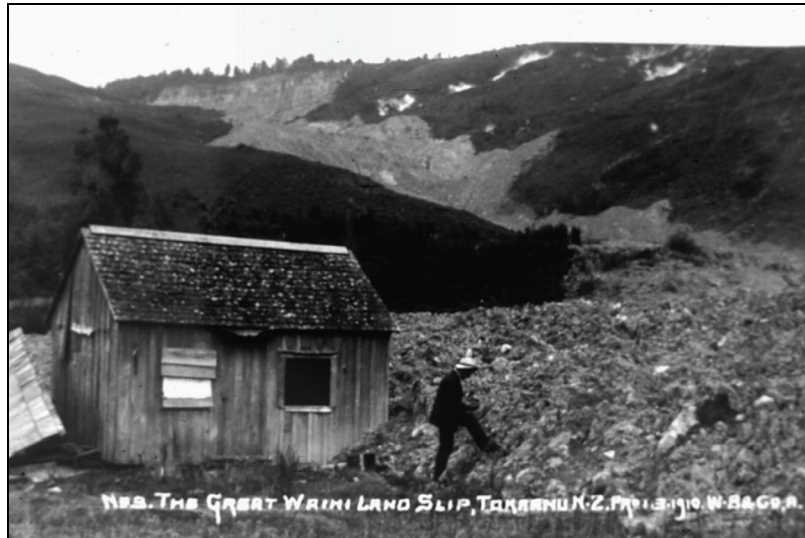
Figure 2 Photo of "The Great Waihi Landslide of 1910" (Photo by W Beattie and Co.)

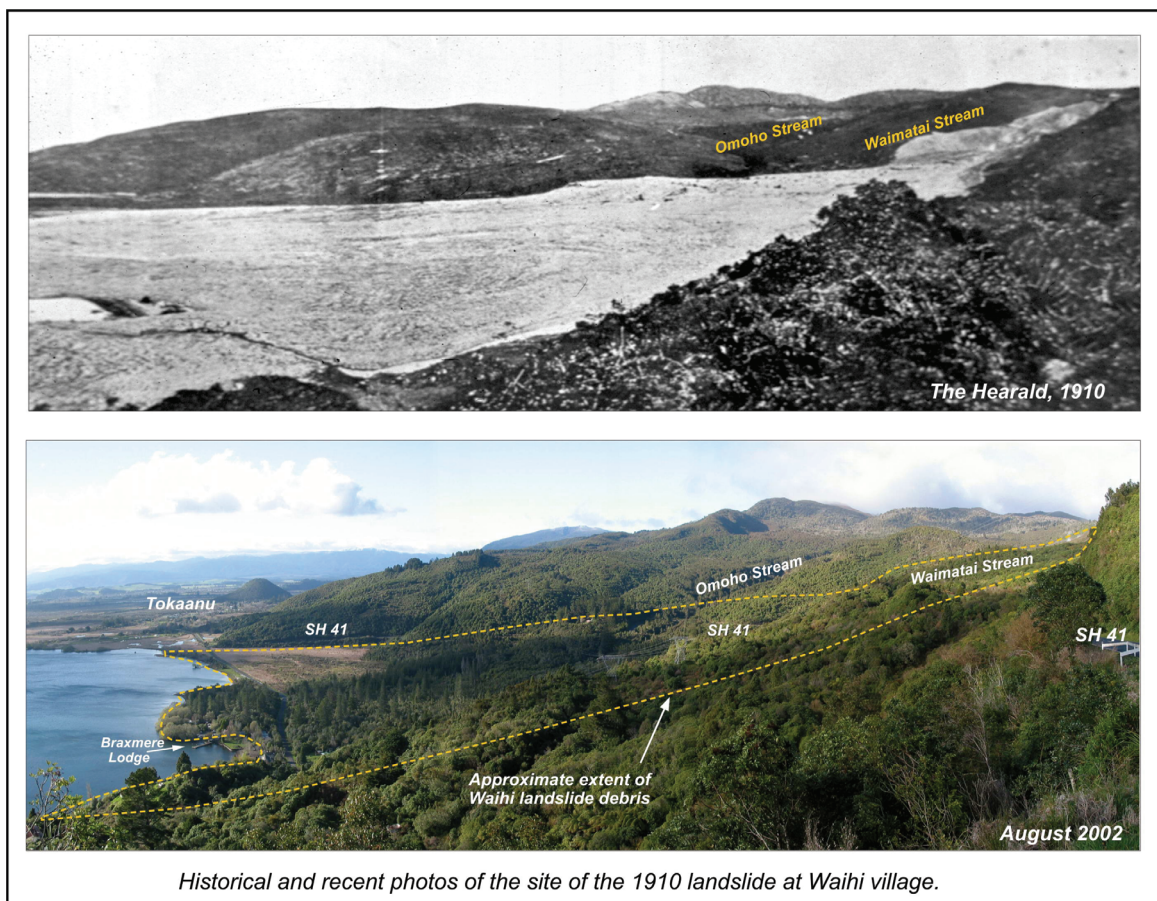
Several large landslides have occurred on the Waihi Fault scarp above the Hipaua thermal field at the southern end of Lake Taupo in the last c. 230 years which have transformed into very large debris flows in Waimatai Stream (see Figures 1 to 7). A well documented event occurred at night in May 1846 with the loss of 64 lives in Te Rapa (Little Waihi) village, including the chief Te Heu Heu (Figure 4). Another occurred on the morning of 20 March 1910 with the loss of only one life as people were alerted and escaped the massive debris torrent (Figures 2 and 3). There is also evidence of an earlier failure in about 1780, which apparently buried at pa at the mouth of nearby Omoho Stream with the loss of possibly 150 lives. The source area of the 1780 landslide is uncertain, but it could have been in the Waihi Fault Scarp just north of the 1910 failure scar, or possibly in Omoho Stream ~500-700 m upstream of SH 41 (Figure 6). Past failures on the steep fault scarp seem to have been related to ongoing tectonic and hydrothermal activity in the area, and also periods of heavy rainfall. The 1846 failures initially formed a small landslide dam in Waimatai Stream, and the main failure occurred when the dam breached during heavy rain. The 1910 landslide also originated of the Waihi Fault scarp about 300 m to the north of the 1846 failure area (Figures 2 and 3). The 1910 failure began with a loud noise and a cloud of steam or dust, and may have been triggered by a geothermal eruption. It was larger than the 1846 landslide (see source scars in Figure 5), and produced a debris flow of about 3 million m³ which flowed 2 km to the southern shore of Lake Taupo (Figure 3), forming a wave about 3 m high.

Figure 3 Historical photo of the 1910 Waihi Landslide showing the 800 m wide debris lobe extending 2 km to the southern shore of Lake Taupo (*top*), and a photo showing the same area in 2002 (*bottom*).

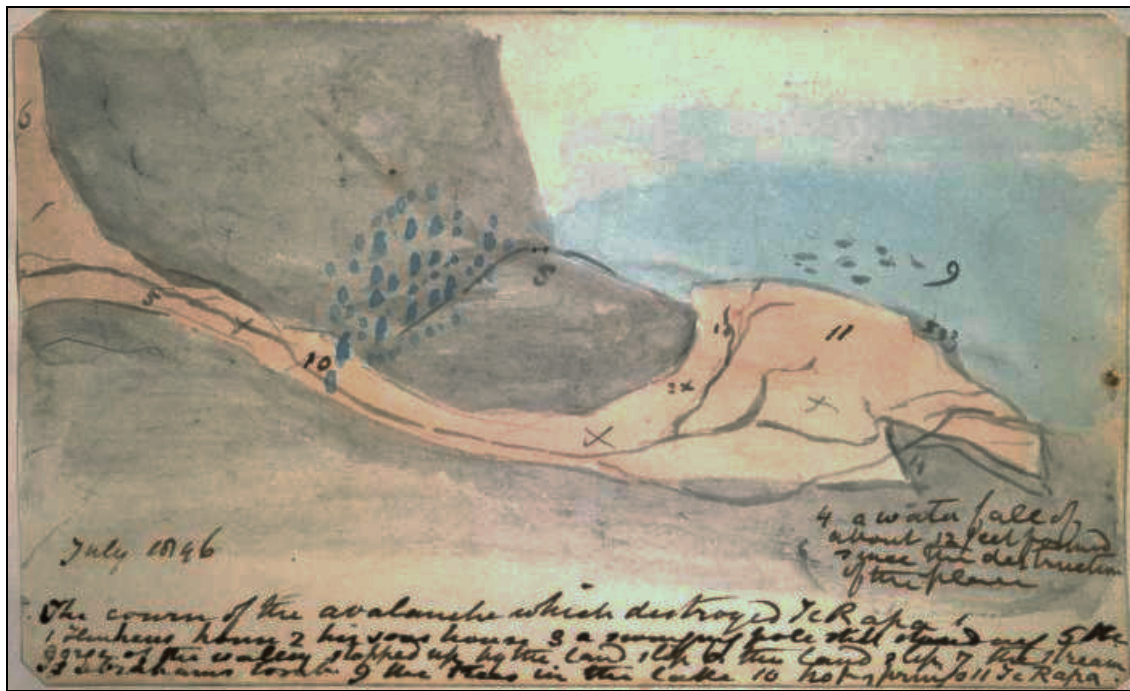
Figure 4 Watercolour sketch by Richard Taylor dated July 1846 showing: the course of the avalanche which, on 7 May 1846, destroyed Te Rapa Village (at the south end of Lake Taupo c.500 m south of the present-day Waihi Village). The features shown and numbered on the sketch are: 1. Te Heuheu's house. 2. his son's house. 3. a swinging pole, still standing. 4. a waterfall of about 12 feet found since the destruction of the place. 5. The gorge of the valley stopped up by the land slip. 6. The land slip. 7. The stream of Abraham's torch[?]. 9. The trees in the lake. 10. Hot springs. 11. Te Rapa. [Alexander Turnbull Library: Reference number: E-296-q-115-2].

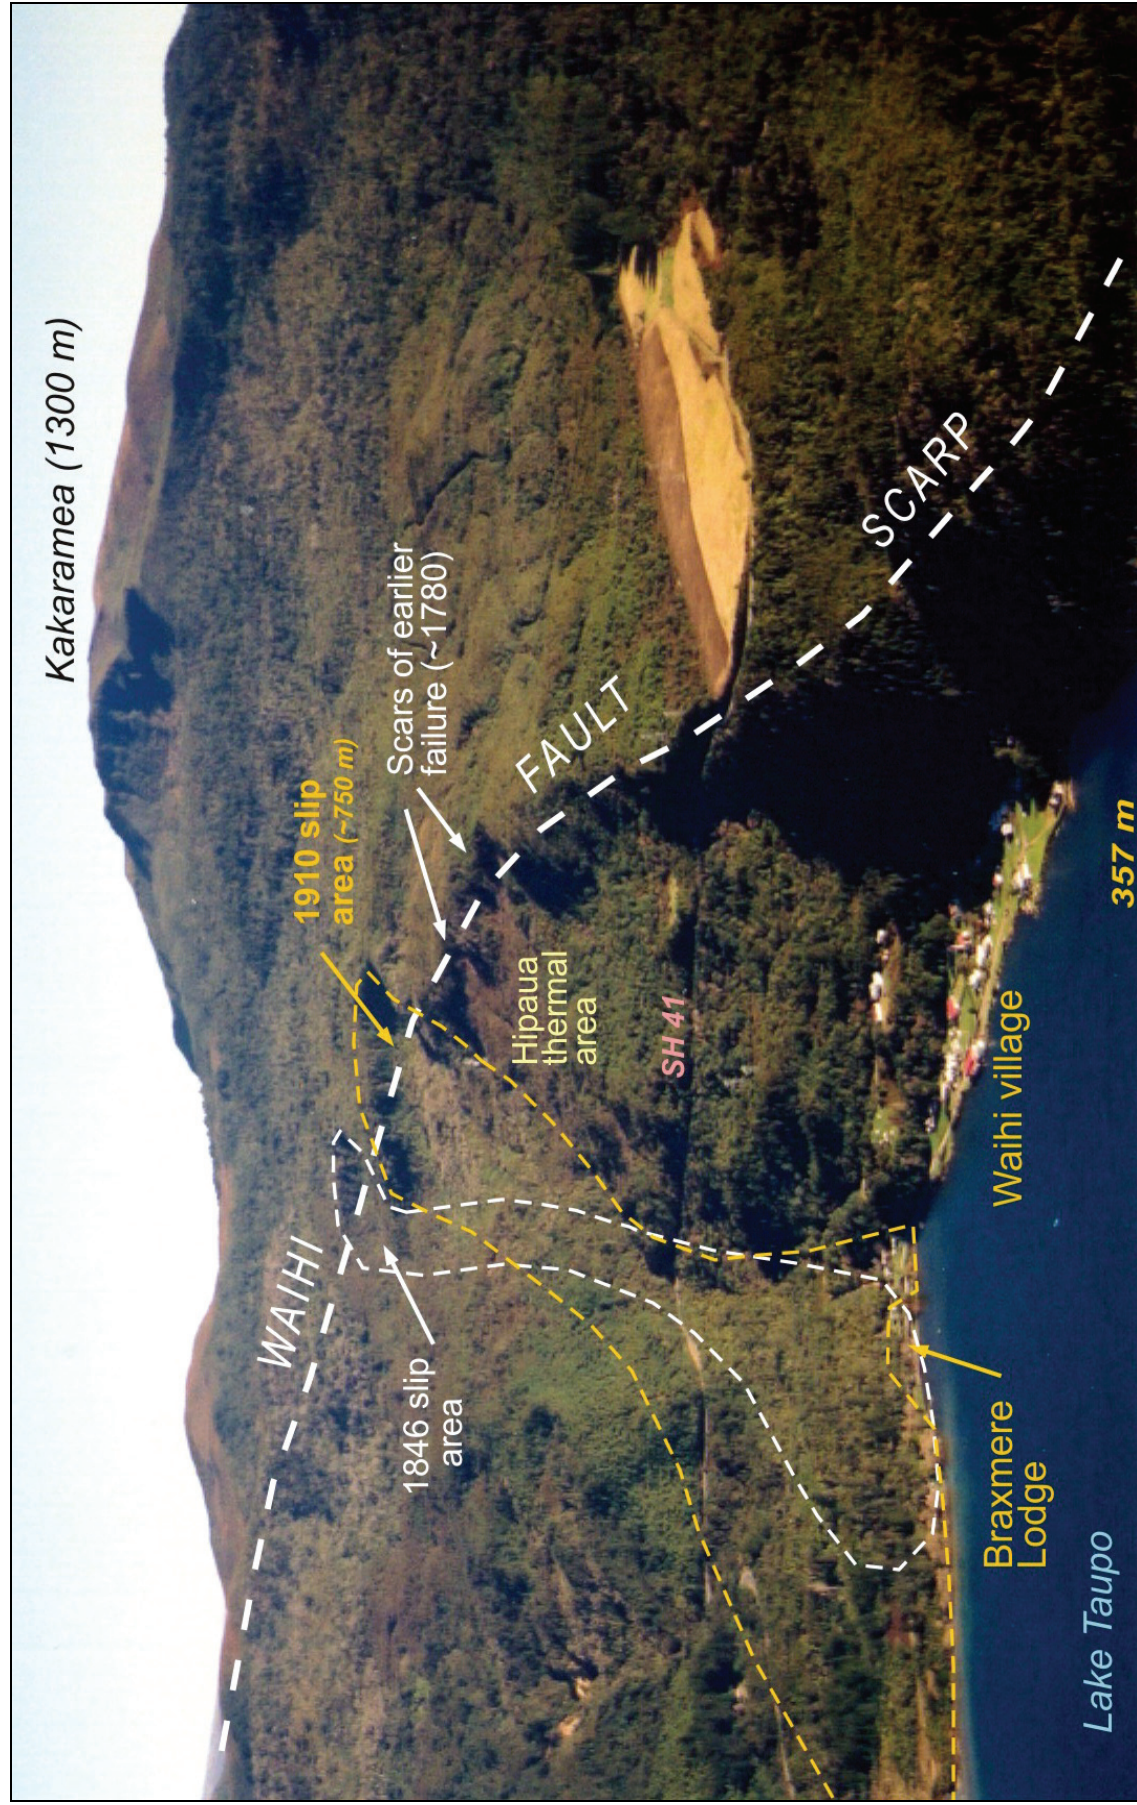
Figure 5 Aerial view of the Waihi Landslide area at the southern end of Lake Taupo showing the source area scars of three large historical landslides from the Waihi Fault scarp which have caused the loss of at least 65 lives, and the extent of the debris lobes at this site. State Highway 41, Braxmere Lodge, and a few houses at the southern end of Waihi Village (near to the lodge) are at considerable risk from future large landslides in this area.

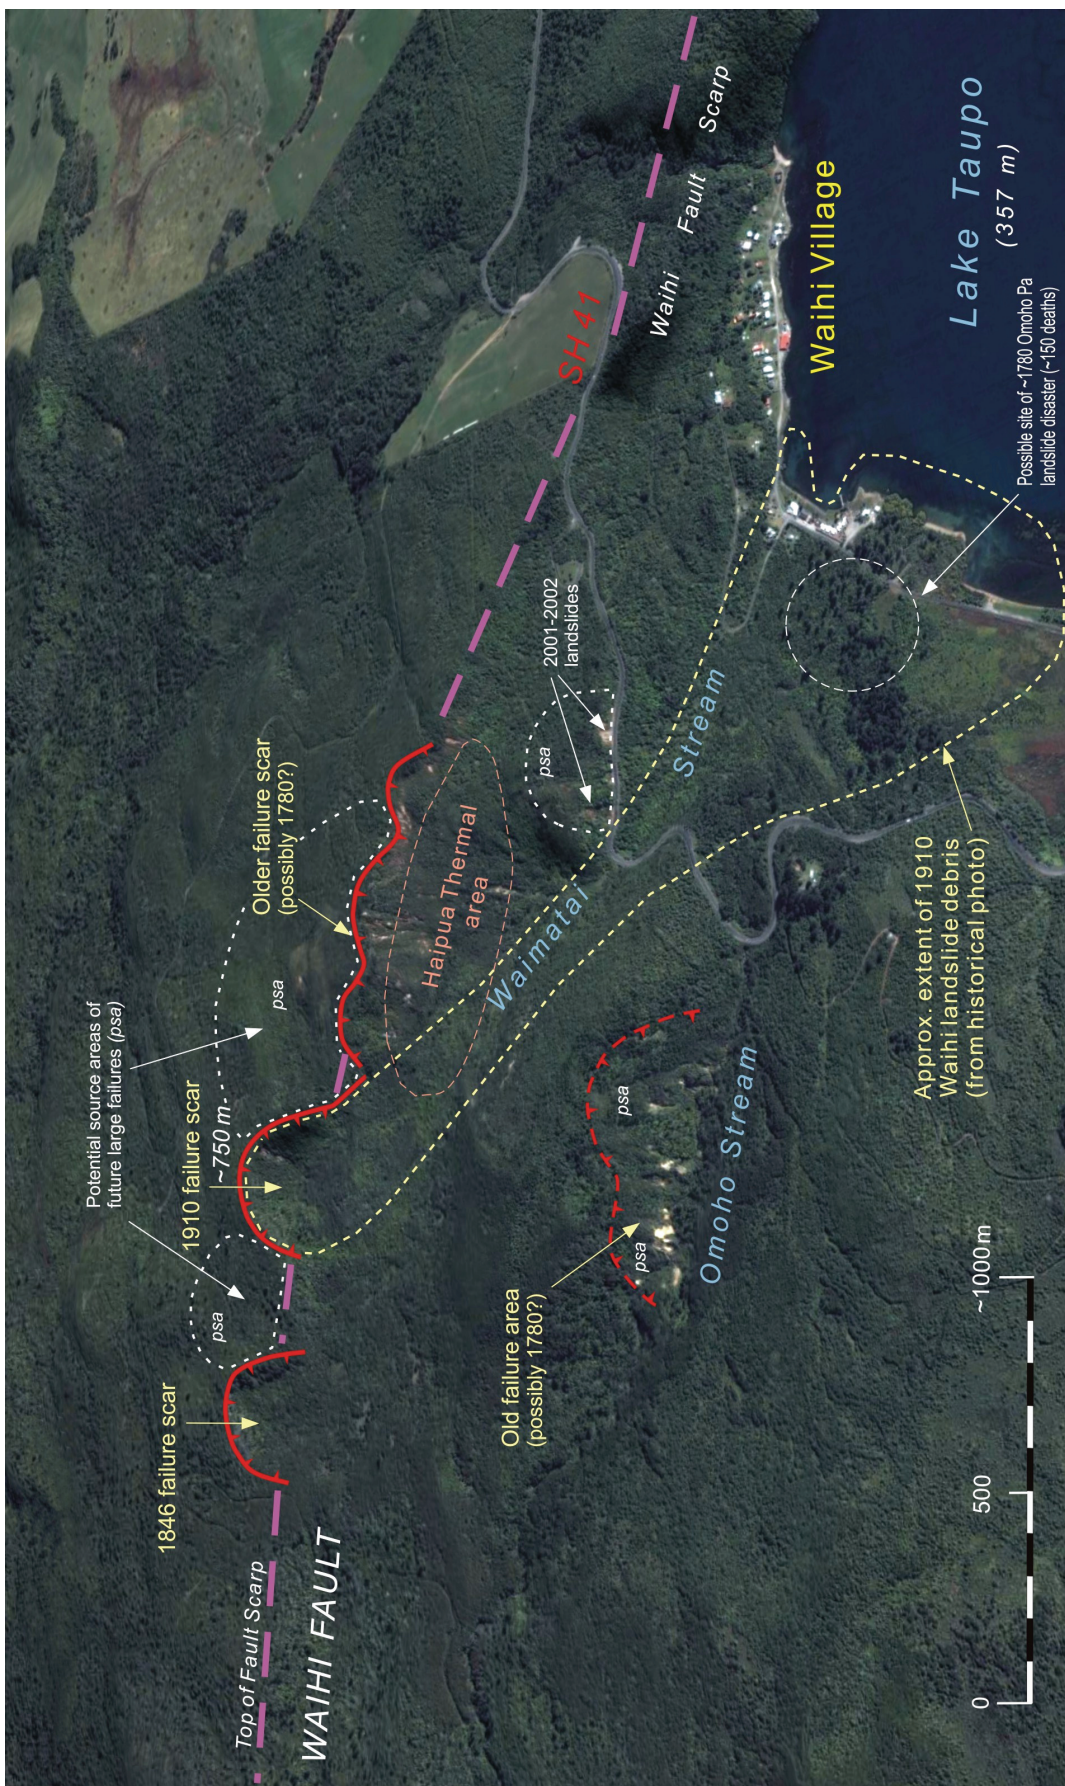
Figure 6 Annotated Google Earth Image (20 March 2007) showing the Waihi Landslide area above Waihi Village. The main features shown include the source areas of three historical failures (1780, 1846, and 1910), and the estimated extent of the 1910 landslide debris, based on a historical photo (Figure 3). The extent of the 1910 debris represents the highest landslide hazard and risk zone of a future large failure from the Waihi fault scarp immediately north (right) of the 1910 scar. Note that the main area of Waihi Village is located outside (north) of the hazard zone. Some potential source areas (psa) of future large landslides are also shown.

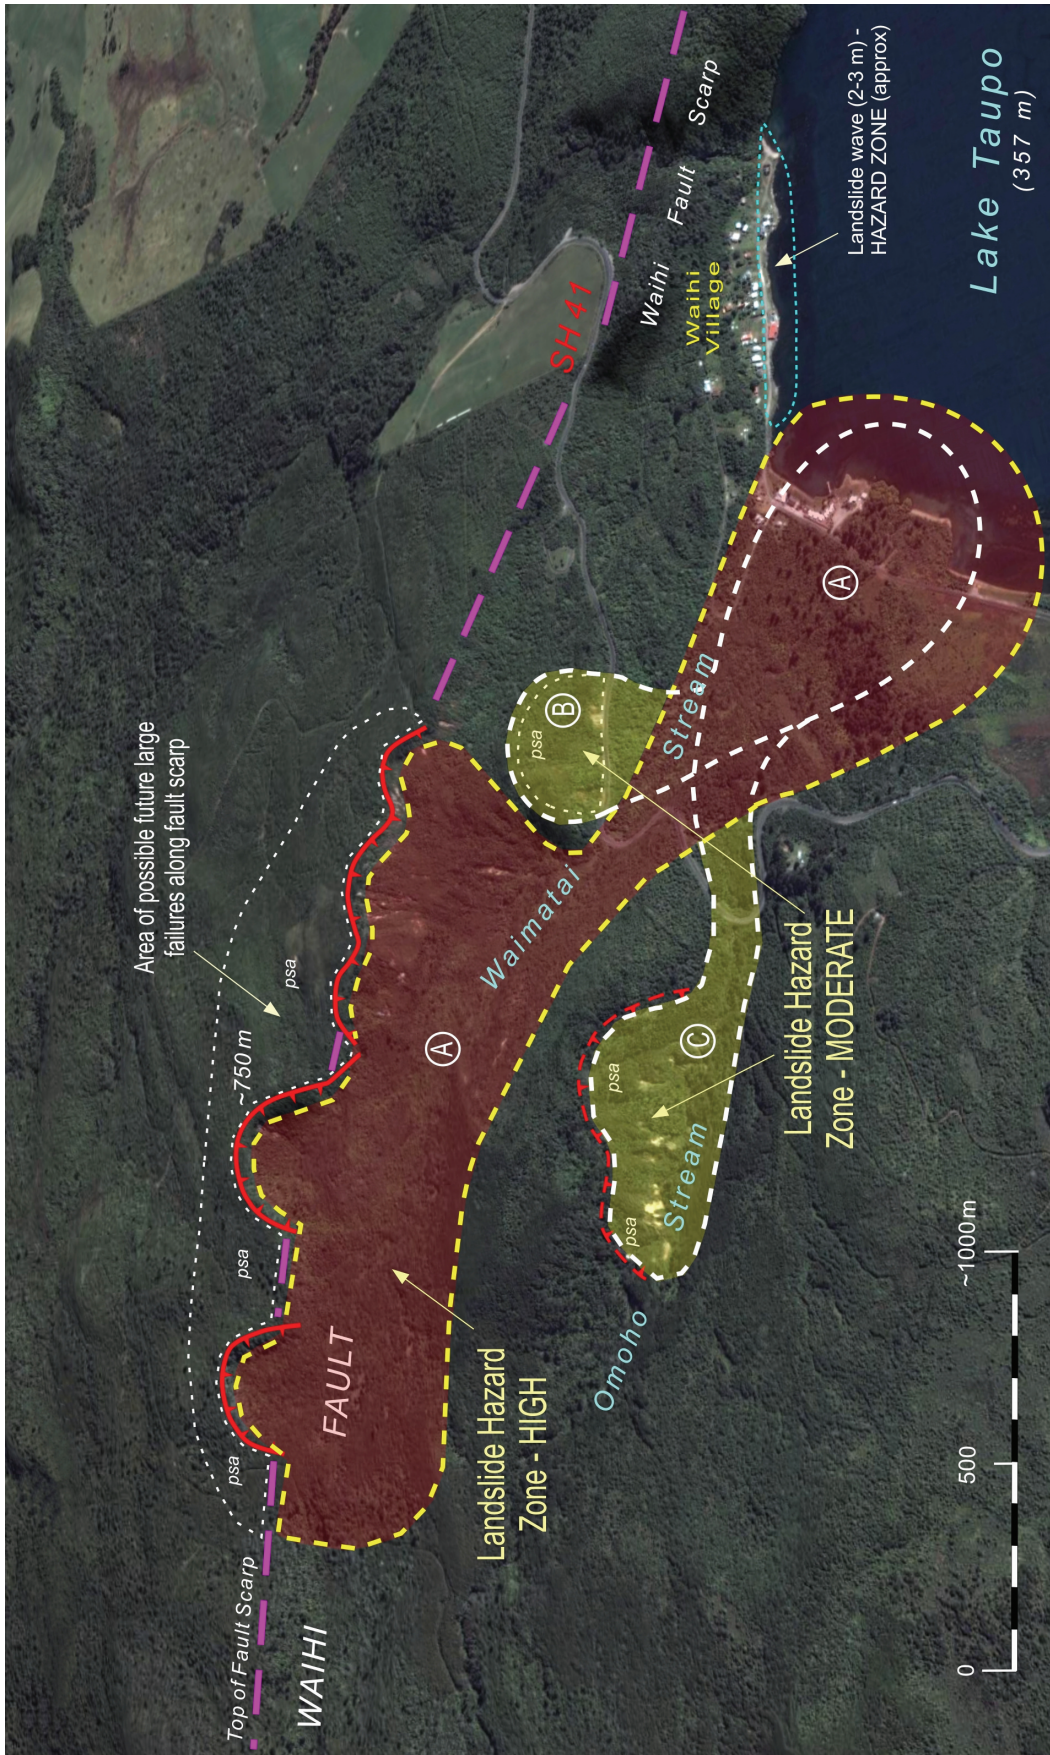
Large failures of this type could occur again, affecting SH 41 over a length of about 300 m in the vicinity of the Waimatai Stream crossing, and possibly overwhelming the Braxmere fishing lodge on the shores of Lake Taupo, and some houses within Waihi Village, which are within the high landslide hazard zone. However, the main part of Waihi Village lies outside (north of) the inferred hazard zones for future large landslides from the Waihi Fault scarp (Figure 7).

Figure 7 Annotated image showing landslide (debris flow/avalanche) hazard zones near Waihi Village determined from the existing literature (listed in Appendix A). The high (red) landslide hazard zone (A), consistent with the extent of the 1910 debris, presents the highest hazard from a future large landslide from the Waihi fault scarp. Areas of moderate landslide hazard (yellow) are inferred above the small landslides (2001-02) along SH 41 (B), and in Omoho Stream above SH 41 (C). The main part of Waihi Village is thought to be outside (north) of the landslide hazard zones, but parts of the village on the lake shore may be within the hazard zone of a landslide wave (~2-3 m high) which could be generated by a future large landslide from the Waihi Fault scarp (in zone A).
