Cox, S. C. 2010. Rock fall at the Takiroa rock art site, May 2010, Duntroon, North Otago, New Zealand. *GNS Science Report* 2010/31, 20 p.

## **ABSTRACT**

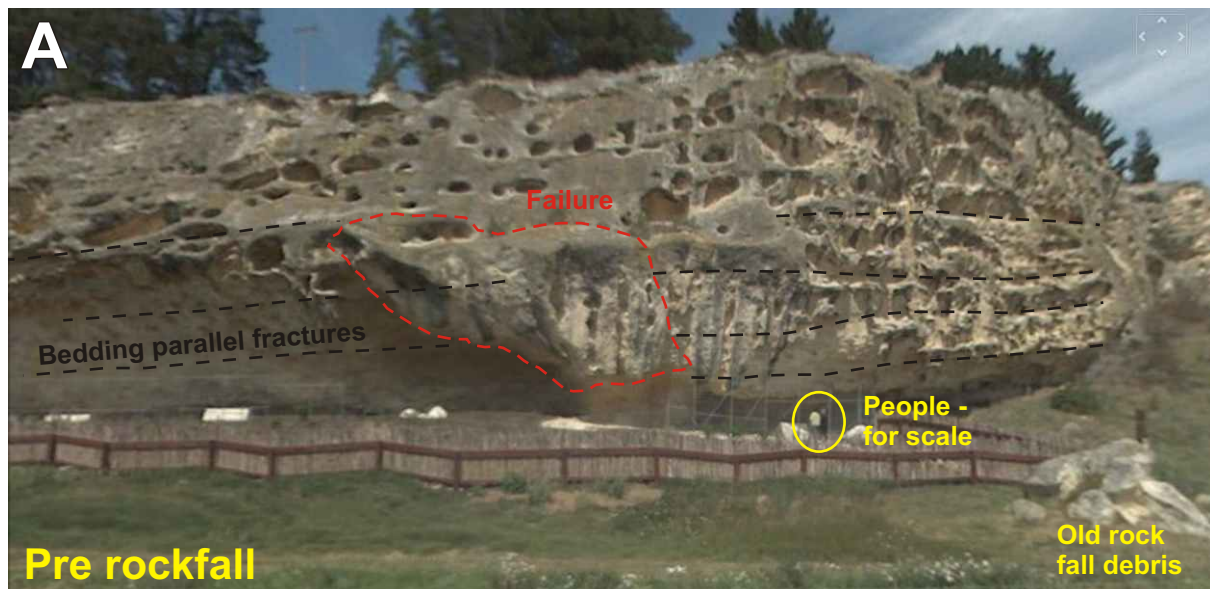
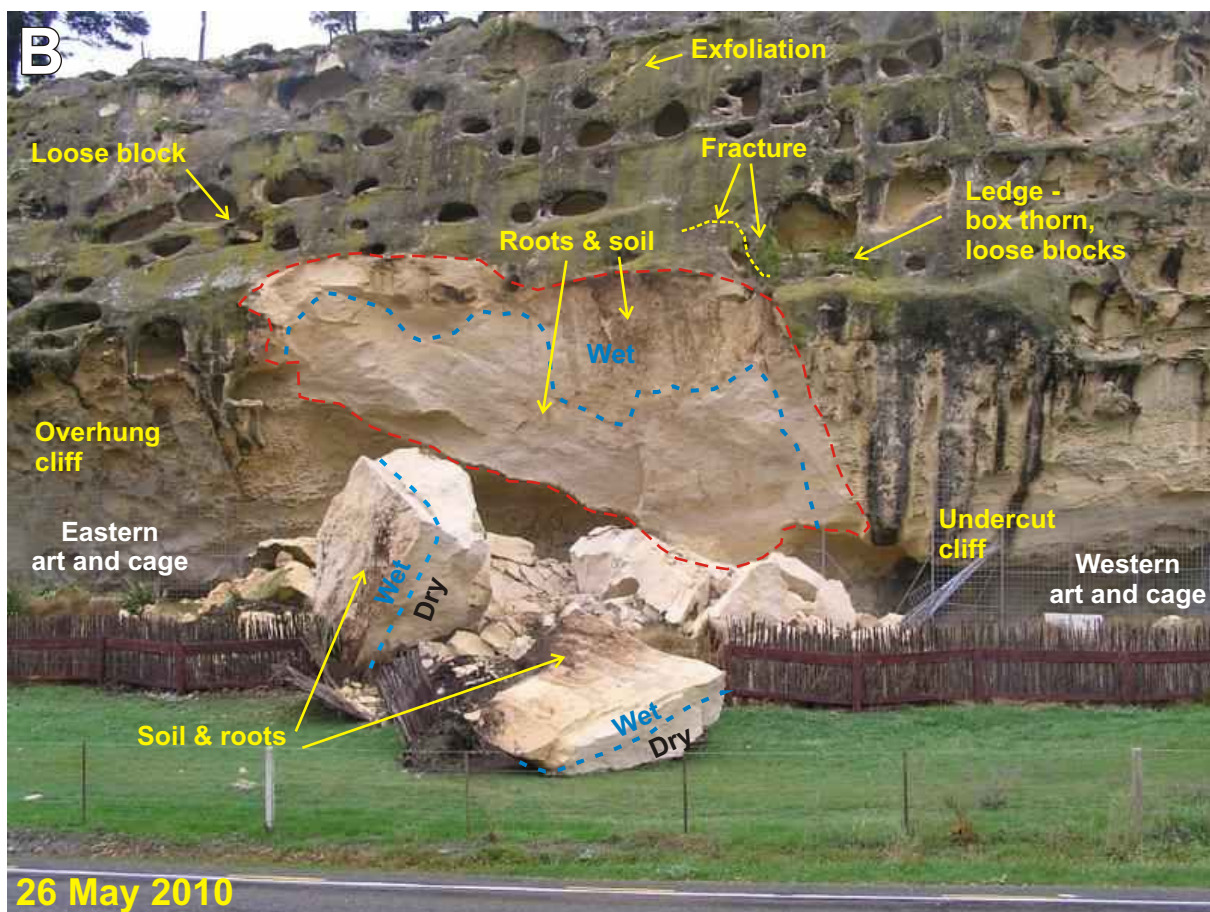
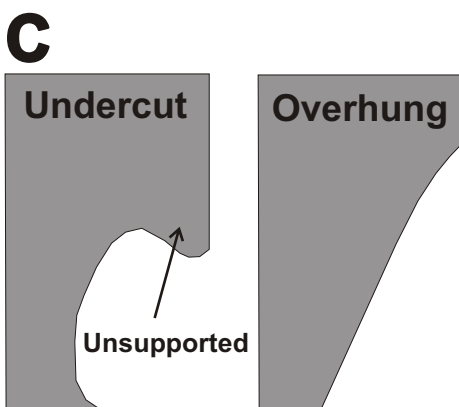
**Figure 3**

Views of the cliff at Takiroa, looking south from the road. (A) Image from Google Earth "Street View" taken around 2006, prior to the rock fall (people provide scale). (B) Closer, annotated, image of the rock fall, taken by Geoff and Jan Keeling, 26 May 2010. The dashed red line shows the area and shape of the rock that fell. (C) Cartoon illustrating the descriptors undercut and overhung as used in this report to describe the cliff shape. Grey area represents the rock of the cliff.

The rock-failure area is marked by a prominent, light-coloured fresh scar between the two main areas of rock art (Fig.3B). By registering photographs to scale in a GIS (Geographic Information System), the scar was digitised and calculated to have an area of 45 m<sup>2</sup>. The scar is relatively planar and overhanging, oriented between 150/60° and 130/65° at the base, and 145/80° at the top (Fig.4). Small variations in orientation occur, particularly a change in dip-direction to 120 at the eastern side of the scar.

Slight colour differences (visible on 31 May 2010) mark variations in moisture content between wet and dry rock (annotated in Fig.3B, shown also in Fig.4). The upper part and right hand (west) side of the scar were nearly saturated, whereas the lower part of the scar was drier. A mat of soil and roots plasters the upper part of the scar, but attached roots also occur on the lower third of the scar. The roots and soil indicate that the failure plane was present in the Takiroa cliff prior to the collapse.

There are no wide-open (gaping) fractures immediately above the fallen rock mass<sup>4</sup>. A narrow, steep closed fracture is, however, present immediately above the failure scar, cutting through the rock immediately to the east (left) of the ledge where box thorn is growing (Fig.3B & 4). The box thorn may be exploiting part of this fracture, with root penetration to provide adequate moisture for plant growth. This fracture is steep, oriented at an angle with potential to aid further collapse. Although it appears to be discontinuous across the surface, it has possibly yet to propagate consistently through the harder grey cemented crust and may be more continuous through the deeper rock mass. It warrants further inspection and consideration in any future geotechnical appraisal.

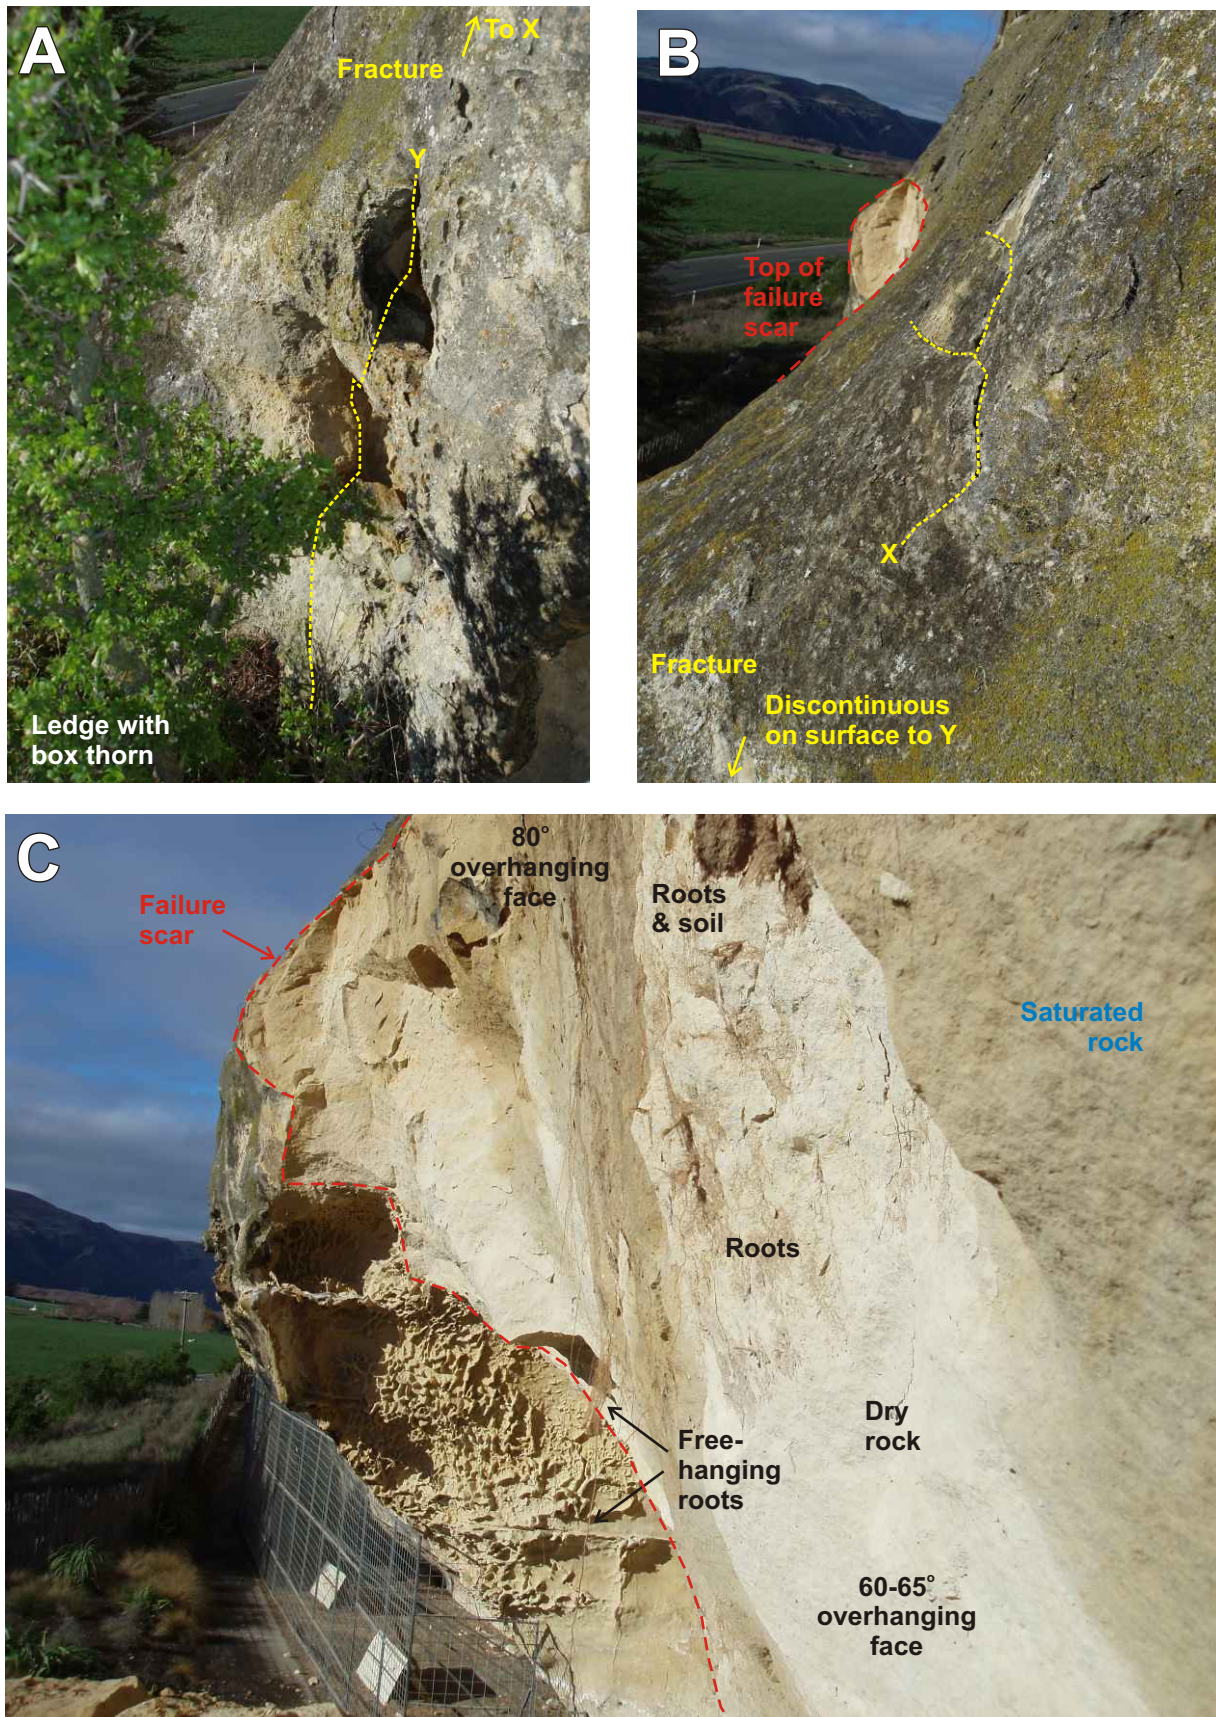
**Figure 4** Close up photographs of the failure area. (A&B) Photographs taken on the box thorn covered ledge above the scar, showing a steeply dipping fracture which has developed in the rock above the failure area (see also Figure 3). The incipient fracture can be seen in the back of solution holes beside the ledge at Y, and appears to link to the fracture at Z. While not a gaping, wide-open feature, it could in future give rise to a similar rock fall. (C) View along the failure area, highlighting the overhung nature of the cliff, variations in water content, and the presence of roots and soil on the face left behind after the failure. All photographs S Cox/GNS Science 31 May 2010.

Much of the upper part of the ~60-65° failure plane was covered with brown soil and roots, indicating that much of this surface had evolved prior to the event. Root growth probably aided crack propagation, but the box thorn may also have helped to absorb some moisture from the crack.

<sup>7</sup> Rock-scaling will require access by abseil. At the same time consideration should be given to the removal of vegetation such as box thorn, thereby reducing the penetration of roots into fractures.

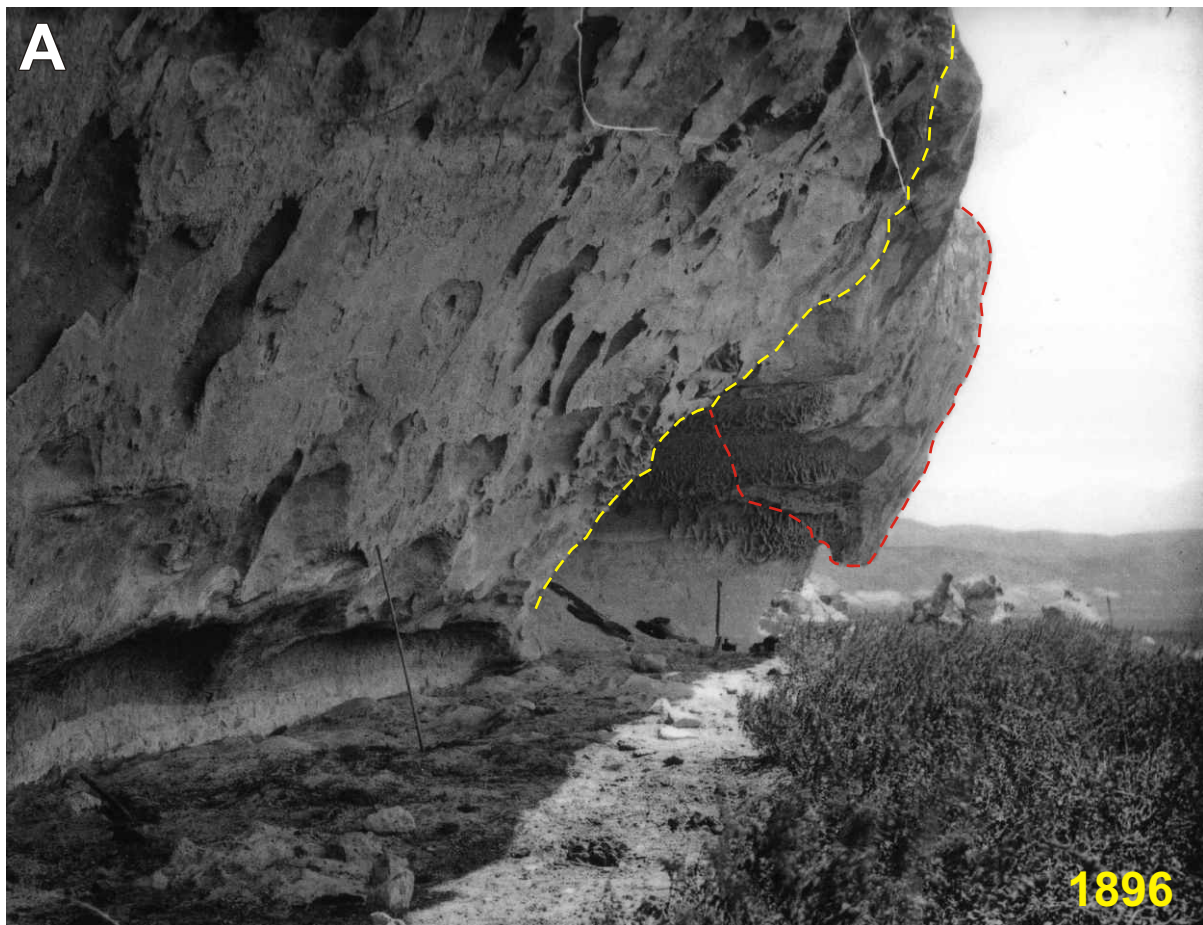
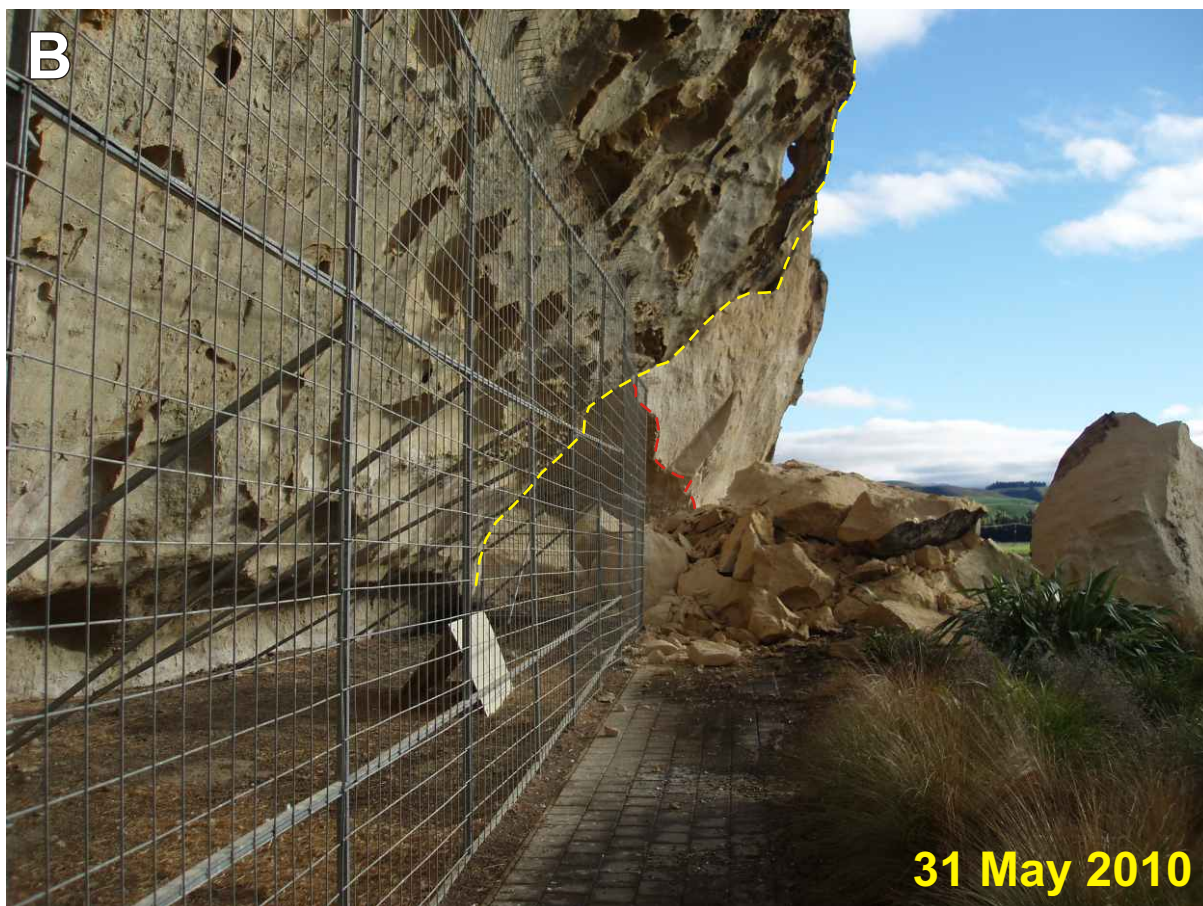
Photographs of the cliff prior to the rock fall show that the failed rock mass was deeply undercut and steeply overhung (Fig.5, see also Figs. 3C and 7). A C-shaped cavern was present below the rock that fell, much of which was unsupported with an 80° overhanging face above. No indication of fractures, either below or above the rock that fell, is visible in photographs and images available for this report.

**Figure 5** Views west along the outcrop from beside the eastern rock art. (A) “Before” photograph by Augustus Hamilton in 1896 (supplied by Ngāi Tahu Māori Rock Art Charitable Trust) and (B) “After” photograph taken by S. Cox/GNS Science on 31 May 2010. Annotated yellow lines highlight the position of a prominent change in orientation of the cliff; the red line shows the failure scar. Note the undercut, unsupported pillar can be seen in A, and the encrusted, planar, 60-65° overhanging cliff face behind the cage. The new face formed by the failure very close to the orientation of the face with the art suggesting this older face may also have formed by a similar collapse prior to 1896.

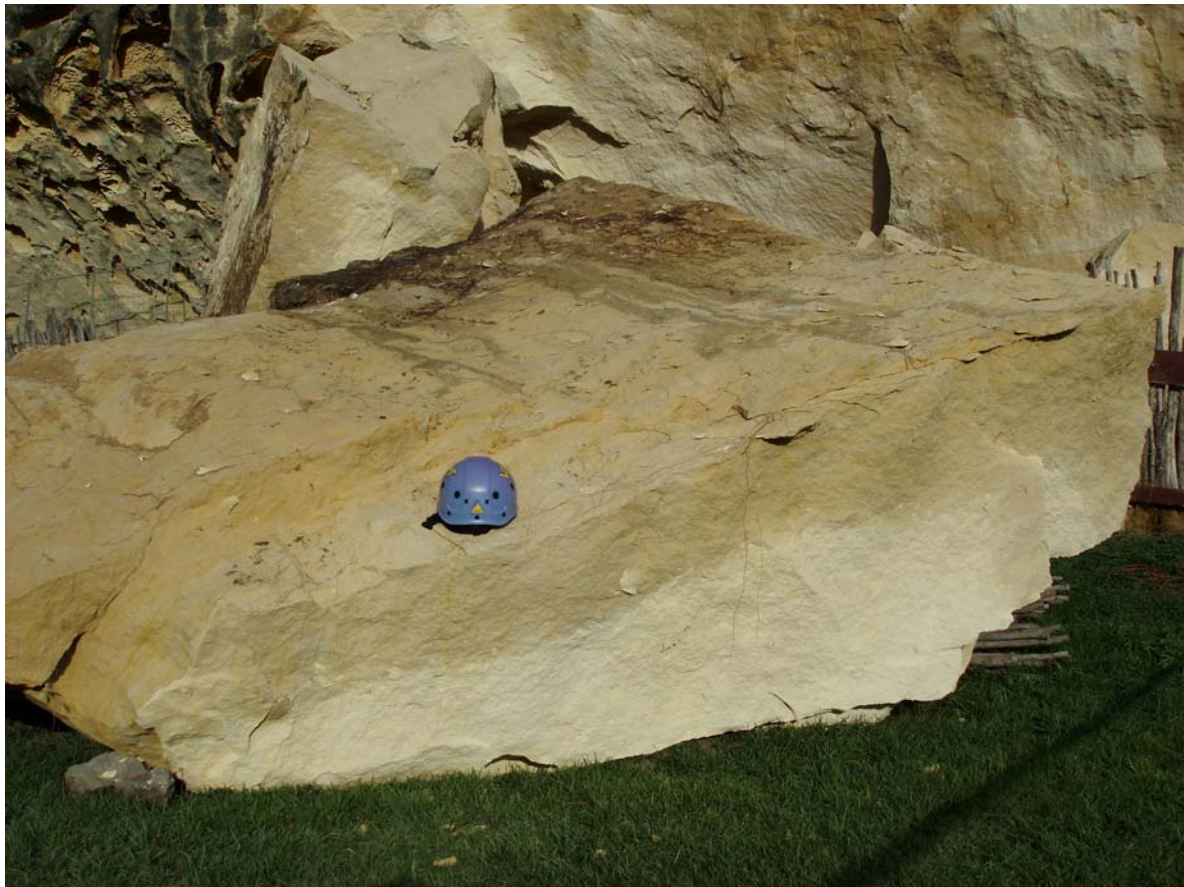
The discoloured, wet area of the failure scar is 20 m<sup>2</sup> (see Fig.3B). Observations of moisture in the fallen blocks indicated that water had penetrated the rock for distances of ~25 cm from the failure crack and cliff surface (Fig. 6). It is inferred that penetration of water occurred prior to failure, since the orientation of the wet-dry transition was observed to have variable orientation in fallen blocks, could not simply be related to wetting of the upper surface of blocks after they had fallen (see annotations Fig.3B). Assuming saturation occurred shortly preceding failure to a 25 cm depth across the entire 20 m<sup>2</sup> wet area, ~2 tonnes of water could have been added to the mass that failed<sup>6</sup>. Accounting for uncertainties, this equates to as much as 5% additional weight from the water. The total weight of the fallen rock, including water, was somewhere between 40 and 77 tonnes.

**Figure 6** A thin layer of roots and soil covers part of the upper side of this block. It matches the upper right-hand (western) edge of the scar on the cliff (see Fig.3B) and corresponds to part of the failure crack. Note the prominent change in colour in the surface beneath the helmet – the upper half of the block (that was once beside the failure crack) is wet (dark) whereas the lower half is dry (light). Water has penetrated the block to a depth of ~25 cm from the failure crack. A similar phenomenon can be seen in the block behind – in this instance the left hand steep side of the block has roots and the wet/dry transition is near-vertical.

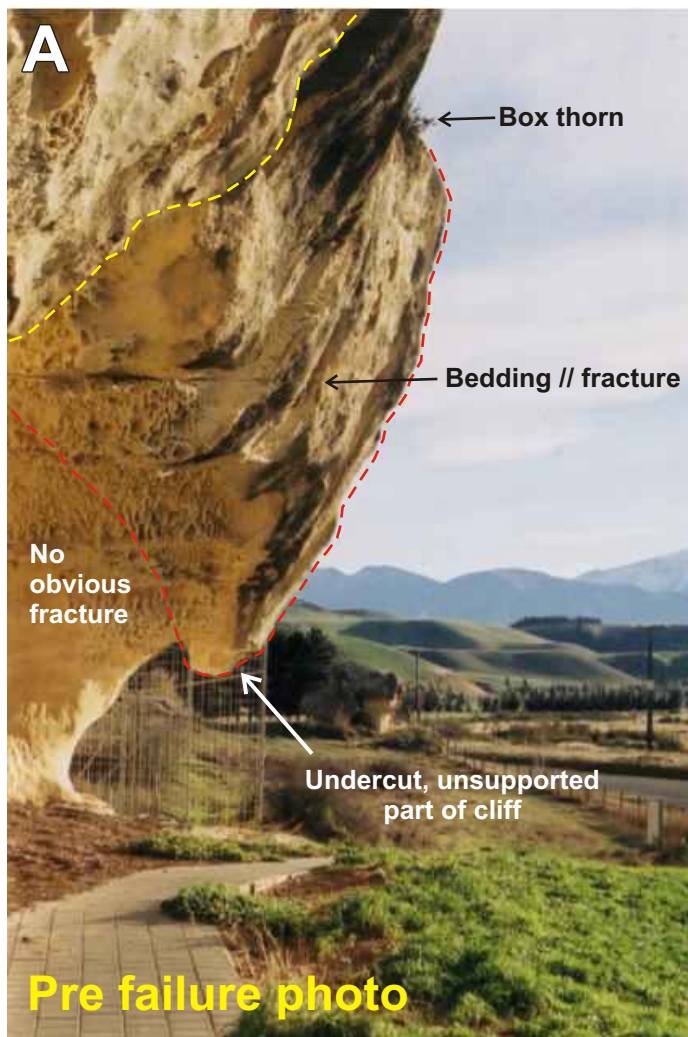
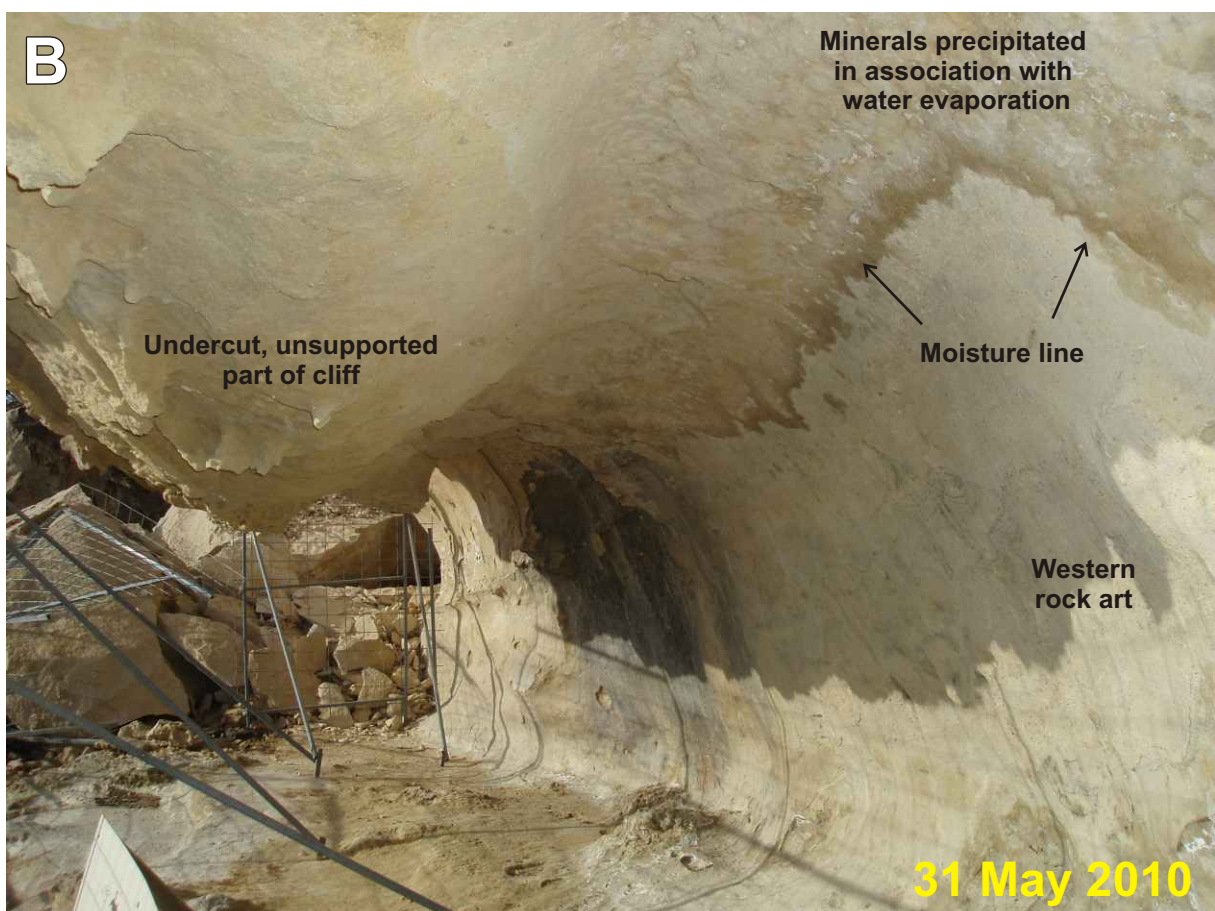
**Figure 7**

Unsupported parts of the cliff. (A) View of the under side of the rock fall area, prior to the failure in May 2010 (Photo supplied by Ngāi Tahu Māori Rock Art Charitable Trust). The failed area is annotated with a red dashed line. No fracture is visible beneath the overhang. (B) An area of focus for geotechnical assessment of safety is behind the cage protecting the western rock art (see also right hand side Fig.3B). This area of the cliff is deeply undercut and unsupported. Variations in moisture content (seen in this photograph) may reflect seepage behind the cliff. Photograph S Cox/GNS Science 31 May 2010.

It is very difficult to predict or quantify the threat of subsequent catastrophic events. Overhanging and undercut sections of cliff, similar to that which failed, are still present on the site (Fig.7). The recent failure has changed stresses in the surrounding rock (increasing and decreasing them in different areas) and this may induce a short-term increase in frequency of rock falls. The 25-26 May 2010 failure removed at least one major hazard from the area, so that the site is now safer than it previously was. But, in retrospect, the site was exceedingly unsafe, so that being safer now does not indicate that it is now safe. Immediate field observations made for this report provide no information on future failure frequency or current safety margins.

The rock art is currently protected from visitors by lightweight metal fences, although the western cage was damaged by the recent rock collapse (Fig.7). The western fence is situated where the cliff is particularly undercut and overhung. Consideration could be given towards the feasibility of replacing these fences with something that provides structural support to the rock face. It may be possible to design a structure that will fit in more naturally with the cultural setting – perhaps disguised by a Māori totem rather than as raw structural steel?

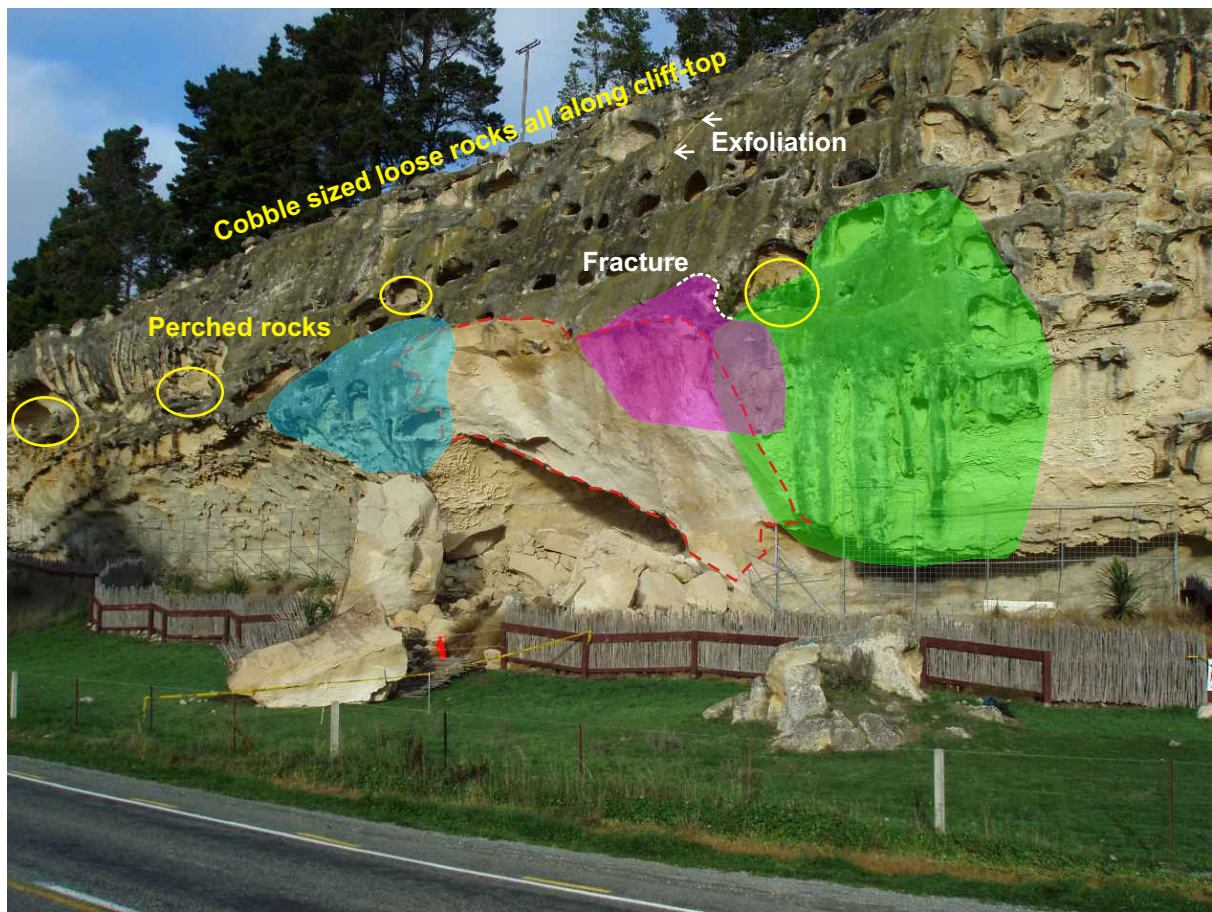
Regardless of whether the frequency of failures has changed, rock falls are an inevitable natural process at this site. Possible future scenarios, some of which may not occur for a hundred or a thousand years, are depicted in Figure 8. It is likely that the chance of any future failure will be greater when the rock mass is wetted by heavy rainfall or runoff.

**Figure 8** Hypothetical scenarios of rock fall at Takiroa in the future, include collapse of the cliff above the western rock art (green), a smaller collapse of the overhung cliff linking back to the open fracture observed near the ledge covered with box thorn (pink), or collapse of the overhanging nose (blue). Rock falls are a natural process at cliffs, but they can be highly infrequent and difficult to quantify. Cobble and some boulder-sized rocks perched on ledges or exfoliating along the cliff top could be relatively easily removed (rock-scaling) to improve public safety. It may be possible to rebuild damaged access paths in a position further out from the cliff face, thereby decreasing average time visitors are exposed to rock fall hazard.

It would be possible to decrease the exposure of visitors to the rock-fall hazard by decreasing the amount of time they spend in the rock-fall runout zone below the cliff. The current layout of the paths has egress along the cliff base, parallel to the cliff in a position so that walkers are exposed to the path of anything that falls from the cliffs for much of the time of their visit. Small cobble and some boulder-sized pieces are currently balanced on ledges above the path, and along the top of the cliff, and could be removed to mitigate some of the hazard at the site<sup>7</sup> (rock scaling – see Fig.8). The path is now covered by debris from the 25-26 May collapse and needs to be rebuilt. It may be possible to redesign routes with more

direct access to the art viewing areas that result in a shorter time spent by the visitor directly beneath the hazard. Signage should also be used to warn and remind visitors that hazards are known to exist around the cliffs. Visitors should be given the opportunity to consider whether the experience of seeing and appreciating the rock art in its natural setting is worth accepting exposure to a natural hazard, and may appreciate being reminded they can minimise their exposure to the hazard by not lingering unnecessarily.
