Hancox, G.T. 2010. Report on the landslide that blocked SH 1 and the railway line near Rosy Morn Stream south of Kaikoura on 10 September 2010, *GNS Science Report* 2010/59. 33 p.

This report describes and evaluates the cause of the landslide which blocked SH 1 and the railway line near Rosy Morn Stream 12 km south of Kaikoura on 10 September 2010. The landslide was a moderately large (about 50,000 m³) debris and rock slide, and occurred on the toe of a large prehistoric landslide on the steep (45-50°) coastal slope. This slope is formed of indurated (hard), interbedded, well jointed greywacke sandstone and mudstone (argillite) bedrock, and is overlain by thin colluvial deposits. The 2010 landslide was a significant event justifying a response and report under the GeoNet Project of GSN Science, mainly because of the disruption it caused to transport by closure of an important road and rail link to Christchurch at a time when supplies were urgently needed there after the Darfield earthquake. Normal road and rail access was blocked for one week while the debris was cleared away.

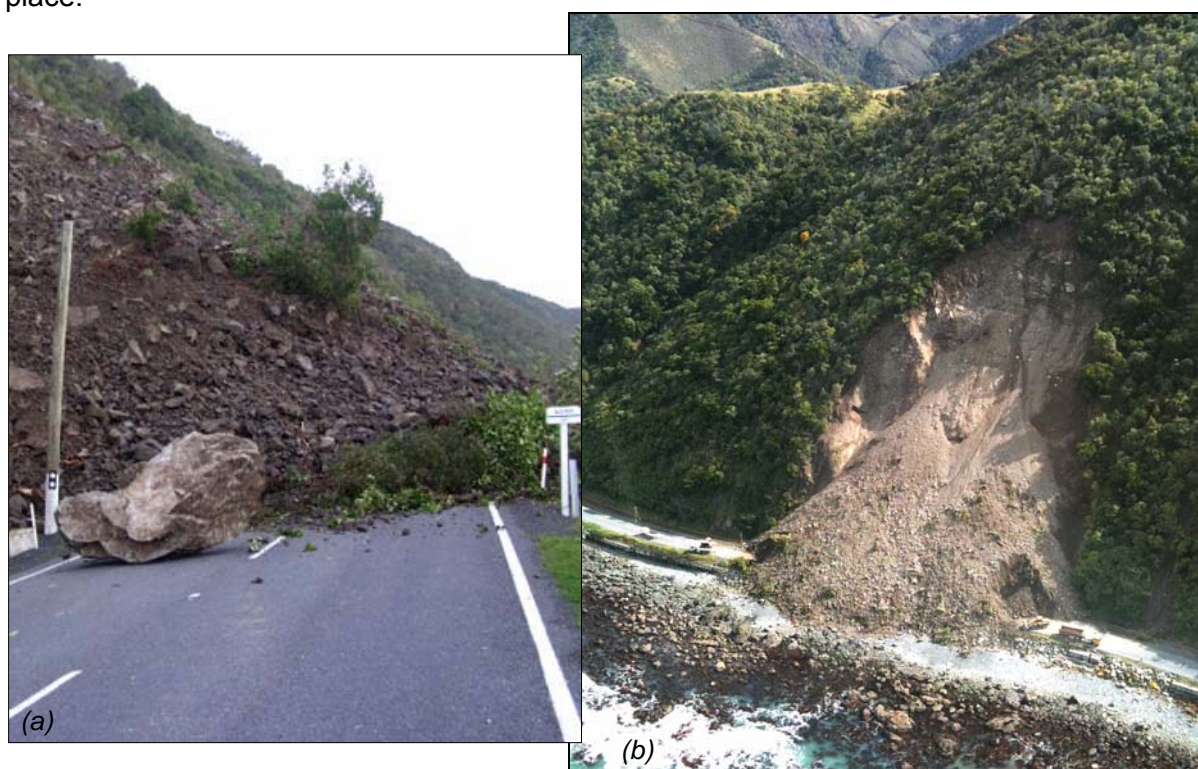
Two photos (Figures 2a and 2b) show the landslide on the morning of Saturday 11 September. Figure 2a is a ground view of the large mass of rocky debris blocking SH 1. Figure 2b shows the landslide location and source area on the steep coastal cliff, and the full extent of the debris cone when earthworks to clear the road had just begun.

Figure 2 (a) Ground view of the southern side of the landslide debris blocking SH 1 on the morning of Saturday 11 September 2010. Angular debris and boulders up to 1.5 m across cover the highway to a depth of about 5 m (*photo NZ Press Association*). (b) Aerial view of the landslide on 11 September, after earthworks to clear the road had just begun. The debris cone extends across SH 1 and sea wall on to the narrow beach below the road (*photo by Wings Over Whales*).

The 2010 landslide debris comprises mainly angular rocks (gravel) with boulders up to 1.5 m across, mixed in with colluvial deposits, stony top soil, and vegetation debris. When observed immediately after the failure (Figure 2), most of the surface debris appeared to have been derived from later failures from the head scarp area, rather than the initial main collapse. The distribution of debris suggests there were three source areas, resulting in two overlapping debris cones, with the southern cone formed first and the northern cone, derived from the head scarp, slightly later (Figure 6a).

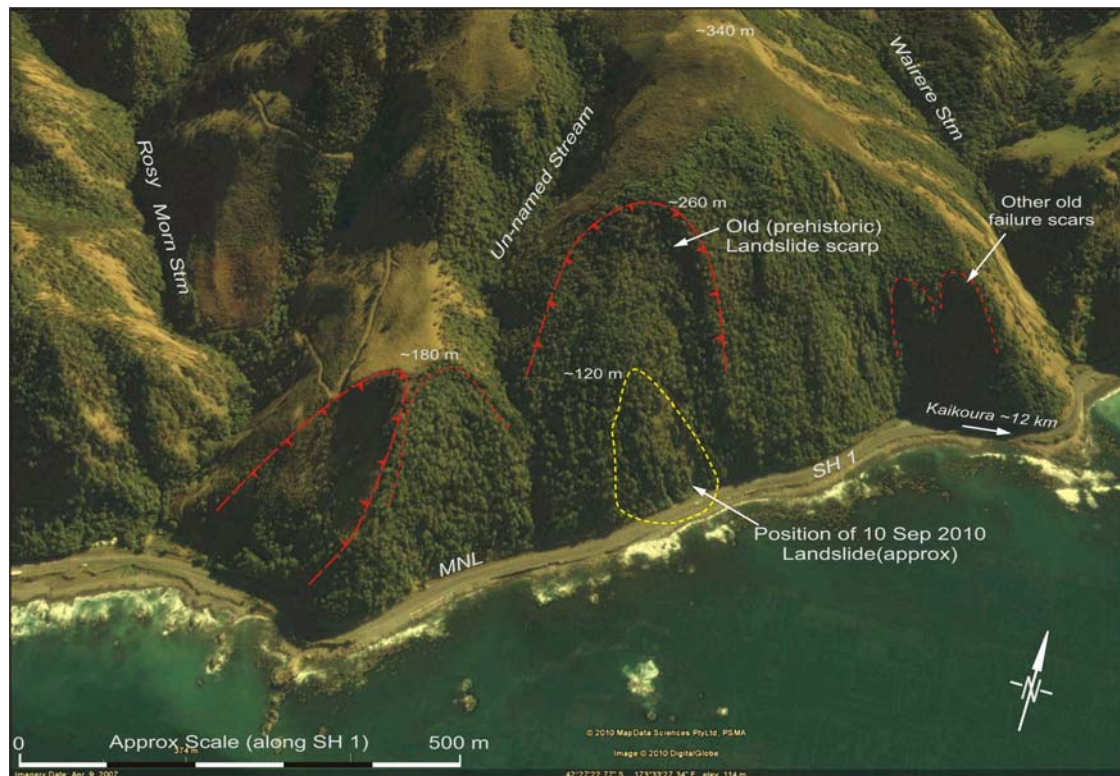
Figure 3 Annotated Google Earth 2007 satellite image showing the position of the 2010 landslide on the coastal slope, and scars of older (prehistoric) failures (*shown in red*). The 2010 failure area on the lower slope seems to be a distinct 'bulge' below the older landslide, the head of which extends to about 260 m above sea level. The railway line (MNL) and main highway (SH 1) are located close to the toe of the steep coastal slope on a slightly elevated shoreline platform about 3 m above the present storm beach.

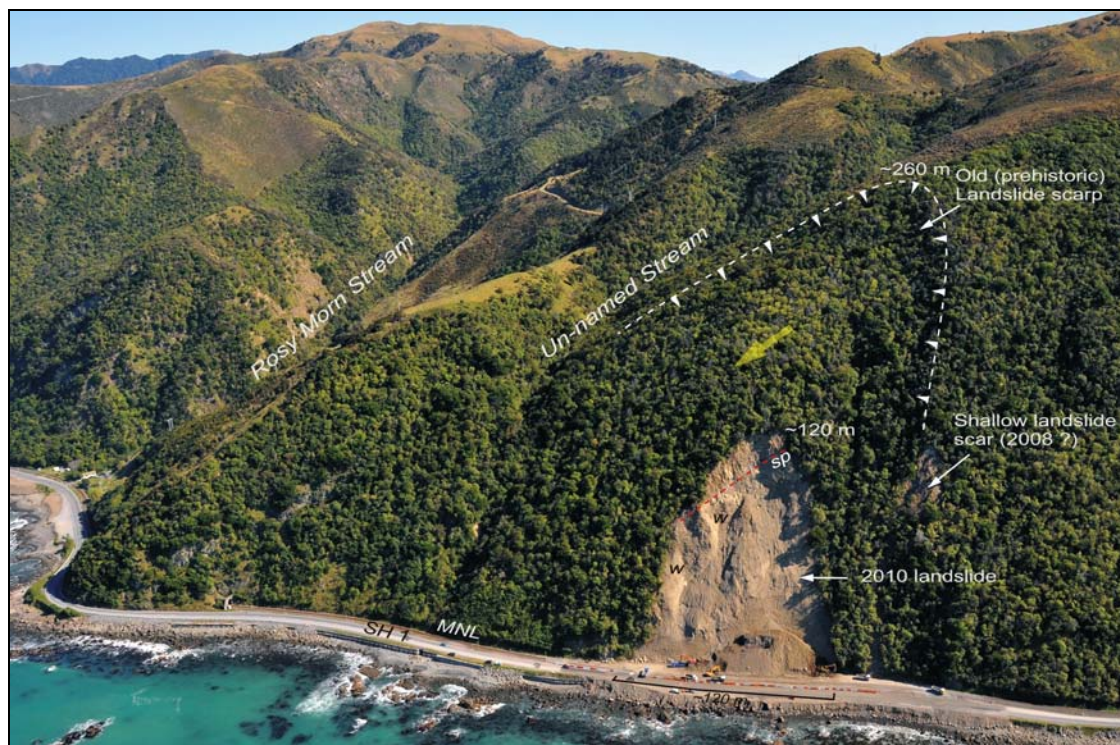
Figure 4 Aerial photo of the 2010 landslide, which occurred on the lower part of a much larger old landslide (*head scarp shown by white dashed line*) which extends up to ~260 m above sea level; its direction of movement is shown by the yellow arrow. The toe of the recent landslide is ~120 m across, and its head scarp extends to an elevation of ~120 m, below which is the slide plane (sp) of the old landslide, and on the south side of the landslide scar, two prominent joint-controlled wedge failures (w).

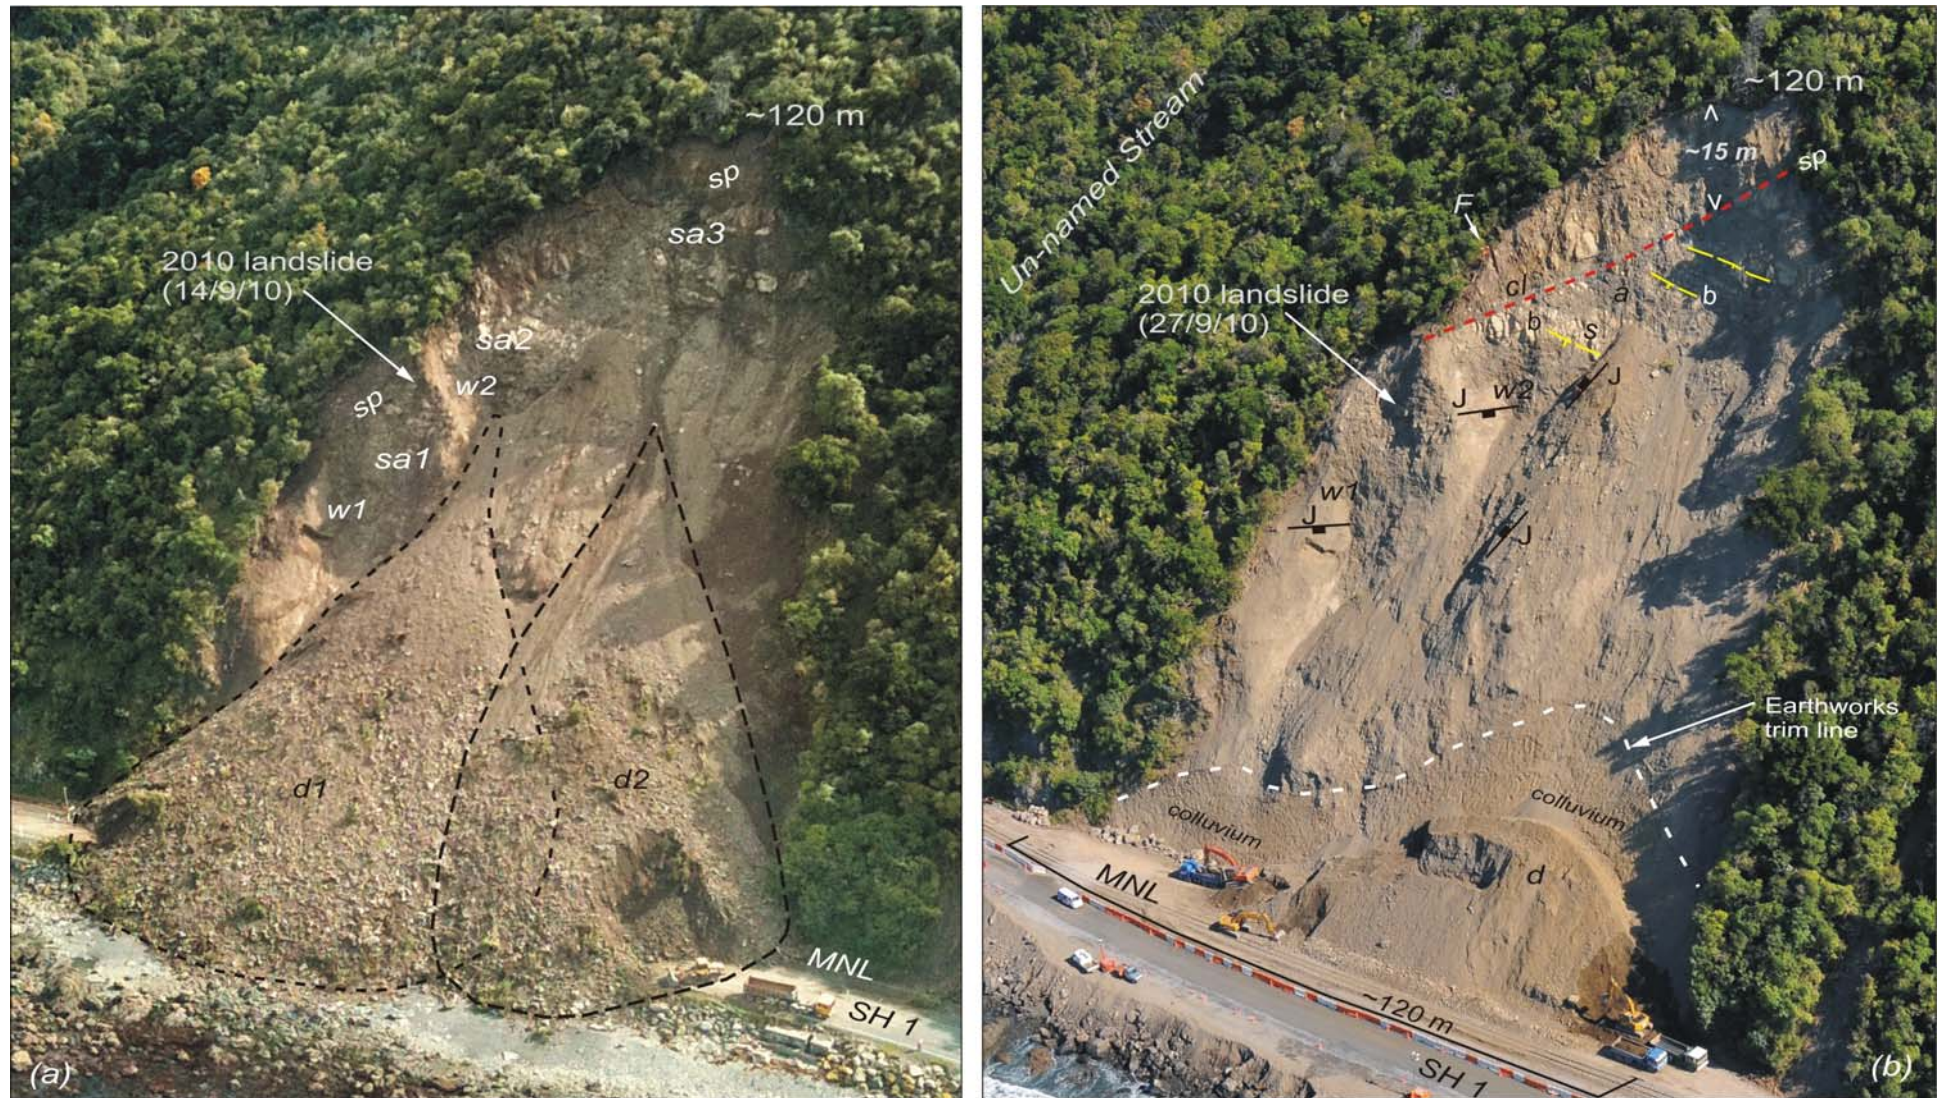
Figure 6 Aerial photos of the 2010 landslide: (a) on 11 September when the full extent of the two debris cones (*d1*, *d2*) and three main source areas (*sa1*, *sa2*, *sa3*) was still visible; (b) on 27 September when most of the debris had been removed exposing the bedrock types (*s* – sandstone, *a* – argillite), structures (*b* – bedding, *J* – prominent joints), and two main wedge failure areas (*w1*, *w2*) on the landslide scar. The area above the slide plane (*sp*) of the old landslide on the upper slope is a ~1 m thick clay layer (*cl*) which appears to dip ~30° southwest towards the un-named stream, and obliquely out of the slope towards State Highway 1 (SH 1). Remnants of old colluvium is exposed at the bottom of the slope below the earthworks trim line. Note the figure in red (*F*) for scale of the landslide scarp.

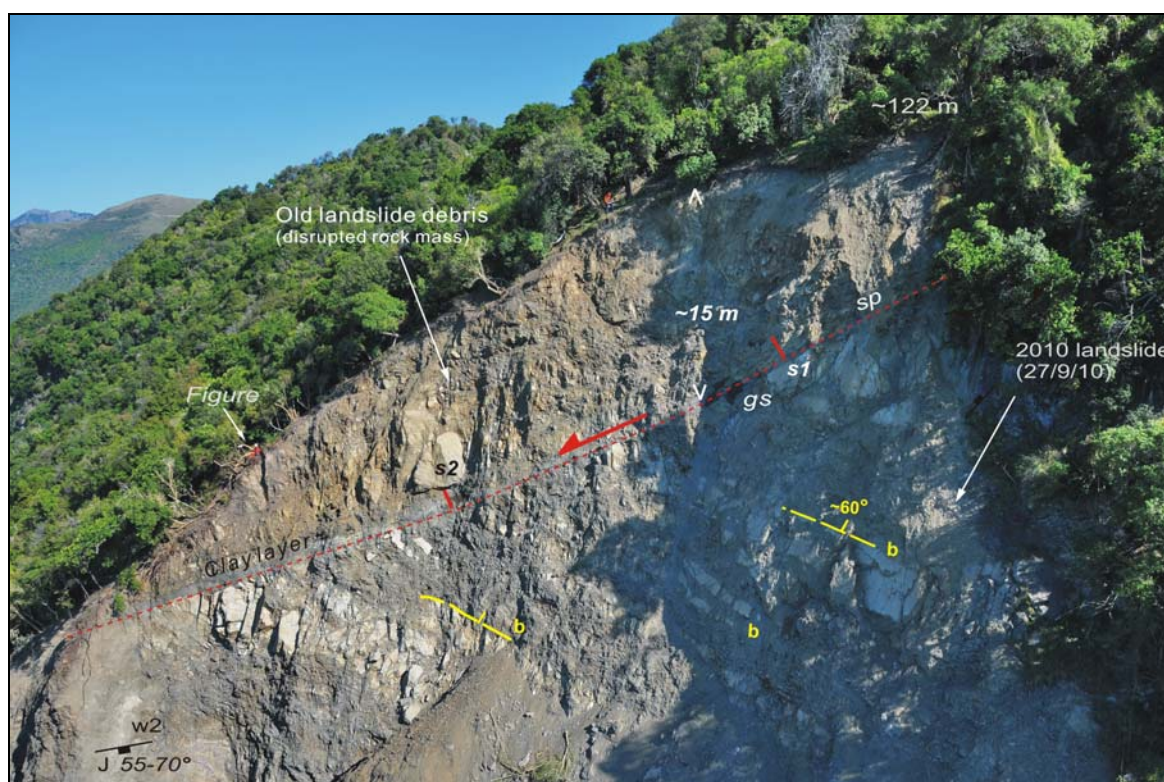
Figure 8 Aerial view of the head of the 2010 landslide showing the clay layer (*cl*), believed to be the slide plane of the older landslide, above which 10-15 m of the overlying material mass is disrupted and more weathered (brown). A thick sandstone bed (*b*) is displaced ~25 m (*s1*–*s2*) by the old failure (note figure in red for scale). The rock mass below the clay layer consists of interbedded light grey sandstone and dark grey mudstone. Other features shown here are groundwater seepages (*gs*) associated with the clay layer, and one of the main joint-controlled wedge failures (*w2*).

The recent failure involved collapse of the more weathered and dilated older slide debris with displaced sandstone beds in it above the clay layer (Figure 8), and the underlying jointed bedrock. Some of the debris from the older landslide on the upper slope appears to have moved about 25 m in a southwest direction, probably several thousand years ago. The displaced mass formed an oversteepened 'bulge' on the lower slope, and locally loaded the underlying rock mass containing persistent joints dipping out of the slope (Figures 7 and 10). The slope is then inferred to have become progressively more unstable over time as it was undercut by wave action, and later by cuts for the railway line and highway. Despite the adverse rockmass condition in the slope it apparently survived for a very long time after the initial slope failure. This was possibly because the joint wedges dipping out of the lower slope were relatively steep in relation to the slope angle, and only the northern wedge (w2) actually daylighted on the cliff face (Figure 10).

Groundwater is also likely to have played a part in the slope failure, but to what extent is uncertain. Water seepages associated with the old slide surface in the headscarp (Figure 8) suggest that the clay layer forms a permeability boundary on the slope, which would have ponded water above it, within the weakened, dilated material. During periods of rainfall these conditions would probably have resulted in locally elevated pore water pressures and increased loading on the lower slope. This would have reduced the overall stability of the slope and increased its likelihood of failure.

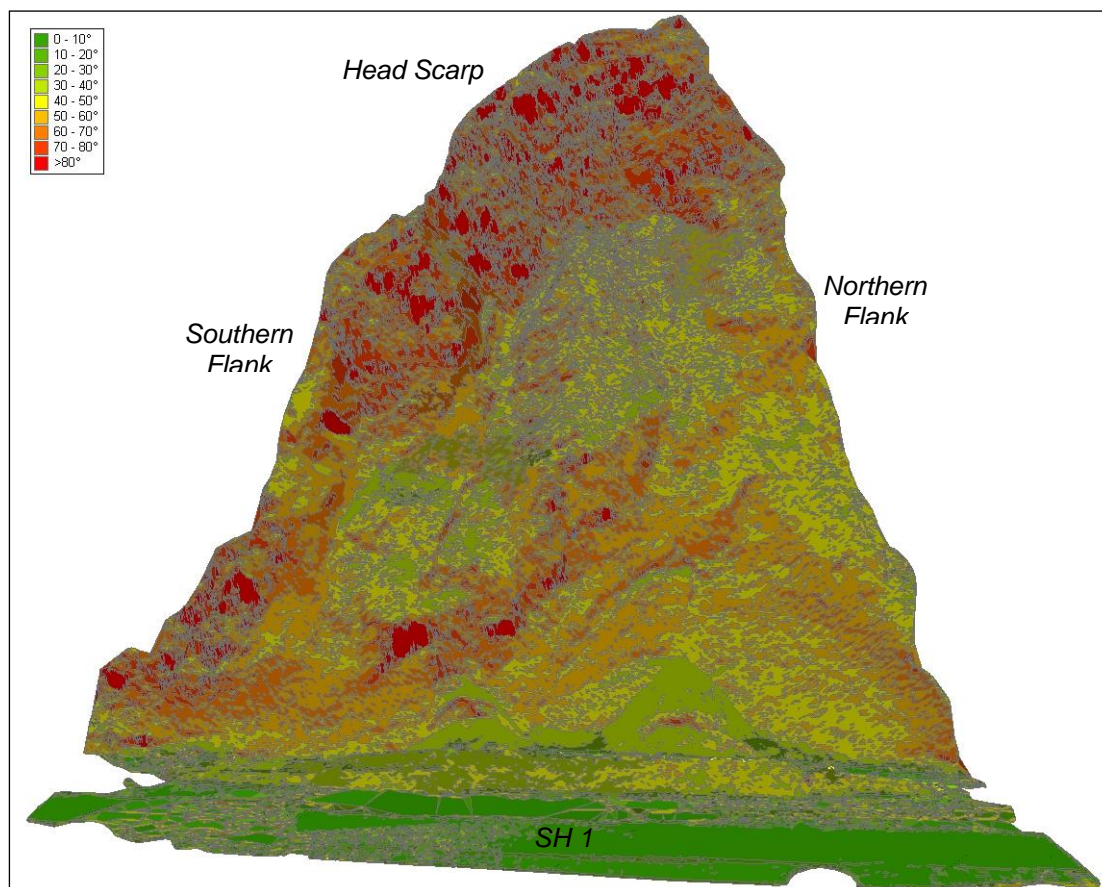
Figure 9 Image of the 2010 landslide showing the slope angles derived from the laser scan model. Red and orange areas are the steeper slopes, and yellow and green areas are less steep; grey areas represent boundaries of slope polygons, and result from the complexity of the model.

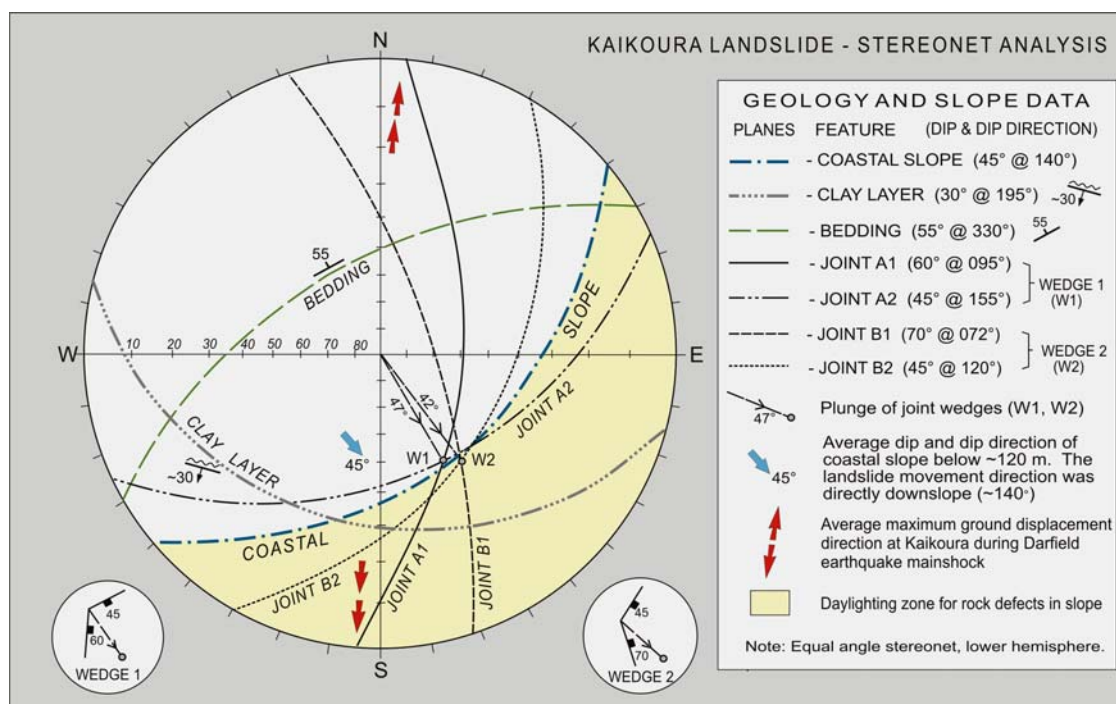
Figure 10 Stereonet analysis of geological structures in the 2010 landslide scar (main joints, wedge intersections (w1, w2), bedding, clay layer or old slide plane) in relation to the slope angle, aspect, and the rock defect daylighting zone on the coastal slope. The directions of landslide movement and earthquake shaking during the Darfield earthquake are also shown.

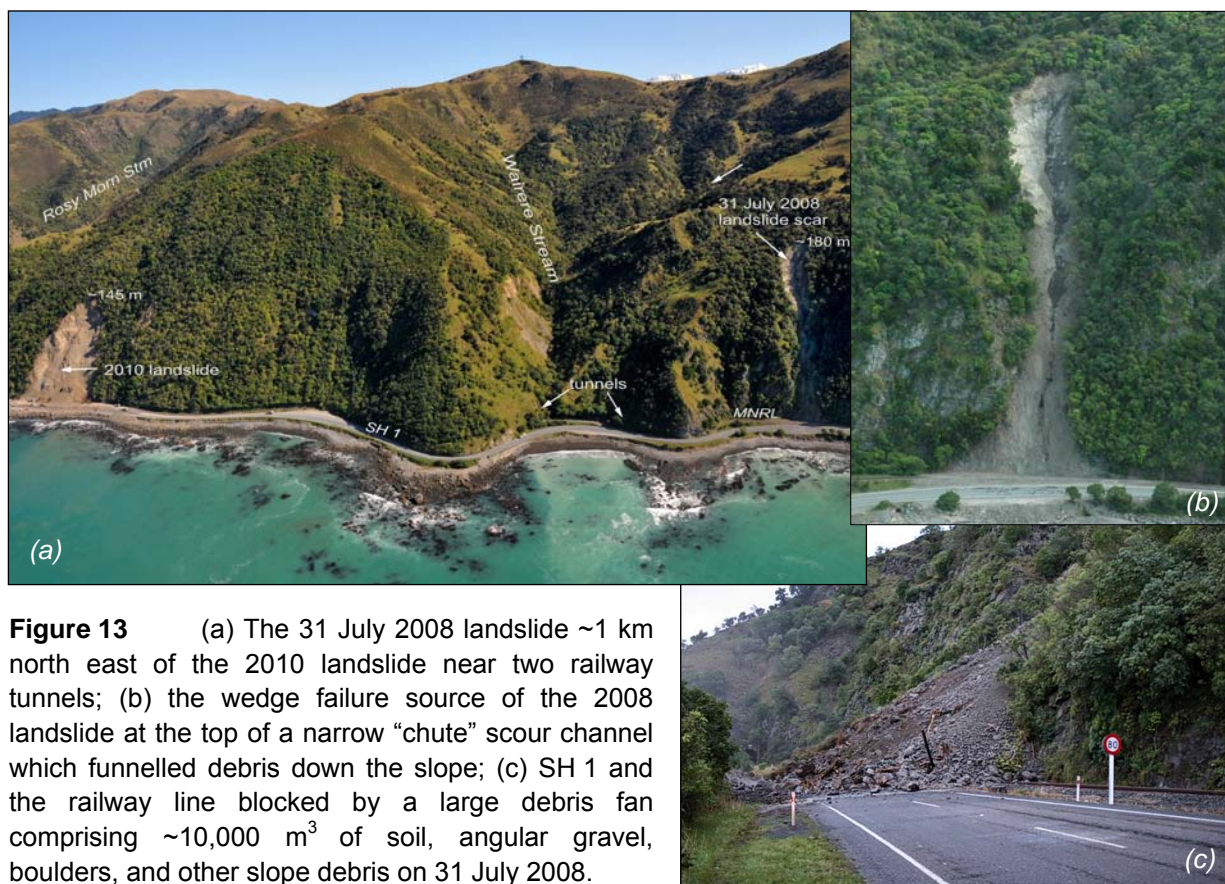
Figure 13 (a) The 31 July 2008 landslide ~1 km north east of the 2010 landslide near two railway tunnels; (b) the wedge failure source of the 2008 landslide at the top of a narrow “chute” scour channel which funnelled debris down the slope; (c) SH 1 and the railway line blocked by a large debris fan comprising ~10,000 m³ of soil, angular gravel, boulders, and other slope debris on 31 July 2008.

The July 2008 landslide occurred after record 1-day rainfall (144 mm) was recorded at Kaikoura on 30 July, and most of the Marlborough to Canterbury region received 200-300% of the mean July rainfall (data from NIWA Monthly Climate Summaries). Although that storm resulted in a significant landslide in the vicinity of the 2010 landslide, the slope on which the 2010 failure occurred was not significantly affected, although the small superficial slip scar just to the north is believed to have occurred during the 2008 storm.
