Beetham, D. 2011. Ohope Beach Landslide of June 2011, *GNS Science Report 2011/46*. 69 p.

This GNS Science/GeoNet landslide investigation, made in response to a landslide which caused a fatality at Ohope Beach on Saturday 18 June 2011, is based on a site visit, interviews with those involved in the immediate response, and council, consultant and media reports. It puts the 18 June 2011 landslide into a context of regular, rain storm generated landslides that have occurred from coastal cliffs within the region since 2004.

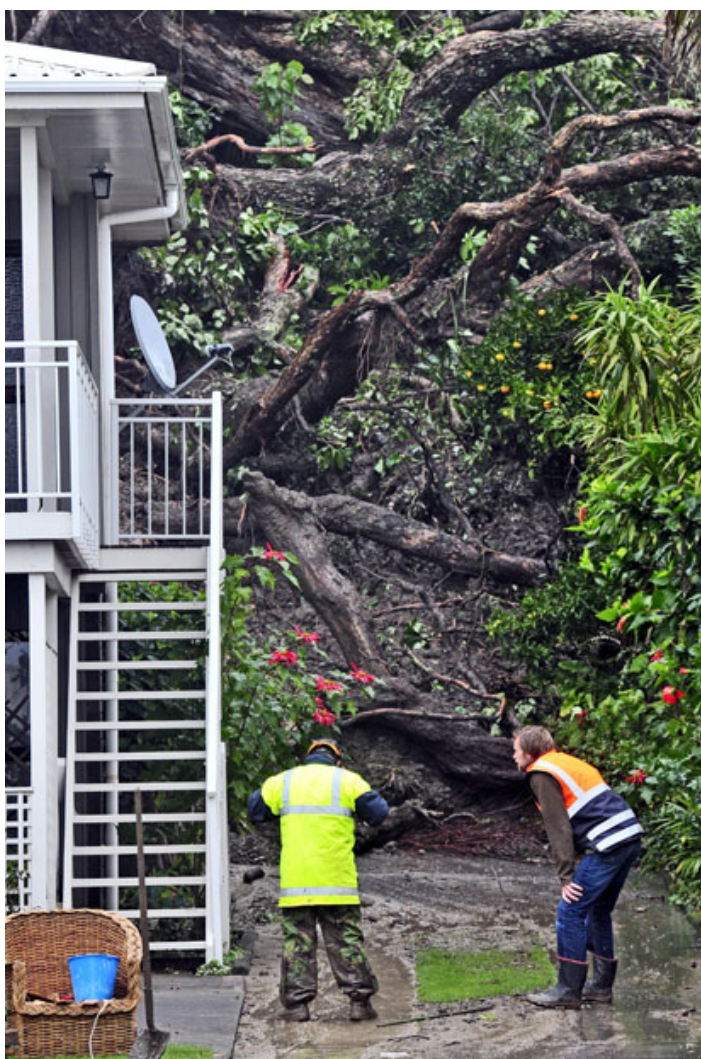
Figure a View of the landslide and tree debris from the driveway on the north side of No 55 West End Road on the afternoon of 18 June. The main emergency response, excavation and recovery was via the driveway on the south side of the house (Figures b & c below). The tree, soil and rock landslide debris seen in this photo also apparently affected the rear of the adjacent house at 56 West End Rd., to the right of this photo. *Photo by Troy Baker, Whakatane Beacon.*

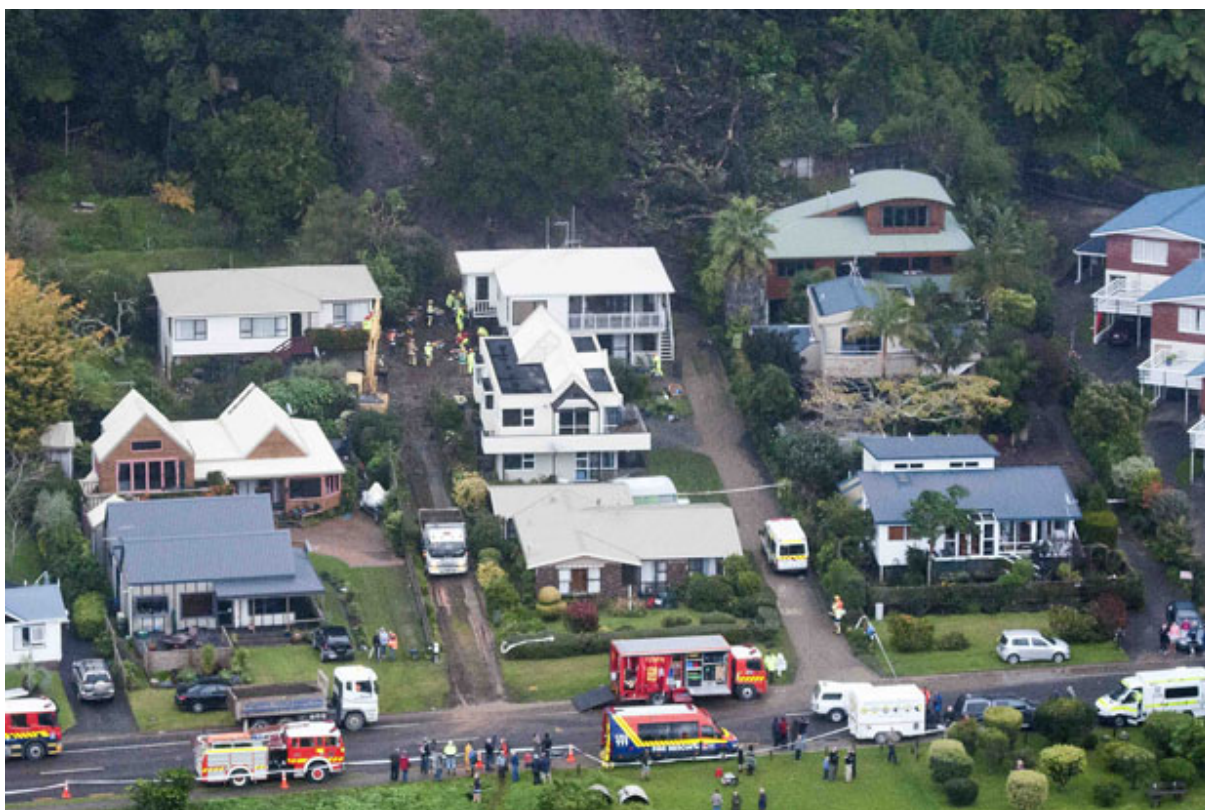
Figure b An oblique aerial view of the landslide and emergency response/recovery at 55 West End Rd. on the afternoon of 18 June (photo by Troy Baker, Whakatane Beacon)

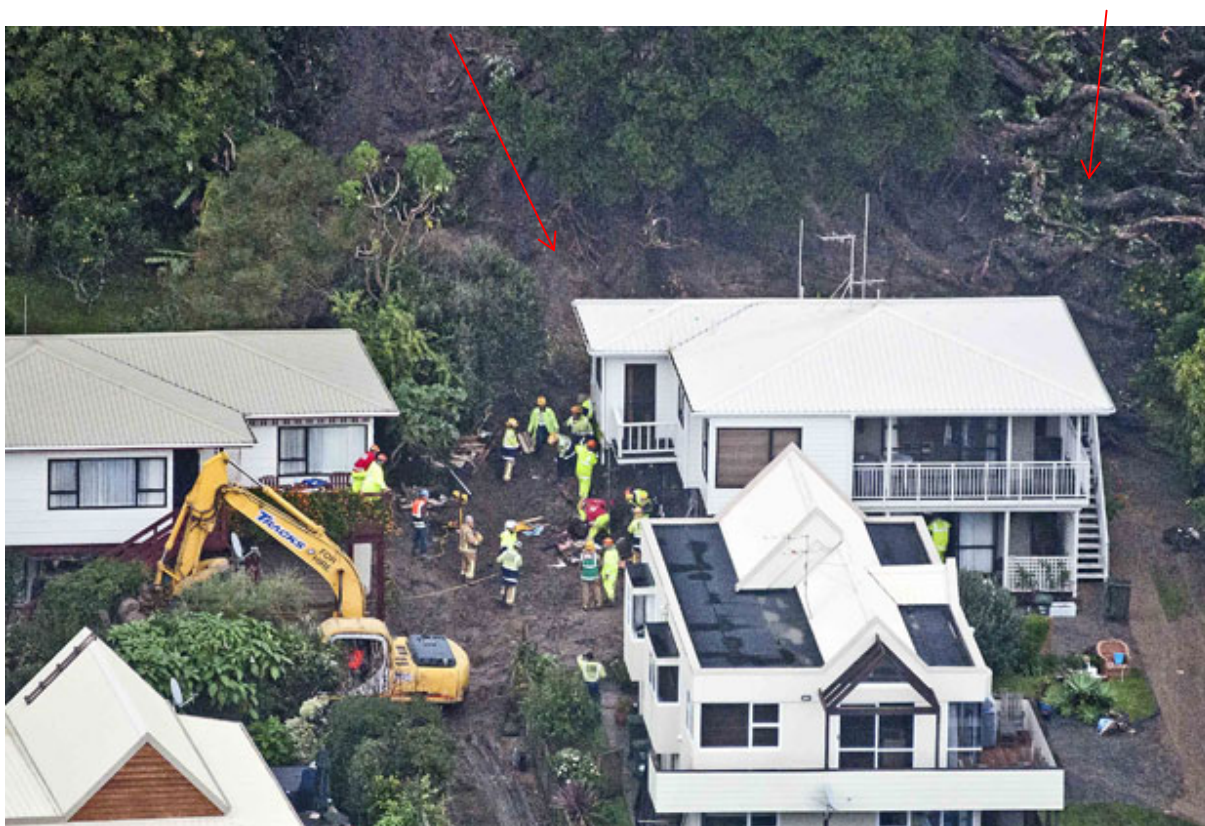
Figure c Detail of Figure (a) above showing landslide and tree debris on both sides of the pohutukawa tree directly behind the house – No. 55 West End Rd. This tree has protected the house against debris impact to some extent - (photo by Troy Baker, Whakatane Beacon).

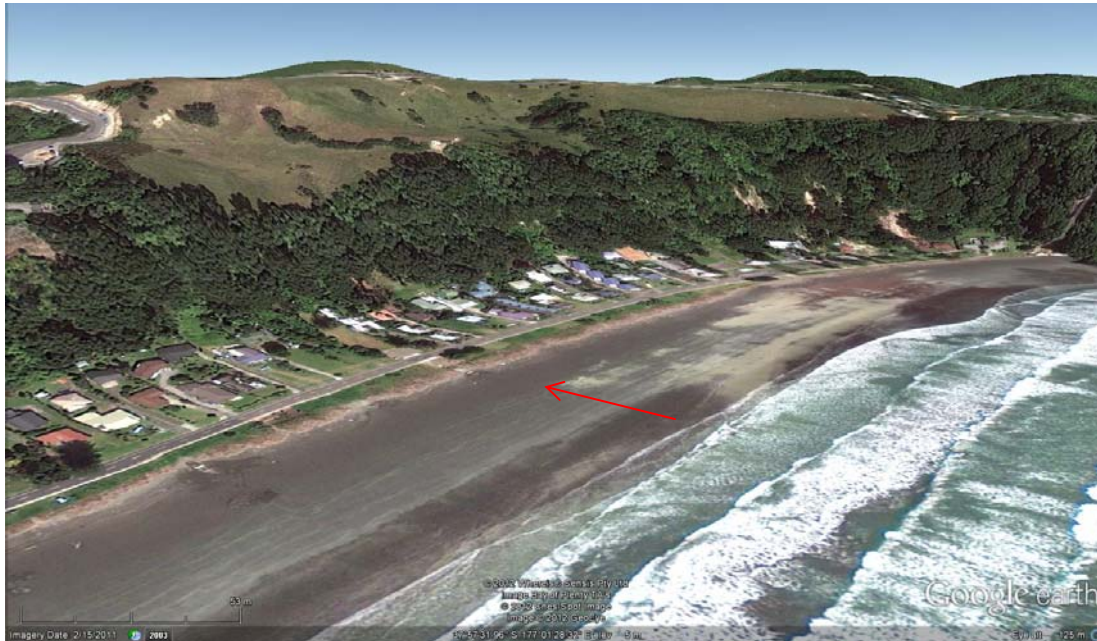
Figure d Oblique Google Earth view of the old cliff escarpment behind West End Rd. The houses at No 55 are arrowed.

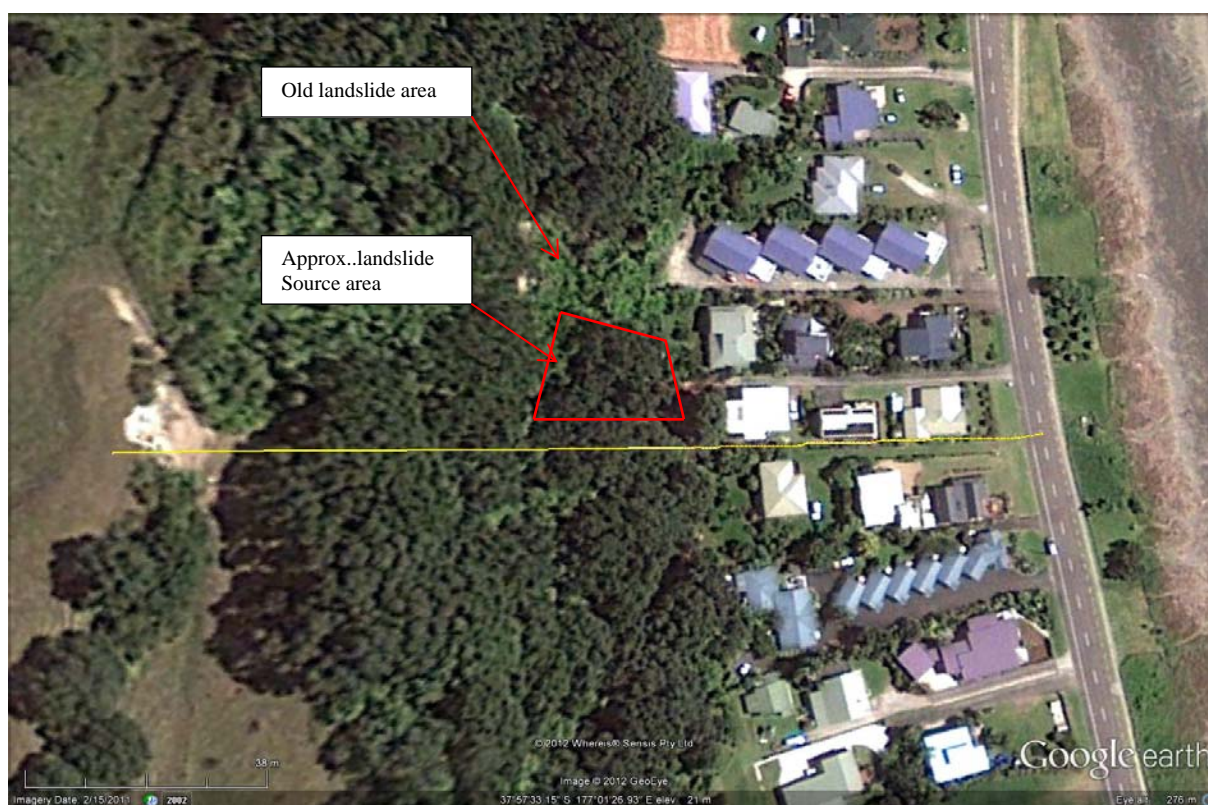
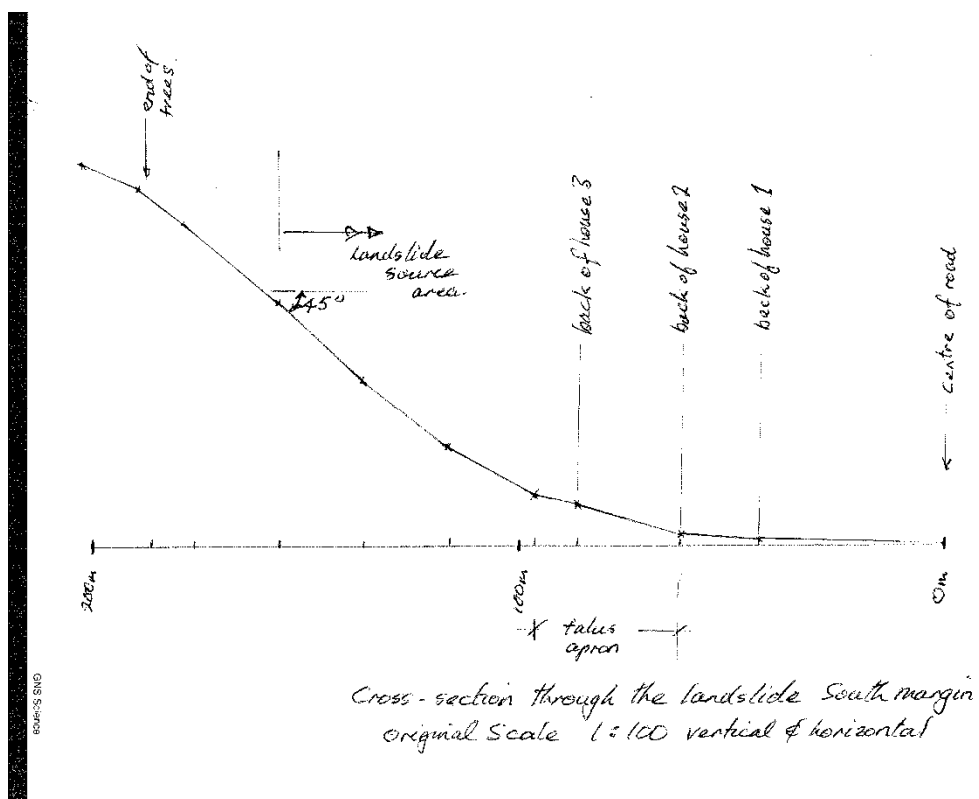
The cross-section sketch shown in Figure e has been drawn using distances and elevations provided from the Google Earth image shown in the upper part of Figure e. The cross-section indicates that the landslide source area on the old cliff has an average slope angle of approximately 45° .

Figure e Top: Google Earth image showing the landslide source area behind No 55 West End Rd. The yellow line is the cross-section shown on the lower sketch figure from the centre of the road to the top of the cliff. The cliff slope angle is approx. 45°.

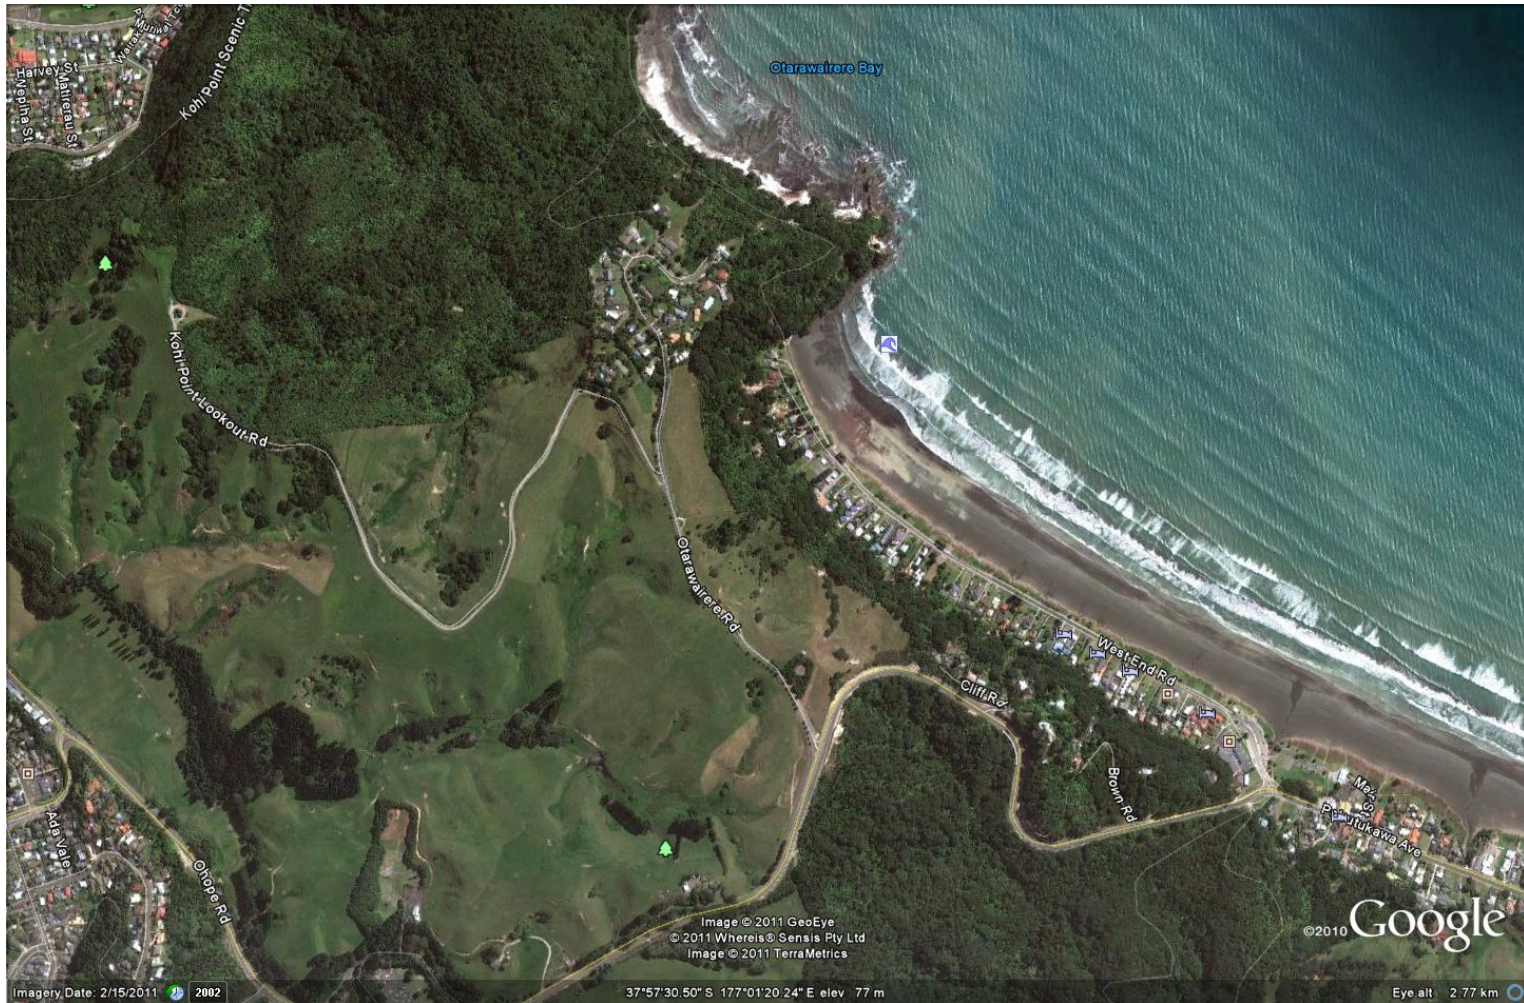
Following the 2004 and 2005 flood events which caused landslides along the Whakatane and Ohope escarpment, including at least one at West End (Figure 32), WDC commissioned the design and installation of a storm and wastewater drainage system for all houses on the escarpment above West End, Ohope. This drainage system is referred to by WDC CEO Diane Turner in her comments recorded in 3.1 above. The drainage system includes the houses at Otawairere settlement, located on top of the old cliff beyond the north-western limit of West End Rd., as well as those accessed via Cliff and Brown Roads on top of the old cliff to the south-east (Figure f - below).

Figure f Aerial view from Google Earth of West End, Ohope below the bush-clad old cliff and the settlements of Otarawairere to the NW and the houses to the SE on top of the old cliff accessed from Cliff and Brown roads. Scenic Otawairere Bay is at the centre top. It has foot access only from West End, Otarawairere settlement and Whakatane – via Kohi Point walkway.

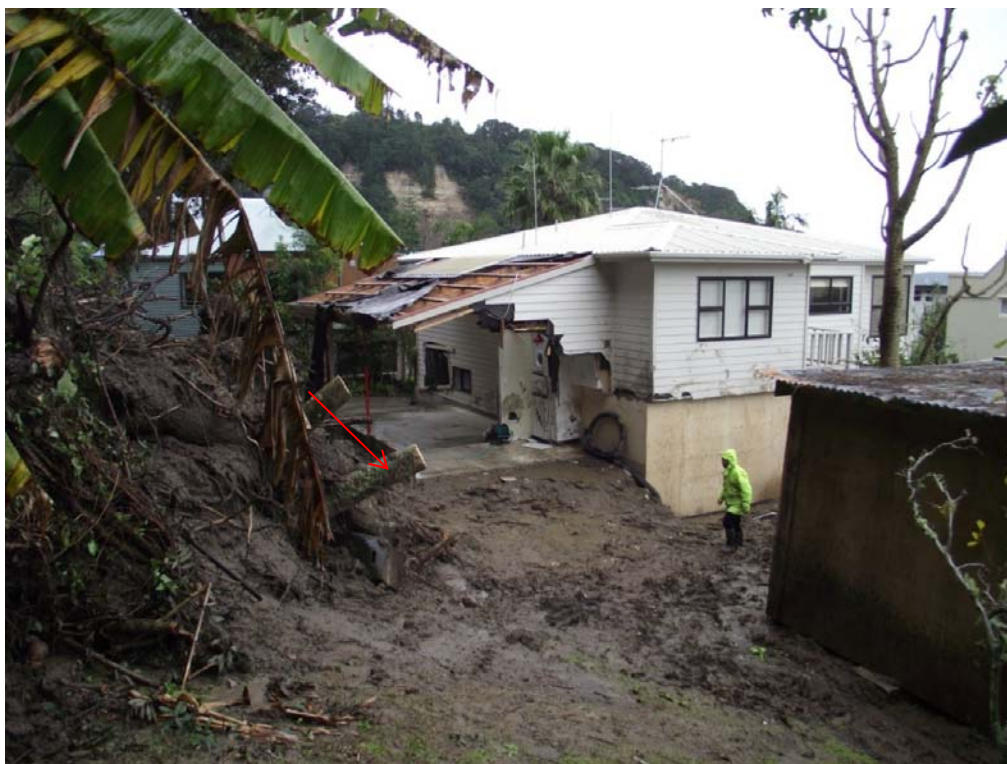
Figure 1 View looking NE to the back of the damaged house, No. 55 West End Road. The area in which the fatality occurred is arrowed. The landslide debris have been cleared away.

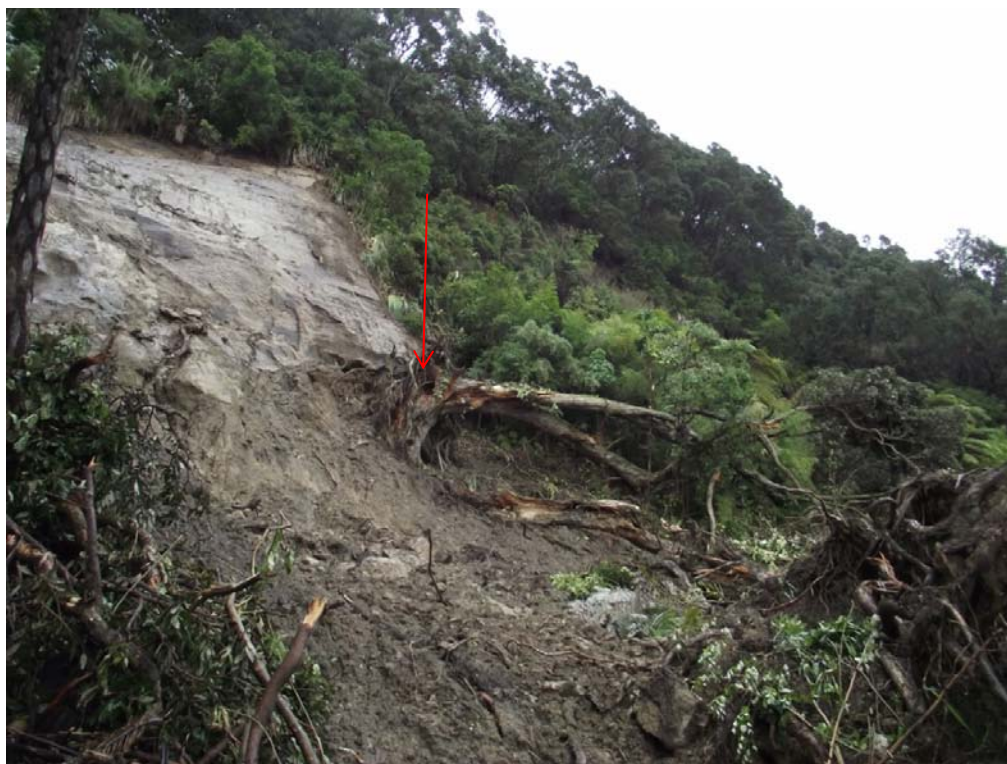
Figure 2 The old cliff source area of the fatal landslide behind the house. The trunk base, root mass and broken branches of a large pohutukawa tree can be seen in place at the centre of the photo (arrowed) and a displaced one in the right-hand corner.

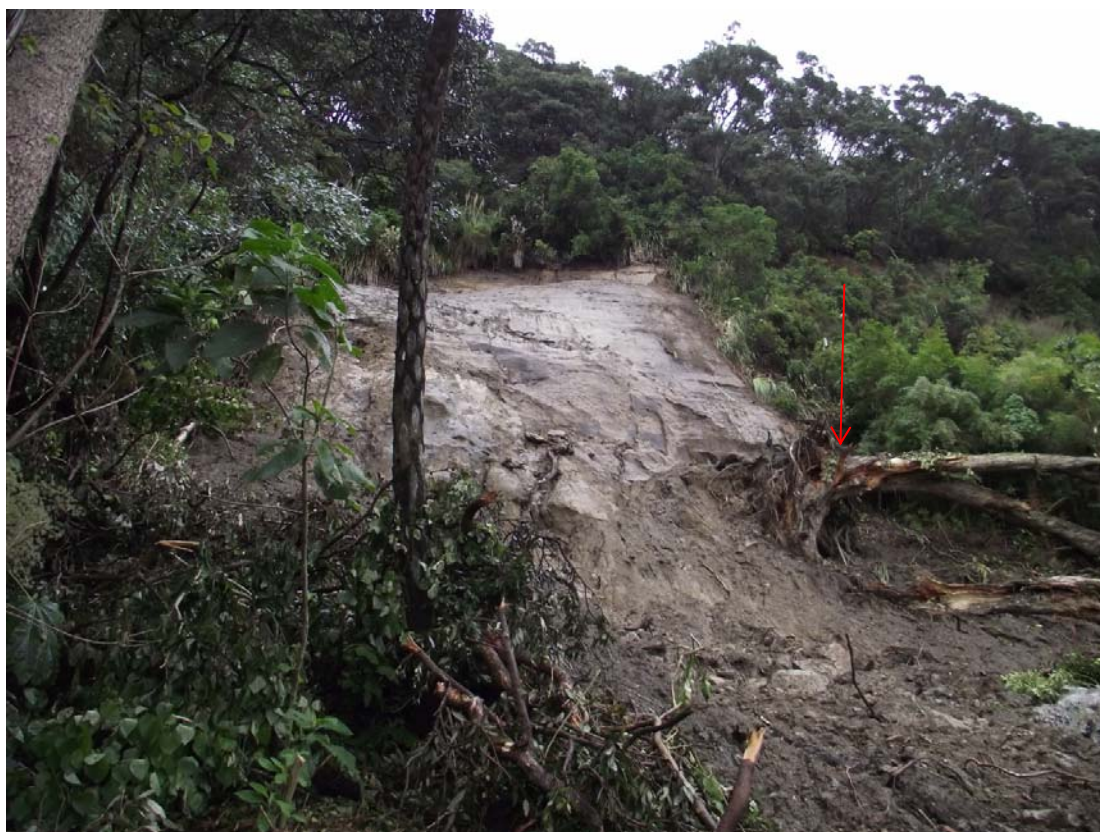
Figure 3 Looking obliquely across the cliff source area of the fatal landslide.

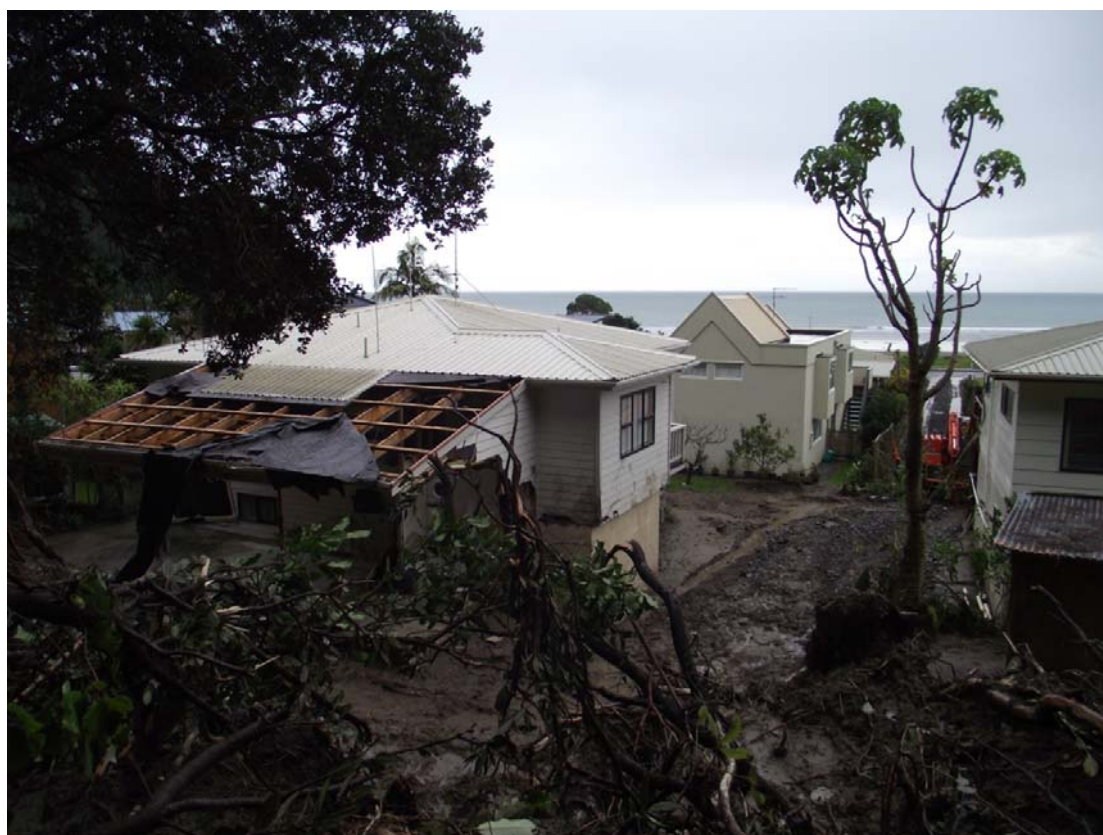
Figure 4 Looking at the damaged house from the toe of the cliff in the southern neighbours' property.

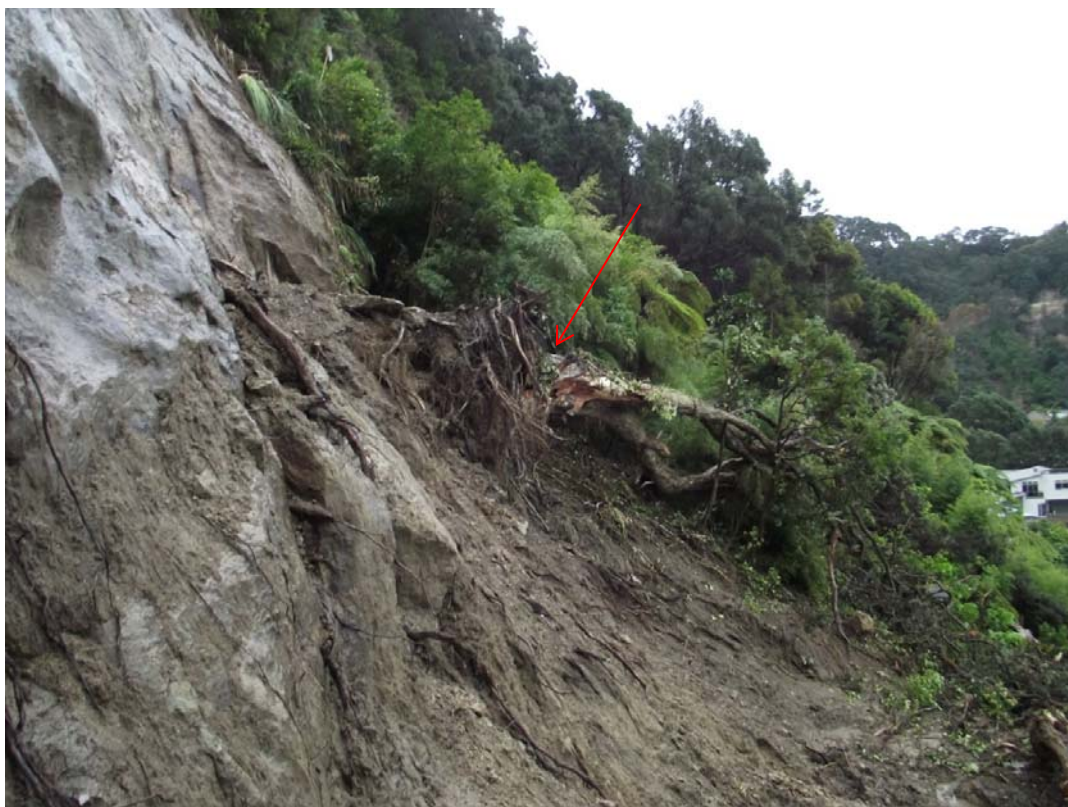
Figure 5 View directly across the cliff source area of the fatal landslide from its southern margin. Note the remnant pohutukawa tree hanging onto the slope in the middle of the photo.

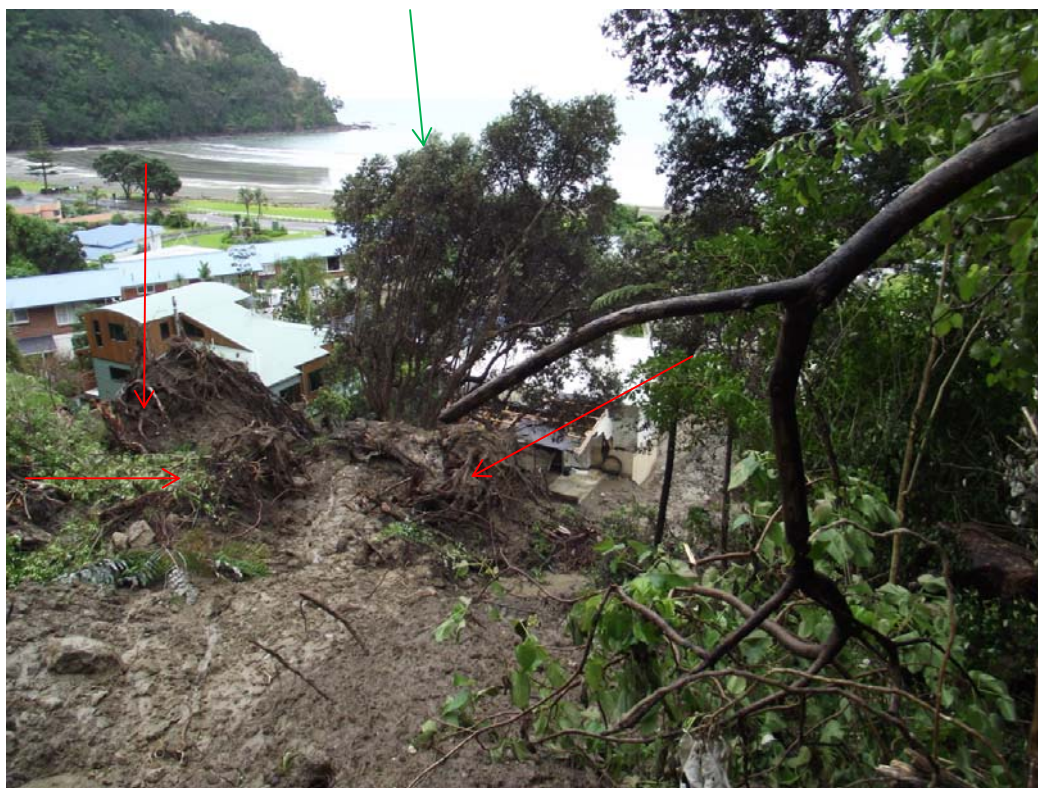
Figure 6 Looking down the path of the fatal landslide from its southern margin. Note the root masses of 2 large and 1 smaller pohutukawa tree (red arrows) caught up behind and on the live pohutukawa tree (green arrow)

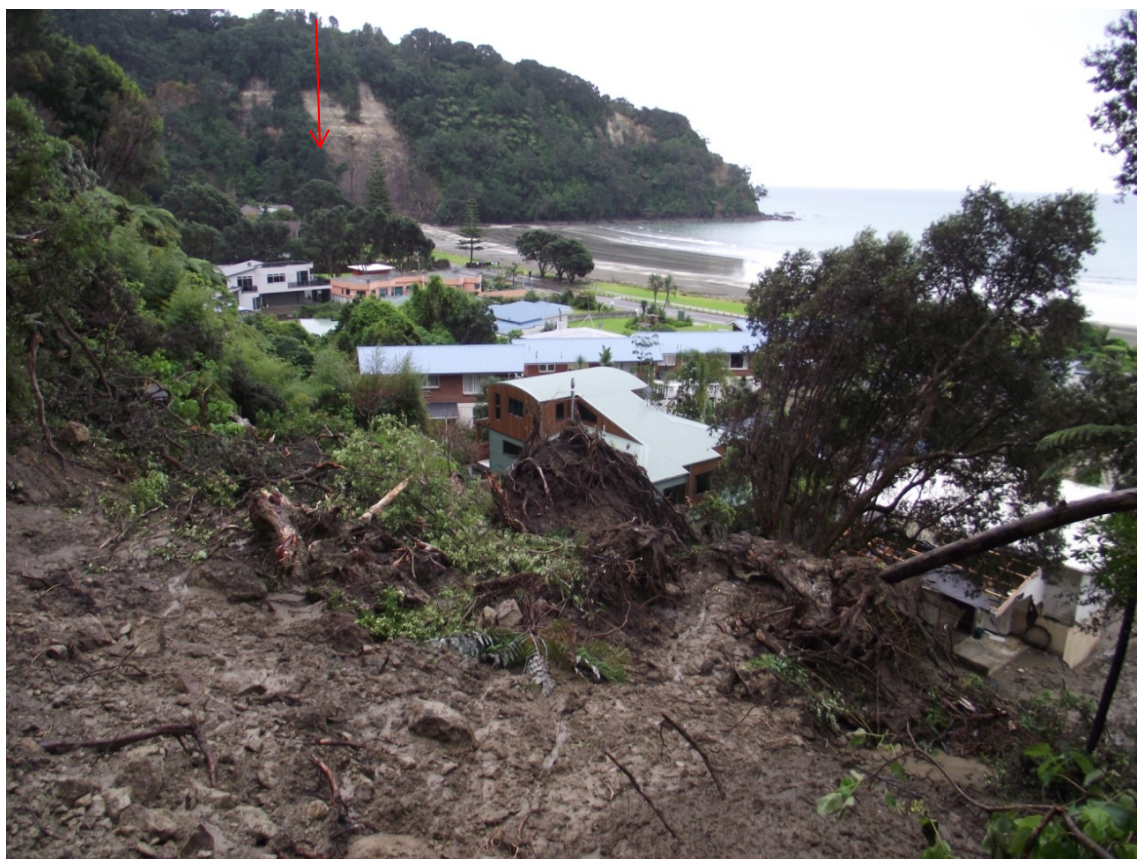
Figure 7 A similar but wider view to Figure 6. The landslide at the north end of Ohope Beach, as seen in Figure 12, is arrowed red.

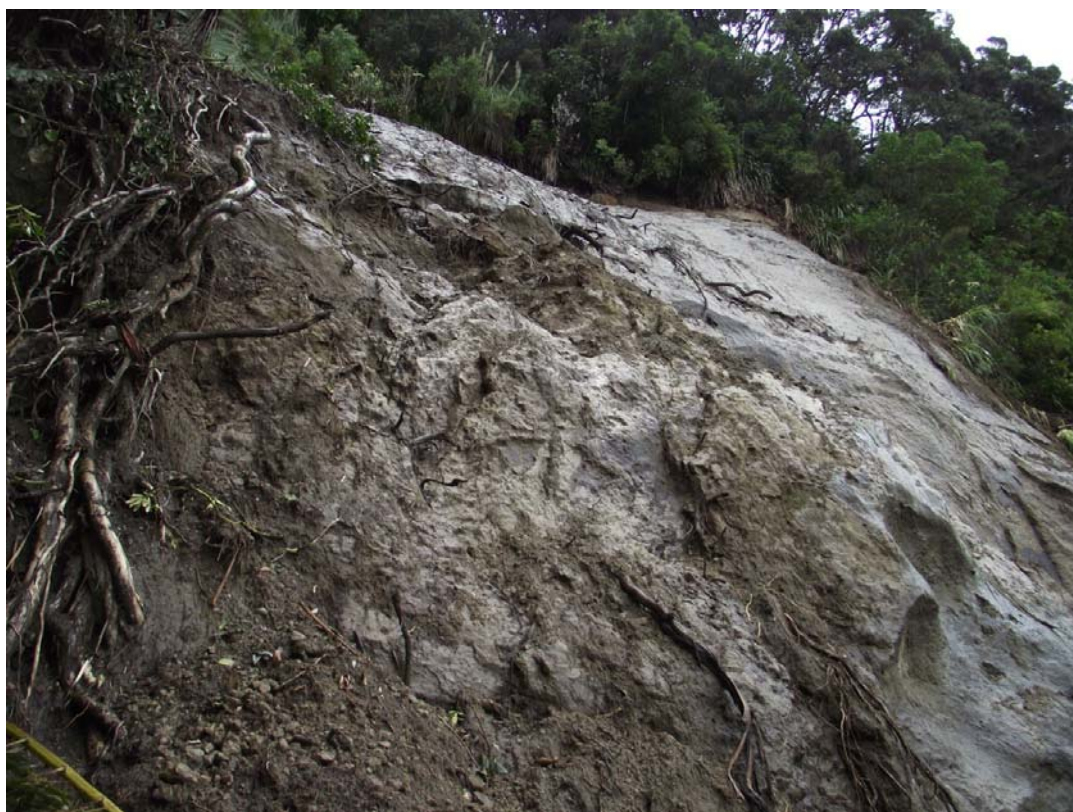
Figure 8 The top and south margin of the fatal landslide source area.

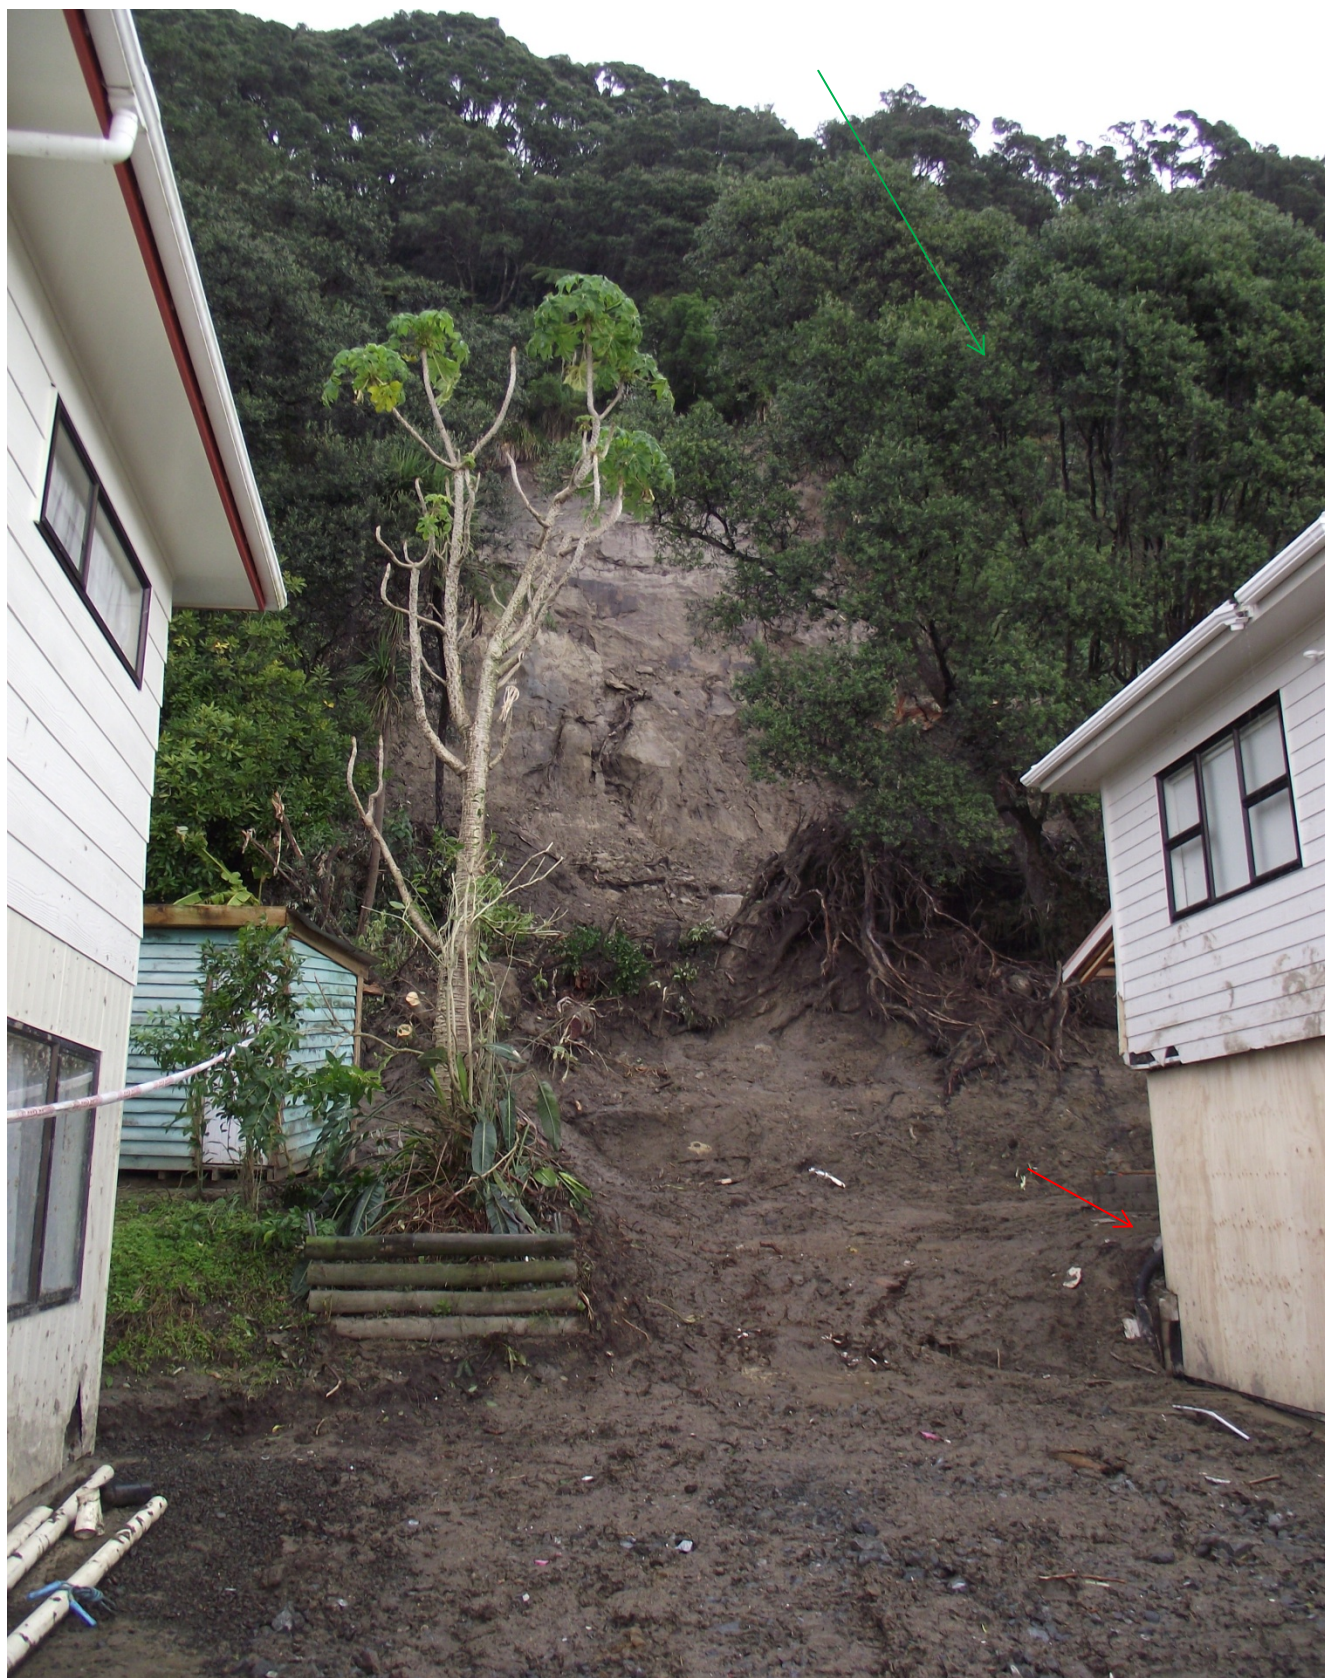
Figure 9 View up the path and cliff source of the fatal landslide. The landslide debris (cleared away here) entered and partially demolished a room (now removed) on the house at the red arrow. The pohutukawa tree which prevented large slipped trees, as shown in Figure 6, from impacting the back of the house, is arrowed green.

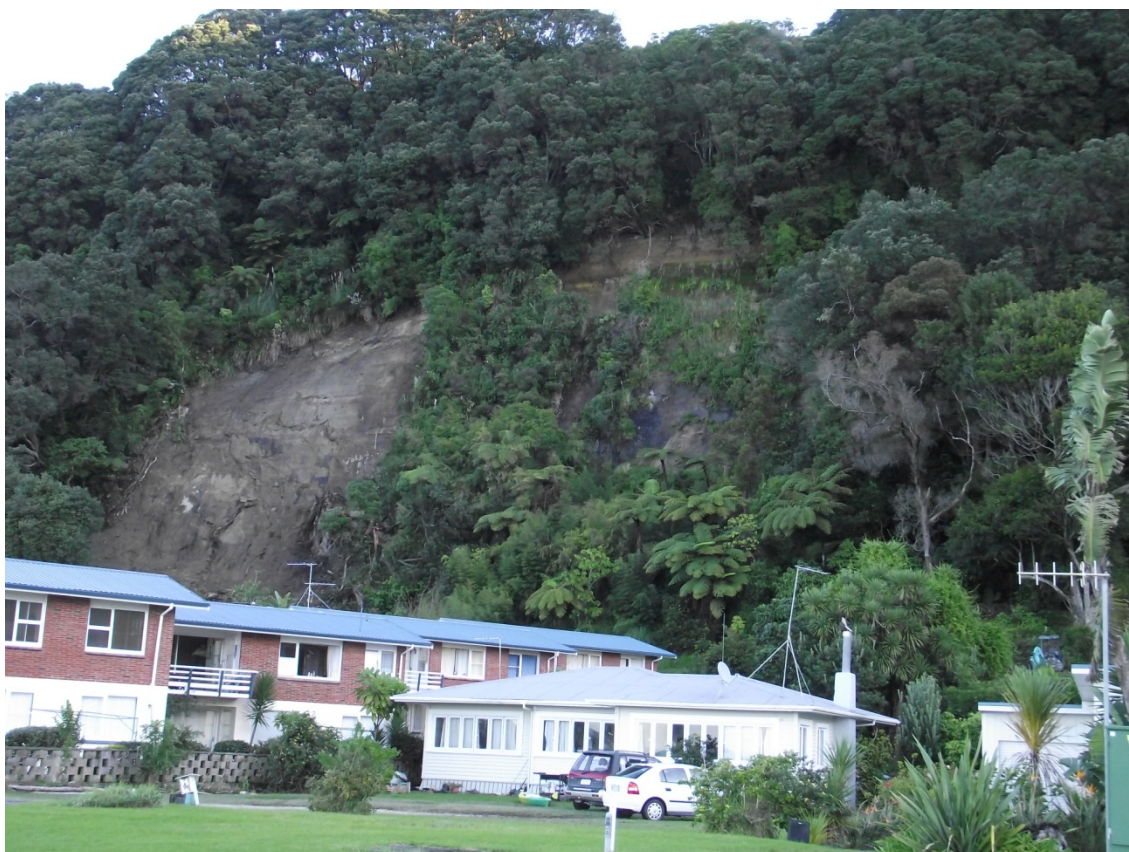
Figure 10 View of the cliff source of the fatal landslide looking SW. The scrub and punga to the right of the landslide scar are regrowth on the scar of an earlier landslide.

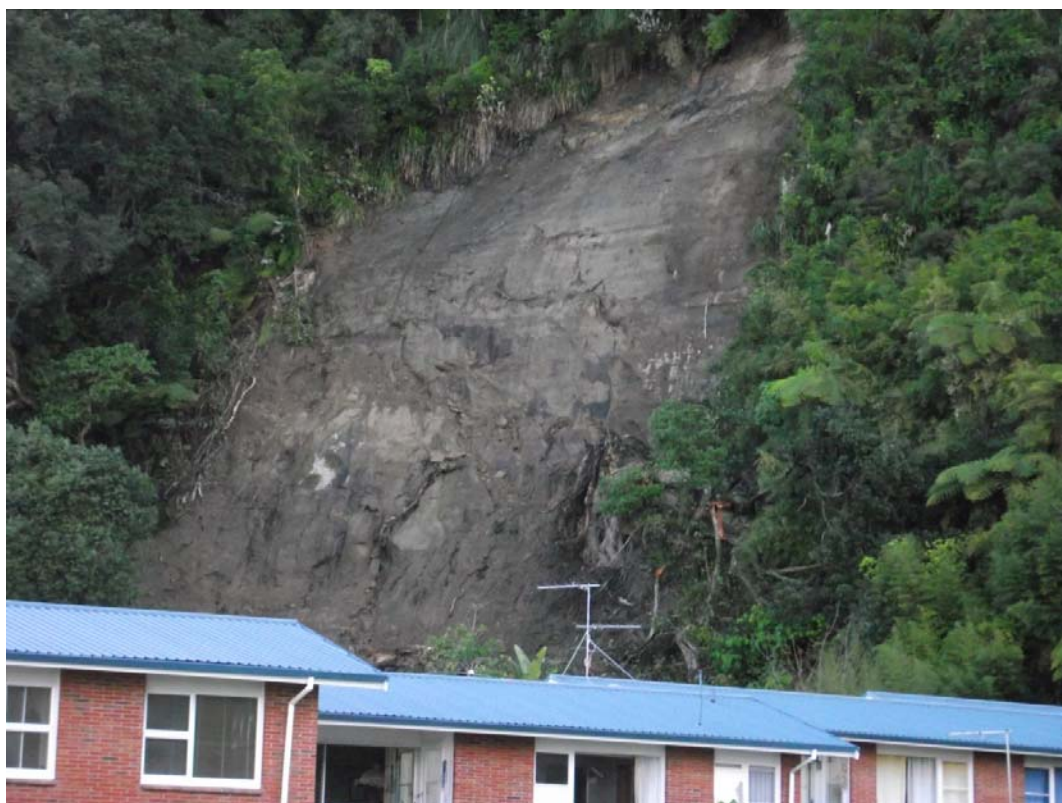
Following a landslide, a fresh face of bare rock is exposed (eg. Figure 11). Gradually small plants colonise the face as the rock weathers and soil begins to accumulate. The soil gradually thickens and larger plants and trees begin to grow. At the same time, the underlying rock weathers as it is affected by carbonic and humic acids. Larger plants also affect the rock mass as roots grow into joints and cause them to open. Eventually the slope becomes overloaded and prone to landslips.

Figure 11 A closer view of the fatal landslide scar in Figure 10.

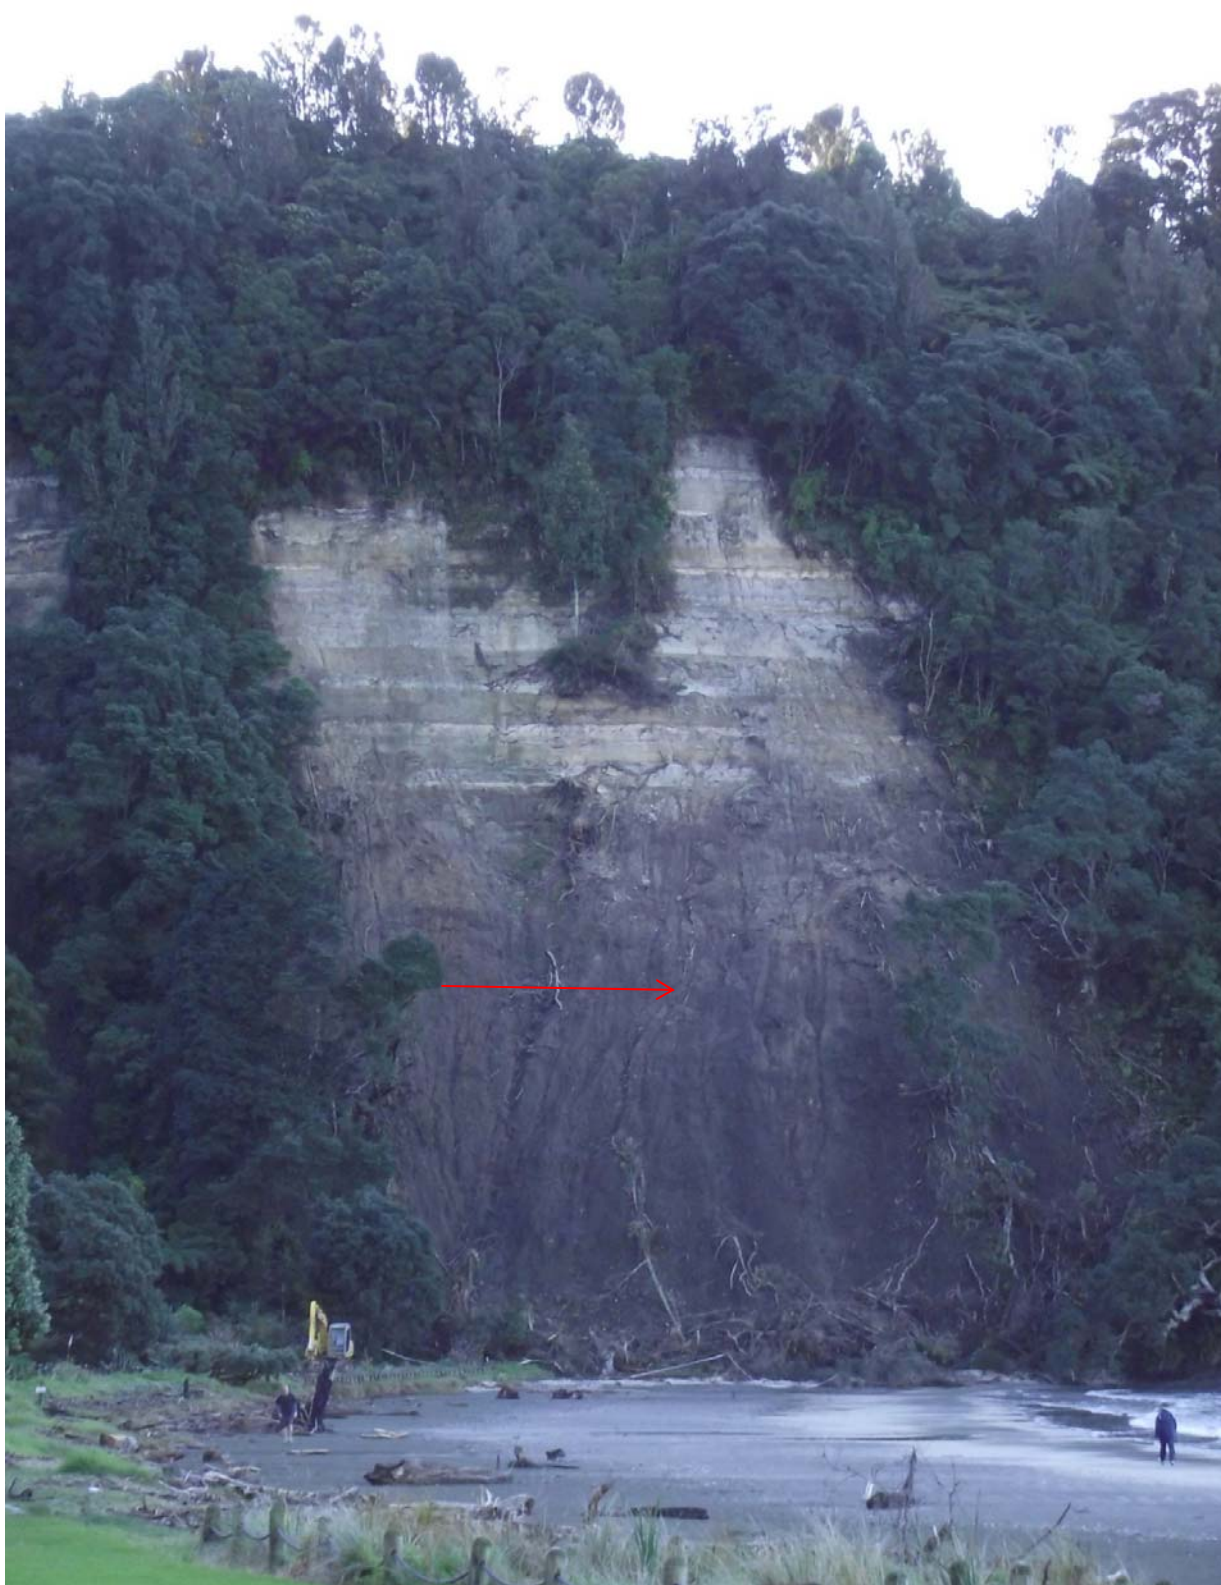
Figure 12 A landslide several hundred metres away at the north end of Ohope Beach which, according to T&T, occurred during a high intensity rainfall storm in April 2011. The West End rainfall records show 107 and 62mm on 25 & 26 April (Appendix 1). This landslide, also seen in Figure 7, has occurred from the cliff face, removing trees and scrub, and leaving a clean scar. The landslide has taken out the walking track to Otarawairere Bay and Kohi Point. Note the debris on the beach at the toe of the landslide. Ancient greywacke rock is found below the arrow, and young Ohope beds above.

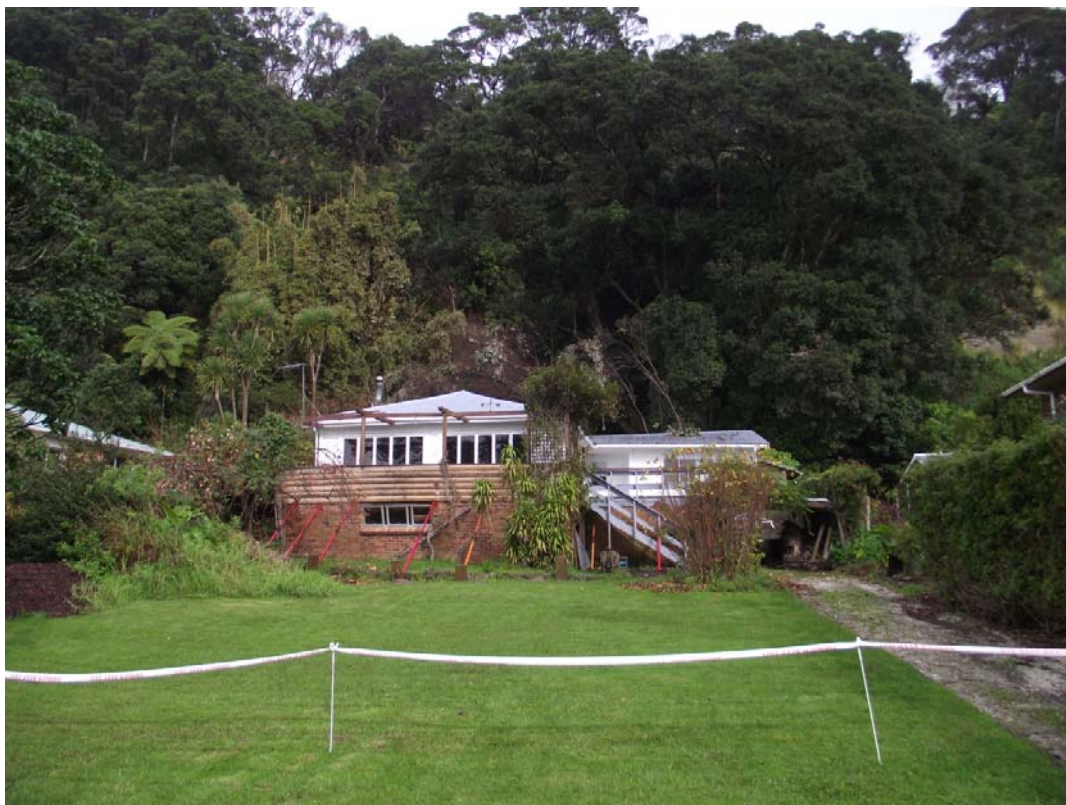
Figure 13 This house at No. 33 West End Road has also been impacted by a landslide from the slope behind.

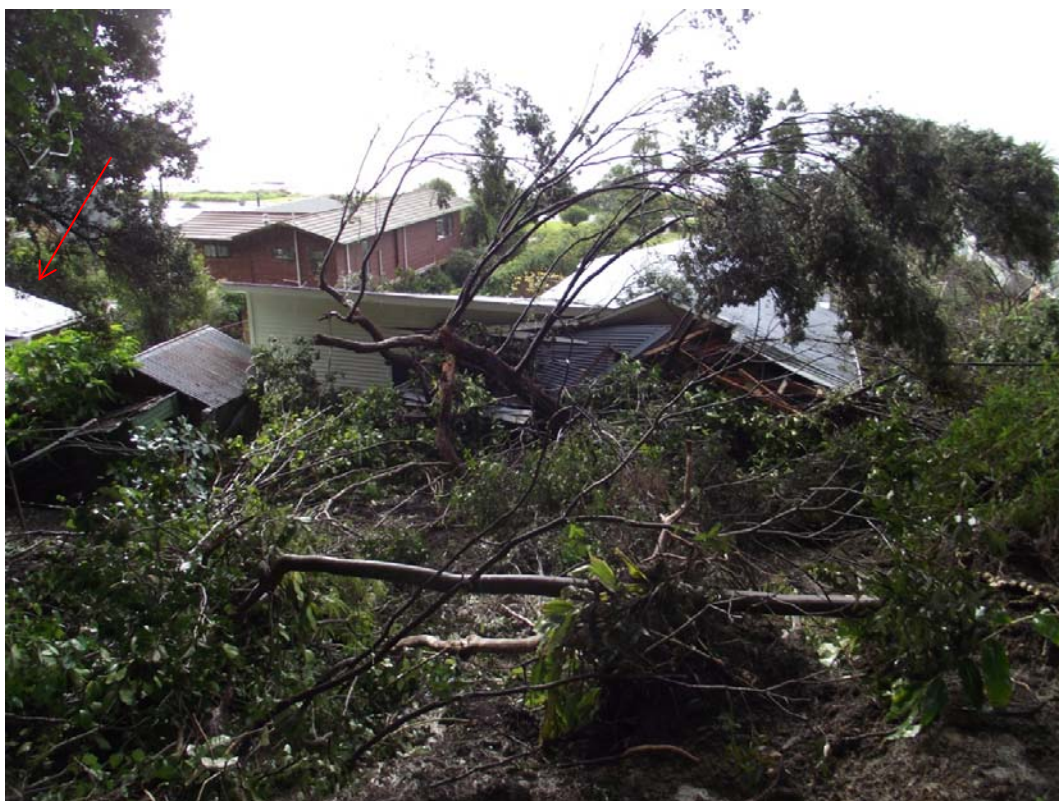
Figure 14 A large pohutukawa tree with root mass & soil dislodged from the lower slope and slid into the house shunting is forward ~half a metre. The back of the adjacent house (red arrow), No. 34, was affected by a landslide in 2004 (Figure 32).
