Beetham, D. 2011. Ohope Beach Landslide of June 2011, *GNS Science Report 2011/46*. 69 p.

This GNS Science/GeoNet landslide investigation, made in response to a landslide which caused a fatality at Ohope Beach on Saturday 18 June 2011, is based on a site visit, interviews with those involved in the immediate response, and council, consultant and media reports. It puts the 18 June 2011 landslide into a context of regular, rain storm generated landslides that have occurred from coastal cliffs within the region since 2004.

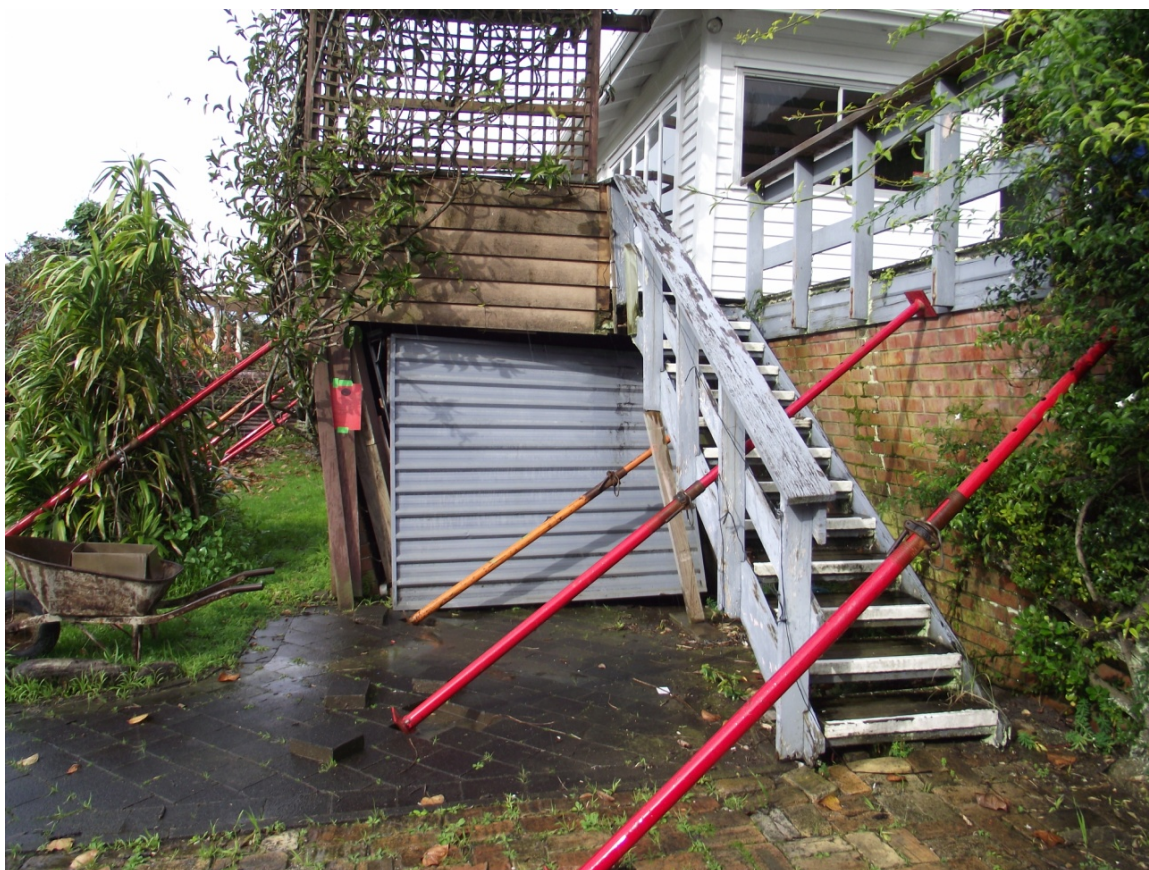
Figure 15 The front of the house propped to prevent further forward tilting.

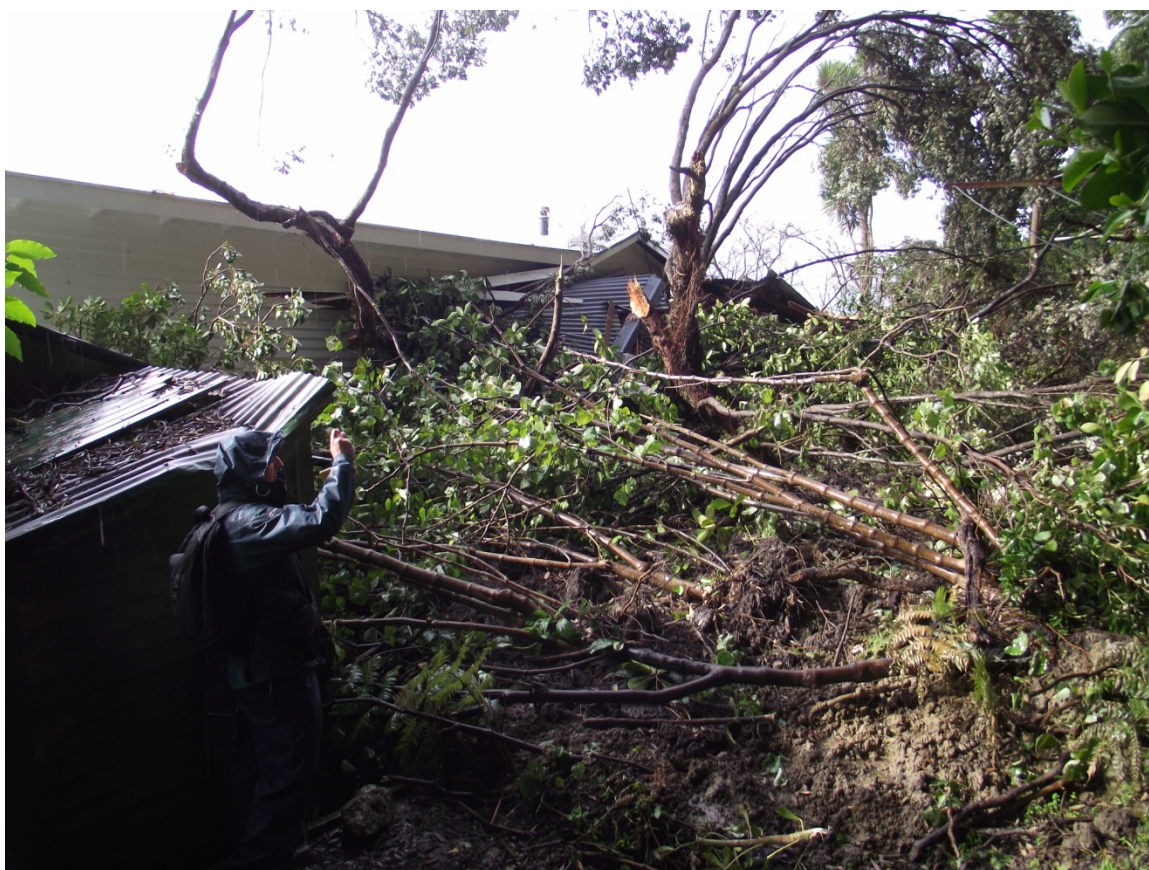
Figure 16 Tree and soil landslide debris at the back of the house.

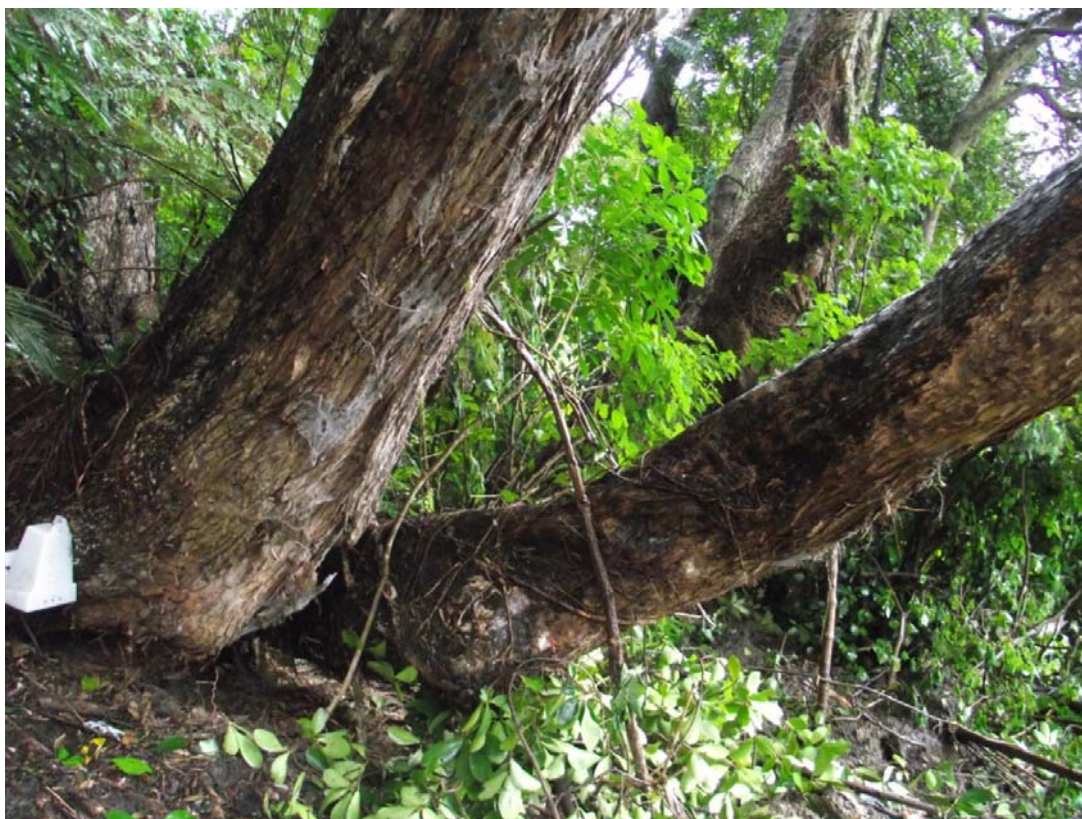
Figure 17 Large pohutukawa trees on the boundary of 33 and 34 West End Road. These trees are growing in the talus fan at the foot of the old cliff where the slope angle is $\sim 20^\circ$. They can provide protection from landslide debris falling from the old cliff above.

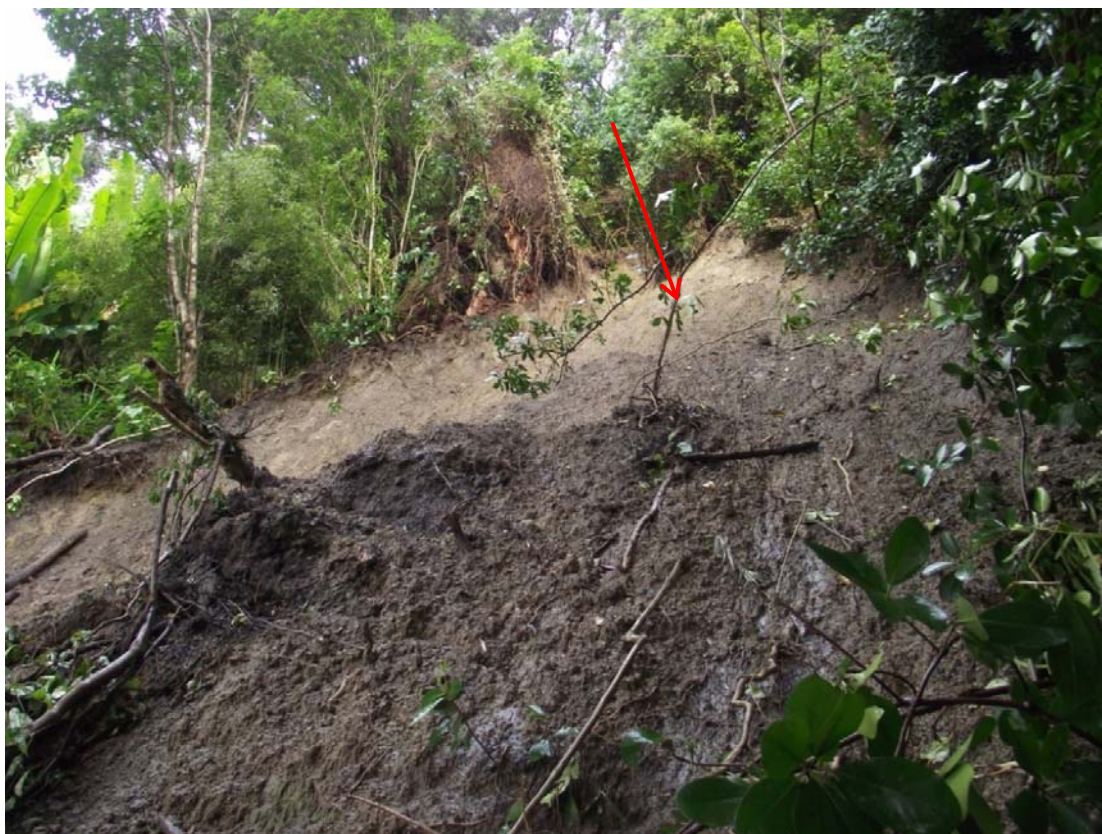
Figure 18 The source of the slipped pohutukawa tree, from near the top of the talus fan and not rock, where the slope angle is steeper, about 25 to 30° .

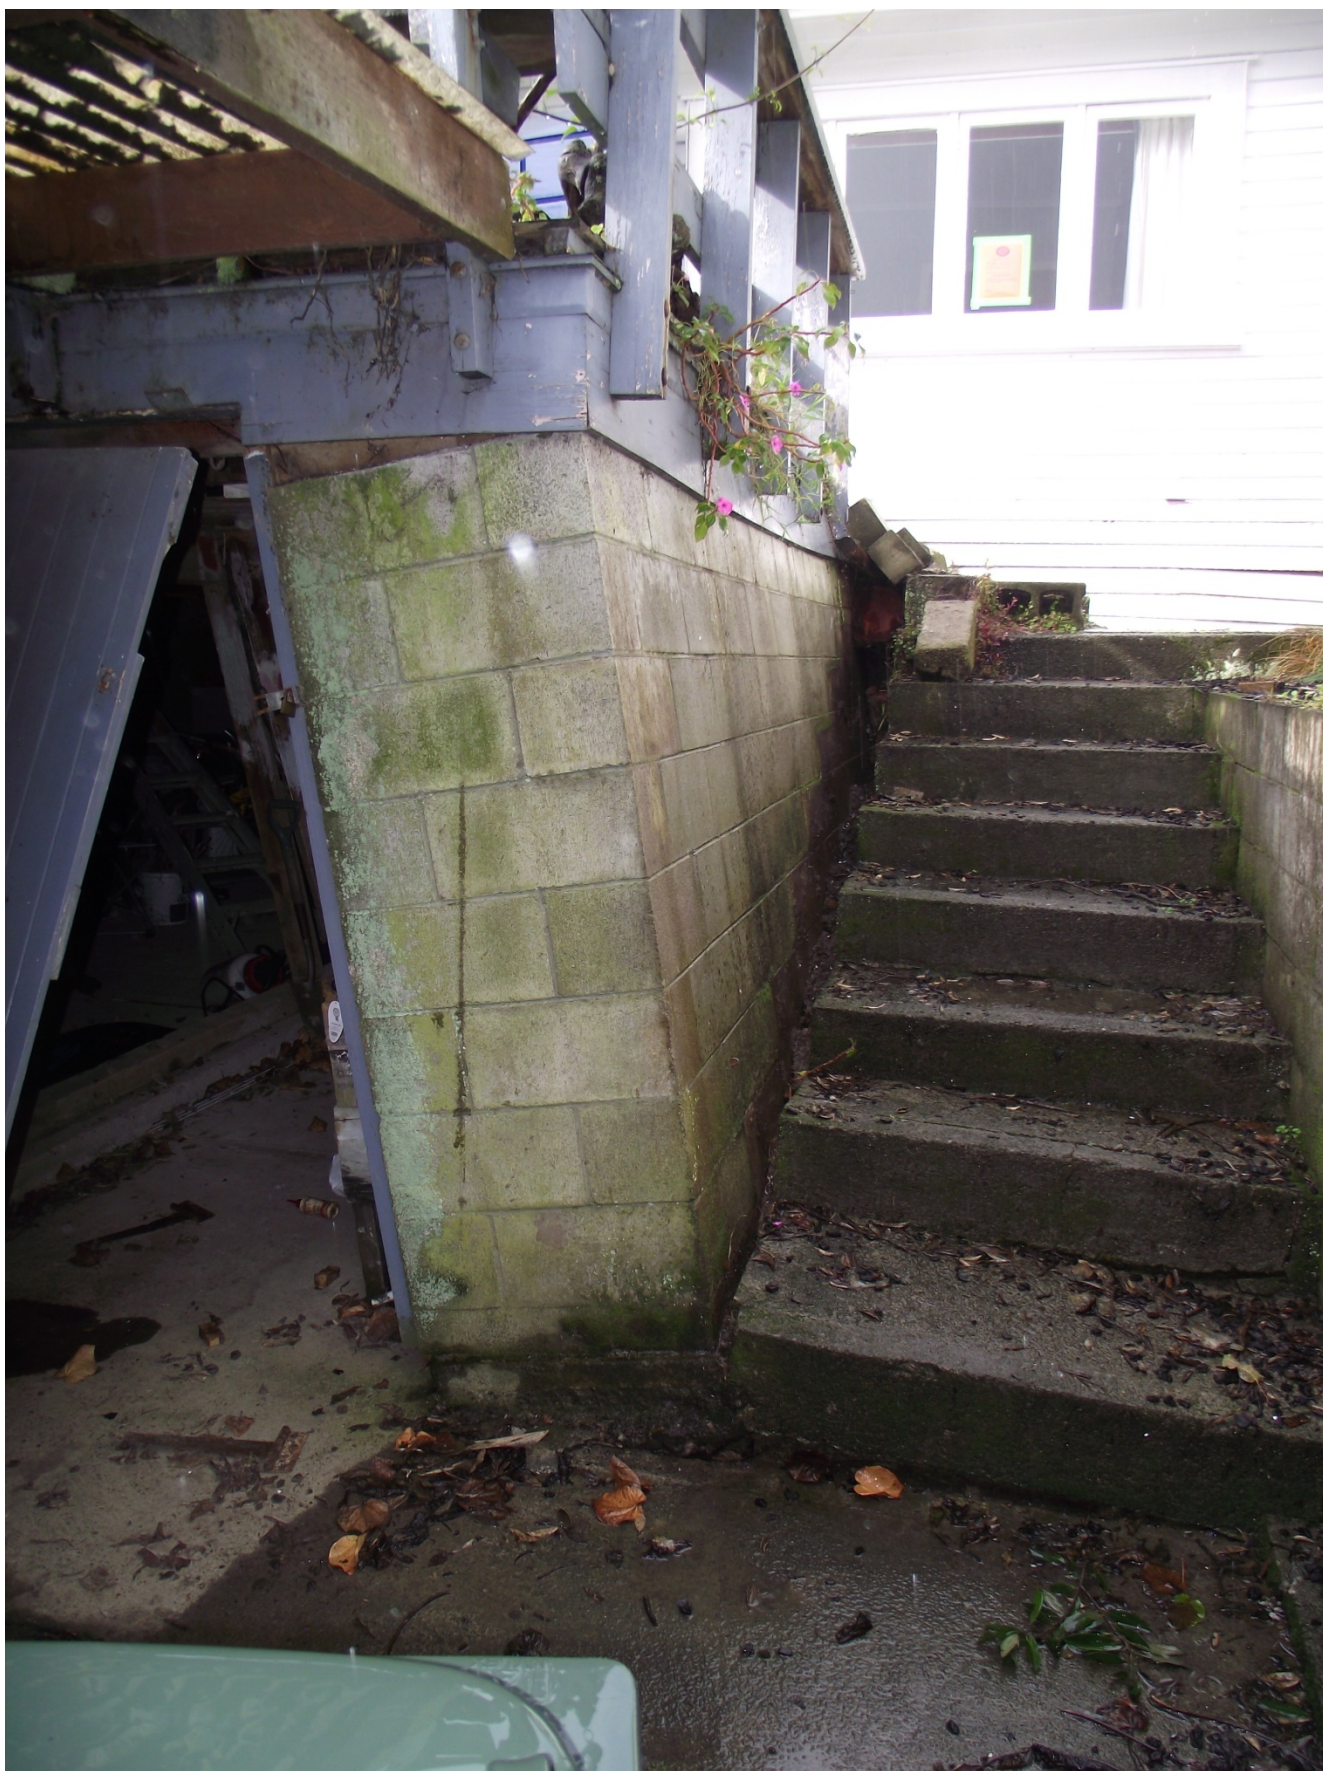
Figure 19 This block wall has been tilted forward with the movement of the house caused by the impact of the pohutukawa tree and associated landslide at the back.

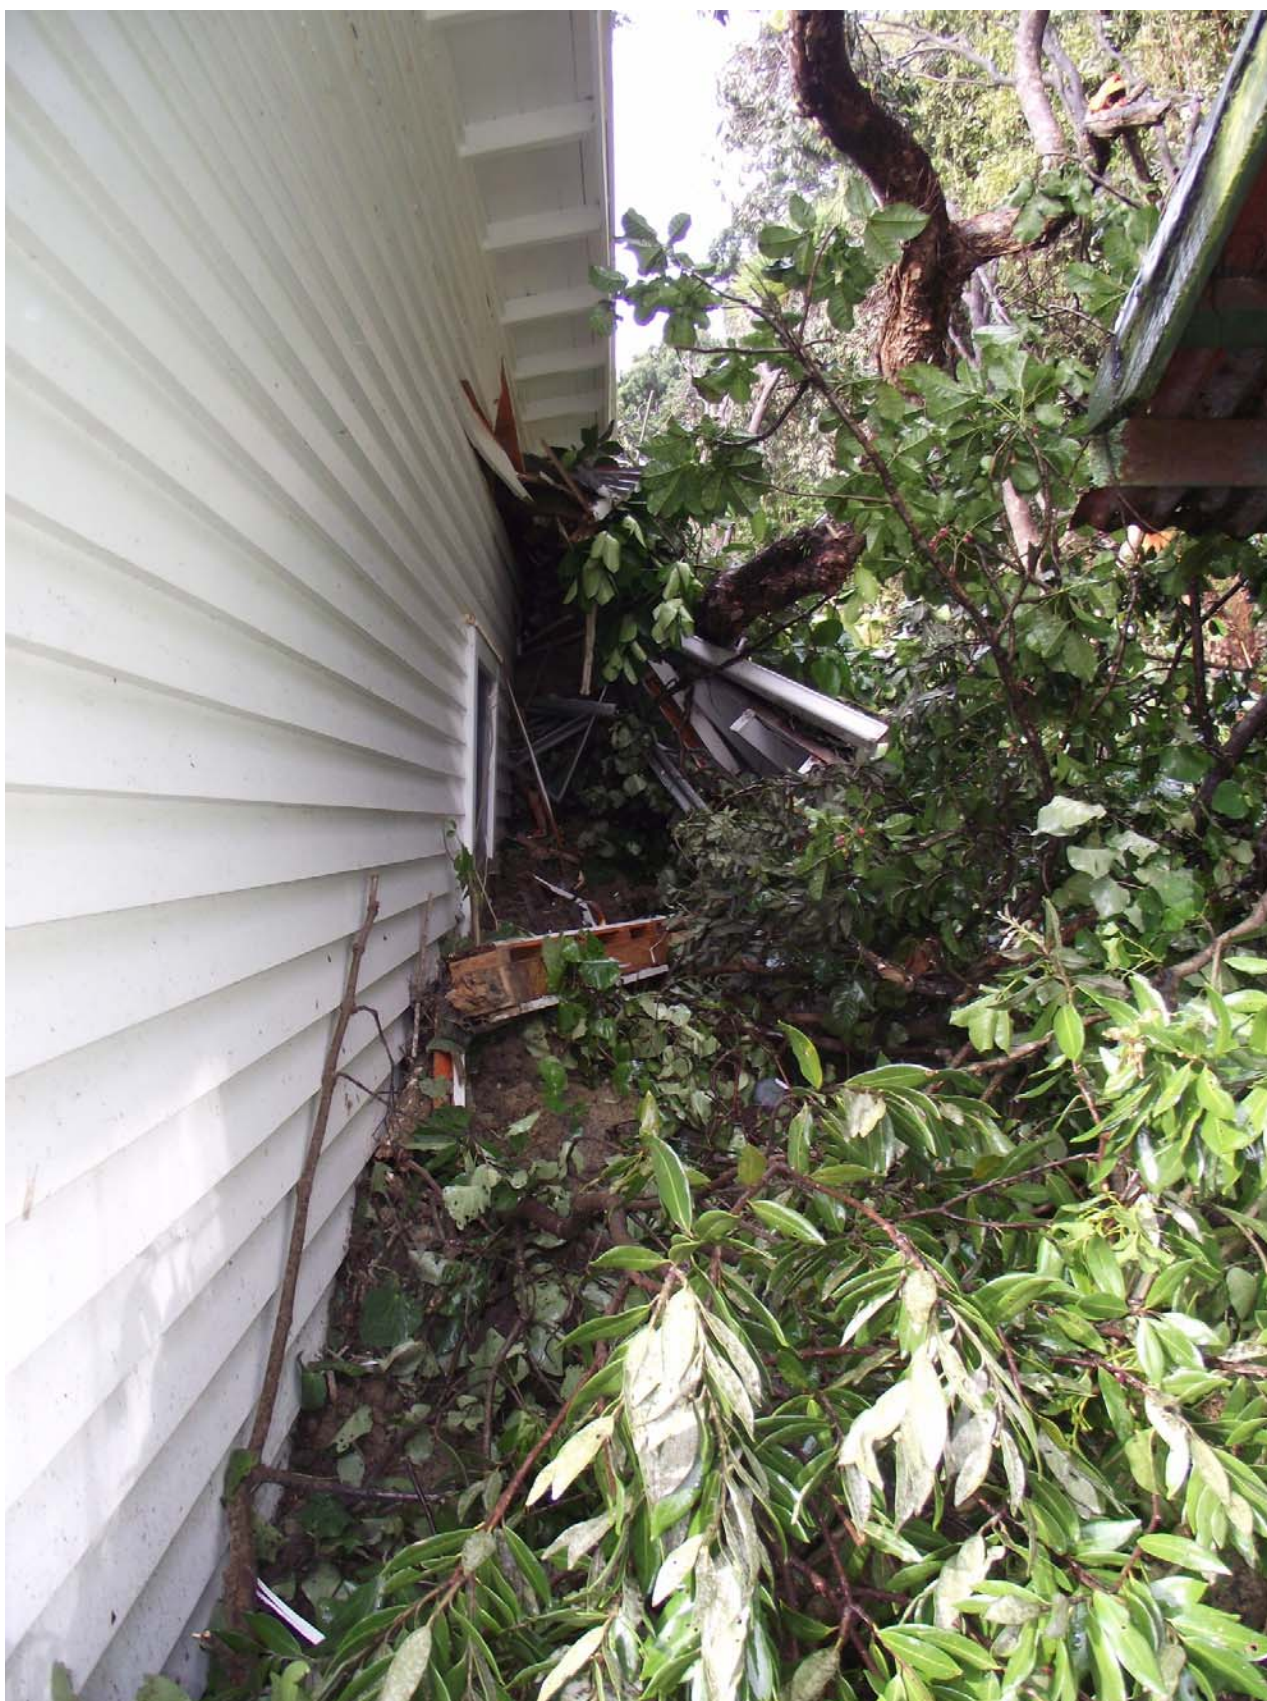
Figure 20 View along the back wall of the house showing tree and soil landslide debris. The main impact appears to have been from the large pohutukawa tree.

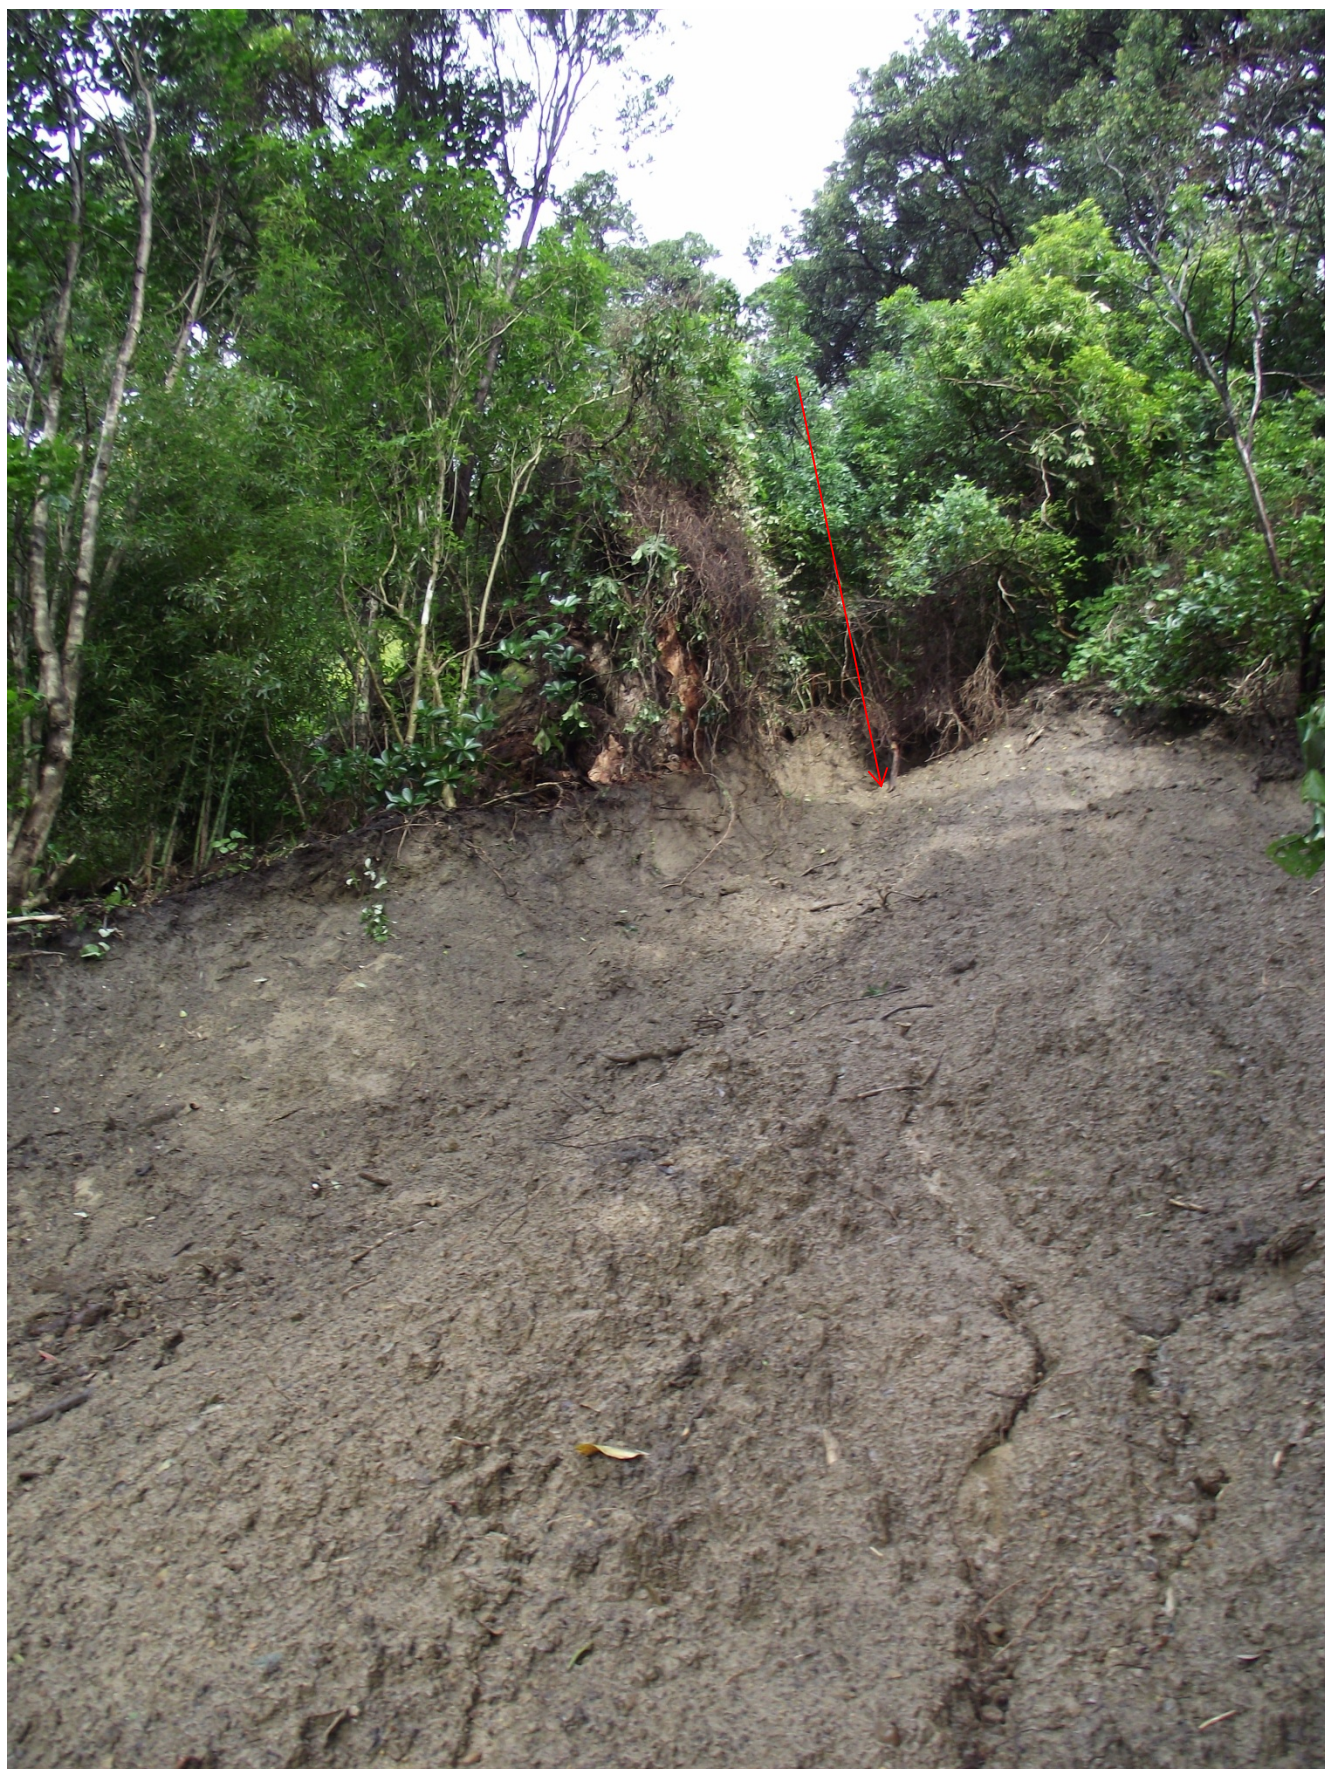
Figure 21 The inferred source (arrowed) and sliding path of the pohutukawa tree that impacted the house.

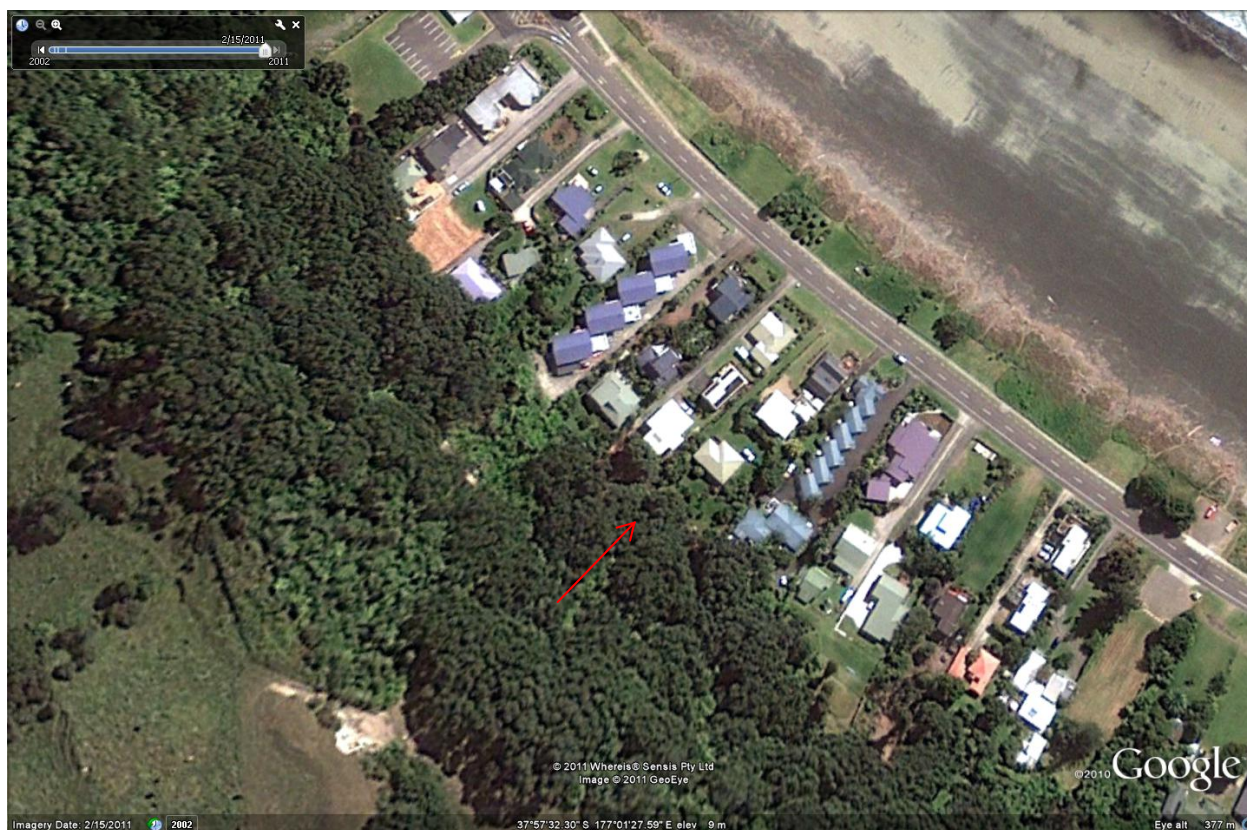
Figure 23 Detail of the source area of the fatal landslide from the 15 February 2011 Google Earth image.

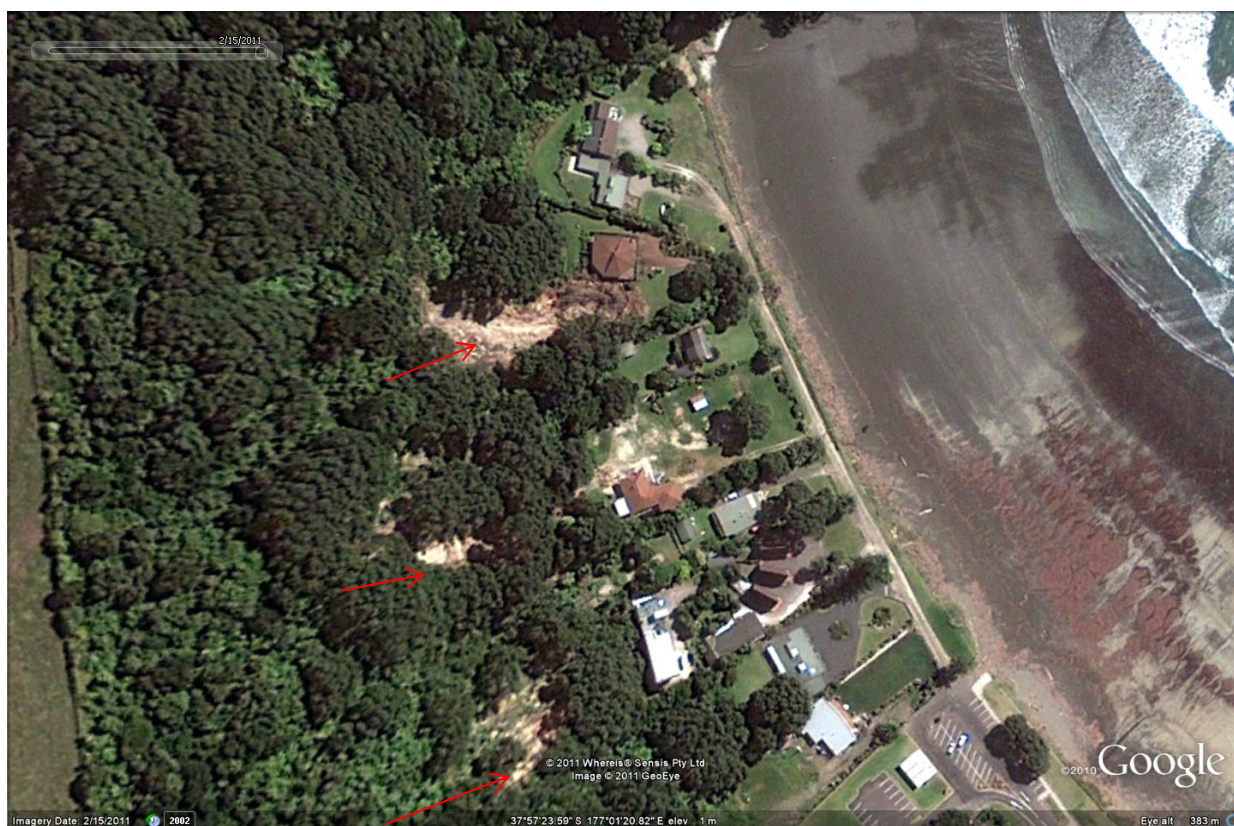
Figure 24 Landslides at the northern part of West End seen on the Feb. 2011 Google Earth image. From top to bottom the landslides indicated by red arrows occurred in January 2011 (top), May 2010 (middle), and June 2010 (bottom) according to the T&T (2011) draft report.

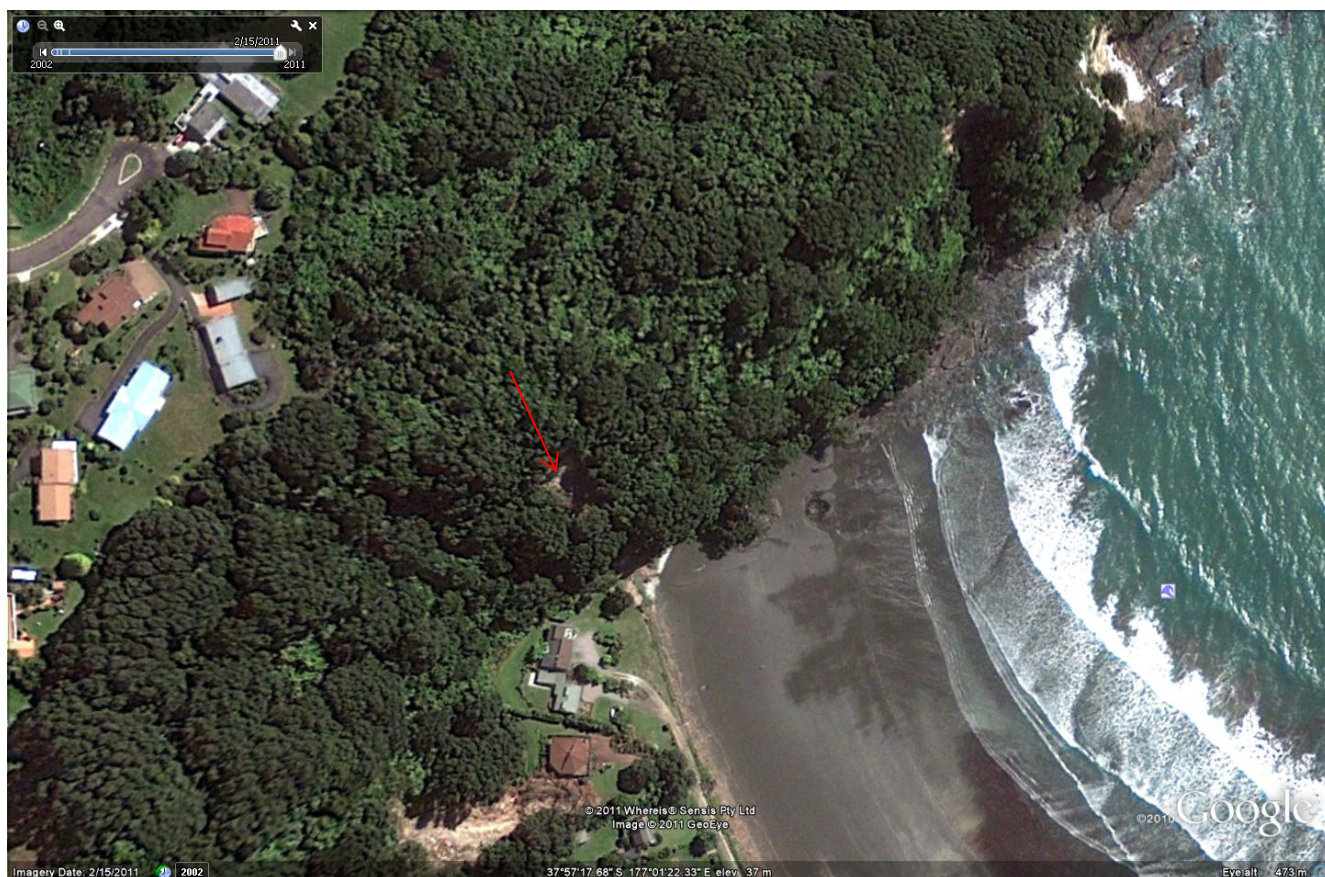
Figure 25 A small landslide can be seen amongst the trees on the northern cliff at West End in the Feb. 2011 Google Earth image. This appears to have expanded in April 2011 to form the much bigger landslide seen in Figure 12.

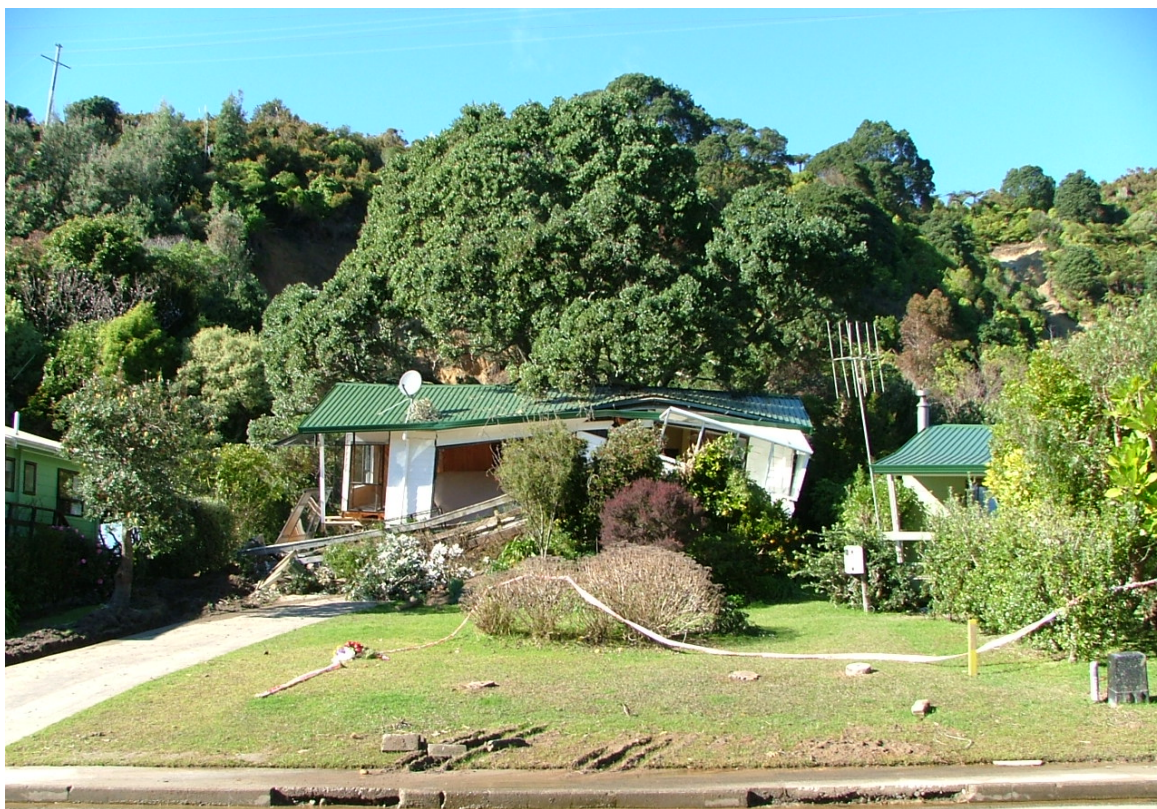
Figure 27 Bryans Beach fatality site in 2004 – front of the house

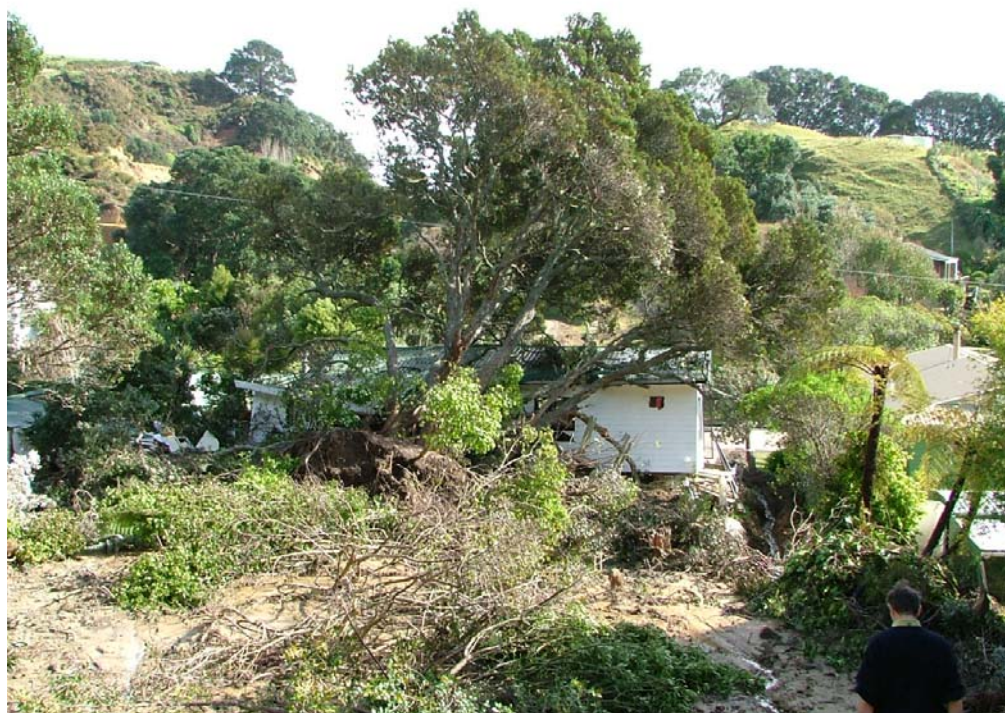
Figure 28 Back of house which was impacted by the displaced pohutukawa tree, which slid down and caused the fatality - a lady who was outside clearing drains.

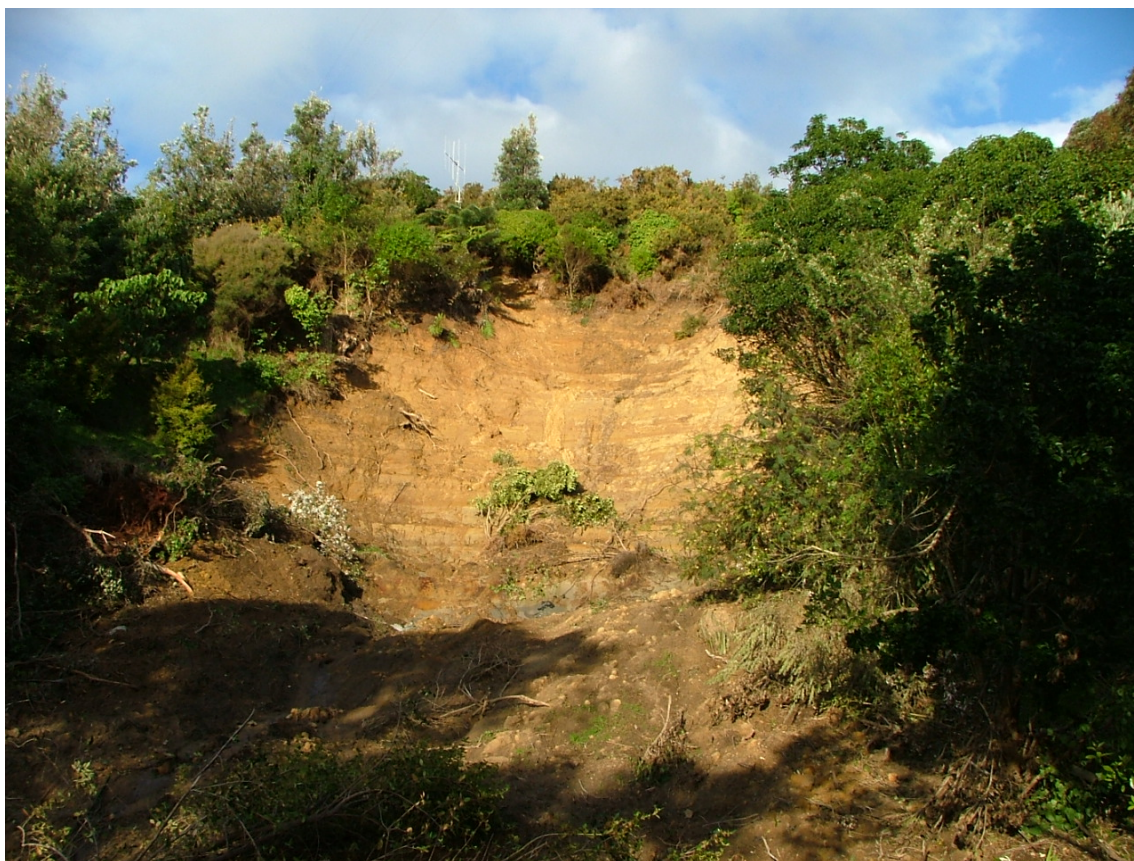
Figure 29 Source area of the pohutukawa tree which caused the fatality in the 2004 heavy rainstorm. The slope angle in the source area is $\sim 35^\circ$.

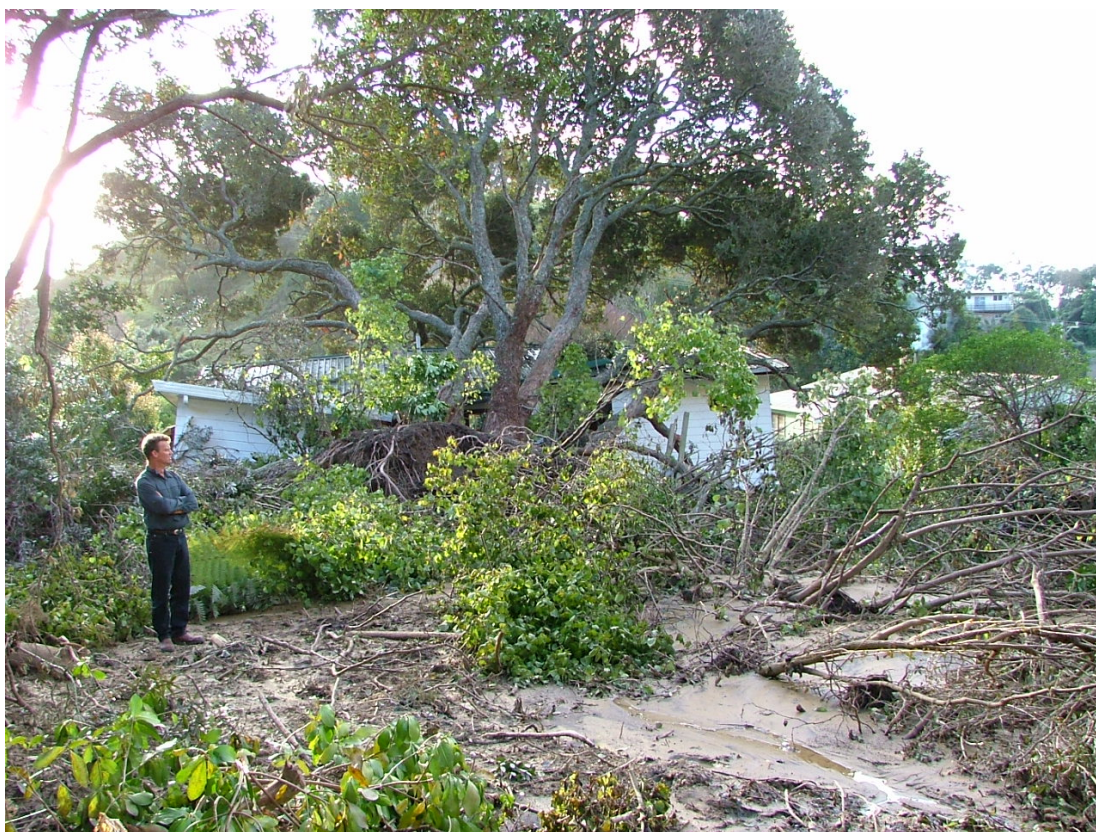
Figure 30 Detail of the debris and tree behind the wrecked house at Bryans Beach.

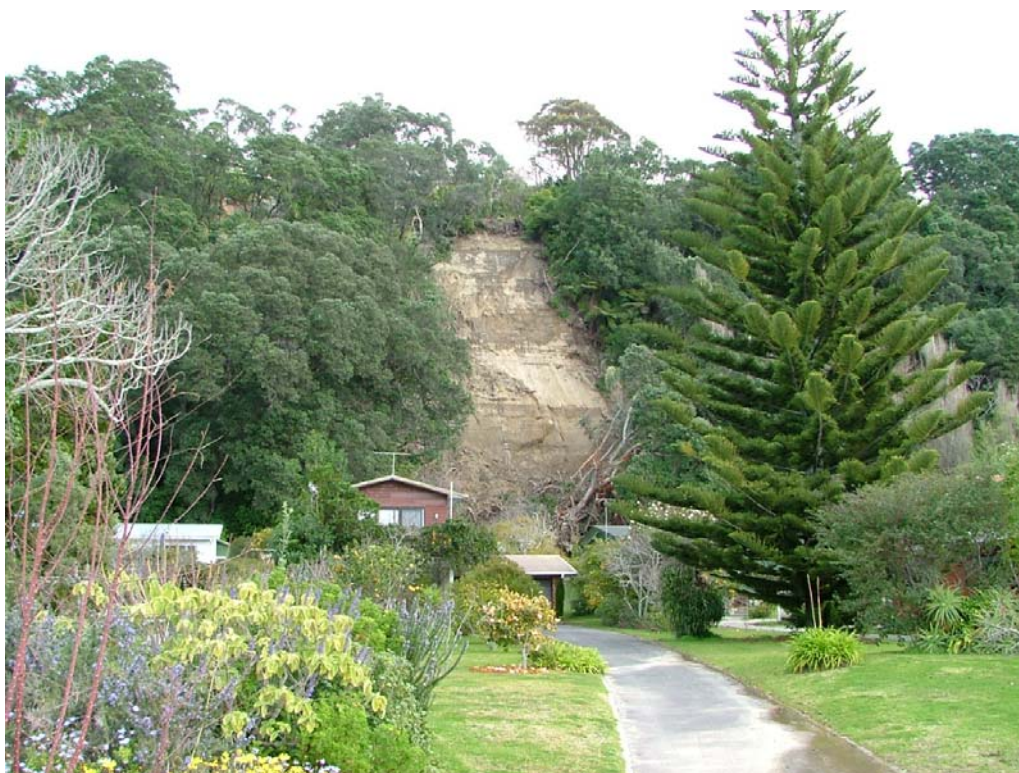
Figure 32 A landslide involving large trees from the ~80m high cliff at West End in 2004 impacted a “batch” at the back of No 34 West End Road.

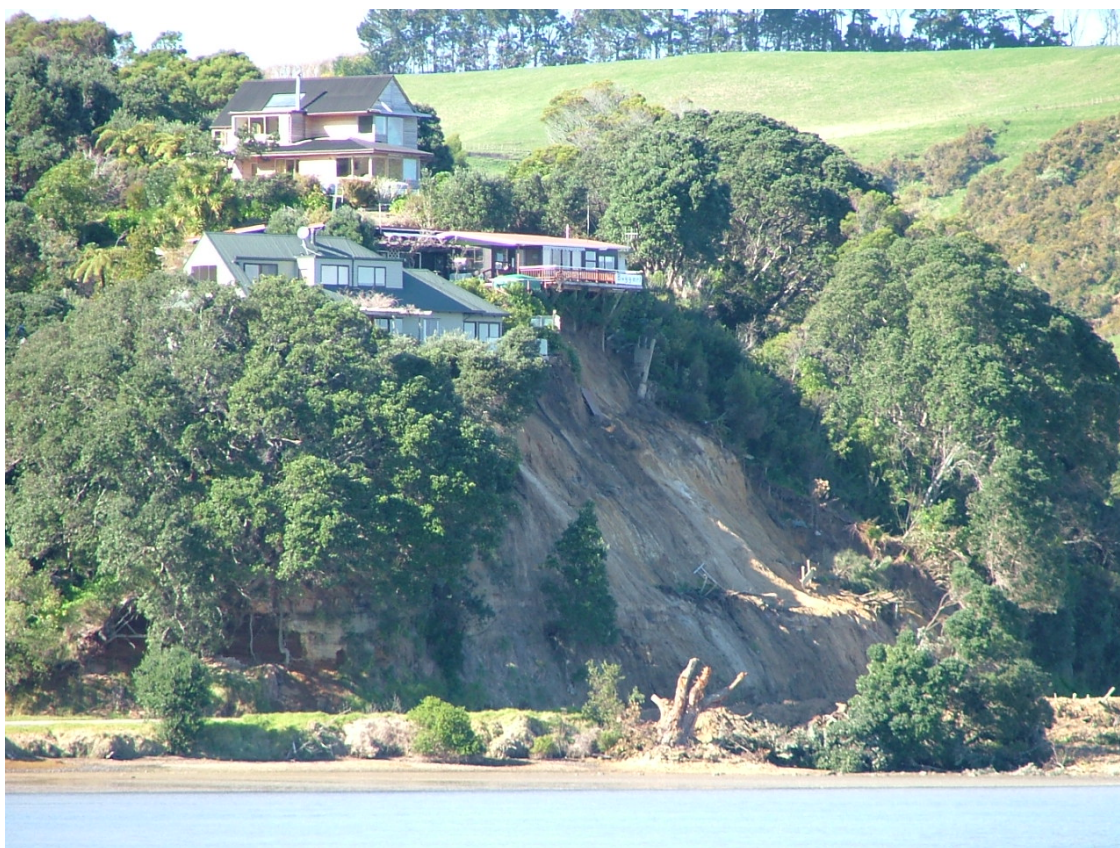
Figure 33 A landslide involving mature pohutukawa trees on a ~20m high cliff below houses at Ohiwa. The slope angle is 30° to 40°.

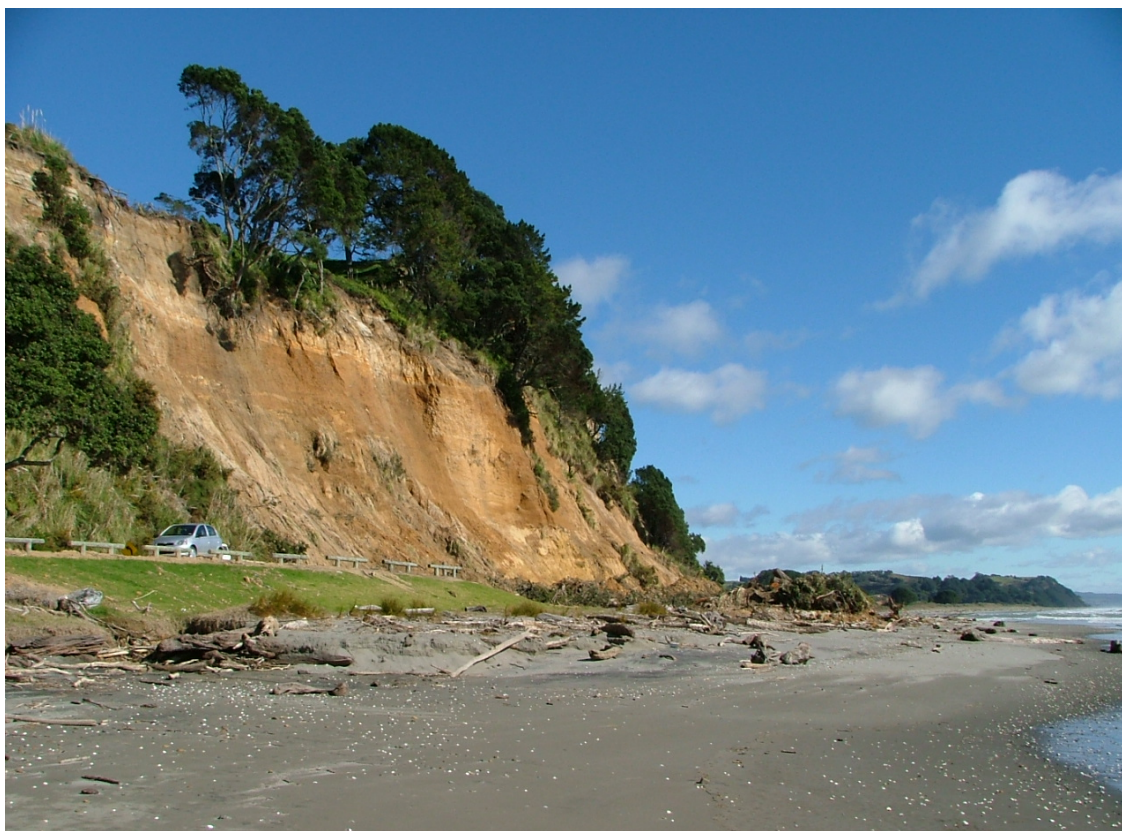
Figure 36 2004 Failures involving large pohutukawa trees from the ~60m high cliffs along SH2/Waiotahi Beach Road where the slope angle is ~40°.

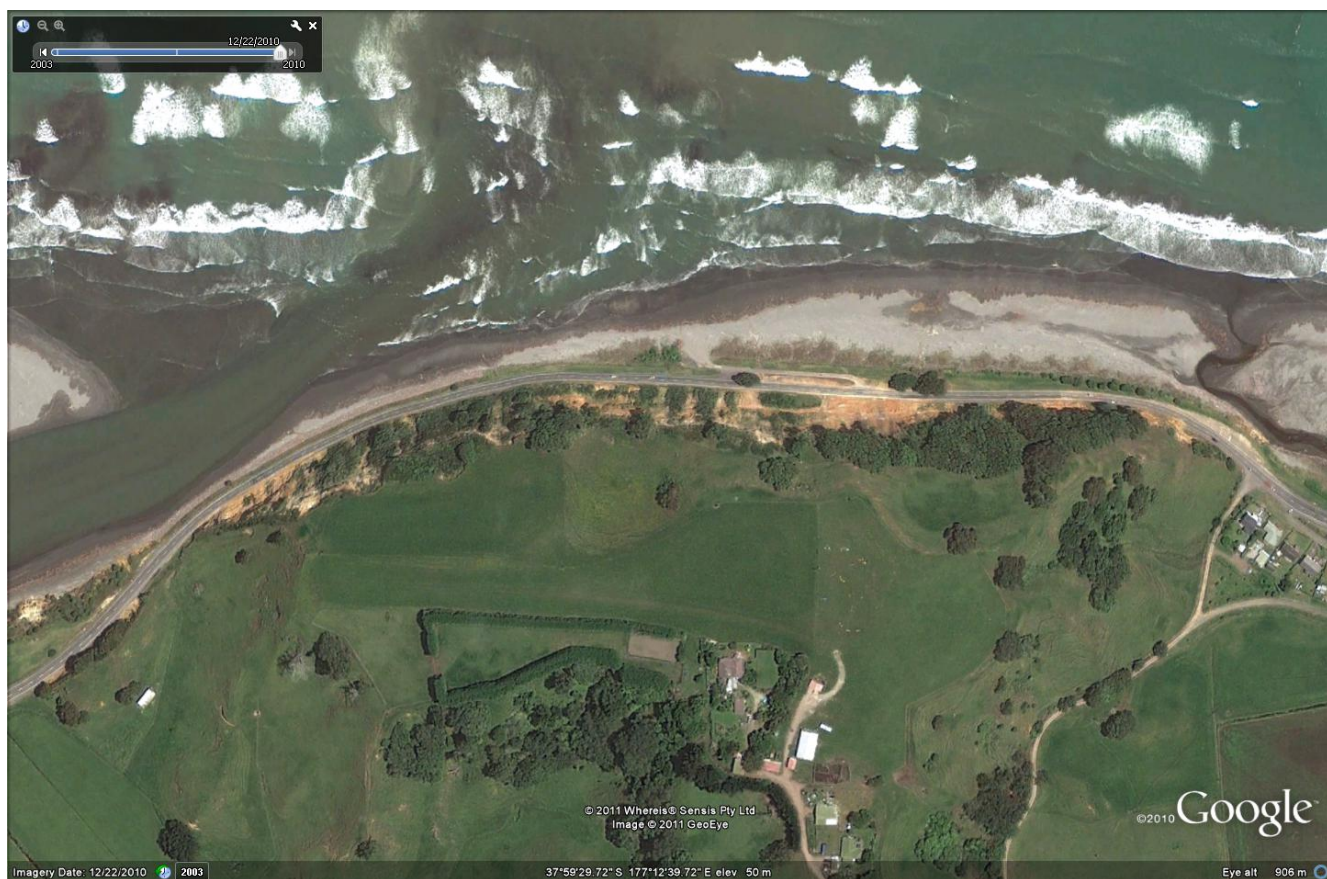
Figure 37c Many new landslide areas have appeared on this 22 December 2010 Google Earth image.

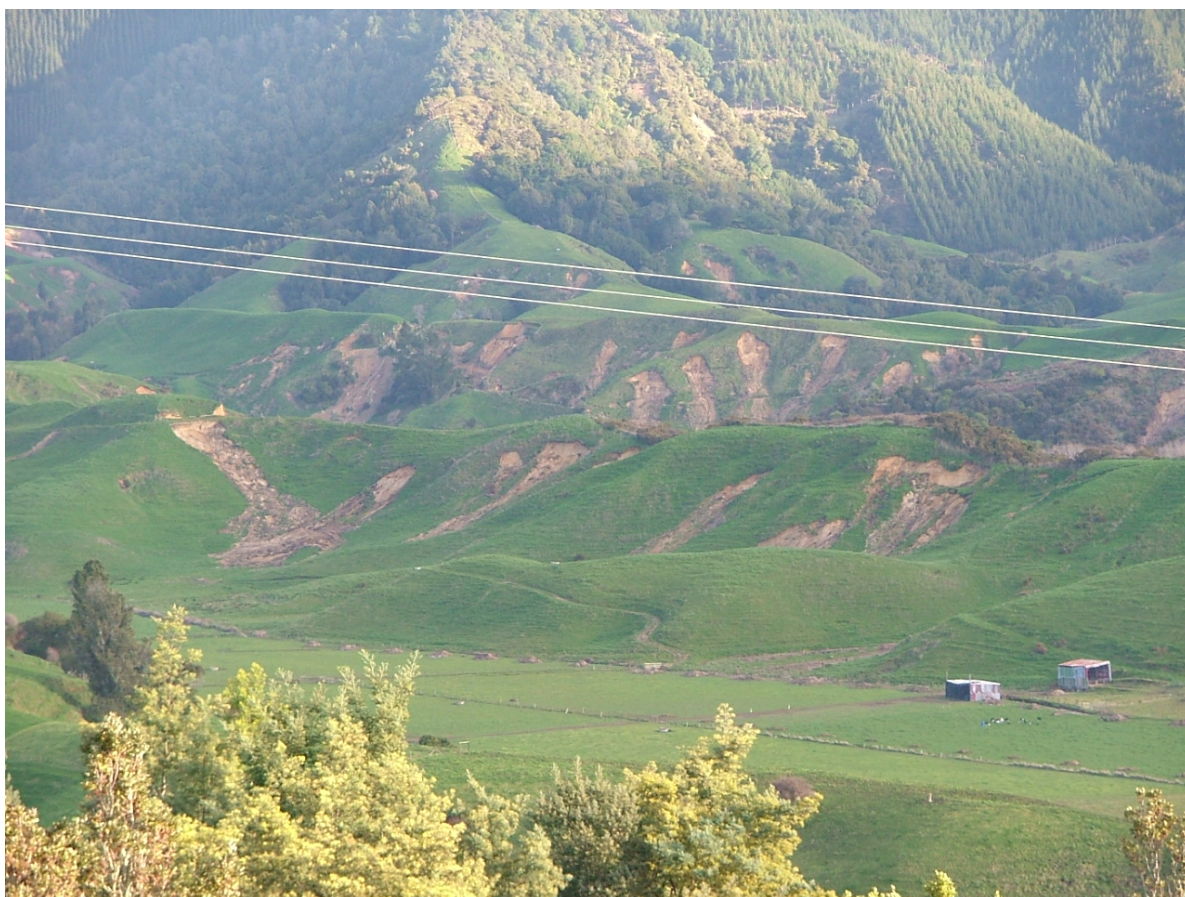
Figure 38 An example of soil flow landslides on moderate to steep grassed slopes in the Waiotahi Valley after the high intensity rainfall in 2004.
