Beetham, D. 2011. Ohope Beach Landslide of June 2011, *GNS Science Report 2011/46*. 69 p.

This GNS Science/GeoNet landslide investigation, made in response to a landslide which caused a fatality at Ohope Beach on Saturday 18 June 2011, is based on a site visit, interviews with those involved in the immediate response, and council, consultant and media reports. It puts the 18 June 2011 landslide into a context of regular, rain storm generated landslides that have occurred from coastal cliffs within the region since 2004.

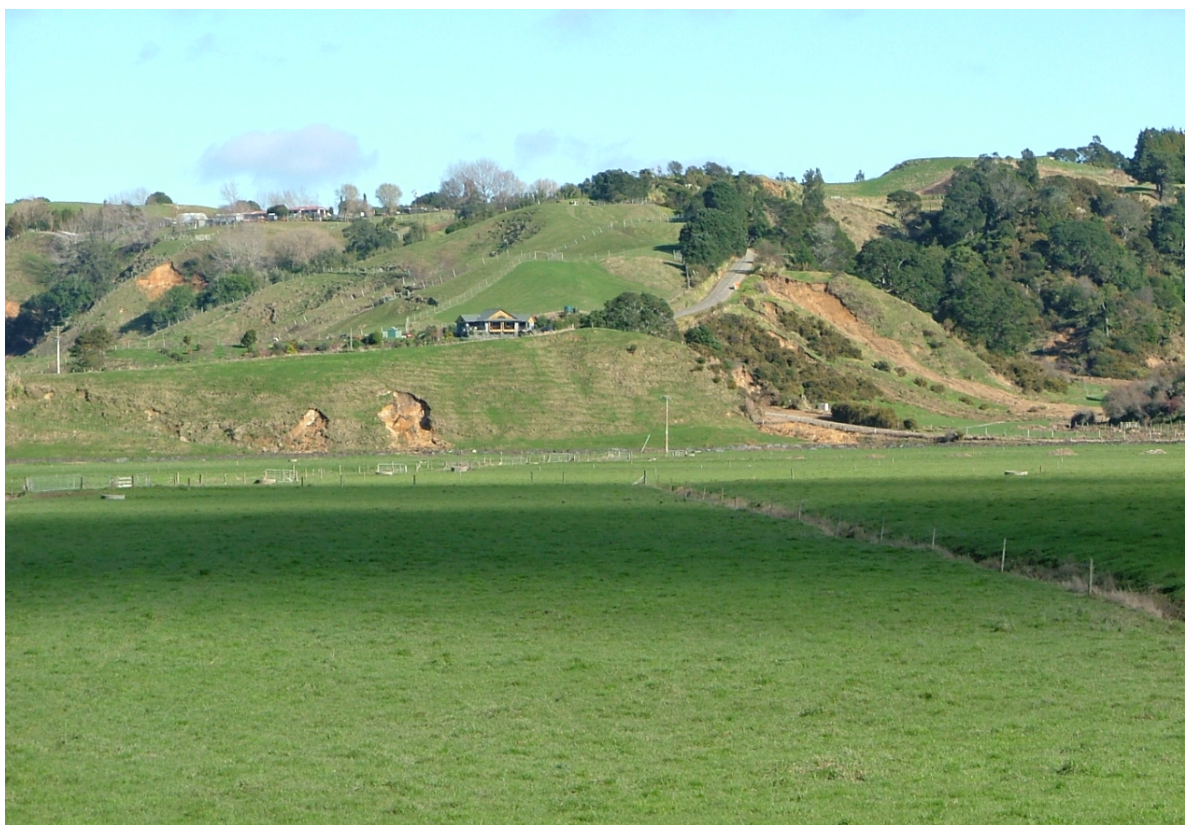
Figure 39 Landslides along Ohiwa Harbour Road at the Waiotahi Valley end in 2004.

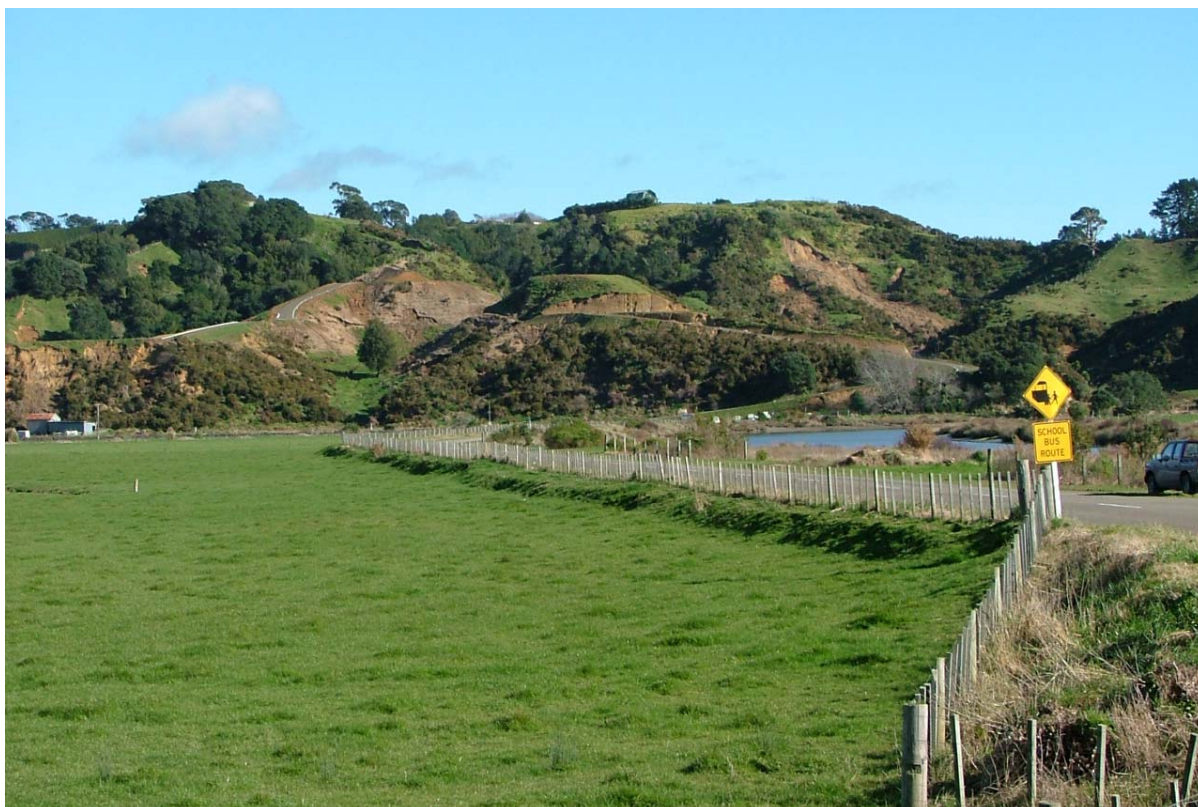
Figure 40a Landslides on a new subdivision at the junction of Ohiwa Beach and Ohiwa harbour Roads.

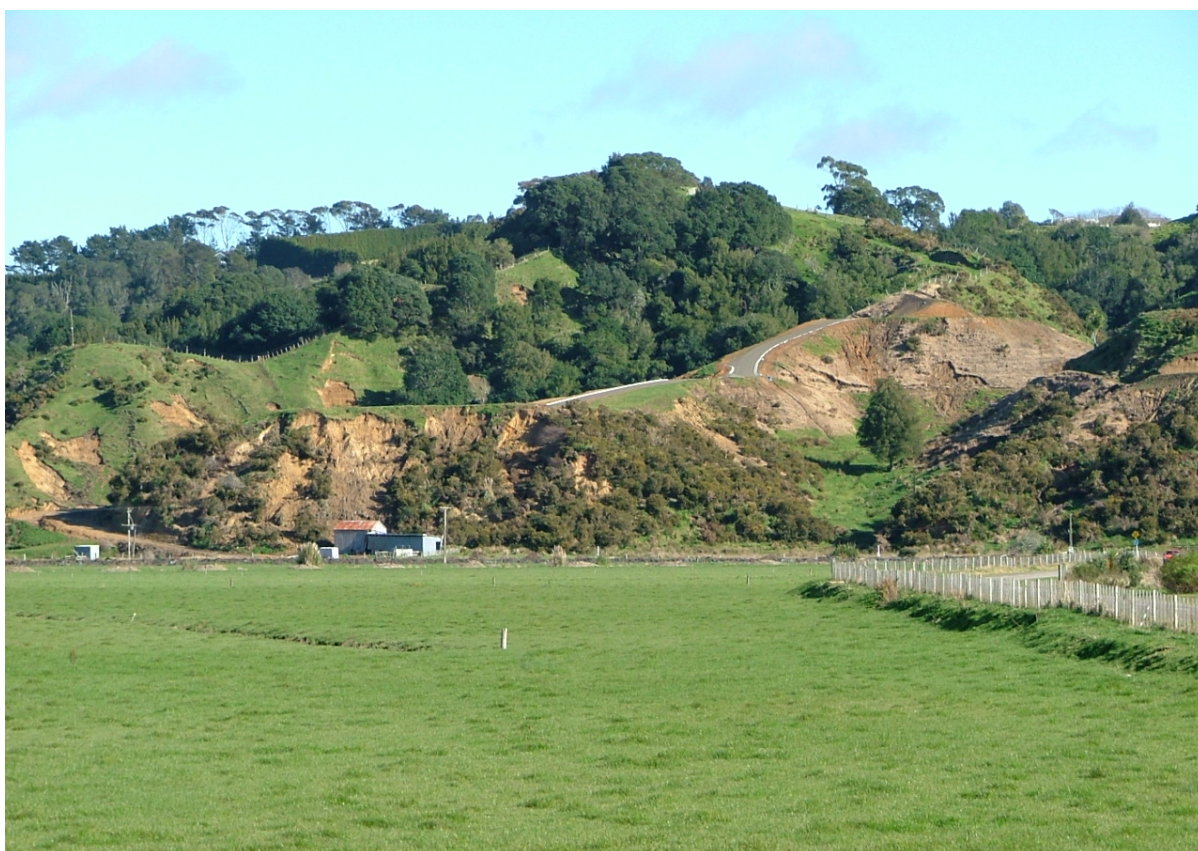
Figure 40b Detail of the landslides on a new subdivision at the junction of Ohiwa Beach and Ohiwa harbour Roads in 2004.

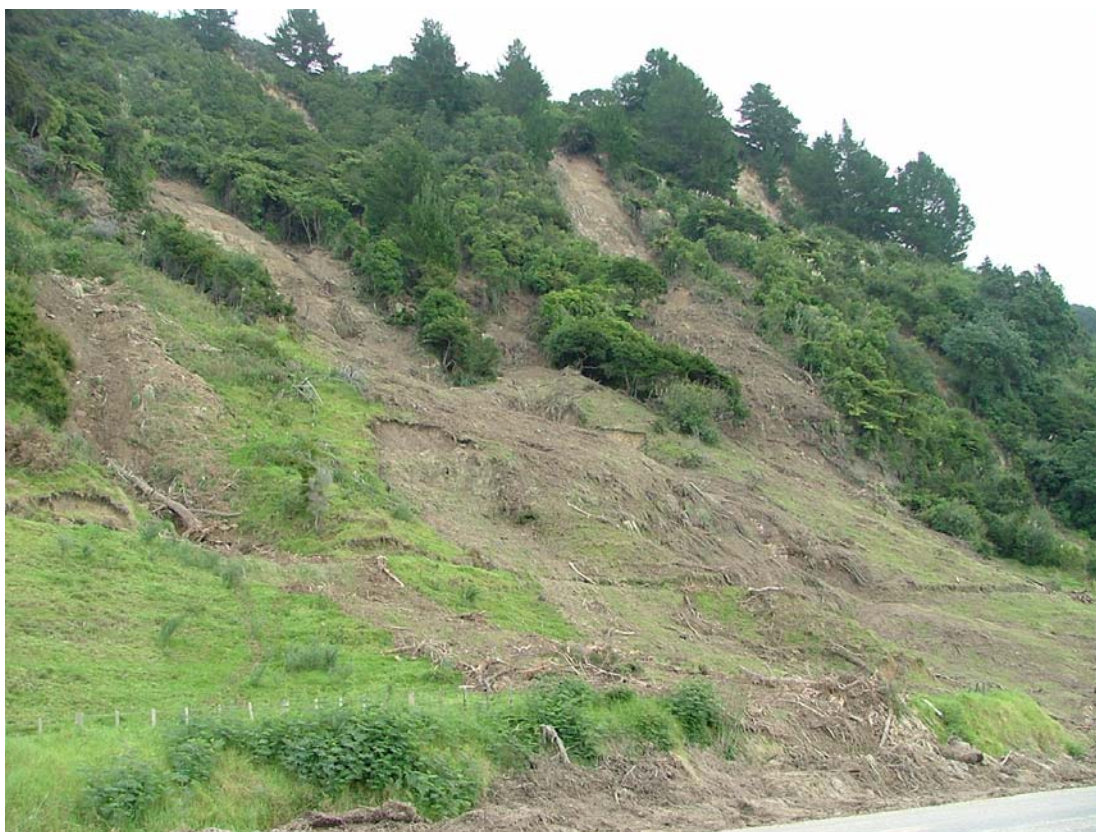
Figure 41a Landslides from the coastal (old cliff) escarpment just north of Matata in May 2005 have been cleared from the roadway, which is on the talus apron.

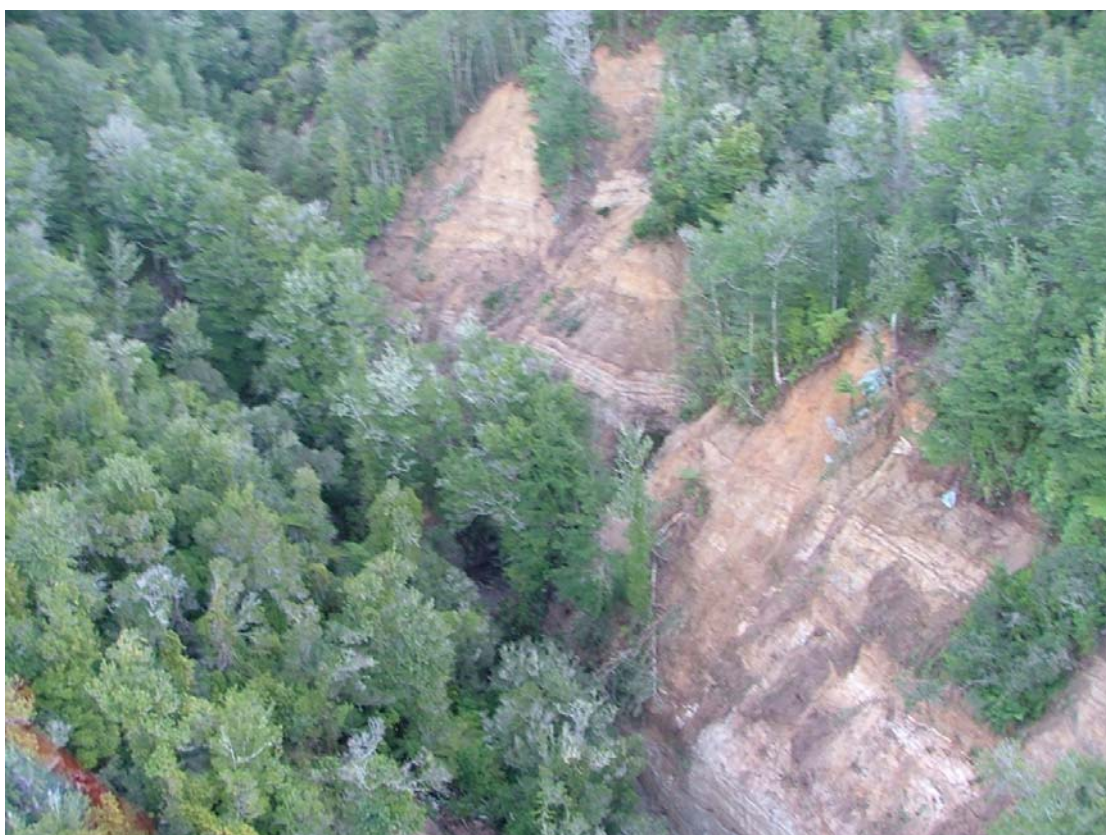
Figure 41b Numerous landslides such as these in the Awatarariki Stream catchment coalesced to form the destructive Matata Debris flows in May 2005.
