Hancox, G. T.; Archibald, G. C.; Cousins, W. J.; Perrin, N. D.; Misra, S. 2013. Reconnaissance report on liquefaction effects and landslides caused by the M_L 6.5 Cook Strait earthquake of 21 July 2013, New Zealand, *GNS Science Report* 2013/42. 20 p.

ABSTRACT

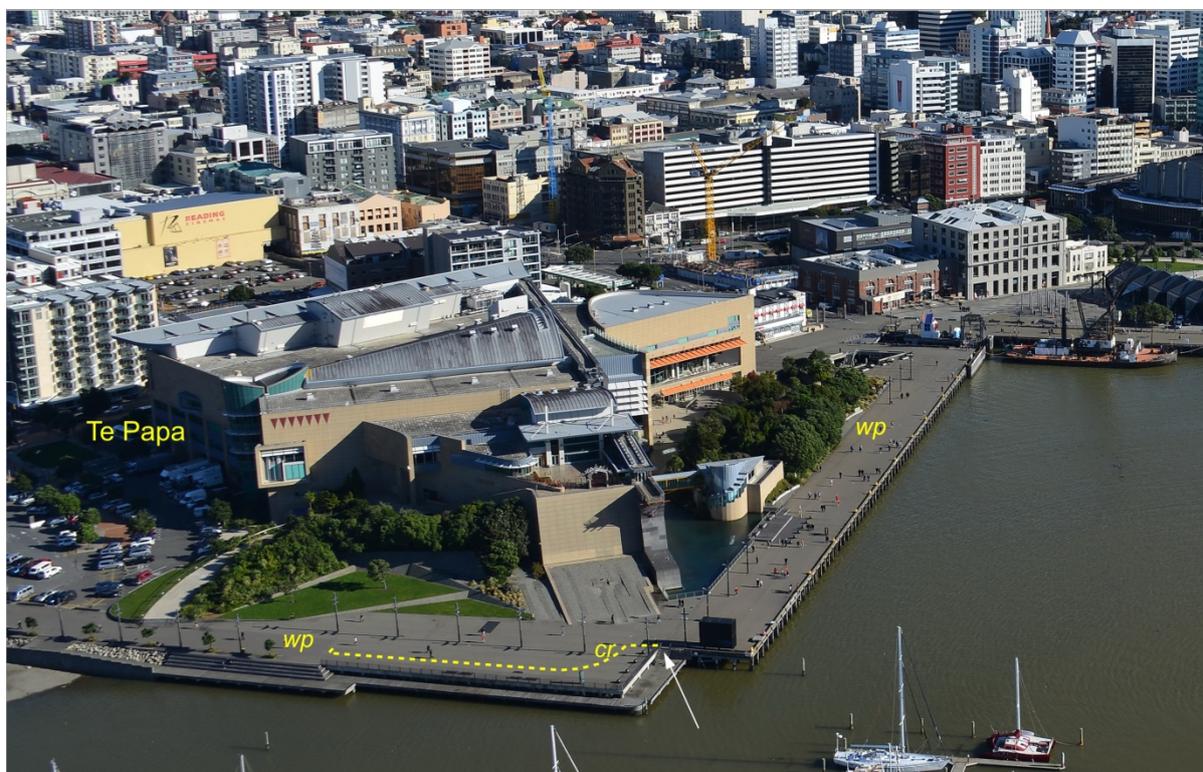
Figure 4 Site of cracking (*cr*) of the wharf promenade (*wp*) at Te Papa. The arrow shows the location of the start of the cracking at the top of the steps leading to the lower deck of the wharf.

A few weeks after the Cook Strait earthquake, cracks were noted on the wharf promenade at Te Papa (Figure 3 and Figure 4). The cracks are ~5–10 mm wide with subsidence of 15–30 mm (Figure 11 and Figure 12), and are located above the edge of the underlying fill, which appears to have settled, possibly due to failure of silt and mud deposits below the fill (Figure 12).

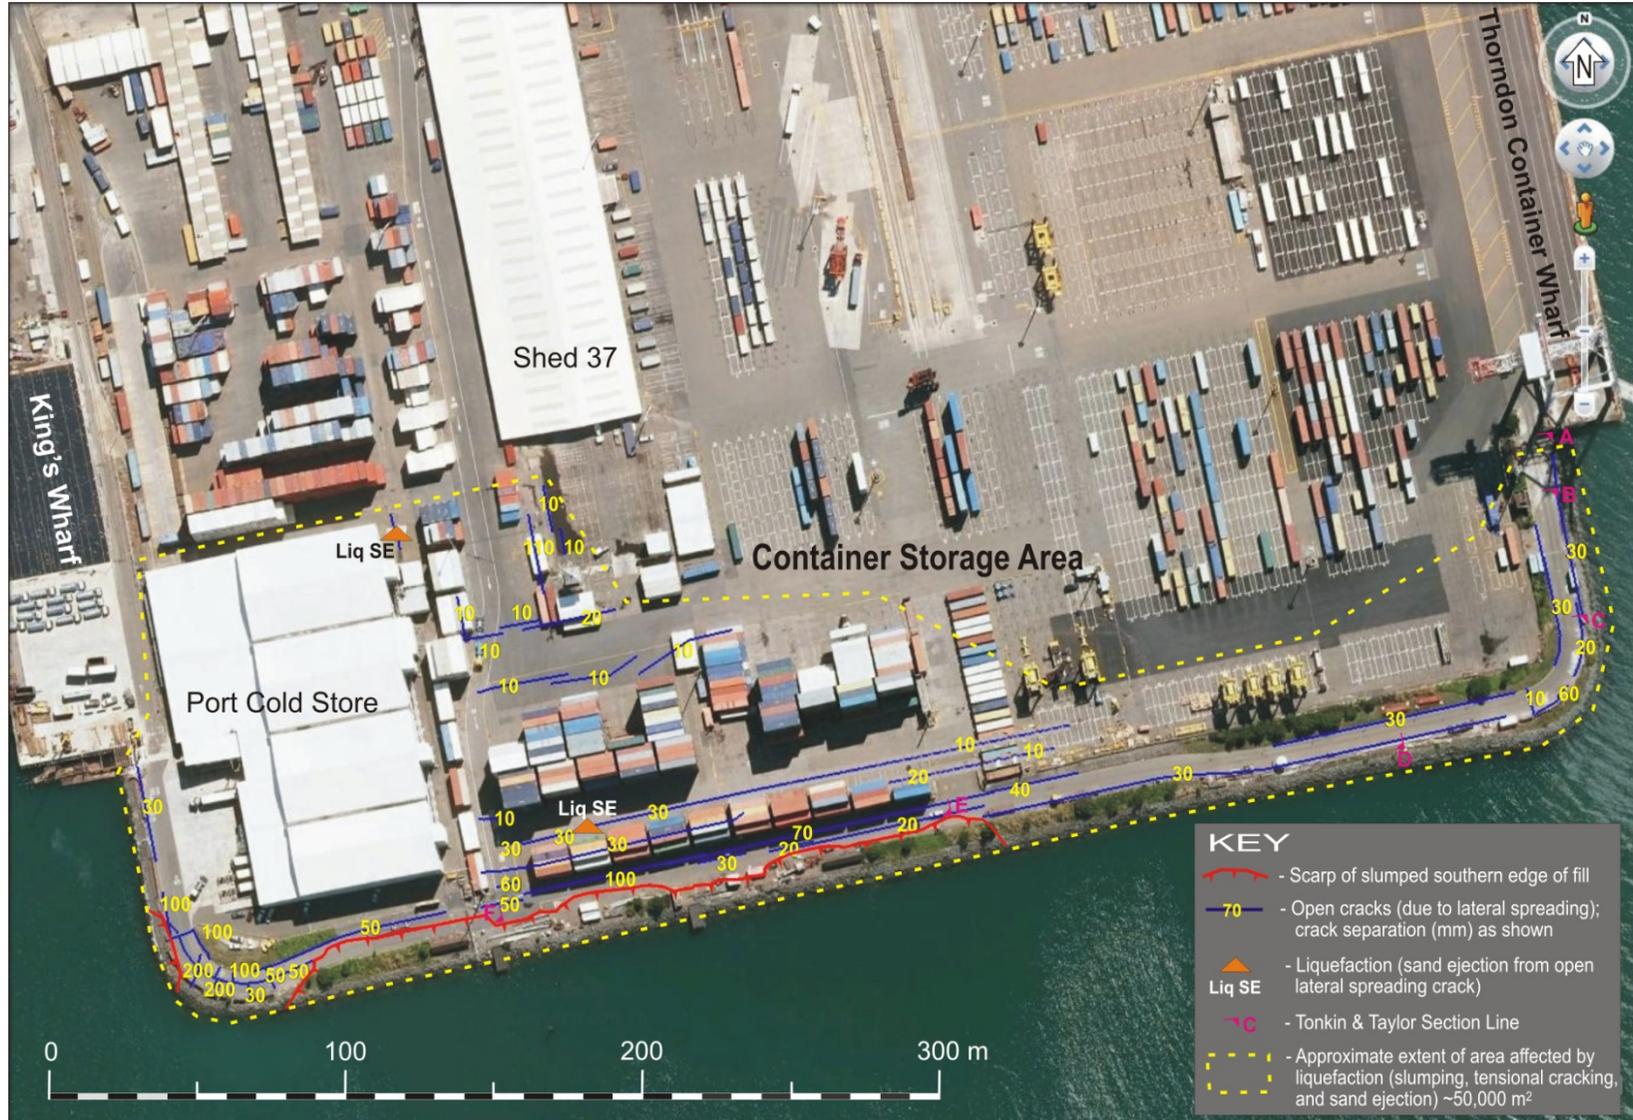
Figure 5 GoogleEarth image overlain with an RTK survey map of liquefaction-induced lateral spreading cracking, sand ejections, and slumping at the Container Storage Area reclamation fill (constructed 1960s and 1970s) into Wellington Harbour caused by the Cook Strait earthquake of 21 July, 2013. About 50,000 m² of the unrestrained southern edge of the reclamation area was affected by liquefaction damage.

The results of the RTK survey and observations are plotted on Figure 5. Our inspection and survey shows that a large area of the unrestrained southern end of the reclaimed land used by CentrePort as a Container Storage Area was damaged by the Cook Strait earthquake. This area, located between the Thorndon Container Wharf and King's Wharf (Figure 5), is part of the Thorndon Reclamation. This gravel fill reclamation area is typically 15 m deep, and was constructed in 1972 (Murashev and Palmer, 1998) The adjoining Thorndon Container Wharf and King's Wharf provide lateral support to the fill batter slope forming the edge of the reclamation, but the southern end of the fill was unsupported.

Minor liquefaction-induced sand ejections were noted at two locations (Figure 5 and Figure 10). Incipient hairline cracking occurred over much of the affected area, and there was also evidence of minor subsidence in one area ~50 m south of Shed 37 (Figure 5).

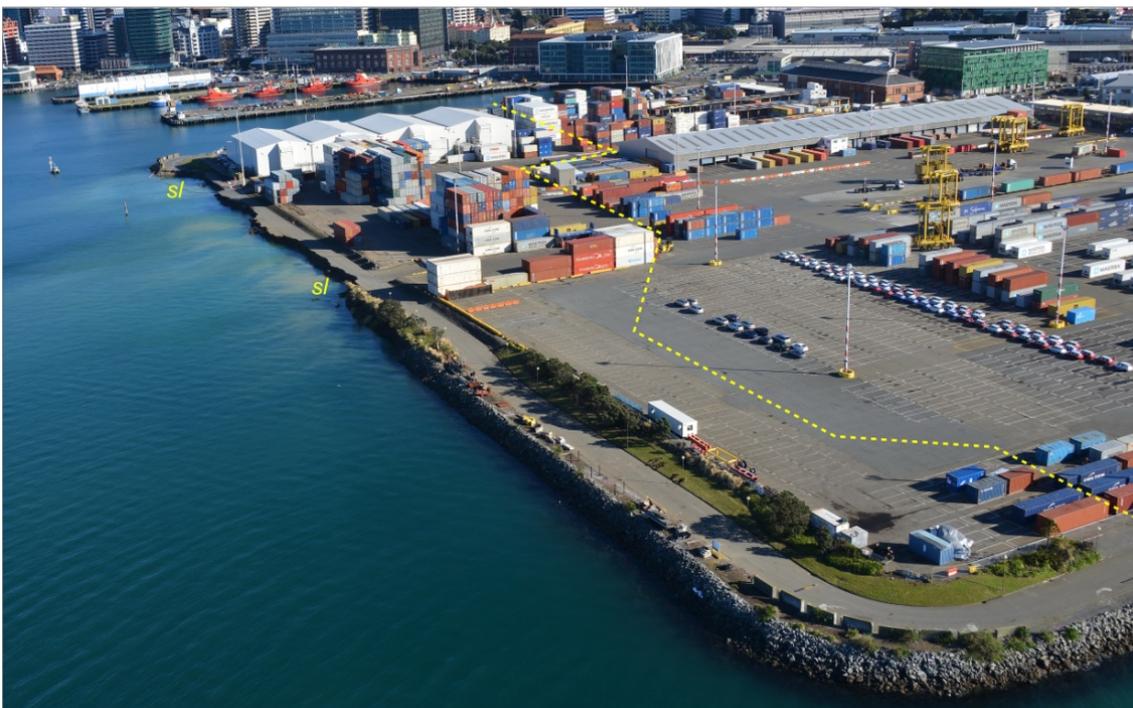
Figure 6 Aerial view of the area of slumping (*sl*) and cracking (yellow dotted line) caused by the Cook Strait earthquake of 21 July, 2013 at the Container Storage Area.

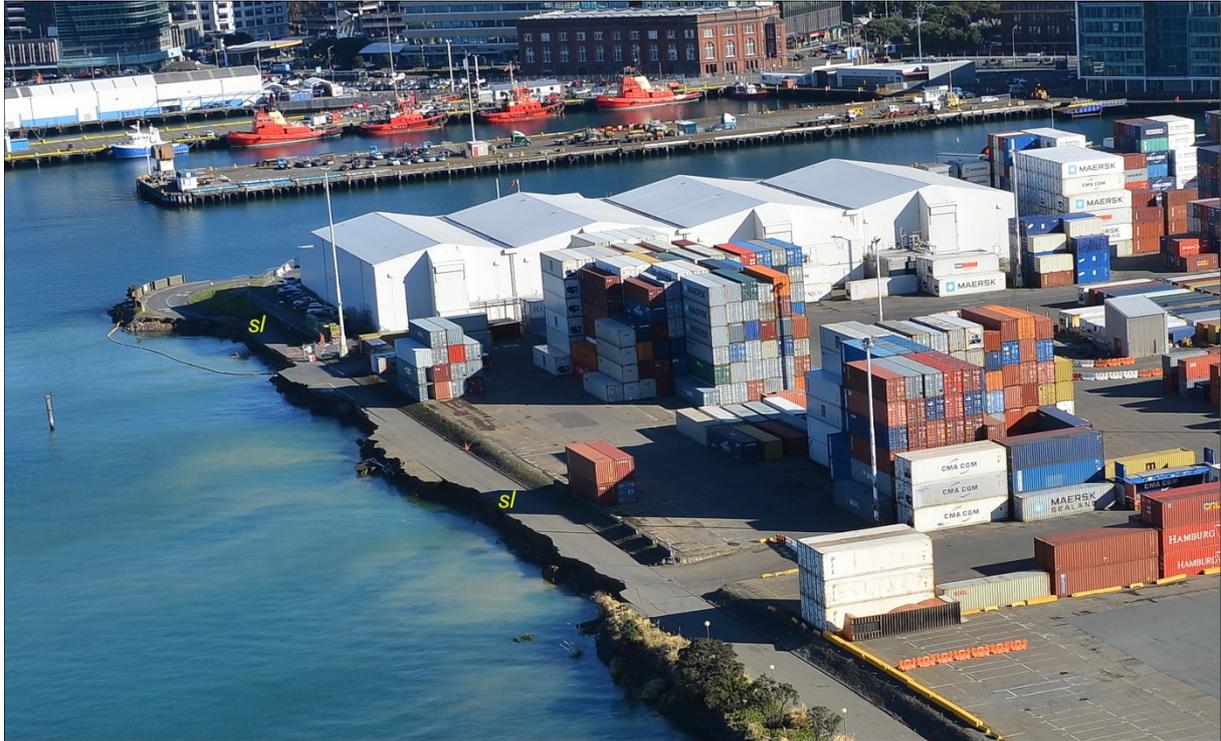
The main damage caused by the earthquake was slumping of a 250 m long section of the western part of the southern end of the reclamation fill batter, and extending 15 to 20 m from the former reclamation shoreline to the centre of the southern perimeter roadway. Slumping and tensional cracking occurred over about ~50,000 m² of the Container Storage Area. A series of open lateral spreading cracks ~200–300 m long and up to ~200 mm wide were formed parallel to and up to ~140 m back from the edges of the reclamation (Figure 5, Figure 6, Figure 7, Figure 8, Figure 9 and Figure 10).

Figure 7 The most serious damage that occurred was slumping (*sl*) over a 250 m length of the roadway at the unrestrained southern end of the reclamation fill that the Container Storage Area is located on.

The ground damage to the unrestrained southern end of the Container Storage area during the July 2013 earthquake clearly showed the vulnerability of reclamation fills that are not confined by sheet piling or a wharf. Kings Wharf and the Thorndon and Aotea Quay wharves appear to have prevented collapse and cracking of the adjacent fill.

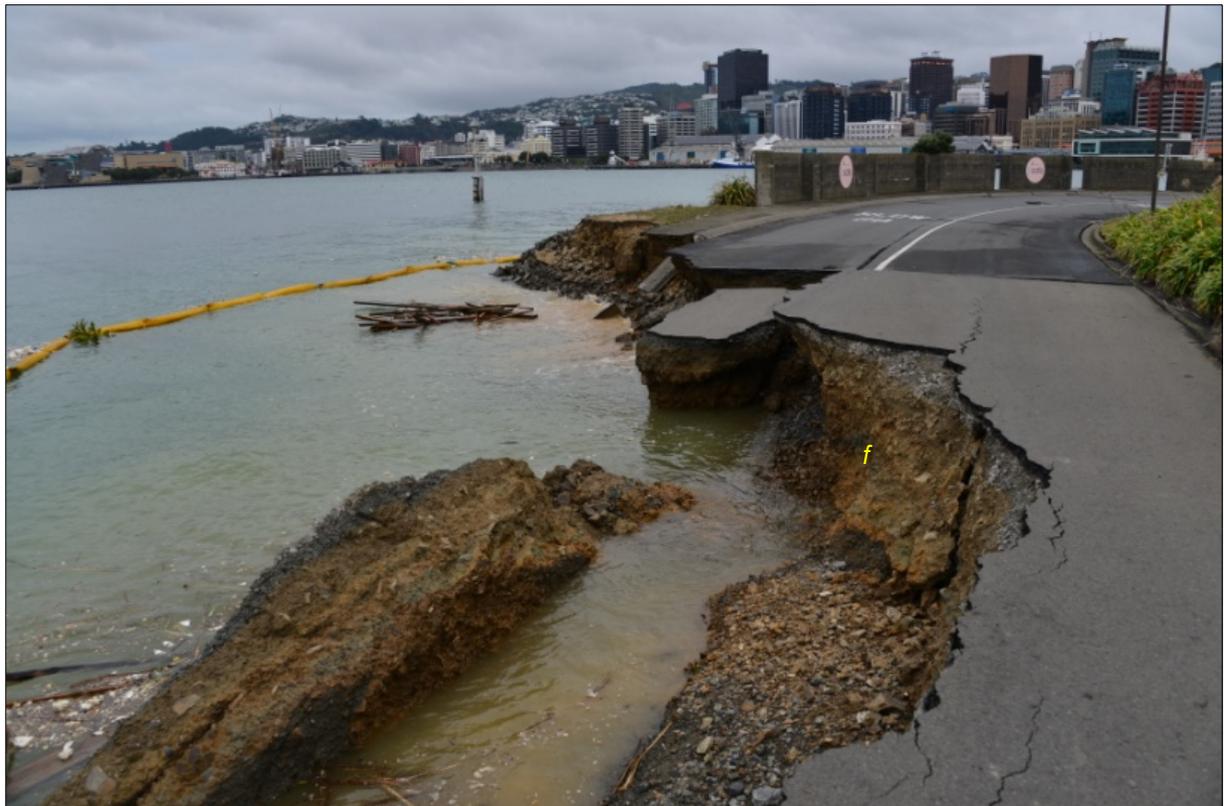
Figure 8 Western end of the slumping of fill into the harbour at the southern end of the reclamation. The clay-gravel fill shown here (*f*) is well compacted, but appears to have failed because the underlying weak (low density) silt and mud on the harbour bottom, on which the fill was placed, have failed.

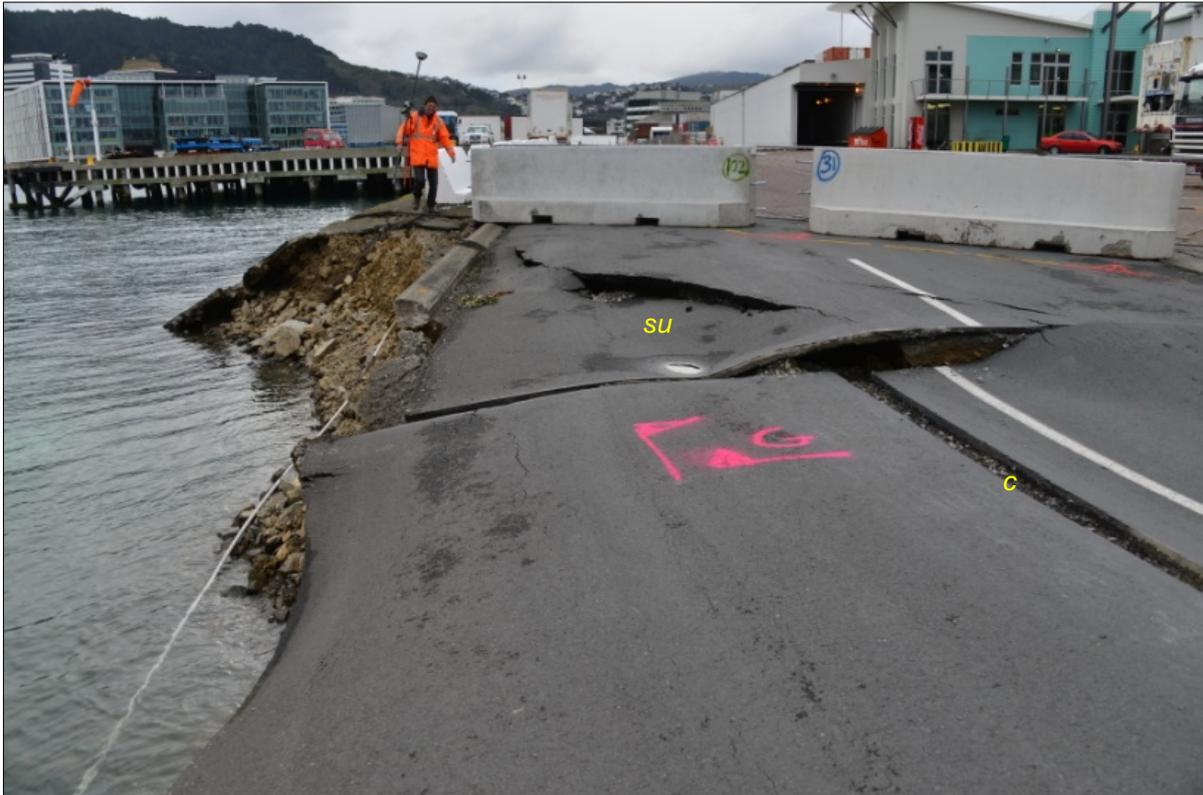
Figure 9 Closer view of the extensive tensional cracking (*c*) and subsidence (*su*) failure area at the southwest end of the reclamation area adjacent to King's Wharf.

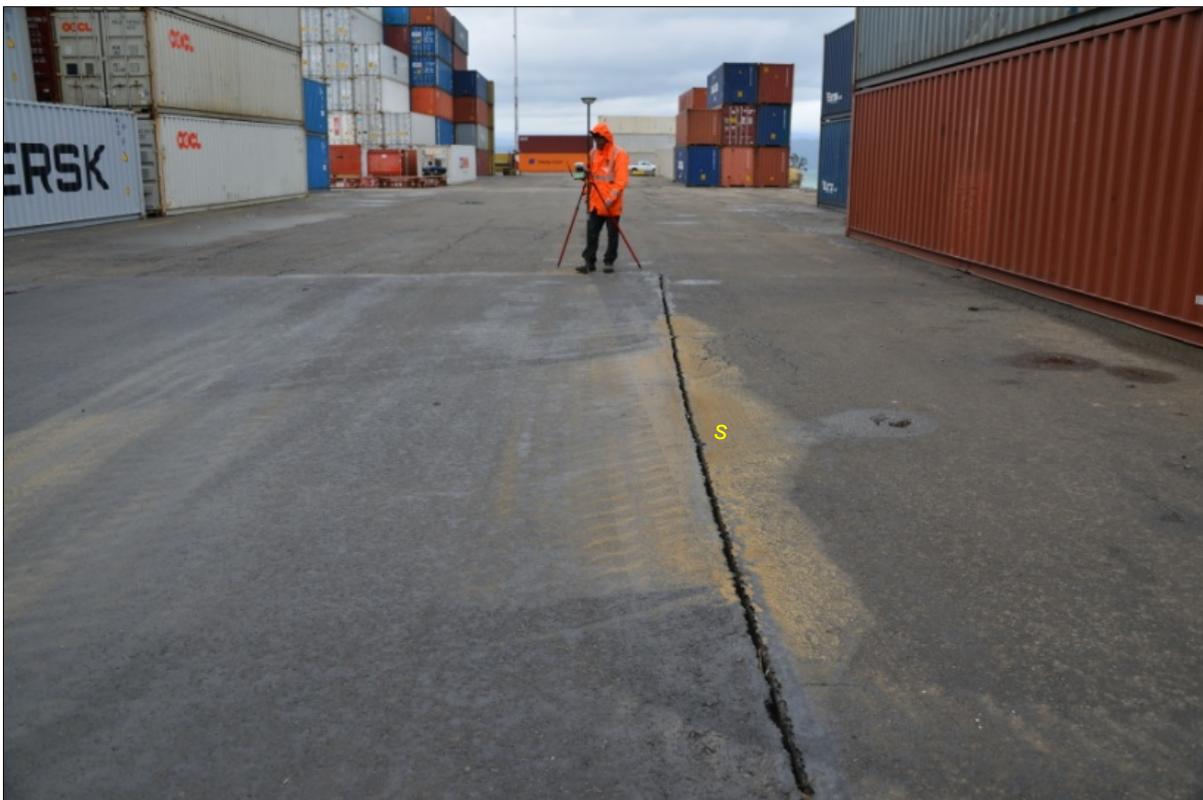
Figure 10 Open tension cracks and sand (*s*) and water ejection (liquefaction) ~30 m in from the toe of the original fill batter at the western end of the reclamation area.

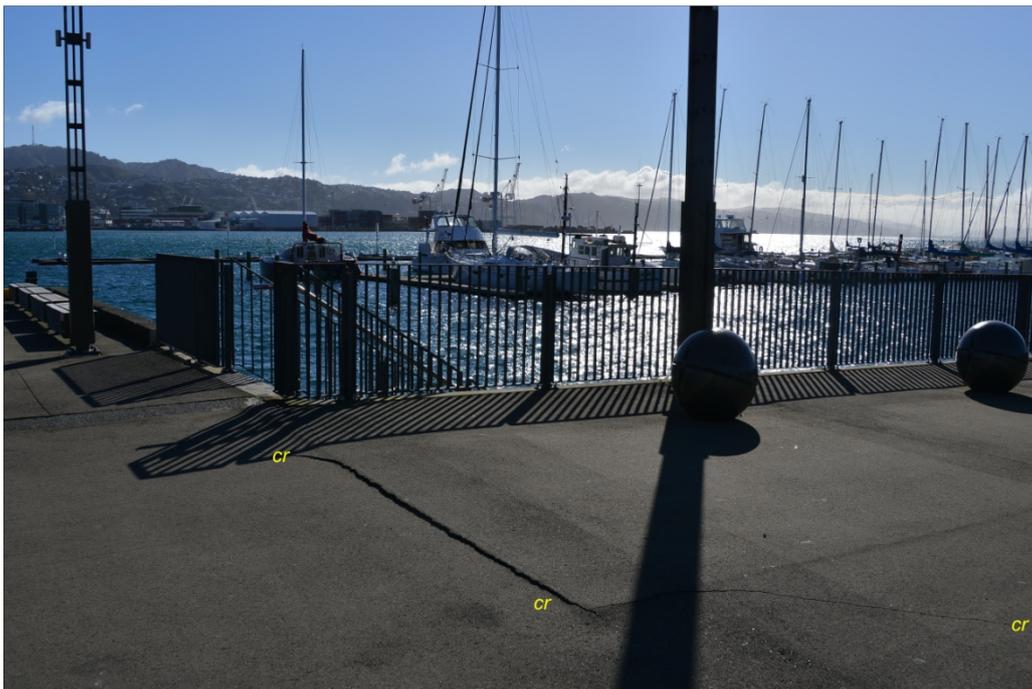
Figure 11 Minor cracking (*cr*) and 15-30 mm subsidence in the pavement of the wharf promenade at Te Papa.

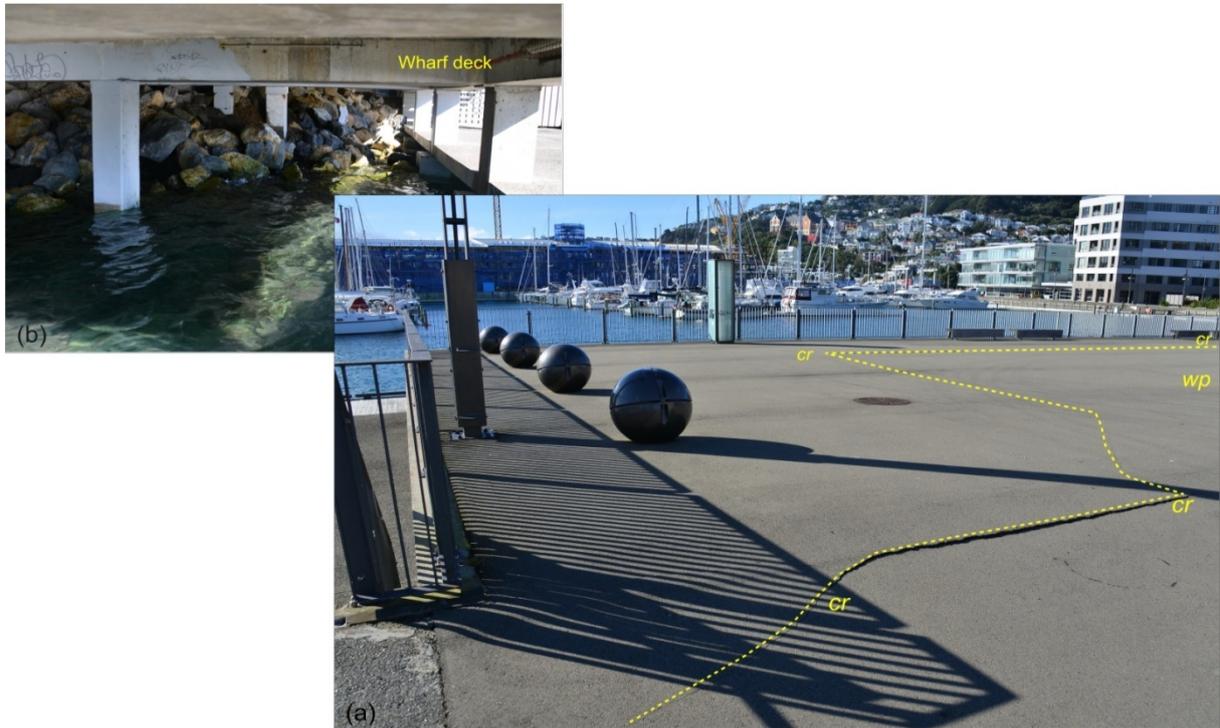
Figure 12 The cracking (*cr*) and subsidence in the pavement of the wharf promenade (*wp*) at Te Papa (a) appears to be aligned with the edge of the fill under the wharf (b). The fill appears to have settled slightly, possibly due to failure of the harbour silts and muds beneath the fill under the wharf.

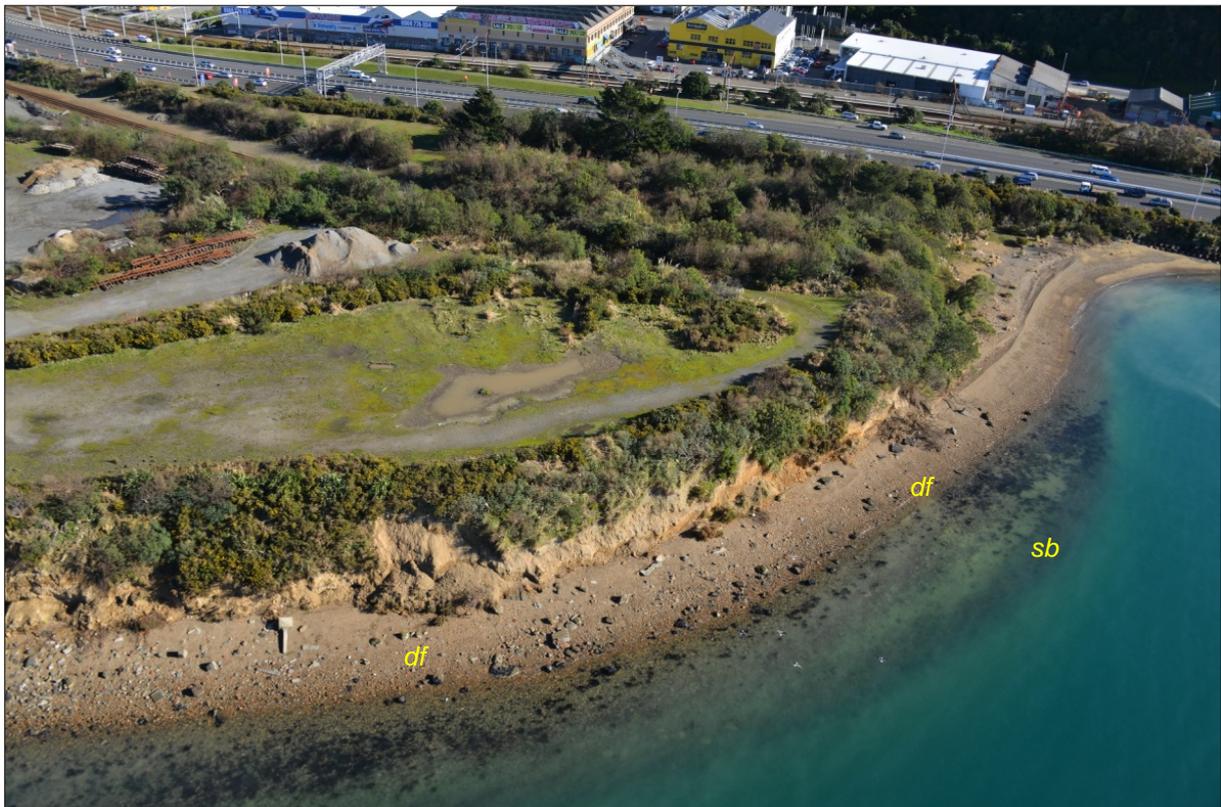
Figure 13 Several small debris falls (*df*) occurred in this area of filled ground at Kaiwharawhara Point during the 21 July Cook Strait earthquake. Small liquefaction-induced sand boils (*sb*) were noted in shallow water at this location.

At Kaiwharawhara Point several small earth and debris falls were observed on the wave-cut end of a fill storage area. These failures are close to what appear to be sub-aqueous sand boils on the edge of the harbour (Figure 13). No other ground damage or landslides were observed in the Wellington area. The reconnaissance flight route in the South Island, and landslides and other ground damage observed in the Seddon area are shown in Figure 15.

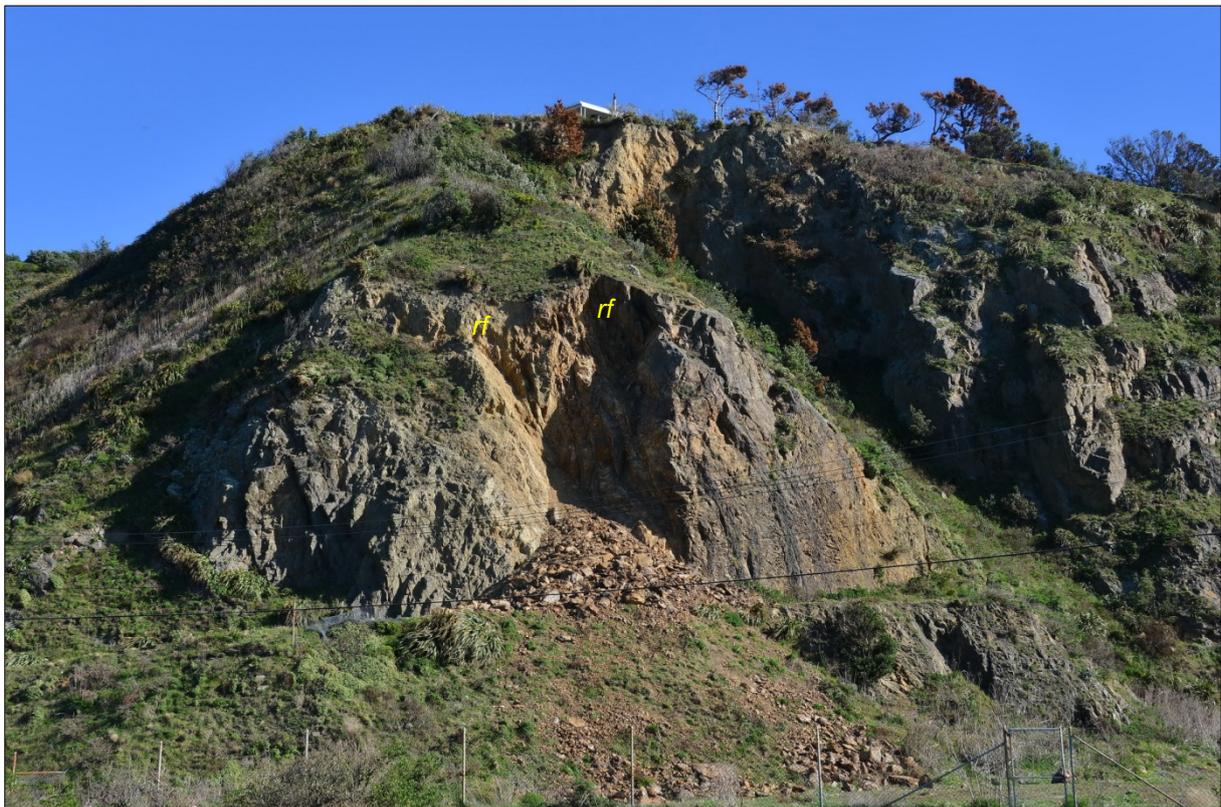
A small rock fall also occurred on an old quarry slope at Arthurs Nose on the west side of Lyall Bay (Figure 3 and Figure 13). This failure, a reactivation of a rock fall which occurred during the 15–20 June rainstorms, was the only landslide on Wellington's southern coast that could be attributed to the Cook Strait earthquake.

Figure 14 Rock fall (*rf*) source areas on an old quarry face at Arthurs Nose on the west side of Lyall Bay, which were reactivated by the Cook Strait earthquake of 21 July, 2013

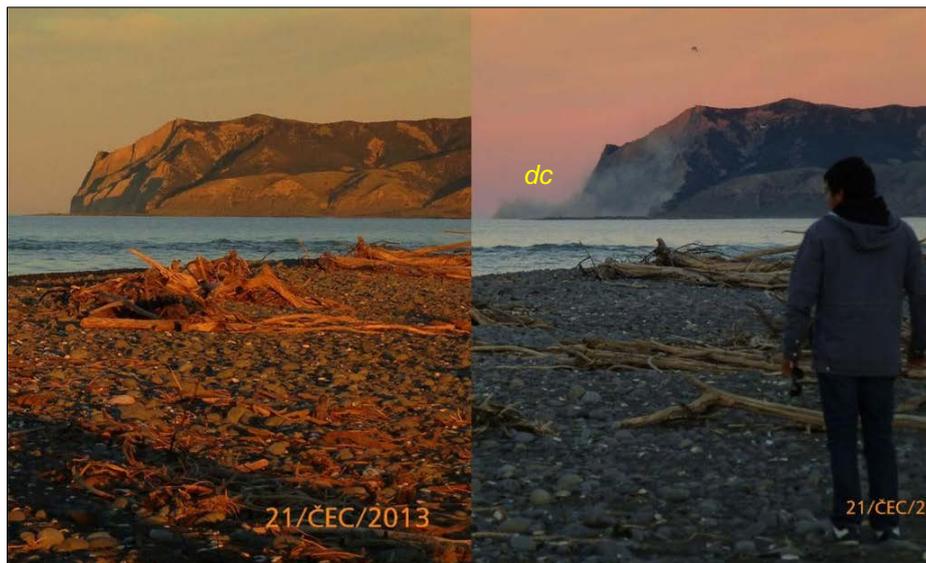
Figure 16 Photos of White Bluff, Marlborough, taken from the Wairau Boulder Bar just before (left) and shortly after the M_L 6.5 Cook Strait earthquake on 21 July 2013 (right). The latter shows the dust cloud (*dc*) from a earthquake-triggered landslide travelling out into the sea (Photos by Luca Zappula, 21 July 2013).

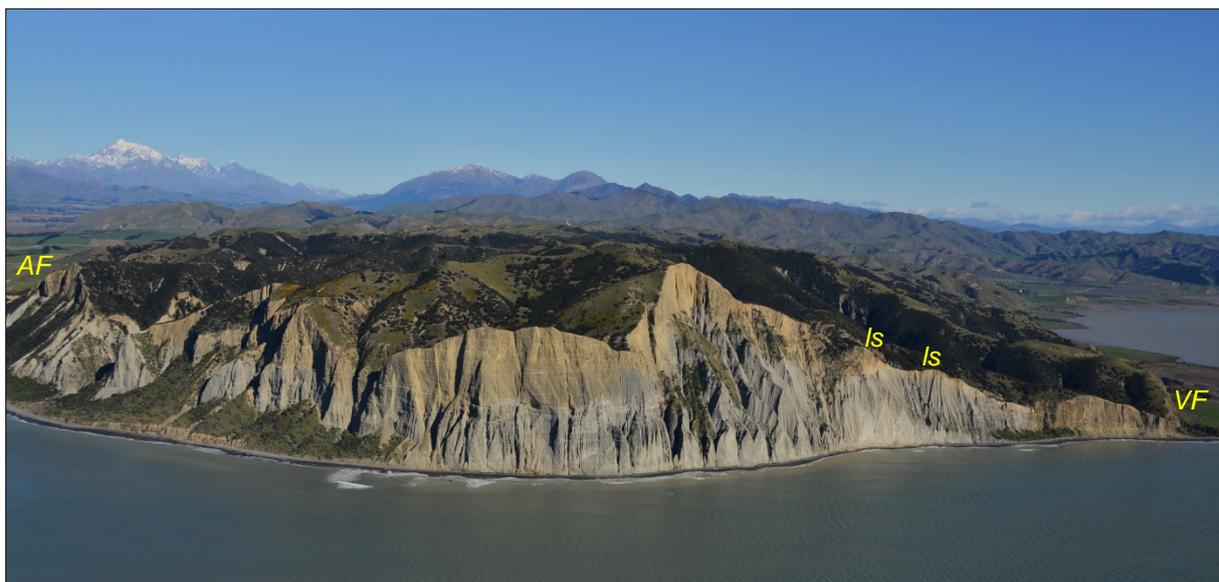
Figure 17 Aerial view of White Bluffs taken after the 21 July Cook Strait earthquake. This 268 m-high headland, located between the active Vernon Fault (*VF*) and the Awatere Fault (*AF*), is formed of Tertiary age (Miocene to Pliocene) sandy siltstone and sandstone (Rattenbury *et al.* 2006). Scars of the July 2013 landslide areas are visible (*ls*) at the western (right) end of the bluffs.

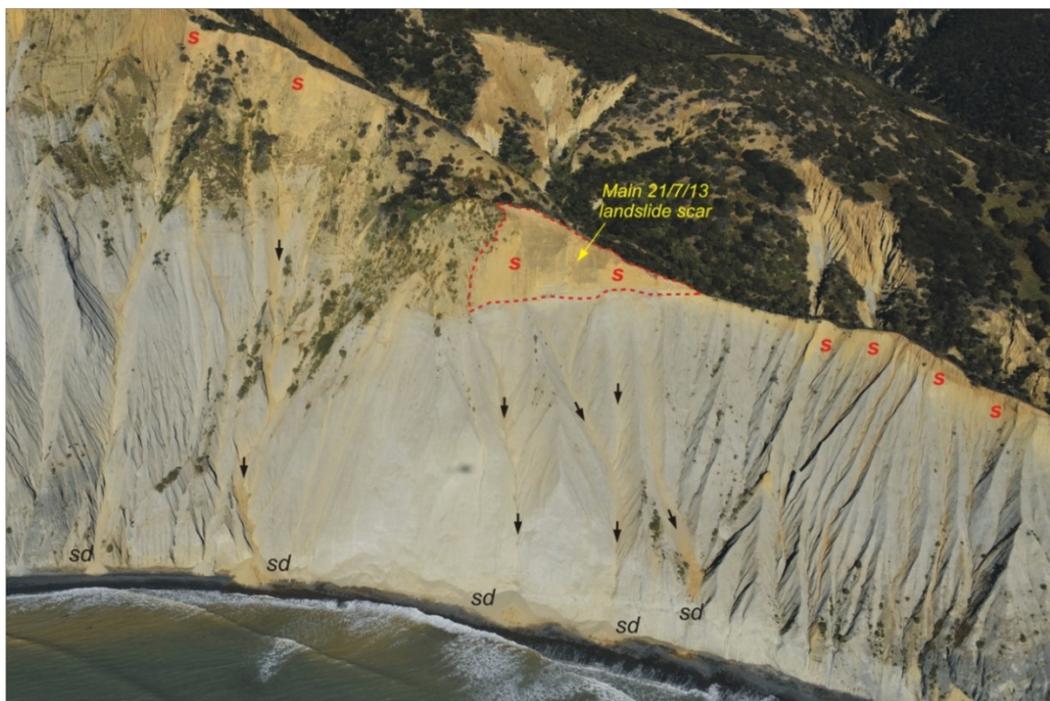
Figure 18 Aerial photo of the landslide site on White Bluffs showing the source area of the main failure on 21 July 2013, a number of smaller failure scars (s), and cones of slide debris (sd) deposited below gullies (arrows) on the steep ($\sim 35^\circ$) cliff face. The angle of repose of the debris cones suggest that the material is relatively dry.

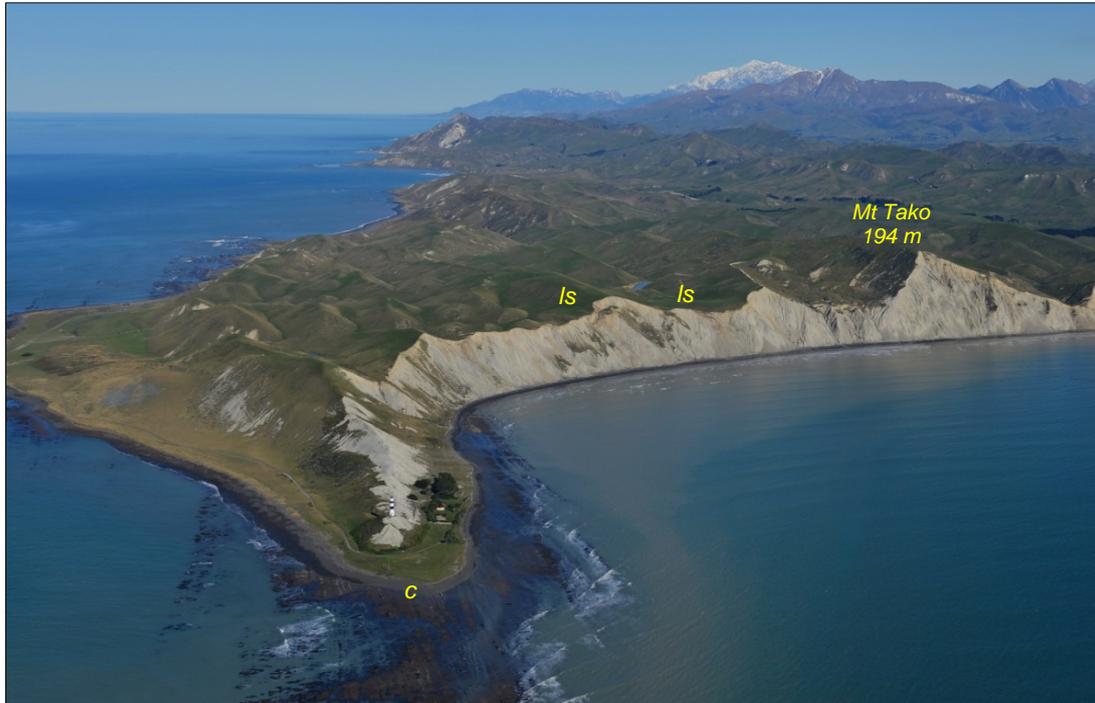
Figure 19 Aerial view of Cape Campbell (*c*) and recent earthquake-induced landslides (*ls*) on the moderately steep (~35°) mudstone cliffs ~1 km to the west, with the Seaward Kaikoura Mountains in the distance (*top right*).

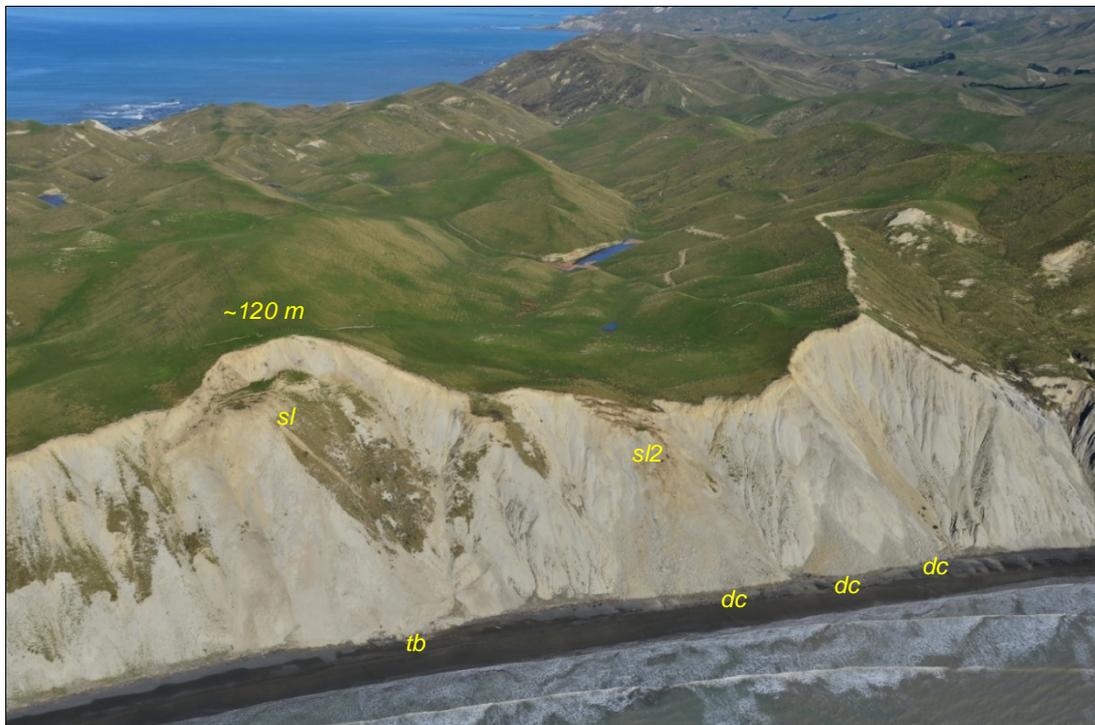
Figure 20 Slope failures triggered by the Cook Strait earthquake on 21 July 2013. The landslide to the left is a large rotational slump of about 100,000 m³ (~70 x 15 x 100 m), which has slumped about 20 m at the head (*sl*). The ~35° slope shows obvious rotational bulging at the toe on the beach (*tb*) but has not completely collapsed. Another large slumped area (*sl2*) and debris cones (*dc*) at the foot of the cliff are visible to the right.

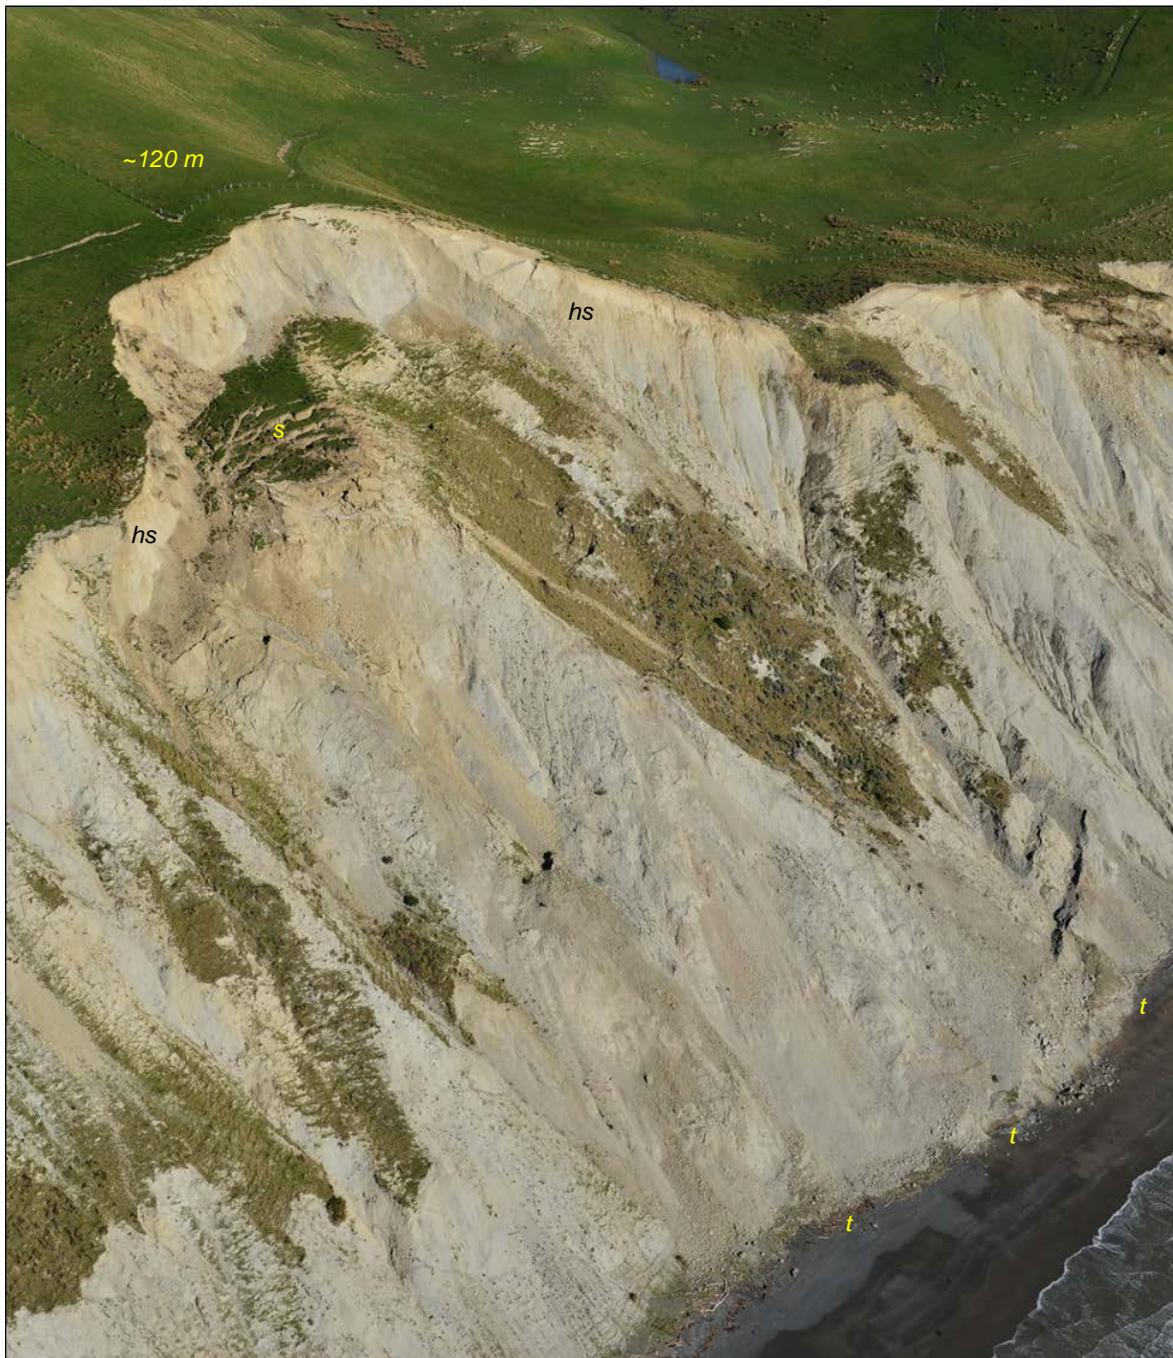
Figure 21 Closer view of the largest landslide triggered by the Cook Strait earthquake on the cliffs 1 km west of Cape Campbell. Multiple fresh slump scarps (*s*) are visible below the ~20 m high head scarp (*hs*) at the top of this rotational landslide. Bulging at the convex toe (*t*) of the failure appears to have locally narrowed the beach.

The largest landslides triggered by the earthquake occurred on the cliff face east of Mt Tako (194 m), where the cliffs are ~100–120 m high. The extensive cracking and fresh slump scarps associated with the largest of these failures are clearly shown in Figure 21. The incomplete nature of the failure suggests that the slope was close to its natural angle of repose (30–35°) for the level of shaking that occurred during the earthquake. Further studies involving topographic, geomorphic, and geological mapping, material sampling and laboratory index and shear testing, and seismic monitoring would enable the slope failure mechanism at this site to be better defined and understood, and the extent to which geological and topographic effects (slope height, angle, and shape) influenced the strength of earthquake shaking and the failure process.

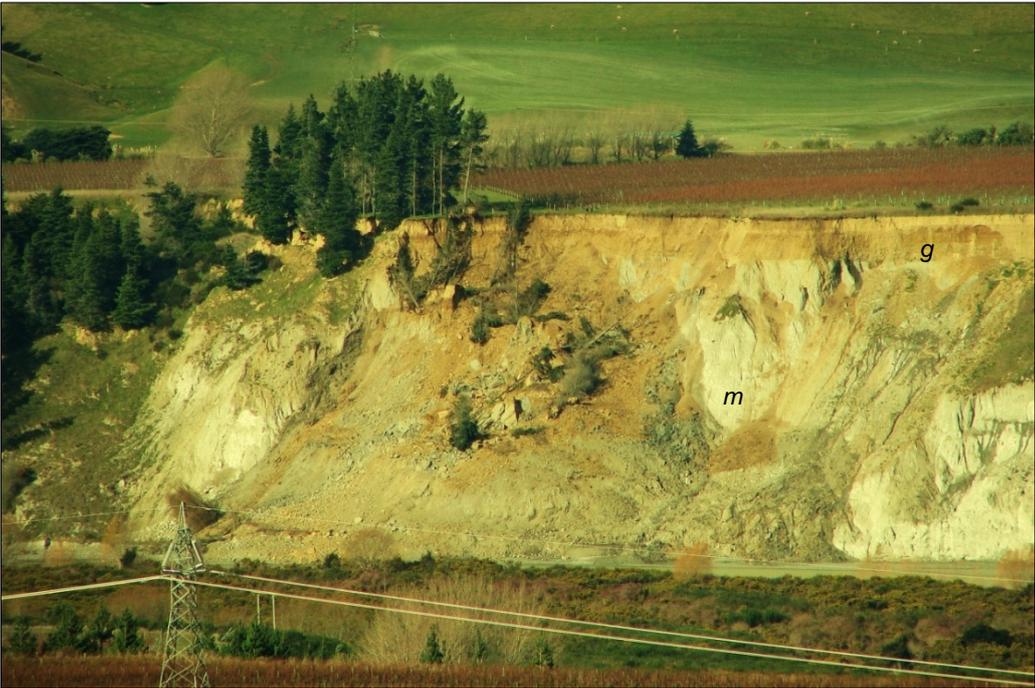
Figure 22 Rotational slump (*sl*) in Tertiary mudstone (*m*) and gravels (*g*) on the edge of a ~20 m high terrace on the right bank of the Awatere River (*AR*), ~15 km southwest of Seddon (*Photo M. Price, 21 July 2013*).

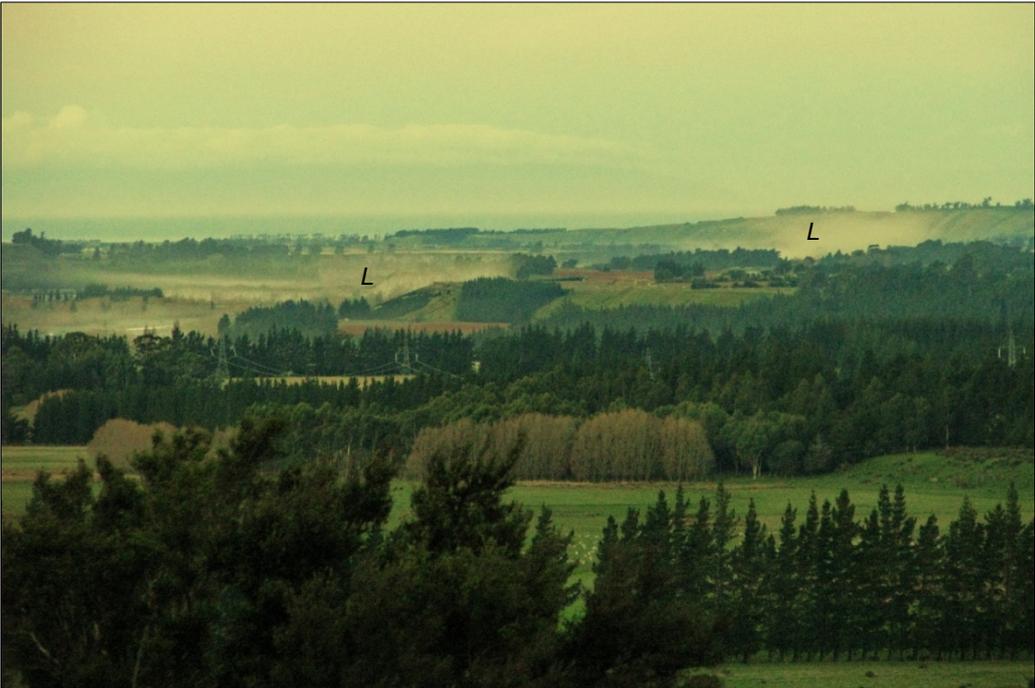
Figure 23 Dust clouds from earthquake-triggered landslides (*L*) on terrace edges in the Awatere Valley southwest of Seddon (*Photo M. Price, 21 July 2013*).

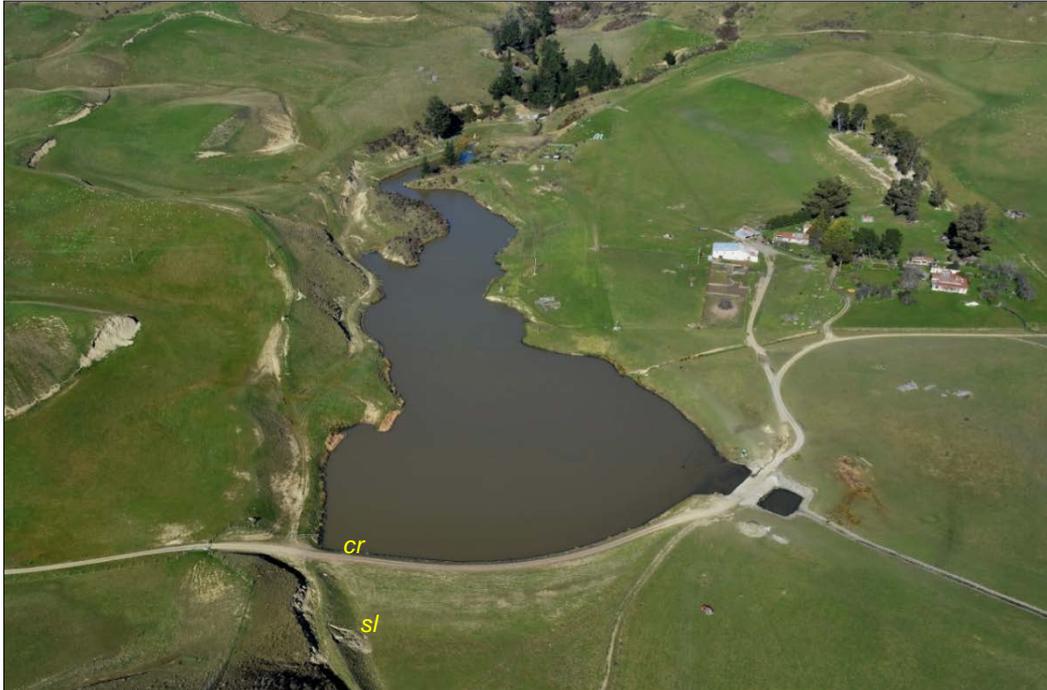
The reconnaissance flight also allowed us to inspect a 19 m high irrigation dam that was damaged by the 21 July earthquake. Figure 10 shows the location of the dam at the end of Haldons Road, about 11 km southwest of Seddon. Figure 19 and Figure 20 show the dam and the damage that occurred after the ~300,000 m³ reservoir had been partly emptied because of concern about its stability and the possibility that the dam might fail during a future earthquake. Draining of the lake was stopped after engineers determined the dam to be safe.

Figure 24 Aerial view of the 19 m high earth dam which was slightly damaged during the earthquake, with a crack about 75–100 mm wide forming on the upstream side crest of the dam crest (cr). No other signs of damage to the structure were seen during the inspection, although a small earth slump (sl) on the access track on the right abutment appears to have been reactivated by the earthquake (*D. Bell pers. comm.*).

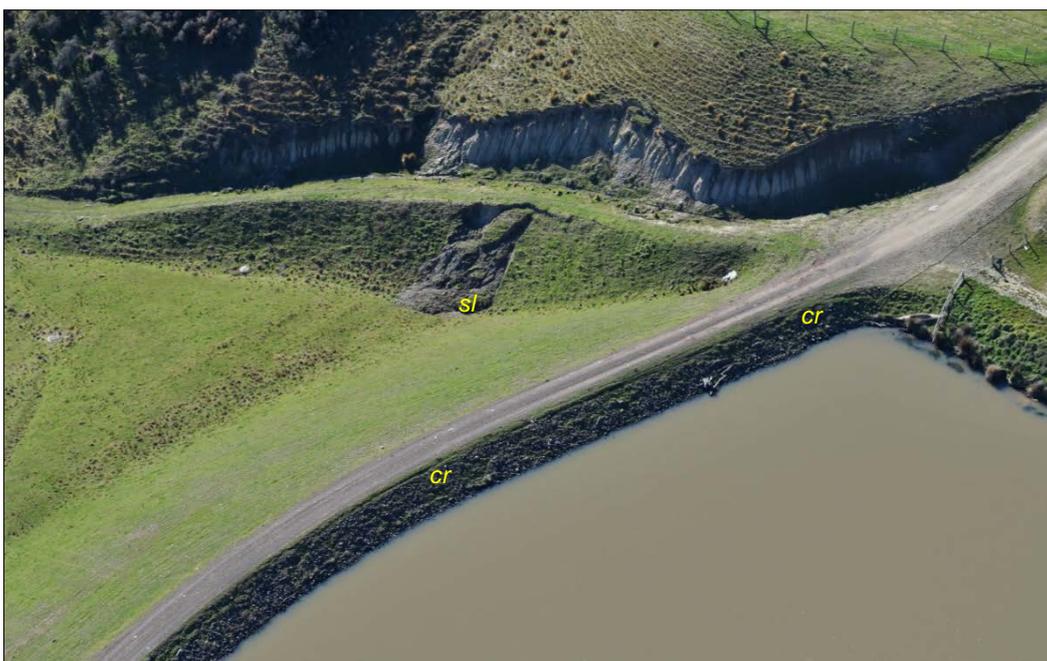
Figure 25 Closer view of the cracking (cr) on the upstream side of the dam crest, and a small slump (sl) on the edge of the right bank access track. The downstream face of the dam does not appear to be damaged.
