Cox, S. C.; McSaveney, M. J.; Rattenbury, M. S.; Hamling, I. J. 2014. Activity of the landslide Te Horo and Te Koroka fan, Dart River, New Zealand during January 2014, *GNS Science Report* 2014/07. 45 p.

The landslide Te Horo lies on the eastern side of Cosmos Peaks, Dart Valley, Otago. It is an active compound rock and debris slide with ancillary debris topples and debris flows commencing from its toe. Te Horo has an area of 0.9 km^2 with a steep toe area that is rapidly eroding on its southern lateral margin to feed $10^5 - 10^6 \text{ m}^3$ of sediment annually onto a debris-flow fan on the valley floor. Debris flows in 2013 and January 2014 crossed the fan and entered Dart River, impeding flow, and impounding a lake which grew from 0.47 km^2 to 1.48 km^2 between December 2013 and January 2014. Between 5 and 15 January 2014, a continually surging debris flow added about $1-2 \times 10^5 \text{ m}^3$ of sediment to the toe of the fan, but the main surge appears to have occurred on 4 January after heavy rain in the area. The lake is expected to persist for decades as the landslide continues to supply debris. The lake level and extent will fluctuate. There is no downstream danger

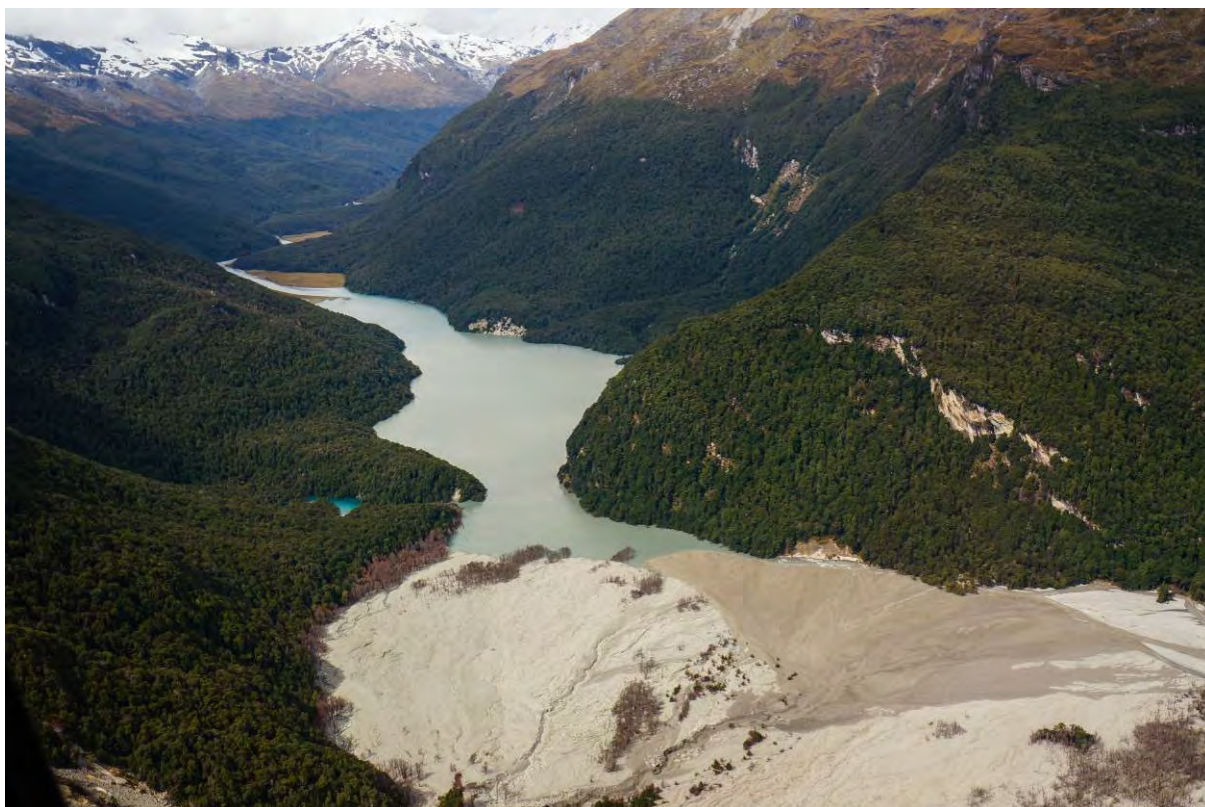
Frontispiece: Overview of the Te Koroka/ Slip Stream debris-flow fan damming Dart River at Dredge Flat (Image: Vladka Kennett, 15 Jan 2014).

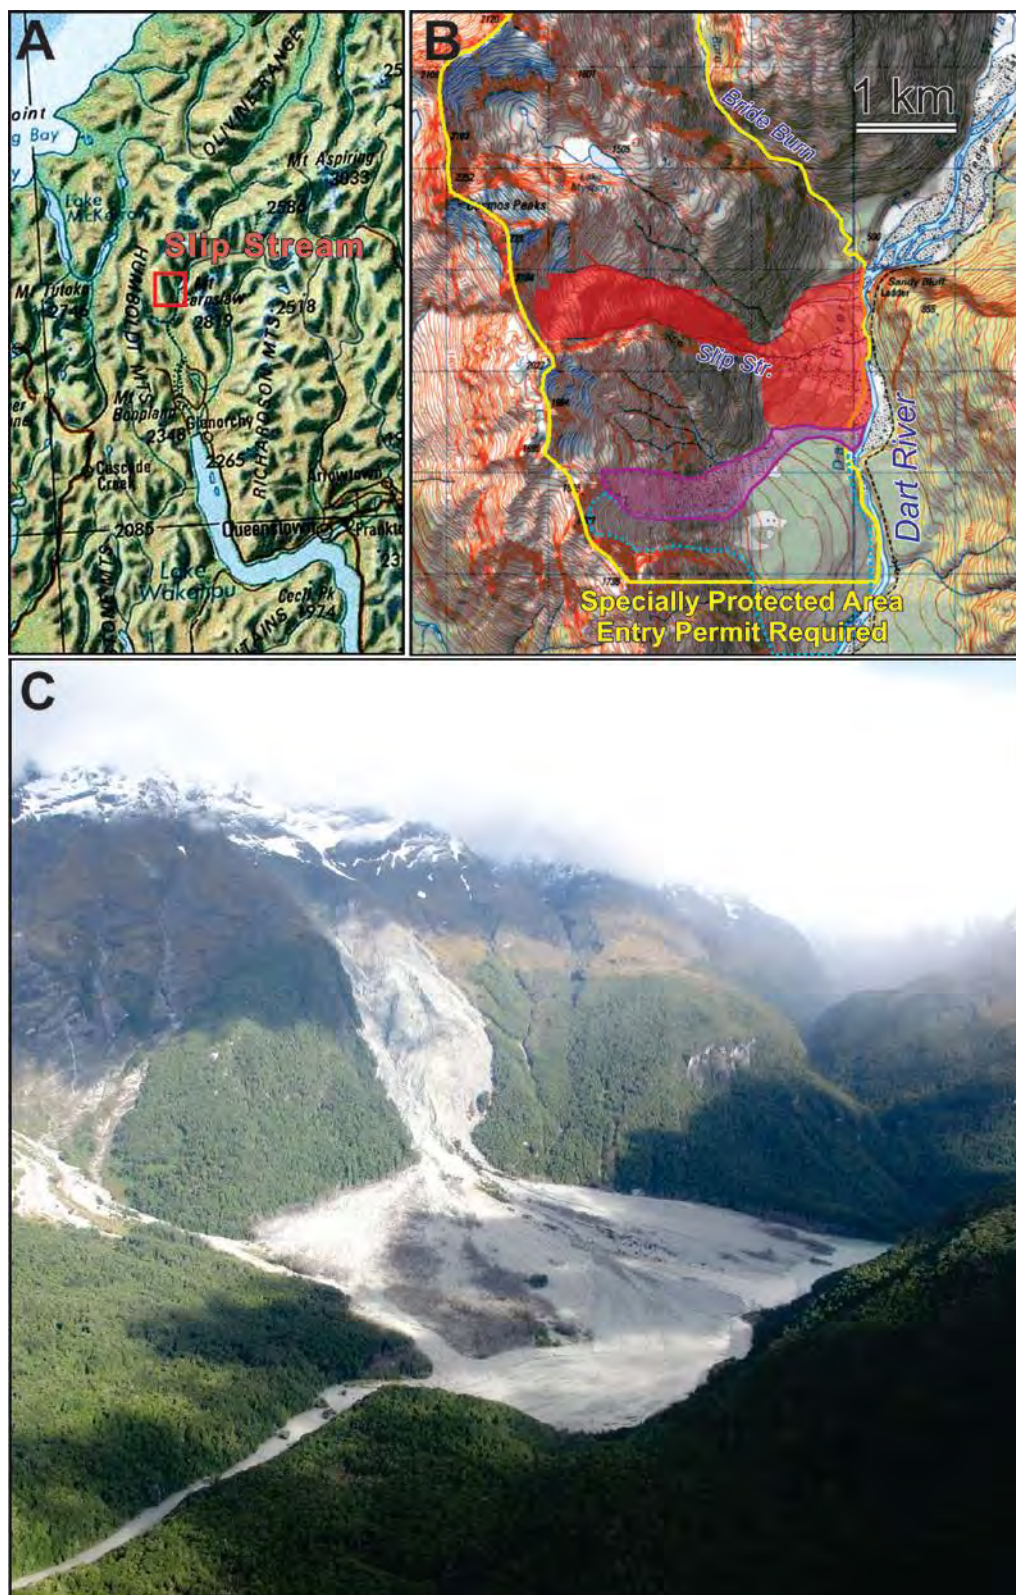
Figure 1 (a) Location of Te Horo and Te Koroka/ Slip Stream in Dart Valley at the head of Lake Wakatipu. (b) Map of the landslide and fan (red), showing the extent of the protected area for which entry requires a special permit. In the catchment south of Slip Stream there is an active landslide (pink shading) commonly mistaken for Te Horo, and possibly a much older landslide (blue dashed outline). (c) Overview of the landslide and fan (Photo S. Cox, 6 Jan 2014).

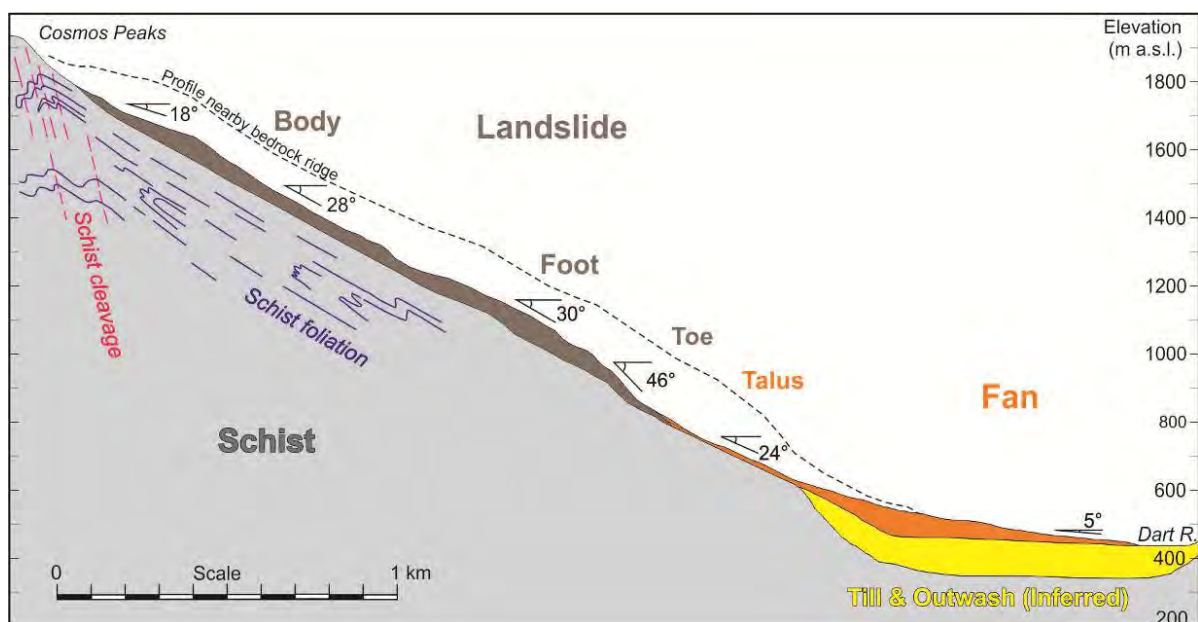
Figure 2 Profile (cross-section) of Te Koroka/Slip Stream and Te Horo landslide (after Thomas & Cox 2009).

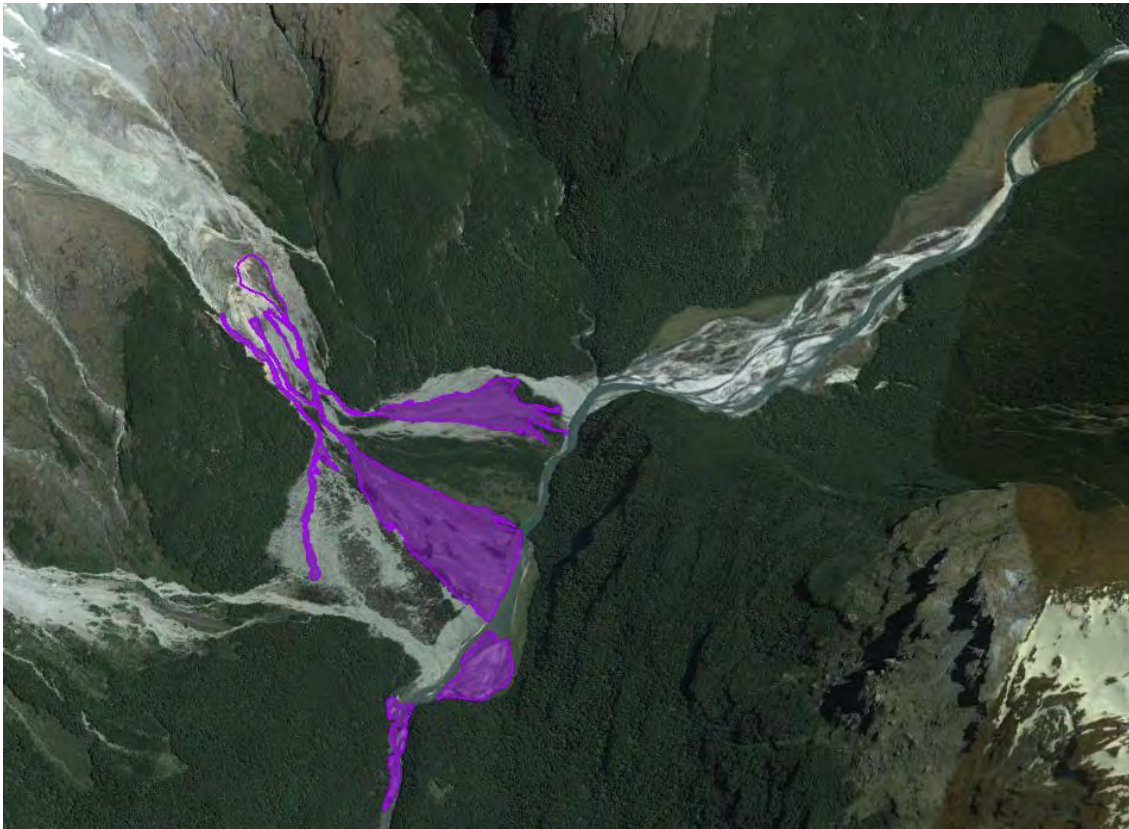
A Late 2010-early 2011

Figure 3 See following pages. Vertical views of Te Horo and Te Koroka fan, overlain on imagery from 8 Jan 2011 in Google Earth, with coloured polygons showing the extent of the debris-flow channels and deposits, redistributed sediment and impounded lake. Source area polygons are hollow. (A) Late 2010-early 2011 phase of activity = purple; (B) Early 2012 phase of activity = yellow; (C) Jan 2013 phase of activity = orange, with smaller January lake (shaded light blue) and larger December lake area (dark blue outline); (D) late 2013 – Jan 2014 phase of activity = green, with blue lake. The pink outline shows an area of intense fracturing thought to be a likely future source area.

- Geoeye-1 imagery of 8 January 2011 (viewed on Google Earth, January 2014) is very clear, showing dark, very fresh looking (still wet) debris-flow deposits in the central and northern parts of the fan. These came from a number of small areas between ~800–900 m elevation on the front of the landslide toe. Debris reached and entered Dart River, and was remobilised downstream to be deposited on gravel bars. The source, debris and remobilised sediment are depicted in Figure 3A.

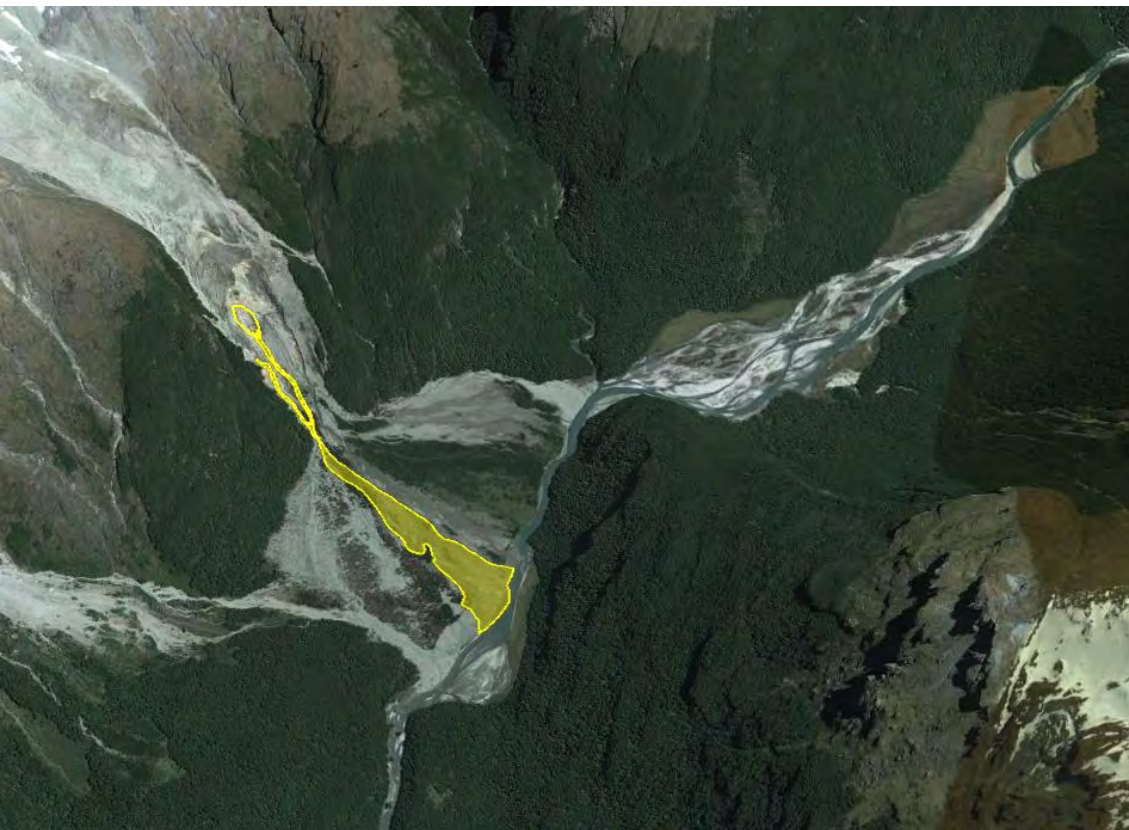
B Early 2012

- Photographs in early 2012 indicate that debris flows had recently been active at mid-altitude (1200 m) on the main body of the landslide, but may not have continued as far as the lower slopes. Some debris was mobilised from between 850–900 m elevation on the south side of the landslide toe, travelling across the central fan to Dart River, where it displaced the channel eastward. Colour of the debris suggests that it was dry when photographs were taken, implying that the phase of activity illustrated pre-dates photography by weeks. An inferred source area and debris flow path are shown in Figure 3B but are not as well defined as other phases.

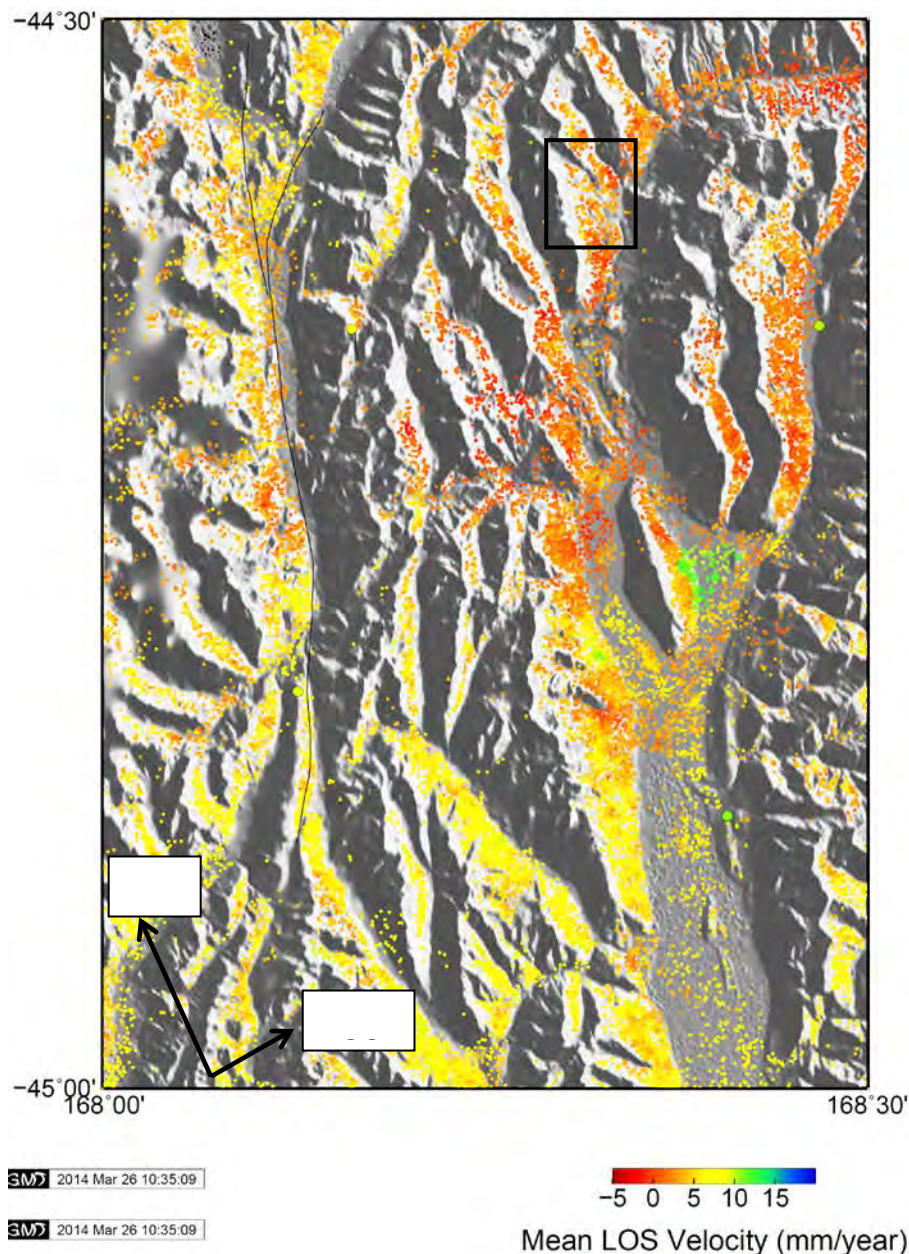
Figure 4 Permanent Scattering points detected using InSAR superimposed onto a 90 m DEM. Positive Line-of-site (LOS) velocities indicate motion towards the Satellite. Arrows show the satellites flight (Az) and look (LOS) direction. A black rectangle shows the area of Figure 1B, in which the landslide is located.

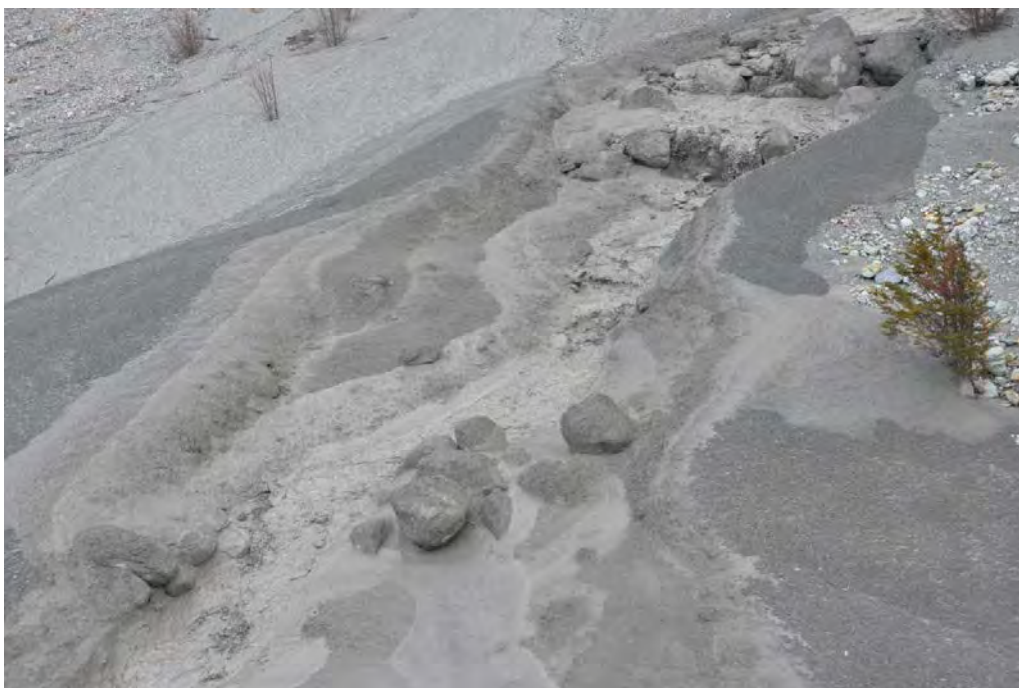
Figure 5 Aerial view of a portion of the Te Koroka/Slip Stream showing various levels reached by debris-flow surges as they passed by on their way to Dart River. A small lobe of debris has spilled out of the channel to reach the young Mountain Beech tree on the right (true left of channel). The larger boulders in the channel are several metres across. (Photo: M.McSaveney).

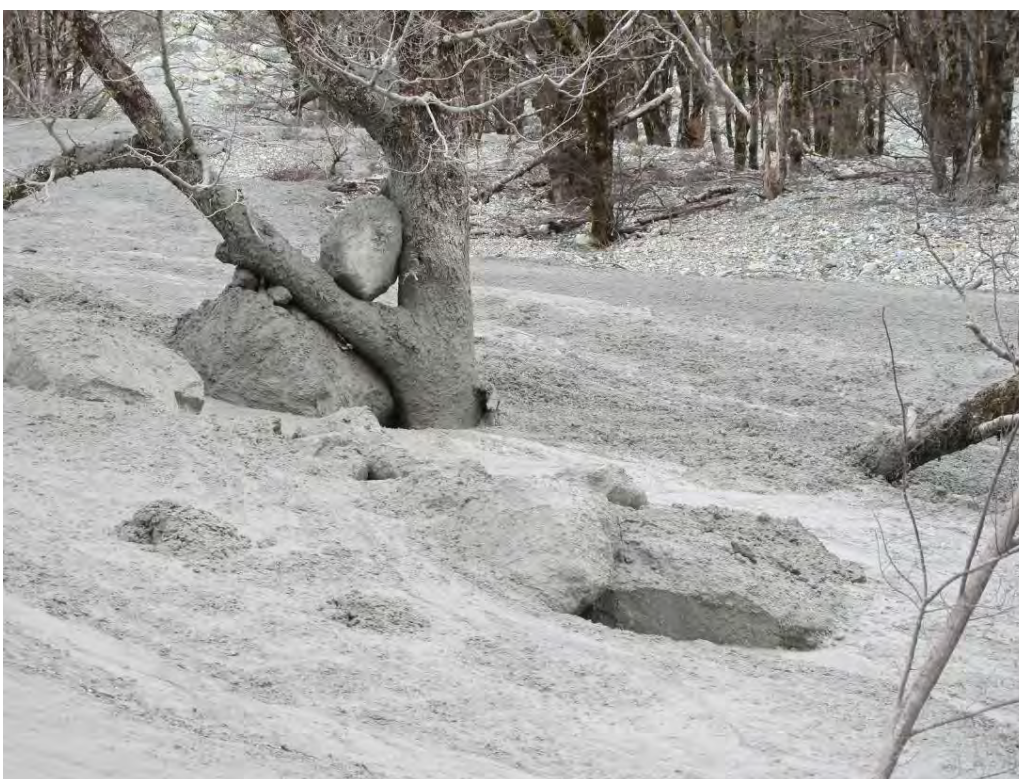
Figure 6 View of a distributary channel of the 5 January debris flow on the Te Koroka/Slip Stream fan. The boulder lodged in the fork of the mature nothofagus tree has a diameter of about 0.5 m. The flow was inactive at the time of photography (7 January) (photo: S. Cox).

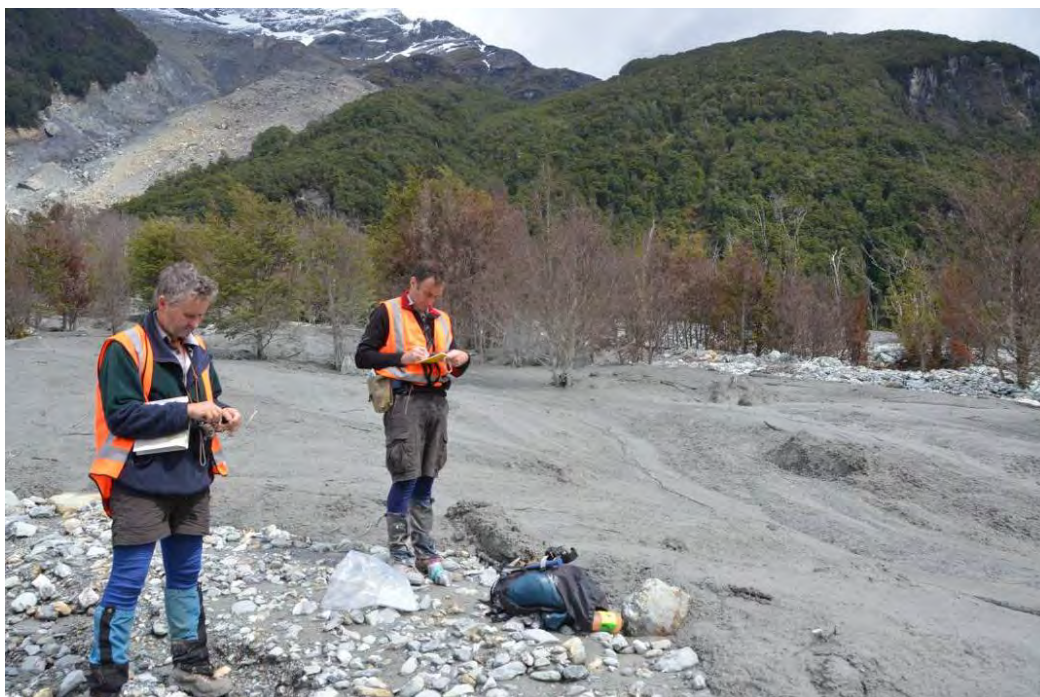
Figure 7 View of inactive debris-flow distributary on Te Koroka/Slip Stream fan. A sample of the debris for particle-size analysis (Fig. 8) was randomly taken from the debris perched atop the log behind the pack (photo: M. McSaveney).

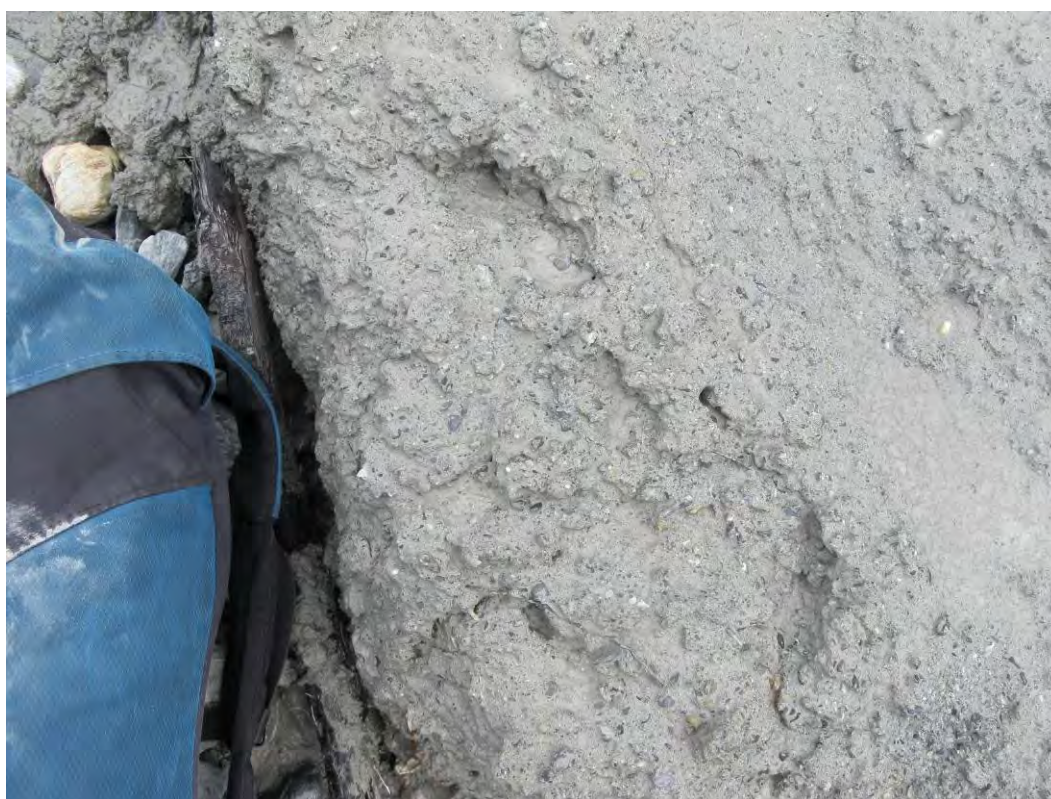
Figure 8 Texture of recently drained debris-flow deposit (two days after deposition). The non-plastic, matrix-supported deposit is an extremely poorly sorted muddy gravel (photo: M. McSaveney).

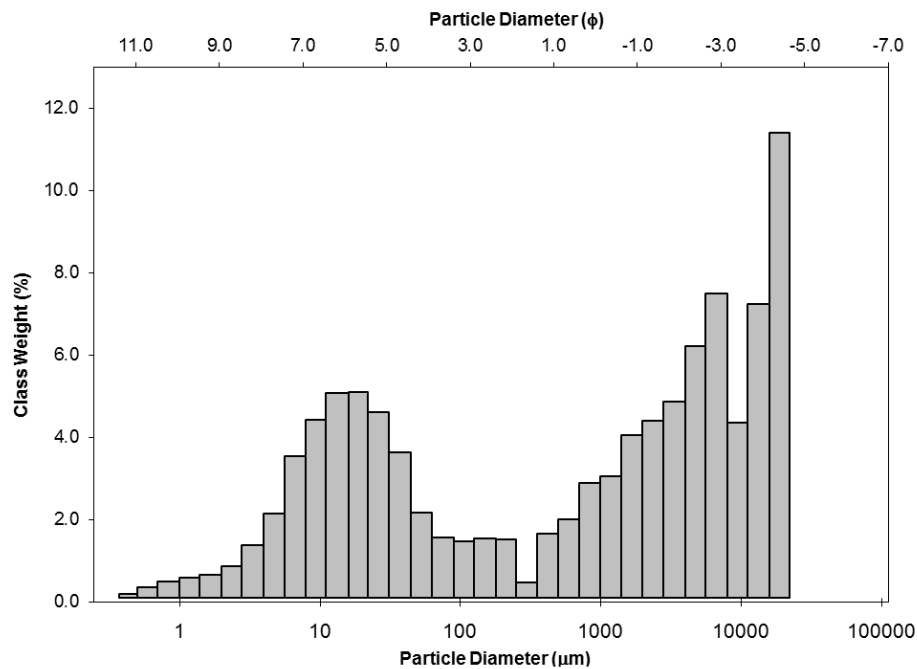
Figure 9 Particle-size histogram of the Te Koroka/Slip Stream debris-flow grab sample, showing the fine silt mode and the truncated coarse debris mode. The coarse debris mode was biased by having to sample at a safe site (an overbank lobe) and consequently material >2 cm up to boulders 4 m across observed in the main channel are not represented.

Safety considerations precluded sampling of the main channel of the active debris flow on 7 January. Instead, a grab sample was taken from an inactive overbank flow lobe probably deposited on 5 January (Figure 7 and Figure 8). The saturated matrix-supported deposit (Figure 8) is a bimodal muddy gravel (Figure 9), with the coarser mode significantly truncated (by our selection of sampling site). The material was readily liquefied when disturbed at the drained field water content and was non-plastic.

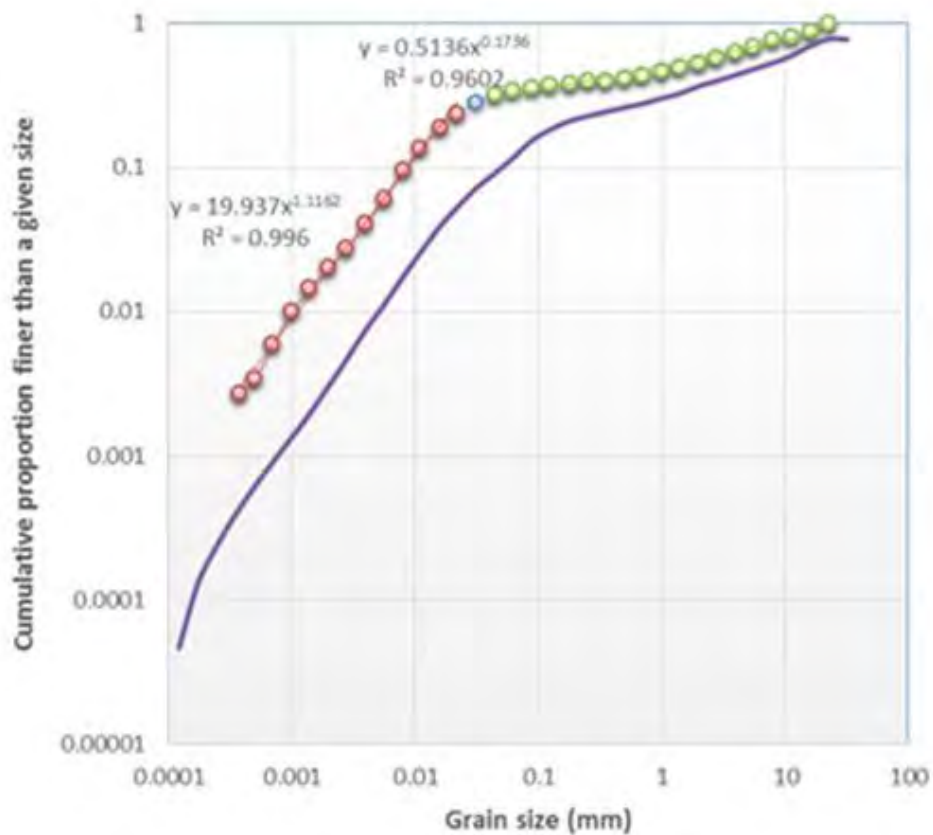
Figure 10 Grain-size distribution of a random sample of debris from a fresh, but inactive debris flow deposit on Te Koroka/Slip Stream fan. Power-law curves are fitted to two sections of the distribution. Also shown in the solid purple line, is a grain-size distribution from a debris flow that occurred in January 2002 in the headwaters of nearby Rees River valley (McSaveney and Glassey, 2002)

The fine and coarse modes appear to form separate fractal distributions (Figure 10) which is remarkably similar to what was found in the Cleft Peak debris flow of January 2002 which occurred in the headwaters of nearby Rees River (McSaveney and Glassey, 2002). The fractal nature of the sediment distribution results from the fragmentation and abrasion of phyllosilicate-rich, schist-derived rocks during transport in the debris flow. The silt and sand fraction is rich in phyllosilicates, including more than trace amounts of talc that probably was originally associated with serpentinite.

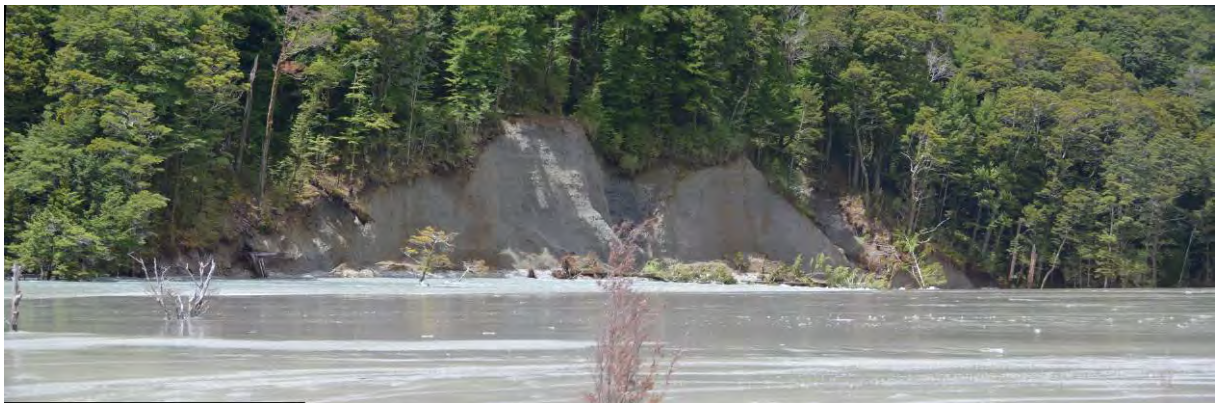
Figure 11 View of the dam crest from low on Te Koraka/Slip Stream fan on 7 January 2014. Lake is to left. The very low gradient, and still moving debris flow forms the foreground. Debris-flow deposition has elevated the bed of the river against the eastern wall of the Dart River valley. A terrace remnant of ancient Dart River alluvium has been undercut and collapsed into the river, taking with it a portion of the Dart River access track.

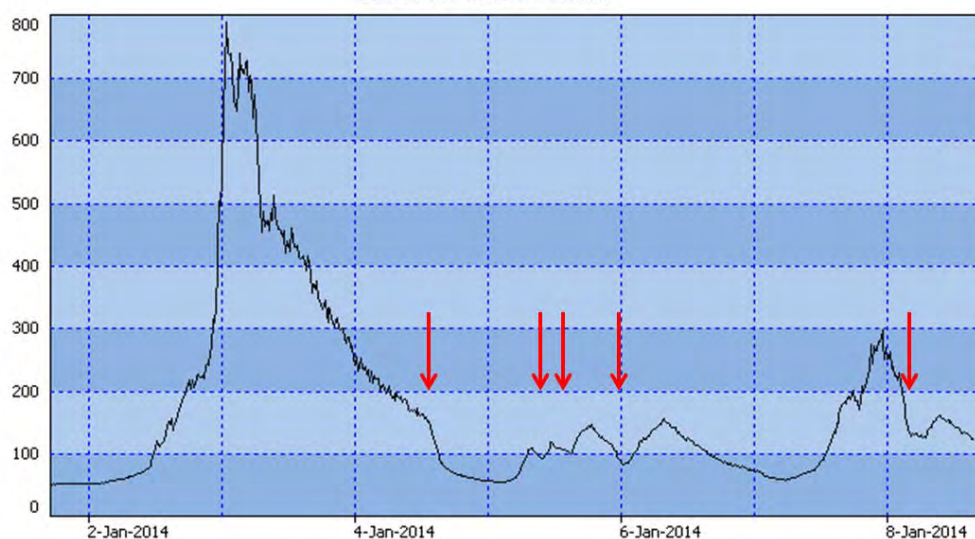
Figure 12 Dart River discharge (cubic metres per second) at the Hillocks river gauge, 24 km downstream from Te Koroka/Slip Stream. River discharge began behaving anomalously (arrowed) when it rapidly decreased from 160 to below 90 cubic metres per second after mid-day on 4 January 2014. Episodic discharge decreases (arrowed) have occurred irregularly through January 2014 (see also Figure 12). Data covering the period 2–8 January 2014 from Otago Regional Council (<http://water.orc.govt.nz/WaterInfo/>).

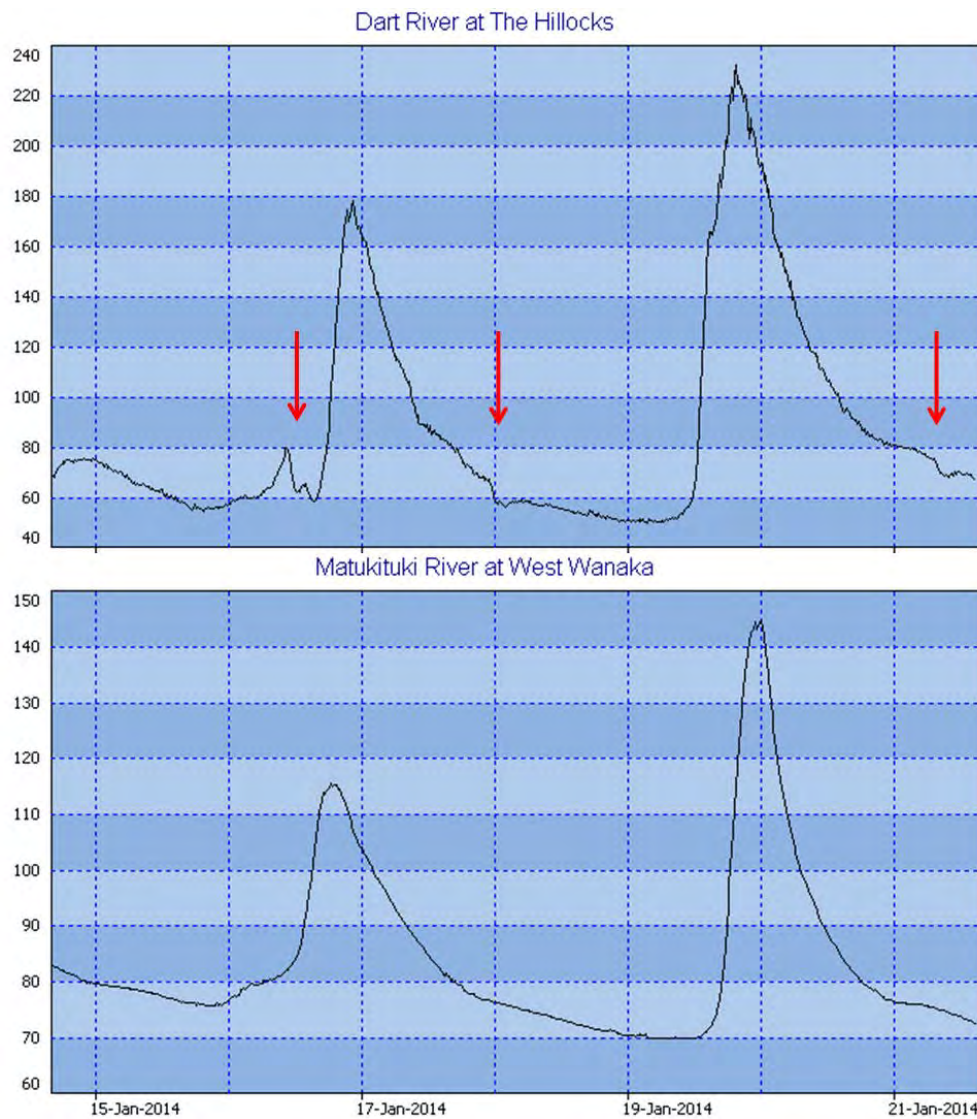
Figure 13 Anomalous discharges (arrowed) of Dart River with respect to Matukituki River are apparent on 16, 18 and 21 January. Discharge is in cubic metres per second. Data covering the period 15–21 January 2014 from Otago Regional Council (<http://water.orc.govt.nz/WaterInfo/>).

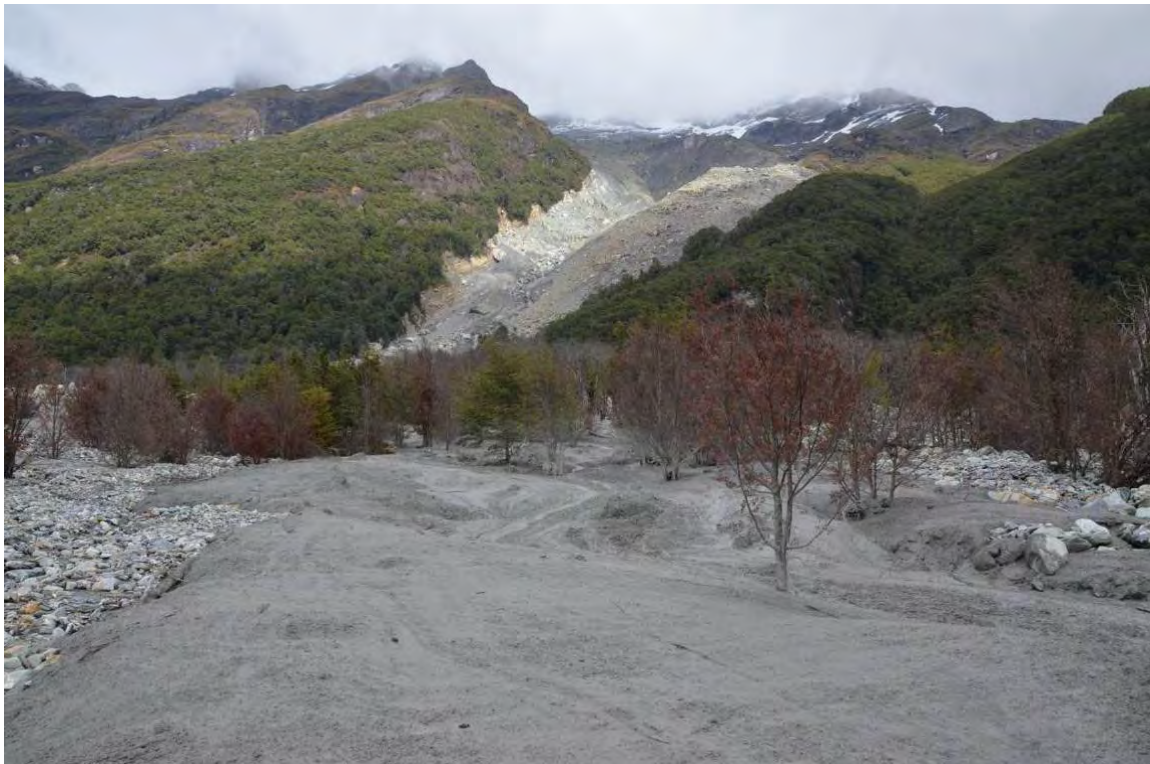
Figure A4 View of fresh debris-flow deposit of 4 January on the Te Koroka/Slip Stream fan. Te Horo is in the background (Photo: M. J. McSaveney, 6 January 2014).

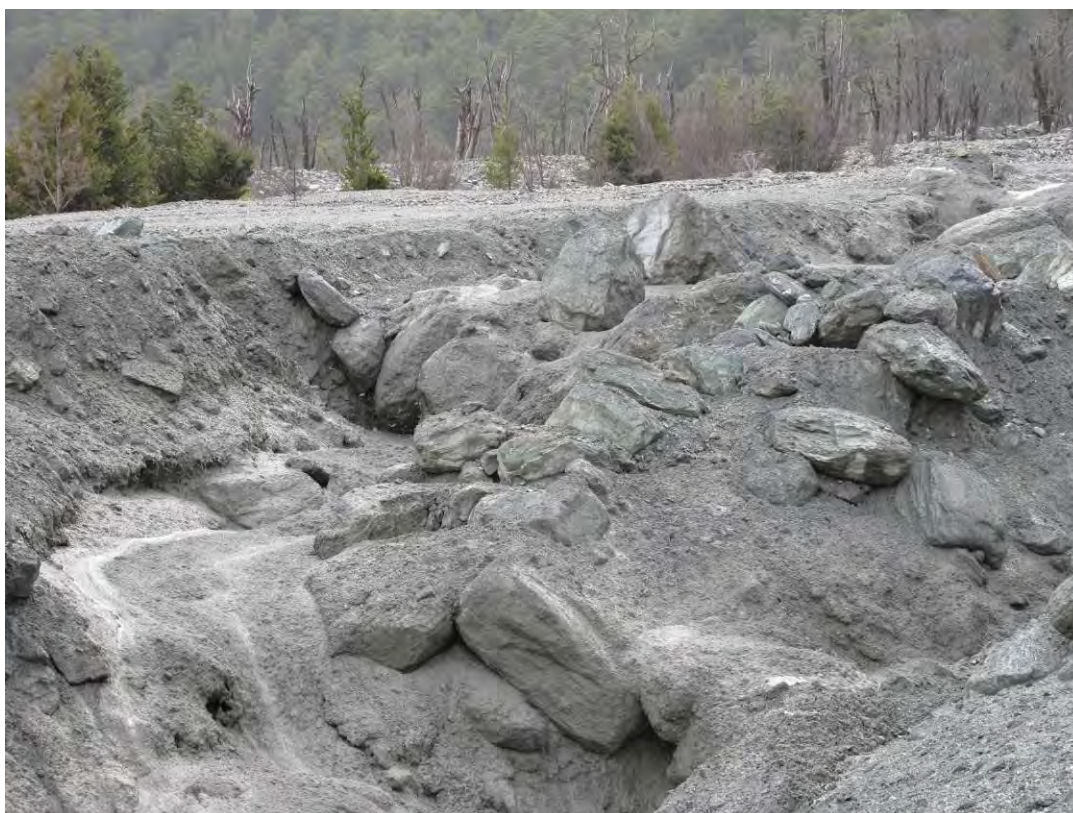
Figure A6 A debris-flow surge pours like wet concrete down the Te Koroka/Slip Stream channel (Photo: S. C. Cox, 6 January 2014).

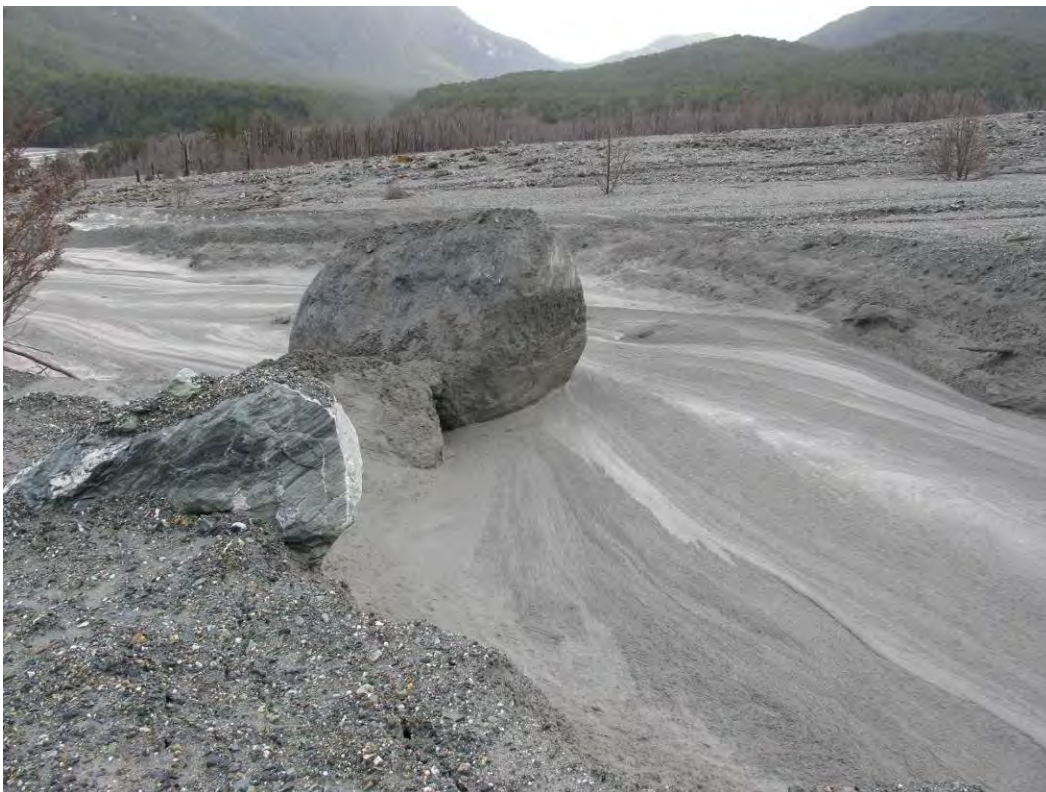
Figure A8 View of a debris flow moving past a 2-m diameter boulder on the Te Koroka/Slip Stream fan. Flow rate was at a fast walking speed (Photo: S. C. Cox, 6 January 2014).

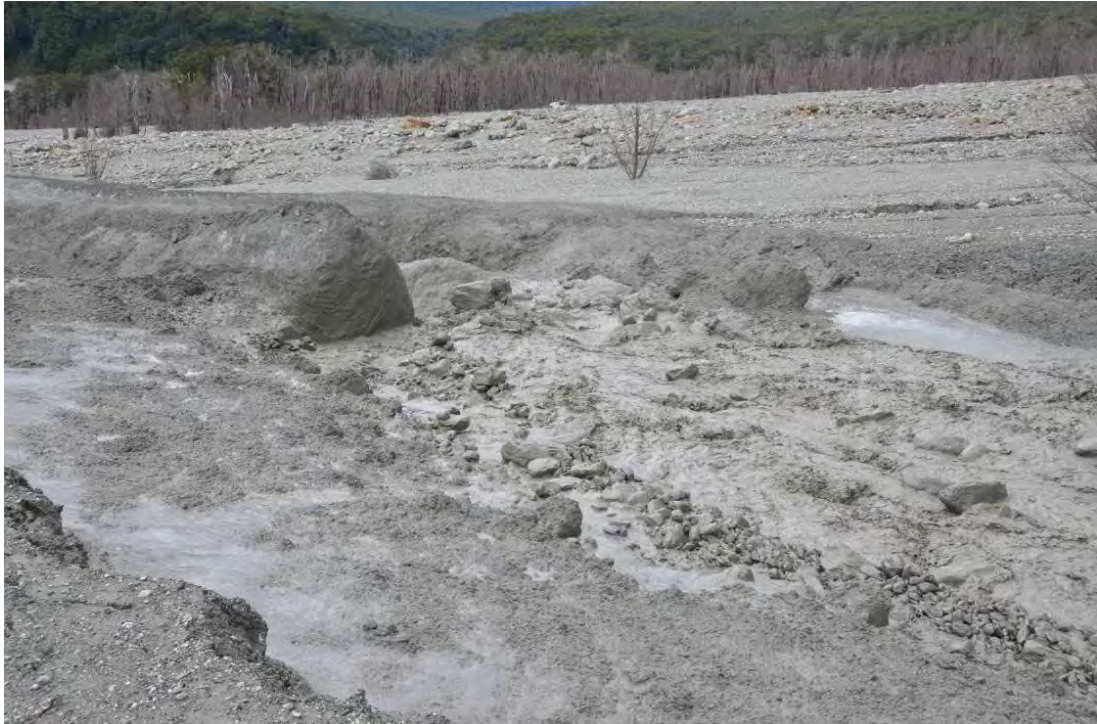
Figure A9 View of the waning stage of a debris-flow surge on the Te Koroka/Slip Stream fan. Flow rate was at a fast sprint (Photo: M. J. McSaveney, 6 January 2014).

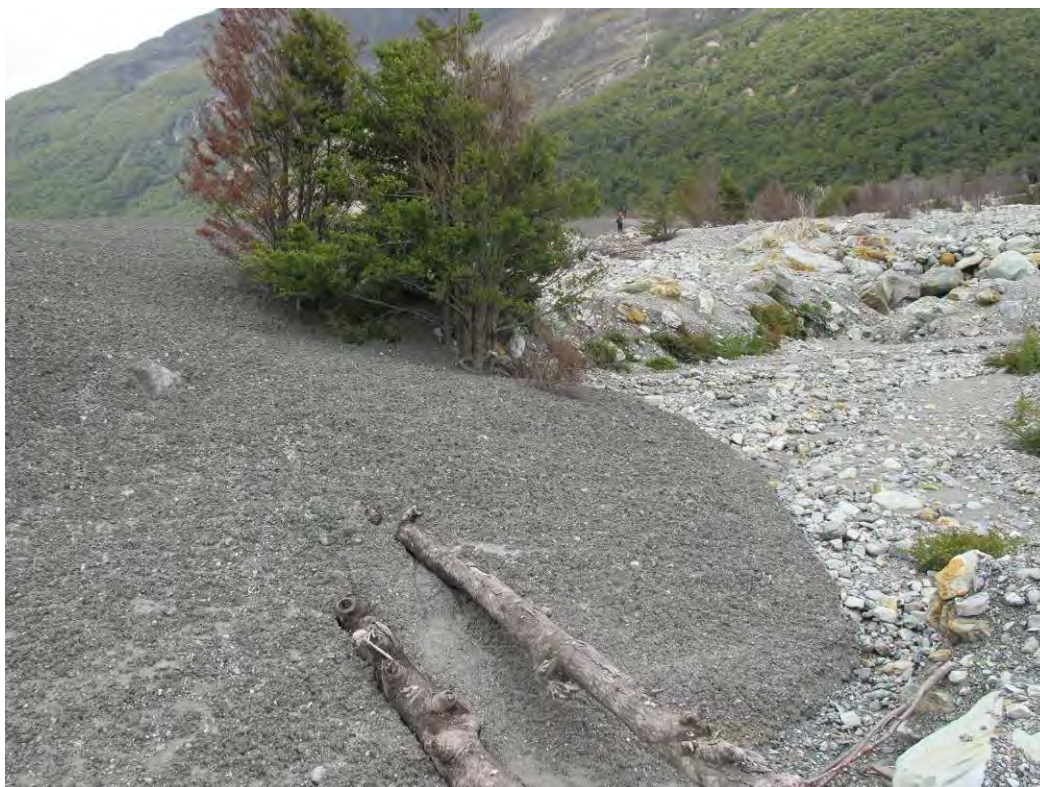
Figure A11 Recently deposited debris-flow lobe of 4 January on the Te Koroka/Slip Stream fan (Photo: S. C. Cox, 6 January 2014).

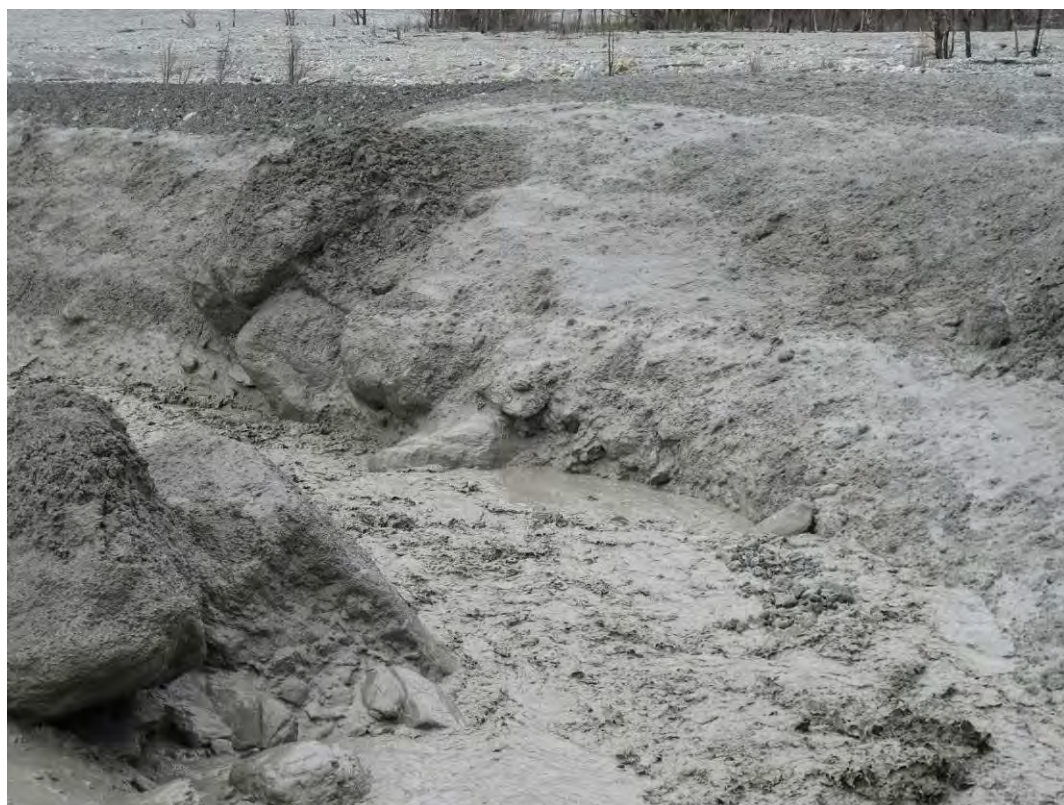
Figure A12 A debris-flow surge in Te Koroka/Slip Stream. Flow rate was at a fast running speed (Photo: S. C. Cox, 6 January 2014).

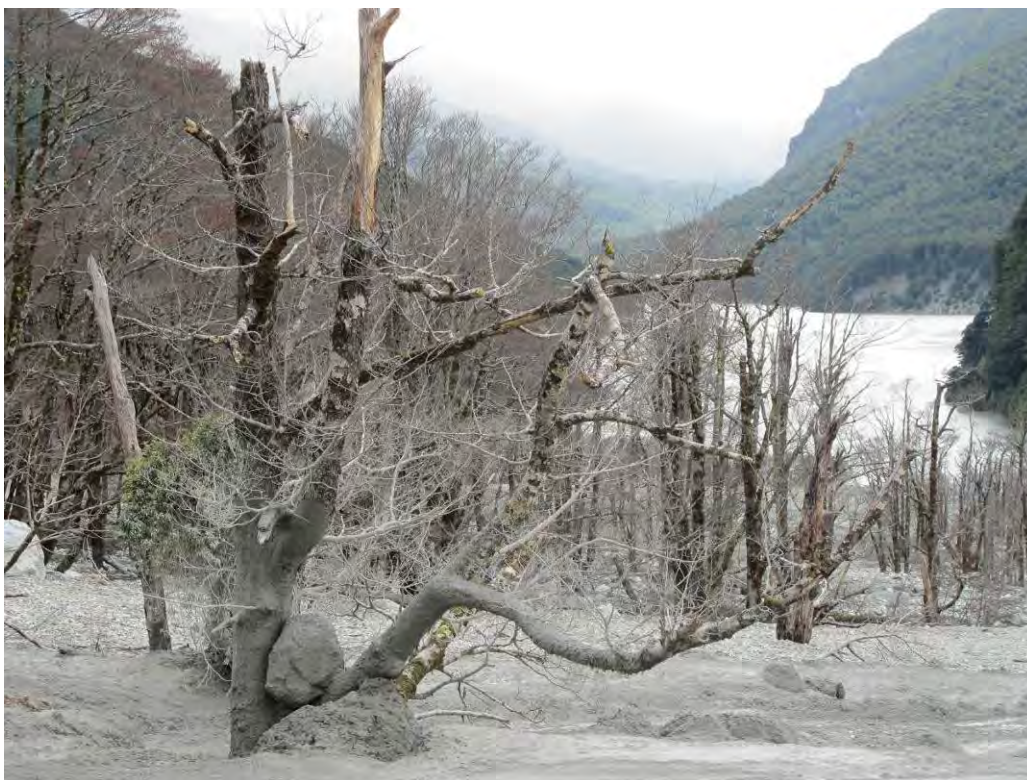
Figure A13 Partially buried trees (from January 2013 debris flows) on the Te Koroka/Slip Stream fan surrounded by 4 January 2014 debris flow deposit (Photo: S. C. Cox, 6 January 2014).

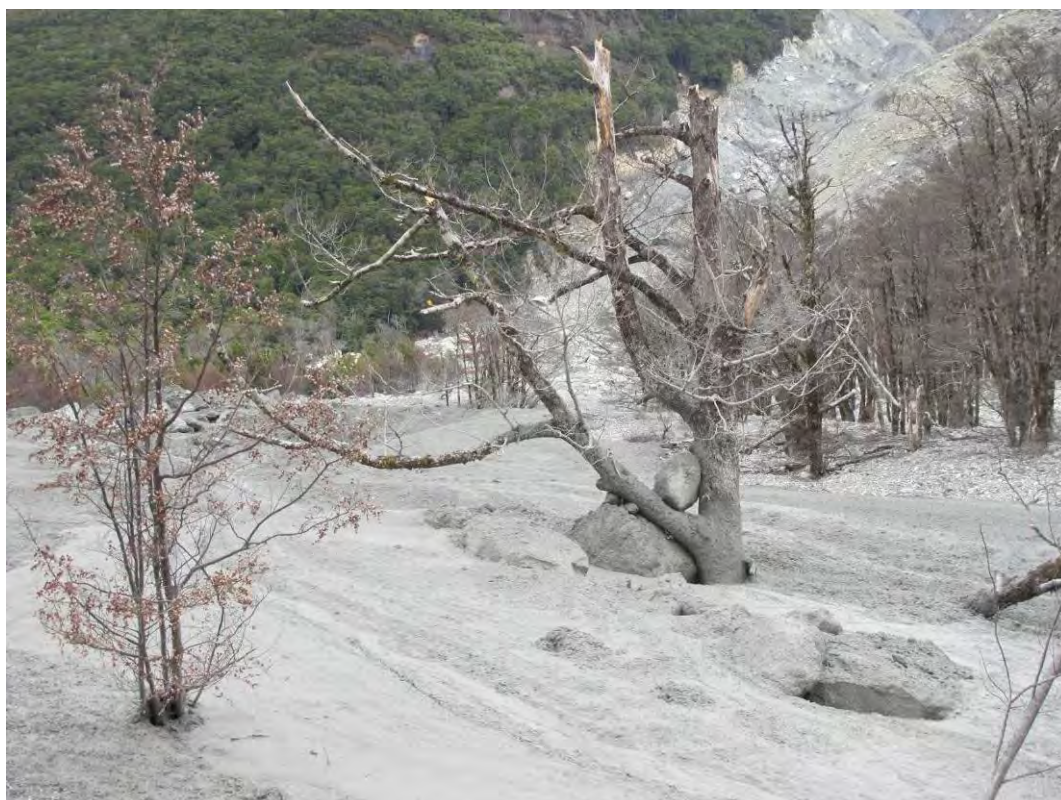
Figure A14 Partially buried trees (from January 2013 debris flows) on the Te Koroka/Slip Stream fan surrounded by 4 January 2014 debris flow deposit (Photo: S. C. Cox, 6 January 2014).
