Cox, S. C.; McSaveney, M. J.; Rattenbury, M. S.; Hamling, I. J. 2014. Activity of the landslide Te Horo and Te Koroka fan, Dart River, New Zealand during January 2014, *GNS Science Report* 2014/07. 45 p.

The landslide Te Horo lies on the eastern side of Cosmos Peaks, Dart Valley, Otago. It is an active compound rock and debris slide with ancillary debris topples and debris flows commencing from its toe. Te Horo has an area of 0.9 km^2 with a steep toe area that is rapidly eroding on its southern lateral margin to feed $10^5 - 10^6 \text{ m}^3$ of sediment annually onto a debris-flow fan on the valley floor. Debris flows in 2013 and January 2014 crossed the fan and entered Dart River, impeding flow, and impounding a lake which grew from 0.47 km^2 to 1.48 km^2 between December 2013 and January 2014. Between 5 and 15 January 2014, a continually surging debris flow added about $1-2 \times 10^5 \text{ m}^3$ of sediment to the toe of the fan, but the main surge appears to have occurred on 4 January after heavy rain in the area. The lake is expected to persist for decades as the landslide continues to supply debris. The lake level and extent will fluctuate. There is no downstream danger

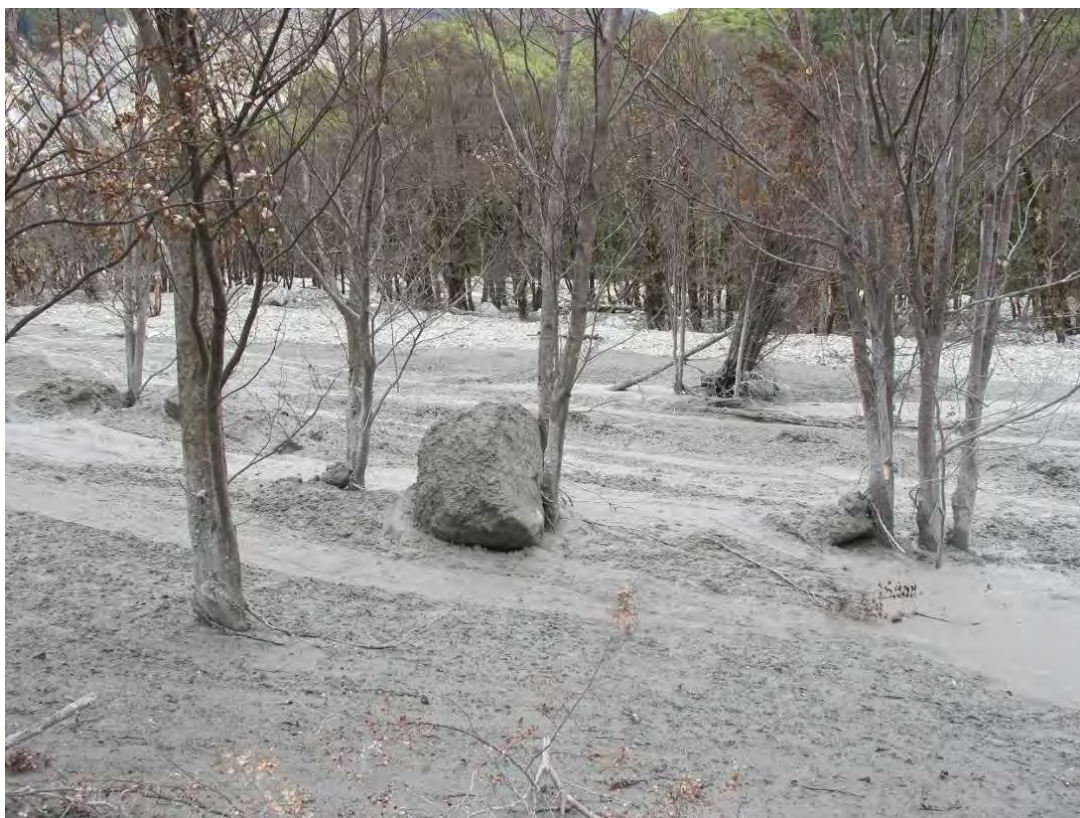
Figure A15 Partially buried trees (from January 2013 debris flows) on the Te Koroka/Slip Stream fan surrounded by 4 January 2014 debris flow deposit (Photo: S. C. Cox, 6 January 2014).

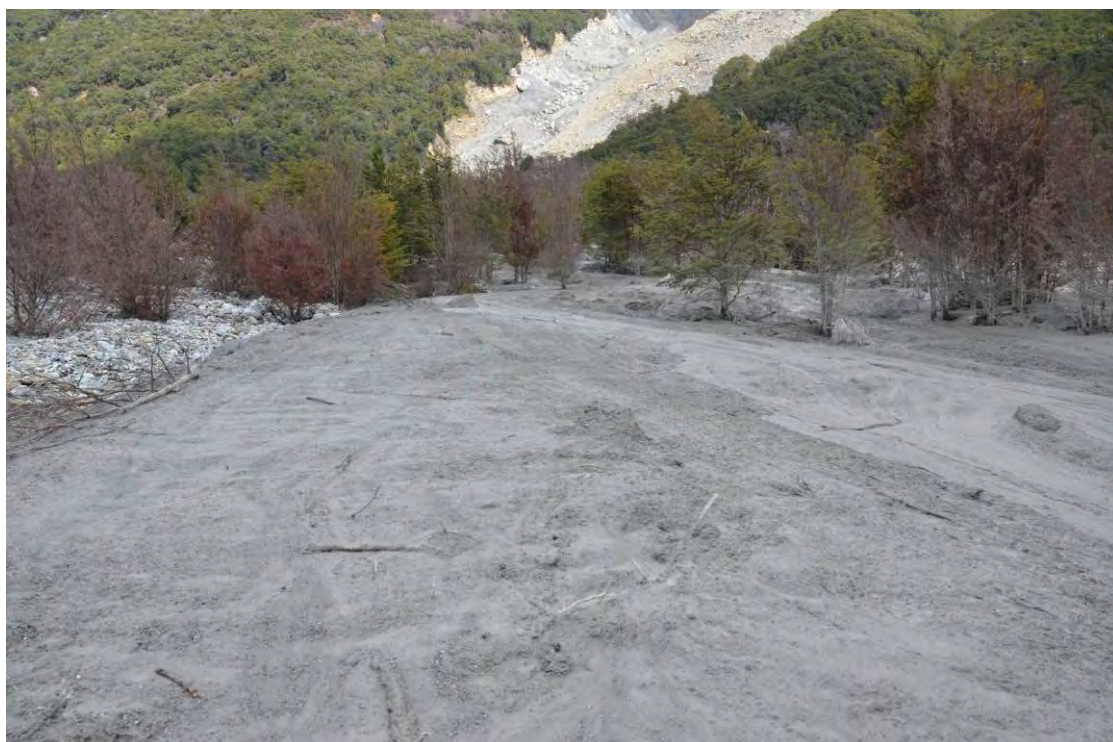
Figure A16 View of a freshly deposited debris flow on the Te Koroka/Slip Stream fan (Photo: M. J. McSaveney, 6 January 2014).

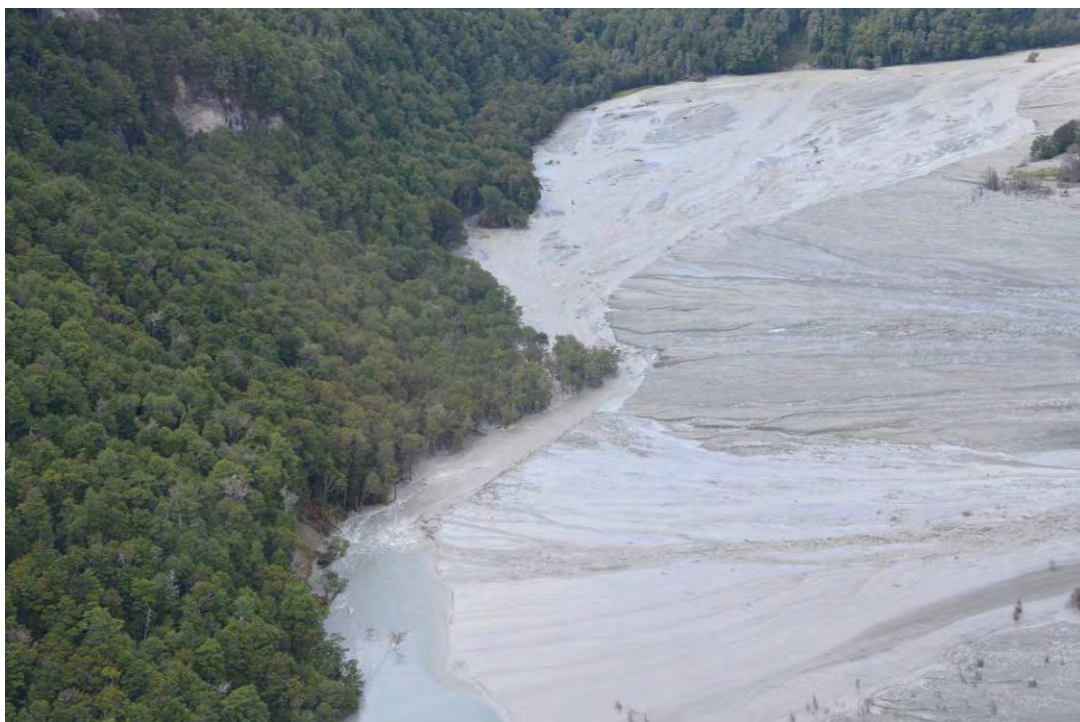
Figure A21 Aerial oblique view to south of the toe of Te Koroka/Slip Stream fan and braided Dart River. Note transition in river turbidity from foreground to background (Photo: M. J. McSaveney, 6 January 2014).

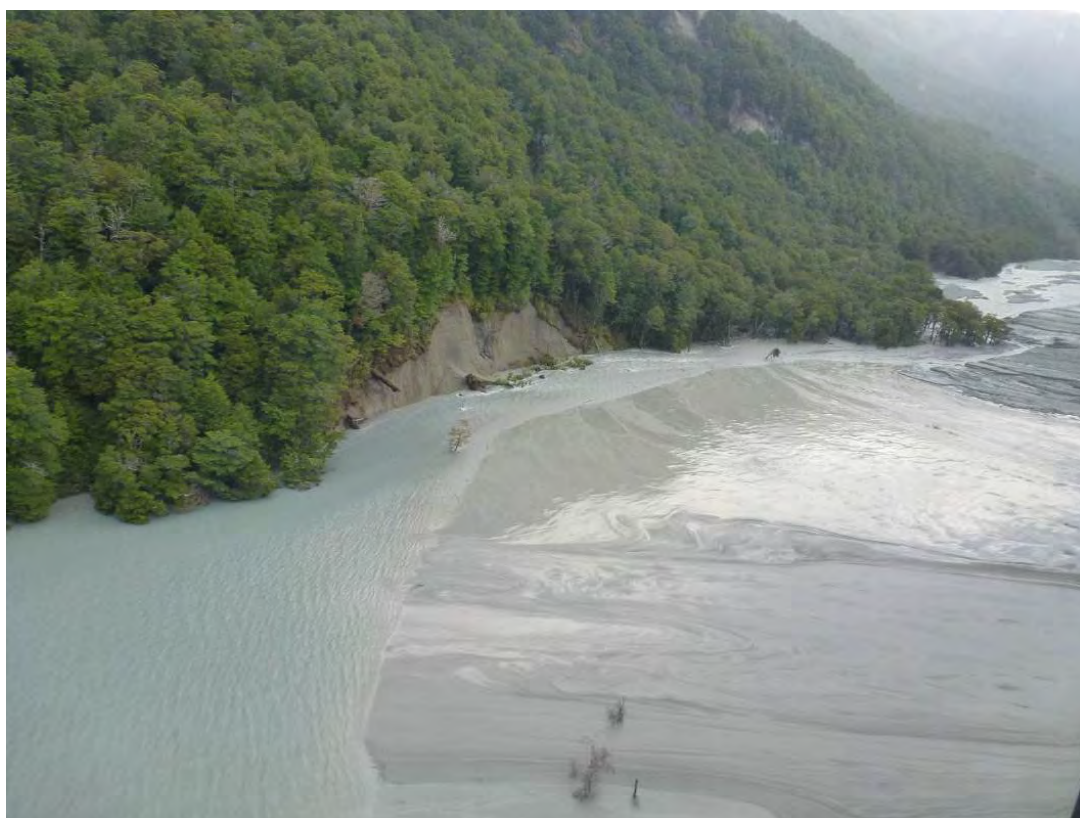
Figure A22 Aerial oblique view to south of the crest of the debris-flow dam, Dart River. The very slowly moving debris flow at the toe of the fan forms the right foreground and middle ground in the image (Photo: M. S. Rattenbury, 5 January 2014).

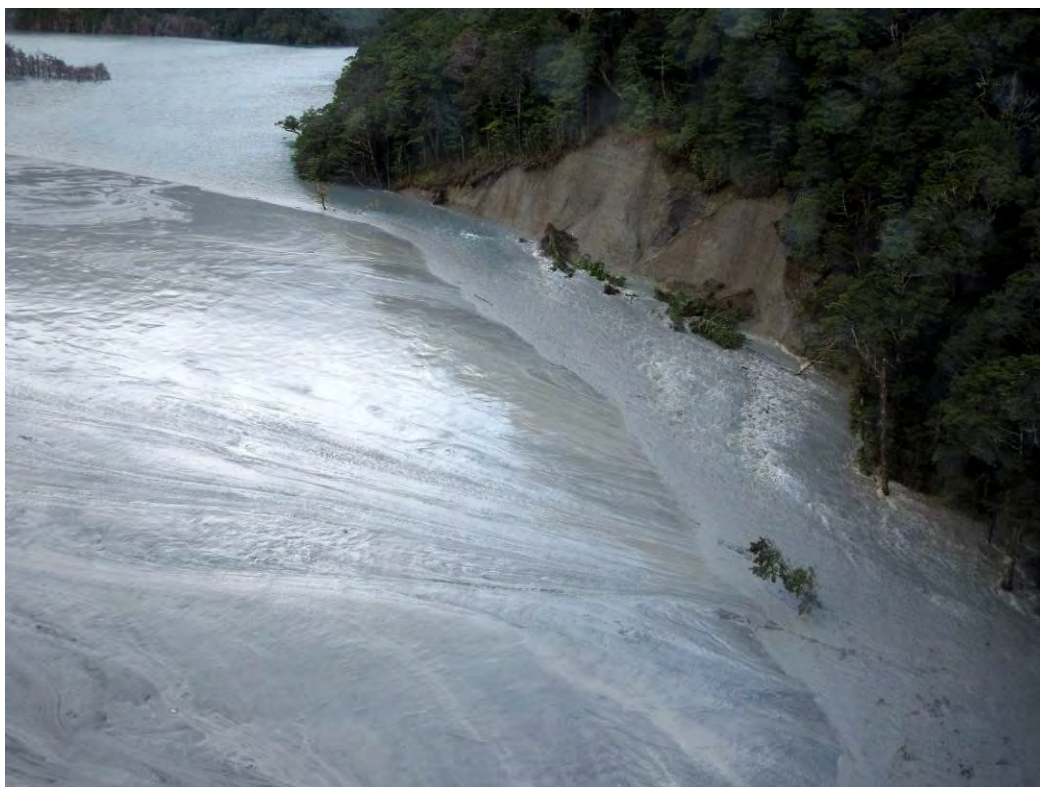
Figure A23 Aerial oblique view (to north) of the active debris flow at the dam crest on Dart River (Photo: S. C. Cox, 6 January 2014).

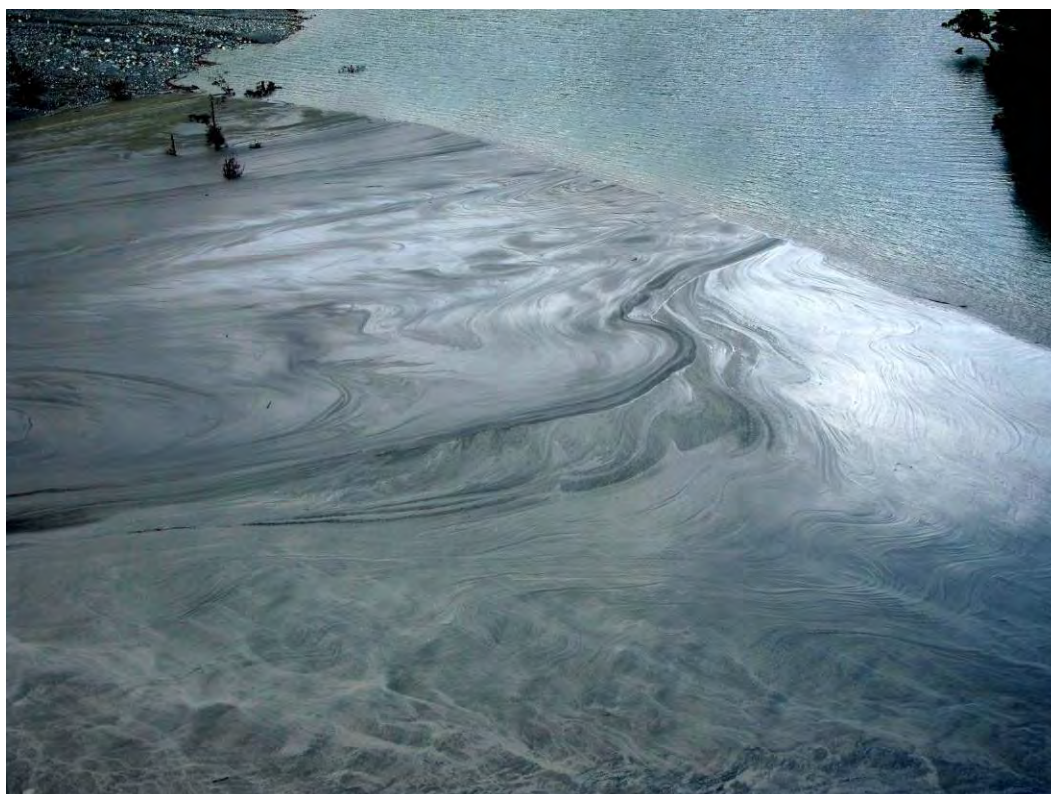
Figure A24 Aerial oblique view (to north) of the active debris flow on Te Koroka/Slip Stream fan where it enters the lake (Photo: S. C. Cox, 6 January 2014).

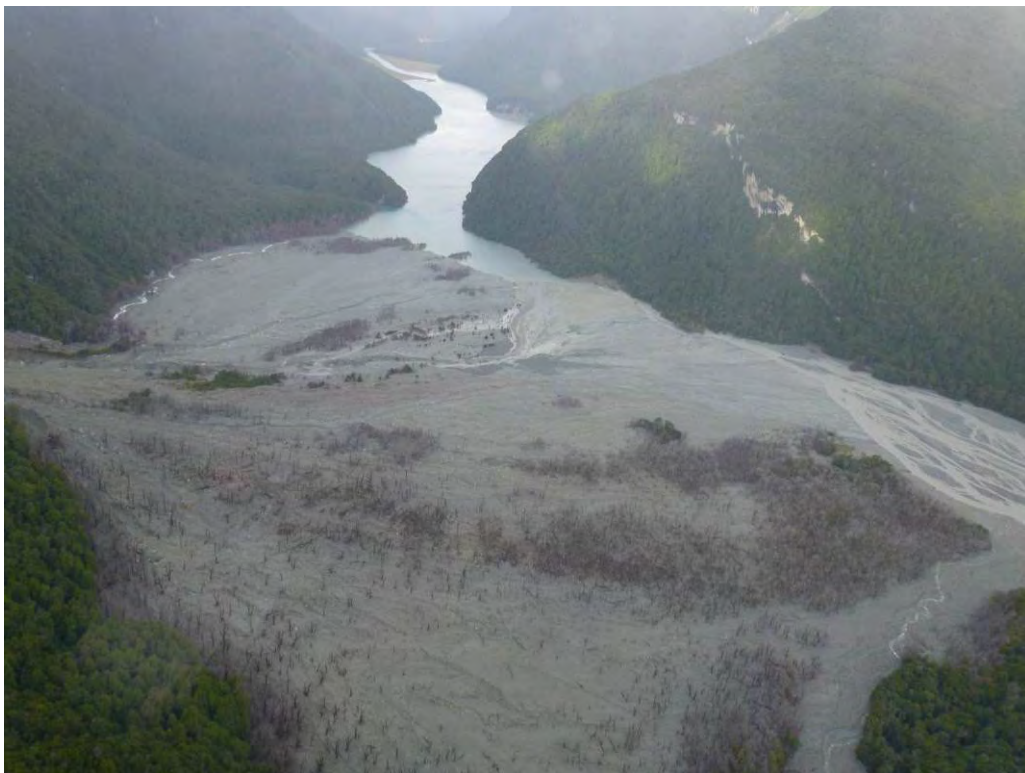
Figure A26 Aerial oblique view to north of Te Koroka/Slip Stream fan and lake, Dart River. Dam crest is formed by an active debris flow in the image. Note the silt-laden braided Dart River channel downstream of the dam in right middle ground (Photo: M. S. Rattenbury, 5 January 2014).

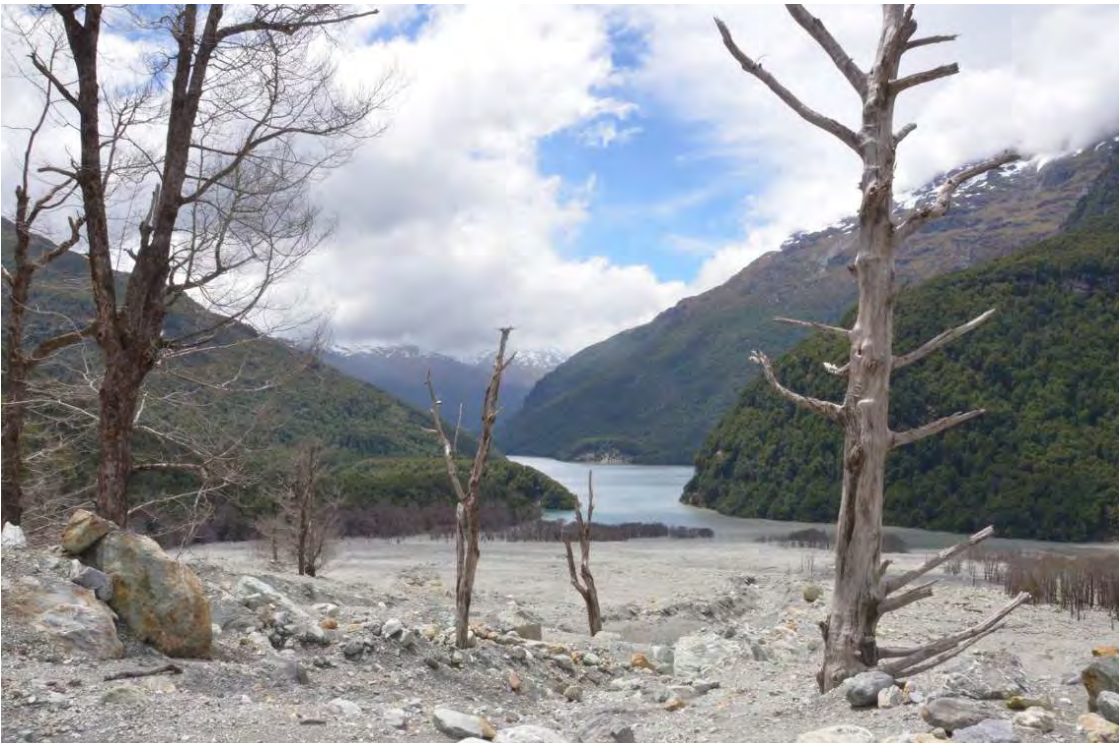
Figure A30 View to north of the Te Koroka/Slip Stream fan and lake. Trees buried in January 2013 (Photo: M. J. McSaveney, 6 January 2014).
