**The 23rd January 2019 Cape Kidnappers Coastal
Cliff Collapse, Hawke's Bay, New Zealand**

**GNS Science Report 2019/26
May 2019**

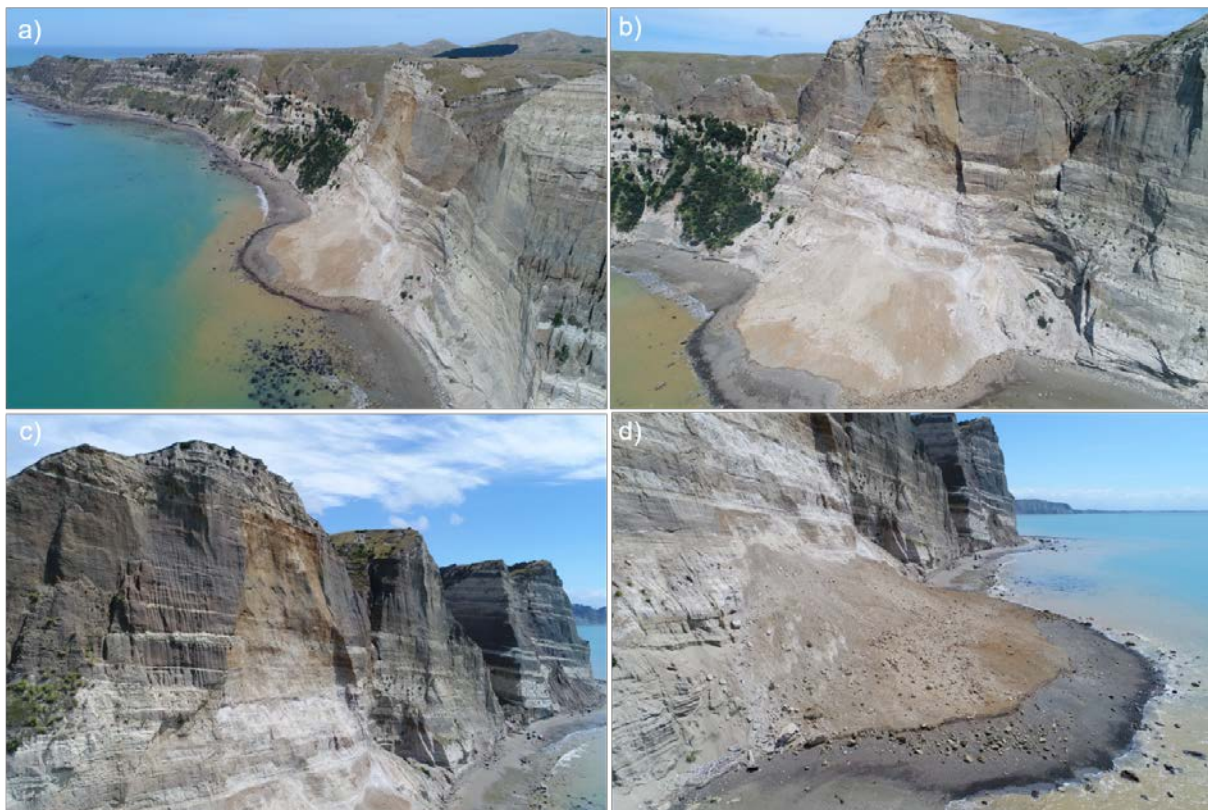
On the 23rd January 2019 at approximately 2.30 pm a large debris avalanche (occurred from the coastal cliffs of Cape Kidnappers, Hawke's Bay, New Zealand (Figures 1.1 and 1.2). The debris avalanche injured two tourists, one critically, who were walking along the beach below the cliff at the time. At low tide the beach provides access to the Cape Kidnappers Gannet Colony, a popular tourist attraction. There were several other walkers and a tractor tour group present on the beach nearby at the time of the debris avalanche. These bystanders captured the debris avalanche event with photographs and video, which can be viewed through several media outlets including:

Figure 1.2 Photographs of the Cape Kidnappers debris avalanche captured via drone on the 25/01/2019. a) & b) Images of the debris avalanche, c) Source area of the debris avalanche, and d) Deposit of the debris avalanche.

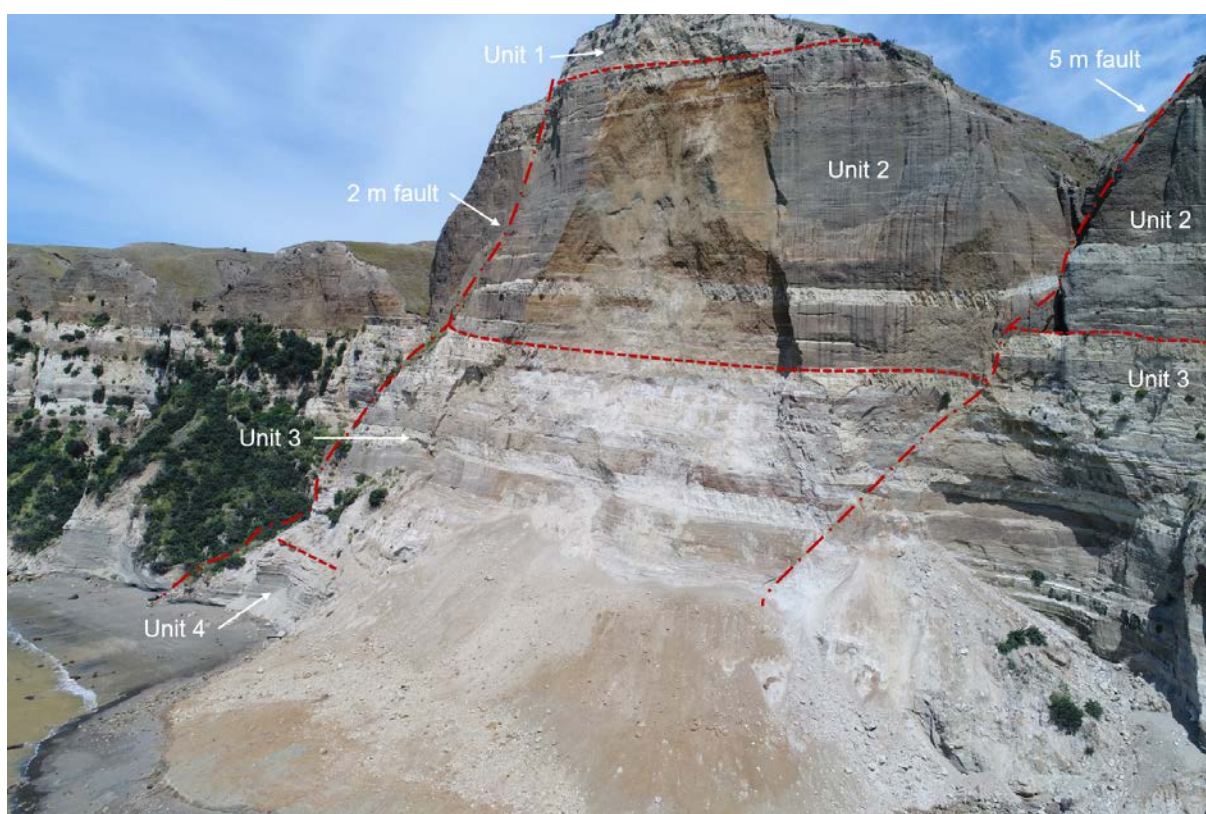
All these units are massive, with bedding dipping at 8° towards the north-west out of slope. Few joints are observed within the cliff. Two faults, colloquially known as 2 m and 5 m fault, bound the debris avalanche on either side, dipping into the slope (Figure 2.1). No seepage was observed from the face of the cliff.

Figure 2.1 Photograph displaying the four different geological units exposed at the cliff surface.

Based on eyewitness accounts and imagery, the upper 50 m of the cliff failed on afternoon of the 23rd January 2019. The source area for the material is mostly within Unit 2 (Figure 2.1). Anecdotal evidence suggests that locally within the wider failure area, toppling may have

The debris avalanche appears to have involved fracture through intact material of Unit 2 in the source area (Figure 2.1). The surface of the debris avalanche scar is irregular with few joint surfaces visible (Figure 2.4). Bedding does not appear to have been a control on instability and the resulting failure mechanism. Non-persistent planar features within the scar surface may represent pre-existing joint surfaces within the cliff, which potentially contributed to the development of the release surface (Figure 2.4). Additionally, the faults or joints do not appear to control the lateral extents of the debris avalanche (Figure 2.1).

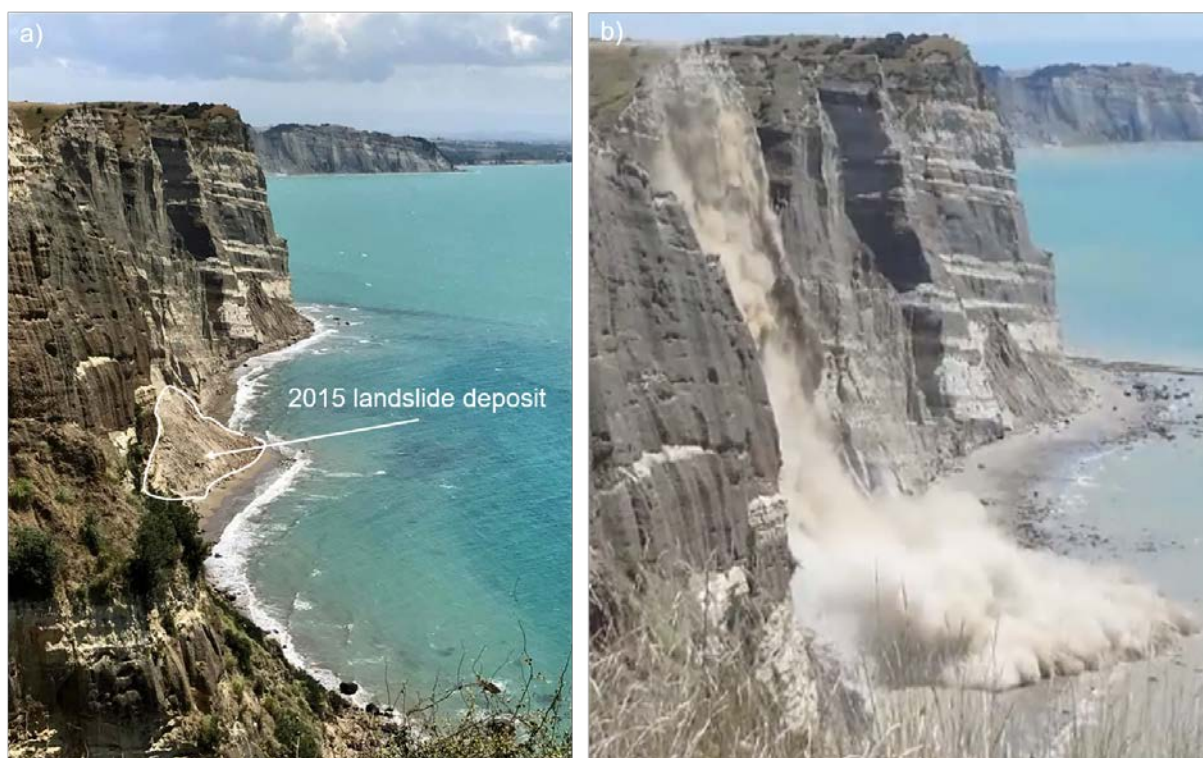
occurred. Once the debris avalanche initiated it travelled extremely to very rapidly downslope, where the pre-existing debris deposit from a 2015 failure (Figure 2.2) acted as a ramp for the debris, allowing the debris avalanche debris to run-out further into the sea.

Figure 2.2 a) Photo of the coastline prior to the 23rd January event, displaying the 2015 rockfall deposit in the same region (Source: J Marshall, 13/01/19). b) Photo of the landslide on the 23rd January (Source: Unknown 3rd Party, 23/01/2019).

The debris avalanche appears to be related to the 2015 event. Marine erosion at the toe of the cliff is likely to have been a contributing factor in this initial 2015 failure at the base of the cliff. Over time, this instability has spread and propagated upwards, with all other recorded rockfalls and the 23rd January event occurring above this 2015 failure.

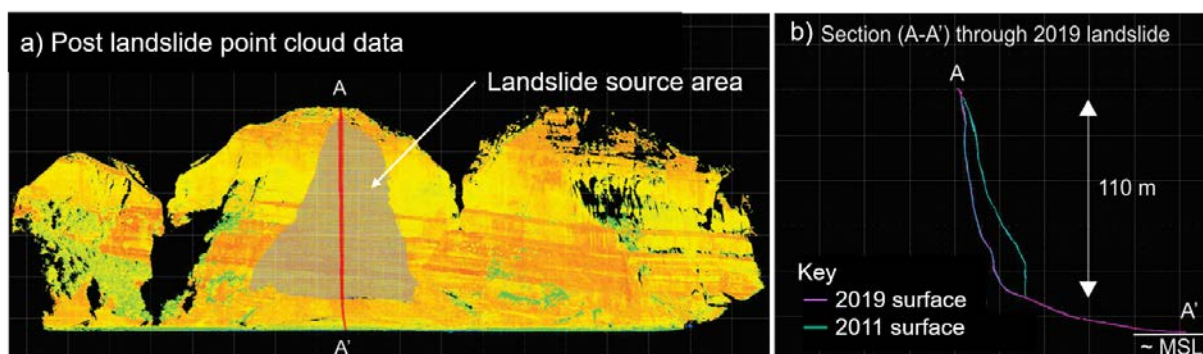
The source area scar has a surface area of approximately 1,200 m², with a volume of 25,500 m³ and an average thickness of about 20 m. The deposit is 125 m wide and initially extended out 75 m from the base of the cliff prior to being subjected to erosion from tide and wave action (based on estimates from Stantec Ltd.). To quantify the volume of the debris avalanche, a 2011 aerial LiDAR data-set of the coast has been compared and differenced with the Terrestrial Laser Scanner scan data collected by GNS on the 25th January 2019. This difference model has shown that between 2011 and 2019, 63,000 m³ has been eroded from the location of the debris avalanche (Figure 2.3). As there was already a substantial debris deposit from 2015 (Figure 2.2), this will account for some of the 63,000 m³ lost from the cliff face. The Stantec Ltd estimate of 25,500 m³ for the 23rd January 2019 debris avalanche is within the range of possible failure volumes constrained by this data.

Figure 2.3 a) Point cloud data derived from terrestrial laser scan (TLS) survey conducted on the 25/01/2019. The grey area displays the debris avalanche source, with this area being used to compare between 2019 TLS data and the 2011 Aerial LiDAR (NZ Aerial Mapping for Hawke's Bay Regional Council). b) Cross-section displaying the difference between 2019 cliff surface and 2011 cliff surface.

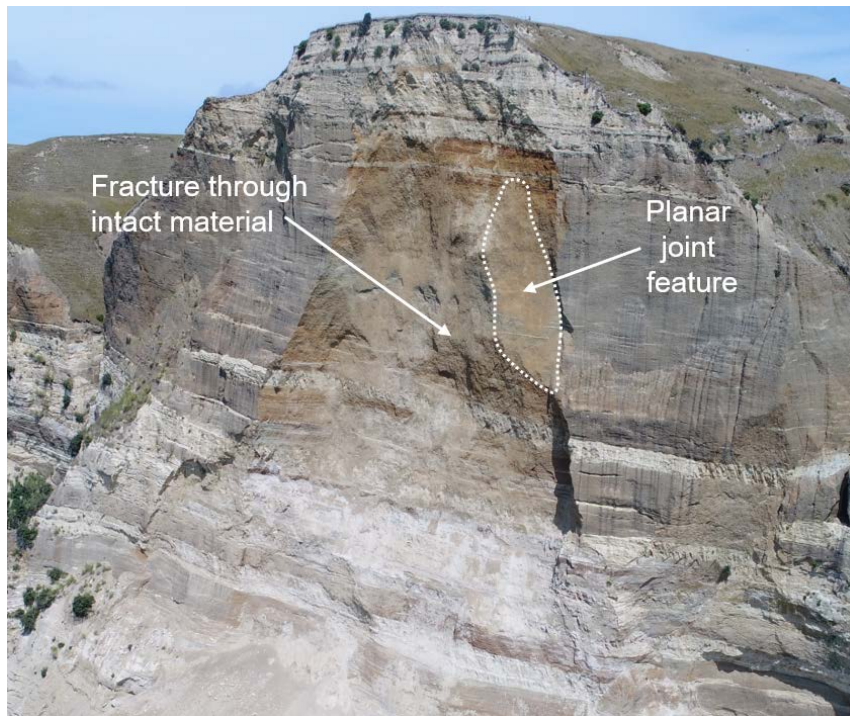
Figure 2.4 Photograph displays the main planar joint features observed within the landslide failure surface. The irregular curved surfaces of the majority of the failure surface is interpreted to be failure through intact material.

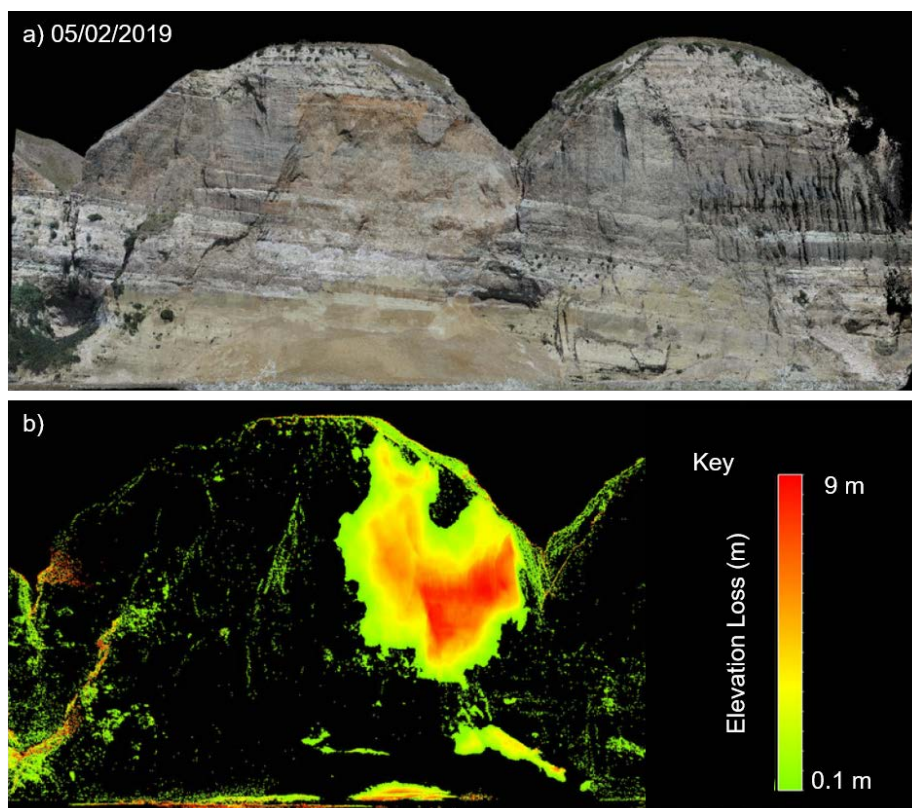
- 26/27 January: 330 m³ rockfall volume located adjacent to the main debris avalanche within Unit 3.
- 2 February: 10,000 m³ debris avalanche located adjacent to the main debris avalanche within Unit 2 (Figure 2.5). The debris avalanche narrowly missed two tourists walking along the beach (though the beach and the walkway were closed at this time).
- 7 February: 2,500 m³ rockfall located above the main debris avalanche within Unit 1 (Figure 2.6).

Figure 2.5 a) Drone imagery of a subsequent debris avalanche captured on the 05/02/2019. b) Elevation loss model derived from differencing of the UAV generated point clouds of the 25/01/2019 and 05/02/2019.(Data Source: Stantec Ltd).

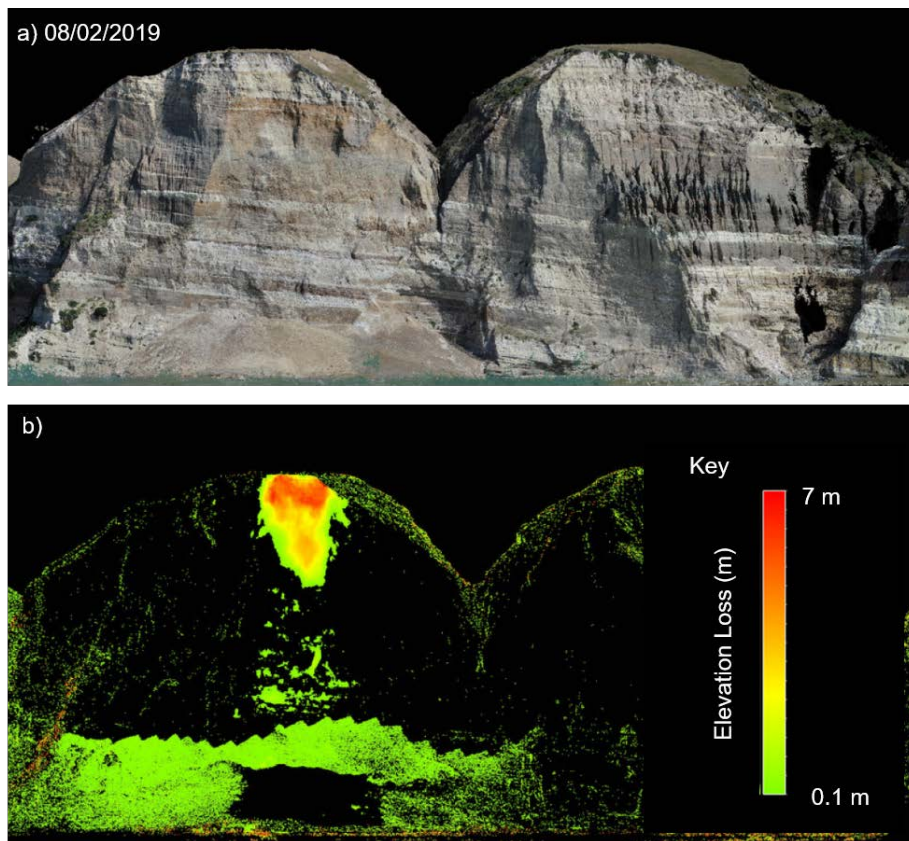
Figure 2.6 a) Drone imagery of another subsequent rockfall captured on the 08/02/2019. b) Elevation loss model derived from differencing of the UAV generated point clouds of the 05/02/2019 and 08/02/2019. (Data Source: Stantec Ltd).

The recorded post-failure debris avalanche and rockfall events may also represent a continuation of this upward movement of failure (in particular, the 7th February rockfall which occurred in Unit 1 at the top of the slope). These subsequent debris avalanche and rockfall events may occur via progressive failure, where a change in the stresses within a slope occurs (i.e. in this case, the 23rd January debris avalanche event), resulting in stress redistribution throughout the surrounding rock mass. As this stress redistributes, this results in further

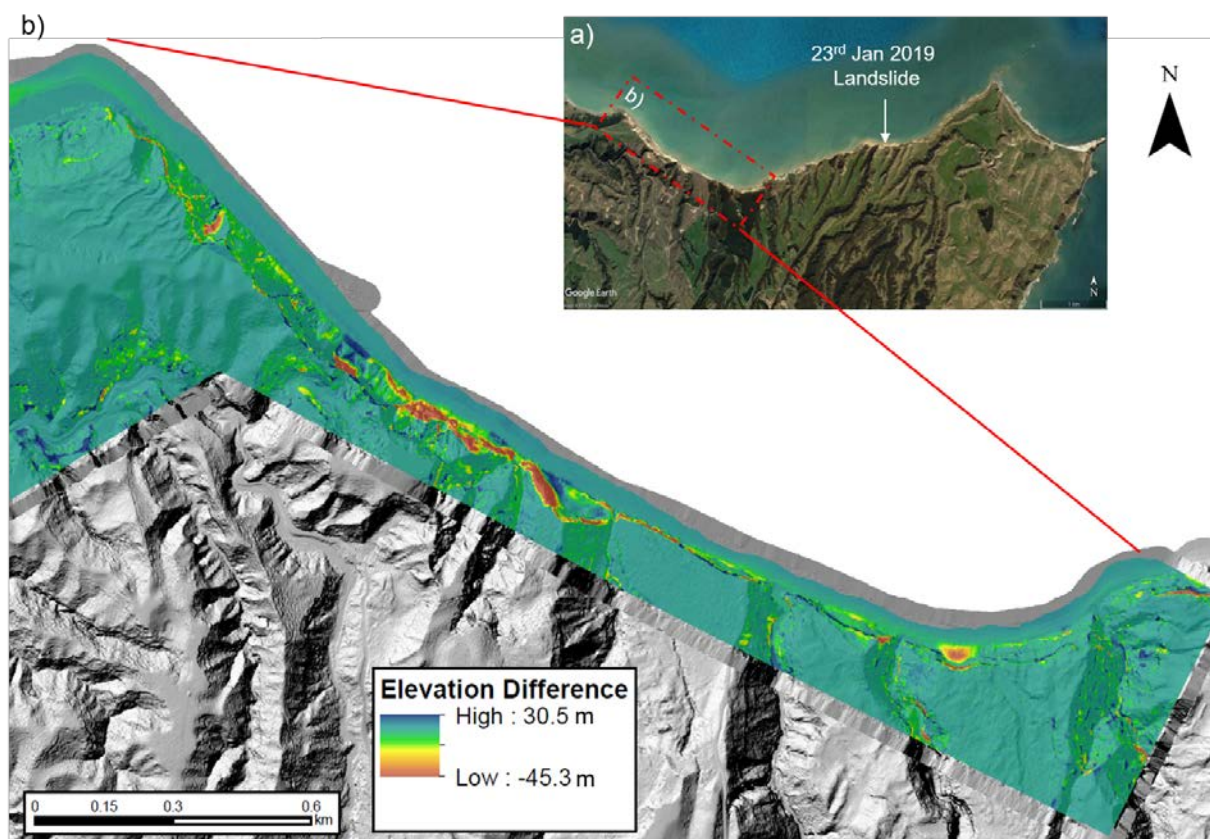
The 23rd January 2019 debris avalanche does not represent an unusual event in this area but is consistent with anecdotal evidence of previous failures observed along this stretch of coastline. In 1989 a similar event occurred, resulting in injuries to two tourists. Field observations show that there are multiple debris deposits located at the base of the cliffs, indicating past events of a similar magnitude to the 23rd January 2019 debris avalanche have occurred. Comparison between Aerial LiDAR captured in 2003 and in 2011 (Figure 3.1) records areas of failure along the coast (red colours within Figure 3.1), confirming the field observations of landslide activity.

Figure 3.1 a) Location and extent of difference model between Aerial LiDAR collected in 2003 (by AAM Geoscan Ltd for Hawke's Bay Regional Council) and 2011 (Aerial Mapping Ltd for Hawke's Bay Regional Council) is outlined in the red box. The LiDAR does not cover the area of the 23/01/2019 debris avalanche. b) Elevation difference model between 2003 and 2011, where red colours represent erosion and blue colours deposition.

However, the rates of activity (i.e. how often failures occur along the coast, and how big they are?) are not quantified, and only qualitatively and anecdotally observed. Baseline levels of landslide activity need to be quantified in order to understand the risk they pose to visitors and users of the accessway.
