Landslides and debris flows caused by the 15-17 June 2013 rain storm in the Marahau-Motueka area, and the fatal landslide at Otuwhero Inlet

GNS Science Report 2013/44 August 2013

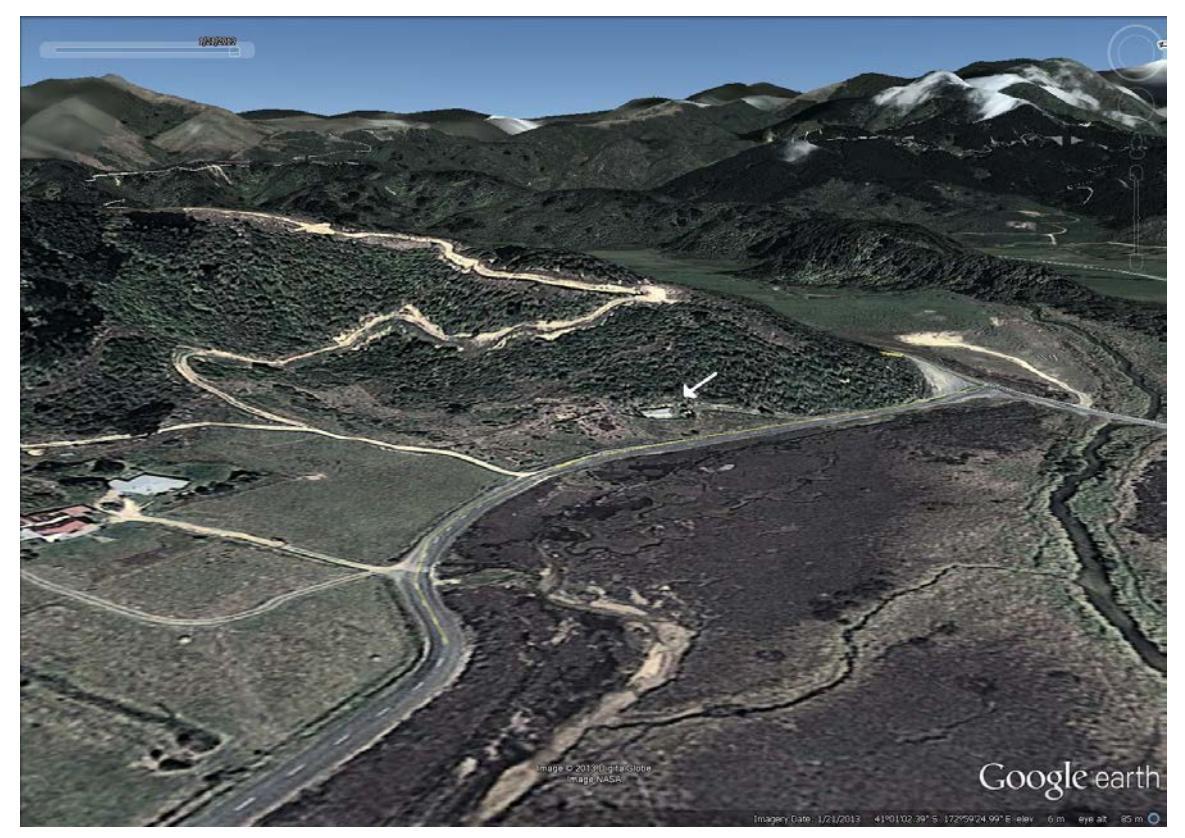
**Figure 3** Oblique Google Earth image (21/01/2013) showing house at 597 Kaiteriteri-Sandy Bay Road before the fatal landslide occurred on 16/06/2013. Note the side castings on the edge of the access track above the house. House is marked with an arrow.

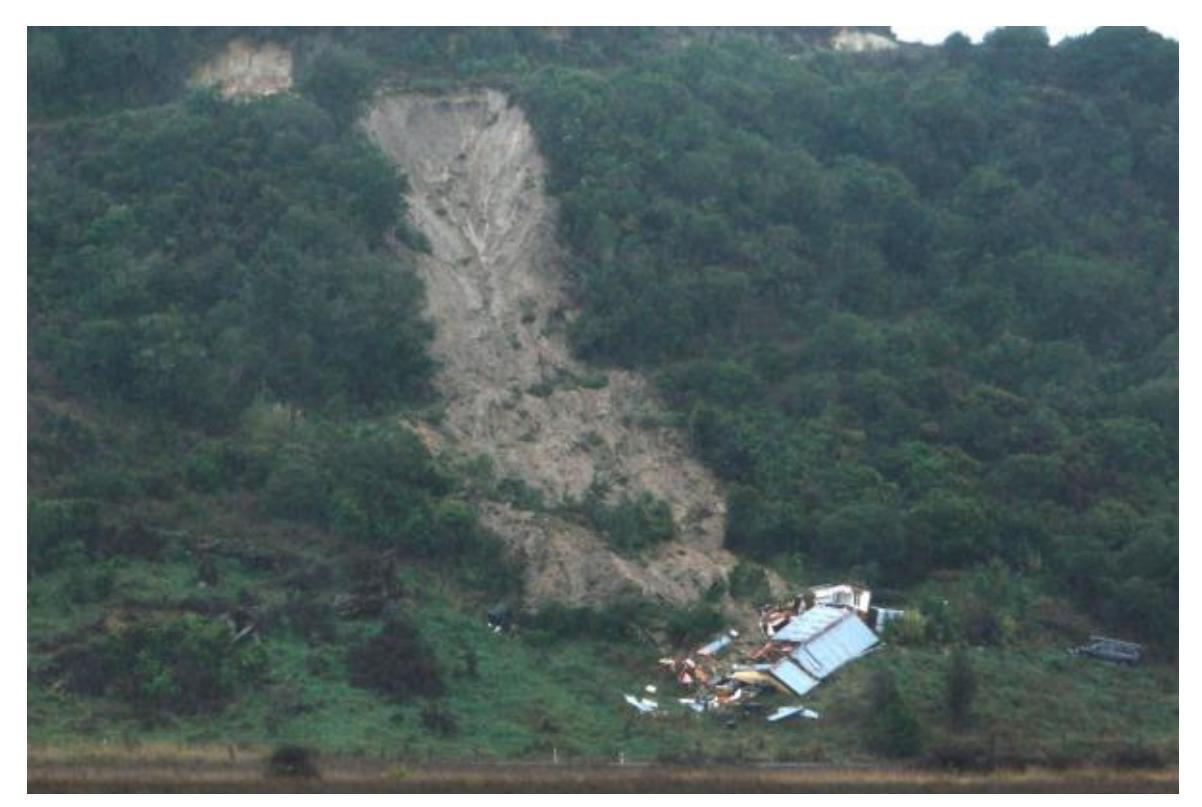
Figure 4 Fatal landslide at 597 Kaiteriteri-Sandy Bay Road. Note access track at top of photo and old track in centre of photo. (*Nelson Mail photo 16/06/2013*).

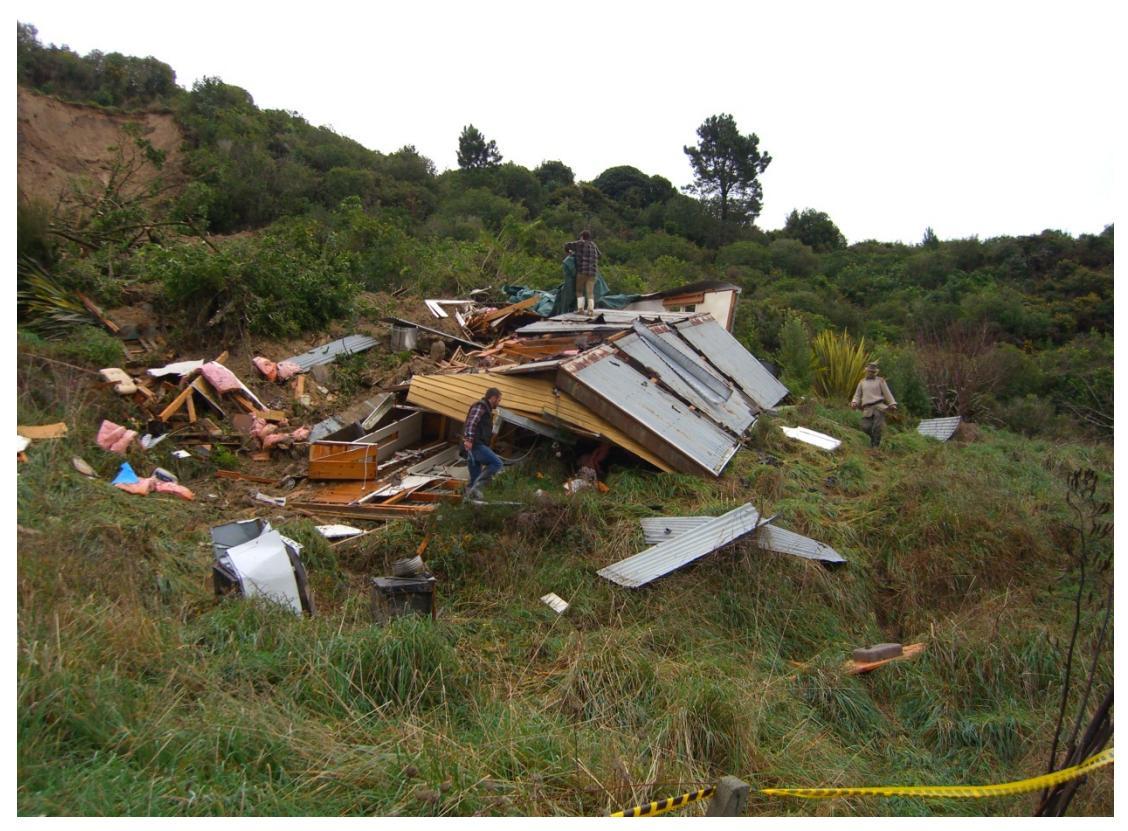
**Figure 7** House at 597 Kaiteriteri-Sandy Bay Road (looking north). The house has collapsed with the impact of debris originating from the landslide scar in the upper left corner of the photo. The house is sited on an old landslide deposit. (*GNS Science photo*).

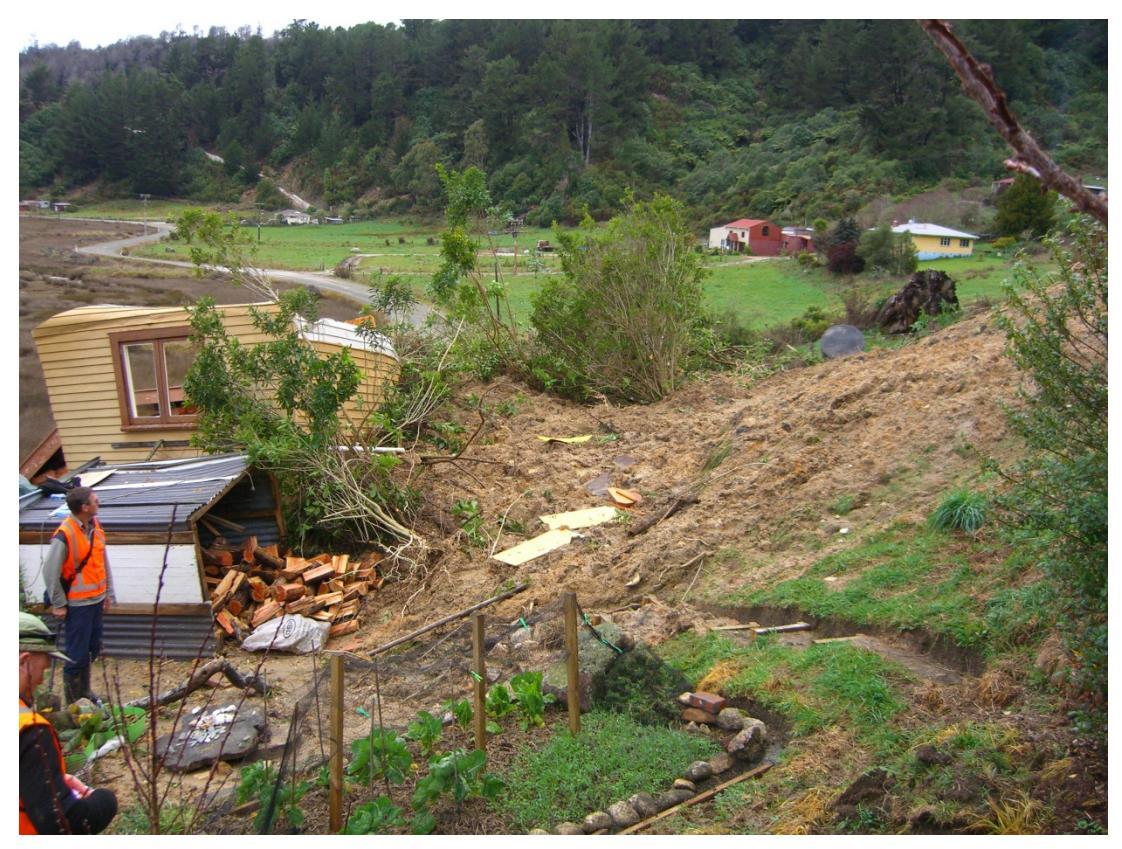
**Figure 8** Remains of house (looking south) showing where landslide debris impacted the house, moving it several meters off its piles. Note how the landslide debris has "ridden up" against the wall. *(GNS Science photo).*

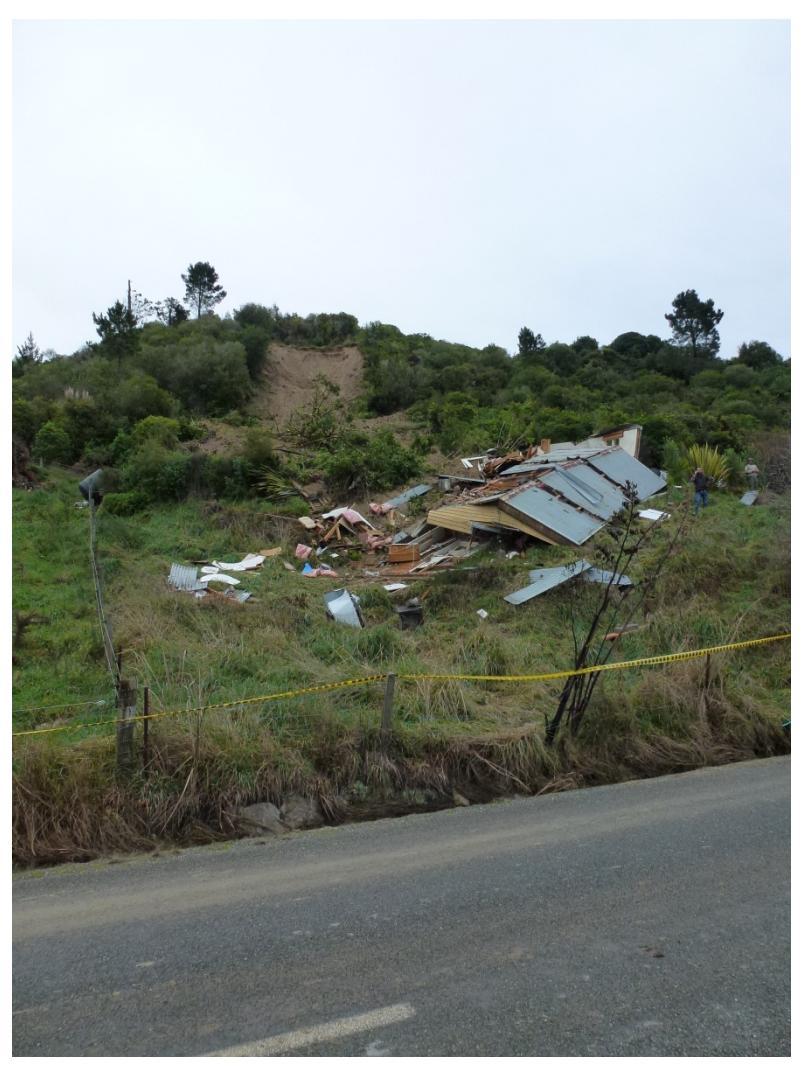
Figure 9 View of landslide looking up slope from Kaiteriteri-Sandy Bay Road. (TDC photo).

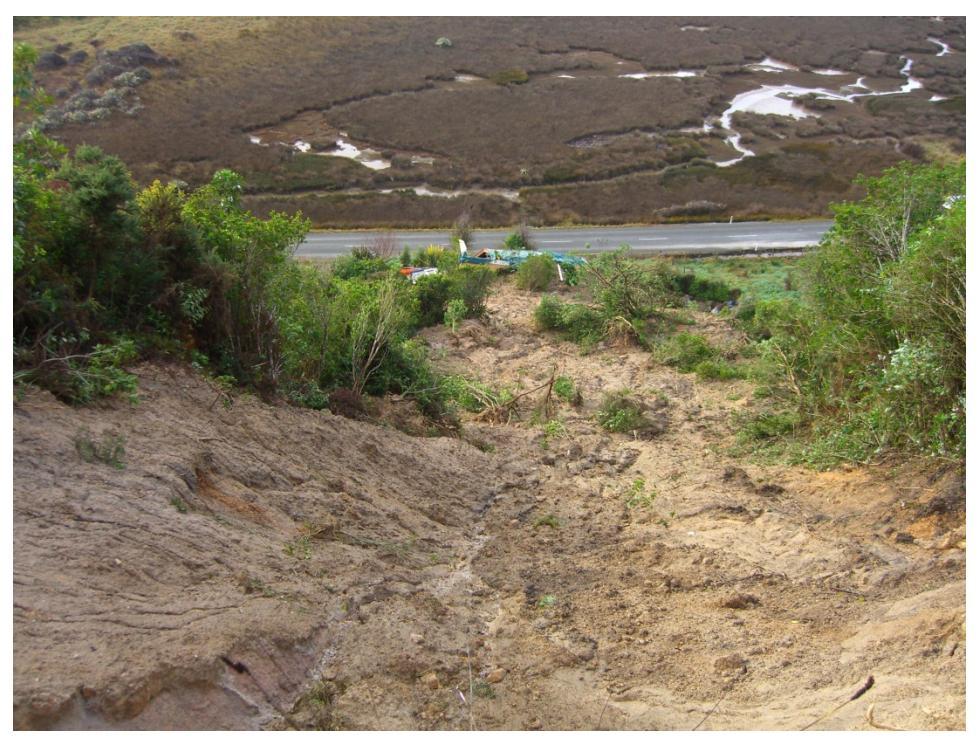
Figure 10 View of landslide looking down slope from access road towards Otuwhero Inlet. (GNS Science photo).

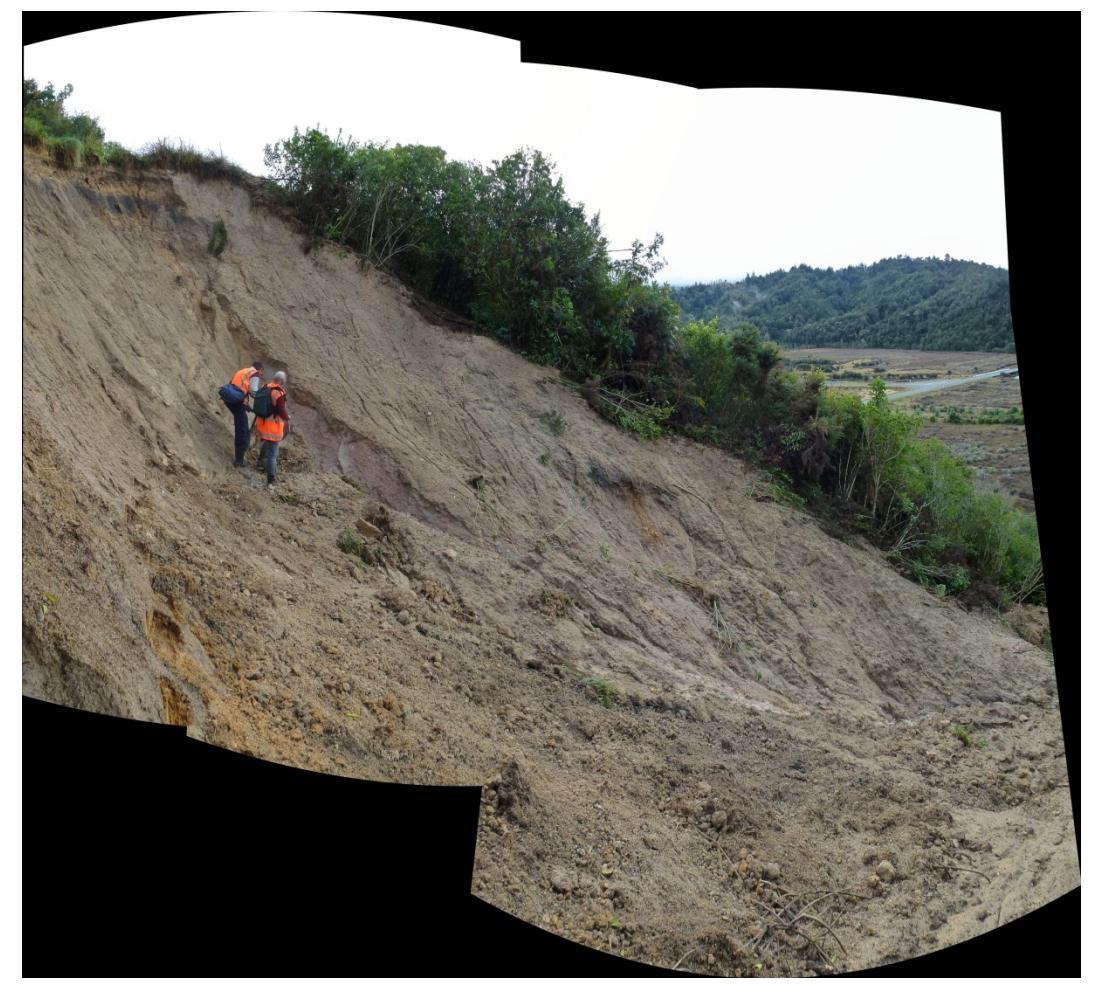
**Figure 11** View of landslide looking across slope to the north. Note zone of red-weathered clay exposed below the slip plane in centre of photo. *(TDC photo).*

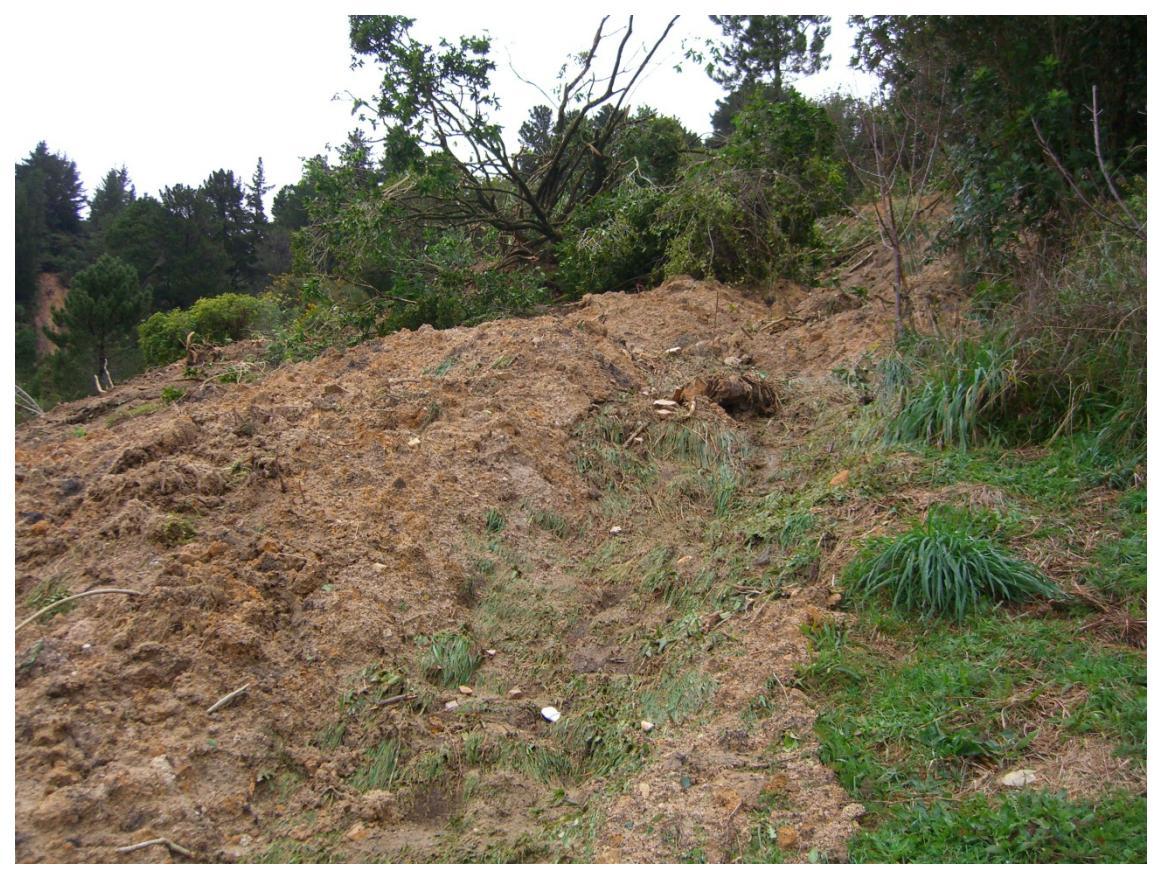
**Figure 13** Landslide debris in the area between the landslide scar (upper right), and the house (lower left). Note debris has ridden over, and been deposited on top of the grass surface. *(GNS Science photo)*.

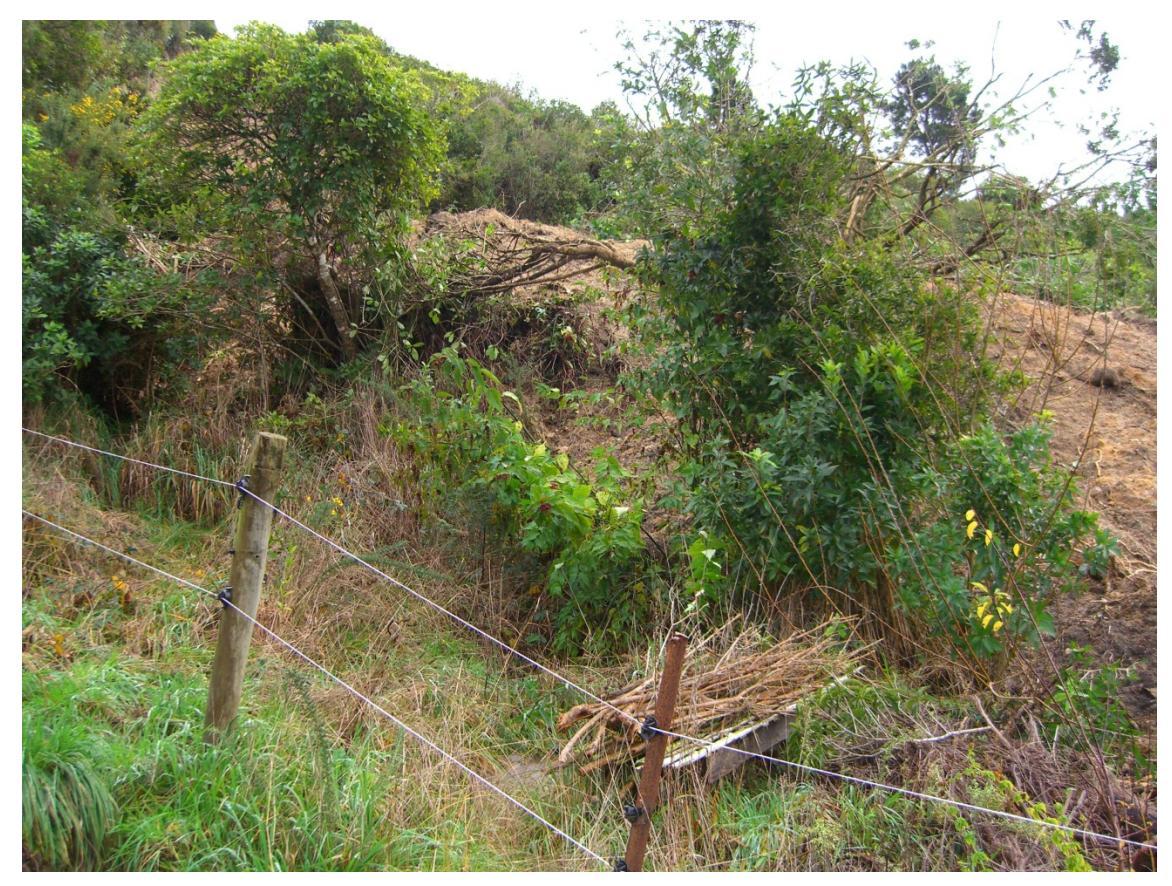
Figure 14 Lateral edge of landslide debris. (GNS Science photo).

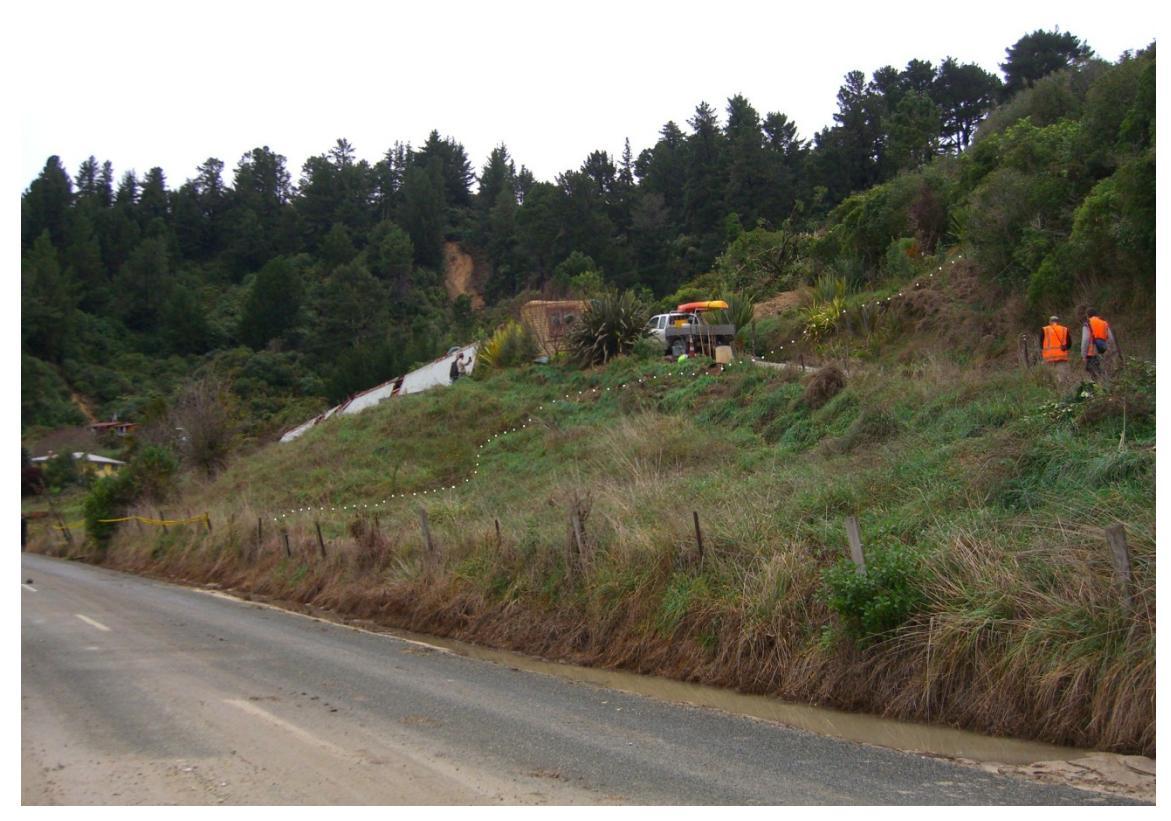
**Figure 15** Lobe of an earlier landslide deposit on which the house was built (outlined in white). *(GNS Science photo)*.

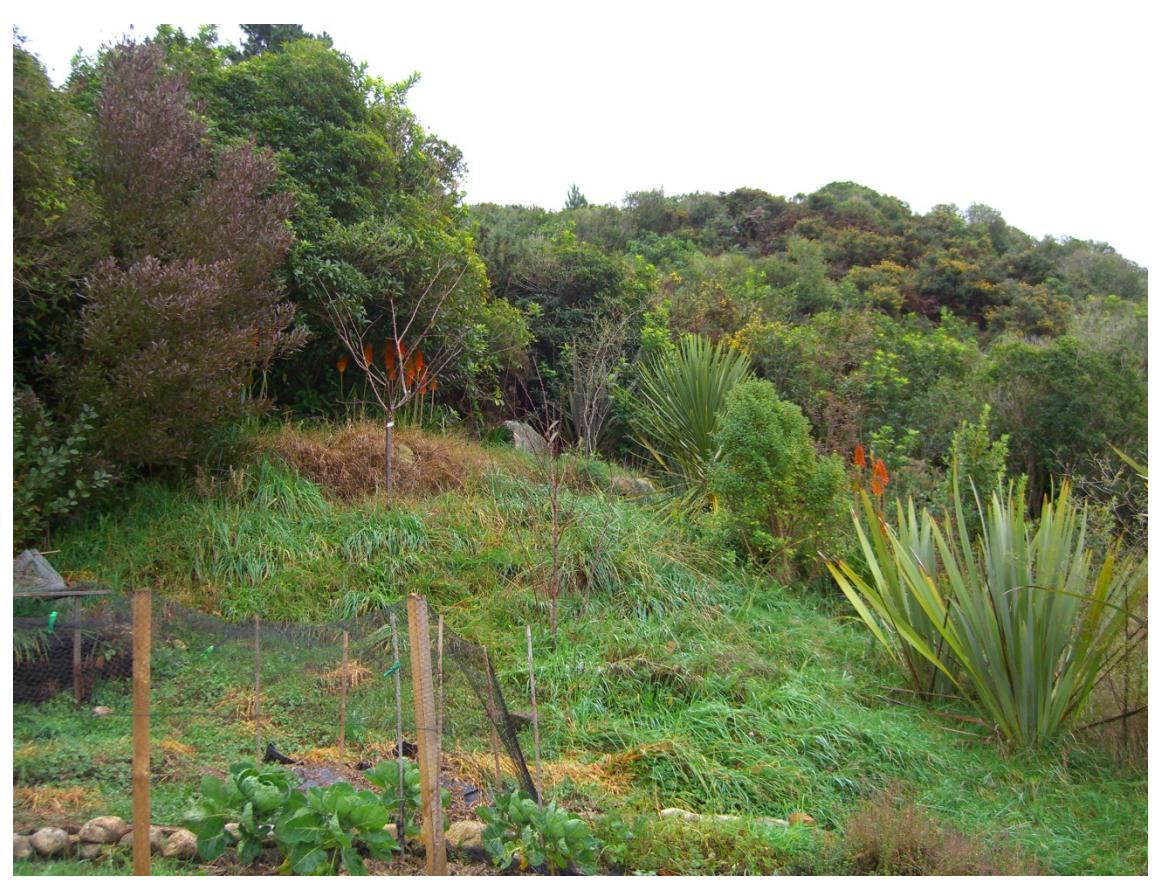
**Figure 16** Part of an earlier landslide deposit above the house. Note the large boulders on the surface. *(GNS Science photo).*

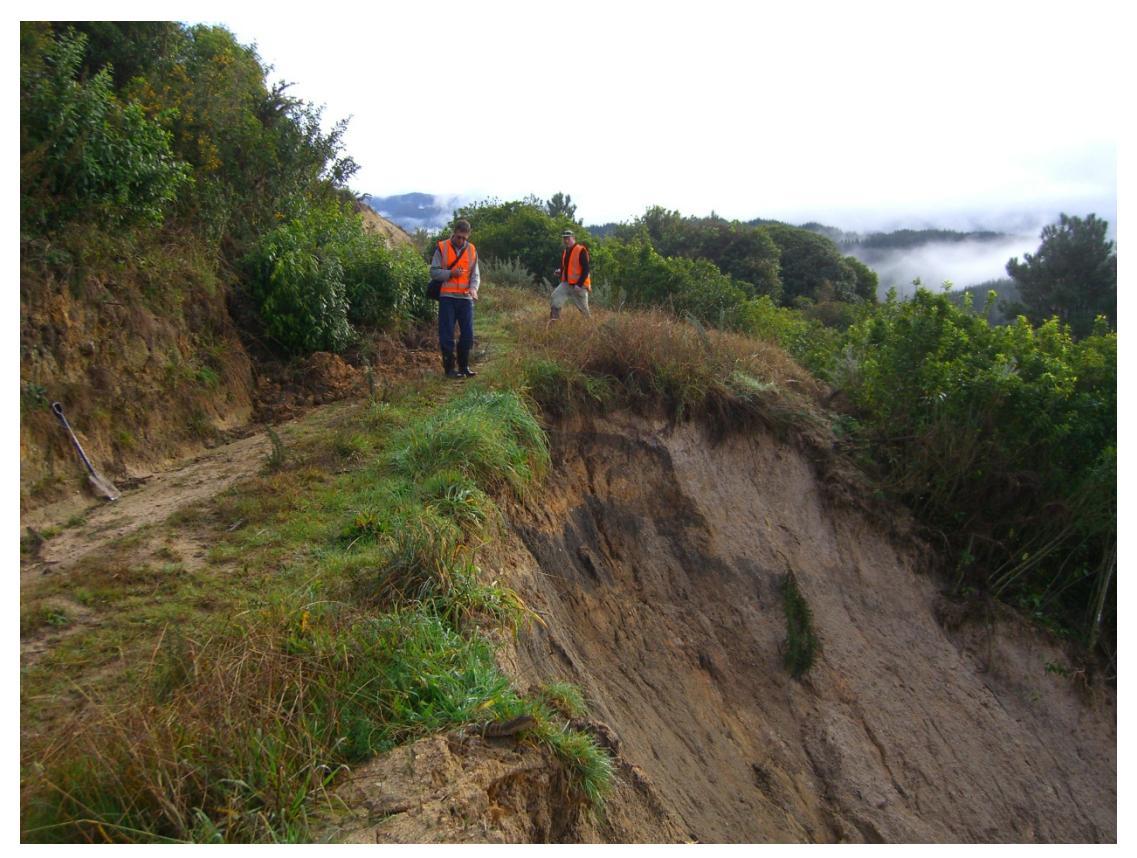
**Figure 17** Head scarp of the landslide at the edge of the access track. The track surface is inclined away from the downslope edge and towards the cut batter to direct water down the track and away from the slope below the track. The head scarp has exposed two buried soils overlain by two side casting deposits. *(GNS Science photo).*

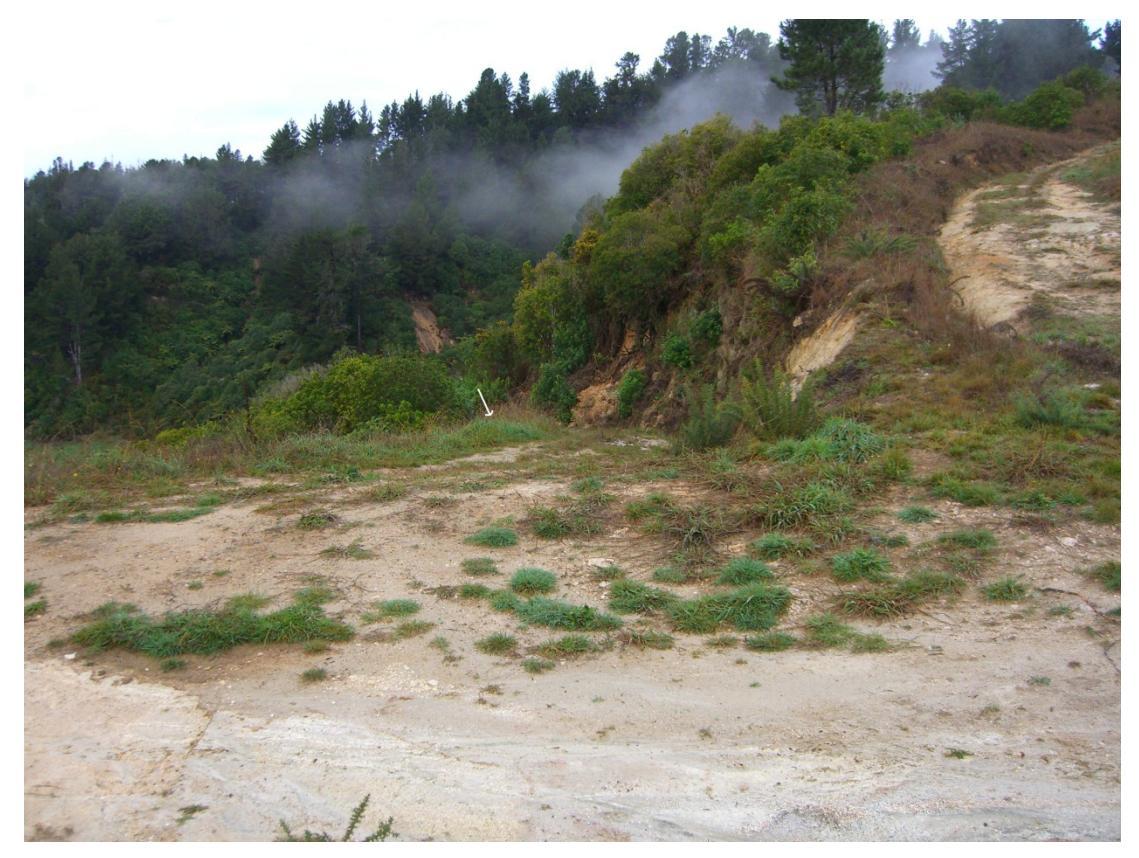
**Figure 18** Hairpin bend 60 m up the track from the landslide (marked with an arrow). Water running down the track above this point is carried under the track by a series of culverts and discharged down slope. *(GNS Science photo).*

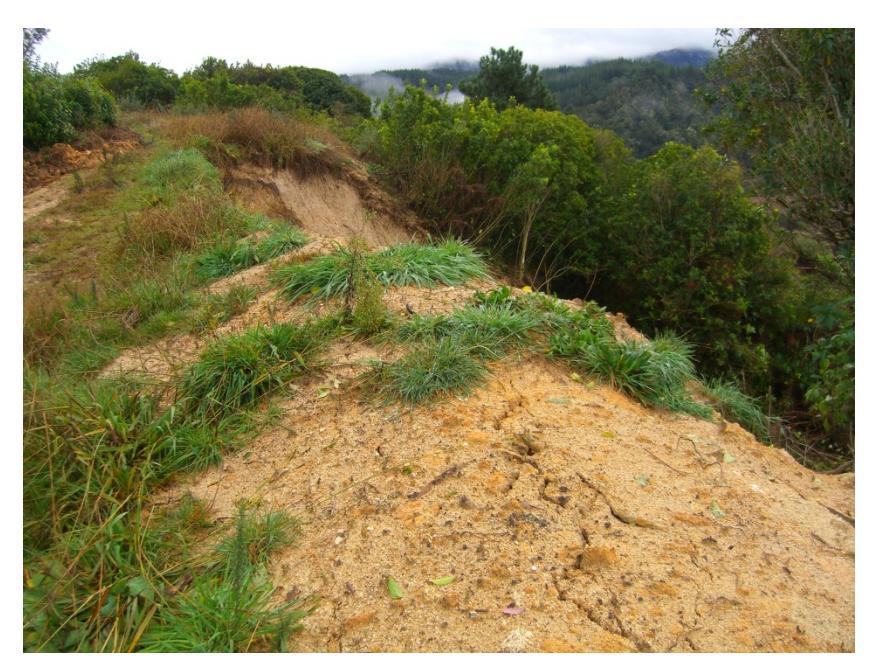
At the head of the landslide, on the outer edge of the track, spoil associated with track construction and maintenance had been deposited. Tension cracks were present in these side castings, indicating that the unsupported outer edge had moved (Figure 21 and Figure 22). This cracking is likely to have increased saturation of the spoil and possibly allowed increased access of water to the natural slope beneath. The exposed head scarp of the landslide shows two separate side casting deposits at the site, an 80–100 cm deposit overlying a buried top soil, which is the side casting from the original track construction, and 40-60 cm of side casting which overlies the top soil developed on the earlier side casting (Figure 23). This second side casting probably was deposited during track maintenance between 2006 and 2010. As previously mentioned, these side castings had a volume of ~50 m<sup>3</sup> and they accounted for about 9% of the total eroded volume of the landslide. Aerial photos taken in 2002 and 2007, and Google Earth images from 2003, 2006, 2010 and 2011 show side castings along much of the track's length (Figure 24). Between ~2001 and 2006 four other landslides occurred on the track, and they were also sited at the edge of the track, in areas of convergent drainage and associated with side casting (Figure 25).

**Figure 21** Side castings on track edge adjacent to head scarp of landslide. The landslide has removed  $\sim$ 50 m<sup>3</sup> of side cast material. Note tension cracks in side cast deposit. *(GNS Science photo).*

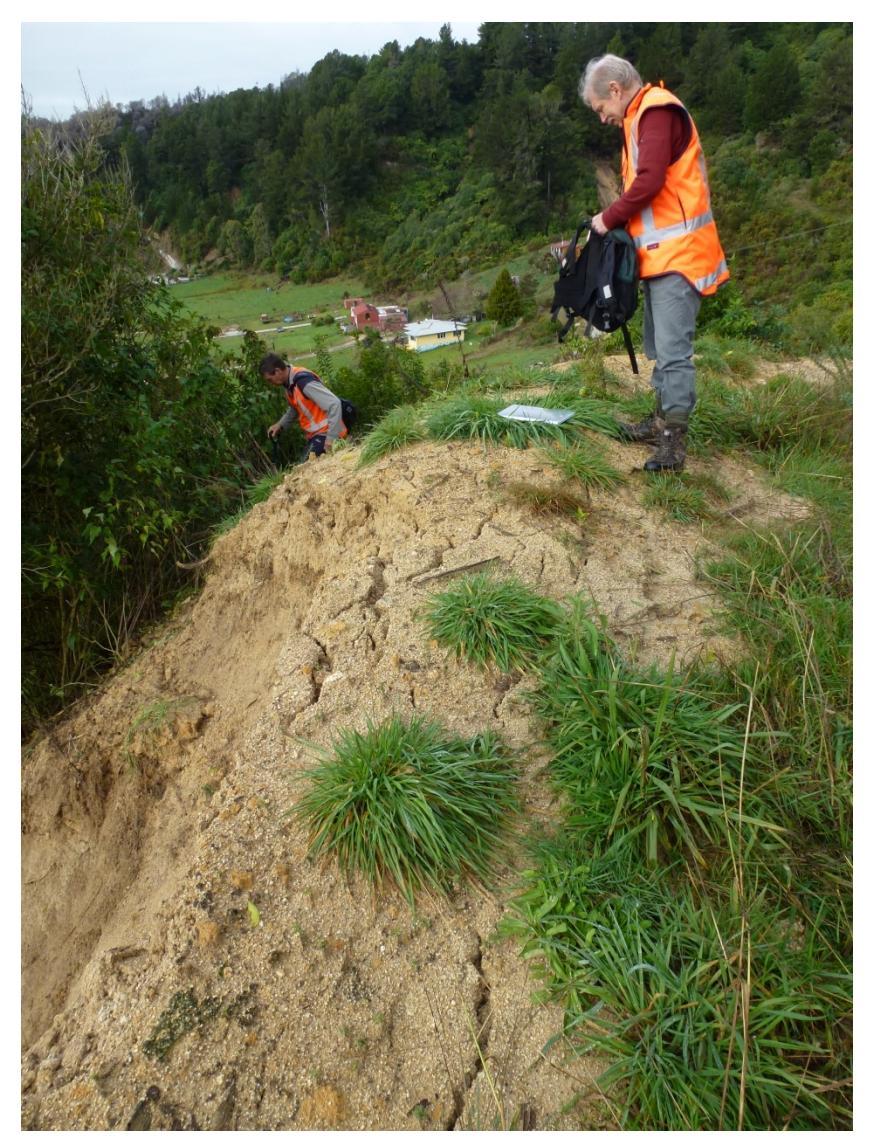
Figure 22 Side castings partially eroded adjacent to head scarp of landslide. Note tension cracks. (TDC photo).

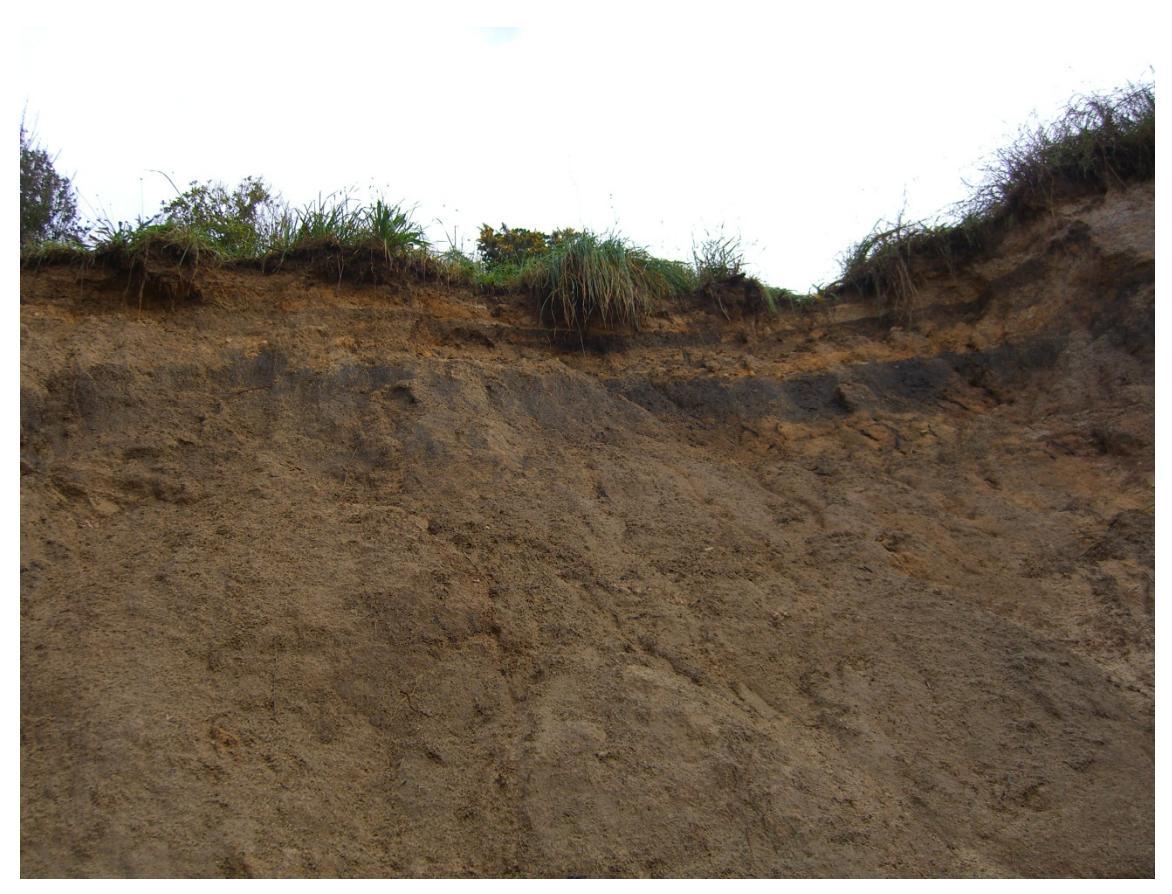
**Figure 23** Head wall of landslide showing original buried soil overlain by side castings from original track construction. A soil formed on these side castings has in turn been buried by a second side casting deposited during track maintenance. Total side casting thickness is ~1.2-1.6 m. (*GNS Science photo*).

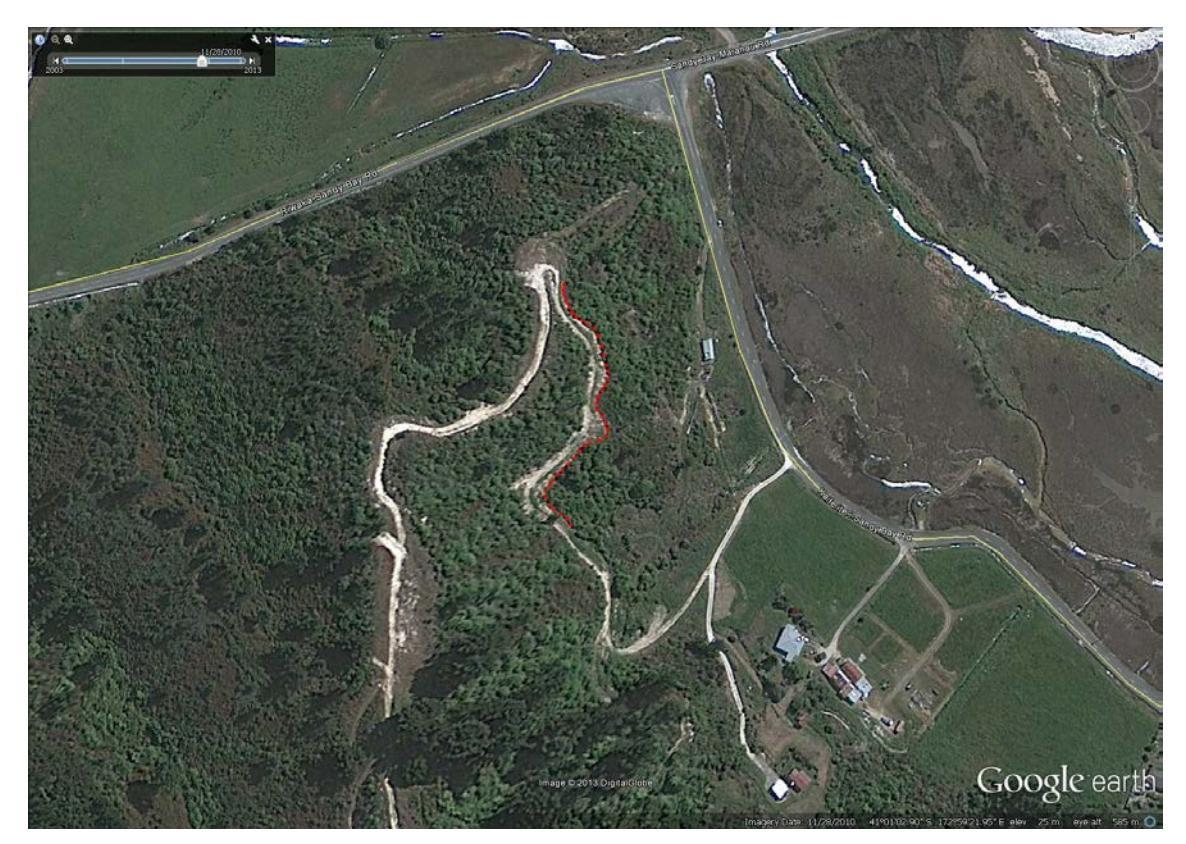
**Figure 24** Google Earth image (28/11/2010) showing recent side castings (outlined in red) deposited between 2006 and 2010 (white and grey curved feature adjacent to the track above the house). Compare with 2006 Google Earth image in Figure 3. Grey areas elsewhere along the track represent earlier side castings.

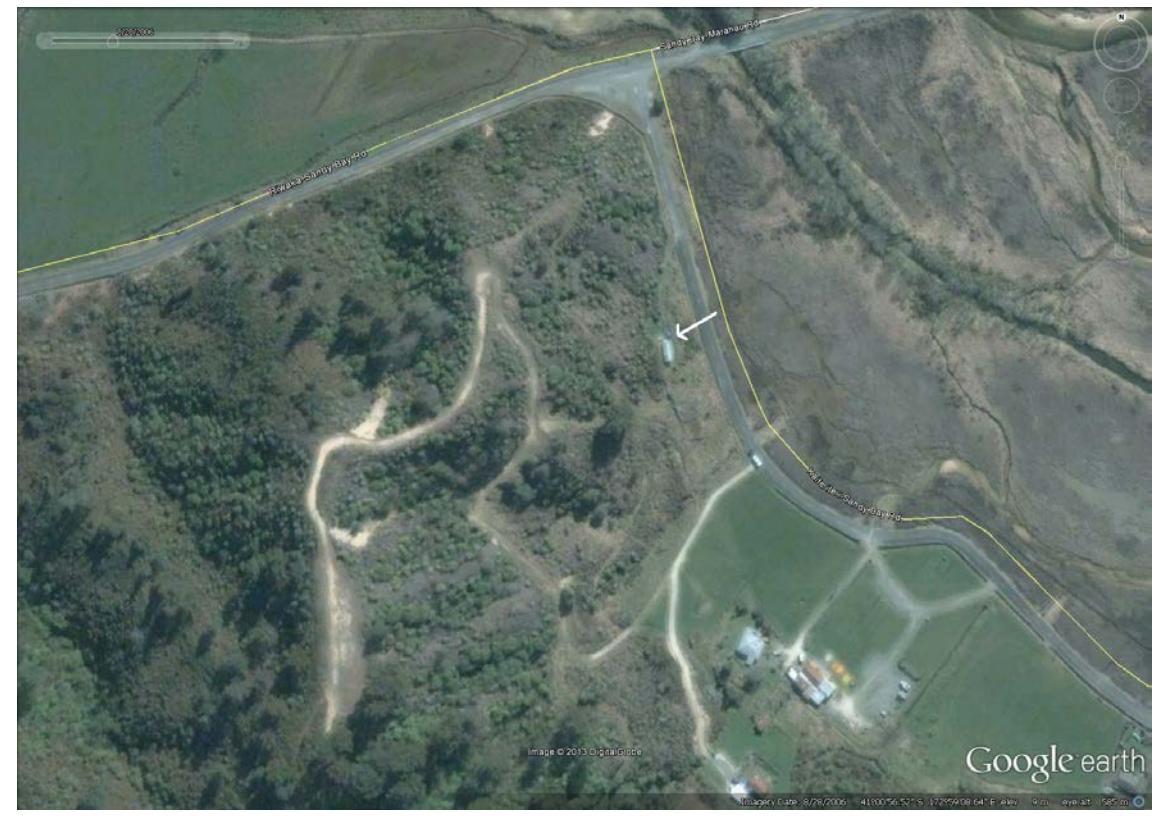
**Figure 25** Vertical Google Earth image (28/08/2006) showing house at 597 Kaiteriteri-Sandy Bay Road before the fatal landslide occurred on 16/06/2013. Note other landslides along access road above the house. House is marked with an arrow.

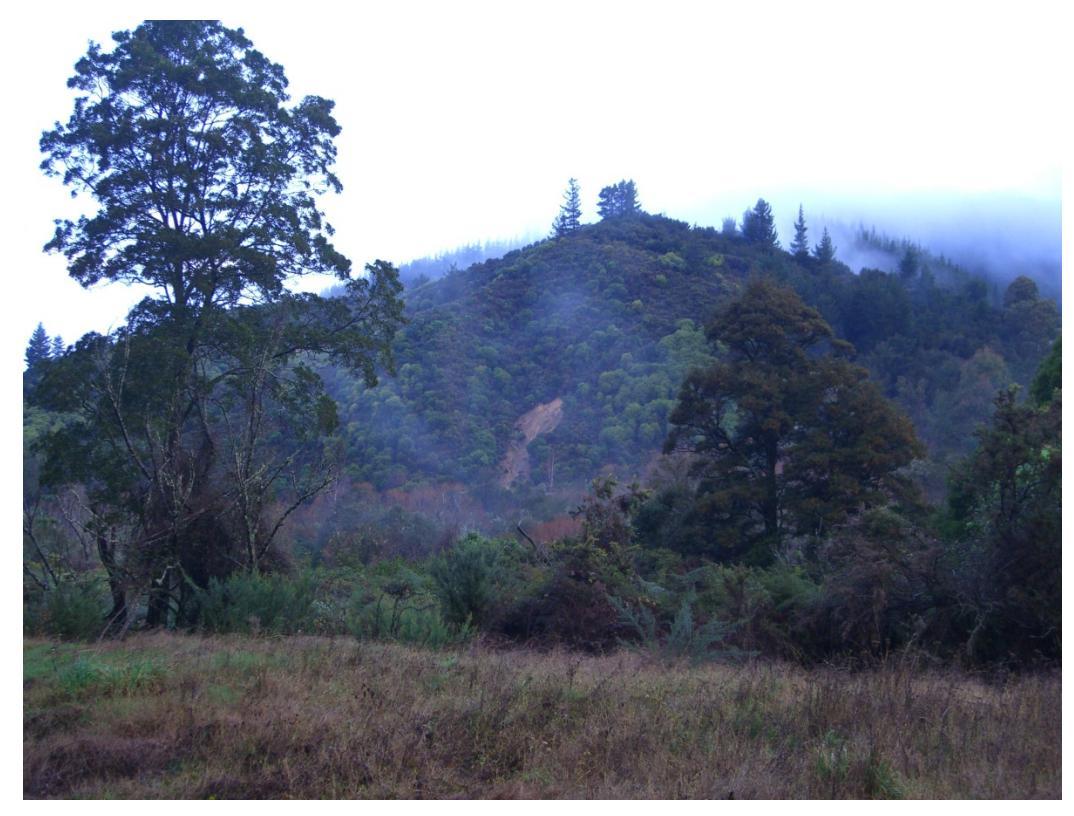
**Figure 26** Landslide that partially destroyed the dwelling at 165 Marahau Valley Road. Photo is taken from Harvey Road on north bank of the Marahau River. *(GNS Science photo).*

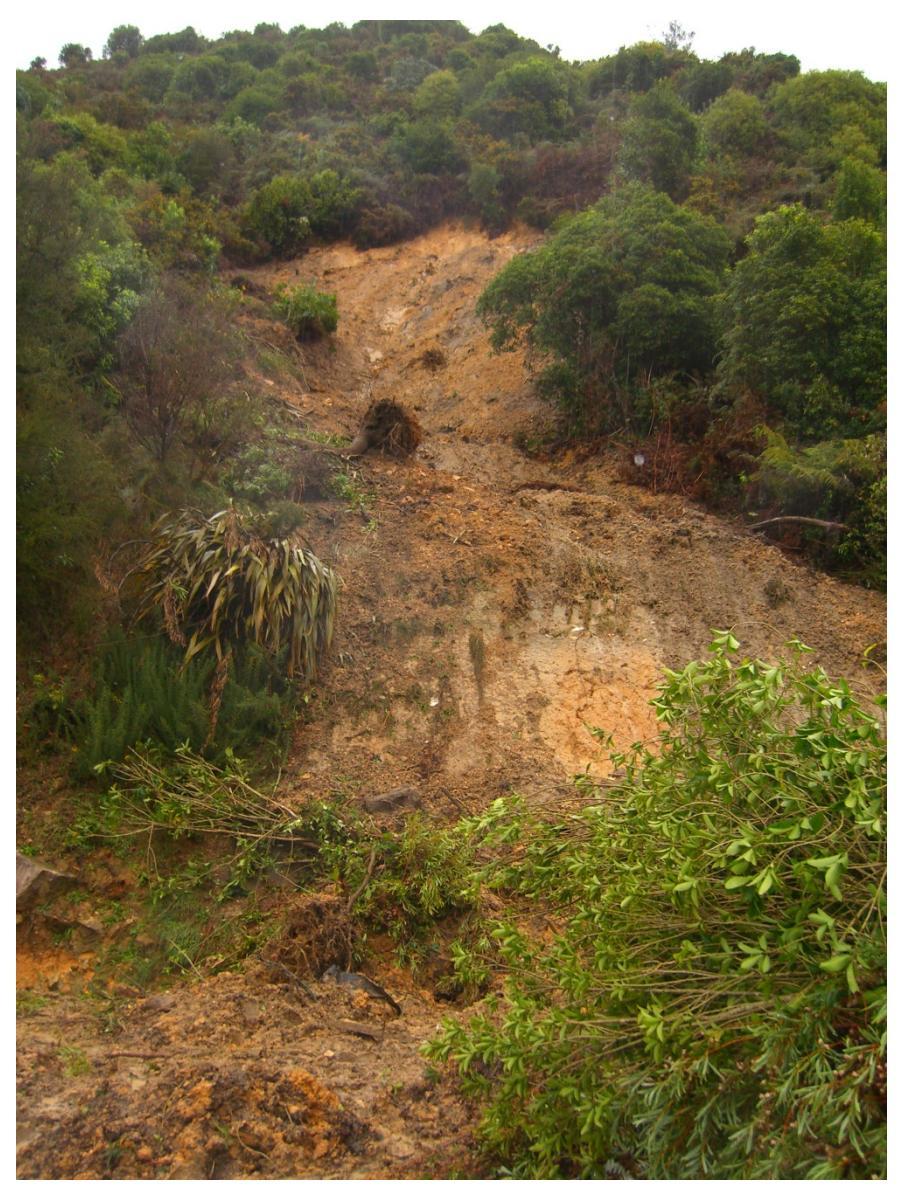
Figure 27 View of landslide looking upslope from levelled building site. (GNS Science photo).

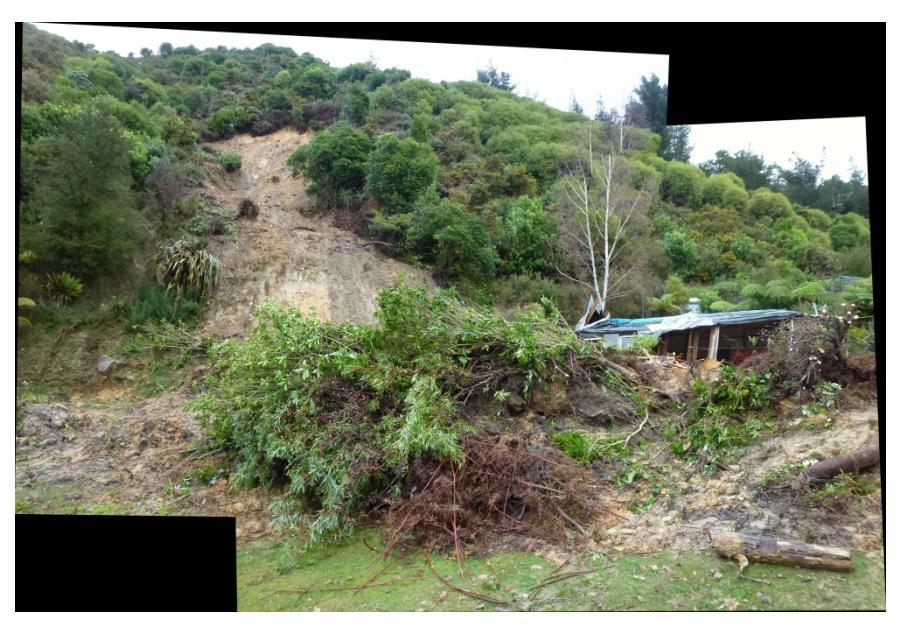
Figure 28 View of landslide, caravan and damaged lean-to. (TDC photo).

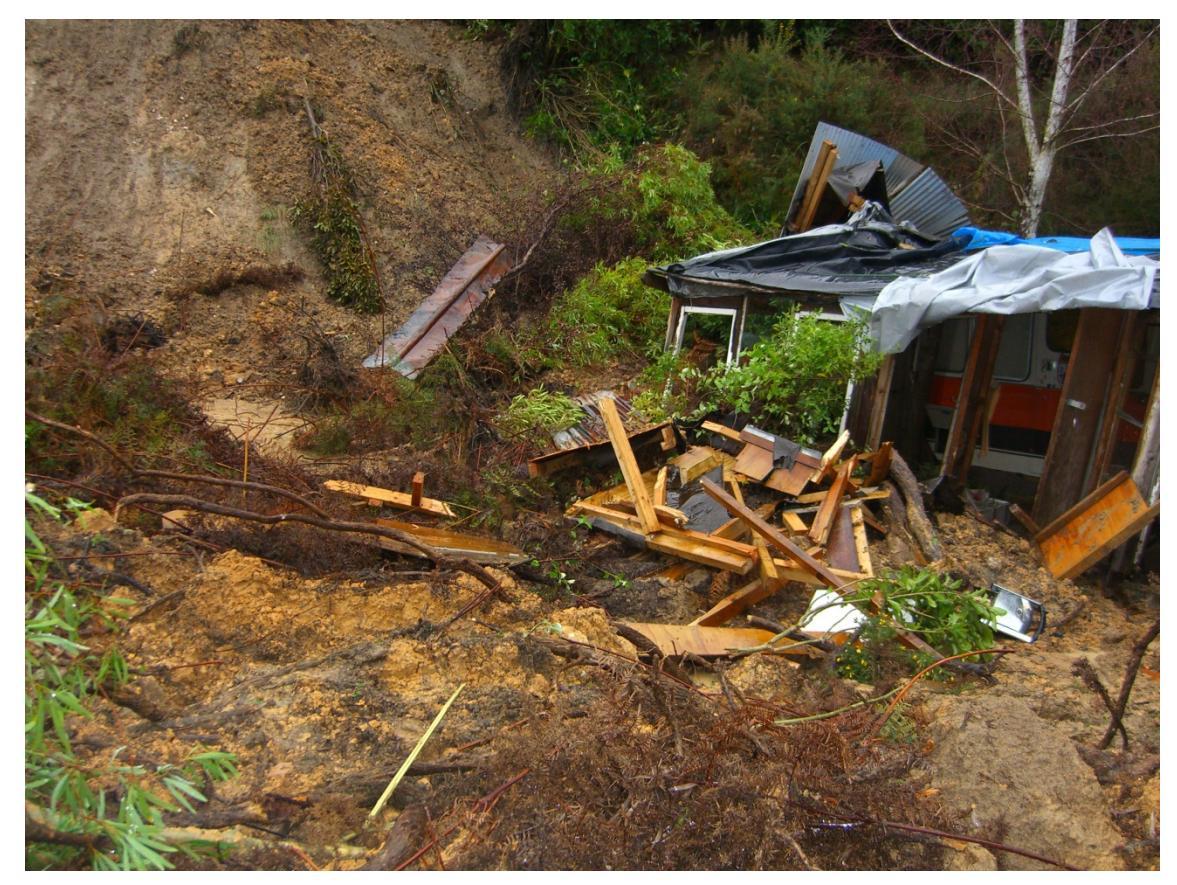
Figure 29 Close up of landslide debris and damaged lean-to. (GNS Science photo).

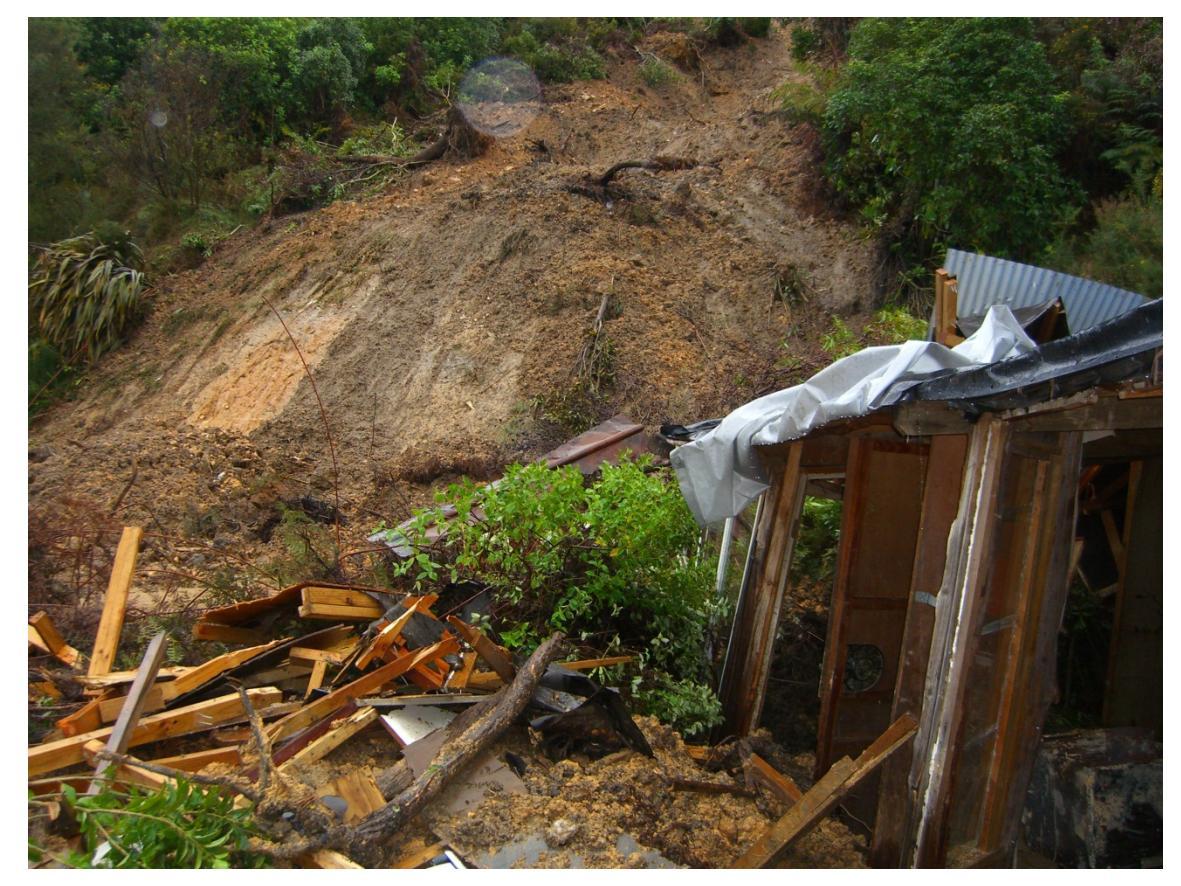
**Figure 30** Close up of landslide debris and damaged lean-to. Note toe of slope has been cut back and oversteepened. *(GNS Science photo).*
