Landslides and debris flows caused by the 15-17 June 2013 rain storm in the Marahau-Motueka area, and the fatal landslide at Otuwhero Inlet

GNS Science Report 2013/44 August 2013

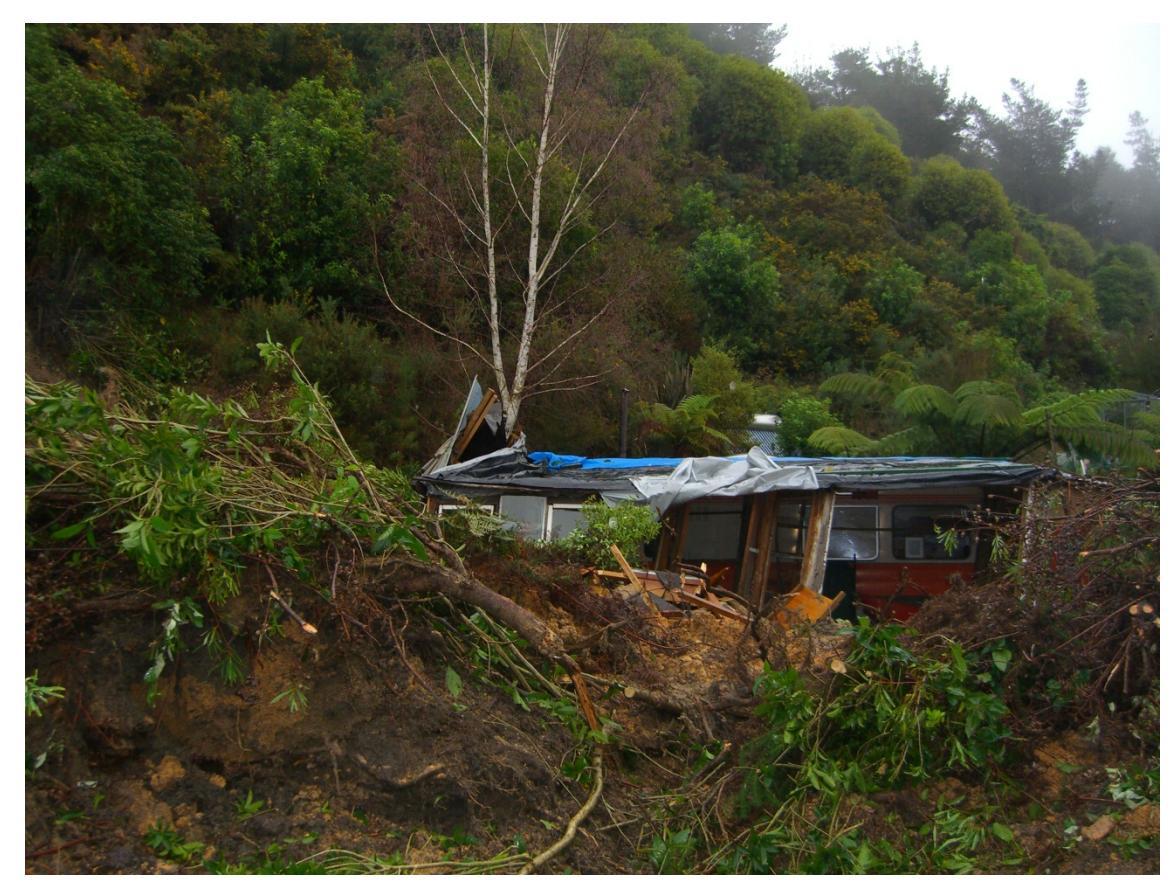
Figure 31 Close up of landslide debris and damaged lean-to. (GNS Science photo).

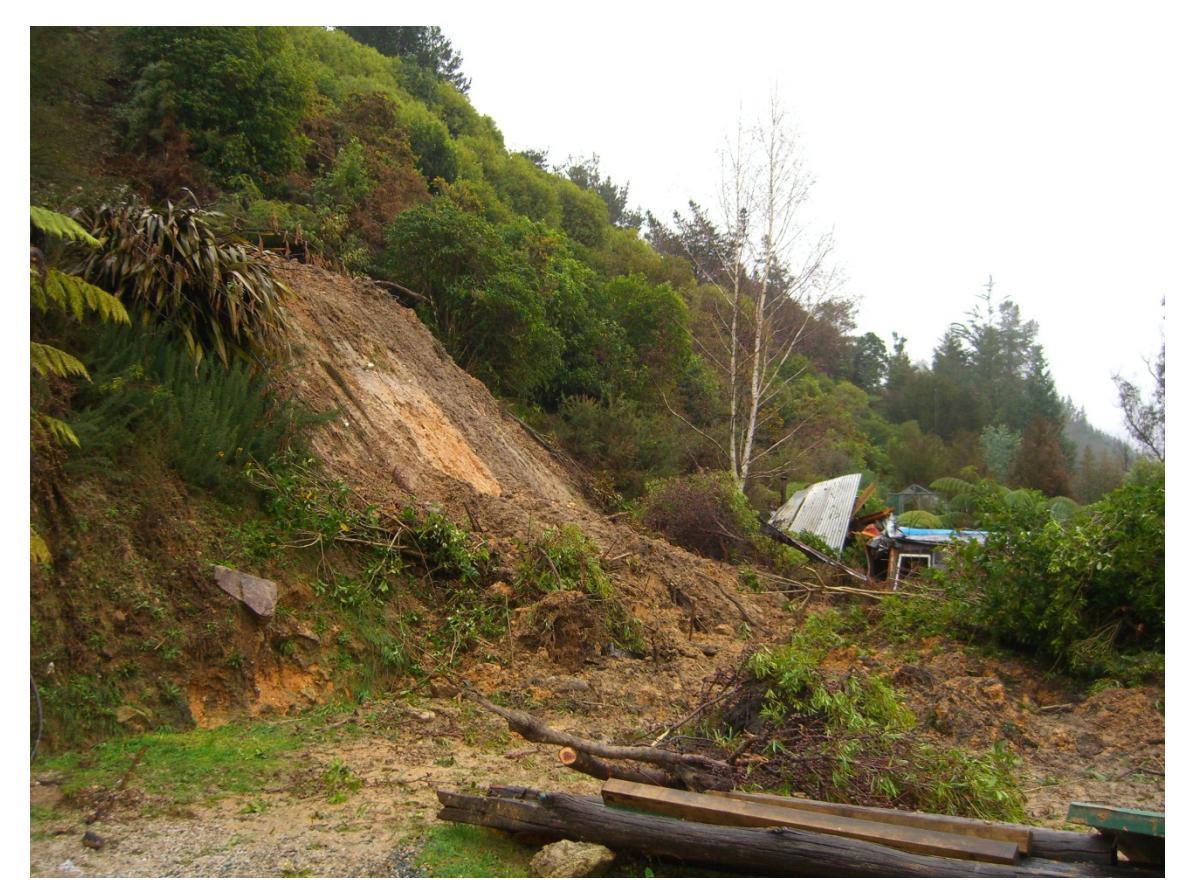
Figure 32 View of cut back, over-steepened toe slope. (GNS Science photo).

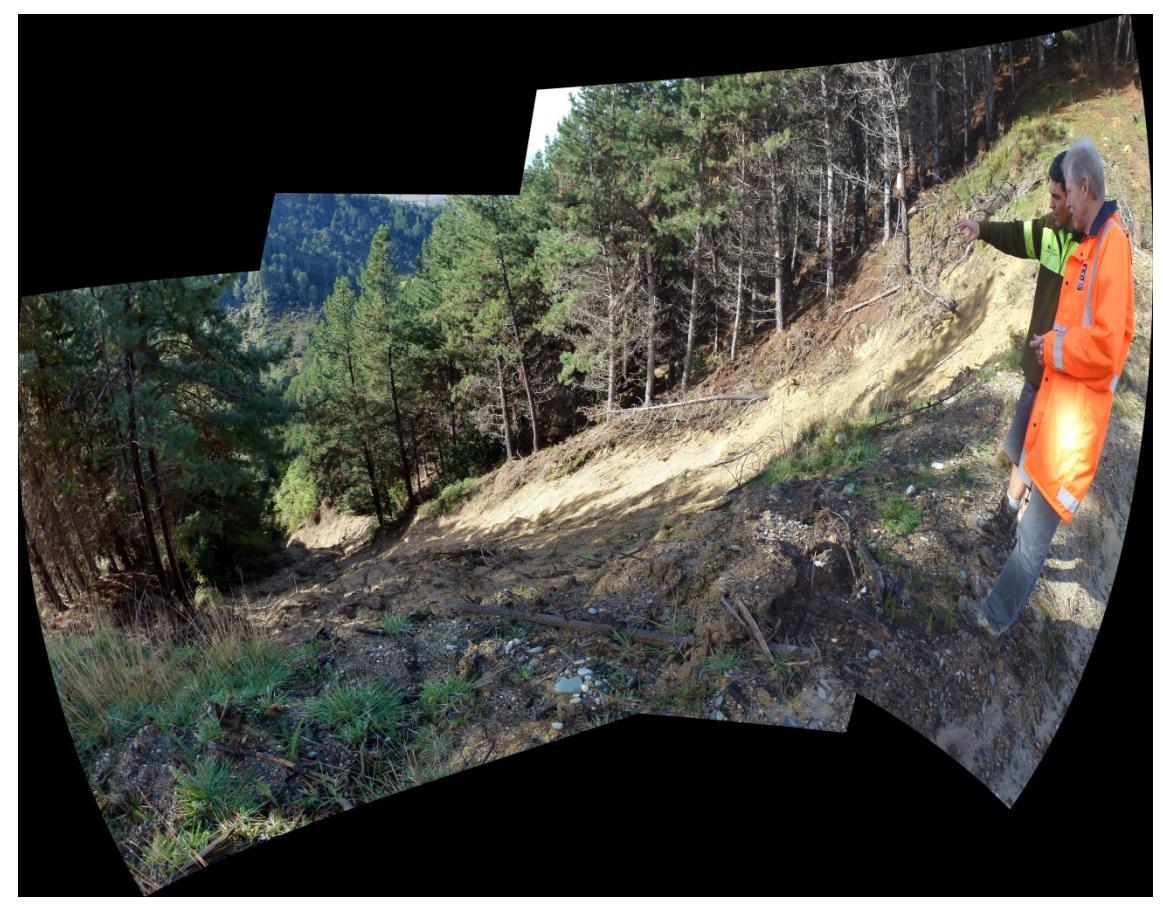
Figure 34 Landslide in established plantation in Shaggery Forest. (TDC photo).

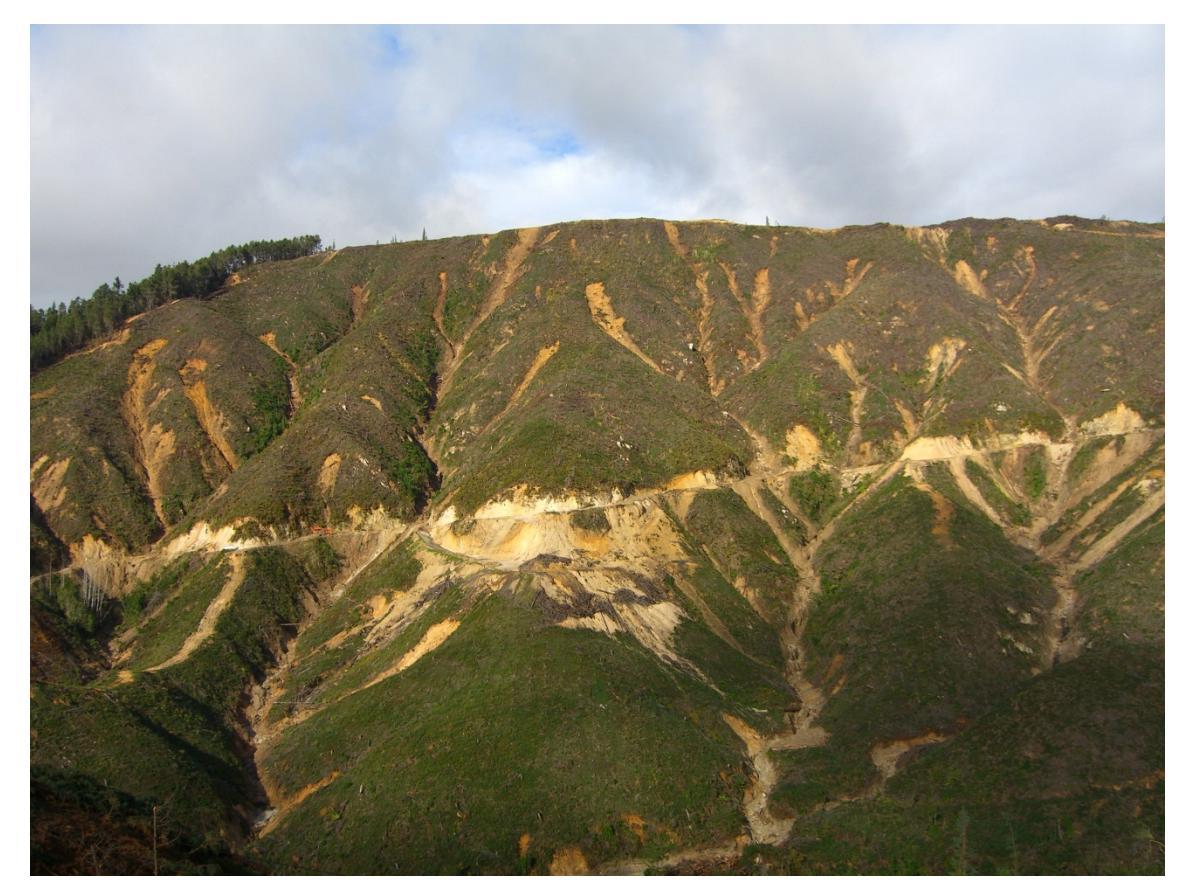
**Figure 35** Landslides in area of Shaggery Forest logged over summer 2012/2013. In addition to the mid-slope forestry road, there is another road along the skyline ridge. Landslides occurred on both natural slopes and associated with the forestry roads. *(GNS Science photo).*

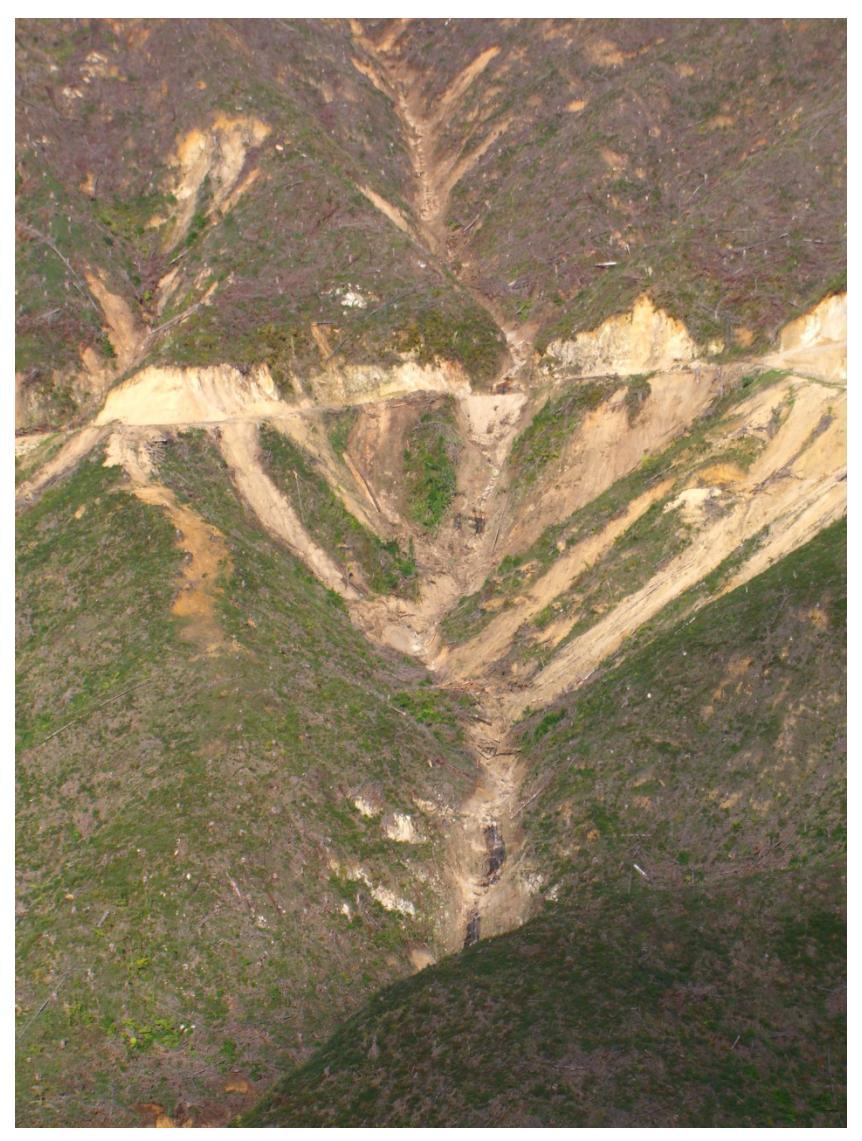
**Figure 36** Landslides associated with the forestry road, where the sediment was delivered directly to a stream channel. *(GNS Science photo).*

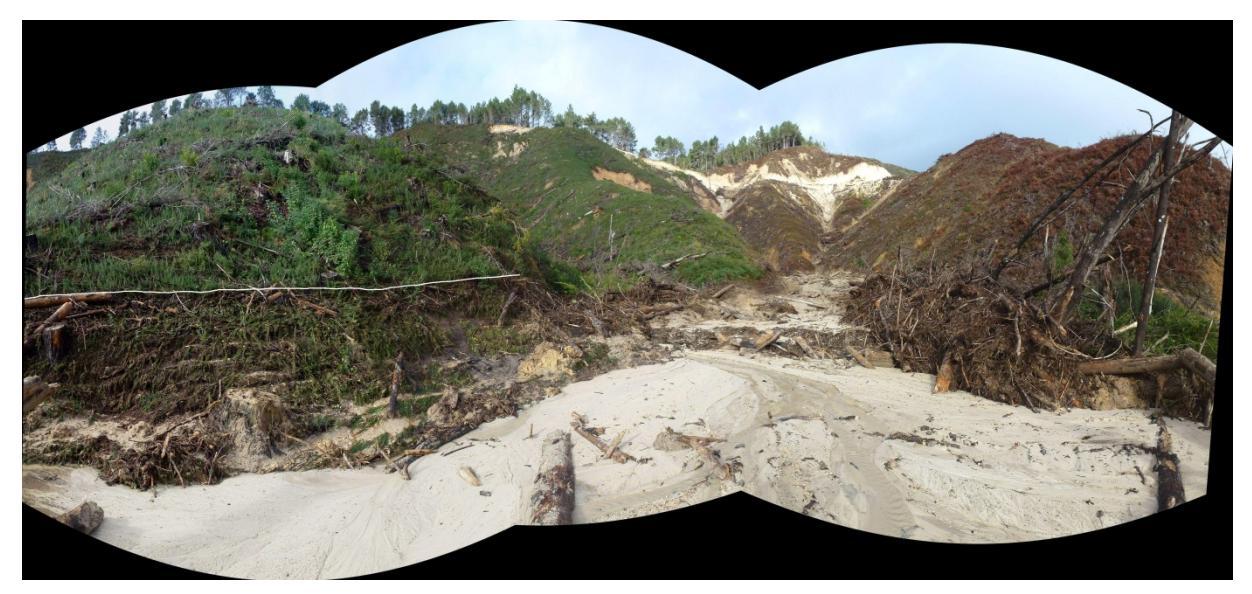
**Figure 37** Landslide sediment and woody debris deposited in stream channel above forestry road. Note trim line in vegetation mid-way up hillslope on left (marked with white line), denoting height of debris flow/flood. *(TDC photo)*.

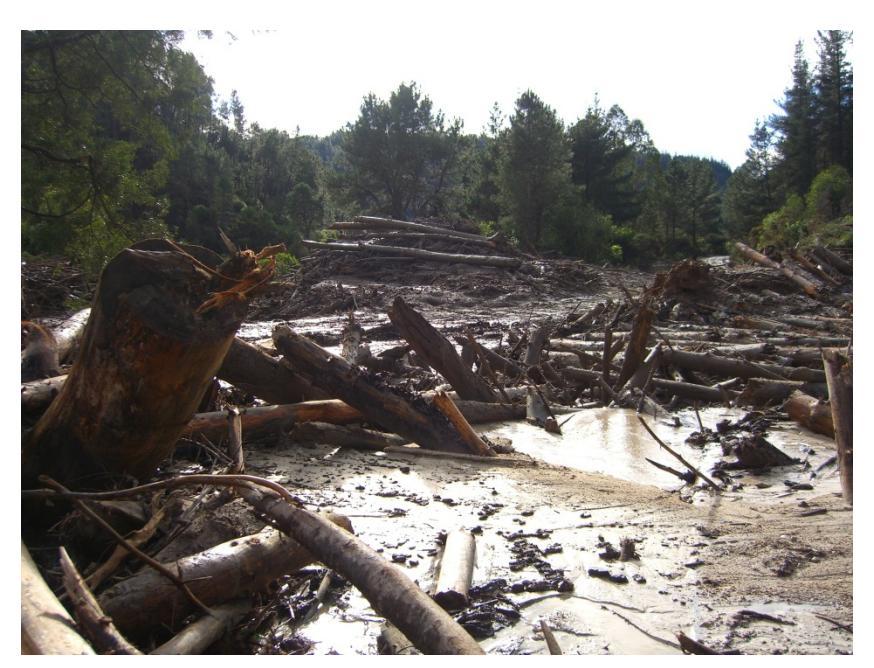
Figure 38 Debris flow deposit on forestry road/landing just downstream of Figure 36. (GNS Science photo).

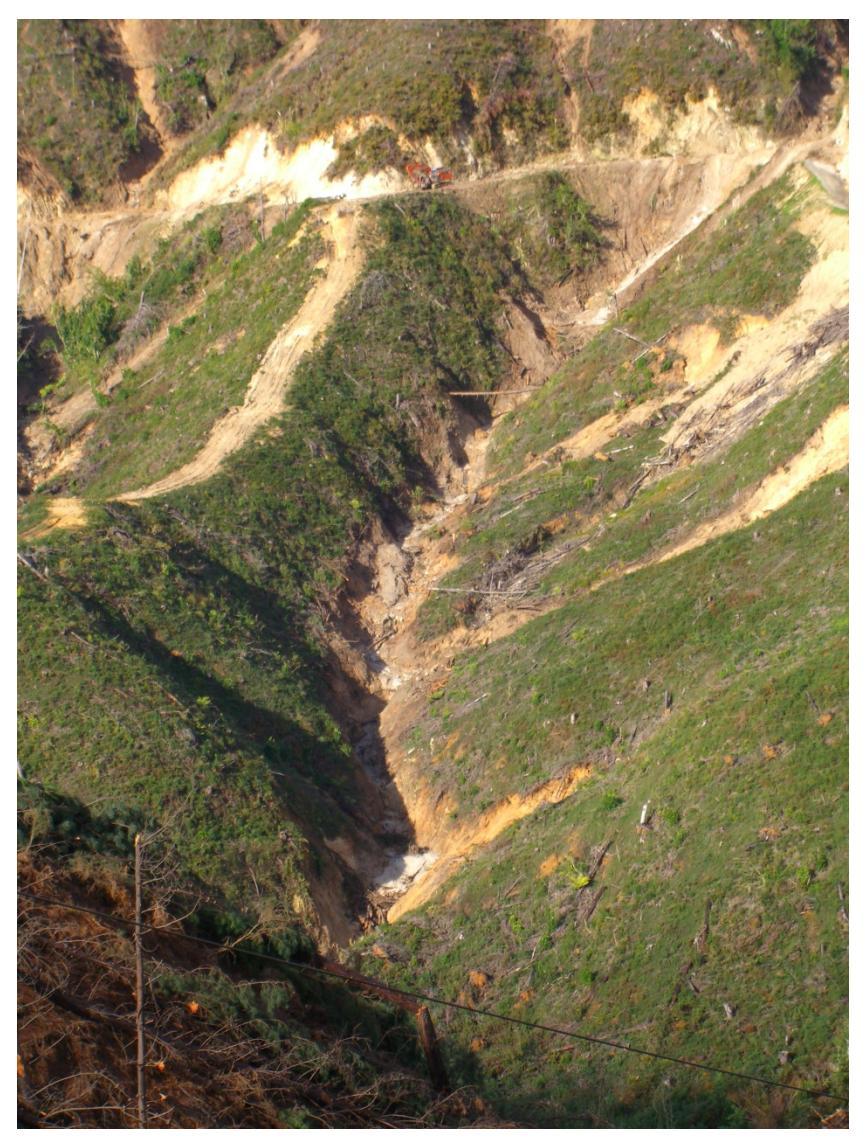
Figure 39 Stream channel scoured by sediment and woody debris-laden debris flow. (GNS Science photo).

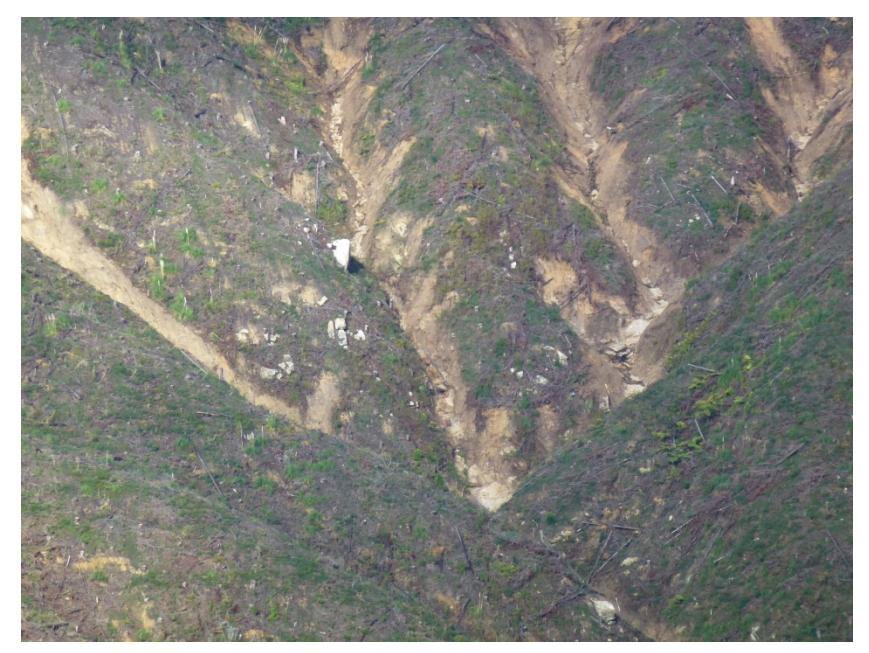
Figure 40 Close up of scoured stream channel. Note exposed bedrock along channel bed. (TDC photo).

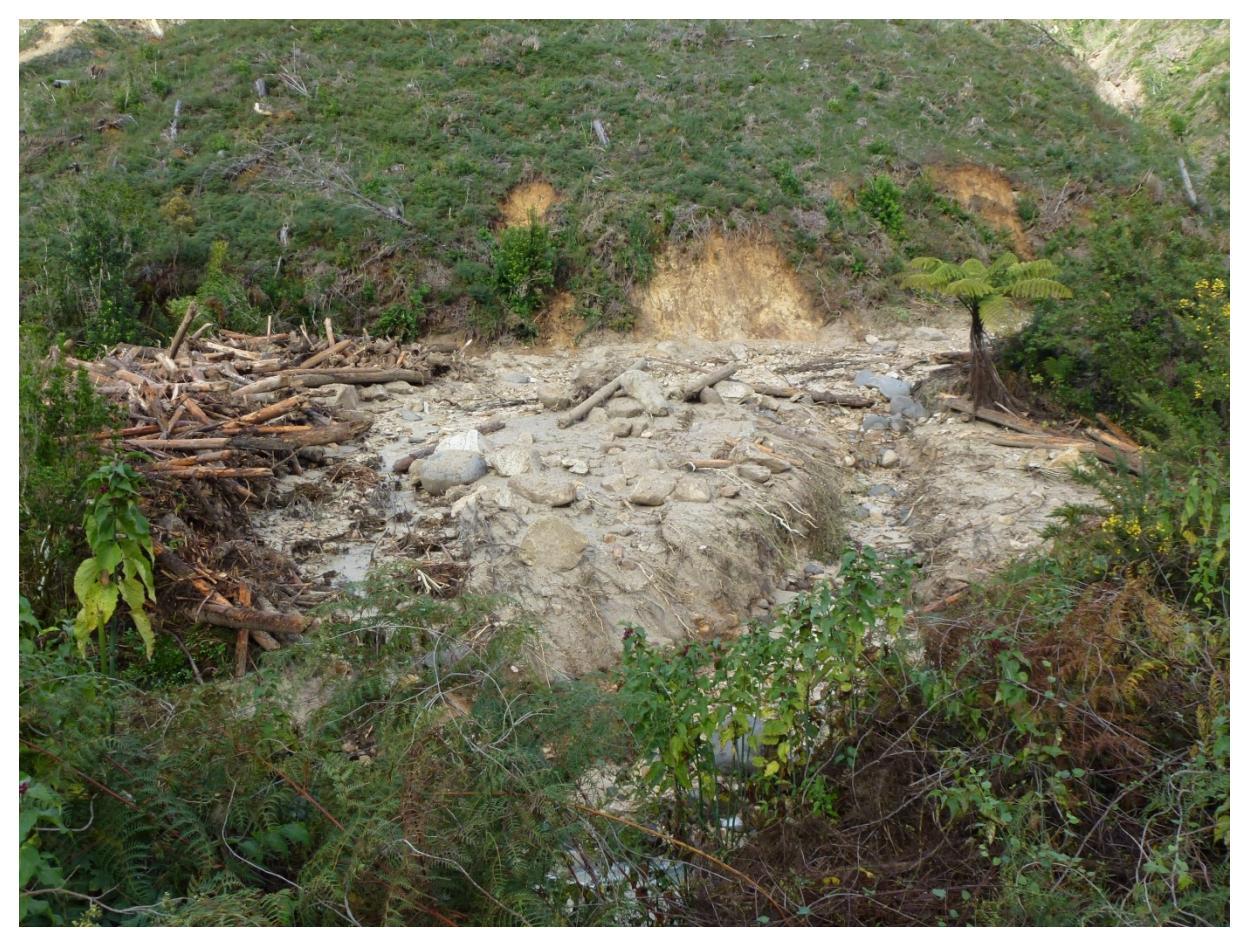
Figure 42 Debris flow deposit from tributary stream at the confluence with the Shaggery River. (TDC photo).

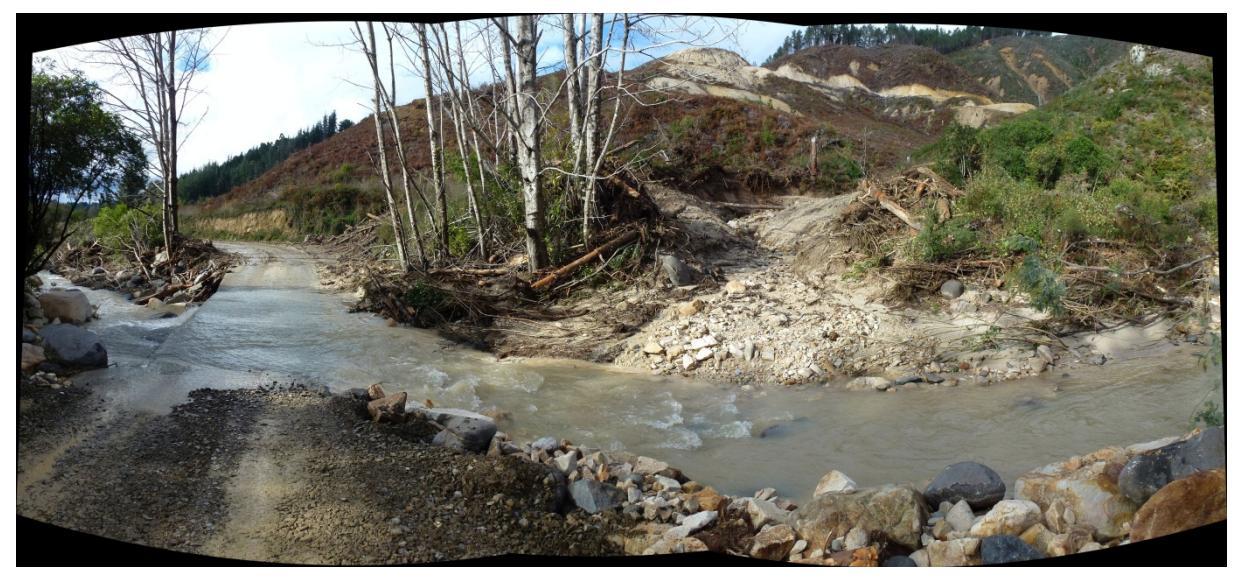
Figure 43 Shaggery River showing sediment and woody debris deposited by tributary stream. (TDC photo).

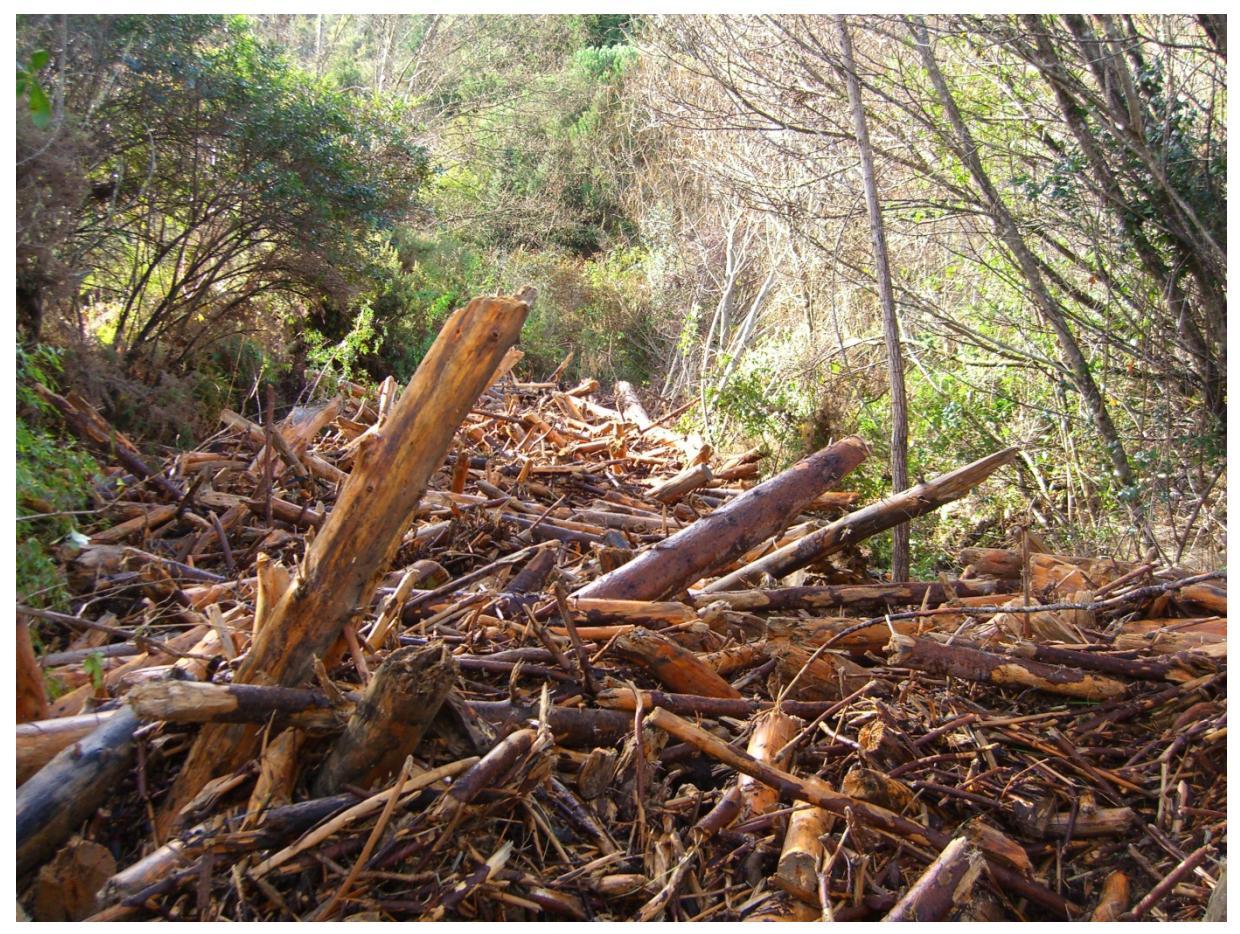
**Figure 44** Woody debris deposited in and adjacent to the Shaggery River, ~1 km downstream from the area of logged forest. *(GNS Science photo).*

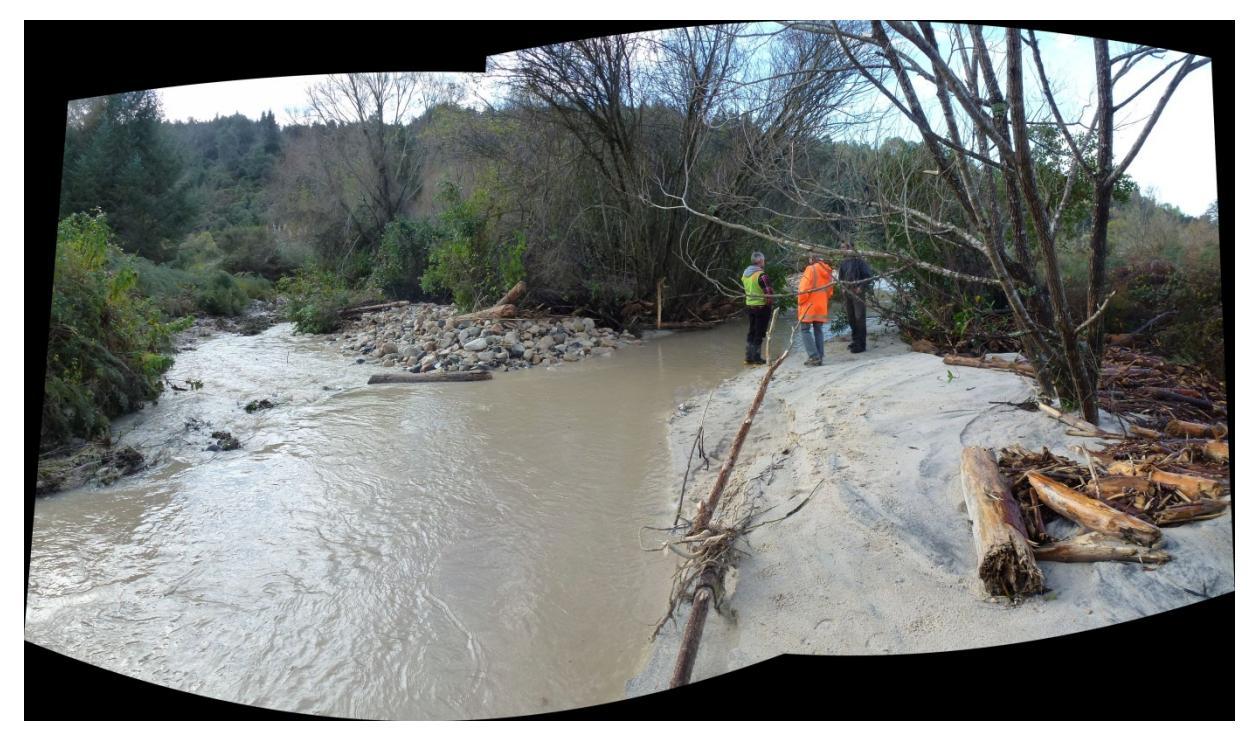
**Figure 45** Shaggery River with main (original) channel to the left, and a post-storm (avulsed) channel to the right. (*TDC photo*).

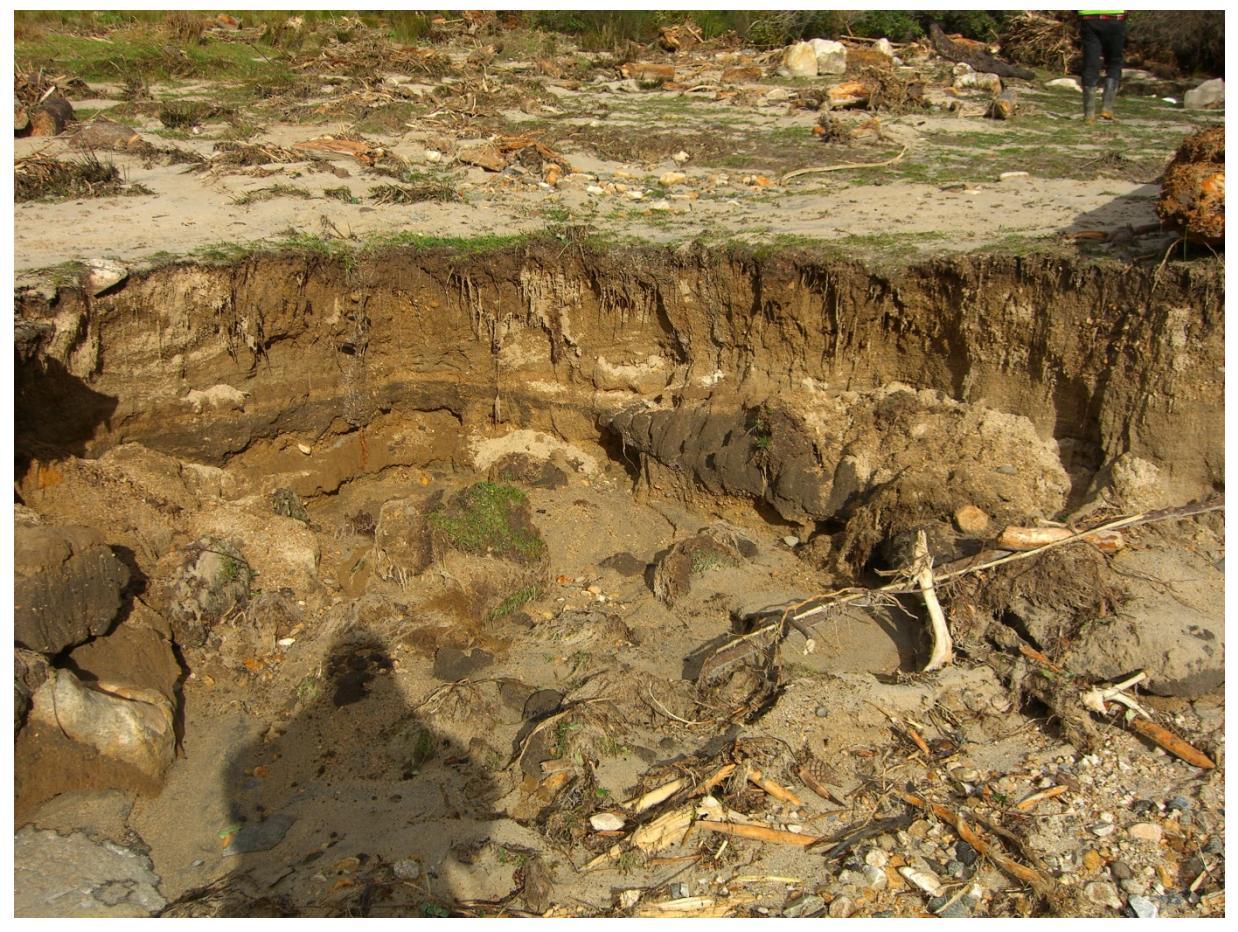
**Figure 47** Sediment deposition on the valley floor ~300 m downstream from the area of logged forest. Earlier flood deposits and a buried soil are exposed in stream bank. *(GNS Science photo).*
