# The 18 May 2005 debris flow disaster at Matata: Causes and mitigation suggestions

Client Report  
2005/71

by M. J. McSaveney, R. D. Beetham & G. S. Leonard

**Whakatane District Council**

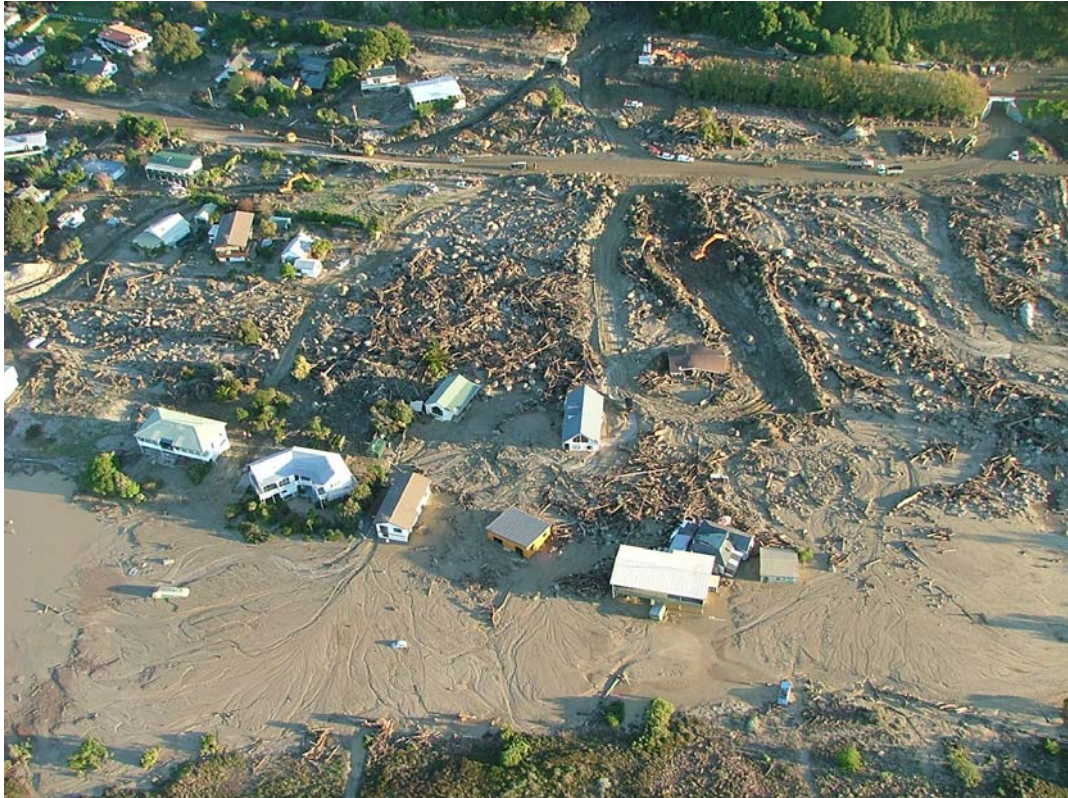
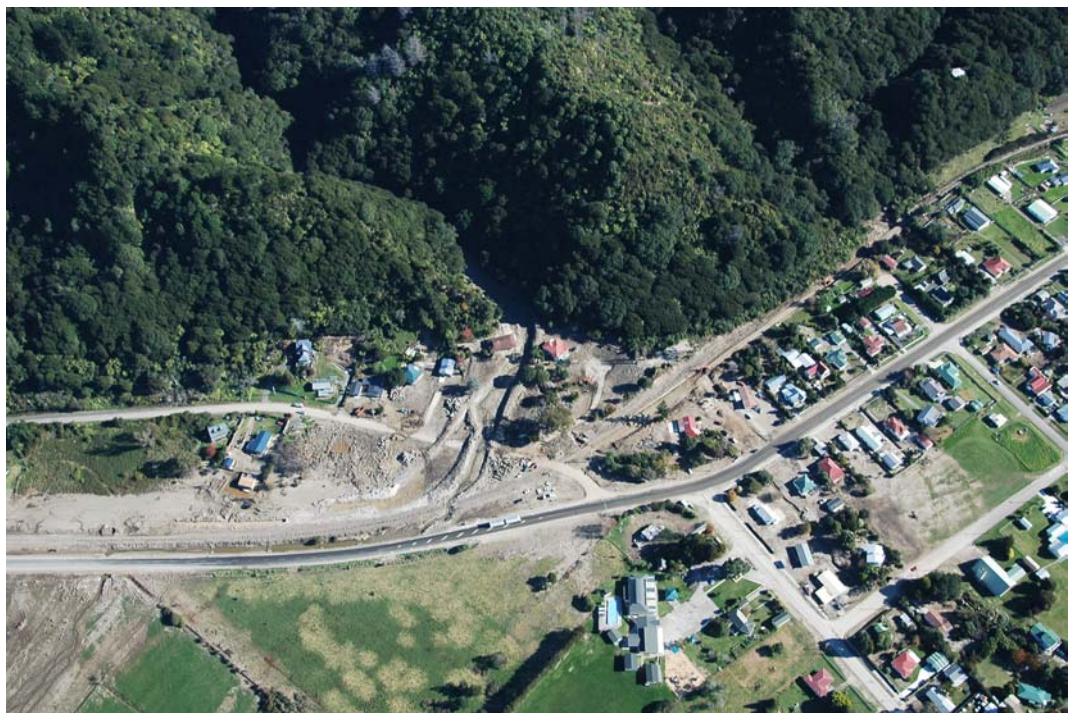
**Frontispiece** “Civilisation exists by geological consent, subject to change without notice.” William Durant, 1885–1981. Debris-flow deposits and damage from Awatarariki (top) and Waitepuru (bottom) Streams at Matata.

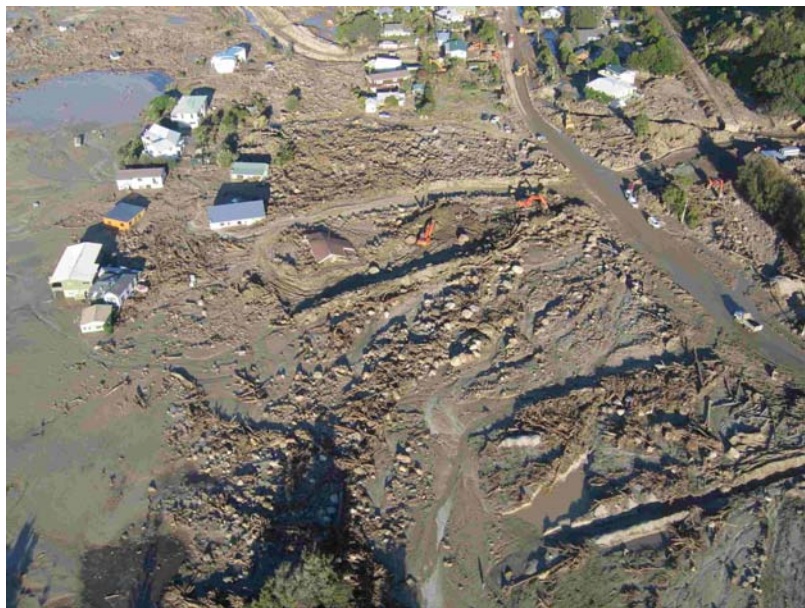
**Figure 1.0.1** A landslide of the type known as a debris flow was the primary hazard at Awatarariki Stream on 18 May, but it was accompanied by flooding too. The boulder-laden debris flow destroyed the rail bridge and houses, then debris-laden water draining from it damaged further houses and property, and filled the lagoon. Photo by Bernard Hegan.

Debris flows were the primary hazard at Matata on 18 May 2005, but they were accompanied by flooding too (Figure 1.0.1). Debris flows do not usually occur without associated flooding downstream. The debris-flow hazard at Matata, hitherto, was unrecognised, even though events now recognised as debris flows have occurred a number of times within the collective memory of the people of Matata. Because debris flows are one of the more destructive natural hazards, now that the hazard is recognised, there is need for the people of Matata to consider ways to reduce the danger. A range of debris-flow mitigation measures is available. They include a variety of engineering works to halt or deflect debris flows, and a range of land-use options. The important thing is to not have people and homes in the way of future debris flows. The people of Matata were very fortunate on 18 May that no one was killed; debris flows are usually lethal.

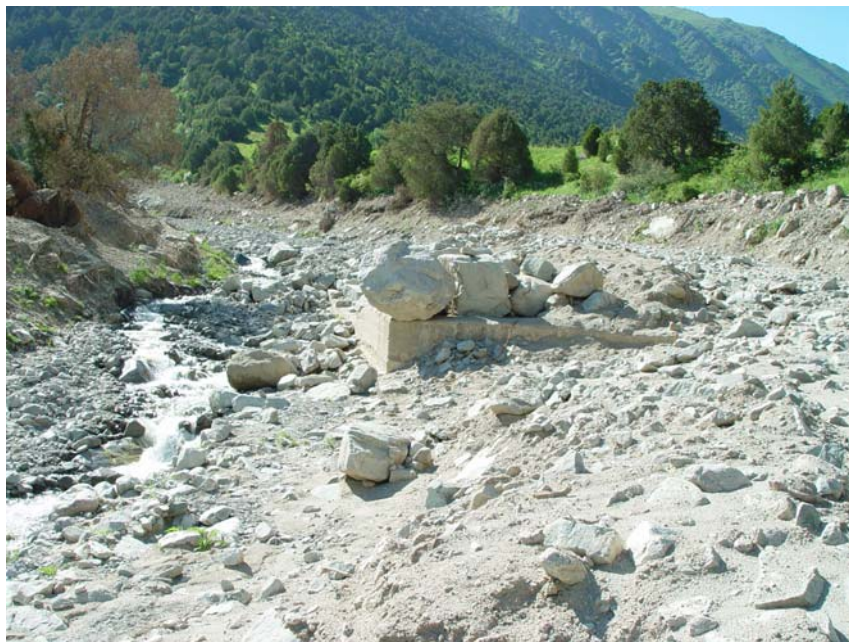
**Figure 1.3.1** Foundations of a farm building destroyed by a debris flow in the Tien Shan Mountains of Kyrgyzstan in 2004. As at Matata, the evidence for past huge debris flows can be read in the landscape, allowing opportunity to avoid such damage though mitigation works and appropriate building restriction where necessary.

- A *debris flow* is a very rapid to extremely rapid (5–10 m/s, 15–30 km/hr) flow of water-saturated, non-plastic (granular) debris in a steep channel. Speeds faster than a fit human can run are common. Besides those at Matata, debris flows have occurred in many New Zealand localities, causing deaths at Blandswood, Te Aroha, Klondyke Corner, Motueka, and the Rees Valley. Huge debris flows occur regularly in the Tien Shan Mountains of Kyrgyzstan during the Spring thaw (Figure 1.3.1).

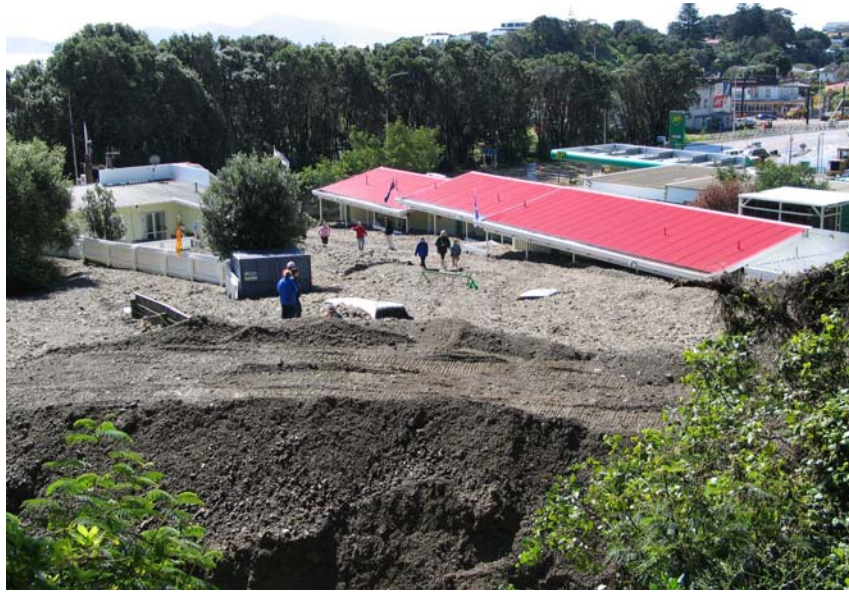
**Figure 1.3.2** *Debris-flood* gravel from the gully exit near Paekakariki Hill Road, north of Wellington, as a result of the storm of 3 October 2003 burying the Belvedere Motel and cars (Hancox G T, 2005).

- A *debris flood* is a very rapid (up to ~5 m/s), surging flow of water, heavily charged with debris, in a steep channel. A damaging debris flood occurred recently at Paekakariki, north of Wellington during an intense rain storm in October 2003<sup>4</sup> (Figure 1.3.2), and again in February 2004 and January 2005.

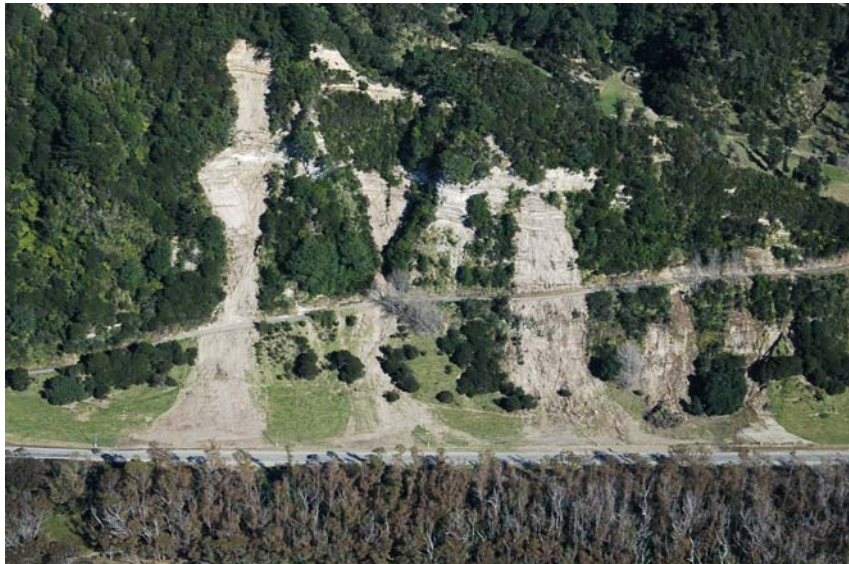
**Figure 1.3.3** *Debris avalanches* from the old seacliff, northwest of Matata, at Herepuru Road. SH2 in the foreground. *Debris avalanches* such as these initiated *debris flows* when they fell into stream channels in catchments behind Matata.

- A *debris avalanche* is a very rapid, to extremely rapid (5–20 m/s, 15–60 km/hr), shallow flow of partially or fully water-saturated debris on a steep slope, without confinement in an established channel. Several debris avalanches which occurred during the storm from the steep cliffs just northwest of Matata spread water laden soil and tree debris over the road and railway line (Figure 1.3.3).

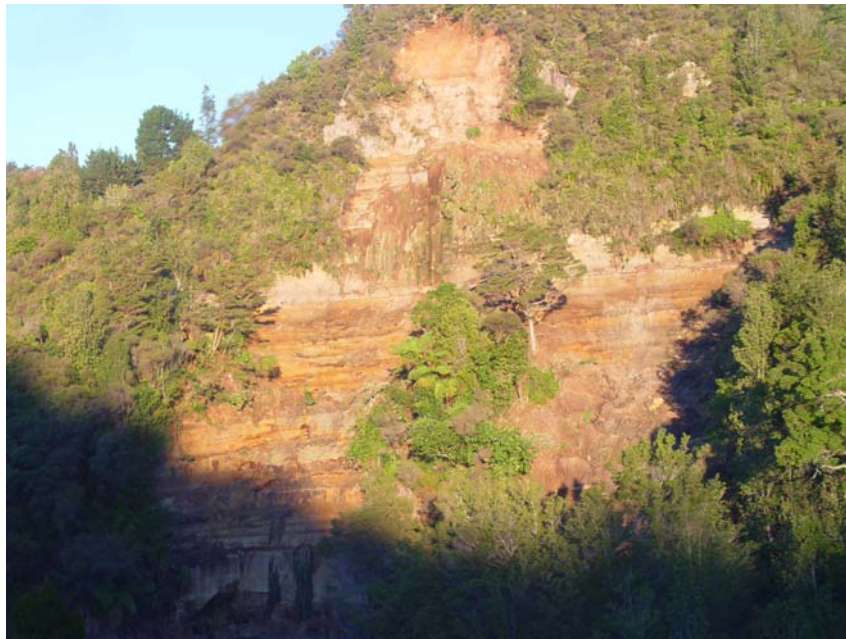
**Figure 1.3.4** Several *debris avalanches* within the headwaters of Awatarariki Stream. Many *debris avalanches* such as these formed *debris flows* when they reached the stream channels.

Immature (sub-mature) forest trees falling from the slopes and eroded from the channel banks contributed to the large volume of woody debris now on the fans (Figure 1.3.4). The forest cover has neither inhibited, not contributed to initiating the debris flows. The trigger was the very high-intensity rain. Had the forest cover been more mature (larger trees), it is possible

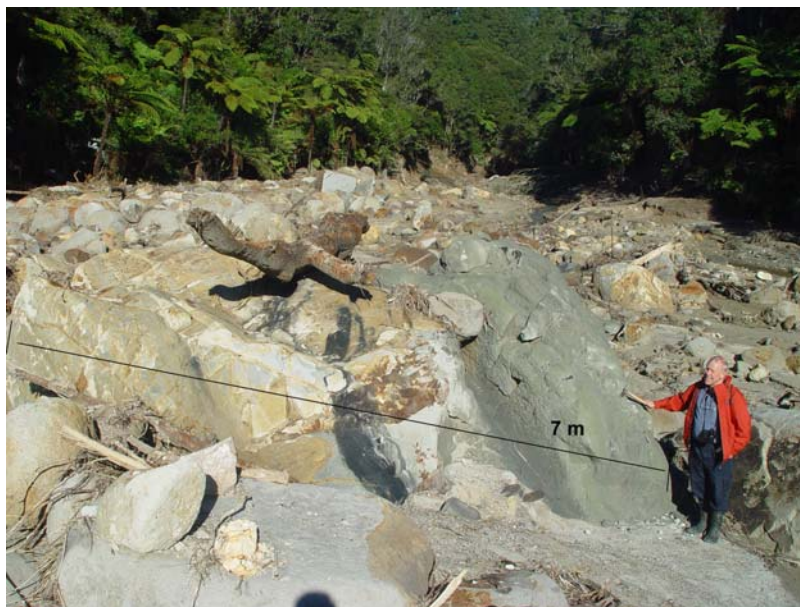
**Figure 1.3.5** Debris flows are known for their ability to transport huge boulders as part of their mix of water, sand, gravel, cobbles and boulders. This huge boulder of bedded siltstone in the bed of Awatarariki Stream probably fell into a passing debris flow when the valley side a hundred metres or so upstream was undercut by the highly erosive debris flows. It was part of a late-phase debris-flow pulse that stopped in the area of the old quarry. Earlier, larger pulses reached out onto the lowland plain at Matata (as in the Frontispiece).

- *Debris* in these contexts is loose, unconsolidated material of low plasticity. In texture, debris is a mix of silt, sand, gravel, cobbles and boulders (Figure 1.3.5), often with a trace of clay, but not necessarily so. Debris also may contain a significant proportion of organic material including logs, stumps, and organic mulch (Figure 1.3.6).

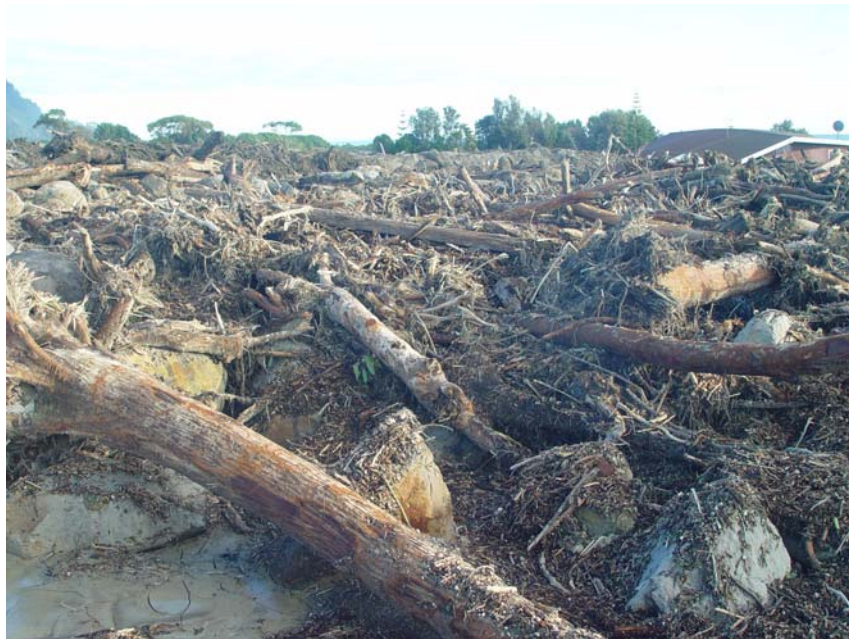
**Figure 1.3.6** Organic debris from the catchment forest cover is estimated to have been perhaps 10% of the total debris carried by the debris flows at Matata.

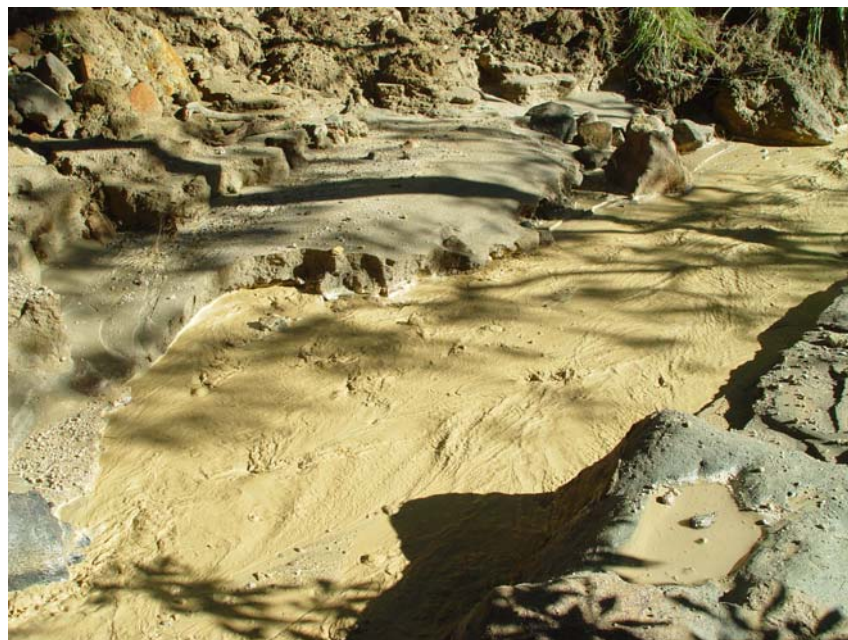
**Figure 1.3.7** A small stream west of Matata, beside SH2 photographed in hyperconcentrated flow on 23 May. The flow appears to be thick and oily. Much of the surface roughness usually seen on a clear stream is damped out because of the high density of the flow. Witnesses described and photographed<sup>7</sup> hyperconcentrated flows at Matata on 18 May.

floods as discussed earlier, are large, sediment-rich flow events, which may or may not involve hyperconcentrated flow. Hyperconcentrated flow is a distinct flow process that can occur at low as well as high discharges. A hyperconcentrated flow is a flow of water so highly charged with sand and silt that much of its turbulence is damped out and its flow appears to be smoothed and oily, though it may be moving faster than an equivalent depth of clean water. The normal small-scale surface choppiness and splashes of water are missing on hyperconcentrated flows. A dense, fast-moving hyperconcentrated flow is capable of moving larger boulders along the bed of the flow than is the equivalent normal flow of water. Some witness descriptions of the floodwater at Matata<sup>6</sup> fit hyperconcentrated flow from debris flows, and we saw one small stream west of Matata in hyperconcentrated flow on 23 May when it was far from being in flood (Figure 1.3.7).

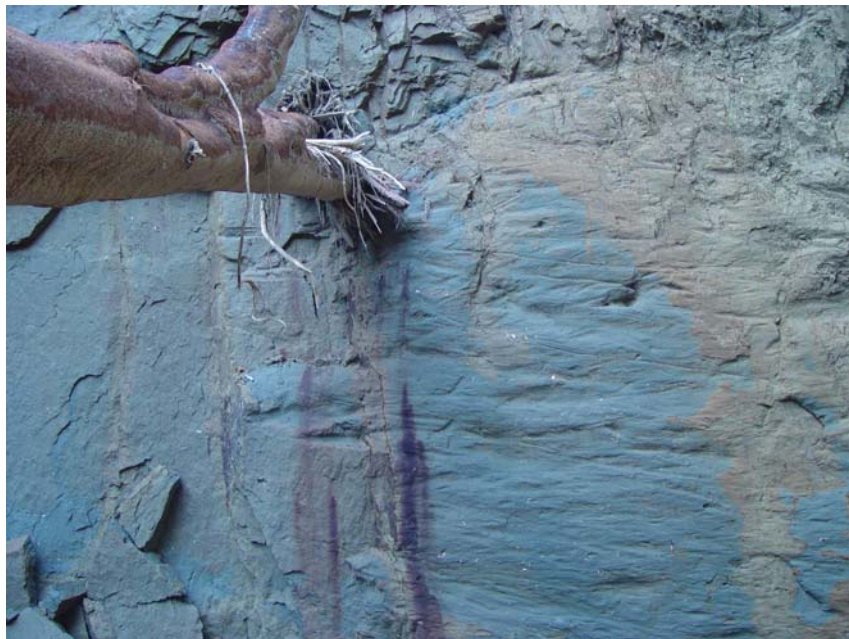
**Figure 2.7.1.** Grooves gouged into the soft siltstone by passing boulders in the debris flows. The parallel grooves indicate that the mass of the debris flow slid past the cliff, much like a glacier (but of course far faster).

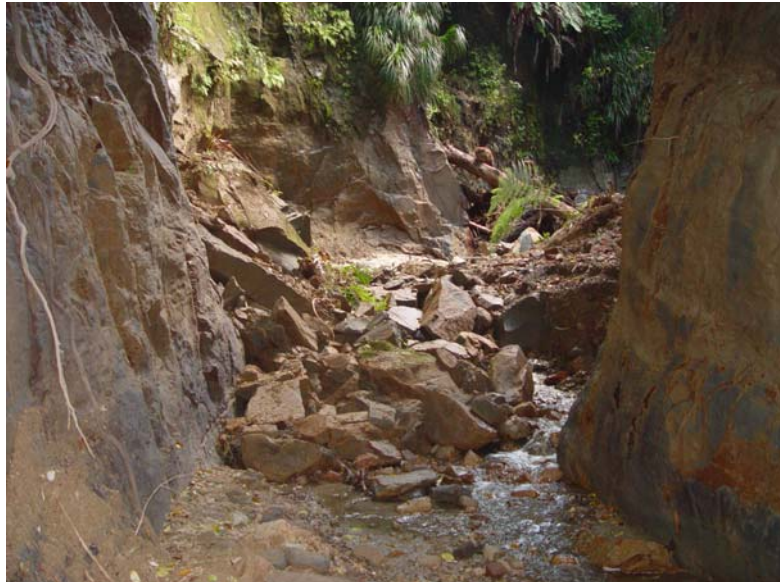
**Figure 2.8.1** A recent small stream-channel landslide. It fell after the debris flow of 18 May, and had yet to be overtopped by water flow.

In the channels of Awatarariki Stream and especially Waitepuru Stream, there is clear evidence of channel damming by landslides, but all of the evidence that we saw was for landslides and dams that were consequent on the severe erosion of the channel banks by the passage of large debris flows. That is, they occurred during and after the debris flow; some, so much later, that the dam material has yet to be overtopped by floodwater (Figure 2.8.1).

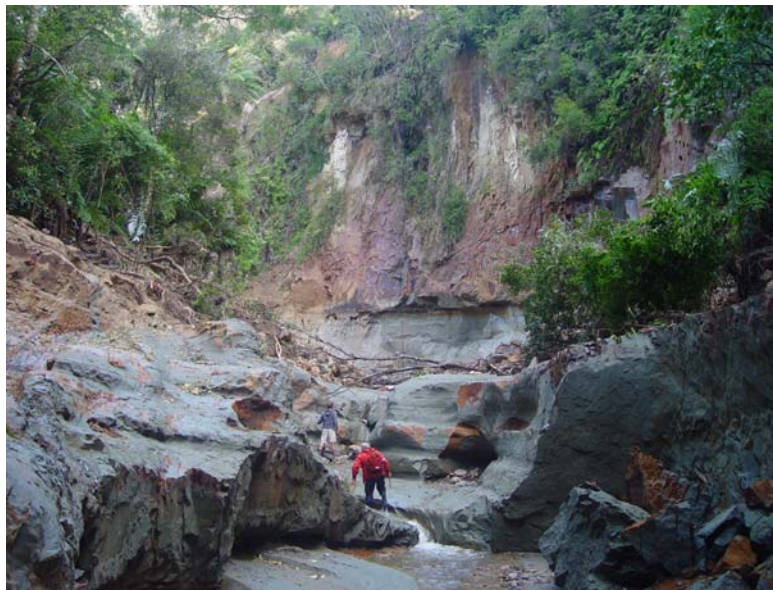
**Figure 2.9.1** Debris flows cut a distinctive U-shaped channel that is highly diagnostic of repeated debris flows over a long time.

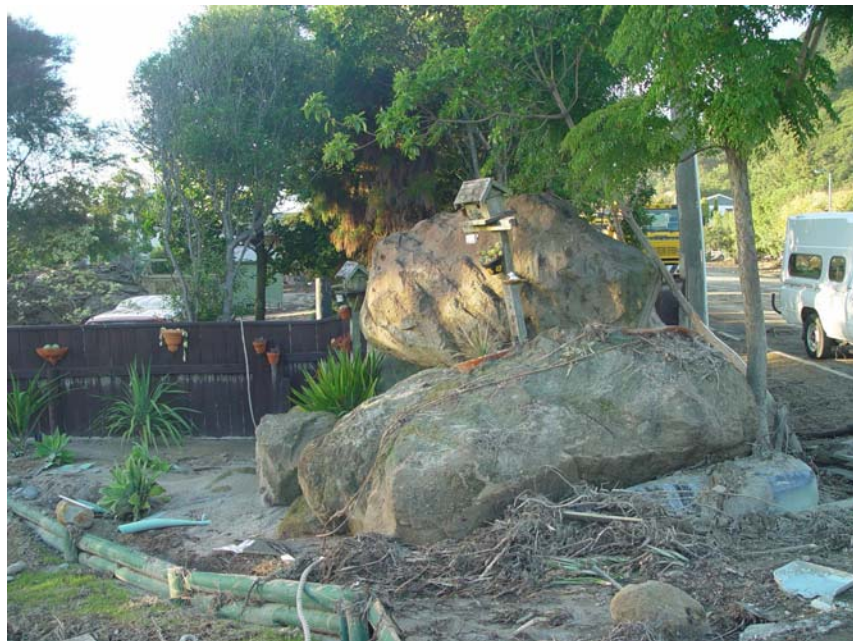
**Figure 2.10.1** Huge boulders from past debris flows are used as landscaping features. They provide clear evidence of past debris flows at Matata.

There is irrefutable evidence for previous debris flows at Matata. The evidence shows that large prehistoric debris flows built the land beneath Matata over the last 7000 years. One of the previous debris flows delivered the huge boulders that were used as landscaping features on the fan of Awatarariki Stream before 18 May (Figure 2.10.1).

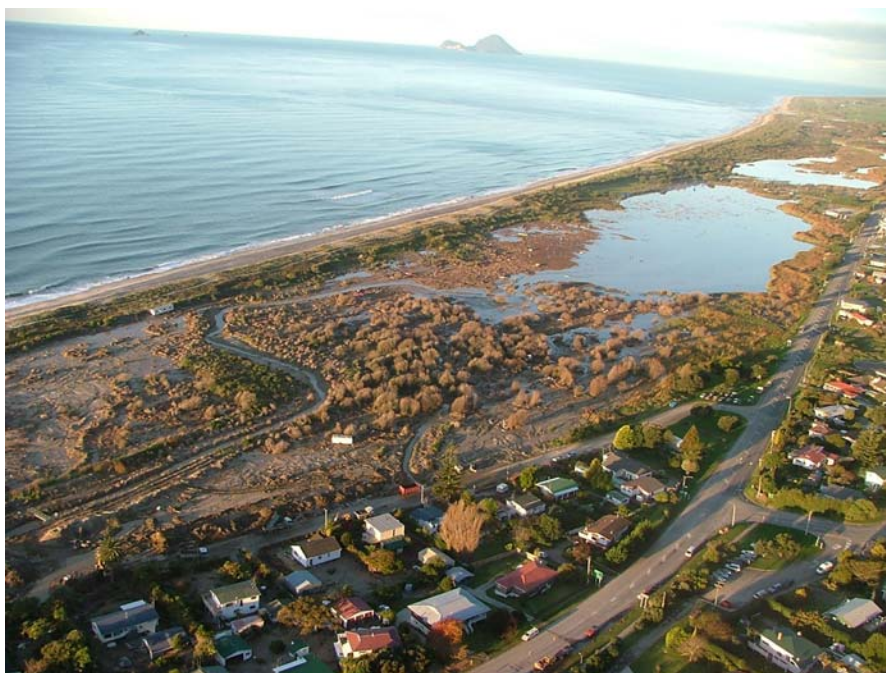
**Figure 3.0.1** Much of the fine sediment (mostly sand and silt) did not stop on the fan of Awatarariki Stream, but was carried into the Matata Lagoon.

We have only been able to make crude estimates of the volumes of solid material deposited at Matata. For Awatarariki Stream, the fan length is about 300 m and width, about 300 m. An average sediment depth of about 2 m leads to a volume estimate of about 100,000 m<sup>3</sup> on the fan. Some 10% of this is “large woody debris” – the larger remnants of the trees (Figure 1.3.4). Perhaps as much again of sediment and woody debris did not stop on the fan and is now in the lagoon and beyond (Figure 3.0.1). In all this adds to a total estimated volume of 200,000 m<sup>3</sup>.

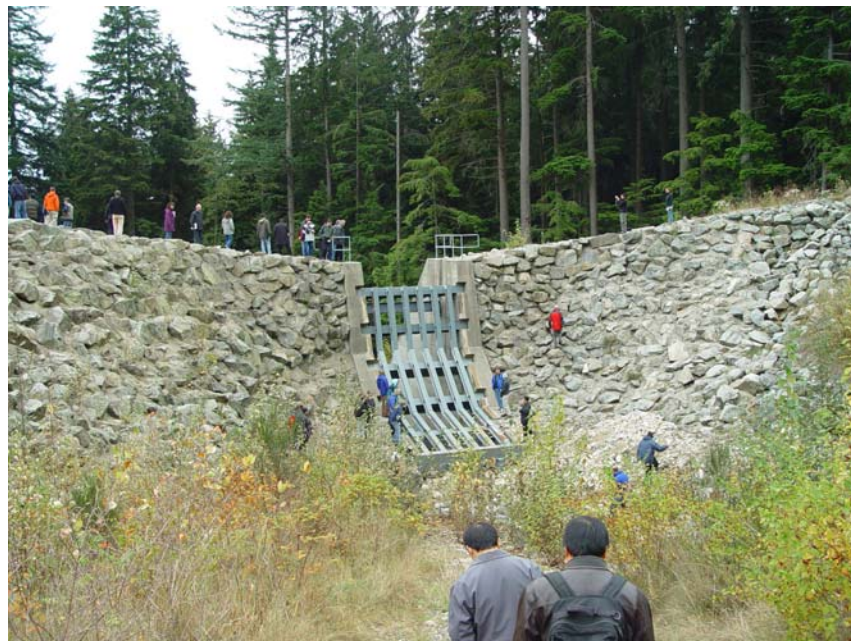
**Figure 6.0.1** A debris-detention outflow structure from a basin protecting a northern suburb of Vancouver, Canada.

A debris-detention basin (Figure 6.0.1) is not intended to stop all sediment. Its purpose is to stop the boulders and logs, and to permit the finer material and flood water to be more readily controlled (maintained in a designated floodway). As with such devices that stop sediment movement, a debris-detention basin requires regular inspection and maintenance to ensure that it retains enough capacity to contain a future debris flow. This is a more costly commitment than merely maintaining large berms.

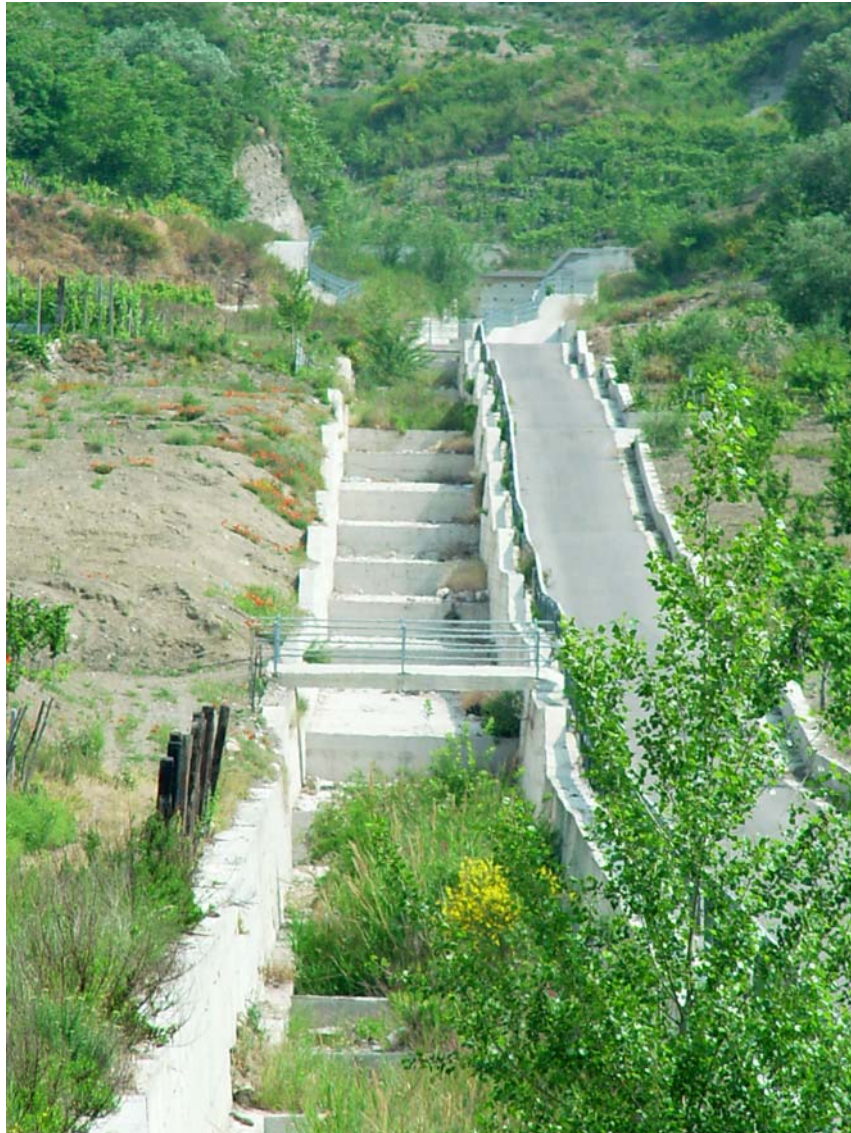
**Figure 6.6.1** A conventional mitigation works for a steep debris-flow fan near Sarno, Italy, built after a recent disaster. In this example, the works mostly protect vineyards.

Engineering work to mitigate the inundation hazard of floods and debris flows on short steep fans usually involves providing a safe route for debris flows through a deep, lined channel, such as illustrated in Figure 6.6.1. Of course, such works must include an area below to safely receive the debris and water.
