Causes and Mitigation Suggestions

By M.J. McSaveney, R.D. Beetham, G. Leonard (of GNS), with assistance from Tom Bassett (of Tonkin & Taylor), Whakatane District Council & Environment Bay of Plenty.

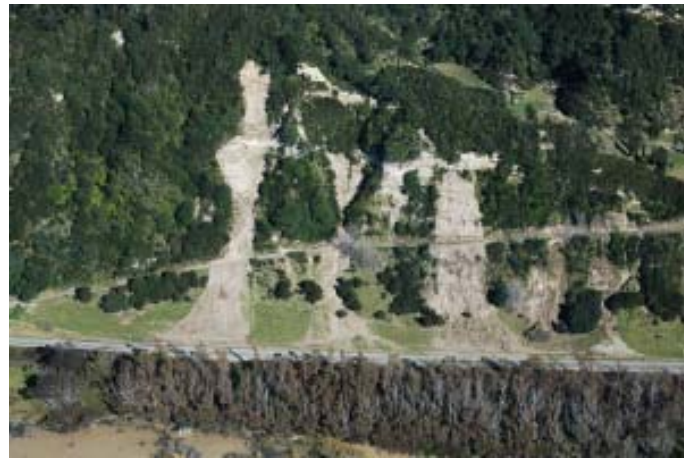
Debris avalanches from the old seacliff, northwest of Matata, at Herepuru Road.

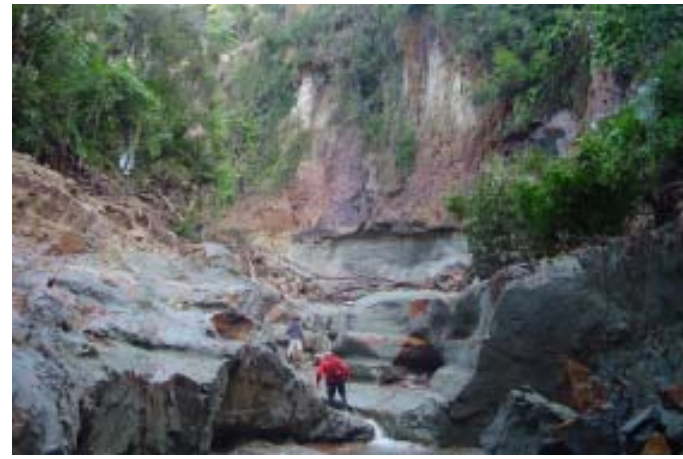
Debris flows cut a distinctive U-shaped channel that is a feature of repeated debris flows over a long time.

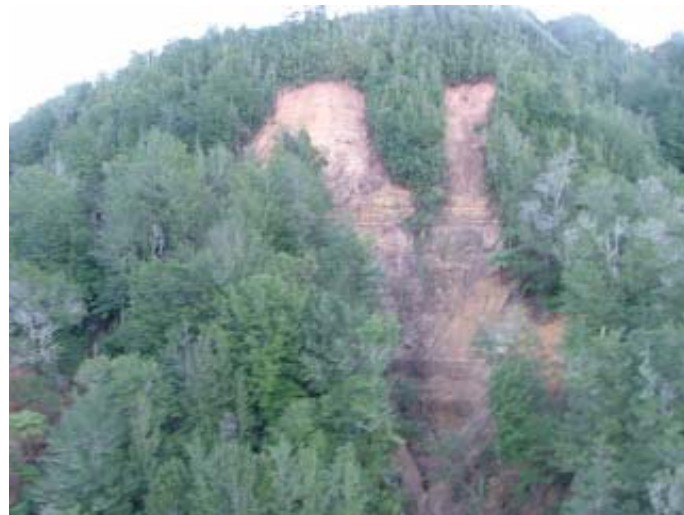
Numerous debris avalanches in the upper Awatarariki and Waitepuru Streams joined in the stream bed to form the debris flows.

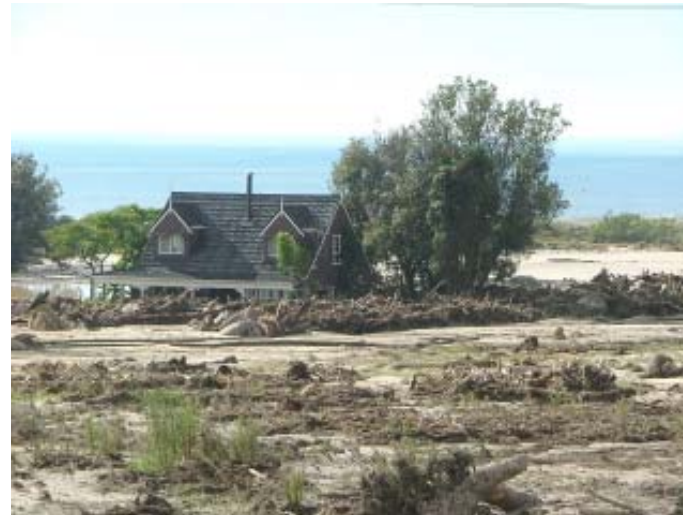
Fine sediment with boulders and trees deposited by a debris flow just beyond the debris flow.

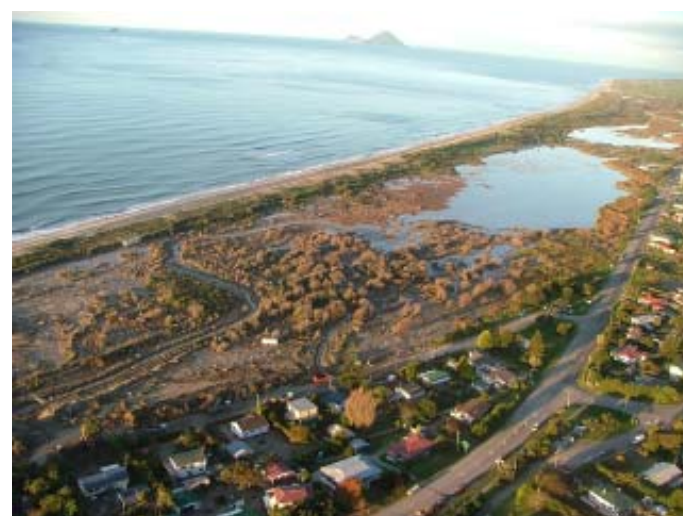
Even with mitigation structures that retain coarse debris, in time fine debris will gradually fill the lagoons.

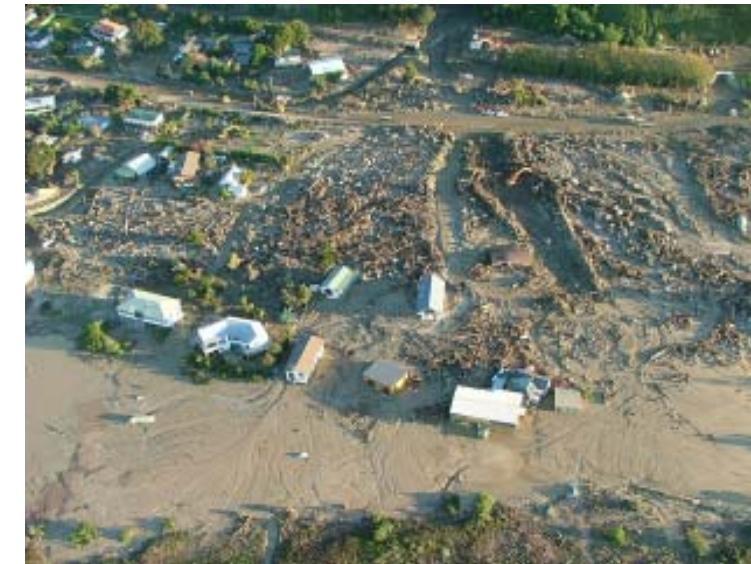
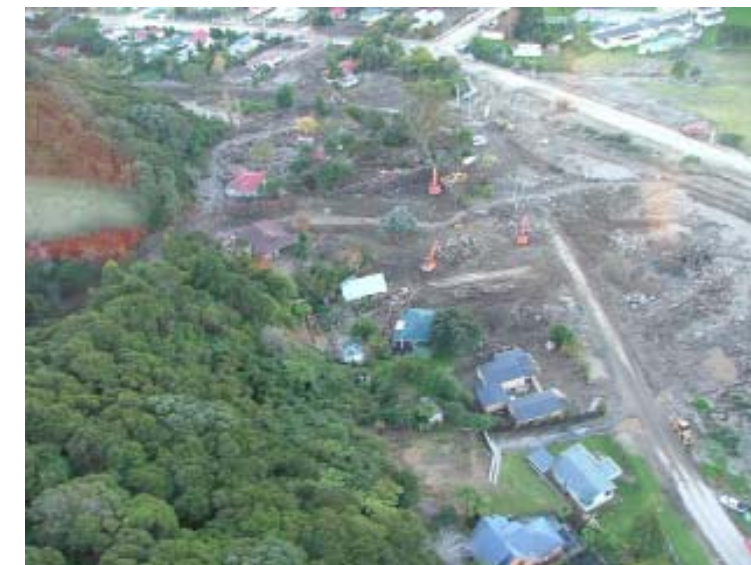
Debris flows from the Awatarariki (top) and Waitepuru streams at Matata on 24 May.

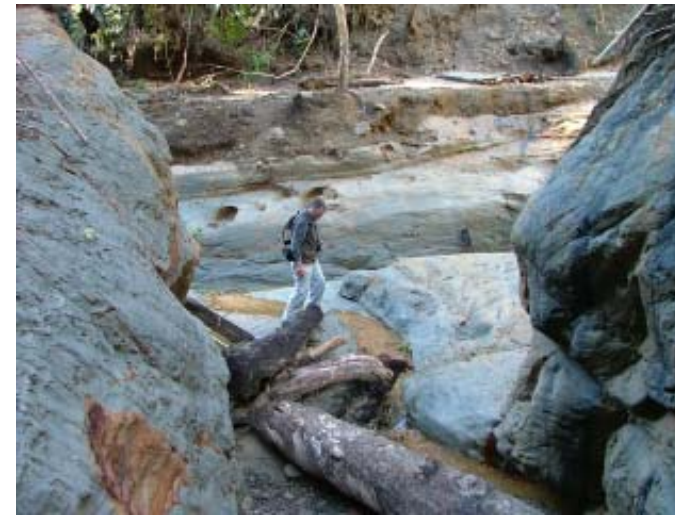
The main stream and a tributary of the Awatarariki both cleaned out by the erosive power of the *debris flows* that passed down them.

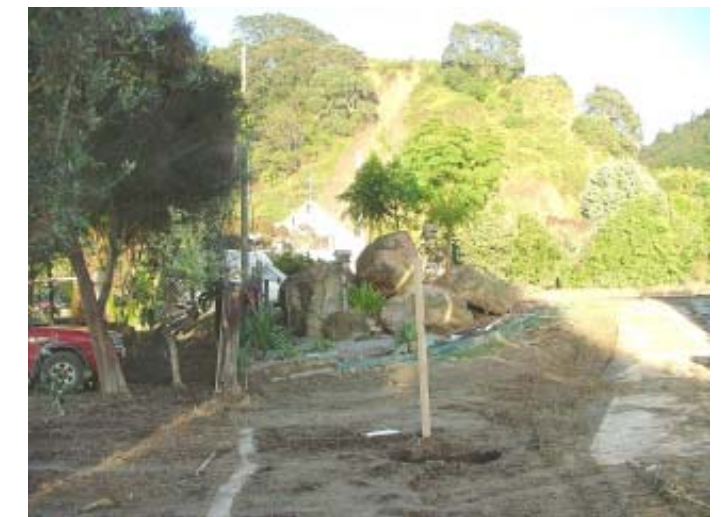
Huge boulders from past debris flows used as landscaping features. They provide clear evidence of past debris flows at Matata.

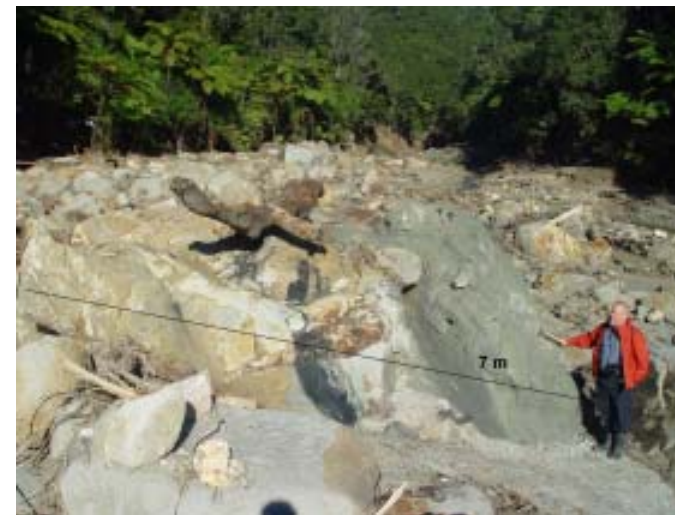
A 7m wide single boulder carried by the powerful *debris flow* in the Awatarariki Stream.

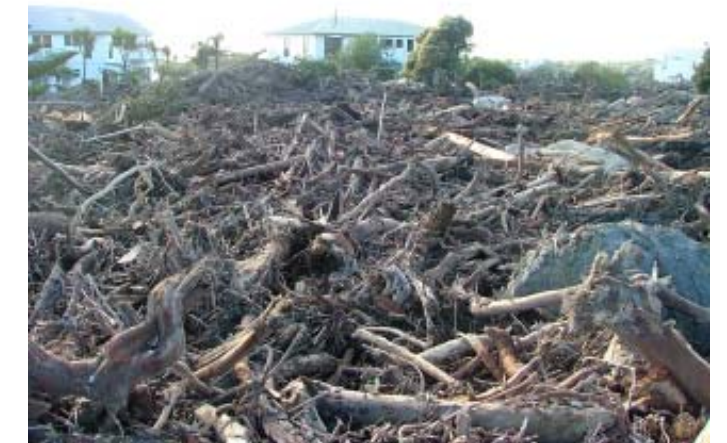
Organic debris from the catchment forest cover is estimated to have been perhaps 10% of the total debris carried by the debris flows at Matata.

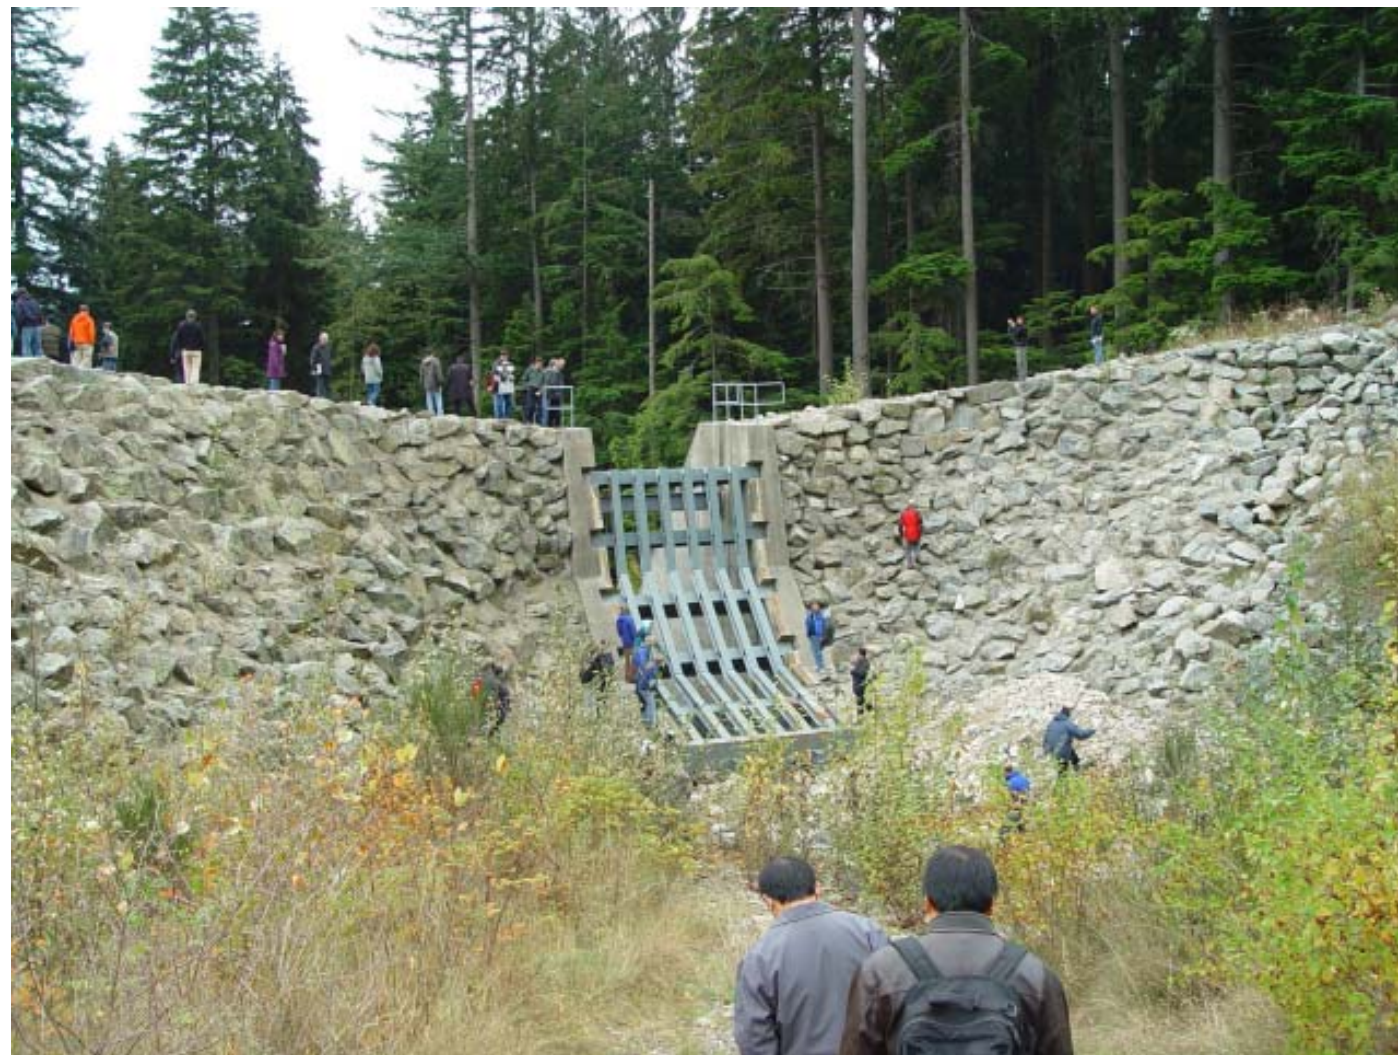
A debris-detention basin outflow structure protecting a suburb of Vancouver, Canada. A similar structure may be feasible in the old quarry just up the Awatarariki Stream.
