Hancox, G.T., Thomson, R., 2013. The January 2013 Mt Haast Rock Avalanche and Ball Ridge Rock Fall in Aoraki/Mt Cook National Park, New Zealand. *GNS Science Report 2013/33*. 31 p.

Two significant landslides occurred in the Aoraki/Mt Cook National Park of New Zealand's Southern Alps in January 2013. The first was a large rock fall on Ball Ridge which occurred during the 9-10 January rainstorm. This was followed on 21 January by much larger rock avalanche from a nearby peak 5 km northeast of Mt Cook. The rock avalanche from the ridge between Mt Haast and Mt Dixon at 2:09 pm on 21 January 2013 originated in very weak rock, associated with a fault zone developed sub-parallel to bedding in the greywacke bedrock. The avalanche was initiated by a collapse of the ridge crest at an elevation of about 3040 m with an estimated volume of up to ~1 million m³. The falling rock debris entrained snow and ice as it flowed down the névé south of Mt Haast with an average velocity of up to 160 km per hour. Although the rock avalanche occurred during fine weather without an obvious trigger, heavy rainfall (>900 mm) during two rainstorms in early January is believed to have strongly influenced the tim

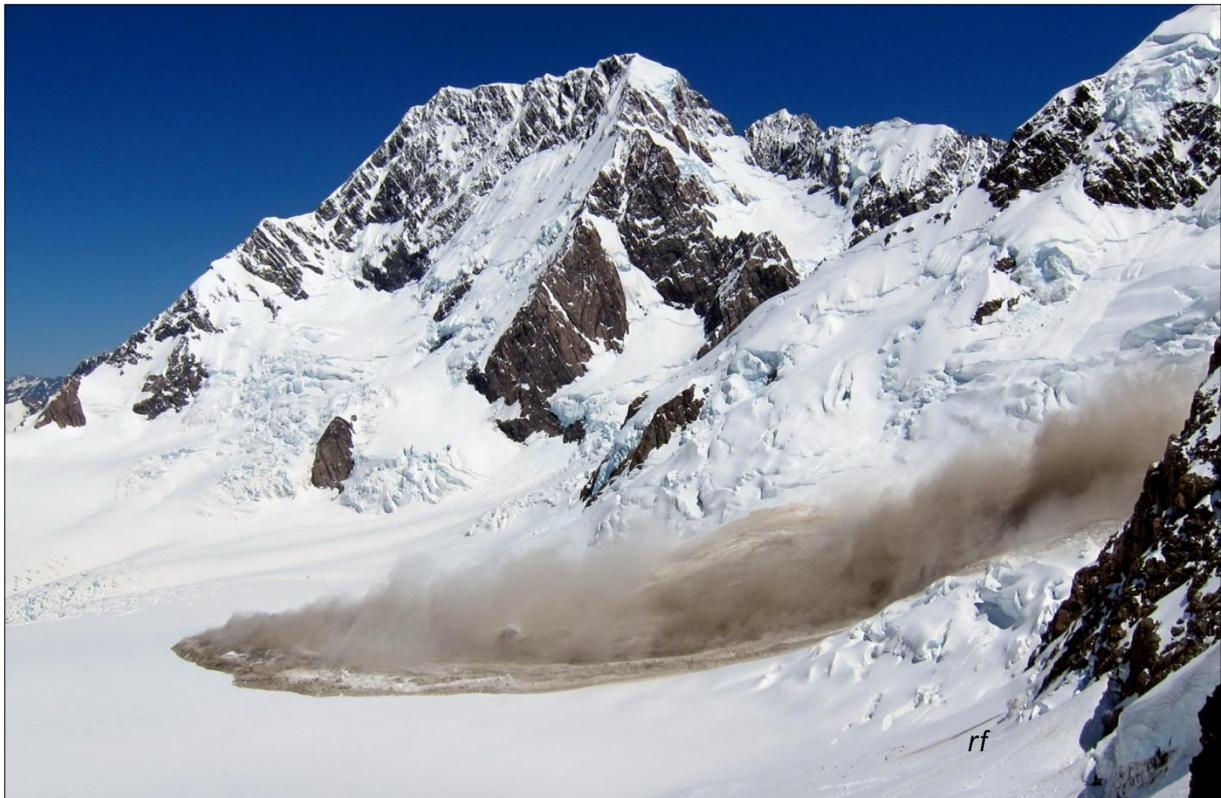
Figure 2 This photo of the highly turbulent frontal part of the Mt Haast rock avalanche running out across the Grand Plateau, with Mt Cook visible in the distance, was taken at 2:09 pm on 21 January 2013. A small rock fall (*rf*) in the foreground, which enlarged several days later, is one of three thought to have been caused by shaking associated with the rock avalanche (*Photo by Anna Seybold, 21 January 2013*).

The extent and main features of the Mt Haast rock avalanche flow path are shown in Figures 5 and 7, while Figure 2 shows the debris flow surging across the Grand Plateau. The shaking associated with the rock avalanche was recorded on several GeoNet seismograph stations in the South Island, including those at Fox Glacier, Inchbonnie, and Jacksons Bay (Figure 12). Using the seismograph records from Fox Glacier, Rata Peaks, Jackson Bay, and Inchbonnie an equivalent average local magnitude of M_L 2.25 has been calculated for the shaking caused by the avalanche (pers. comm. Brian Ferris).

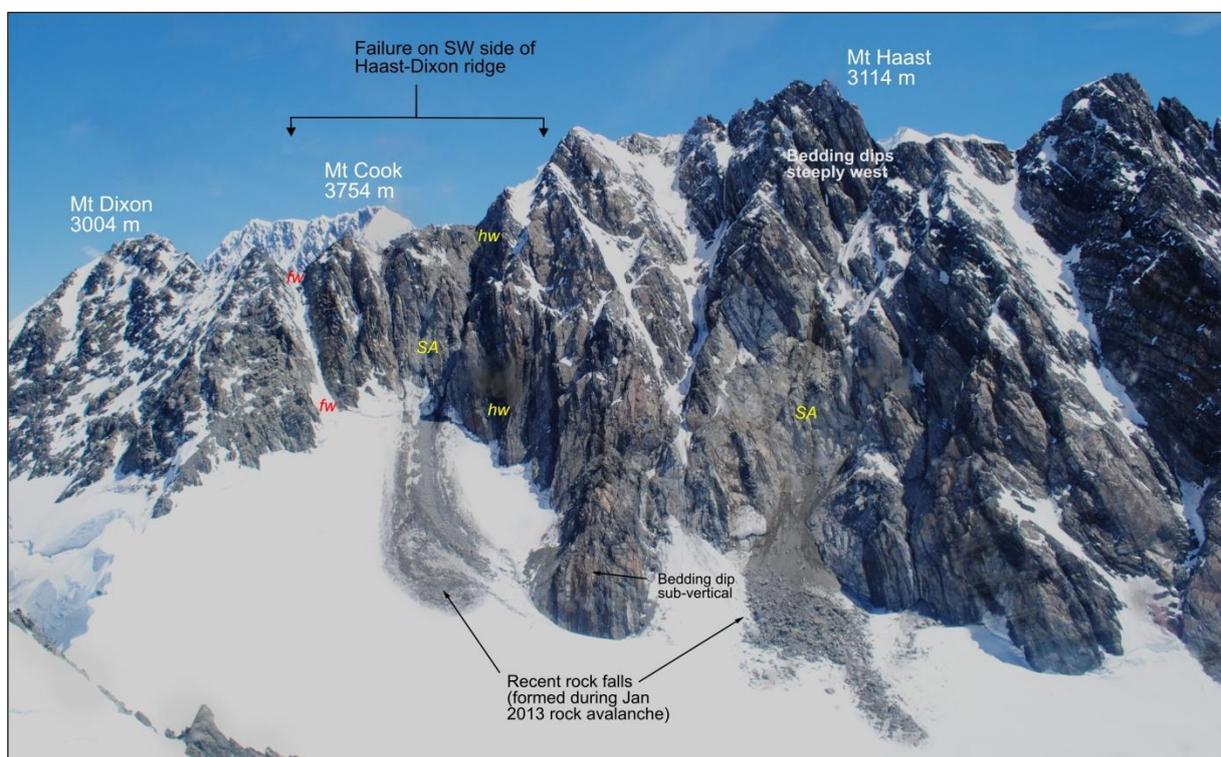
Figure 11 Aerial view of the Mt Dixon–Mt Haast ridge from the northeast showing the position of the 2013 failure on the opposite side of the ridge, the footwall (*fw*) and hanging wall (*hw*) of the fault zone, and the source areas (*SA*) of recent rock falls which are attributed to shaking associated with the rock avalanche. (Photo by R. Thomson, 22 Jan 2013)

(b) **Bedding:** Bedding dips to the west at about 75° within the Mt Dixon massif, but it is poorly developed and the lithology appears to be mainly sandstone (Figure 9). Steep west-dipping bedding is also present on the north flank of the failure zone and at lower parts of the failure area, where a mixture of sandstone and argillite is present (Figure 9). To the west of the failure scarp, bedding within the Mt Haast massif dips steeply ($\geq 65^\circ$) to the west, but some minor folding is also present, as indicated by the vertical beds at lower level at the bottom/centre in Figure 11.

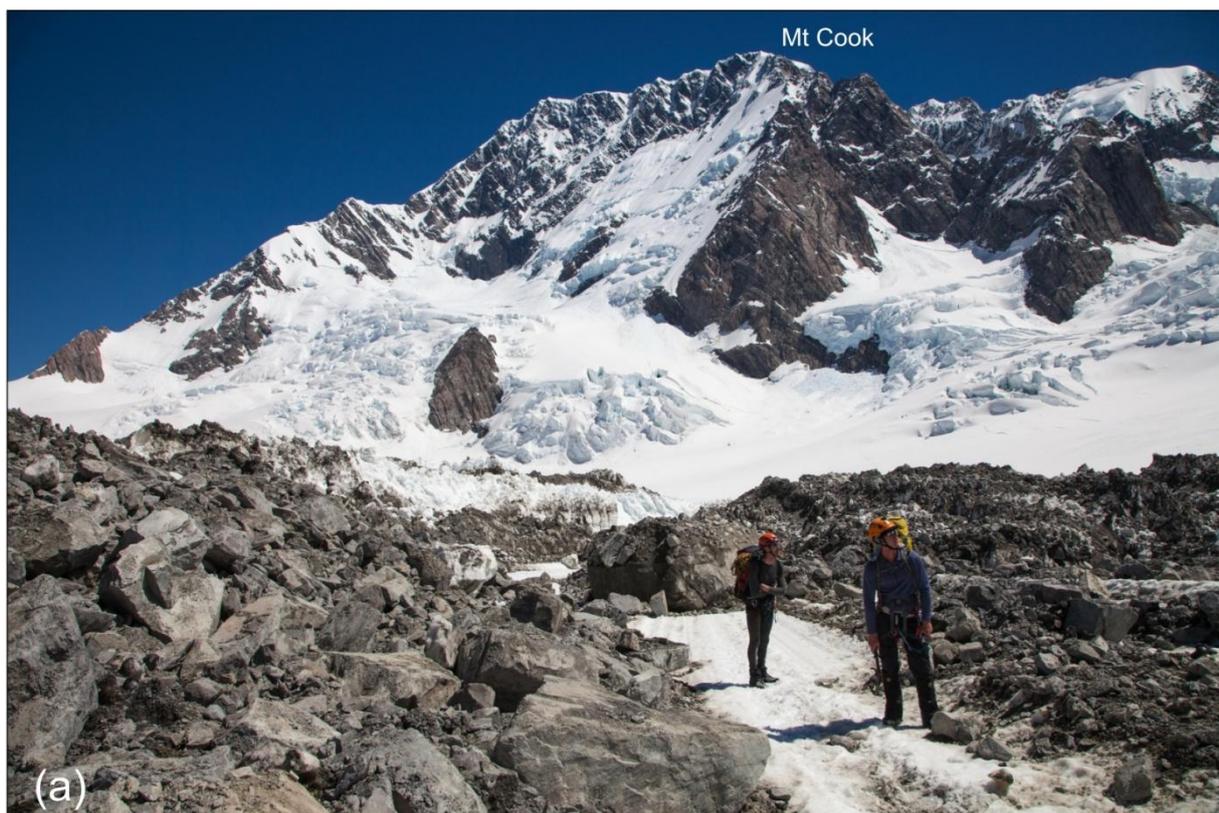
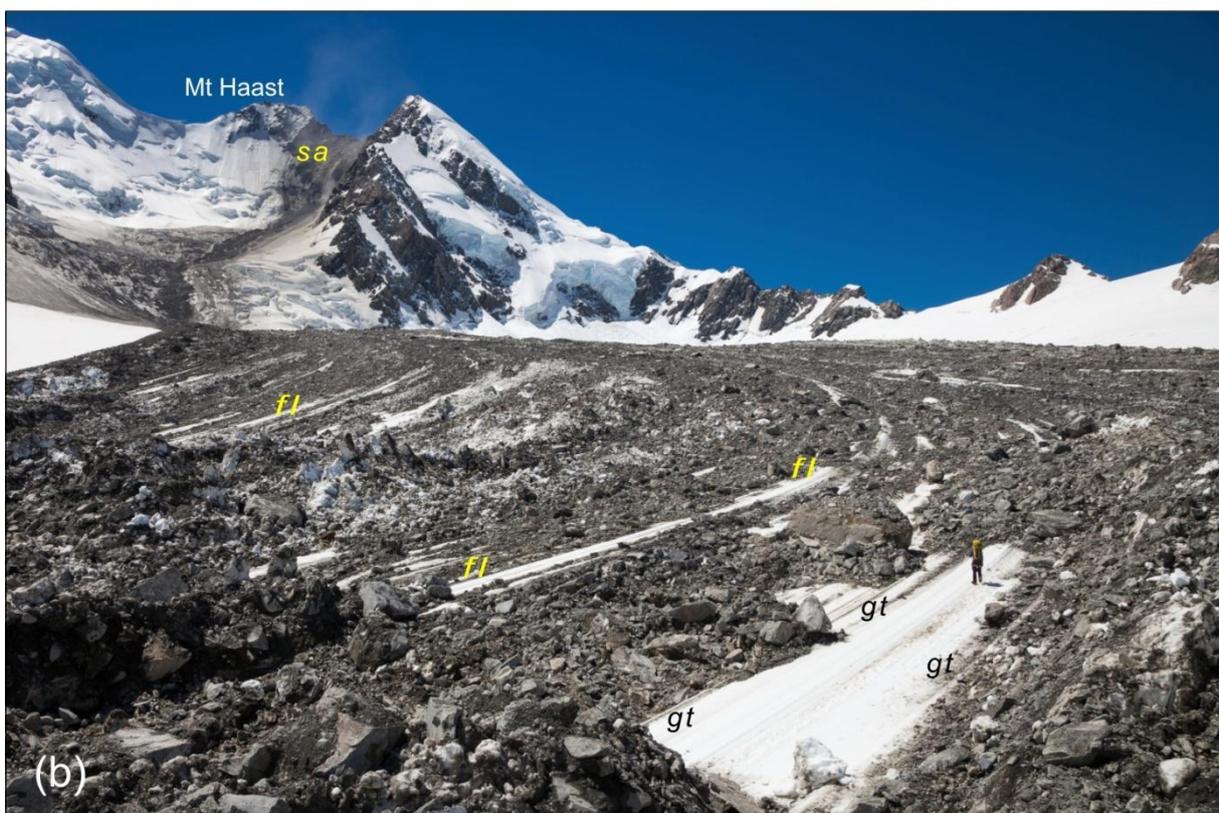
Figure 14 Close up views of the rock avalanche debris in the toe area showing (a) the deposits of angular gravel and boulders with Mt Cook in the distance, and (b) distinctive gravel trails (*gt*) and flow lines (*fl*) which were formed as the mounds of gravel and boulders slid slowly forward on the firm snow surface. The figures in both photos indicate the scale of the deposits (Photos by Mark Watson, 22 January 2013)

The seismograph records suggest that the travel time for most of the 2.9 km runout of the rock avalanche was approximately 65 seconds, indicating an average velocity of 160 km per hour (Figure 12). This is similar to the velocity (up to 150 km/hour) indicated by live video of the final stages of the debris flow as it travelled across the Grand Plateau towards Plateau Hut. The video footage indicates that the distal lobes of debris formed during the final creep phase of the avalanche, during which piles of boulders, gravel, and entrained snow and ice in the avalanche toe area slid slowly across the snow surface (Figures 13 and 14).

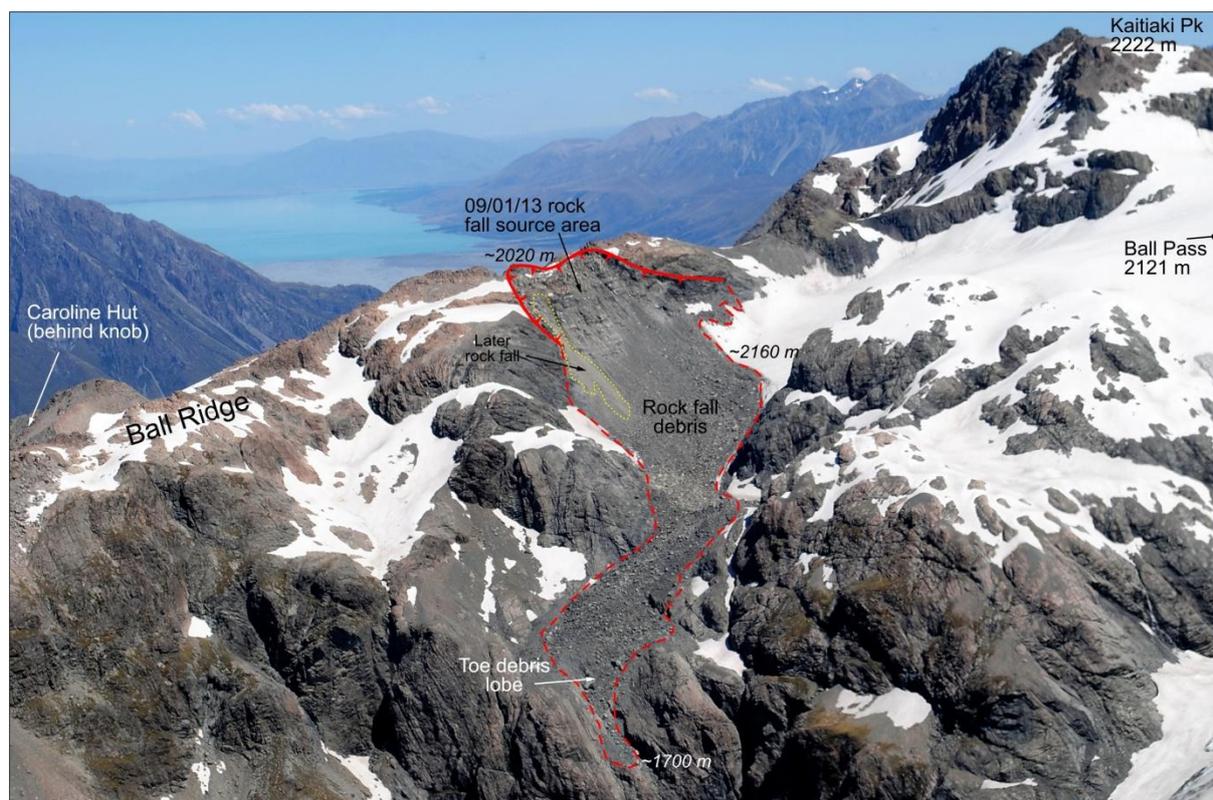
Figure 16 Aerial view of the rock fall on the northwest side of Ball Ridge, about 800 m east of Ball Pass.

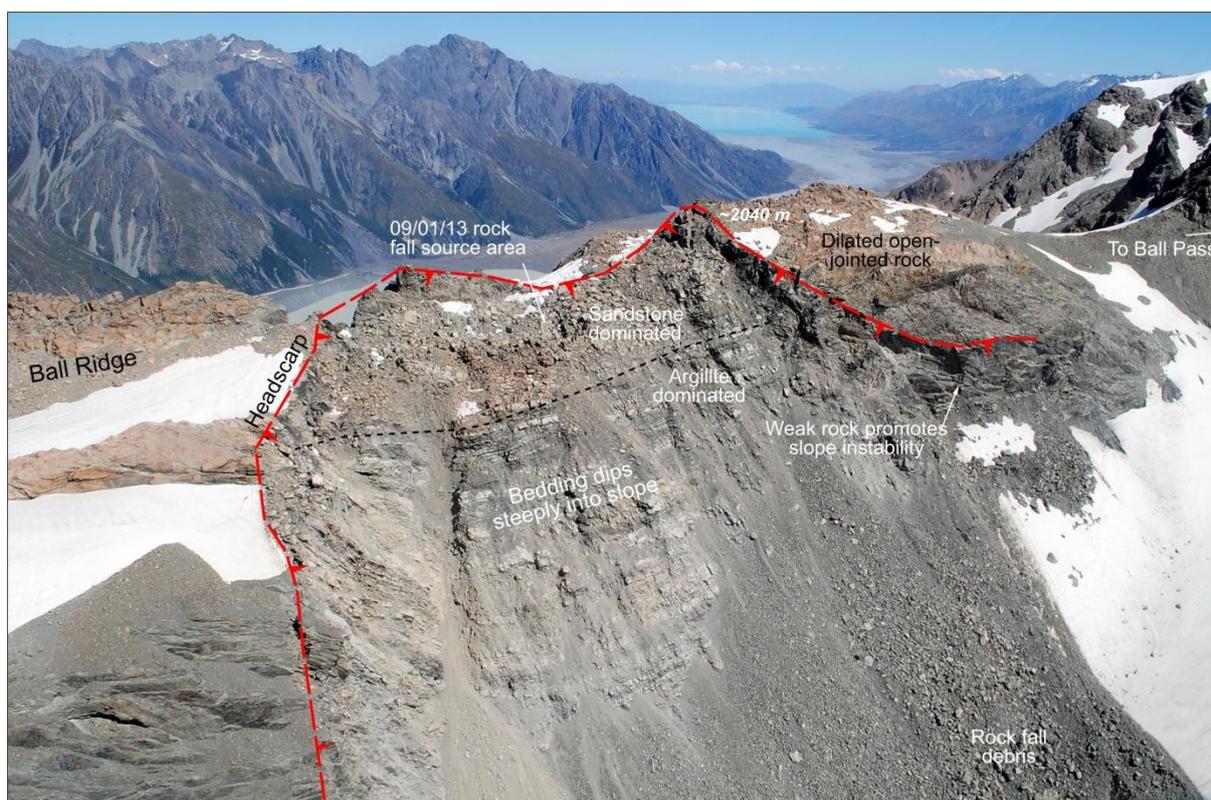
Figure 19 Aerial view of the Ball Ridge rock fall looking south and showing the rock types and characteristics in the source area, where the bedding dips steeply into the slope. The failure process is mainly by toppling, and is propagating to the southwest where the rock is observed to be dilated and open-jointed.

The location of the rock fall source on the ridge crest suggests that the instability has been initiated by glacial erosion, and has accelerated due to glacial retreat over the last 100 years. Figure 19 shows the area of weak, argillite-dominated rock mass in the source area, where bedding dips into the slope and the failure process is mainly by toppling. The dilated, open-jointed rock around the headscarp (red dashed line in Figure 19) shows that the failure is likely to propagate to the southwest, and also upslope (east) across the ridge line where it has already caused a drop in the ridge profile. This process is likely to be ongoing.
