**GeoNet Landslide Response:
Nelson Tasman District, 16–19 August 2022**

**GNS Science Report 2022/58
September 2022**

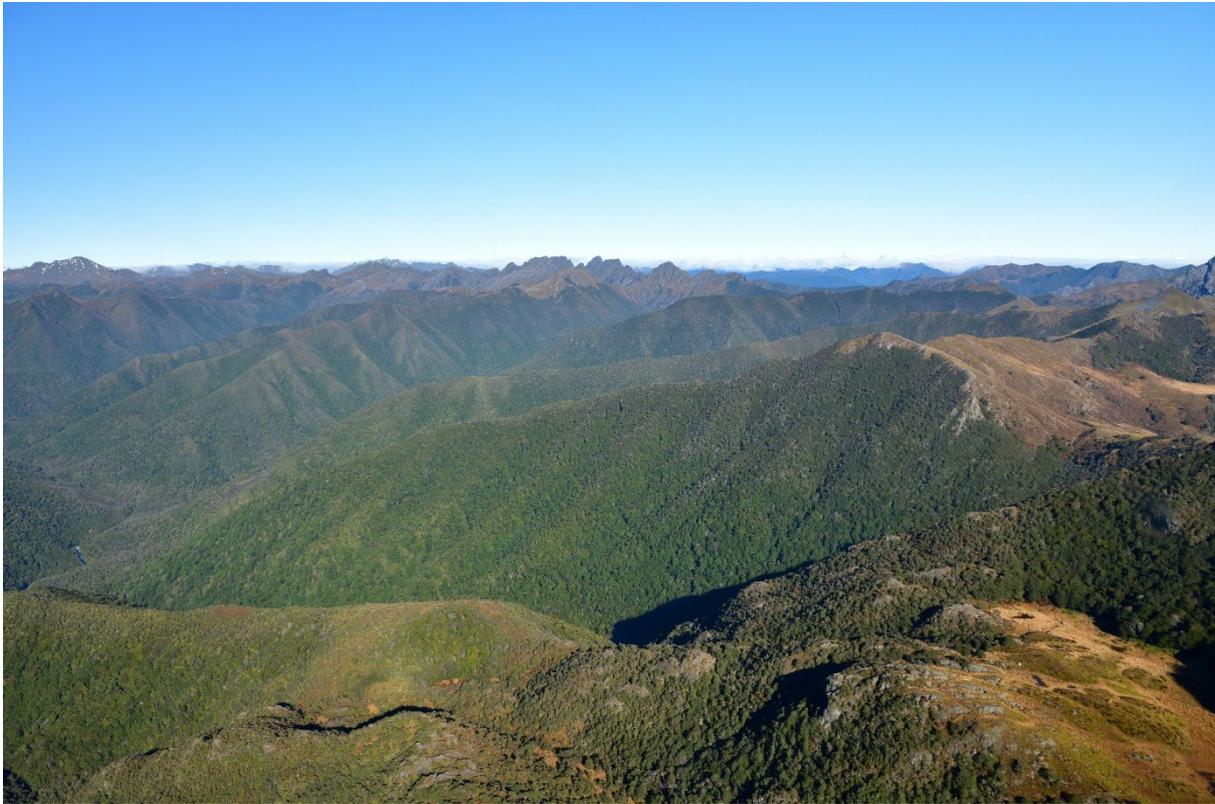
Figure A1.1 Photo 855_8398: Kahurangi (Haupiri Range).

Locality	No. of Landslide Photos	No. of Media Reports	Four-Day Total Precipitation (mm)	Max. 24-Hour Precipitation (mm)	Max. 1-Hour Precipitation (mm/h)	Observations
Kahurangi National Park	4	1	717	386	23	Generally no landslide damage (Figure A1.1). Existing landslides appear stable. Some small activations of scree slopes.
Kotinga	8	2	573	273	20	Landslides onto the road appear to have cut the community off.
Motupipi	17	4	481	237	22	Several debris flows in close proximity to dwellings and roading. Arcuate tension cracks in hillslopes indicate incipient movement (Figure A1.2).
Ligar Bay	62	14	466	228	20	Many landslides on roading (Figure A1.3), at least one located immediately downslope of dwelling. Deeper landslides and tension cracks are visible on steeper hillslopes. Notable slumping of a valley fill in farmland.
Mārahau – Totoranui	26	13	446	221	19	Many coastal cliff collapses (Figure A1.4). Several debris flows extend down to the waterfront. One minor landslide in close proximity to a dwelling noted.

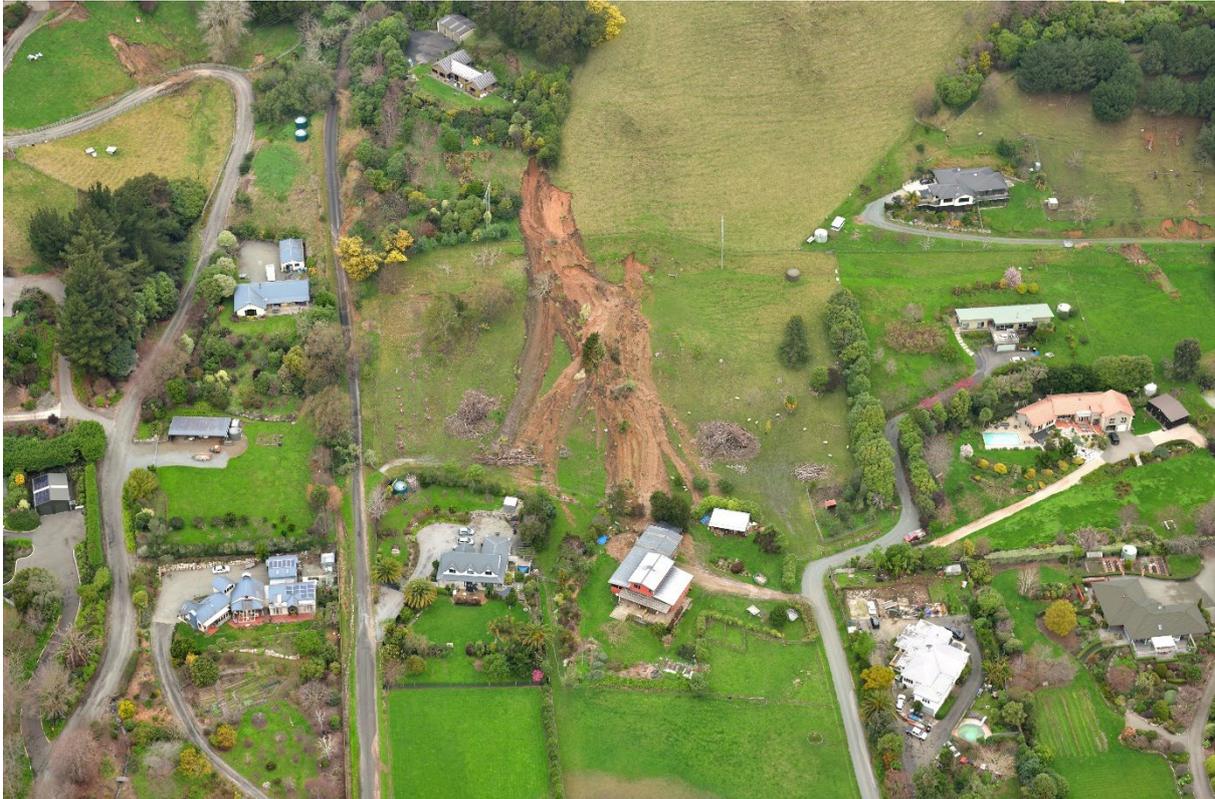
Figure A1.7 Photo 855_8232: Richmond (Aniseed Hill).

Locality	No. of Landslide Photos	No. of Media Reports	Four-Day Total Precipitation (mm)	Max. 24-Hour Precipitation (mm)	Max. 1-Hour Precipitation (mm/h)	Observations
Kaiteriteri	36	6	437	216	17	Several landslides onto roading and a debris flow extending down to the beach. Shallow slides in forestry, and a larger landslide from regenerating forest has crossed a road and blocked a small stream (Figure A1.5).
Takaka hill	6	3	306	146	11	Re-activated scree slopes common. Two river bank collapses have since been washed away. Small failure above a quarry and a few cut-slope failures onto roading.
Ruby Bay	36	4	154	13	1.3	Numerous landslides from cliffs onto the beach. Approximately one dwelling has been inundated (impacted) by debris. Gully erosion from cliffs has generated debris cones on the beach (Figure A1.6).
Richmond	10	5	142	105	12	Multiple landslides on roading and in close proximity to dwellings. Several slopes appear to have newly formed tension cracks. Notably long debris runouts (Figure A1.7).

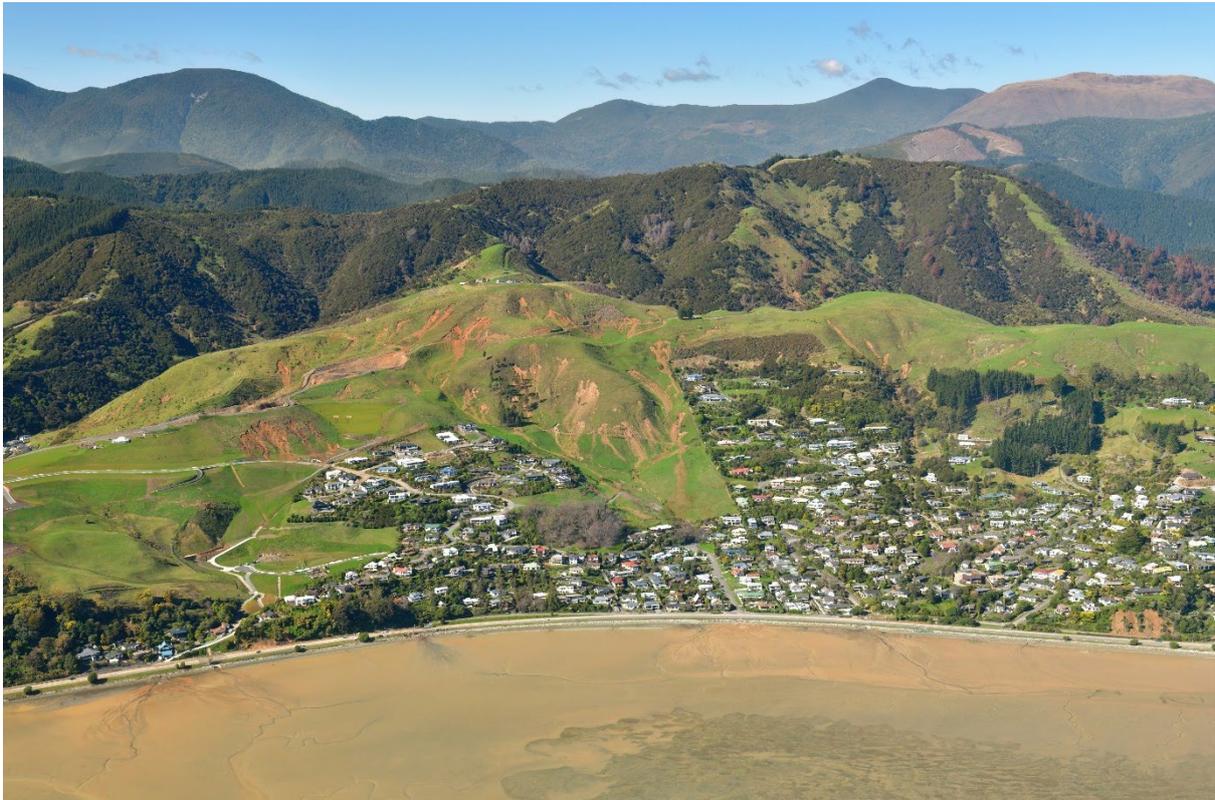
Figure A1.8 Photo 855_9176: Nelson/Stoke (Atawhai).

Nelson/Stoke	253	35	250	130	23	Widespread landsliding, predominantly associated with new subdivisions (Figure A1.8), farmland (Figure A1.9), riverbank erosion and roading (Figure A1.10). Many dwellings and infrastructure affected, particularly in the region of Tāhunanui Slump (Figures A1.11 and A1.12). A landslide originating in forestry land in the Maitai Valley damaged a water supply pipeline (Figure A1.13).
Wakapuaka – Pepin Island	167	34	461	253	24	Generally steep slopes and tall cliffs have generated larger, deeper failures than observed elsewhere. Many landslides and debris flows and incipient landslides behind buildings (Figures A1.14 and A1.15), in farmland and in forestry. Large cliff failures have deposited debris cones on the waterfront (Figure A1.16). Pepin Island has been particularly hard hit (Figures A1.17 and A1.18).

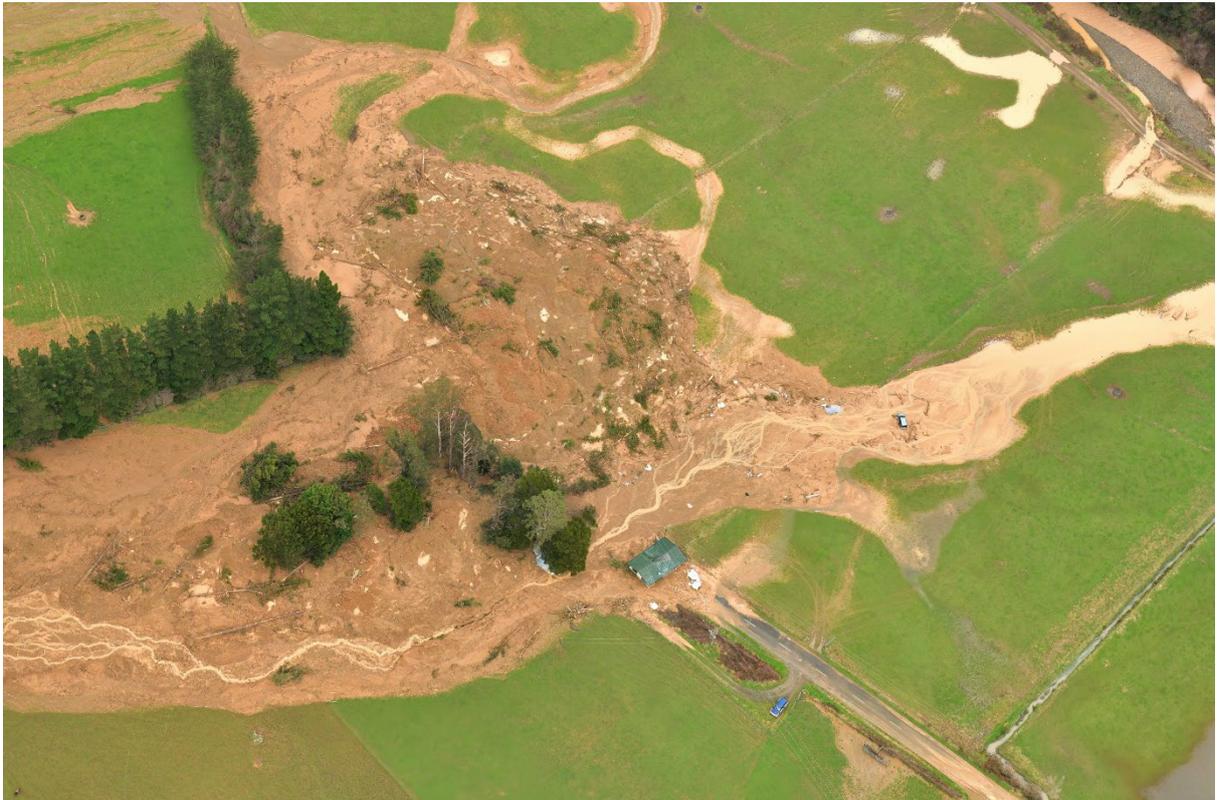
Figure A1.22 Photo 855_7835: Northern Rai Valley (Ronga River valley).

Locality	No. of Landslide Photos	No. of Media Reports	Four-Day Total Precipitation (mm)	Max. 24-Hour Precipitation (mm)	Max. 1-Hour Precipitation (mm/h)	Observations
Delaware Bay	54	4	587	307	27	Many earth flows, debris flows and shallow landslides in both gullies and open slopes throughout the region (Figure A1.19).
Whangamoia River	30	8	657	336	28	Small landslides adjacent to the coast and on river banks. A couple of debris flows from vegetated gullies (Figure A1.20).
Southern Rai Valley	3	0	513	252	22	Isolated debris flows and landslides in forestry land.
Northern Rai Valley	53	16	604	285	24	Extensive debris flows, originating from moderate gradient hillslopes, extend down to the valley floor (Figure A1.21). Dwellings, roading and river channels affected (Figure A1.22). Most appear to originate in forestry and farmland.
