Reconnaissance studies of landslides caused by the M_L 5.4 Lake Rotoehu earthquake and swarm of July 2004

Institute of Geological & Nuclear Sciences science report 2004/24

**Institute of Geological & Nuclear Sciences Limited
Lower Hutt, New Zealand
27 September 2004**

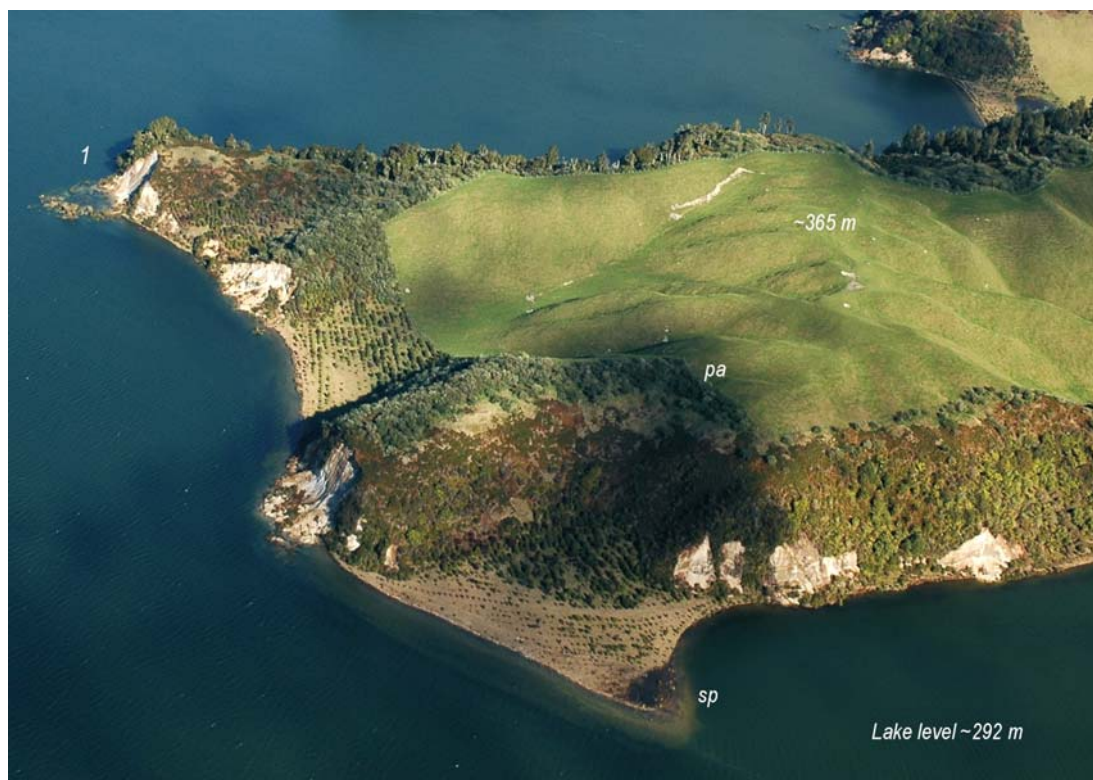
Figure 4. Aerial view of several moderately large 'soil' slumps and falls on steep slopes of Waipuia Point, near Maraua Pa (pa) site on the western side of Lake Rotoehu. It also shows a collapse area with sand ejections and cracking (due to liquefaction) at the end of the sand spit (sp). [Photo: GH-BOP0725]

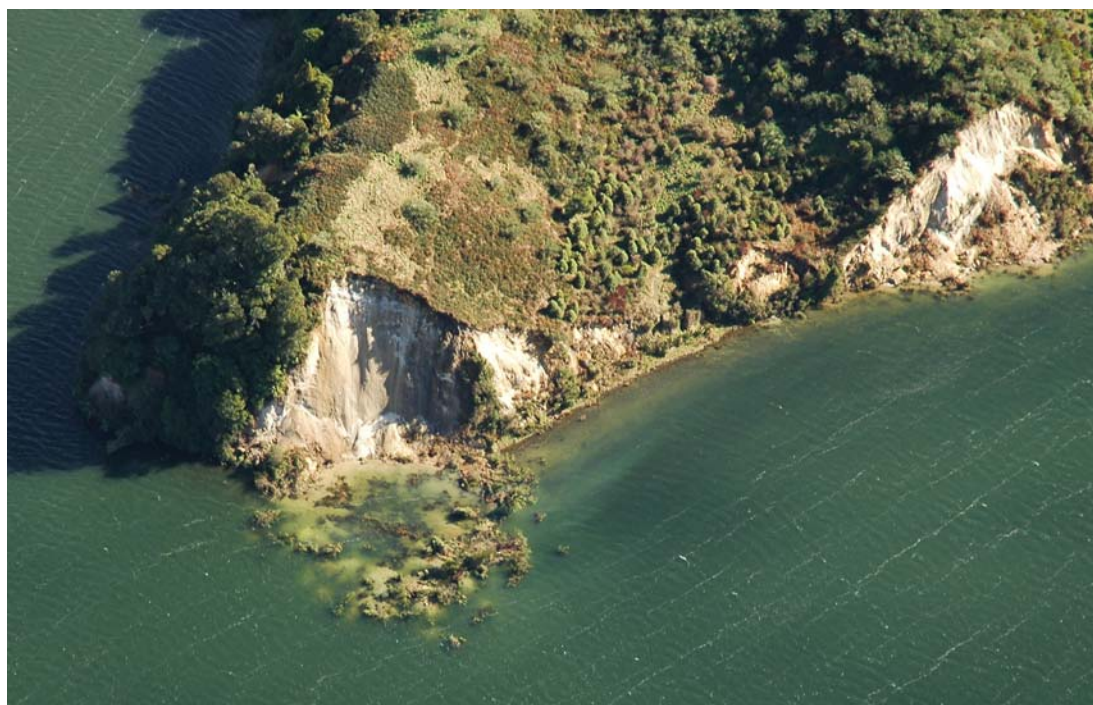
Figure 5. Aerial view of moderately large (~3000-5000 m³) soil slump (Slide 1, Figure 3) from steep ~25 m high slope in weak, unconsolidated rhyolitic pyroclastic deposits ~400 m south of the Maraua Pa site shown in Figure 4. The landslide is about 60 m wide and 25 m high and the slide debris has travelled at least 50 m out into the shallow lake. [Photo: GH-BOP0718]

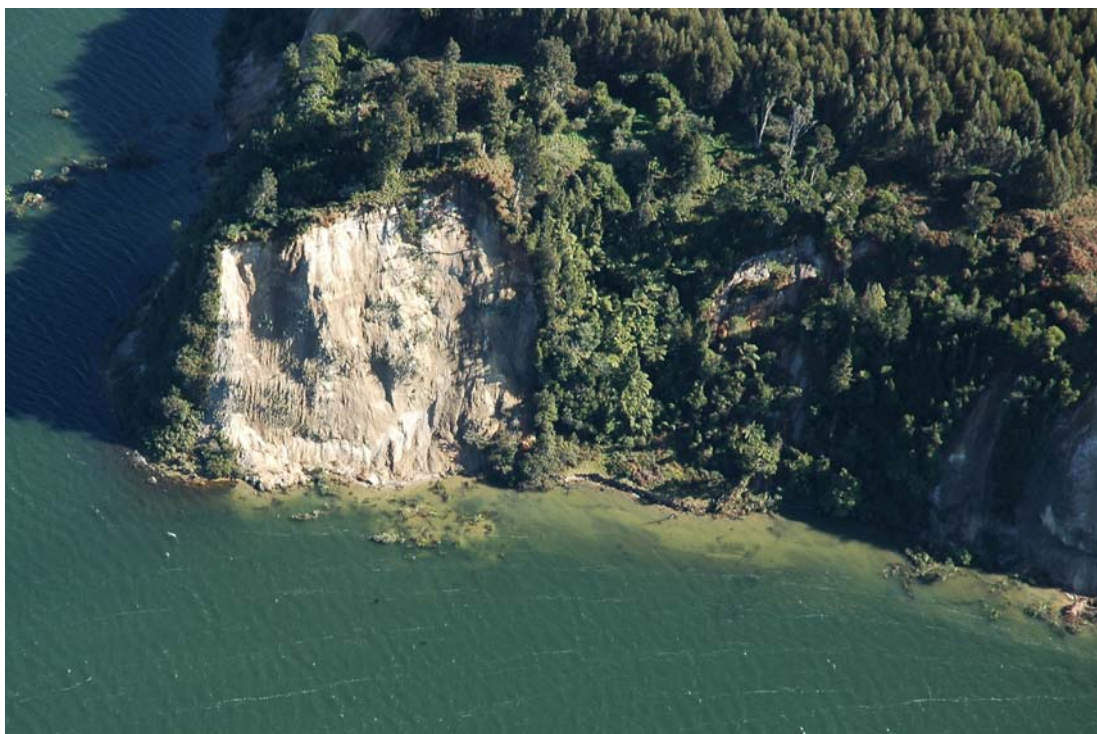
Figure 6. Extensive (~45 m high x 100 m wide) but superficial soil fall on a very steep (~75°) bush-covered slope at the south end of Okahu Point on the western side of Lake Rotoehu (Slide 3 in Figure 3).
[Photo: GH-BOP0715].

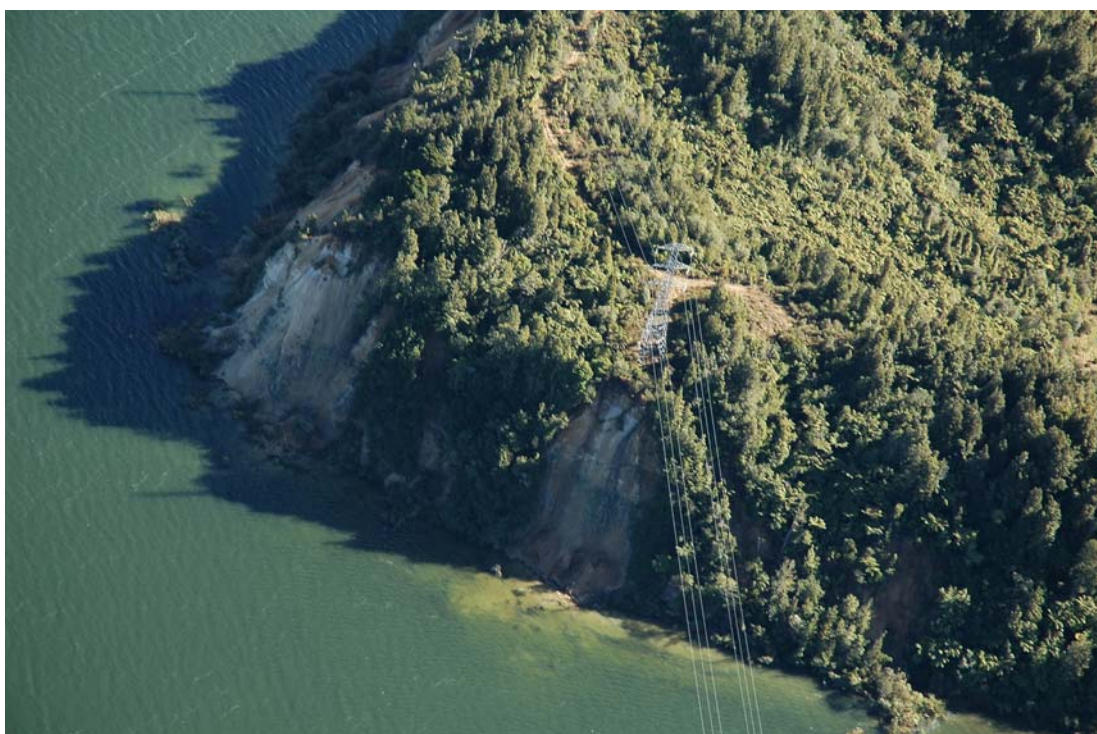
Figure 7. Moderate size (~50 m high x 20 m wide) soil fall from this steep bush-covered slope threatens a power pylon on a major transmission line at the northern end of Lake Rotoehu (Slide 4 in Figure 3). The pylon is clearly located unnecessarily close to edge of the steep cliff edge.
[Photo: GH-BOP0714]

Aerial reconnaissance allowed the main landslides around the shores of Lake Rotoehu and Rotoma to be located and the extent of landsliding to be determined more accurately. The main area affected by larger landslides covers about 70 km², centred mainly on the northern and western sides of Lake Rotoehu. The total area affected by earthquake-induced landsliding was about 200–300 km², with at least 100 landslides mapped so far (Figure 3). The largest landslides (all are small in accepted terminology* - Hancox *et al.*, 1997; 2002; INQUA, 2003) occur on steep headlands around the lake shores (numbered slides in Figure 3). These are illustrated by photos taken on the aerial reconnaissance (Figures 4–13). One of the largest slides (Slide 1, in Figures 3 and 4) was an extensive soil slump and fall of ~3000–5000 m³ on a steep (45–65°) scrub-covered slope at the south end of Waipuia Point near Maraua Pa on the western side of Lake Rotoehu (Figure 5). The sand spit at the northern end of the Waipuia point (2, Figure 3) also subsided within the lake, associated with what appears to be liquefaction-induced sand ejection ('boil') and cracking (Figure 4). Another extensive soil fall occurred on a very steep (~75°) bush-covered slope at the south end of Okahu Point (Slide 3 in Figure 3; Figure 6), while a number of similar falls occurred on a point ~700 m to the north (Slide 4 in Figure 3), undermining and threatening the foundations of two power pylons located unnecessarily close to the edge of a steep lake-edge cliff (Figures 7 and 8).

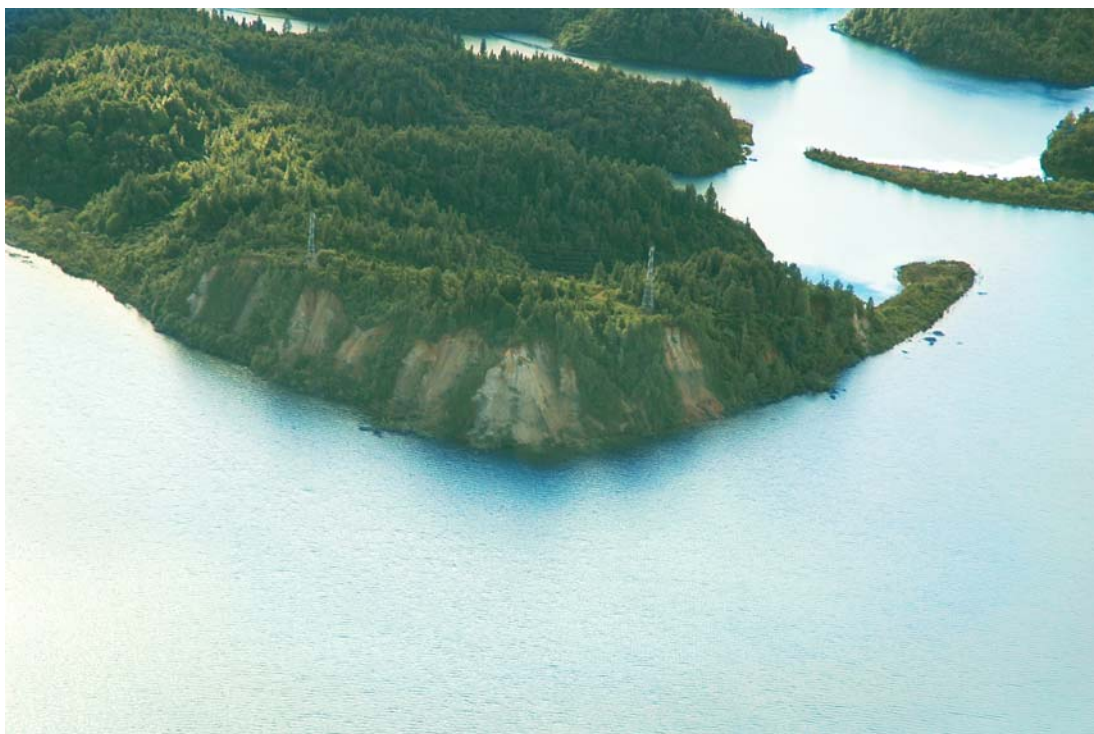
Figure 8. More distant view of power pylons threatened by several large soil slides on steep bush-covered slope at the northern end of Lake Rotoehu.

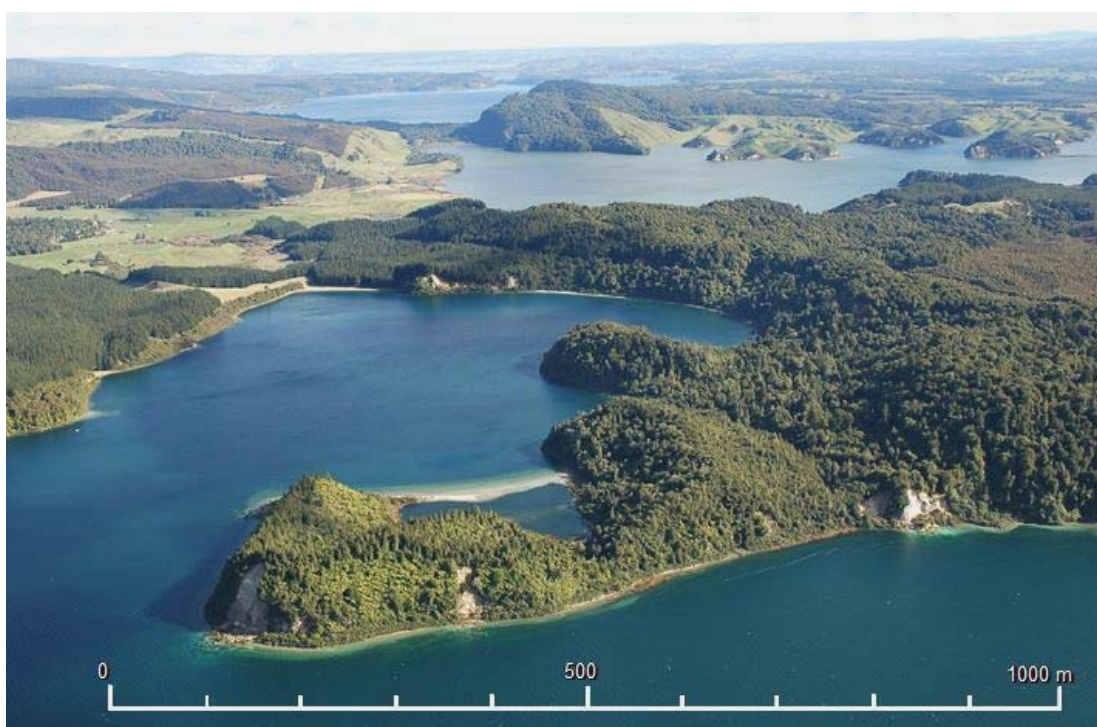
Figure 9. Aerial view of some of the large soil falls and slumps on Otunarakura Point at the northwest corner of Lake Rotoma (Slide 5 in Figure 3 bottom left). The scale in the foreground shows the approximate size of these landslides. In the distance the numerous landslides scarring steep headlands on the western shoreline of Lake Rotoehu can also be seen (top right). Note that the landsliding is restricted to very steep slopes around lake edges (whether or not they were bush-covered) and local road cuts, with few if any failures on other slopes in the area.

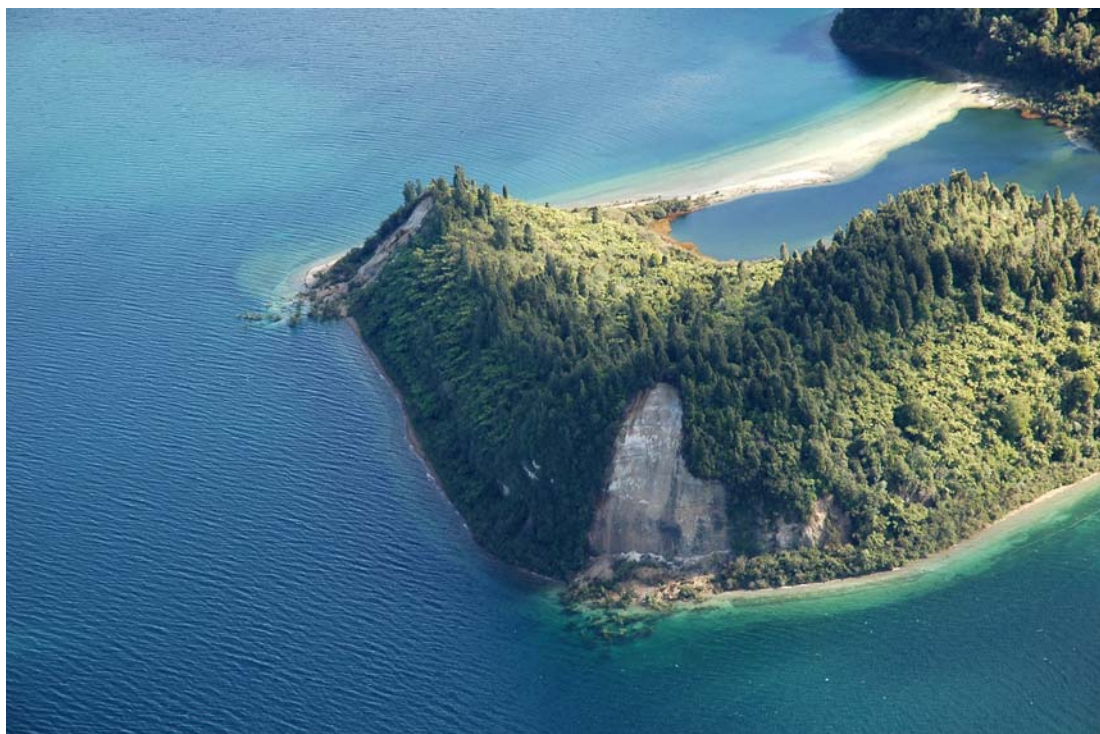
Figure 10. Closer view of the large ($4000\text{--}5000\text{ m}^3$) soil slump on steep, 40 m high bush-clad lake shore on Otunarokura Point (west side of Lake Rotoma - Slide 5 in Figure 3). *[Photo: GH-BOP0740]*

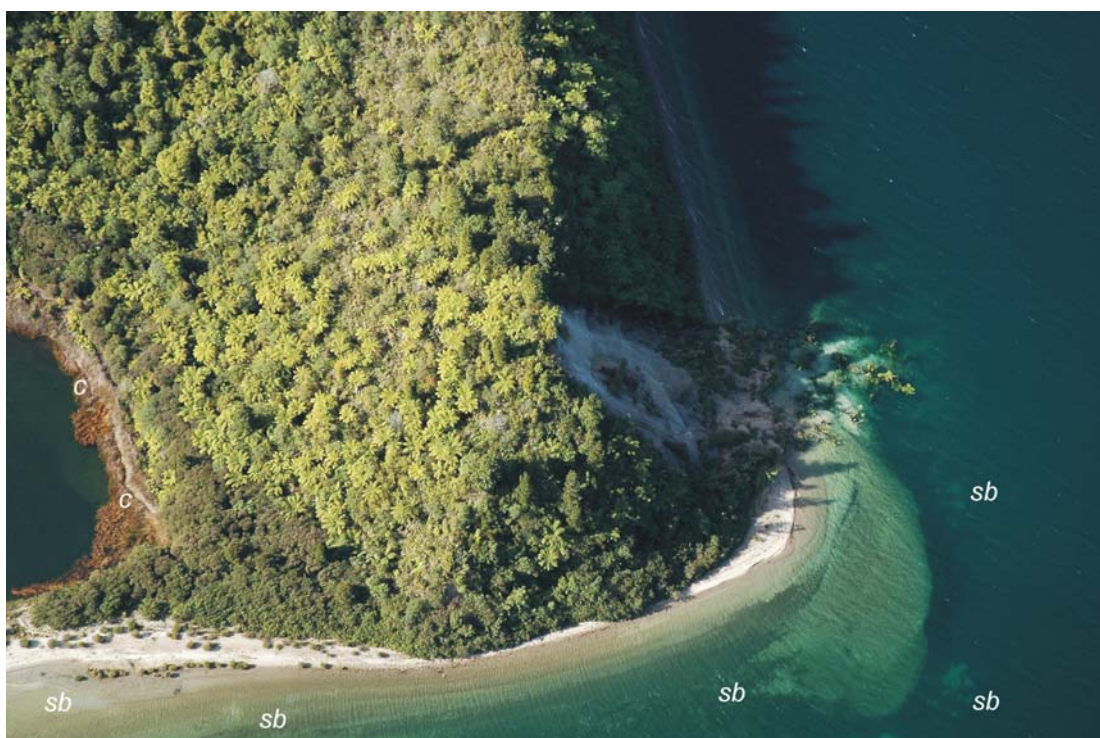
Figure 11. Moderately large soil slide and sub-aqueous sand flow with small sand boils in shallow water on the southwest end of Otunarokura Point (Slide 6 in Figure 3). The underwater sand boils (*sb*) are minor liquefaction effects in fine-grained, highly susceptible lake shore sediments. There is also some cracking around the lake edge just above water level (*left, c*). *[Photo: GH-BOP0734]*

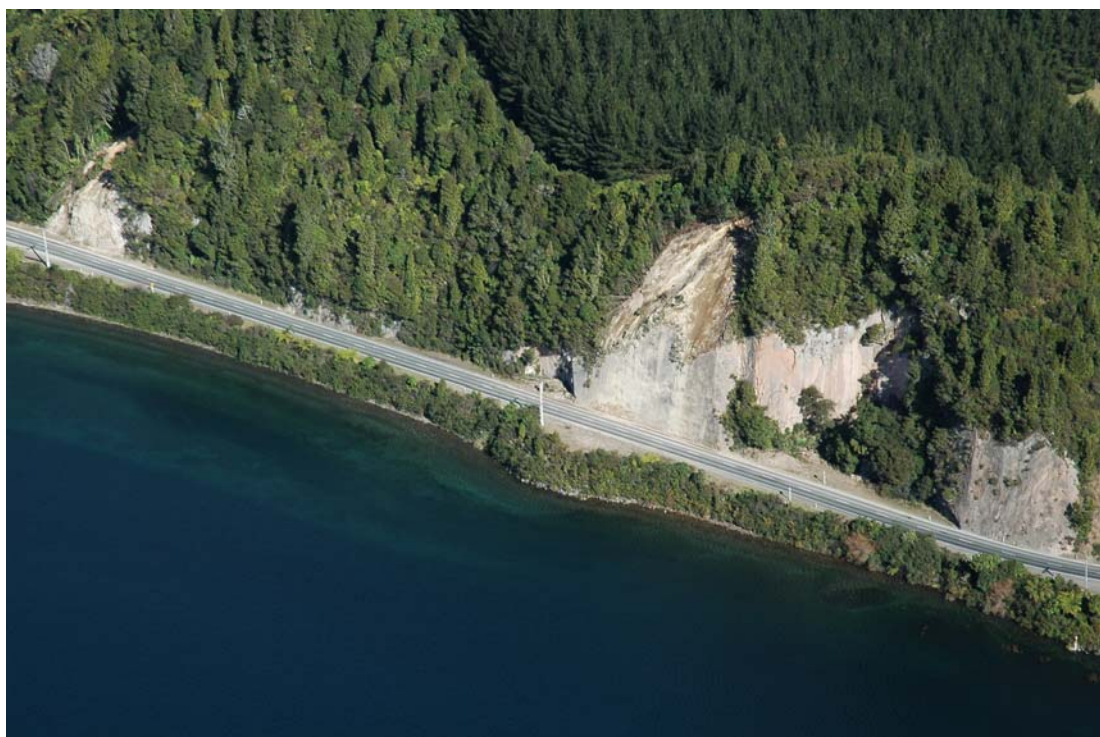
Figure 12. Shallow regolith failure which temporarily blocked SH 30 at the southern end of Lake Rotoma (Slide 7 in Figure 3), but had been cleared when this photo was taken. *[Photo: GH-BOP0742]*

The aerial reconnaissance also showed the after-effects of several significant landslides road cut along SH 30 on the south side of Lake Rotoma, as shown in Figures 12 and 13. These failures, which were mainly shallow soils slides of ash and regolith sliding off harder rhyolitic lavas, partly blocked the road for a day or so. Other ground damage and landslides affecting roads are shown in Figures 14–16. Most of the failures observed were disrupted soils falls and slides of relatively dry sandy debris (Figures 14 and 16). Ground cracking on the Pongakawa Valley Road ~1 km east of Lake Rotoehu (Slide 10 in Figure 3 was associated with an incipient failure of the largest (~10,000 m³) earthquake-induced landslide observed (Figure 15).

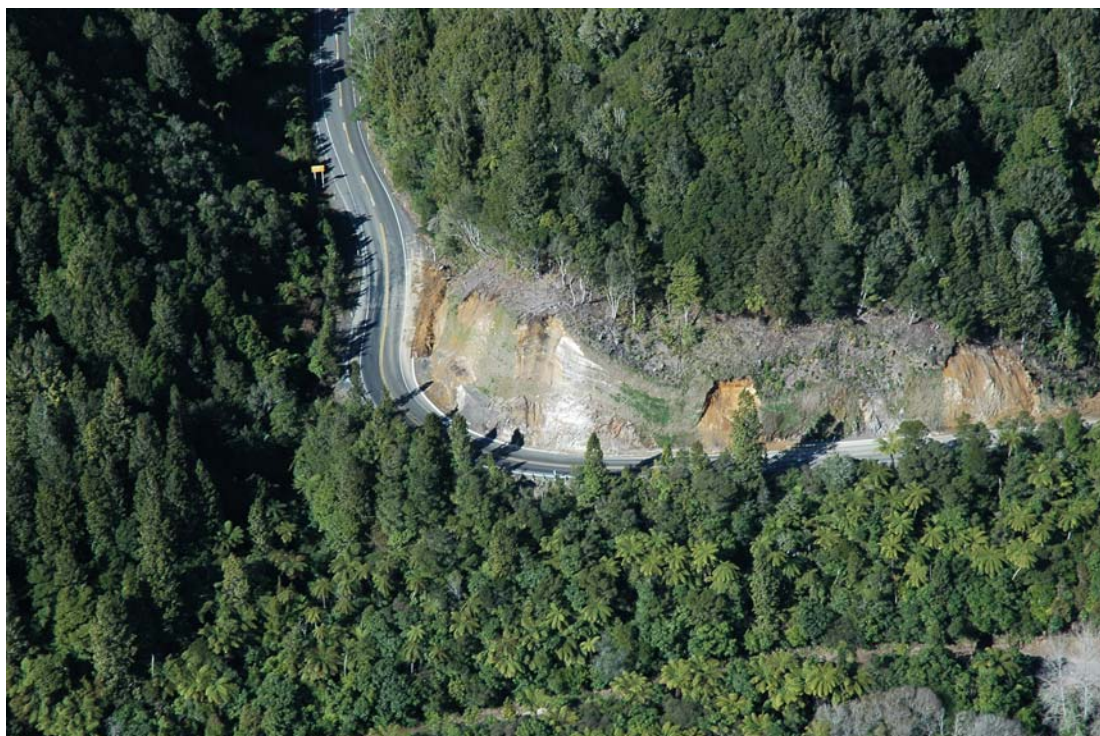
Figure 13. Other shallow regolith failures at the south end of Lake Rotoma (Slide 8 in Figure 3) which partly blocked SH 30 but were quickly cleared. *[Photo: GH-BOP0743]*

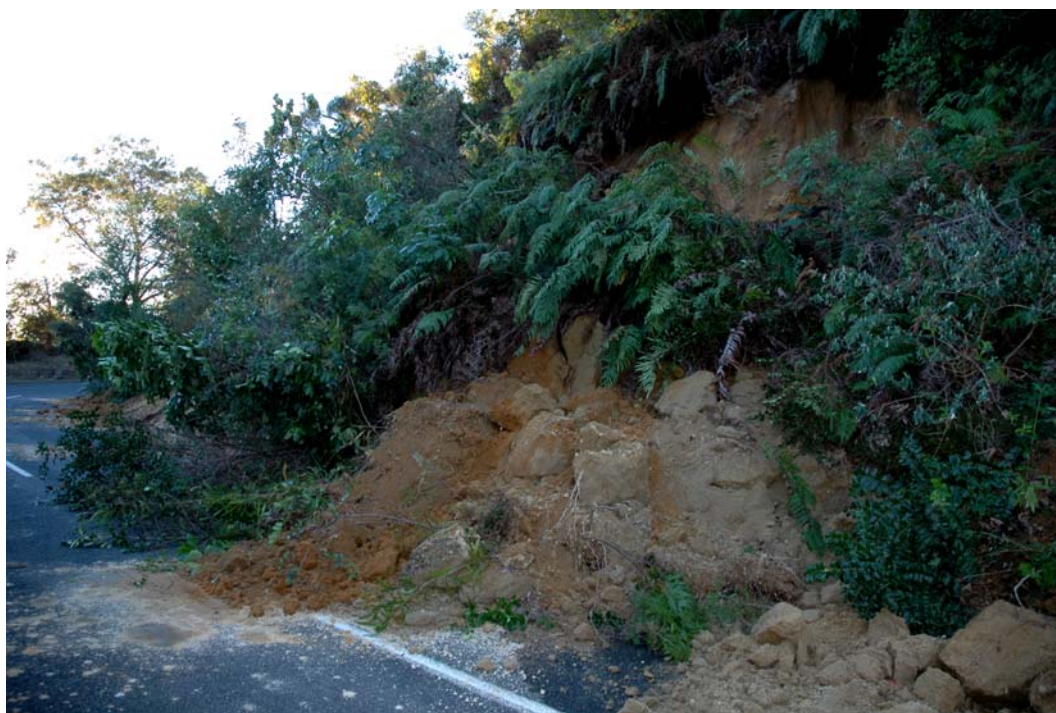
Figure 14. Typical disrupted soil fall on Pongakawa Valley Road just east of Lake Rotoehu (Slide 9 in Figure 3). This landslide was reported by local residents to have occurred during the largest earthquake (M 5.4 at 4.22pm on 18 July 2004) while they were walking past. Note the relatively dry nature of the sandy landslide debris. *[Photo: M.J. McSaveney, 19/7/04]*

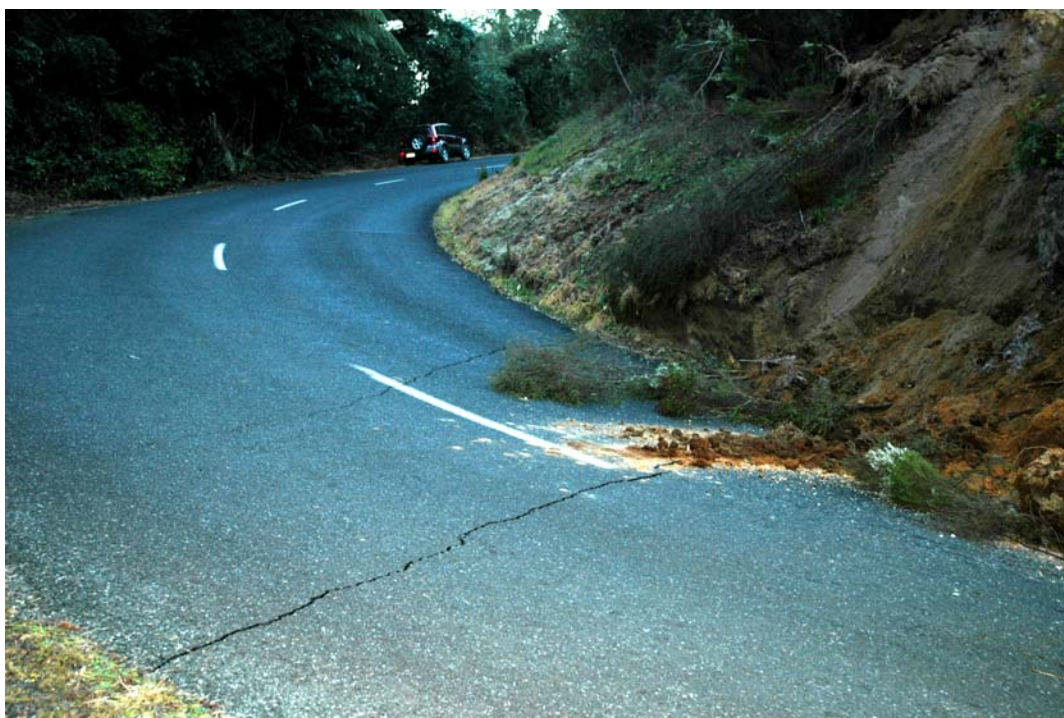
Figure 15. Ground cracking on the Pongakawa Valley Road ~1 km east of Lake Rotoehu (Slide 10 in Figure 3). The crack in the foreground crossing the road can be traced across a low spur to re-cross the road several metres past the vehicle. This incipient landslide was the largest observed landslide caused by the earthquake ($\sim 10,000 \text{ m}^3$). [Photo: M.J. McSaveney, 19/7/04]

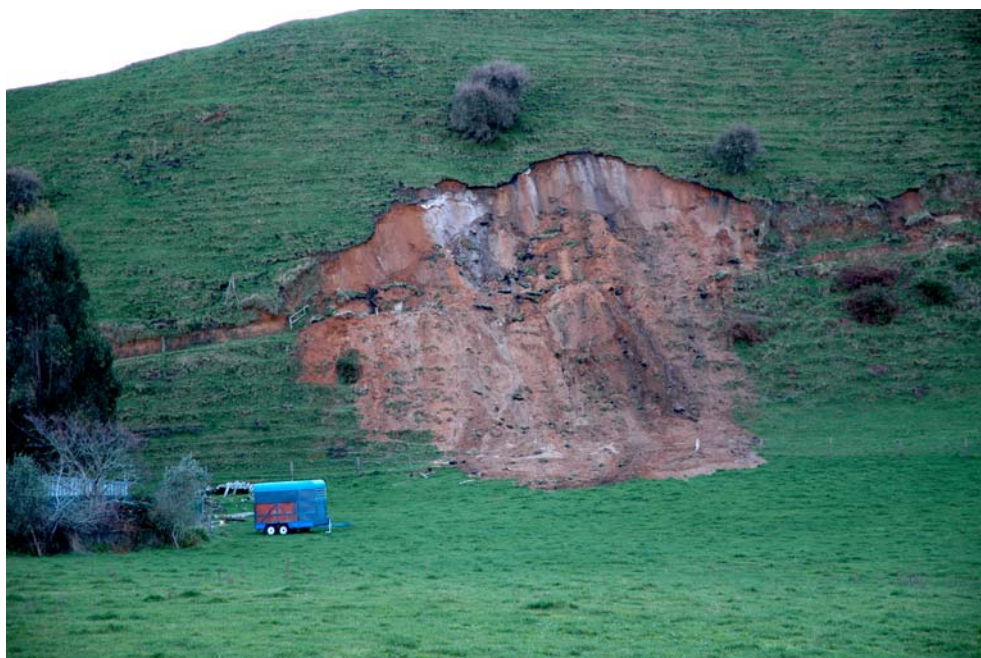
Figure 16. Disrupted soil slide affecting a farm track near the Pongakawa Valley village (Slide 11 in Figure 3). This landslide, on a slope predisposed to failure by the cutting of the track, was one of the few observed on farmland. Note the relatively dry nature of the debris. [Photo: M.J. McSaveney, 19/7/04]

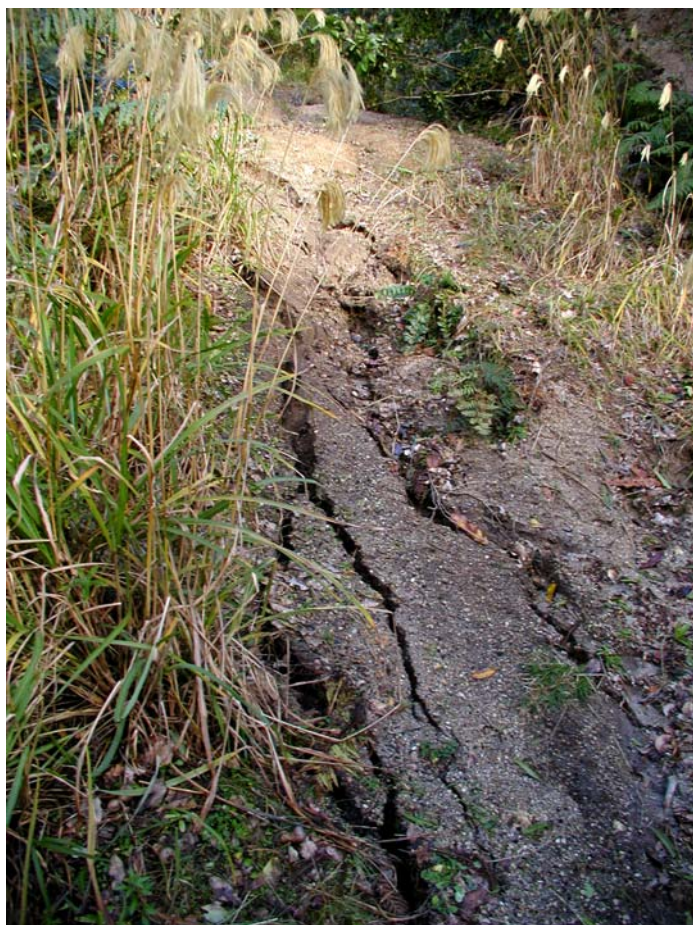
Figure 17. Ground cracking observed in a sidling fill for a track to water reservoirs above Lake Rotoiti village (Feature 12 in Figure 3). Cracking in sidling fills was observed along this track for a distance of 200-300 m *Photo: G Dellow, 23/7/04].*

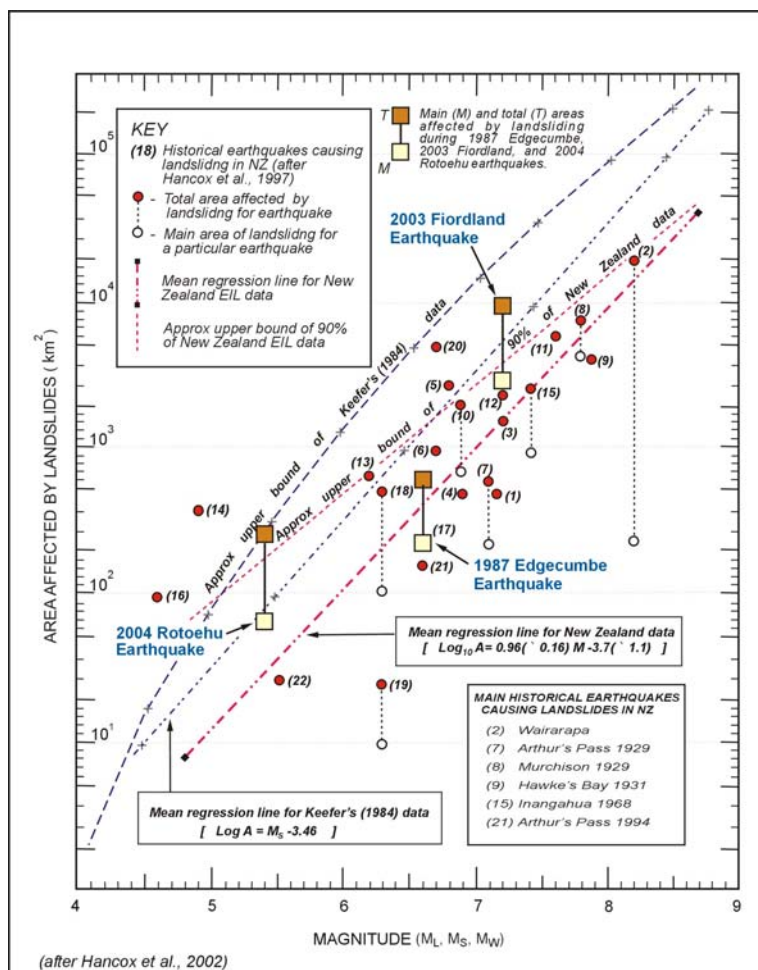
Figure 18. Plot showing relationship of the main and total areas affected by landslides during the 2004 Rotoehu earthquake swarm, here compared to the 2003 Fiordland earthquake, the 1987 Edgecumbe earthquake (the largest historical earthquake in the Bay of Plenty area), and other historical earthquakes of different magnitude in New Zealand (Hancox *et al.*, 2002) and overseas (Keefer 1984).

When plotted on an area/magnitude graph (Figure 14) the main and total areas affected by landsliding during the 2004 Rotoehu earthquake fit well against the mean regression line for worldwide earthquake data, but are slightly above the mean regression line for historical earthquakes in New Zealand (Hancox *et al.*, 2002), especially the 1987 Edgecumbe earthquake. This is thought to reflect the higher susceptibility of slopes in the Rotorua Lakes area to landsliding in July 2004 because of the very heavy rainfall over the preceding two days. Slopes around the shoreline of Lake Rotoehu and Lake Rotoma did not fail during the March 1987 Edgecumbe earthquake (MM 7 at Lake Rotoehu and MM 8 at Lake Rotoma), which occurred in summer when the slopes would have been much drier.
