# **Landslides caused by the February 2004 rainstorms and floods in southern North Island, New Zealand**

**G.T. Hancox and K. Wright**

**Institute of Geological & Nuclear Sciences science report 2005/10**

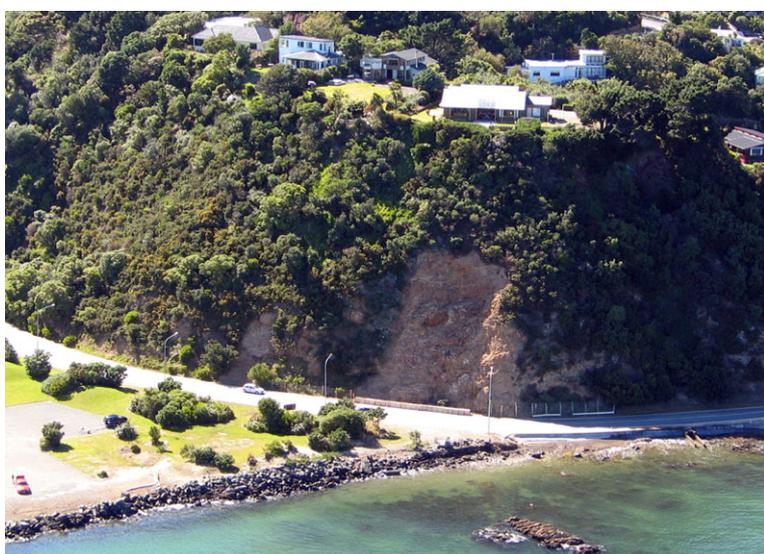
**Figure 11.** This moderate sized (~100-200 m<sup>3</sup>) rockfall in weathered greywacke closed the road to Eastbourne for several hours. It was typical of slope failures in the Wellington area during the February 2004 storm. [GNS Photo: GH1726]

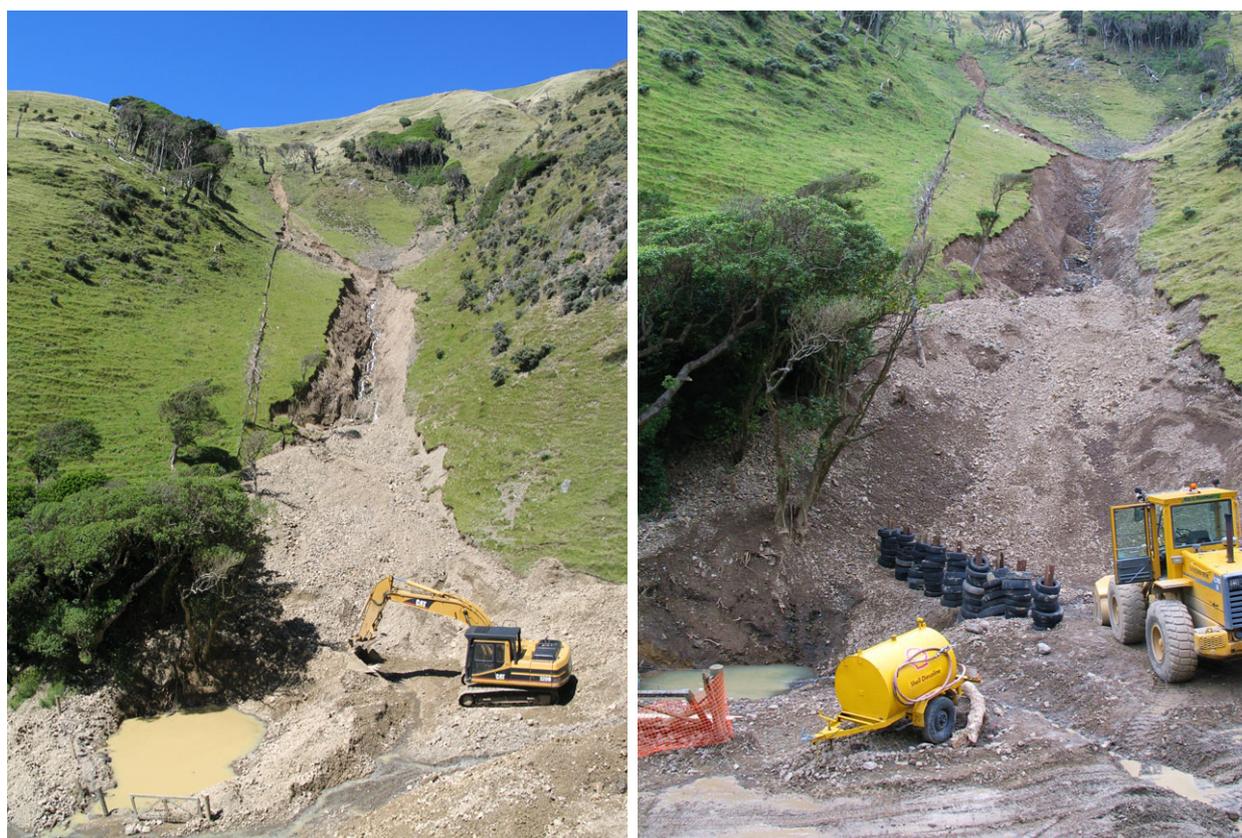
**Figure 13.** During the February 2004 storm, gully erosion and debris flood gravel closed Paekakariki Hill Road at the 'hair-pin' gully. A steel and tyre *catch fence* constructed after the storm (right) prevented a recurrence of such damage during the January 2005 storm. [GNS Photos: GH1574(L) / GH2261(R)]

Similar debris flood gravel problems also closed the Paekakariki Hill Road at the 'hair-pin' gully in 2003, and again in 2004, but construction of a recommended debris fence at the gully mouth above the road prevented further problems in January 2005 (Figure 13).

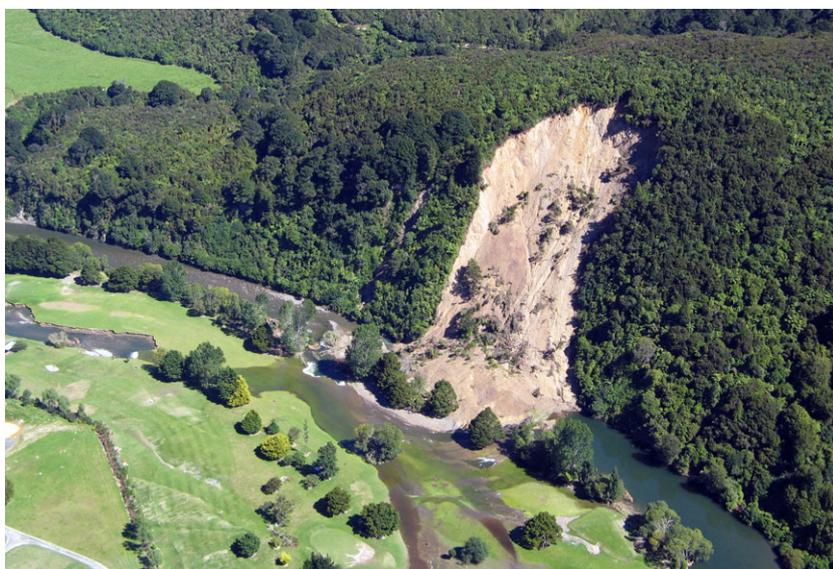
[GNS Photo: GH1745]

The largest and most spectacular landslide in the greater Wellington area occurred during heavy rain on Tuesday (pm) 17 February 2004. A large (200,000–300,000 m<sup>3</sup>) deep-seated rock and debris slide in regolith and bedrock occurred on the eroded old Wellington fault-line scarp north of Upper Hutt. The landslide dammed the Hutt River and diverted it through the Te Marua golf course, causing extensive erosion damage and creating a new ‘water hazard’ through the fairway (Figure 14a). This was the largest bedrock landslide that has occurred in the Wellington area in several decades. It may have formed on a pre-existing failure area. Remedial earthworks have since been completed at the site to clear landslide debris from the river channel, construct a stop bank to reposition the river in its former channel, and repair damage to the golf course (Figure 14b). The top of the landslide scar is now significantly oversteepened and remains vulnerable to further slope failures, which could be initiated by river erosion of the debris cone, by heavy rainfall, or by strong earthquake shaking. However, no new failures were noted during rain storms in August 2004 and March 2005, or several moderately strong (MM 5-6) earthquakes in January 2005.

**Figure 14a.** Aerial photo of the large rock/debris slide (~200,000 – 300,000 m<sup>3</sup>) which dammed the Hutt River at Te Marua near Upper Hutt and diverted it through the golf course causing significant erosion damage.

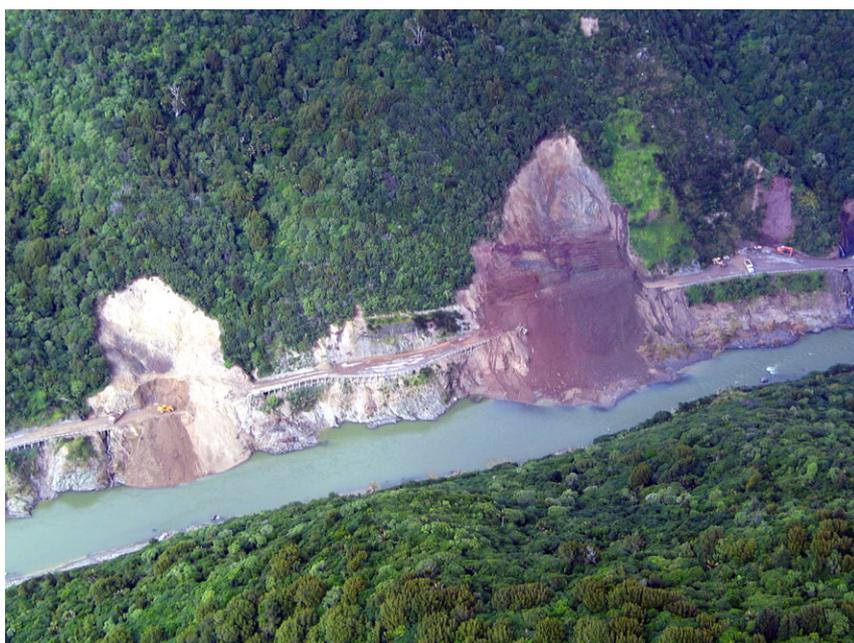
Several large debris and rock falls occurred along SH 3 on the south side of the Manawatu Gorge, with one very large landslide at the eastern end of the gorge taking about three months to clear (Figure 17). Almost all of the landslides were road cutting failures in colluvium, regolith, and weathered bedrock, some of which extended ~50–100 m above the road. No significant landslides were seen on the northern or railway side of the gorge. Cuts along the railway line are much smaller and older than those along SH 3. The road through the Manawatu Gorge remains susceptible to further slope failures and closures, but the existence of alternative routes across the Pahiatua Track and Saddle road apparently make a permanent solution to reduce landslide hazard in the gorge uneconomic (pers. comm. Transit NZ).

**Figure 17.** Large rock and debris slide (80–100,000m<sup>3</sup>, right) in the Manawatu Gorge which blocked SH 3 for about 3 months after initial failure during the February 2004 storm. A series of ~6 further failures delayed road clearing at this site. [GNS Photo: GH2287, 12/3/04]

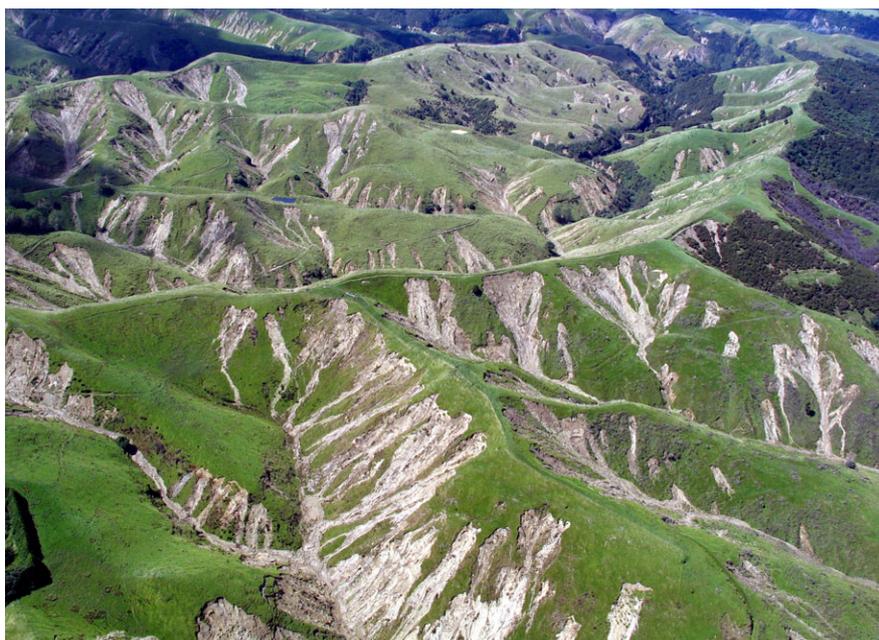
[GNS Photo: GH1848]

**Figure 18.** Multiple shallow (~0.5–1 m deep) soil/debris slides and flows scarring steep grass-covered hills on the west side of the Pohangina valley.

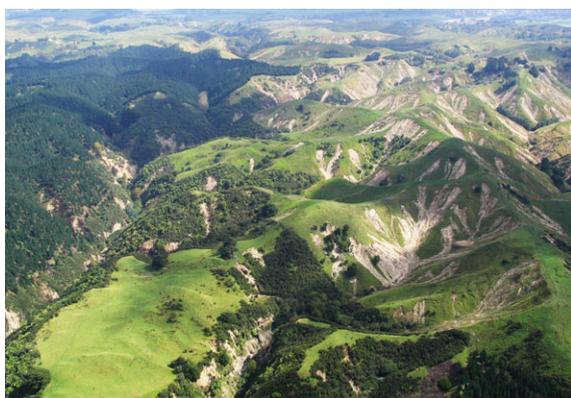
**Figure 19.** Although shallow soil slides and flows were widespread on steep grass-covered hill slopes of the lower Pohangina valley, there were few failures in areas of scrub and exotic forest (left).

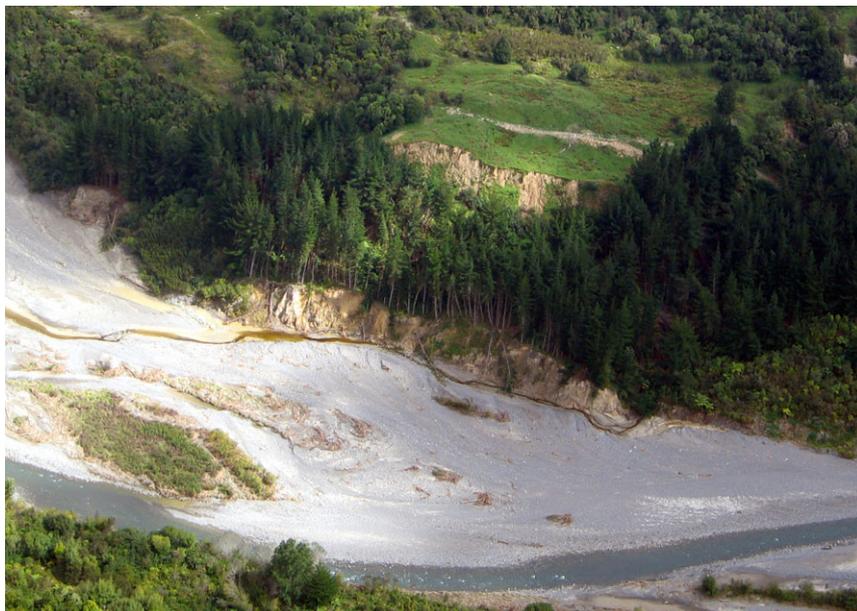
[GNS Photo: GH2376]

Although exotic forest provided good protection against landsliding on hill slopes, trees planted close to river banks collapsed into the river channel when undercut by rivers in flood. Collapse of pine trees into the Pohangina River (Figure 20) contributed to the vegetation and tree debris that caused the collapse of the road bridge at Ashhurst (Figure 21, about 25 km downstream from the site shown in Figure 20). Pine trees planted close to the river channel do little to prevent river bank erosion, and in this situation the trees are a potential (man-made) hazard.

**Figure 20.** Area of pine trees planted close to the river bank in the upper Pohangina valley. Some trees collapsed into the river during the February 2004 flood. Debris from the fallen trees contributed to the collapse of the road bridge across the Pohangina River at Ashhurst ~25 km downstream (left).

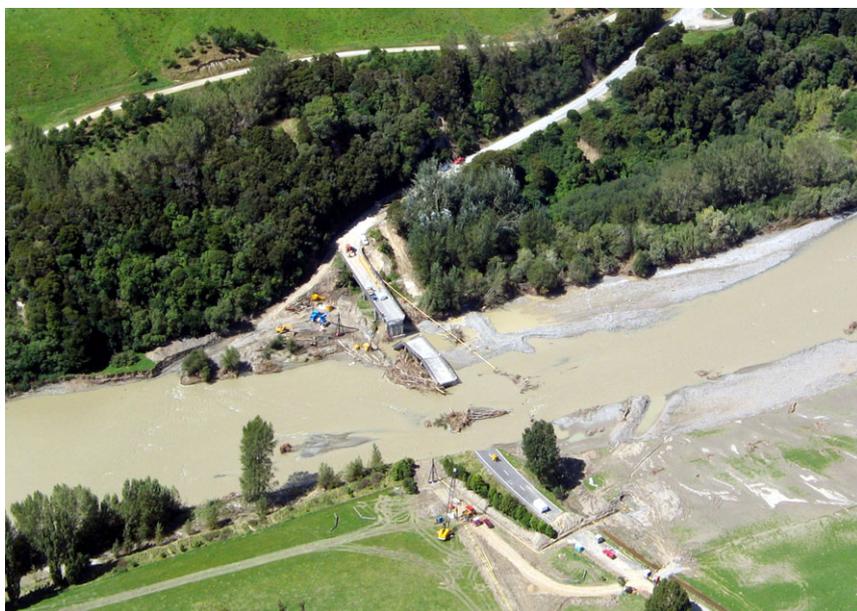
**Figure 21.** Pine and poplar tree debris contributed to collapse of the Saddle Road bridge across the Pohangina River at Ashhurst.

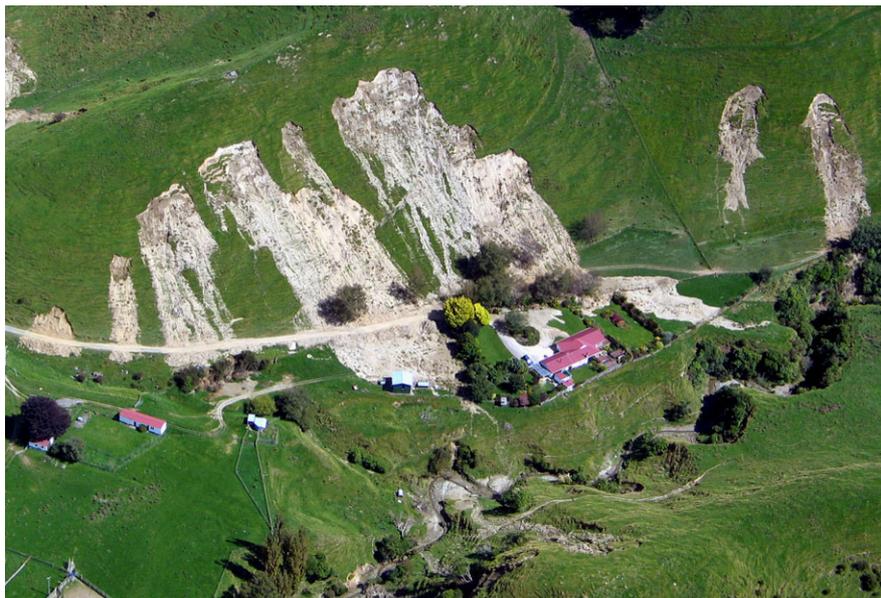
**Figure 22.** Large shallow soil slides and flows which came close to damaging a farmhouse in the hills above the Rangitikei valley. Trees stopped most of the debris but the soil-charged watery part of the flow reached the house. [GNS Photo: GH2425]

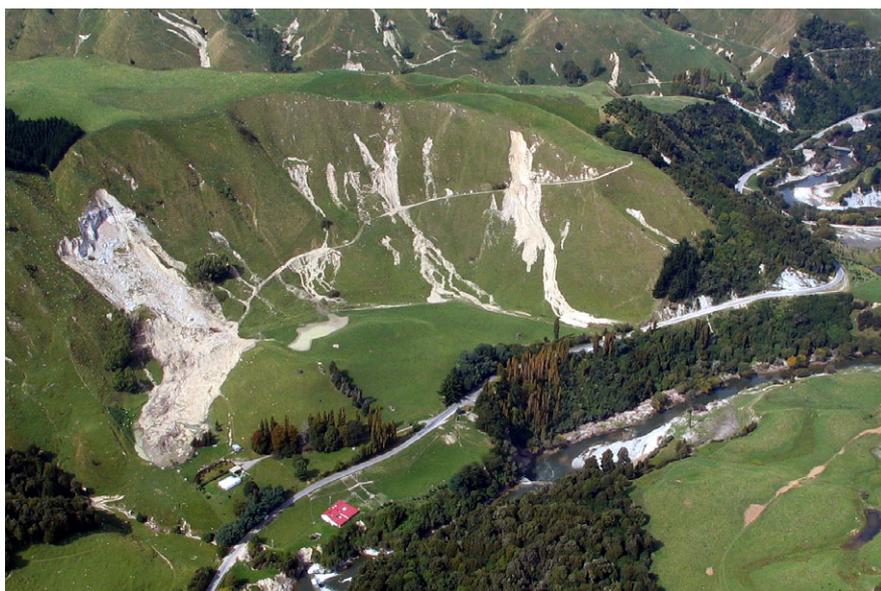
**Figure 23.** Large (~2000 – 5000 m<sup>3</sup>) soils slides and flows which damaged farmland and tracks close to SH 4 in the Mangawhero valley. The bedrock failure (left) was typical of many larger slides in the area. [GNS Photo: GH2728]

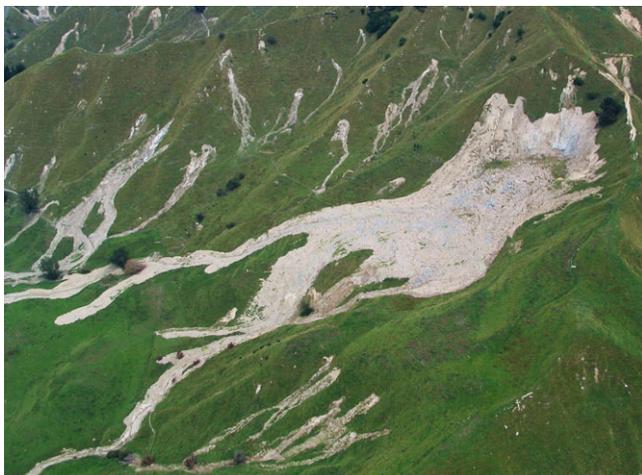
**Figure 25.** Closer view of the  $\sim 200,000\text{m}^3$  rotational slide in the Mangawhero valley. The scale of the slide can be seen here by the head scarp, which is about  $50\text{ m}$  high and cuts deeply into mudstone bedrock. Soil and debris flows associated with this failure extended almost  $1\text{ km}$  to the Mangawhero River. Slide debris caused significant damage to fences. [GNS Photo: GH2159]

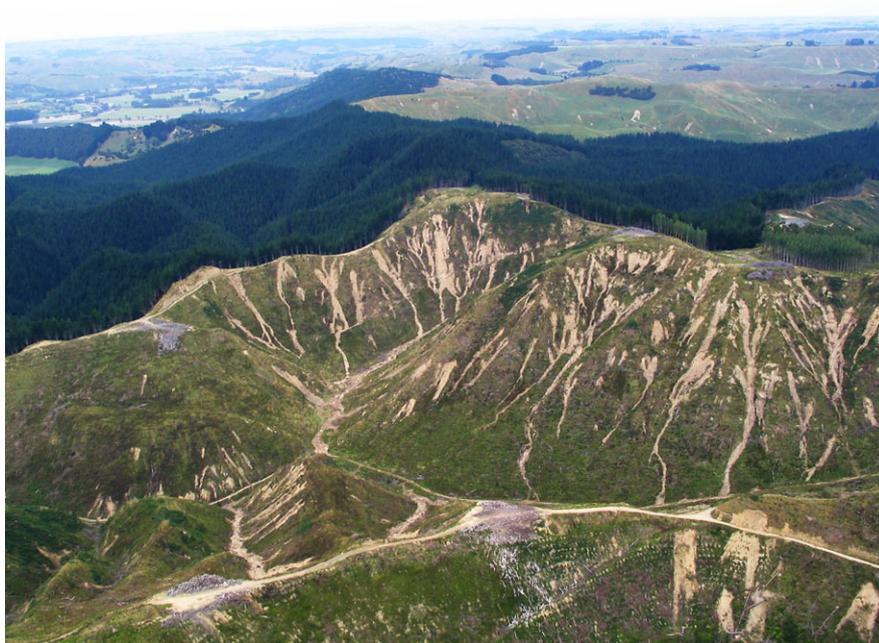
[GNS Photo: GH2130]

**Figure 26.** Oblique aerial photo of numerous small shallow slides and flows on recently-milled hills in the Mangawhero valley, but no obvious slides in mature un-milled forest in this area.

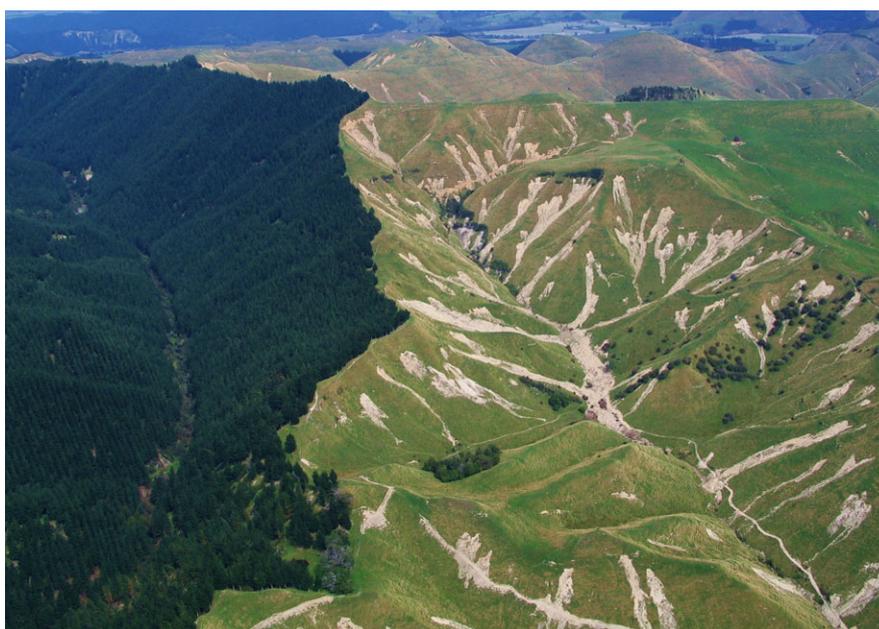
**Figure 27.** Aerial photo showing numerous shallow soil slides and flows on grass-covered hills in the Mangawhero valley, with few obvious landslides in areas of mature forest. Lower intensity rainfall is inferred in grass-covered areas little affected by landslides (top right) [GNS Photo: GH2667]

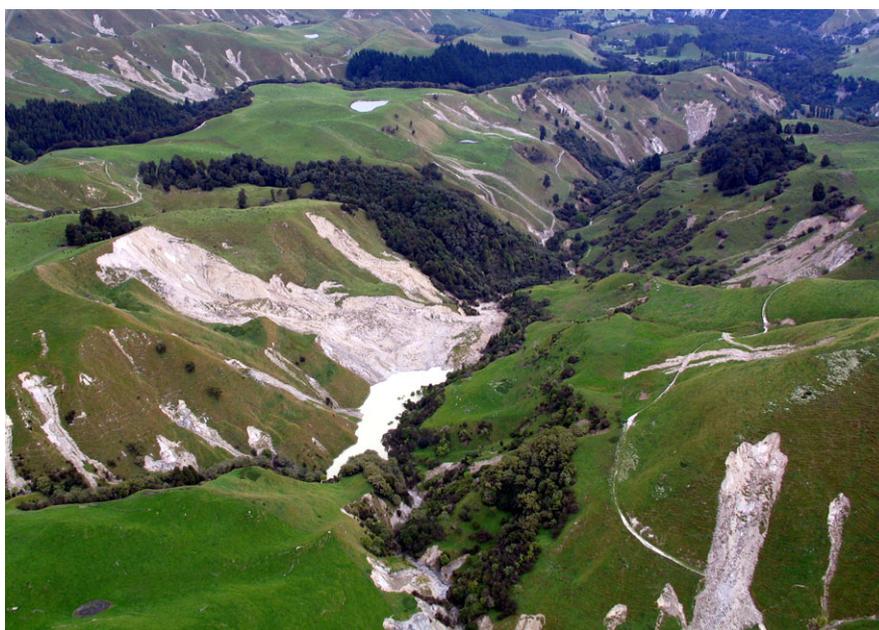
[GNS Photo: GH2193]

**Figure 28.** Small landslide dammed lake formed by a large rotational landslide in a small side stream of the Whangaehu River.

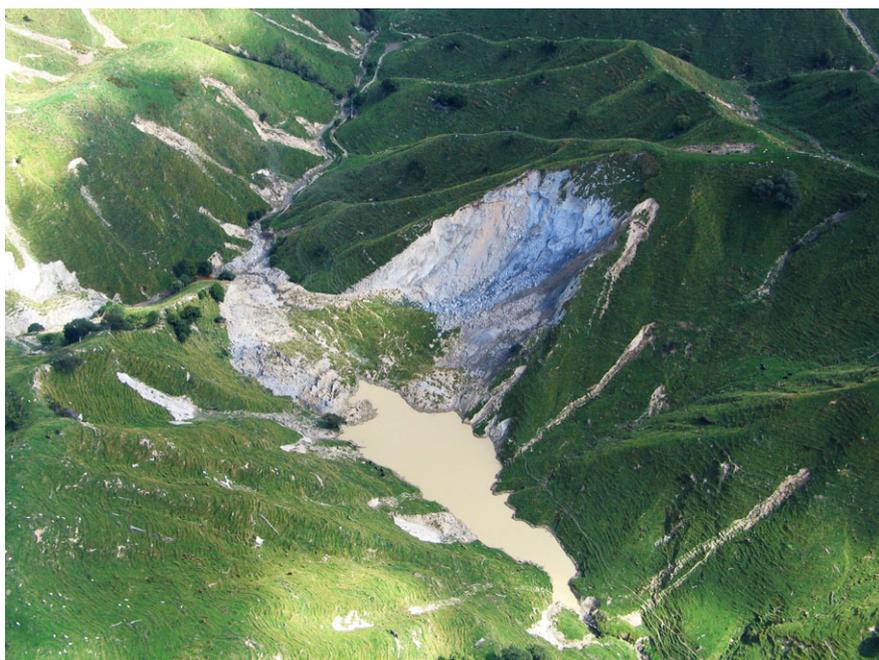
**Figure 29.** Landslide-dammed lake impounded by a large rotational landslide in mudstone. This example is located at the head of the Mangapapa River in the upper Turakina valley.

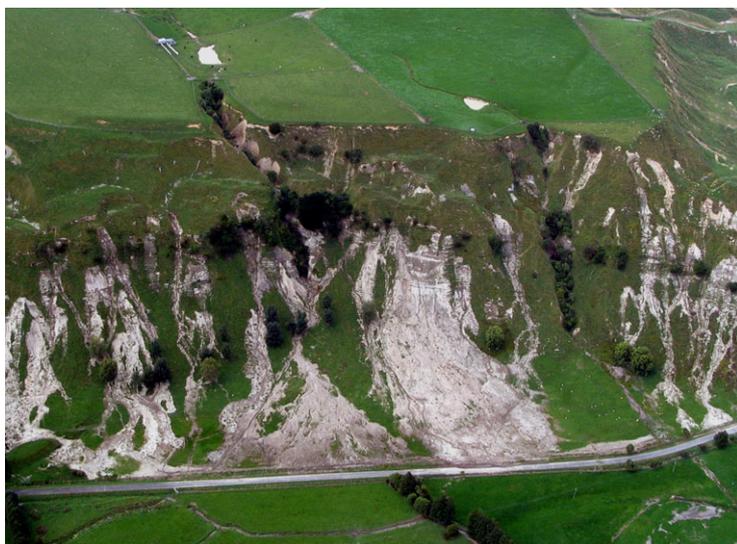
**Figure 30.** Extensive debris and soil flows from this steep terrace riser temporarily blocked the road in the upper Pohangina valley but did little serious damage. The slide debris had been cleared away and the road reopened when this photo was taken on 12 March 2004. [GNS Photo: GH2339]

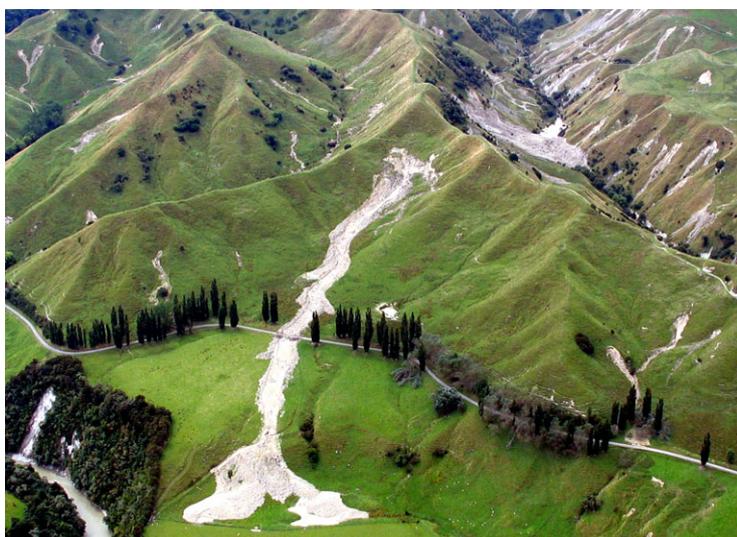
**Figure 31.** This debris flow briefly cut the Whangaehu valley road but did no serious damage. The spread and form of the distal lobes indicate the high fluidity of the flow. A small landslide-dammed lake can be seen in a side valley (top right). [GNS Photo: GH2183]

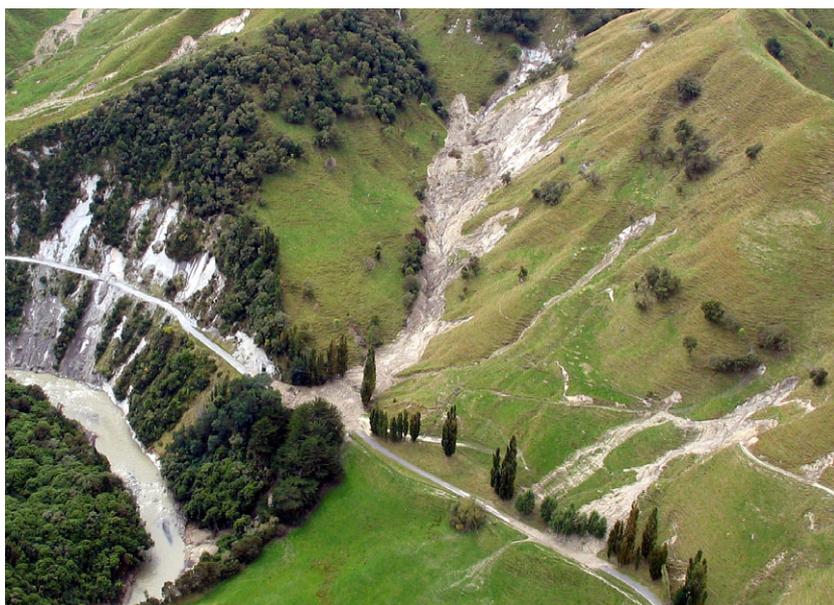
**Figure 32.** Debris flows and small rock falls (in cutting left) still blocked the Whangaehu valley road when this photo was taken (27 February 2004).  
[GNS Photo: GH2205]

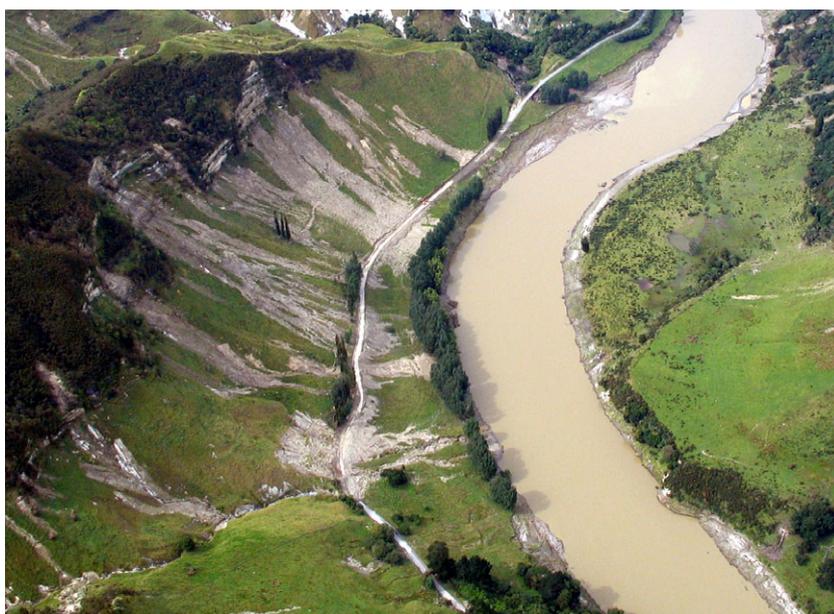
**Figure 33.** Debris flows from steep natural slope briefly blocked the Wanganui valley road, but the debris had been cleared when the photo was taken on 27 February 2004.  
[GNS Photo: GH2097]
