BIBLIOGRAPHIC REFERENCE

Beetham, R.D.; Grant, H. 2006. Reconnaissance of landslide and flood damage in the Gisborne area caused by the 2005 Labour Weekend storm., *GNS Science Report 2006/022* 35 p.

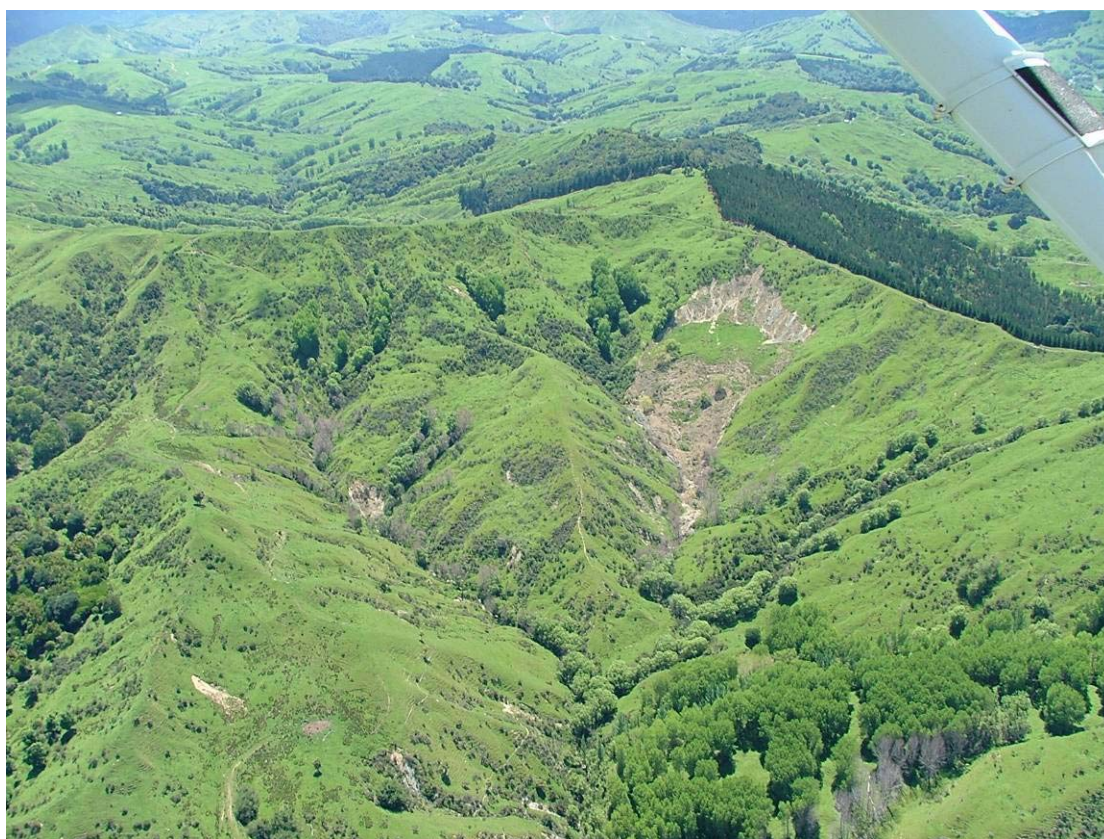
A number of discrete large (~10,000 m³) landslides were observed between Gisborne and Tolaga Bay (Figures 6-8). It is likely that these were pre-existing active or dormant landslides which were further activated by the Labour Weekend storm.

Figure 6 Large landslide on farmland north of Gisborne.

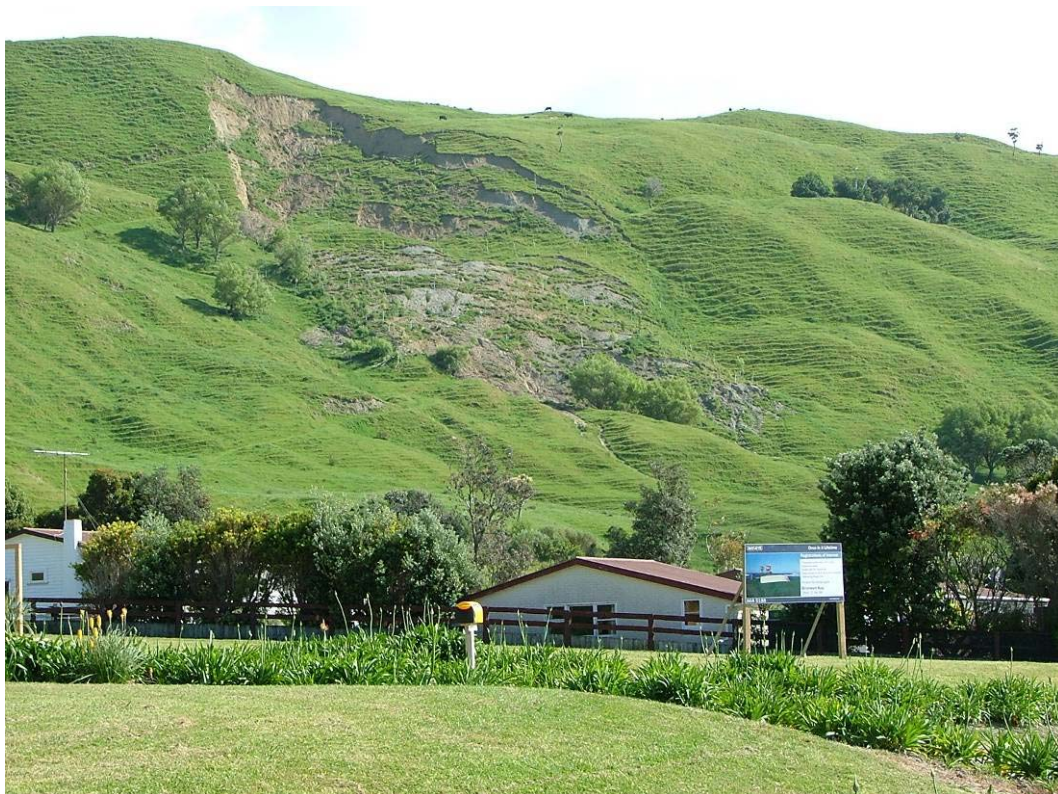
Figure 7 “Old” landslide on slope behind Tatapouri Bay (approx Y18:576717).

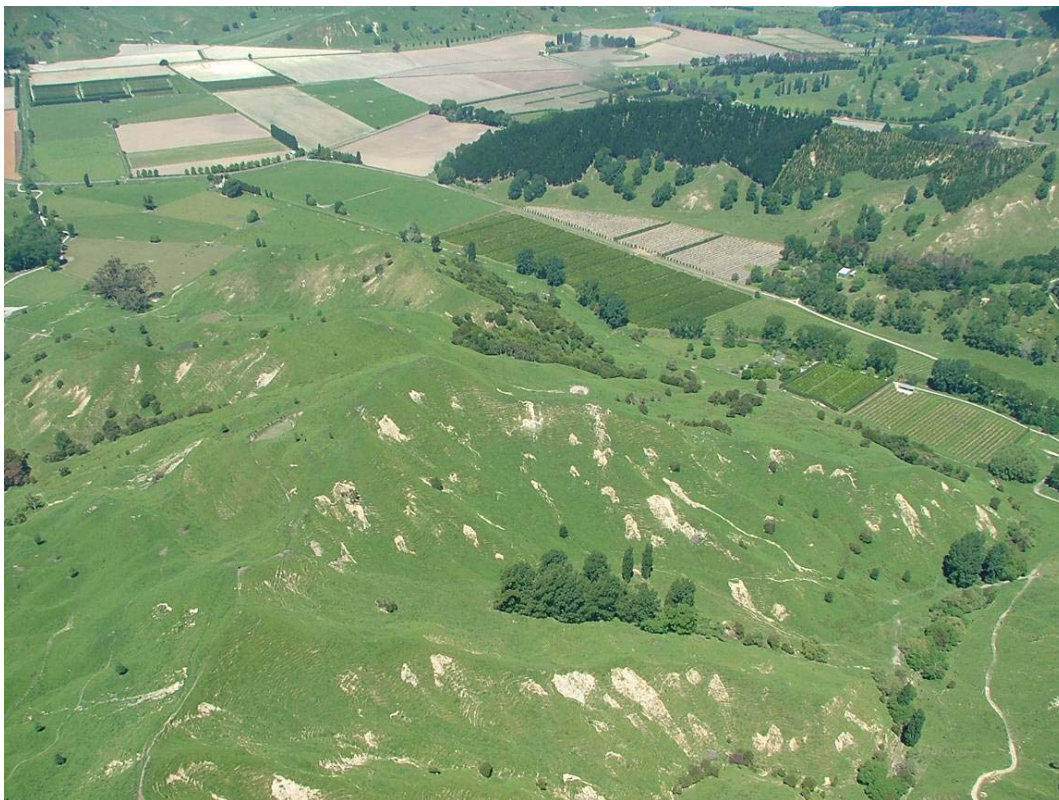
Figure 9 Shallow soil slides/flows in the hills southeast of Poverty Bay.

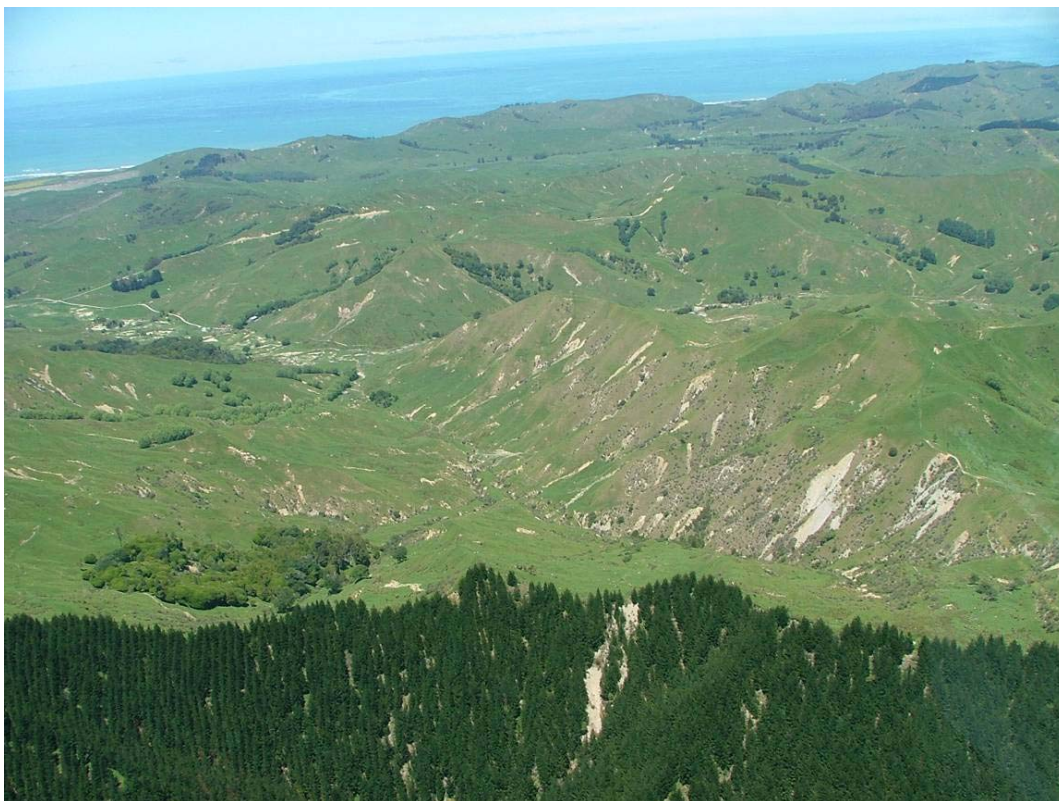
Figure 10 Small landslides on farmland between Gisborne and Tolaga Bay.

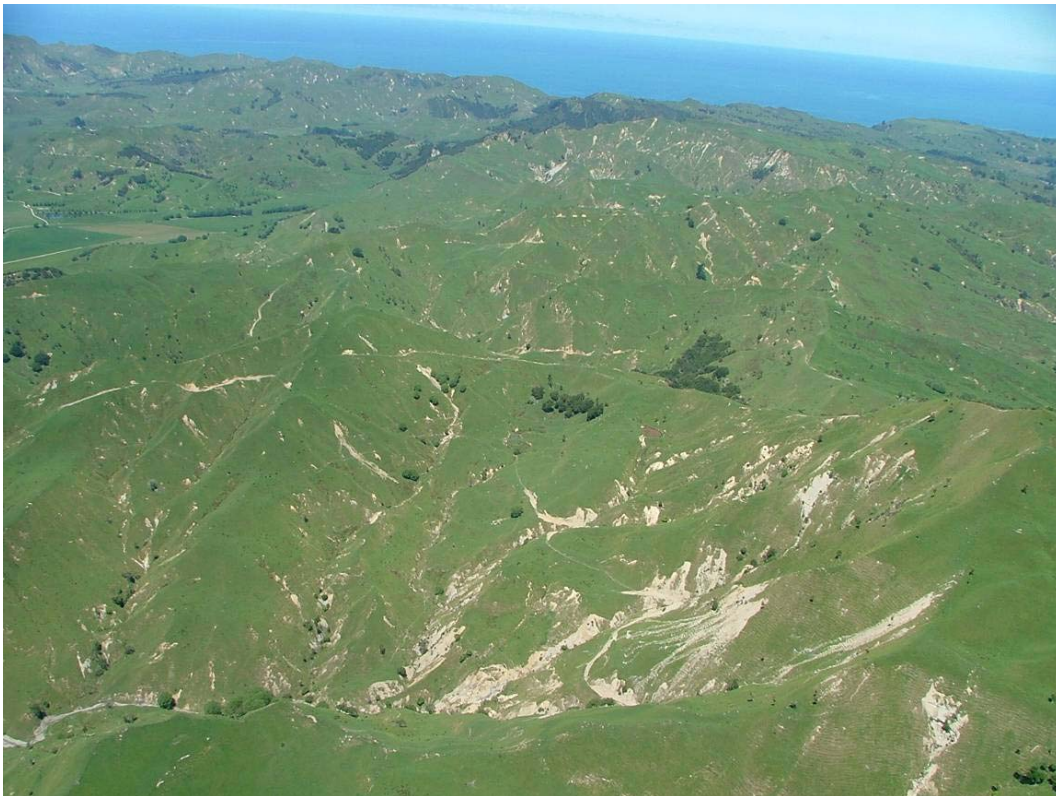
Figure 11 Soil slides/flows in steep farm country between Gisborne and Tolaga Bay.

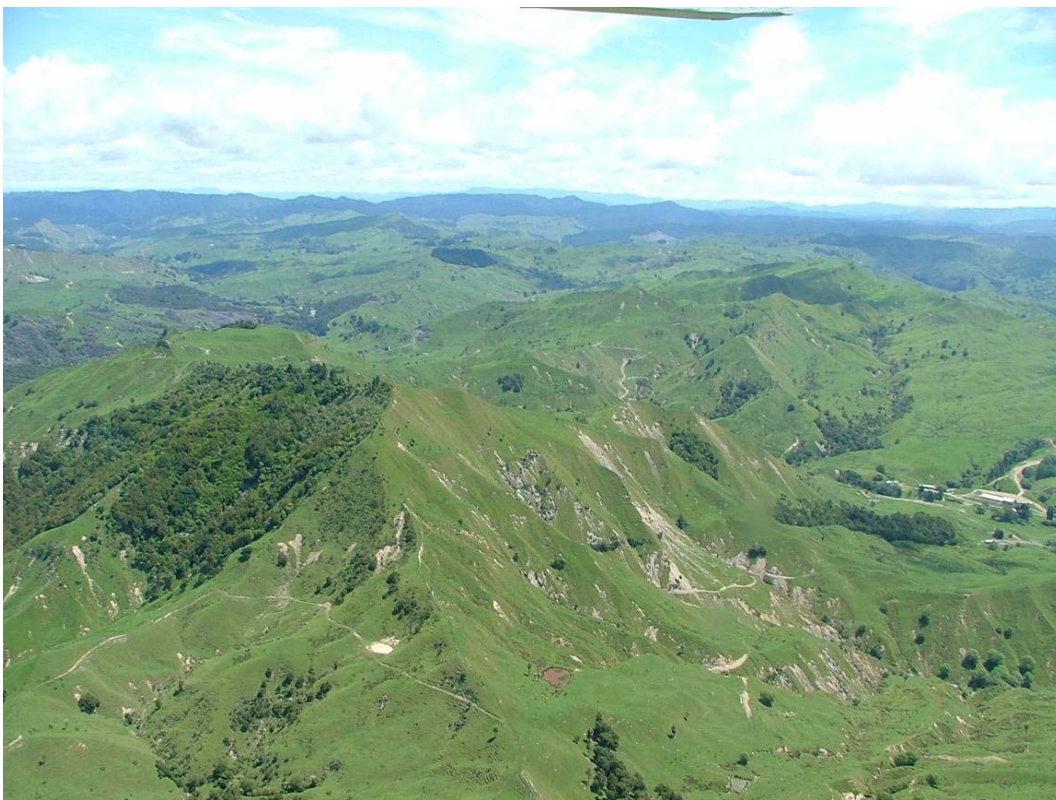
Figure 12 Small landslides on farmland between Gisborne and Tolaga Bay.

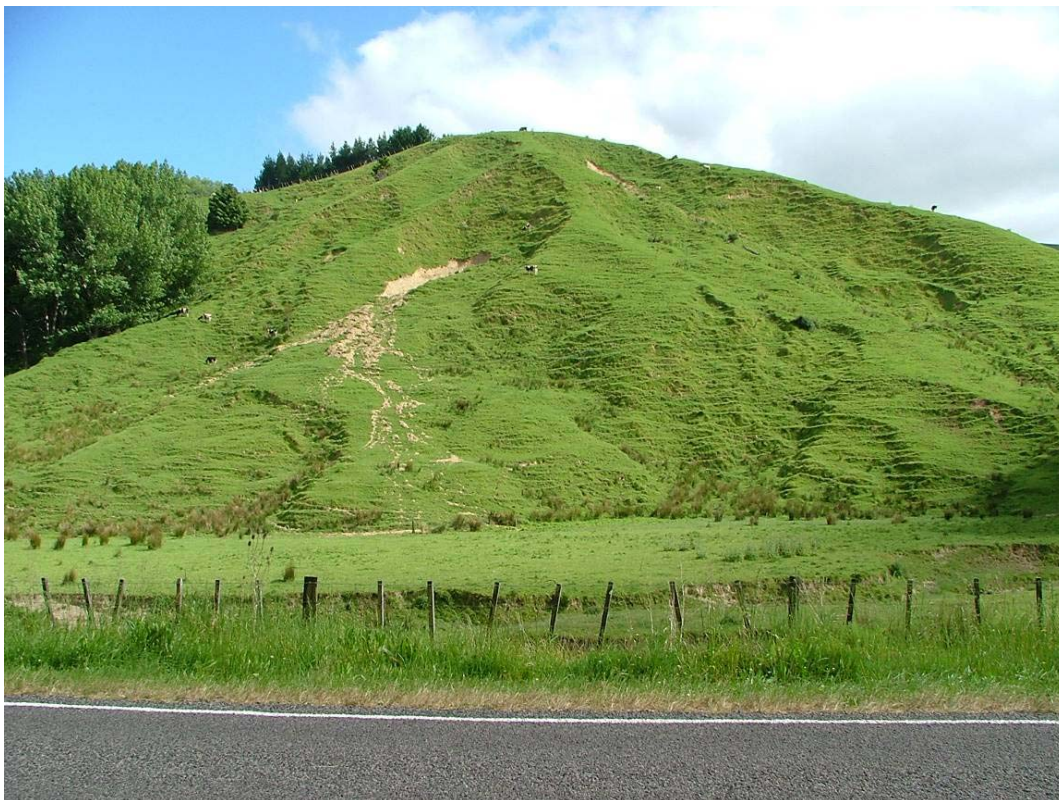
Figure 13 Example of a saturated soil flow in farmland approximately 11 km south of Tolaga Bay (approx Y17:687905). Note the “healed” landslide scars.

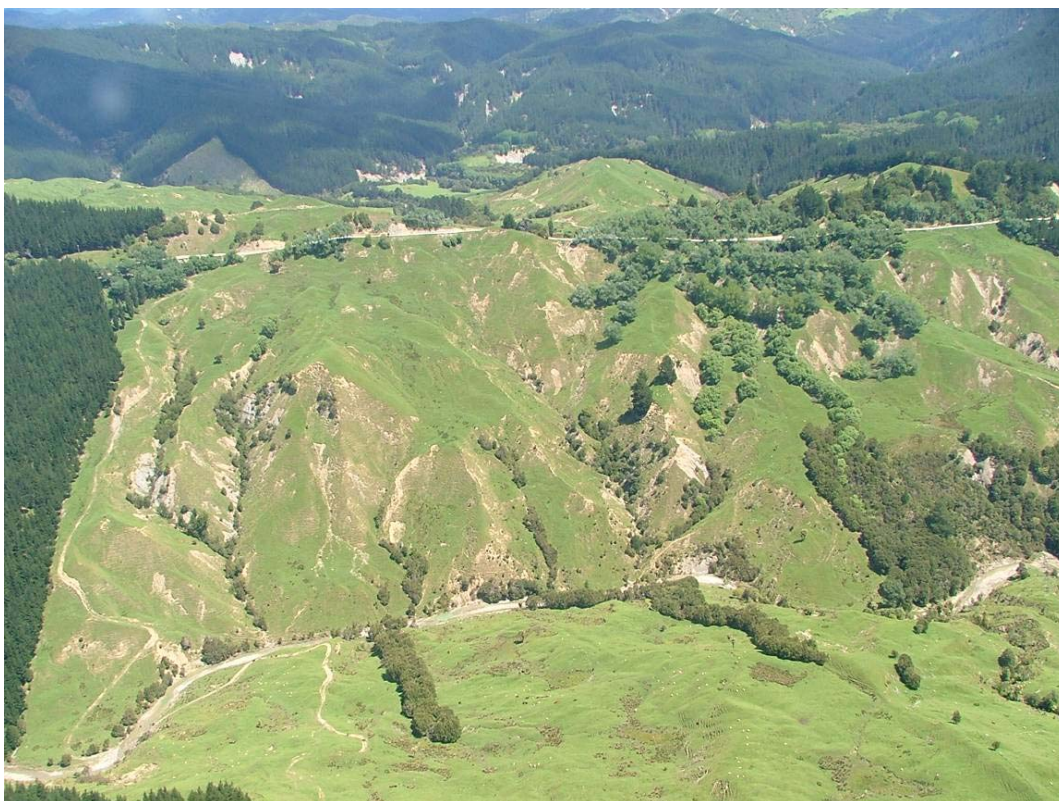
Figure 14 Typical farmland and forest terrain between Tolaga and Tokomaru bays.

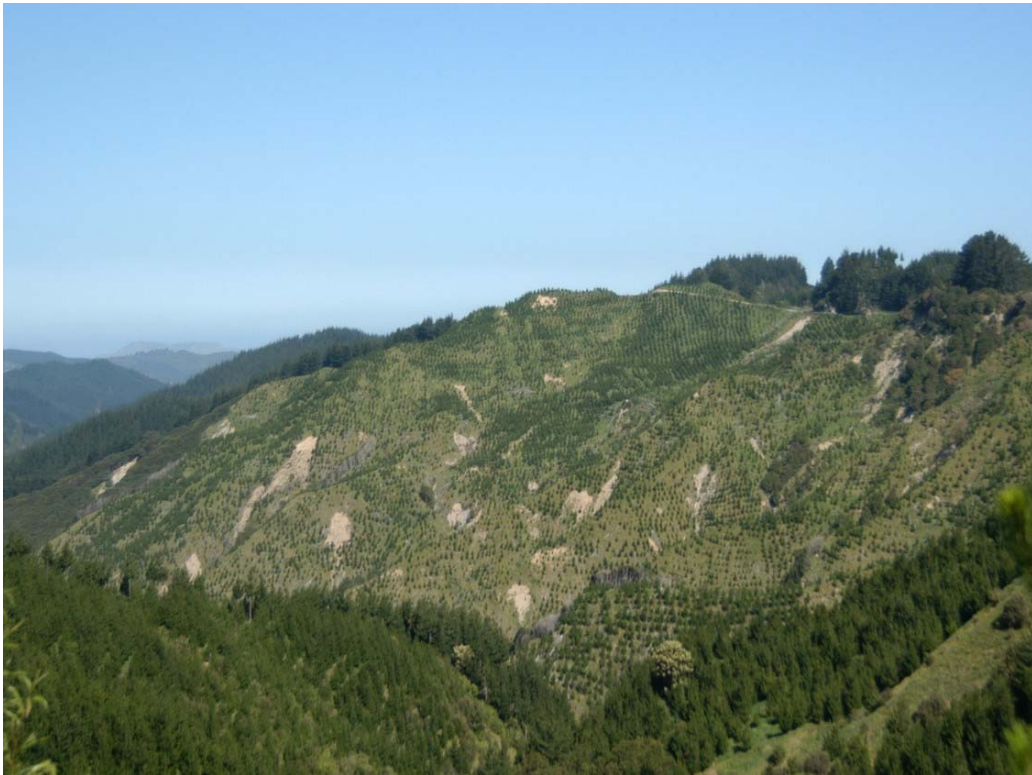
Figure 15 Numerous landslides in a north facing late Miocene mudstone slope planted in young pine forest, upper Ramanui Stream catchment, 2.5 km south of Tauwhareparae (approx Y16:562103).

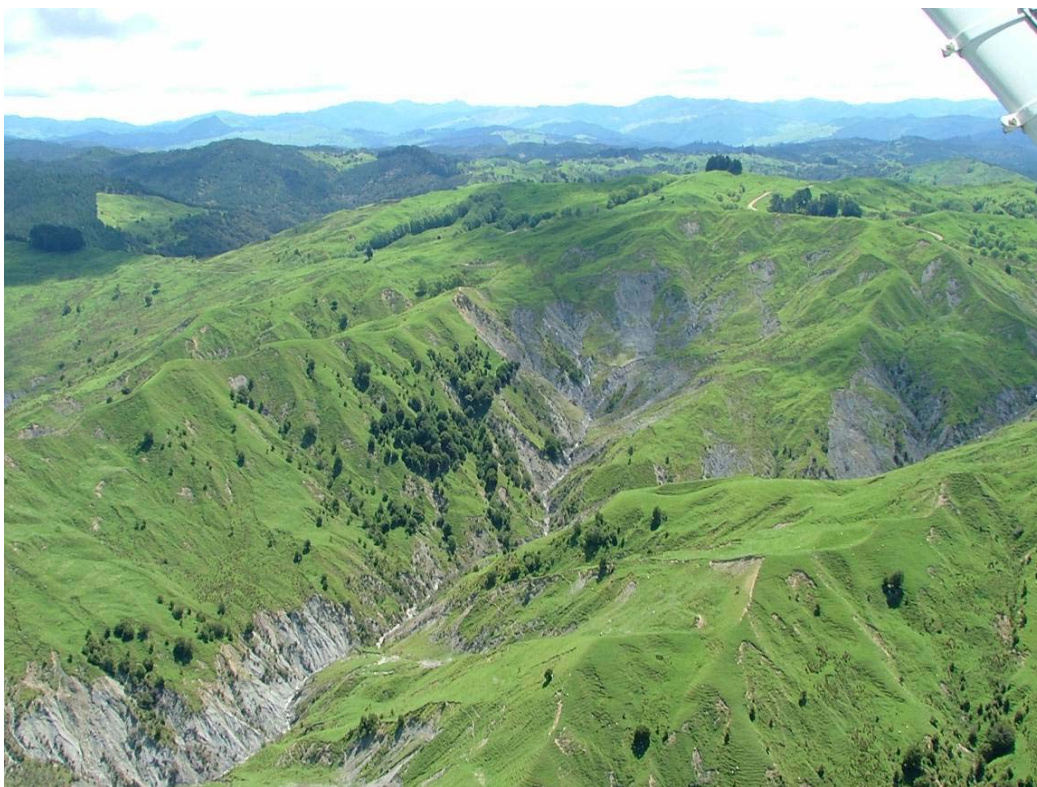
Gullying, in some places severe, was observed in the headwaters of the Hikuwai catchment (including the Waiau and Mangatokerāu catchments) (Figures 17-22). This gullying is ongoing but the Labour Weekend storm most likely caused a significant amount of erosion

Figure 17 Farmland gully erosion in mid to late Miocene mudstone in the upper Hikuwai (Waiau) catchment inland of Tokomaru Bay. Note the many healed landslide scars, particularly in the right foreground, from Cyclone Bola.

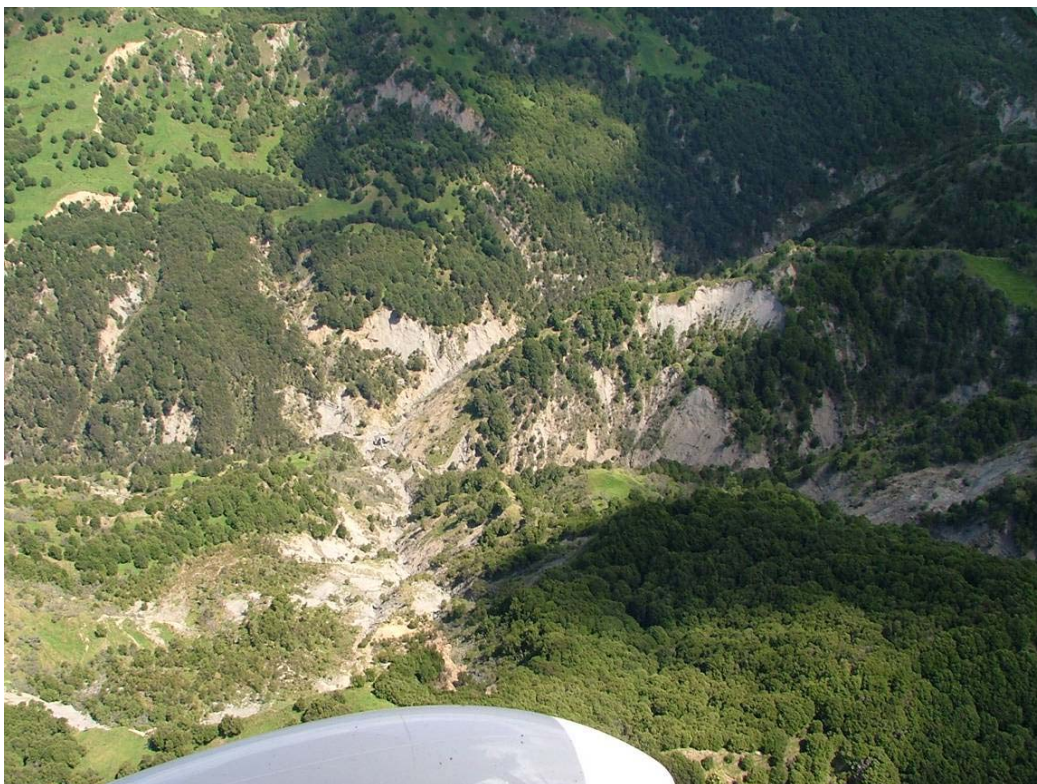
Figure 18 Gully erosion in late Miocene mudstone in the Hikuwai catchment inland from Tolaga Bay.

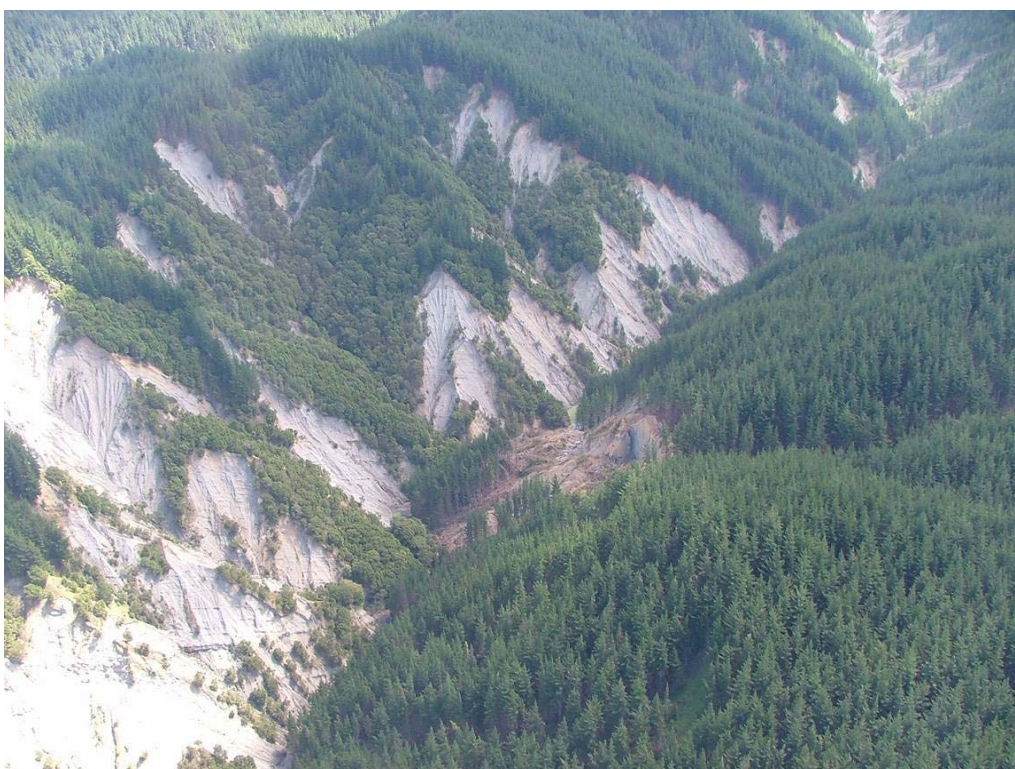
Figure 20 Severe gully erosion in mid to late Miocene mudstone in the upper Hikuwai (Waiau) catchment inland of Tokomaru Bay. Note the block slide in the mid foreground. These landslides date from Cyclone Bola and were reactivated to some degree in the Labour Weekend storm.

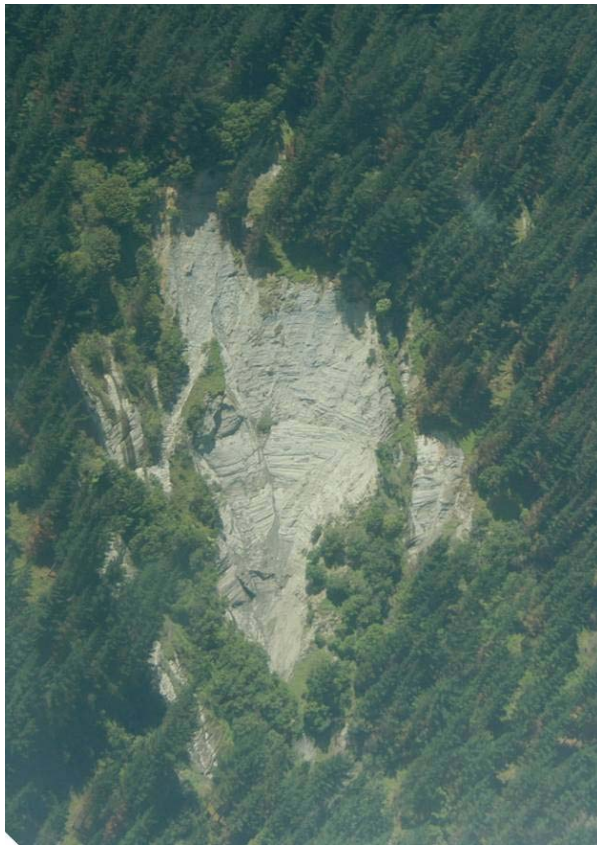
Figure 21 Detail of severe gully erosion in late Miocene mudstone in the upper Hikuwai (Waiau) catchment.

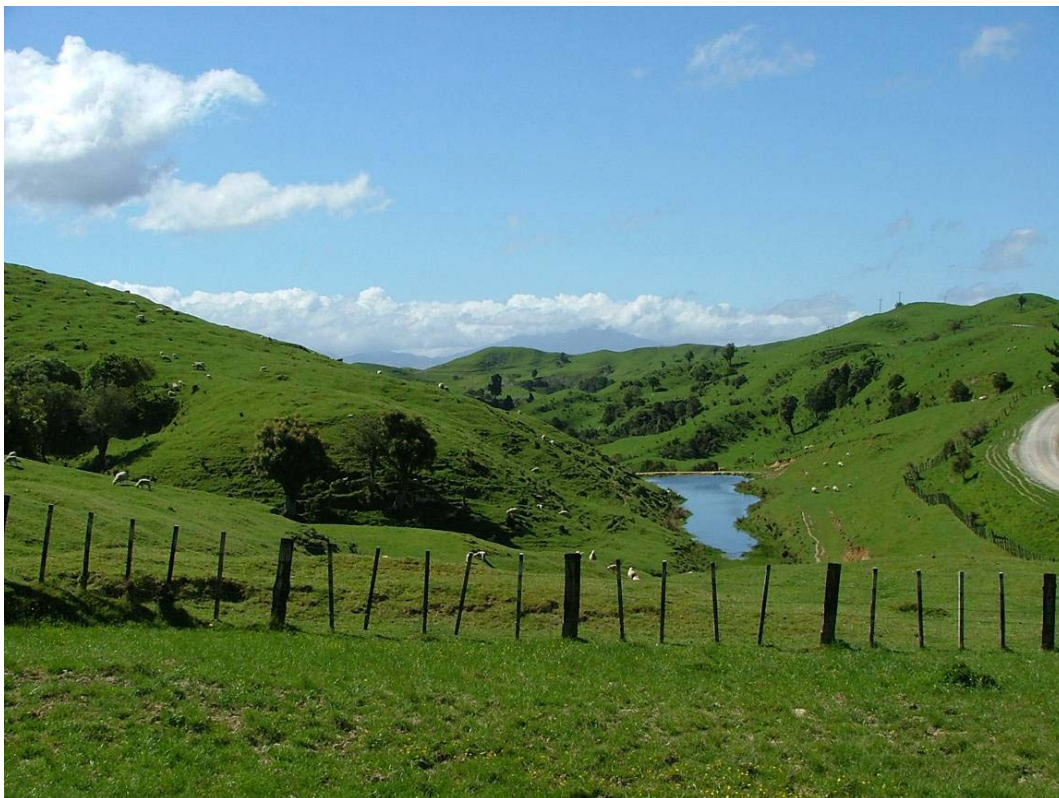
Little landsliding was observed in the relatively stable farmed “tableland” of the Tutamoe Plateau north of Tauwhareparae (Figure 23).

Figure 23 Relatively stable farmed “tableland” in early Miocene mudstone on Fernside Road on the Tutamoe Plateau, approximately 20km inland from Tokomaru Bay. Photo is facing north looking towards Mt Hikurangi in the distance (taken from approx Y16:548214).

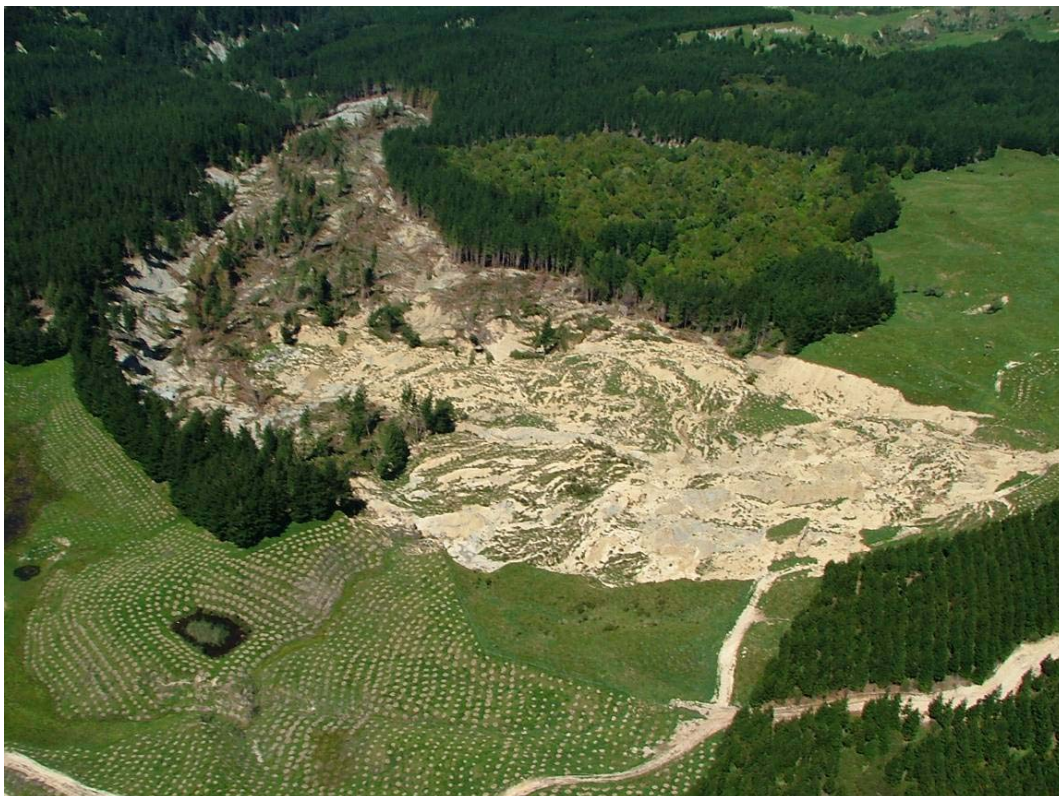
A large earthflow near Waingake was also included in the reconnaissance (Figures 24 and 25). This earthflow has been active for a number of years and is too large to be stabilised with exotic forest. The earthflow continues to move and enlarge and it is not known how responsive it is to large events such as the Labour Weekend storm.

Figure 24 A very large earth flow near Waingake, southeast of the Poverty Bay flats (approx Y18:308564). This earth flow predated the Labour Weekend storm but may have been enlarged by it.

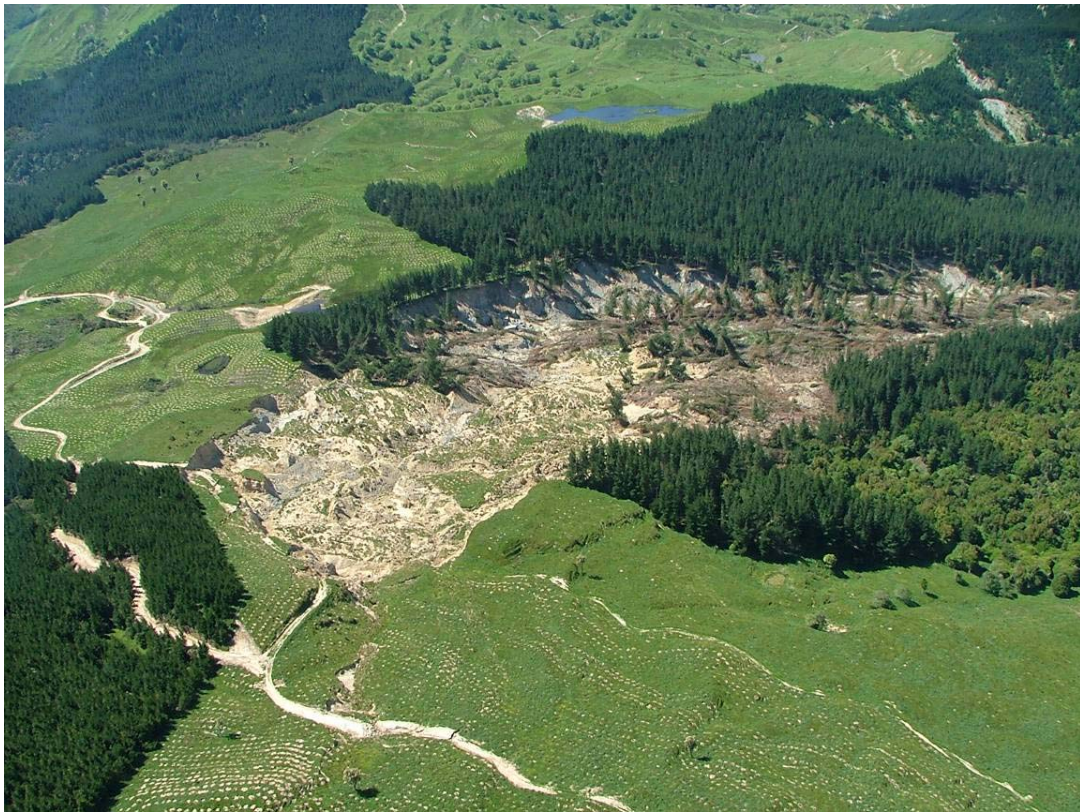
Figure 25 Another view of the earthflow at Waingake. Forestry planting has not prevented further movement on this slide.

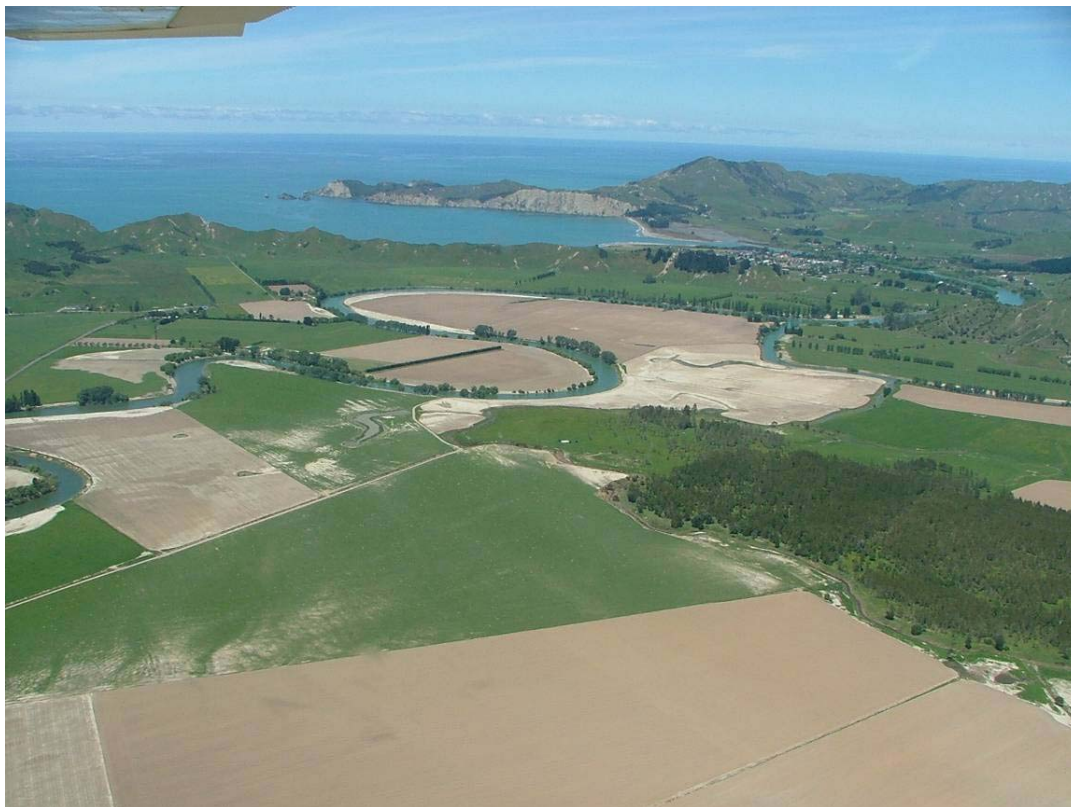
Figure 26 Looking southeast over the lower Hikuwai (Uawa) River flats towards Tolaga Bay.

Landsliding in the Hikuwai and, to a lesser extent, the Waipaoa catchments supplied large quantities of silt to the rivers which was deposited over approximately 1000 hectares of low lying land around Tolaga Bay (Figures 26-32) and 2000 hectares of land on the Poverty Bay flats. Much of this land had recently been planted with squash, sweet corn, maize and broccoli and most crops (around 2100 hectares in total) were totally destroyed. The total farm gate value of crops lost was estimated at \$8.4 million with total losses over \$10 million when including lost wages (GDC recovery report). Floodwaters also entered seven houses around Tolaga Bay depositing silt and debris. The Mangatuna Marae near Tolaga Bay was inundated damaging the kitchen and meeting house floors and mattresses (GDC recovery newsletter).

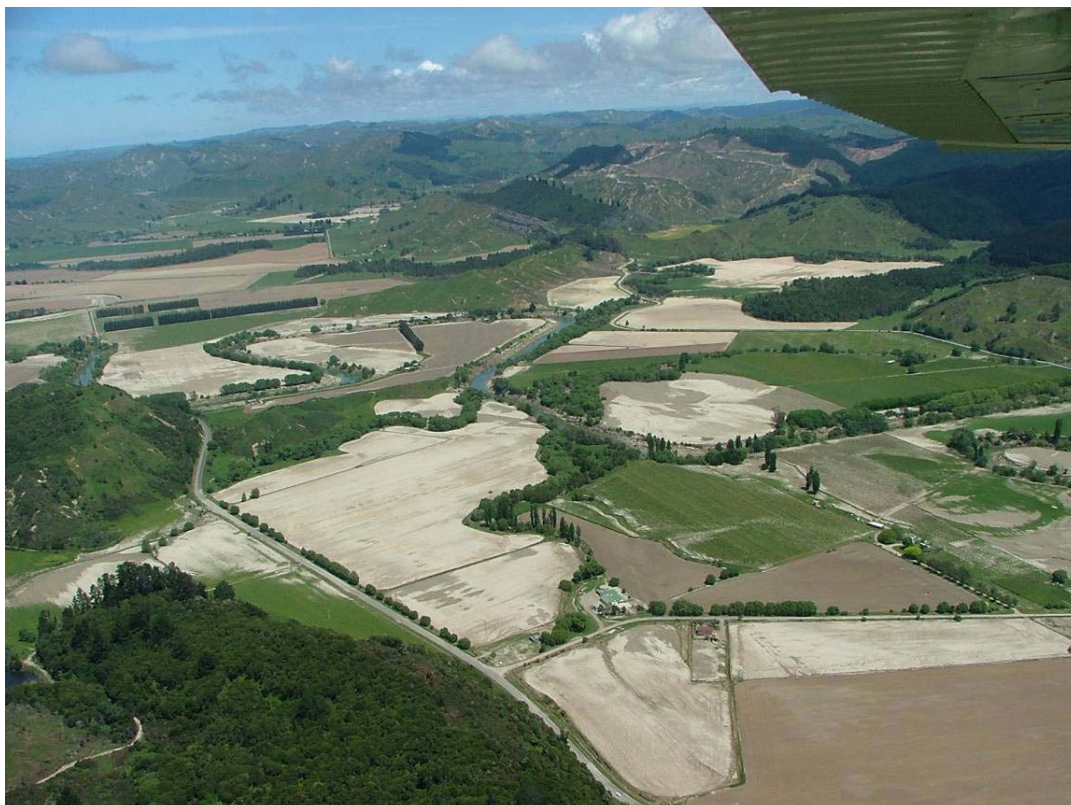
Figure 27 Looking southwest over the Hikuwai River flats at Mangatuna, north of Tolaga Bay. The Mangatuna Marae is located at the intersection of SH 35 and Mangatuna Road in the centre foreground.

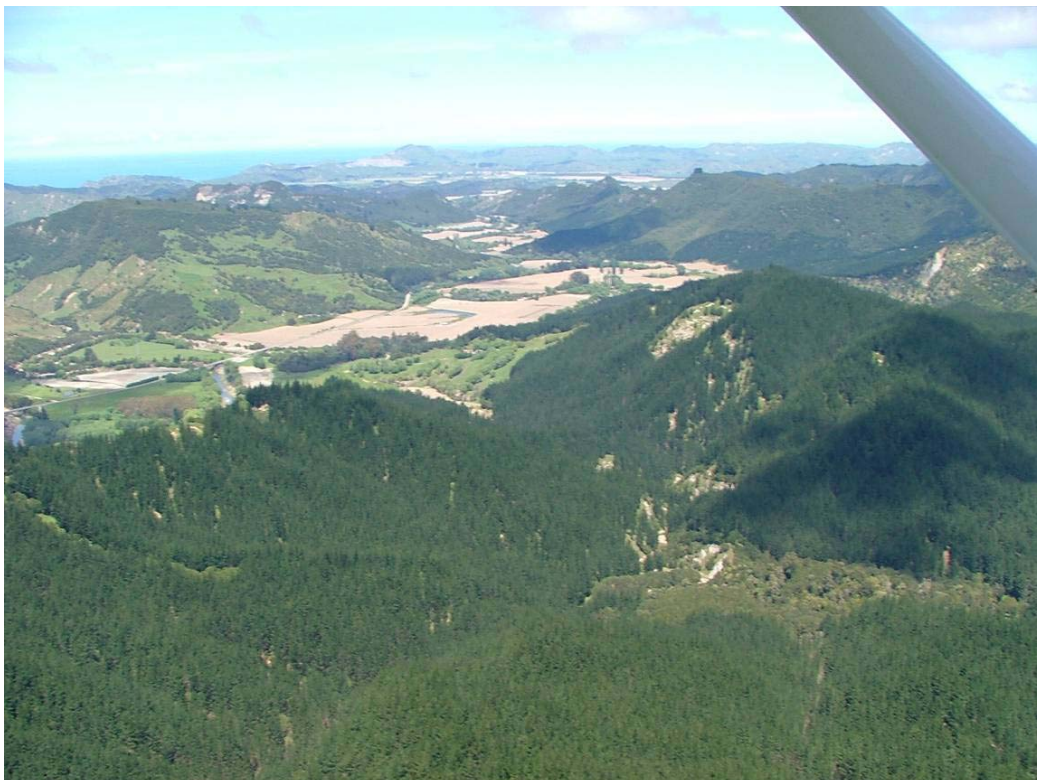
Figure 28 Looking south down the Hikuwai River towards Tolaga Bay from the Mangatokerau catchment. Note the large areas of silt deposition in the Hikuwai valley floor.

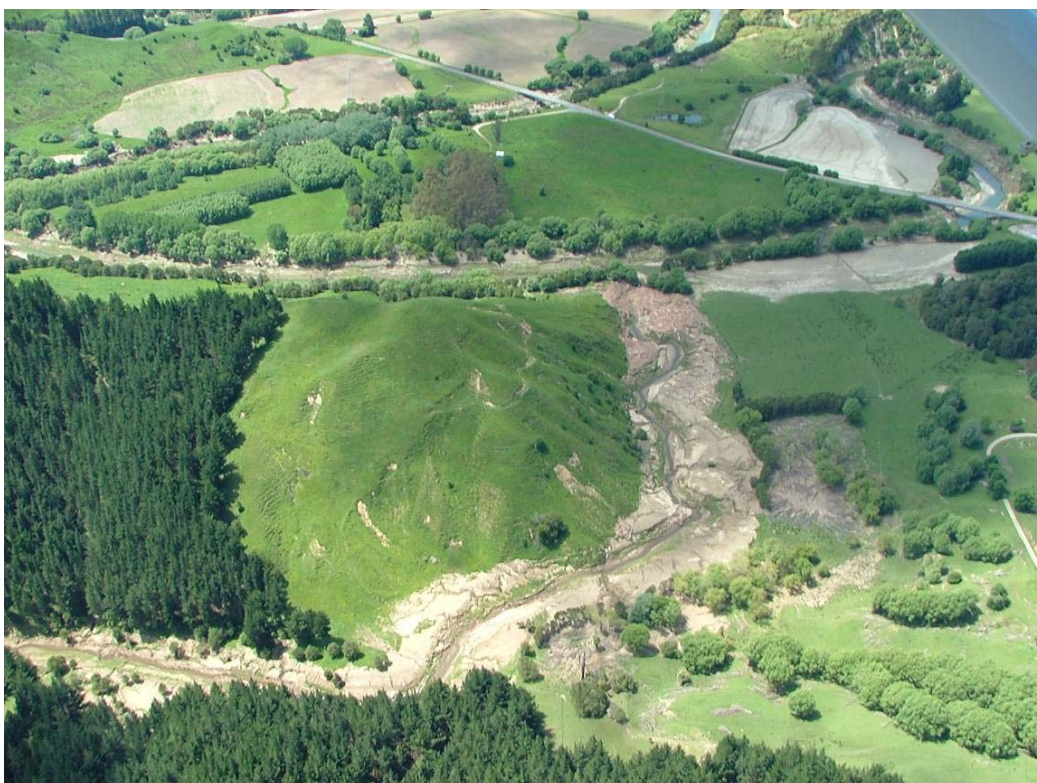
Figure 29 Waitoroko Stream, having carried silt and logs, meets the Hikuwai River at The Three Bridges. Logs have backed up at the confluence in the right centre of the photo (approx Y16:694149).

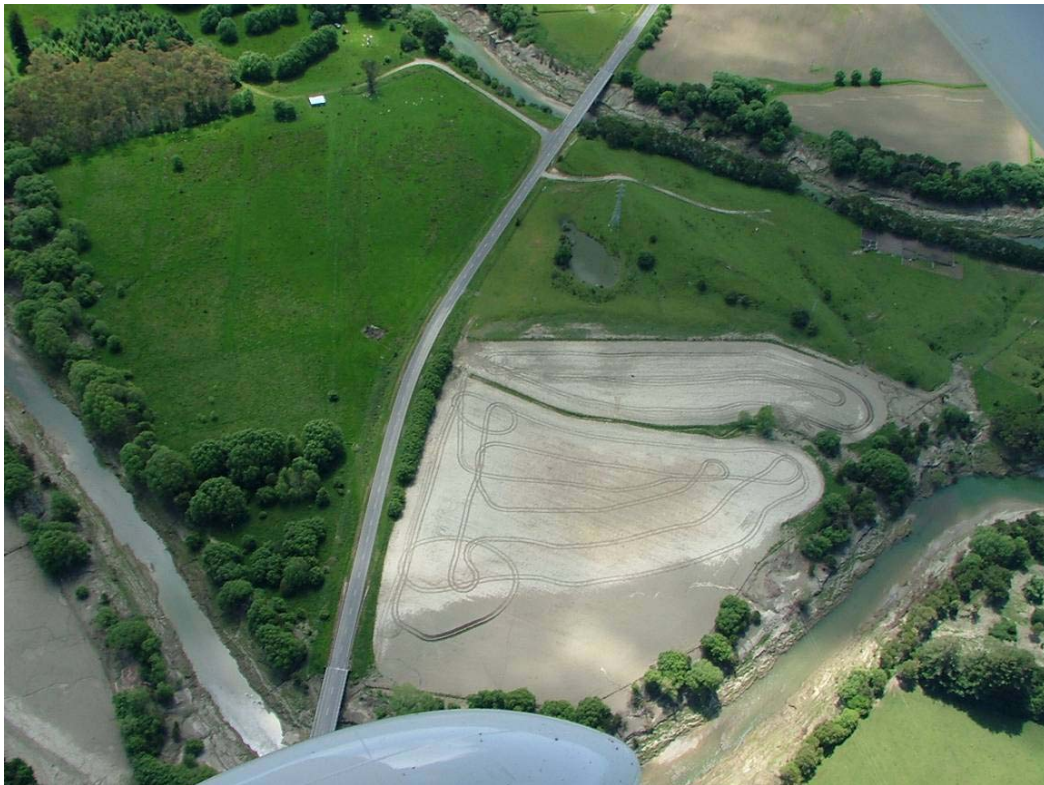
Figure 30 Silt deposits being prepared for resowing on the Hikuwai River at The Three Bridges. Note the river bank slumping along the river (approx Y16:697148).

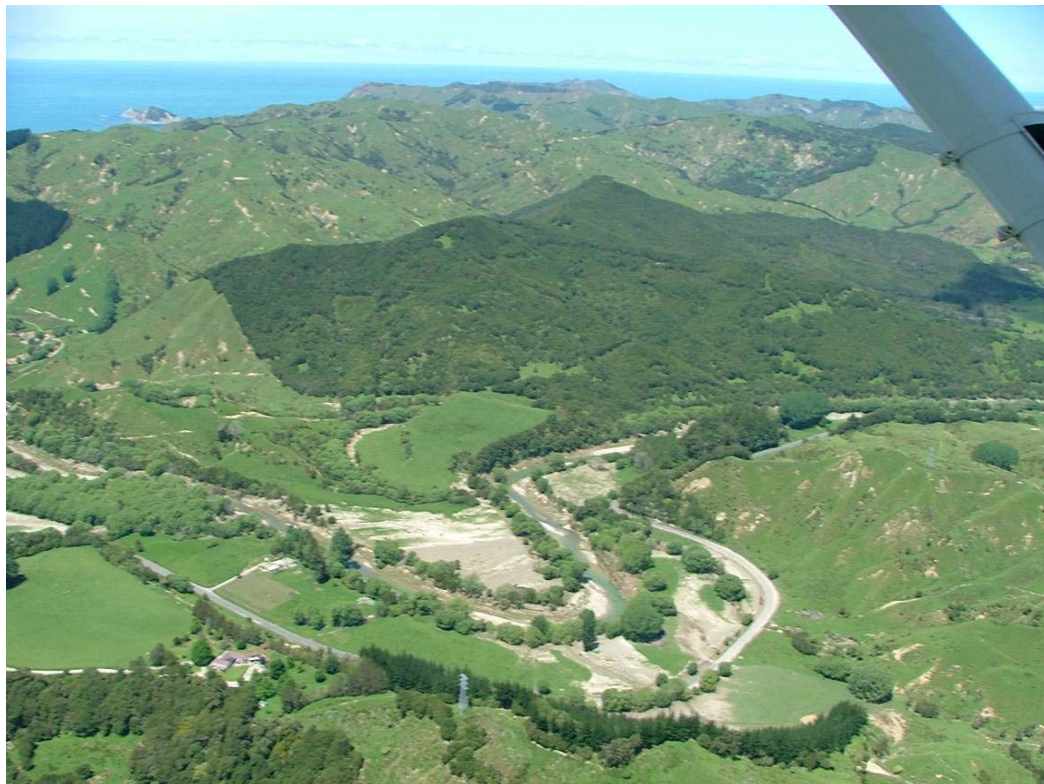
Figure 31 Looking east over the Hikuwai valley near Arero, between Tolaga and Tokomaru bays. Note the silt deposition from overland flow.

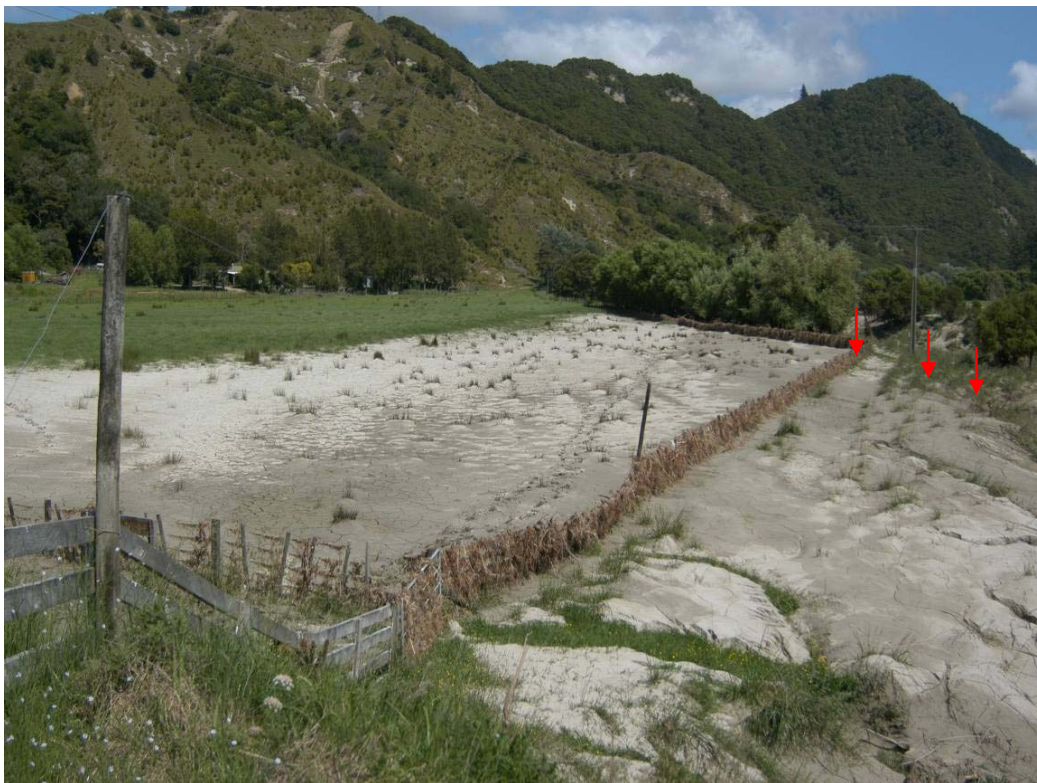
Figure 32 Thick silt deposits from the Hikuwai River, intersection of SH 35 and Paroa Road, approximately 9 km north of Tolaga Bay. River channel indicated by arrows (approx Z17:707099).

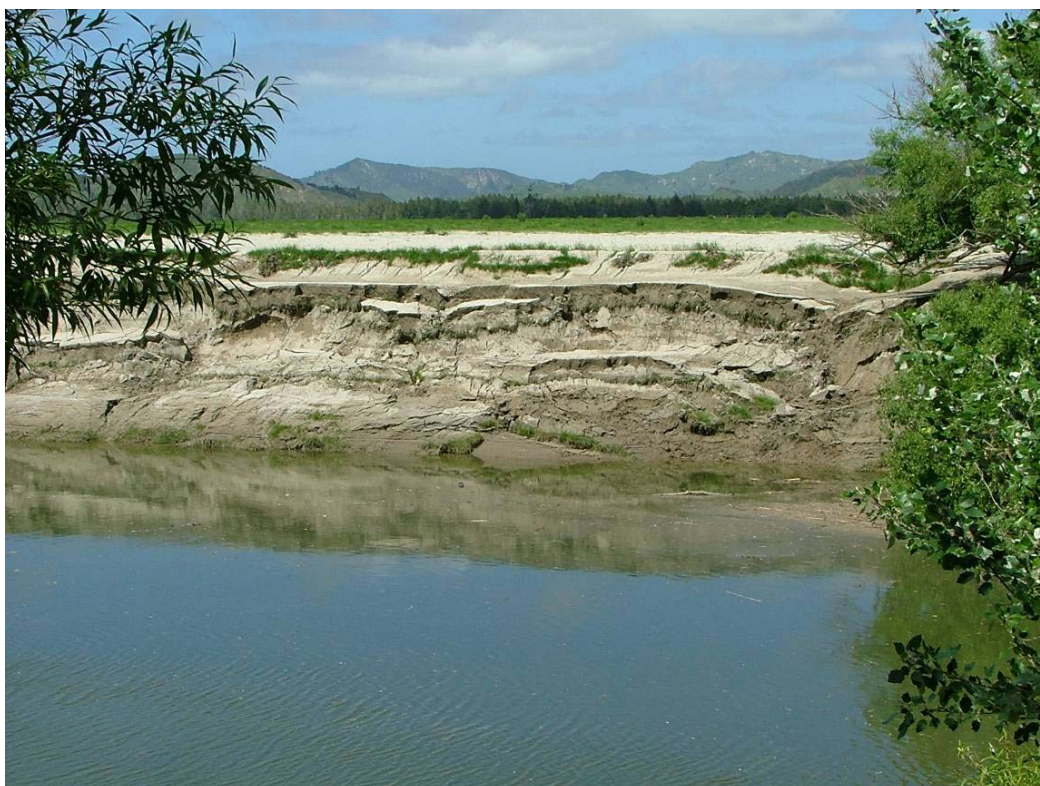
River levels receded quickly in the 24 hours following the flood peak in the early hours of Saturday 22 October. This rapid recession generated elevated pore water pressures in saturated silty stream banks causing widespread slumping. Stream bank slumping of in situ alluvial silts was observed along most of the length of the Hikuwai River (Figures 30, 33 and 34), as well as on many smaller watercourses between Gisborne and Te Puia, such as the Parakae River (Figure 35). Damage from this slumping was generally confined to localised fence damage and, in one observed instance, subsidence of a power pole.

Figure 33 River bank slumping on the lower Hikuwai (Uawa) River adjacent to SH 35 approximately 4 km north of Tolaga Bay (approx Z17:717052). This slumping was common along the Hikuwai River.

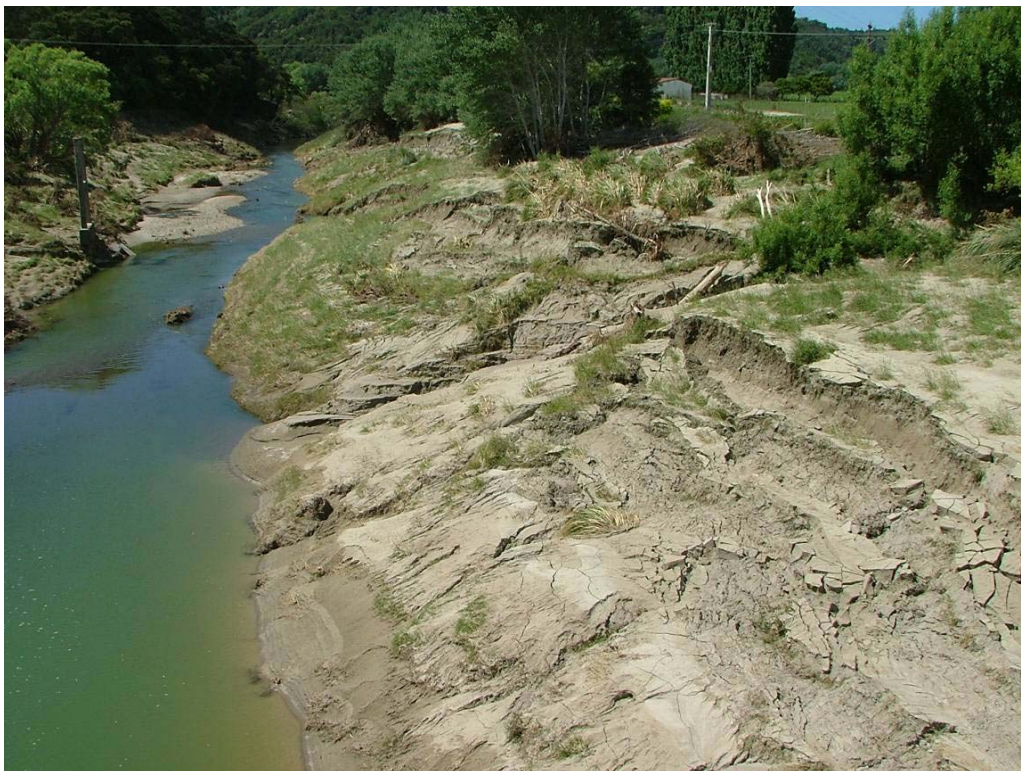
Figure 34 River bank slumping in the Hikuwai River at the intersection of SH 35 and Paroa Road, approximately 9 km north of Tolaga Bay (Z17:708098).

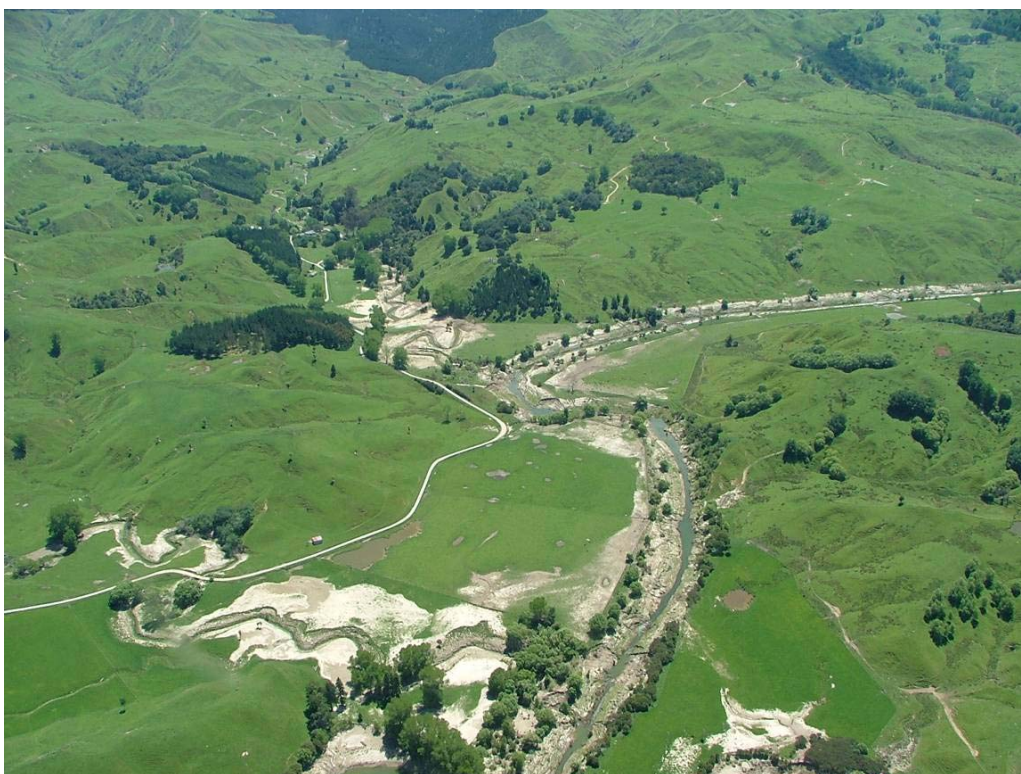
Figure 35 Looking north along the Pakarae River near Puriri homestead between Gisborne and Tolaga Bay. Note silt deposition and river bank slumping (approx Y17:645905).
