BIBLIOGRAPHIC REFERENCE

Beetham, R.D.; Grant, H. 2006. Reconnaissance of landslide and flood damage in the Gisborne area caused by the 2005 Labour Weekend storm., *GNS Science Report 2006/022* 35 p.

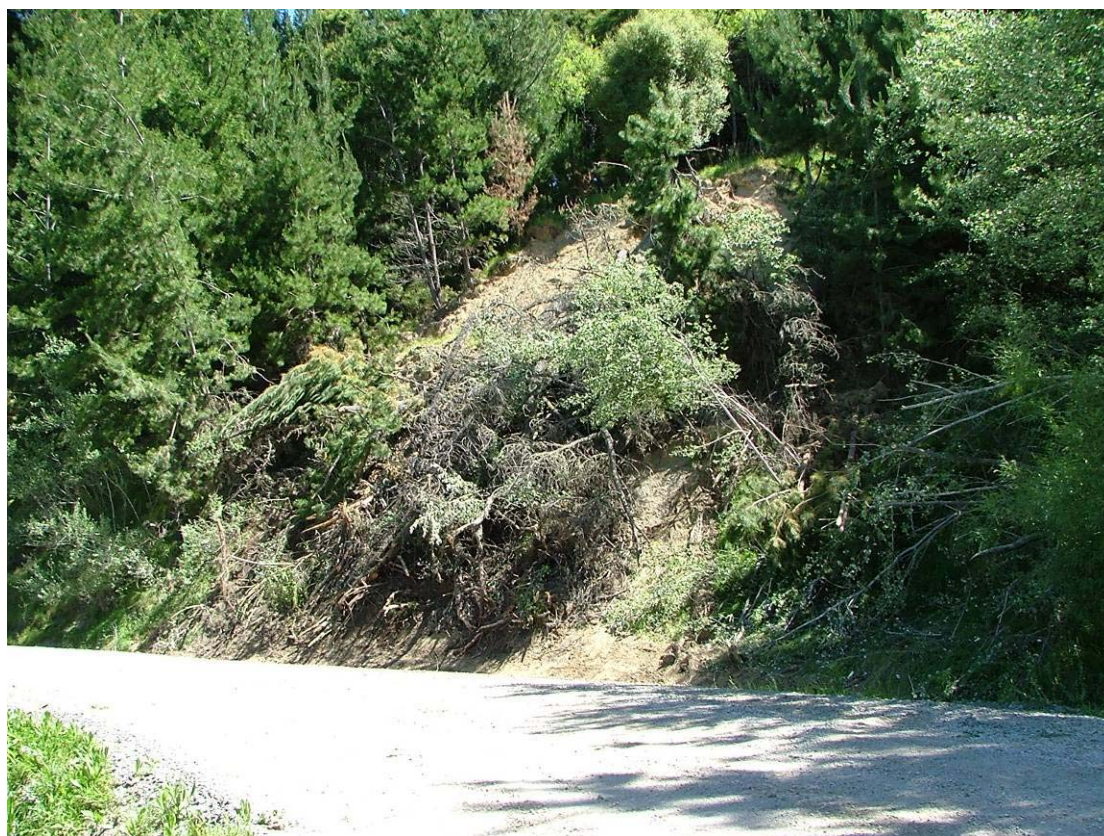
State Highway 35 north of Gisborne, and some local roads, were blocked at several locations by flood-deposited silt and debris and, in places, by landslide debris (Figure 36) or undermine collapse (Figures 37 and 38). Batter failure was common in cuts in Miocene mudstone (Figure 39), particularly on the inland road between Tokomaru Bay and Waimata (Figures 40-42).

Figure 36 Typical landslide in early Miocene mudstone on the unsealed Fernside Road, inland from Tokomaru Bay.

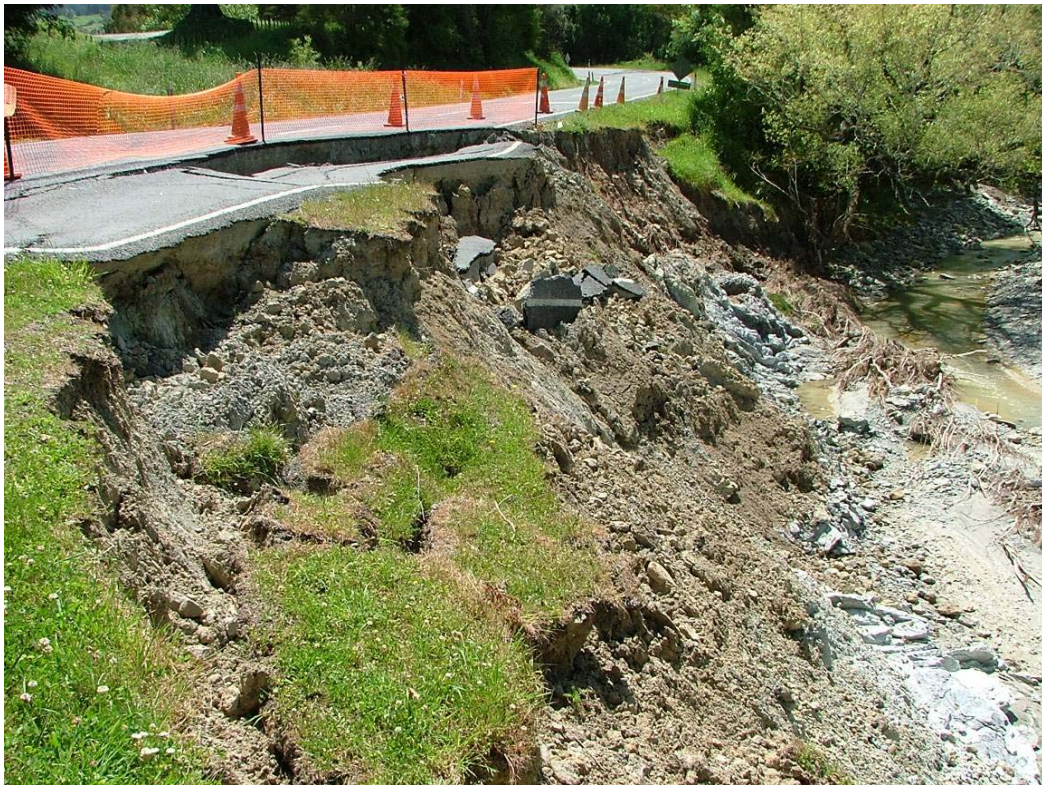
Figure 37 Road washout on SH 35 beside the Mangahauini River between Tokomaru Bay and Te Puia Springs, closing one lane (approx Z16:744325).

Of interest was the check dam constructed in the Mangahauini River between Tokomaru Bay and Te Puia Springs (Figure 43), part of works to help prevent scour of the river channel and subsequent damage to the road such as that in Figure 37.

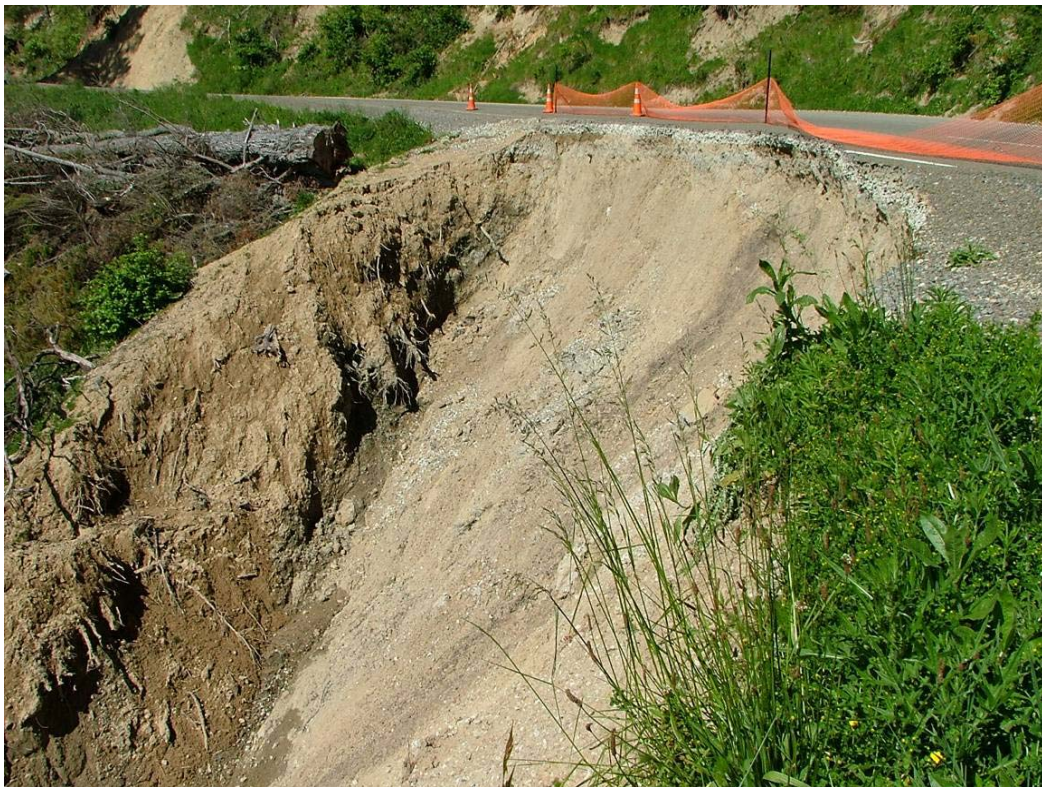
Figure 38 Landslide in late Miocene mudstone on a new section of Tauwhareparae Road south of Tauwhareparae (approx Y17:567120 \pm 1km north or south).

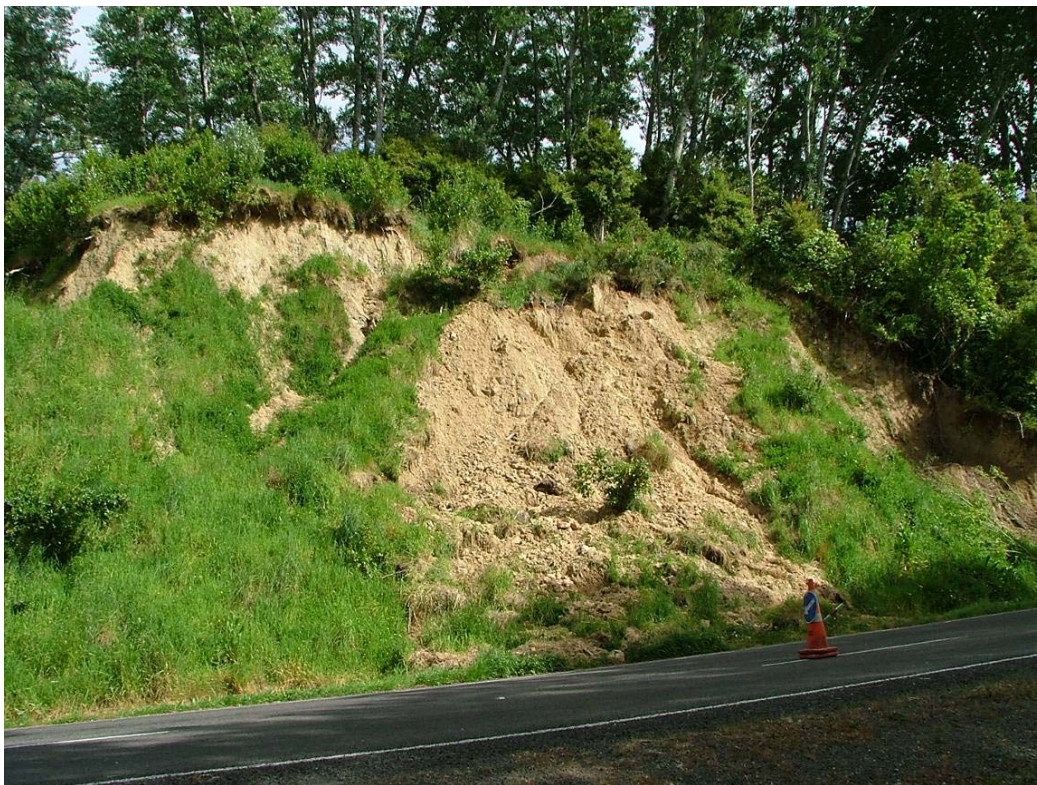
Figure 39 Batter failure on SH 35 south of Tolaga Bay. This had occurred prior to the Labour Weekend storm but had been exacerbated by it.

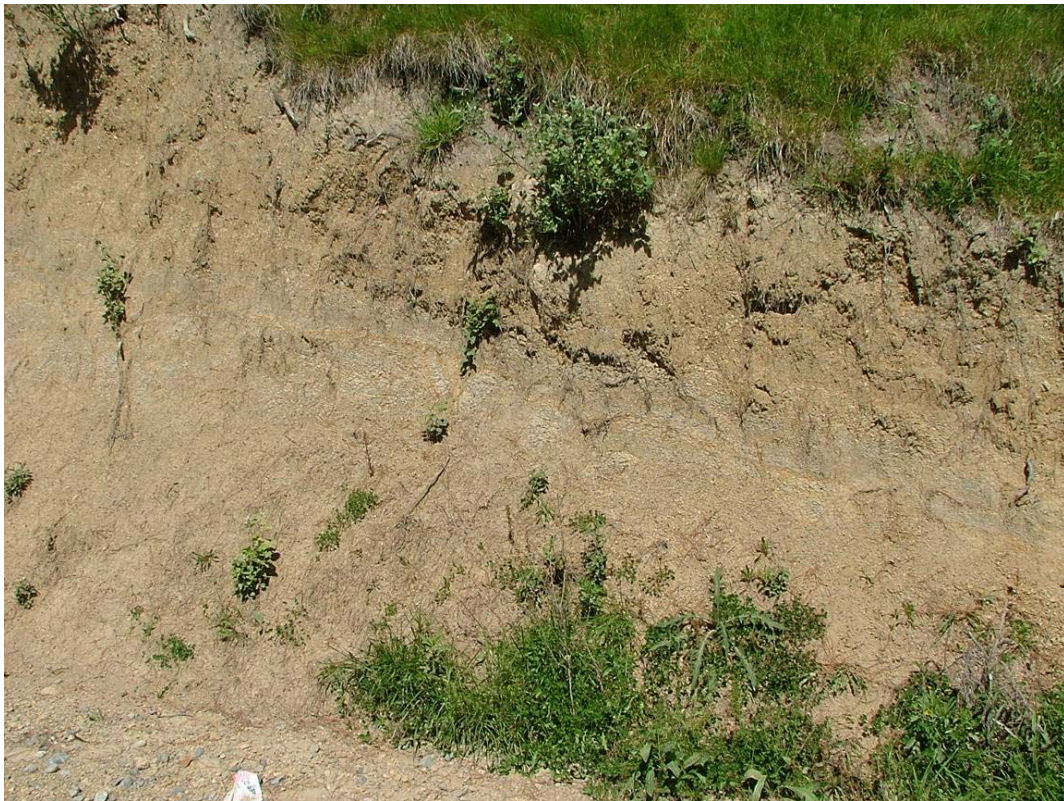
Figure 40 Typical fretting of slaked early Miocene mudstone on the unsealed Fernside Road, inland from Tokomaru Bay.

Figure 41 Detail of Figure 40.

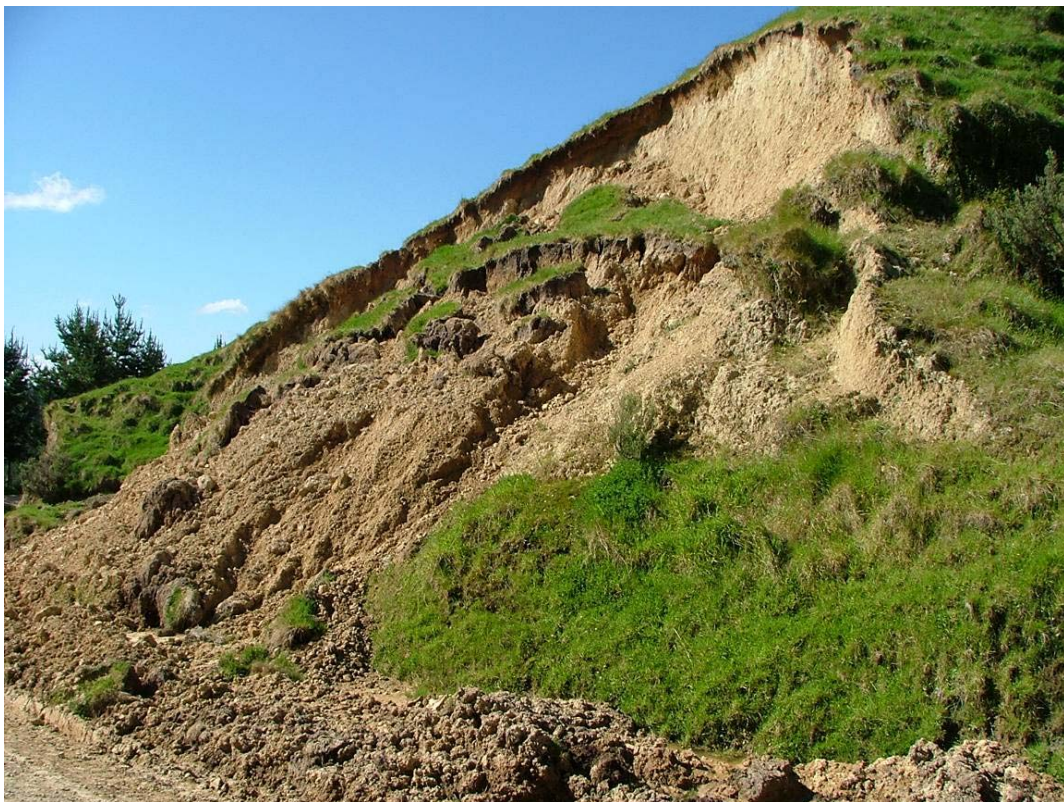
Figure 42 Road cut failure on Waimata Valley Road, approximately 7 km north of Waimata.

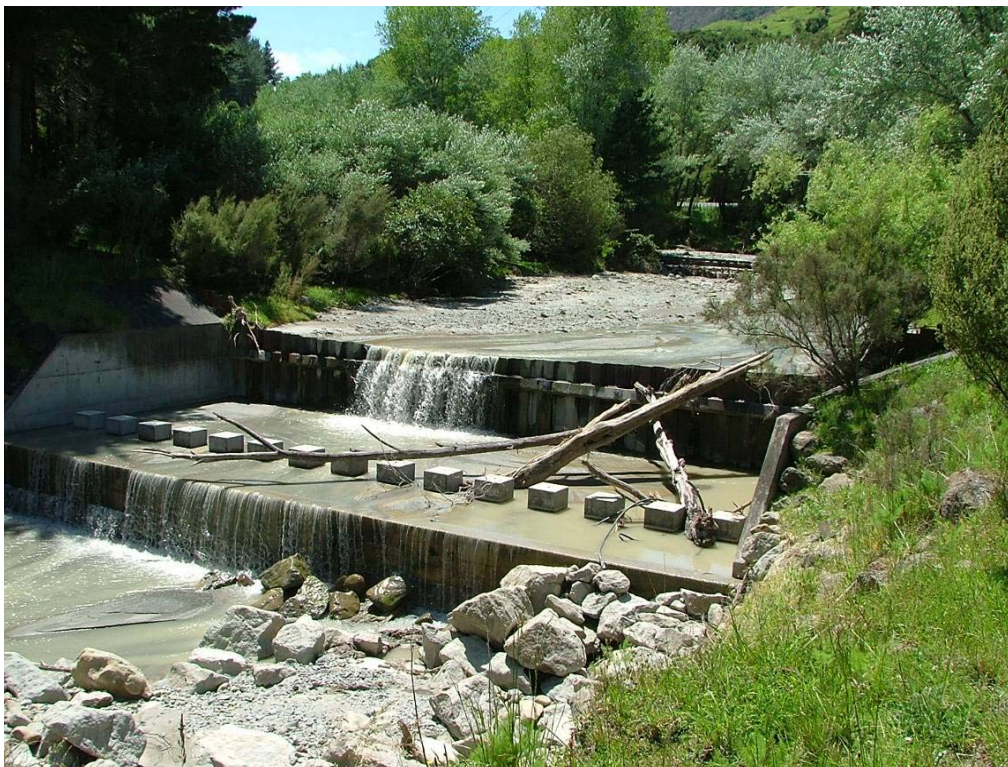
Figure 43 Check dam in the Mangahauini River between Tokomaru Bay and Te Puia Springs to help stabilise river channel.
