**Vampire rock avalanches,
Aoraki/Mount Cook National Park,
New Zealand**

**GNS Science Report 2008/10
May 2008**

Rock avalanches fell from Vampire (2645m) peak onto Mueller Glacier in Aoraki/Mount Cook National Park (AMCNP) during 2003 and January 2008. An unwitnessed and previously unrecorded 2003 event has been inferred to have occurred sometime between 23 February and about November 2003 from dated images and photographs. Approximately 120,000 m³ (\pm 40,000) of rock collapsed from a 65° slope between 2440-2560 m. Release involved complex failure on joint surfaces and sandstone-argillite bedding. The falling debris was directed down a gully, through the Bannie Glacier icefall, and out 1.9 km across Mueller Glacier, where it formed a 280,000 m² deposit. Some unknown time afterward (probably during the same collapse sequence, but clearly prior to 2006) up to 100,000 m³ of the debris deposit collapsed and formed a remobilised tongue spreading further down the glacier. The 2003 avalanche dropped a maximum height of 890 m and the angle of reach was 24°.

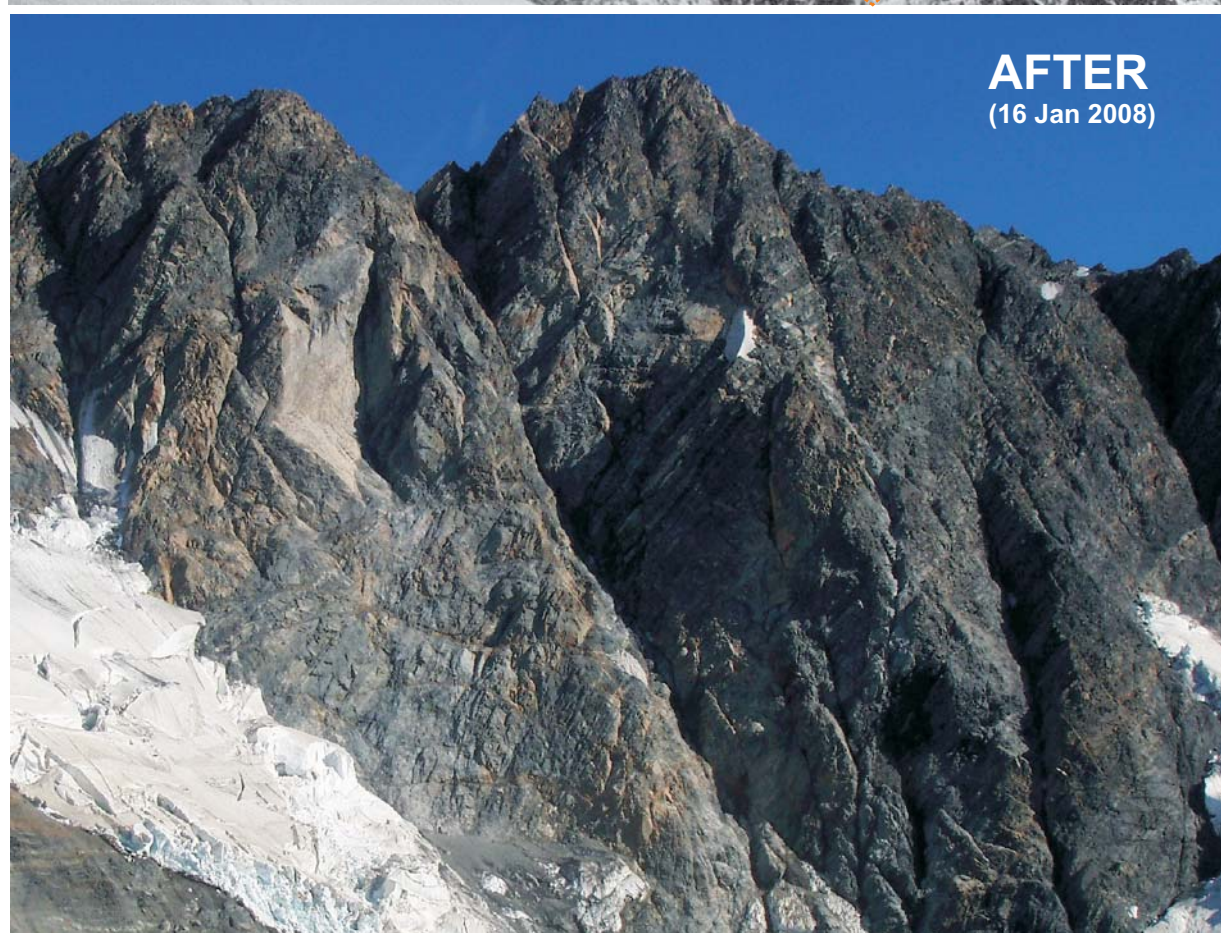
Figure 3 Views of Vampire (2645m) before and after the avalanches. Red and blue lines show the area of rock failure in 2008 and 2003, respectively. The orange lines delineates areas of rock where failure is thought to be imminent. Photographs: A. Palman/NZ Alpine Club, prior to 2001 (top); S. Cox/GNS Science, 16 Jan 2008 (bottom).

Searches of historic photographs, aerial photography and satellite imagery were undertaken for comparison with the new photographs, in order to try to establish the timing and sequence of events (e.g. Figure 3). Satellite images from the ASTER (Advanced Spaceborne Thermal Emission and Reflection Radiometer), NASA Terra sensor, and Digital Globe imagery (<http://earth.google.com/>) constrained the older rock avalanche to have occurred between February and November 2003. No events identifiable as having been caused by rock avalanches were located using the national seismograph network in 2003, probably

Comparison of pre-2001 and new oblique photographs (Figure 3) indicated an area of rock between 2440 and 2560m has fallen from a buttress immediately below the main summit of Vampire (Figure 7), beside a different climbing route called “Nosferatu” (Palman 2001). In January 2008 this area was free from fine dust, had a small patch of old snow, and looked comparatively stable. The failure area is approximately 120 ± 10 m high, with a maximum width of 110 ± 10 m. Digitising from scaled photographs indicates that the scar area is in the vicinity of 6500 m^2 . Pre- and post-avalanche photographs (Figure 3) were compared to estimate the thickness of the failed area, which has a maximum 20 ± 10 m. By allocating thicknesses of between 10-25 m to selected domains within the failure area, the rock-failure volume is estimated to be $120,000 \text{ m}^3$ ($\pm 40,000 \text{ m}^3$) which is similar to the 2008 failure volume ($150,000 \pm 50,000 \text{ m}^3$).

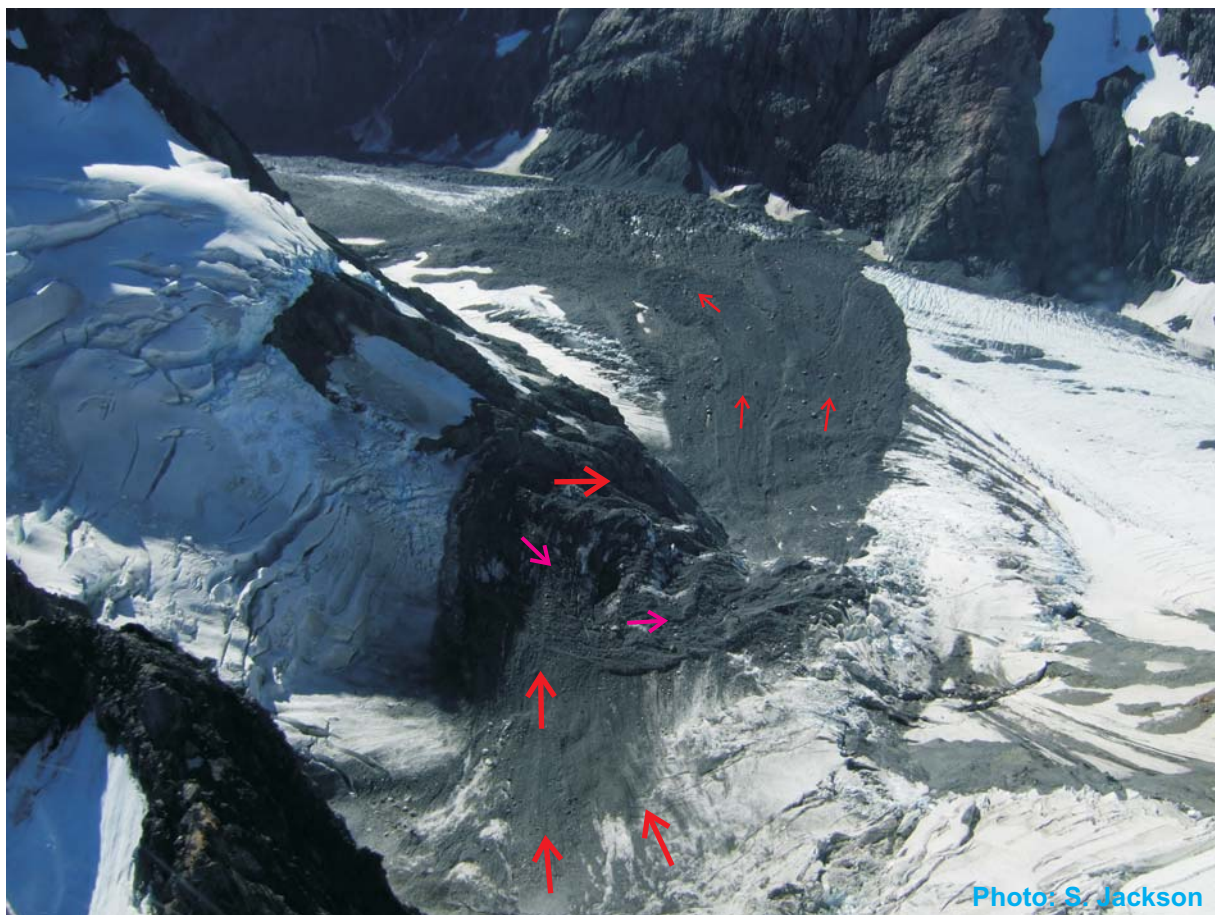
Figure 8 January 2008 avalanche flow path. Top - looking straight down the flow path, onto the Bannie Glacier (foreground) and Mueller Glacier (far distance). Bottom - looking across the Bannie Glacier icefall towards the SE spur of Mt Bannie. Arrows indicate the main direction of flow (red) and secondary collapse flow direction (pink/purple). Note the ridge of debris (yellow dots) developed at a high angle, and relatively undisturbed by, flow of the main avalanche. Photographs: S. Jackson/DoC, 16 Jan 2008 (top); S. Cox/GNS Science, 16 Jan 2008 (bottom).

An indication of the general direction of flow is provided by streaks and ridges within the debris and by scour marks (Figure 8). At the top of the icefall, adjacent to the area where the flow path rises on the Mt Bannie spur, a prominent debris ridge is developed at right angles to the general direction of flow. Nearby, the veneer of debris is thin, and ice is exposed with striations both in the general direction of avalanche flow and downslope towards the icefall. We infer a secondary collapse has occurred here, remobilising debris that was piled against the south east ridge of Bannie, and collapsing the debris pile downslope across the general direction of avalanche flow. The debris ridge (yellow dotted line, Figure 8) marks levee deposition at the uphill lateral margin of the secondary collapse. The secondary collapse was the last event in the local sequence at this site, but may have been part of a continuous avalanche-debris flow sequence. It occurred after the main flow(s) have passed because the debris ridge is fresh and shows no sign of having been eroded or overridden by subsequent debris from the source area. Within the icefall the flow scoured the ice to a smooth grooved surface, and may have involved collapse of crevassed seracs within the icefall.

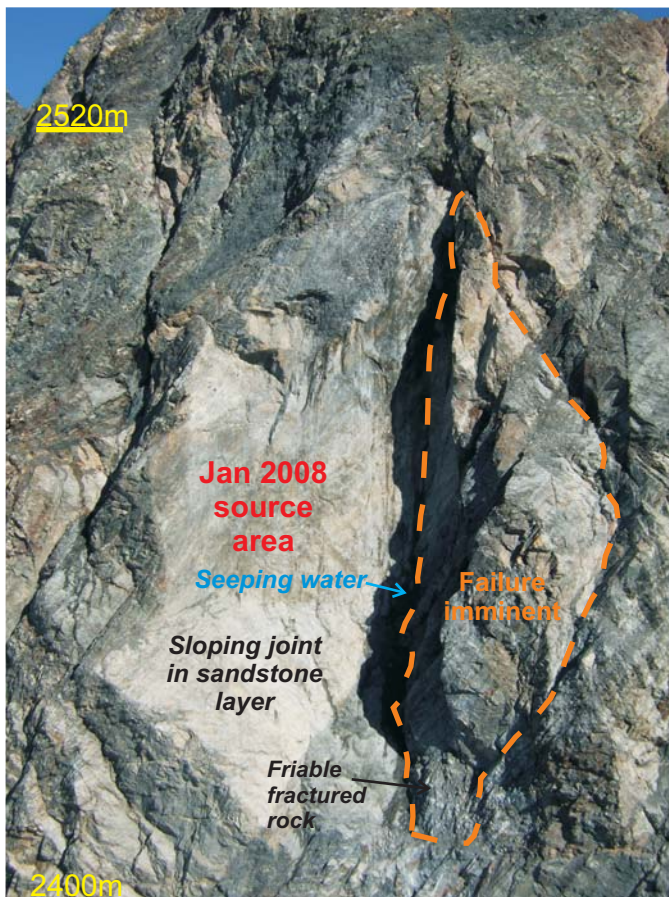
Figure 11

Rock mass failure on the south face of Vampire is not yet complete. A large block lies to the east (right) of the 2008 avalanche source area, with weak crushed rock at its base and with open fractures behind. Failure of this block is imminent. A buttress below the 2003 source area has the same fracture and bedding pattern as the 2003 avalanche source area. Failure of this buttress is likely. Photographs: S. Jackson, 16 Jan 2008 (top); S. Cox/GNS Science, 16 Jan 2008 (bottom).

3. The south face of Vampire is still considered to be quite unstable. Collapse of a large block from beside the 2008 avalanche source area appears imminent. A pillar below the 2003 avalanche source area is also likely to collapse. Both appear to be of sufficient volume that they can be expected to form avalanche-like flows that run out across Mueller Glacier. While specifically identified for this site, the hazard is not necessarily greater than beneath many other, steep, fractured slopes within Aoraki/Mount Cook National Park.

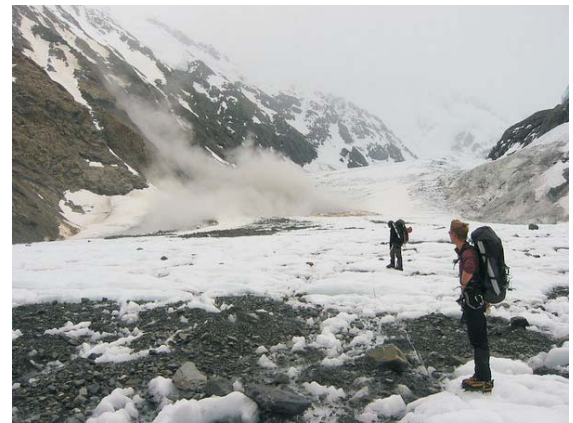
Figure 13 Beatrice rock avalanche. Map, photograph of the event, and two-lobe deposit.
Photographs: Neil Monteith (middle), 23 Nov 2004; S. Allen (bottom), 19 Jan 2007.

On the morning of 23 November 2004 some Australian climbers witnessed a rock avalanche from Mt Beatrice (2528 m) engulfing an area they had walked over just 15 minutes previously (Figure 13). Tim Billington's diary describes "*A huge plume of dust was kicked up over the glacier and the land slide tumbled across the glacier like a wave on the beach*". The fall initiated between 1620 and 1700 m, from a 60° sloping area on the east face which had been spalling small amounts of rock for at least two days preceding the avalanche. The final distribution of debris is very clear in the 04 May 2006 Digital Globe (Google Earth) image, which shows two distinct debris lobes reaching 1.2 km from the source area. An earlier lobe was deposited along a trough on the true right side of the glacier. It was cross-cut by a second lobe which spread across the middle of Hooker Glacier. The avalanche dropped a maximum height of 440 m over a 20° angle of reach. The first deposit lobe covers an area of 87,000 m², while the second covers 90,000 m². Photographs taken in January 2007 (Figure 13) indicate the second lobe is comparatively thick, locally perhaps as much as 10 m. The Beatrice avalanche deposit volume is therefore inferred to be between 10⁵ and 10⁶ m³.

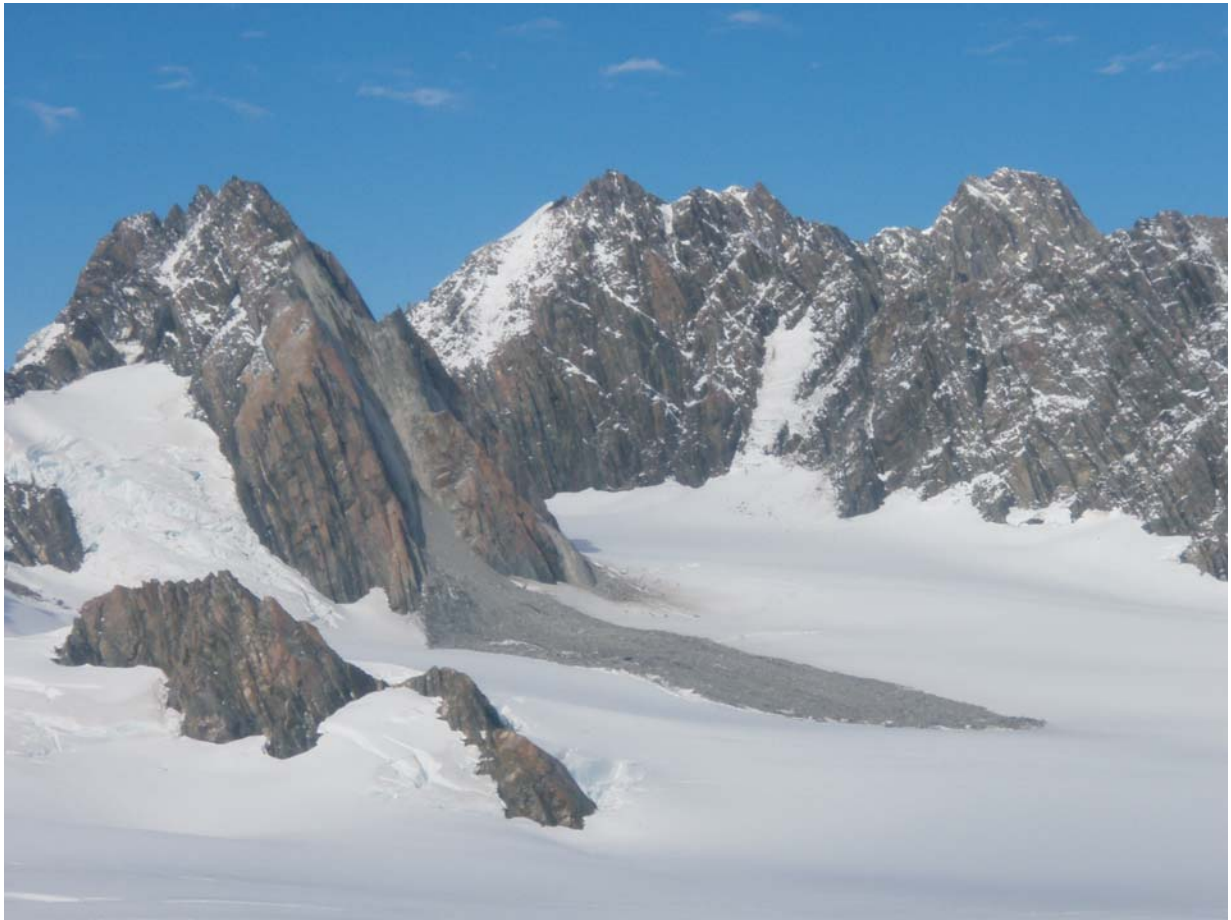
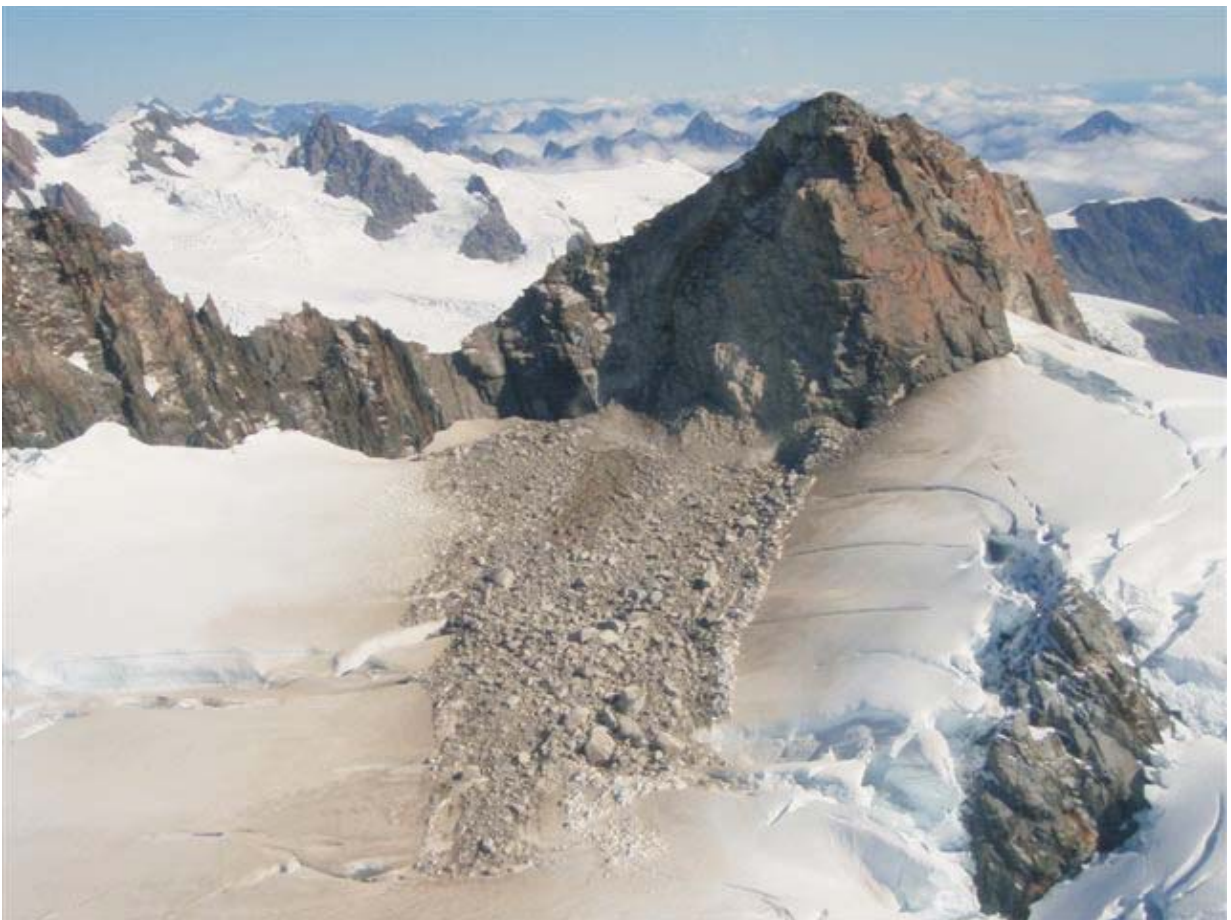
Figure 15 Rockfalls from Mt Spencer (top) and Halcombe Peak (bottom) at the head of the Franz Josef Glacier. Photographs: Greg King, 9 Apr 2008 (top) and 24 Apr 2008 (bottom).

On 24 April 2008 Greg King photographed a collapse of the west face Mt Halcombe (2659 m), also at the head of Franz Josef Glacier (Figures 14, 15). The collapse involved an 80m wide area between 2590 and 2650m altitude, which was still active when he photographed it. The debris covers 15,000 m² and includes some very large blocks of sandstone, estimated to be >10 m across. Debris is spread out 200 m from the face, down to 2510 m altitude. The maximum drop was 140 m, giving a 35° angle of reach. No significant rainfall had been measured in the week leading up to the rock fall, which occurred in a period when temperatures were probably fluctuating about freezing level (Figure 16).
