BIBLIOGRAPHIC REFERENCE

Page, M.J.; Rosser, B.J.; Townsend, D.B.; Carey, J.M.; Ries, W.F. 2015. Reconnaissance report on landsliding caused by the 19–20 June 2015 rainstorm in the Taranaki-Wanganui-Manawatu region. *GNS Science Report* 2015/47. 50 p. + Appendices

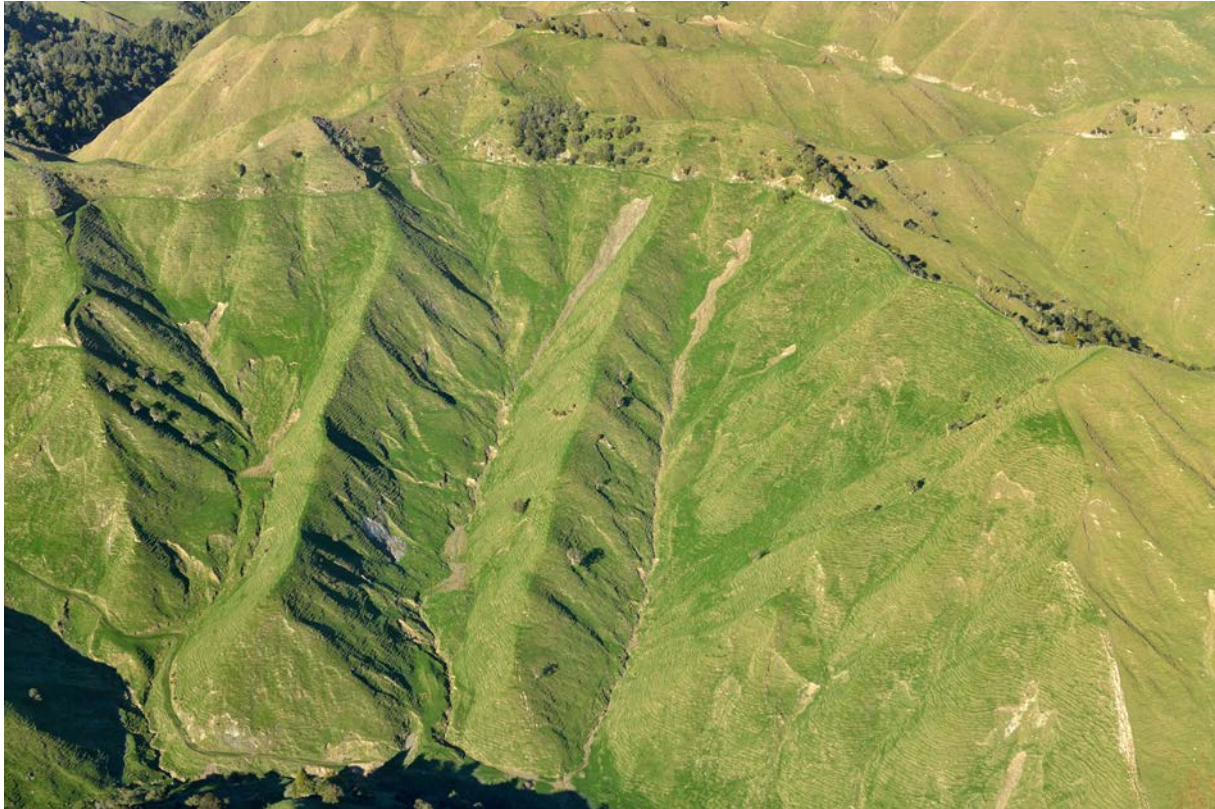
Figure 3 Slight landsliding on mudstone/siltstone between Papanui Junction and Kakatahi, Whangaehu catchment. (GNS Photo: D02_1181)

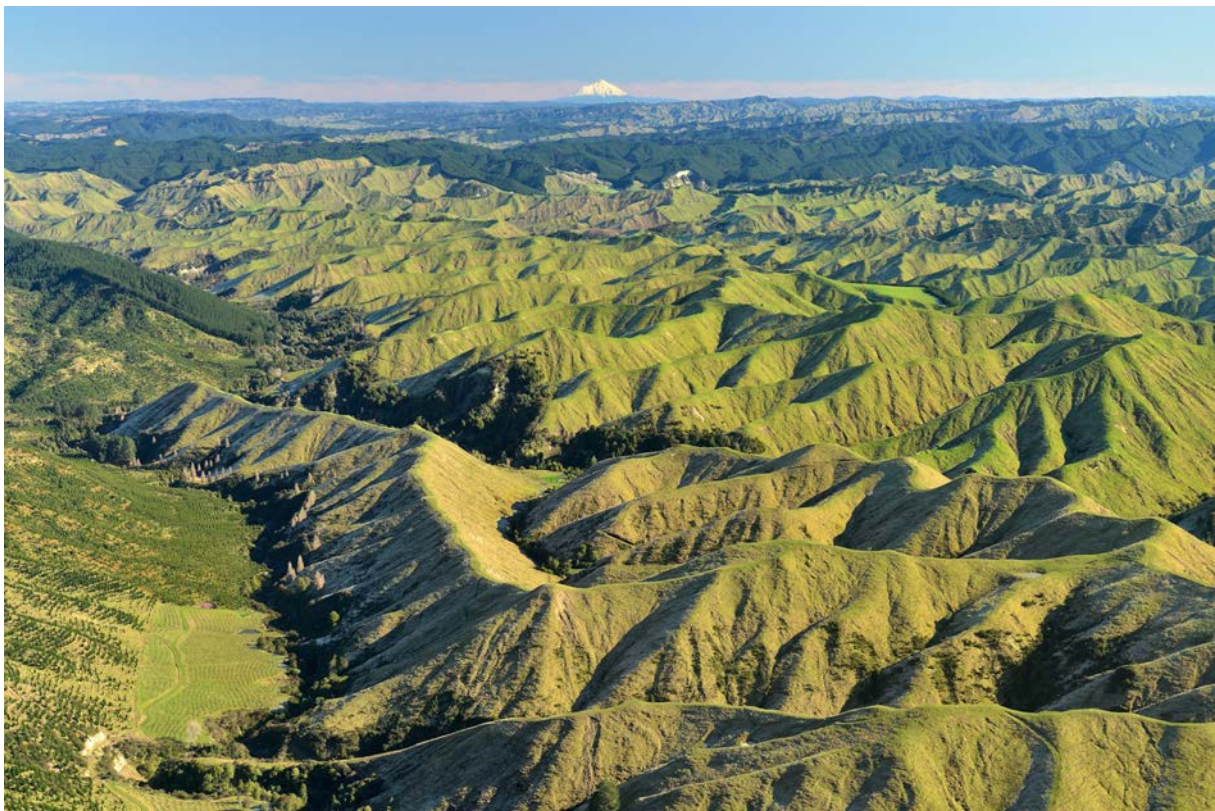
Figure 4 Looking west near Poukiore, Turakina catchment. Slight landsliding in foreground on sandstone/siltstone, and moderate landsliding in background. (GNS Photo: D02_1158)

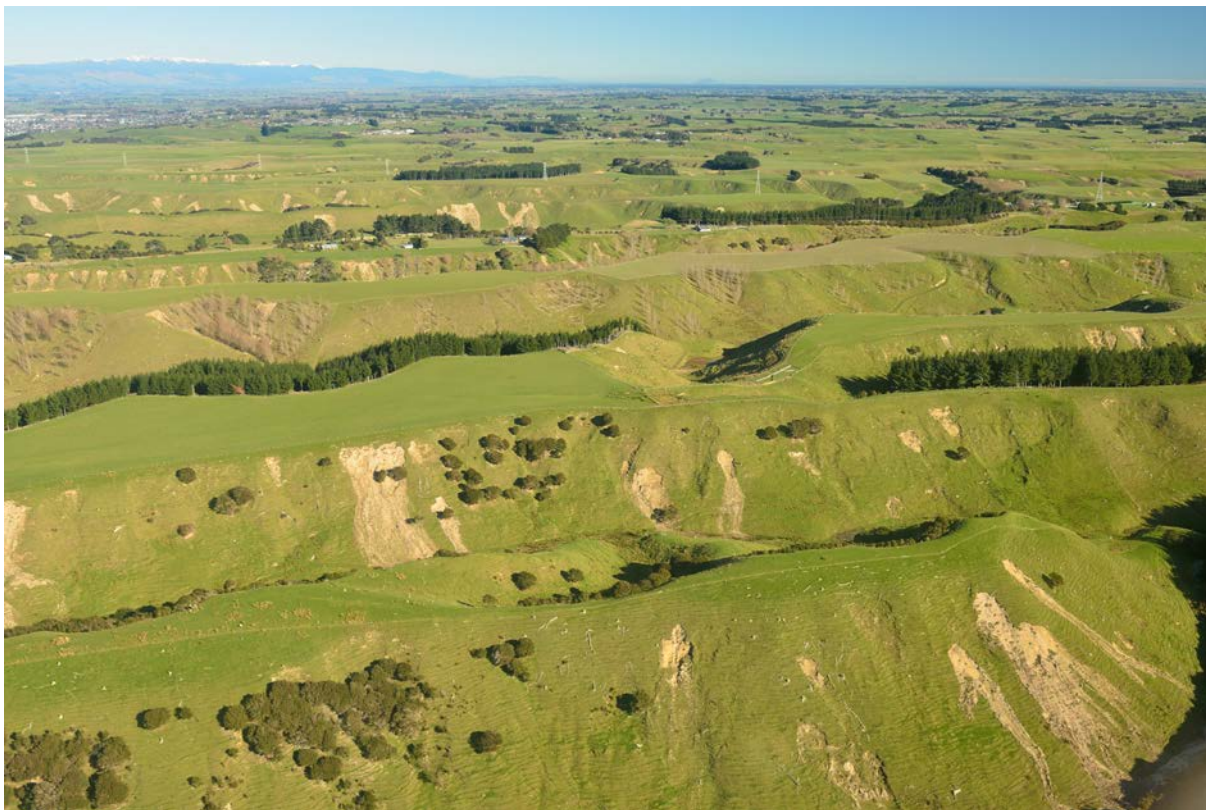
Figure 5 Moderate landsliding on Shakespeare Group (Quaternary) marine sediments, 6 km east of Halcombe (north-facing slopes). (GNS Photo: D02_1840)

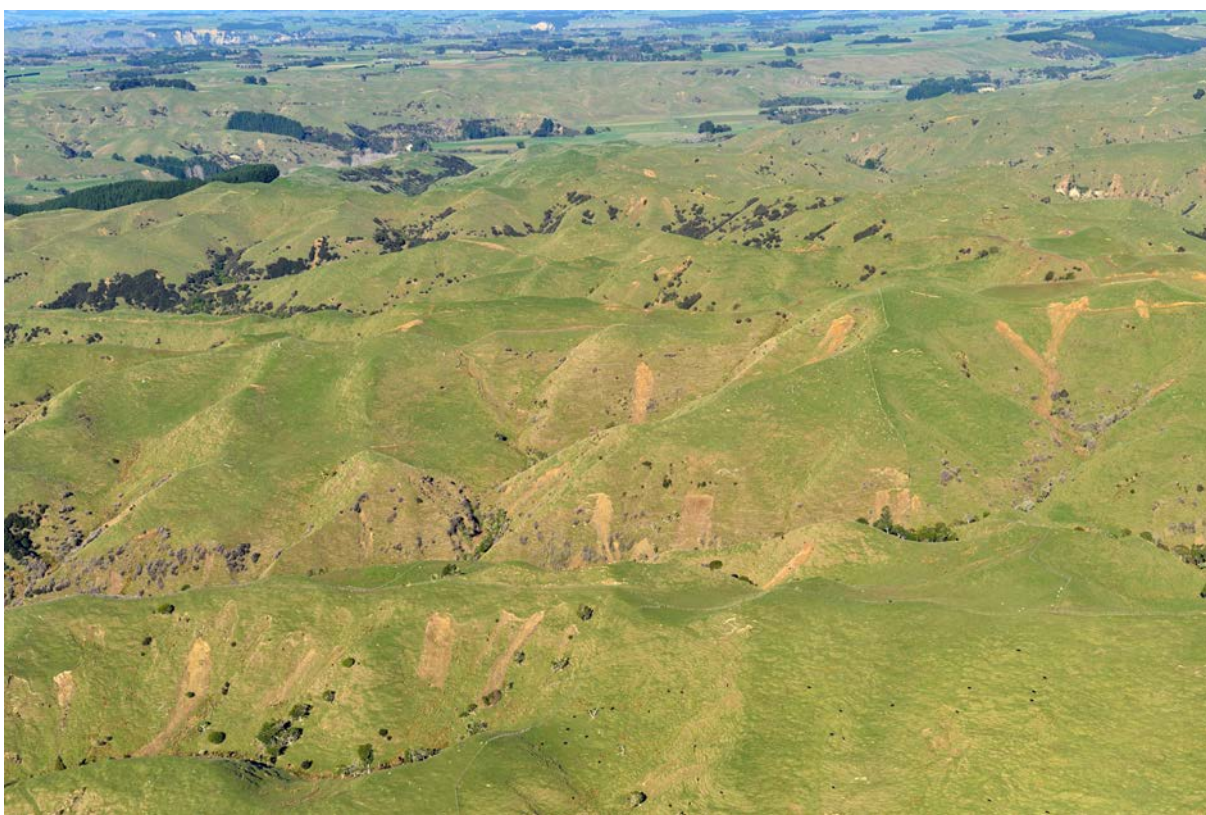
Figure 6 Moderate landsliding in Kiwitea Stream area, in Okehu Group Quaternary sandstone. (GNS Photo: D02_1132)

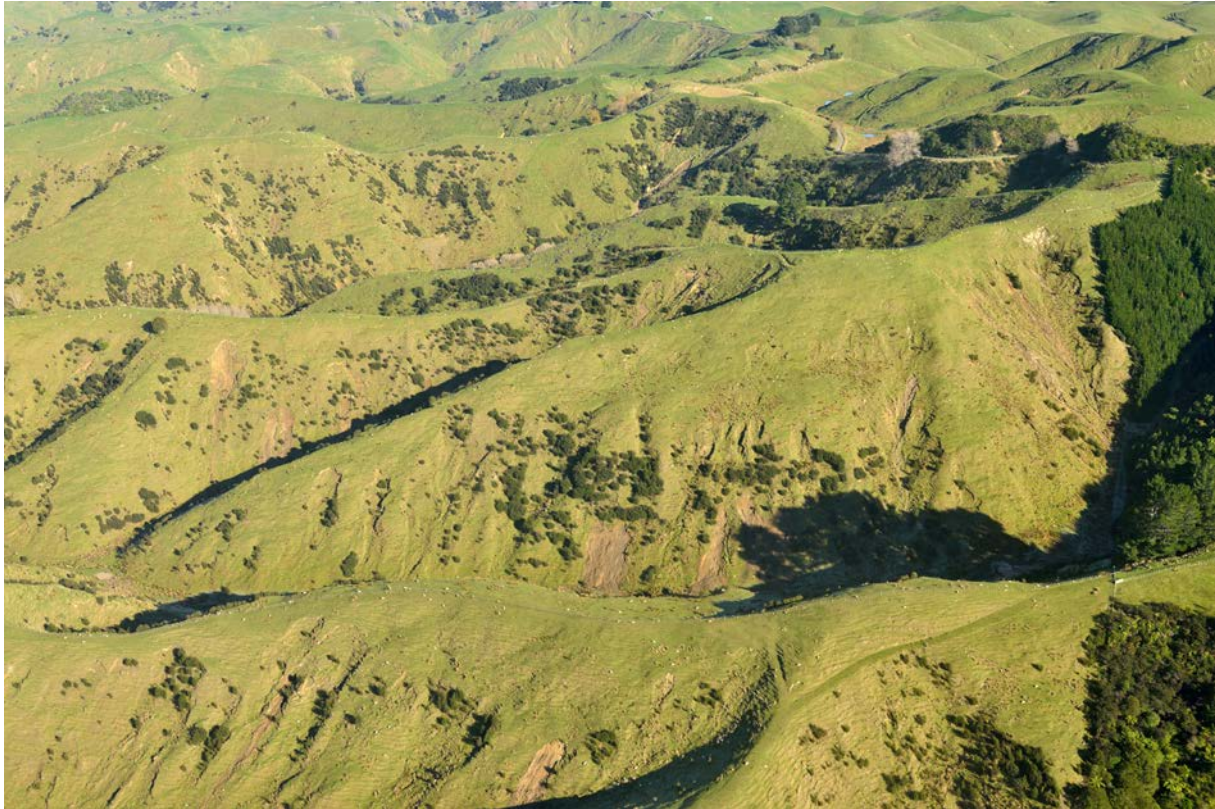
Figure 7 Moderate landsliding in foreground, in Quaternary sandstone. Upper Beehive Creek, Pohangina catchment. (GNS Photo: D02_1119)

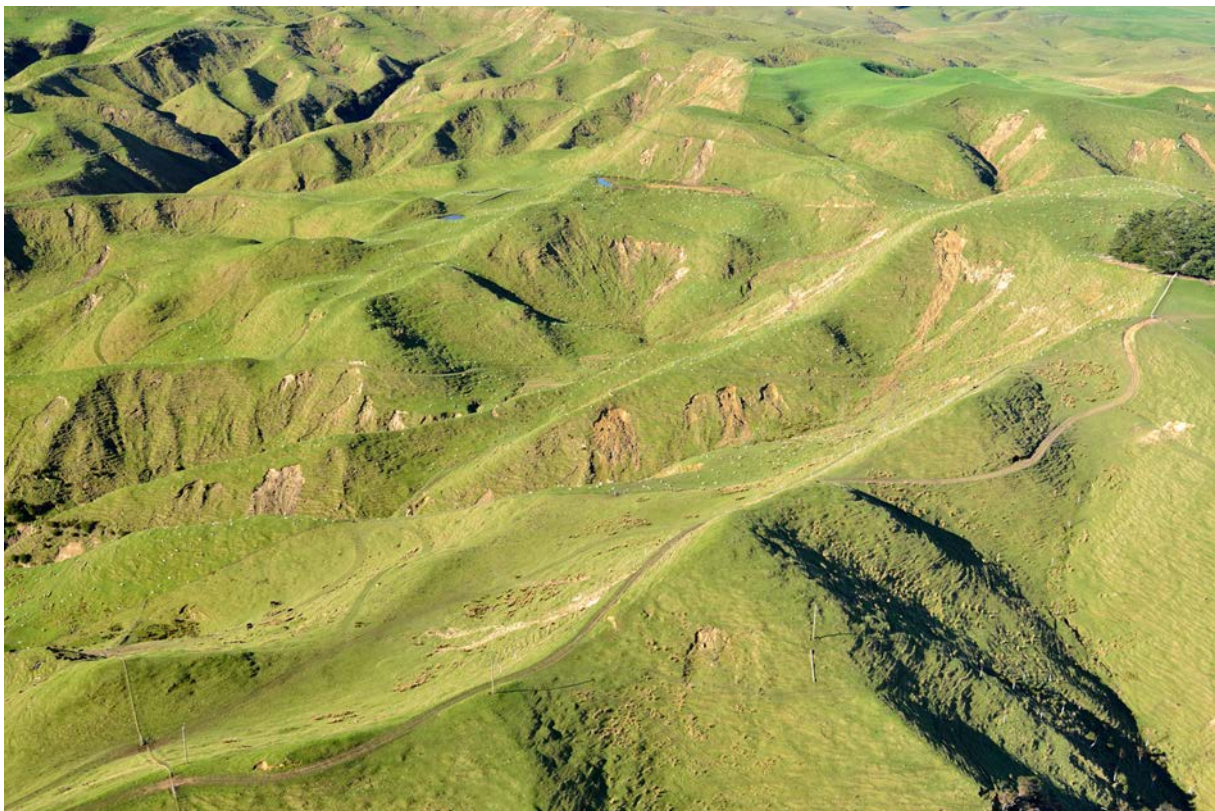
Figure 8 Moderate landsliding on Quaternary sediments, Rangitikei Valley, 4 km northwest of Waituna West. (GNS Photo: D02_1800)

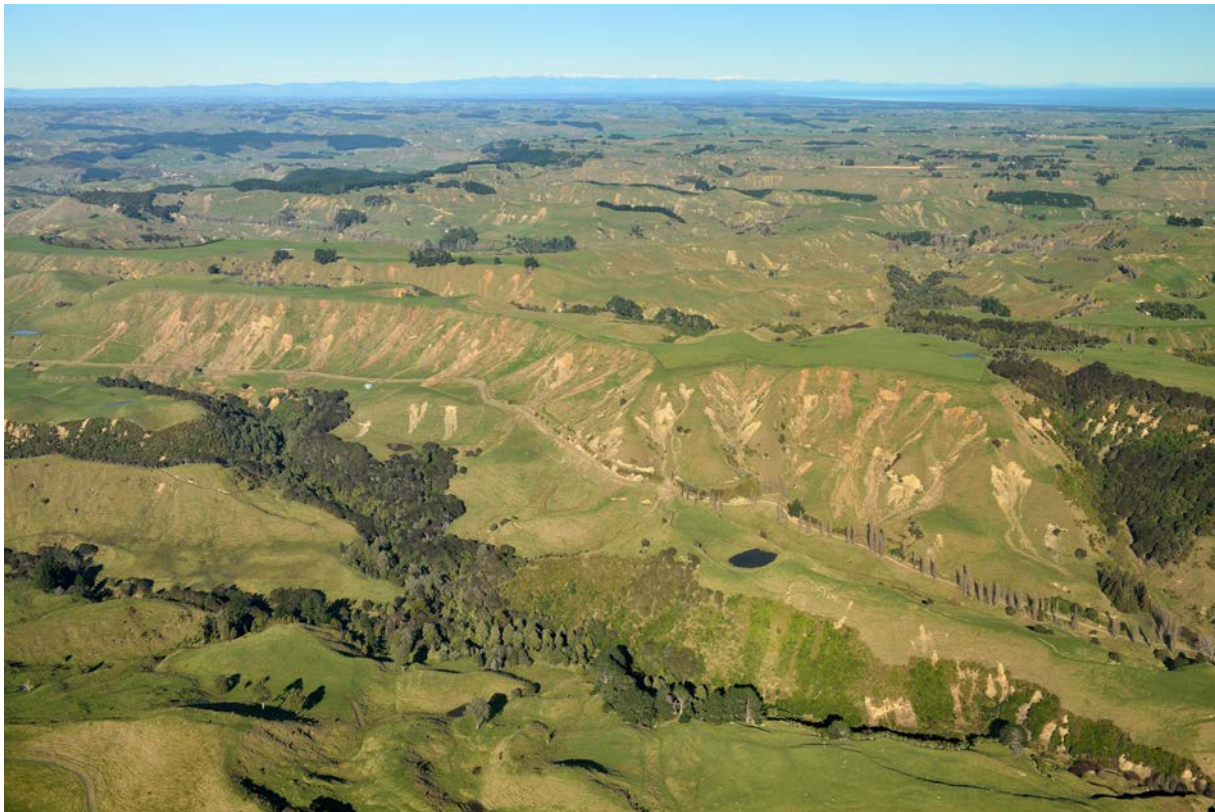
Figure 9 Severe landsliding, Makirikiri Valley. (GNS Photo: D02_1510)

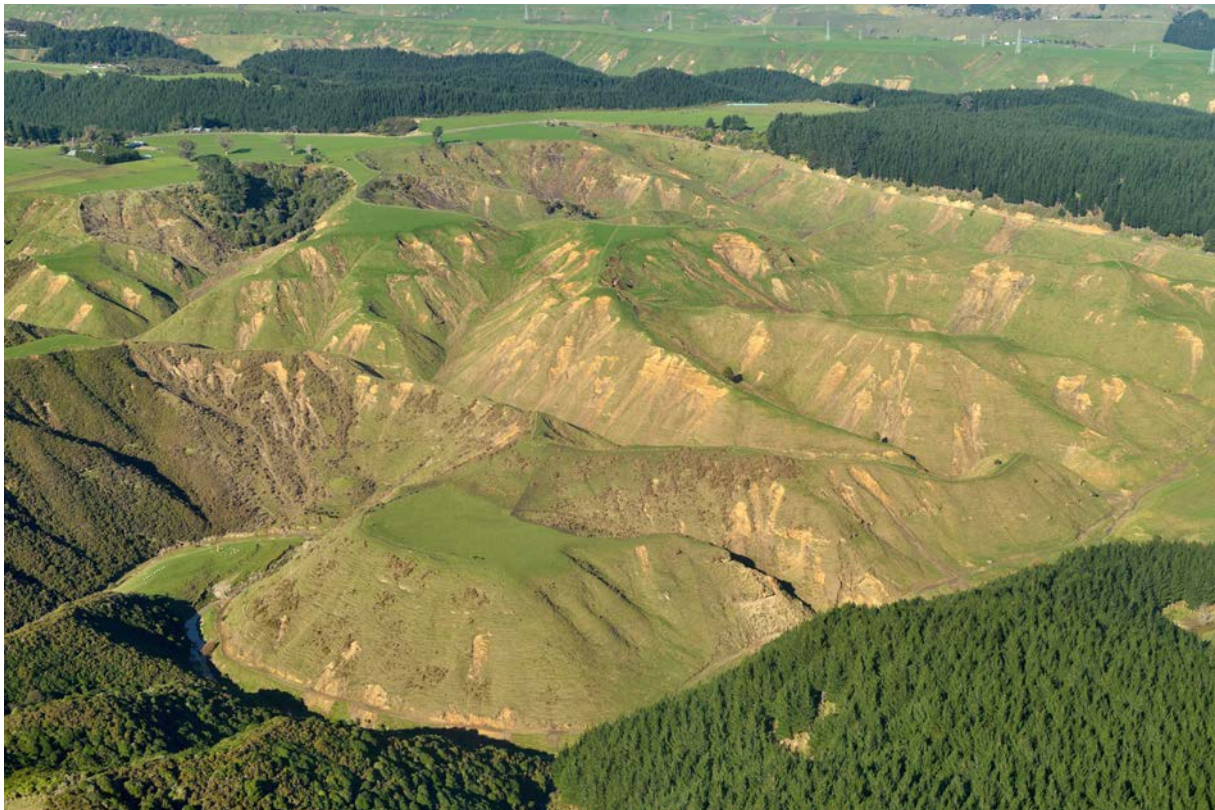
Figure 10 Severe landsliding, Kai-Iwi catchment, Brunswick Rd in distance. Maxwell and Nukumar Group sandstone/siltstone. (GNS Photo: D02_1458)

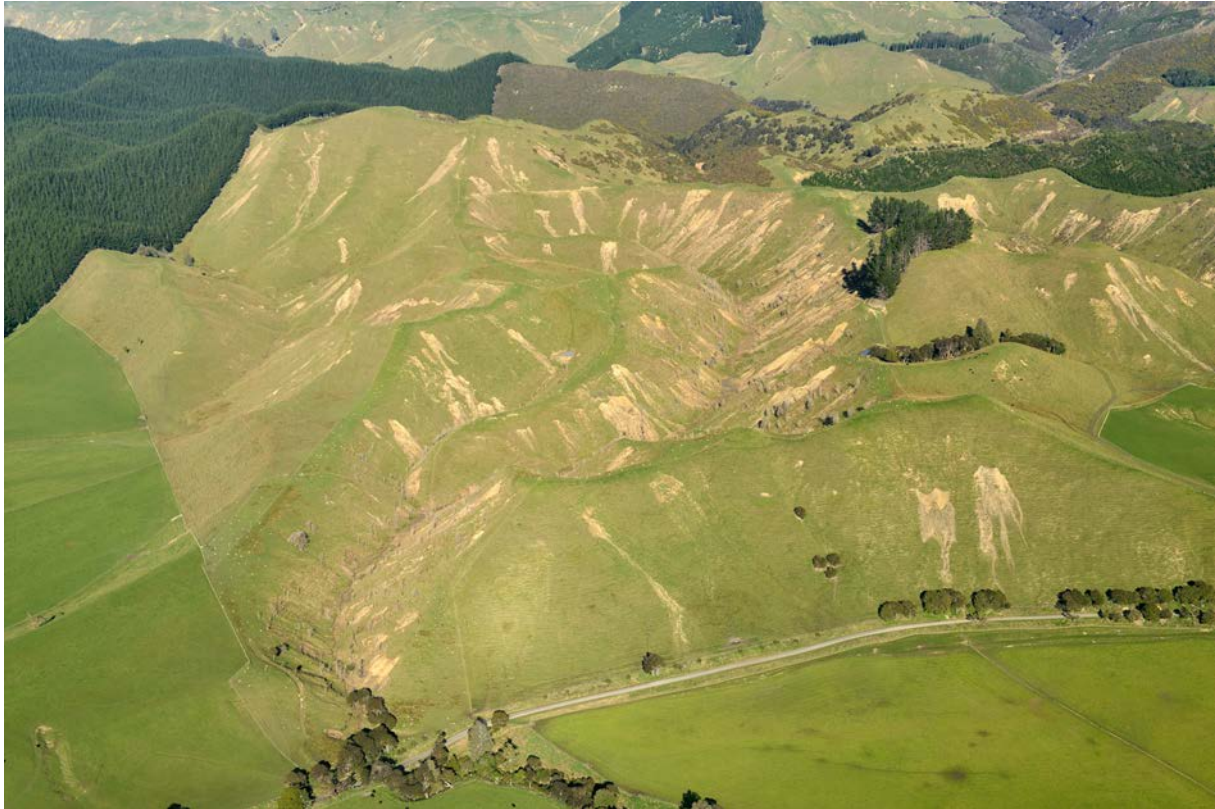
Figure 13 Severe landsliding (centre of photo) within area where landsliding has been classified as moderate. Turakina Valley near Lakes Ngaruru and Namunamu. (GNS Photo: D02_1708)

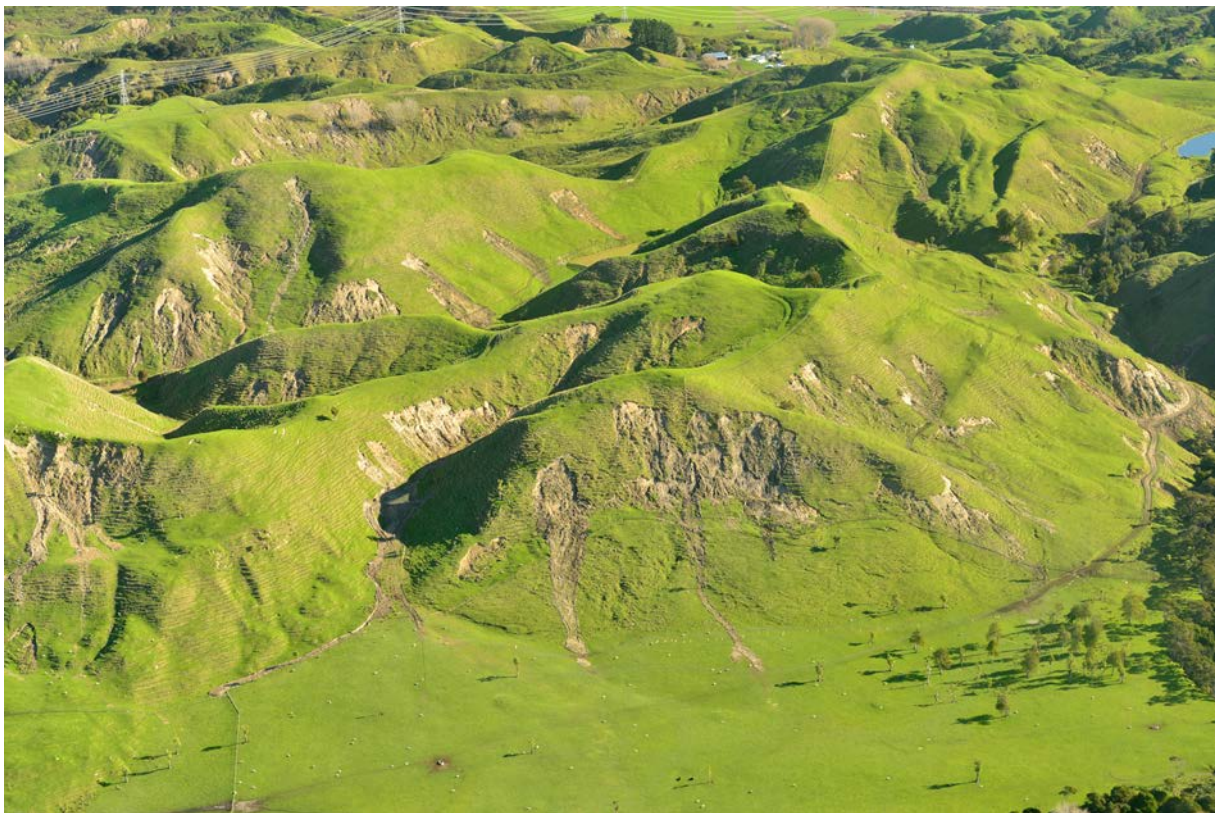
Figure 14 Small area of severe landsliding on Kai-Iwi Group (Quaternary) sediments, Turakina Valley near Makuhou Rd. (GNS Photo: D02_1734)

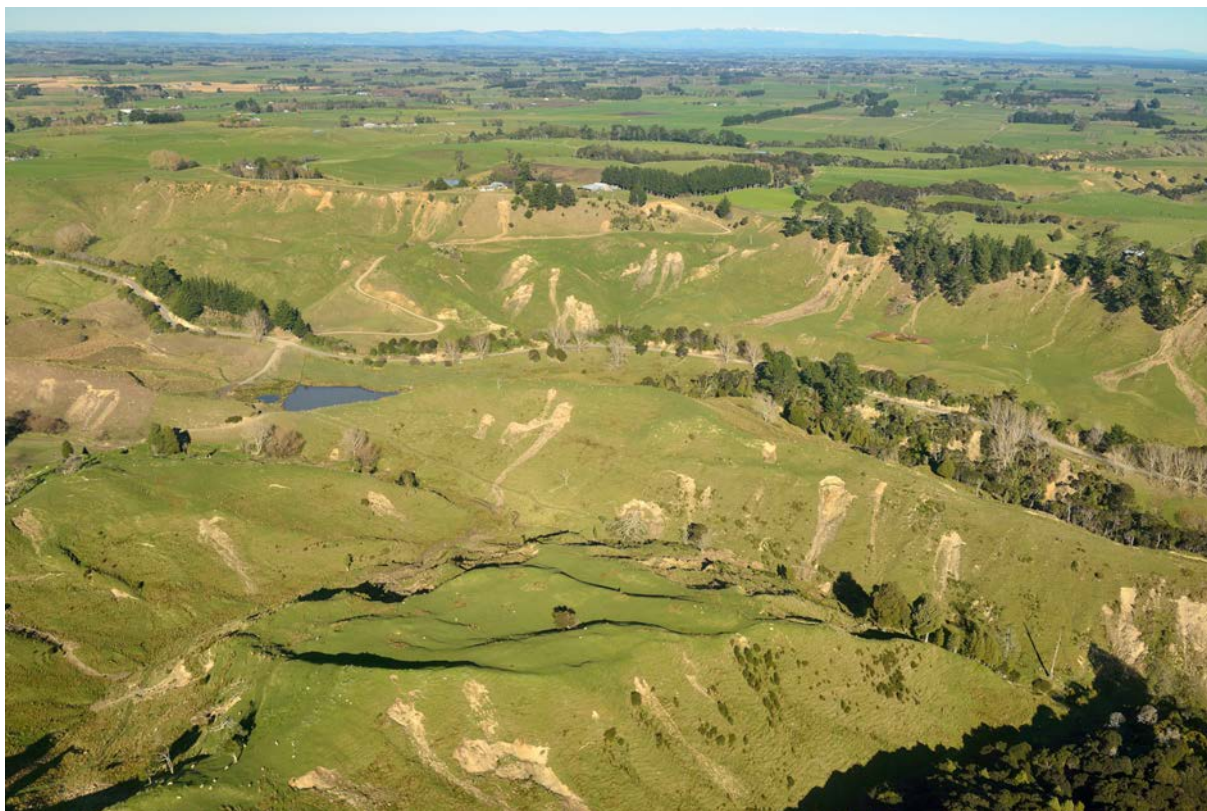
Figure 15 Moderate landsliding on Kai-Iwi Group sandstone/siltstone with loess cover deposits, Makuhou Rd, near Marton Reservoirs. (GNS Photo: D02_1764)

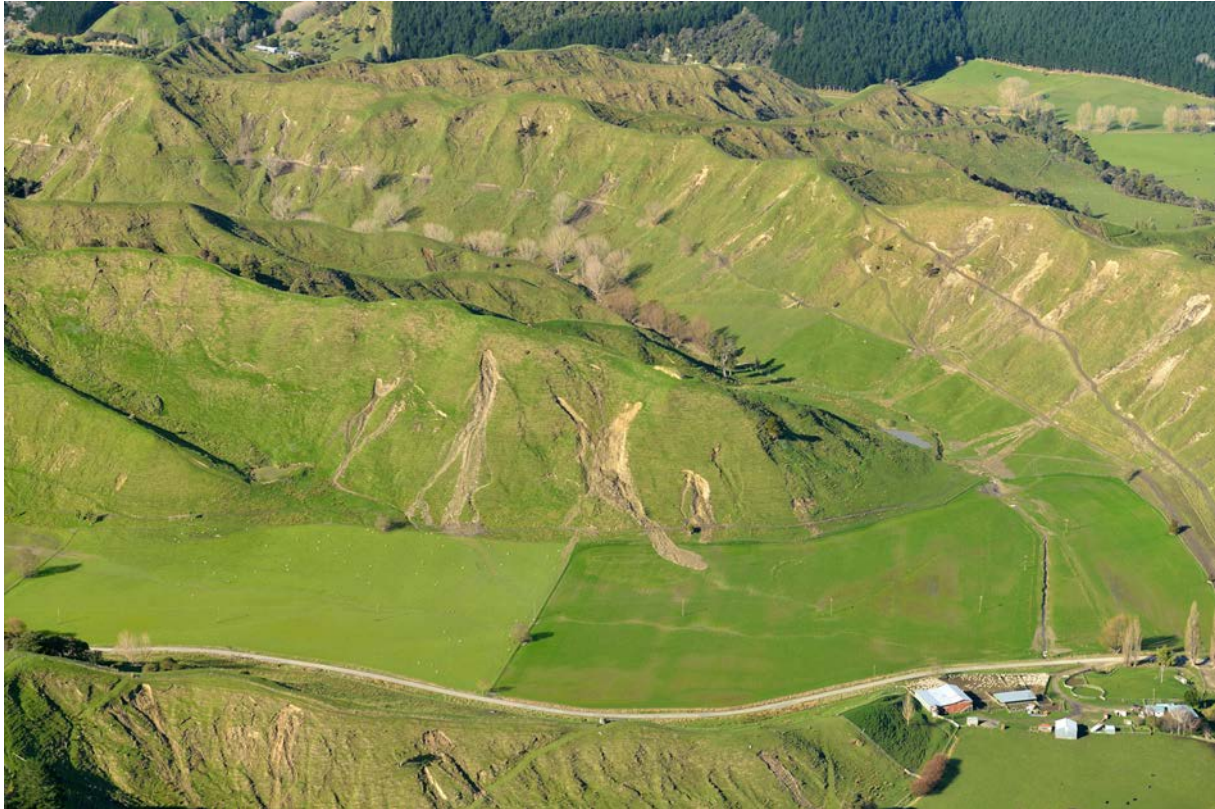
Figure 16 Moderate landsliding on Pliocene sandstone, Whangaehu Valley, near Mangamahu. (GNS Photo: D02_1649)

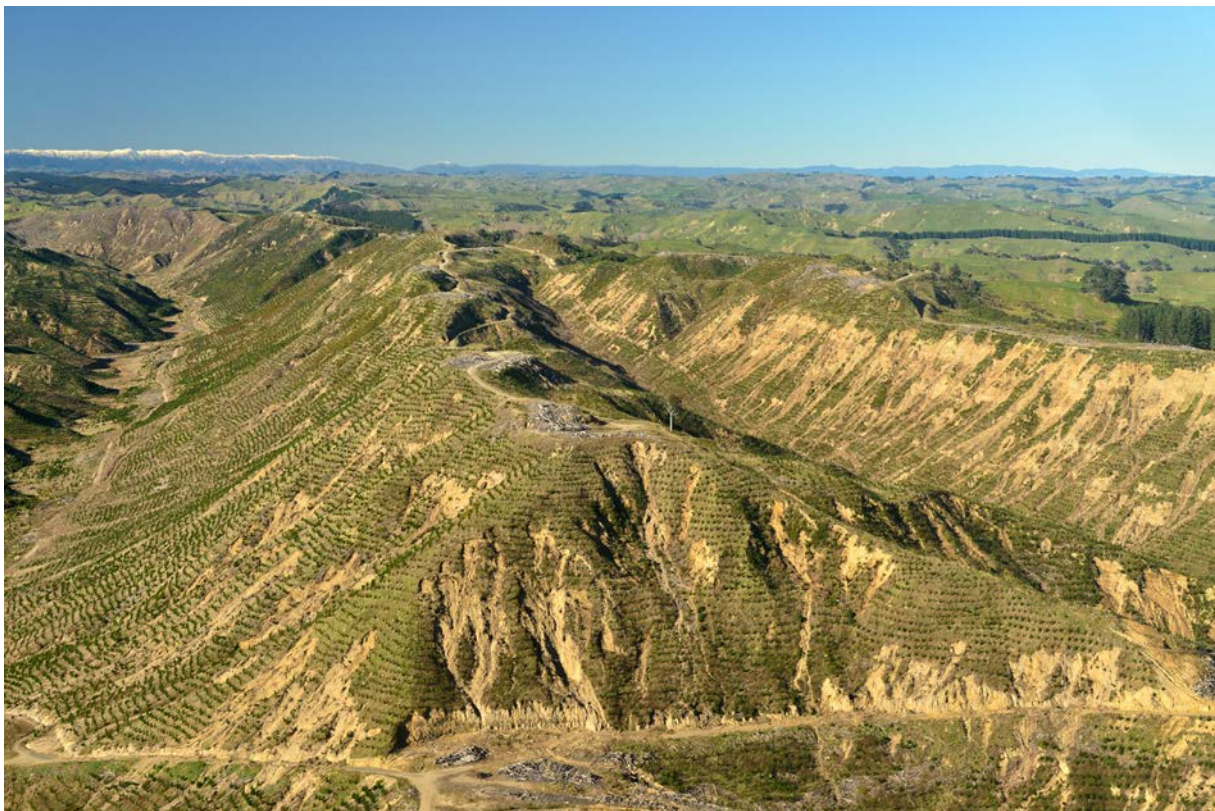
Figure 17 Severe landsliding in areas of new plantings on Maxwell Group sandstone, Matariki Forest, Whangaehu Valley. (GNS Photo: D02_1596)

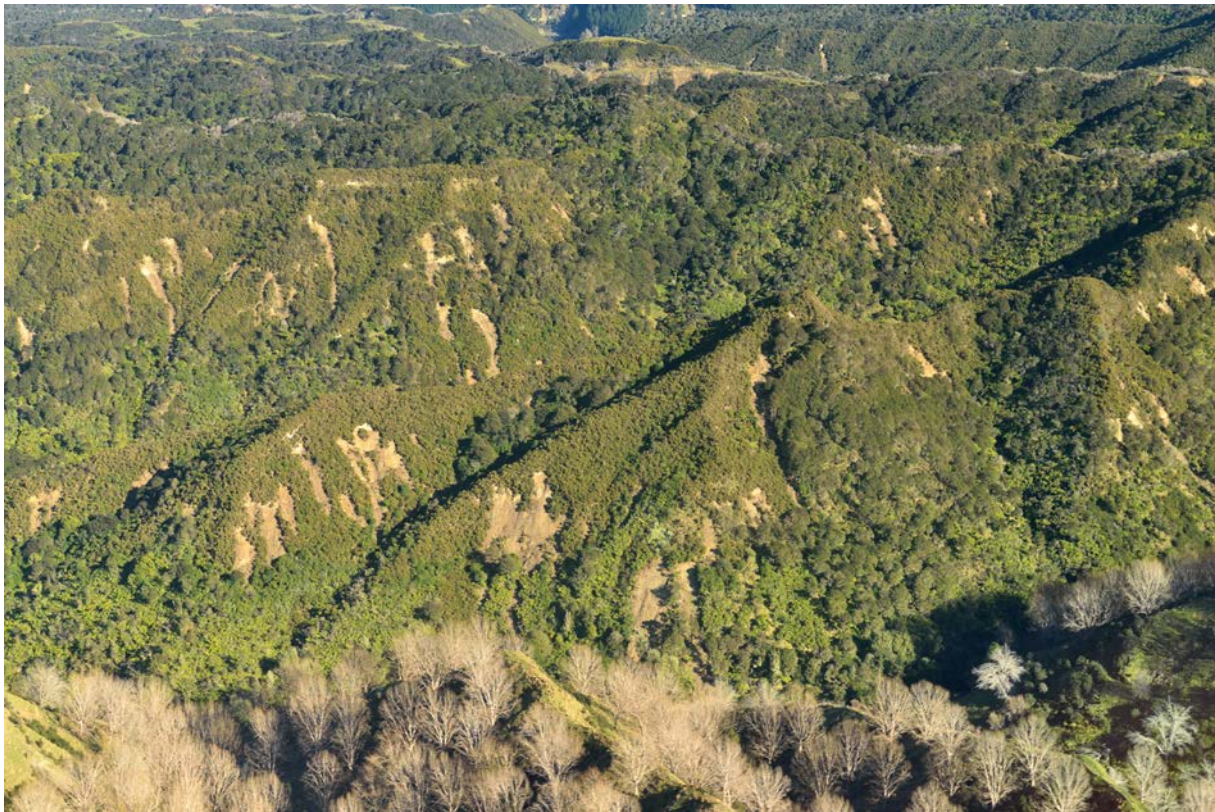
Figure 18 Moderate landsliding in scrub underlain by Pliocene sandstone, 5 km north of Parikino, on western side of the Whanganui River. (GNS Photo: D02_1211)

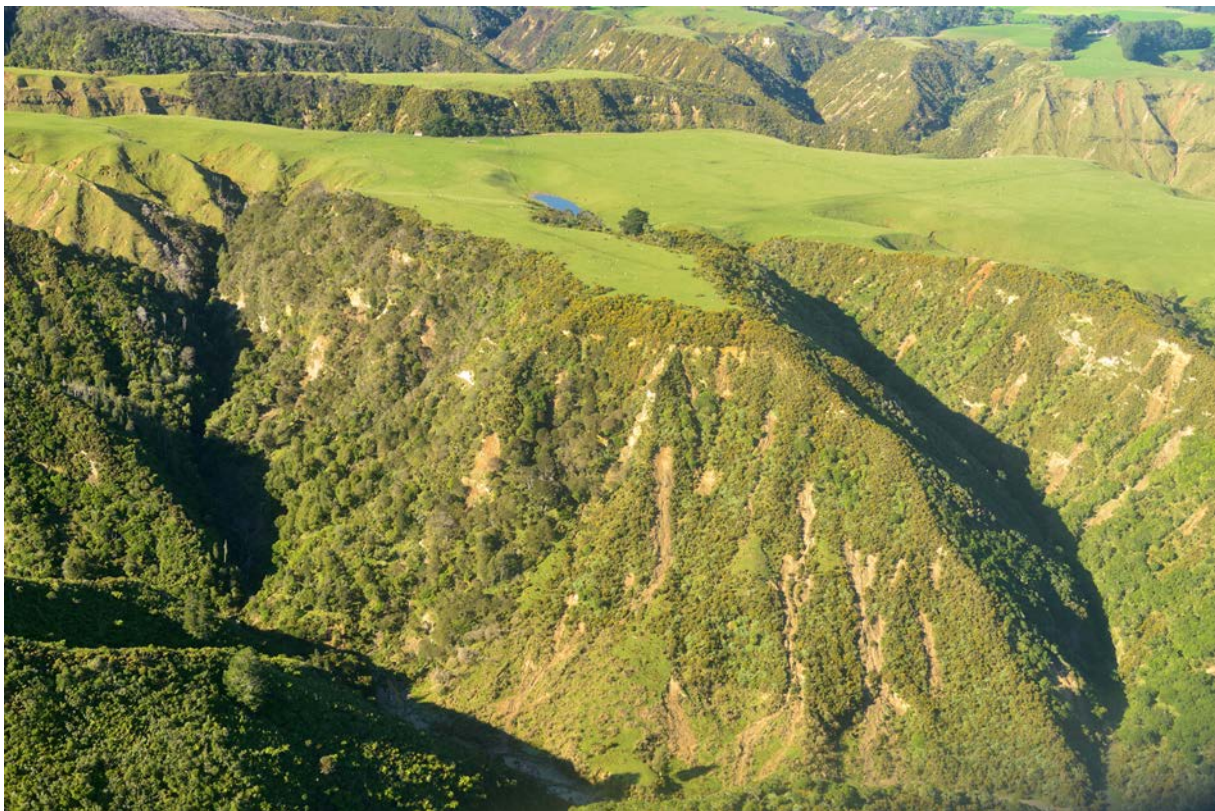
Figure 19 Moderate landsliding in scrub on Whenuakura Group sandstone, near Ridge Rd north of Ngutuwera, Waitotara catchment. (GNS Photo: D02_1370)

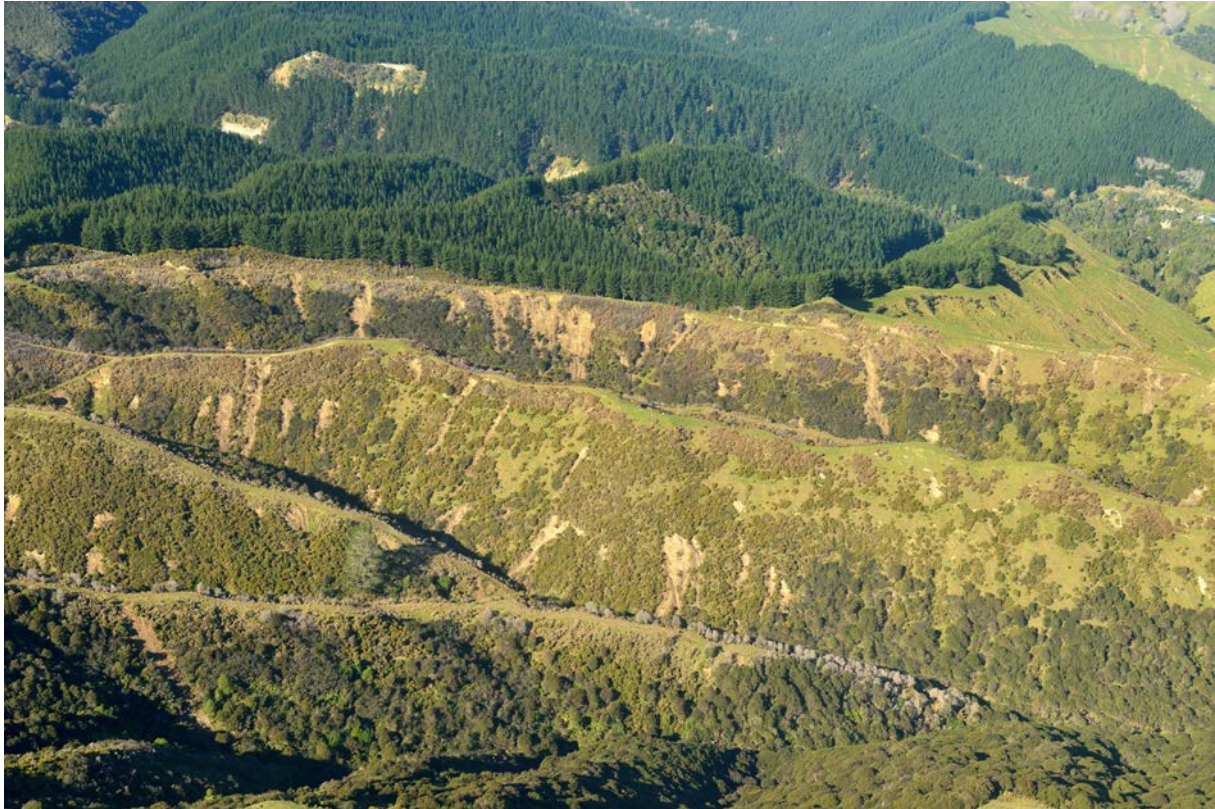
Figure 20 Moderate landsliding on scrub, Whangaehu Valley, 3.5 km north of Mangamahu. Note lack of landslides in exotic forest (background). (GNS Photo: D02_1659)

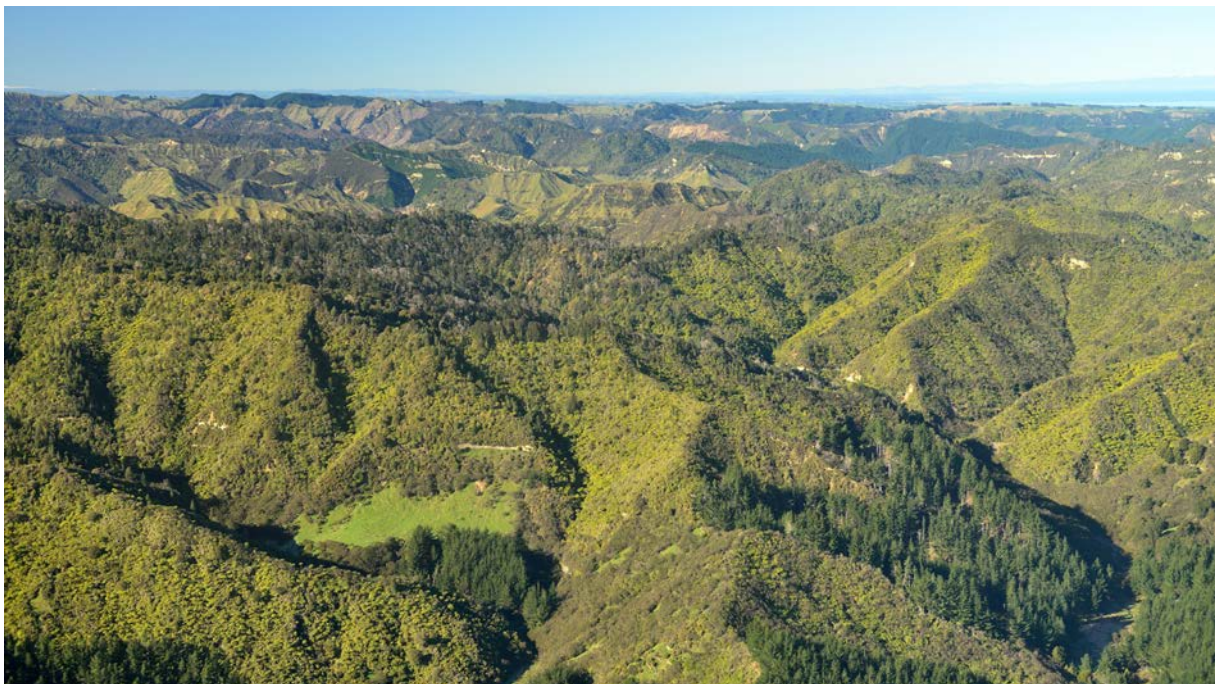
Figure 21 Indigenous forest and scrub on Whenuakura Group sandstone, near Mangawhio, Weraweraonga catchment. Note there are very few landslides. (GNS Photo: D02_1382)

1. Landsliding was generally confined to areas where 48-hour rainfall totals were >100 mm (Figure 1). This approximated an Average Recurrence Interval of between 20–100 years (from HIRDS).
2. Landsliding was largely confined to areas in pasture (Figure 15 and Figure 16), or recently planted or logged forest (Figure 17). Landsliding was less common in scrub (Figure 18, Figure 19, Figure 20), and infrequent in areas of indigenous forest and closed-canopy exotic plantation forest (Figure 21 and Figure 22).

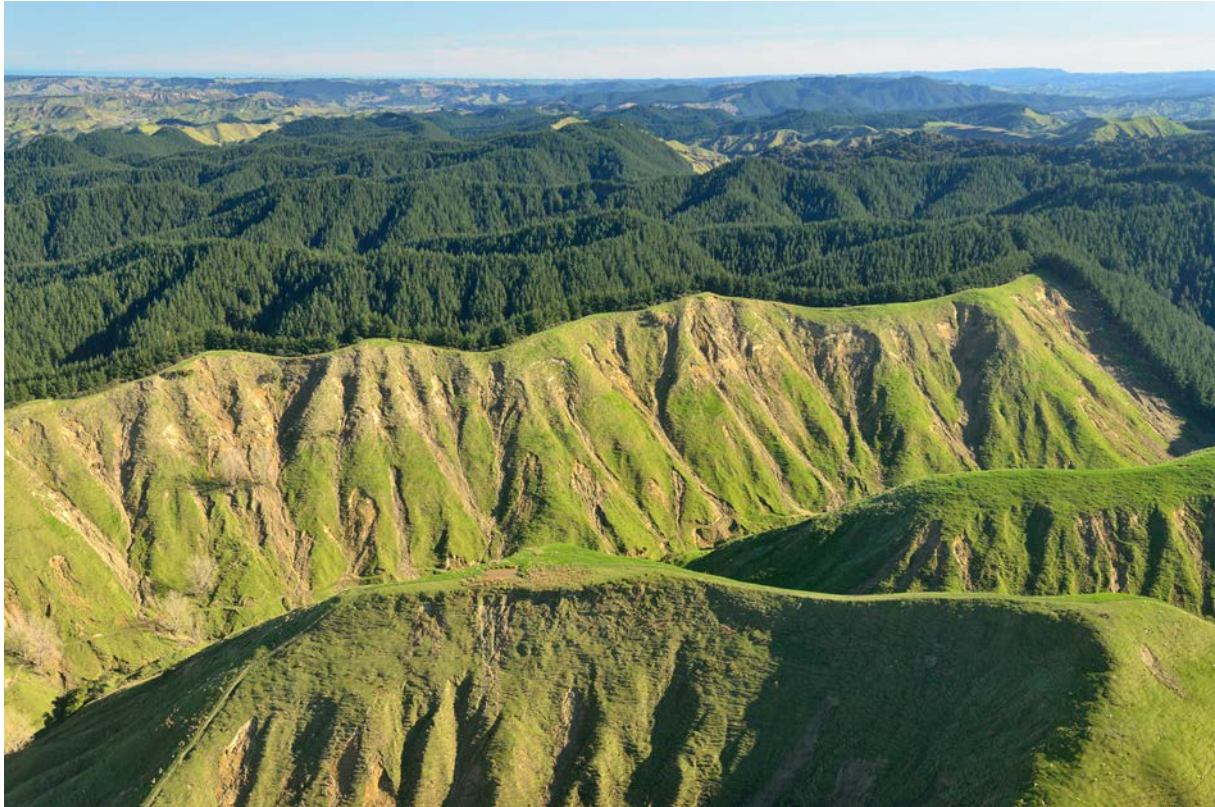
Figure 22 Localised severe landsliding at Otairi, Turakina Valley. Note lack of landslides in exotic forest. (GNS Photo: D02_1697)

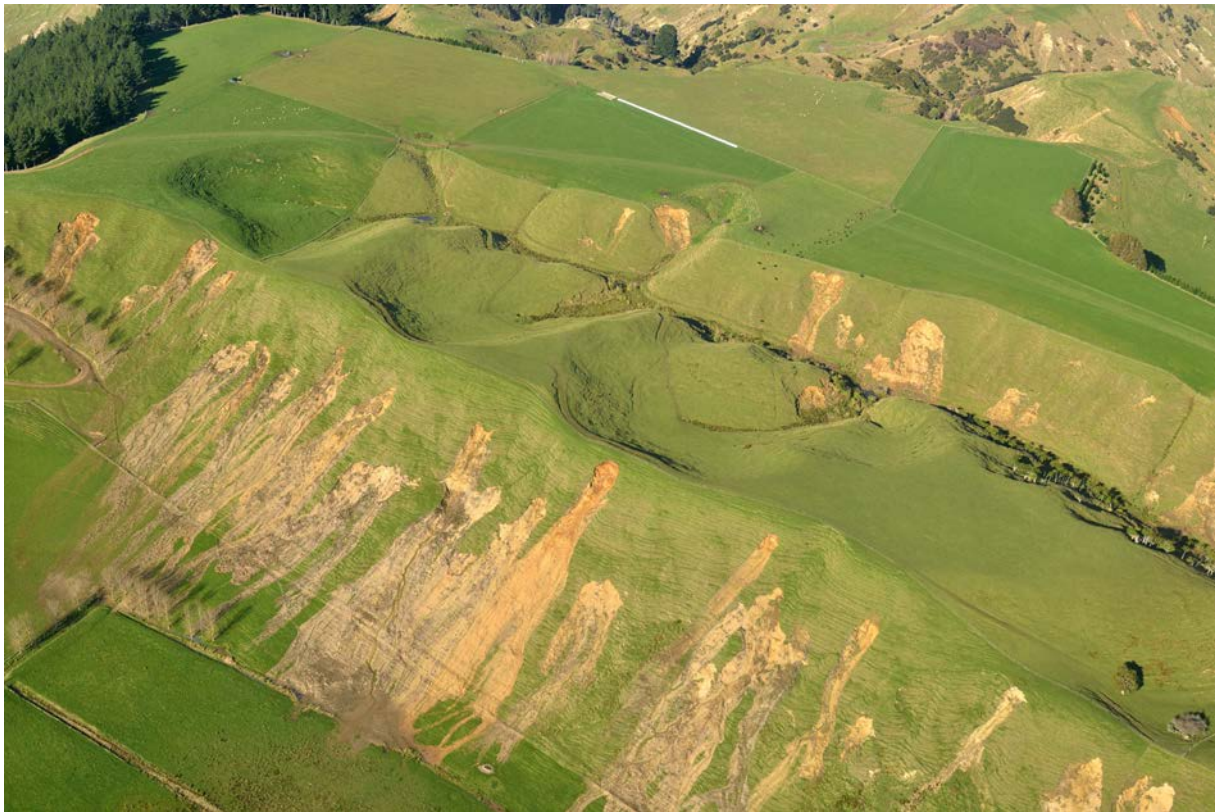
Figure 23 Severe landsliding in Kai-Iwi Group (eQk) early Quaternary sandstone/siltstone terrace scarps. Note brown colour of landslides near ridge line, indicating presence of weathered tephra/tephric loess cover deposits. Head of Makirikiri Valley, lower Whanganui catchment. (GNS Photo: D02_1504)

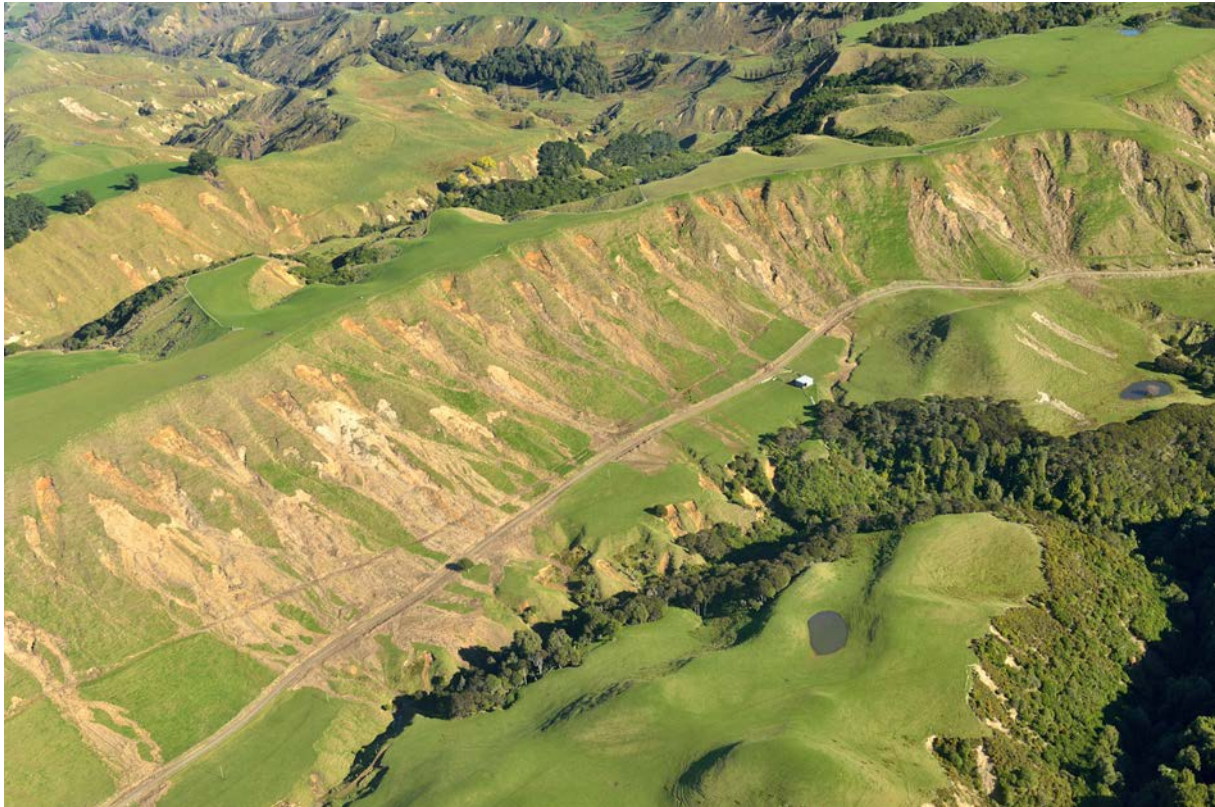
Figure 24 Severe landsliding on scarps of Kai-Iwi Group marine terraces, Makirikiri Valley. (GNS Photo: D02_1505)

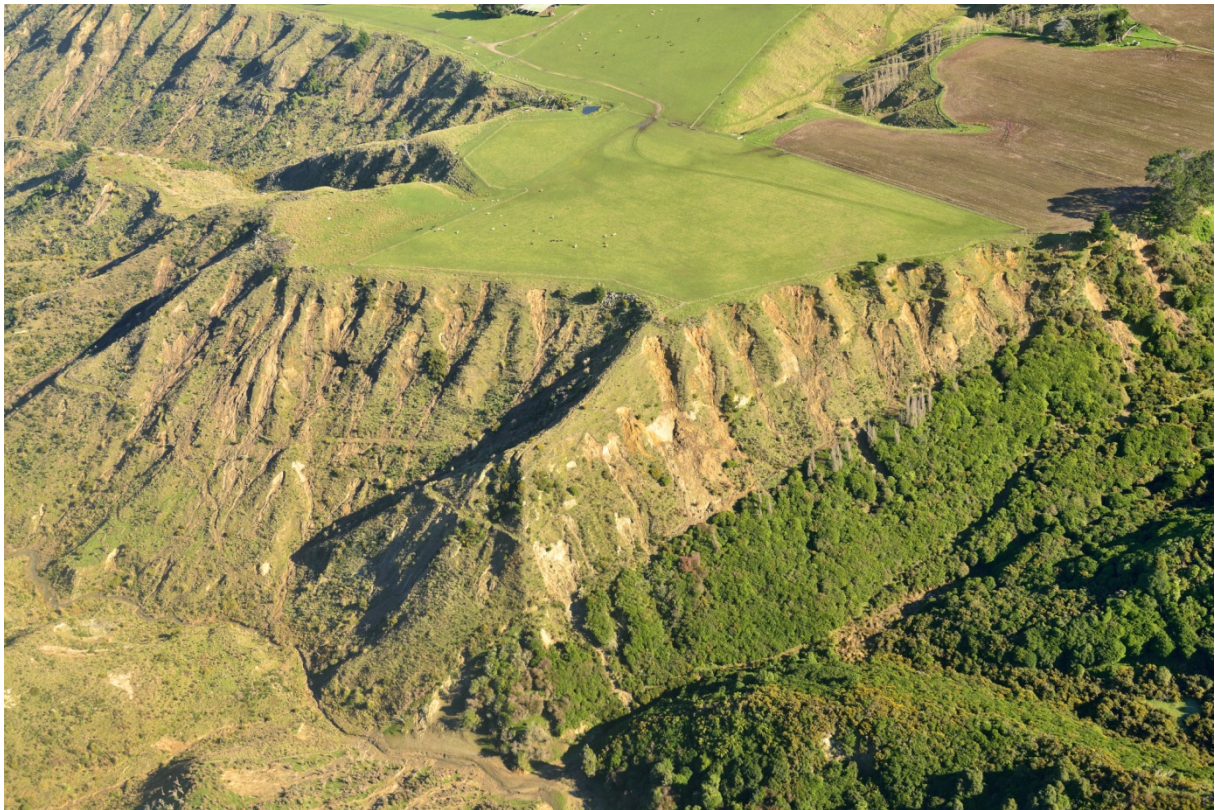
Figure 25 Severe landsliding in head of Matarawa Stream, north of Fordell. Note location of landslide initiation at terrace-scarp boundary. (GNS Photo: D02_1496)

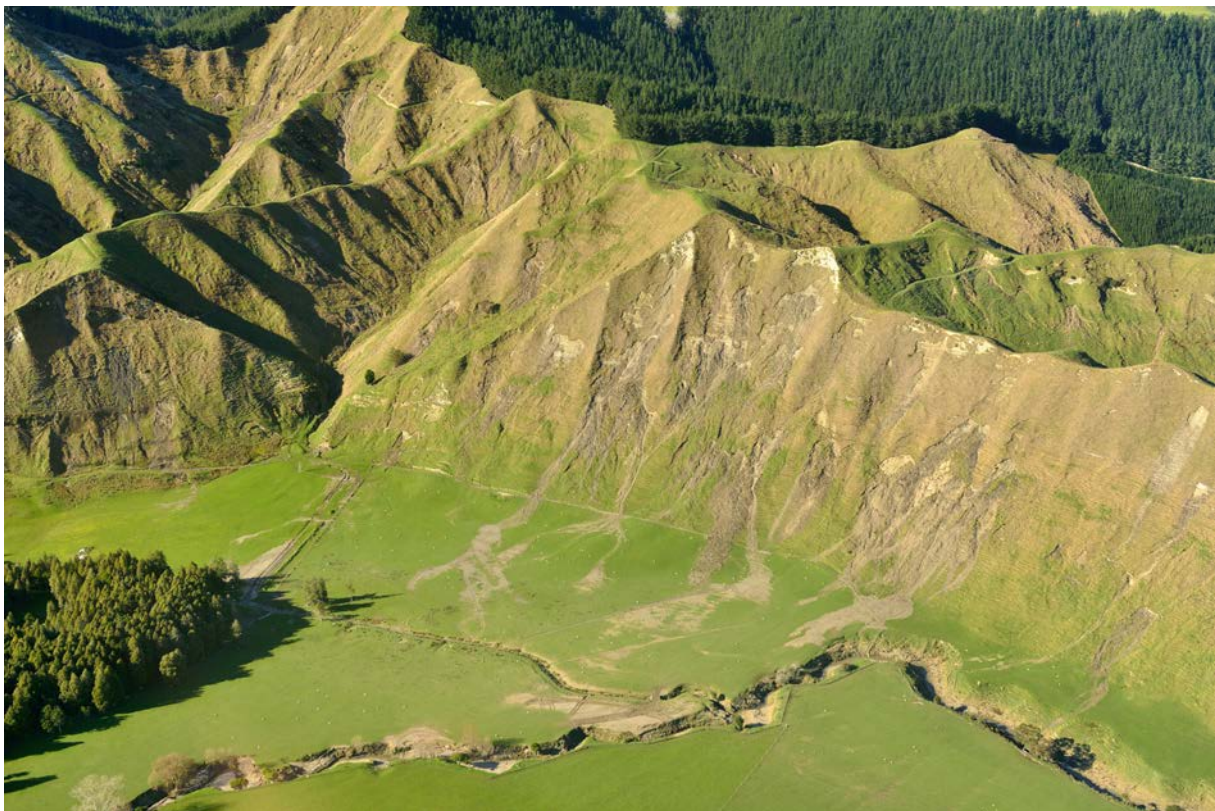
Figure 26 Moderate landsliding with area of severe landsliding in centre. Pliocene sandstone, Parikino, Whanganui River. Note presence of old debris fans (in pasture) at foot of slope. (GNS Photo: D02_1218)
