BIBLIOGRAPHIC REFERENCE

Page, M.J.; Rosser, B.J.; Townsend, D.B.; Carey, J.M.; Ries, W.F. 2015. Reconnaissance report on landsliding caused by the 19–20 June 2015 rainstorm in the Taranaki-Wanganui-Manawatu region. *GNS Science Report* 2015/47. 50 p. + Appendices

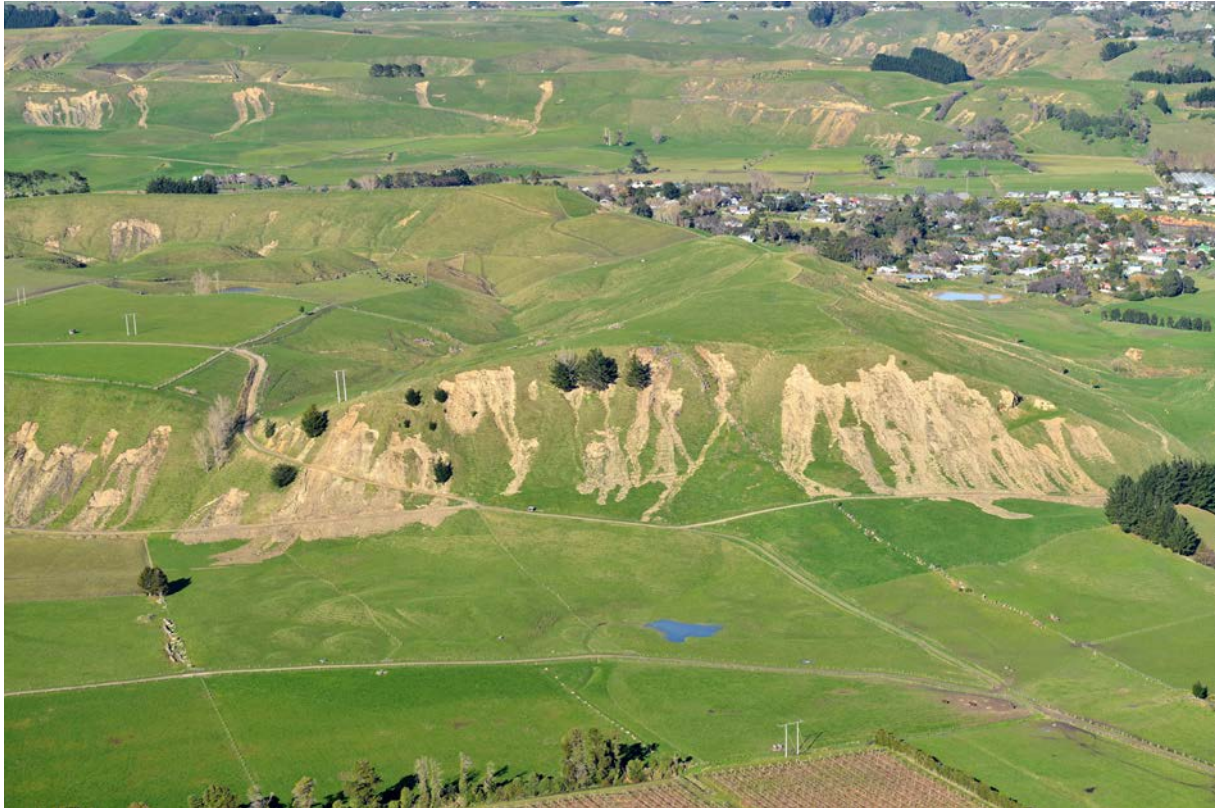
Figure 27 Severe landsliding on north facing scarp of Kai-Iwi marine terrace. Outskirts of Whanganui East in right background. Note coalescing of adjacent landslide scars and debris tails. (GNS Photo: D02_1247)

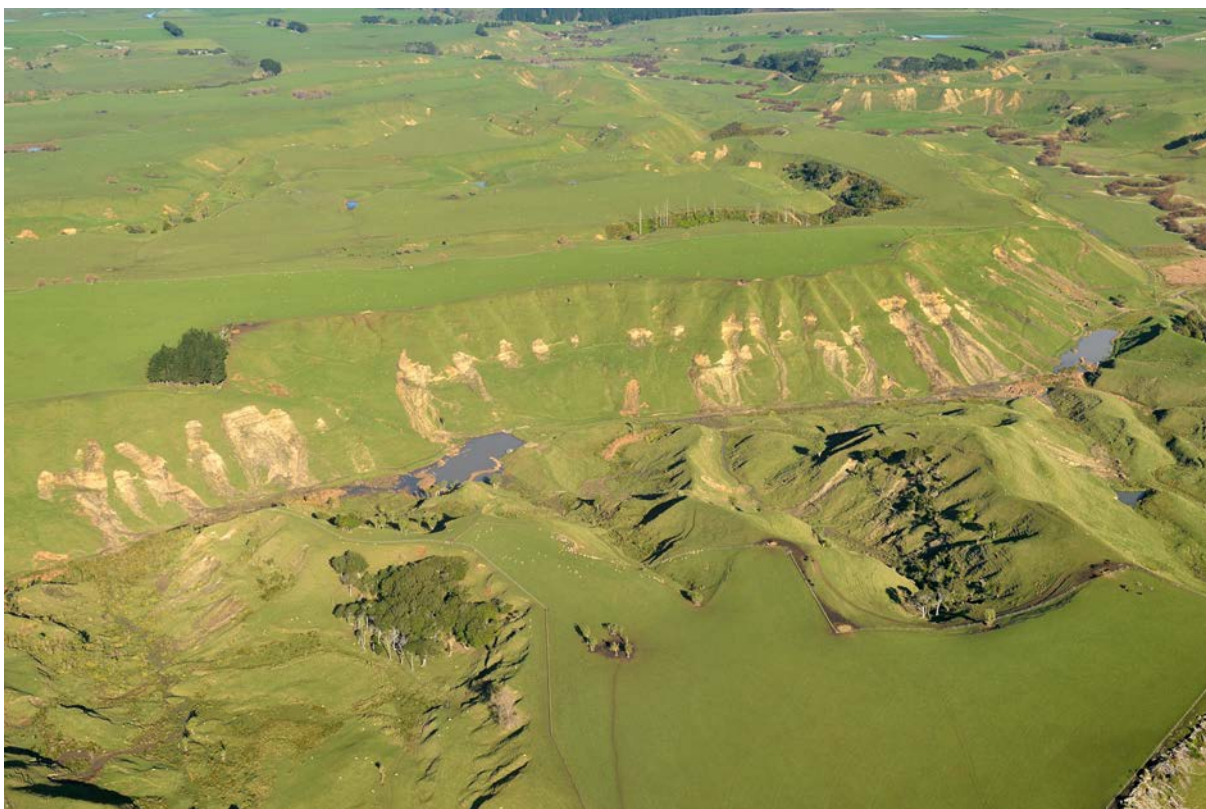
Figure 28 Severe landsliding on north facing terrace scarps, Okehu catchment, between Kai Iwi and Maxwell. Late Pliocene to early Quaternary sandstone/siltstone. (GNS Photo: D02_1282)

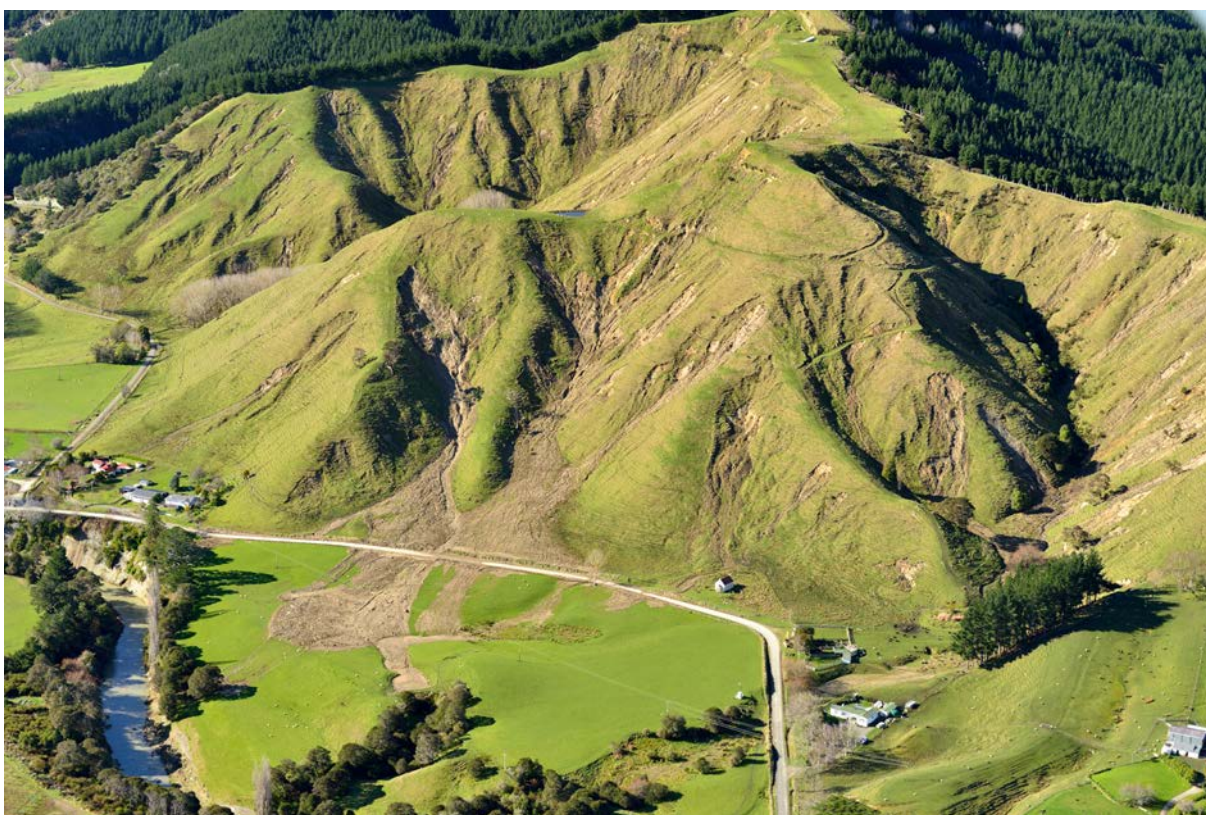
Figure 29 Severe landsliding at Mangamahu, on Pliocene sandstone. Coalescing of landslide debris tails has increased run-out distance. (GNS Photo: D02_1653)

5. The majority of landslide failures can be classified as soil slides and soil flows.
6. Landslides were typically small to medium size ($<100\text{--}1000\text{ m}^3$), shallow (1–2 m deep) and occurred in regolith or cover beds (tephra and loess).
7. Most landslides occurred on steep slopes ($\sim 20\text{--}35^\circ$).
8. The most severe landsliding was on north facing slopes (Figure 27 and Figure 28). This observation was based on the reconnaissance flights.
9. In areas of severe landsliding both landslide scars and debris tails often coalesced with those of adjacent landslides (Figure 29 and Figure 30).

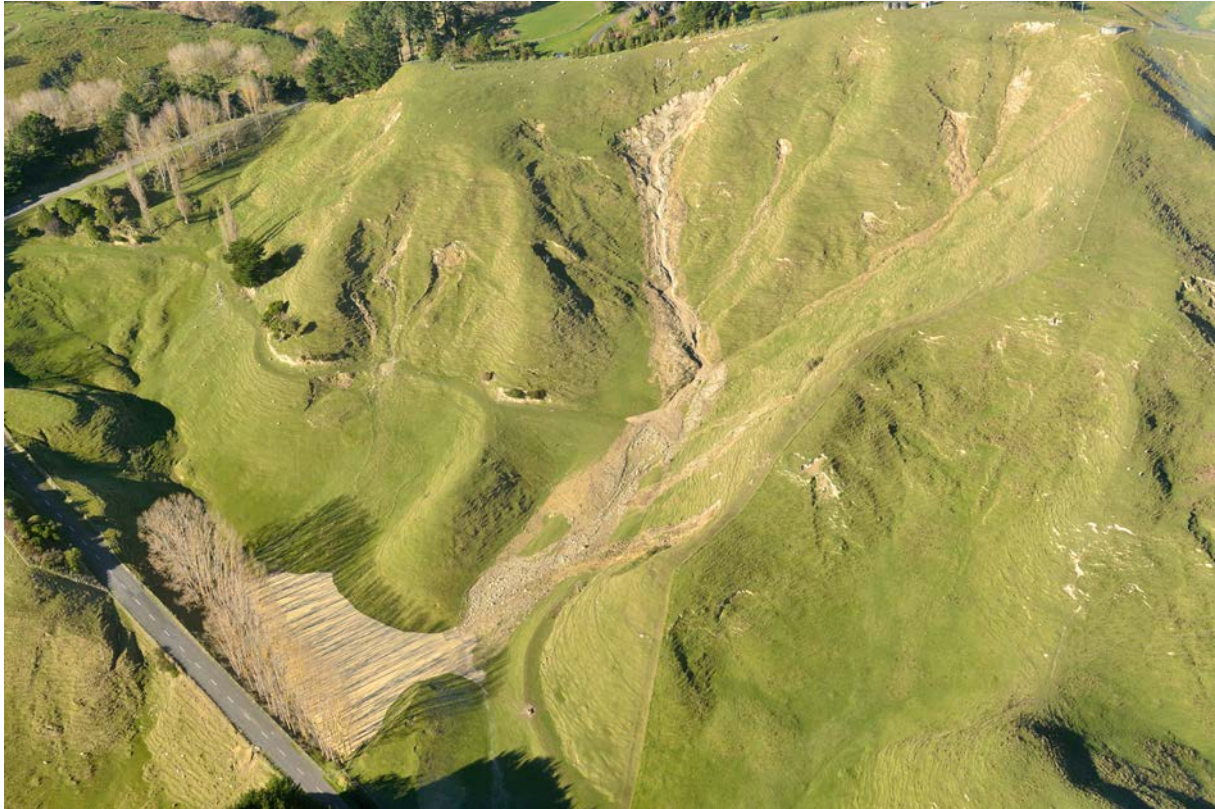
Figure 30 Rangatira Rd east of Hunterville. Note gullying along debris tail path, and resulting deposition of bedrock material on lower slopes, and ponding of sediment-laden water beside road. (GNS Photo: D02_1145)

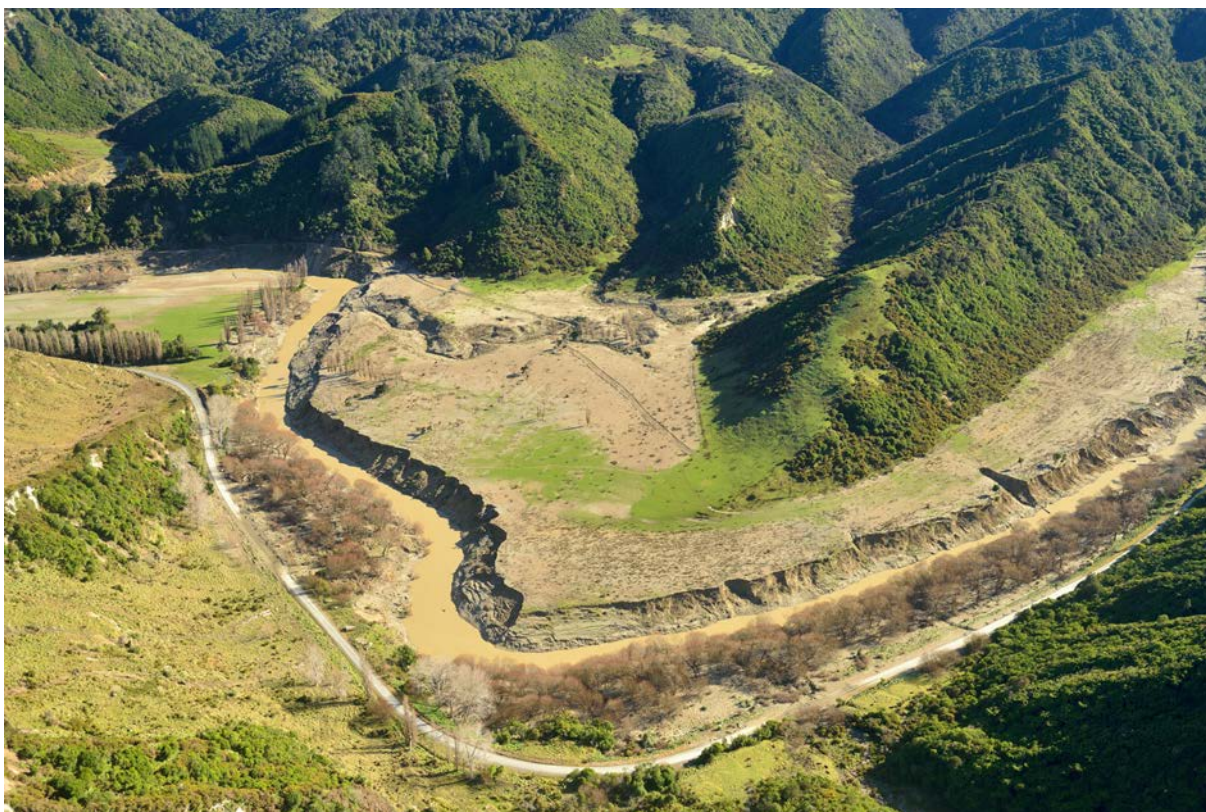
Figure 31 Example of streambank erosion and sediment deposition in the Waitotara Valley, just north of Rangitatau. Note fresh bank failures (exposed brown sediment) at right, and incision (gully) of channelized flow into streambank. (GNS Photo: D02_1318)

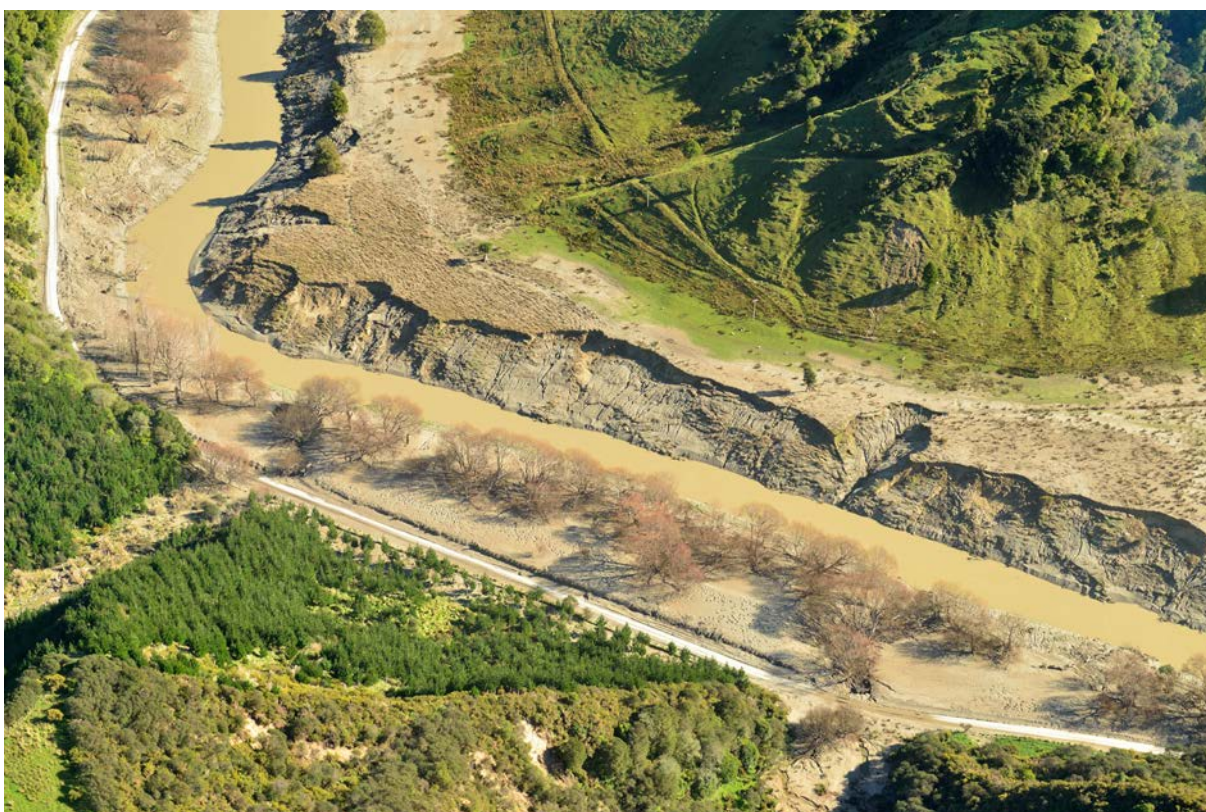
Figure 32 Streambank erosion in the Waitotara Valley, just north of Puao. Note drape of fresh grey silt deposited on banks. (GNS Photo: D02_1333)

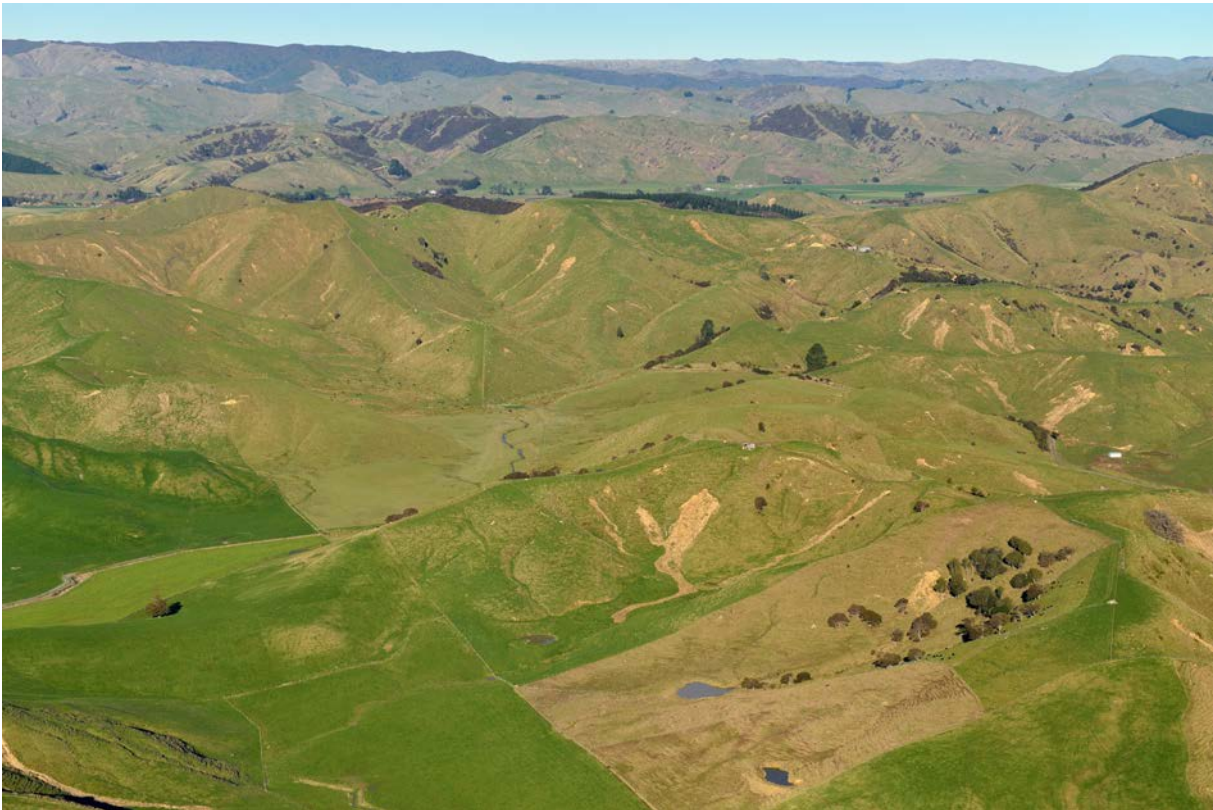
Figure 33 Slight landsliding east of Woodville. (*GNS Photo: D02_1888*)

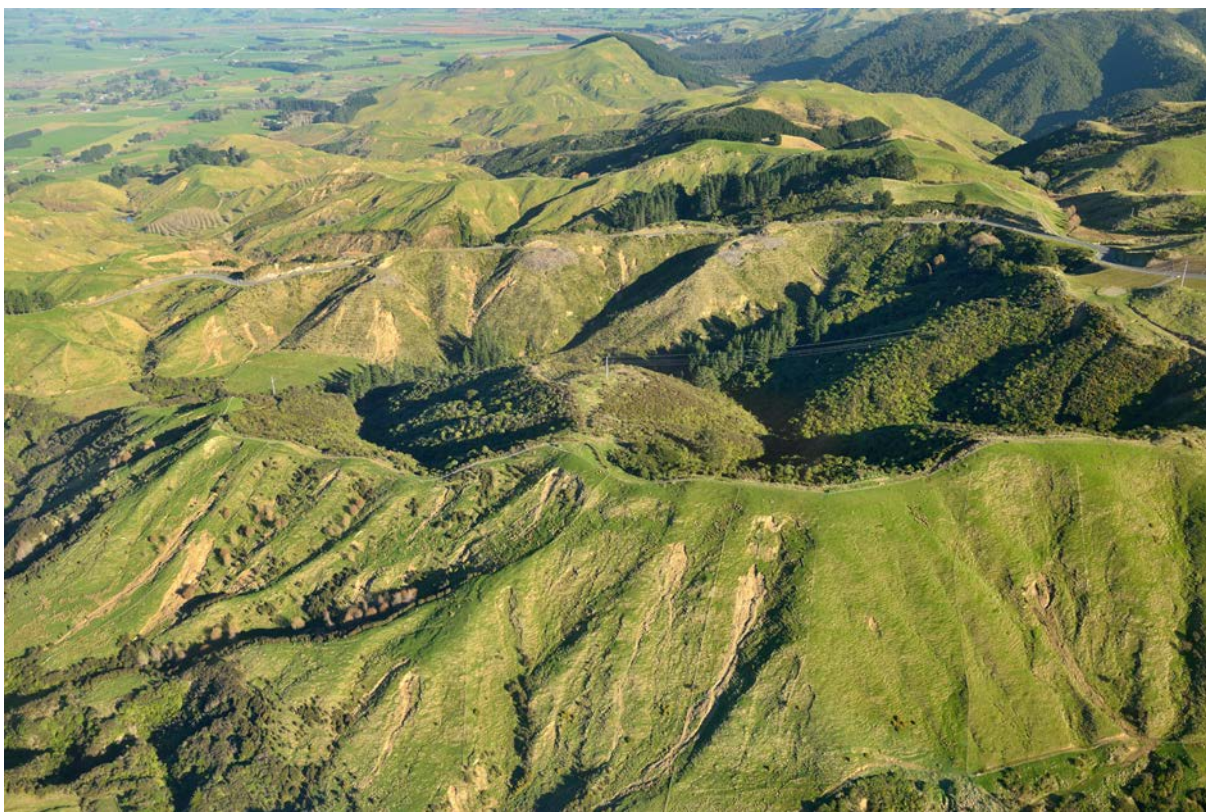
Figure 34 Moderate landsliding on mudstone near Saddle Rd, north of Manawatu Gorge. (GNS Photo: D02_1872)

12. There appeared to be less streambank erosion along reaches of streams and rivers planted with willows.
13. Woody debris was largely absent from the sediment deposited on the floodplains of the major rivers. However, woody debris was observed on the beaches immediately south of the Whanganui River, and around the supports of a number of bridges.
14. Landsliding extended for several kilometres north and south of the Manawatu Gorge, and several kilometres into the hills east of Woodville (Figure 33), and several kilometres south of Pahiatua. Landsliding in this area was only slight, except for a small area of moderate landsliding near the Saddle Rd (Figure 34).

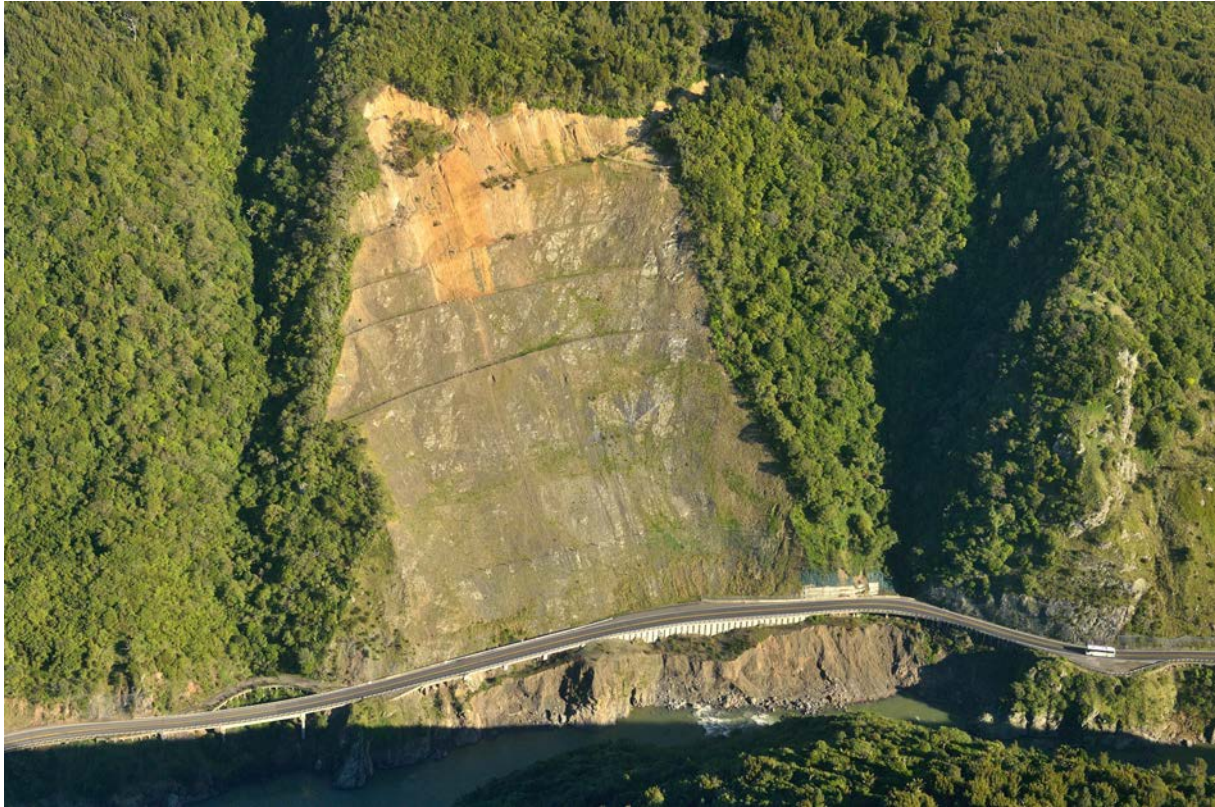
Figure 35 Head scarp failure of pre-existing landslide in Manawatu Gorge. The landslide had been benched and drainage installed following major failures in 2004 and 2011. (*GNS Photo: D02_1859*)

15. There are a number of large landslides in the Manawatu Gorge that periodically reactivate, at times blocking the highway for several weeks to several months. Almost all are failures associated with road cuttings. Following failures in 2004 and 2011, the largest of these landslides was cleared of surficial material, the slope benched, and drainage pipes installed in the rock face. During the June 2015 storm an area of the cleared head scarp of the landslide failed, and the resulting debris accumulated on three of the benches below (Figure 35).

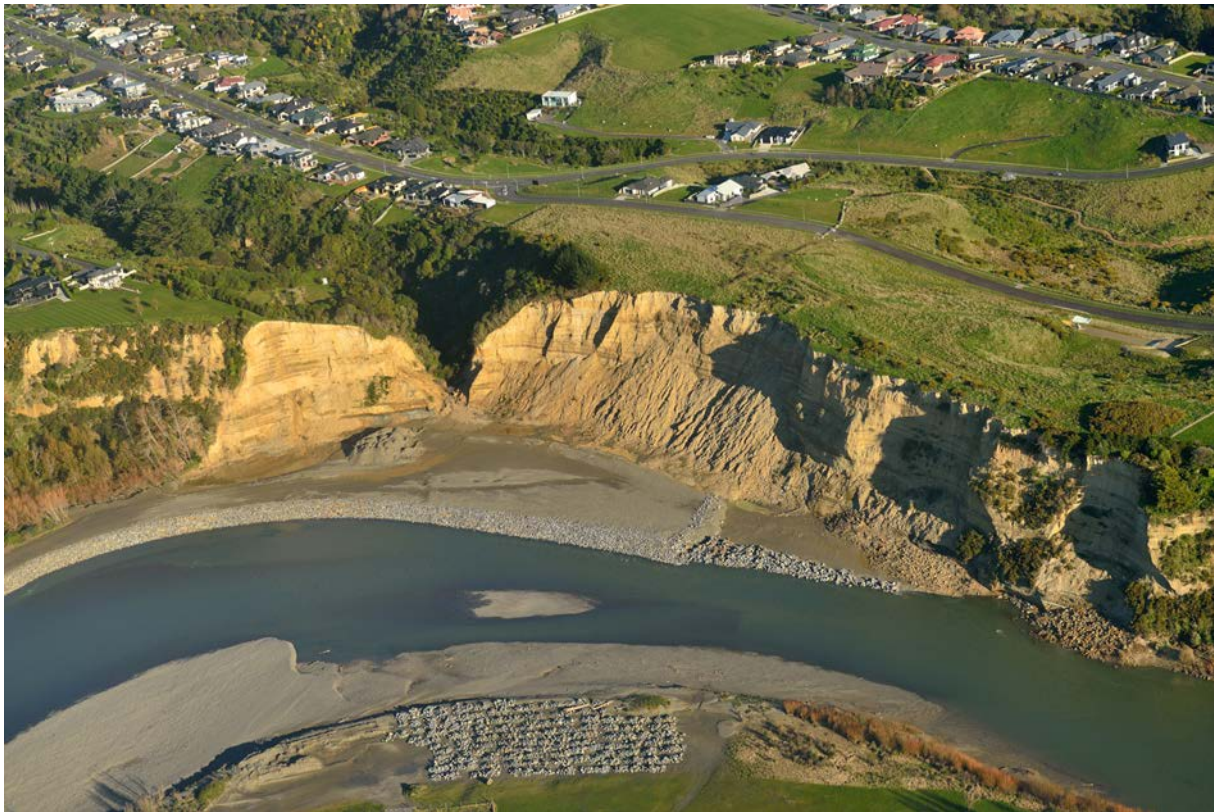
Figure 36 Cliff failure along the Manawatu River at Anzac Park, Palmerston North. (GNS Photo: D02_2080)

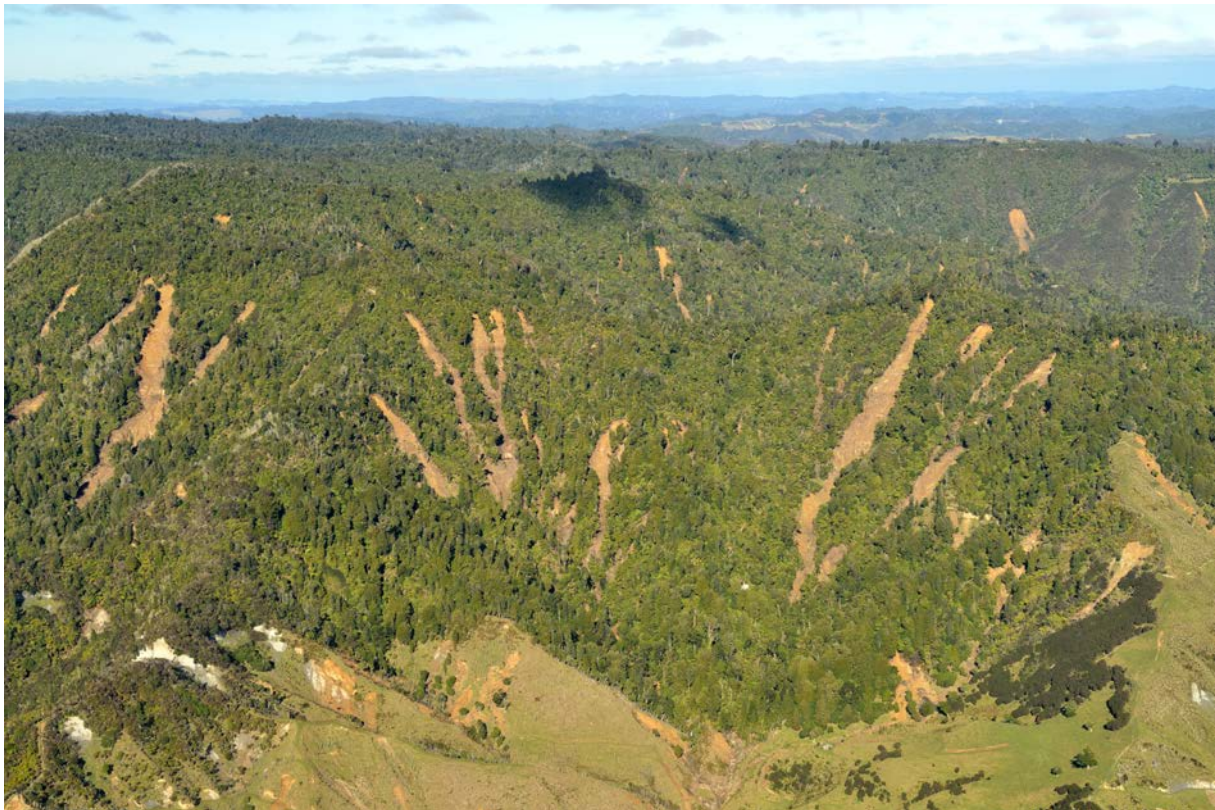
Figure 37 Landslides on mature indigenous forest covered slopes in the Puniwhakau Stream catchment, a tributary to the Mangaehu Stream, Matemateaonga Range near Tututawa. Whangamomona Group sandstone. (GNS Photo: D02_2767)

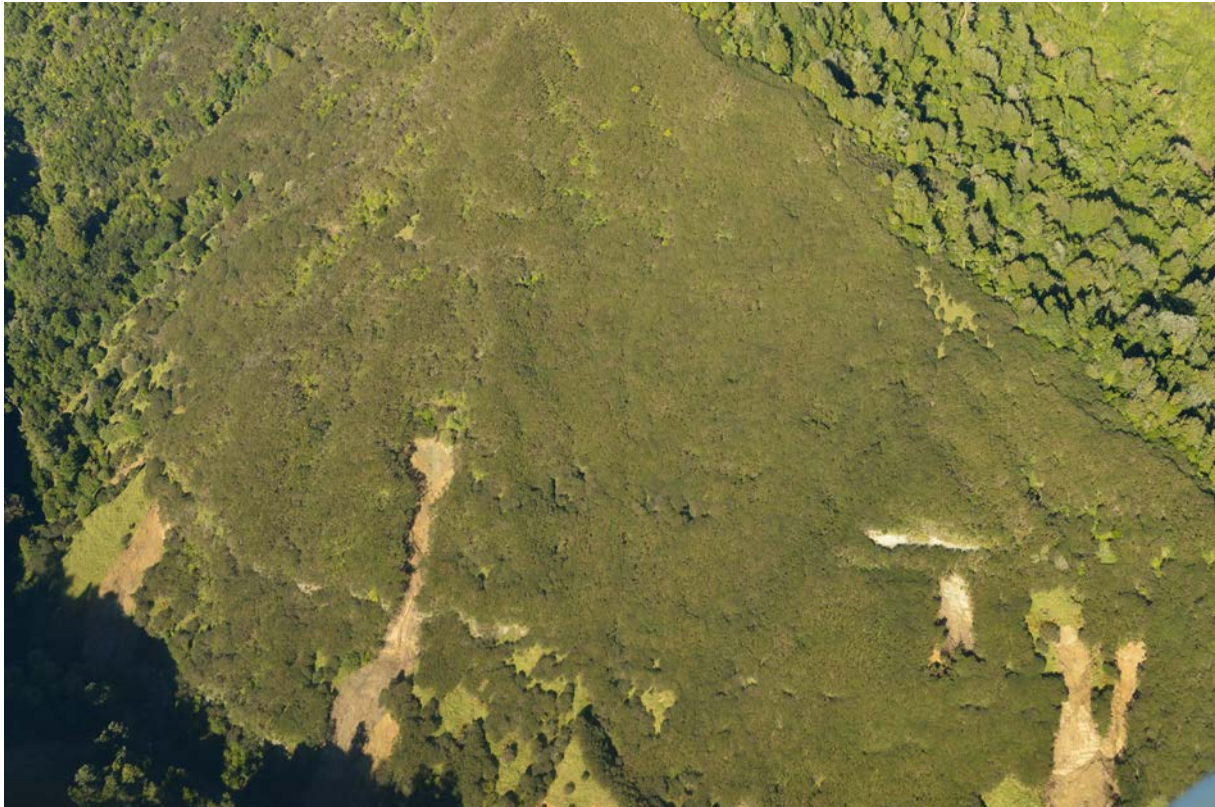
Figure 38 Moderate landsliding on scrub covered slopes on Whangamomona Group sandstone on the Matemateaonga Range near Makahu. (GNS Photo: D02_2788)

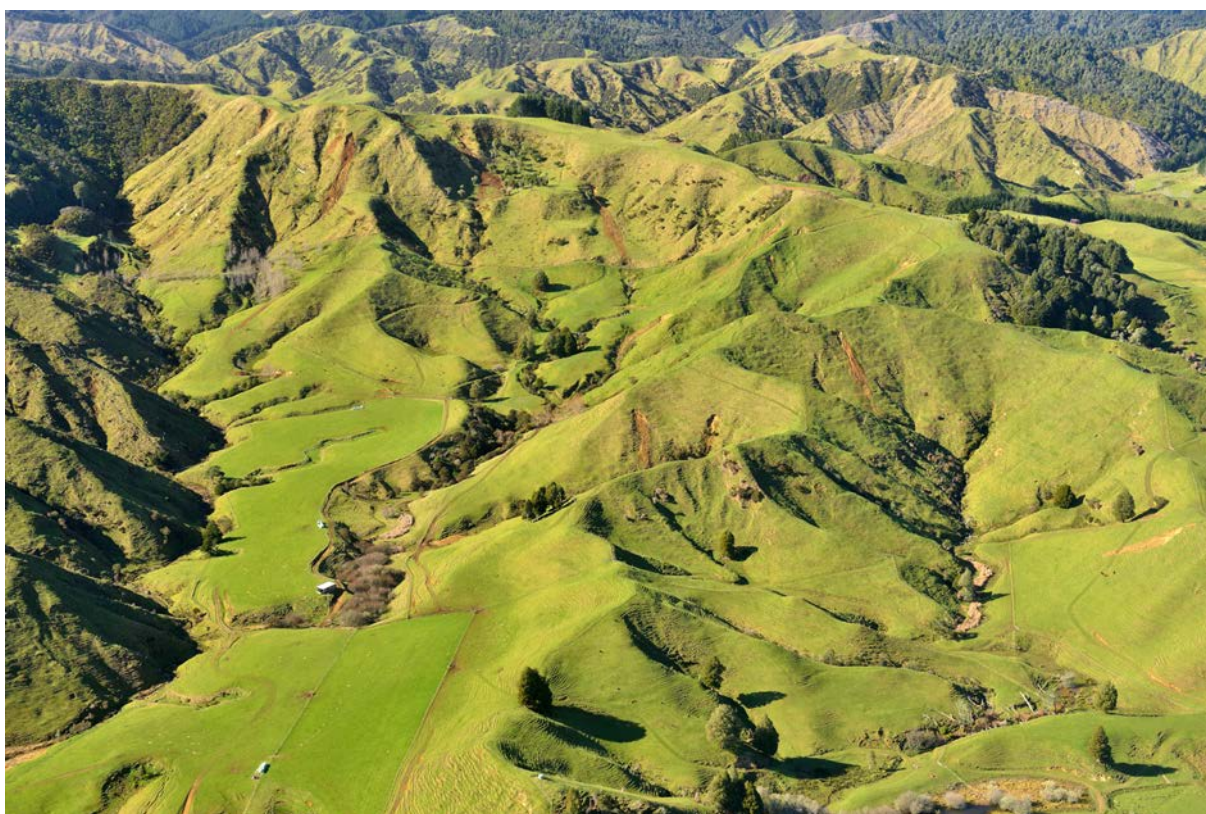
Figure 39 Moderate landsliding near Makahu. Kiore Formation sandstone, Whangamomona Group. (GNS Photo: D02_2486)

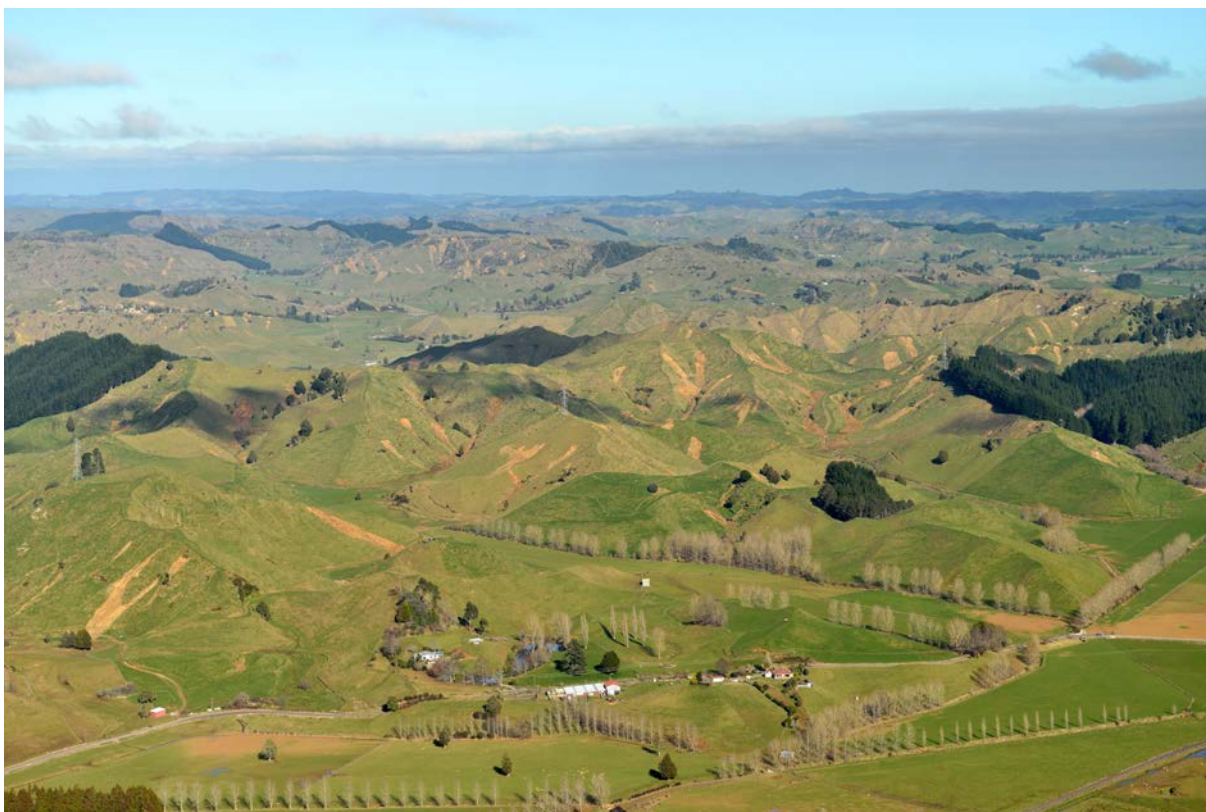
Figure 40 Moderate landsliding on Miocene age Whangamomona Group Sandstone in the Mohakau Stream catchment near Huiroa (inland from Stratford). (GNS Photo: D02_2721)

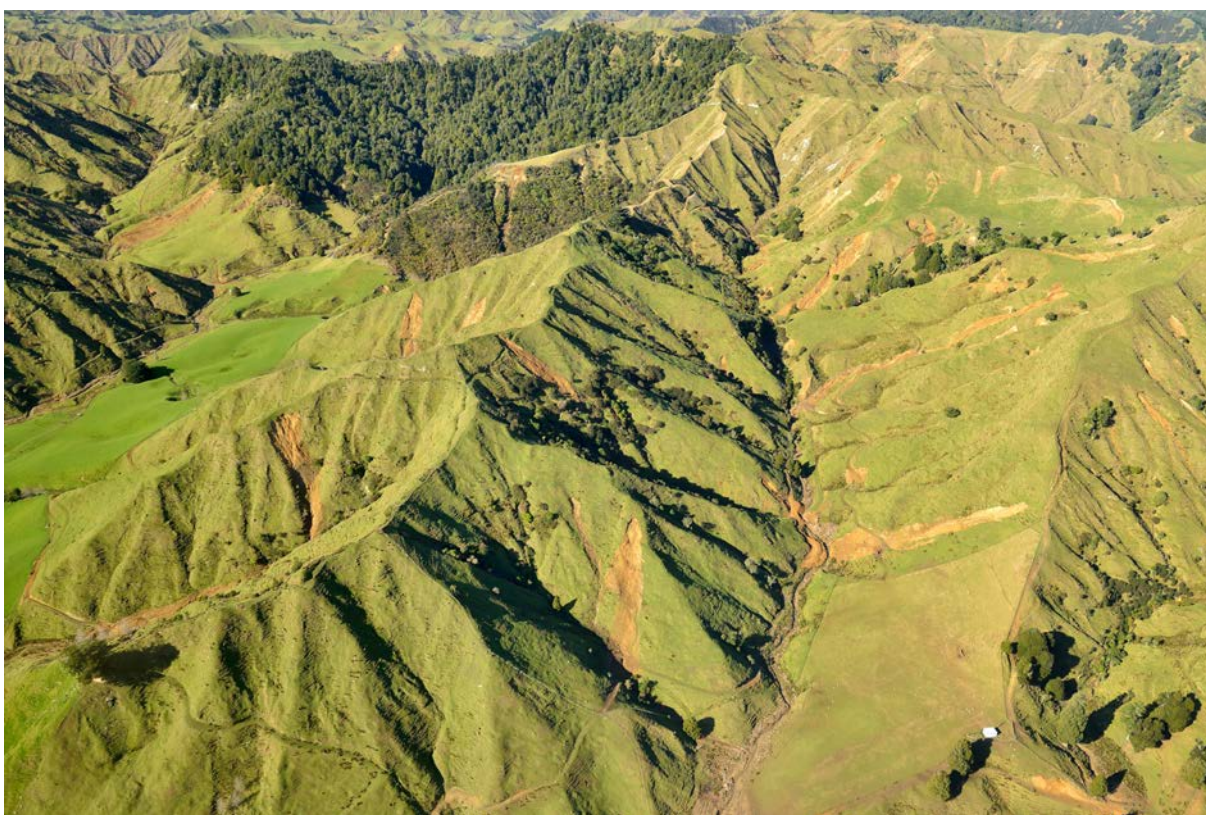
Figure 41 Moderate landsliding on Miocene age Whangamomona Group Sandstone in the Mangaotuku Stream catchment, near Strathmore. (GNS Photo: D02_2741)

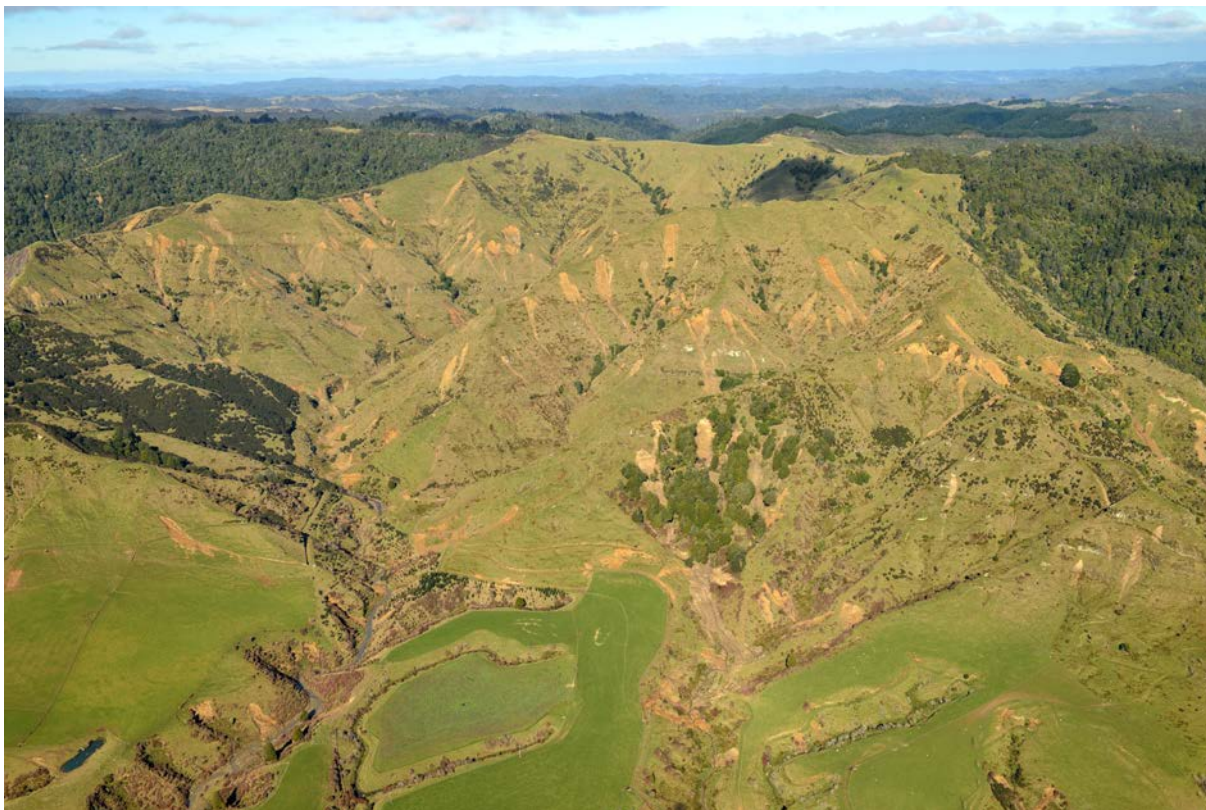
Figure 42 Moderate landsliding in the Mangaehu Stream catchment on Miocene age Whangamomona Group Sandstone. (GNS Photo: D02_2758)

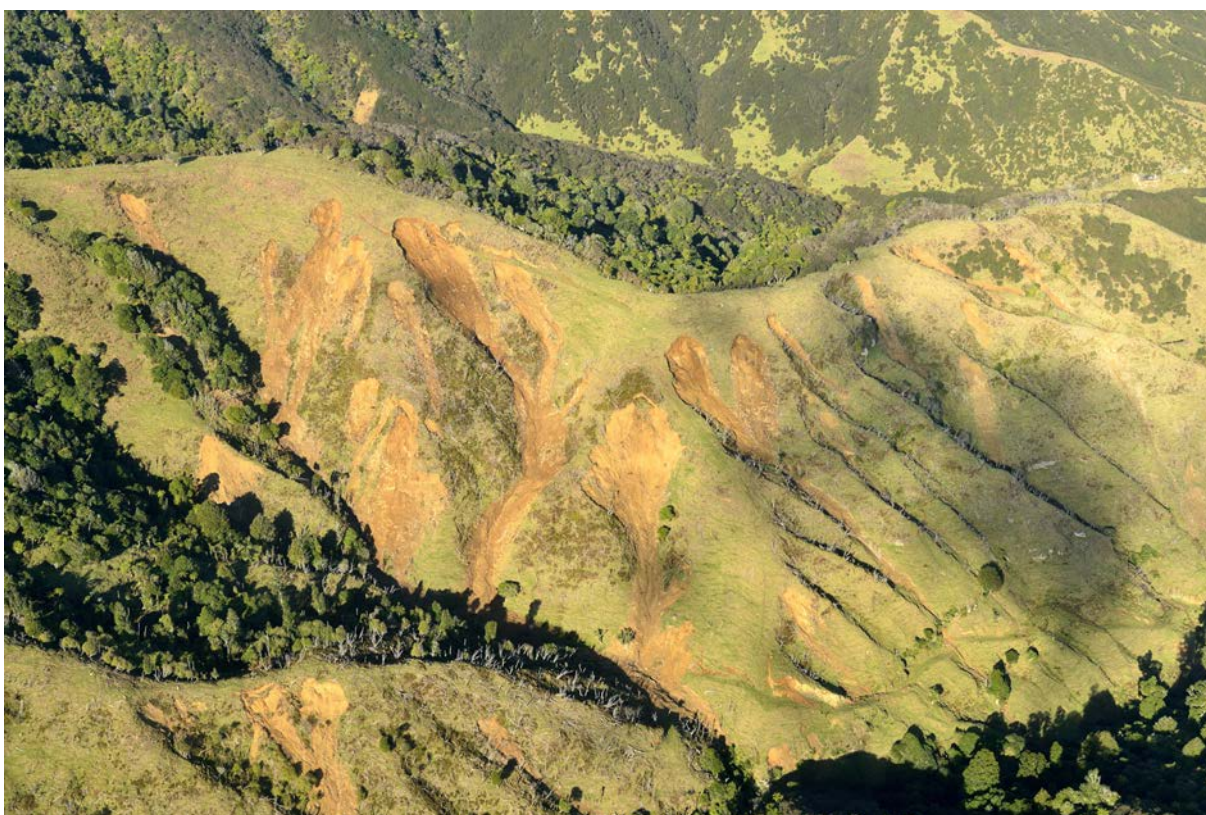
Figure 43 Localised severe landsliding on Miocene age Whangamomona Group Sandstone in the Mangaehu Stream catchment near Tututawa. (GNS Photo: D02_2796)

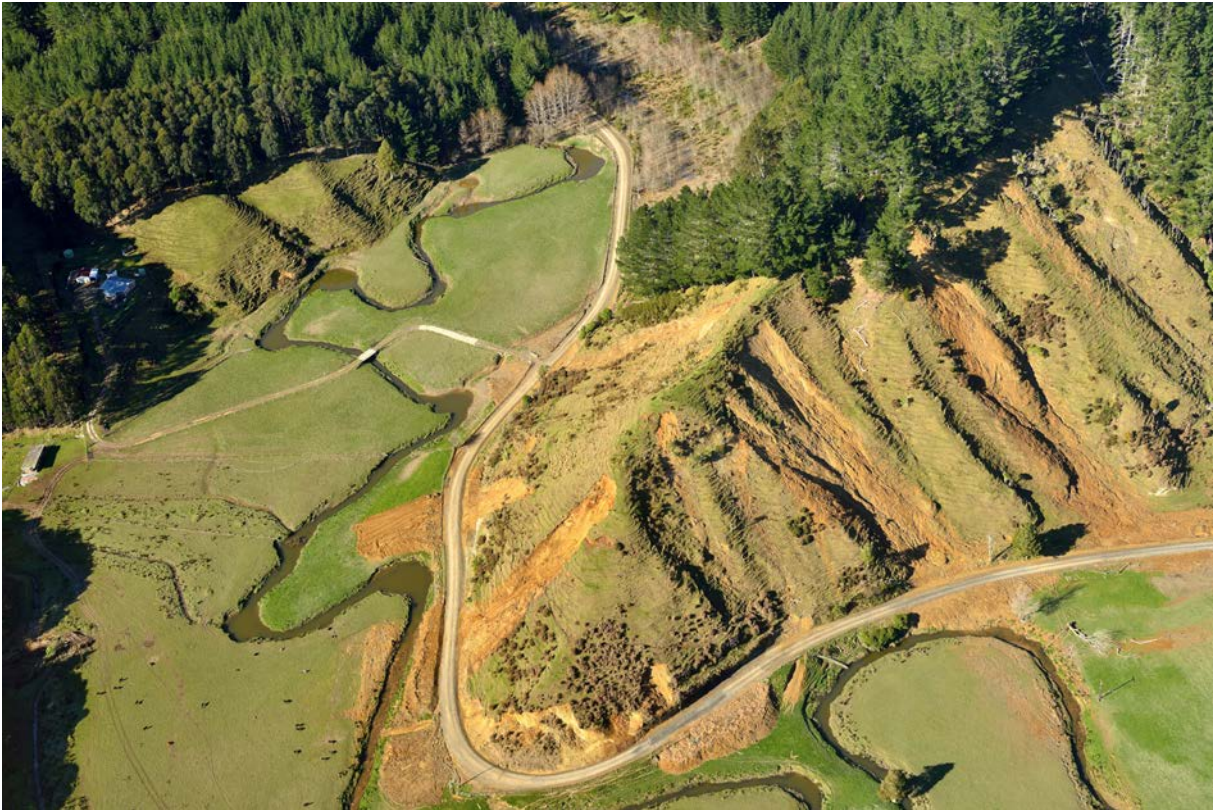
Figure 44 Localised severe landsliding near Uruti, on Miocene age Mt Messenger Formation sandstone, Whangamomona Group. (GNS Photo D02_2579)

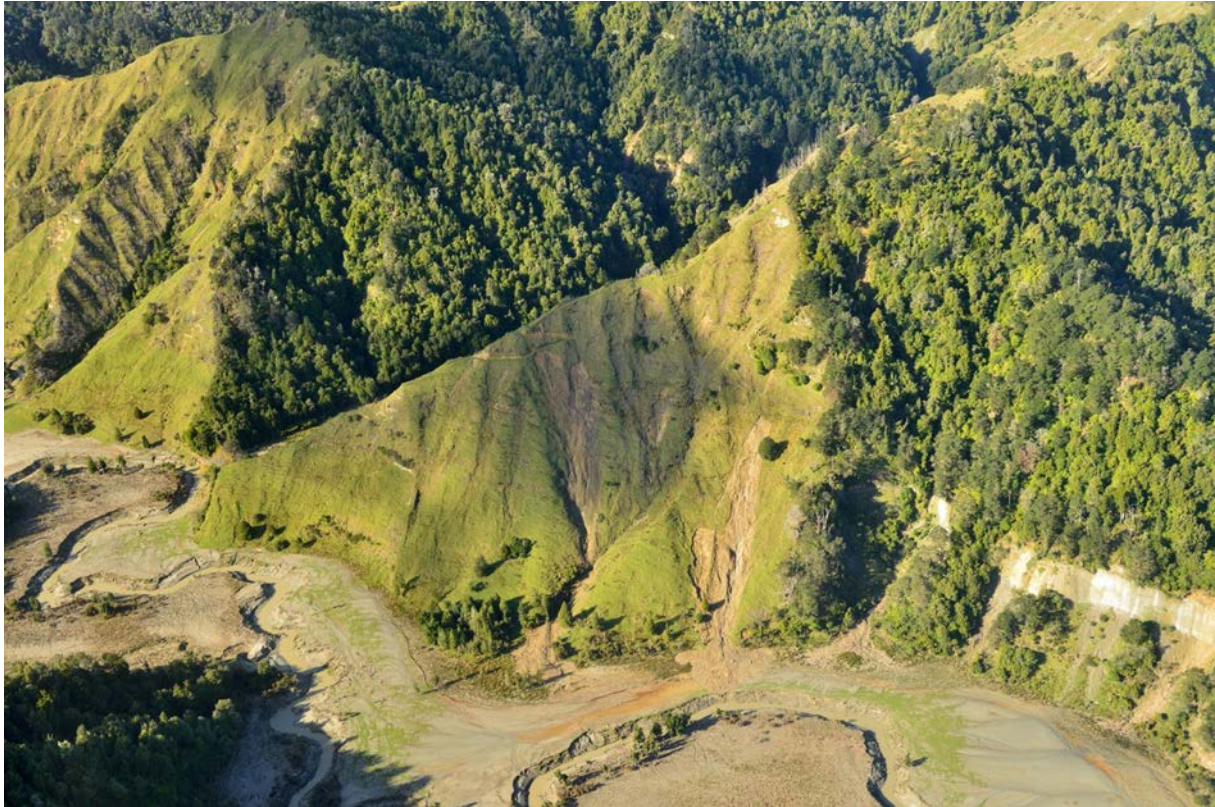
Figure 45 Landsliding on steep hillsides adjacent to the Pokeka Stream, tributary of the Waitotara River. The landslides are formed on Whangamomona Group sandstone. (GNS Photo D02_3095)

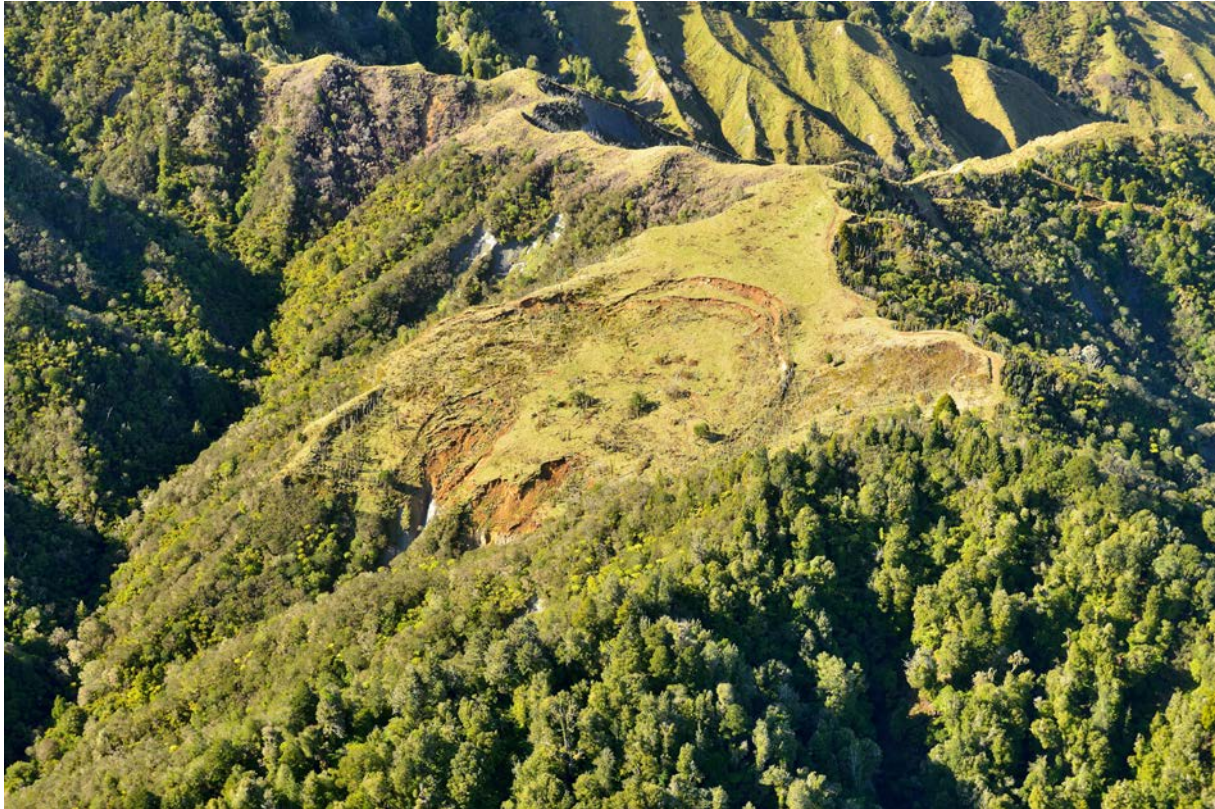
Figure 46 Large, deep-seated landslide near Whangamomona, in Whangamomona Group, siltstone. (GNS Photo: D02_2516)

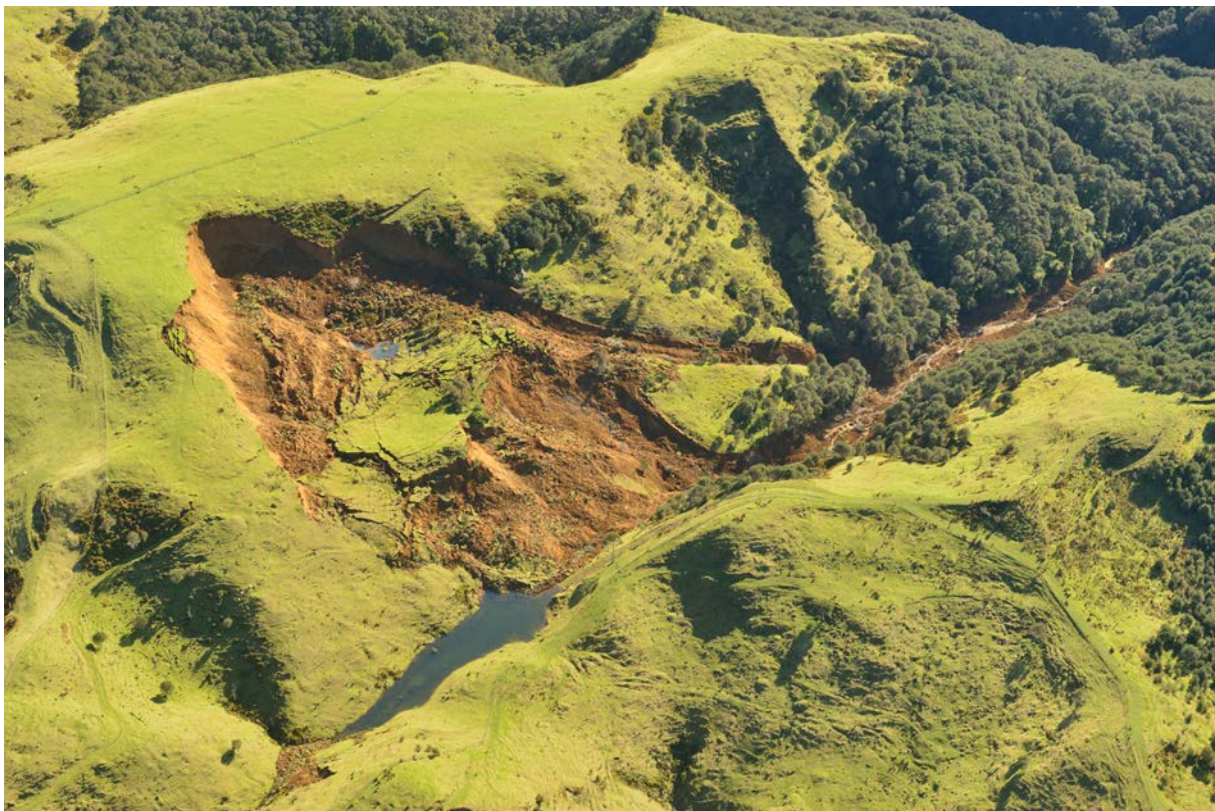
Figure 47 Deep-seated landslide near Pohokura saddle, Waitara River, on Miocene age Whangamomona Group sandstone (Kiore Formation). Note the small lake formed upstream of the landslide debris. (GNS Photo: D02_2620)

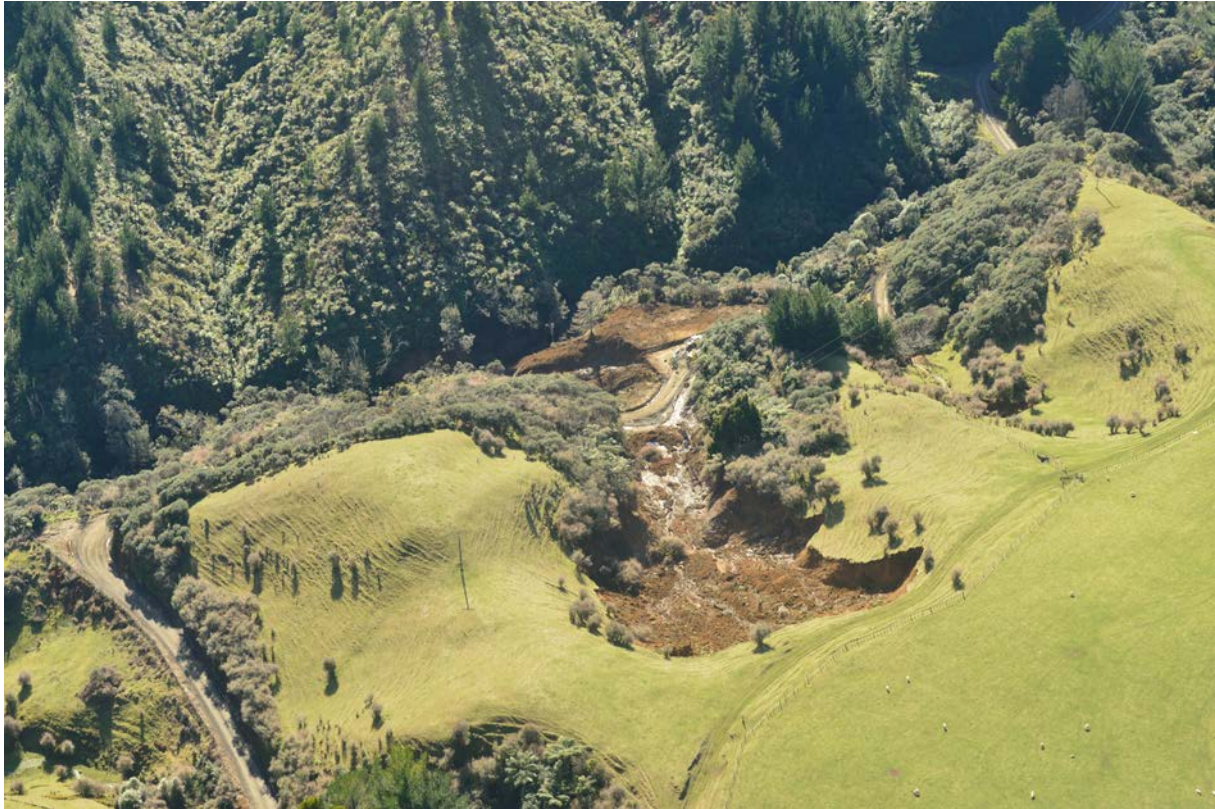
Figure 48 Moderate deep-seated landslide near Huiroa (inland from Stratford) that blocked the channel of the stream below. The landslide is in Miocene age Whangamomona Group Sandstone. (*GNS Photo: D02_2713*)
