BIBLIOGRAPHIC REFERENCE

Page, M.J.; Rosser, B.J.; Townsend, D.B.; Carey, J.M.; Ries, W.F. 2015. Reconnaissance report on landsliding caused by the 19–20 June 2015 rainstorm in the Taranaki-Wanganui-Manawatu region. *GNS Science Report* 2015/47. 50 p. + Appendices

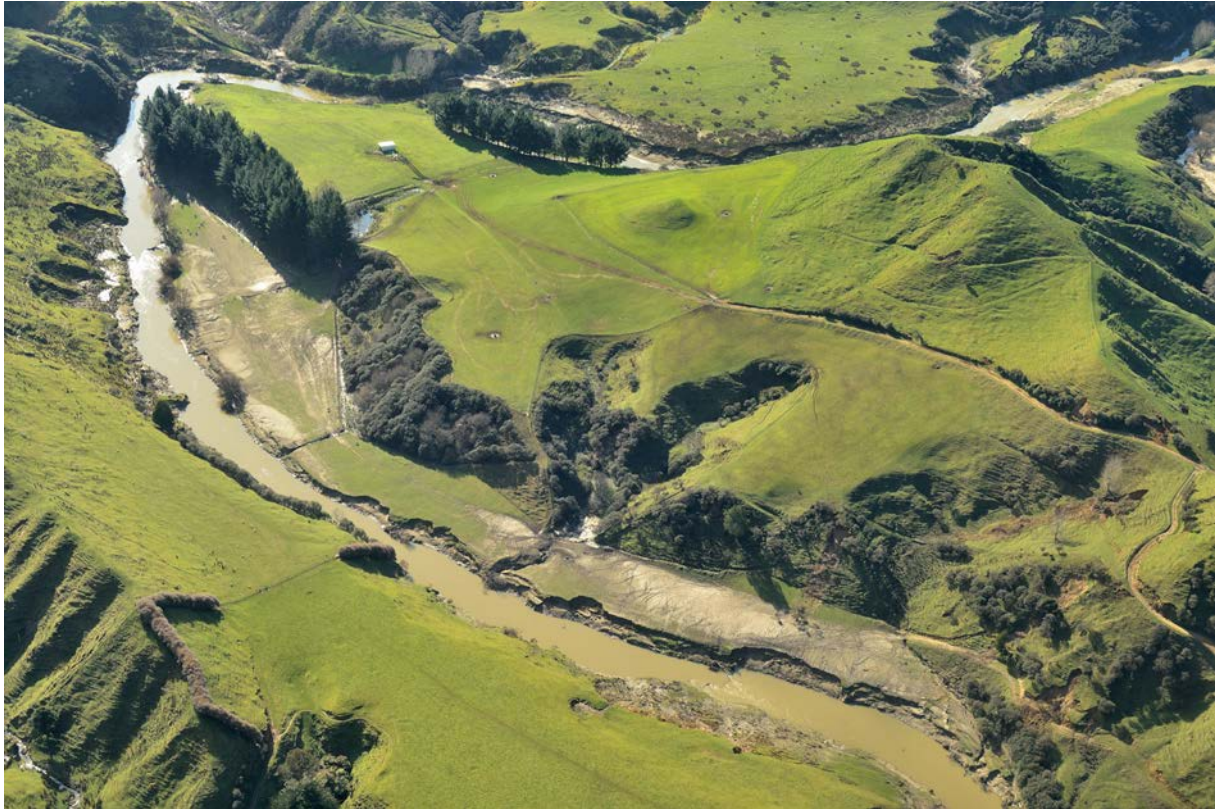
Figure 49 Severe streambank erosion along the Mangaehu Stream, tributary to the Patea River. (GNS Photo: D02_2802).

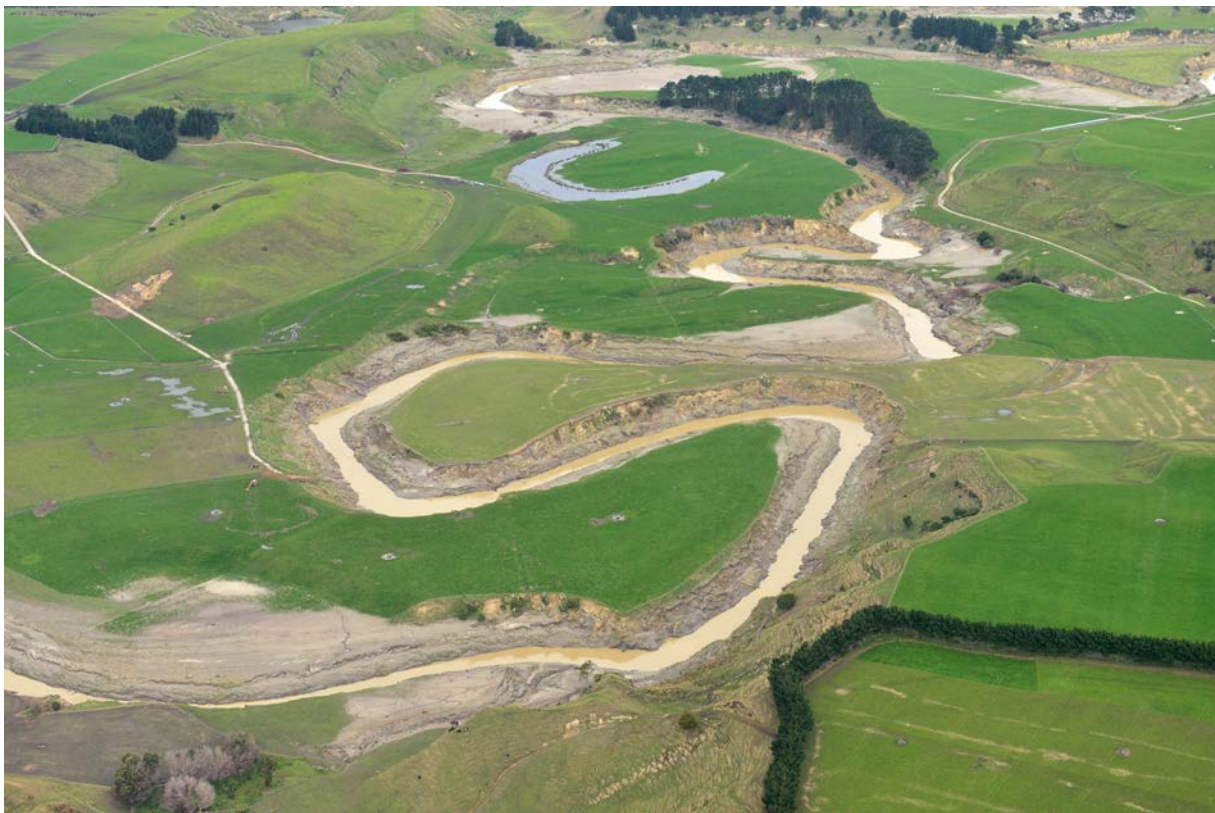
Figure 50 Severe streambank erosion along the lower reaches Whenuakura River, near Patea. (GNS Photo: D02_2920)

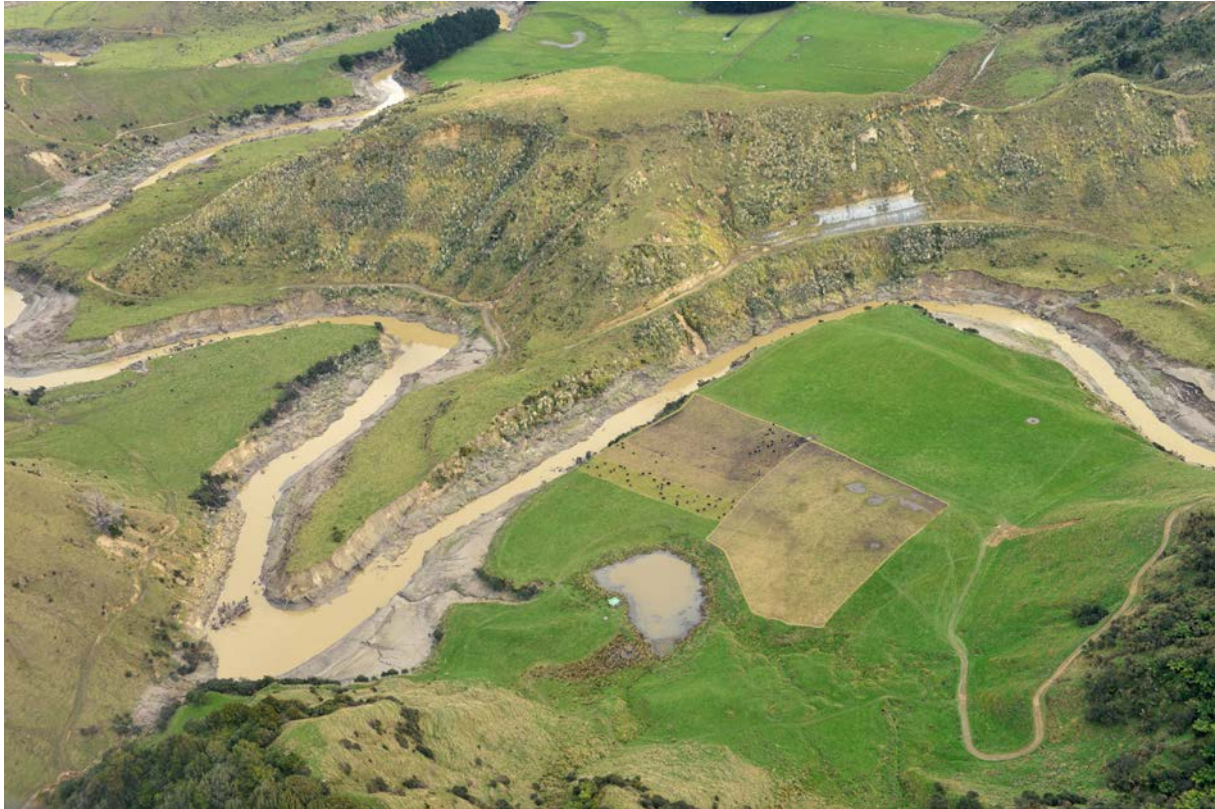
Figure 51 Severe streambank erosion along the lower reaches Whenuakura River, near Patea. (GNS Photo: D02_2930)

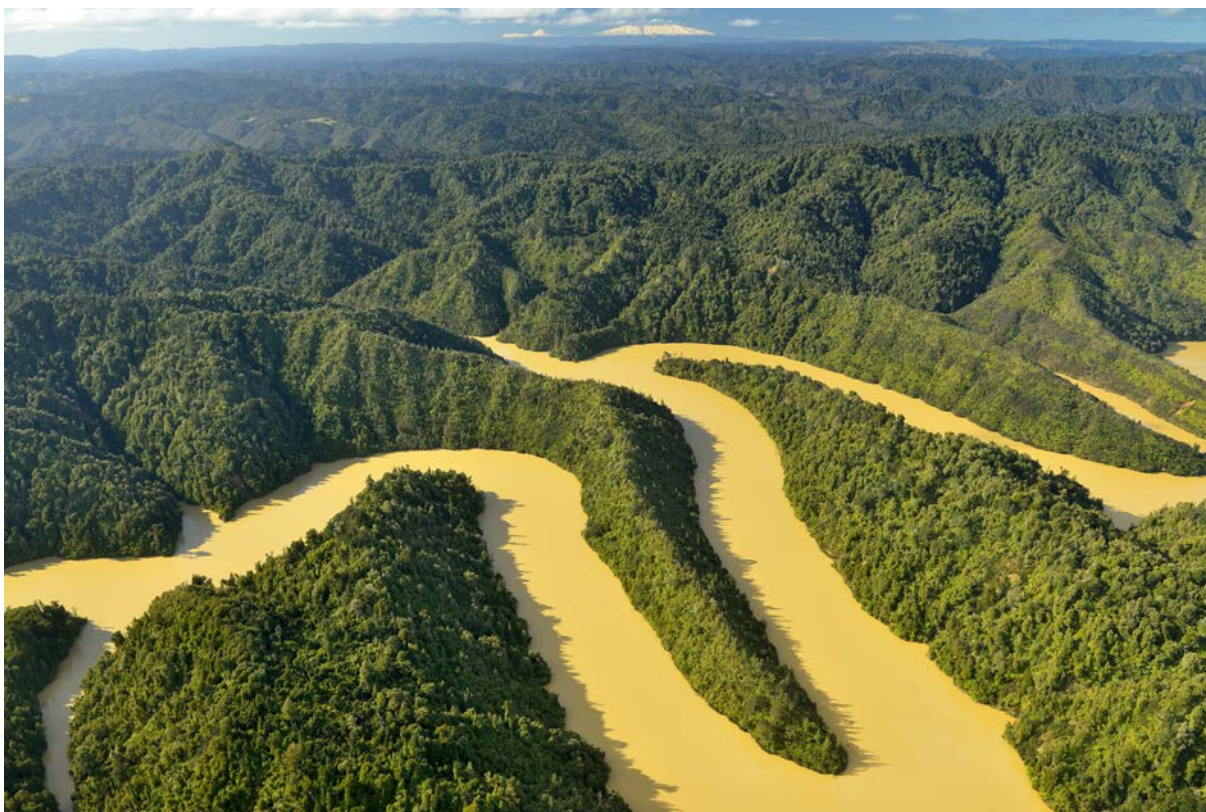
Figure 52 Lake Rotorangi on the Patea River, upstream of the Patea Dam, discoloured by sediment. (GNS Photo: D02_2845).

17. There was less streambank erosion along reaches of streams and rivers planted with willows.
18. Lake Rotorangi on the Patea River was highly discoloured by sediment (Figure 52). Adjacent to the Patea Dam there is an ancient deep-seated landslide, on which there are pre-existing cracks that indicate landslide movement (Figure 53). It was not possible to determine if there had been any movement caused by the June 2015 rainstorm event. TransPower has installed equipment to monitor movement of the landslide, and analysis of these data could determine whether the rainstorm has had any effect on movement of the landslide.

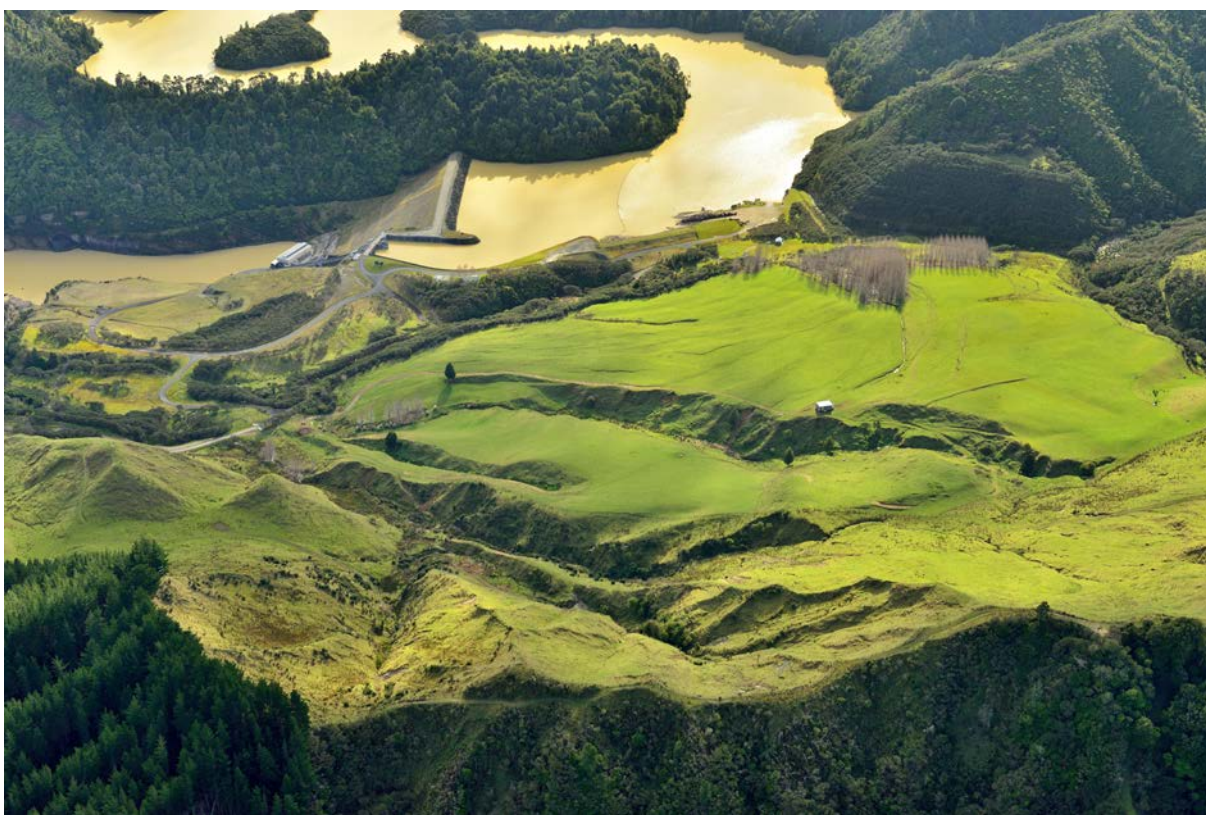
Figure 53 The Patea Dam, and an ancient deep seated landslide to the centre right. Note pre-existing signs of movement on the landslide (cracks). However, it was not possible to determine whether the rainstorm had caused movement of the landslide. (GNS Photo: D02_2856)

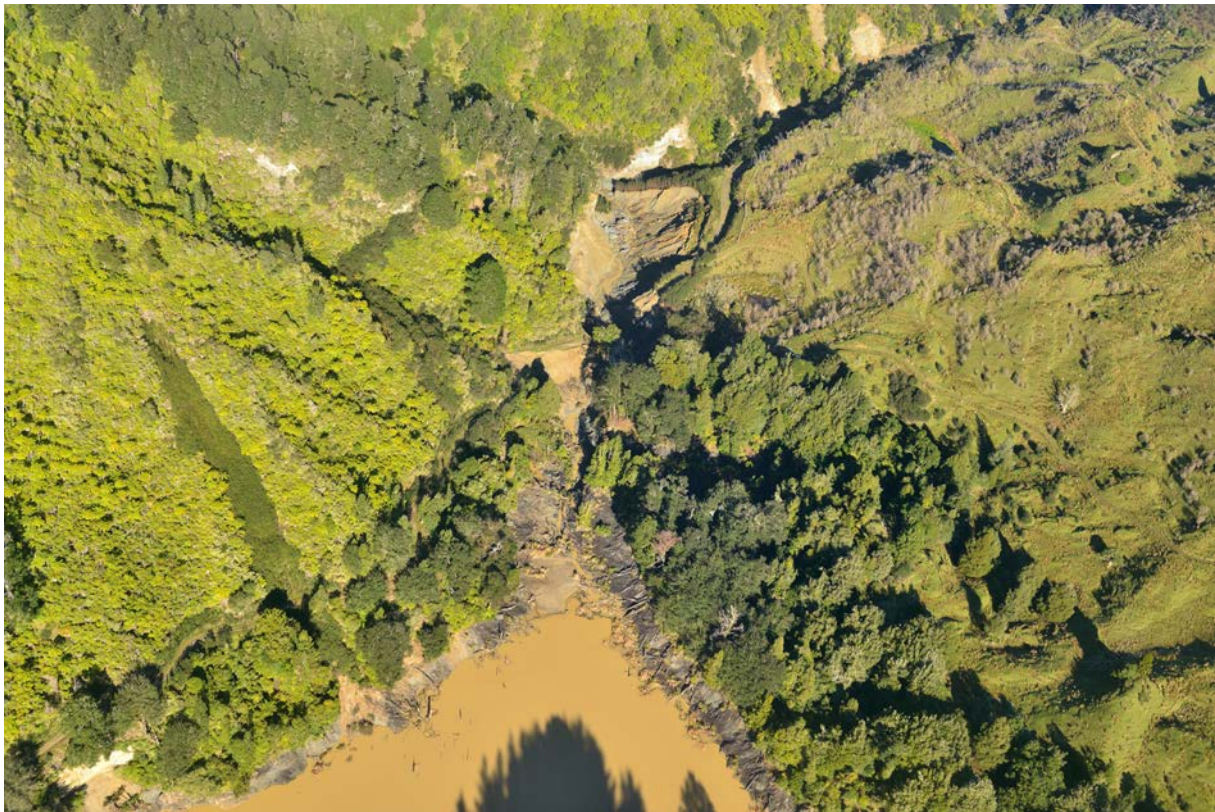
Figure 56 Outlet of Lake Mangawhio, showing drop in lake level and exposed lake margin. (GNS Photo: D02_1393)

Once access is restored to these sites, GNS Science recommends that field visits be made to investigate the circumstances leading to the drop in lake levels, the consequences of a rapid release of water on flood levels downstream, assess the future stability of the channels, and potentially collect organic material from the exposed landslide debris and lake sediments for radio-carbon dating.

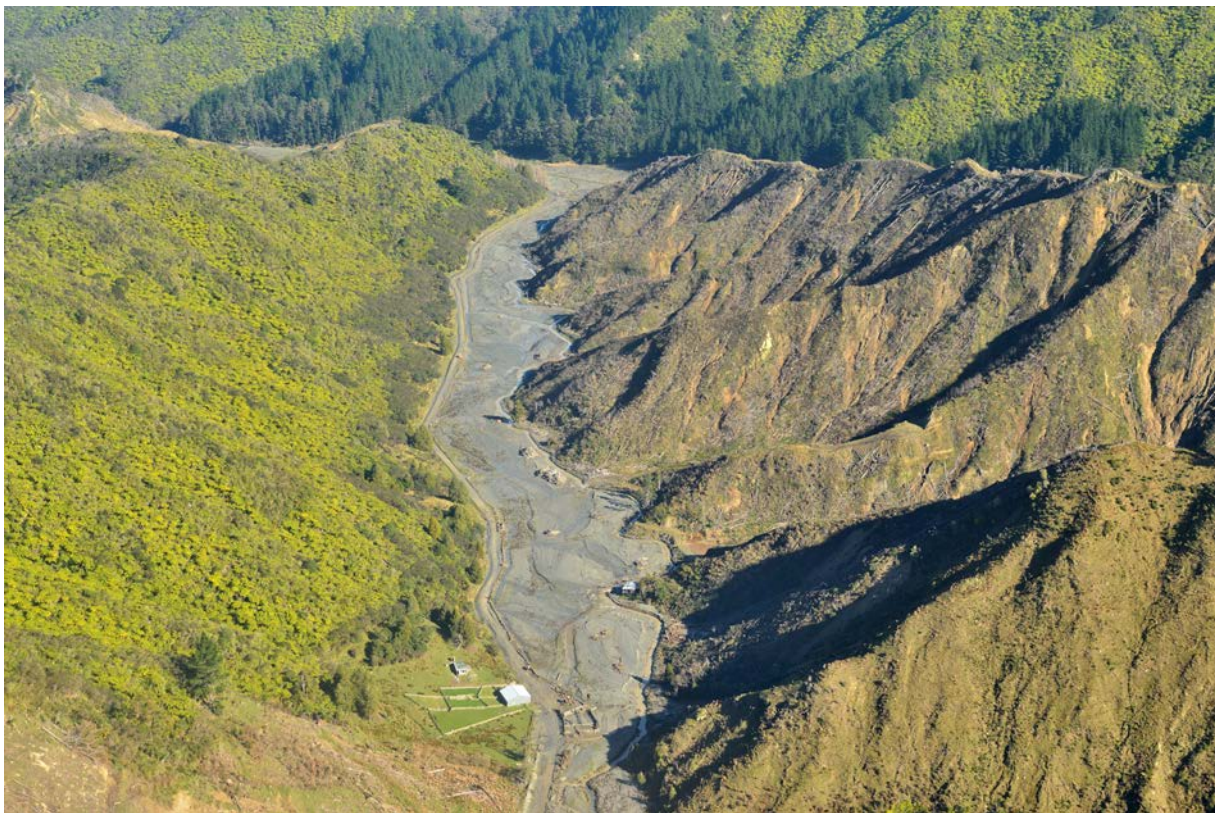
Figure 57 Sediment covering the valley floor downstream of Lake Mangawhio. (GNS Photo: D02_1388)

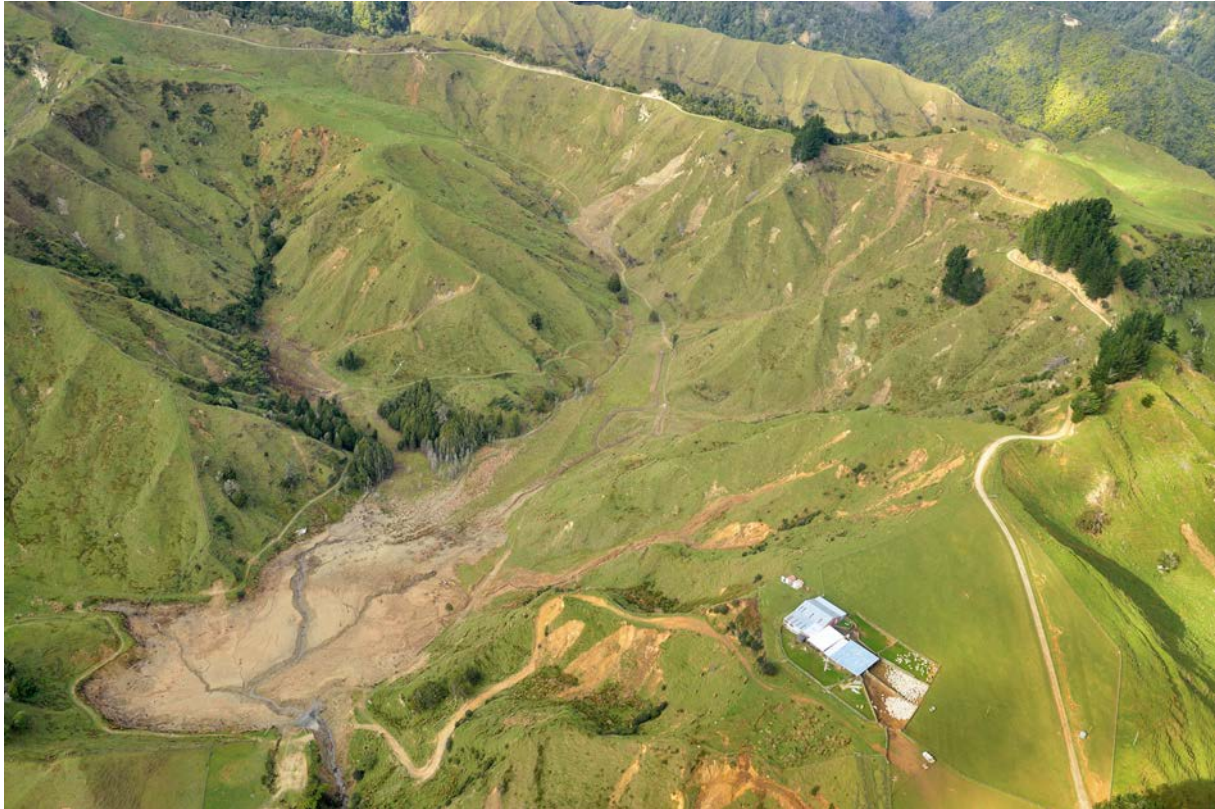
Figure 58 Small, unnamed lake near Karahaki, Whenuakura catchment. The lake drained following incision of the outlet channel in the June 2015 storm. Note incision of outlet channel, farm track across outlet and gullying within the lake-bed sediments. (GNS Photo: D02_2946)

These are the only observed instances of pre-existing landslide-dammed lakes being affected by erosion of the landslide debris that led to their formation, and there are numerous such lakes in the south-eastern Taranaki hill country. Further, none were affected by the 2004 storm. In the case of Lake Mangawhio, it may be that the upgrade of the road and establishment of the culvert were instrumental in the erosion of the outlet channel and drop in lake level during the June 2015 storm. Similarly, for the small lake in the Whenuakura catchment, it would appear that culverting of the outlet under the access track around the lake may have been instrumental in the erosion of the outlet channel and subsequent draining of the lake.

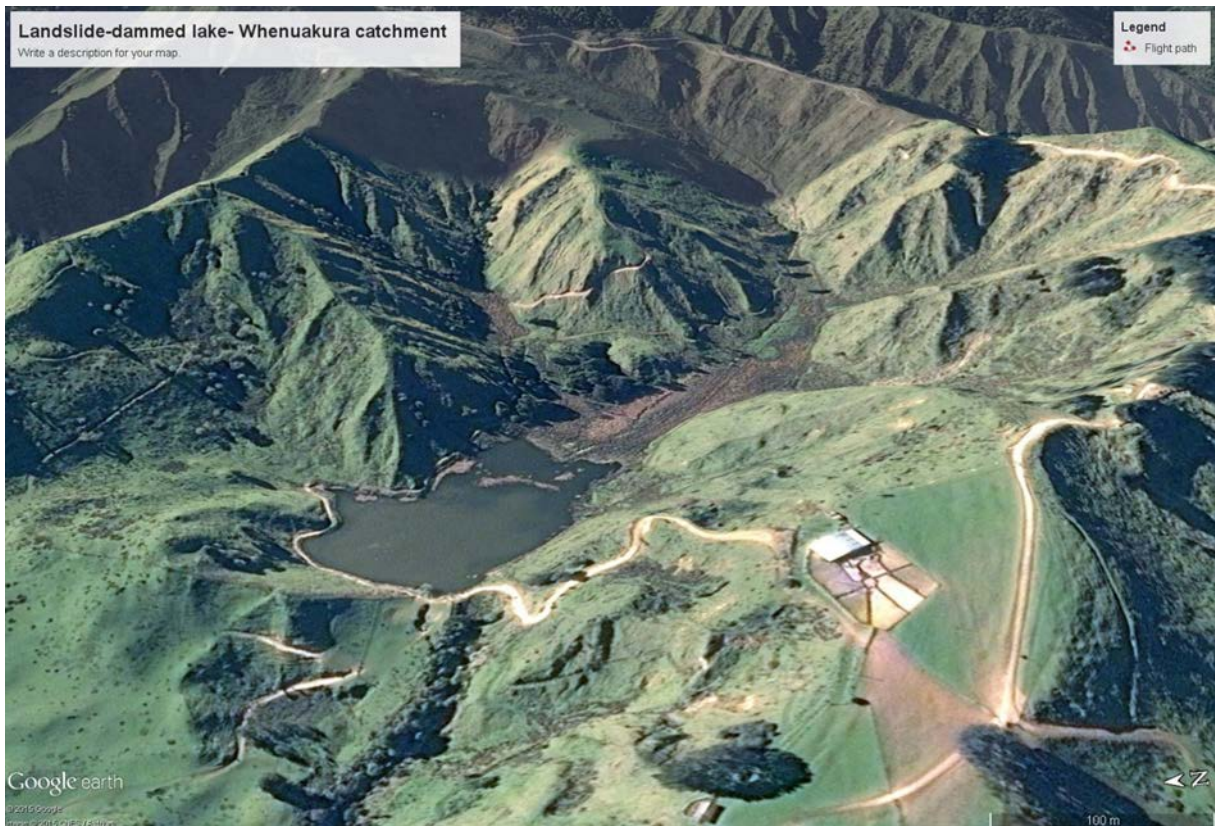
Figure 59 Google Earth image (September 2013) showing lake, outlet and access track prior to failure.
