Cox, S.C.; Barrell, D.J.A.; Dellow, S.; McColl, S.T.; Horspool, N. 2015. Landslides and ground damage during the Mw5.8 Matukituki Earthquake, 4 May 2015, central Otago, New Zealand. *GNS Science Report* 2015/17. 12 p.

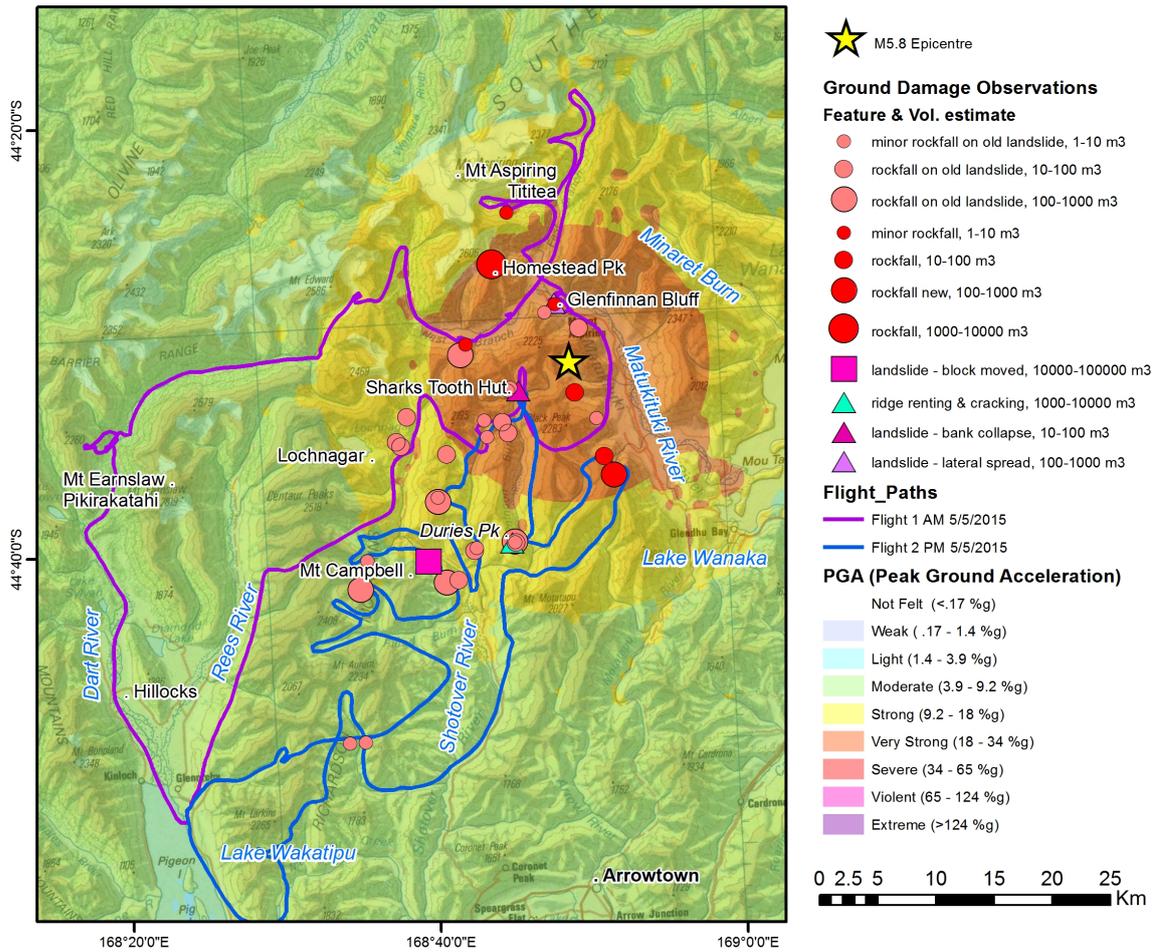
Figure 2 Map of rapid response aerial reconnaissance flight routes and new earthquake-induced landslide locations in relation to the predicted shaking intensity (%g) and the 4 May 2015 M5.8 Matukituki Earthquake epicentre.

The reconnaissance survey identified 37 mass movements and one site of especially intensive ground damage (ridge renting/cracking) (Figure 2). Of the 37 mass movements, 27 were reactivations of existing landslides, and 10 appear to be sites of new activity. The observed landslides were restricted to within an area of 800 km², with the most distal landslide located 38 km S-W from the epicentre. First-time failures were restricted to an epicentral distance of 16 km.

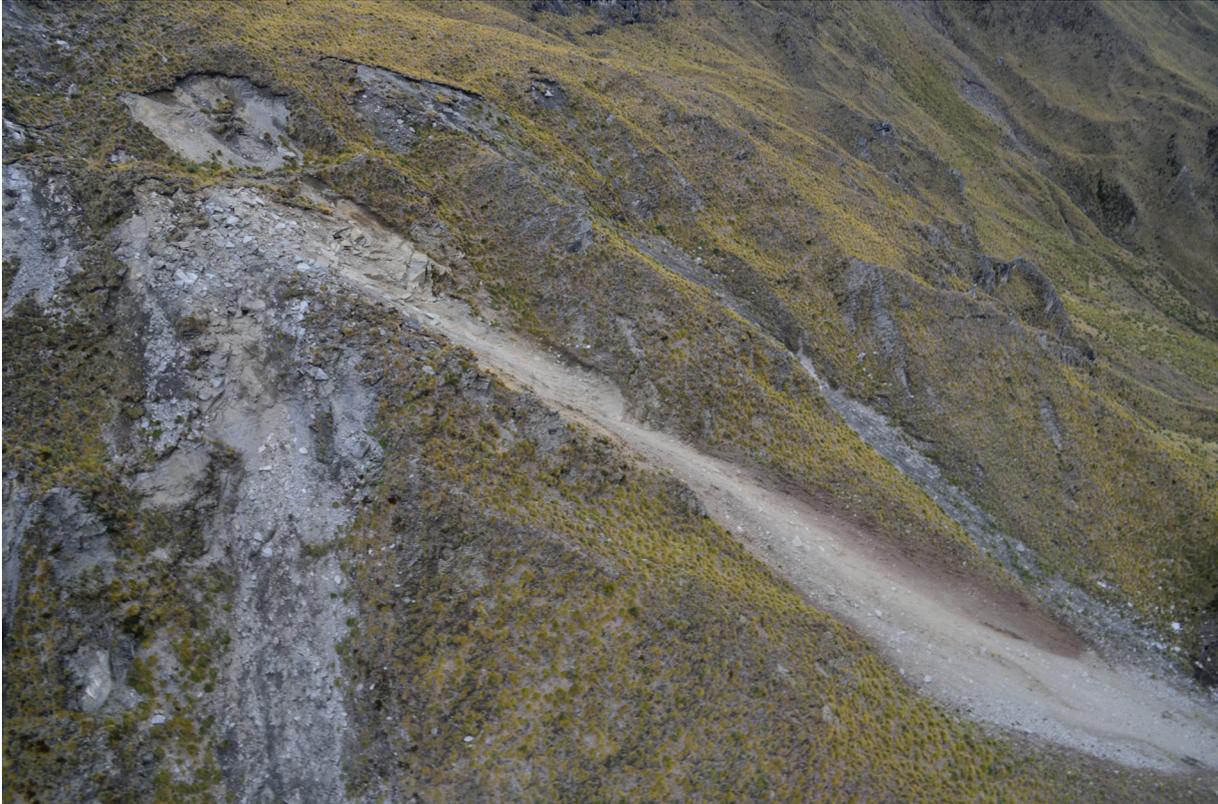
Figure 3 Aerial view of reactivated landslide on the east face of Duries Peak 1645 m, Poolnoon Burn, about 15 km south of the epicentre. Notice the fresh brown dirt/dust confirming it is a recent event. Photo: Simon Cox, GNS Science/GeoNet, 5 May 2015.

Relatively small rockfalls, or collapse of loose debris into gullies, were the most common (33 of 36) features identified (e.g., Figure 3). These almost invariably occurred from steep slopes (>40°). Fifteen rockfall volumes were estimated at 1-10 m³; 12 at 10-100 m³; 6 at 100-1000 m³; and 1 about 1,000-10,000 m³. The largest rockfall occurred from near Homestead Peak into the Glacier Burn, 12 km from the epicentre on the other side of Matukituki Valley. It produced a dust cloud that was captured by a webcam at the Whare Kea Chalet (www.wharekealodge.com) a farther 12 km to the north (Figure 4).

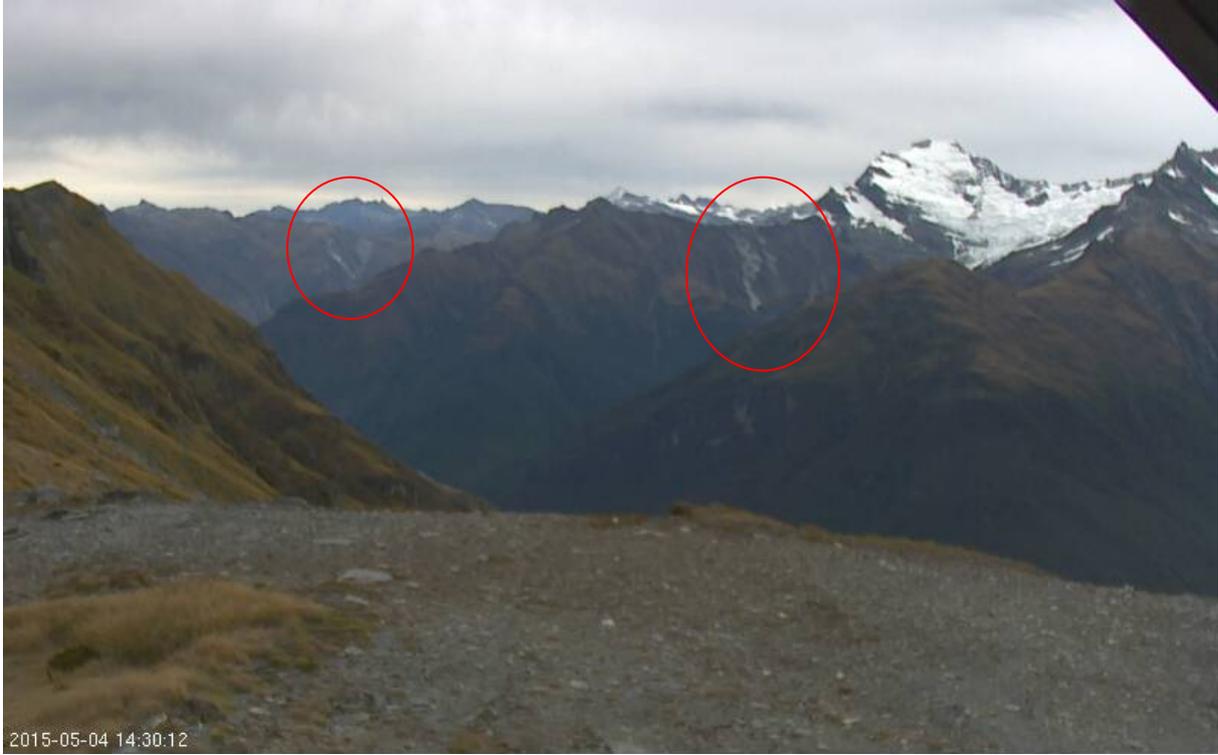
Figure 4 Webcam view of dust clouds, to left of the snowy Homestead Peak generated by a rockfall into the Glacier Burn (about 15 km northeast of the epicentre) and in the far distance from peaks above the West Matukituki into Downs Creek. Photo: <http://www.wharekealodge.com/nz/chalet-webcamSW/>.

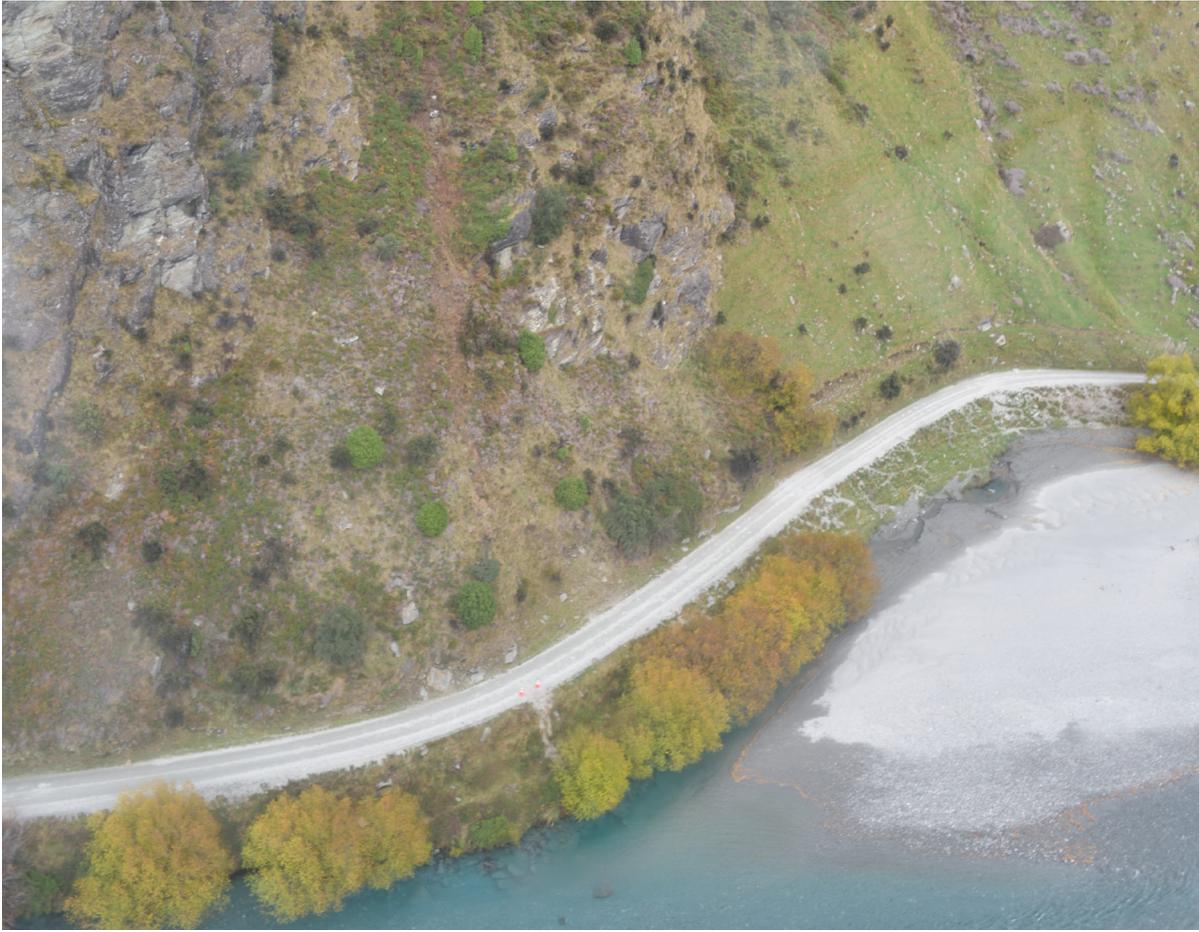
Riverbank collapse and lateral spreading were observed at two locations. At Glenfinnan Bluff, Matukituki Valley, a small section of the riverbank and Mt Aspiring road translated towards the river, involving approximately 100-1,000 m³ of material (Figure 5). A small section of riverbank collapsed just upstream from Sharks Tooth Hut in the upper Poolnoon Burn (Middle Branch) involving about 10-100 m³.

Figure 5 Aerial view of the Mt Aspiring road where it traverses Glenfinnan Bluff. The brown track of a fresh rockfall can be tracked down to the road in centre photo, where two orange road cones mark its passage to the river. Cracks have opened in green grassy slopes above the road (right) where the back has spread out into the river. Photo: Simon Cox, GNS Science/GeoNet, 5 May 2015.

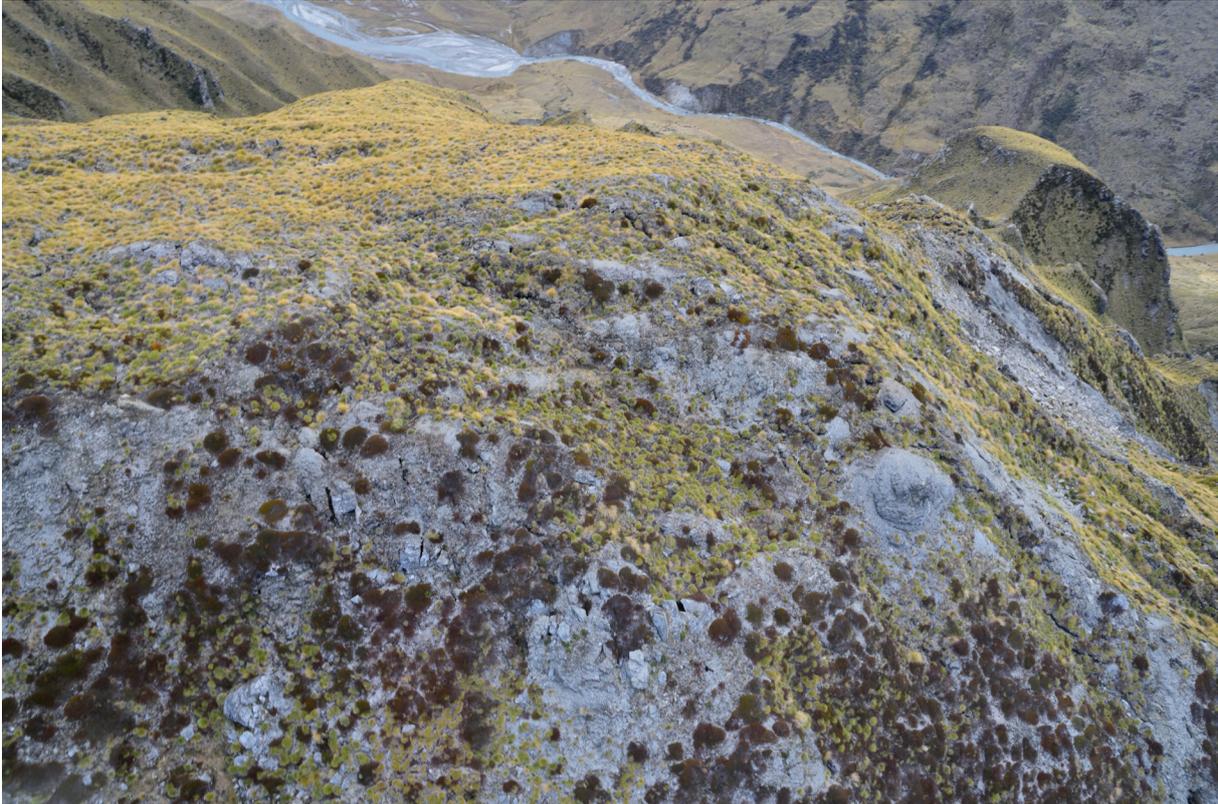
Ridge-renting and cracking occurred on the southeast ridge of Duries Peak (1645m), Poolnoon Burn, about 15 km south of the epicentre (Figure 6). Earthquake waves appear to have been amplified by the ridge and cracked open about 150 x 100 m of the existing rock fractures. Some of these may have been gravity-related features present prior to the earthquake.

Figure 6 Aerial view of freshly opened fractures and rentings of a ridge on Duries Peak 1645 m, Poolnoon Burn, about 15 km south of the epicentre. Photo: Simon Cox, GNS Science/GeoNet, 5 May 2015.

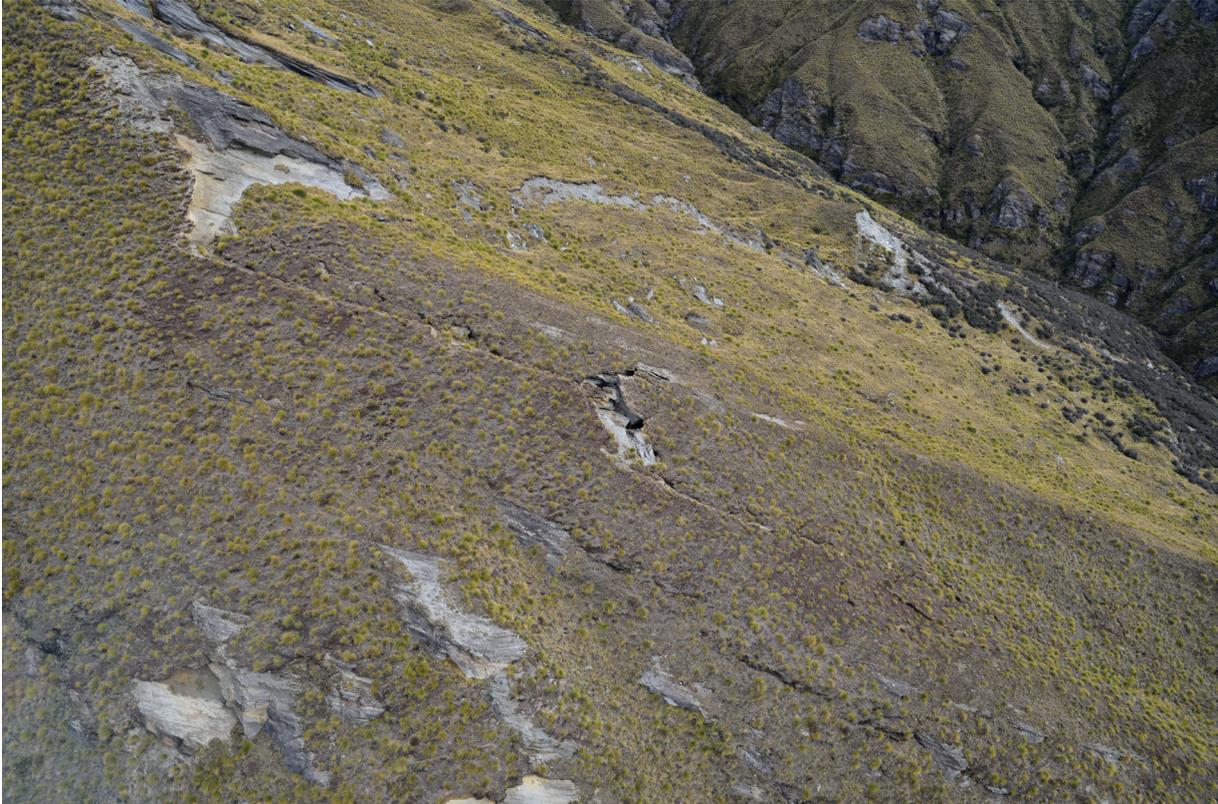
A landslide on a ridge on the north face of Mt Campbell appears to have moved ~4 m downslope as a result of the earthquake, before coming to a halt (Figure 7). The landslide was visible as an incipient feature prior to the earthquake, in satellite imagery, but appears to have accelerated and translated downslope as a result of the shaking.

Figure 7 Aerial view of a relatively low-displacement landslide located on a ridge on the north face of Mt Campbell. The landslide translated ~4 m downslope before coming to a halt. About 18 km south of the epicentre. Photo: Simon Cox, GNS Science/GeoNet, 5 May 2015.
