GeoNet Landslide Response: New-Zealand-wide storm August 16–20, 2022

**GNS Science Report 2022/60
October 2022**

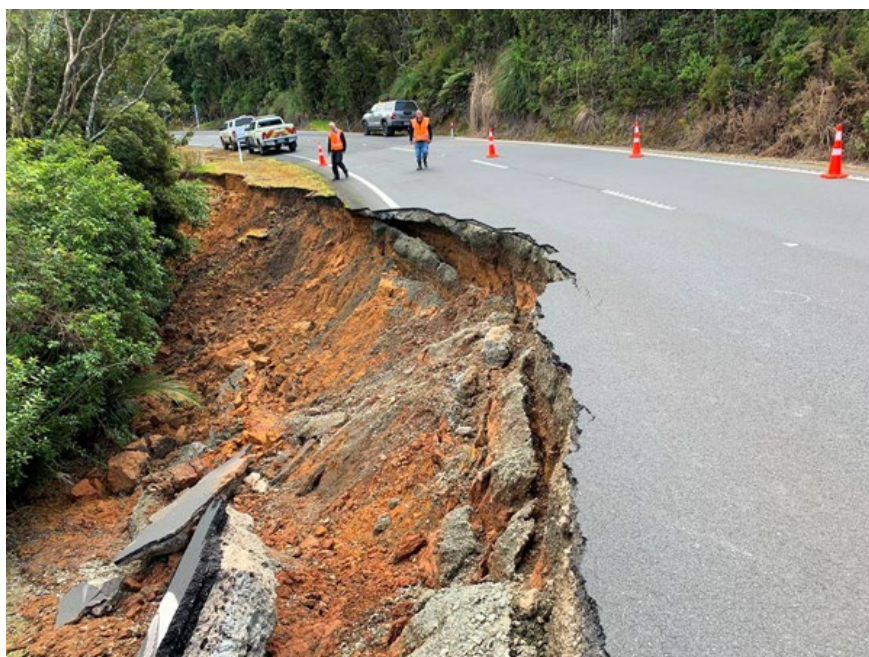
Figure 3.2 One of the landslides (drop-out) affecting State Highway 1 through Mangamuka Gorge (Photo: Waka Kotahi).

The heavy rain in Northland caused extensive flooding that cut off Kaitiāia, forced people to evacuate their homes and closed State Highway (SH) 10 at Kāeo. Multiple landslides were triggered in Mangamuka Gorge, closing SH 1 indefinitely. Waka Kotahi reported that there were about 18 landslides in Mangamuka Gorge – three landslides, where material fell onto the road; and 15 dropouts, where a landslide occurred beneath the road (Figure 3.2), six of which were serious. Minor landslides and dropouts were reported near Opua, and a large landslide at Lemon Hill (from 2018) was re-activated. In total, 28 landslides are known to have occurred during this event in Northland.

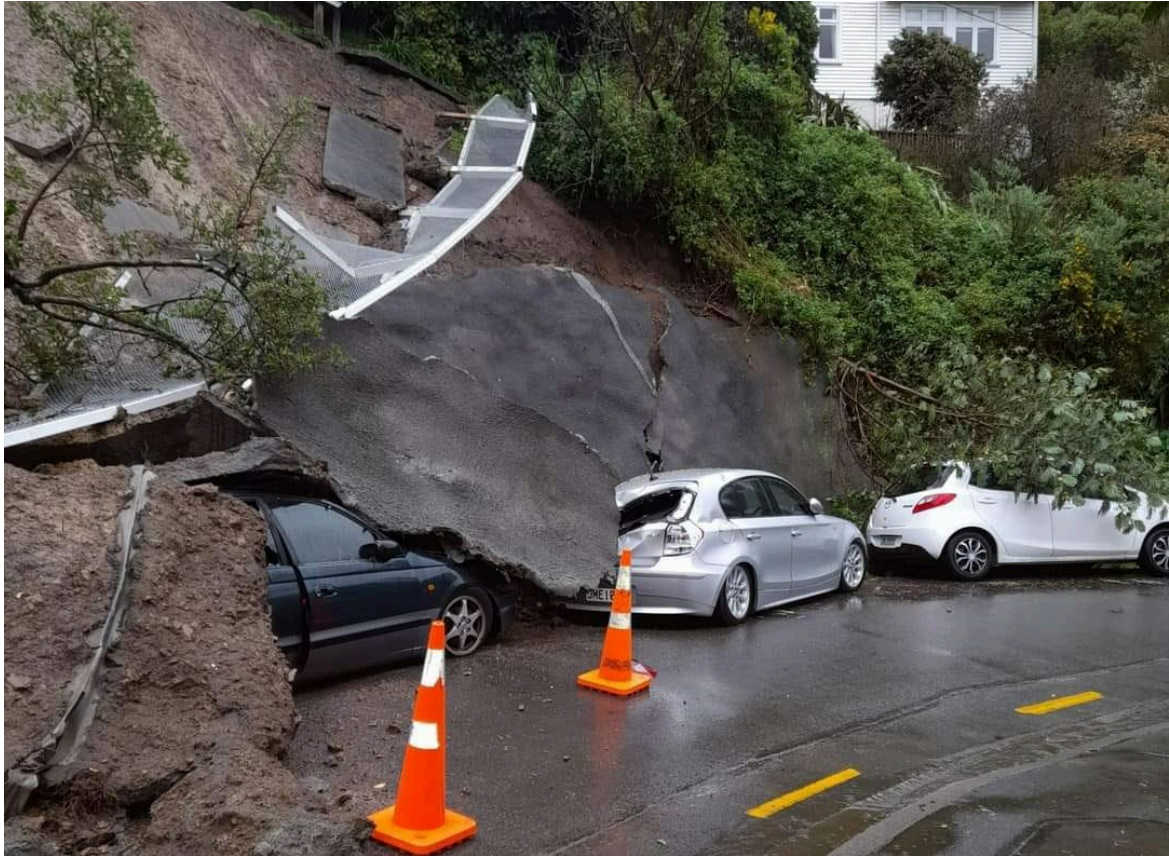
Figure 3.4 A retaining wall collapsed onto cars on Sutherland Crescent in Melrose. (Photo: Mark Remfrey / Wellington Region Emergency Management Office (WREMO) Facebook page).

Wellington City Council reported 271 landslides in Wellington City from the August 16th to 20th storm event. This included 209 landslides that occurred during the rainfall event and a further 62 in the week following. A total of 89 landslides occurred on August 19th. Three residential properties were evacuated from Onslow Road in Khandallah due to a landslide causing road subsidence. Another landslide that occurred earlier in August on Woodhouse Avenue in Karori also re-activated during the storm. Other notable landslides included a large landslide on the Wainuiomata Hill Rd, a retaining wall collapsed onto parked cars on Sutherland Crescent in Melrose (Figure 3.4) and a landslide that closed SH 59 at Paekākāriki (Figure 3.5). Most of these landslides occurred between August 18th and 21st.
