## **GeoNet Landslide Response: Auckland Anniversary Storm, 26–30 January 2023, northern New Zealand**

**GNS Science Report 2025/32  
November 2025**

## ABSTRACT

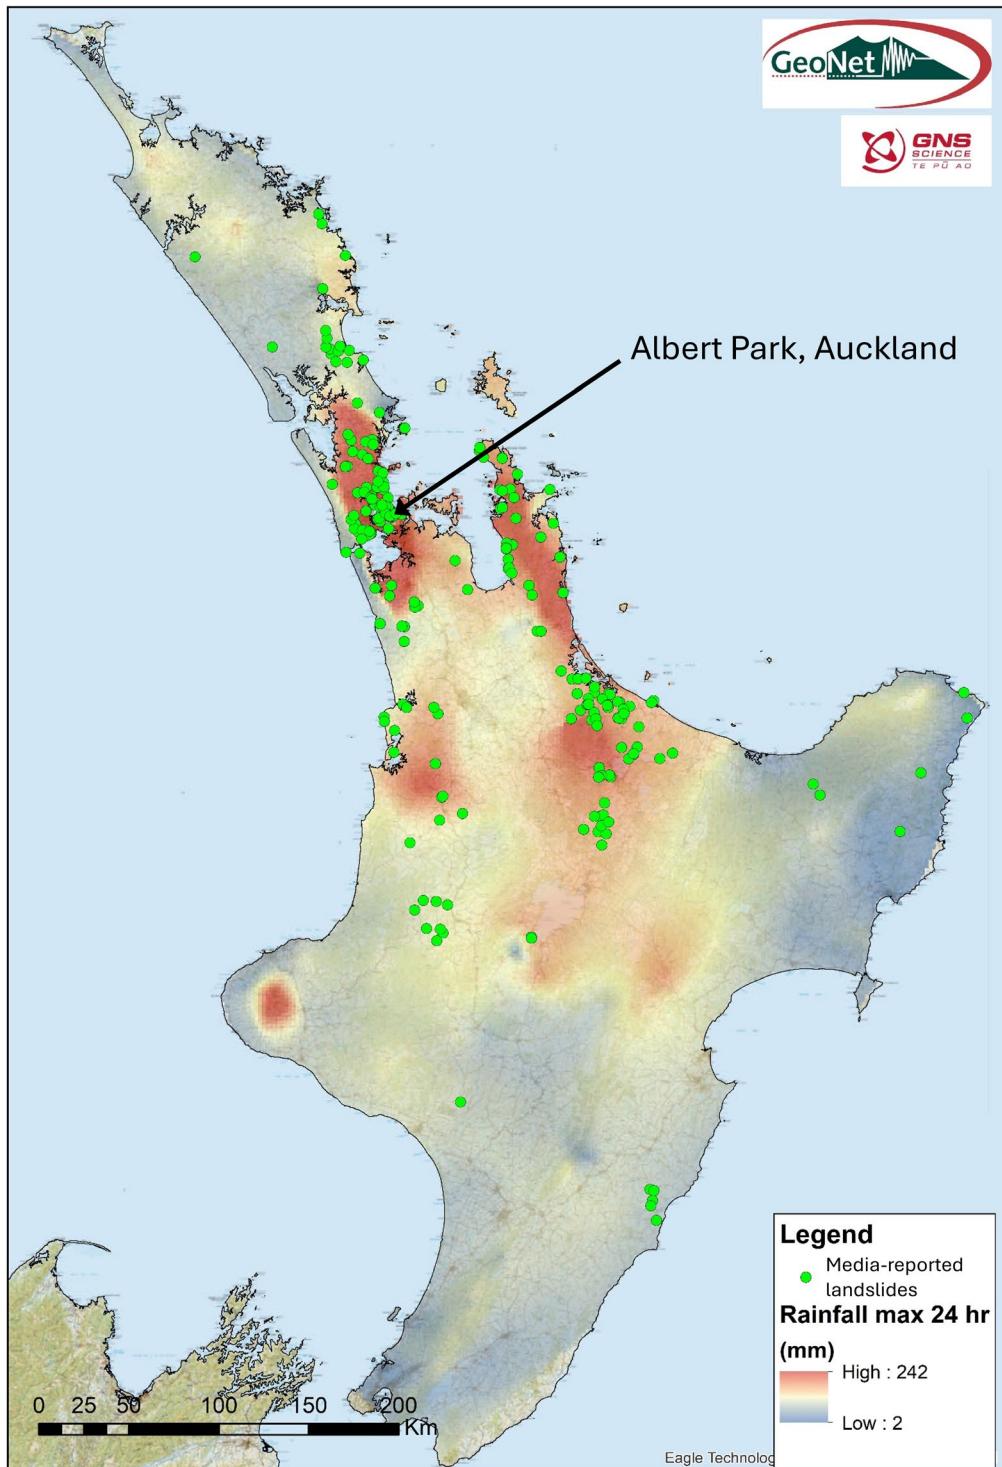
Figure 1.1 Interpolated maximum daily rainfall over the North Island (from MetService rain gauges) and landslides reported through media and social media up until 2 February 2023. This does not include additional landslides identified by GNS Science during the landslide-rapid-response reconnaissance.

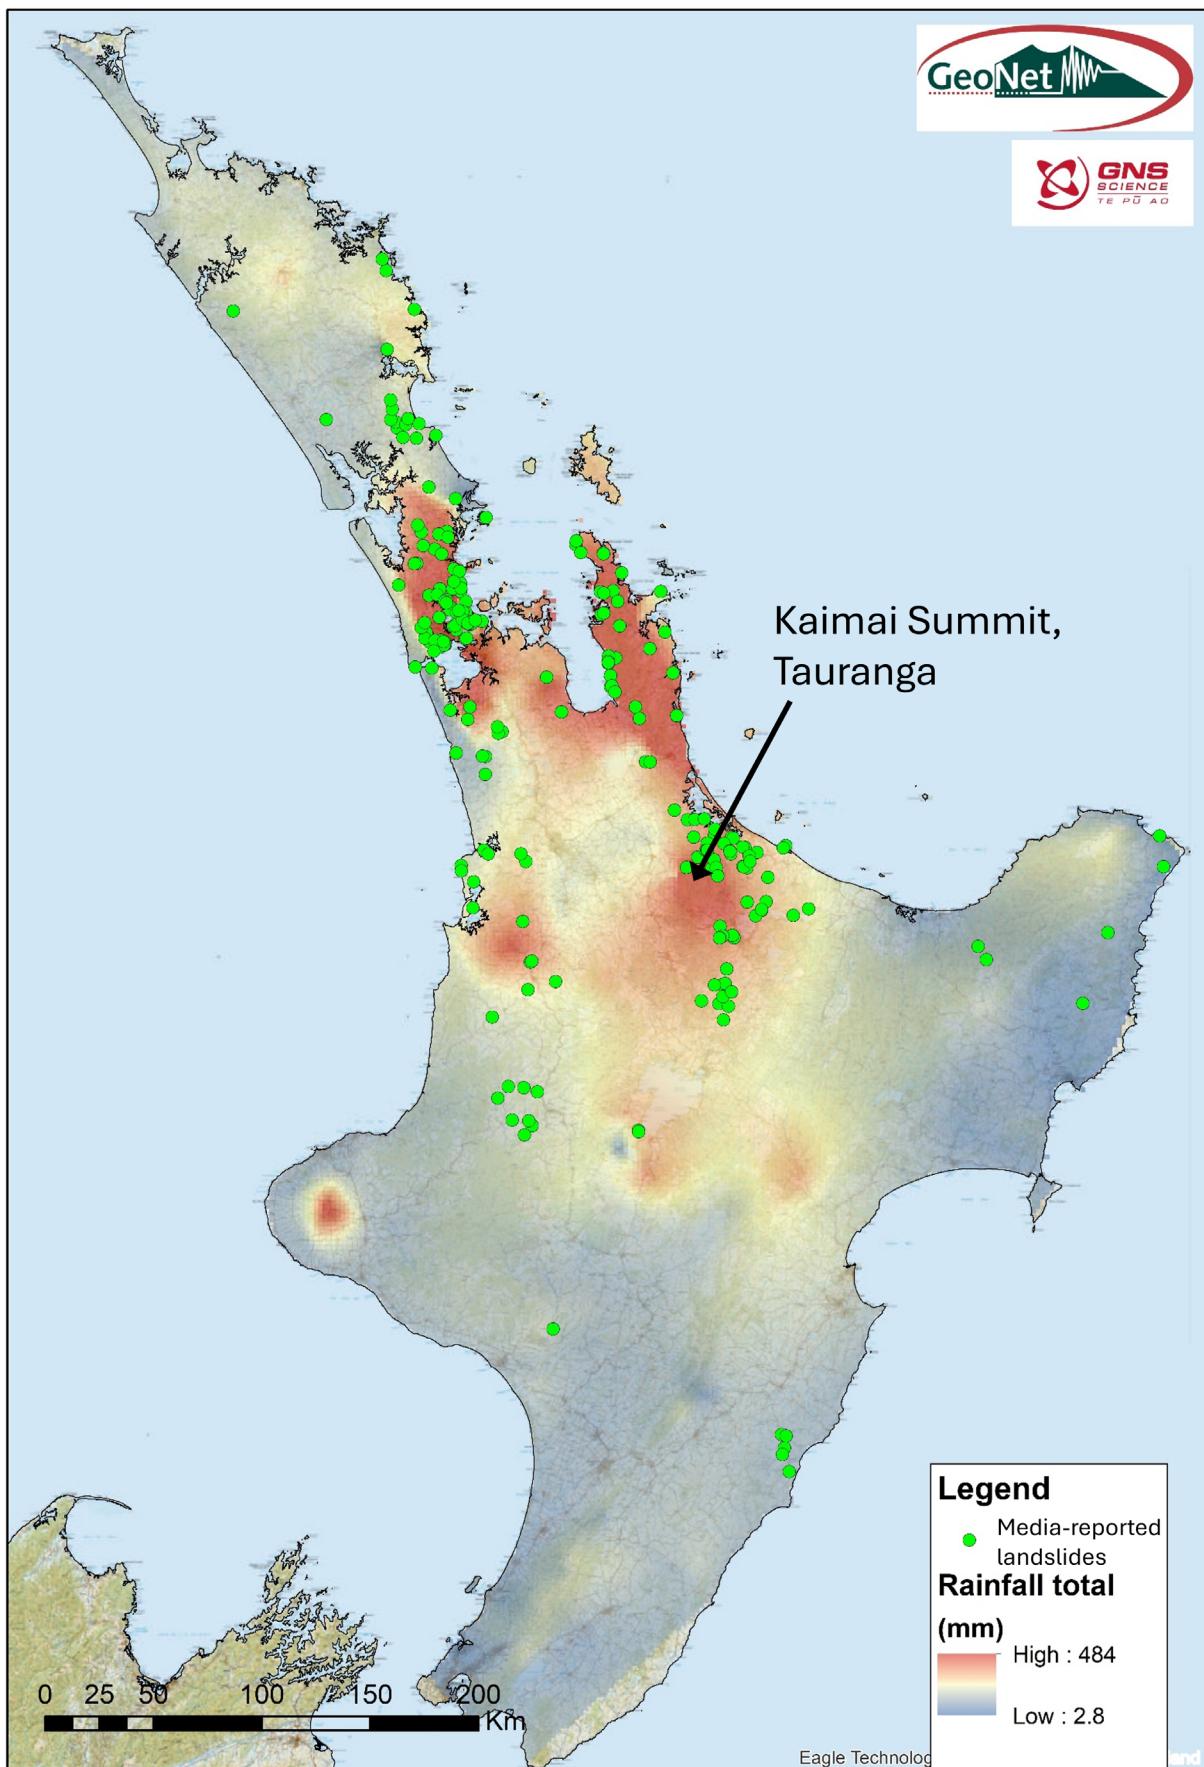
Figure 1.2 Total cumulative rainfall over the North Island (from MetService rain gauges) and landslides reported through media and social media up until 2 February 2023. This does not include additional landslides identified by GNS Science during the aerial reconnaissance.

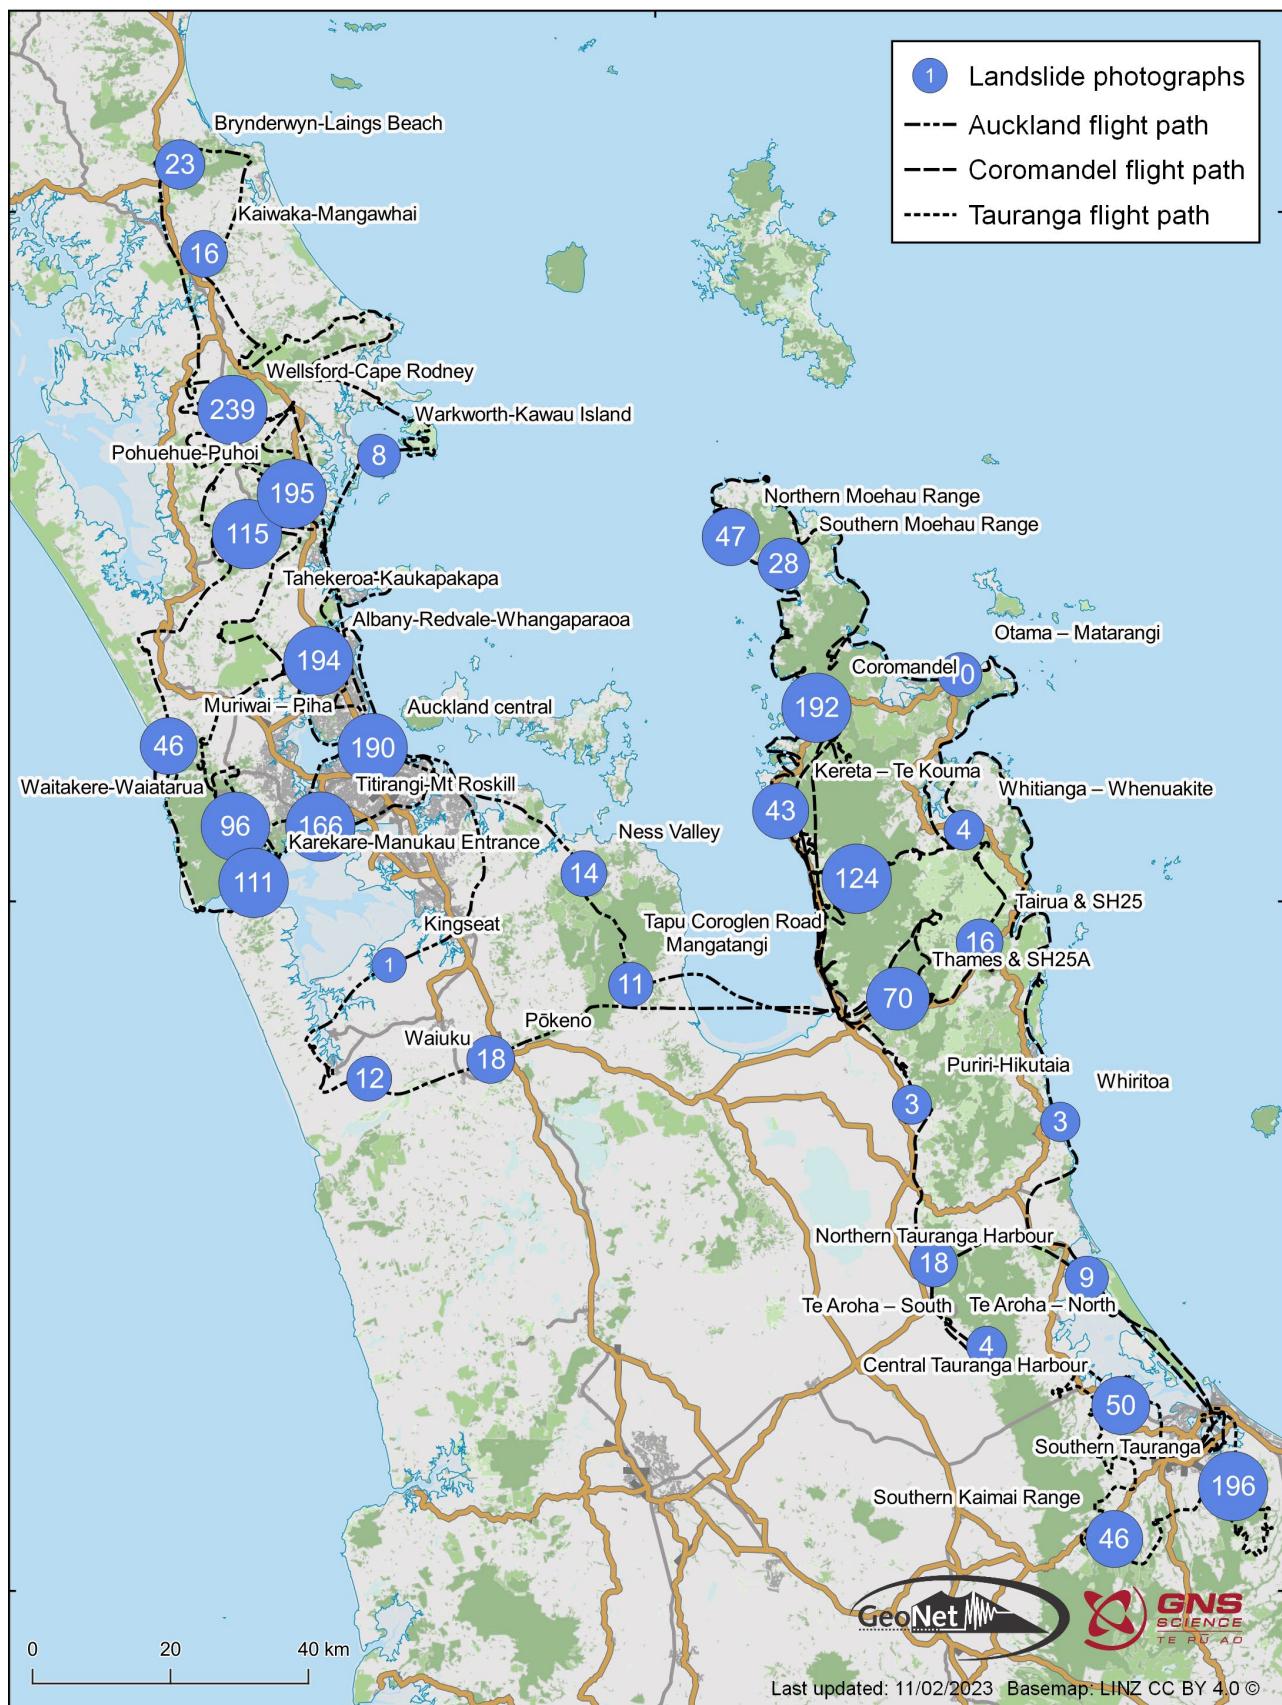
Figure 2.1 Aerial survey of rainfall-induced landslides resulting from the January 2023 Auckland Anniversary Storm. The map shows the helicopter flight paths and summary number of photos collected at various locations along the flight paths. The named location labels relate to the location summaries given in Table 3.1.

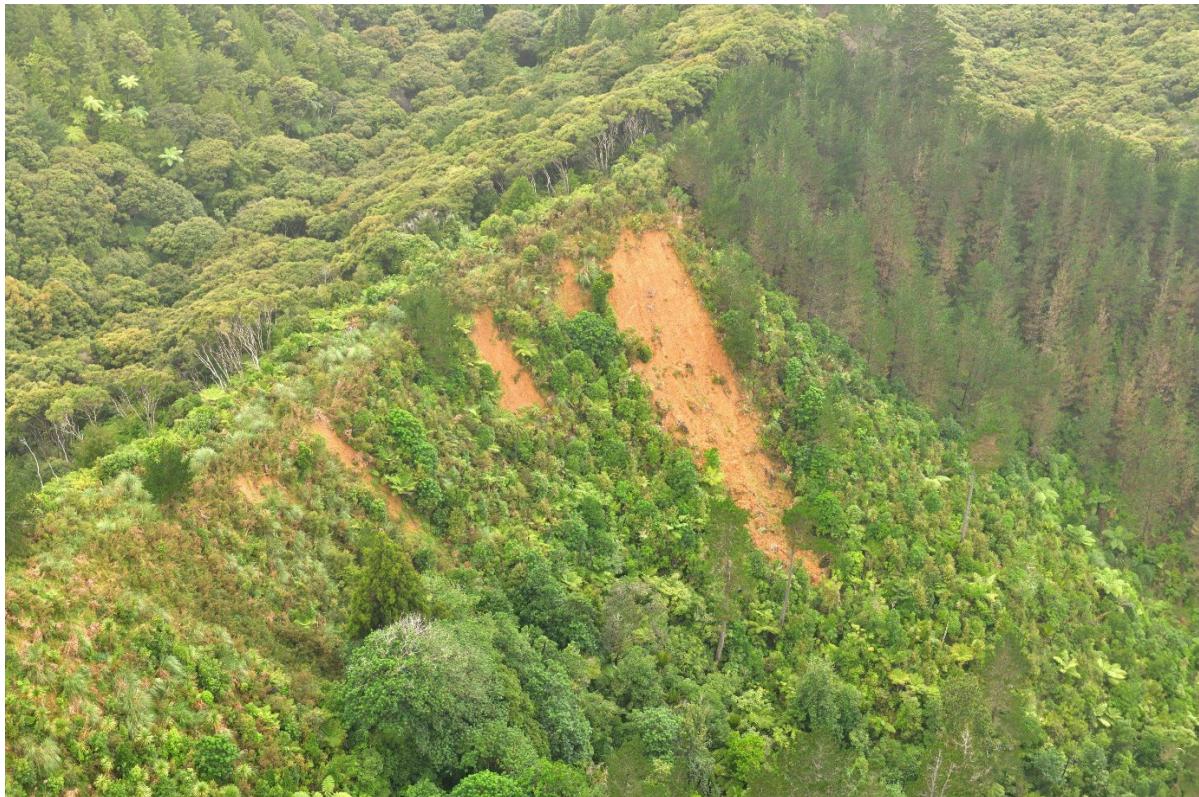
Figure A1.1 Photo 856\_3829: Shallow landslides in regenerating forest/scrub inland from Langs Beach.

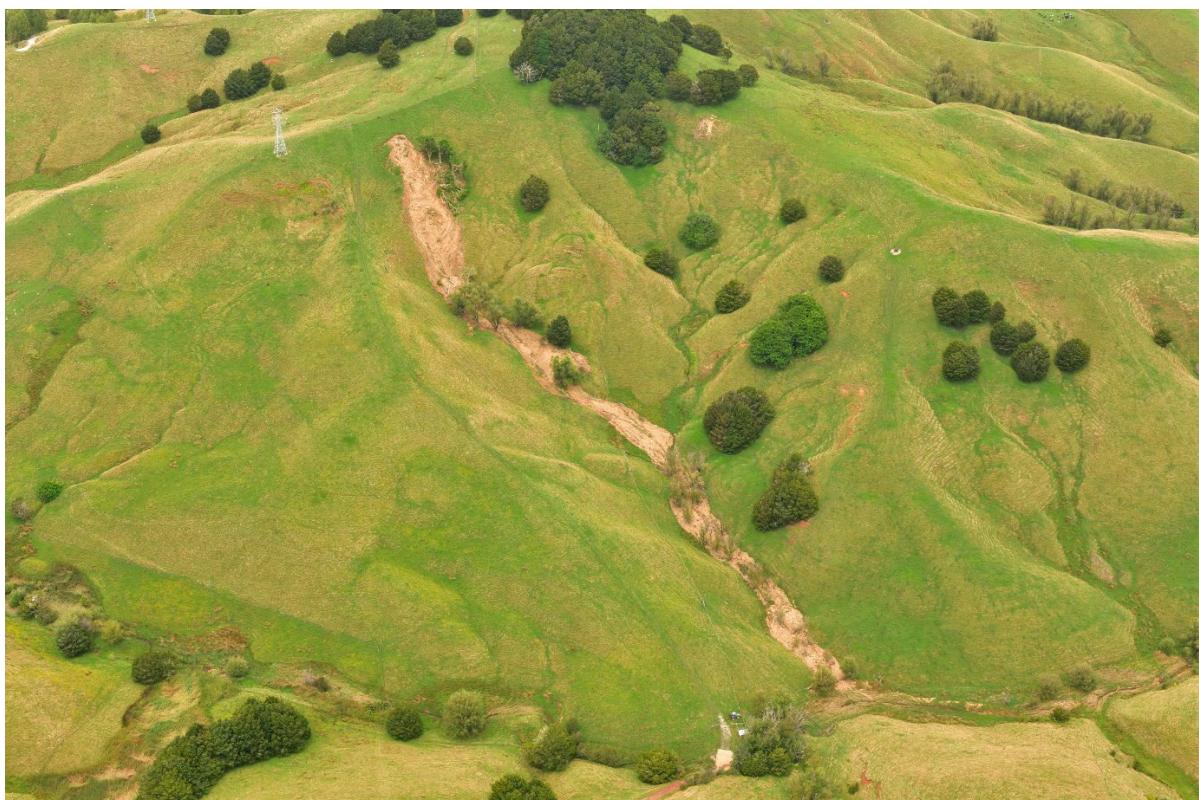
Figure A1.2 Photo 856\_3848: Debris flow in farmland southeast of Kaiwaka.

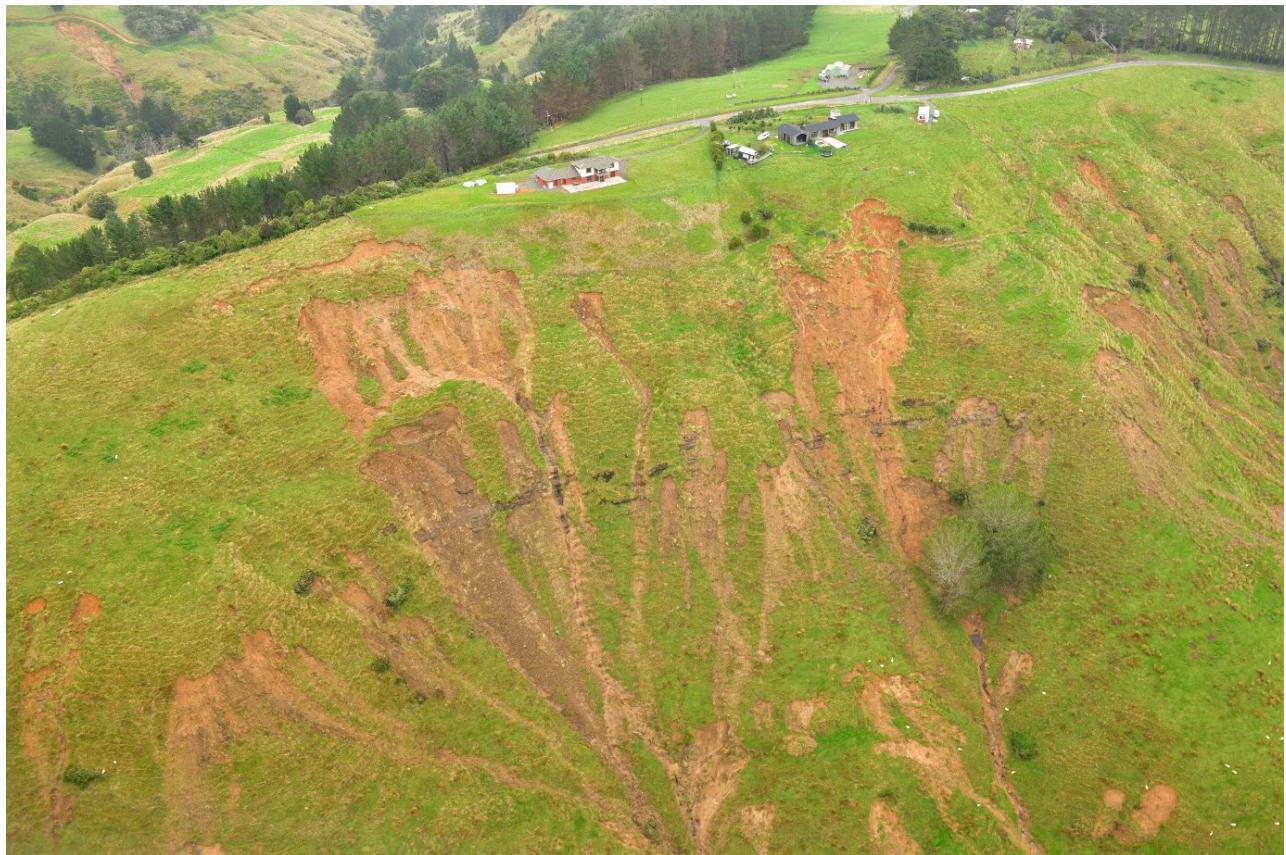
Figure A1.3 Photo 856\_2472: Multiple coalescing shallow slides in farmland near Kaipara Flats.

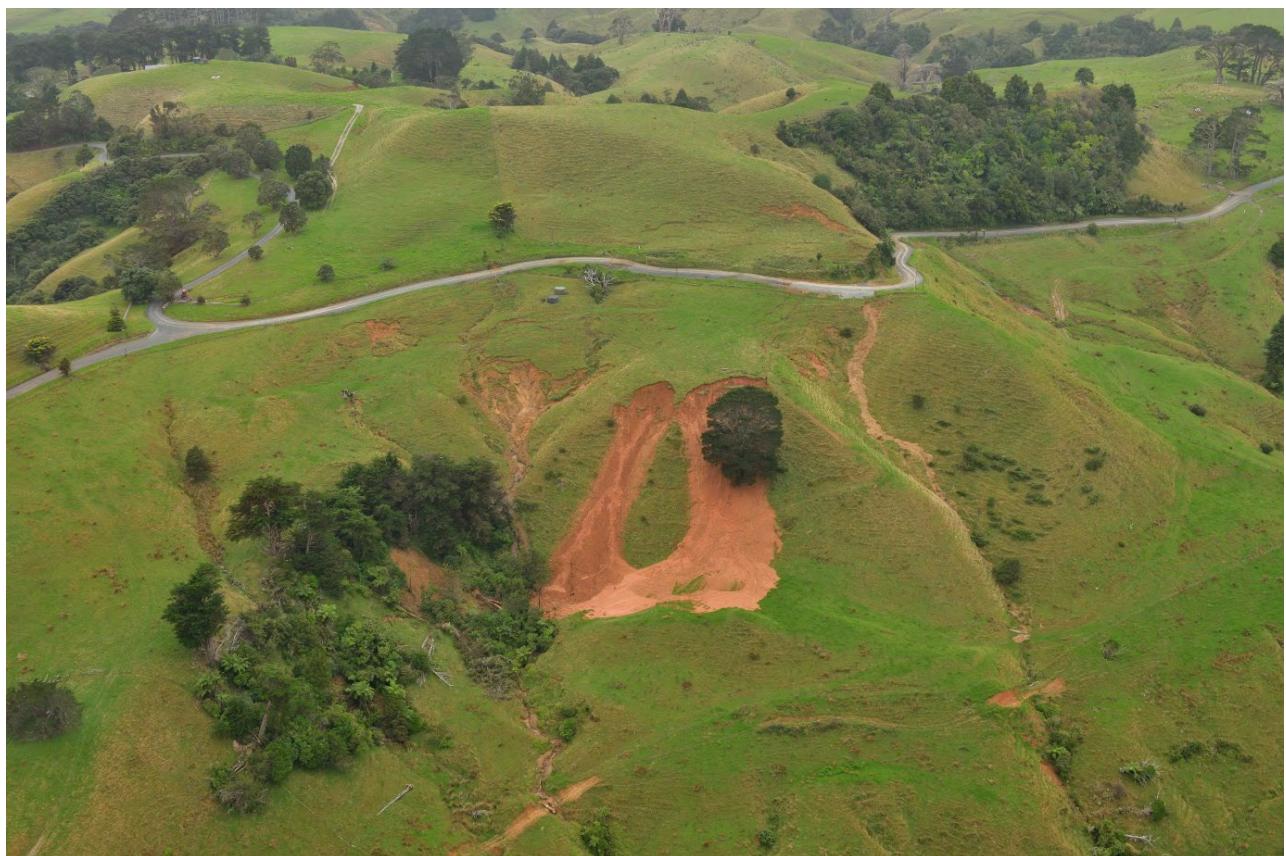
Figure A1.4 Photo 856\_2523: Slumping and cracking in farmland and across Kaipara Hills Road. Note the fresh headscarp cracks in the paddock above the road.

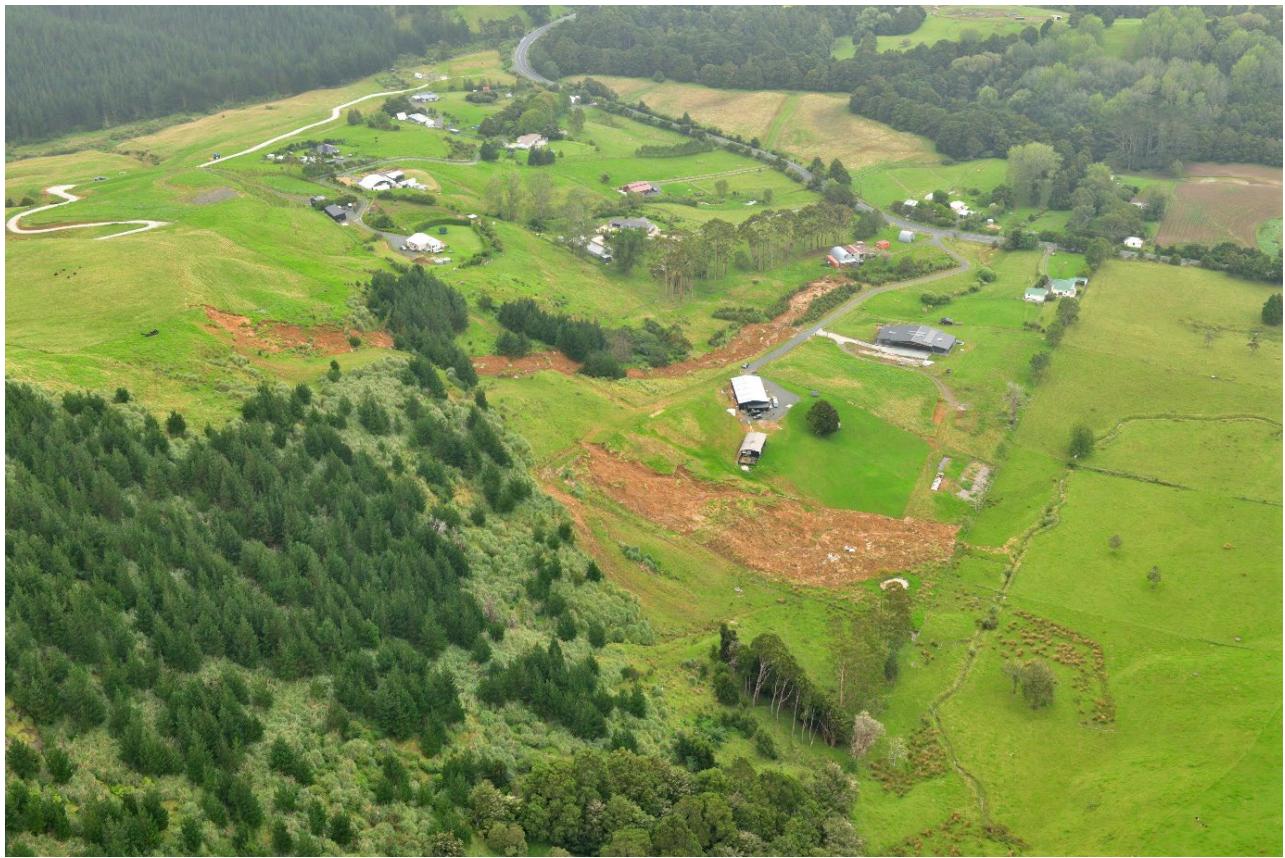
Figure A1.5 Photo 856\_3888: Multiple slides and slumps at Whangaripo, east of Wellsford.

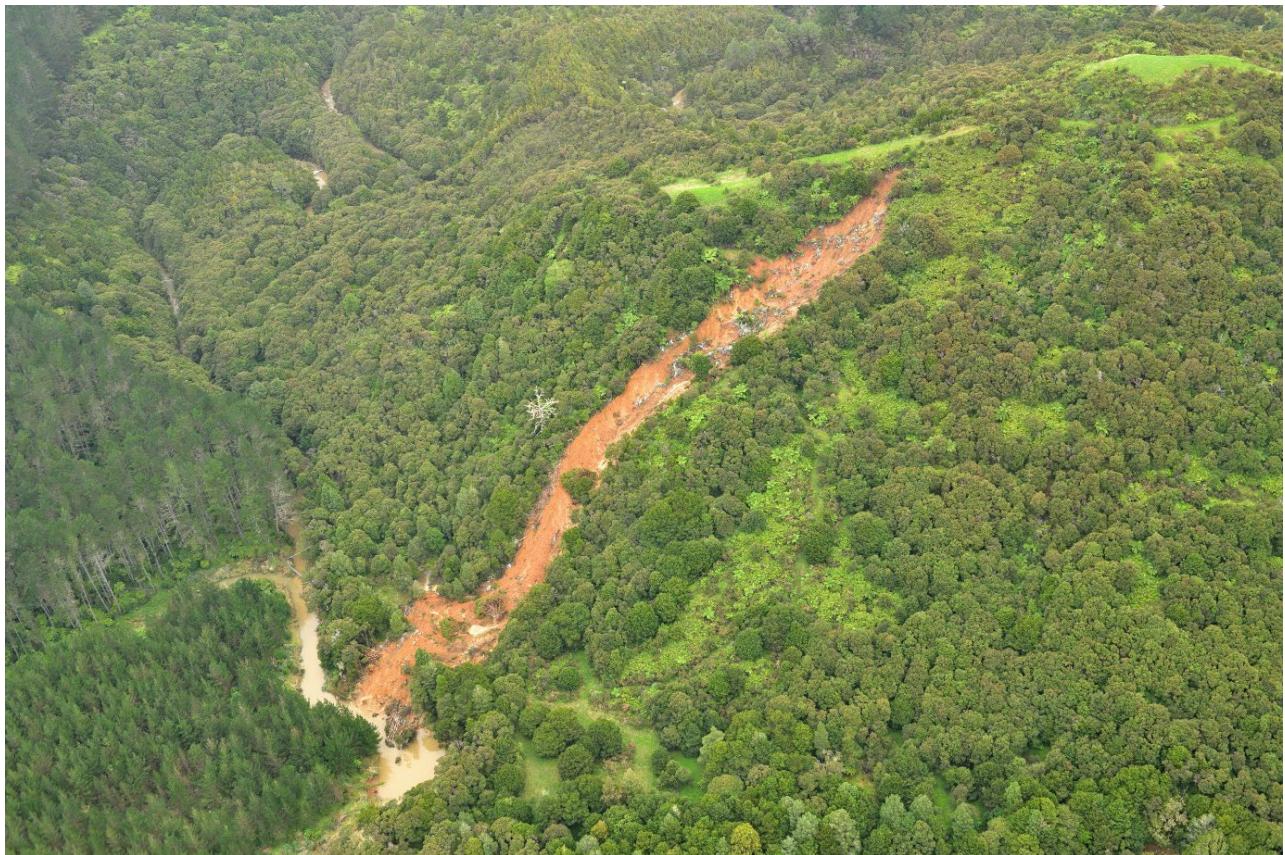
Figure A1.6 Photo 856\_3861: Debris avalanche partially blocking Waiwhiu Stream, east of Wellsford.

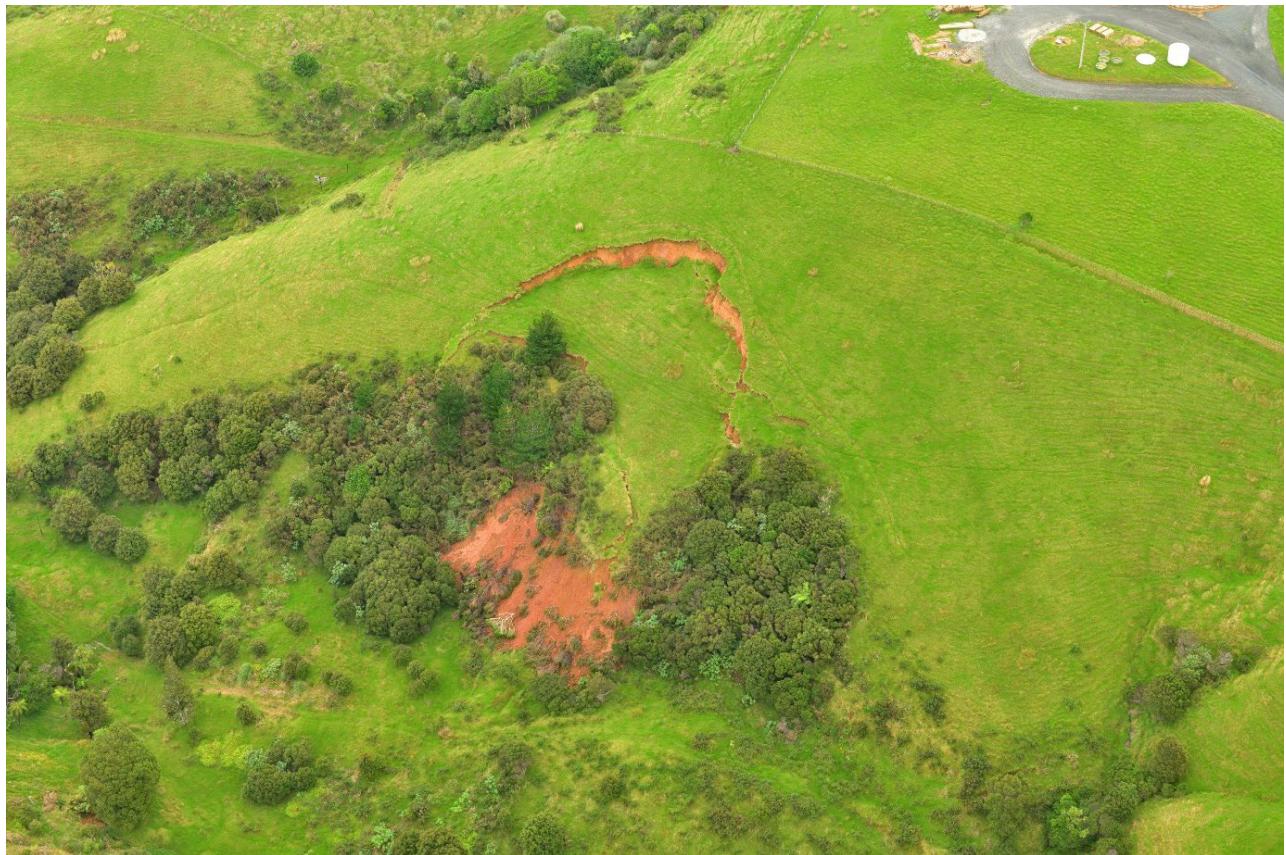
Warkworth-Kawau Island	8	0	107	60	There are relatively few landslides in this area, with one prominent re-activation of an old slump in farmland near Tāwharanui (Figure A1.7). A few landslides were noted on Kawau Island, but it was not clear whether these occurred during the Auckland Anniversary Storm or are somewhat older.
Pōhuehue-Pūhoi	195	15	265	152	Many small landslides in farmland and scrub; mainly shallow. Some affect properties (Figure A1.8). Some debris avalanches in recently cleared forestry have entrained logs/slash and formed debris dams (e.g. near The Crag [Figure A1.9; see 3D model <sup>6</sup> ]).
Tāhekeroa-Kaukapakapa	115	0	101	56	Multiple shallow slides in soil transforming downslope to debris avalanches or flows (Figure A1.10). Also, many deeper slides/avalanches, some forming small dams (Figure A1.11). A particularly large slide has formed a long run out, piling debris over the North Auckland Line railway and Tāhekeroa Road (Figure A1.12; see 3D model <sup>7</sup> ).

Figure A1.7 Photo 856\_3928: Re-activation of deep-seated slump near Tāwharanui.

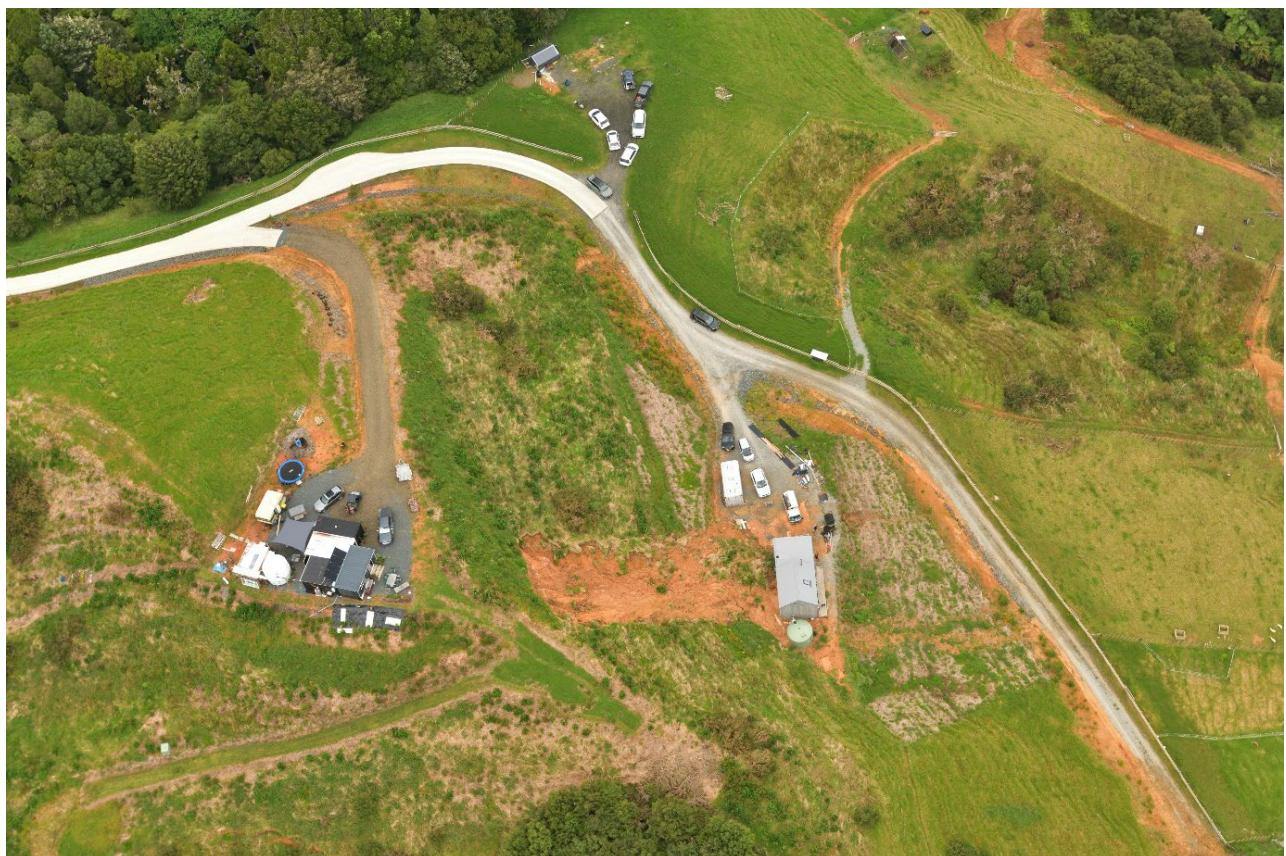
Figure A1.8 Photo 856\_3534: Small debris avalanche in developed farmland near Pūhoi, impacting a recently built house.

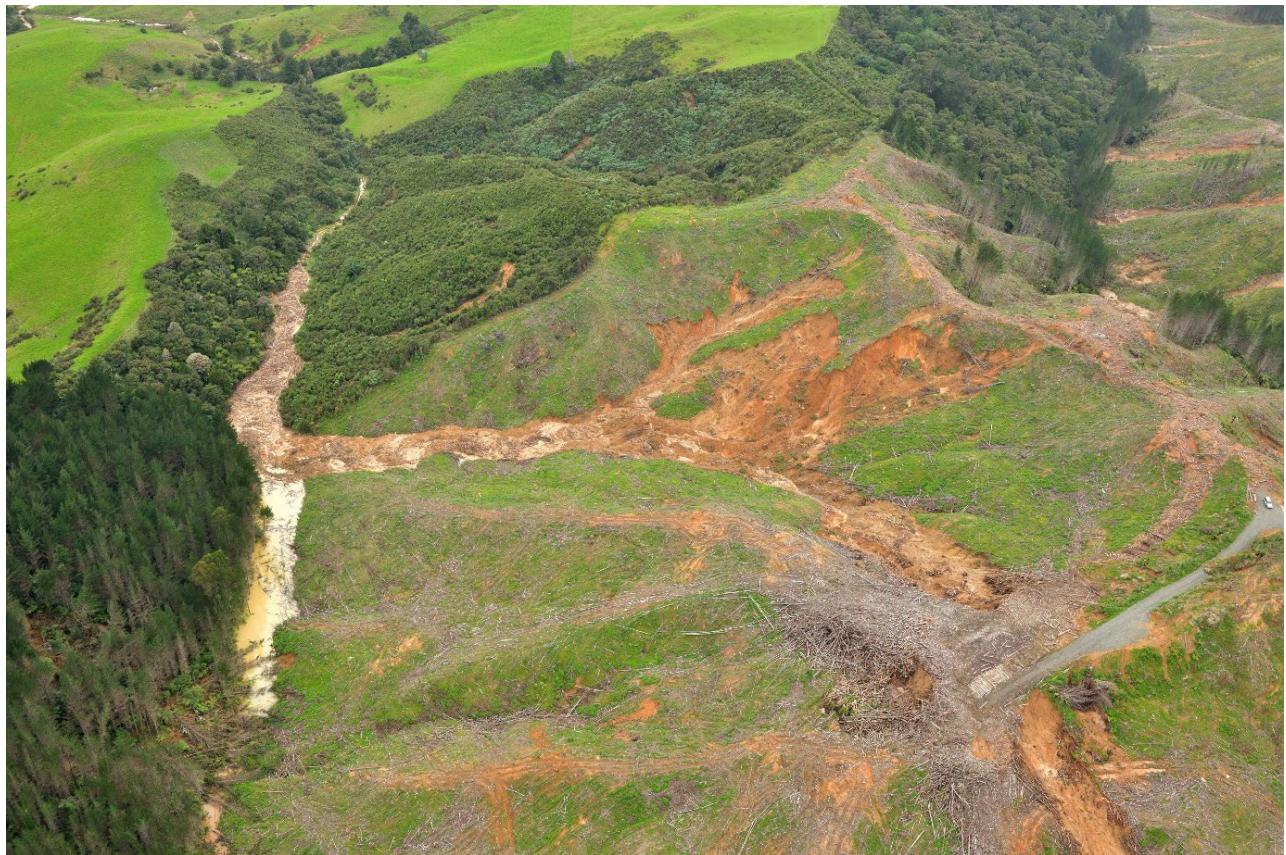
Figure A1.9 Photo 856\_3570: Debris avalanches entraining forestry slash and forming a small dam in a gully that feeds into Hikauae Creek near Cook Road, just north of Pūhoi, Auckland. The stream drains towards State Highway 1.

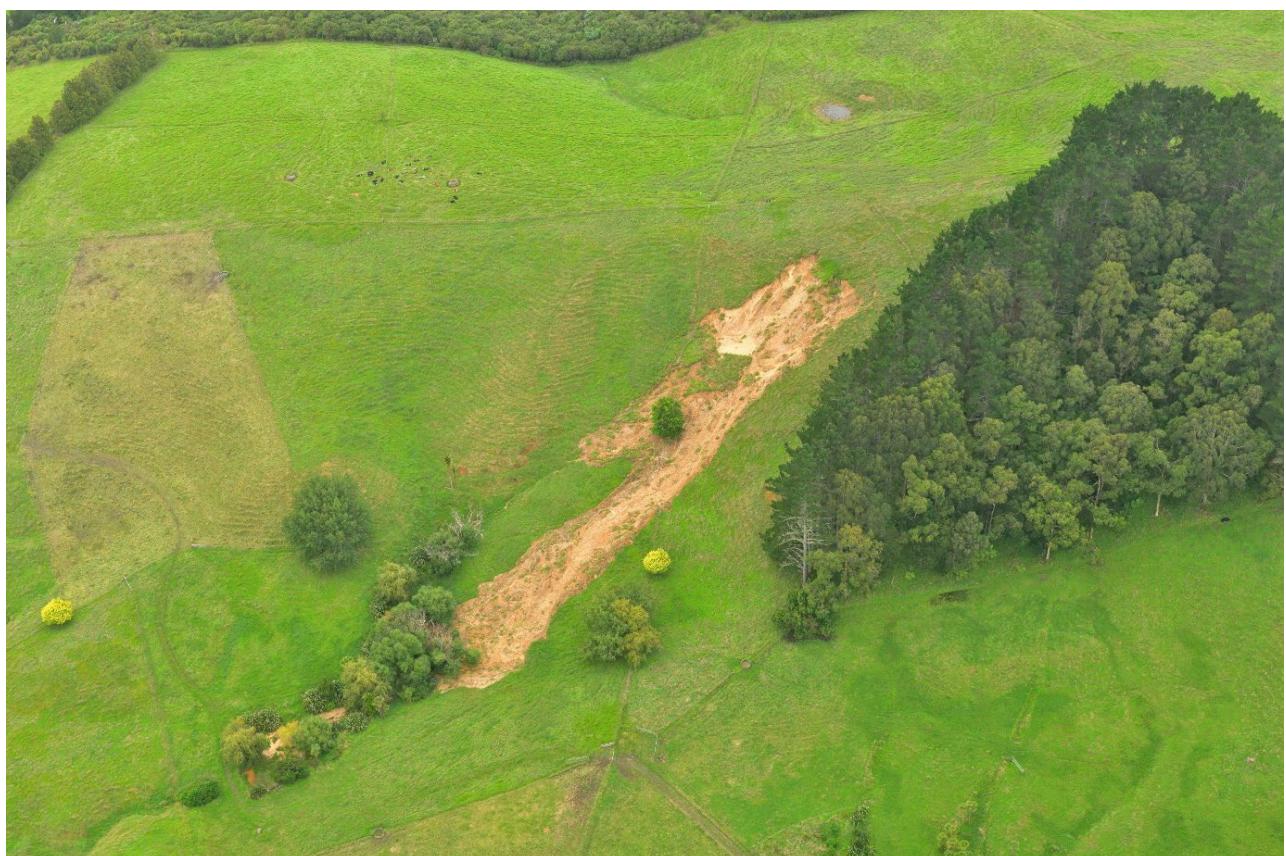
Figure A1.10 Photo 856\_3419: Typical small debris avalanche in farmland near Dairy Flat.

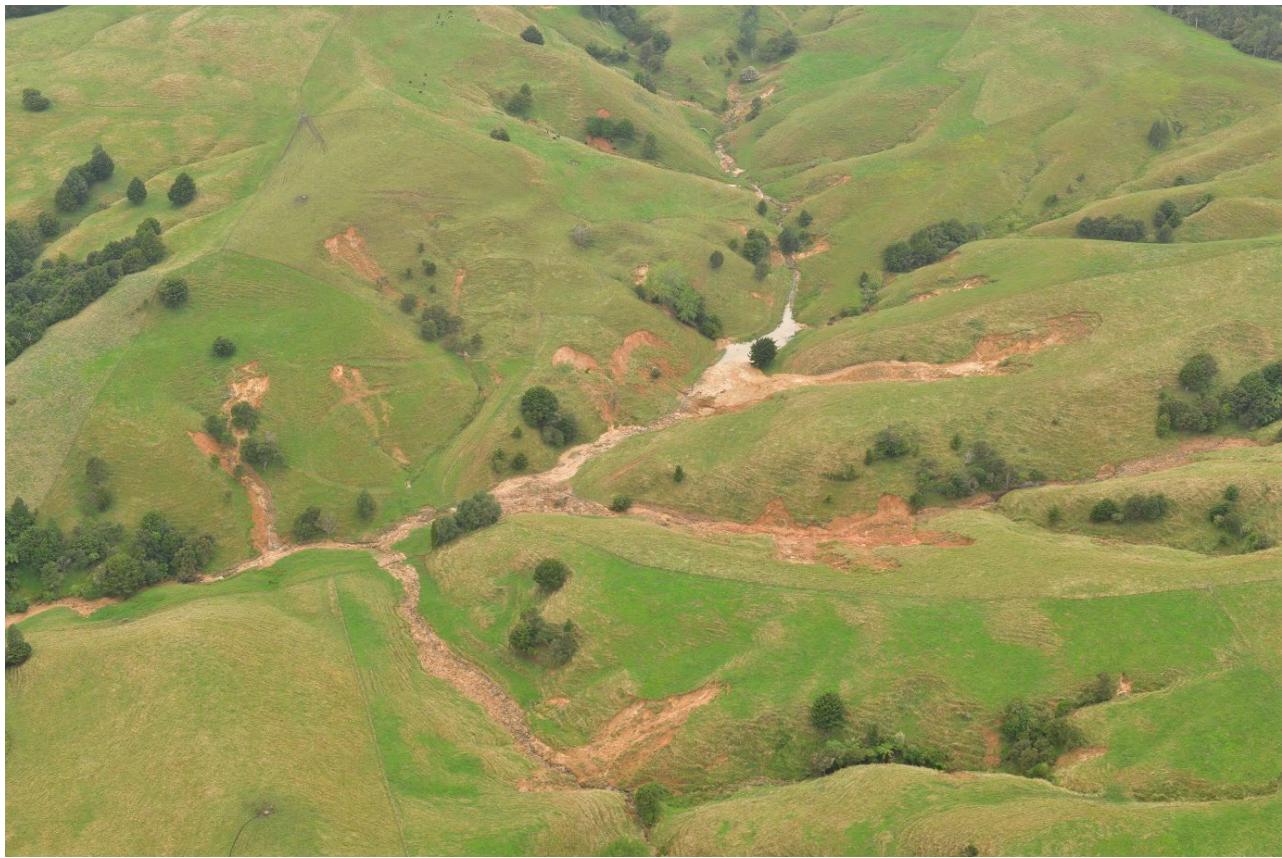
Figure A1.11 Photo 856\_2558: Landslides forming debris flows and avalanches in farmland at Komokokiri, near Kaukapakapa. One has blocked the valley, forming a small dam.

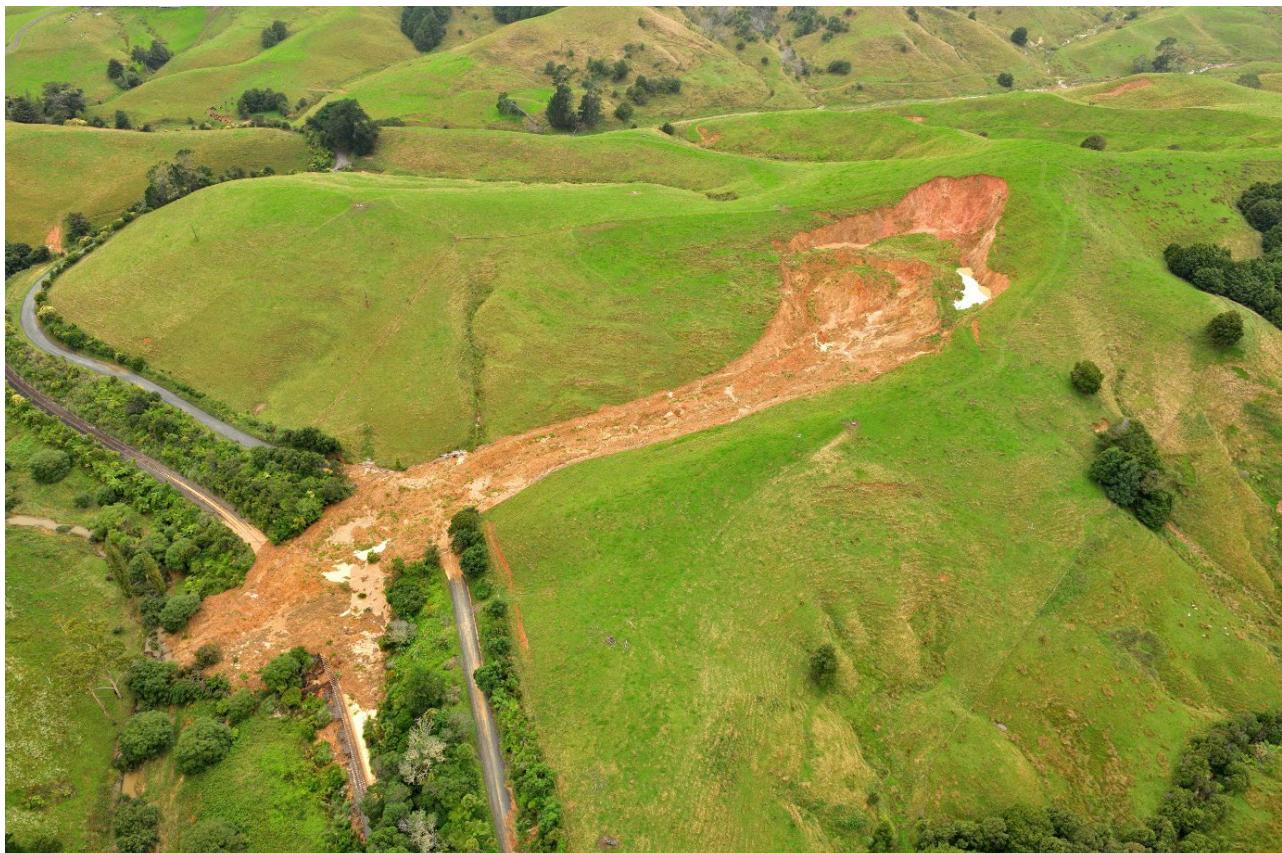
Figure A1.12 Photo 856\_2616: Large debris avalanche in farmland near Tāhekeroa, sending debris over the North Auckland Line railway and Tāhekeroa Road.

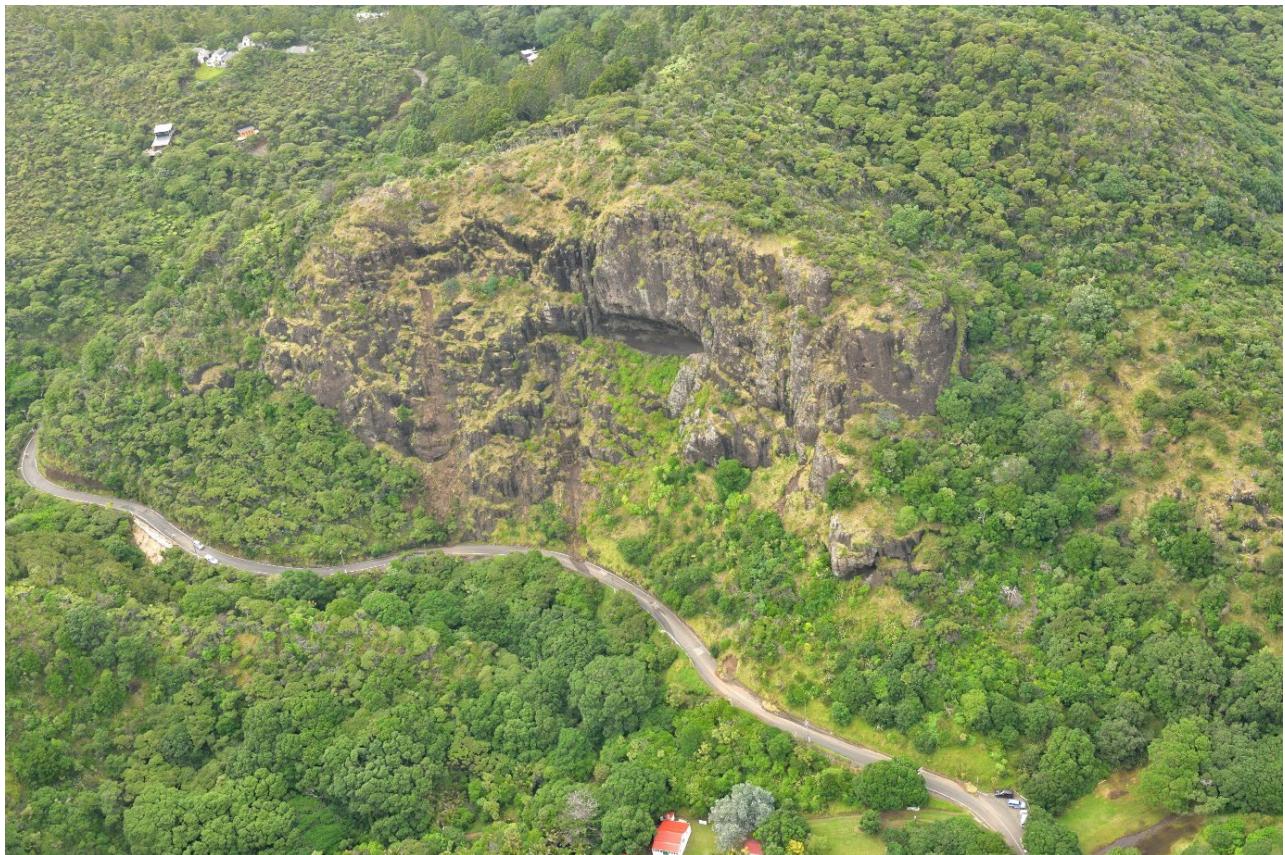
Figure A1.13 Photo 856\_2751: Debris flows and slumps along the road at Karekare.

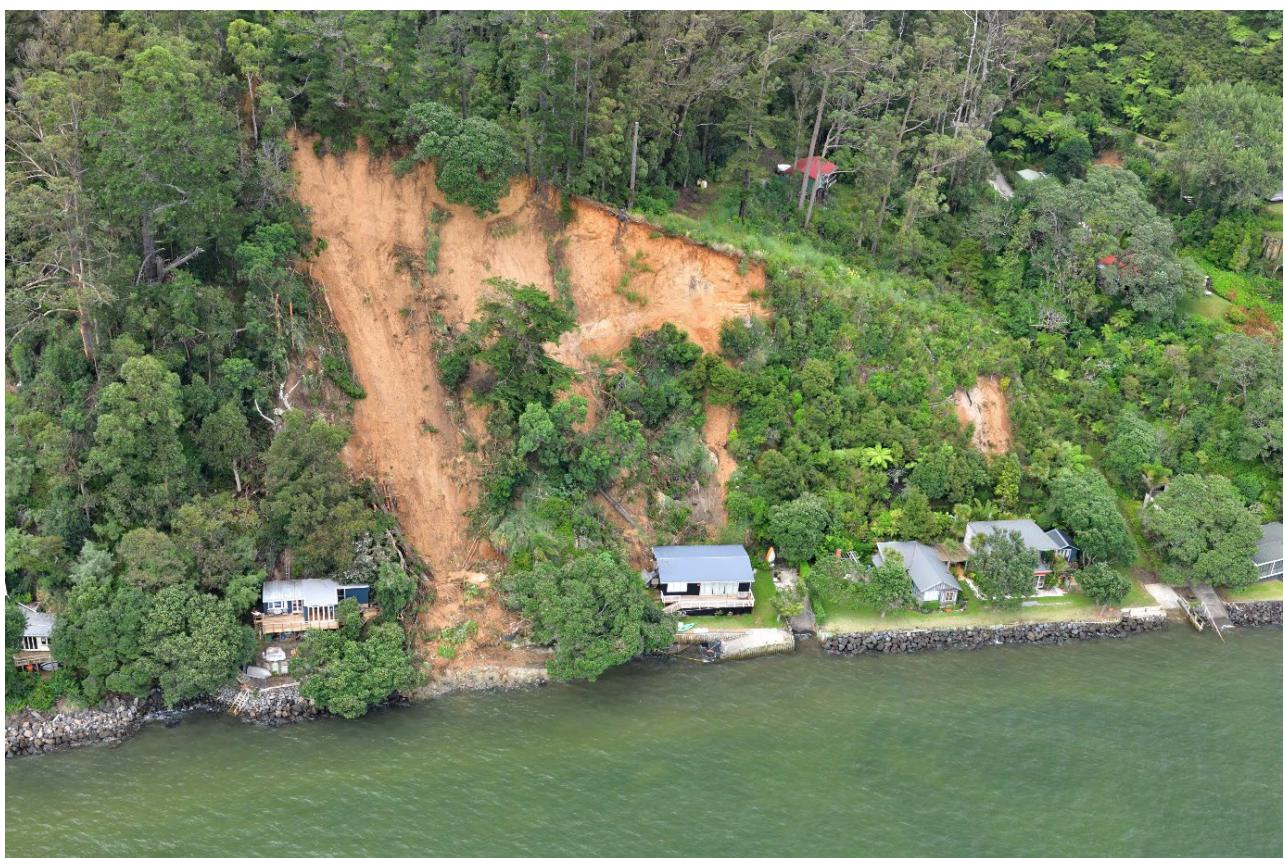
Figure A1.14 Photo 856\_2833: Coastal cliff collapse at Ōrua Bay, northern Āwhitu Peninsula, where debris impacted a bach (now removed) trapping three occupants.

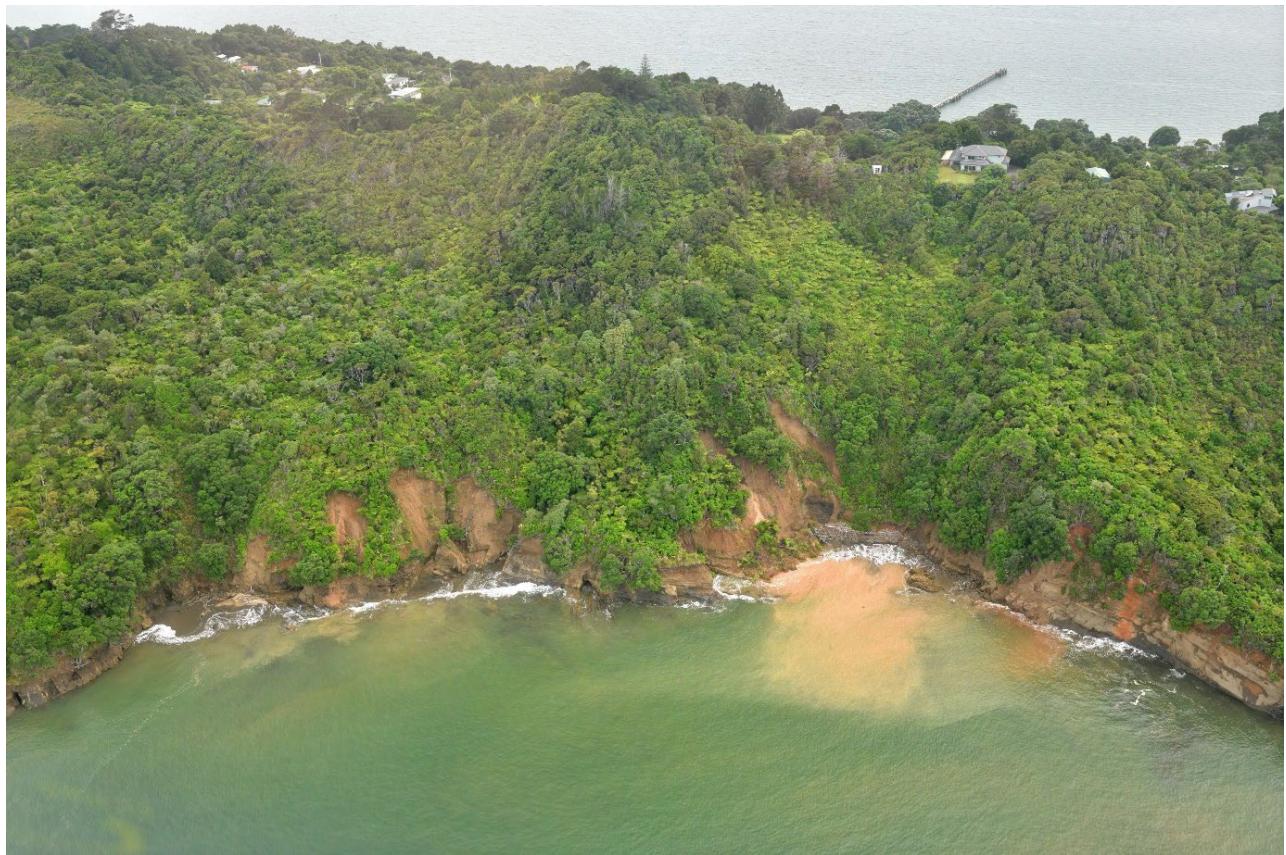
Figure A1.15 Photo 856\_2910: Collapse of volcaniclastic rocks along the coastline near Cornwallis.
