## **GeoNet Landslide Response: Auckland Anniversary Storm, 26–30 January 2023, northern New Zealand**

**GNS Science Report 2025/32  
November 2025**

## ABSTRACT

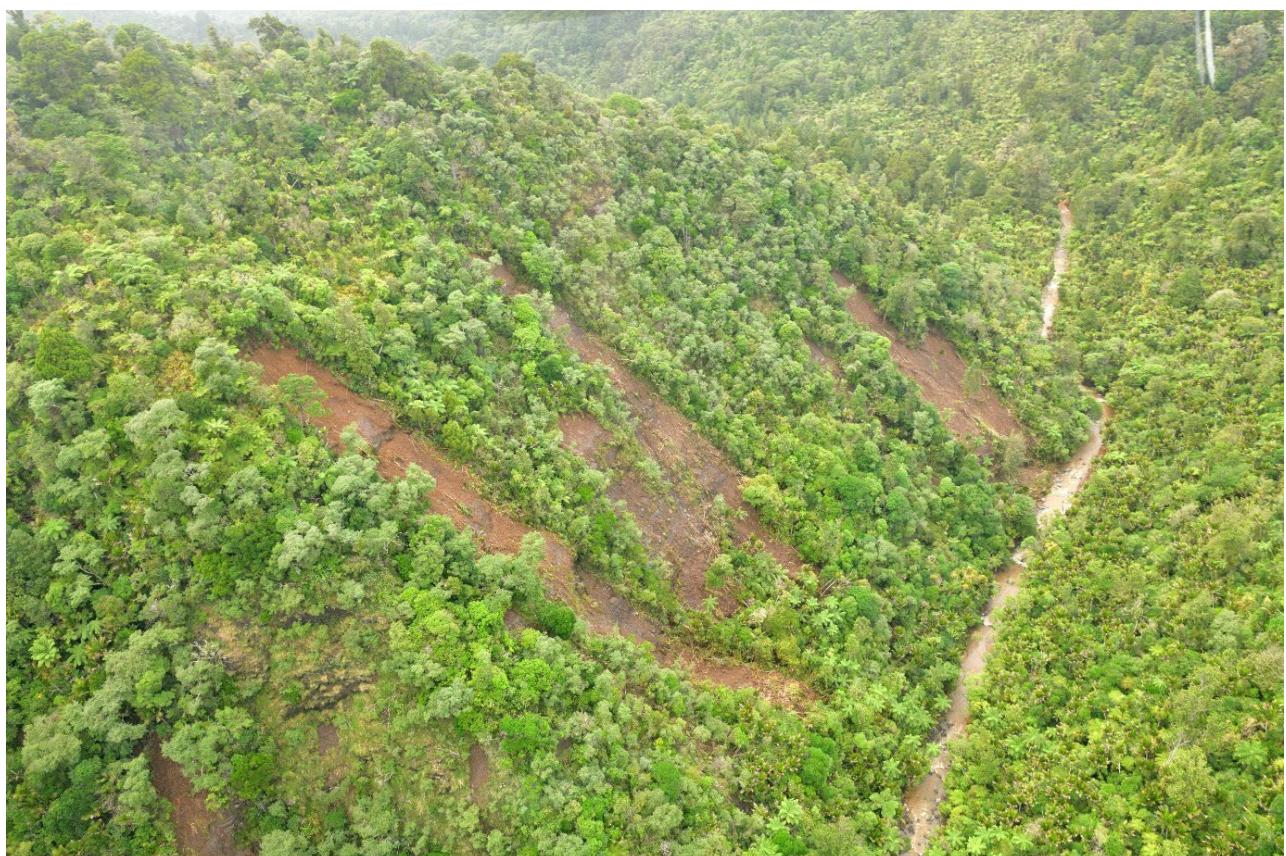
Waitākere-Waiatarua	96	0	164	74	There were several shallow slides noted in the ranges, mainly involving soil (Figure A1.16), but also a few deeper ones in rock and some re-activations of older slides. It was difficult to gauge whether some of these were new. Around Waiatarua and to the north, there were many shallow landslides in soil, some near houses (Figure A1.17). A house in Parekura Stream valley appeared to have been inundated by debris.
Titirangi-Mt Roskill	166	31	316	222	Northeast of about Lawry Point, the coastal cliffs are formed in East Coast Bays Formation (Waitematā Group alternating sandstone and mudstone), with beds of volcaniclastic rocks (mentioned above) overlying at higher elevations and inland. At Laingholm, for example, there are some collapses within Nihotupu Formation (submarine volcaniclastic grit, sandstone and siltstone) beneath houses along the ridgeline (Victory Road; Figure A1.18), whereas landslides observed along the coastline in this area more often involve collapses of the weathered cover material (loess, regolith, volcanic soils) overlying the Waitematā Group bedrock (Figures A1.19–A1.22). There were also a few landslides affecting properties and roads inland around Titirangi (Figure A1.23).

Figure A1.16 Photo 856\_2953: Shallow debris slides in soil/regolith in the Waitākere ranges.

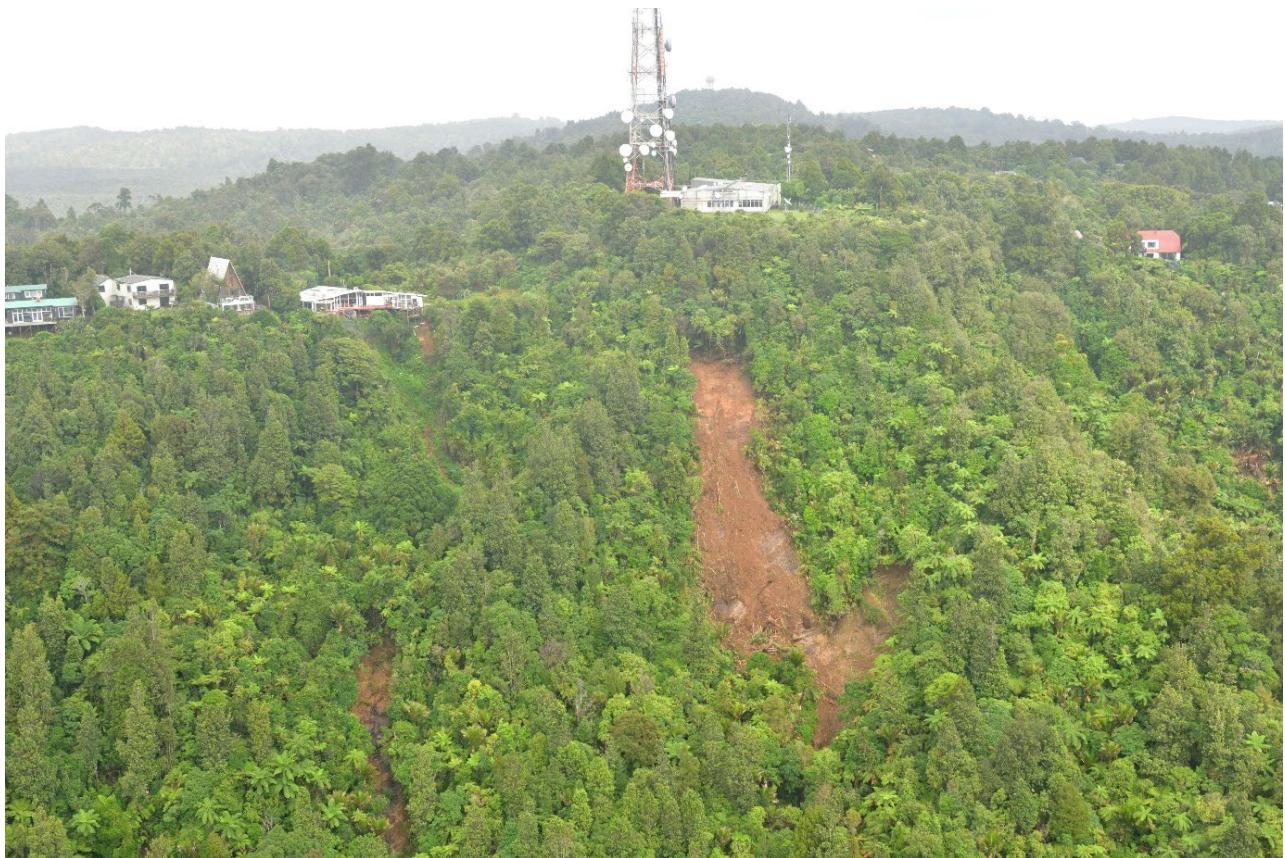
Figure A1.17 Photo 856\_3317: Shallow landslides in soil/regolith below Parkinsons Lookout, Waiatarua.

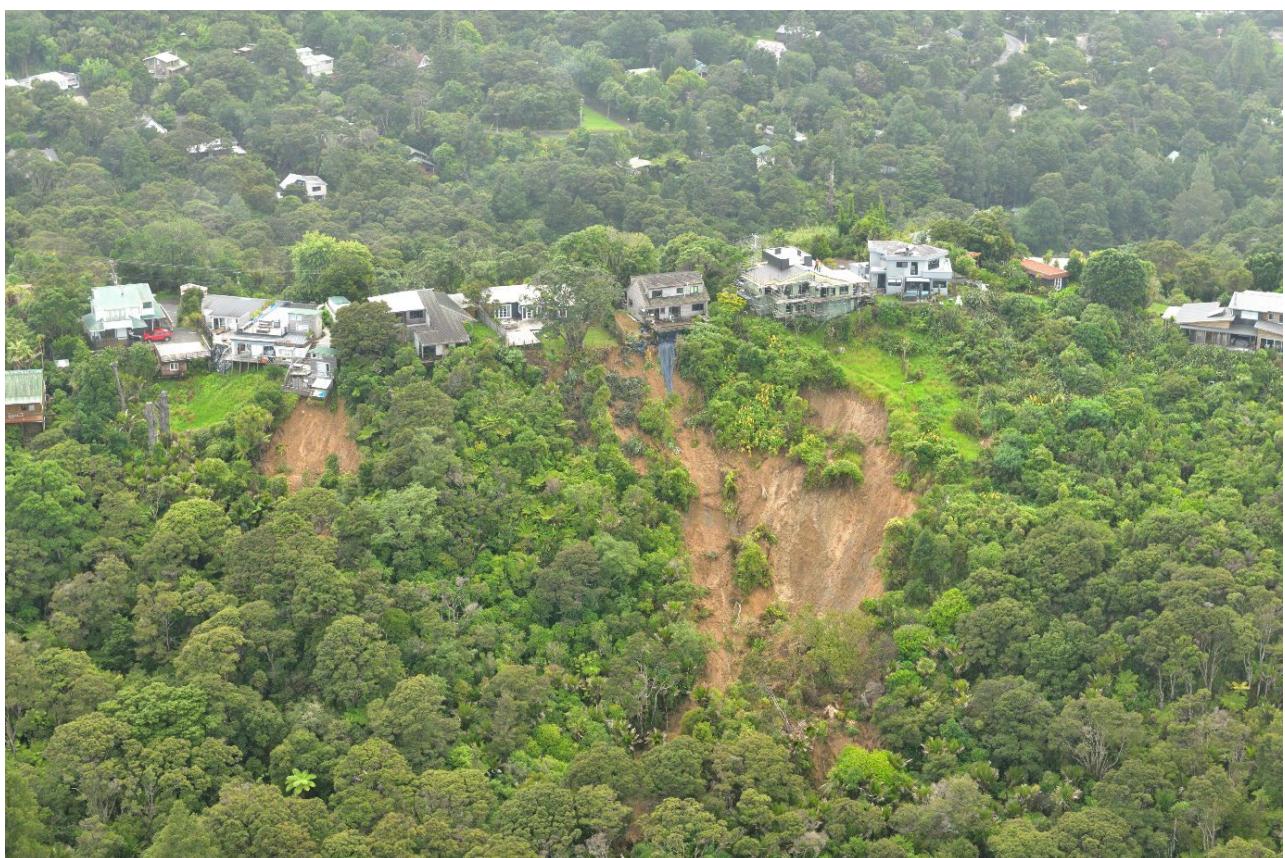
Figure A1.18 Photo 856\_2969: Collapse of regolith from volcaniclastic rocks (Nihotupu Formation) beneath houses at Laingholm.

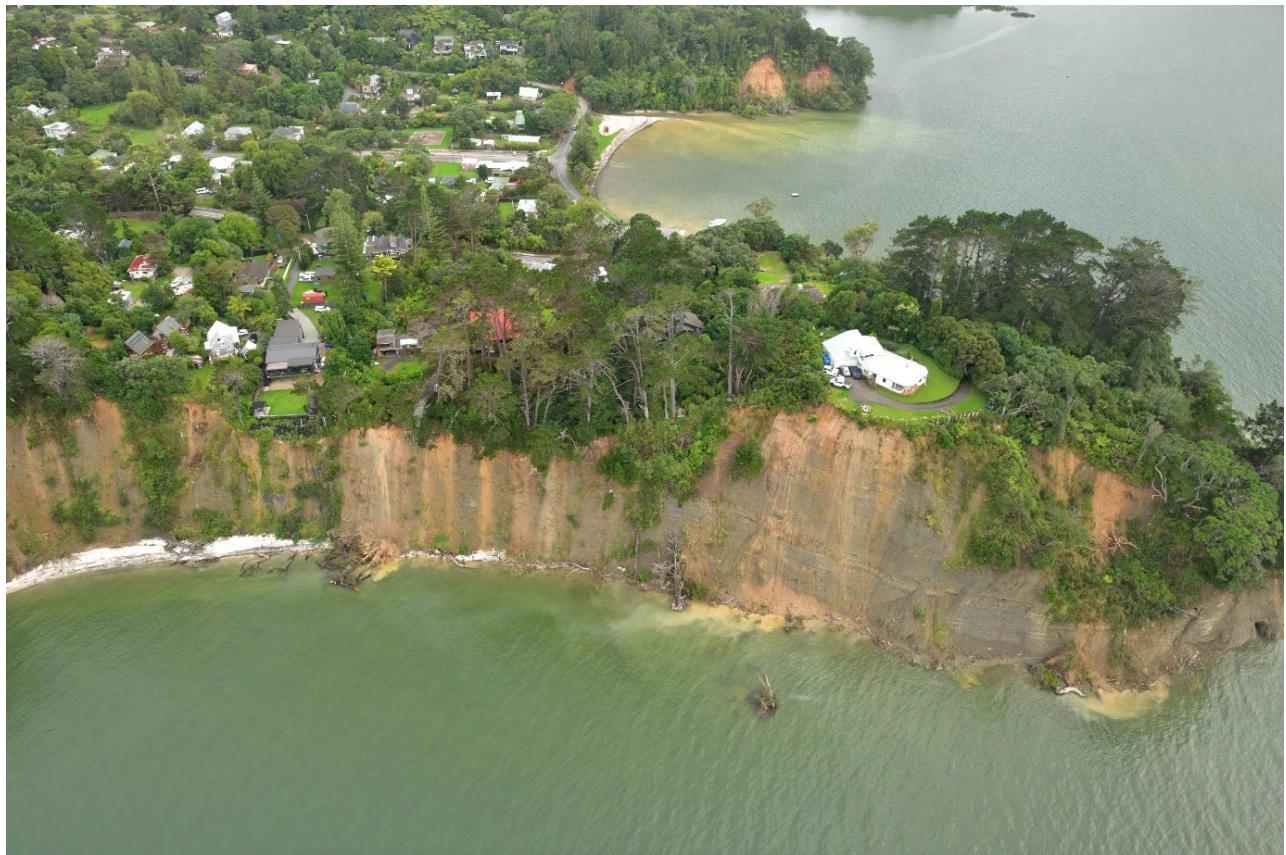
Figure A1.19 Photo 856\_2979: Multiple collapses along the clifftops near Tokoroa Point. The failures are mainly in the weaker coverbeds (regolith/loess and volcanic soils) that overlie Waitematā Group rocks.

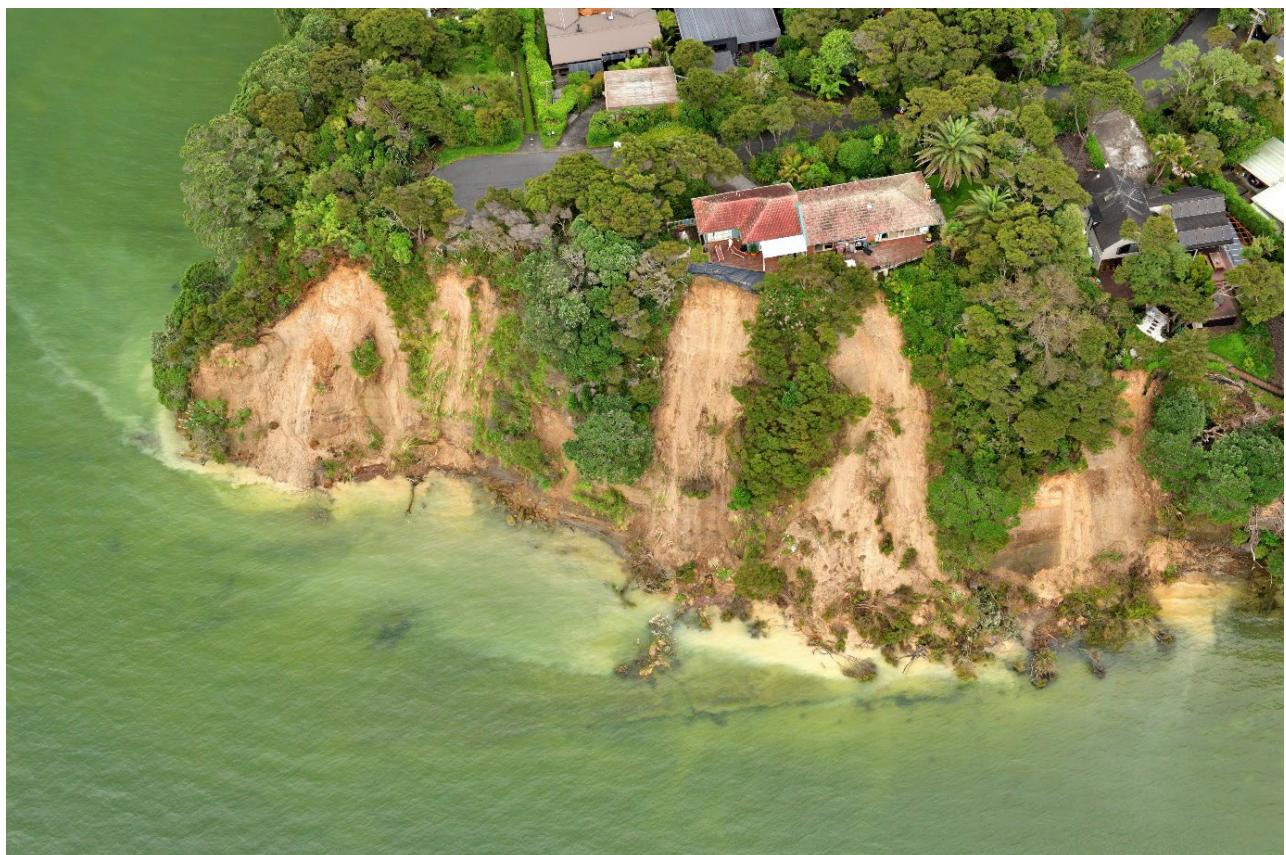
Figure A1.20 Photo 856\_3009: Multiple collapses along the clifftops between Wood Bay and Oatoru Bay.

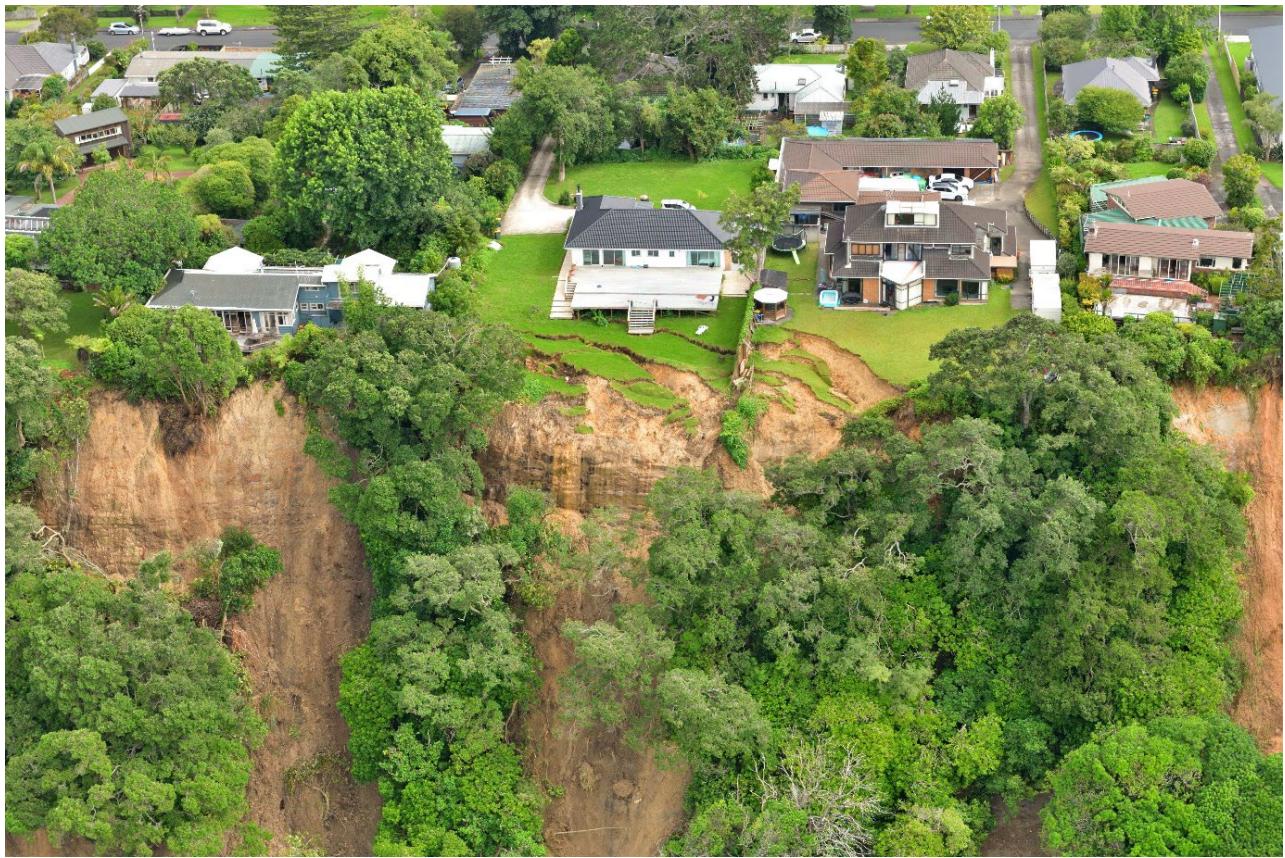
Figure A1.21 Photo 856\_3066: Rotational slumping in cover beds above Waitematā Group rocks at Green Bay.

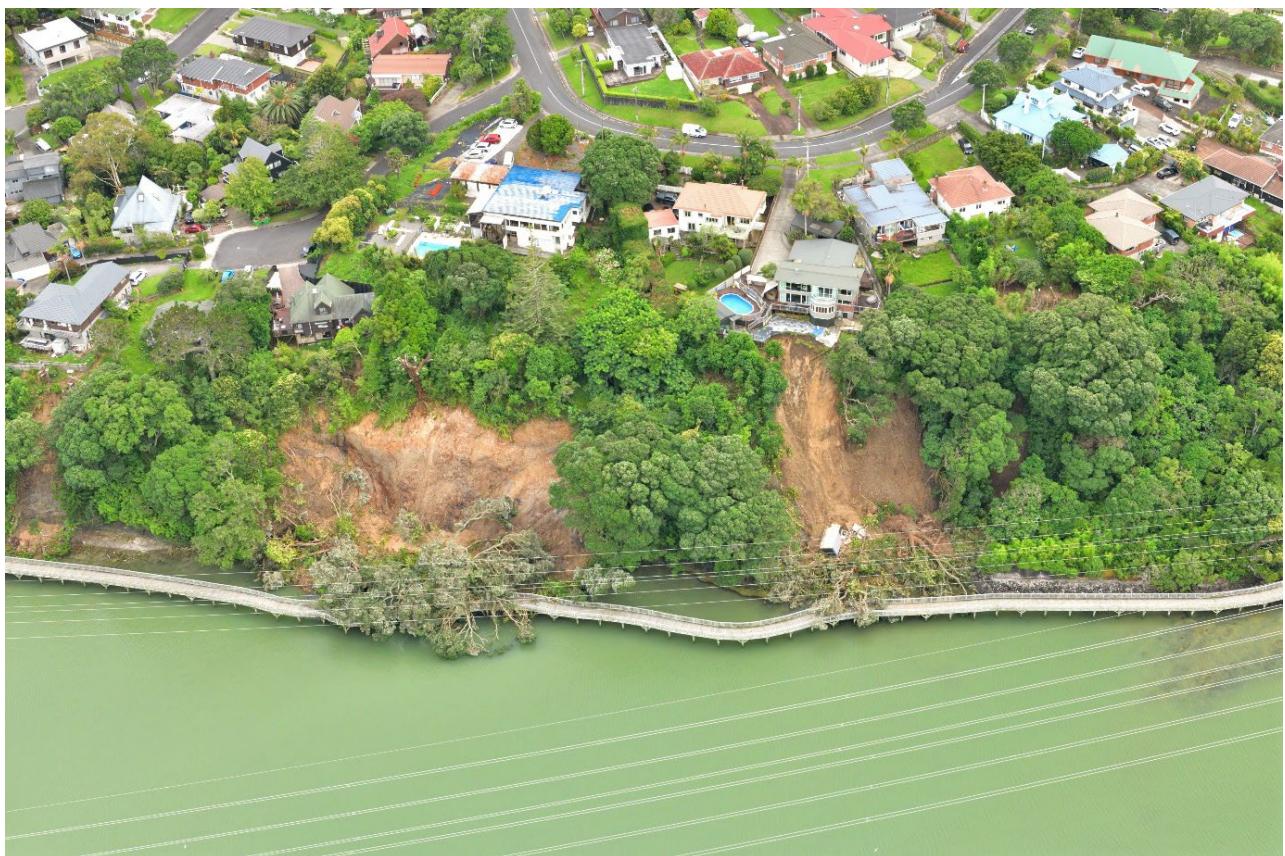
Figure A1.22 Photo 856\_3150: Collapse of coastal cliffs undermining property and houses at Hillsborough.

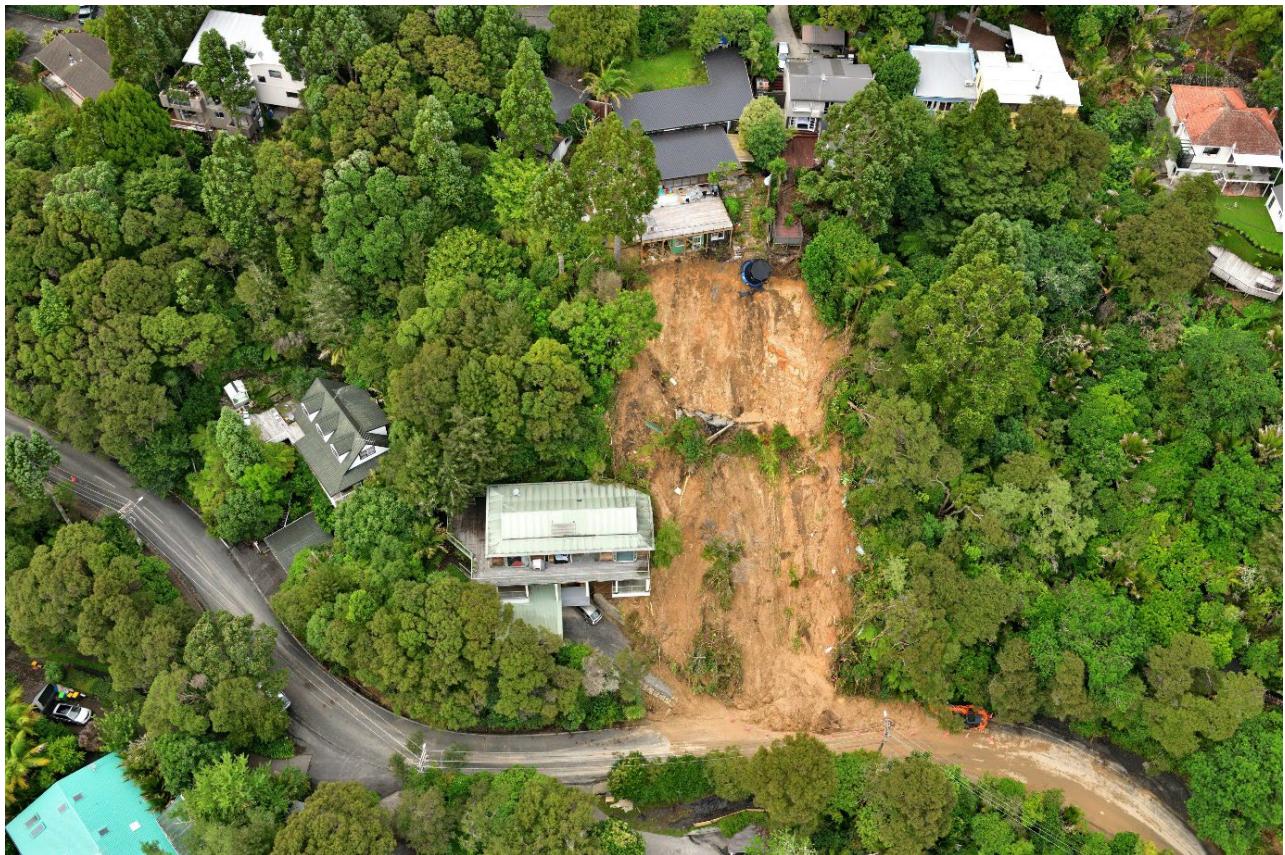
Figure A1.23 Photo 856\_3022: Cliff collapse from beneath a house, onto another house and Wood Bay Road, Wood Bay, Titirangi.

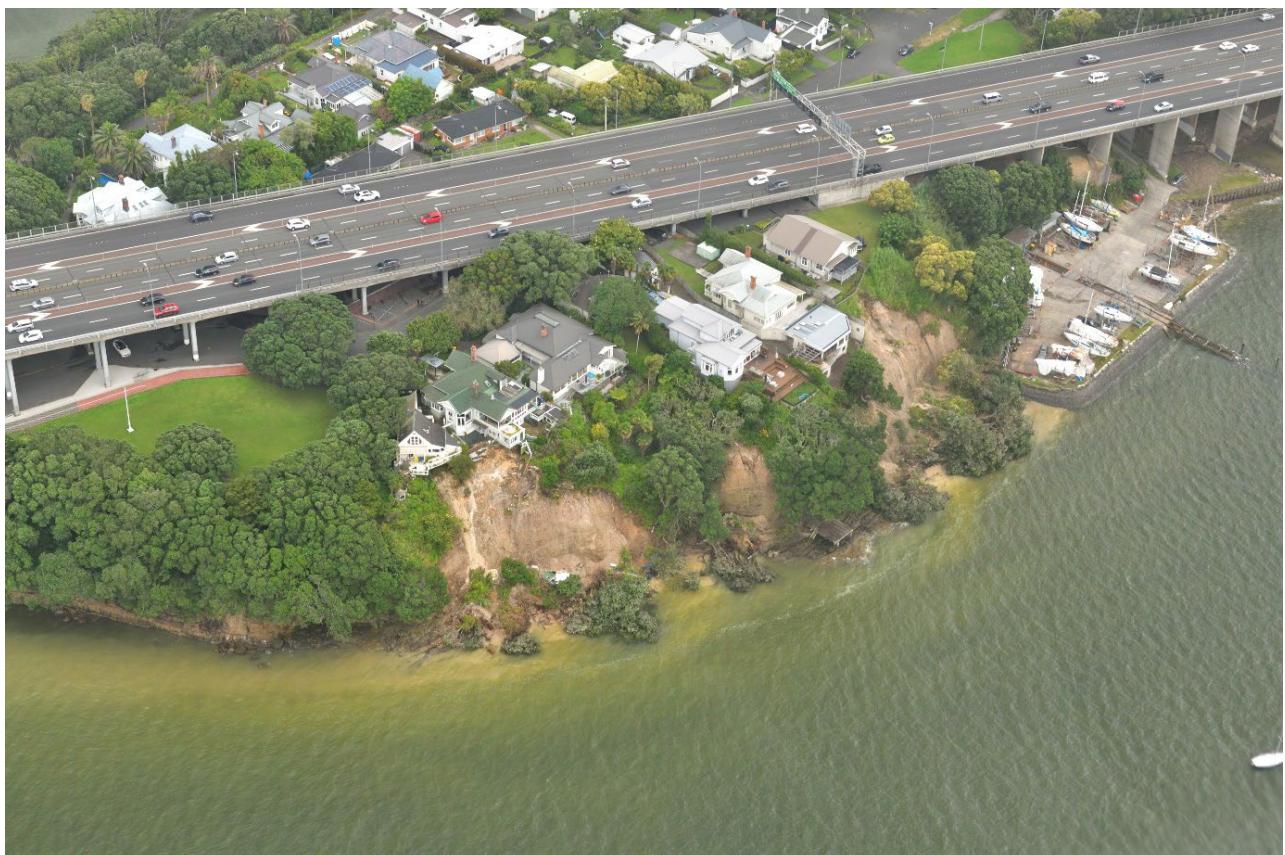
Figure A1.24 Photo 856\_3249: Coastal cliff collapses at Stokes Point, undermining houses.

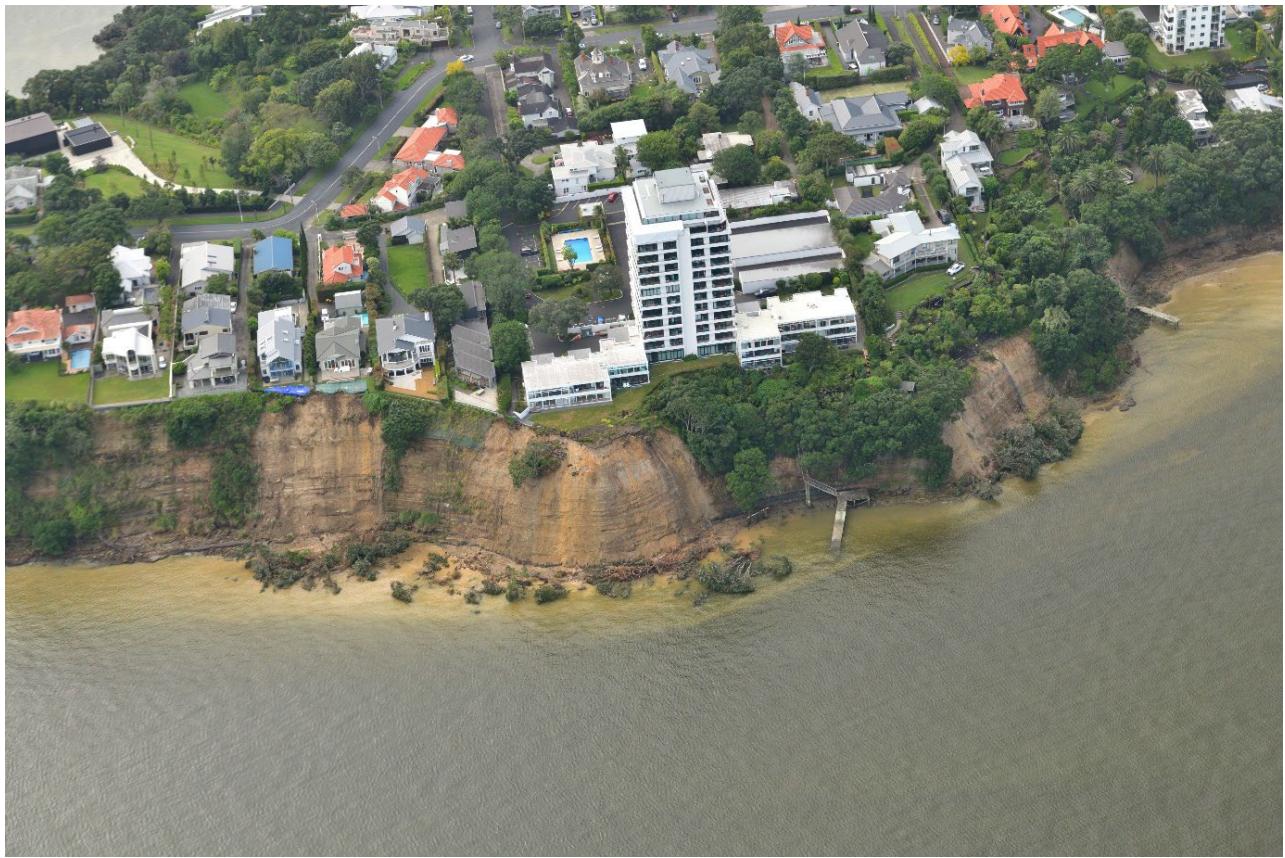
Figure A1.25 Photo 856\_4494: Multiple shallow failures along the clifftops near Stanley Bay, Devonport. Failures are mainly in the weaker coverbeds (regolith/loess and volcanic soils).

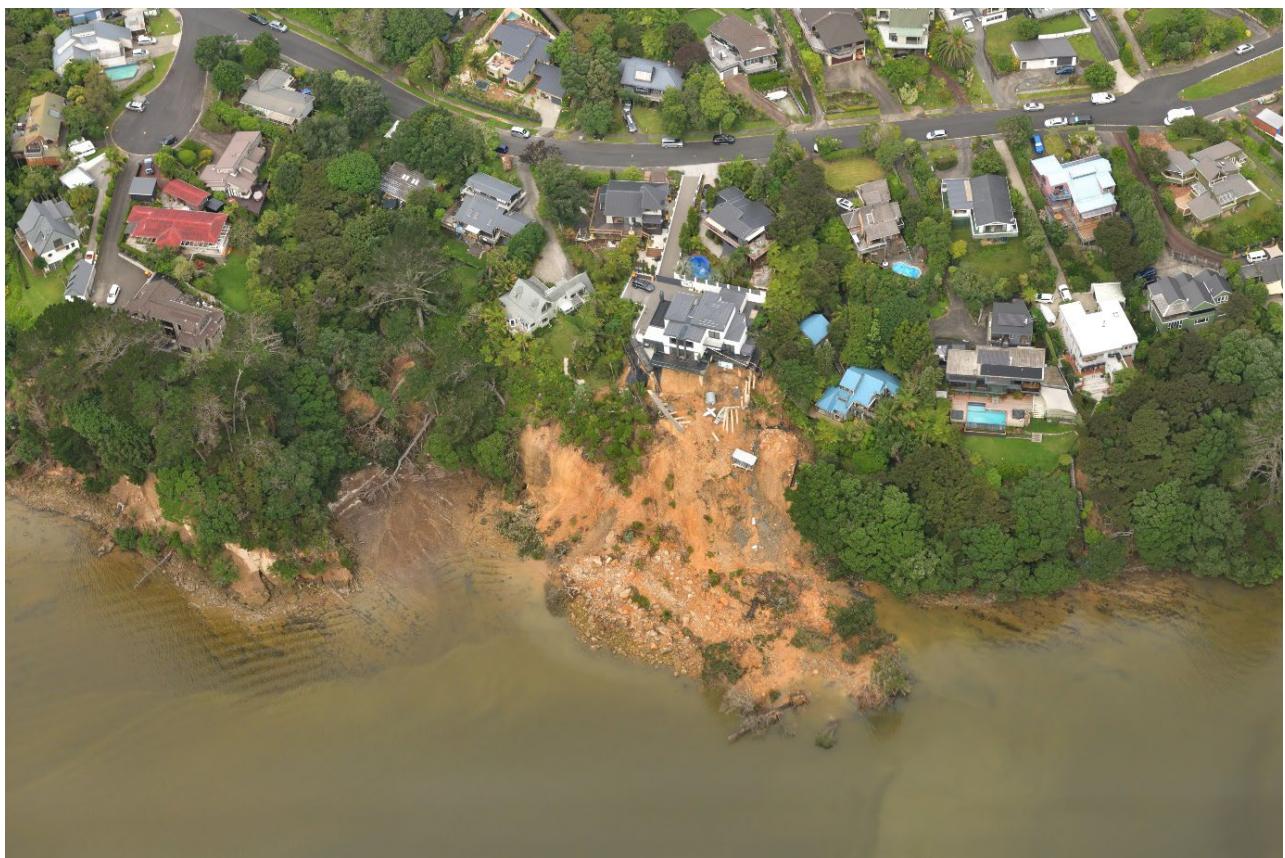
Figure A1.26 Photo 856\_4428: Deep-seated collapse of weathered Miocene East Coast Bays Formation, undermining a house near Beach Haven, Birkenhead.

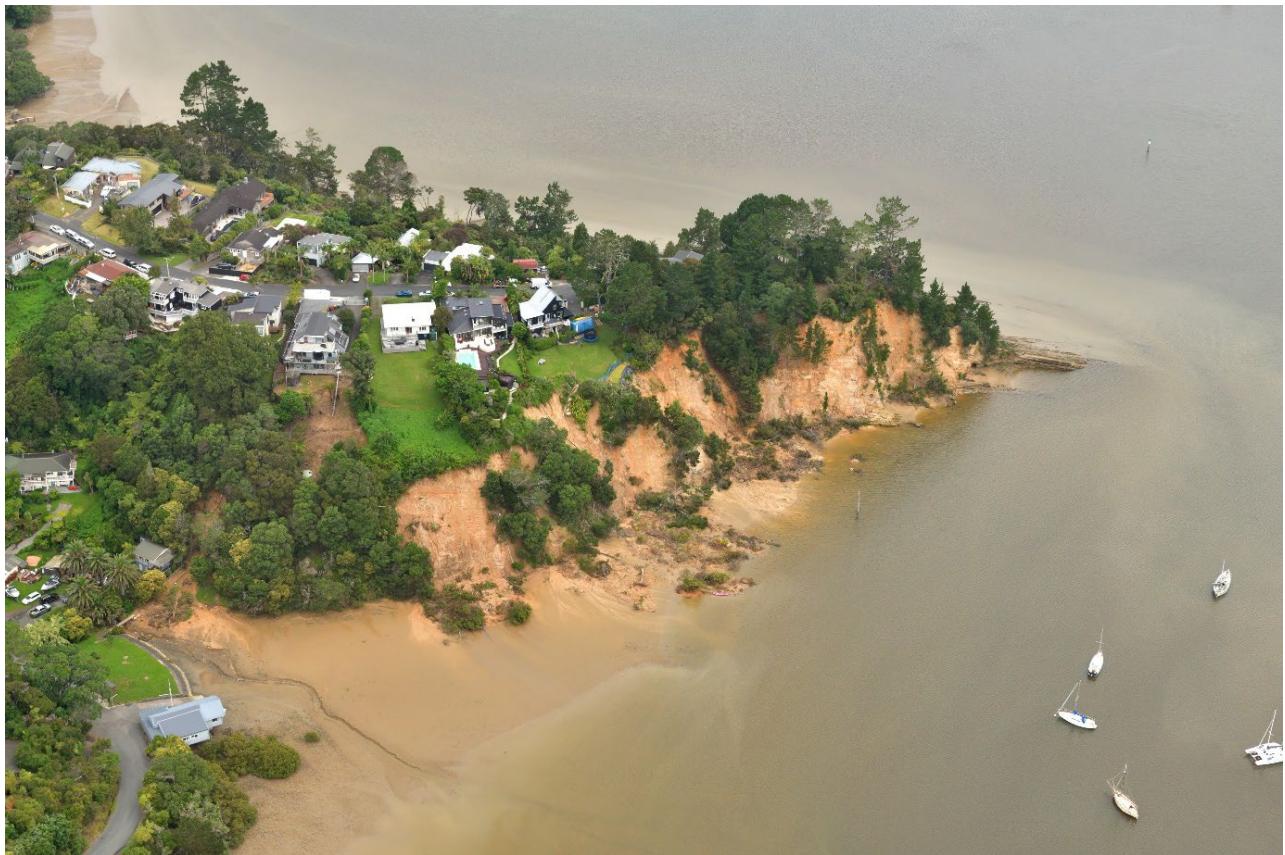
Figure A1.27 Photo 856\_4392: Multiple failures in weathered East Coast Bays Formation, Greenhithe.

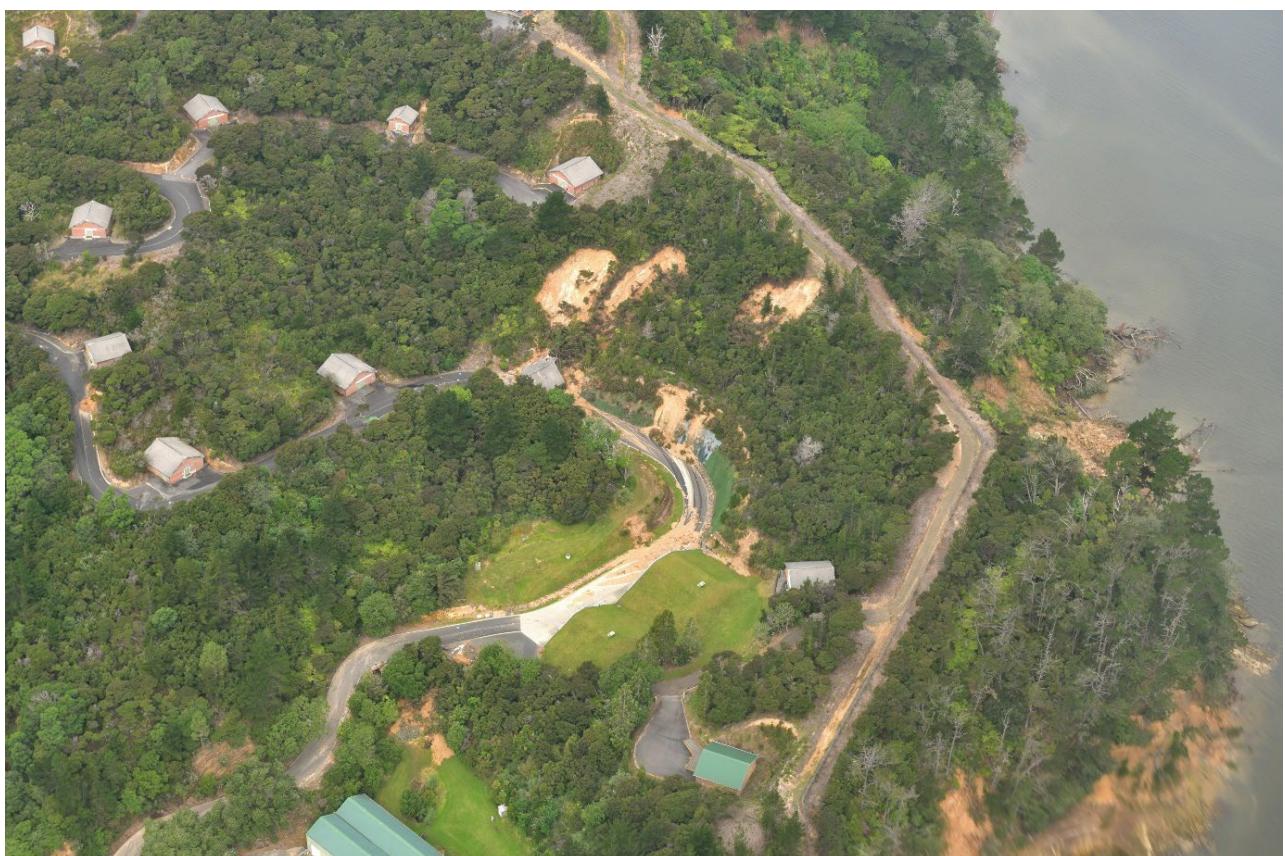
Figure A1.28 Photo 856\_4440: Multiple small failures at Onetaunga Bay, Chatswood. Note that one building has been pushed off its foundations and is now on the road.

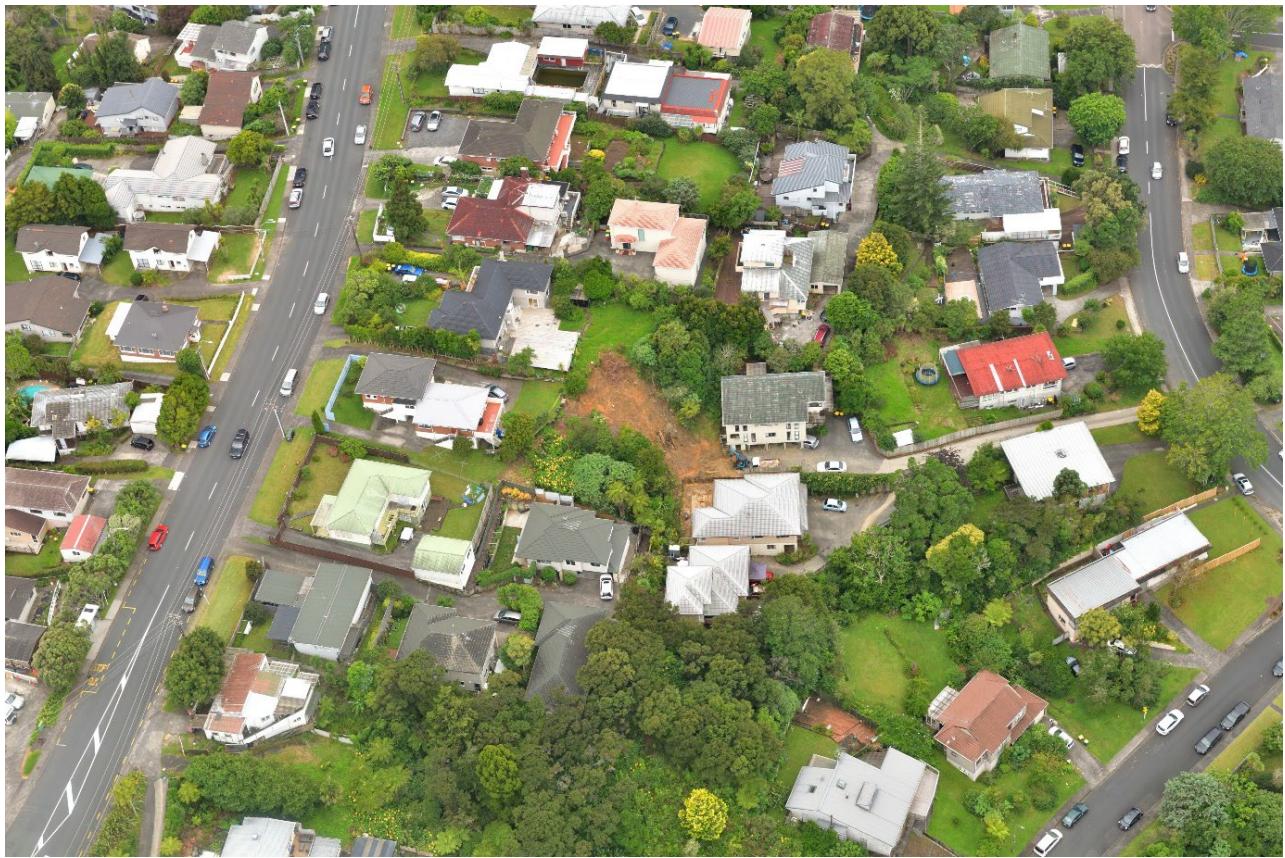
Figure A1.29 Photo 856\_4028: Collapse of a property at Glenfield.

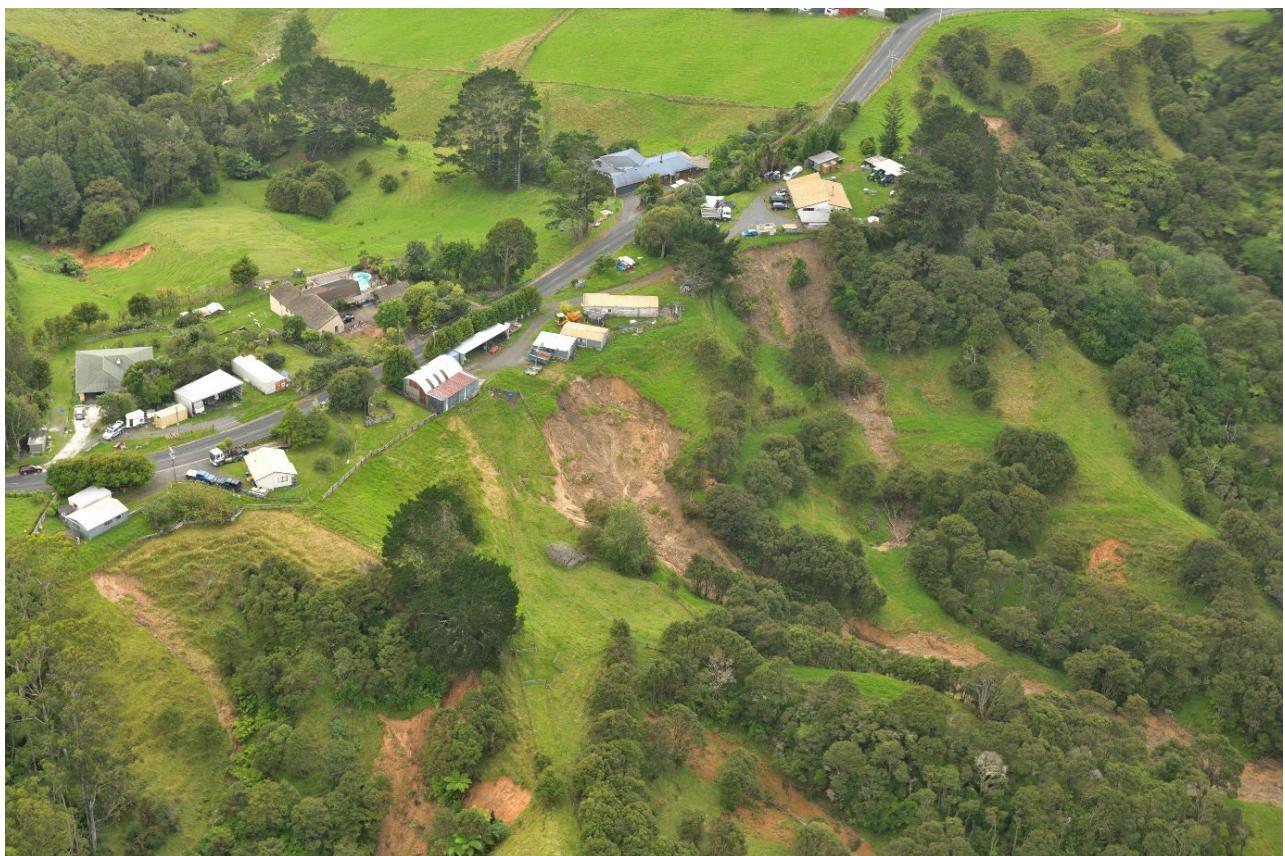
Figure A1.30 Photo 856\_4359: Multiple collapses affecting properties at Albany Heights.

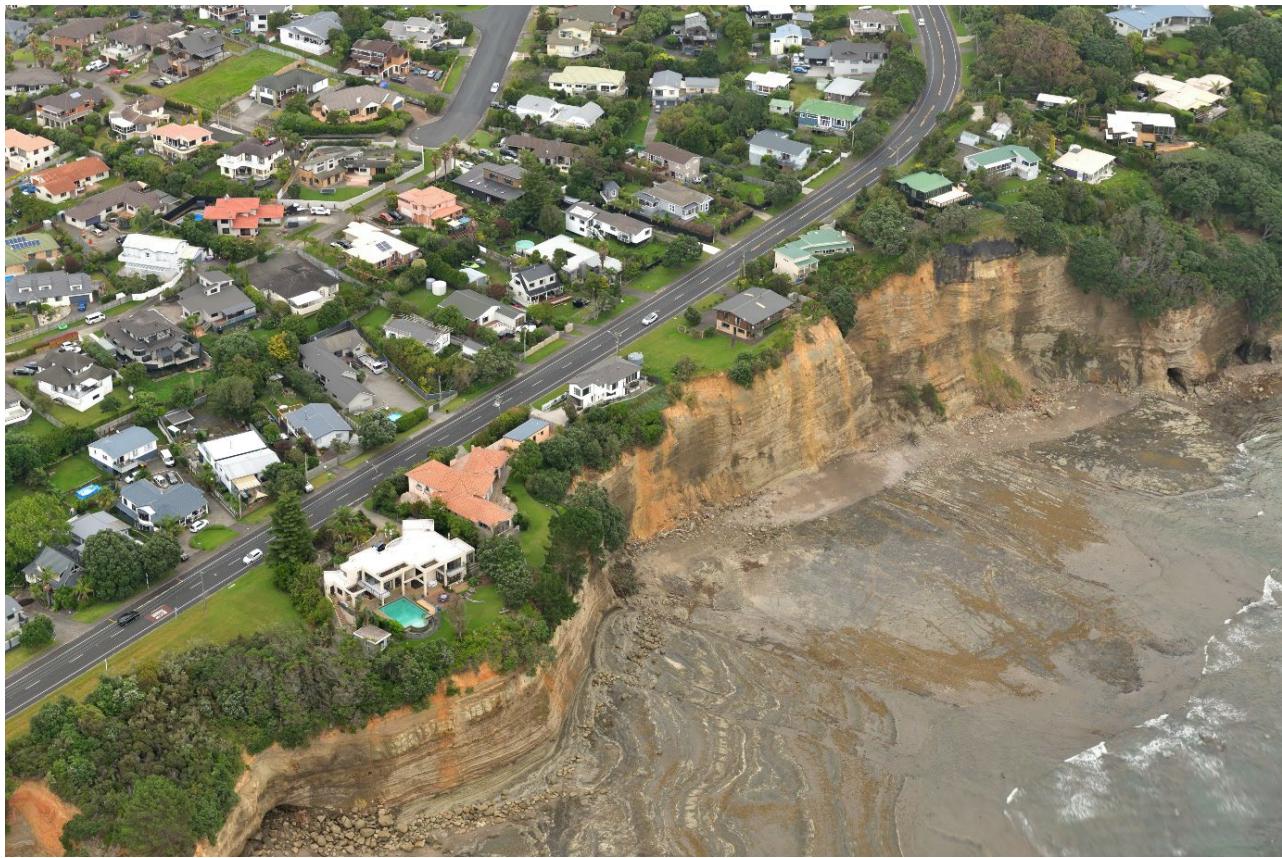
Figure A1.31 Photo 856\_3975: Minor clifftop collapses, Whangaparāoa Peninsula.

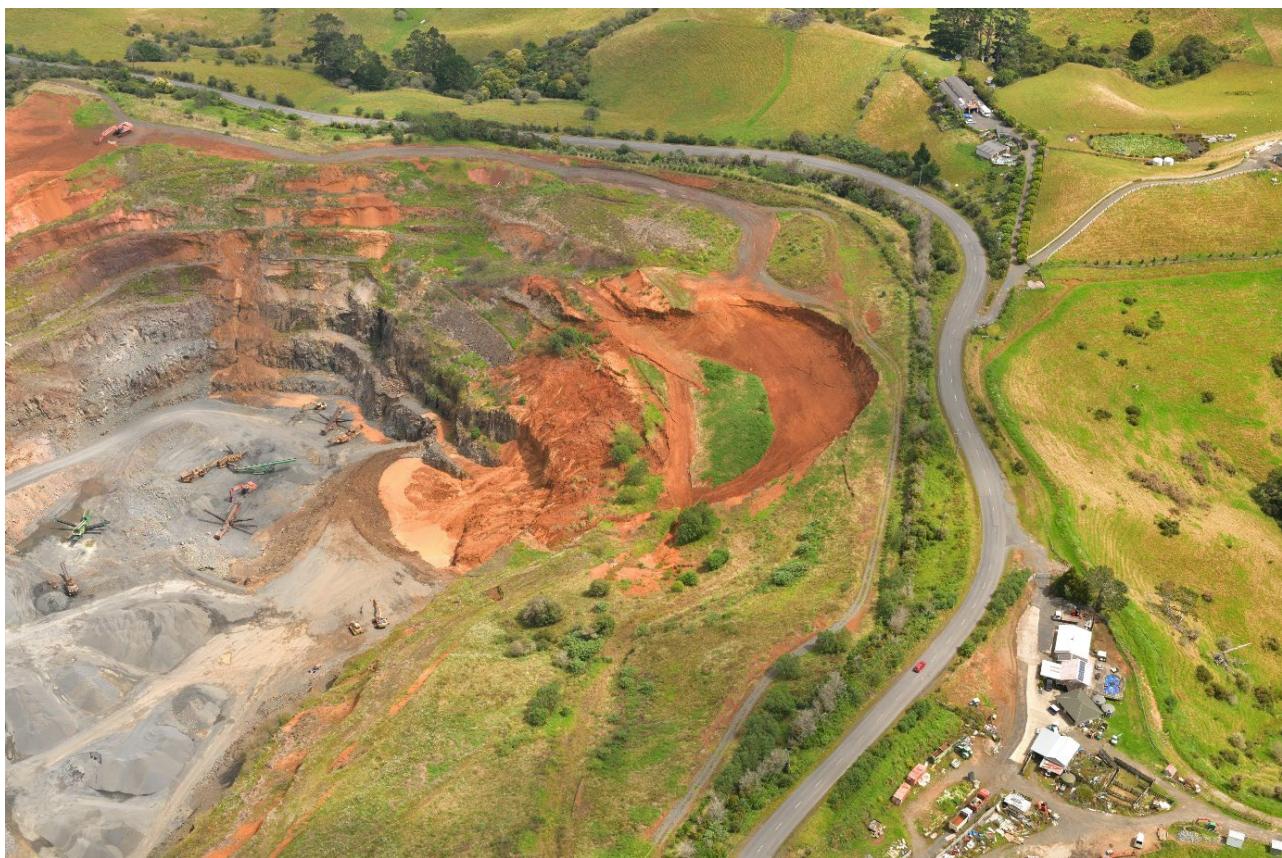
Figure A1.32 Photo 856\_4126: Collapse in a quarry near Pōkeno, likely to be a re-activation of an earlier slump.

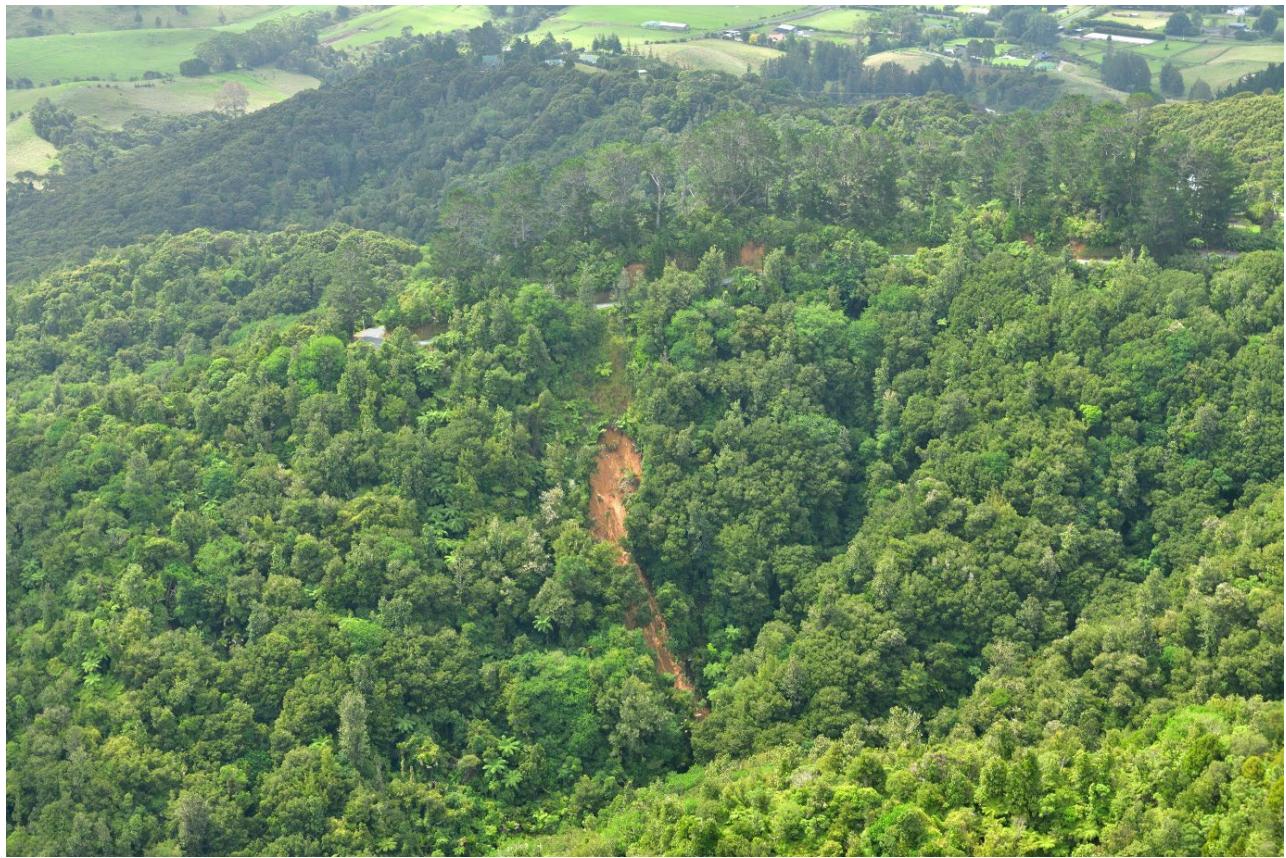
Figure A1.33 Photo 856\_4209: Minor collapses in bush and along road cuttings, Ness Valley, north of the Hūnua Ranges.

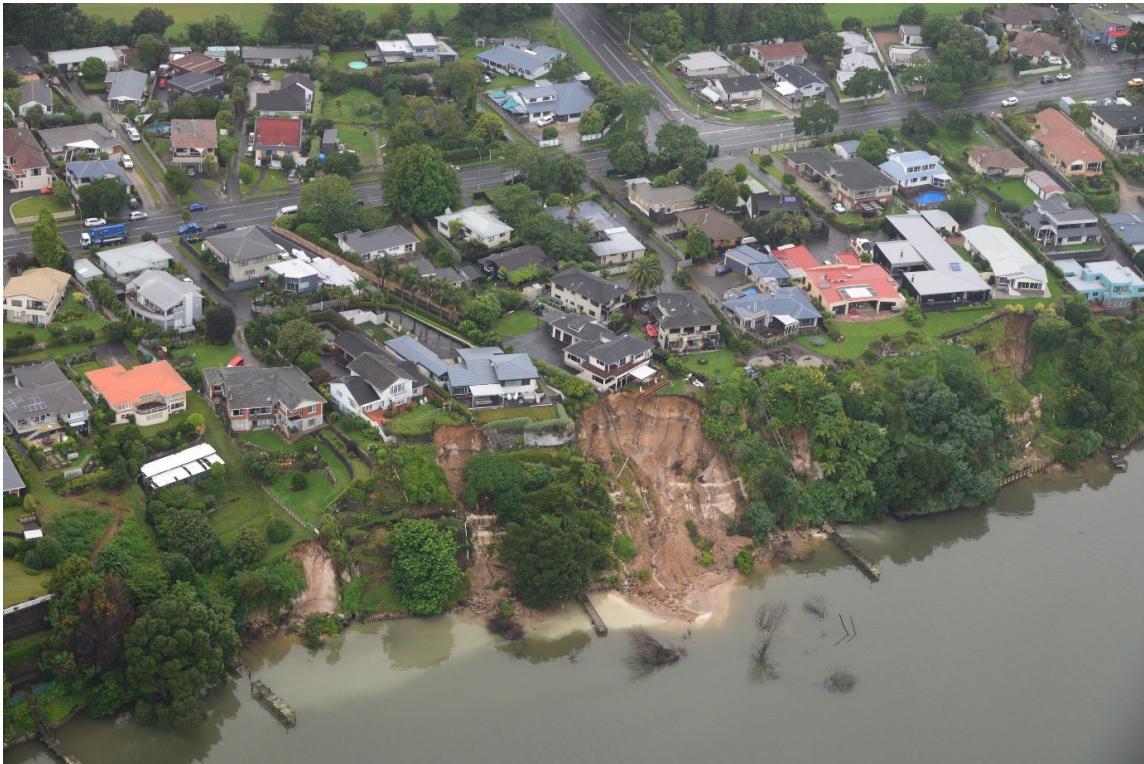
Figure A2.1 Photo DSC\_9385: Landslides along steep coastal slopes and cliffs of Waimapu Estuary (Tauranga), some of which have affected residential properties.

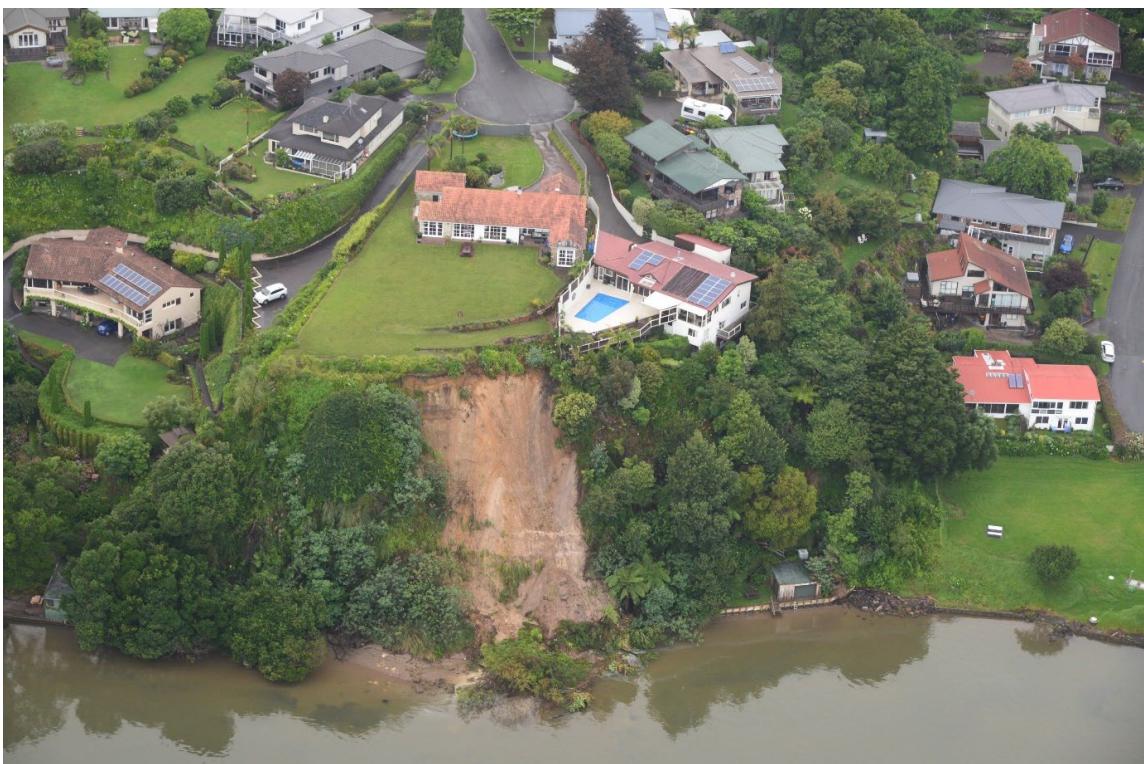
Figure A2.2 Photo DSC\_9392: Example of landslide from steep coastal slope of Waimapu Estuary (Tauranga).
