## **GeoNet Landslide Response: Auckland Anniversary Storm, 26–30 January 2023, northern New Zealand**

**GNS Science Report 2025/32  
November 2025**

## ABSTRACT

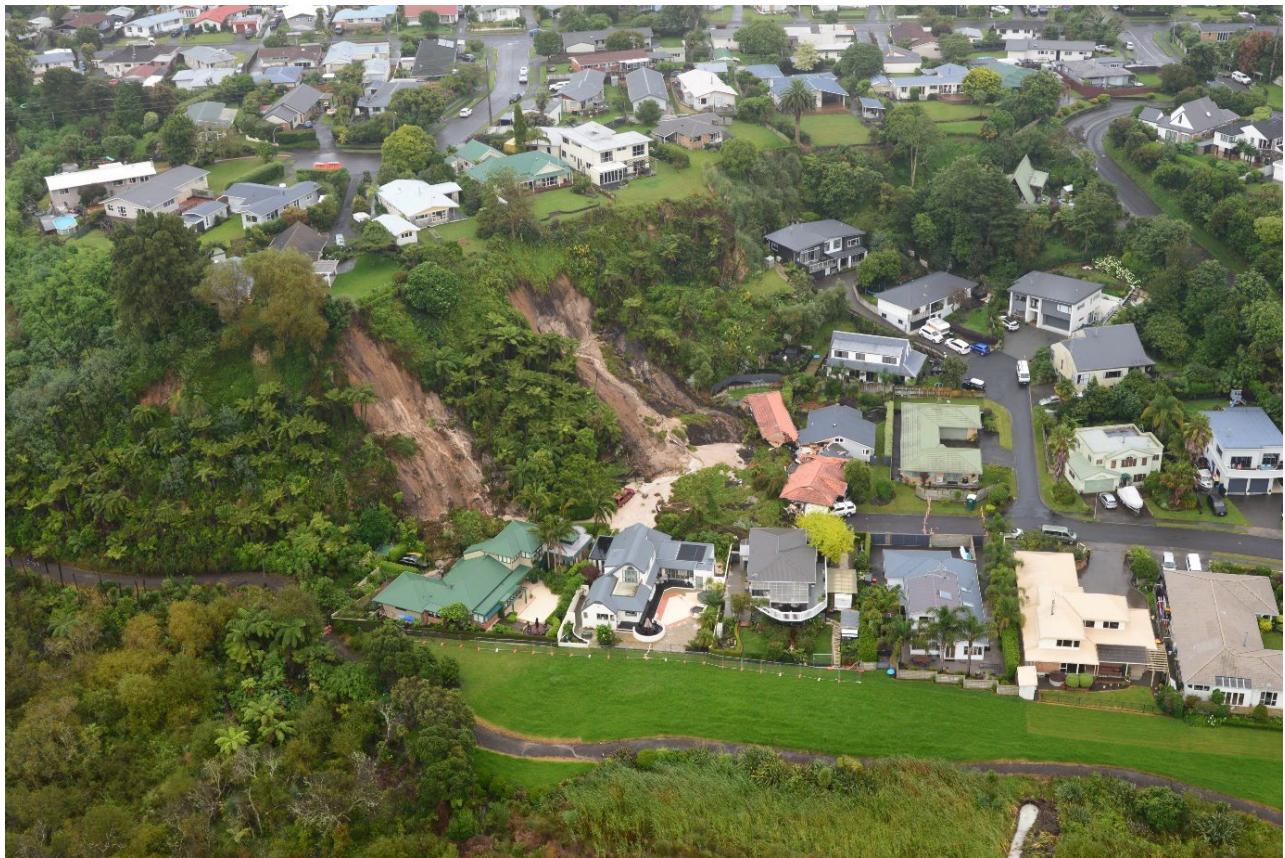
Figure A2.3 Photo DSC\_9359: Two landslides in Welcome Bay (Tauranga) that significantly impacted houses, with one displacing a house by tens of metres.

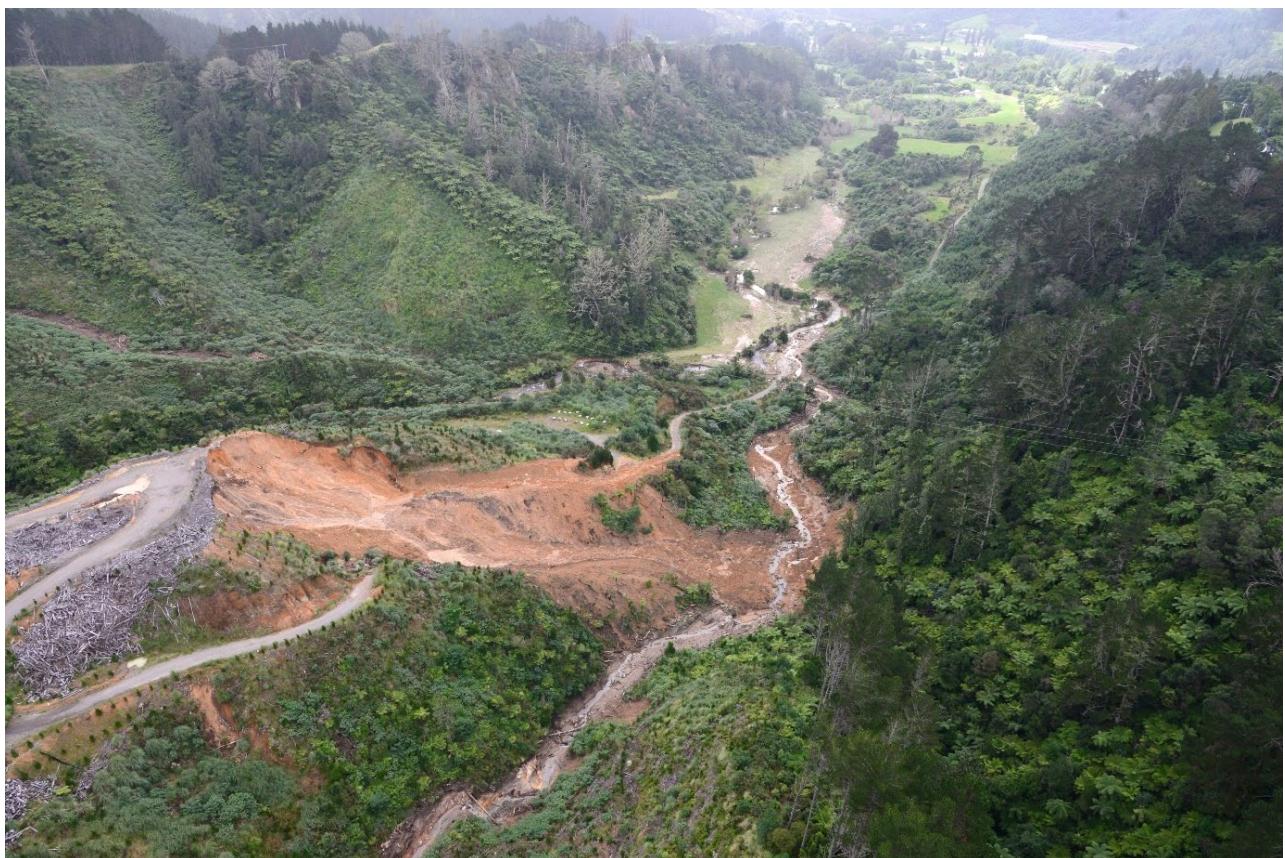
Figure A2.4 Photo DSC\_9154: A debris flow from a forestry slope that has choked a stream with sediment and woody debris, in the Waitao catchment (Tauranga).

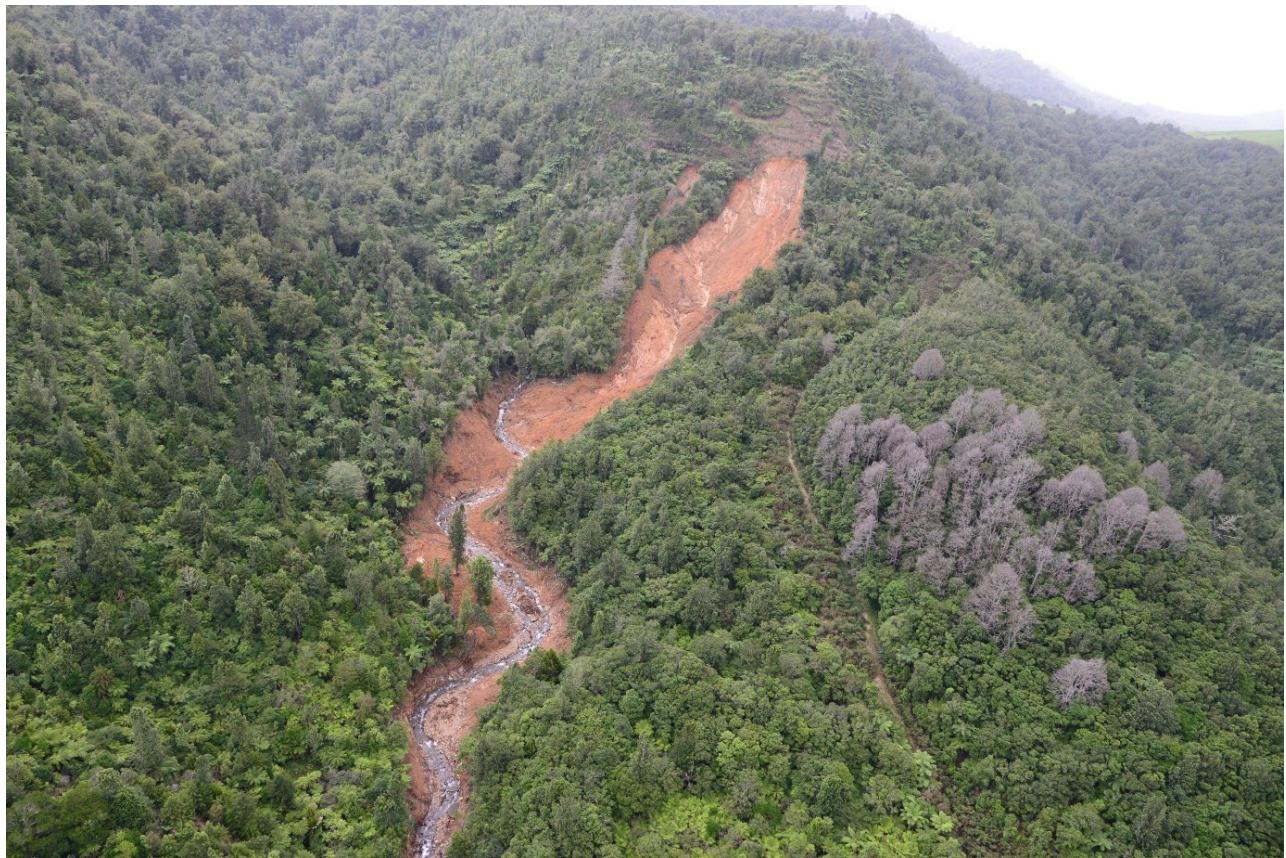
Figure A2.5 Photo DSC\_9224: Large debris flow in regenerating forest southwest of Te Puke (Bay of Plenty).

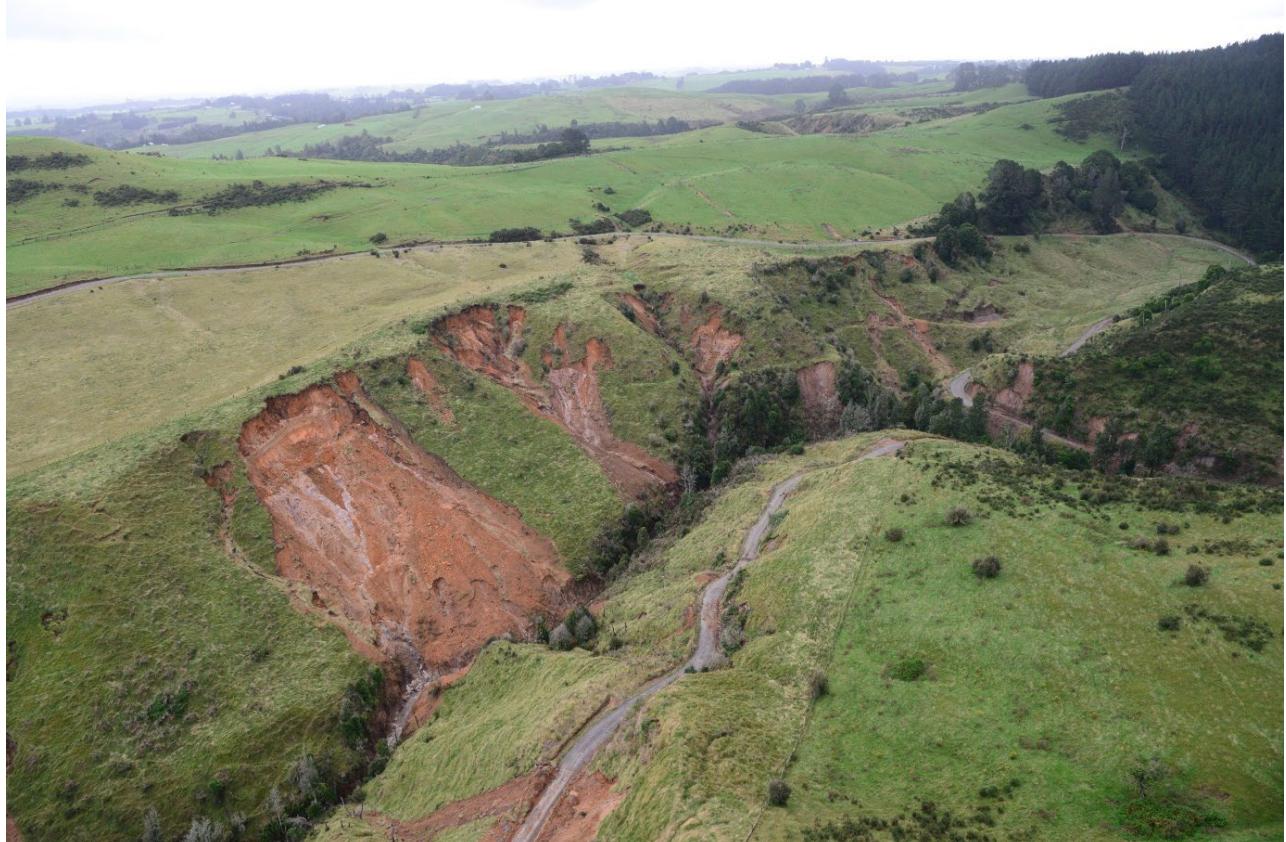
Figure A2.6 Photo DSC\_9198: Examples southwest of Te Puke (Bay of Plenty) of landslides along valley shoulders (breaks in slope), which were particularly common in pasture and scrub.

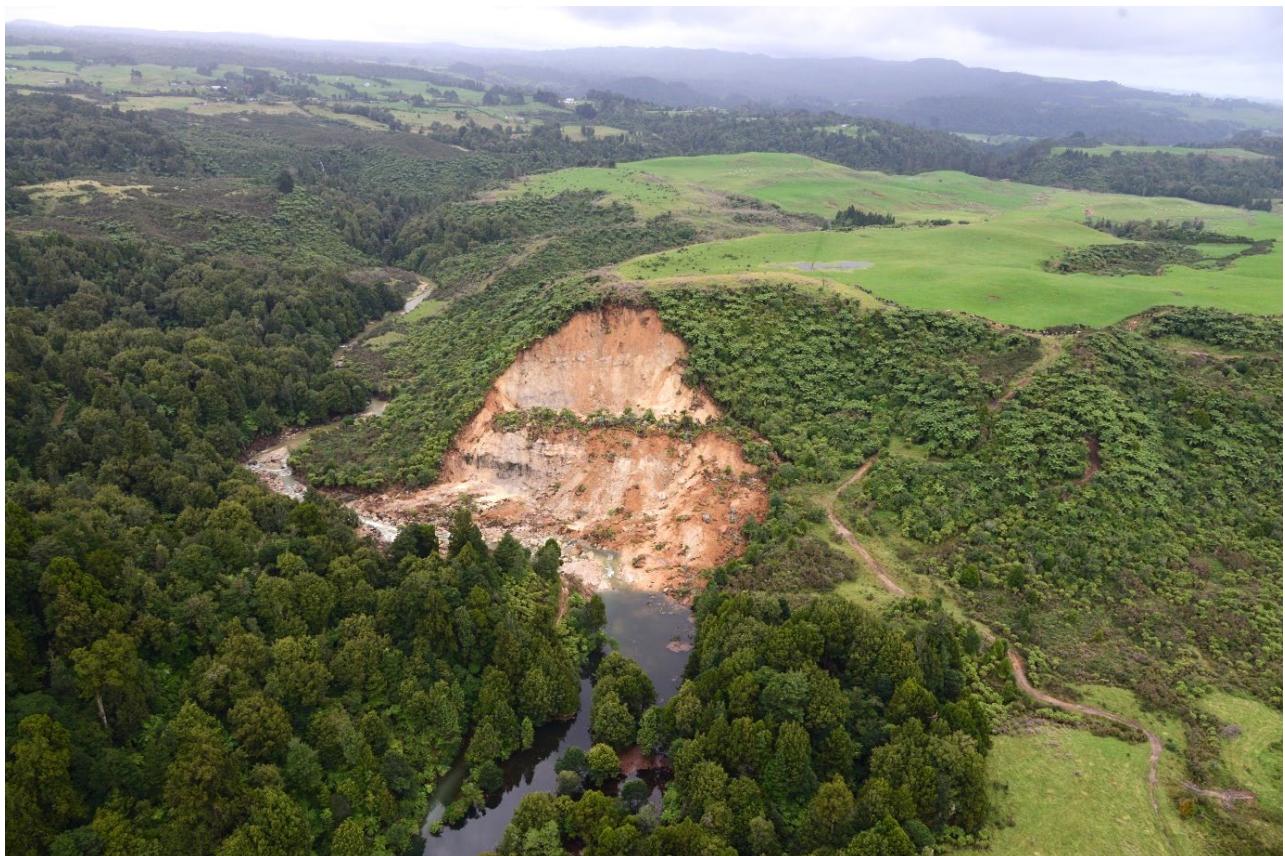
Southern Kaimai Range	46	10	301	127	Landslides mostly in native forest along river valleys, some affecting property (Figure A2.7). One large landslide blockage of Kaukaumoutiti Stream, involving collapse of spur on outside bend of river (Figure A2.8). Lake still present at time of photograph, but dam breached (overtopped). A few minor failures in areas of pasture (Figure A2.9). Mostly occurred within volcanic rocks (Mamaku Plateau Formation, Whakamārama Group, and Pokai Formation).
Central Tauranga Harbour	50	6	200	96	Landslides in this area were mostly shallow debris slides and avalanches from steep coastal slopes, typically within mid-Pleistocene sediments. Several appear to be re-activations of older landslides (Figure A2.10). Several occurred close to residential properties or affected horticultural areas (Figure A2.11). A landslide damaged Wairoa Road (Figure A2.12).
Northern Tauranga Harbour	9	0	243	119	Debris falls and slides from steep coastal slopes, some re-activations, generally distant from built-up areas (i.e. in public reserve; Figure A2.13).

Figure A2.8 Photo DSC\_9274: A large rotational landslide from outside of a bend in the of Kaukaumoutiti Stream in southern Kaimai Range (Bay of Plenty), and the impounding of the river by the debris dam.

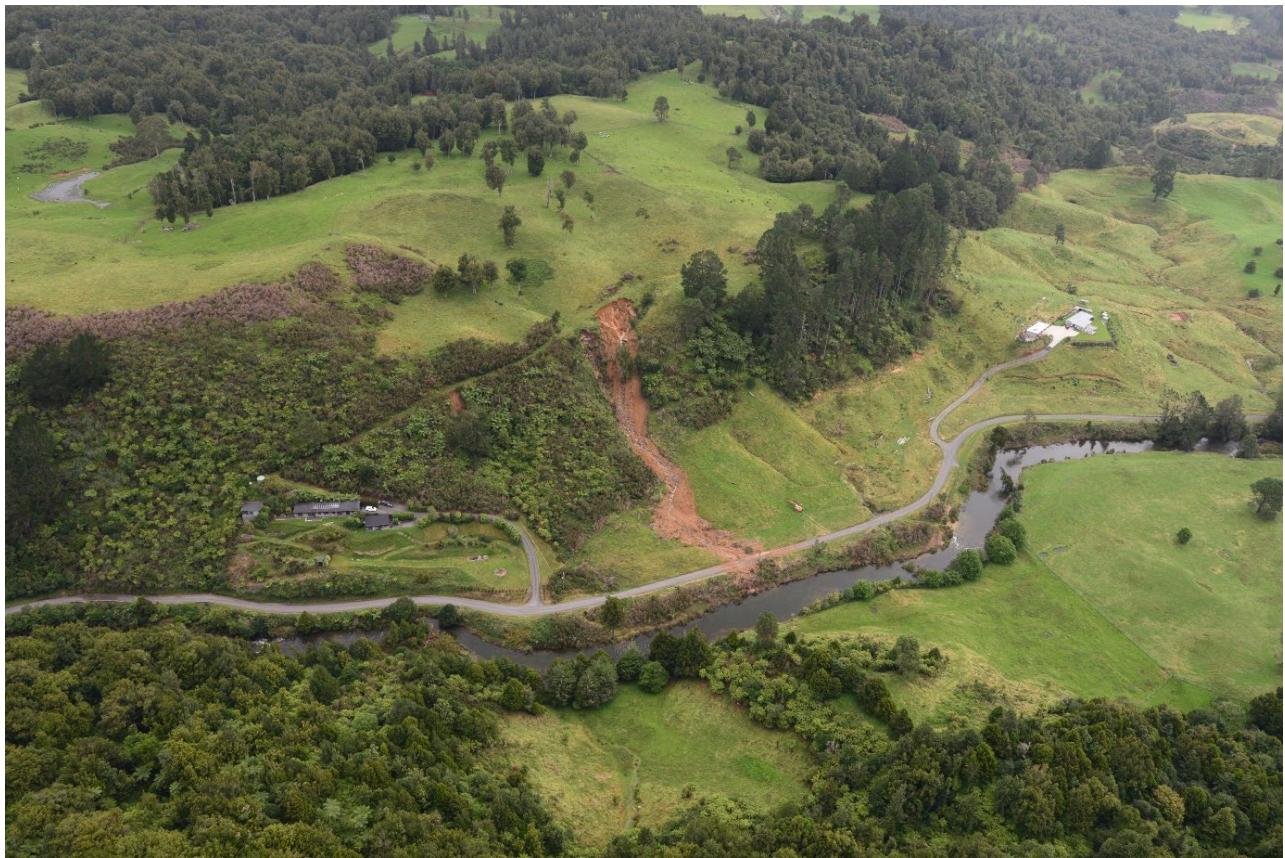
Figure A2.9 Photo DSC\_9284: Example of small debris flow onto a vehicle track, southern Kaimai Range (Bay of Plenty).

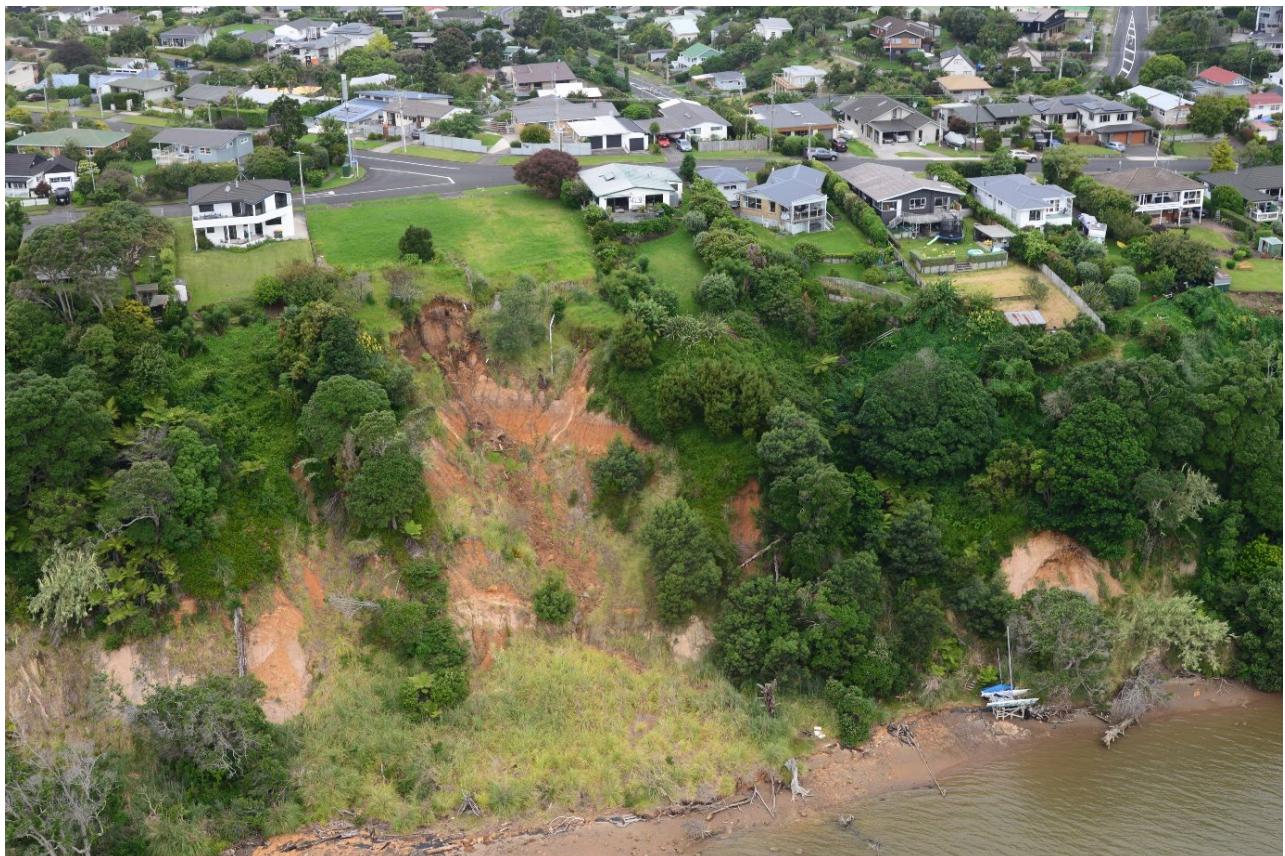
Figure A2.10 Photo DSC\_9308: Example of small shallow debris avalanche near Tauranga Harbour.

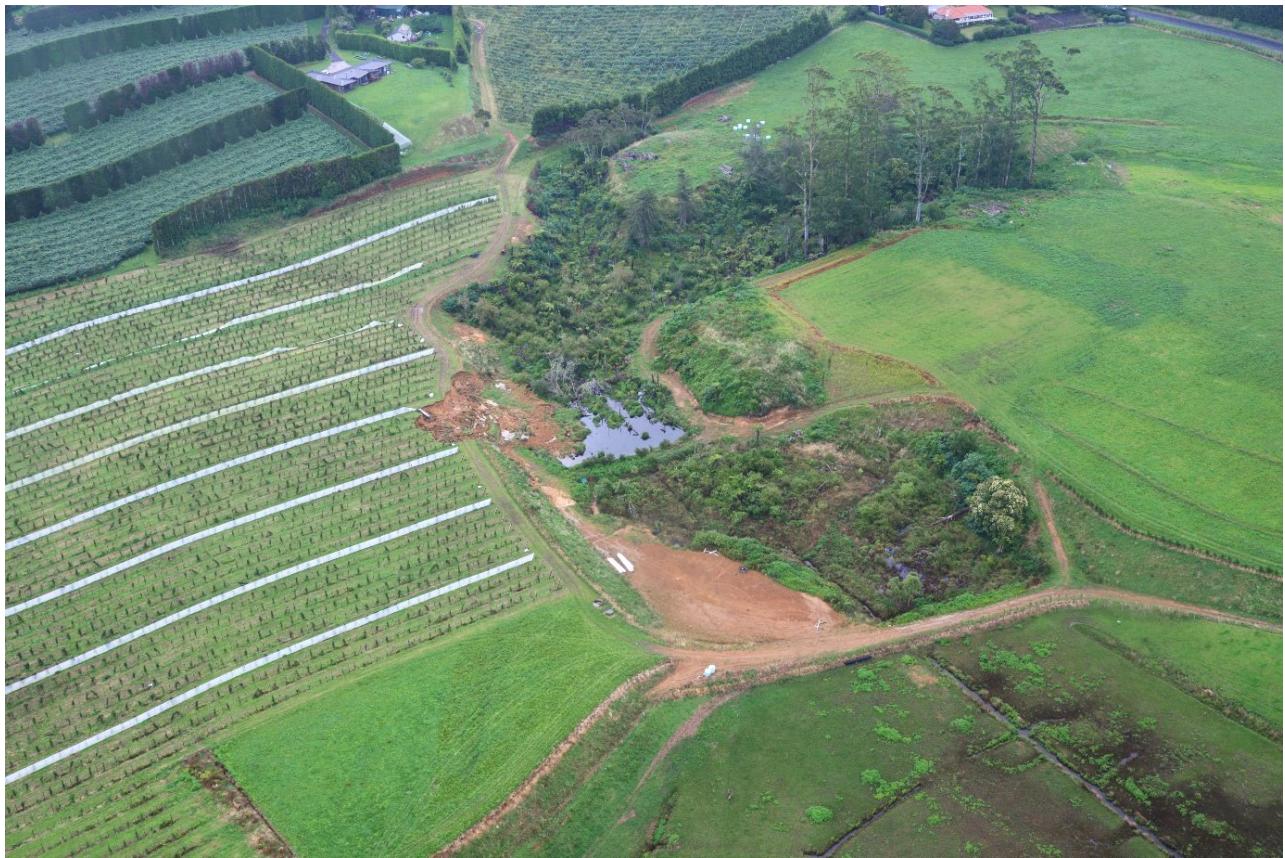
Figure A2.11 Photo DSC\_9303: Example of a debris slide affecting horticultural land in Aongatete, Tauranga Harbour.

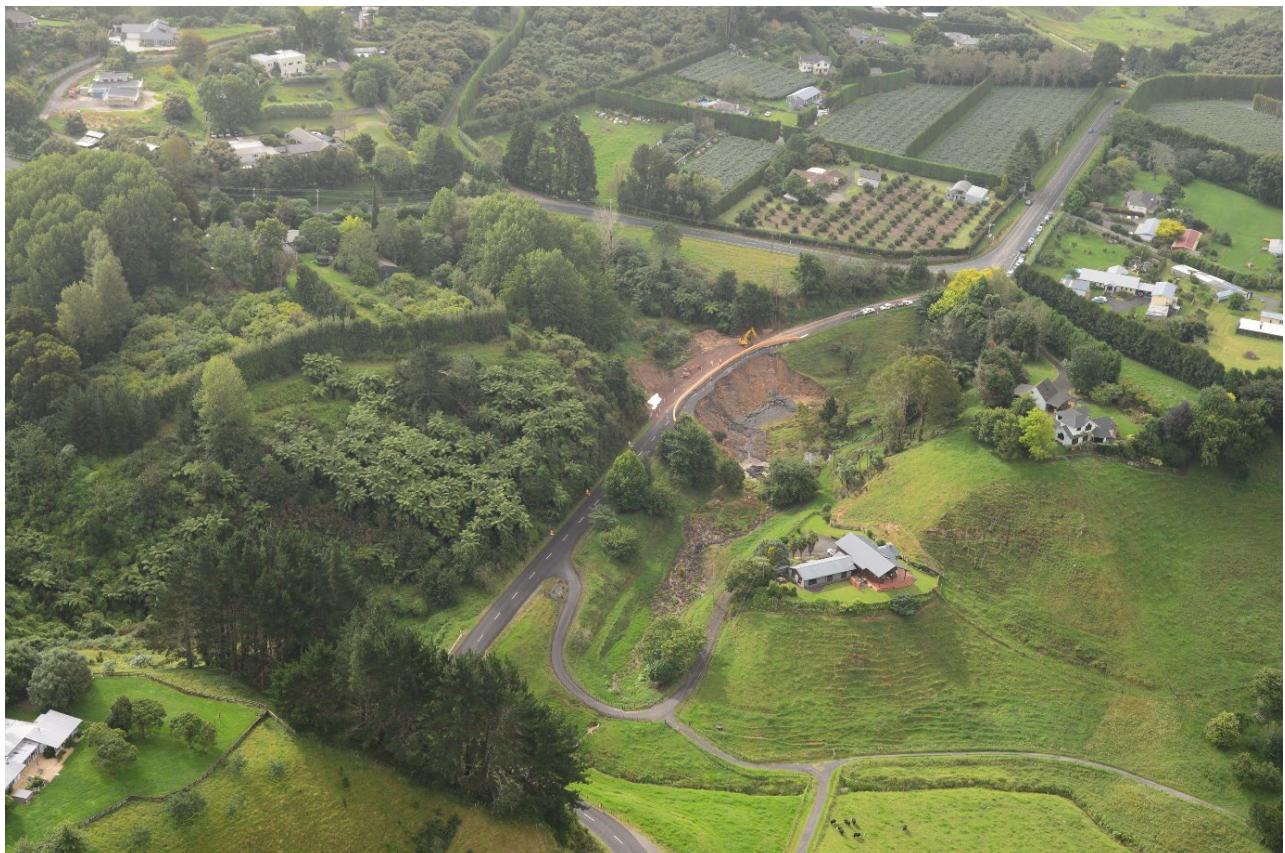
Figure A2.12 Photo DSC\_9335: Landslide that damaged Wairoa Road (Wairoa, Tauranga Harbour), for which remedial works were underway.

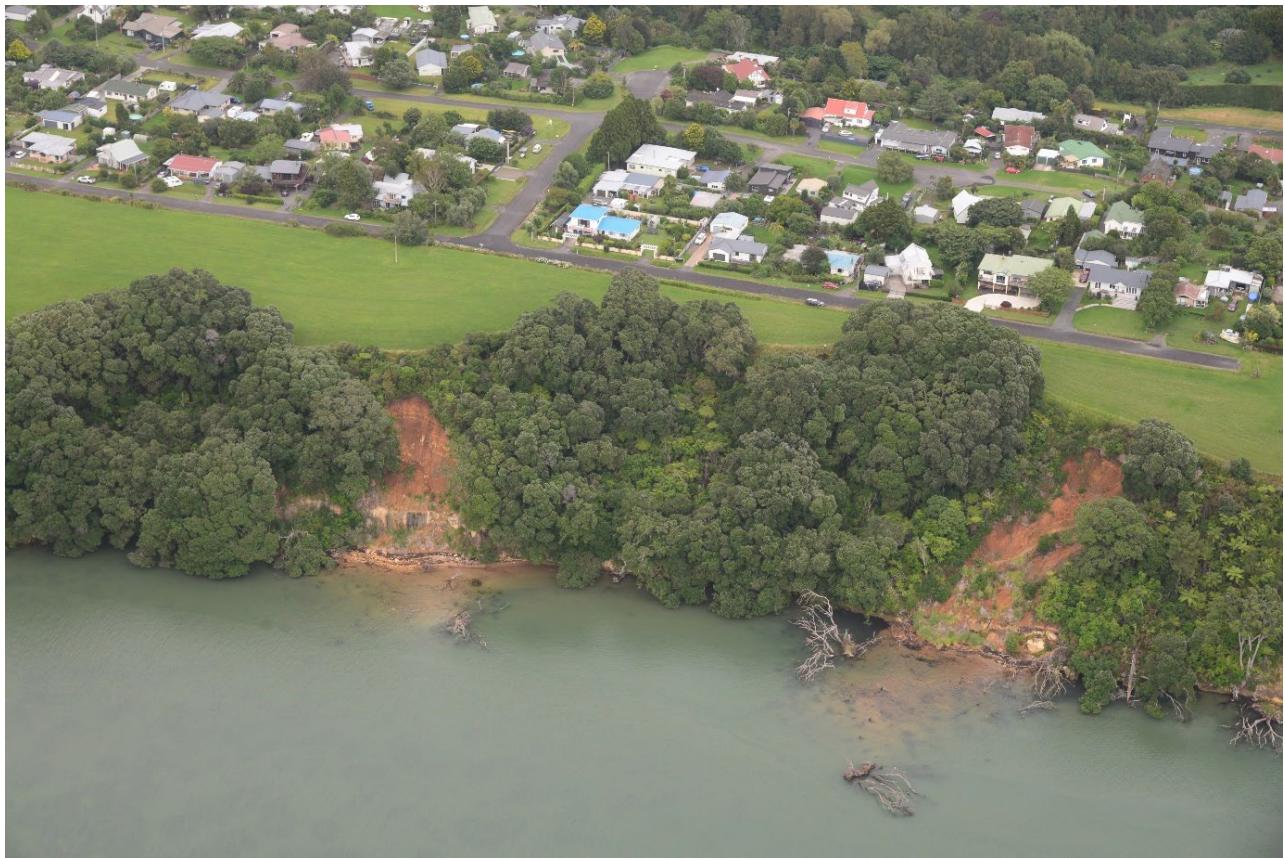
Figure A2.13 Photo DSC\_9399: Small debris slides and avalanches in regenerating bush at Kauri Point, Tauranga Harbour.

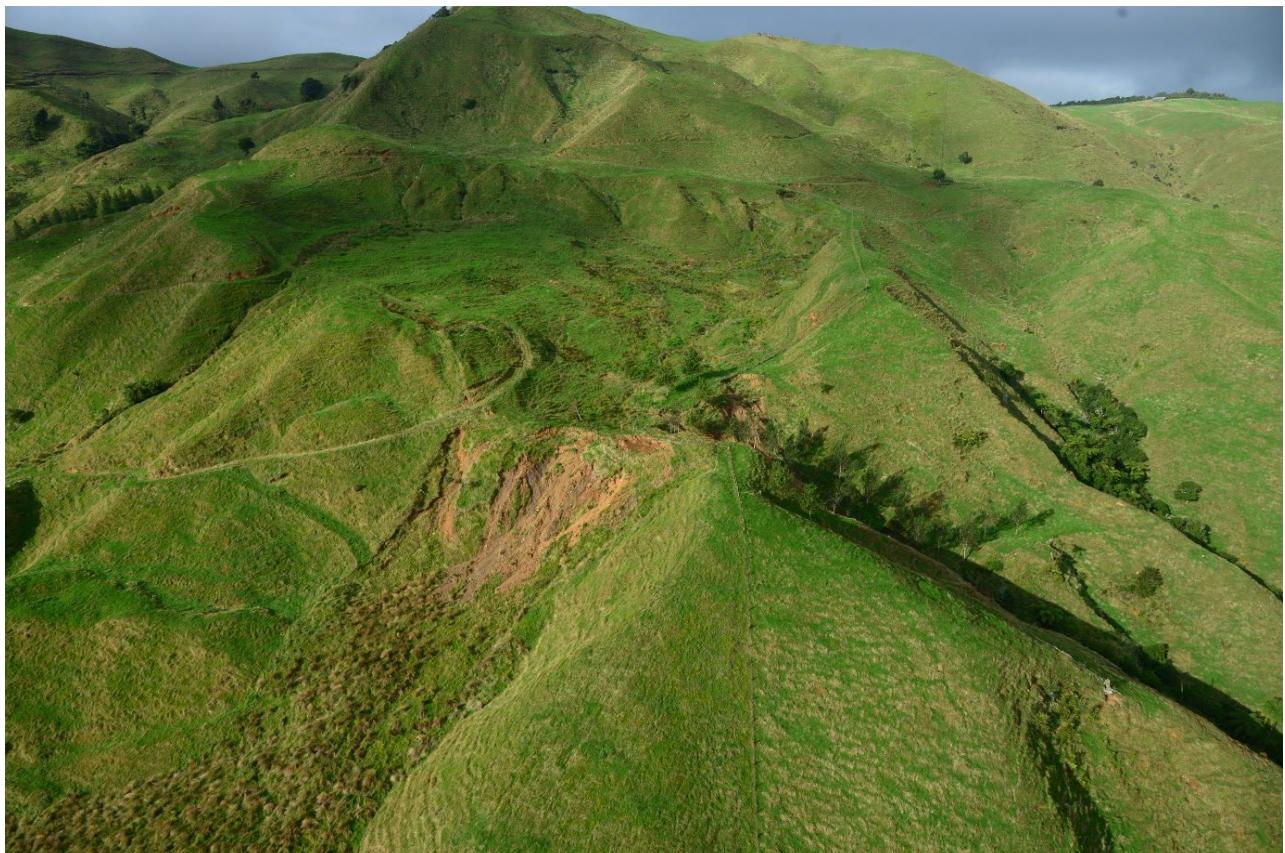
Figure A2.14 Photo DSC\_9955: Example of small, shallow soil avalanches/flows on hill country terrain (in pasture), near Te Aroha, Kaimai Range.

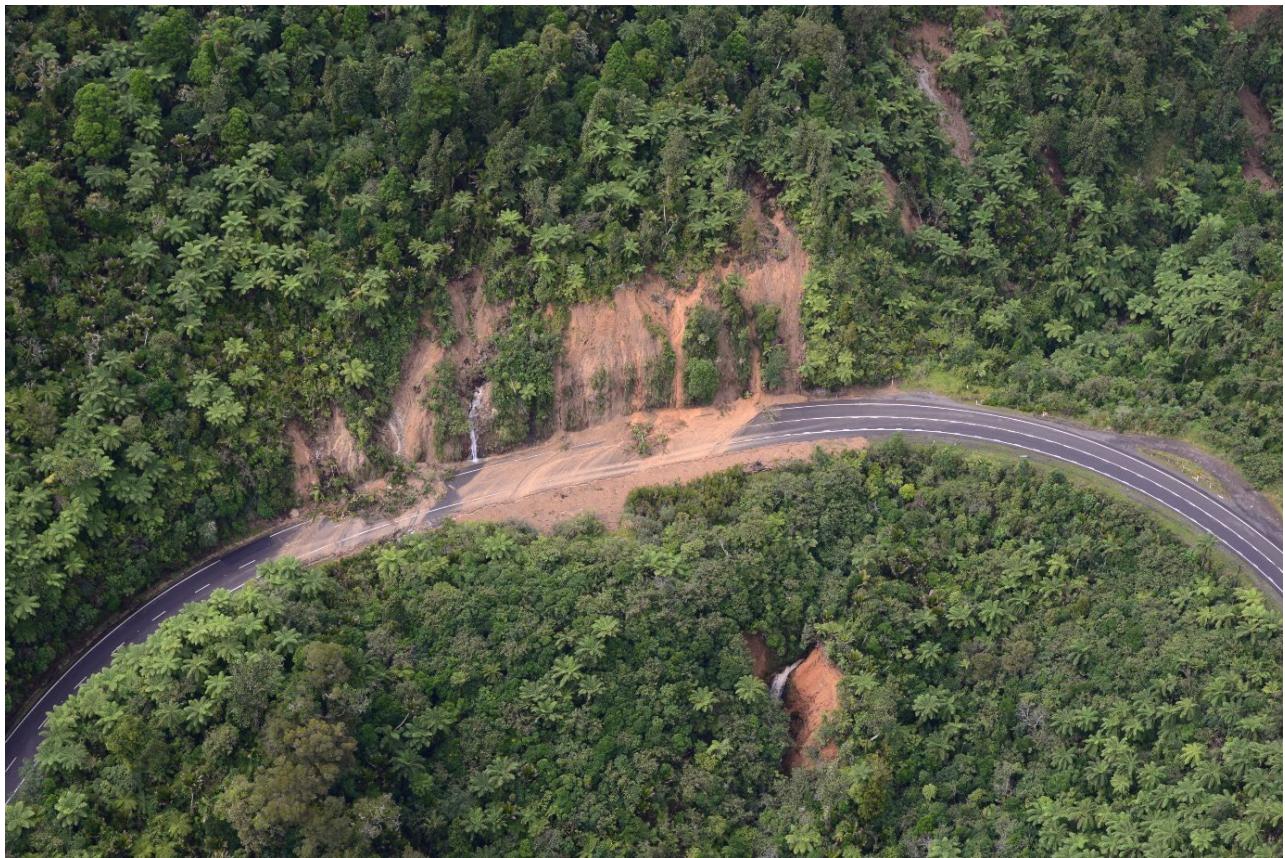
Figure A2.15 Photo DSC\_9428: Shallow soil and vegetation failures onto State Highway 25A, Neavesville, Coromandel Peninsula.

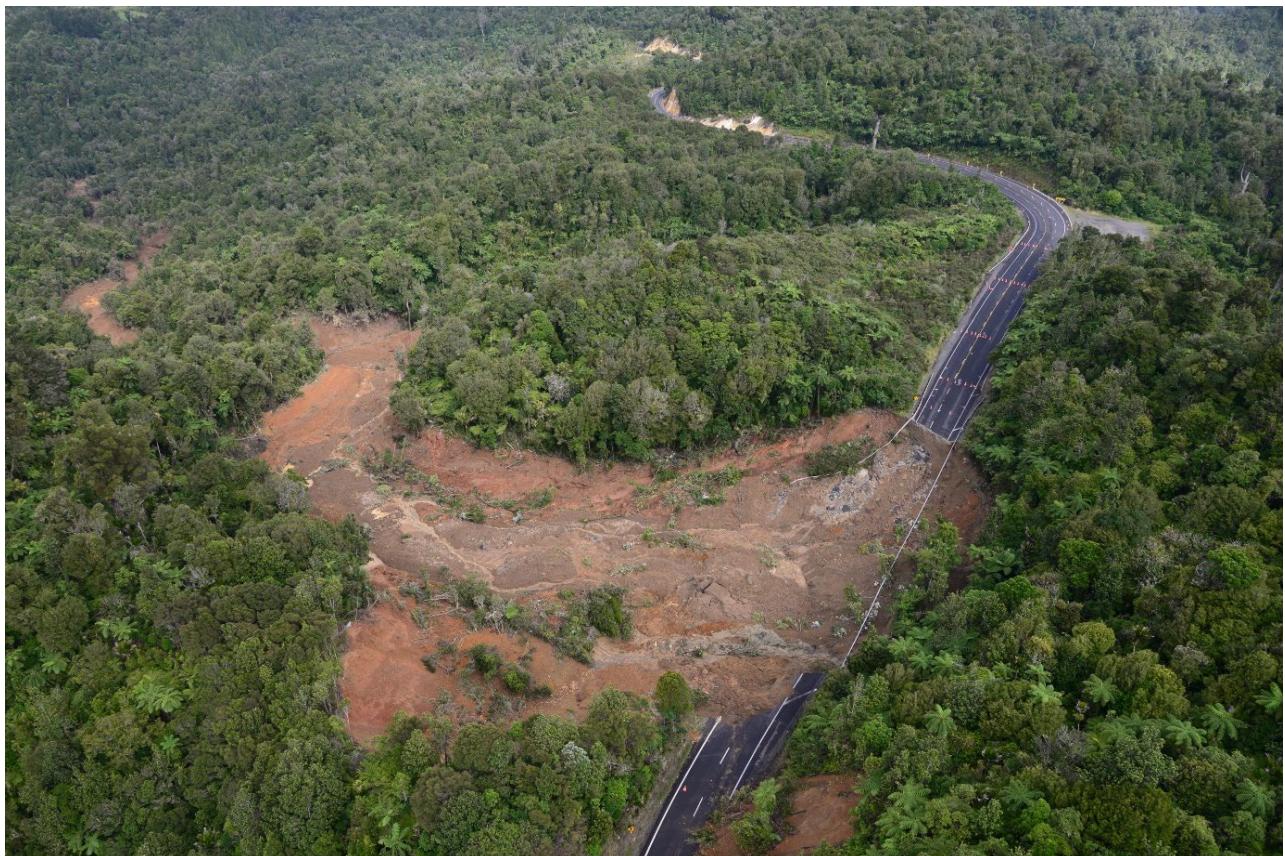
Figure A2.16 Photo DSC\_9444: Large debris flow sourced from a gully-head failure that has undermined State Highway 25A, Coromandel Peninsula. The debris flow travelled 1.5 km into Kirikiri Stream.

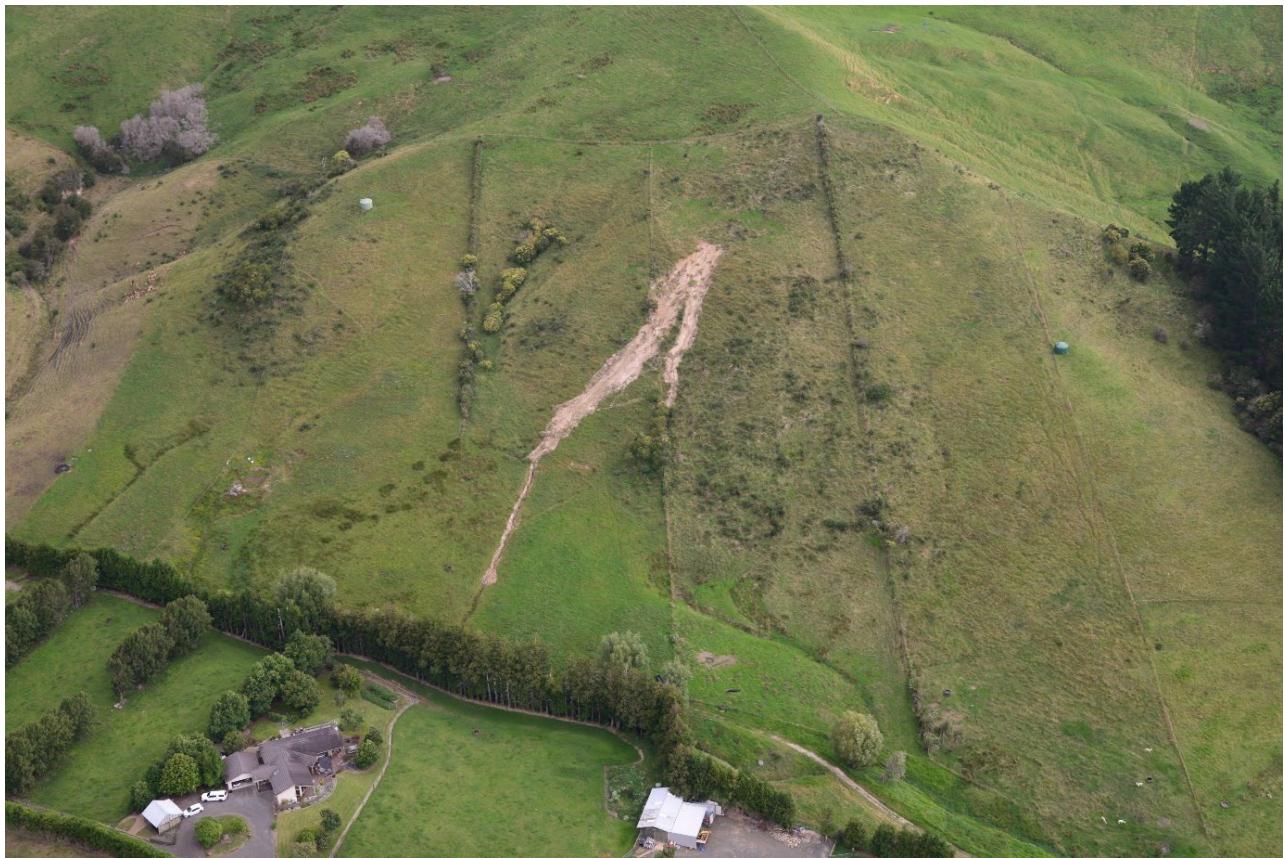
Figure A2.17 Photo DSC\_9936: Example of small debris flow above a house, in Puriri, Coromandel Range.

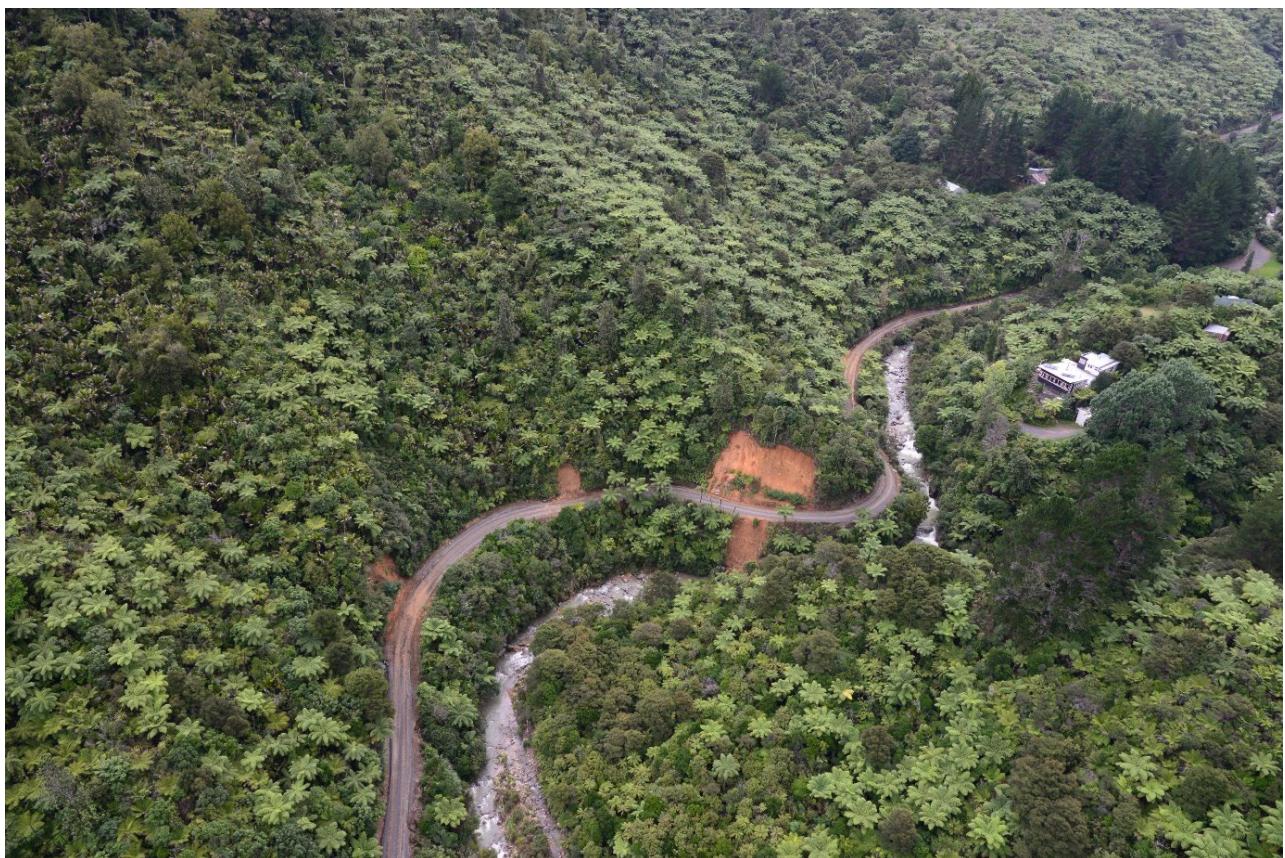
Figure A2.18 Photo DSC\_9458: Examples of landslides along roads, commonly failing from the upslope side (cut bank) of the road. Tararu, Coromandel Range.

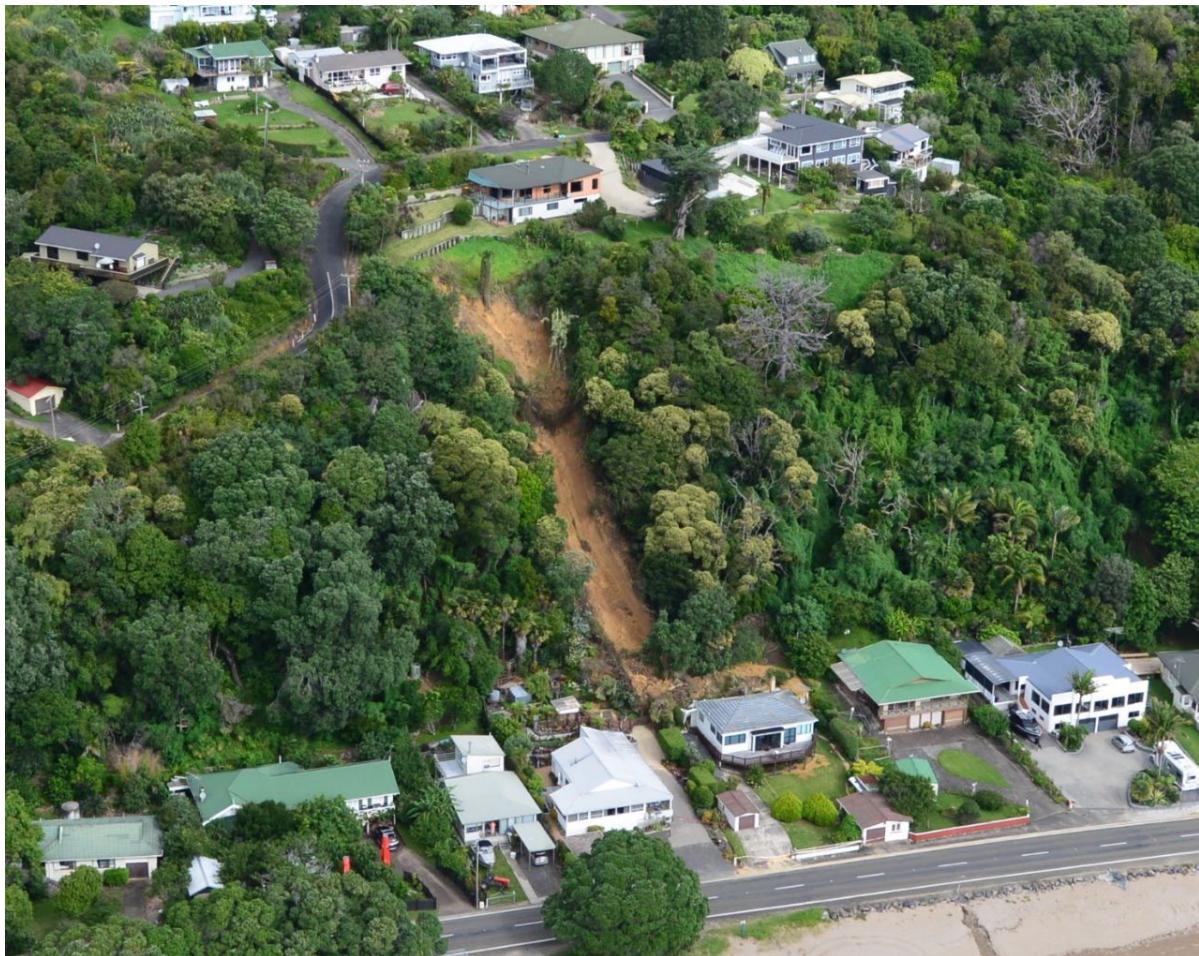
Figure A2.19 Photo DSC\_9913b: Debris slide that transitioned into a flow and impacted a house in Thornton Bay, Coromandel Range.

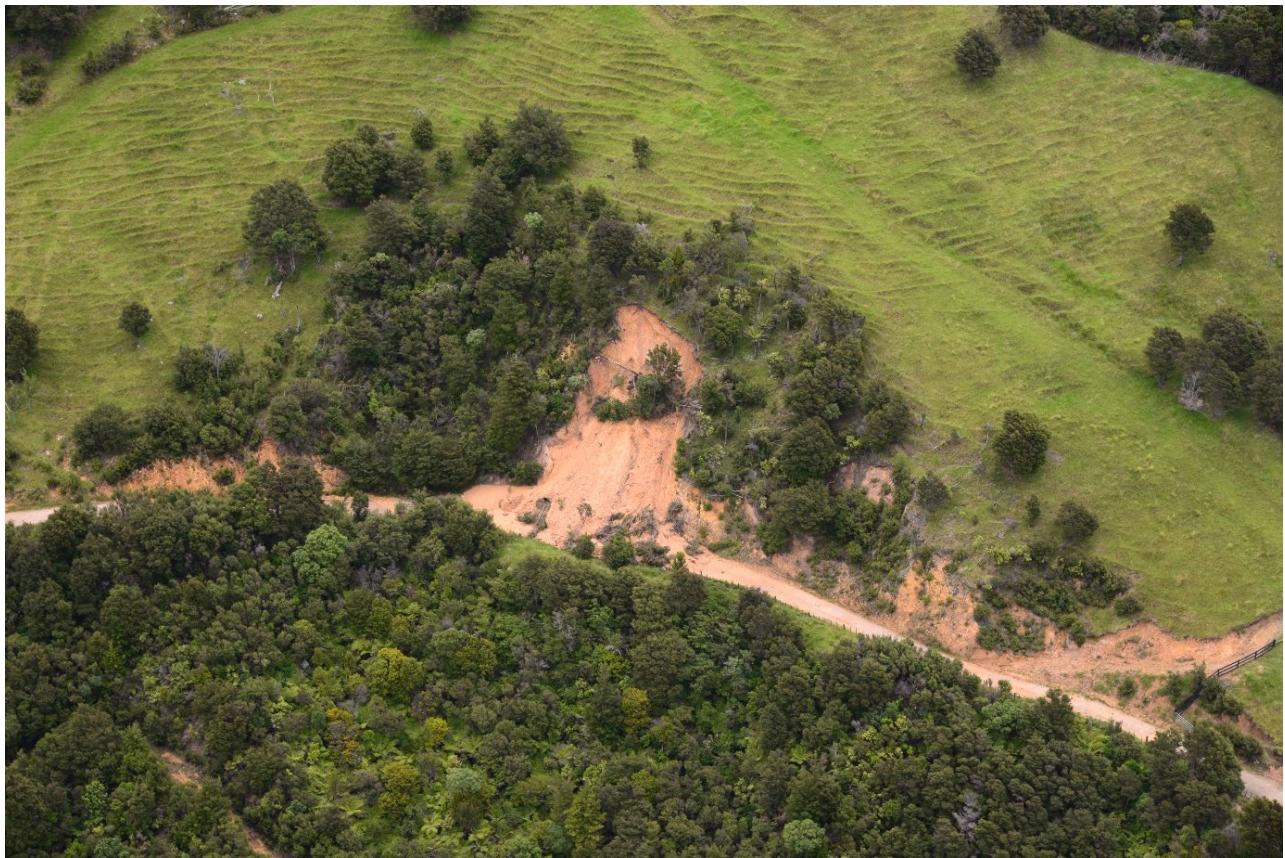
Figure A2.21 Photo DSC\_9464: Debris slides and falls were common along rural roads, driveways and farm tracks, such as in this example from Waiomu, Coromandel Range.

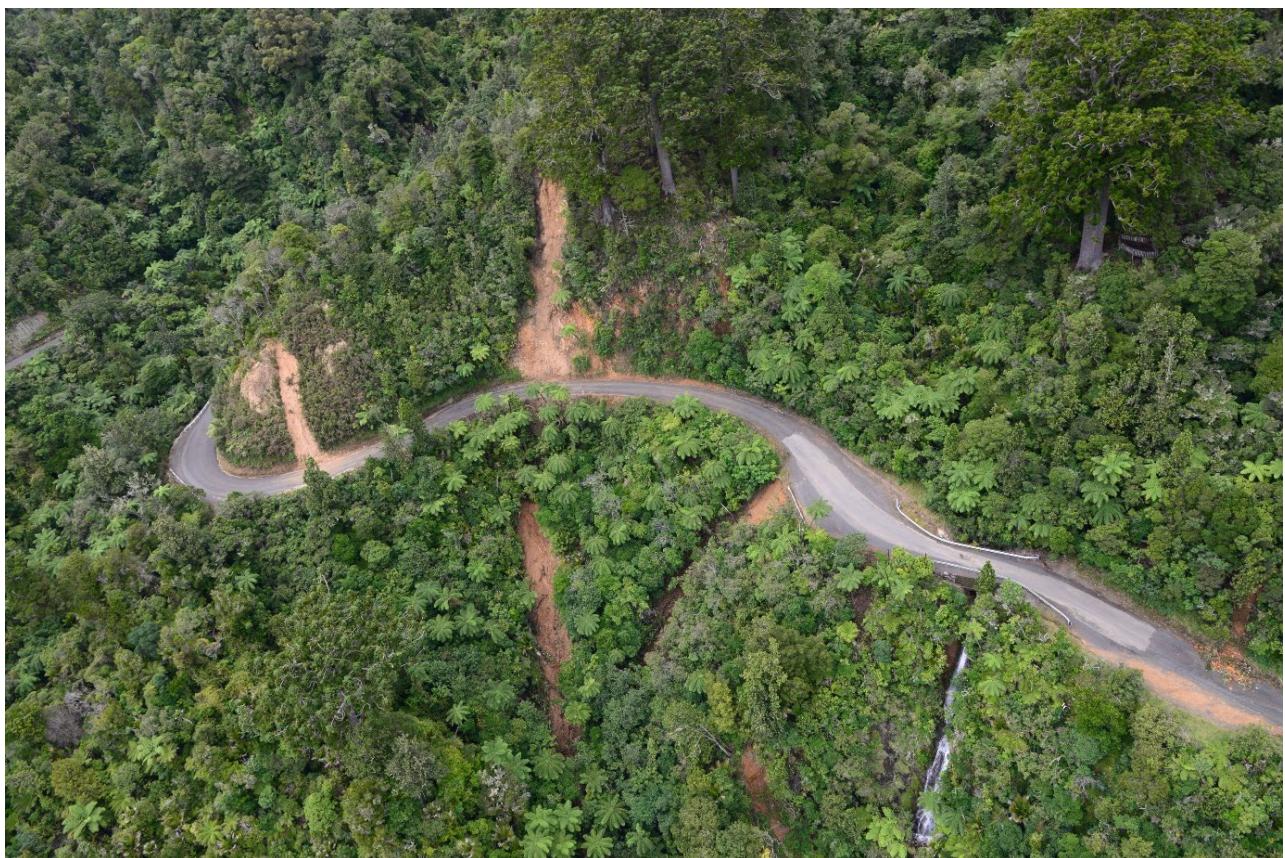
Figure A2.22 Photo DSC\_9501: Examples of failures above and below the Tapu Coroglen Road, Coromandel Range.

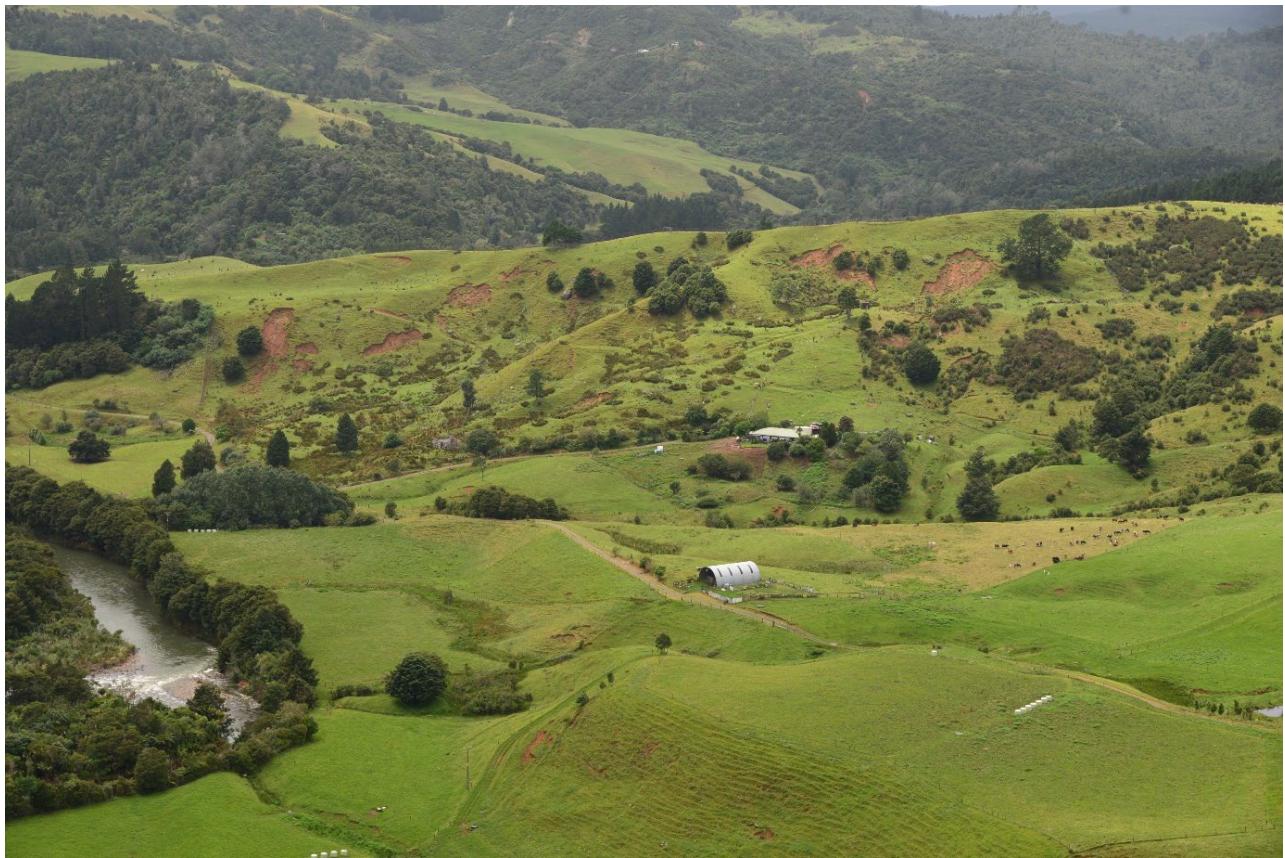
Figure A2.23 Photo DSC\_9549: Shallow soil failures affecting farmland near the eastern end of Tapu Coroglen Road, Coromandel Range.

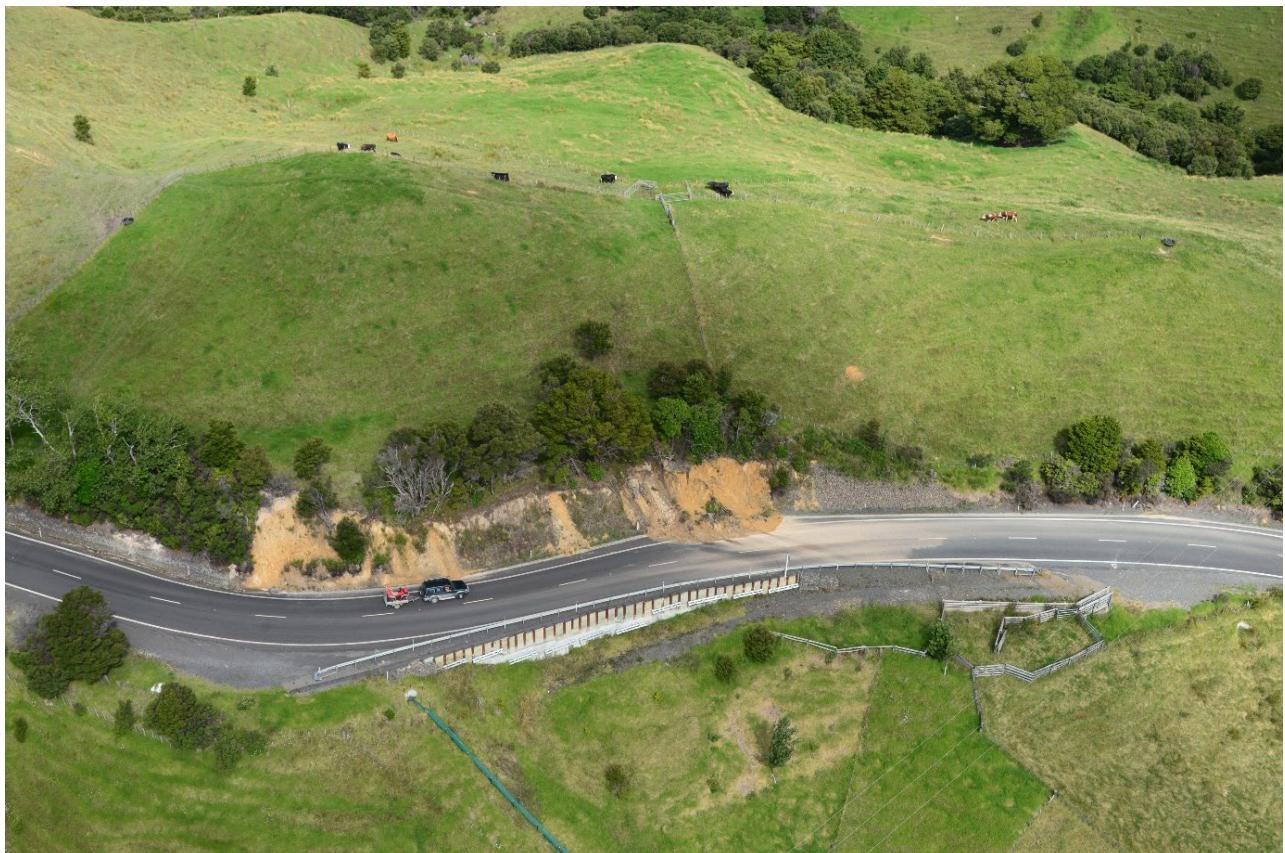
Figure A2.24 Photo DSC\_9856: Examples of road-cut failures along State Highway 25, Wilson Bay, Coromandel Range.
