## **GeoNet Landslide Response: Auckland Anniversary Storm, 26–30 January 2023, northern New Zealand**

**GNS Science Report 2025/32  
November 2025**

## ABSTRACT

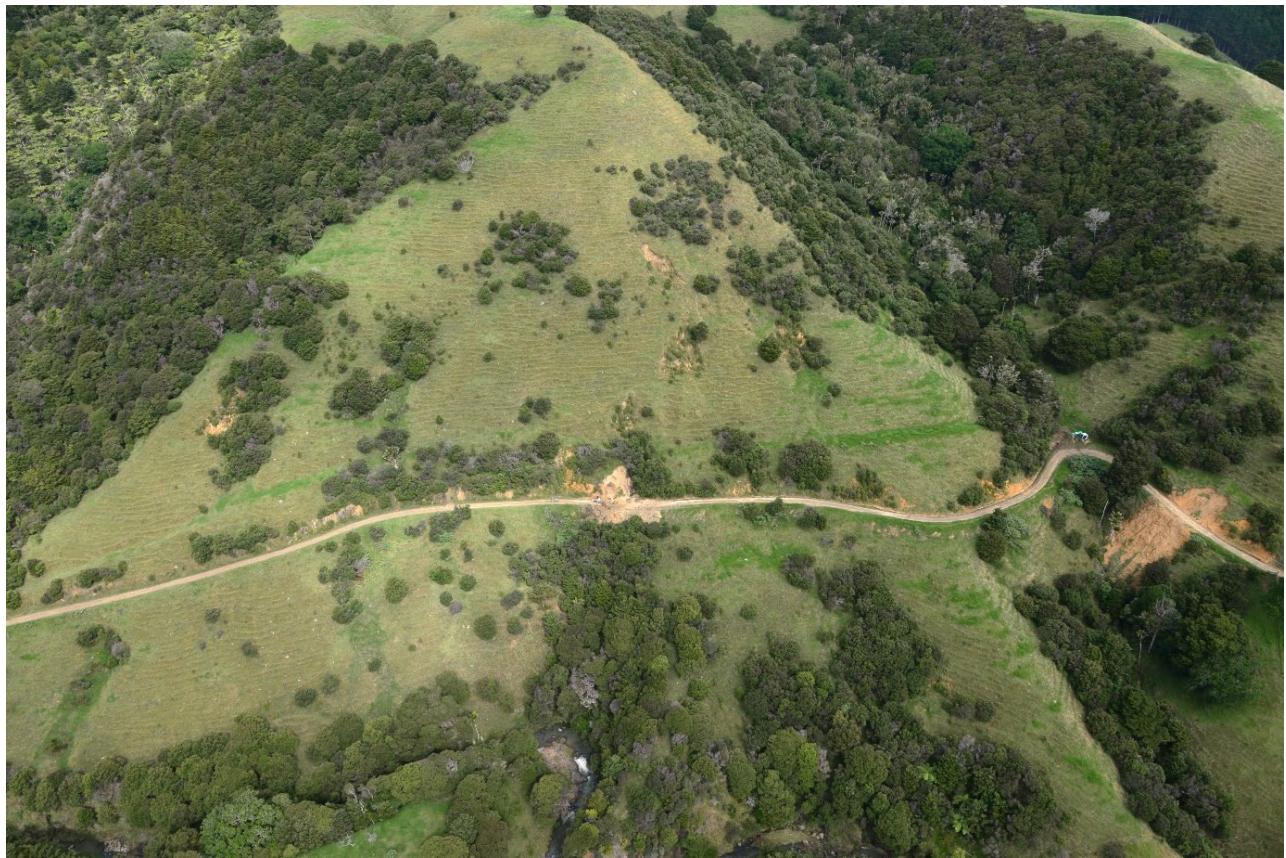
Figure A2.25 Photo DSC\_9866: Examples of failures affecting farm tracks and small rural roads. This photo shows Russek Road, Coromandel Range.

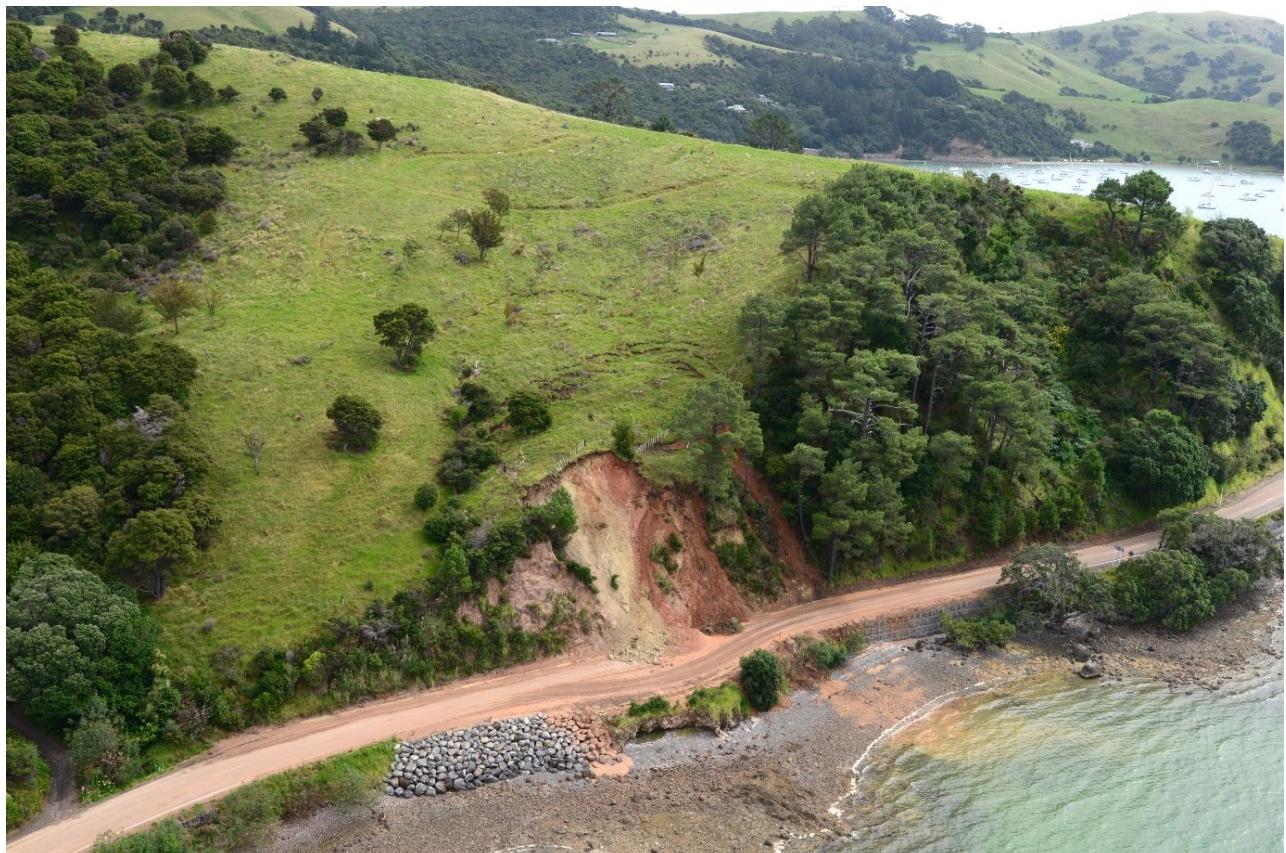
Figure A2.26 Photo DSC\_9830: Example of an incipient failure (note the cracks visible in pasture above the debris failure) at Waipapa Bay, Coromandel Harbour.

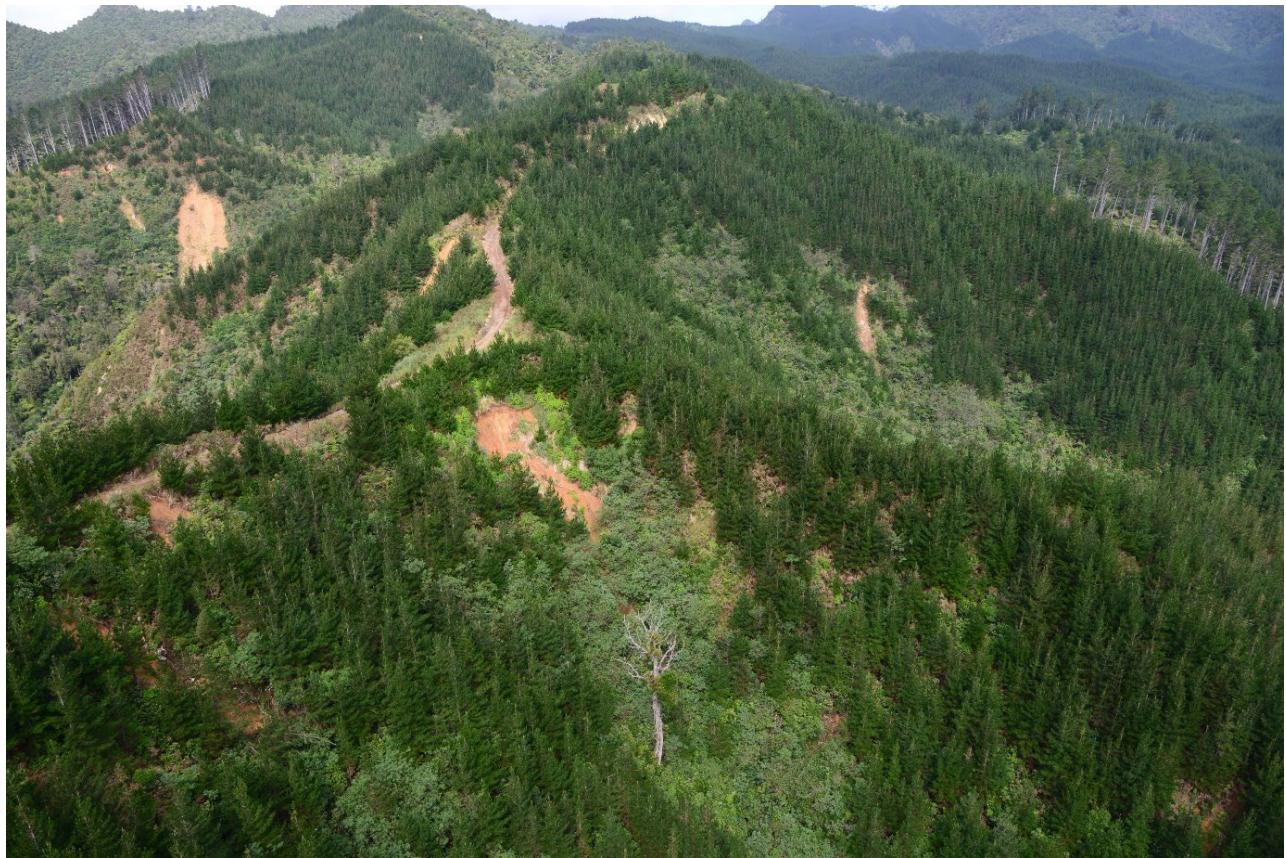
Figure A2.27 Photo DSC\_9790: Landslides were common in forestry areas, particular in young or recently cut-over slopes. The photo is taken in a forestry block between Mātāwai and Purunui streams, Coromandel.

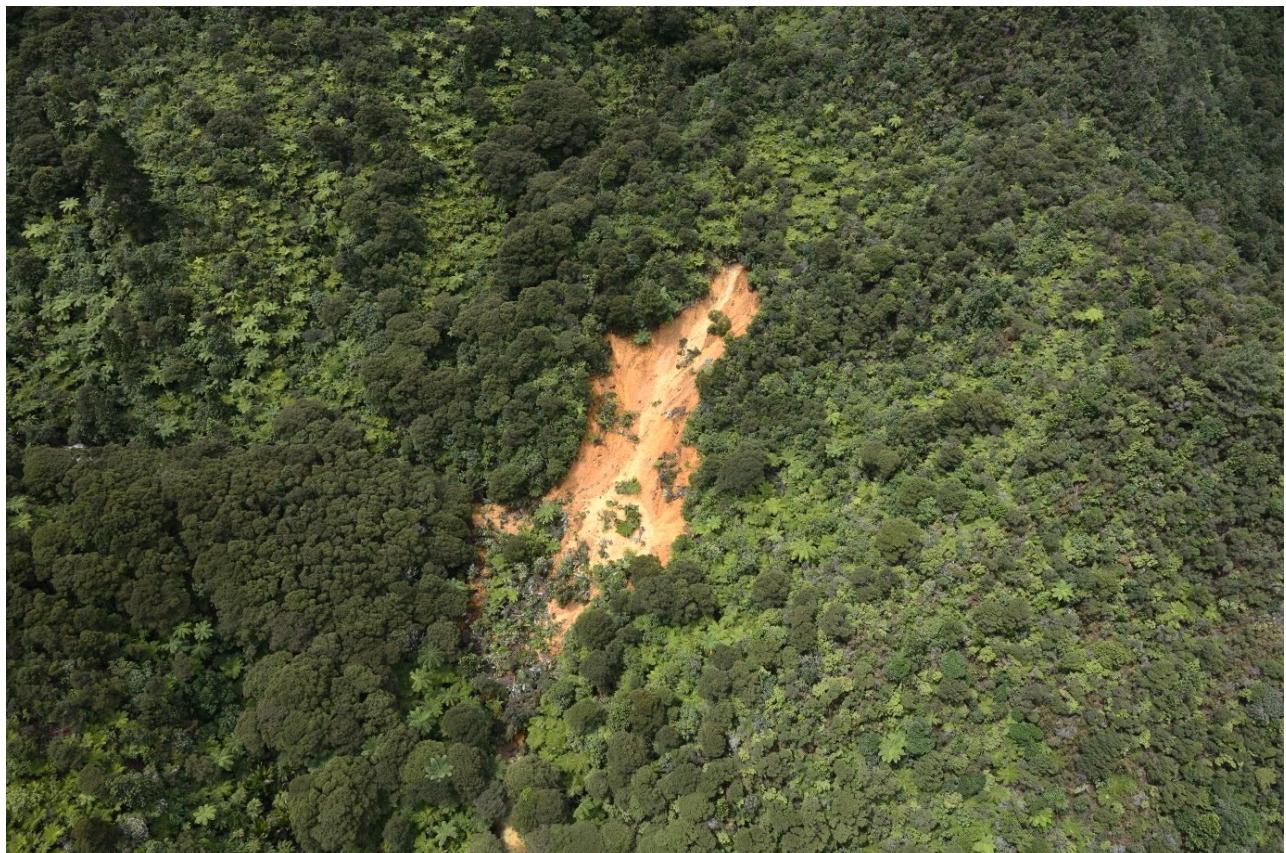
Figure A2.28 Photo DSC\_9745: Failure in native forest (likely immature/regenerating) above Pukewhau Stream, Coromandel.

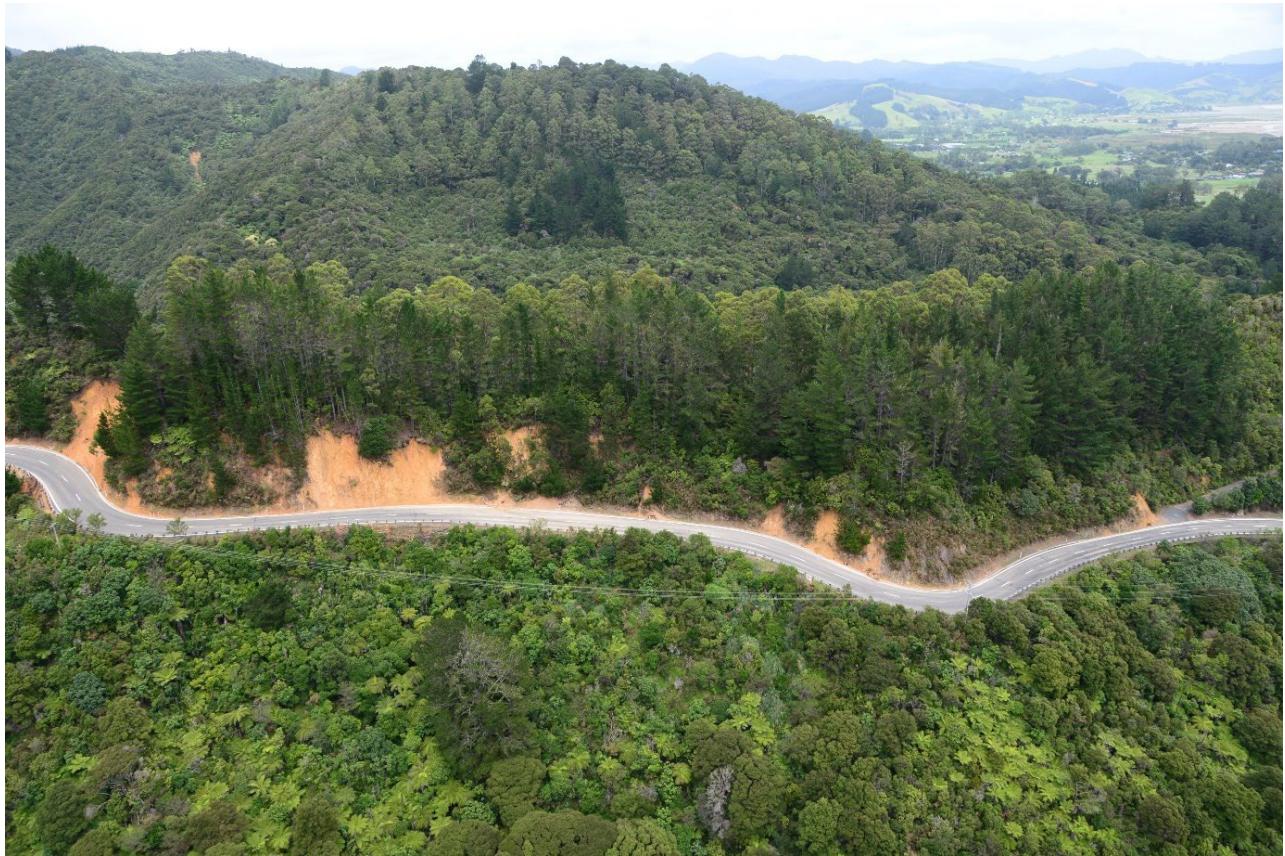
Figure A2.29 Photo DSC\_9731: Examples of failures of the cut bank along State Highway 25, Coromandel.

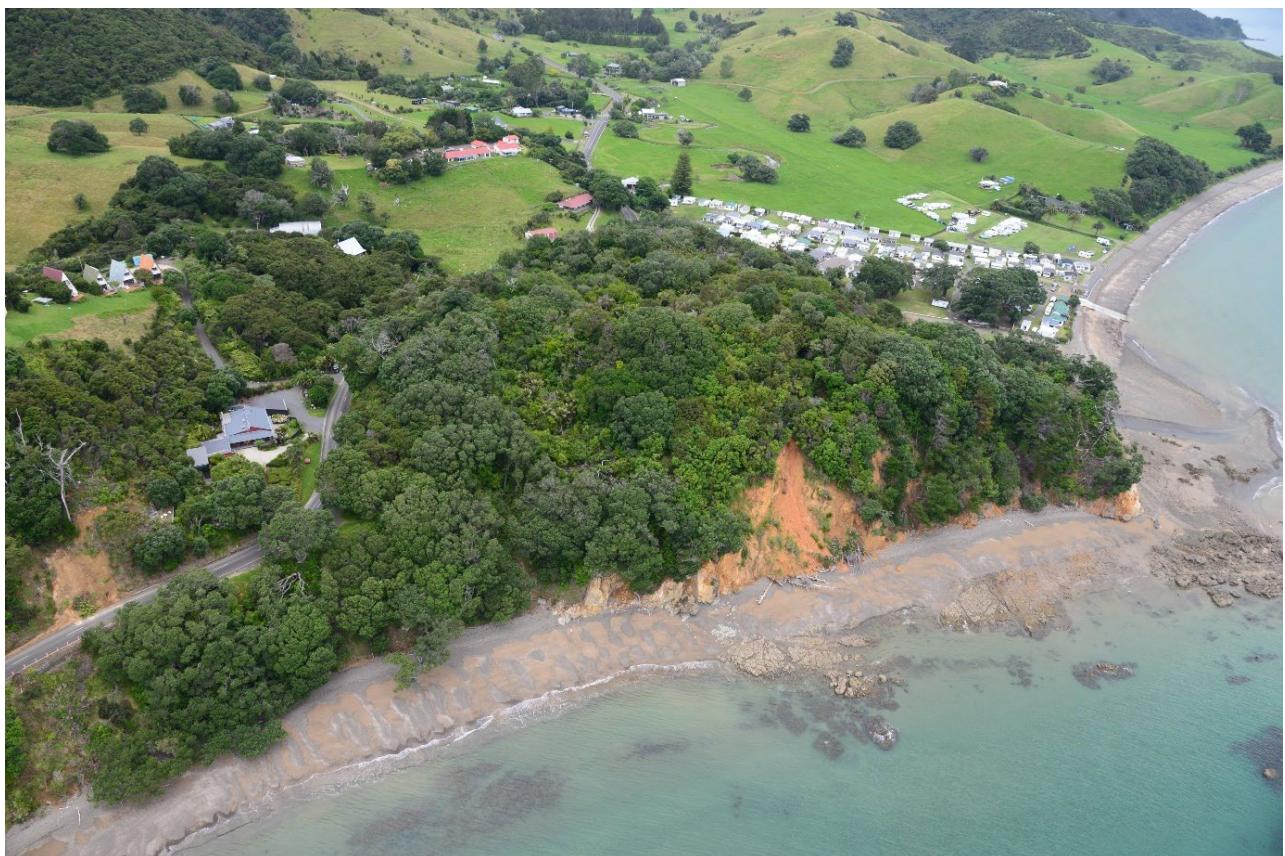
Figure A2.30 Photo DSC\_9688: Coastal landslide and small failure onto Colville Road, Papaaroa.

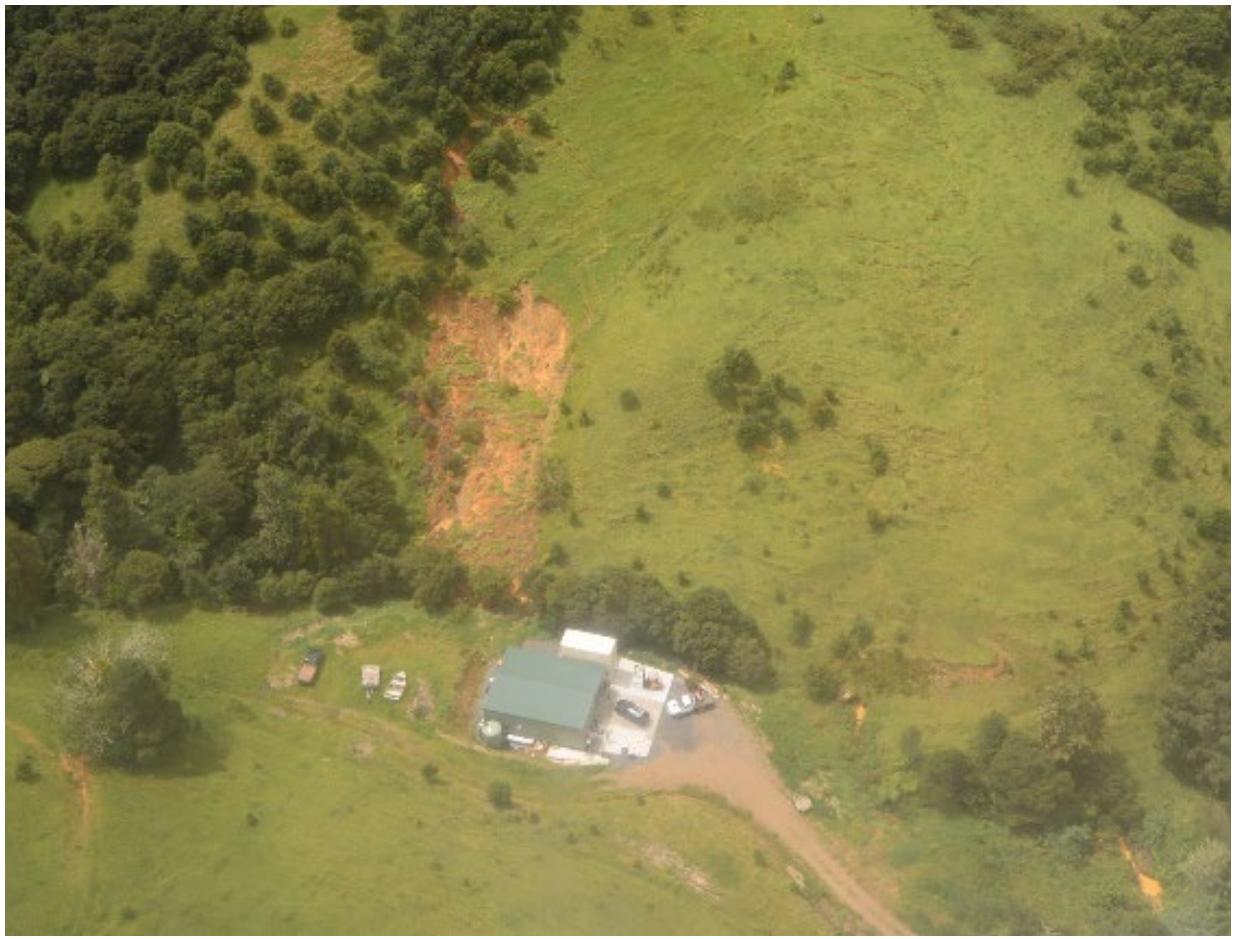
Figure A2.31 Photo DSC\_9711: An incipient failure (note cracks and deformed ground visible above and right of the fresh landslide scar) situated near a building; Kikowhakarere Bay, Coromandel.

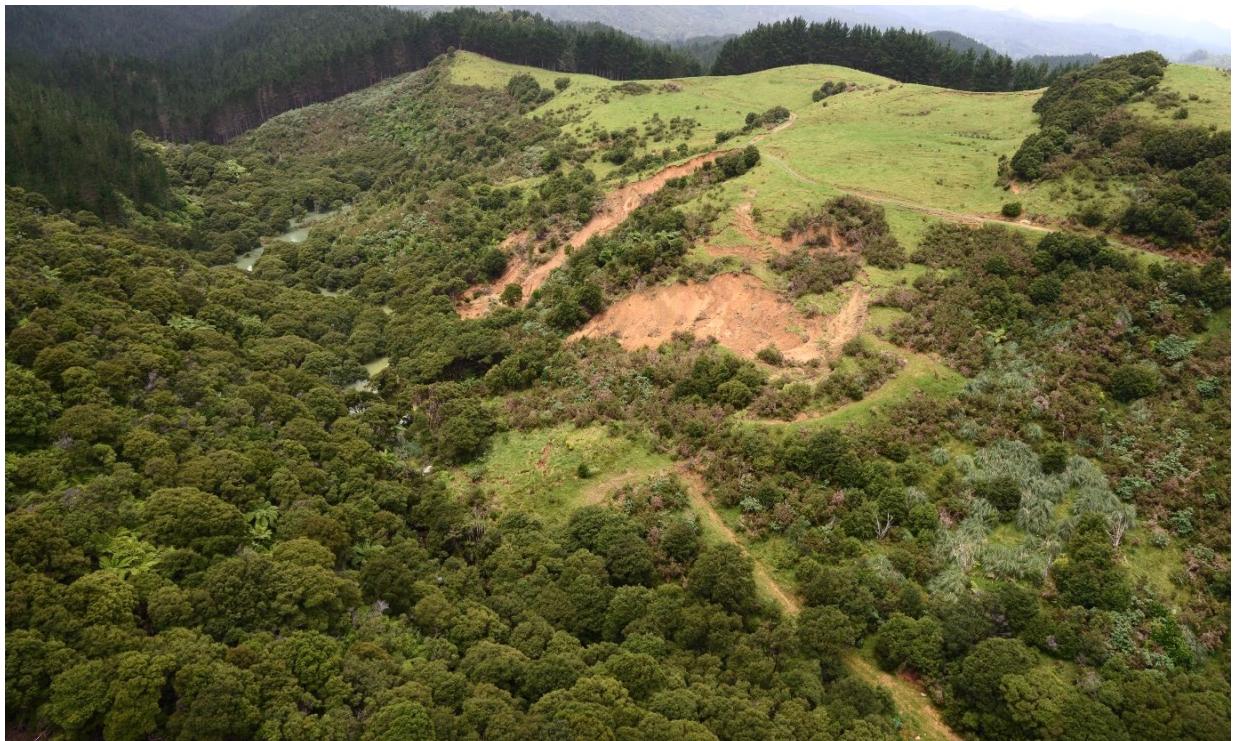
Locality	Number of Landslide Photos	Number of Media Reports	Five-Day Total Precipitation (mm)	Maximum 24-Hour Precipitation (mm)	Observations
Coromandel	192	7	431	166	Several landslides affecting hill country and coastal roads around the south of Coromandel Harbour (i.e. Te Kouma), including one incipient failure above the road with a developed head scarp and open fractures (Figure A2.26). Multiple landslides in forestry (Figure A2.27) and native bush (Figure A2.28) occurred southeast of Coromandel Harbour, several associated with roads and tracks, and most appear to be within the Te Mata Group sedimentary rocks. Multiple debris avalanches and small landslides (or re-activations) affected SH 25 near Coromandel township (Figure A2.29), along coastal sections of Colville Road (Figure A2.30) and on minor roads and driveways. Northeast of Coromandel Harbour, there were incipient failures common within hill country (e.g. Figure A2.31). One landslide blocked the south branch of Waiwhango River, with a lake still present (Figure A2.32). Scarps and cracks extend to the top of the hillslope, suggesting potential for retrogression/enlargement of the dam.

Figure A2.32 Photo DSC\_9702: Rotational slide that has blocked the south branch of Waiwhango River, Coromandel, with a lake still present at the time of the photo. Cracks are also observed at the top of the hillslope, suggesting that a larger failure mass is involved.

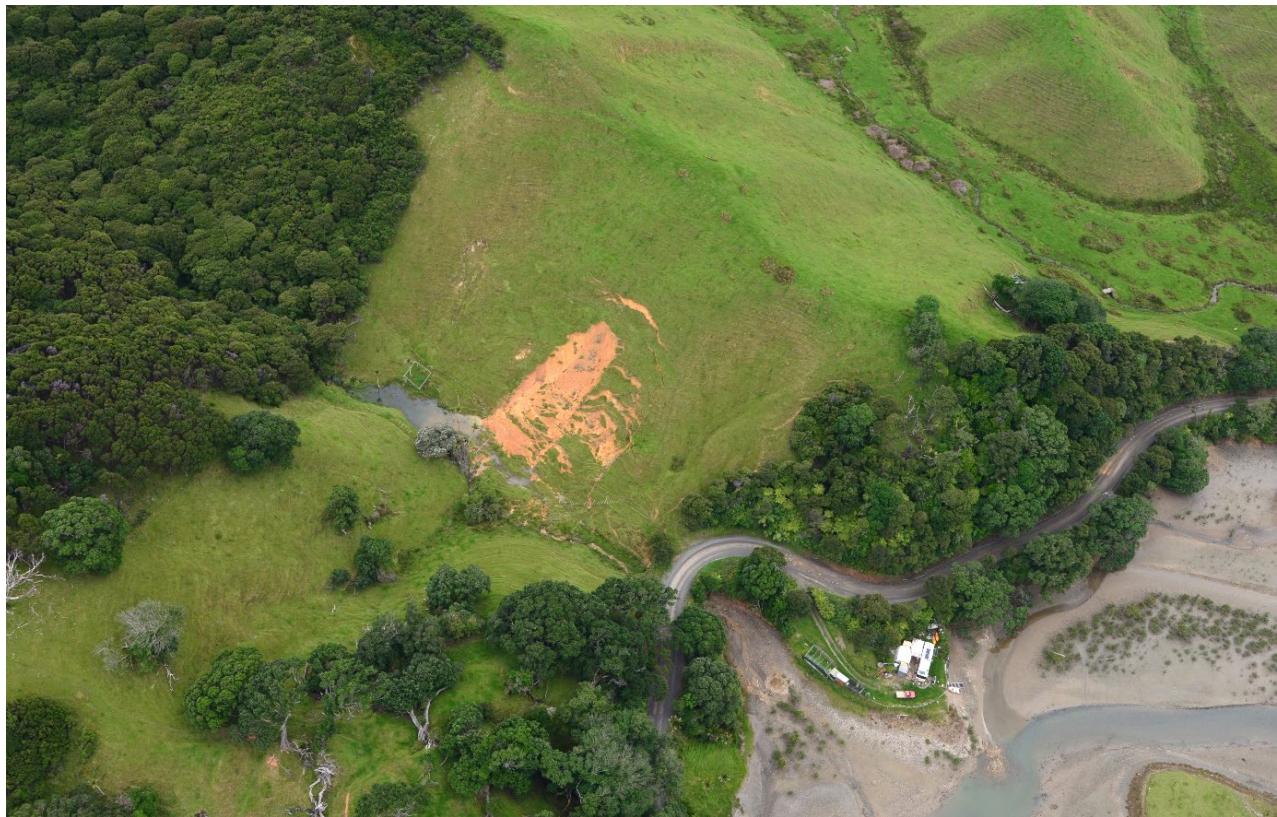
Figure A2.33 Photo DSC\_9652: A slide in regolith/soil has blocked a small stream, creating a small lake upstream of a road and small dwelling, with potential for further displacement and enlargement of the landslide mass indicated by cracks in the hillslope above the freshly exposed debris. Port Jackson Road, Waiaro.

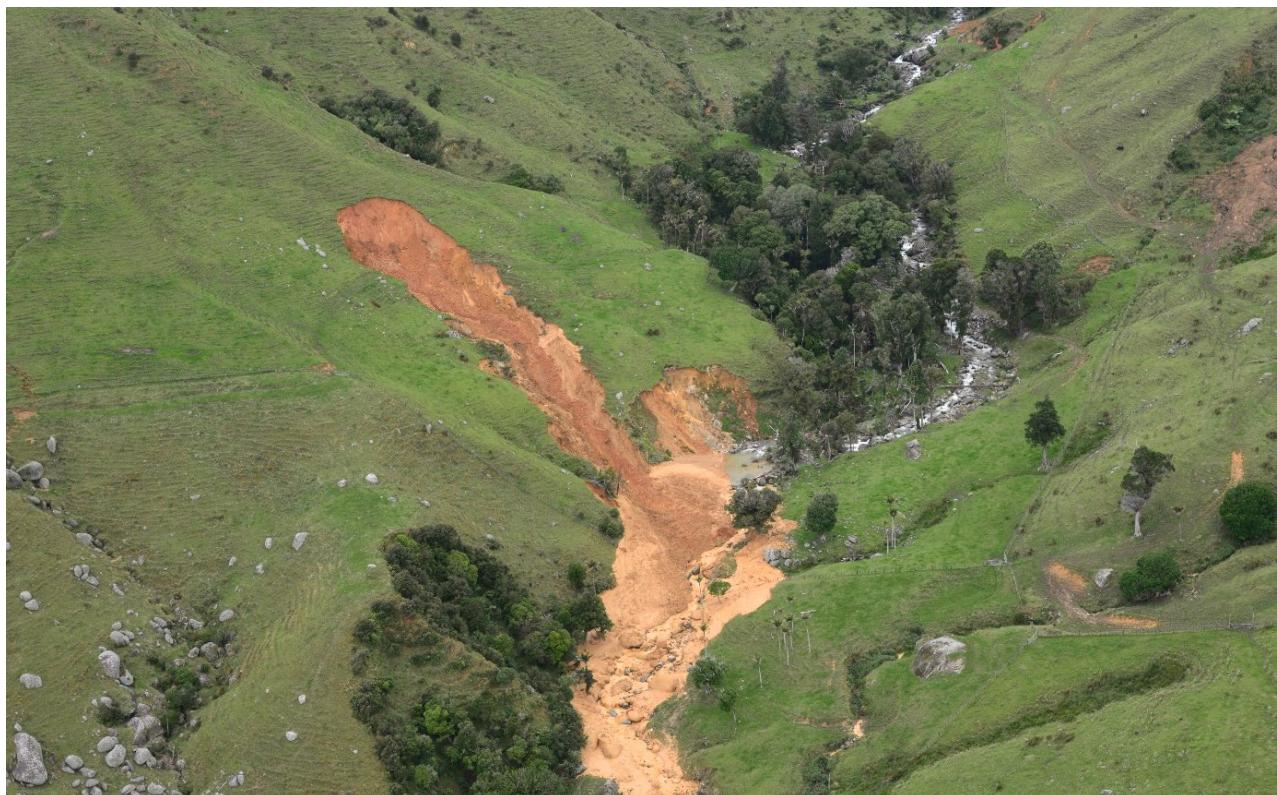
Figure A2.34 Photo DSC\_9621: Slope failures were prevalent in the Te Mata Group sedimentary rock and overlying regolith in Coromandel. Some of these, such as the example here from Ohinewai Stream, Moehau Range, transitioned downslope into debris flows.

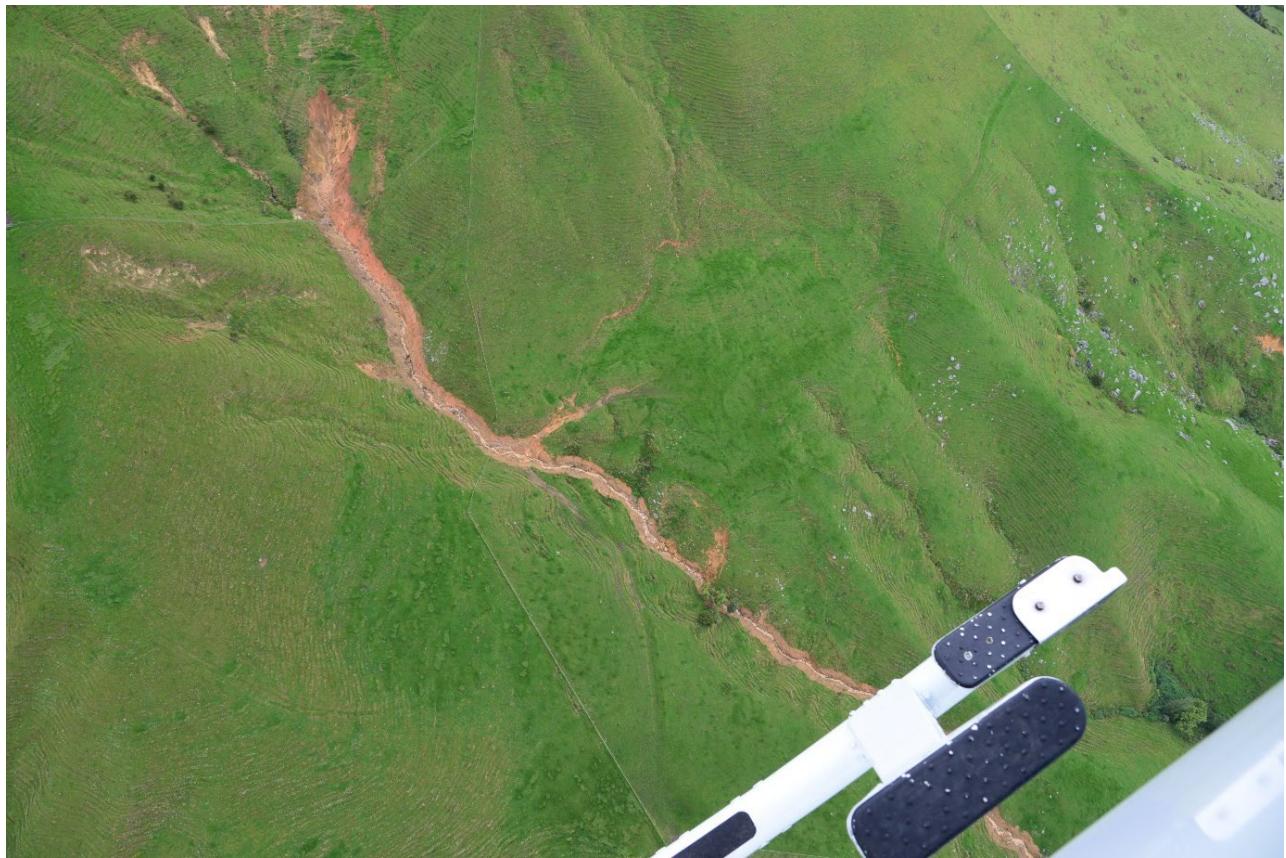
Otama – Matarangi	10	1	141	59	Coastal roads and tracks affected by slippage and debris/rockfall; several appear to be re-activations. Landslides particularly prevalent in Te Mata Group sedimentary rock (no photos).
Southern Moehau Range	28	0	268	113	Rock falls and debris avalanches, as well as shallow landslides, common along roads and coastal rock slopes. Stream blockage by a large soil/regolith failure, located above Port Jackson Road and a small temporary dwelling (Figure A2.33). Landslides particularly prevalent in Te Mata Group sedimentary rock.
Northern Moehau Range	47	5	248	108	Multiple soil/regolith slides, some generating channelised debris flows and blockages (Figure A2.34), and a large number of incipient failures in hill country (pasture) (Figure A2.35). Landslides particularly prevalent in Te Mata Group sedimentary rock.

Figure A2.35 Photo DSC\_9632: A debris flow and several incipient failures (indicated by scarps and cracking in the hillslopes). This example is between Ohinewai and Ongohi streams, Moehau Range, Coromandel.
