## Wilberforce Earthquake: Preliminary findings of the landslide and ground deformation rapid aerial reconnaissance survey

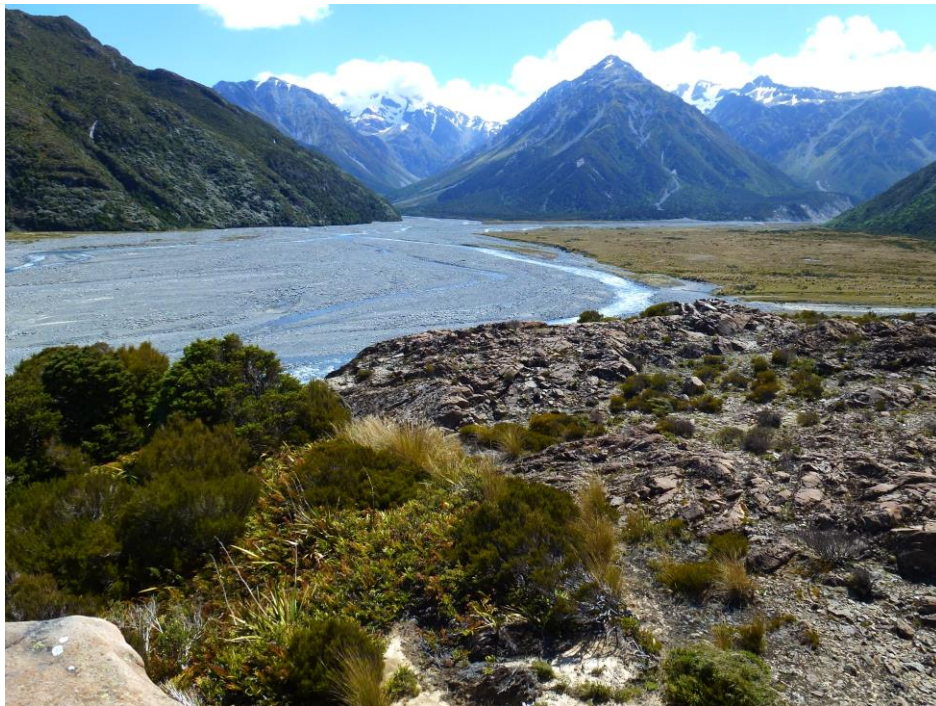
**Figure 2.** Confluence of the Upper Wilberforce River (looking upstream), Unknown Stream and Griffiths Stream

The most likely location for surface rupture was predicted to be near the confluence of the upper Wilberforce River with a tributary called the Unknown Stream. The area was flown and photographed in detail during the reconnaissance survey but no evidence of a surface rupture of the fault was observed.

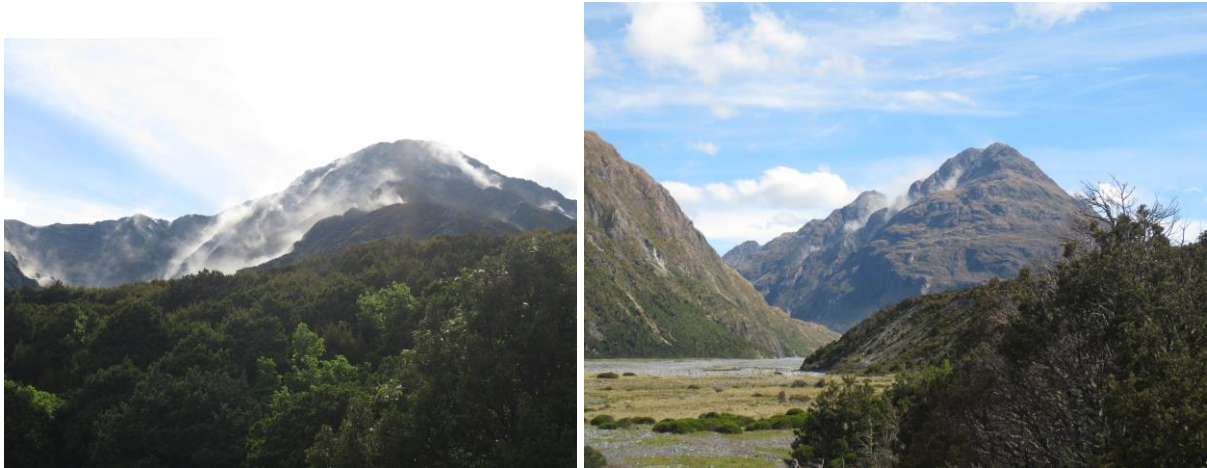
**Figure 3.** Photos taken immediately after the earthquake looking down the Wilberforce river Valley above the confluence with the Unknown Stream, illustrating the dust generated from the multiple small to medium sized rockfalls.

sections of Wilberforce River during the earthquake and subsequent aftershocks show the dust created by the many small to moderate rockfalls(Figure 3).

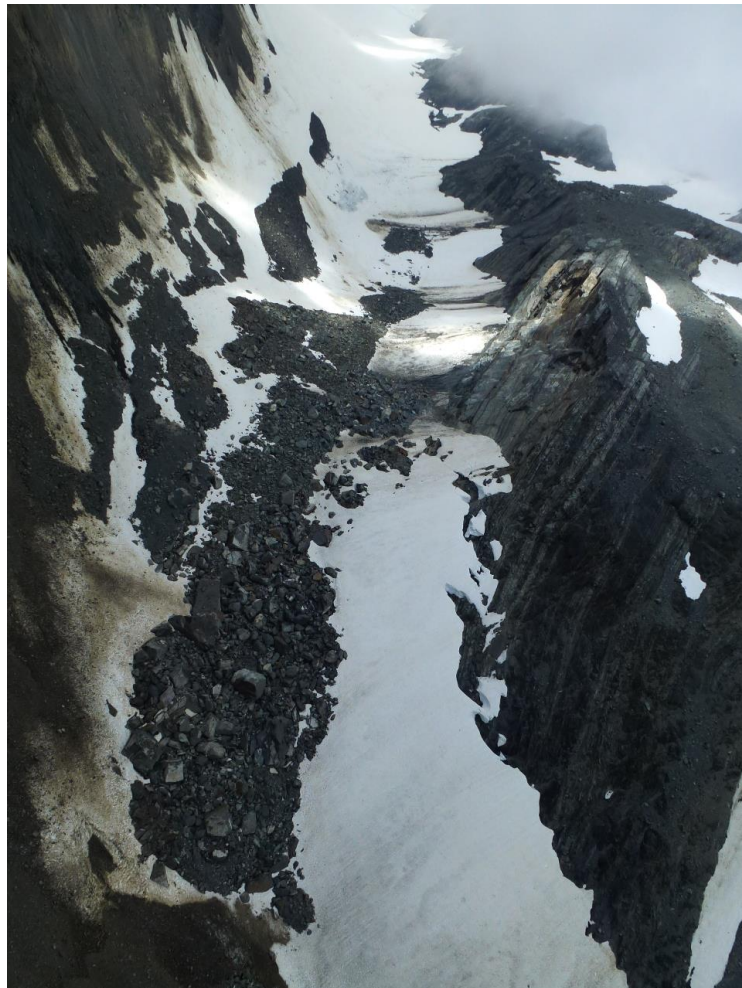
**Figure 4.** Large rock avalanche in the upper reaches of Griffiths Stream.

Many small to moderate rockfalls and a several rock avalanches were observed on the steep slopes close to the earthquake epicentre. The largest rock avalanche was observed in the upper reaches of Griffiths Stream near the Main Divide at an elevation of approximately 1500 m and about 7 km from the epicentre. In this location a series of large rock avalanches had occurred from an exposed rock outcrop and the failure debris formed a large debris fan (or lobe?) within the drainage line (Figure 4). The volume of the largest failure was estimated to be greater than 140,000 m<sup>3</sup>.

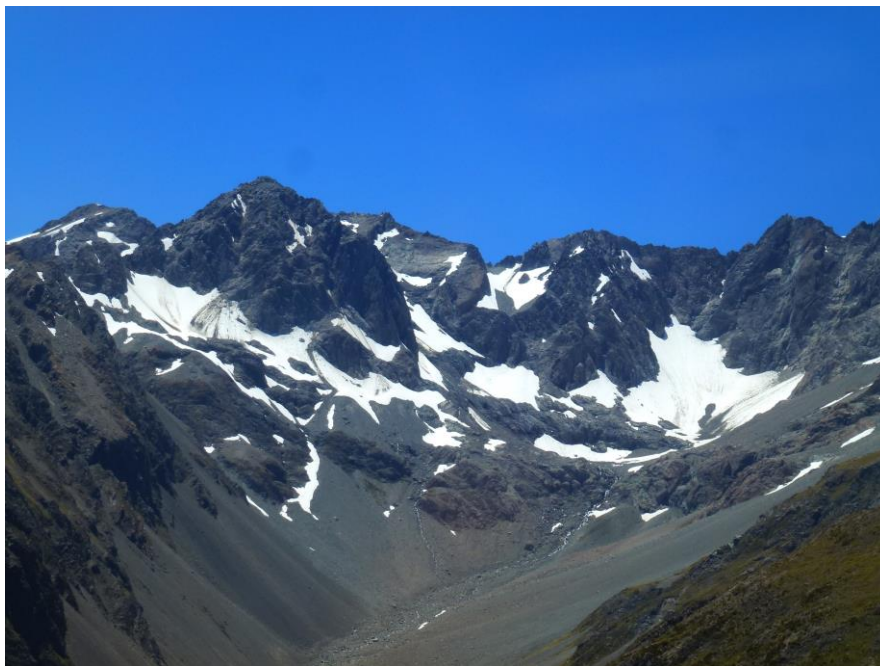
**Figure 7.** Local rockfall failures from the upper slopes of Burnet Stream (debris on snow cover).

Similar localised rock falls were observed in the eastern tributaries of the Wilberforce River (e.g. Figure 7). Whilst the failures were very similar in size, the density of failures observed appeared to be lower.

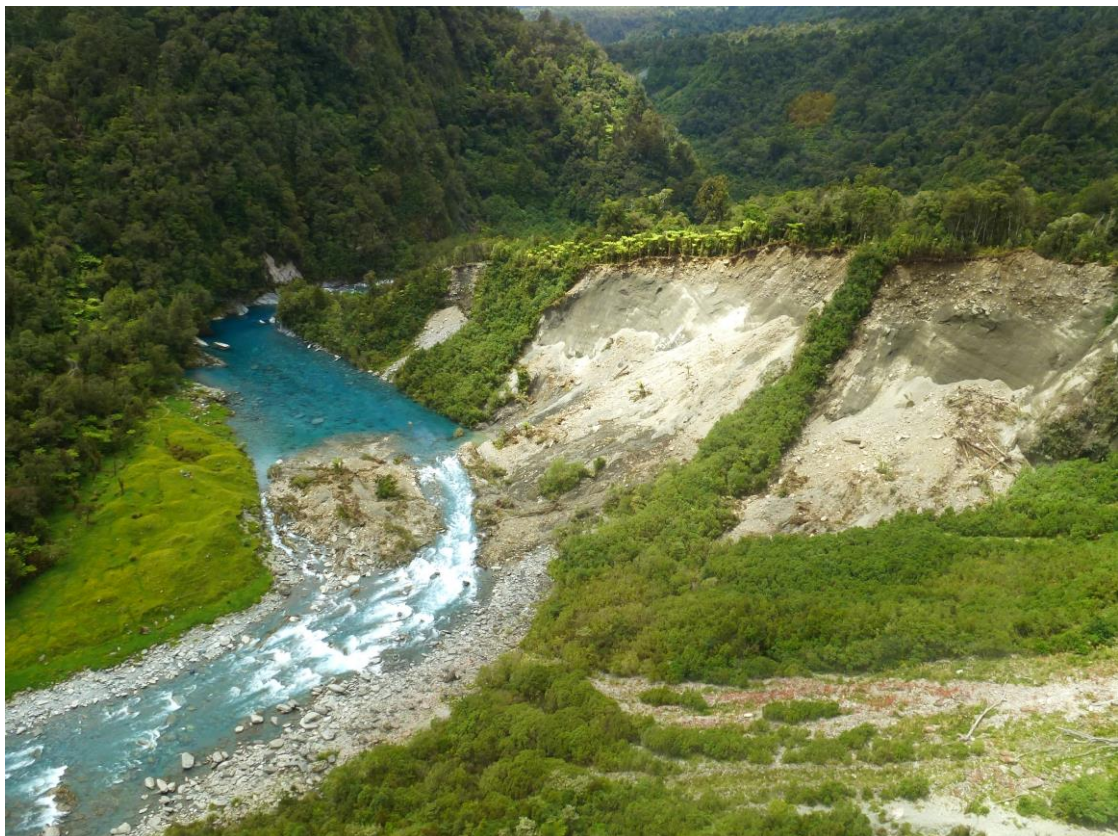
**Figure 8.** Large landslide triggered by the Wilberforce earthquake that temporarily blocked the Arahura River, in the lower reaches of Second Gorge (centre). The two other landslides were also triggered by the earthquake but did not affect the river. Part of a larger older failure is visible in the lower right corner and old landslide deposits on the bar opposite.

One large landslide was observed on the western side of the Main Divide and was reported on the 6<sup>th</sup> January to have temporarily blocked the Arahura River, at the downstream end of Second Gorge (Figure 8). Two other smaller failures also occurred at the same site but did not affect the river. The site was included in the aerial reconnaissance and at the time of the visit was no longer blocking the river flow (it was still impeding the flow because there was a small lake formed upstream). The landslide occurred from a 60 m high hillside adjacent to the river channel composed of glacial alluvial gravels, glacial moraine deposits. The volume of the largest failure was estimated to be about 25,000 m<sup>3</sup>. The presence of adjacent old landslide headscarps and re-vegetated scars along with undulating topography on the opposite channel bank (landslide deposits) indicate that landslides have occurred at this site before which were also likely to have blocked the river (Figure 8).
