Introduction

The North Branch of the Young River, near Lake Wanaka, New Zealand, was blocked by a large landslide at 4:40 am on 29 August 2007. The debris avalanche occurred in closely jointed schist, forming a dam 70 m high across the valley. Water immediately began impounding behind the dam and has now overtopped, scouring an outflow channel on the downstream face of the dam.

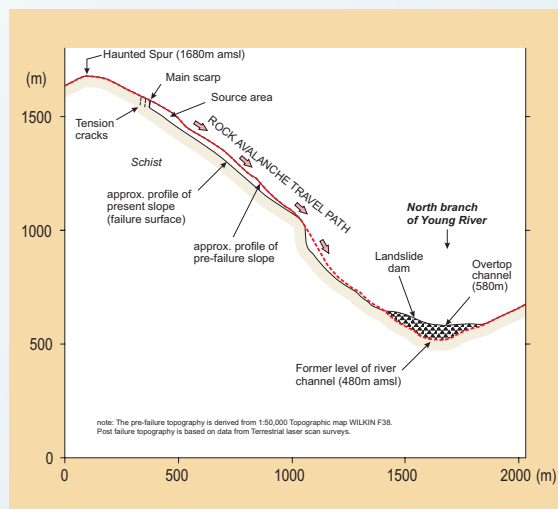
Cross section of Young River debris avalanche and landslide dam

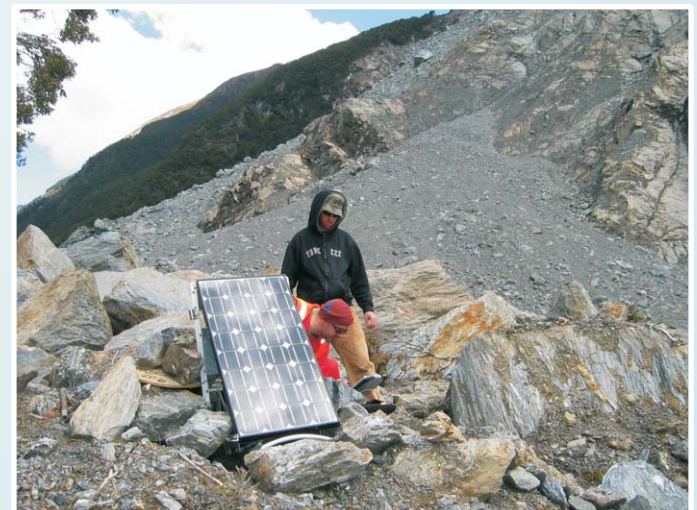
Solar panels provide power to lake level monitoring instrumentation and communication equipment.

The dam is about 70 metres high at the outflow and the impounded lake is approximately two kilometres in length and 500 metres at its widest point. Water overtopped the dam on Friday 5 October, approximately 5 weeks after its formation. Water continues to flow over the dam crest and has scoured material from along the outflow channel after periods of high rainfall and associated outflows. Equipment to remotely monitor the lake level has been installed.

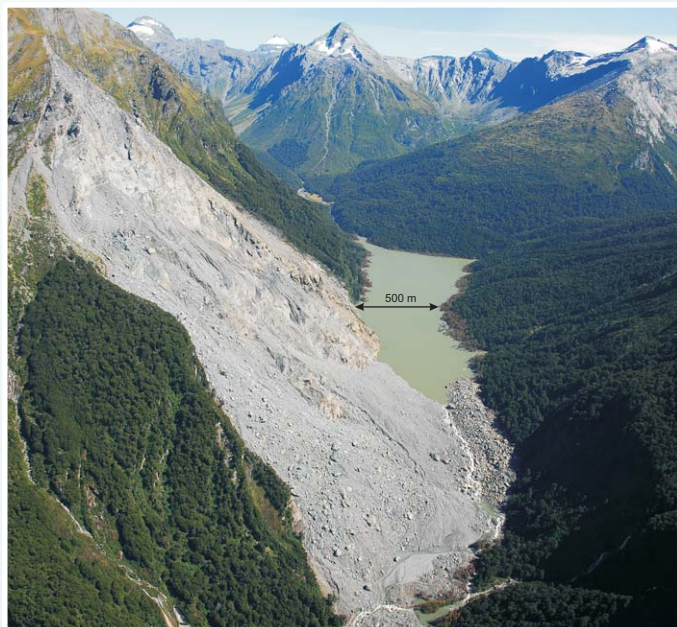
View of landslide and dam looking north west.

The source of the avalanche was located on what is locally referred to as Haunted Spur, above the river's true right bank. The main scarp is at an elevation of 1600 m, with an elevation difference (between the top of the source area and toe of the debris) of 1100 meters. Several terrestrial laser scans (TLS) of the landslide dam (deposit) and source area (using a RIEGL LMS-Z420i scanner) have been carried out. These data have been used to generate a three-dimensional model of the landslide deposit. This model has been compared with the pre-failure topography, to calculate the landslide and lake volumes. This information has been used by both GNS scientists and emergency management officers at the Otago Regional Council and has provided essential information for assessing its future stability as a dam.

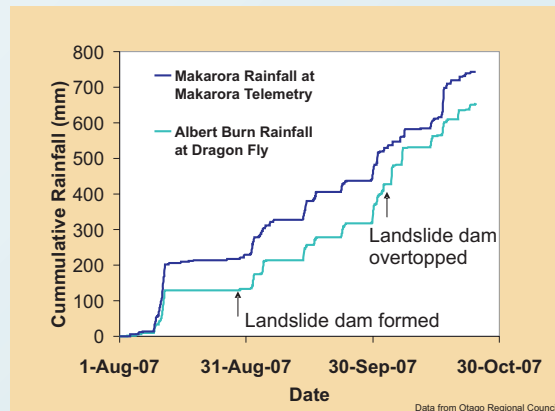
Young River area rainfall data.

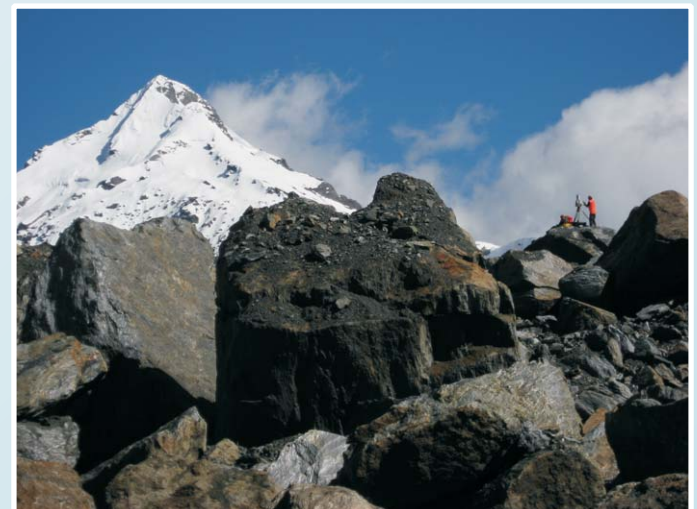
View of landslide debris forming dam, looking north west.

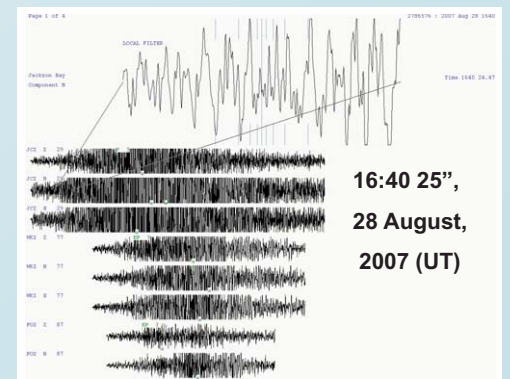
Seismic trace generated by the landslide.

The Young River landslide is in a remote headwater tributary of the Makarora River and was first recognised by a helicopter pilot three weeks after initiation. Seismic shaking generated by the landslide was the equivalent of a magnitude 2.9 earthquake, and was recorded by the GeoNet seismic network. Debris from the landslide travelled approximately 1.8 kilometres in 60 seconds, suggesting a minimum debris speed of 100km/hour.

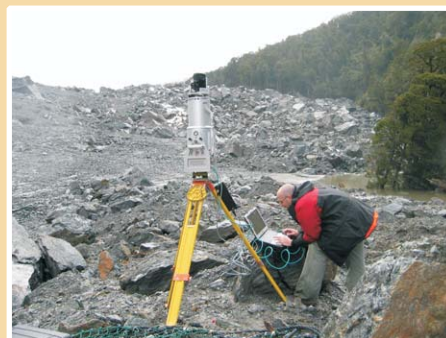
Using a tripod-mounted laser scanner, geologist Chris Massey and surveyor Neville Palmer, both of GNS Science, have measured the volume of the landslide at 11 million cubic meters.

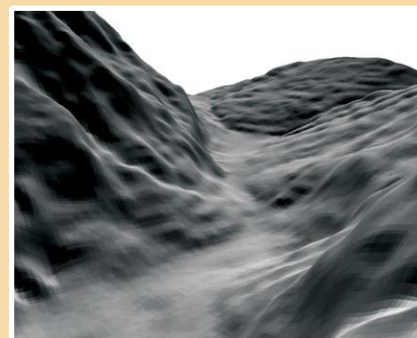
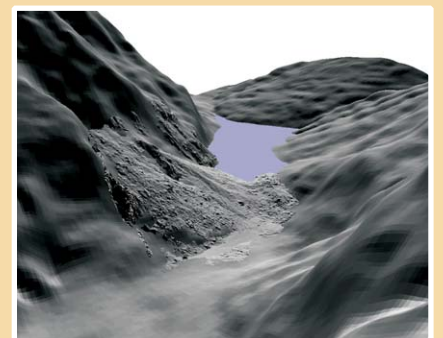
These images show the 3D model before, and after the landslide.

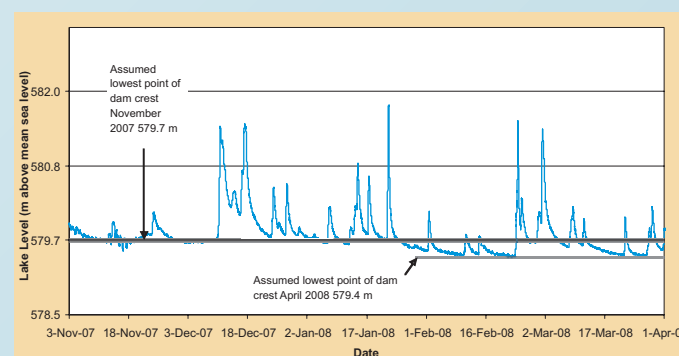
Young River lake level monitoring data.
