**Landslides and debris flows in the Tasman District
caused by ex-Tropical Cyclone Gita,
20-21 February, 2018**

**GNS Science Report 2019/34
July 2020**

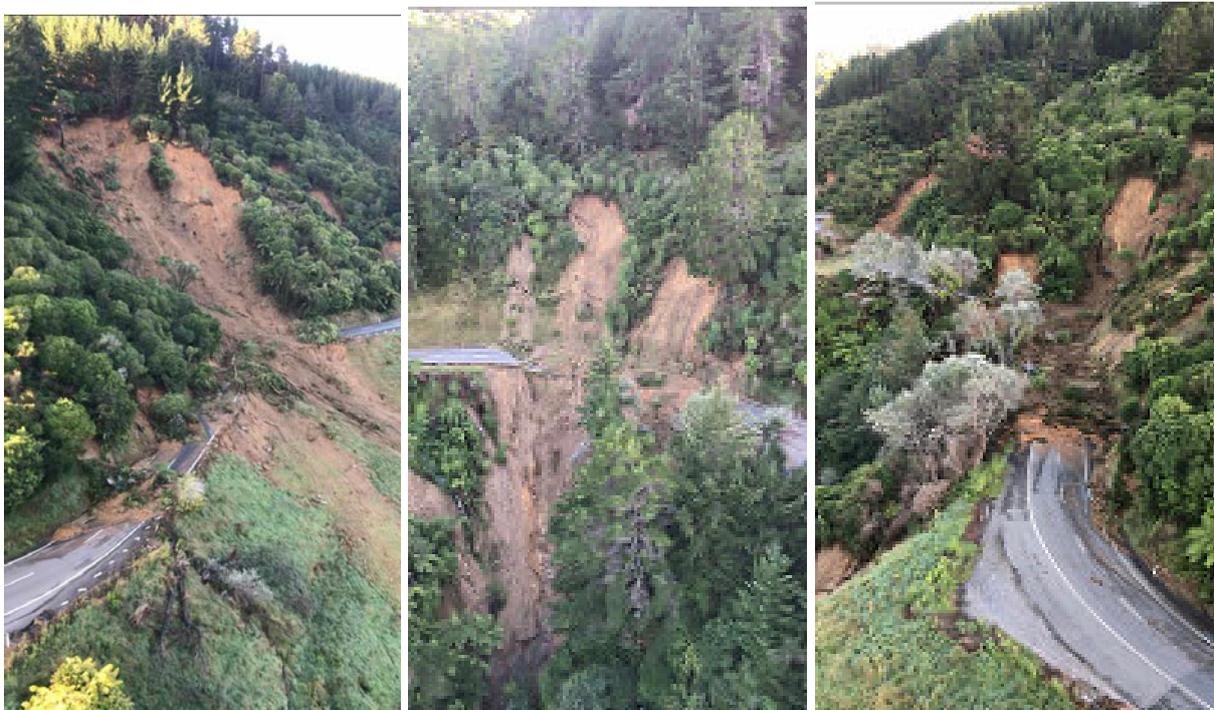
Figure 1.1 The Takaka Hill Road immediately following ex-Tropical Cyclone Gita (Photos: NZTA, 22 February 2018).

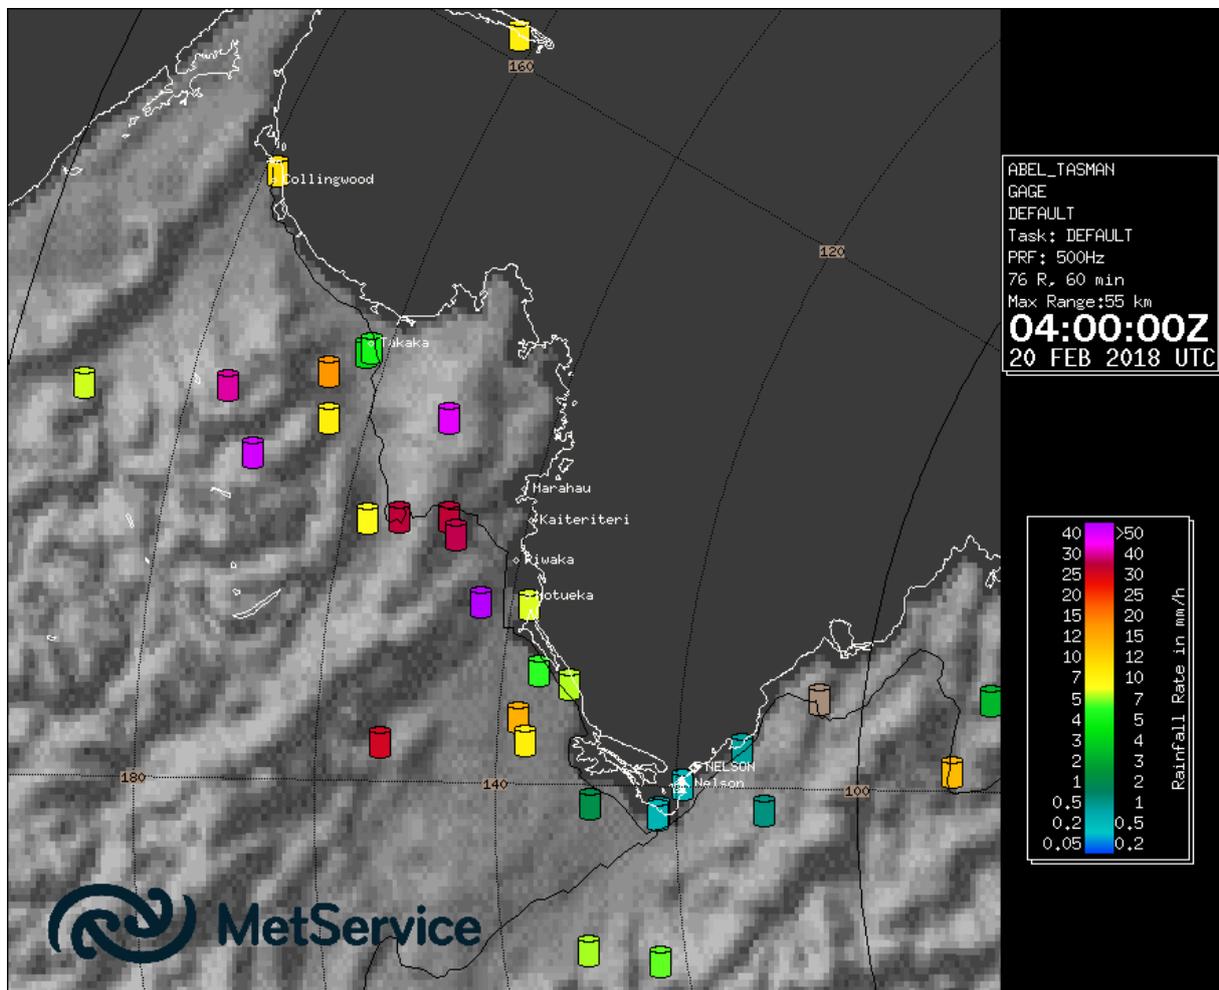
Figure 1.2 Rain-gauges used by MetService for the correction of rain radar data for the event. Map shows the 1-hour rainfall intensity in mm/hr during the period of heaviest rain between 03 and 04 UTC (4 pm and 5 pm NZDT) 20 February 2018.

Rain radar data was recorded approximately 140 km from Marahau at Wellington. MetService provided gauge-corrected rain radar data for the event. The rain radar correction was made using a combination of available MetService, Tasman and Marlborough District Council and HortResearch rain gauges, shown in Figure 1.2. Gauge-corrected rain radar totals for the maximum 1-hour, 3-hour, 6-hour, 12-hour and 18-hour (storm total) for this event for various locations are summarised in Table 1.1 and the maximum 1-hour, 3-hour and 18-hour (storm total) rainfall totals are illustrated in Figure 1.3 to Figure 1.5.

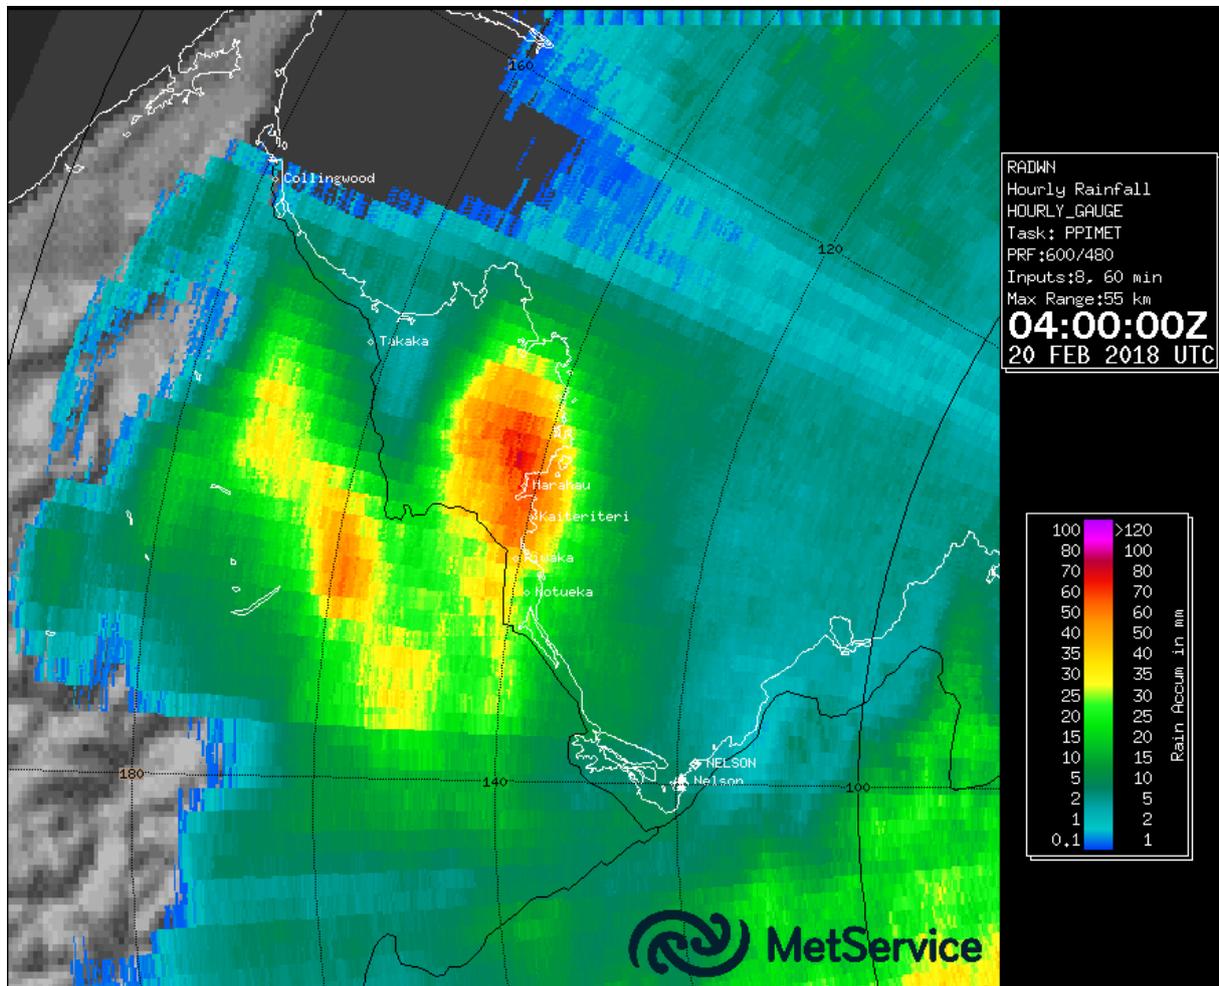
Figure 1.3 Rain radar image for the maximum 1-hour rainfall. The maximum 1-hour rainfall occurred in the area north of Marahau and over the Takaka Hill between 03 and 04 UTC 20/02/2018 (4-5pm NZDT) and was typically between 60–75 mm/hr, with a maximum value of 78 mm/hr just to the north of Marahau.

The radar data demonstrates that the most intense rainfall was isolated and occurred over a 3-hour period between 3 pm and 6 pm (NZDT) in the Riwaka and Marahau areas (Figure 1.4). It was during this 3-hour period that most of the landslides were triggered (Glenn Stevens, pers comm). These areas had already received approximately 80 mm over the preceding 12 hours.

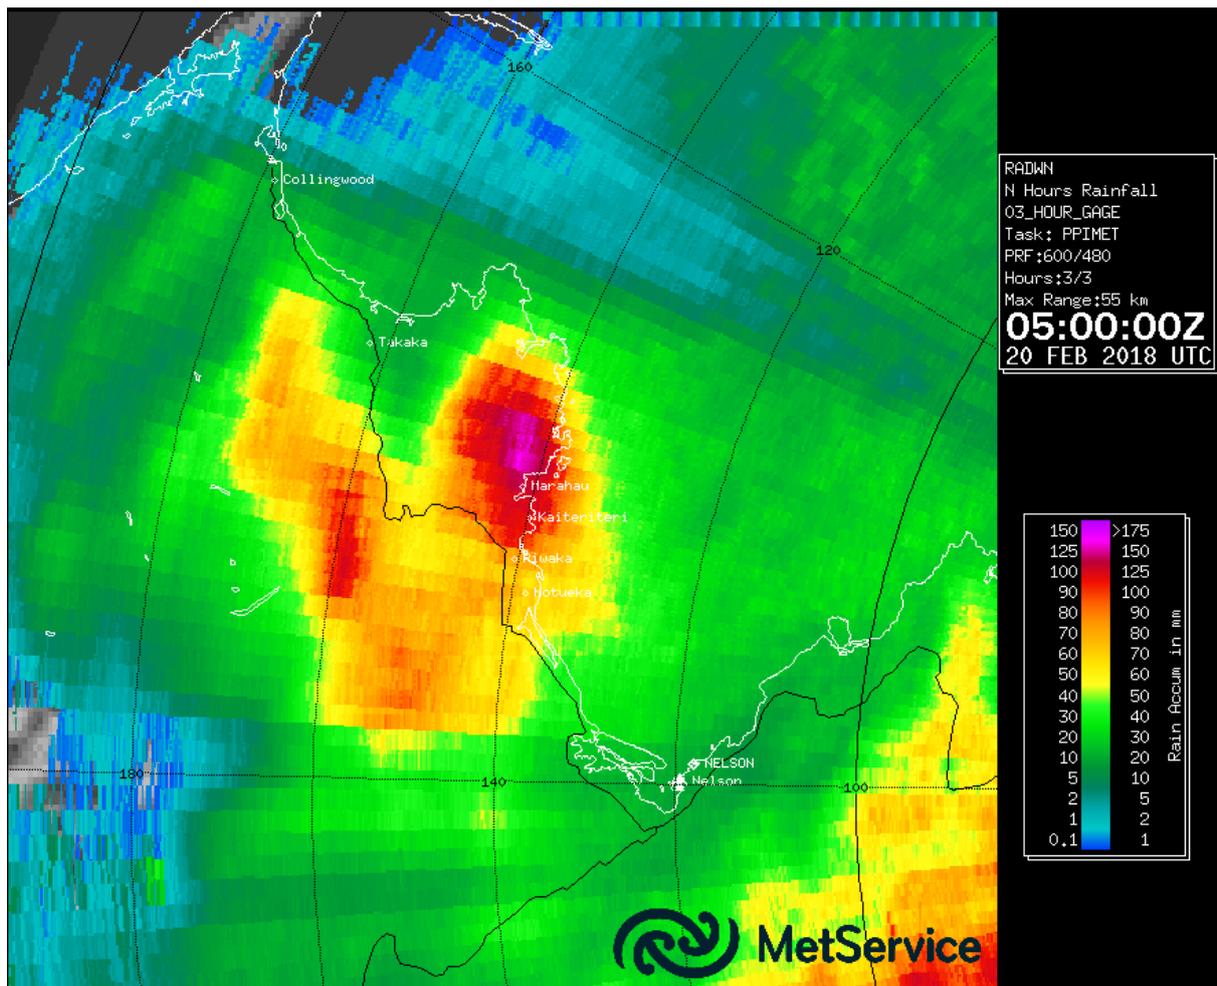
Figure 1.4 Rain radar image for the 3-hour maximum rainfall total. The 3-hour maximum rainfall occurred in the area north of Marahau between 02 and 05 UTC 20/02/2018 (3-6 pm NZDT) and was between 130–140 mm, with a maximum value of 148 mm just to the north of Marahau. This 3-hour period is when most of the landslides were triggered. (Note scale is different to Figure 1.3).

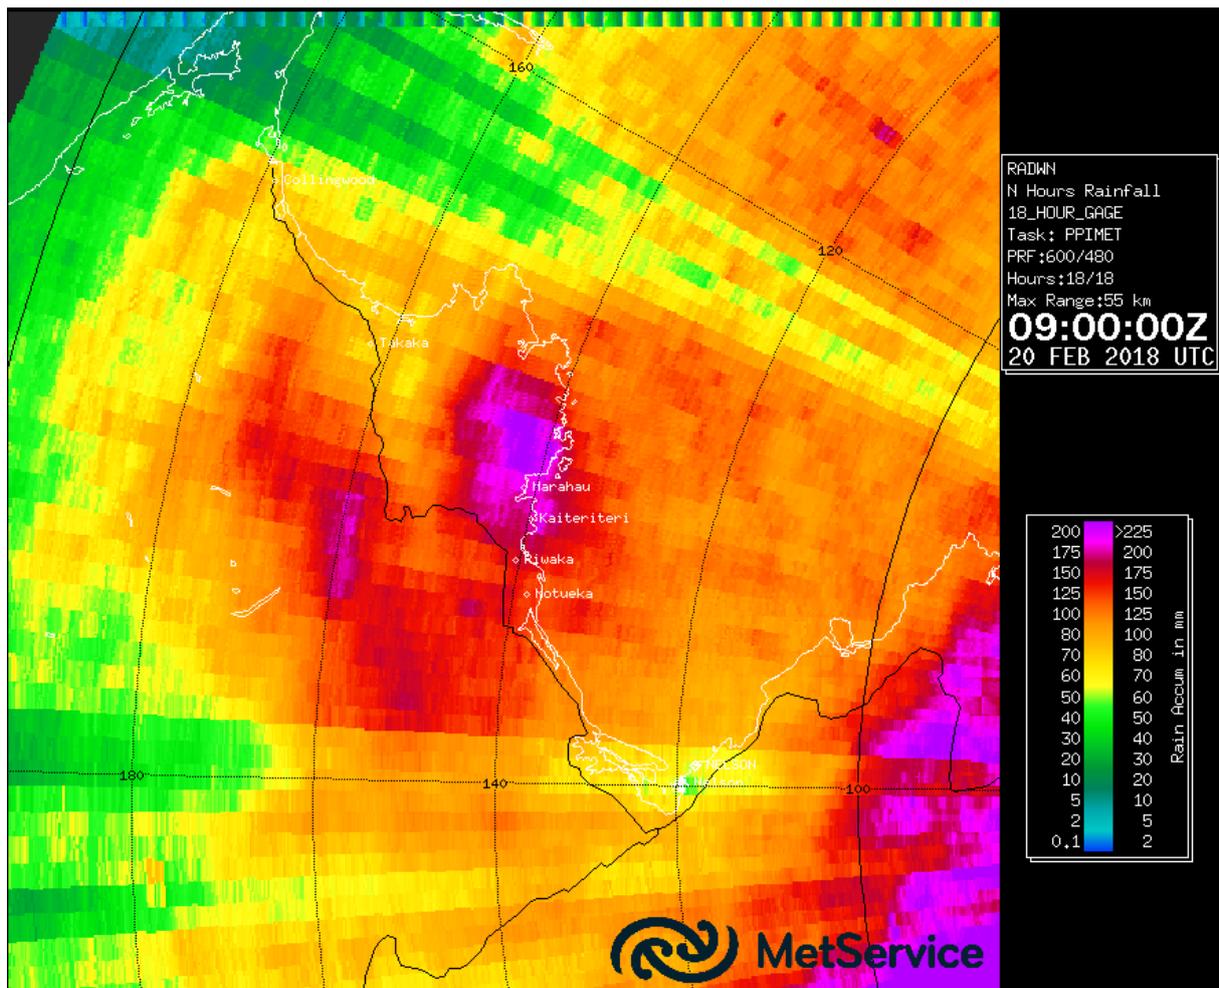
Figure 1.5 Rain radar image for the storm total (18-hour) rainfall. The maximum 18-hour rainfall occurred in the area north of Marahau from 15:00 UTC 19/02/2018 to 09:00 UTC 20/02/2018 (4am–10pm NZDT) with rainfall totals of about 230–235 mm over the area north of Marahau, about 195 mm over Marahau, and about 175–190 mm about the eastern part of the Takaka Hill Road. (Note scale is different to Figure 1.3 and Figure 1.4).

The maximum rainfall of 235 mm over the 18-hour duration of the storm was recorded in the Abel Tasman National Park, to the north of Marahau (Figure 1.5). The maximum rainfall intensity of 75 mm/hr was also recorded in this area (Figure 1.3), and up to 175 mm of rain fell in just 3 hours (Figure 1.4). The average rainfall intensity for the storm was 13 mm/hr. The landslide distribution is shown in relation to the storm rainfall total in Figure 4.4. The threshold for landsliding in the storm event in the Marahau area was about 60 mm/3 hrs or 130mm/18 hrs.

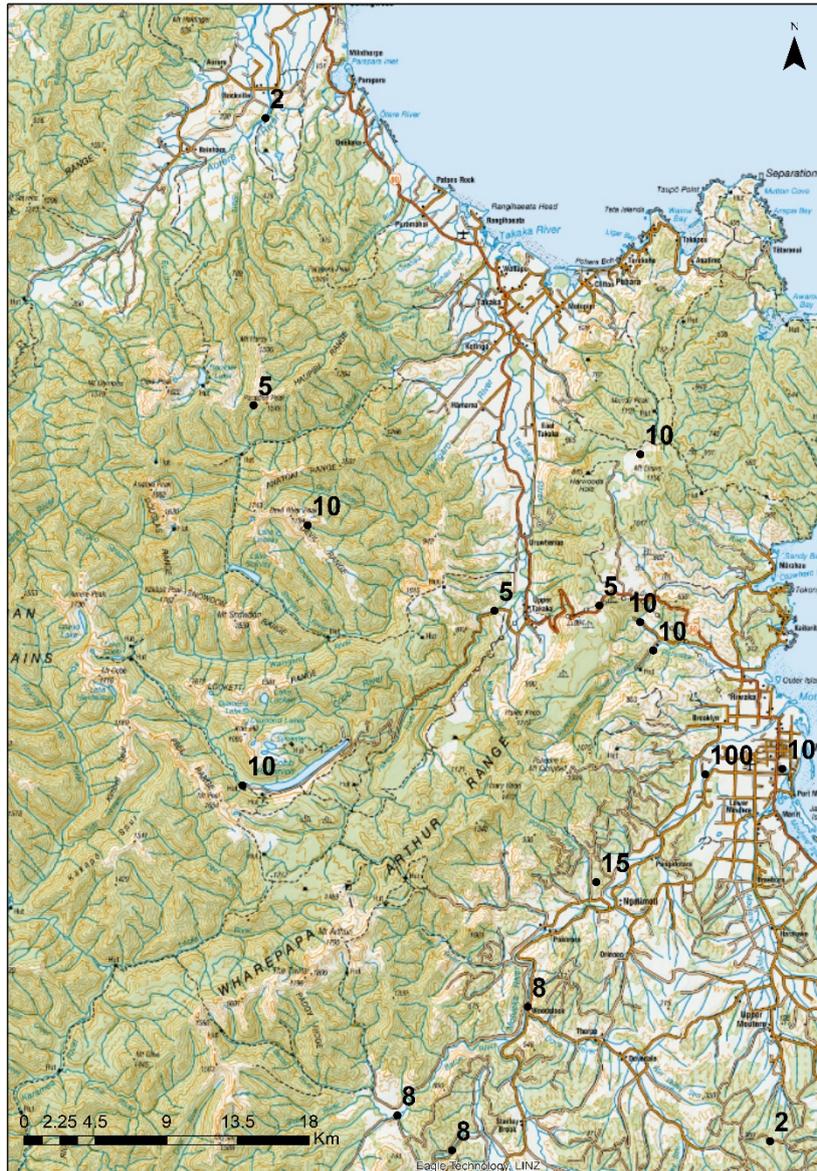
Figure 1.6 Annual Return intervals for 1-hr rainfall amounts at Tasman District Council rain-gauges (Data from Tasman District Council/HIRDS).

Data from the National Institute for Water and Atmospheric Research’s (NIWA) High Intensity Rainfall Design System (HIRDS) (<https://hirds.niwa.co.nz>) indicates that the annual return interval (ARI) for the 1, 12, and 18-hour rainfall totals for the areas that received the maximum amount of rain (Marahau and Riwaka) during ex-Tropical Cyclone Gita were in excess of 100 years, and the ARI for the 1 and 12-hour totals may exceed 200 years at Marahau and the Abel Tasman National Park. However, as indicated in Figure 1.6, at most rain gauges in the region, the ARI for the 1-hour maximum was below 10 years, which further demonstrates that the heaviest rainfall was very localised.

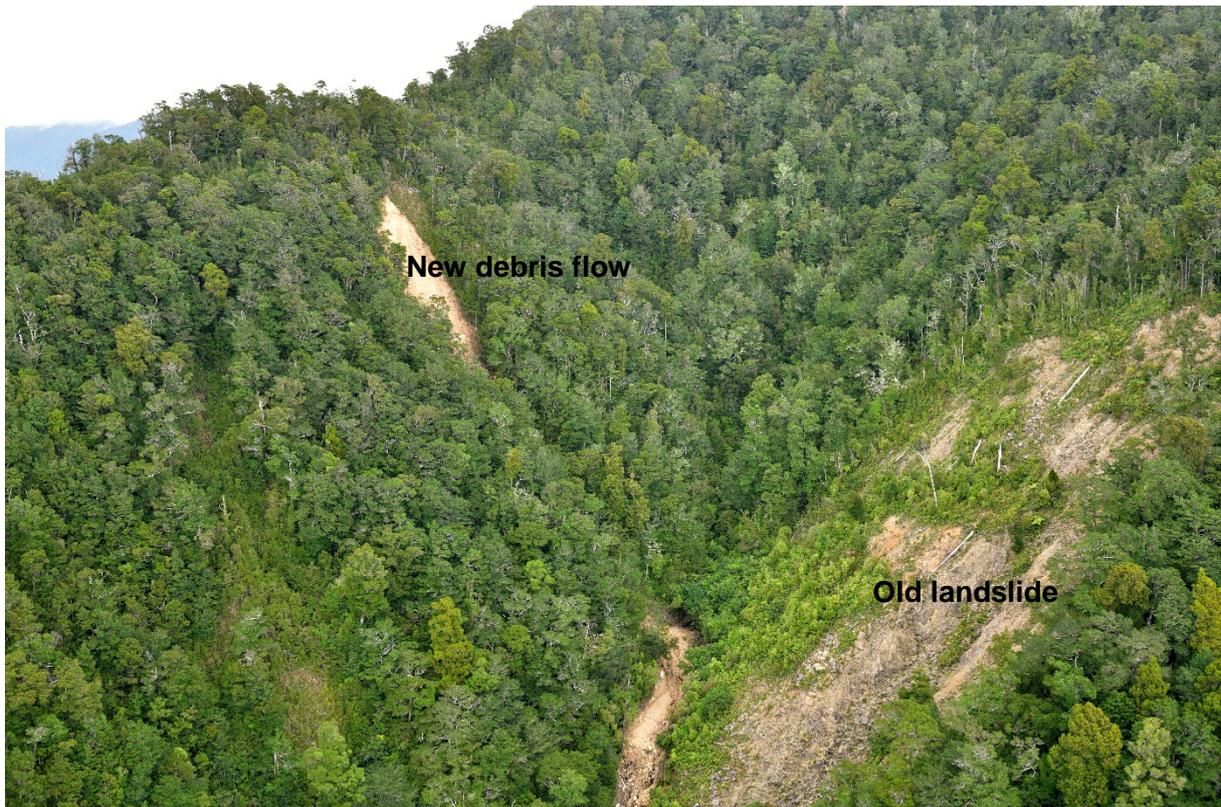
Figure 2.2 Example of shallow debris flows sourced in soil regolith and/or colluvium overlying weathered bedrock. Tributary of Granity Creek, Aorere River. There is also an older landslide scar on the hillslope on the right-hand side.

A cluster of landslides was observed in the Aorere-Kaituna River area in the Kahurangi National Park, and along the SE-facing side of the Burnett Range to the north (Figure 2.1). The landslides were predominantly shallow debris flows, sourced in soil regolith and/or colluvium overlying weathered bedrock, mainly initiating in heads of gullies (Figure 2.2). The majority of debris flows were strongly coupled with stream channels, which confined debris flow runout along the channel networks. In some locations, the debris flows were able to spread over flatter, farmed terrain lower in the catchments. A concentrated debris flow caused notable damage to a bridge (Figure 2.3) crossing the Kaituna River. In this location, water and entrained debris (mainly trees) were built up behind the bridge before spilling out onto the surrounding farm land. Another bridge further downstream was undermined and had supporting material washed away from the foundations of its central pile, causing the central section of the bridge to sag (Figure 2.4).

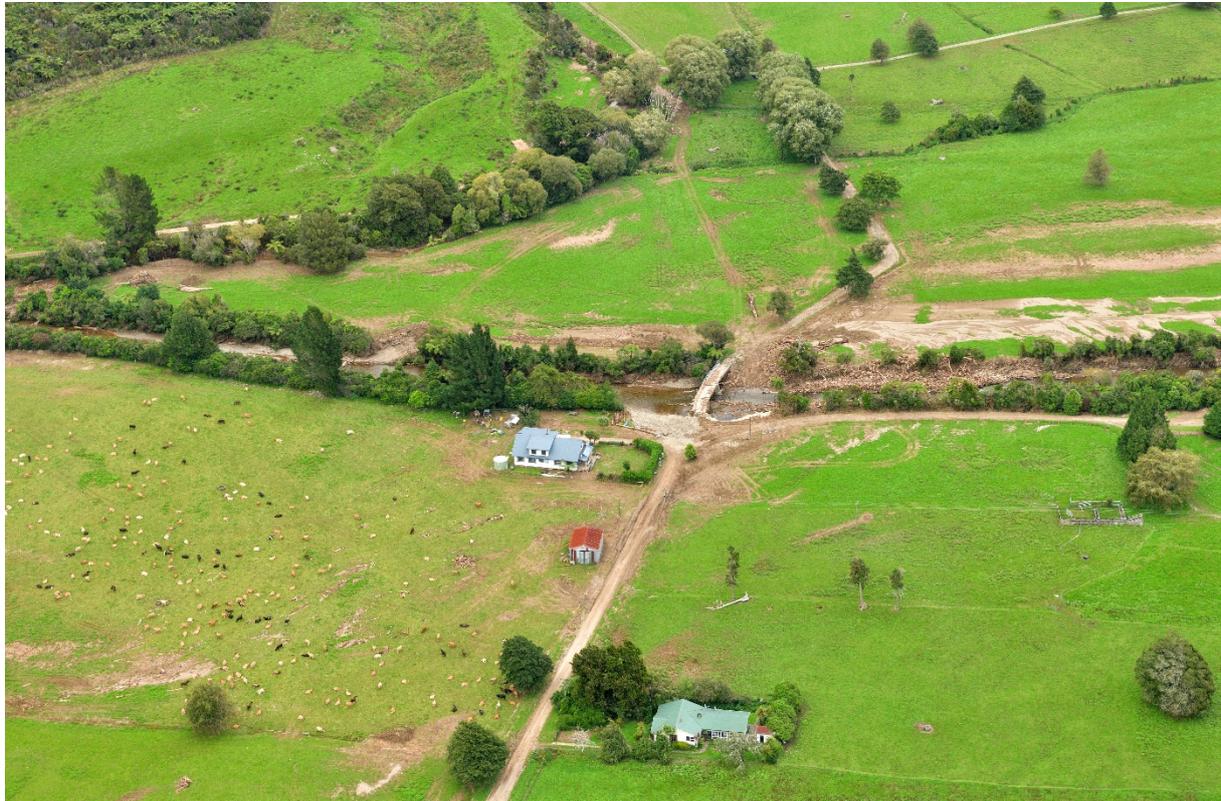
Figure 2.3 Damage to a bridge crossing the Kaituna River, near Aorere, caused by a channelised debris flow. In this location water and entrained debris (mainly trees) built up behind the bridge before spilling out onto the surrounding farm land.

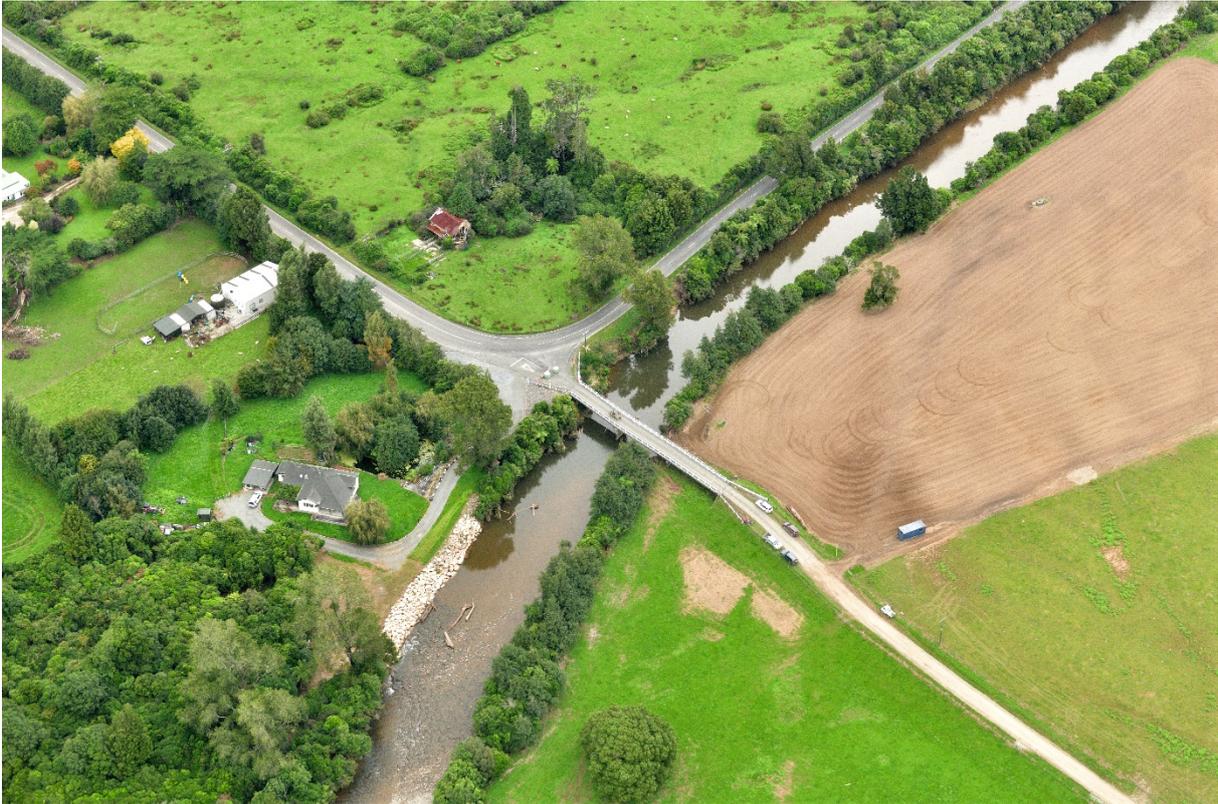
Figure 2.4 Another bridge over the Kaituna River, slightly downstream from of that shown in Figure 2.3, was undermined causing the central section of the bridge to sag.

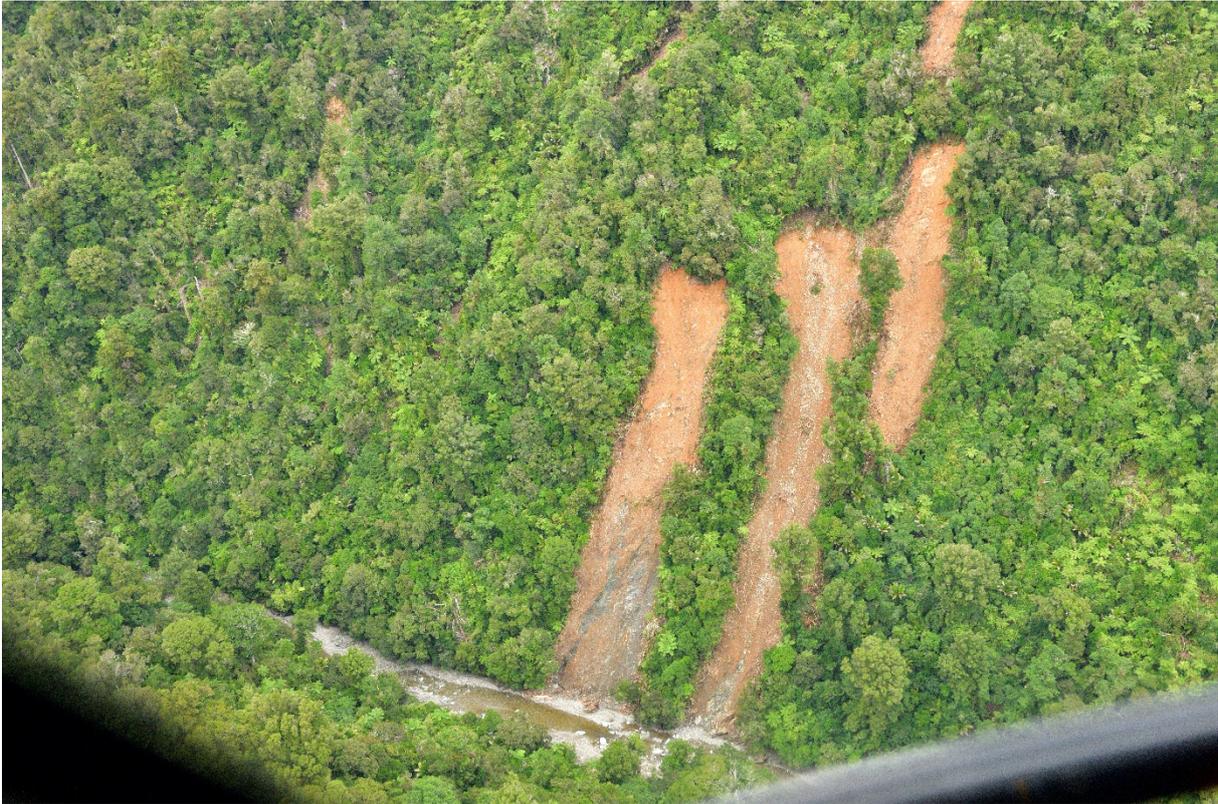
Figure 2.5 Examples of shallow soil and regolith landslides that occurred on open hillside faces and directly coupled to the stream channel (Upper Kaituna River).

In addition to debris flows in gully heads, several landslides occurred on open hillside faces (Figure 2.5 and Figure 2.6). While these landslides were also typically shallow failures in soil regolith and colluvium overlying weathered bedrock (and in some instances ran out to reach the stream channels), they appeared to have occurred less frequently than the channelised debris flows.

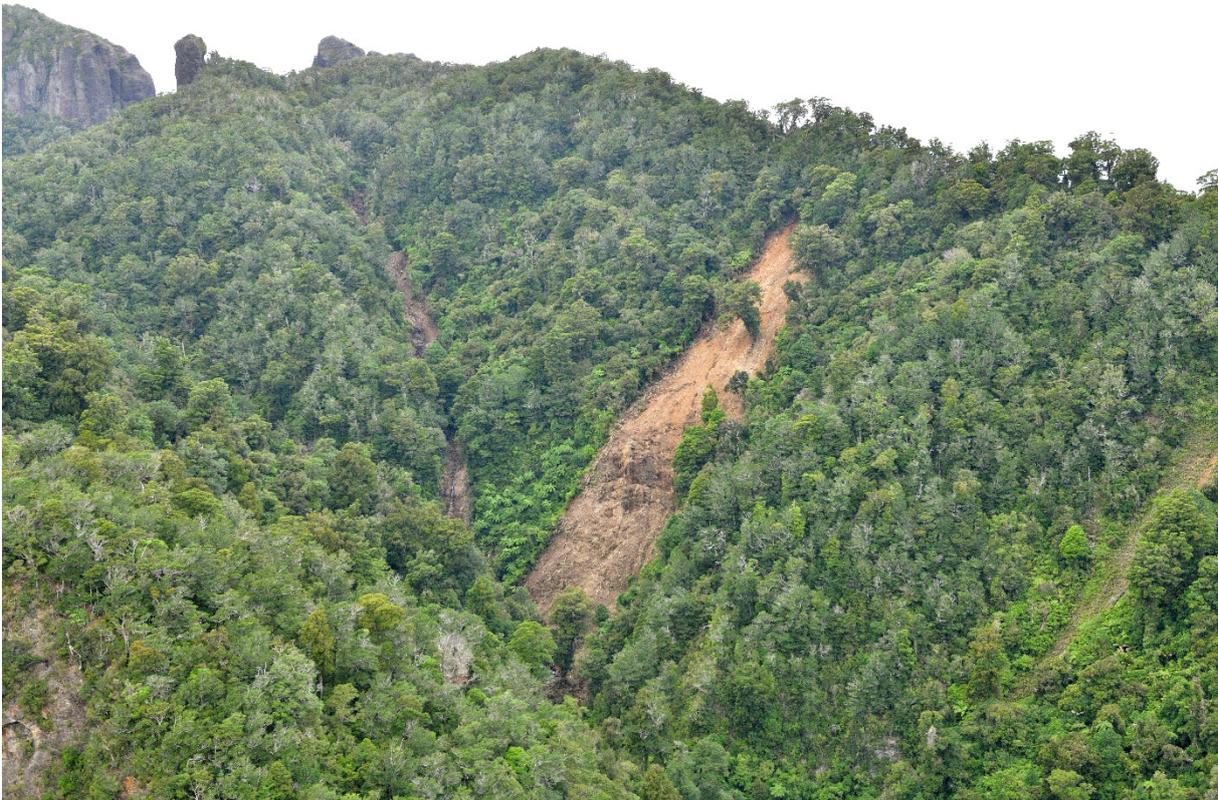
Figure 2.6 Example of landslides that occurred on open hillside faces that were directly coupled to the stream channel (Kaituna River, near Mt Hardinger).

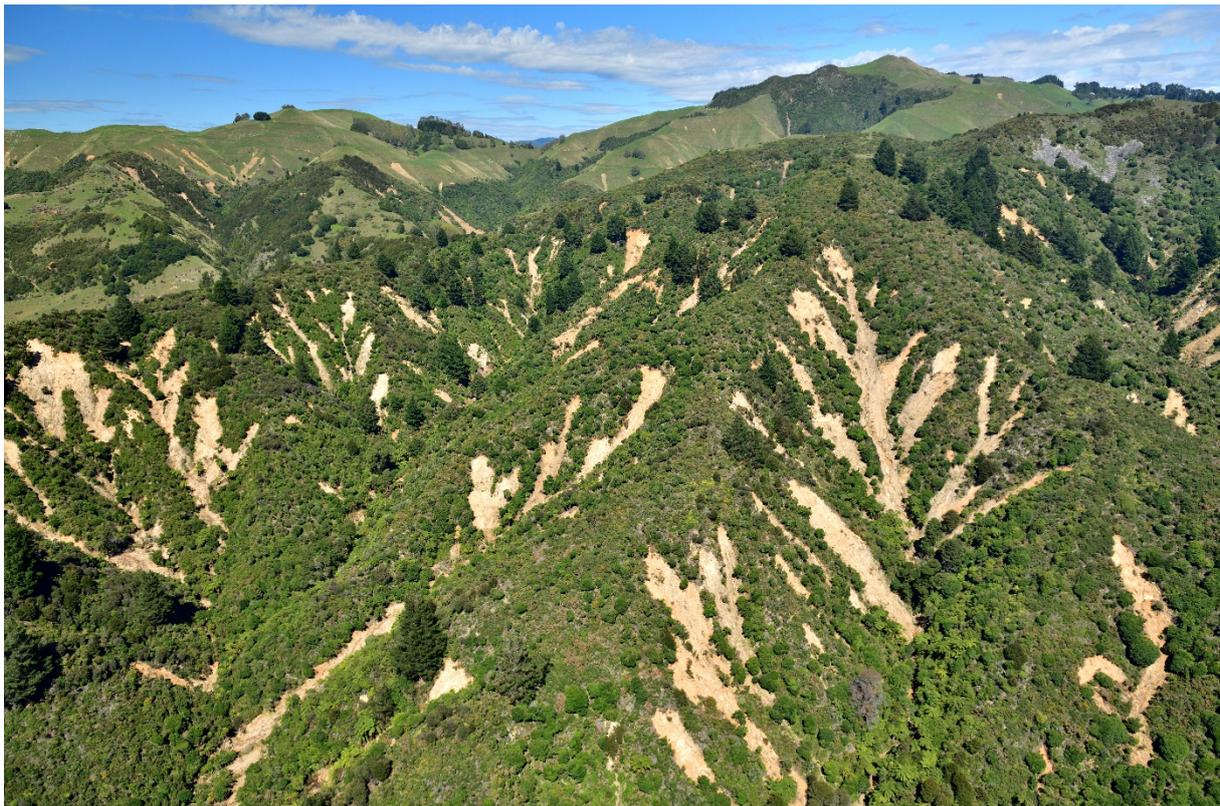
Figure 2.7 Shallow debris flows initiated in soil or colluvium in gully heads in the Otuwhero River catchment.

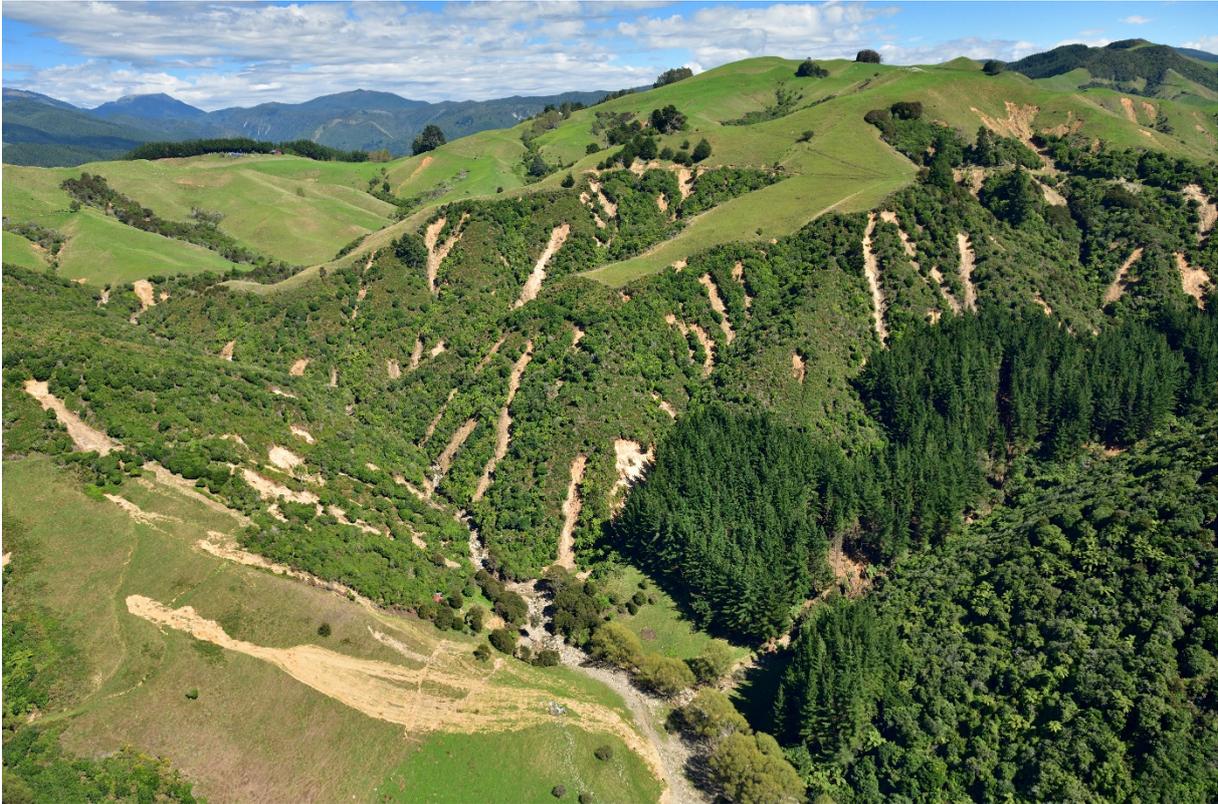
Figure 2.8 Shallow debris flows initiated in soil or colluvium in gully heads in the Atua Stream catchment, near Kaiteriteri.

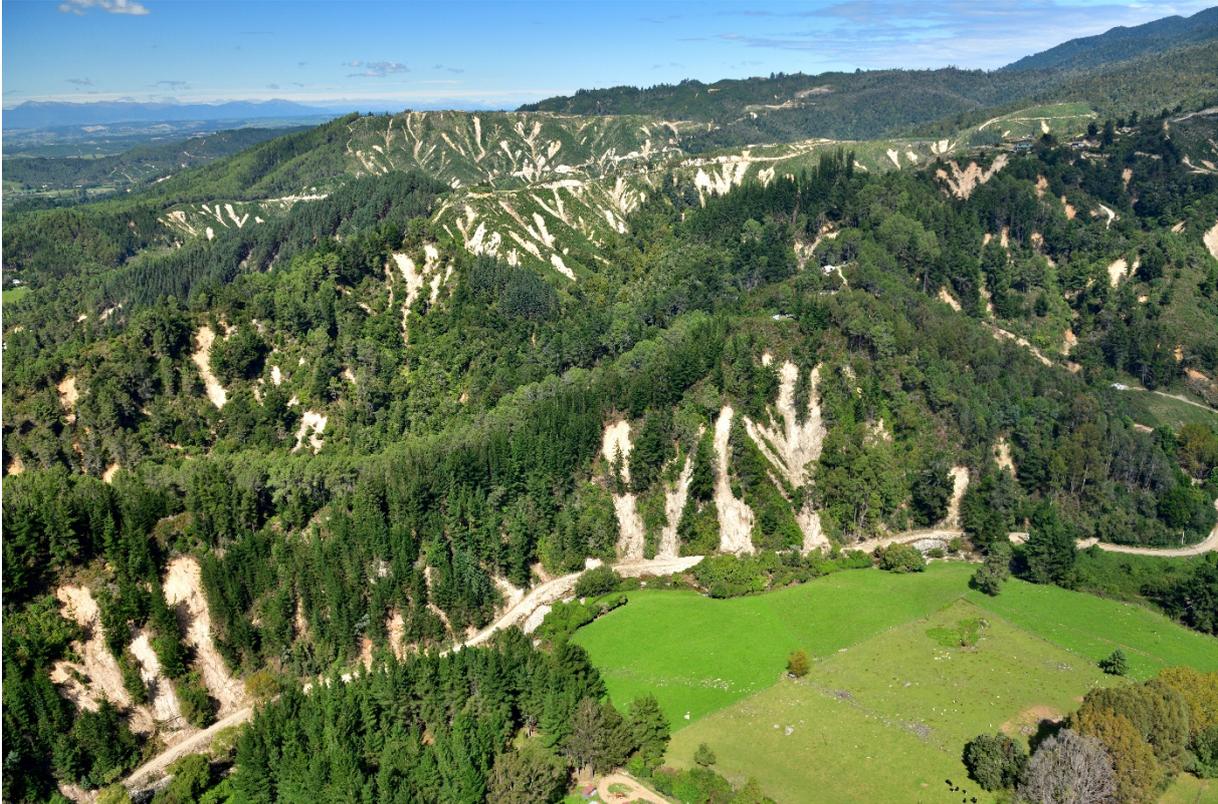
Figure 2.9 Shallow debris flows initiated in soil or colluvium in gully heads. Several debris flows initiated from forestry roads or skid platforms (far centre) (tributary of Holyoake Stream, near Kaiteriteri).

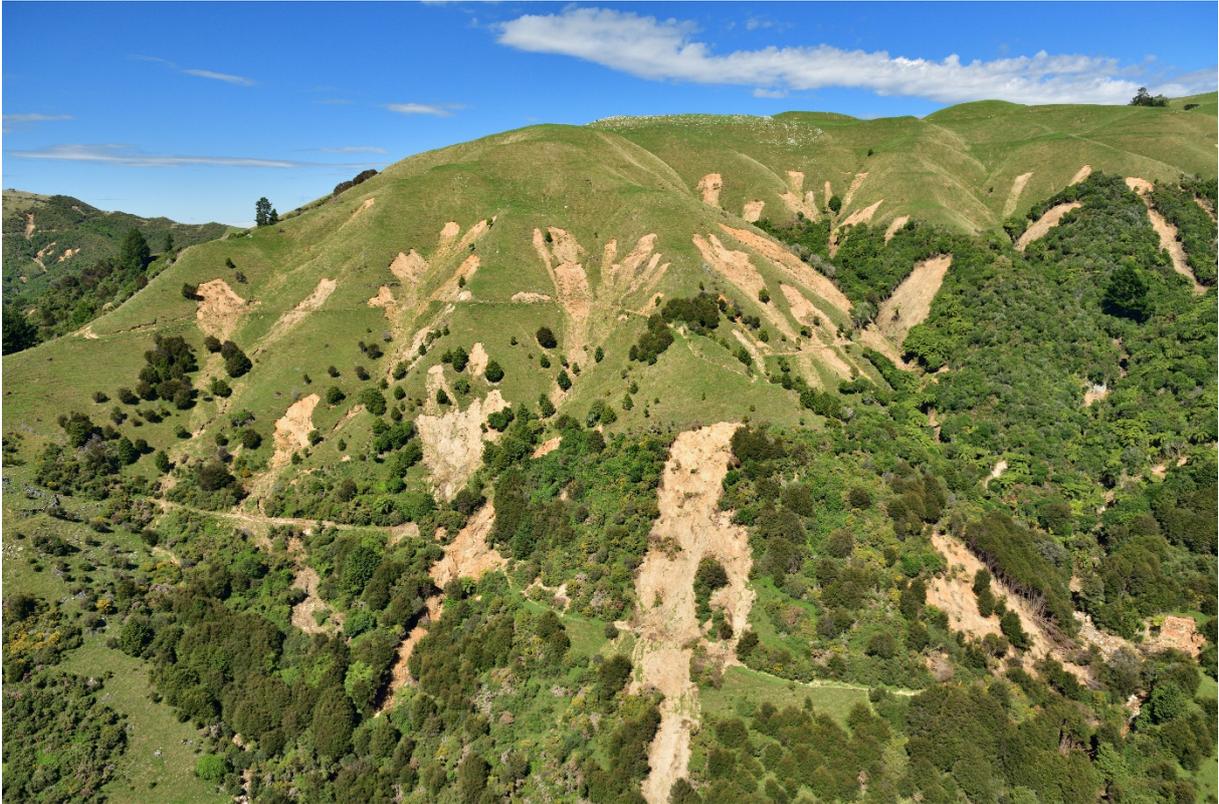
Figure 2.10 Shallow debris flows initiated in soil or colluvium in gully heads (tributary of Holyoake Stream, near Kaiterteri).

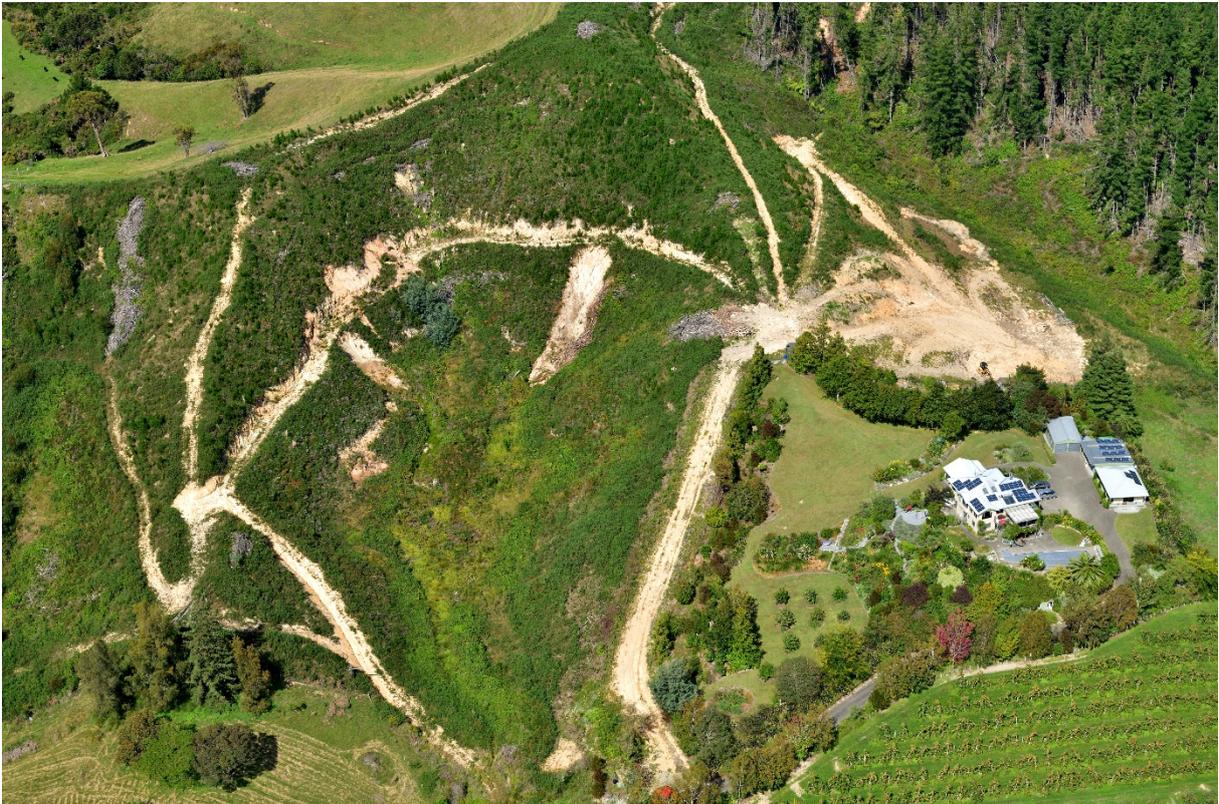
Figure 2.11 Shallow debris flows initiated in soil or colluvium in gully heads in the Brooklyn Stream catchment, near Brooklyn. Several debris flows initiated from forestry roads or skid platforms.

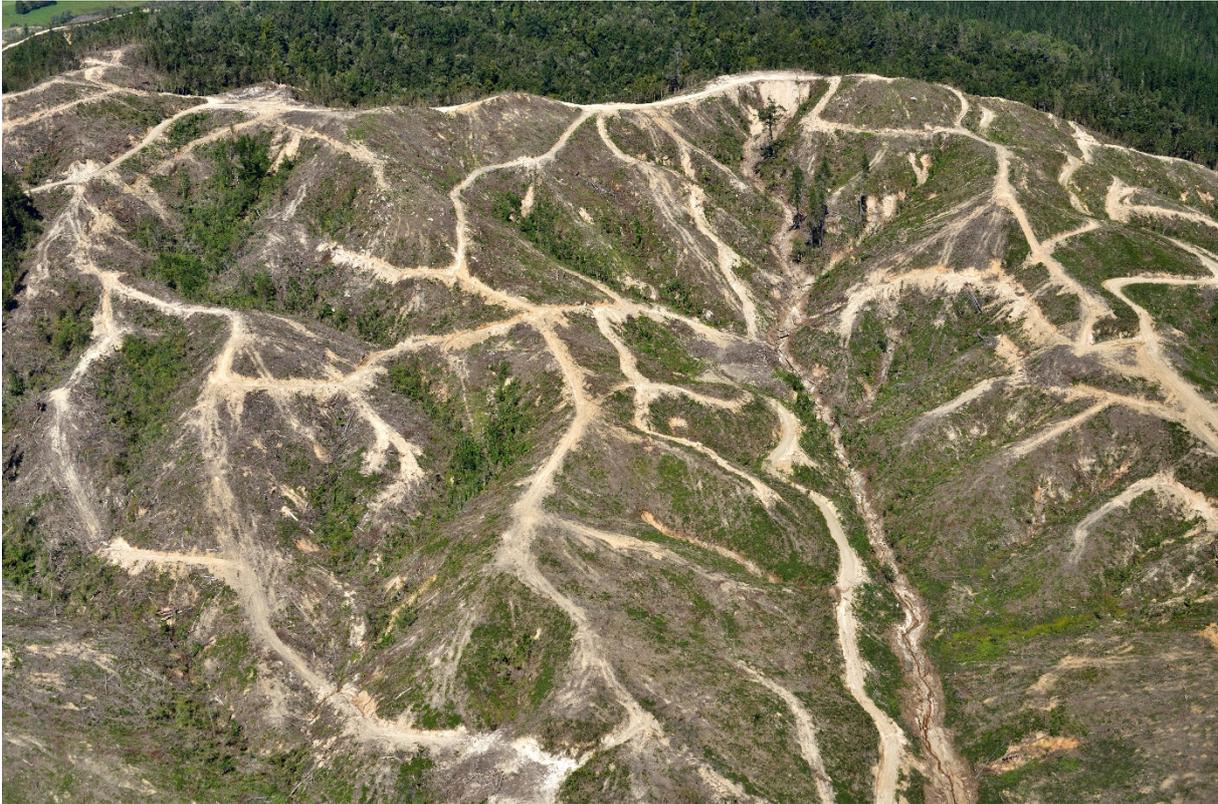
Figure 2.12 Shallow debris flows initiated in soil or colluvium in gully heads in the Waiwhero Creek catchment, near Pangatotara. Several debris flows initiated from forestry roads or skid platforms.

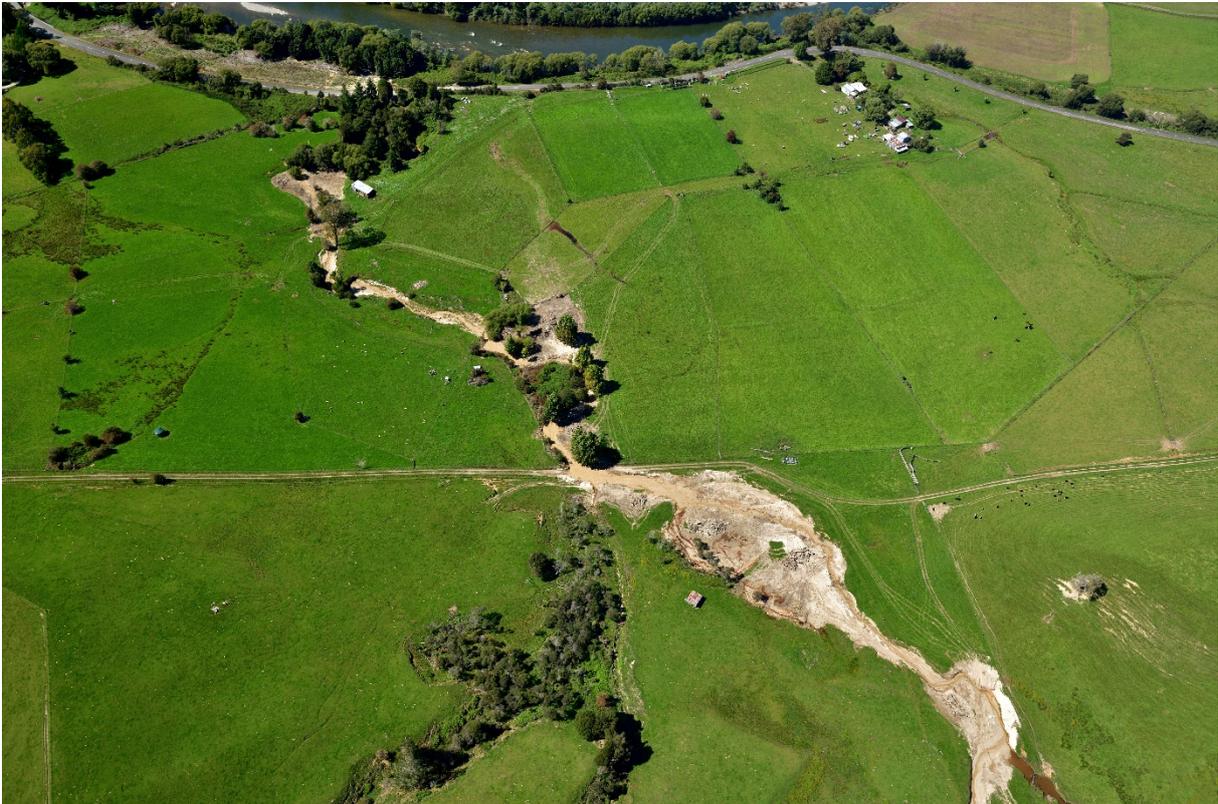
Figure 2.13 Channelised debris flow on the west bank of the Motueka river, near Pangatotara.

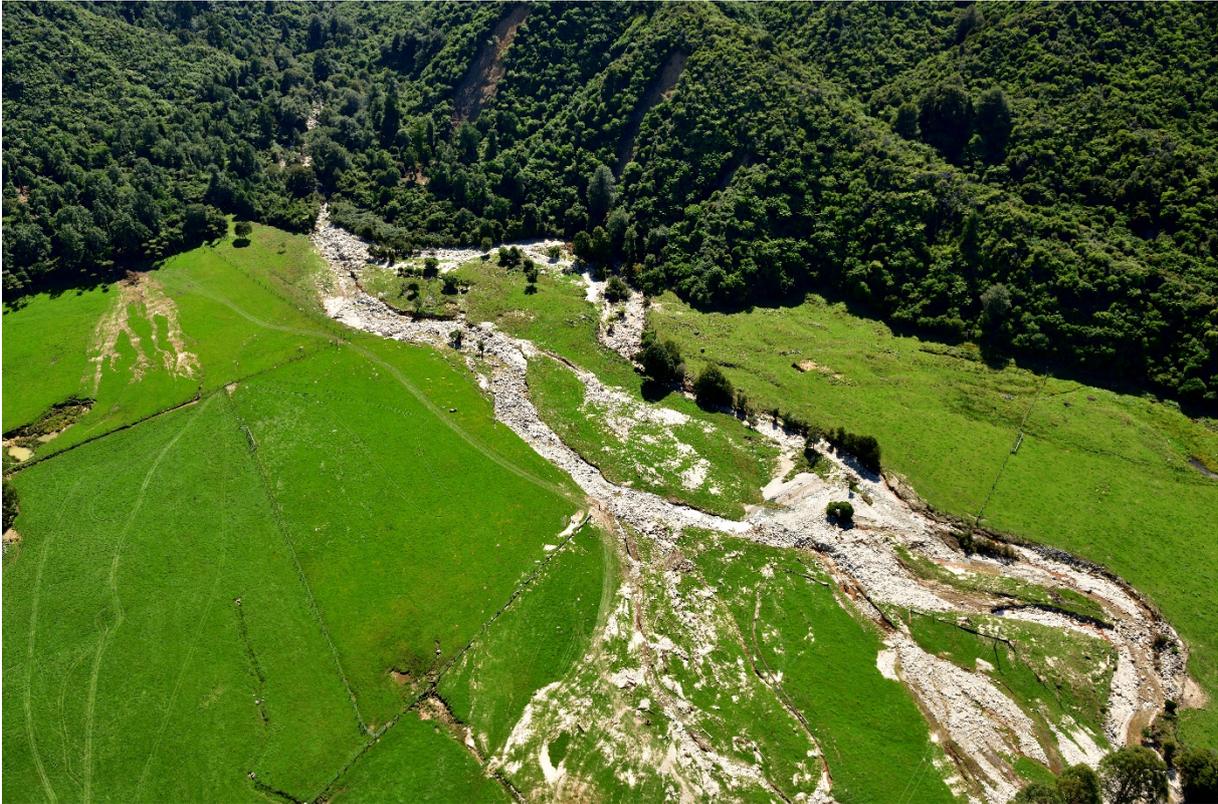
Figure 2.14 Debris flow that overwhelmed the channel of a tributary to Little Pokororo River, near Ngatimoti.

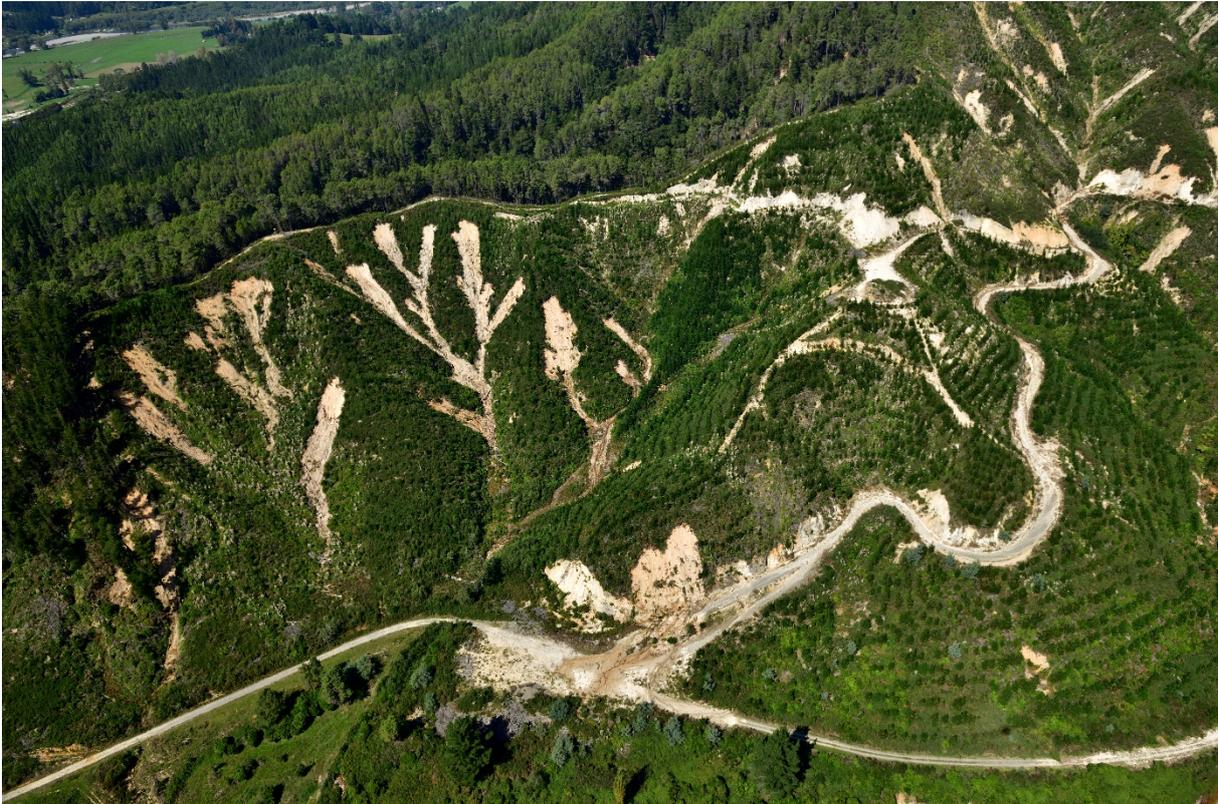
Figure 2.15 Multiple coalesced landslides adjacent to the Marahau River that did not produce significant debris flow runout.

Most of the high density landsliding occurred within the southeast facing sub-catchments of the Motueka River, along the northern end of the Arthur Range (Takaka Hill), about 8 km west of Motueka. As also observed in the Aorere-Kaituna area, the predominant landslide type was shallow debris flow (Figure 2.7). Again, these were mainly initiated in gully heads in soil regolith and/or colluvial deposits (Figure 2.8 and Figure 2.9) overlying weathered bedrock. Whilst the majority initiated in natural ground (Figure 2.10), several debris flows initiated from forestry roads or skid platforms (Figure 2.11 and Figure 2.12). Most of the debris flows were strongly coupled to channels and so were mainly confined (Figure 2.13), or they coalesced and spread out when reaching flatter terrain (Figure 2.14). Not all cases of coalescing landslides into a channel produced a debris flow (Figure 2.15).
