**Landslides and debris flows in the Tasman District
caused by ex-Tropical Cyclone Gita,
20-21 February, 2018**

**GNS Science Report 2019/34
July 2020**

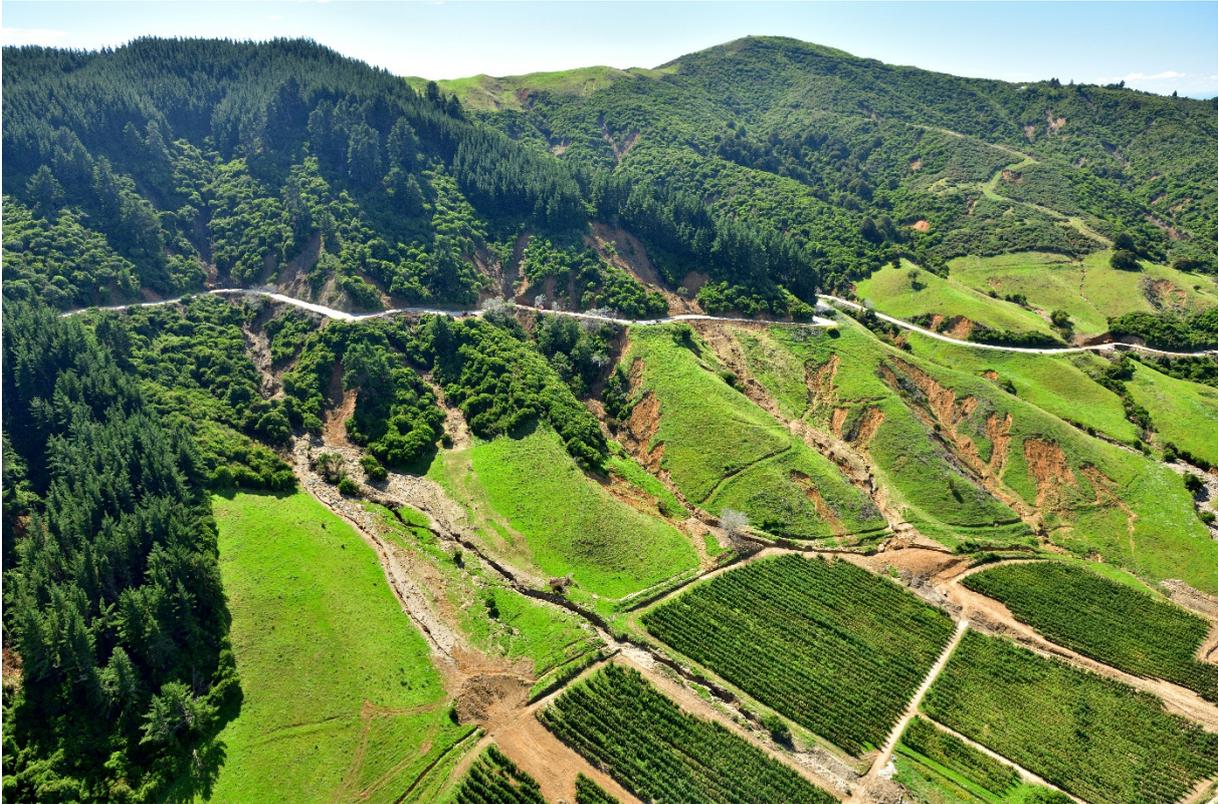
Figure 2.16 Landslides and debris flows badly damaged the Takaka Hill Road on the north side of the Riwaka valley. In some instances, the road was inundated by debris making it impassable. Many of the debris flows had enough power to erode the edge of the roadway, causing wash-outs below the road.

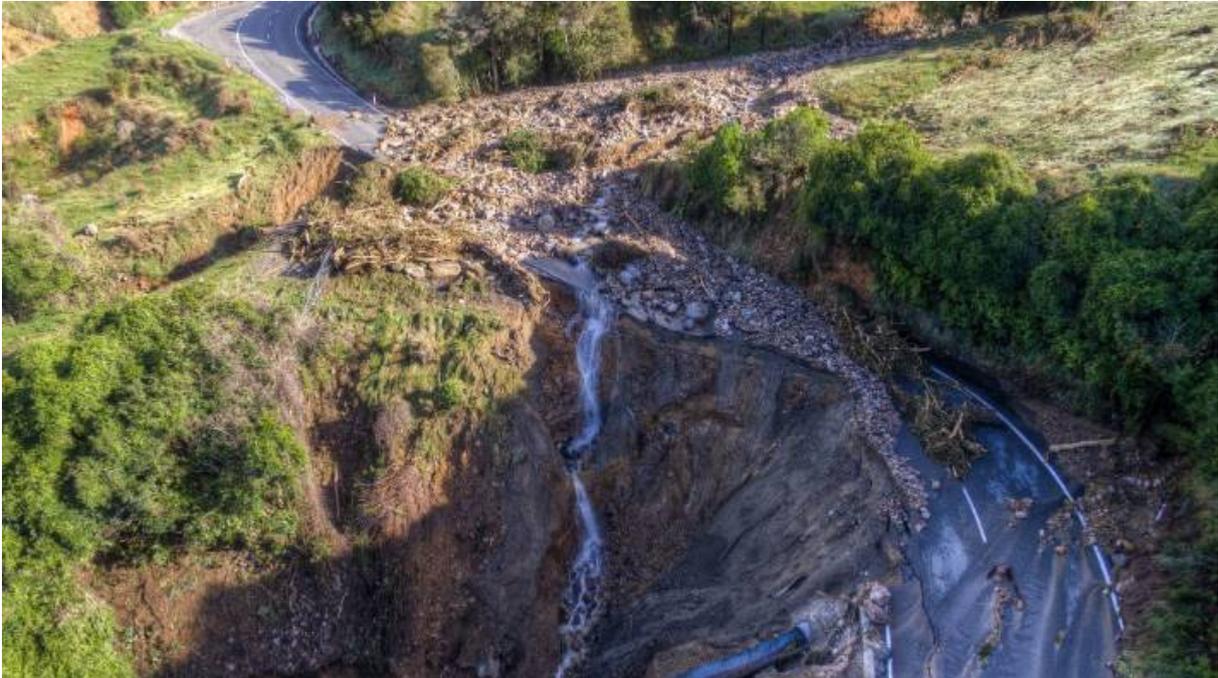
Figure 2.17 A debris flow on the Takaka Hill Road that eroded the edge of the roadway and caused a large washout (Photo: Stuff.co.nz, 22 February 2018).

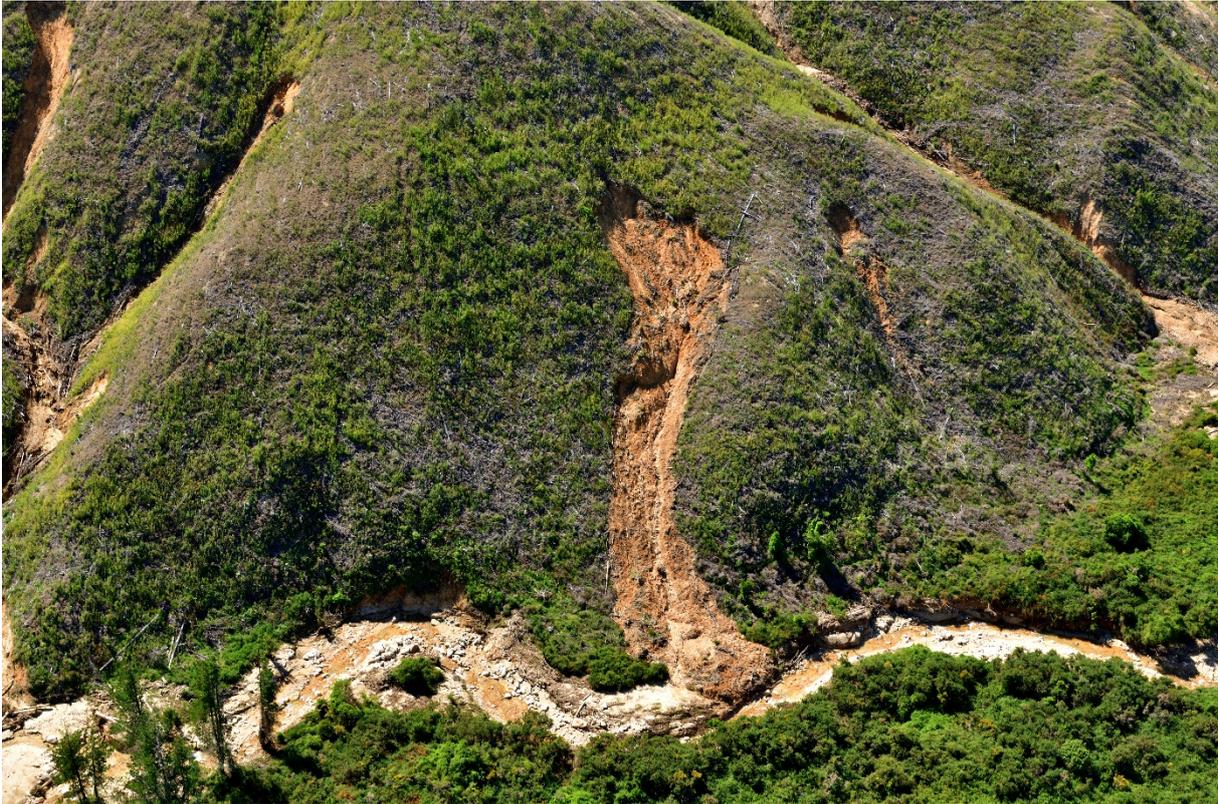
Figure 2.18 Example of a deeper-seated landslide adjacent to an unnamed stream in the Otuwhero River catchment, near Marahau.

In addition, several deeper-seated landslides and flows were observed (Figure 2.18 and Figure 2.19), some of which also involved local cracking and slumping (Figure 2.20). Some localised rock falls were also identified (Figure 2.21).

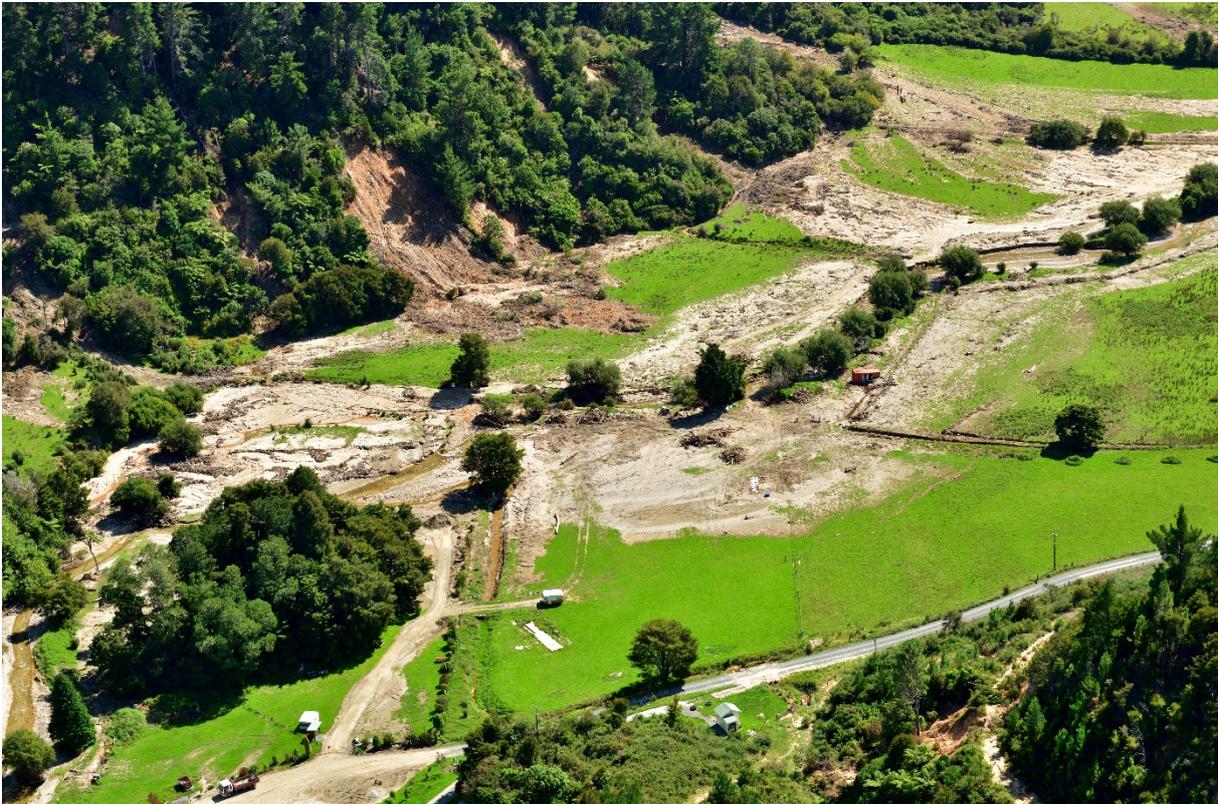
Figure 2.19 Examples of deeper-seated landslides in the Holyoake Stream catchment, Moss Rd, near Otuwhero Inlet.

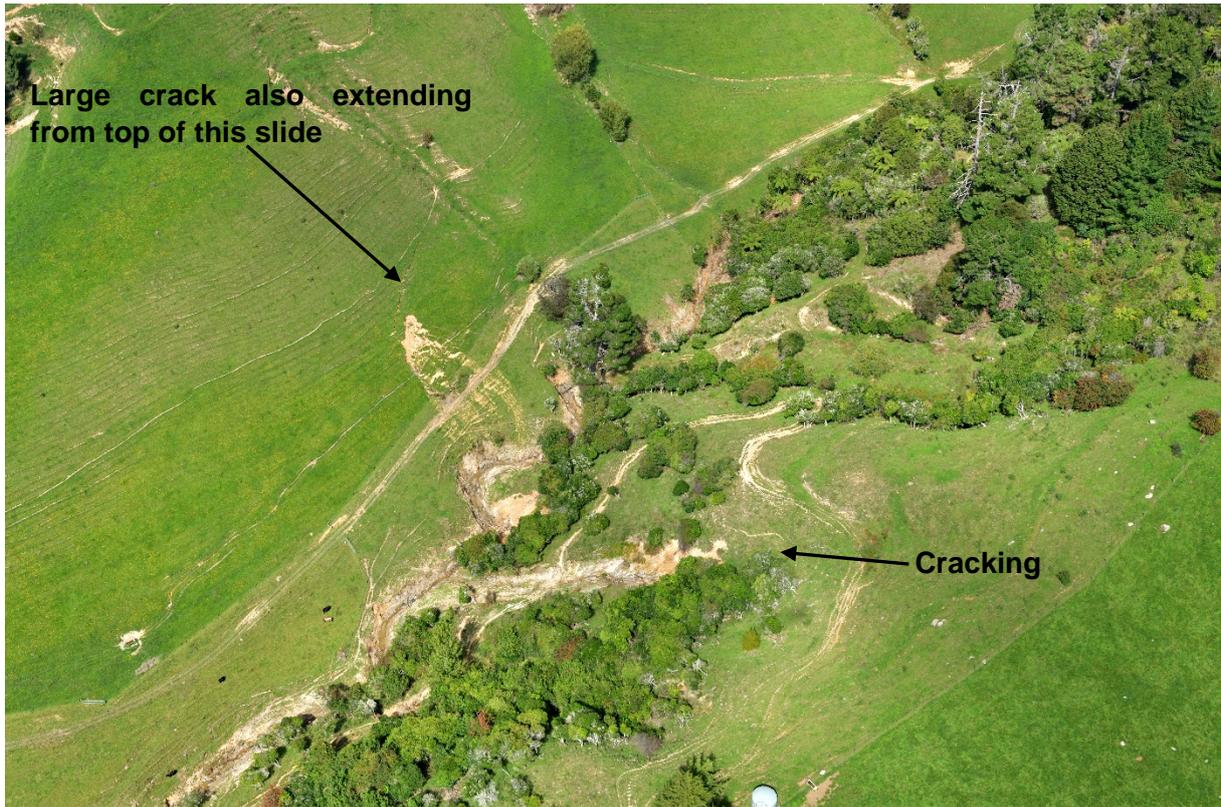
Figure 2.20 Localised cracking and slumping associated with a deep-seated landslide off Little Sydney Rd, near Riwaka.

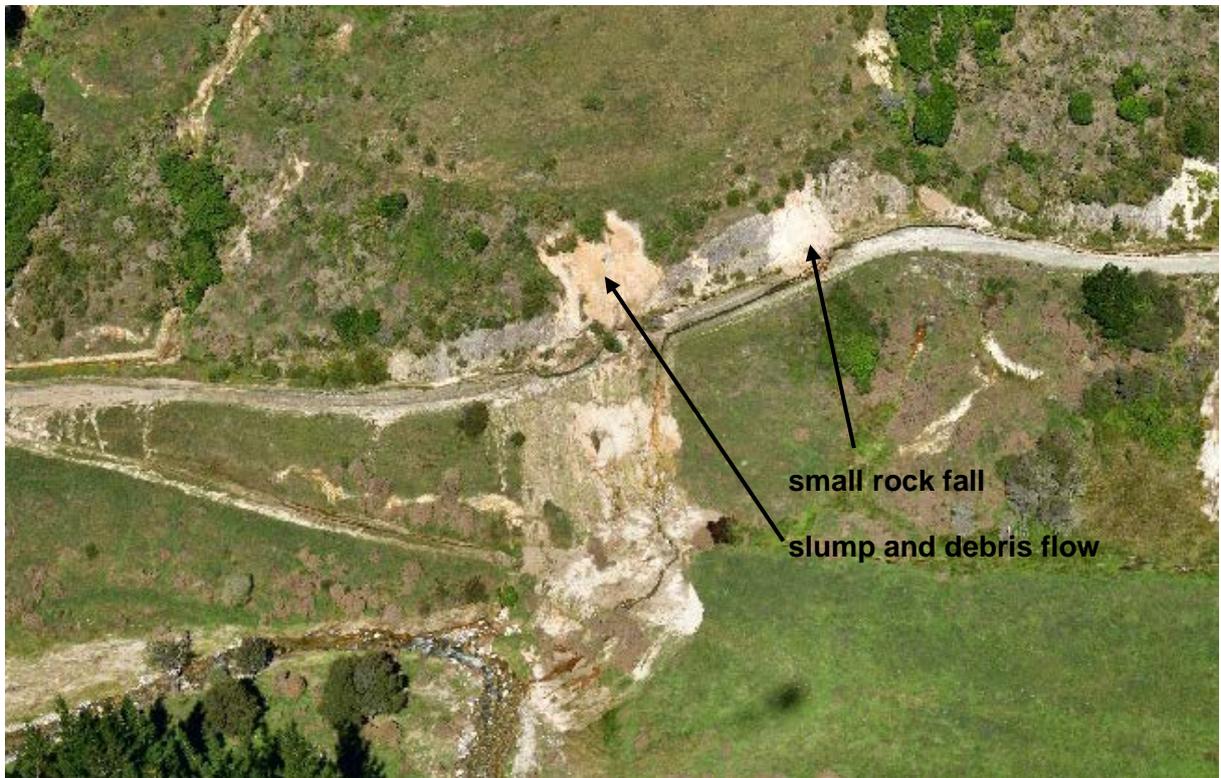
Figure 2.21 Localised rock falls in the Little Pokororo River catchment near Ngatimoti.

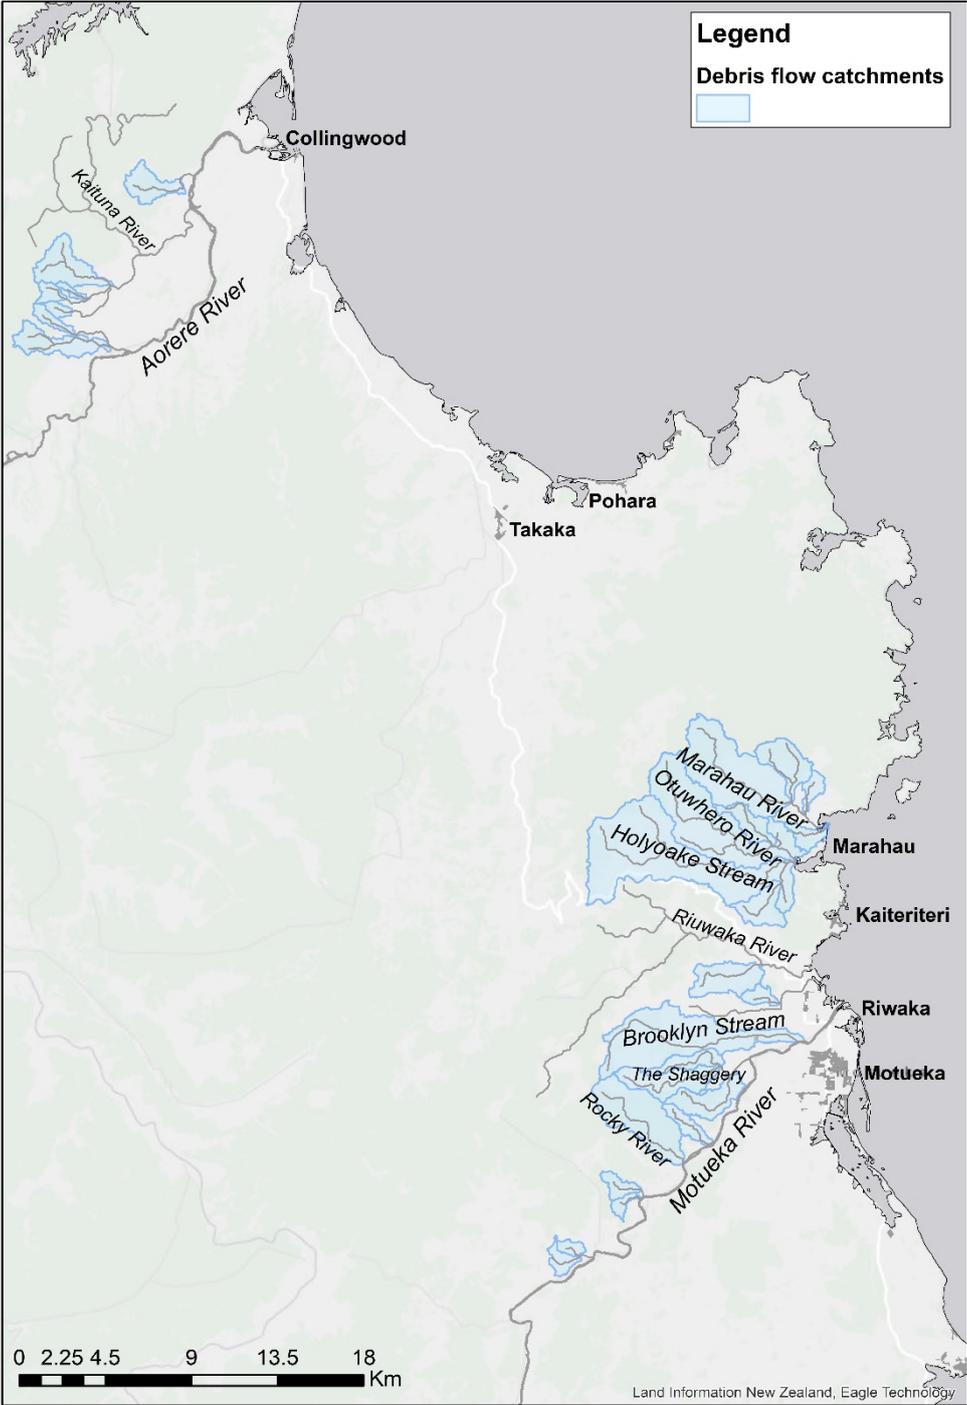
Figure 2.22 The locations of catchments that experienced debris flows during ex-Tropical Cyclone Gita.

Debris floods and flows occurred in many of the river and stream channels downstream of the landslides. The locations of these catchments are shown in Figure 2.22. The catchments where debris flows occurred in the Riwaka-Marahau area included the Marahau River, Otuwhero River (Figure 2.23 and Figure 2.24), Holyoake Stream (Figure 2.25), Riwaka River and lower sub catchments of the Motueka River including Brooklyn Stream, the Shaggery, and Rocky River. In the Kahurangi National Park area, debris floods and/or flows occurred in at least 6 sub-catchments of the lower Aorere and Kaituna Rivers.

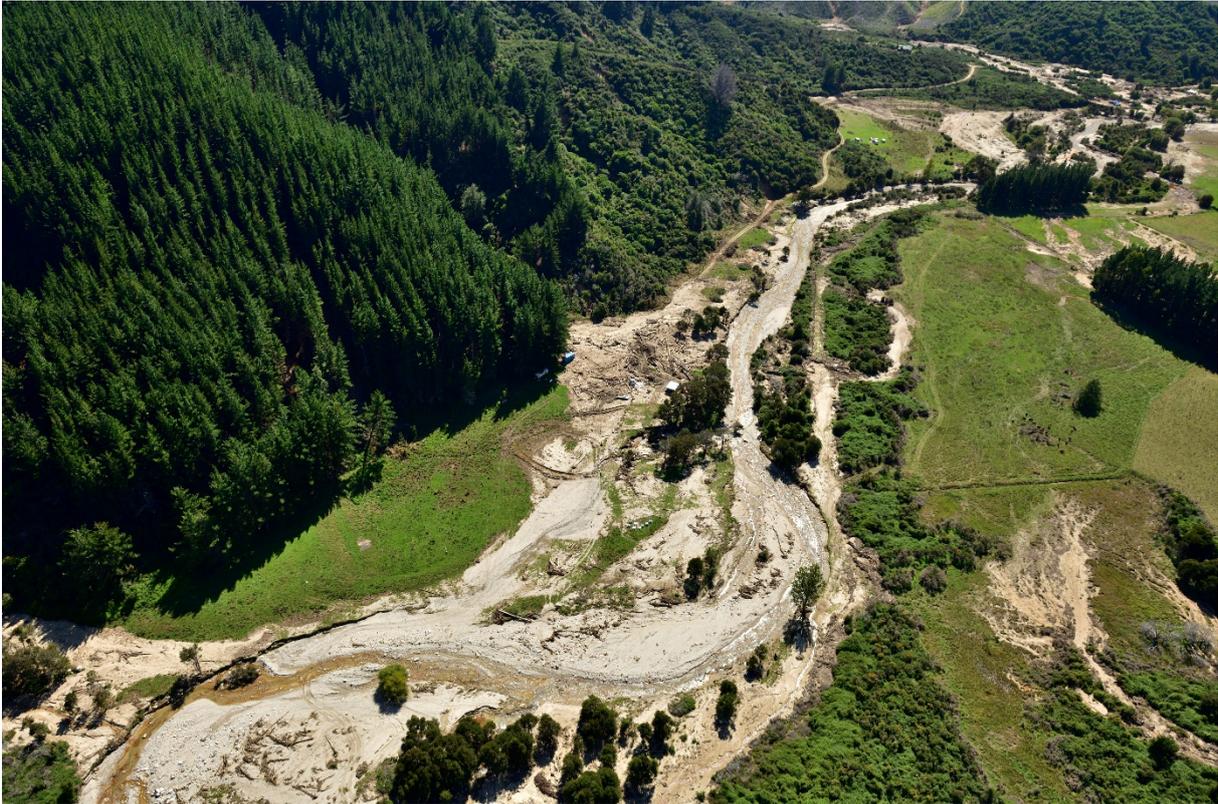
Figure 2.23 Debris flow deposit in the Otuwhero River near the upper end of the floodplain.

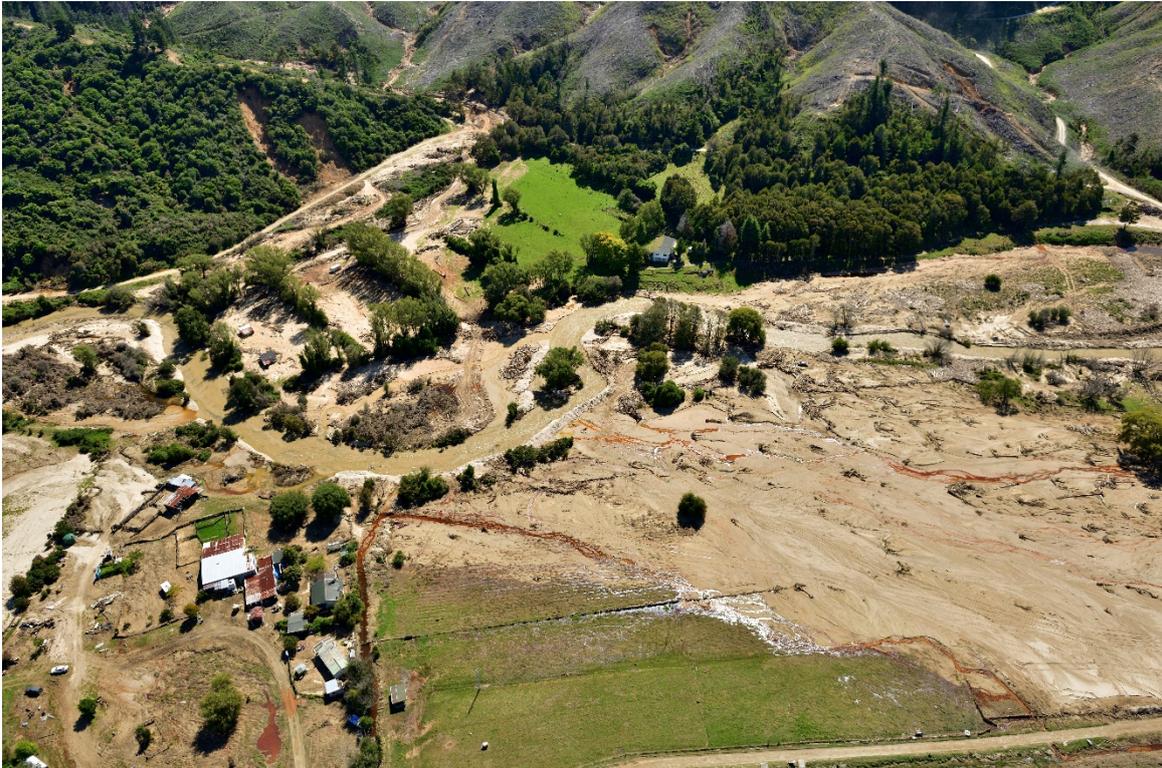
Figure 2.24 Debris flow deposit in the Otuwhero River catchment, at Otuwhero Valley Rd.

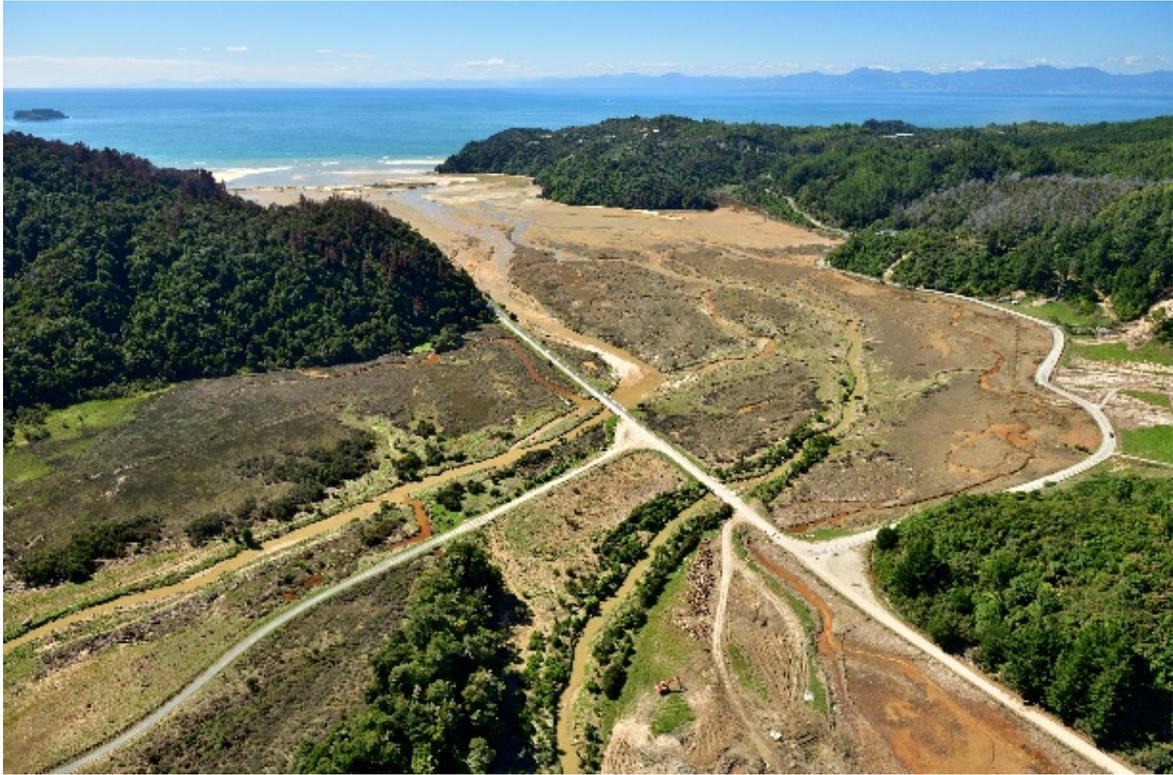
Figure 2.25 Thin debris flow and over bank deposits, lower Holyoake Stream valley and mouth, Otuwhero inlet.

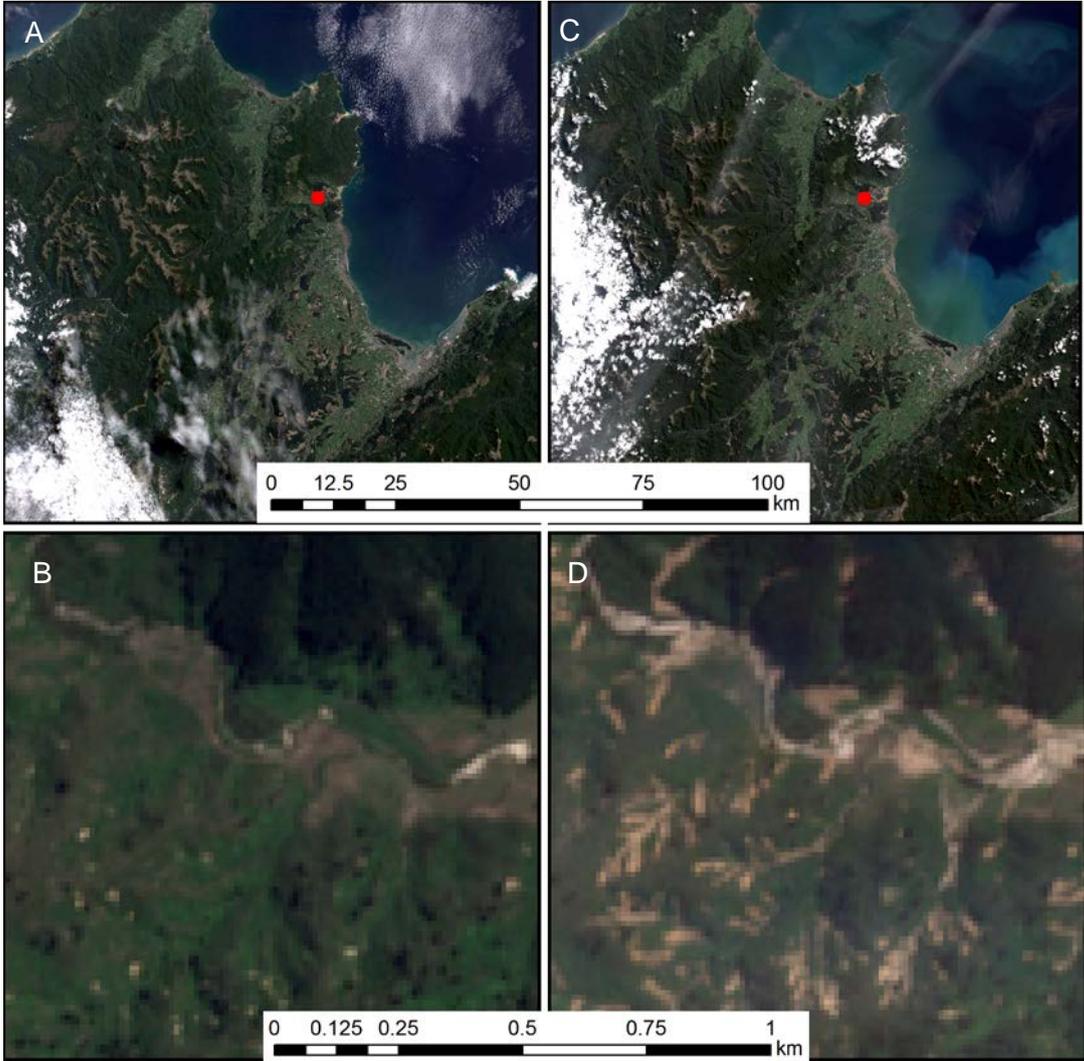
Figure 3.1 Sentinel-2 10 m True Colour Image tiles captured on A-B) 24 January 2018 and C-D) 23 February 2018, following ex-Tropical Cyclone Gita. Landslide damage in the Riwaka area (red square) is clearly visible on C-D. (Copernicus Sentinel data 2018, processed by ESA).

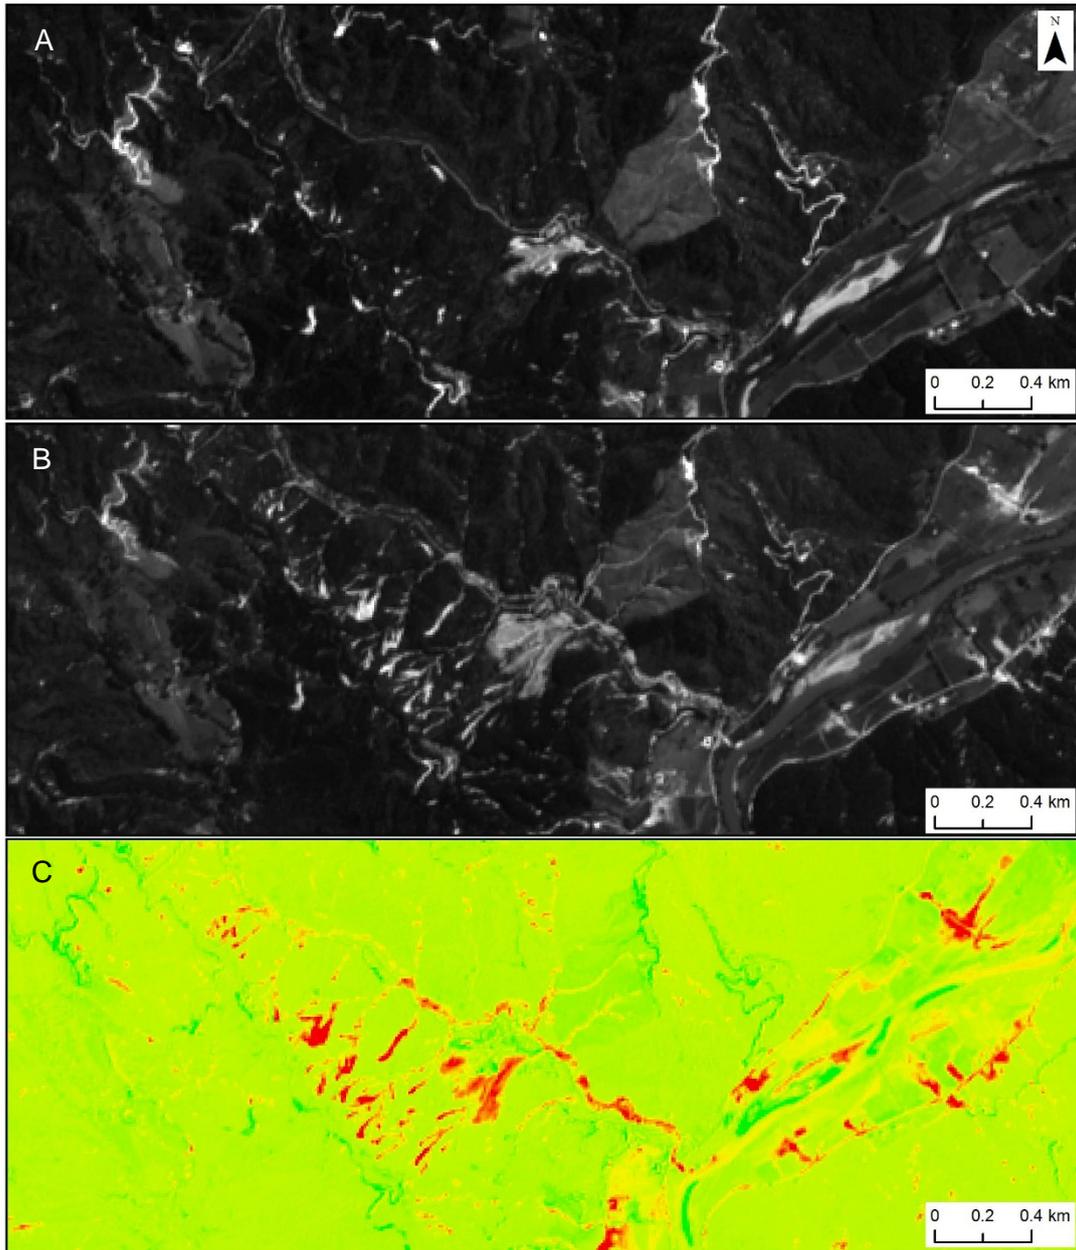
Figure 3.2 Red band change detection methodology for extracting landslide polygons A) Sentinel-2 pre-event dataset showing only the red band stretch. B) Sentinel-2 post-event dataset showing only the red band stretch; the landslide scars can be seen (in white) with high red band pixel values. C) Difference between the pre- and post- red band datasets, showing areas with a significant increase in red band values as red. These areas show stronger reflection due to the bright, fresh landslide scars and sediment transported downslope.

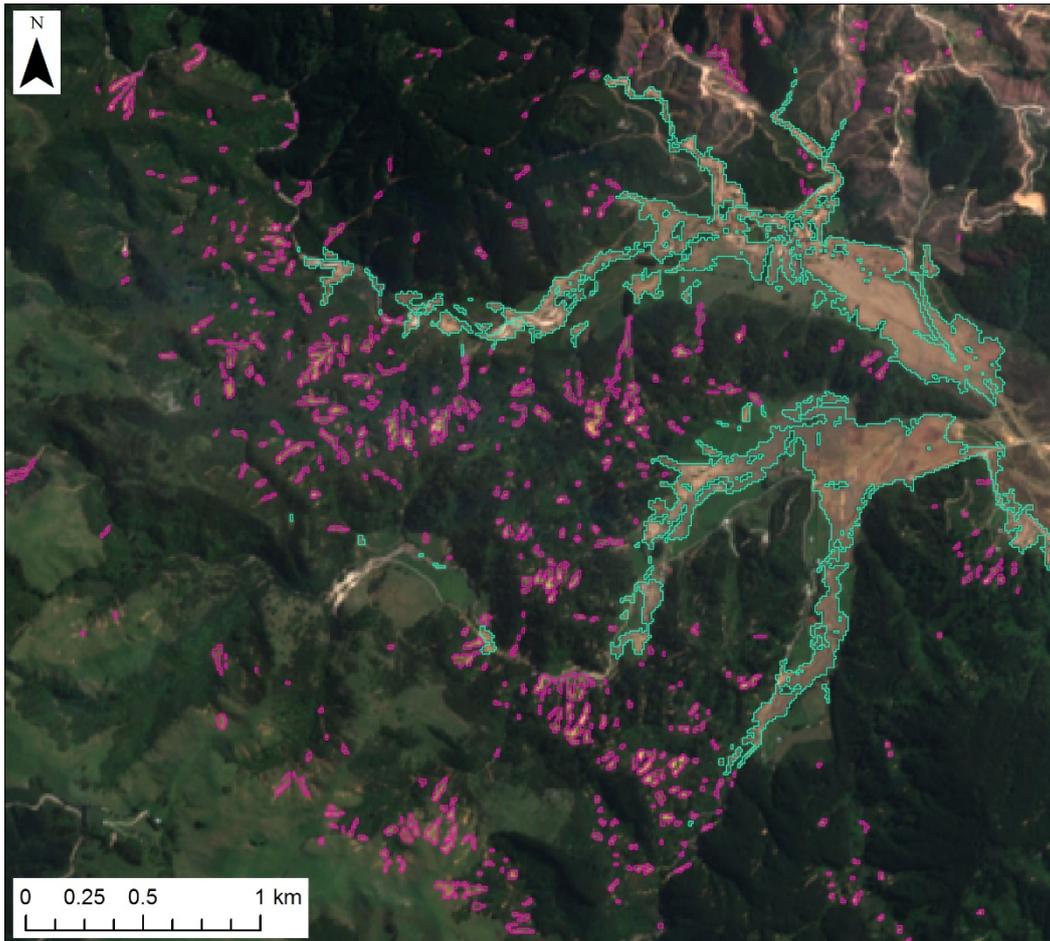
Figure 3.3 Mapped landslide (pink) and overbank deposition (green) polygons in the Otuwhero catchment using the Red Band Automatic extraction method from 10 m Sentinel imagery. Background image 23 February 2018 (Copernicus Sentinel data 2018, processed by ESA).

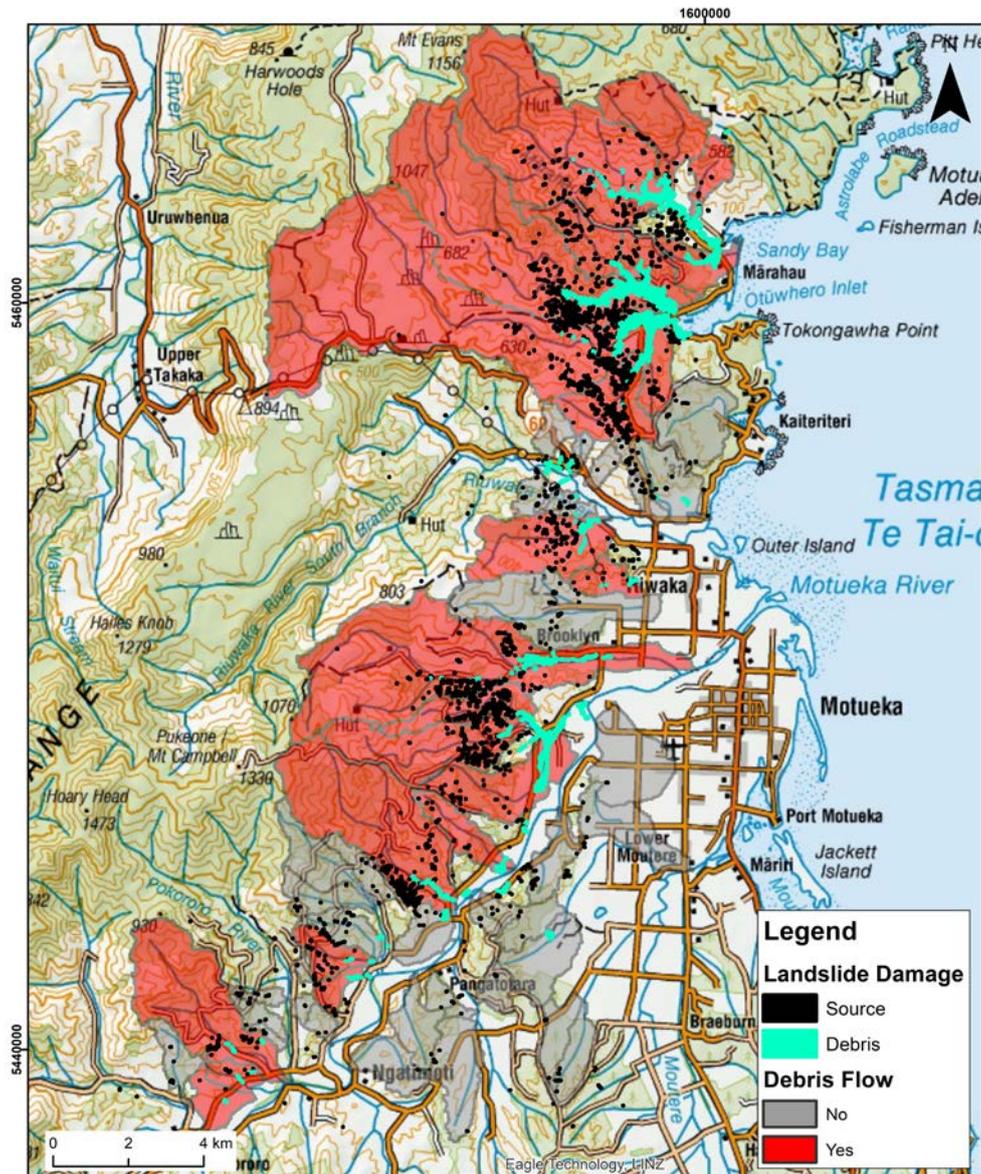
Figure 3.4 Location of the 58 catchments used to calculate Melton Ratios for this study. The catchments that generated a debris flood or flow are shown in red, and those that didn't in grey.

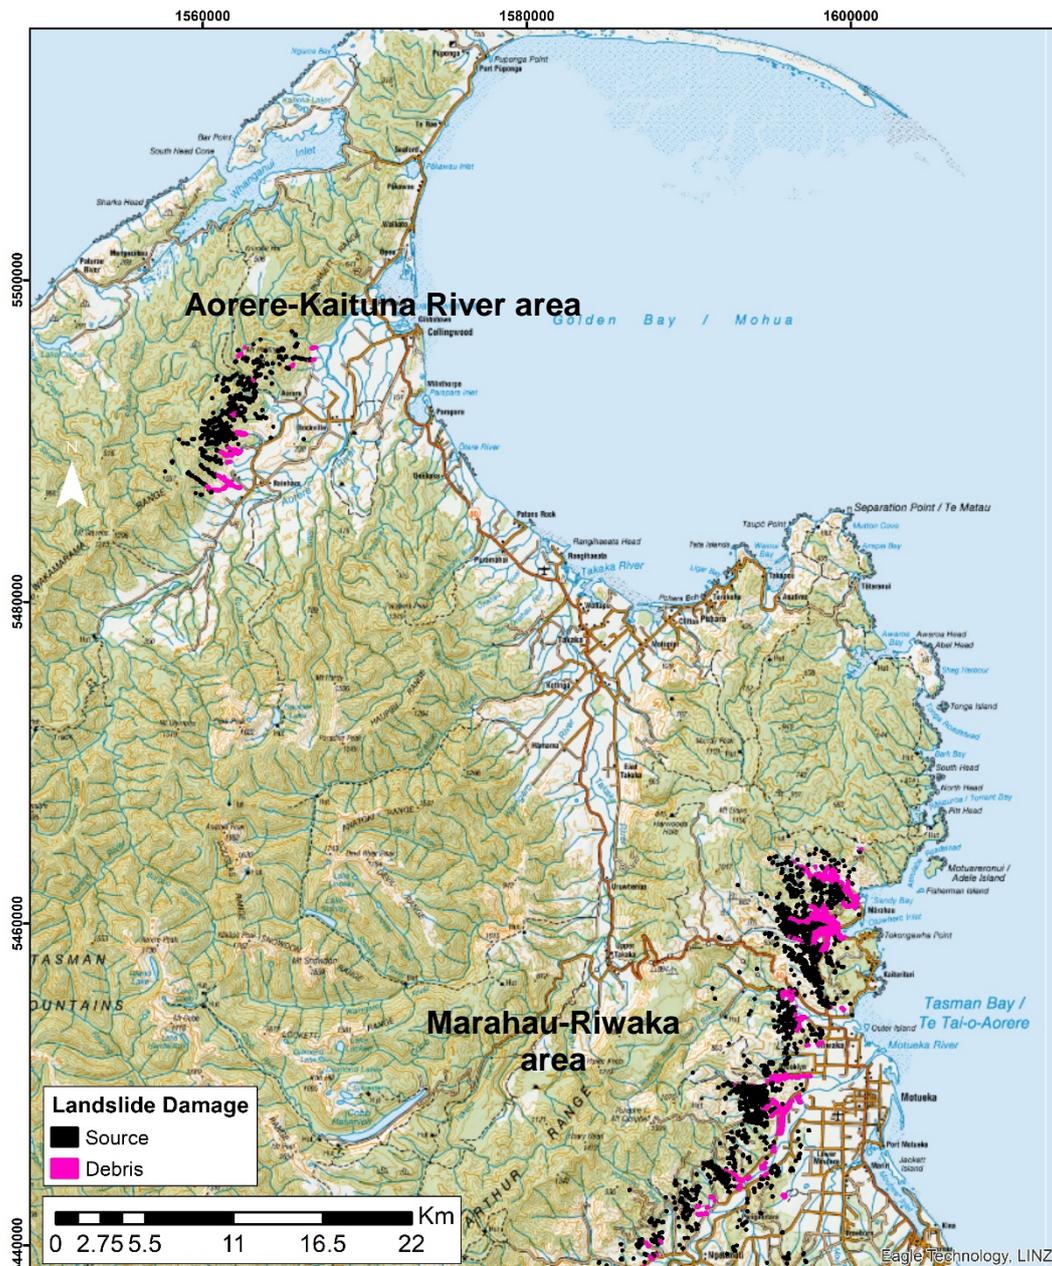
Figure 4.1 Location of landslides and debris flood/flow deposits triggered by ex-Tropical Cyclone Gita, showing the two areas of landslides.

Our analysis identified 1958 landslides across the study area that were triggered during ex-Tropical Cyclone Gita (Figure 3.4). The landslides occurred in two distinct areas. The majority (1638) of the landslides occurred along south-east facing hill range north west of the Motueka valley, from Ngatimoti in the south to Marahau in the north. The remaining 417 landslides occurred along the south-east facing Burnett Range in the Aorere-Kaituna River area in the Kahurangi National Park, c. 10 km west of Collingwood. These two areas are a significant distance (50 km) apart with distinctively different geology and topography and are therefore discussed separately in sections 4.1. and 4.2 below.

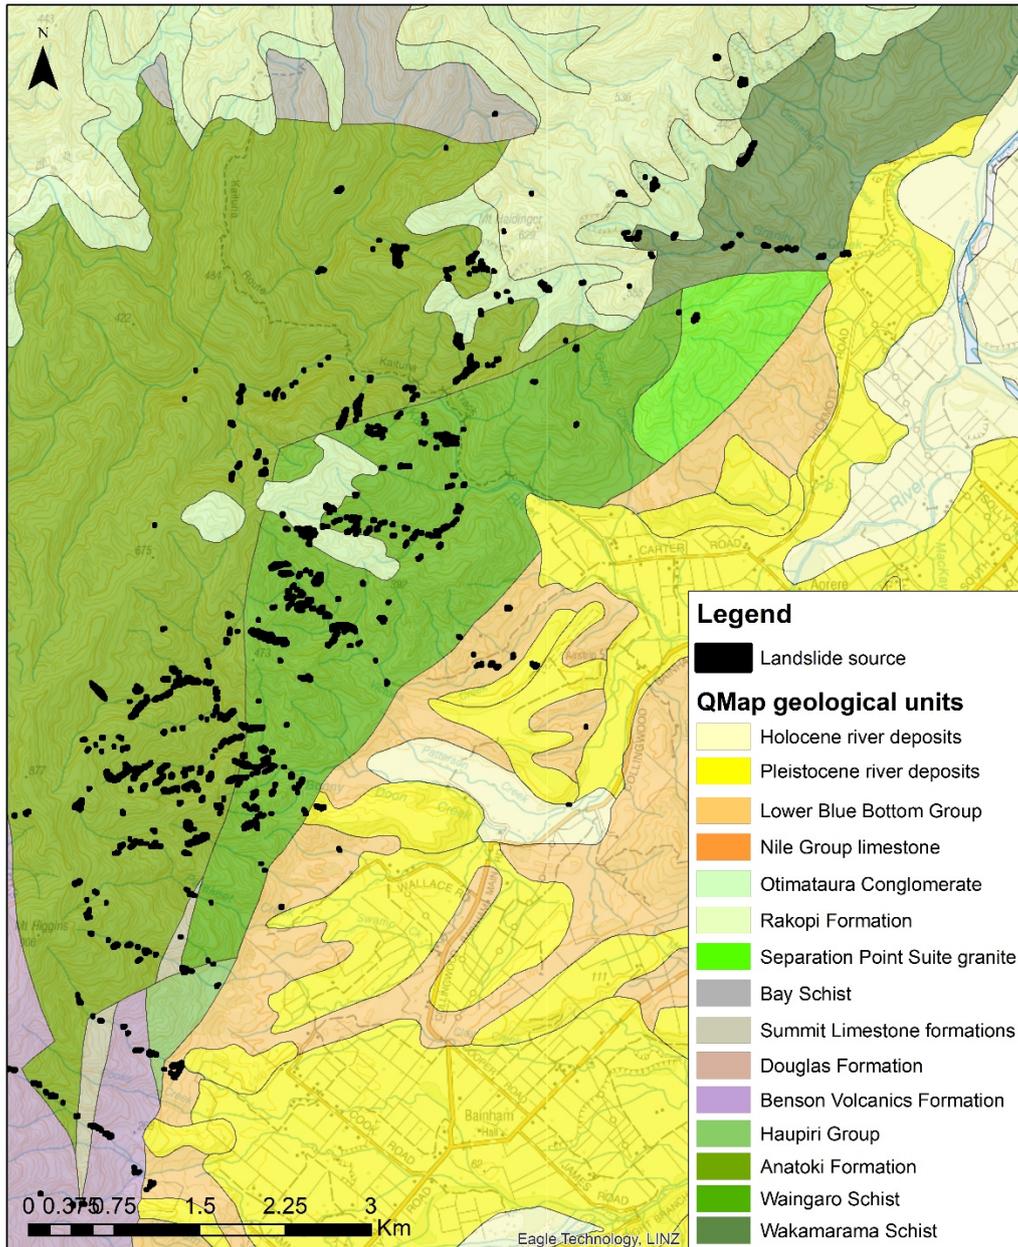
Figure 4.2 Landslide source areas shown in relation to the underlying geology (after Heron 2018) in the Aorere-Kaituna area.

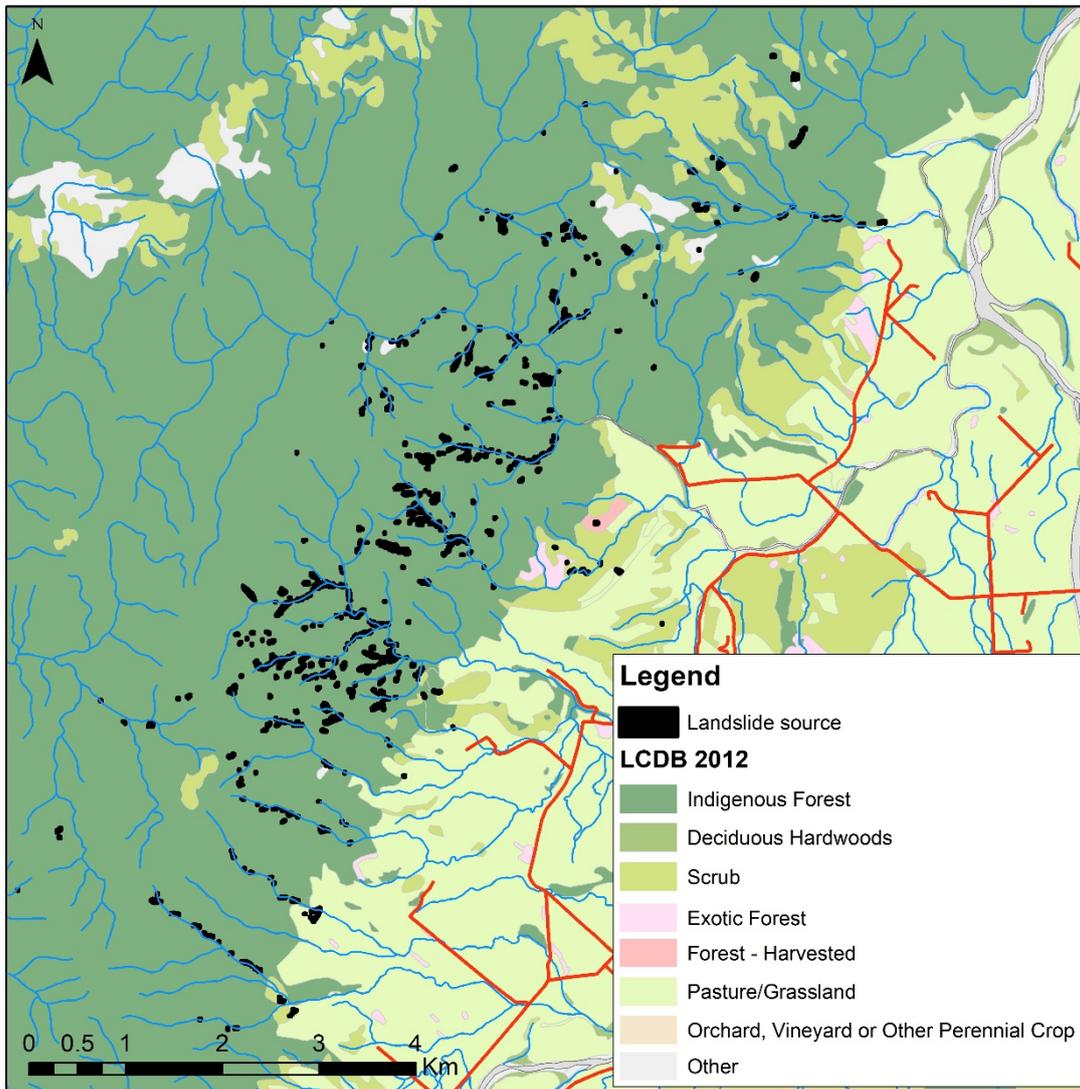
Figure 4.3 Landslide source areas shown in relation to Land use categories from LCDB 2012.

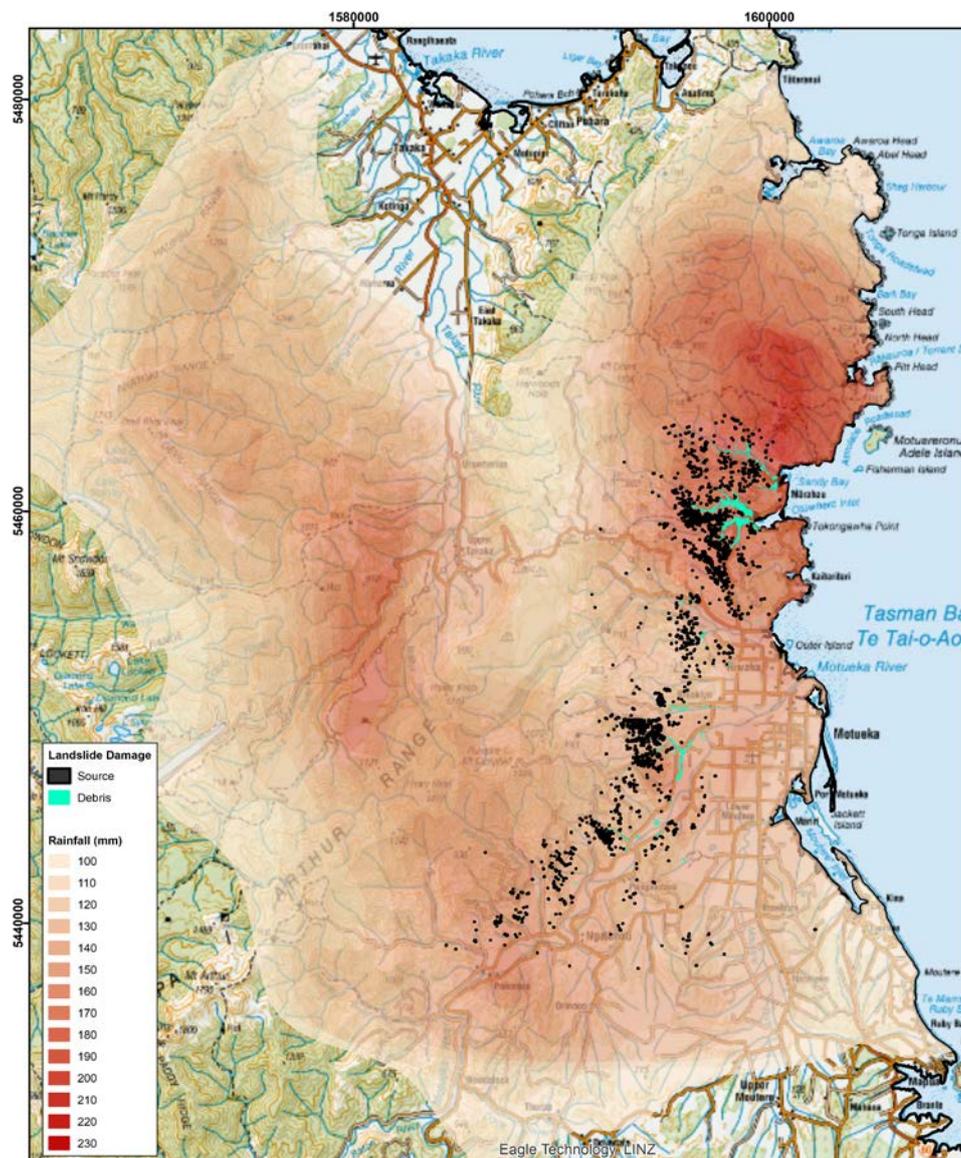
Figure 4.4 The location of landslide source areas shown in relation to the storm rainfall total (over 18 hrs). Rainfall contour intervals calculated from the rain radar statistics are also shown for the area of >100 mm rainfall.

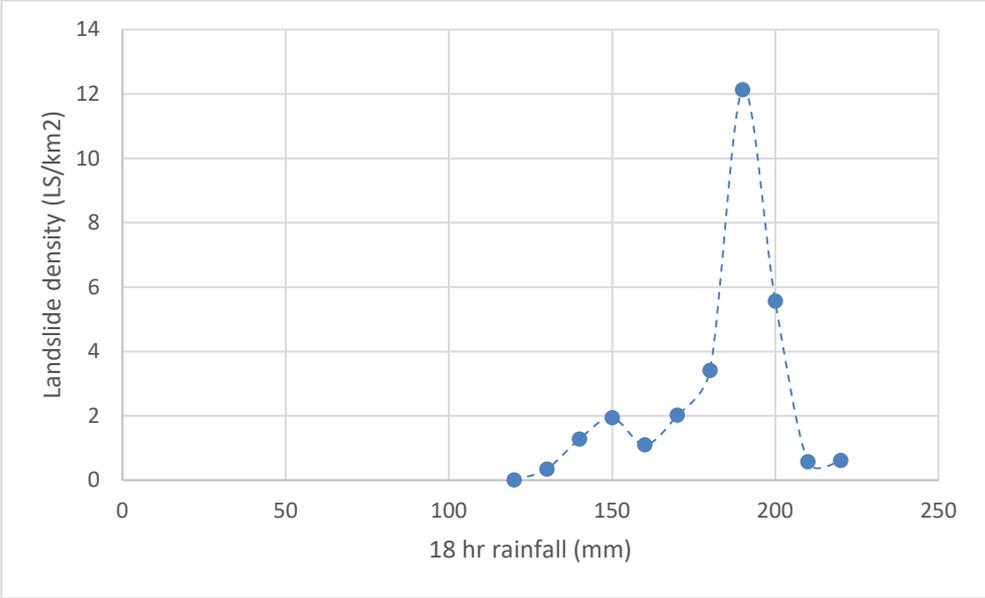
Figure 4.5 Relationship between landslide density and storm rainfall.

Although there is an increasing number (and density) of landslides as rainfall increased, there was not a simple relationship between rainfall amount and landslide density (Figure 4.5). The data indicates that the maximum landslide density occurred in the areas that received 190–200 mm of rainfall, not in the area that received the maximum rainfall (235 mm/18 hrs). The northern limit of landslides is the Marahau River catchment, although the highest rainfall was just north of this area. The northern extent of the landslides was confirmed using the TDC aerial photography flown soon after ex-Tropical Cyclone Gita. The highly erodible Separation Point Granite continues north into the Abel Tasman National Park. We would have expected the landslide distribution to also continue further north into Abel Tasman National Park, but this was not the case. Some possible reasons for this are discussed below. In addition to the high intensity rainfall, the surface geology appears to have been a critical factor controlling landslide initiation, with 80 % of the landslides occurring in Separation Point Granite (Figure 4.6 and Table 4.4), which occupies only 22.8 % of the area within the 130 mm rainfall contour, indicating that the geology was a major factor influencing where the landslides occurred.

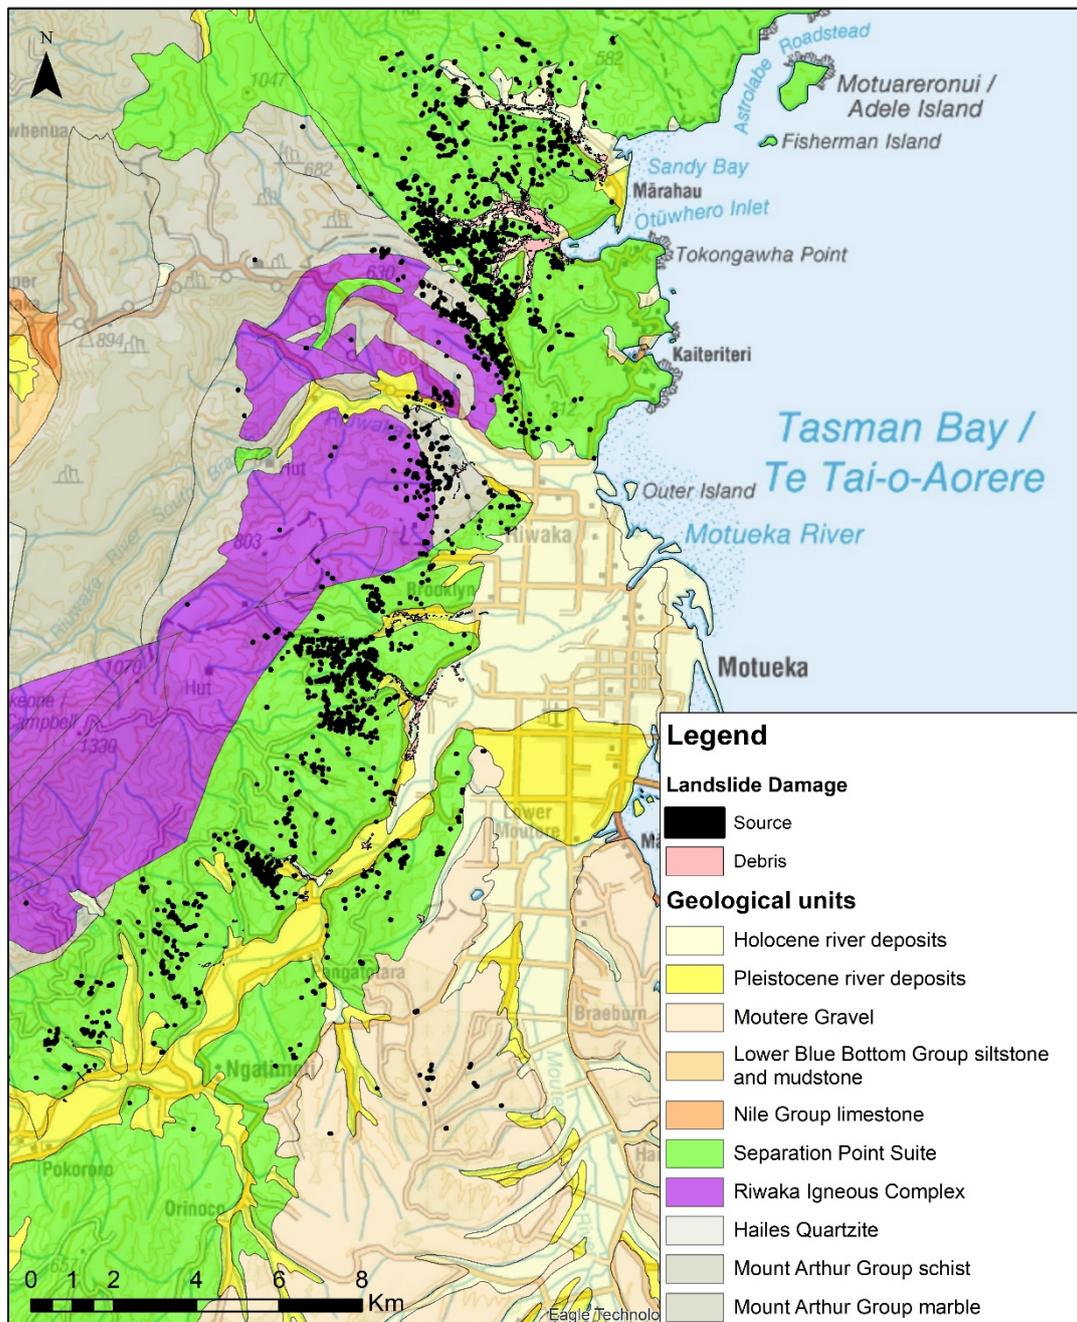
Figure 4.6 Landslide source area locations shown in relation to the underlying geology (after Heron 2018). Separation Point Granite is highlighted in green.
