**Landslides and debris flows in the Tasman District
caused by ex-Tropical Cyclone Gita,
20-21 February, 2018**

**GNS Science Report 2019/34
July 2020**

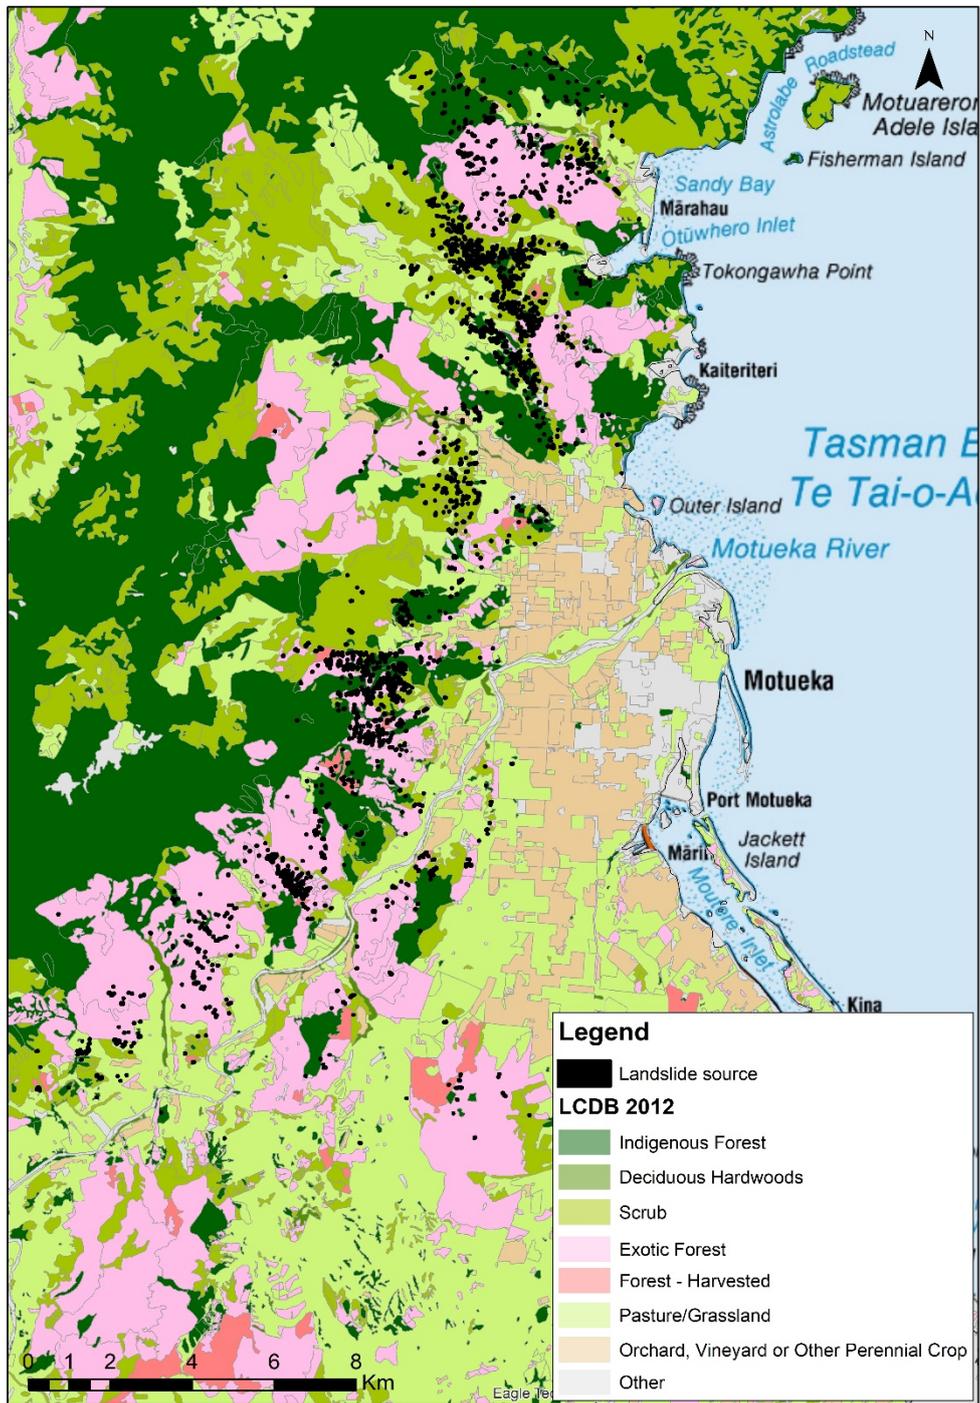
Figure 4.7 The distribution of landslides triggered by ex-Tropical Cyclone Gita in relation to main vegetation and land use classes (as mapped in 2012) in the Marahau-Riwaka area.

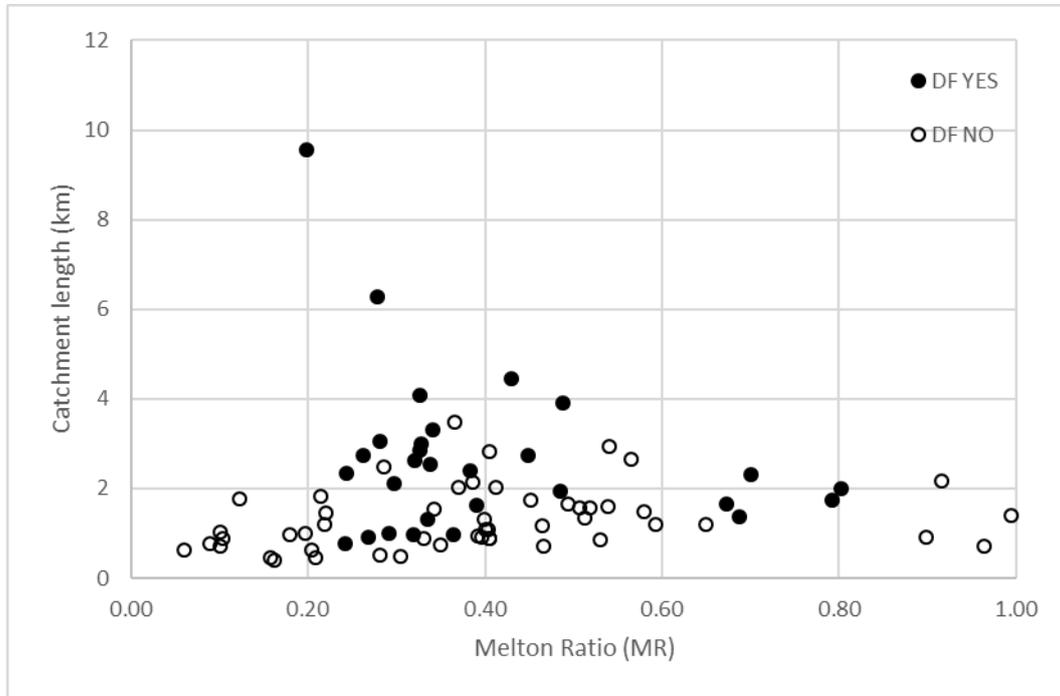
Figure 4.8 Melton Ratio and catchment length for the 58 affected catchments in the Marahau area. Catchments were classified according to debris flood/flow occurrence in ex-Tropical Cyclone Gita. The dashed line shows MR=0.3, above which catchments are thought to be capable of generating debris floods or debris flows.

Melton Ratios were calculated for the 58 affected catchments in the Marahau area. Catchment characteristics and Melton Ratios (R) for these catchments are listed in Appendix 1. A scatterplot of Melton Ratio against catchment length is shown in Figure 4.8.

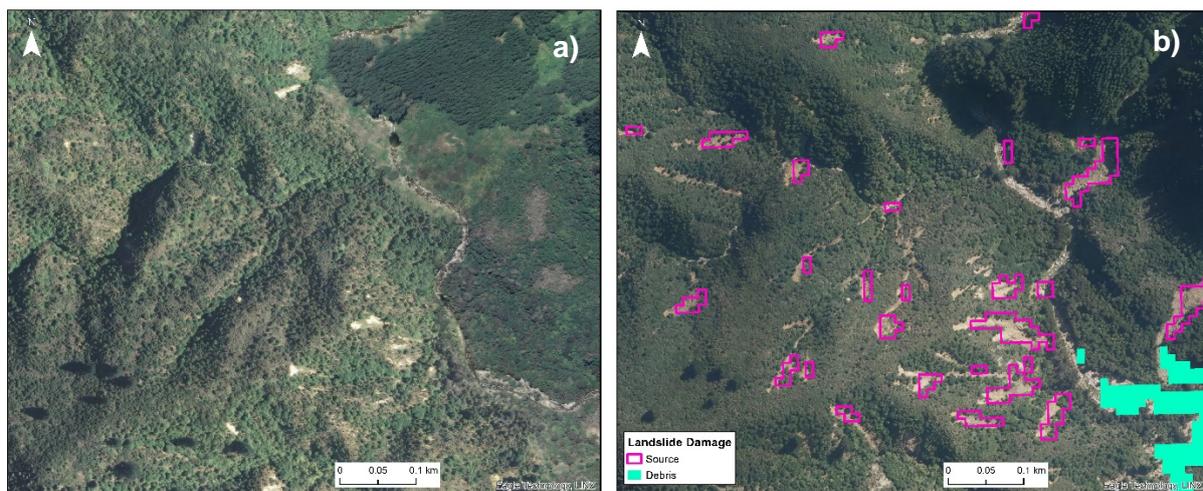
Figure 5.1 Aerial photographs of landslides in The Shaggy catchment taken a) before (2016) and b) after ex-Tropical Cyclone Gita (March 2018), showing the landslide polygons derived from Sentinel imagery differencing. There are several existing landslides evident in the pre-storm imagery. Differencing was not able to detect many of the observed new landslides or enlargement of existing landslides. It was also not able to differentiate landslide sources areas from deposits or landslides with coalescing deposits. Aerial photos (0.3 m resolution) were provided by TDC.
