**Institute of Geological
& Nuclear Sciences
Science Report**

2002/03

**The fatal Cleft Peak
debris flow
of
3 January 2002,
Upper Rees Valley,
West Otago**

**M. J. McSaveney
P. J. Glassey**

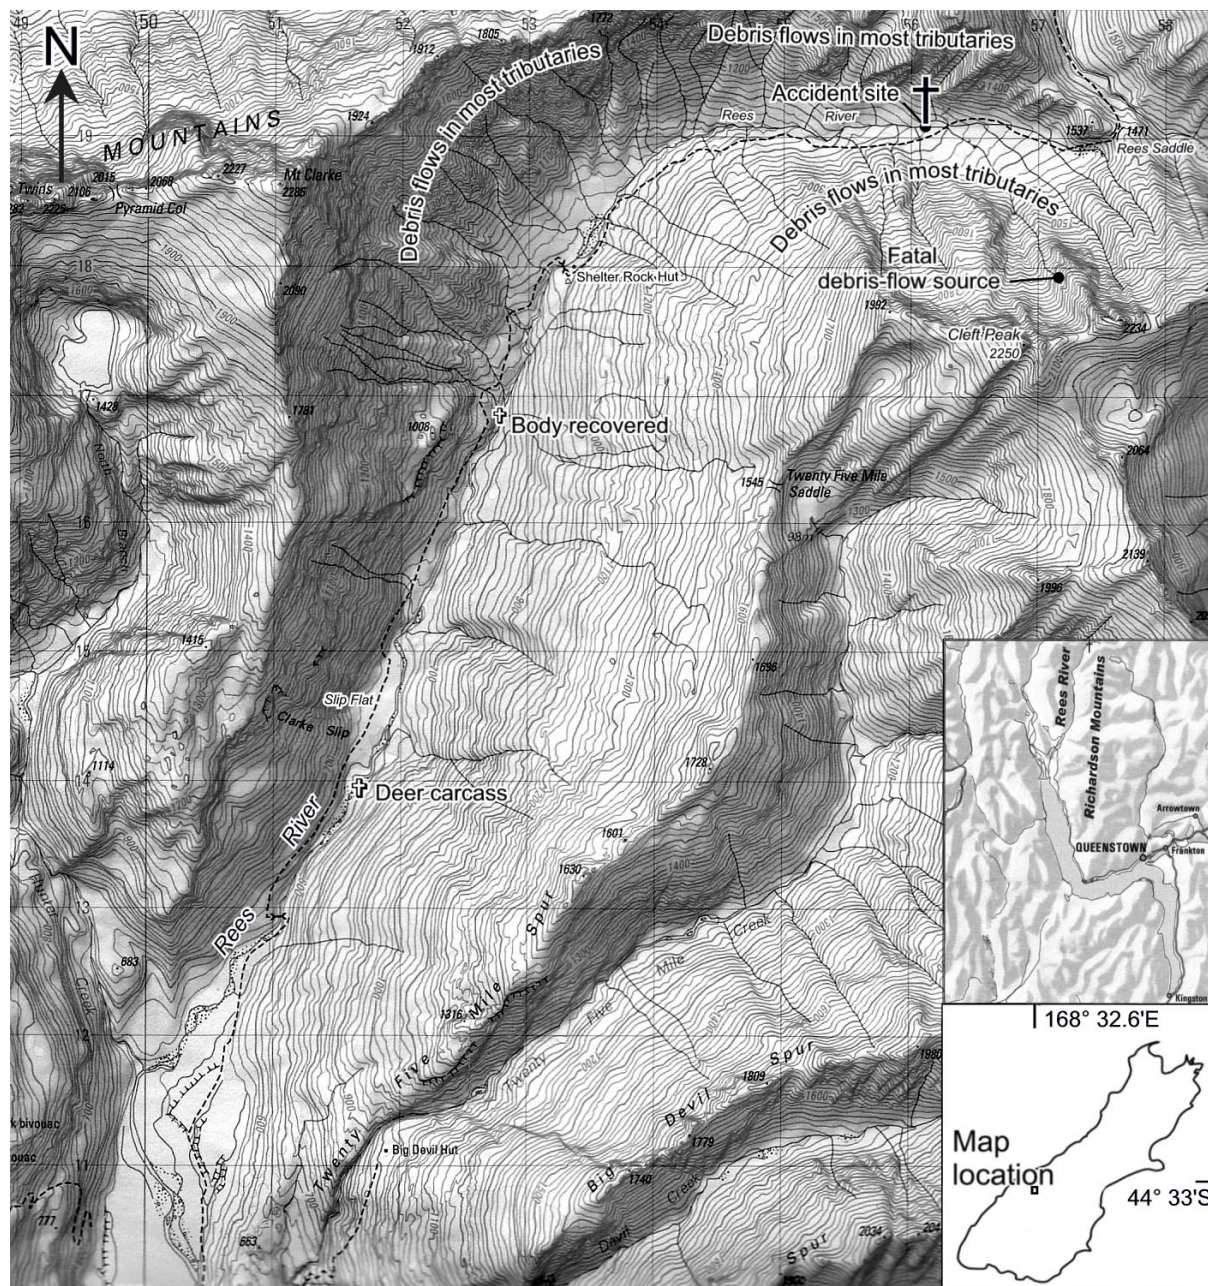
Figure 1 Topographic map of the upper Rees River valley. Grid is 1 kilometre square. From Topographic Map 260-E40 Earnslaw (2000). Fatal debris flow came from the north flank of Cleft Peak (See Figure 2 for details). Track locations (dashed lines) are imprecise, and the fatality occurred on the track route. A deer possibly killed by a debris flow was deposited by the river at the south end of Slip Flat.

It is notable, as an indication of the sudden onset of the landscape damage on 3 January, that an adult deer was also killed by an event (probably another of the many debris flows) somewhere in the upper Rees that morning. Its carcass was deposited at the lower end of Slip Flat (Figure 1).

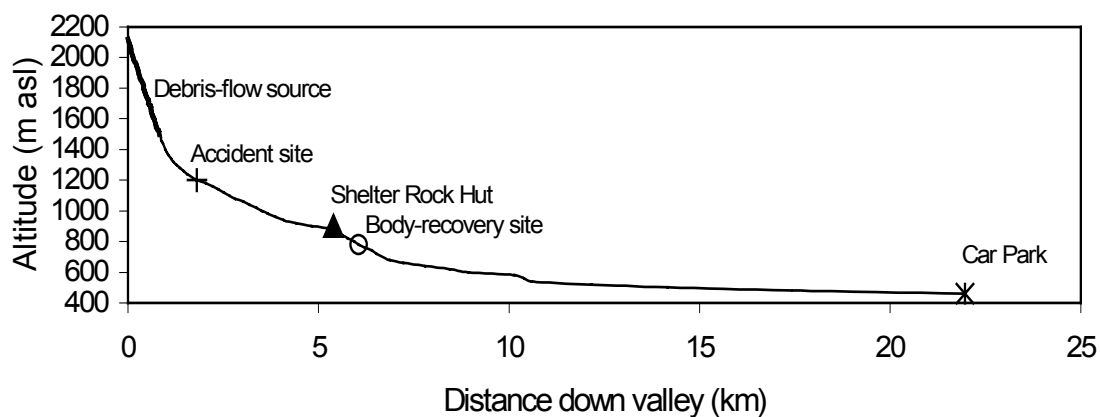
The accident occurred on the lower slopes of the debris-flow fan, where the channel slope is at the lower limit of the range of slopes on which a debris flow can flow. The profile of the stream channel from the debris-flow source through to the car park in the lower Rees valley is shown in Figure 5. There was nothing unusual about the geomorphology of the accident site, or the site where the body was recovered that might have contributed to their respective roles in the event. The accident site (Figure 6) was a logical and normally safe location to cross the stream.

Figure 5 Profile of the Upper Rees valley from the source of the Cleft Peak debris flow to the Car Park in the lower Rees valley. Topographic data from Topomap 260-E40 at 20-m contour interval.

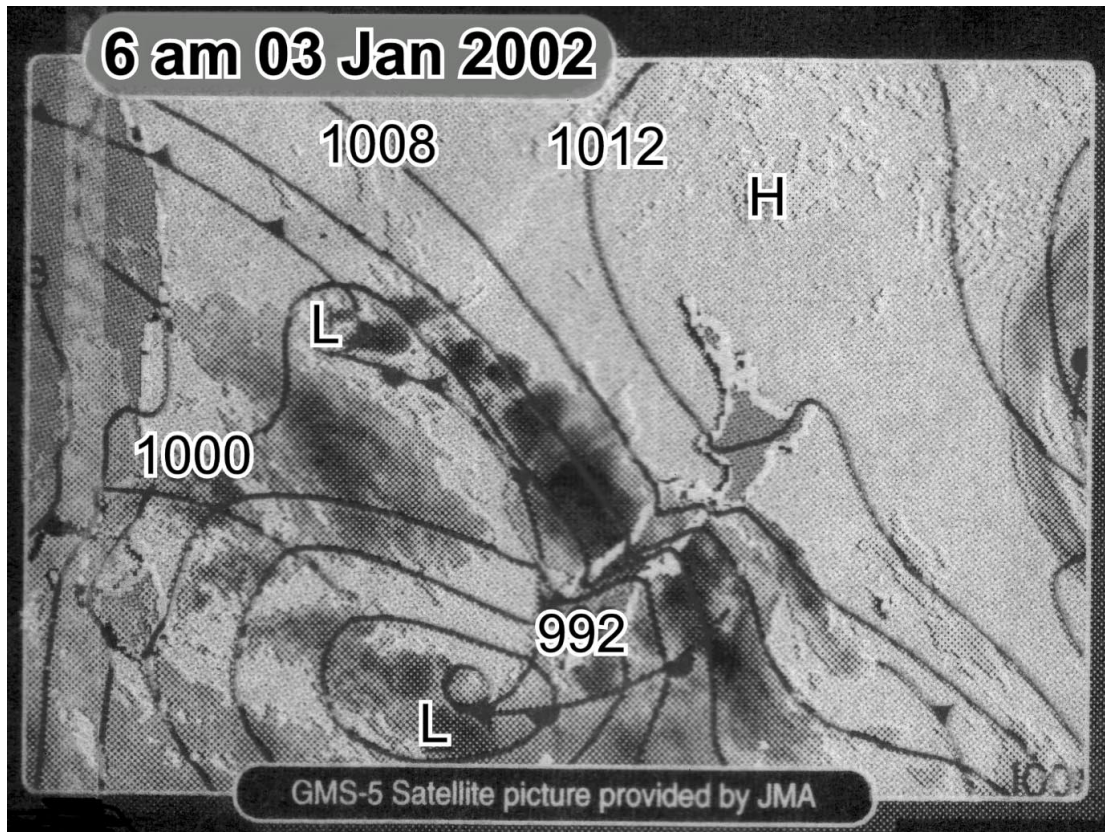
A northwest airflow covered much of the country on 3 January 2002, caused by a low of <984-hPa southwest of South Island. A series of cold and occluded fronts were embedded in the warm, moist, unstable air (Figure 7). Associated with the fronts were numerous convective cells forming cumulo-nimbus clouds bringing localised very heavy rain.

Figure 7 Annotated satellite image (negative), showing the New Zealand weather situation at 6 am, 3 January 2002, approximately 4 hours before the fatal accident (Image modified from the Evening Post of 3 January 2002). The centre of the depression (L) southwest of South Island is at >984 hPa.

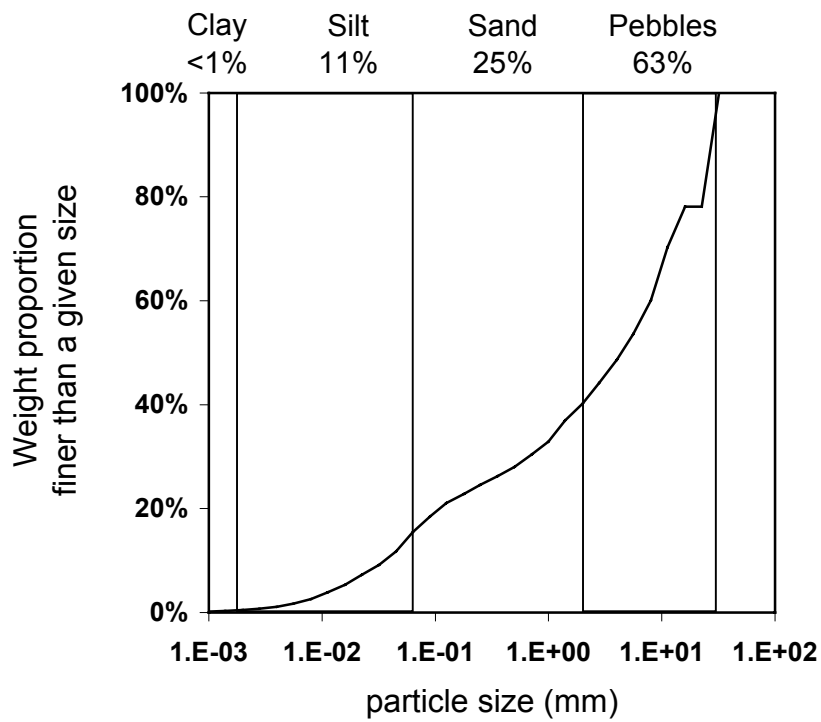
Figure 9 Particle-size distribution for sediment forming the matrix of the 3 January, fatal debris flow.
