Hancox, G.T., Nelis, S., 2009. Landslides caused by the June–August 2008 rainfall in Auckland and Wellington, New Zealand. *GNS Science Report 2009/04*. 30pp.

GeoNet Landslide Response Report (Project No. 430W6000)

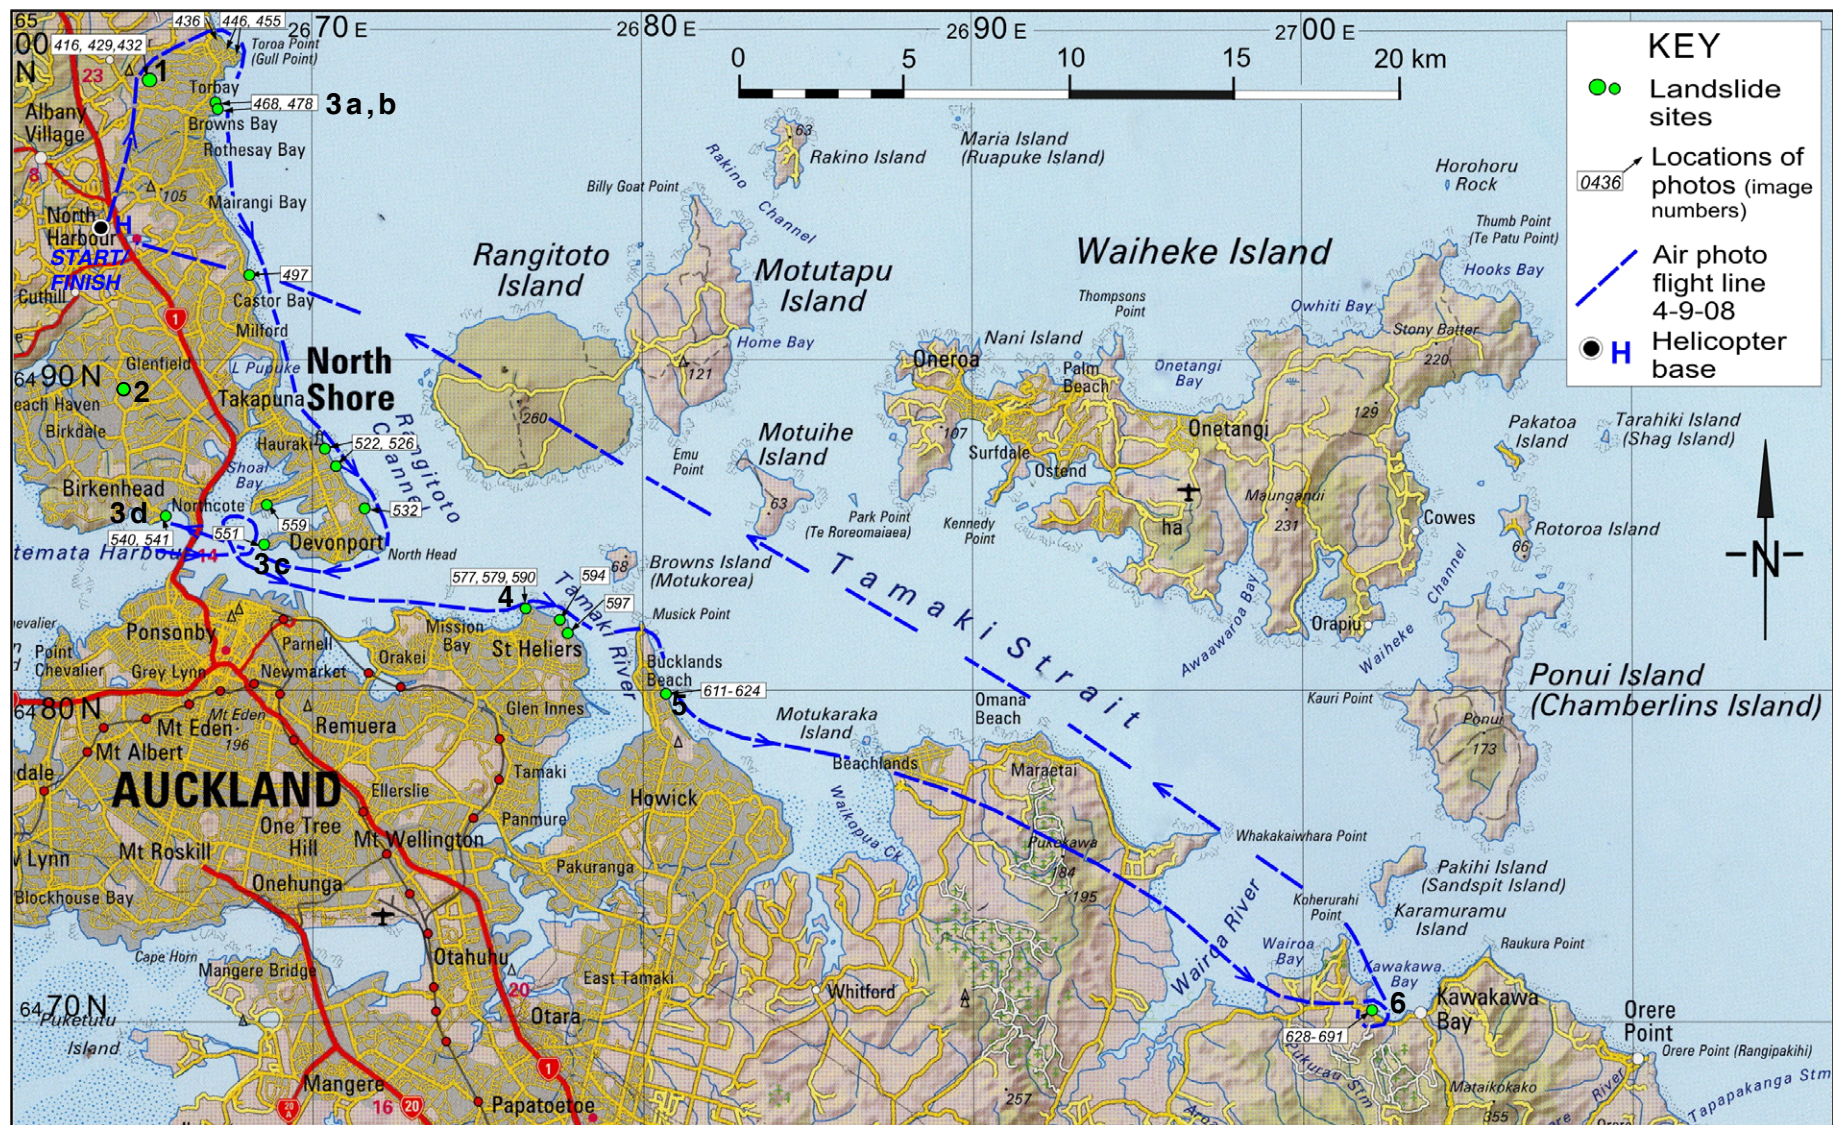
Figure 1. Map showing the flight line for the Auckland aerial reconnaissance on 4 September 2008, locations of the main landslides that occurred during the winter 2008, and image numbers of selected landslide photos presented in the report. *Main landslide locations: 1 – Torbay landslide; 2 – Glenfield Landslide; 3a,b,c,d – Smaller cliff failures; 4 – Cliff Road, St Heliers; 5 – Buckland’s Beach landslide; 6 – Kawakawa Bay landslide).*

On 29-30 July 65 mm rain in Auckland caused flooding and numerous damaging landslides. A house in Torbay on Auckland's North Shore was evacuated and later demolished because of damage by slow movements of a deep-seated landslide (Figures 1 and 2). Several other houses in the area were also affected and evacuated temporarily.

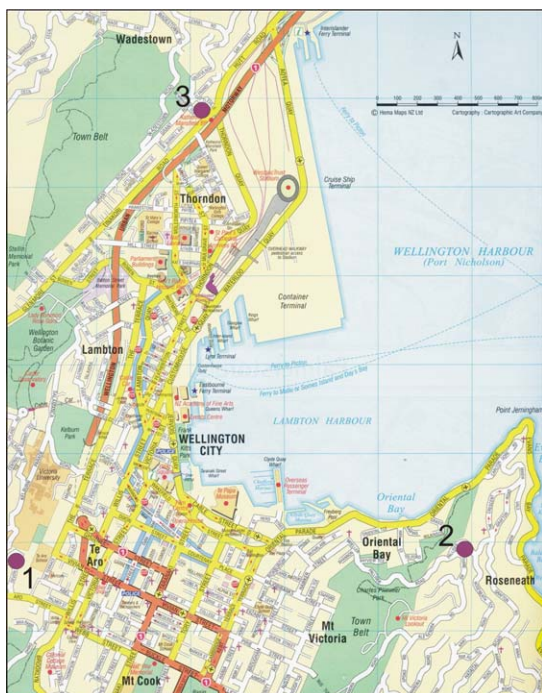
Figure 23. Map of Wellington City area showing locations of significant landslides in Devon Street (1), Palliser Road (2), and Tinakori Road (3).

Rain fell almost continuously from 22-31 July 2008 (Table 1). On 23 July the persistent rain caused a slip that derailed a train on the Johnsonville railway line near Ngaio station (about 2 km NW of slide (3) in Figure 23), disrupting train services for 20 hours.

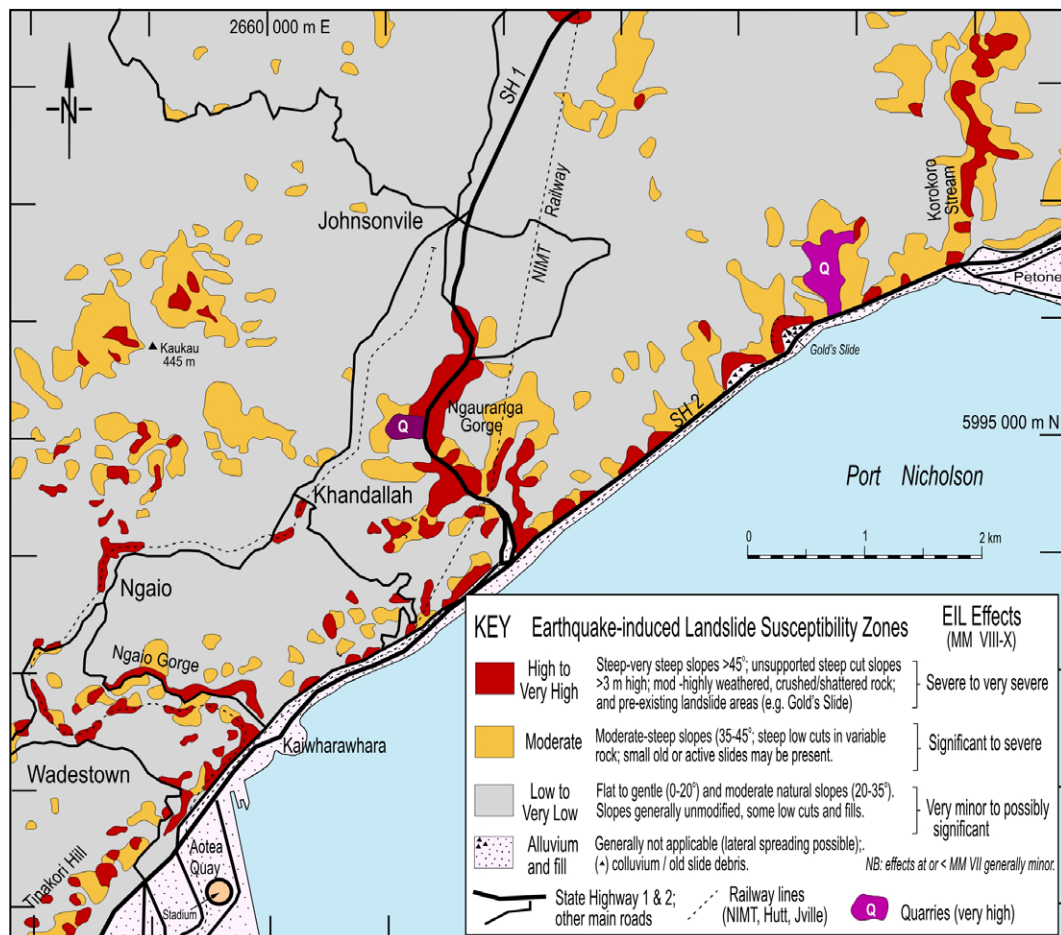
In the early 1990s the Wellington Regional Council commissioned a series of studies to assess seismic hazards in the Wellington region, including earthquake-induced slope failure (Brabhakaran et al. 1994). Figure 31 shows the modelled earthquake-induced landslide (EIL) susceptibility zones in the northern Wellington City area (*based on factors such as slope angle, geology, slope modification, and existing landslides*), and the predicted severity of landslide effects under strong earthquake shaking (MM8 to MM10). Such shaking is expected during a Wellington Fault earthquake, which is regarded as having a relatively 'high' probability of occurring in the next 50 years ⁽¹⁾.

Figure 31. Earthquake-induced landslide susceptibility hazard map of the northern Wellington City area (after Brabhaharan et al. 1994).

The landsliding effects predicted by Brabhaharan et al. (1994) for different susceptibility classes (Figure 31) for MM8–MM10 shaking during a Wellington Fault earthquake were:
