Hancox, G.T. 2010. Report on the landslide that blocked SH 1 and the railway line near Rosy Morn Stream south of Kaikoura on 10 September 2010, *GNS Science Report* 2010/59. 33 p.

This report describes and evaluates the cause of the landslide which blocked SH 1 and the railway line near Rosy Morn Stream 12 km south of Kaikoura on 10 September 2010. The landslide was a moderately large (about 50,000 m³) debris and rock slide, and occurred on the toe of a large prehistoric landslide on the steep (45-50°) coastal slope. This slope is formed of indurated (hard), interbedded, well jointed greywacke sandstone and mudstone (argillite) bedrock, and is overlain by thin colluvial deposits. The 2010 landslide was a significant event justifying a response and report under the GeoNet Project of GSN Science, mainly because of the disruption it caused to transport by closure of an important road and rail link to Christchurch at a time when supplies were urgently needed there after the Darfield earthquake. Normal road and rail access was blocked for one week while the debris was cleared away.

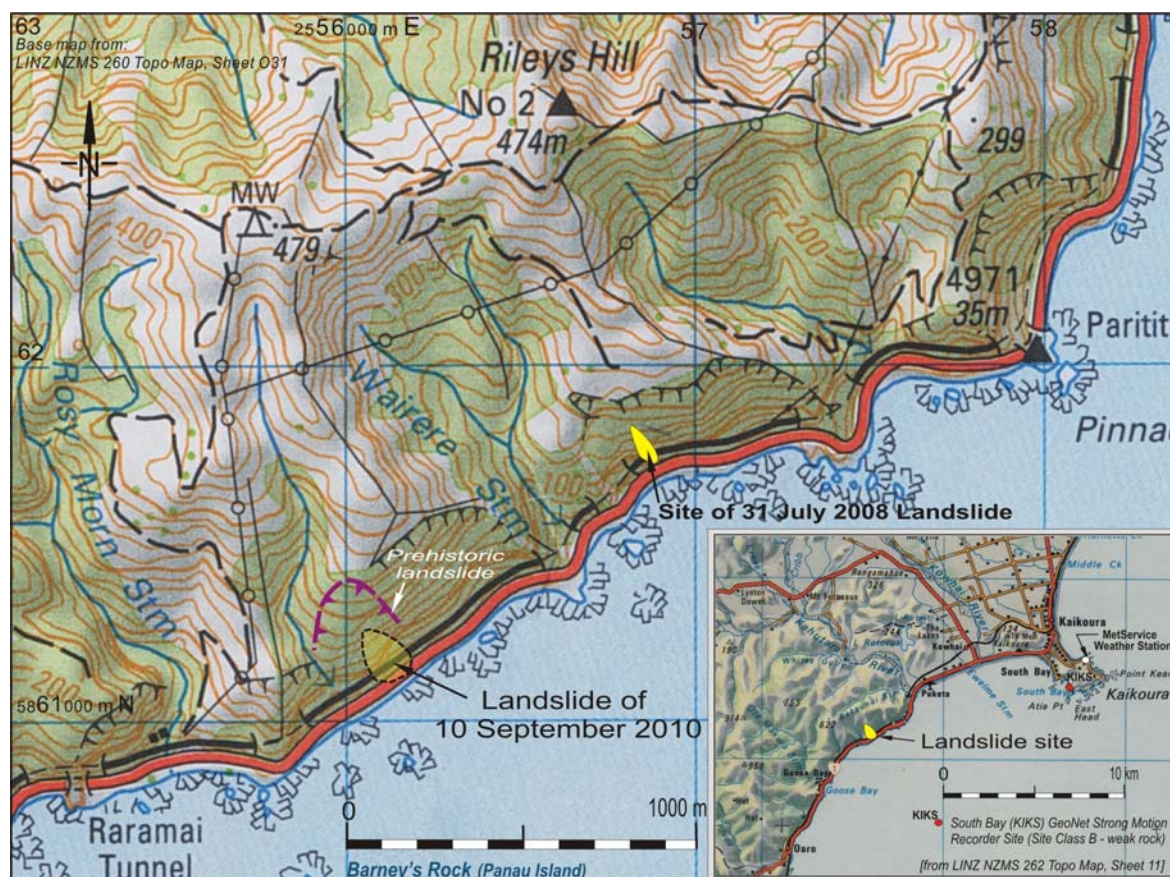
Figure 1 Maps showing the location and topographic setting of the landslide of 10 September 2010 which closed SH 1 and the Main North Railway Line ~12 km southwest of Kaikoura. The locations of the Kaikoura MetService weather station, the GeoNet Strong Motion recorder site (KIKS), and the site of a smaller landslide which blocked the railway line and SH 1 in July 2008 are also shown.

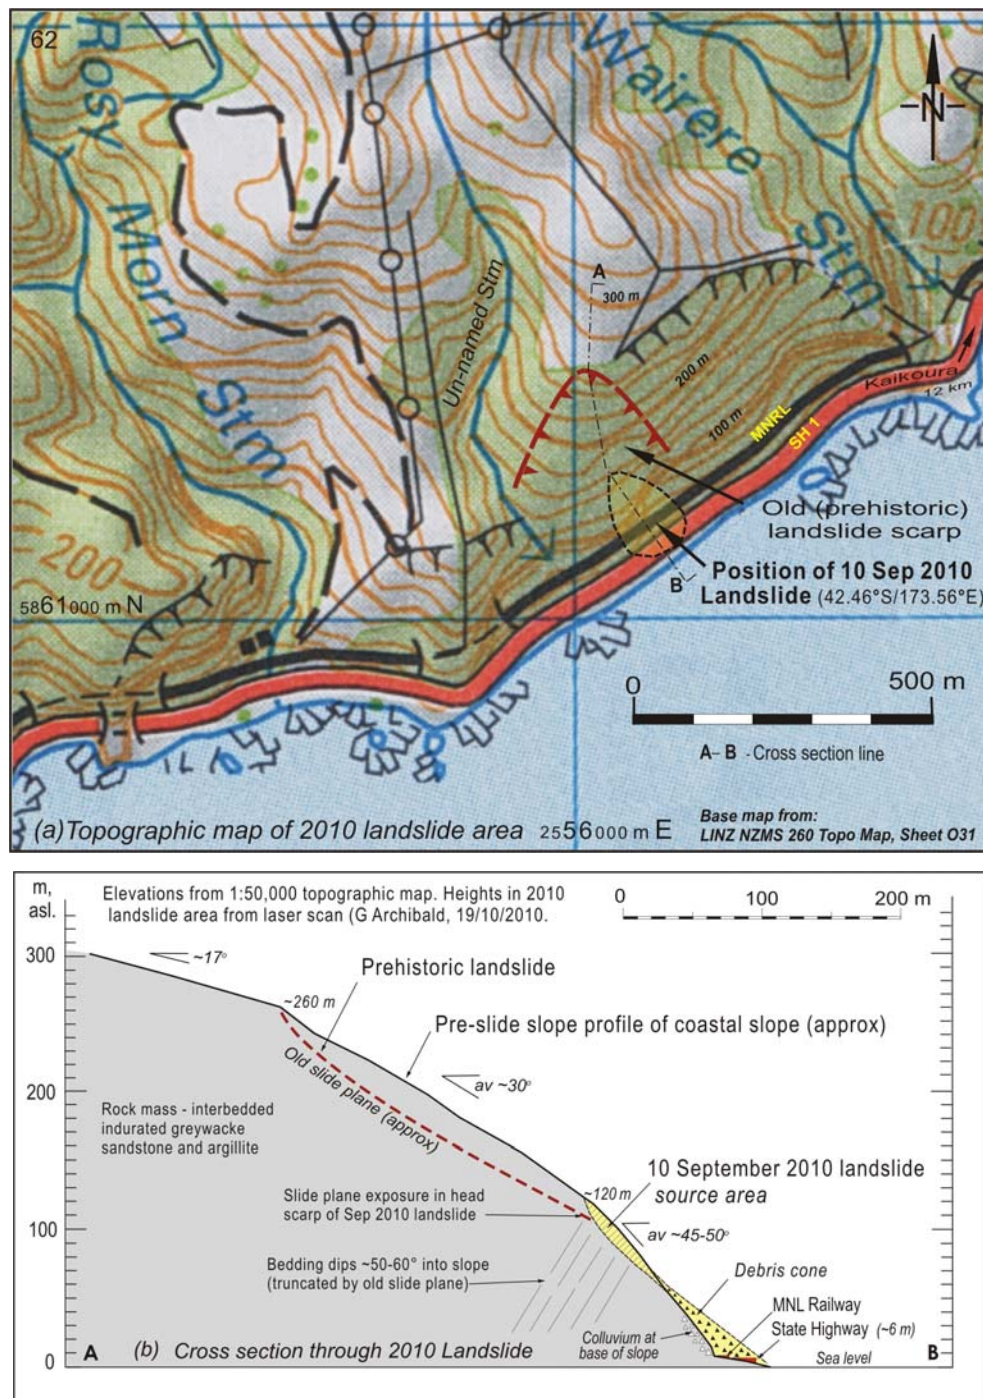
Figure 4 and other aerial photos have been used to plot the 2010 landslide as accurately as possible on a topographic map (Figure 5a) to determine its location and dimensions, and construct a cross section (Figure 5b) to show its position on the slope and relationship to the older landslide on the slope above it. Field mapping was made difficult due to the steep topography and restricted access to the site while earthworks were being carried out.

Figure 5 Topographic map (a) and cross section (b) through the 2010 landslide near Rosy Morn Stream, and the large prehistoric landslide on the slope above.

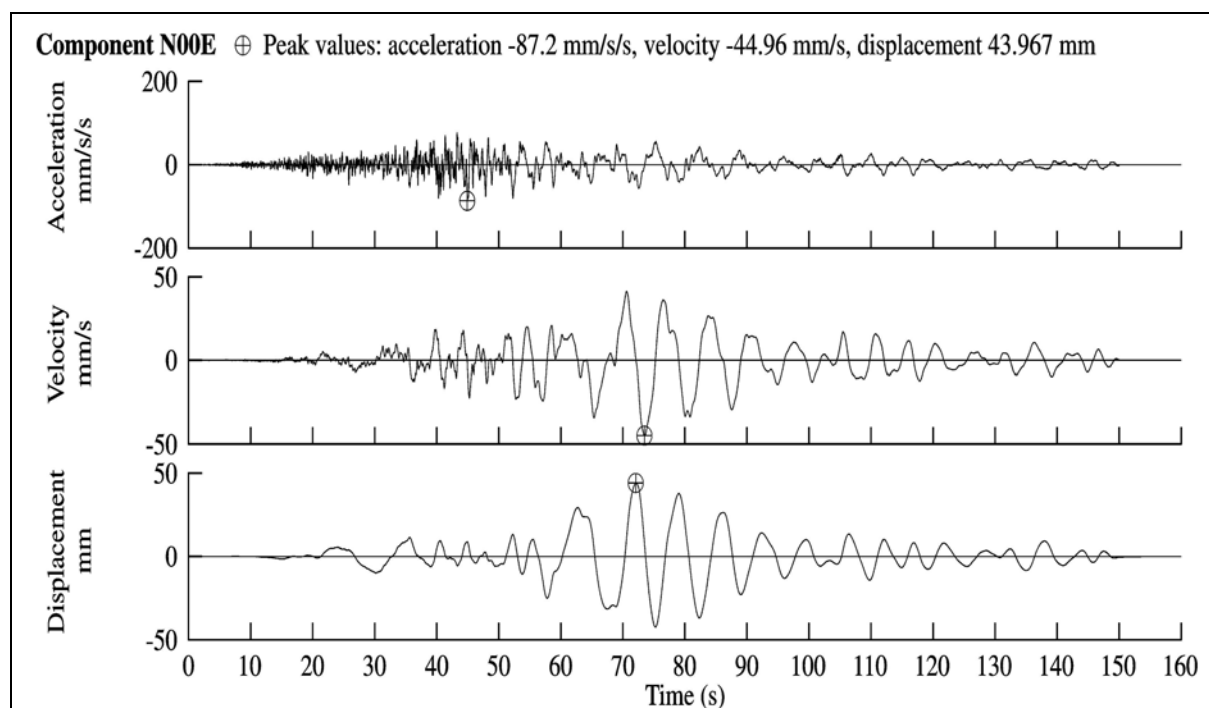
A feature of the mainshock records was the long-period content, even in records as distant as a strong motion recording site on weak rock (Site Class B) at South Bay in Kaikoura, 12 km east-northeast of the landslide site (Figure 1), and about 175 km from the earthquake's epicentre (Figure 11). A consequence of the long-period content of the motions was that the peak ground displacement at South Bay, 44 mm, was very large in relation to the peak ground acceleration of about 0.01 g, and there was also a marked north-south polarisation to the motion (Figure 12, pers. comm. Jim Cousins, 2010). The mainshock was also notable for its long duration (~150 seconds) and relatively high peak velocity (~45 mm/s) which coincided with peak displacement (Figure 11). All of these factors would have increased the significance of the mainshock at the landslide site.

Figure 11 North-south motions computed from strong-motion recording from South Bay, Kaikoura.

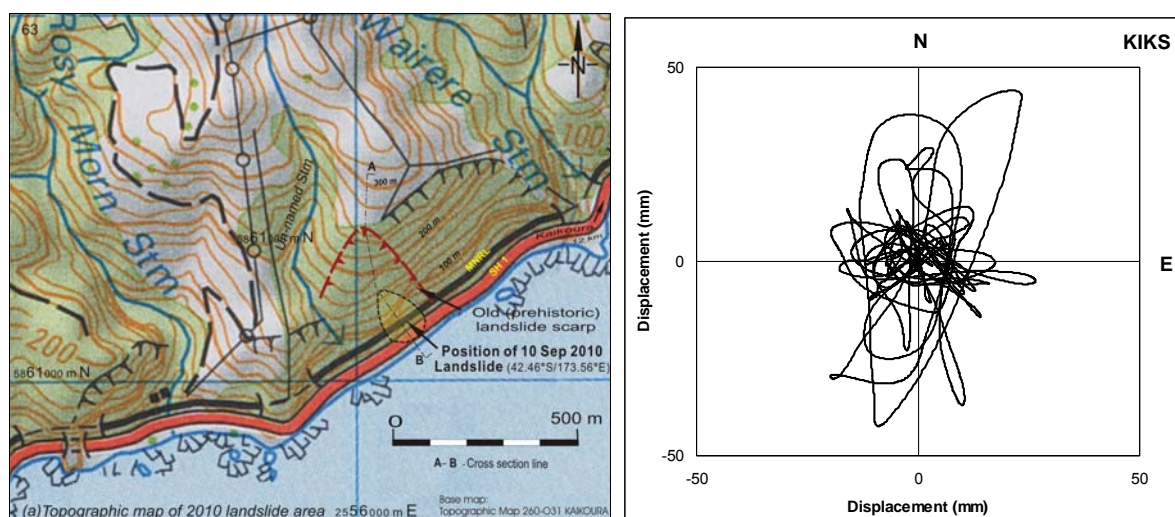
The motions described above equate to a felt intensity of MM 5 in the South Bay area (GeoNet Website). However, at the landslide site on the steep coastal cliff south of Kaikoura the ground motions are likely to have been amplified to some extent by topographic effects, and may have reached ~MM 6 high on the cliff face. The dominant north-south direction of the long-period ground displacement is also likely to have had a destabilising effect on the landslide as these motions are slightly oblique to aspect of the slope and the south-southeast (~140°) direction of the landslide movement (see Figures 10 and 12).

Figure 12 Horizontal ground displacements at Kaikoura (*right*) shown in relation to the landslide site (*left*).

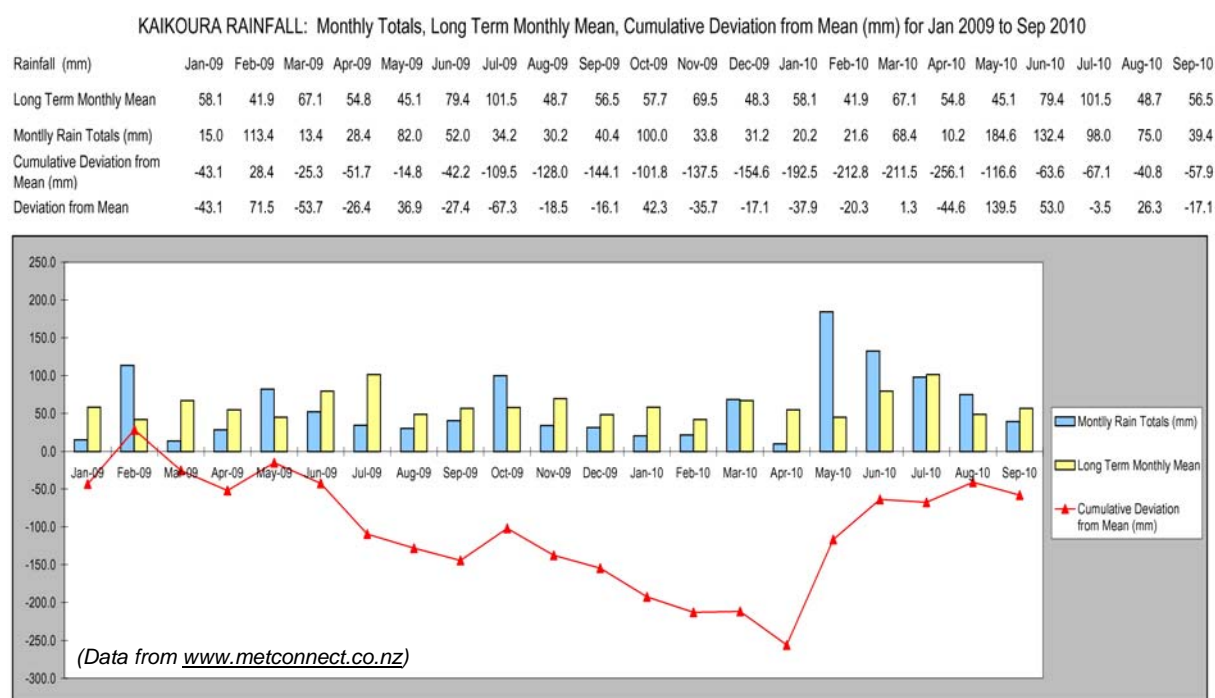
The long term rainfall data on the NZ Metrological Service website (www.metconnect.co.nz) show that there was an increase in monthly rainfall at Kaikoura over three months prior to the September 2010 landslide, particularly May and June during which the monthly rainfall totals were significantly greater than the mean (Figure 14). Although such a trend can lead to increased antecedent soil moisture on some slopes, there is no evidence this was a significant factor at the landslide site or elsewhere on the slope. When the 2010 landslide occurred the cumulative deviation from the mean rainfall at Kaikoura was still negative, after less than average rainfall over 12 of the last 16 months (Figure 14).

Figure 14 Monthly rainfall totals and cumulative deviation from mean at Kaikoura 2009-2010.

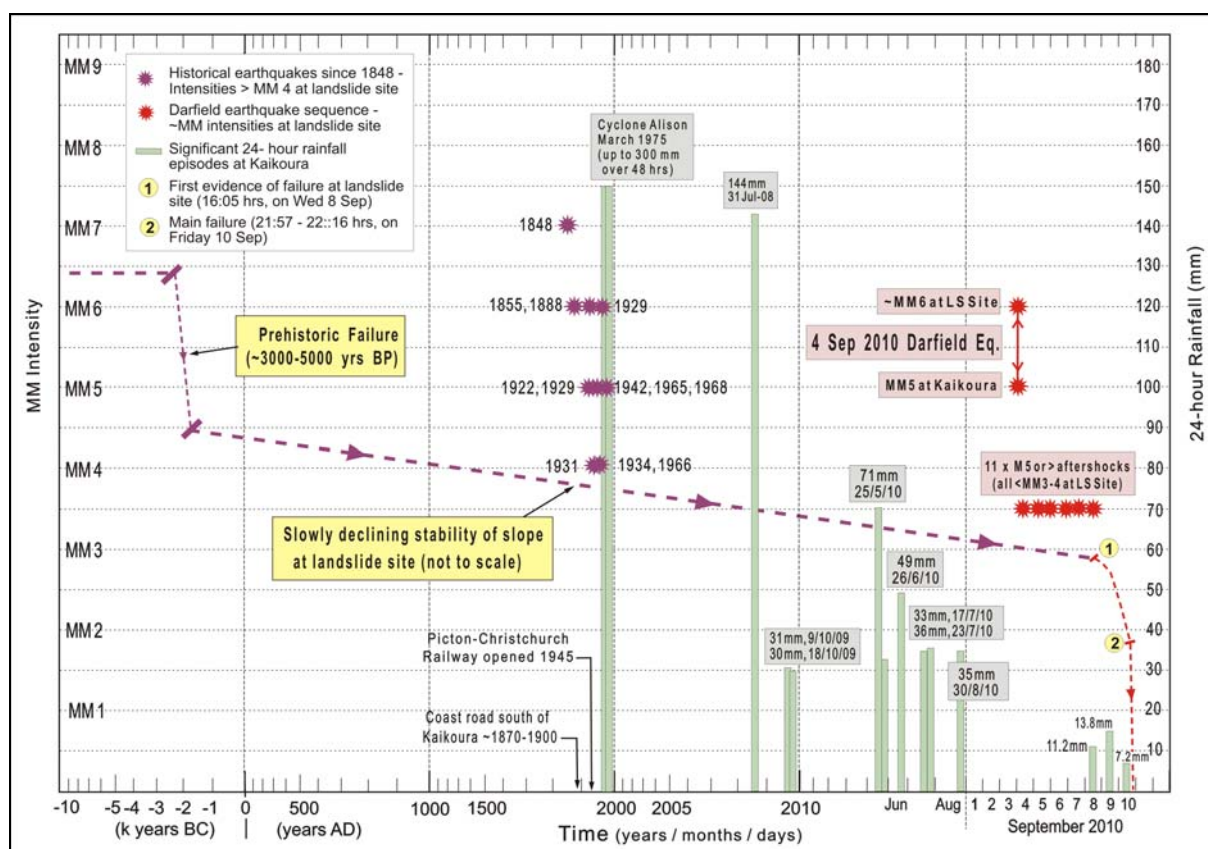
Figure 15 Graphical representation of the timeline of large earthquakes, significant rainfall episodes, and other events that may be relevant to the triggering of the September 2010 landslide.

Given the previously described unfavourable geological conditions and failure history of the slope on which the landslide occurred, greater than average rainfall over the preceding four months, prolonged low intensity shaking associated with the Darfield earthquake and the numerous aftershocks, and low to moderate rainfall over three days appear to have combined to trigger the landslide on 10 September 2010. Long-term weathering processes ('slope ripening') over several thousands of years will also have played an important role in weakening and preparing the slope for another failure after its partial prehistoric collapse, as will the excavation for the railway line at the toe of the slope in the late 1800's (Figure 15).

After considering the effects of past rainstorms and earthquakes in the Kaikoura area, and the sequence of events before the landslide occurred (Table 1, Figure 15), the Darfield earthquake mainshock and its long sequence of aftershocks appear to have an increased importance in the initiation of the 2010 landslide. The key details of the process contributing to the failure are:
