Beetham, D. 2011. Ohope Beach Landslide of June 2011, *GNS Science Report 2011/46*. 69 p.

This GNS Science/GeoNet landslide investigation, made in response to a landslide which caused a fatality at Ohope Beach on Saturday 18 June 2011, is based on a site visit, interviews with those involved in the immediate response, and council, consultant and media reports. It puts the 18 June 2011 landslide into a context of regular, rain storm generated landslides that have occurred from coastal cliffs within the region since 2004.

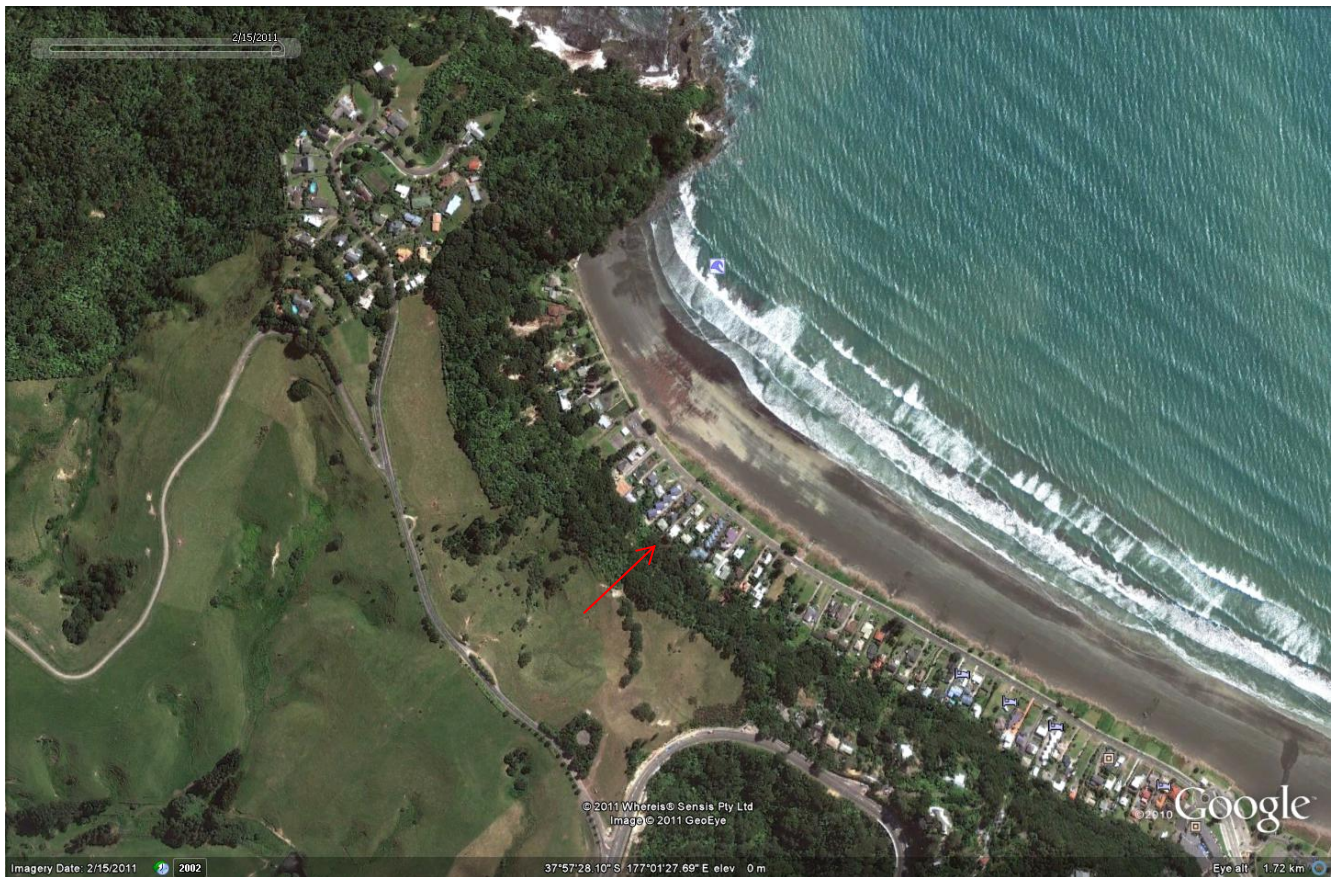
Google Earth often provides a series of past aerial photo images which can be referred to and compared with more recent images. These are valuable for comparing changes to the landscape with time, as has been done for West End Ohope with Figures 22a (Feb 2011 image), 22b (Nov. 2009), 22c (March 2003) and 22d (Sept. 2002). An enlargement of the latest of these aerial photos (15 Feb. 2011) is shown in Figure 24. In Figure 24 three landslides can be seen which have affected houses on the talus apron at the foot of the cliff. These landslides occurred at the northern end of West End in January 2011 and in May and June 2010 (T&T 2011) and affected houses at No.'s 70, 68, 67 and 65D West End Rd. The building at No 65D is multi-level apartments built high on the talus apron under the old cliff. However, these multi-level apartments are more strongly built than a house and have not been significantly damaged by the landslides (June 2010 and Jan. 2011) from the cliff directly behind, although there is apparently an overhanging pohutukawa tree on the cliff which is raising concern (Kevin Hind, T&T, pers. com.).

Figure 22a A 15 February 2011 Google Earth aerial photo of West End, Ohope Beach. For comparison, the following images 22a, b, c & d are all of the same area at the same scale.

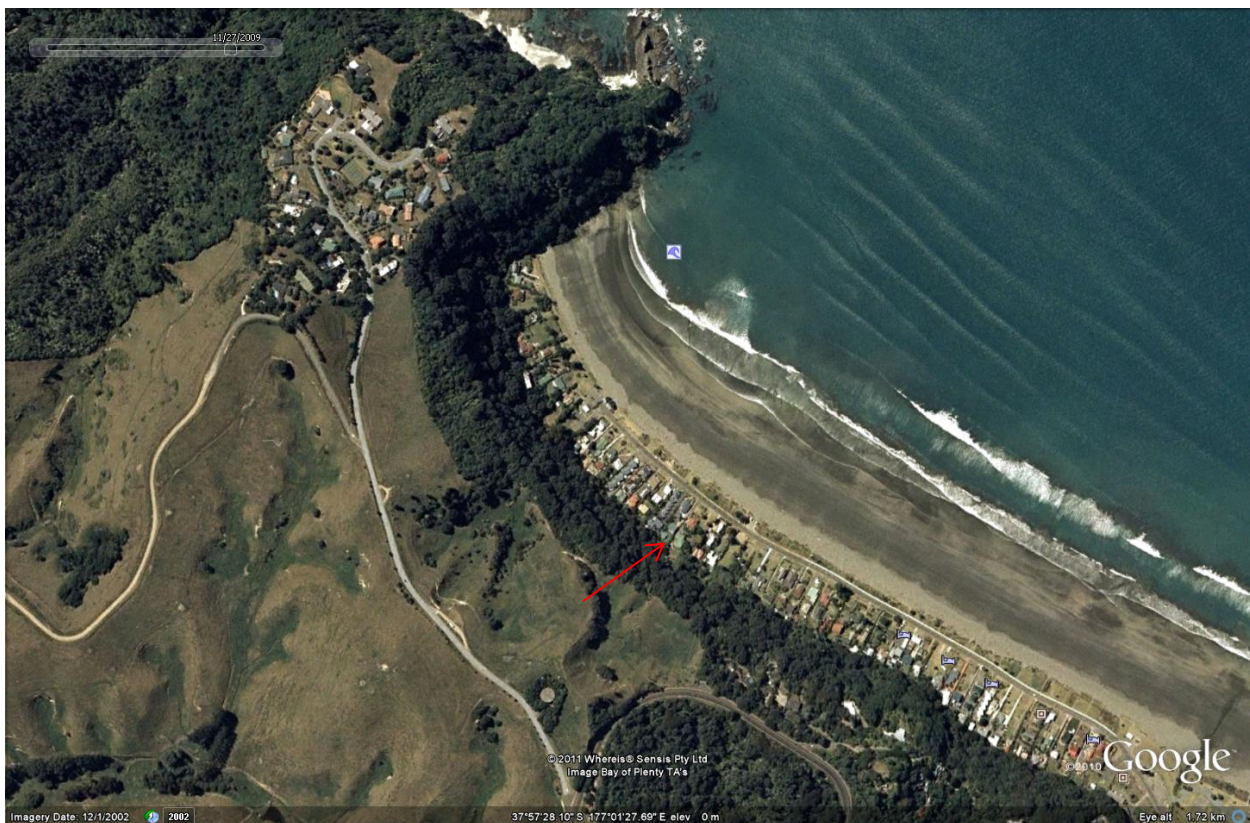
Figure 22b A 27 November 2009 Google Earth aerial photo of West End, Ohope Beach.

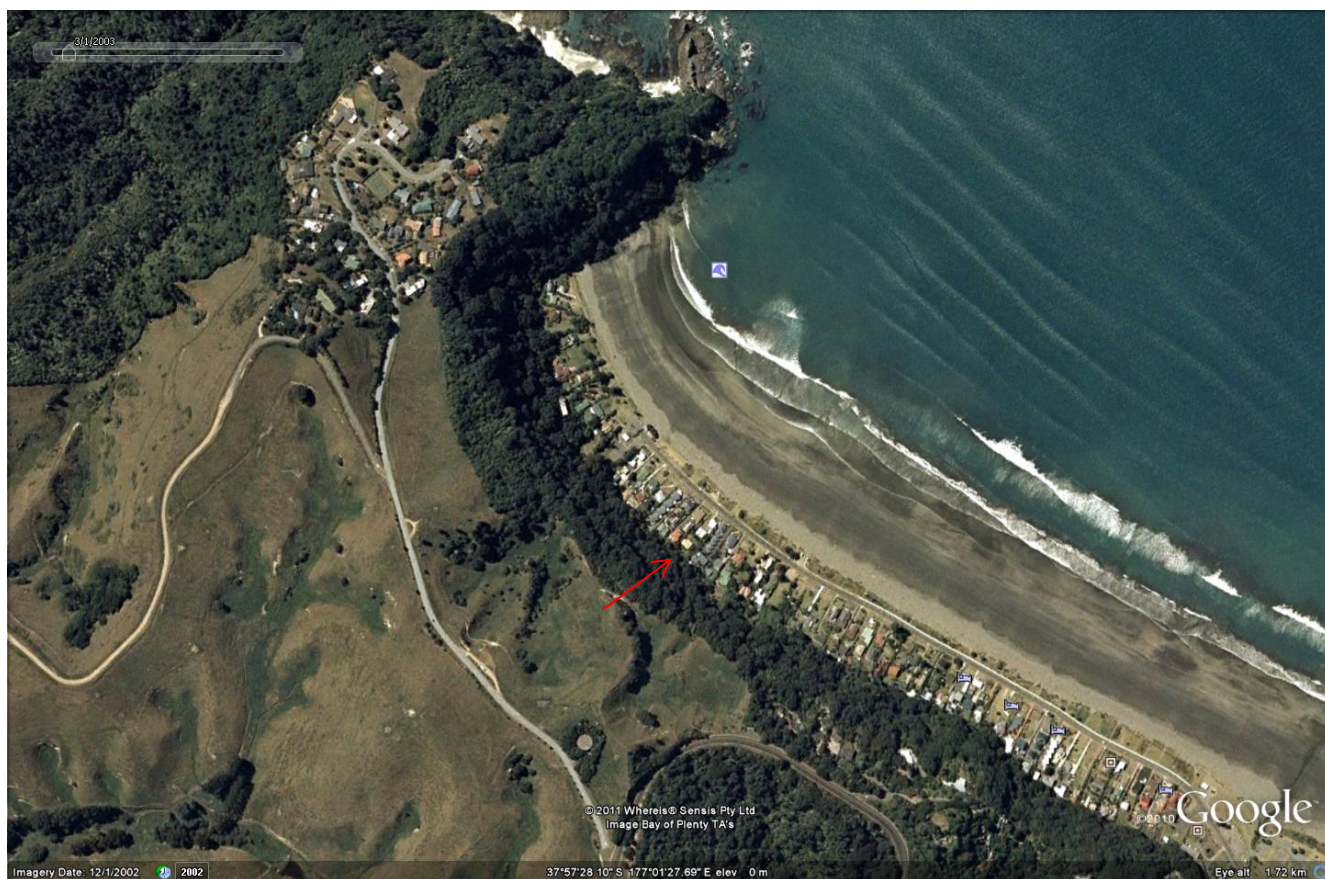
Figure 22c A 01 March 2003 Google Earth aerial photo of West End, Ohope Beach.

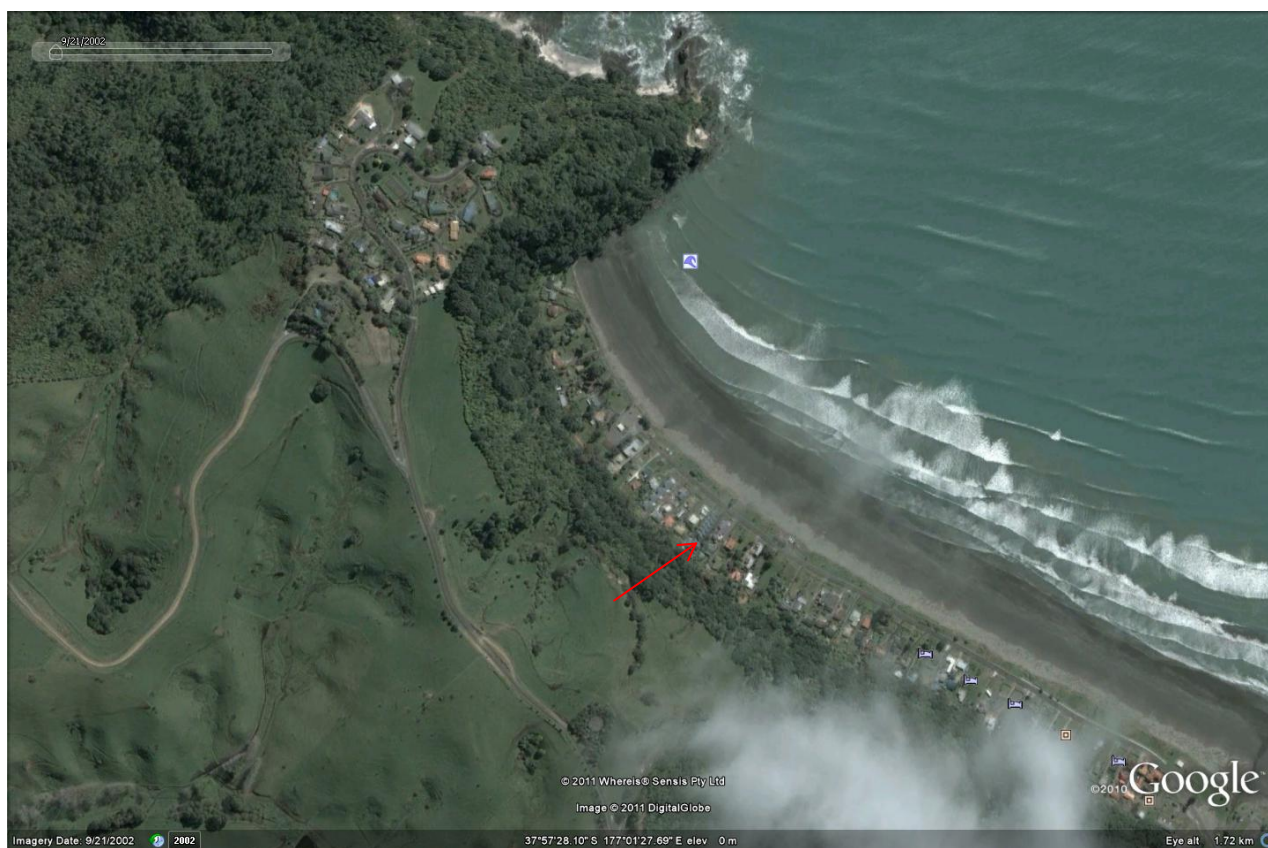
Figure 22d A 21 September 2002 Google Earth aerial photo of West End, Ohope

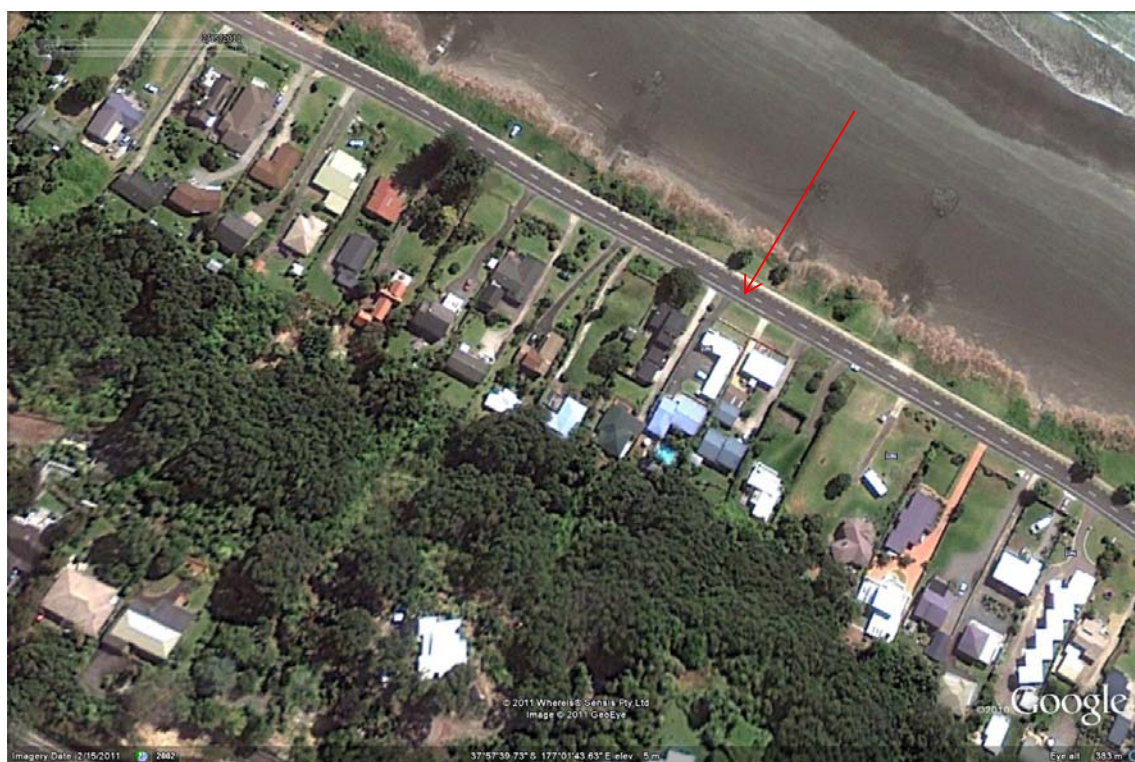
Figure 26 A 2011 Google Earth image of No. 33 West End Road, taken just a month before the landslide which wrecked the house.

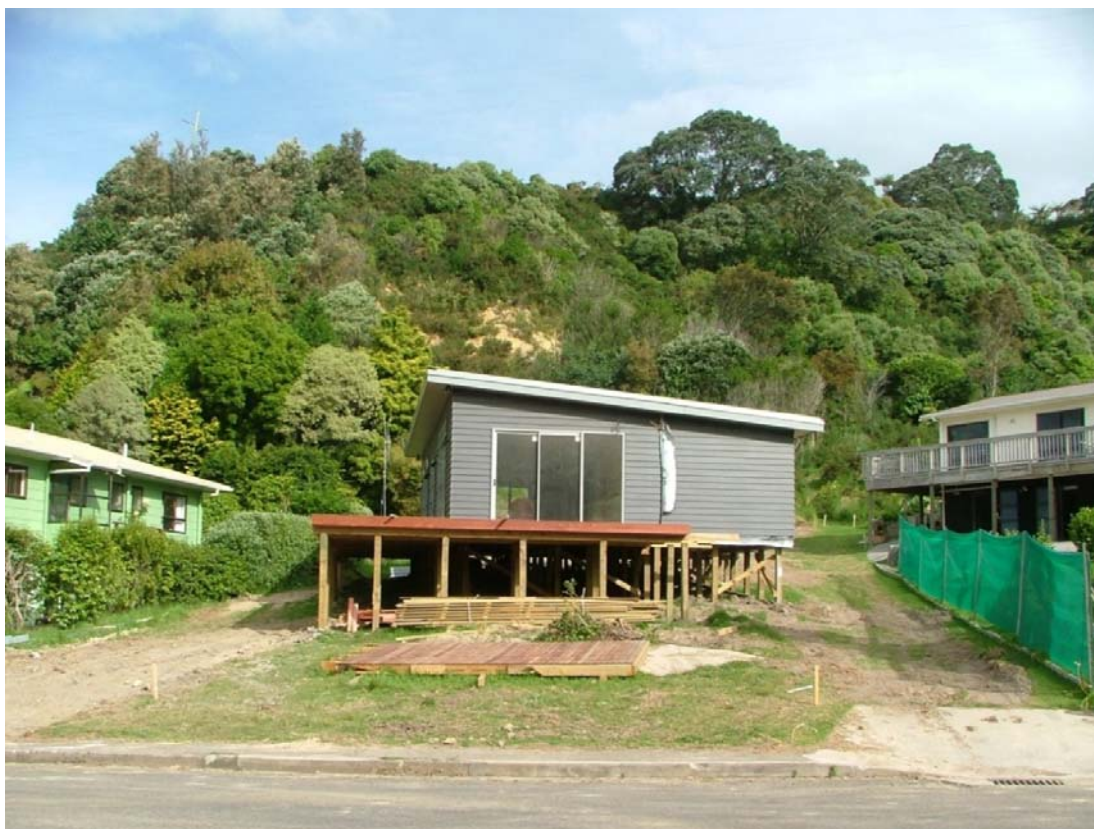
Figure 31 A 2009 photo of the new house built on the site at Bryans Beach. The landslide scar behind the house is revegetating.

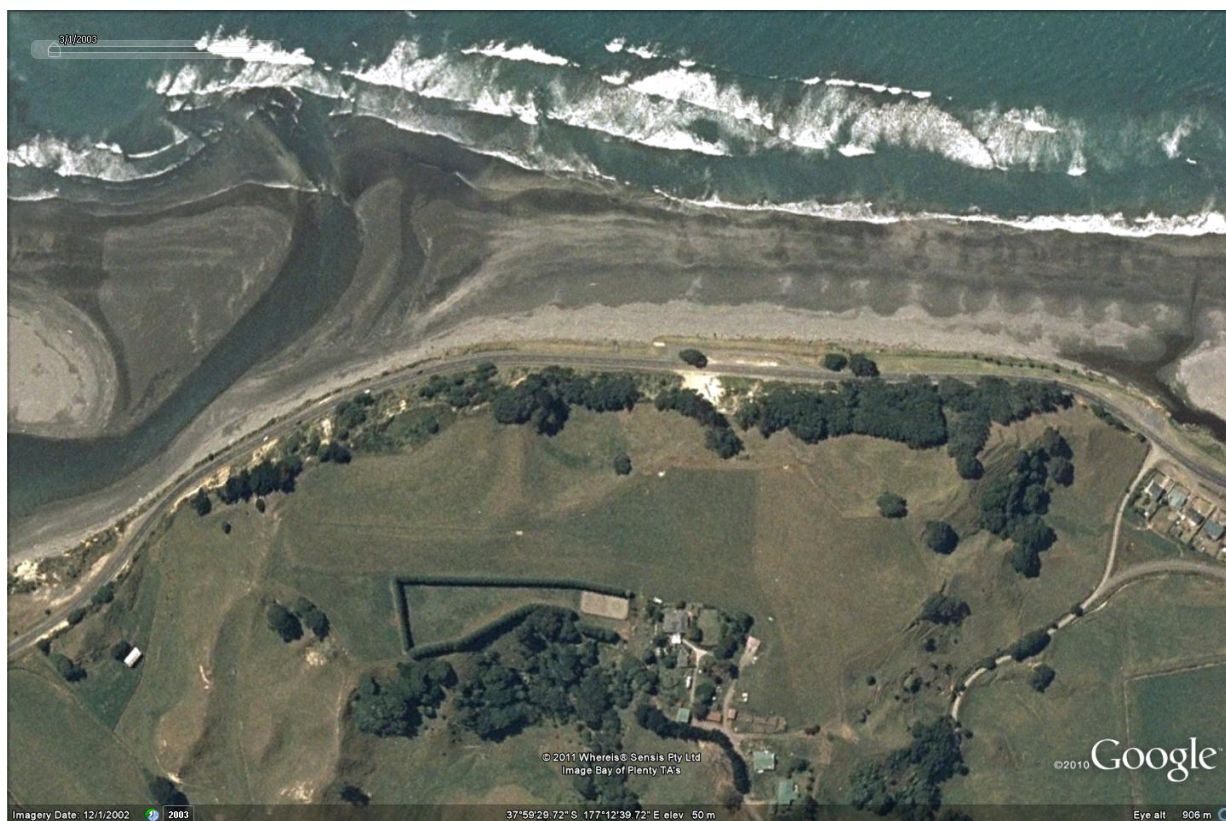
Similarly Figures 37a, b and c are Google Earth images of the pohutukawa clad cliffs at SH2/Waiotahi Beach Road taken in Dec. 2002, Feb. 2007 and Dec. 2010. The development of landslides on the cliff since 2002 is well illustrated by the Google Earth images. The landslides from these cliffs were photographed by the author in 2004 (Figure 36). It is clear that there have been new landslides from the cliffs since 2004 and that the 2004 landslide areas are revegetating by Dec. 2010.

Figure 37a A 12 December 2002 Google Earth image of Waiotahi Beach Road/SH2 when much of the cliff is intact. For comparison the following Google Earth images 37b & 37c are of the same area at the same scale. They illustrate how different parts of the cliff have shed landslides and trees between Dec. 2002 and Dec. 2010.

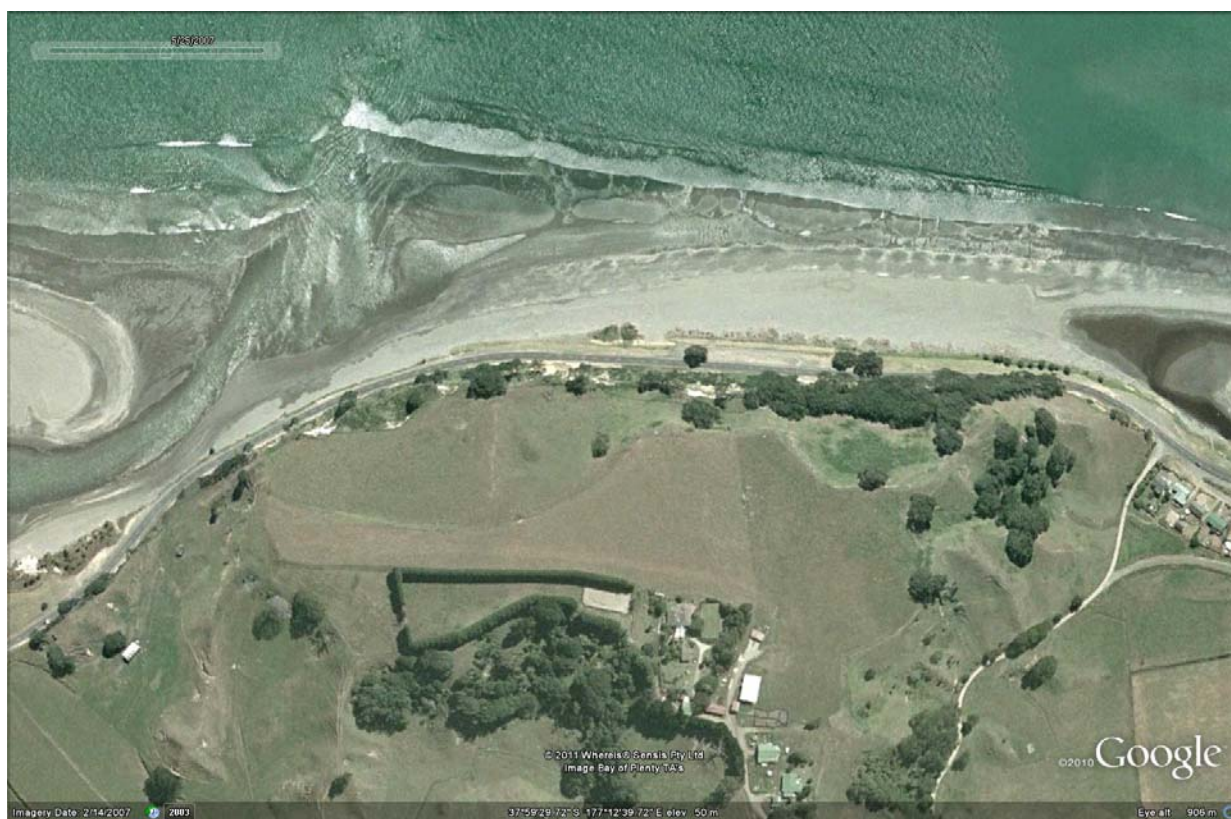
Figure 37b In this 14 February 2007 Google Earth image the landslide areas from 2004 are revegetating.

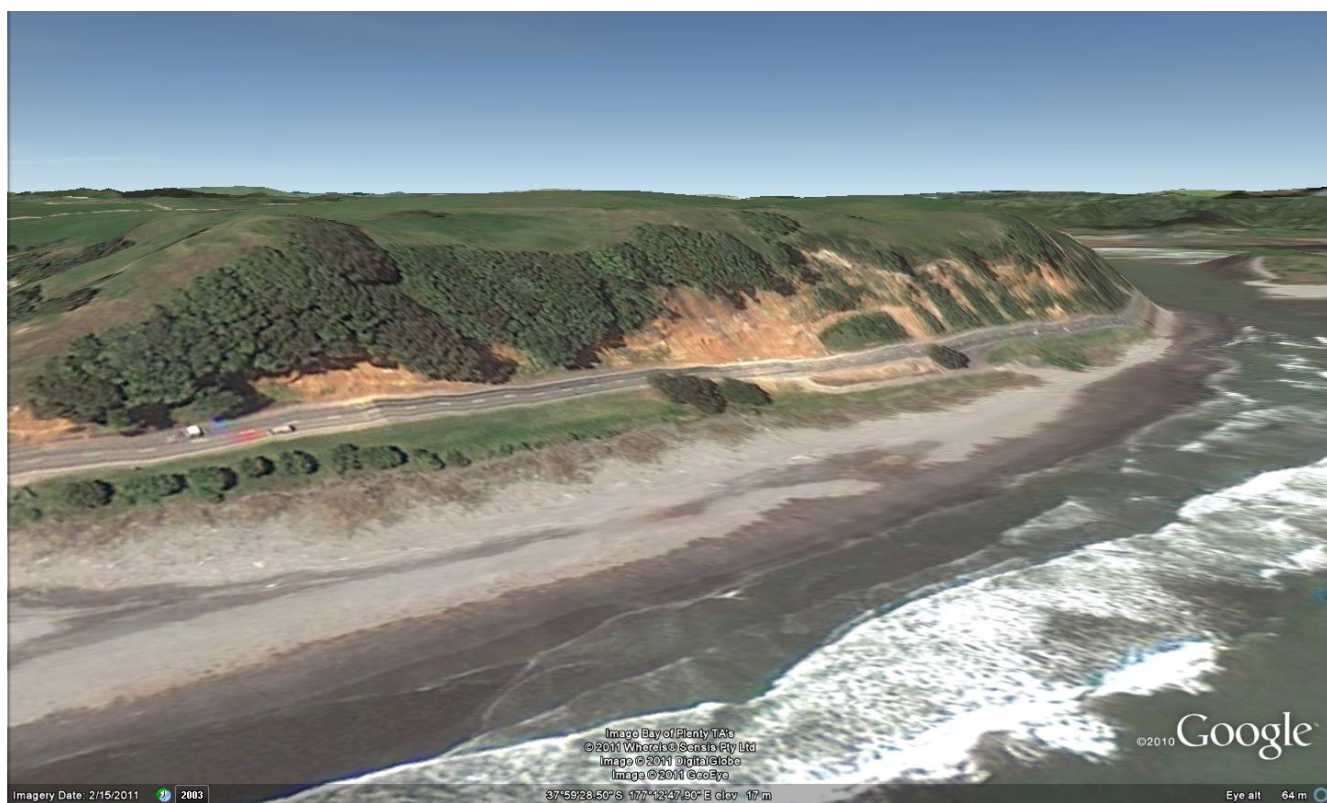
Figure 37d The 22 Dec. 2010 image seen in Figure 37c above has been rotated in Google Earth to form this oblique view of the ~60m high cliff.
