Hancox, G. T.; Archibald, G. C.; Cousins, W. J.; Perrin, N. D.; Misra, S. 2013. Reconnaissance report on liquefaction effects and landslides caused by the M_L 6.5 Cook Strait earthquake of 21 July 2013, New Zealand, *GNS Science Report* 2013/42. 20 p.

ABSTRACT

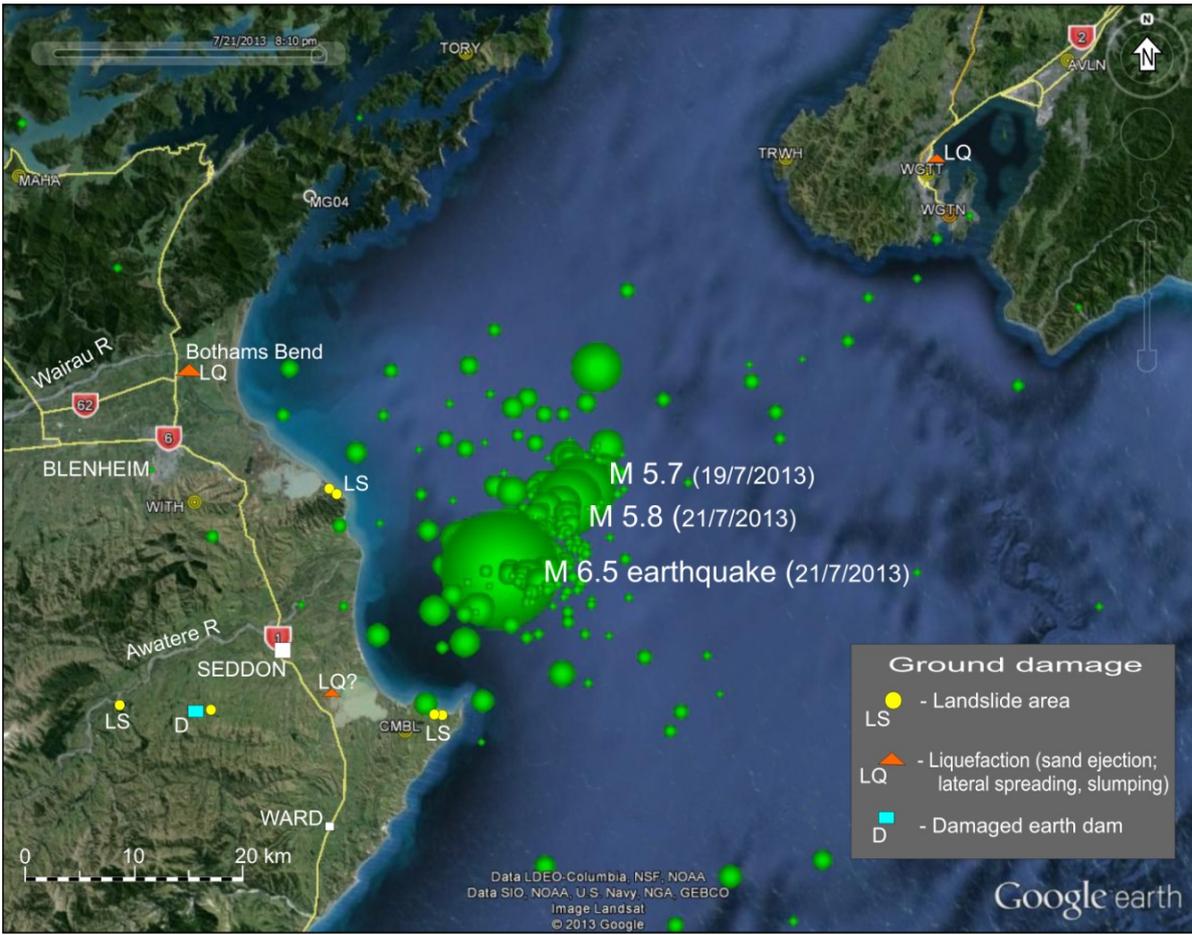
The magnitude (M_L) 6.5 Cook Strait earthquake on Sunday, 21 July 2013 at 5:09:30 pm (NZ Standard Time) is reported by GeoNet to have been located in the southern part of Cook Strait (epicentre: 41.60°S, 174.33°E) 25 km northeast of Seddon at a focal depth of ~13 km (Figure 1) (see also Holden *et al.*, 2013). The maximum Modified Mercalli (MM) intensity modelled for the earthquake is MM 9 (using Dowrick and Rhoades 2005 attenuation model).

Figure 1 Annotated GoogleEarth image map showing the locations of epicentres of earthquakes that occurred during the Cook Strait earthquake swarm from 21–29 July 2013 (from GeoNet), and the main areas of landsliding and liquefaction ground damage caused by the M_L 6.5 earthquake on 21 July 2013.

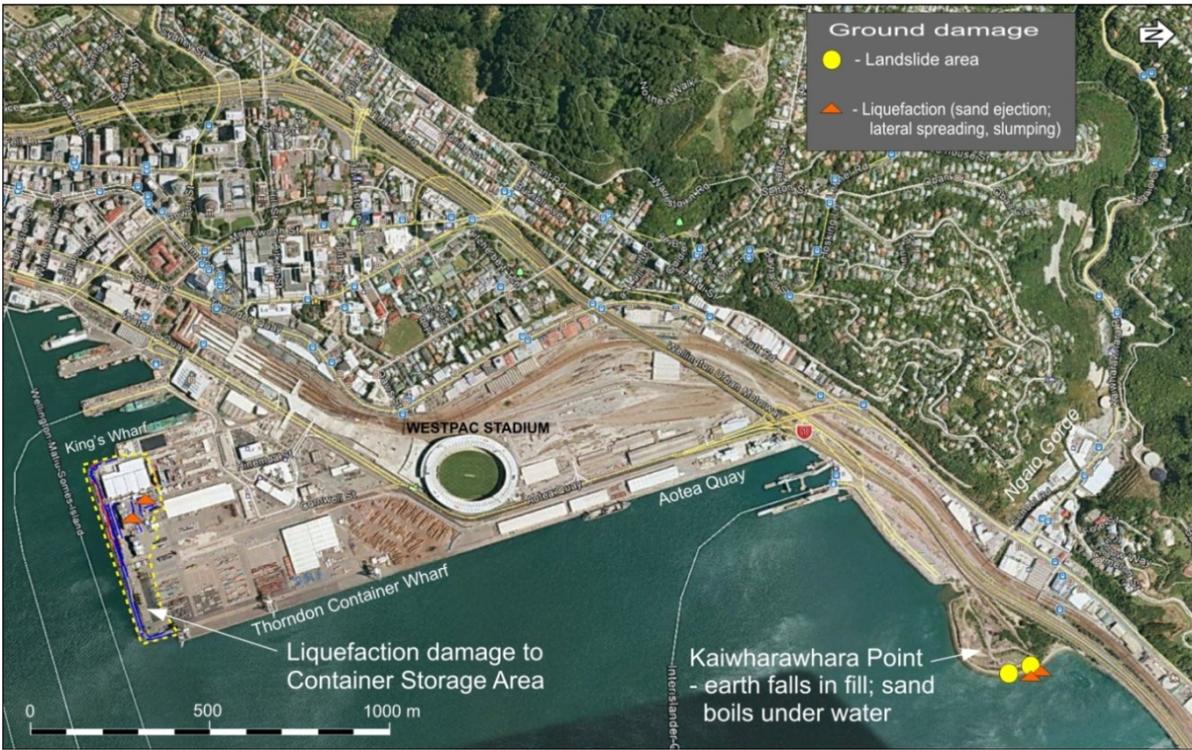
Figure 2 Annotated GoogleEarth image showing the location of liquefaction damage at the container storage reclamation area, and landsliding and liquefaction at Kaiwharawhara Point in Wellington Harbour which was caused by the Cook Strait earthquake of 21 July, 2013.

The slumping, sand ejection and ground cracking in reclamation fill in the Container Storage Area at CentrePort Wellington, along with sand boils in shallow water at Kaiwharawhara Point (Figure 2) are believed to be liquefaction effects caused by the M_L 6.5 Cook Strait earthquake on 21 July 2013. Those liquefaction effects are similar to the isolated subsidences and sand boils that occurred during the M_W 7.2 Masterton earthquake of 24 June 1942 (Murashv and Palmer, 1998; Downes *et al.*, 2001). That earthquake and the 2013 Cook Strait earthquake have caused the most substantial liquefaction damage in the Wellington City area since the 1855 Wairarapa earthquake (Grapes *et al.*, 1998; Hancox *et al.*, 1997).

A helicopter reconnaissance of landslides and ground damage caused by the M_L 6.5 Cook Strait earthquake was undertaken by Graham Hancox, Nick Perrin, and Santanu Misra on Thursday 25 July 2013. Our aerial inspection began in Wellington Harbour, where fresh slumping and sand boils were noted at Kaiwharawhara Point (Figure 2).

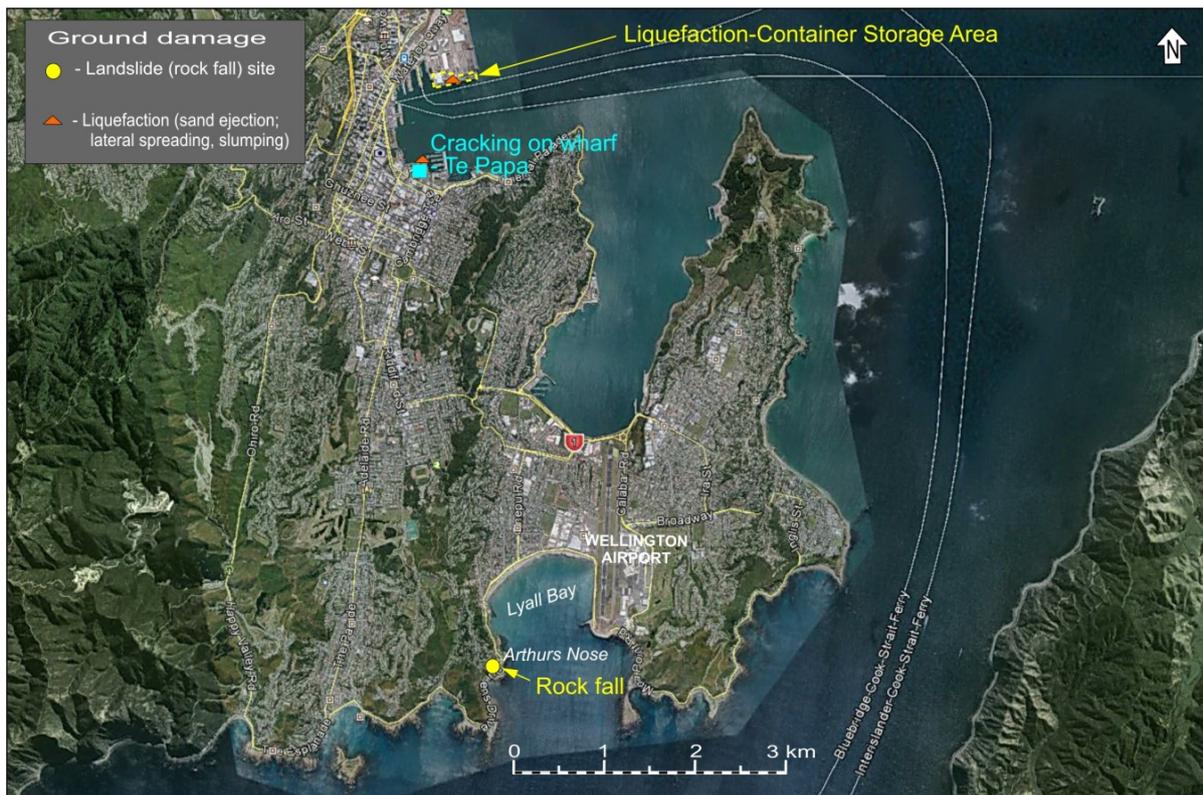
Figure 3 Annotated GoogleEarth image showing the locations of the cracking on the wharf at Te Papa and the small rock fall at Arthurs Nose on the west side of Lyall Bay about 5.5 km to the south of Te Papa, but closer to the epicentre of the Cook Strait earthquake.

A few weeks after the Cook Strait earthquake, cracks were noted on the wharf promenade at Te Papa (Figure 3 and Figure 4). The cracks are ~5–10 mm wide with subsidence of 15–30 mm (Figure 11 and Figure 12), and are located above the edge of the underlying fill, which appears to have settled, possibly due to failure of silt and mud deposits below the fill (Figure 12).

A small rock fall also occurred on an old quarry slope at Arthurs Nose on the west side of Lyall Bay (Figure 3 and Figure 13). This failure, a reactivation of a rock fall which occurred during the 15–20 June rainstorms, was the only landslide on Wellington's southern coast that could be attributed to the Cook Strait earthquake.

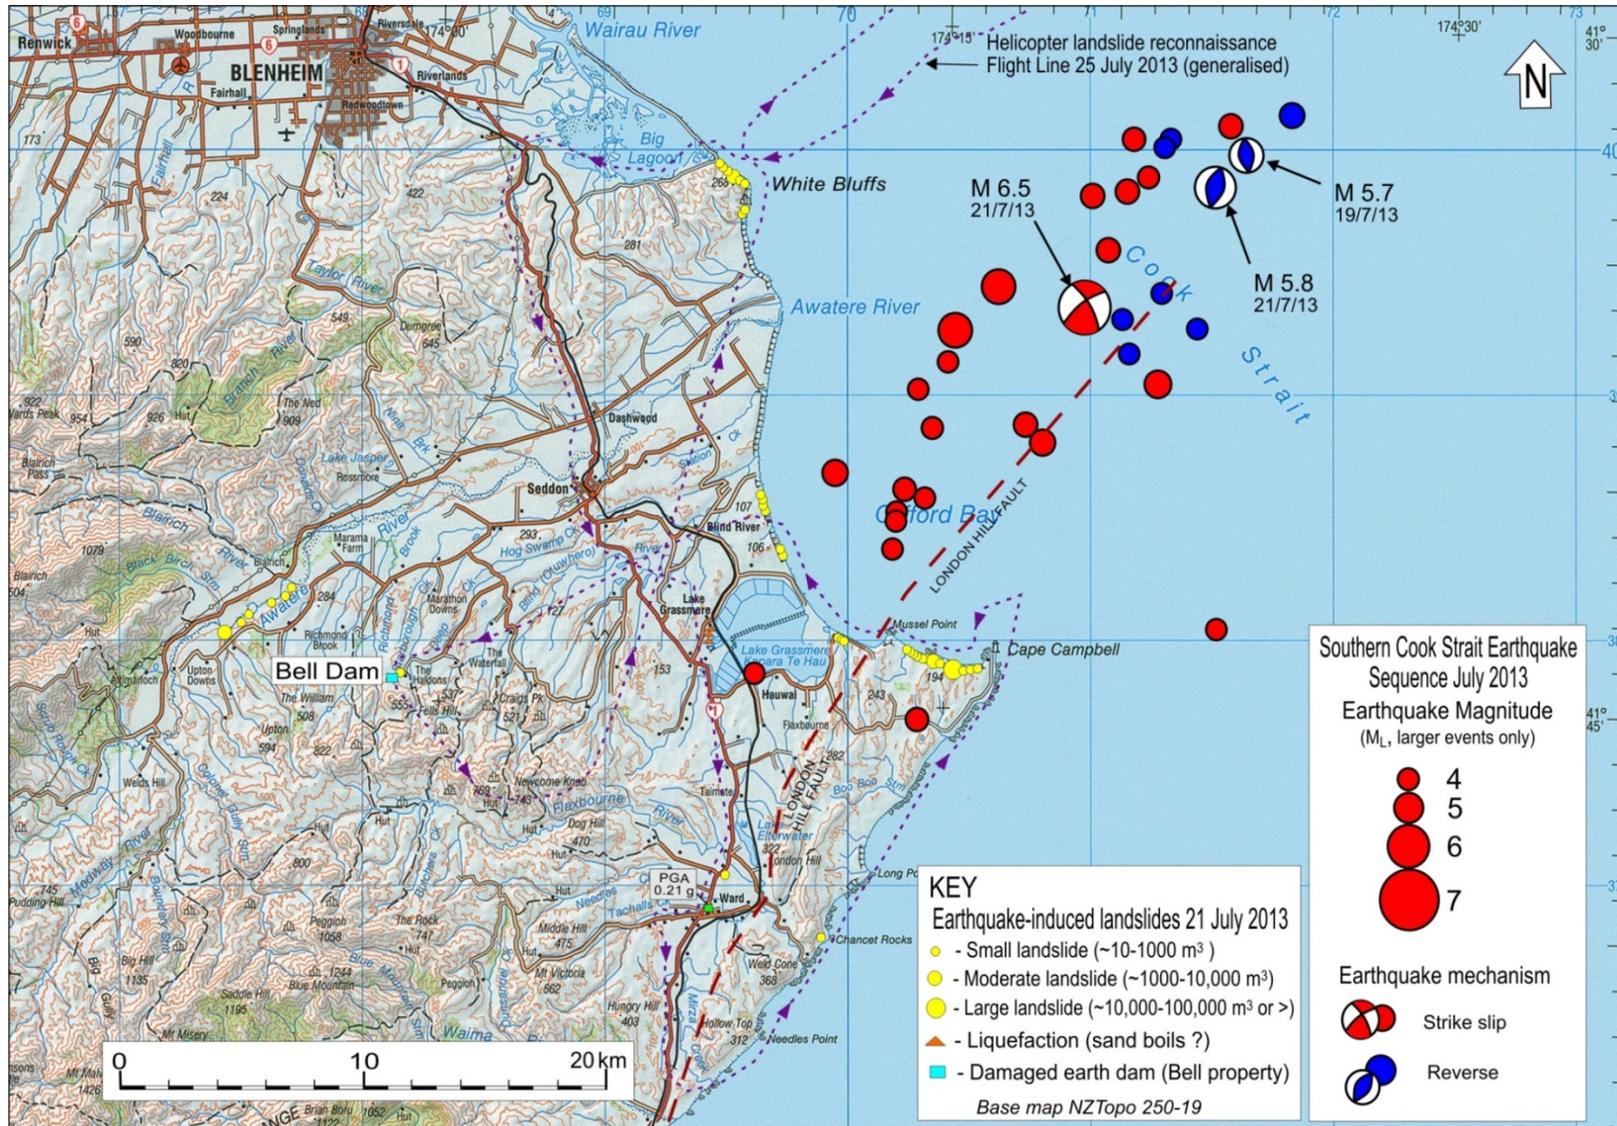
Figure 15 Map showing the route of the helicopter reconnaissance on 25 July 2013 and landslides and other ground damage attributed to the M_L 6.5 Cook Strait earthquake on 21 July 2013. The epicentre locations and mechanisms of the main earthquakes ($>M$ 4) from 19-25 July 2013 are from the GeoNet website. The strongest PGA recorded was 0.21 g at Ward (for more detail regarding ground motions recorded during the Cook Strait event, see Holden *et al.* (2013).

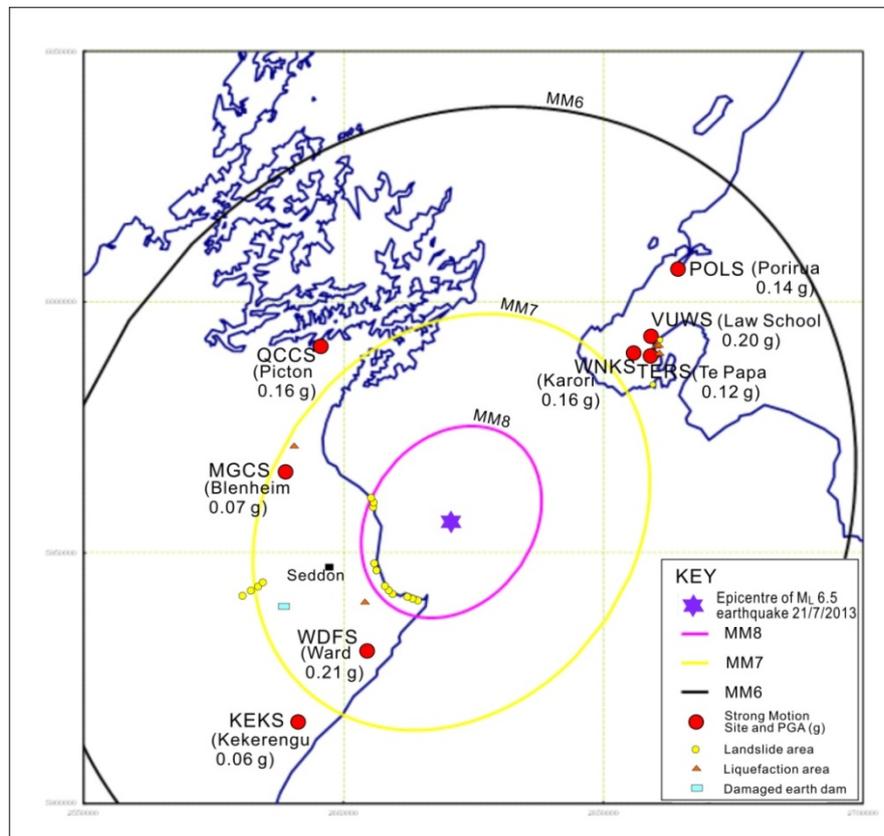
Figure 26 Maximum recorded peak ground accelerations (pga) and modelled Modified Mercalli (MM) shaking intensity map for the M_L 6.5 Cook Strait earthquake on 21 July 2013 based on the Dowrick and Rhoades (2005) attenuation function. The approximate locations of the main landslide and liquefaction areas and the damaged earth dam discussed in this report are also shown.

Figure 26 shows that most of the landslides and liquefaction effects occurred within the modelled MM8 and MM7 isoseismals, although some damage, such as in Wellington Harbour, the west side of Lyall Bay, and the middle Awatere Valley, occurred at MM6.5 to MM7, about 35 to 55 km from the epicentre. The most numerous and largest landslides which occurred on the coastal cliffs from Cape Campbell to White Cliffs, are on the edge of the MM8 isoseismal zone, about 16 km from the epicentre.
