Landslides and debris flows caused by the 15-17 June 2013 rain storm in the Marahau-Motueka area, and the fatal landslide at Otuwhero Inlet

GNS Science Report 2013/44 August 2013

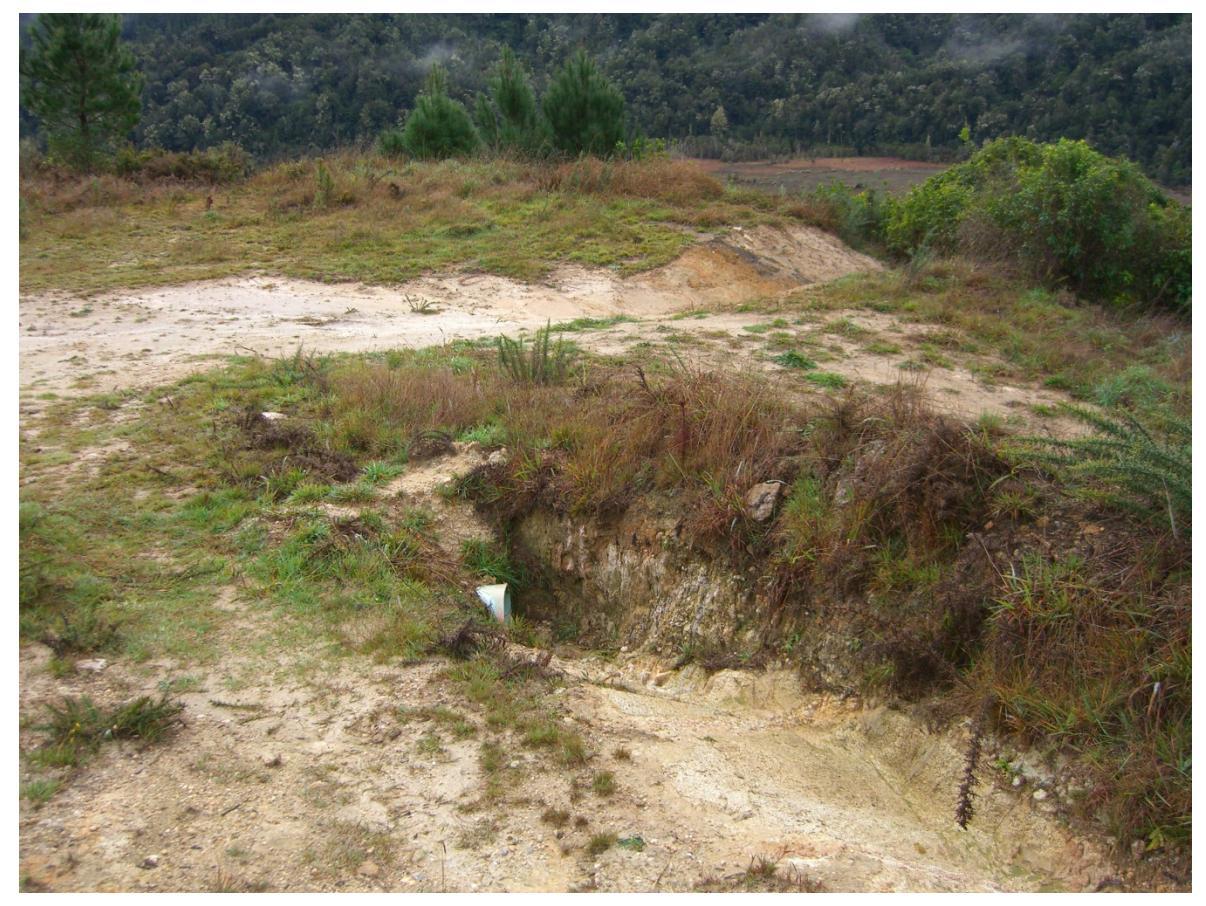
Figure 19 Hairpin bend showing culverts to discharge water from the track. (GNS Science photo).

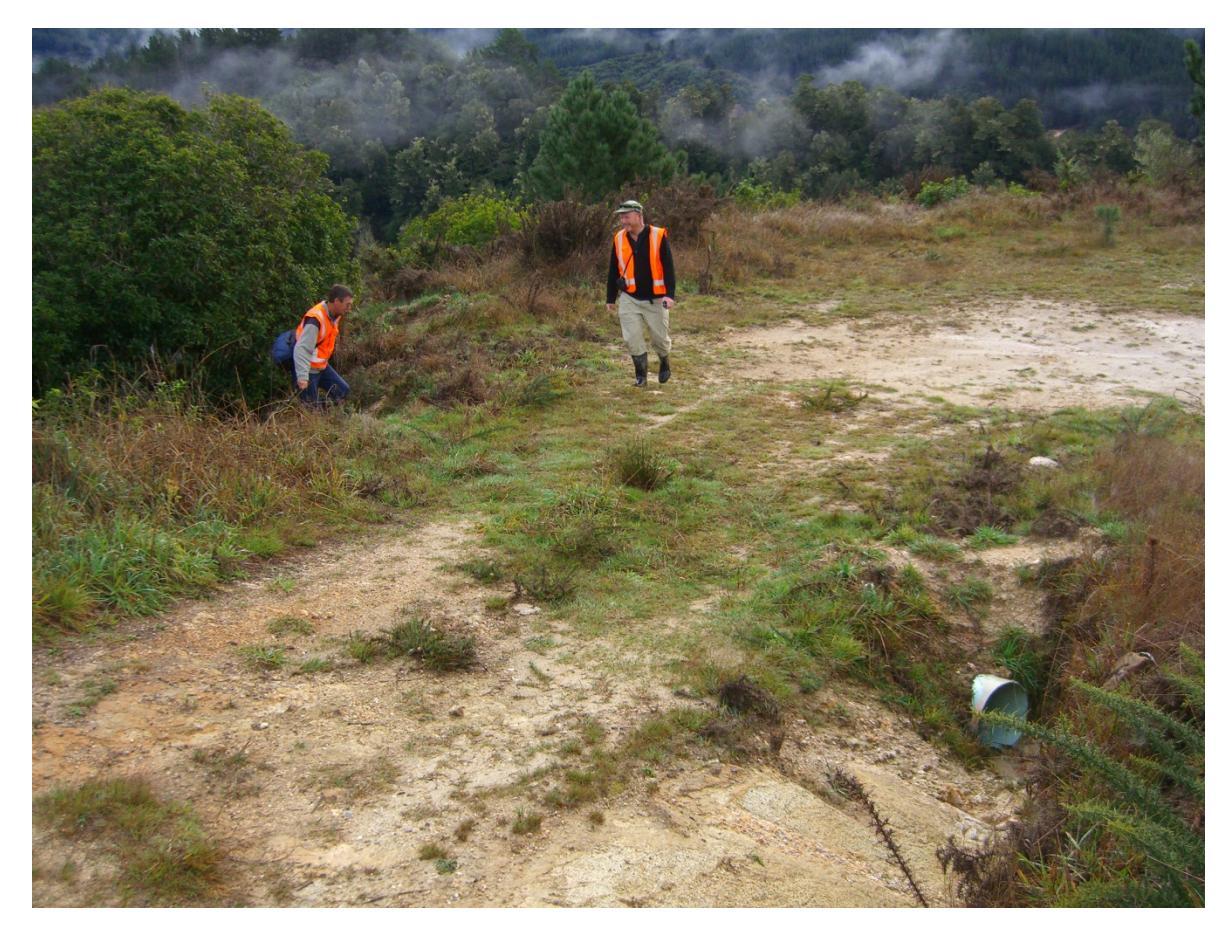
Figure 20 Culvert under access track just above hairpin bend. (GNS Science photo).

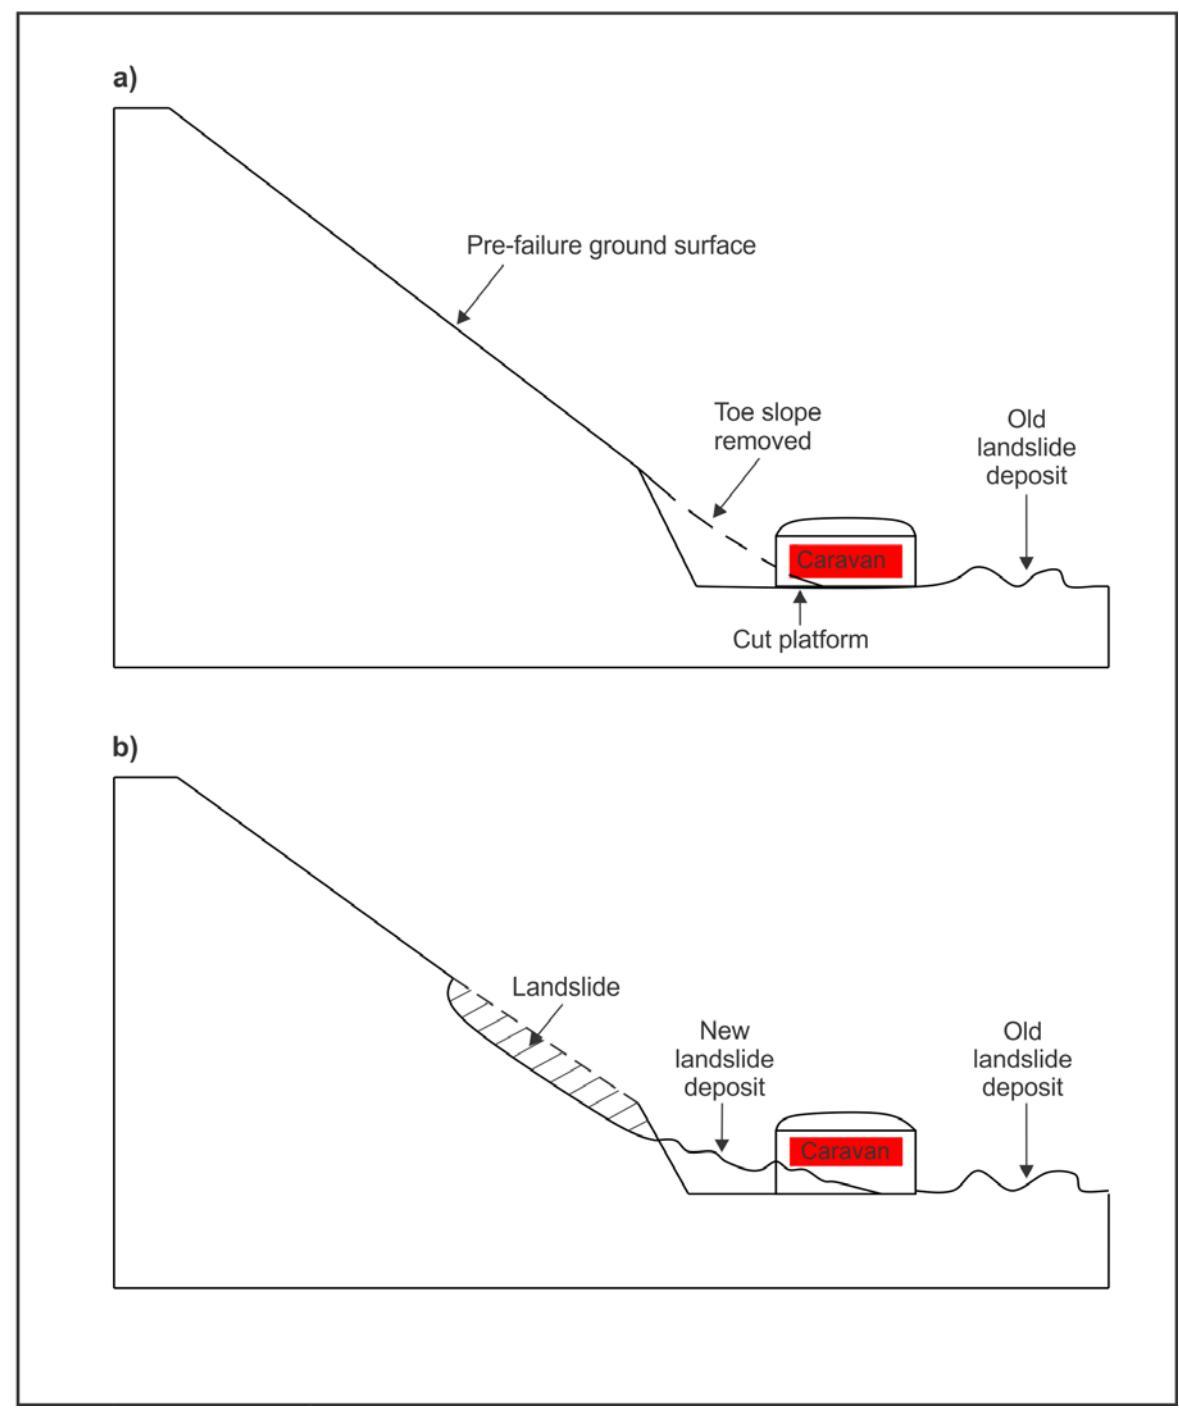
**Figure 33** Cartoon showing **a**) profile of slope before landslide, with cut toe slope, levelled building platform and earlier landslide deposit **b**) profile of slope after landslide, with new landslide material deposited on cut platform and impacting on dwelling.

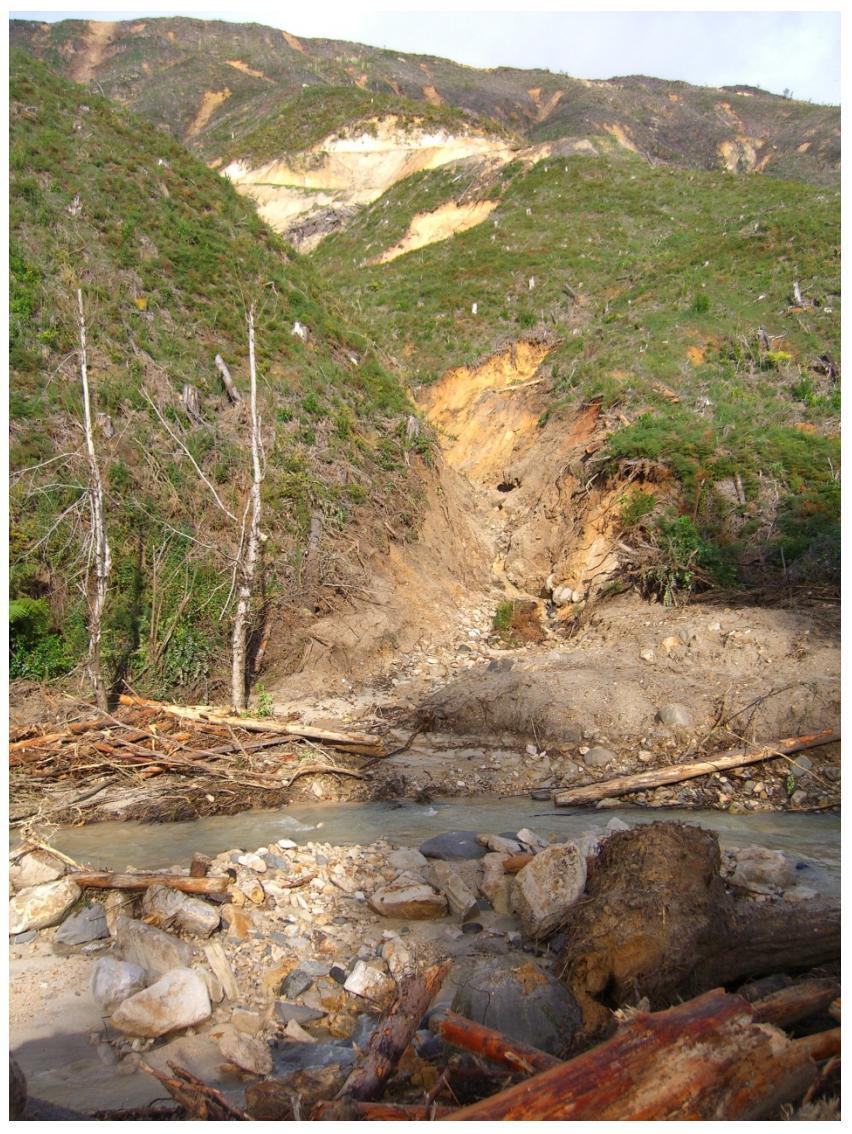
Figure 41 Tributary stream channel at the confluence with the Shaggery River. (GNS Science photo).

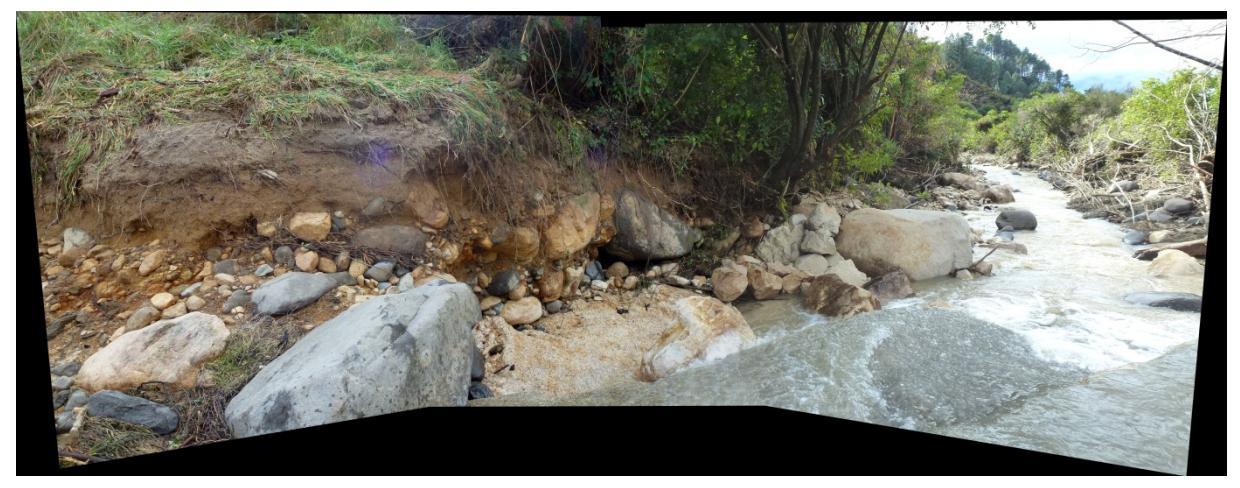
**Figure 46** Paleo-debris flow deposit exposed in a bank of the Shaggery River, next to the ford shown in Figure 43. (*TDC photo*).

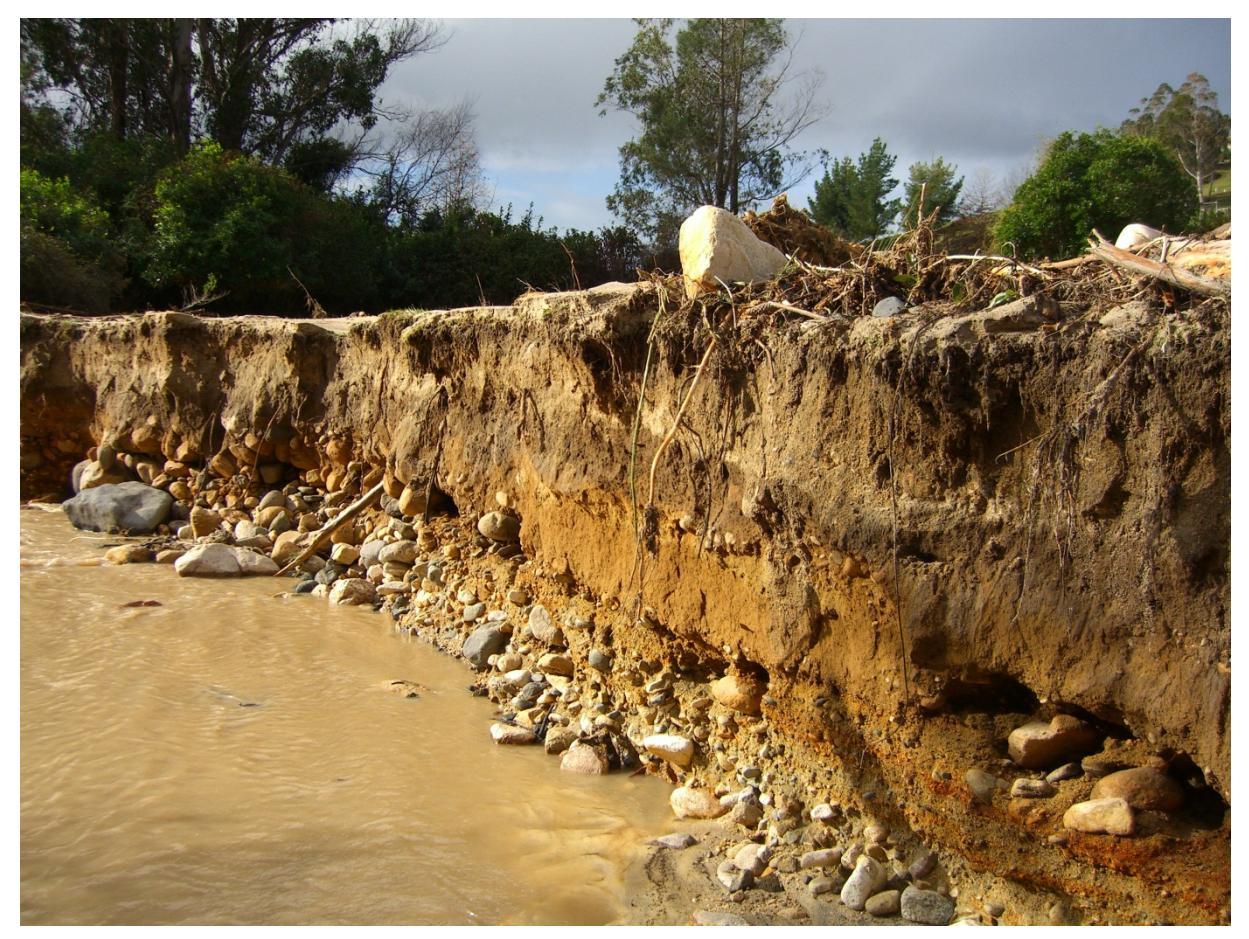
**Figure 48** Flood deposits overlying a buried soil in a bank of the Shaggery River directly downstream from Figure 47. (*GNS Science photo*).
