Cox, S. C.; McSaveney, M. J.; Rattenbury, M. S.; Hamling, I. J. 2014. Activity of the landslide Te Horo and Te Koroka fan, Dart River, New Zealand during January 2014, *GNS Science Report* 2014/07. 45 p.

The landslide Te Horo lies on the eastern side of Cosmos Peaks, Dart Valley, Otago. It is an active compound rock and debris slide with ancillary debris topples and debris flows commencing from its toe. Te Horo has an area of 0.9 km^2 with a steep toe area that is rapidly eroding on its southern lateral margin to feed $10^5 - 10^6 \text{ m}^3$ of sediment annually onto a debris-flow fan on the valley floor. Debris flows in 2013 and January 2014 crossed the fan and entered Dart River, impeding flow, and impounding a lake which grew from 0.47 km^2 to 1.48 km^2 between December 2013 and January 2014. Between 5 and 15 January 2014, a continually surging debris flow added about $1-2 \times 10^5 \text{ m}^3$ of sediment to the toe of the fan, but the main surge appears to have occurred on 4 January after heavy rain in the area. The lake is expected to persist for decades as the landslide continues to supply debris. The lake level and extent will fluctuate. There is no downstream danger

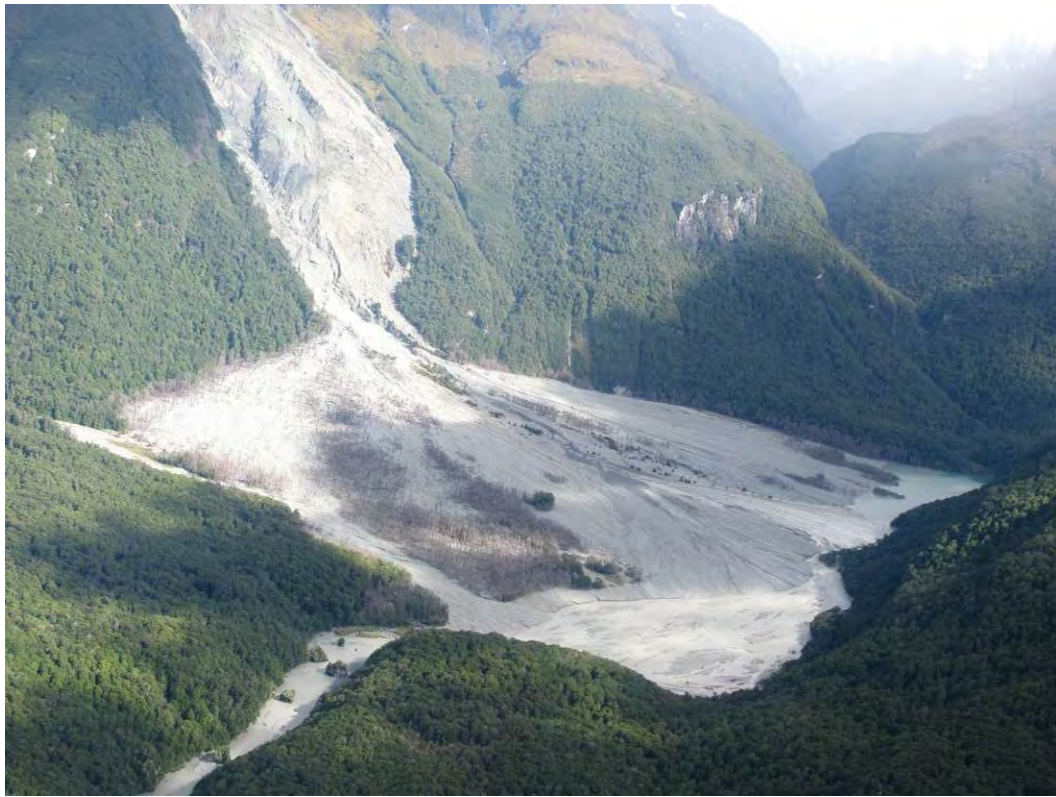
Figure A1 Aerial oblique view (to west) of the Te Koroka/Slip Stream fan below Te Horo. Dart River in foreground (Photo: S. C. Cox, 6 January 2014).

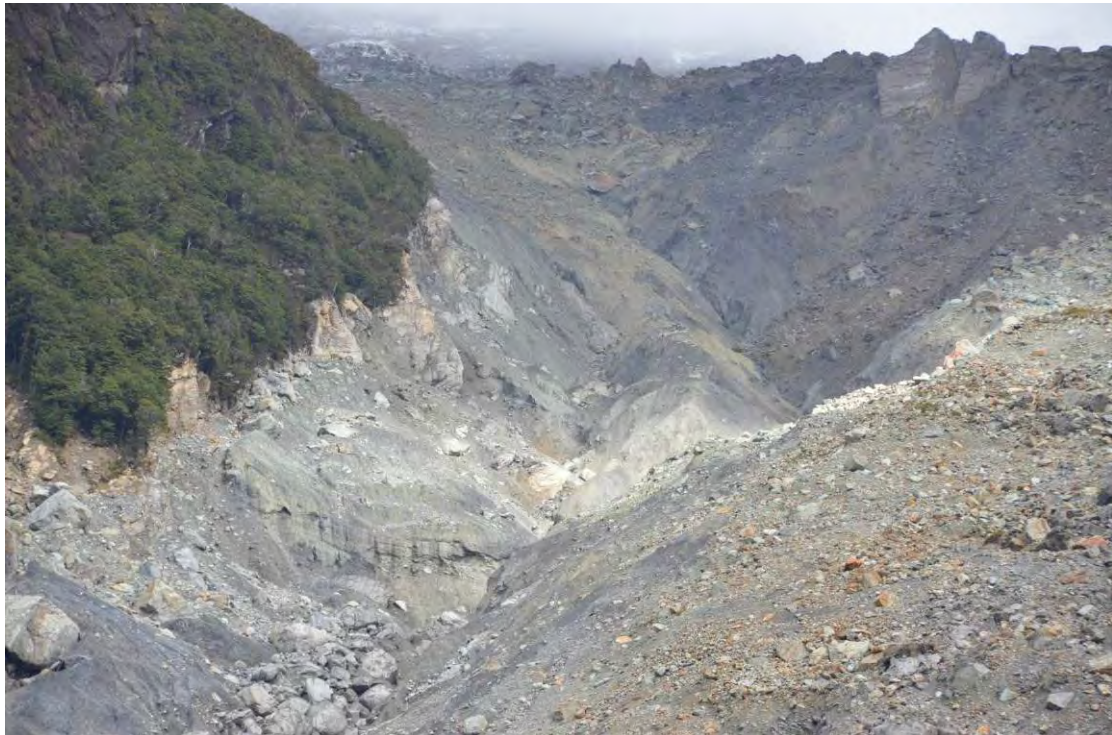
Figure A2 Aerial oblique view to west of the debris-flow catchment of Te Koroka/Slip Stream and the Te Horo landslide (Photo: M. J. McSaveney, 6 January 2014).

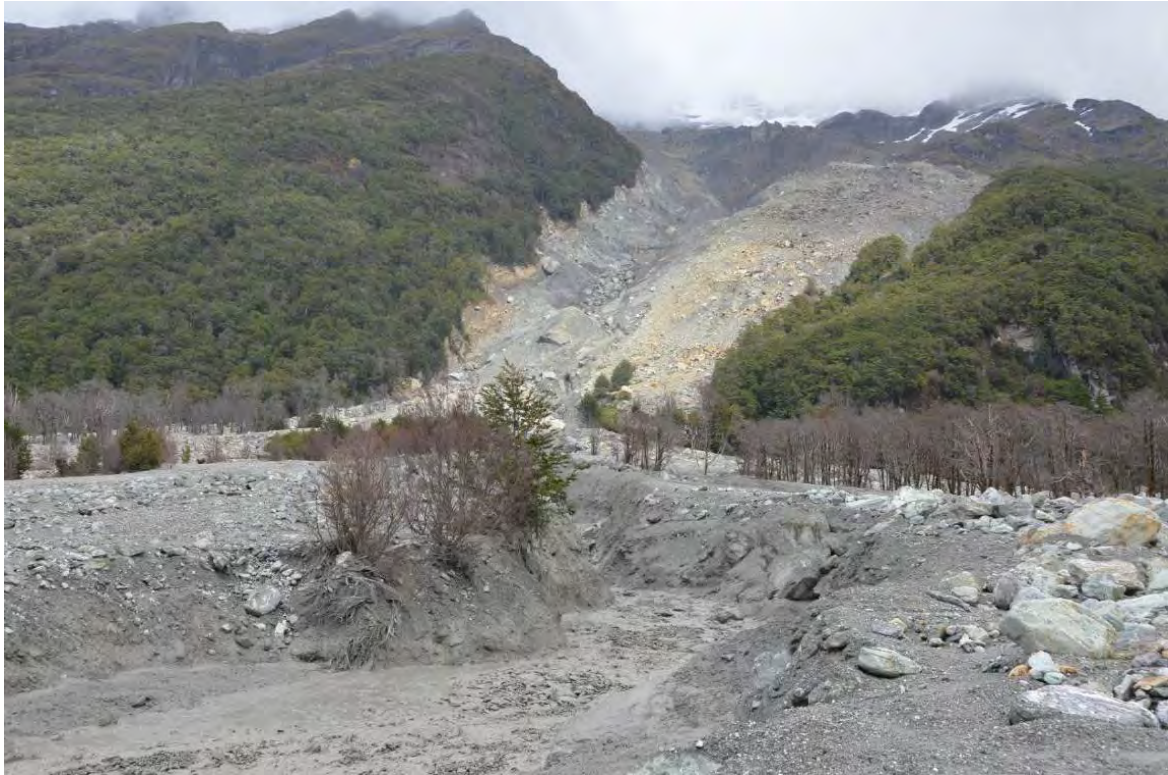
Figure A3 View of the Te Koroka/Slip Stream debris-flow channel, upper fan, and T e Horo landslide (Photo: M. J. McSaveney, 6 January 2014).

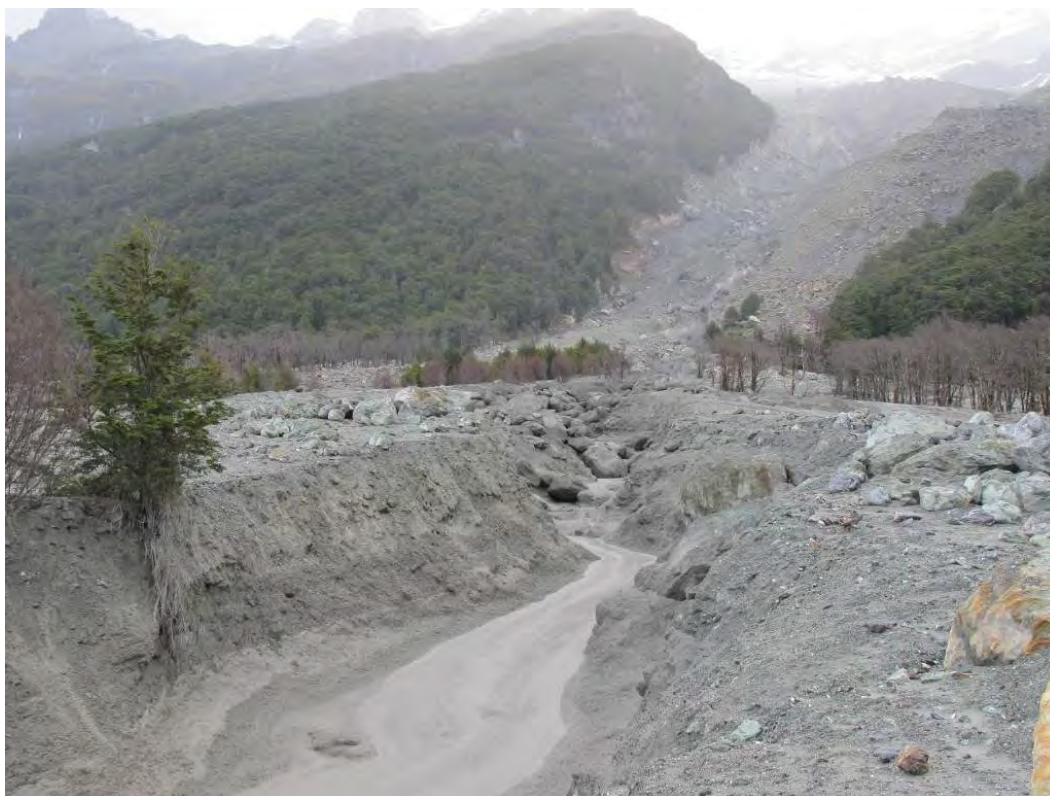
Figure A5 A debris flow in the incised channel of Te Koroka/Slip Stream (Photo: S. C. Cox, 6 January 2014).

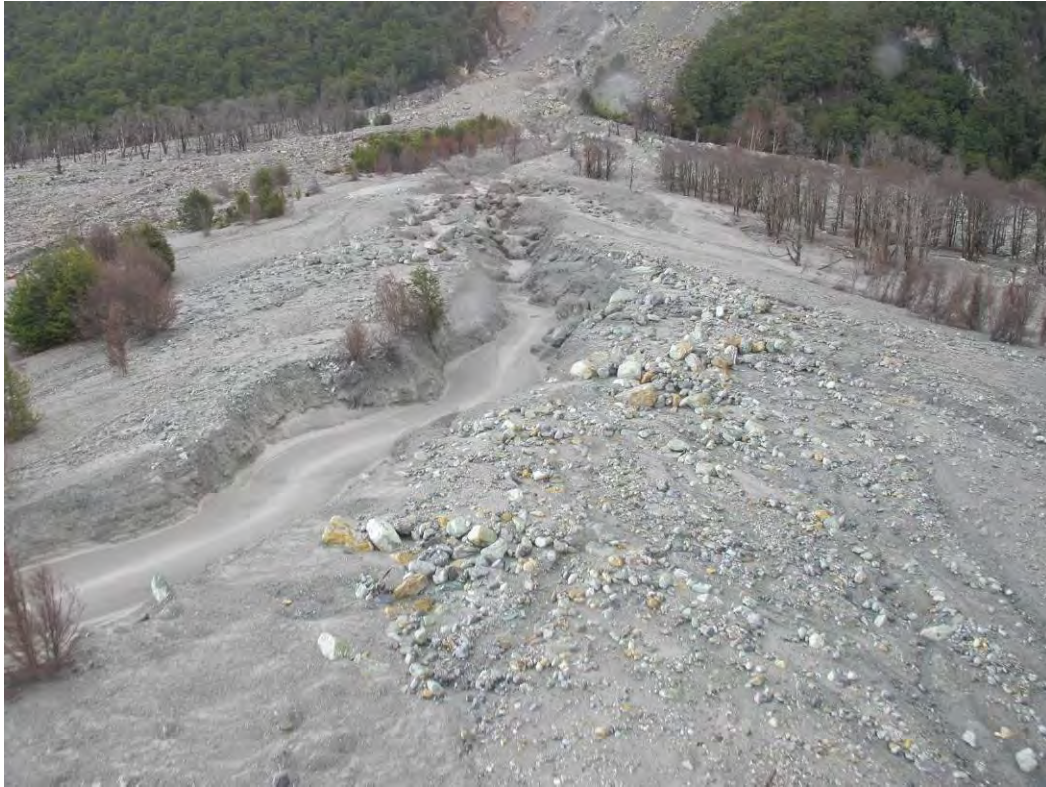
Figure A7 Aerial oblique view (to west) of the upper Te Koroka/Slip Stream fan with debris flow in channel (Photo: S. C. Cox, 6 January 2014).

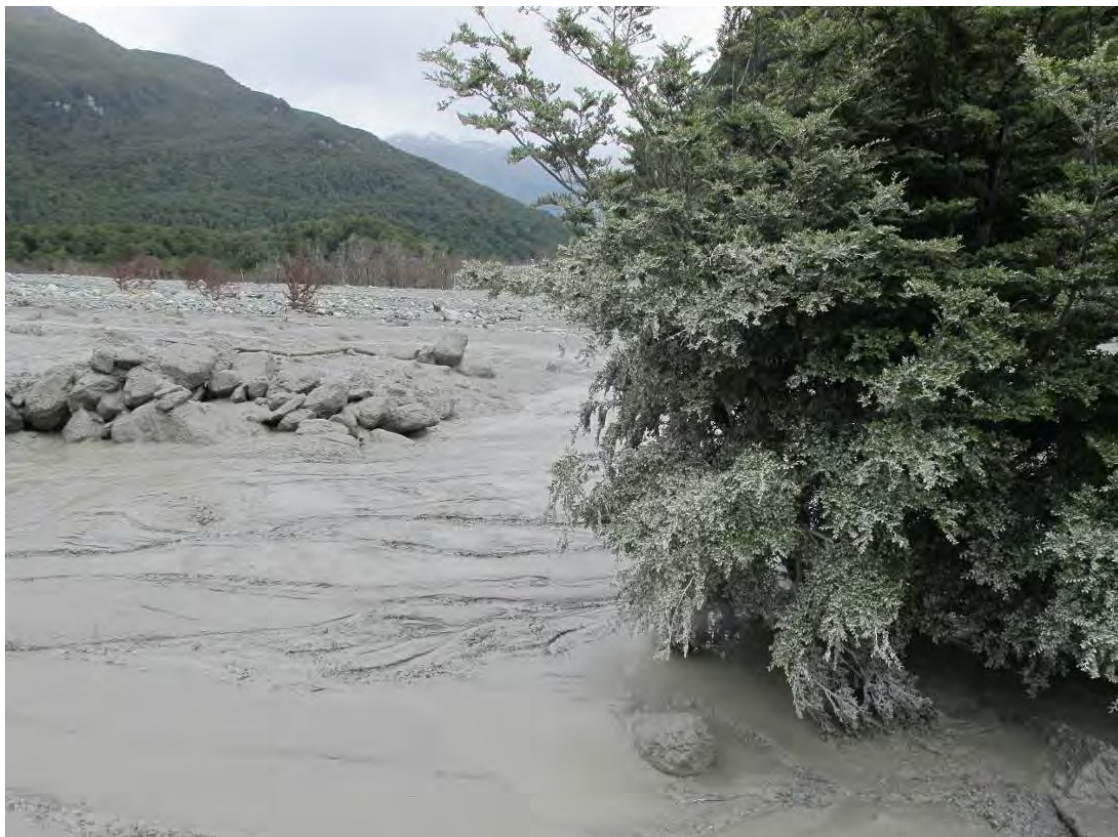
Figure A10 A debris flow in Te Koroka/Slip Stream (Photo: S. C. Cox, 6 January 2014).

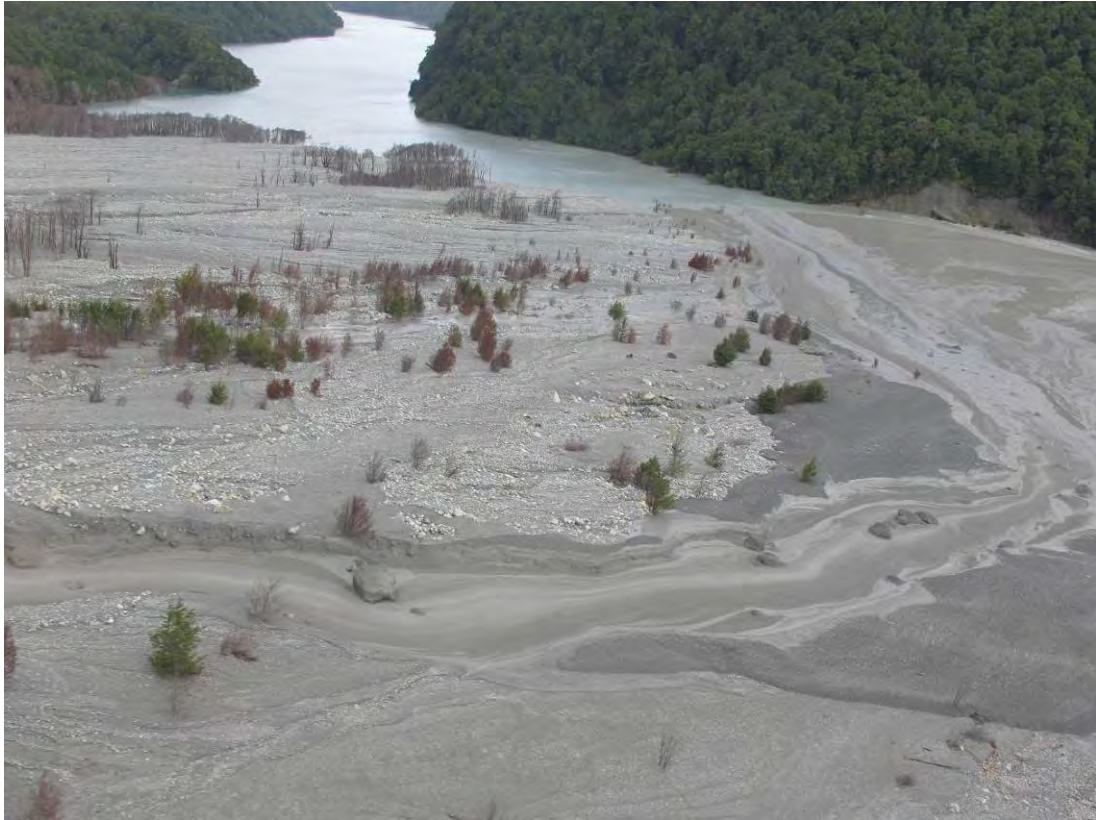
Figure A17 Aerial oblique view (to north) of the Te Koroka/Slip Stream fan and active debris-flow channel (Photo: S. C. Cox, 5 January 2014).

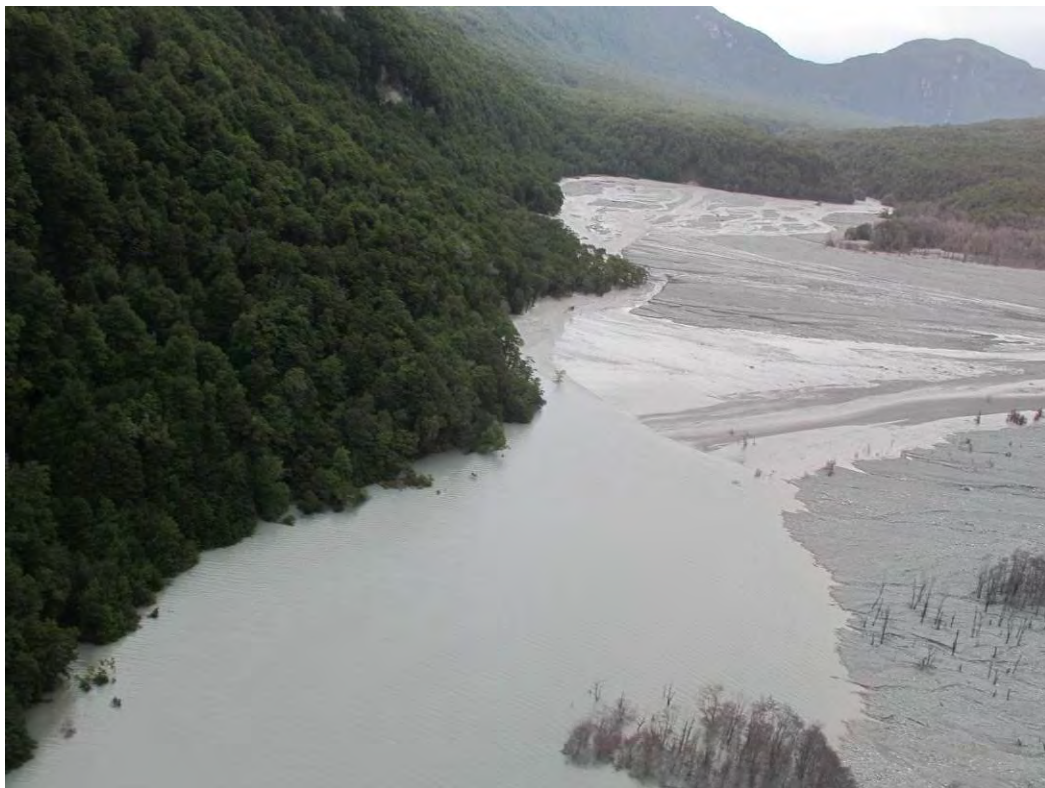
Figure A18 Aerial oblique view (to south) of dam crest on Dart River and the toe of Te Koroka/Slip Stream fan. Lake is in the left foreground (Photo: S. C. Cox, 5 January 2014).

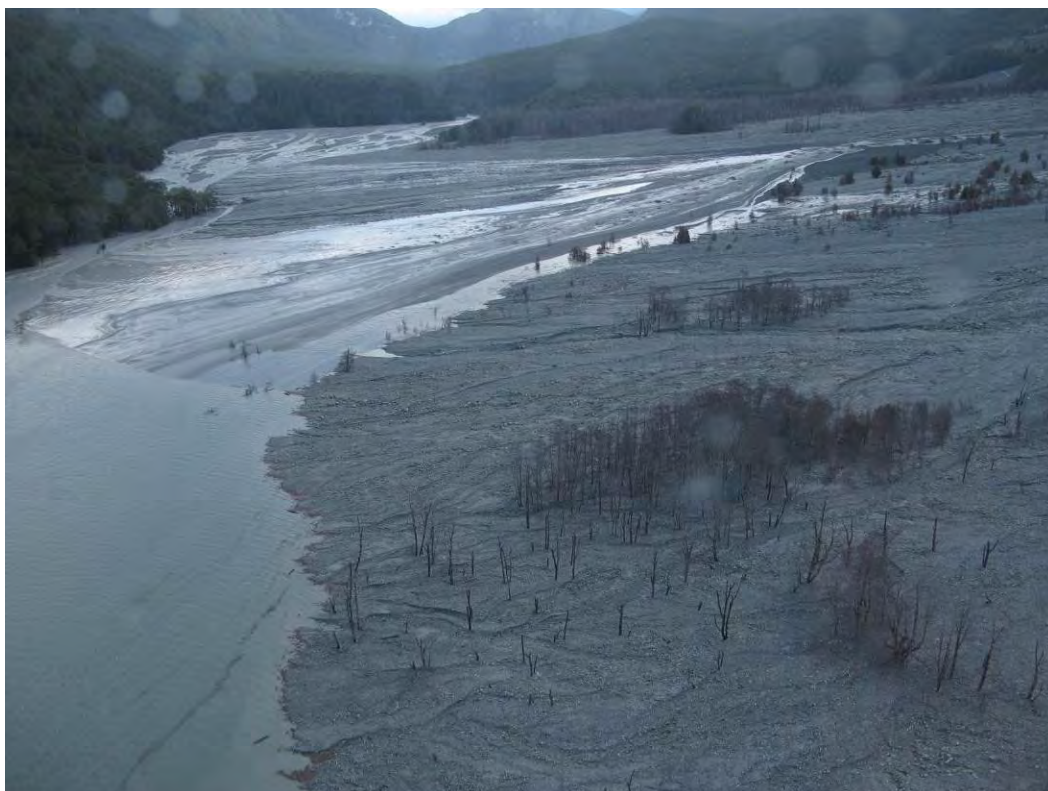
Figure A19 Aerial oblique view (to south) of the toe of Te Koroka/Slip Stream fan and dam crest (Photo: S. C. Cox, 5 January 2014).

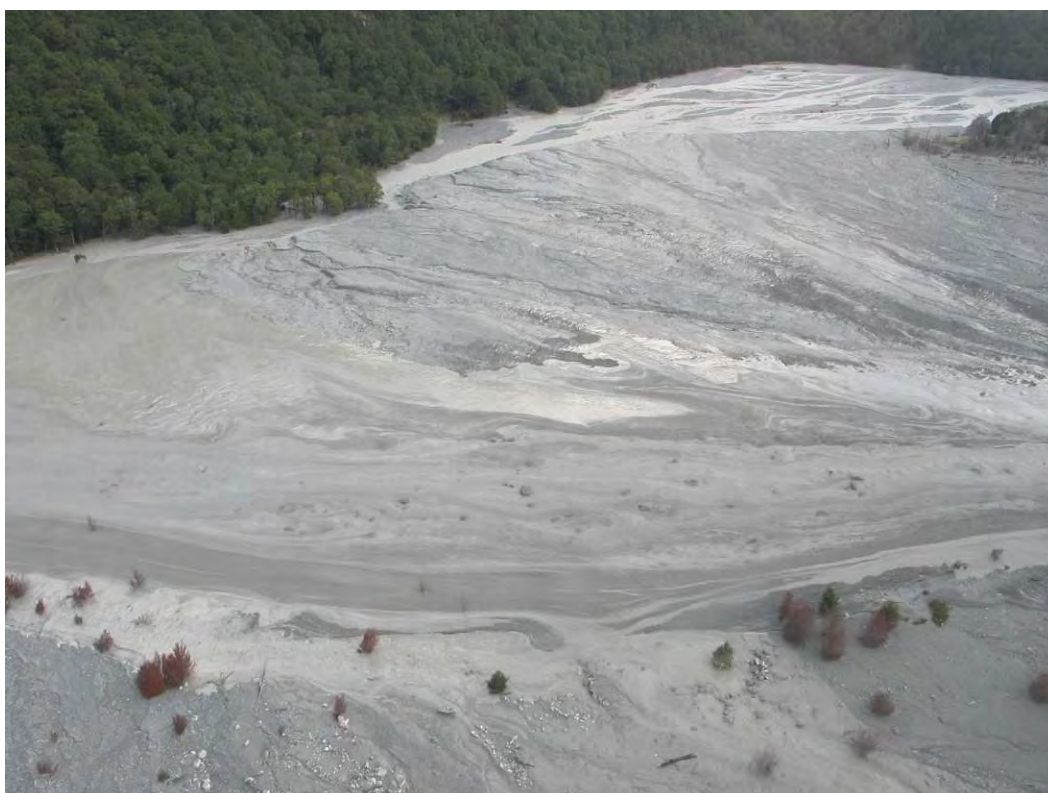
Figure A20 Aerial oblique view (to south) of the toe of Te Koroka/Slip Stream fan and braided Dart River (Photo: S. C. Cox, 6 January 2014).

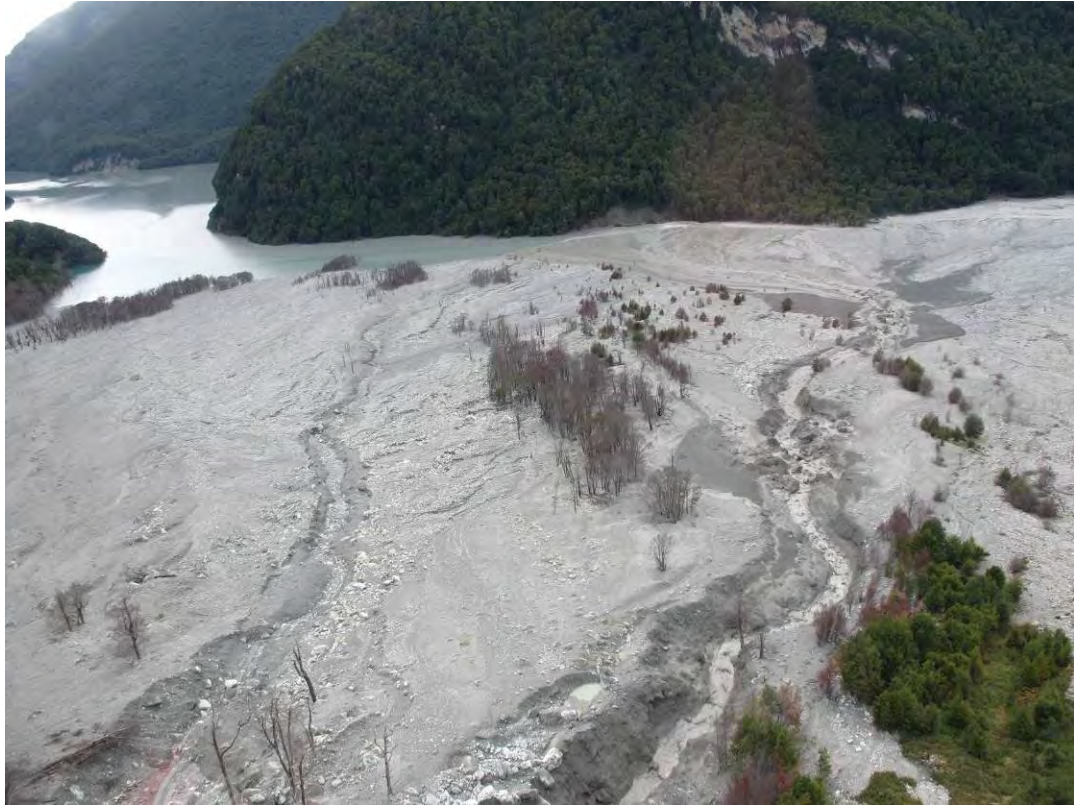
Figure A25 Aerial oblique view (to east) of the toe of Te Koroka/Slip Stream fan and dam crest on Dart River (Photo: S. C. Cox, 6 January 2014).

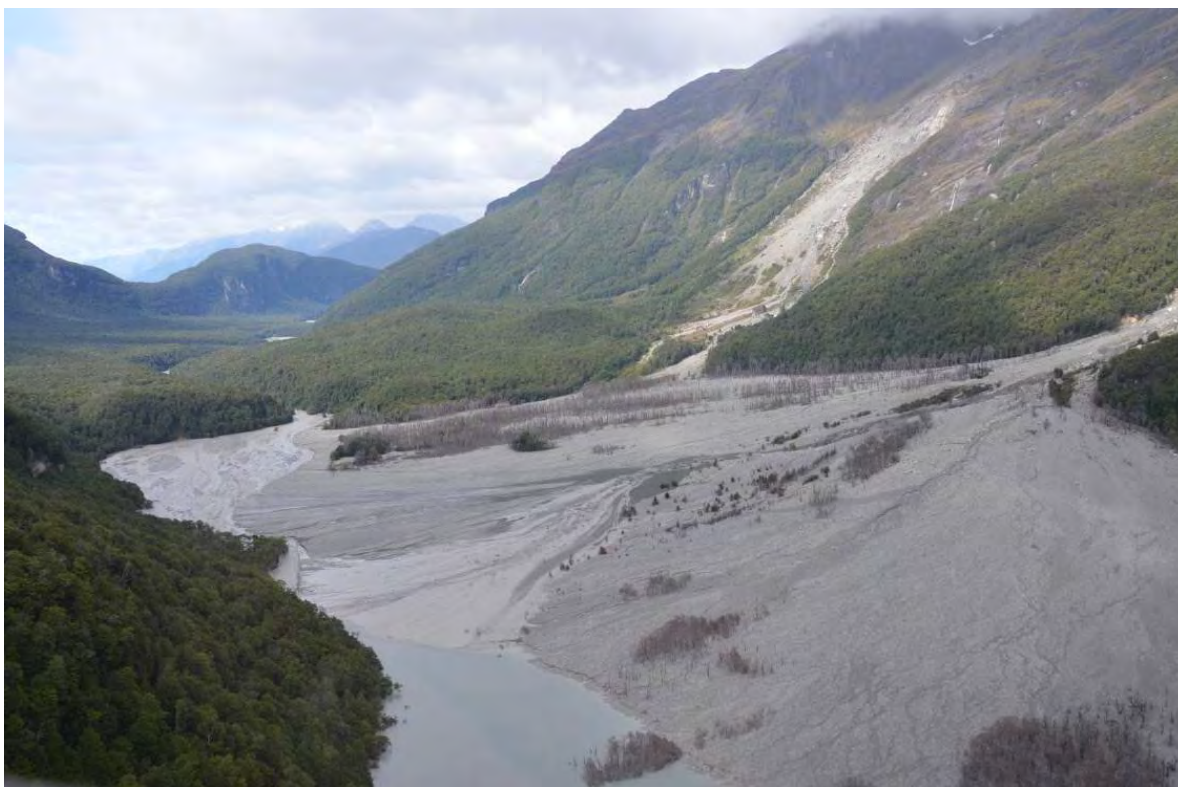
Figure A27 Aerial oblique view to south of the Te Koroka/Slip Stream fan. The landslide in the right background is often mistaken for Te Horo (Photo: M. J. McSaveney, 6 January 2014).

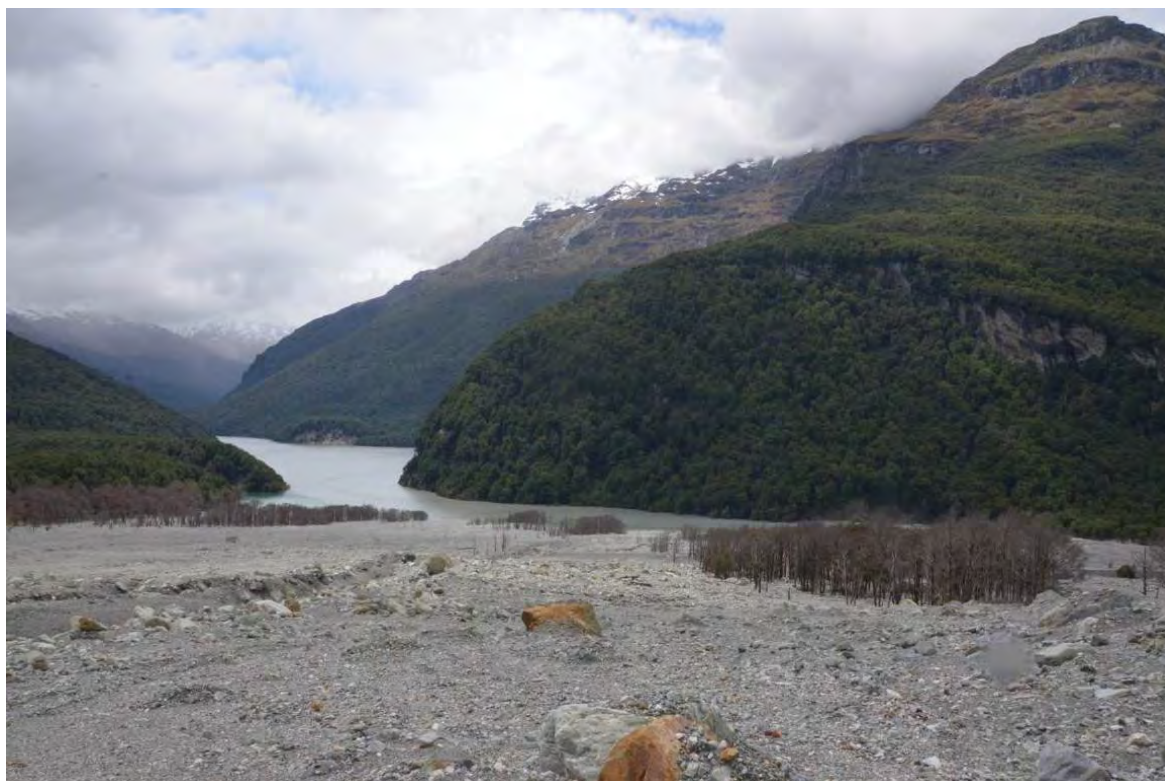
Figure A28 View to north of the Te Koroka/Slip Stream fan and lake. This area of the fan was active in January 2013 (Photo: M. J. McSaveney, 6 January 2014).

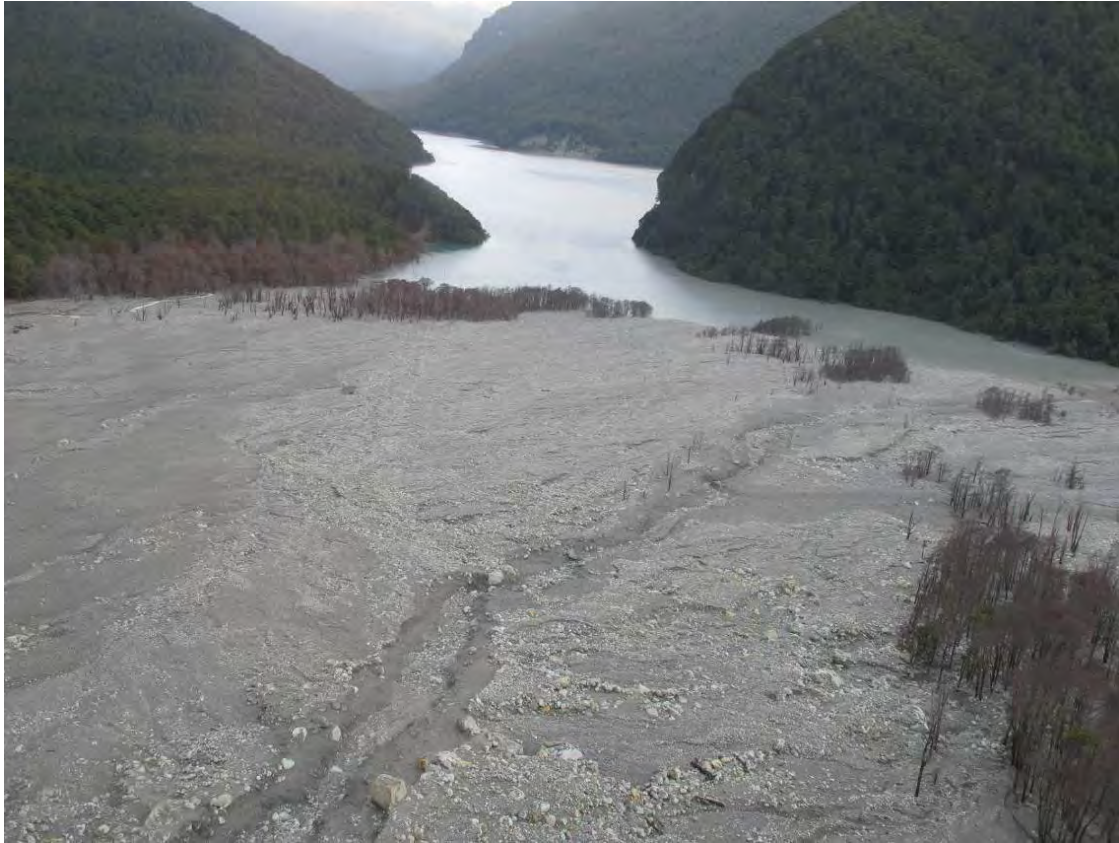
Figure A29 Aerial oblique view (to north) of the Te Koroka/Slip Stream fan and lake. This area of the fan was active in January 2013 (Photo: S. C. Cox, 5 January 2014).

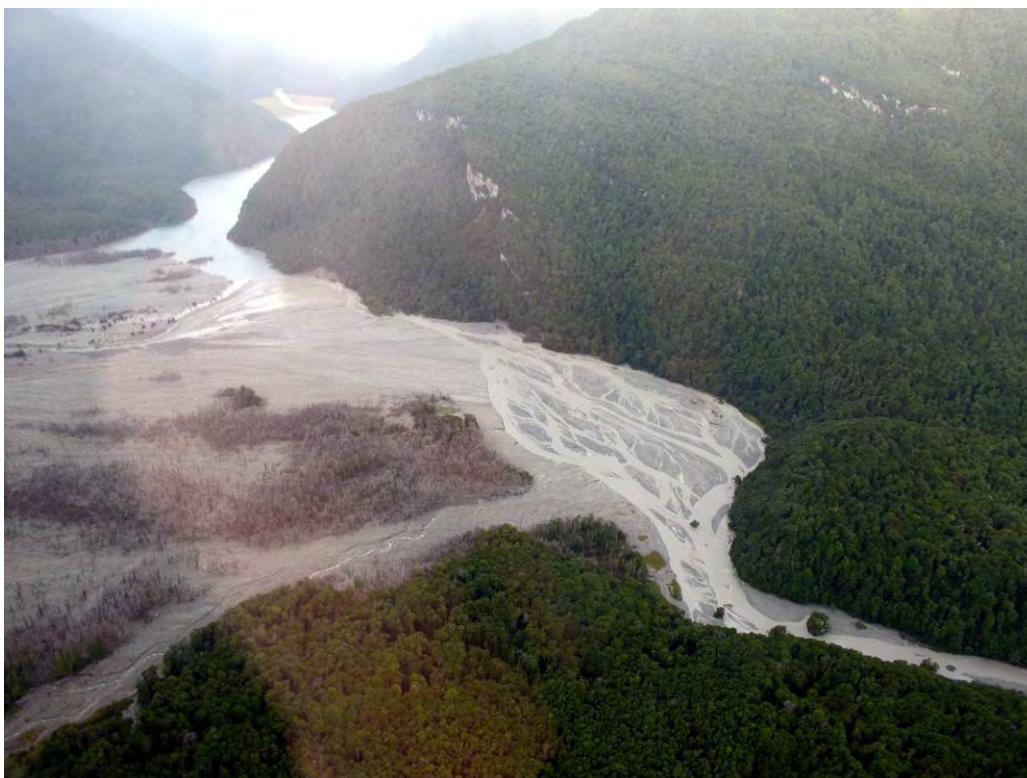
Figure A31 Aerial oblique view (to north) of the Te Koroka/Slip Stream fan and dammed Dart River (Photo: S. C. Cox, 6 January 2014).

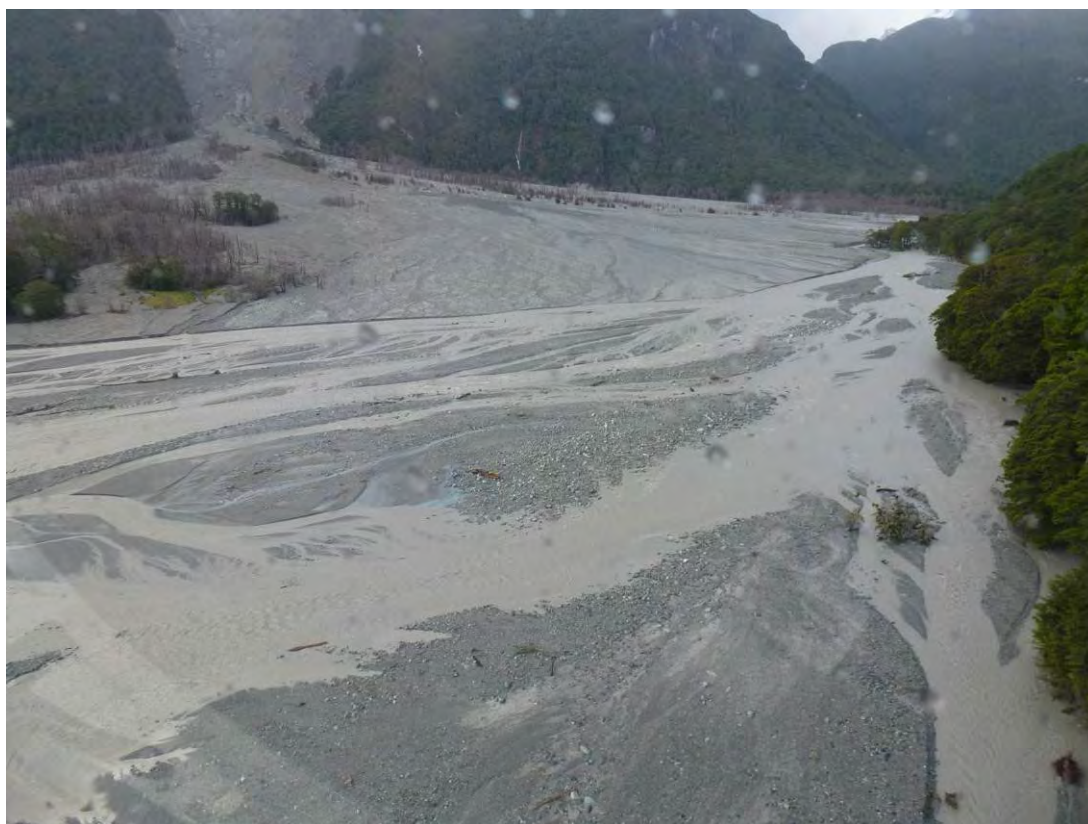
Figure A32 Aerial oblique view to north of the Te Koroka/Slip Stream fan and braided Dart River channel downstream of the dam (Photo: M. S. Rattenbury, 5 January 2014).

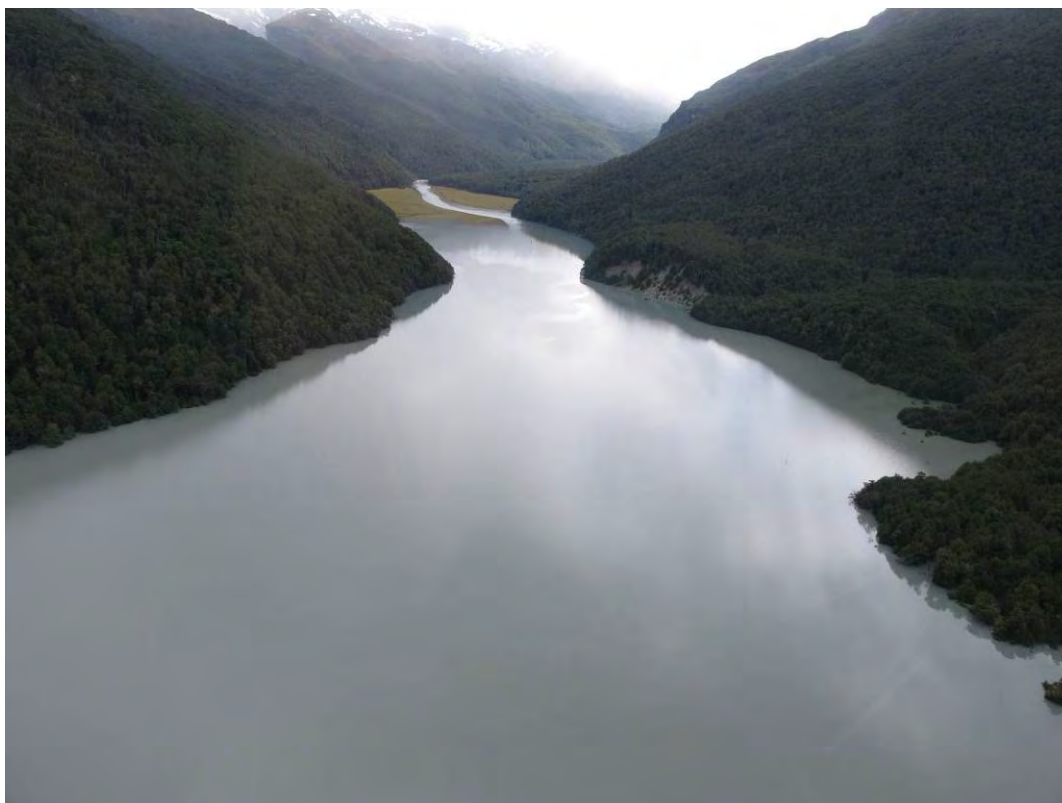
Figure A33 Aerial oblique view (to north) of the lake on Dredge Flat (Photo: S. C. Cox, 6 January 2014).

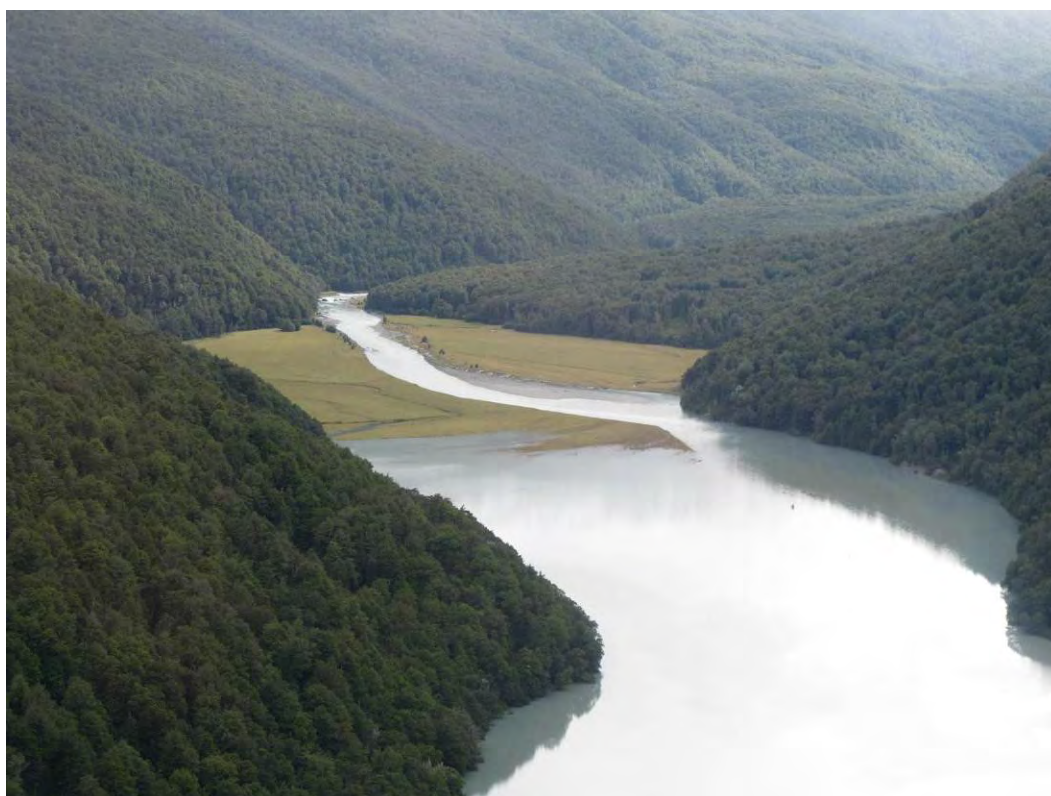
Figure A34 Aerial oblique view (to north) of the head of the lake on Dredge Flat (Photo: S. C. Cox, 6 January 2014).

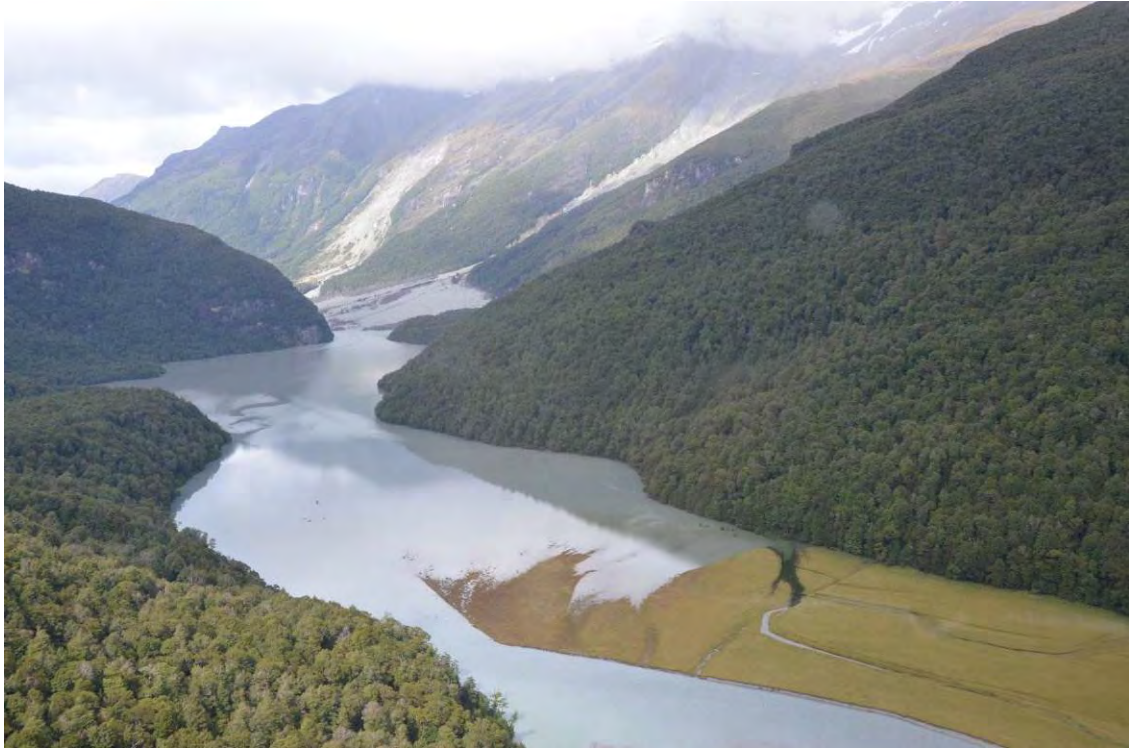
Figure A35 Aerial oblique view to south of the new lake on Dredge Flat. The Te Koroka/Slip Stream fan is in the background (Photo: M. J. McSaveney, 6 January 2014).
